**STATE OF HAWAII**  
**DEPARTMENT OF LAND AND NATURAL RESOURCES**  
**COMMISSION ON WATER RESOURCE MANAGEMENT**  
 Stream Protection and Management Branch

**FIELD INVESTIGATION REPORT**  
**FI2009021005 (East Maui, Waiokamilo Stream)**

<b>Date of Field Investigation:</b>	February 10, 2009	<b>Time (24-hour):</b>	1400 - 1600
<b>CWRM Staff:</b>	Ed Sakoda, Dean Uyeno, Ronnie Torres, and Chui Ling Cheng		
<b>Individuals Present:</b>	Isaac Kanoa, Gladys Kanoa		
<b>Hydrologic Unit:</b>	Piinaau (6053), Waiokamilo (6055)		
<b>Stream Name:</b>	Piinaau Stream, Palauhulu Stream, Waiokamilo Stream

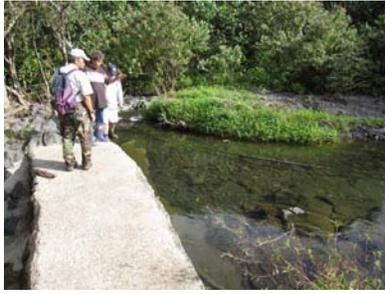
**20090210069.jpg**

<b>File Name:</b>	<b>Brief Description:</b>
20090210069	Dam 3 on Waiokamilo Stream.
20090210071	Waiokamilo Stream upstream of Dam 3.
20090210072	USGS gaging station gage pool at dam 3 on Waiokamilo Stream.
20090210073	Losing section upstream from Dam 3 on Waiokamilo Stream.
20090210074	Where the stream leaks into the losing section upstream from Dam 3 on Waiokamilo Stream.
20090210083	Waiokamilo Stream upstream of the losing section upstream from Dam 3 on Waiokamilo Stream.
20090210085	Large pond about 400 feet upstream of Dam 3 on Waiokamilo Stream.
20090210090	Location where the large pond (see image 2009021085) flows into two branches of Waiokamilo Stream.
20090210092	Location where the large pond (see image 2009021085) flows into two branches of Waiokamilo Stream.

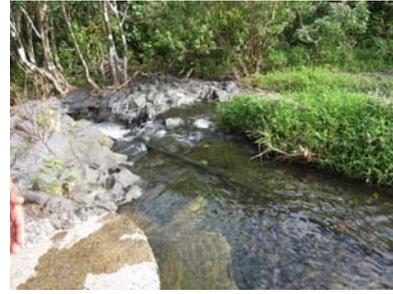
**20090210072.jpg**

Thereafter, Gladys Kanoa and staff visited Dam 3 on Waiokamilo Stream. Compared to the conditions observed during last year's field visits, the stream channel at the downstream end of the USGS gage pool at Dam 3 was observed to be wider during this field visit. This could be the result of high flows from heavy rains that occurred throughout the months of November to January.

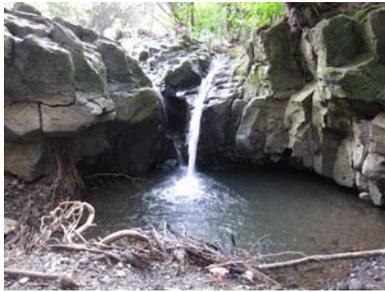
**20090210073.jpg**

From Dam 3, Gladys Kanoa and staff hiked upstream to a losing section where water from Waiokamilo Stream flows into a pond and disappears underground. It is unknown where that water returns to the surface, if at all. Originally, staff planned to measure the amount of streamflow gained from blocking the flow into this losing section by creating a small temporary dam upstream. However, staff discovered another location where the stream leaked quite a large amount of flow into this losing section (see image 20090210074). This leak was not observed during the previous field visits. Due to the multiple leakages observed, staff was unable to measure the amount of flow gained from diverting water away from the losing section upstream from Dam 3.

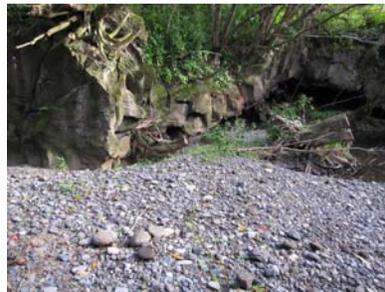
**20090210090.jpg**

Staff continued to hike upstream on Waiokamilo Stream for about 400 feet to a large pond. According to Gladys Kanoa, water from this pond used to split into two branches. Facing mauka, the water from the pond currently flows to the right branch. The left branch was completely blocked by gravel, trees, and other debris (see images 20090210090 and 20090210092).
