STAFF SUBMITTAL

February 18, 2020
Honolulu, Hawai'i

Issuance of Written Notice of Violation for Enforcement Against Waste, and Recommendation to Impose Fines Against Wailuku Water Company, LLC, Owner/Operator of Waihe'e Ditch, In Response to HRS §174C-13, Citizen Complaint filed by Hui o Nā Wai 'Ehā Alleging Waste by Wailuku Water Company at Pale'a'ahu Gulch, Nā Wai 'Ehā Surface Water Management Area, Maui, TMK No. (2) 3-6-004:003

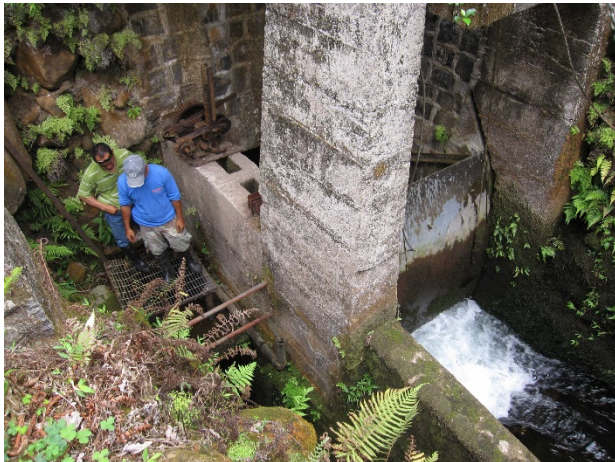
In this matter, the Commission must also consider the condition of the ditch system and the ability of WWC to adequately control intake amounts and monitor ditch flows to make system adjustments as needed. It is the understanding of Commission staff, through numerous site visits and interactions with Mr. Chumbley, that: 1) the intake gates for Waihe'e Ditch on Waihe'e River were damaged following a 2018 storm event (See Figure 2); and 2) the intake gate for Spreckels Ditch on Waihe'e River is frozen in its current open-position and cannot be adjusted (See Figure 3).

Figure. 2. Control gate at Waihe'e Ditch Intake on Waihe'e River. August 9, 2010.

- c. Repair the intake control gate at the Waihe'e Ditch diversion on Waihe'e River.
 - d. Replace current gaging stations on Waihe'e Ditch and Spreckels Ditch with real-time, continuous gaging stations to improve measurement and monitoring of diverted water amounts from Waihe'e River to improve water system management.

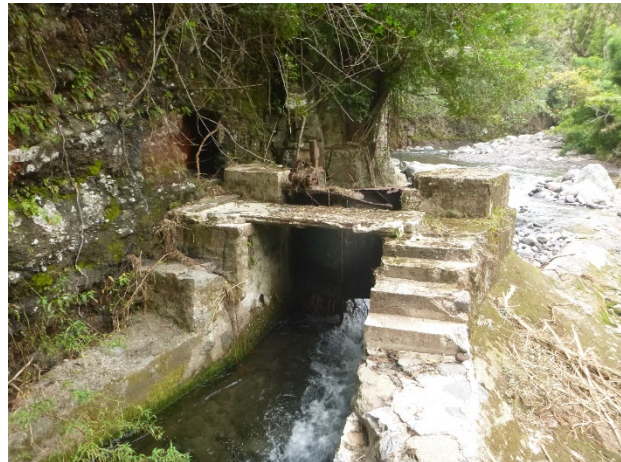
Figure 3. Spreckels Ditch Intake on Waihe'e River. March 5, 2018.

- a. Seal release gate at Pale'a'ahu Gulch to prevent any future dumping events.
 - b. Repair the intake control gate at the Spreckels Ditch diversion on Waihe'e River.

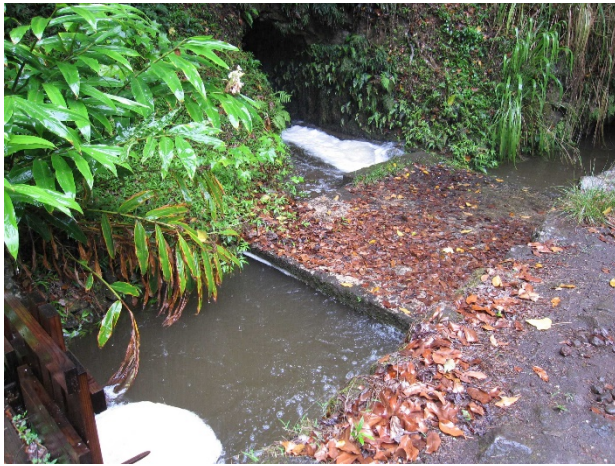
In the normal operation of the system, water can be dropped to Spreckels Ditch (See Figure 4) from Waihe'e Ditch and the Spreckels Ditch flow is controlled immediately thereafter so that water can be returned to the Waihe'e River as needed. The damaged control gate on Waihe'e Ditch results in WWC frequently diverting more water from Waihe'e River than needed, then returning the water to Waihe'e River via a drop ditch from Waihe'e Ditch to Spreckels Ditch and a subsequent control gate and return located on Spreckels Ditch (See Figure 5).

Figure 4. Water from Waihe'e Ditch Drop Ditch entering Spreckels Ditch on Waihe'e River. July 13, 2009.

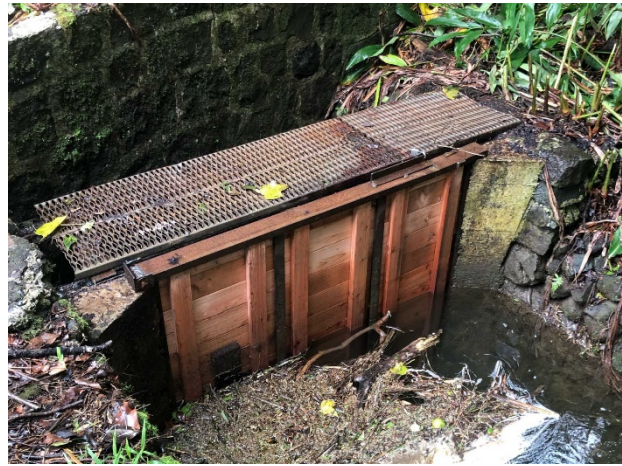
Figure 5. Control gate on Spreckels Ditch allows for water to be returned to Waihe'e River. January 10, 2020.

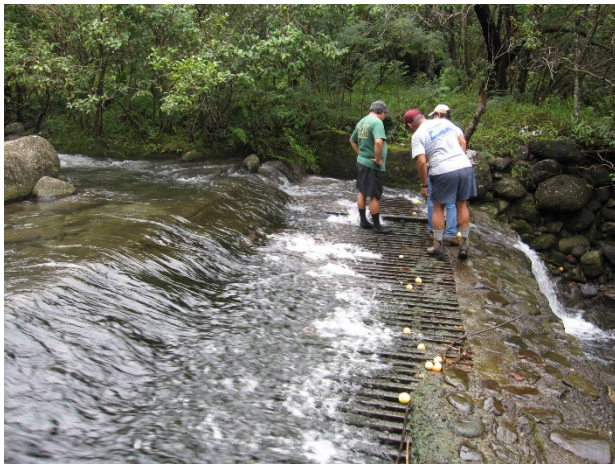
Furthermore, the intake for Waihe'e Ditch on Waihe'e River consists of two separate intake grates (referred to as north and south intakes) across the stream channel (See Figures 6 and 7). Recent Commission staff observations indicate the intakes are partially filled with cobble and sediment and water is bypassing portions of the intakes.

Figure 6. Waihe'e Ditch South Intake on Waihe'e River. November 1, 2011.

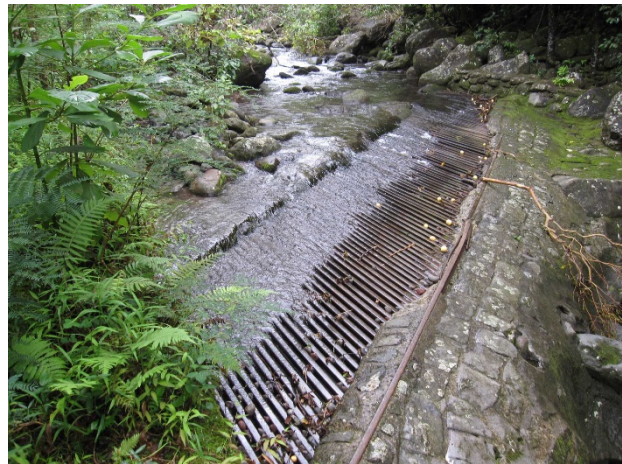
Figure 7. Waihe'e Ditch North Intake on Waihe'e River. November 1, 2011.

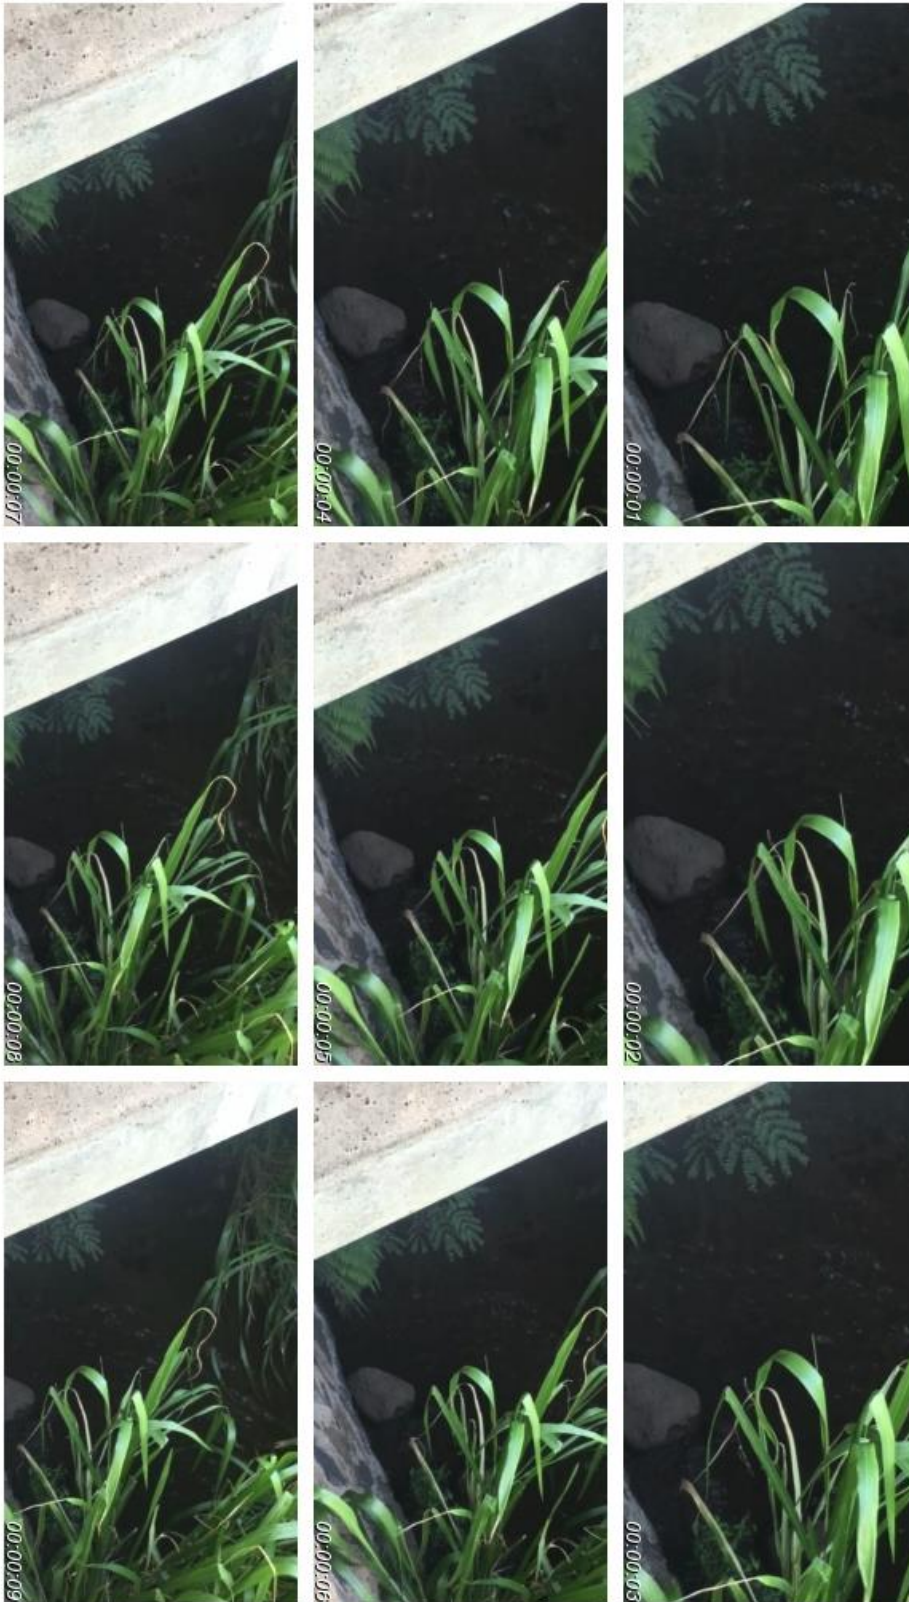
Exhibit 8.1: Thumbnails of 19-second video clip submitted by Hui o Nā Wai 'Ehā of water flowing at Pale'a'ahu Gulch on September 24, 2019.

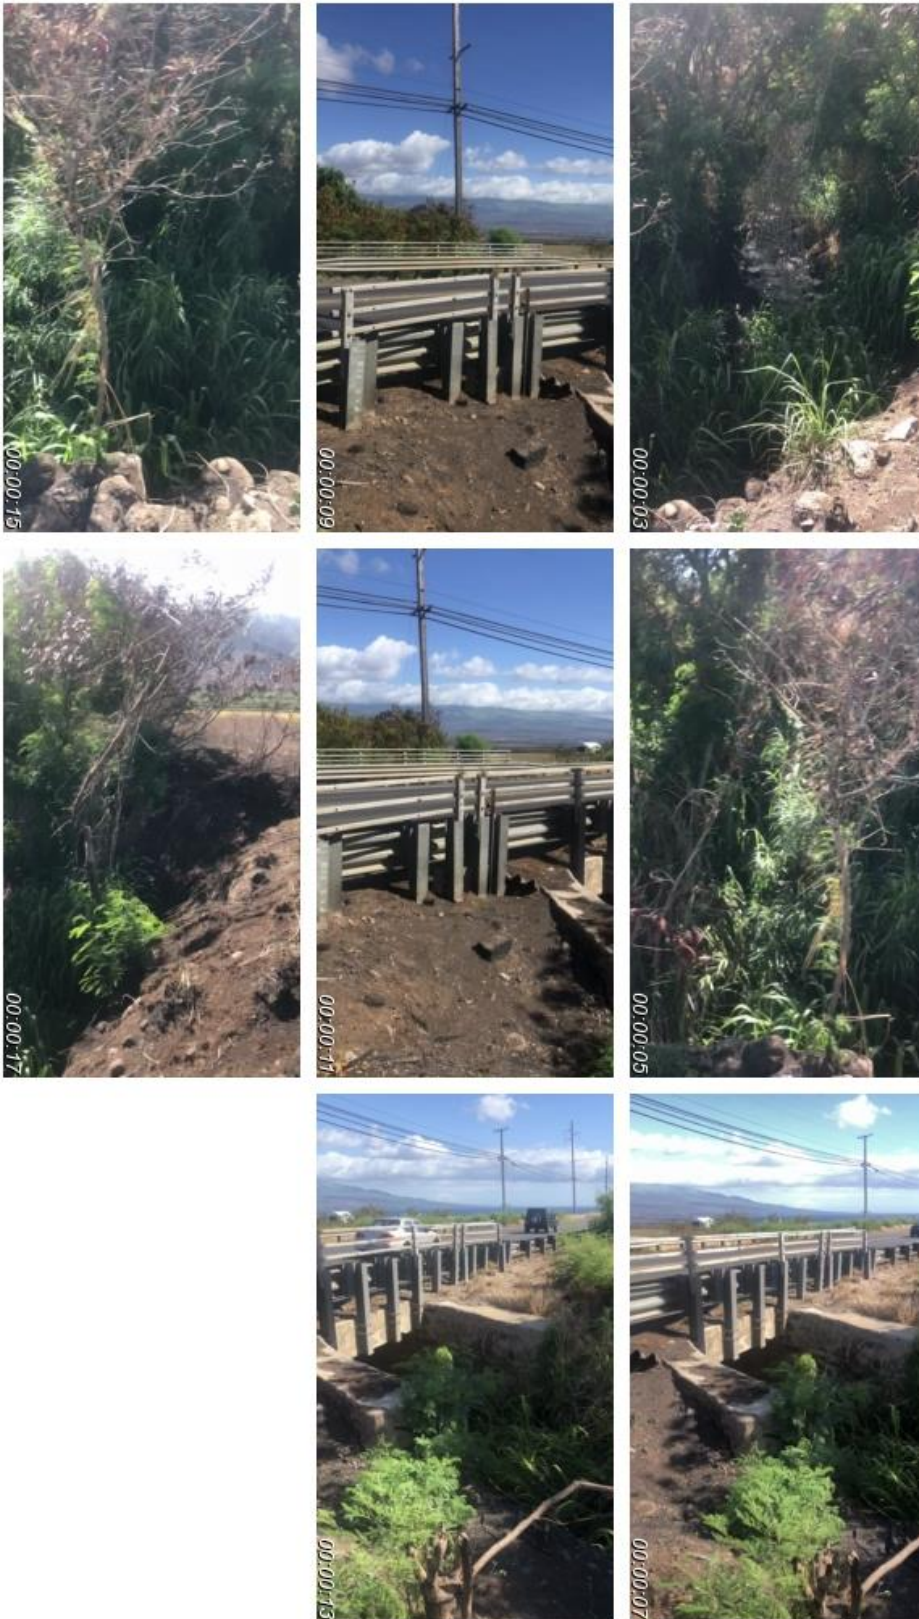
Exhibit 8.2: Thumbnails of 17-second video clip submitted by Hui o Nā Wai 'Ehā of water flowing at Pale'a'ahu Gulch on September 29, 2019.

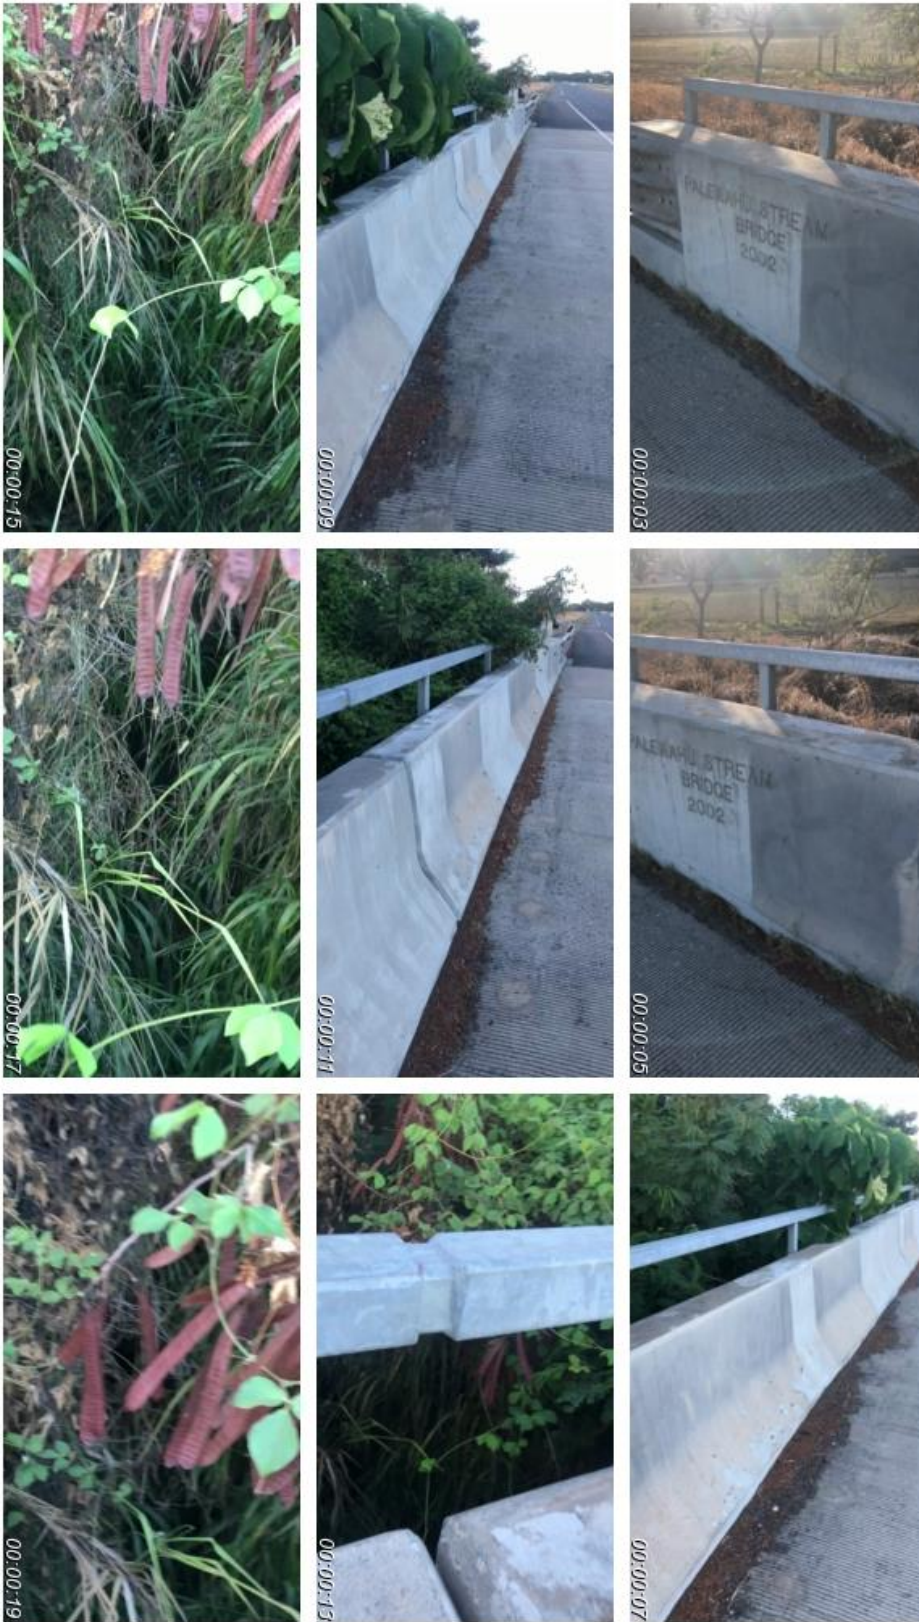
Exhibit 8.3: Thumbnails of 28-second video clip submitted by Hui o Nā Wai 'Ehā of water flowing at Pale'a'ahu Gulch on September 29, 2019.

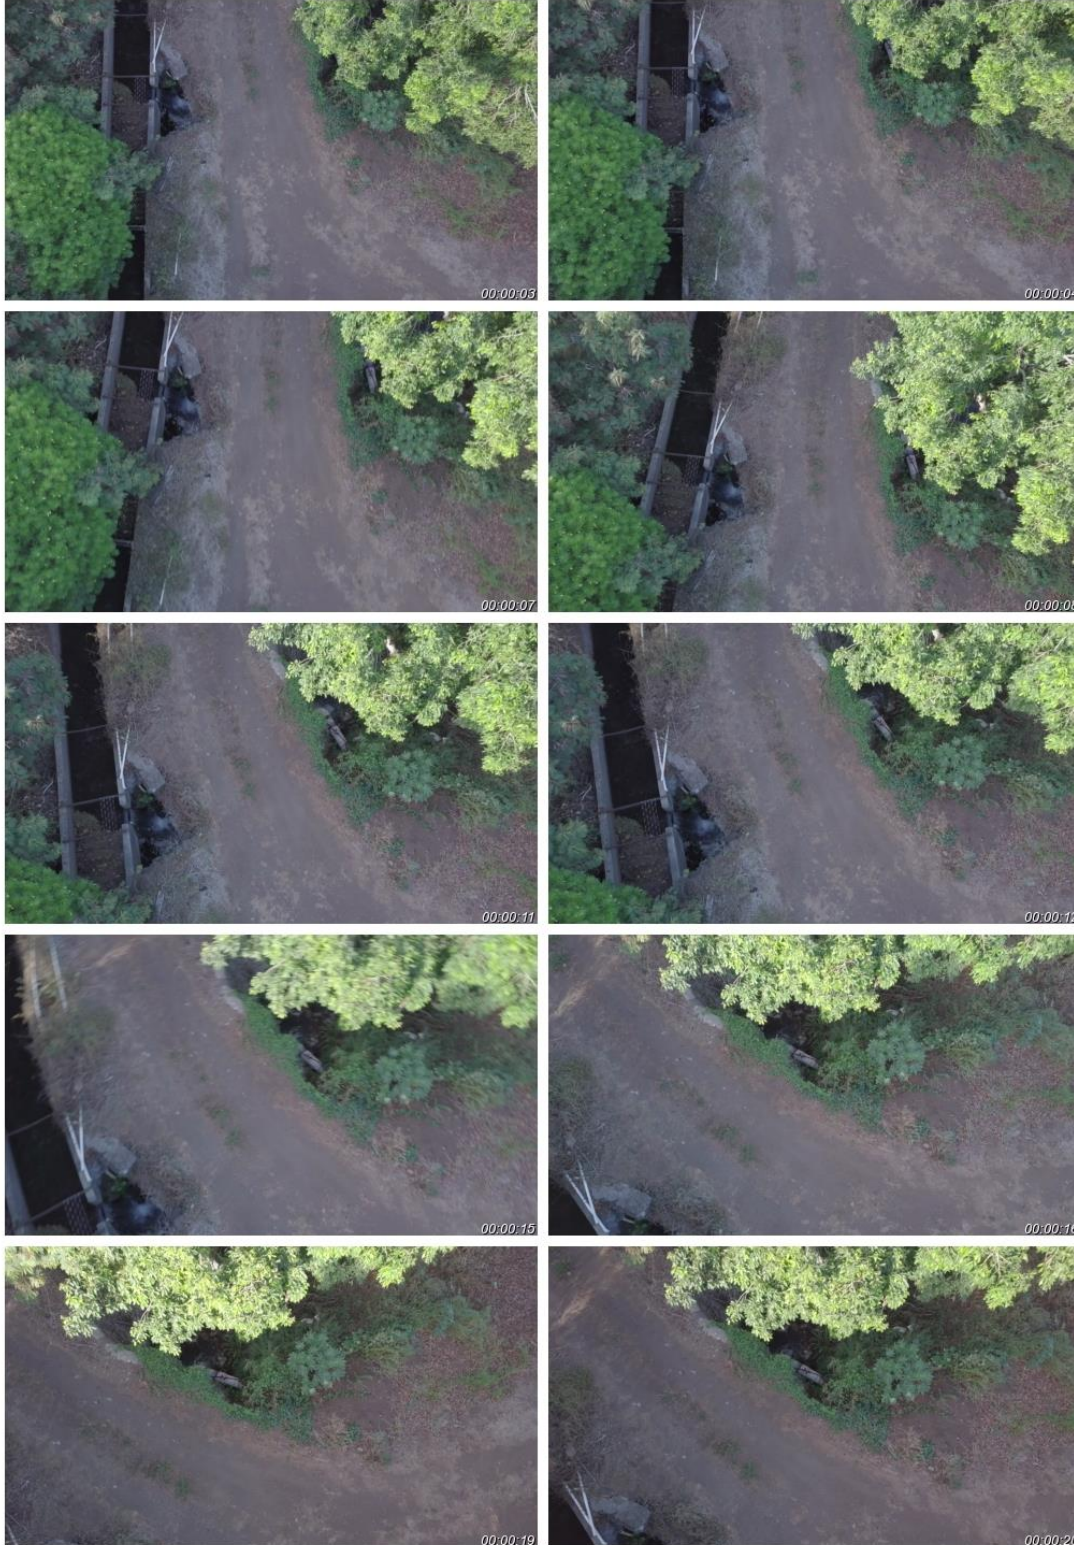
Exhibit 8.4: Thumbnails of 25-second video clip (drone footage) submitted by Hui o Nā Wai 'Ehā of water flowing at Pale'a'ahu Gulch on September 29, 2019.

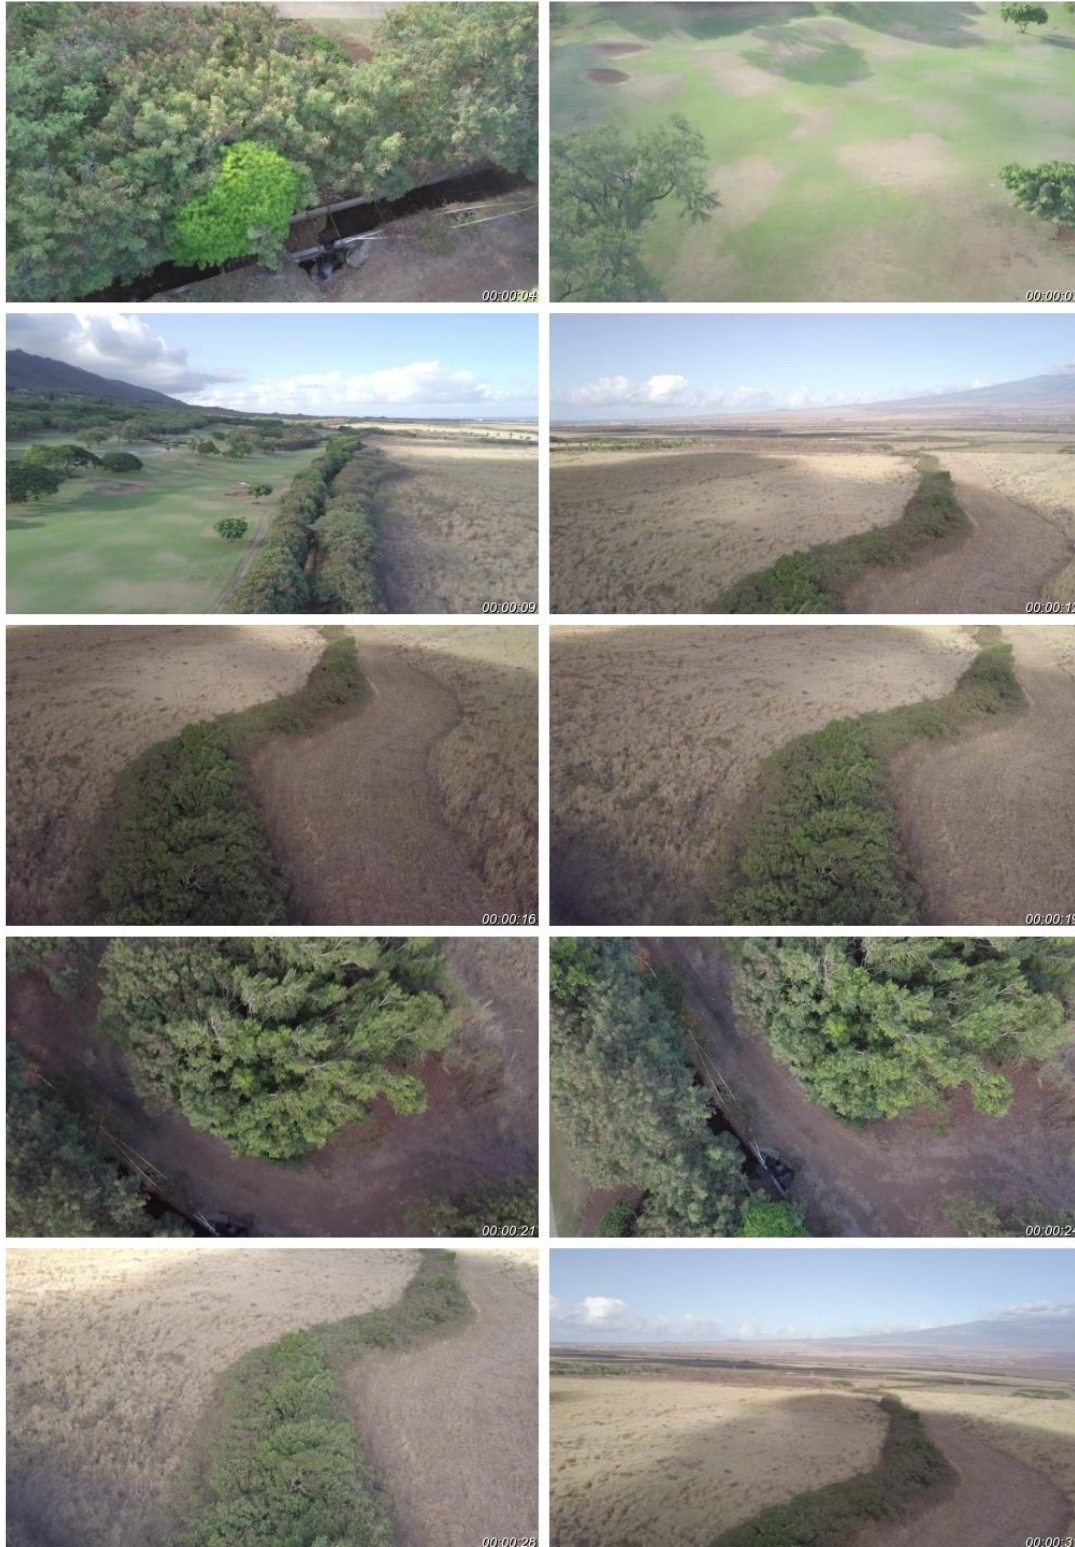
Exhibit 8.5: Thumbnails of 41-second video clip (drone footage) submitted by Hui o Nā Wai 'Ehā of water flowing at Pale'a'ahu Gulch on September 29, 2019.

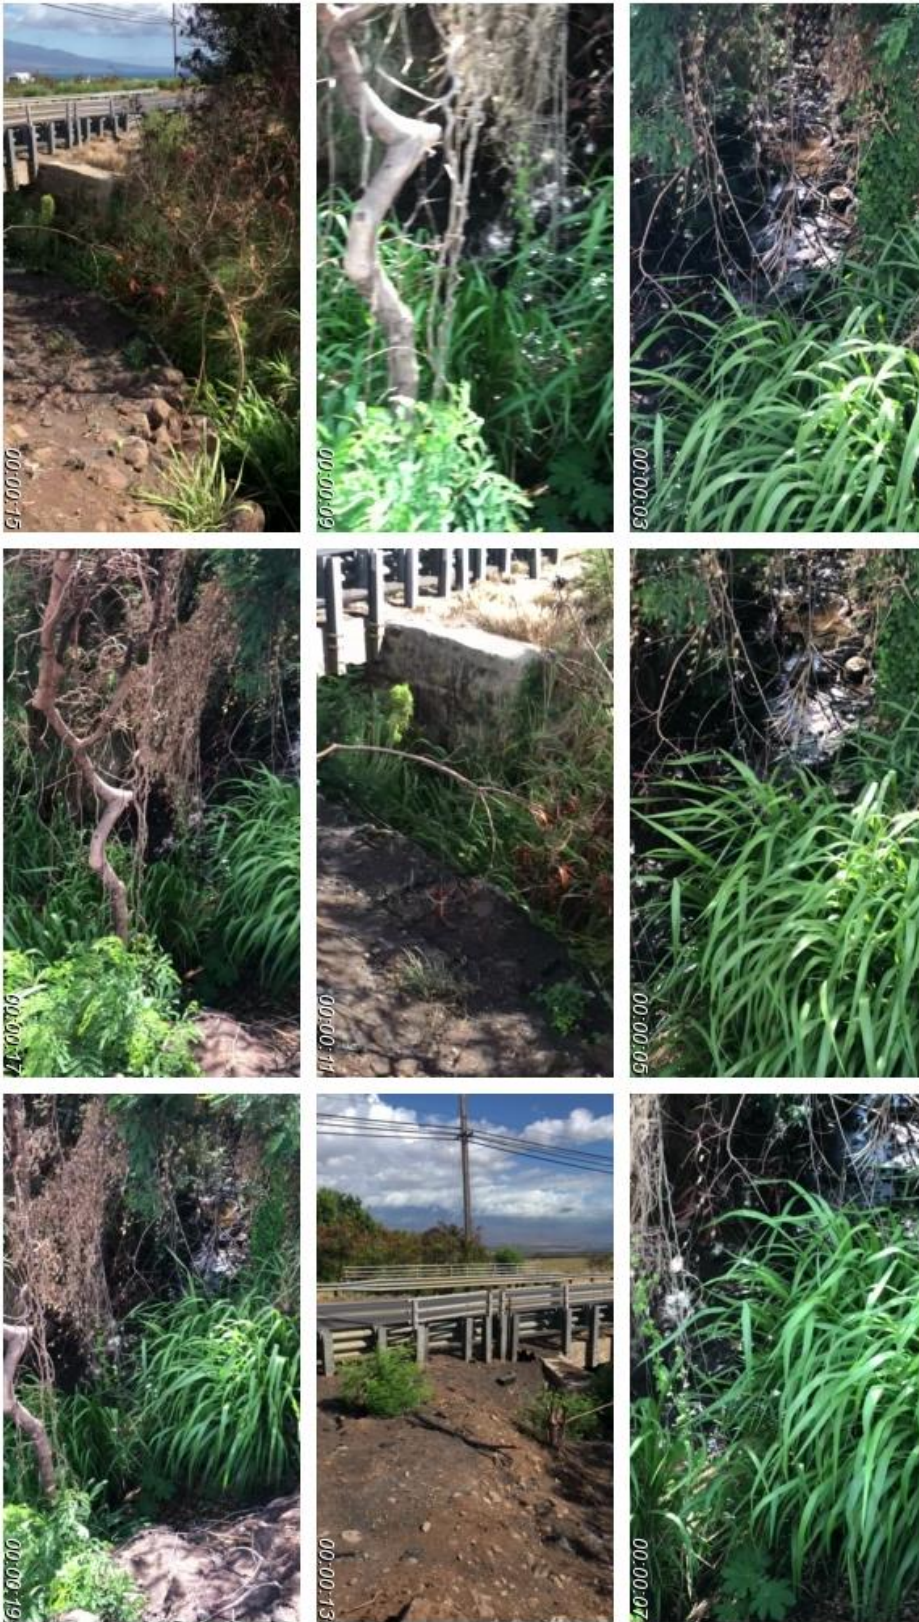
Exhibit 8.6: Thumbnails of 25-second video clip submitted by Hui o Nā Wai 'Ehā of water flowing at Pale'a'ahu Gulch on September 30, 2019.

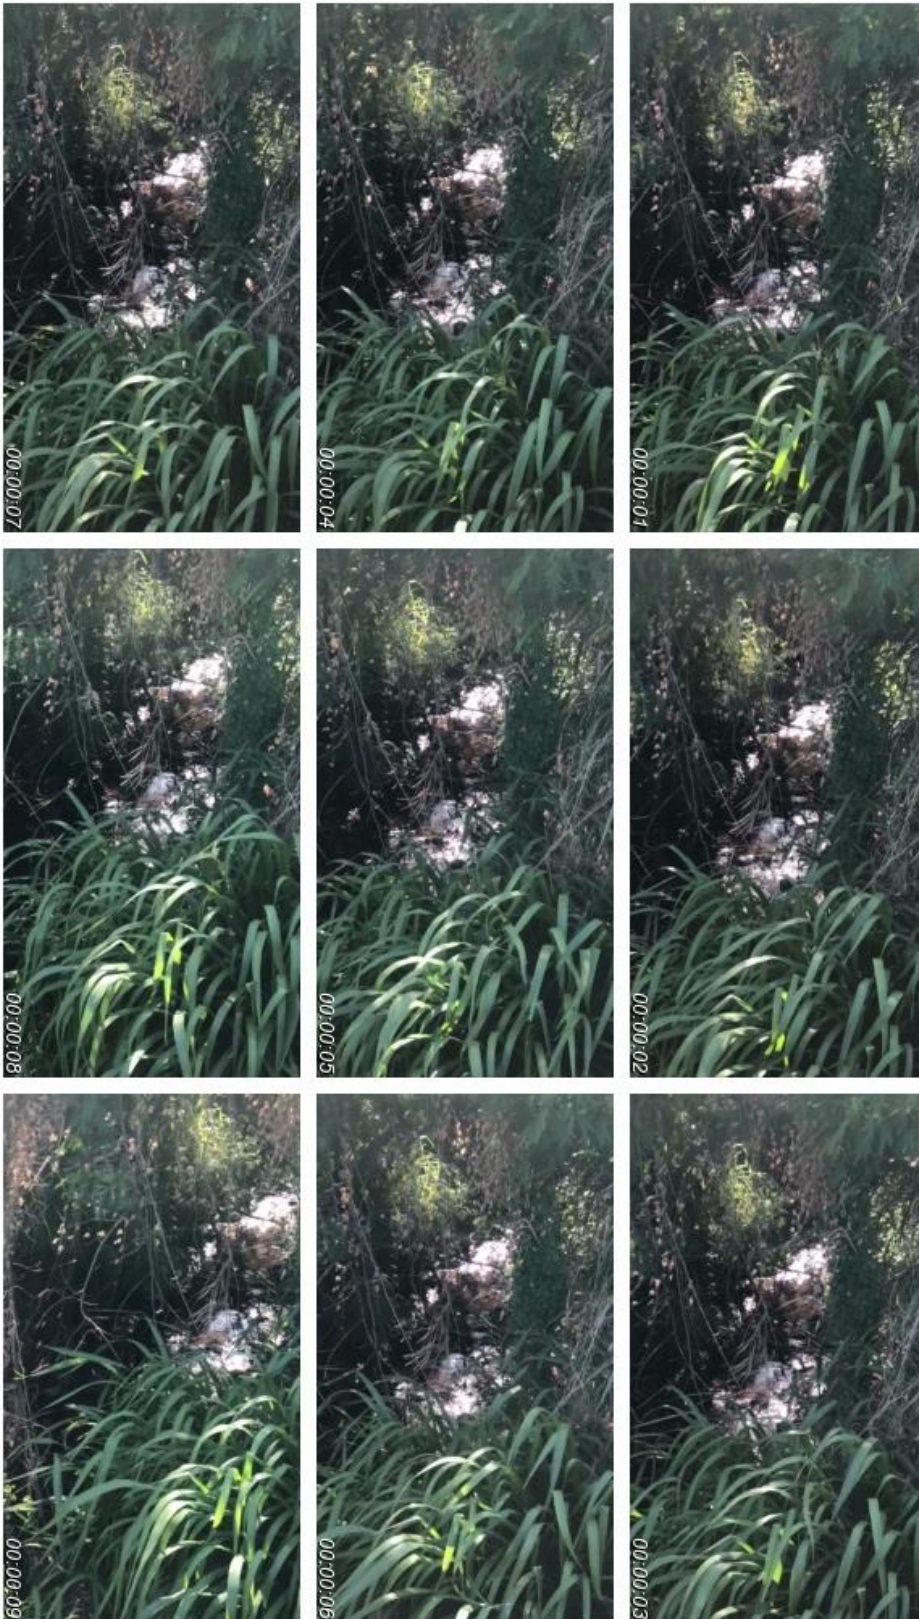
Exhibit 8.7: Thumbnails of 13-second video clip submitted by Hui o Nā Wai 'Ehā of water flowing at Pale'a'ahu Gulch on October 1, 2019.

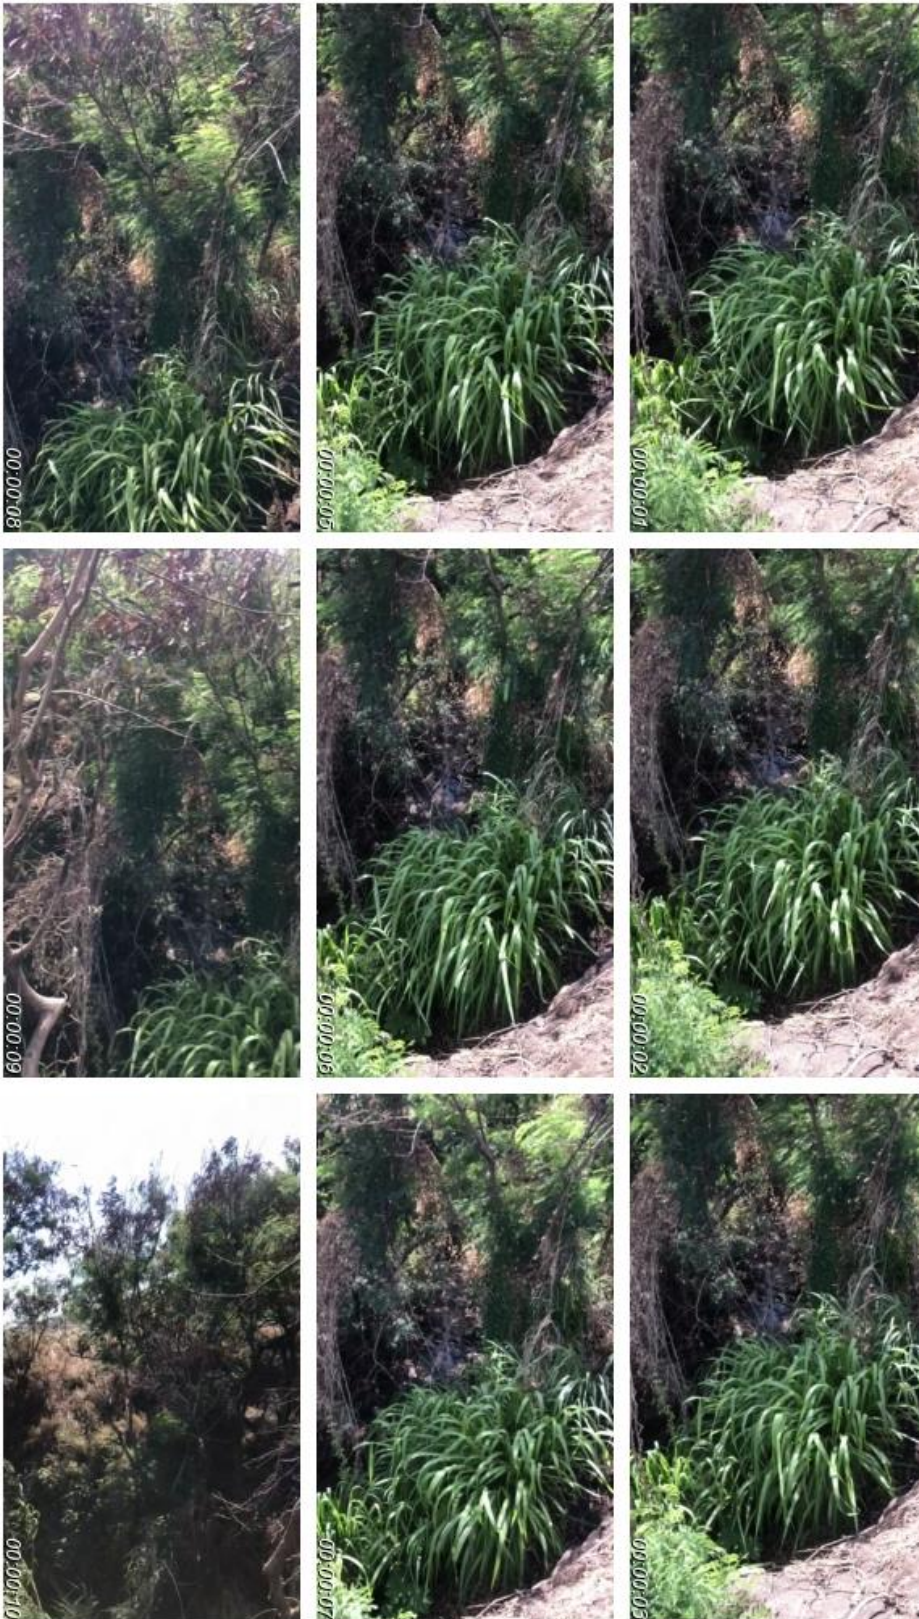
Exhibit 8.8: Thumbnails of 14-second video clip submitted by Hui o Nā Wai 'Ehā of water flowing at Pale'a'ahu Gulch on October 2, 2019.

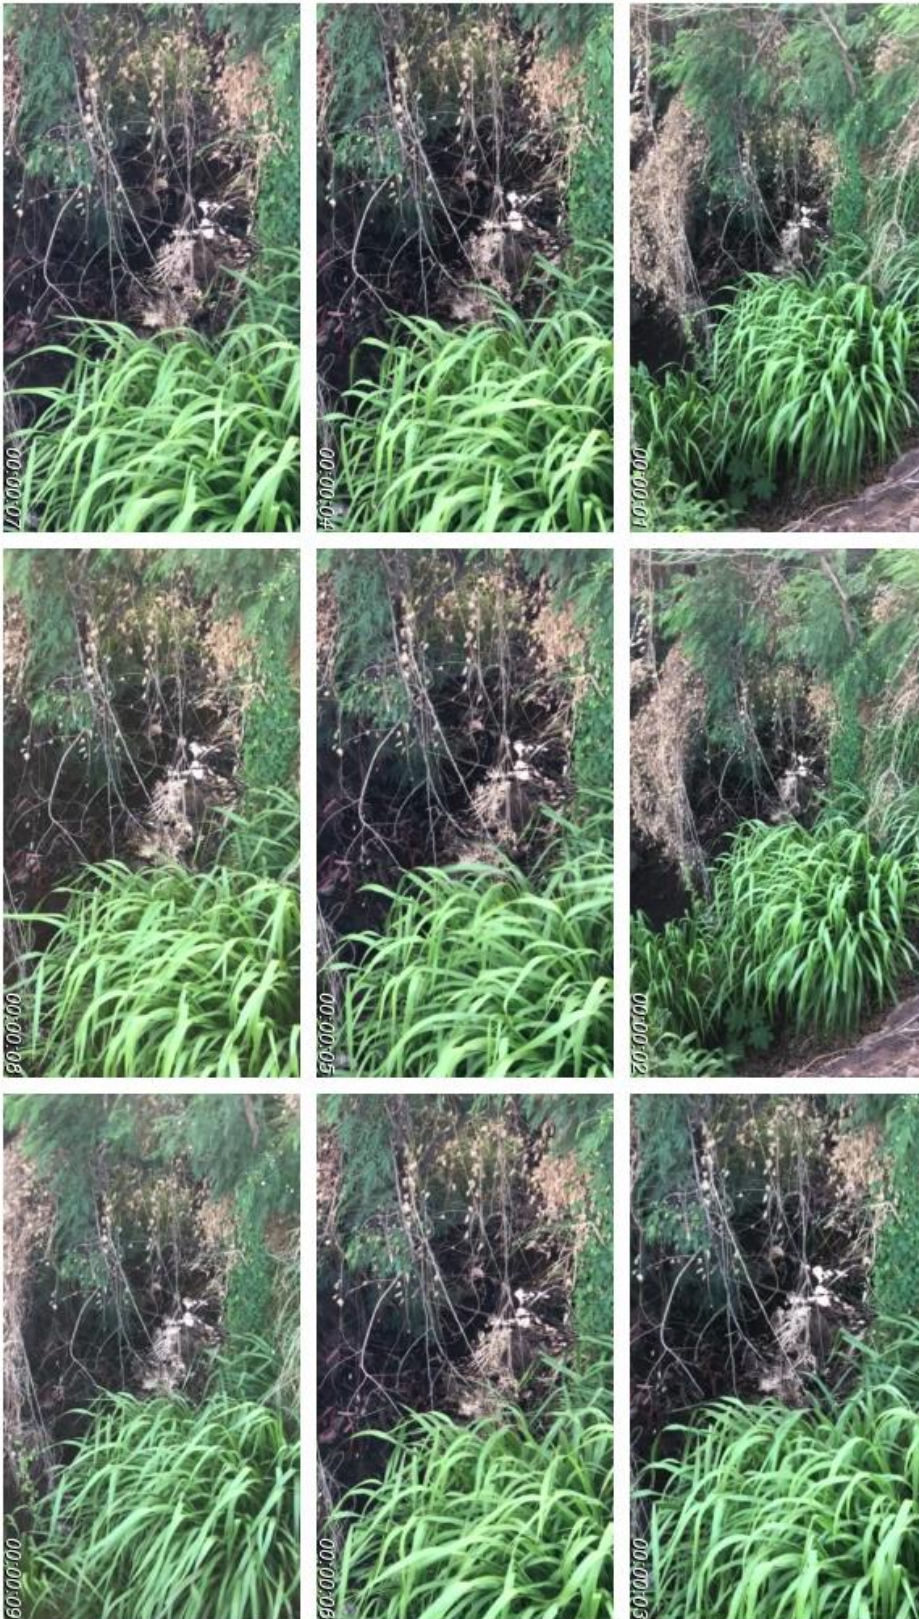
Exhibit 8.9: Thumbnails of 16-second video clip submitted by Hui o Nā Wai 'Ehā of water flowing at Pale'a'ahu Gulch on October 4, 2019.

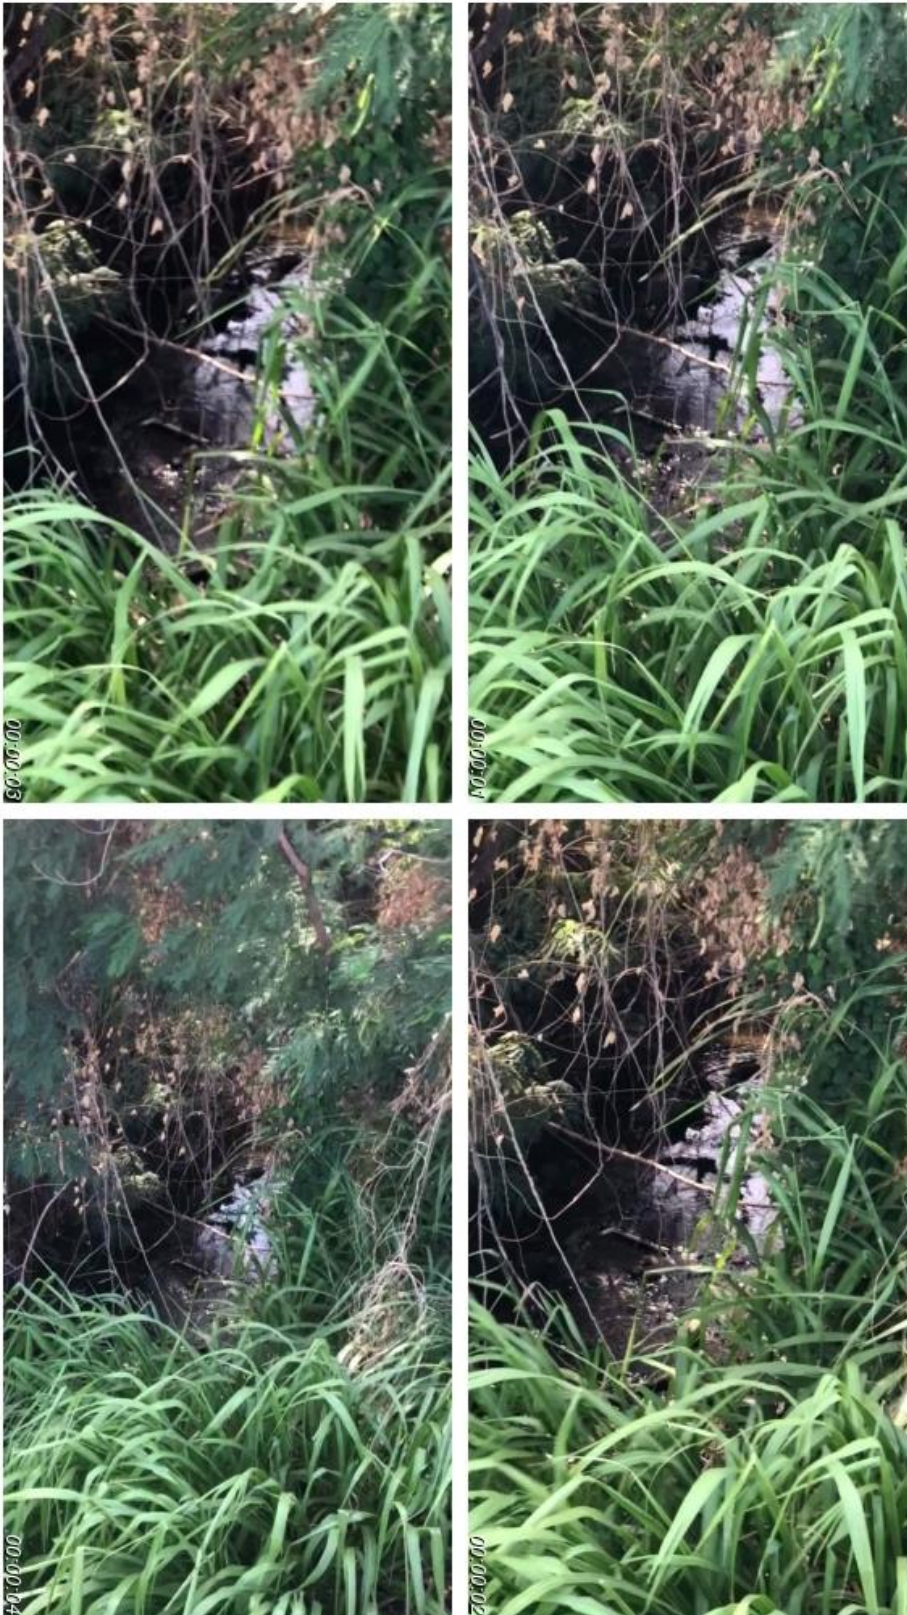
Exhibit 8.10: Thumbnails of 6-second video clip submitted by Hui o Nā Wai 'Ehā of water flowing at Pale'a'ahu Gulch on October 22, 2019.

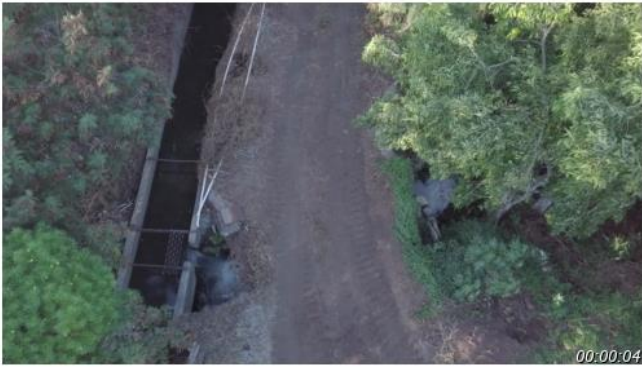
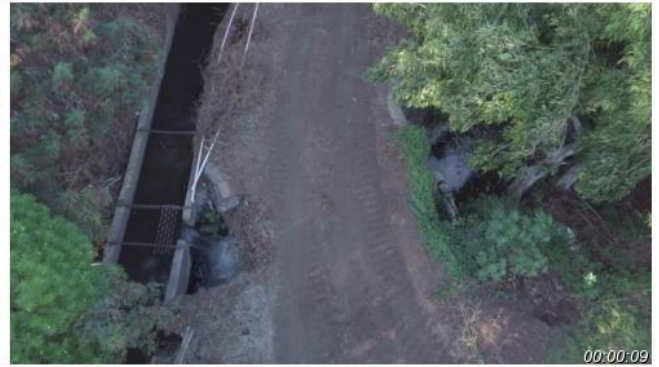
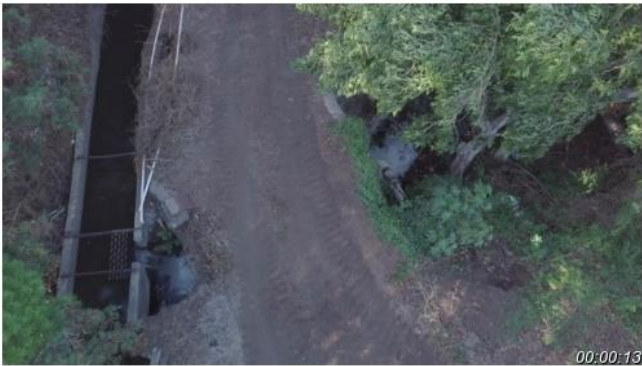
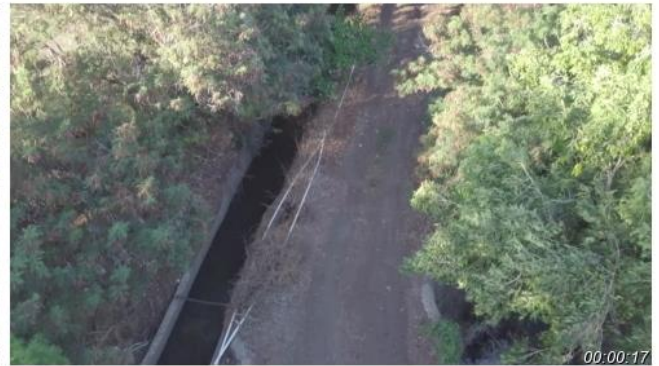
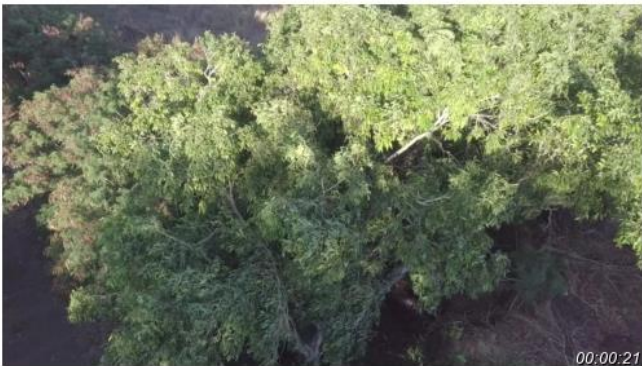
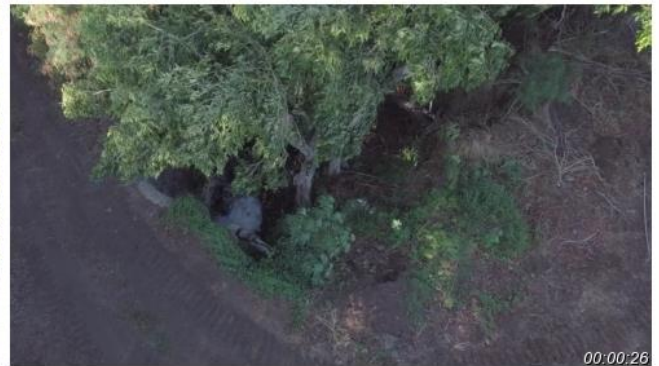
Exhibit 8.11: Thumbnails of 33-second video clip (drone footage) submitted by Hui o Nā Wai 'Ehā of water flowing at Pale'a'ahu Gulch on November 3, 2019.

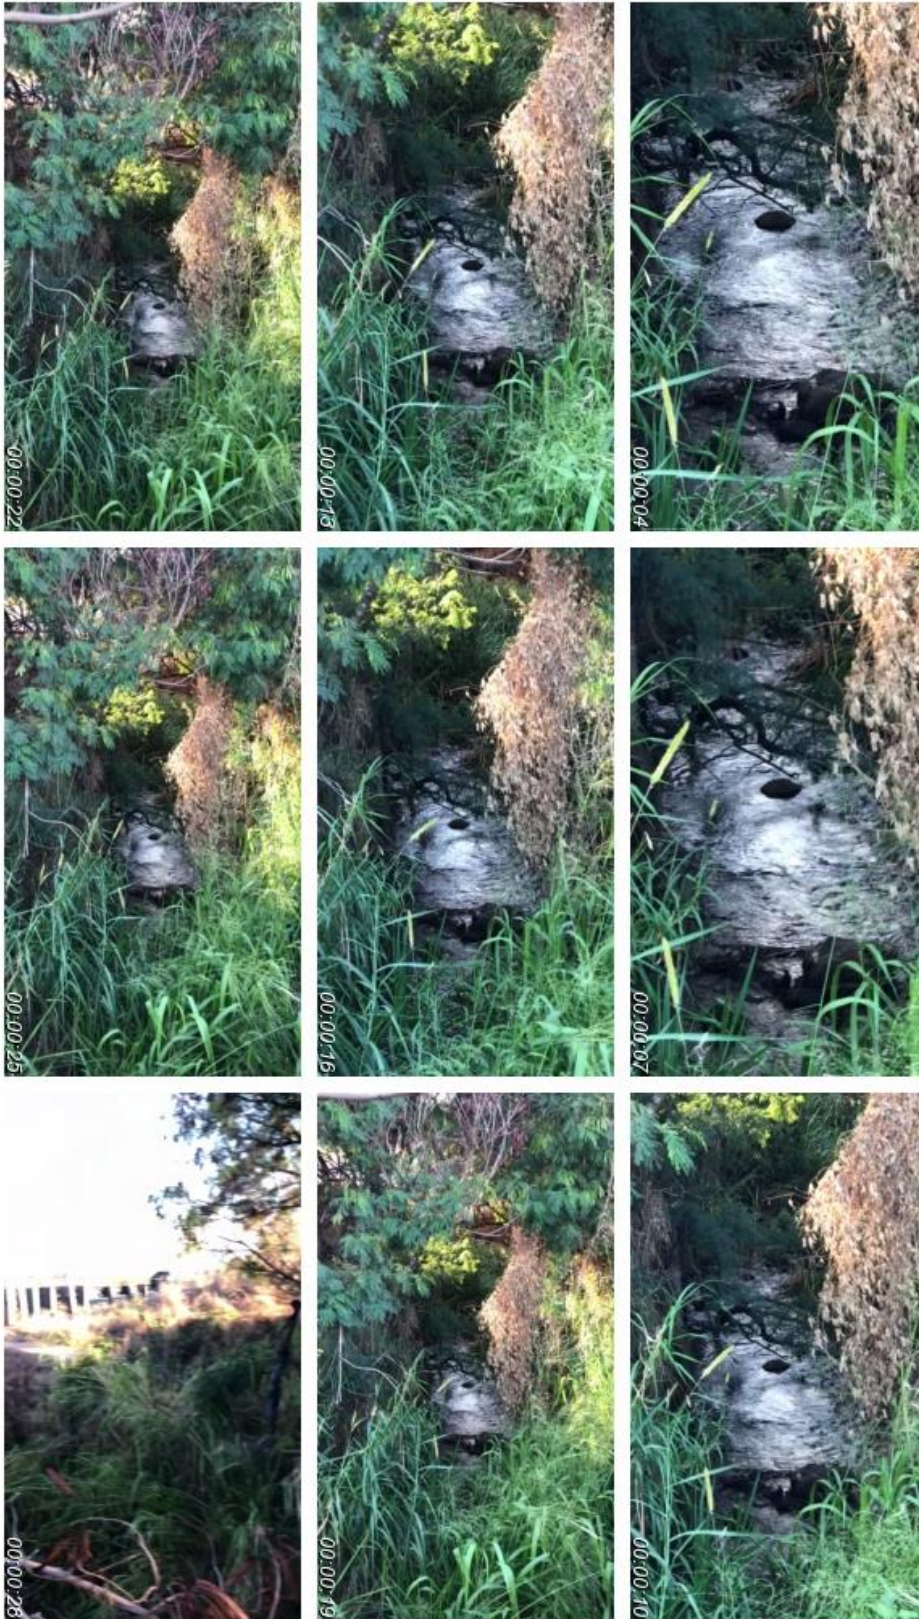
Exhibit 8.12: Thumbnails of 34-second video clip submitted by Hui o Nā Wai 'Ehā of water flowing at Pale'a'ahu Gulch on November 3, 2019.

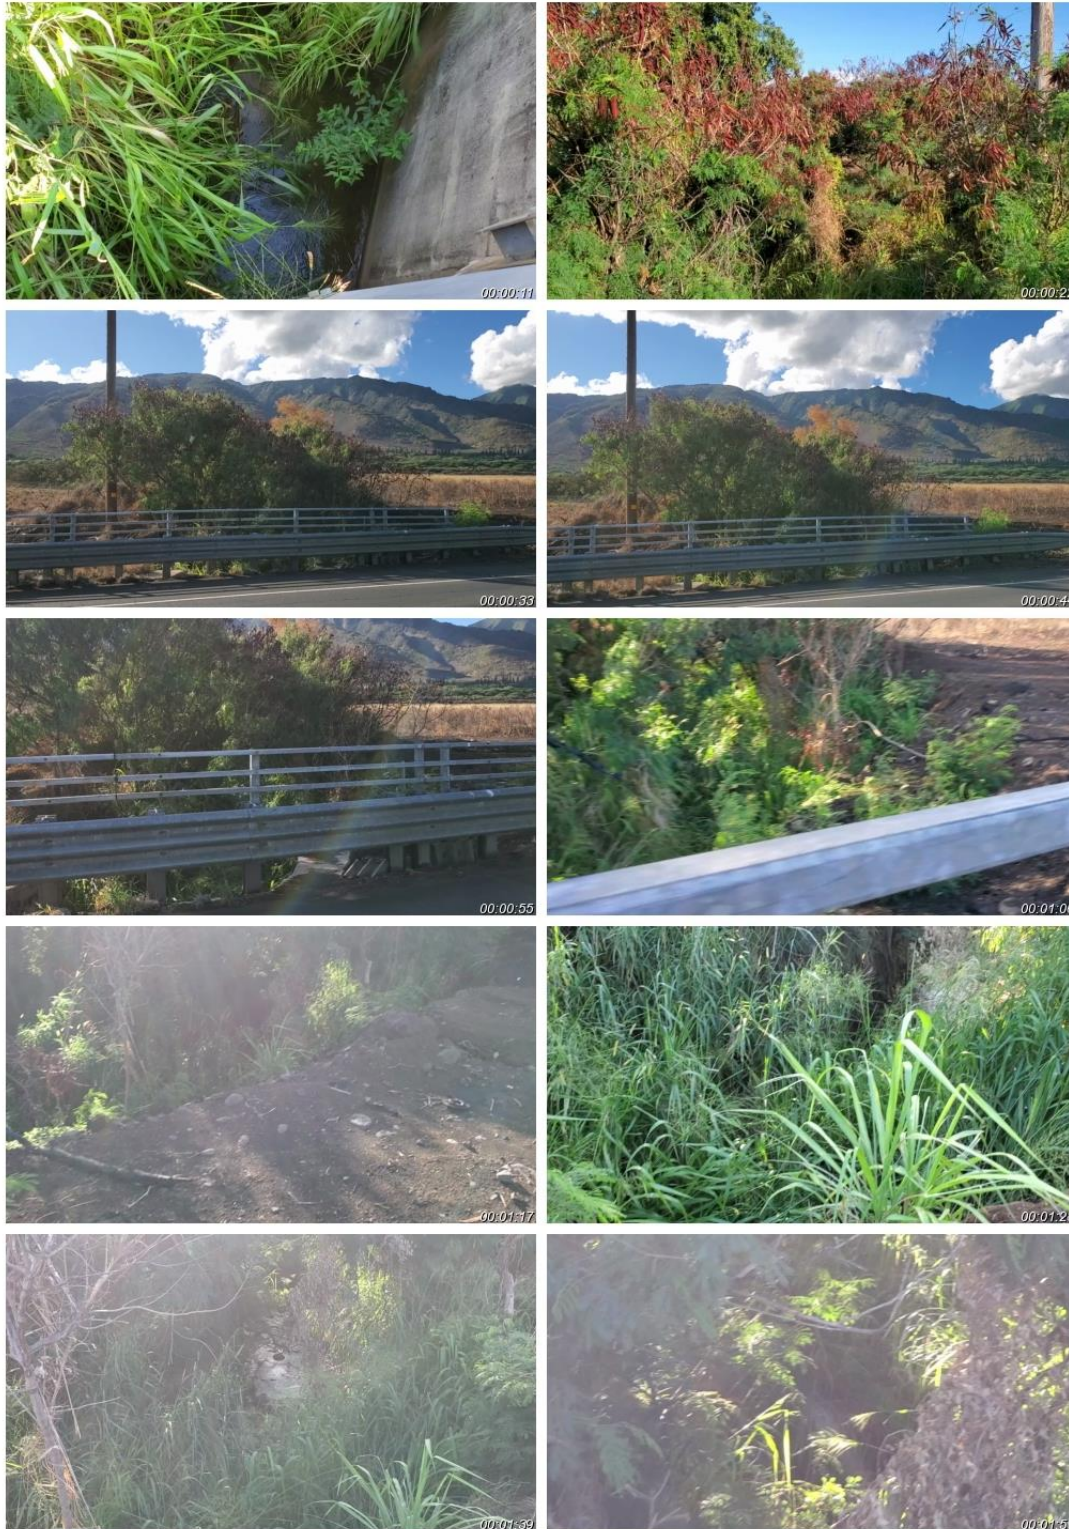
Exhibit 8.13: Thumbnails of 2-minute, 10-second video clip submitted by Hui o Nā Wai 'Ehā of water flowing at Pale'a'ahu Gulch on November 3, 2019.
