STAFF SUBMITTAL

February 18, 2020
Honolulu, Hawai'i

Issuance of Written Notice of Violation for Enforcement Against Waste, and Recommendation to Impose Fines Against Wailuku Water Company, LLC, Owner/Operator of Waihe'e Ditch, In Response to HRS §174C-13, Citizen Complaint filed by Hui o Nā Wai 'Ehā Alleging Waste by Wailuku Water Company at Pale'a'ahu Gulch, Nā Wai 'Ehā Surface Water Management Area, Maui, TMK No. (2) 3-6-004:003

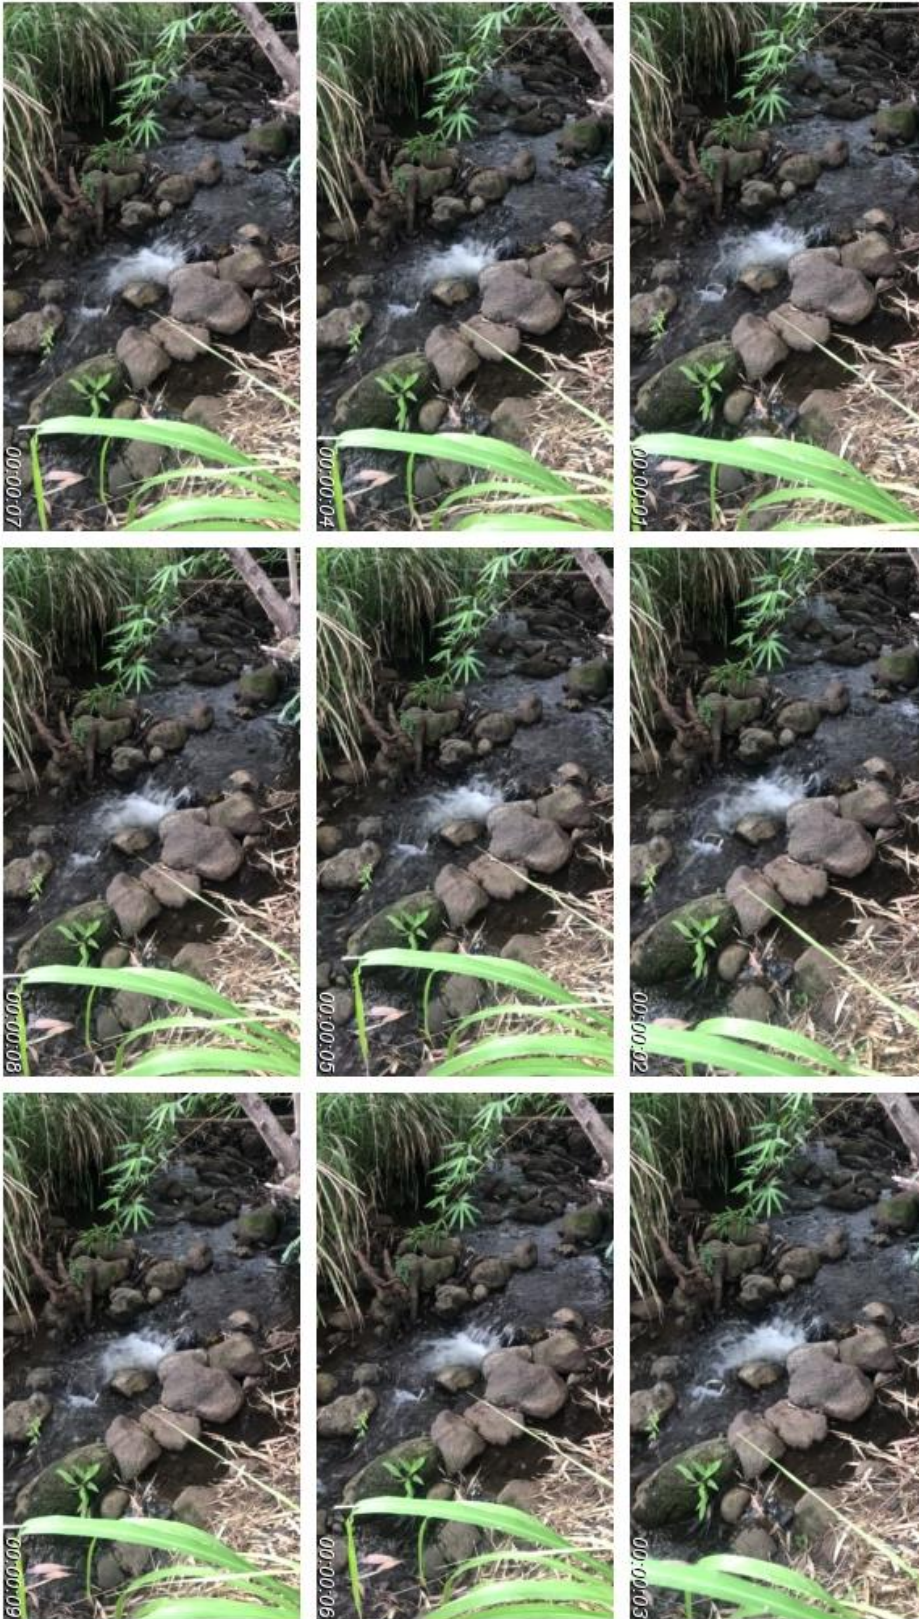
Exhibit 8.14: Thumbnails of 14-second video clip submitted by Hui o Nā Wai 'Ehā of water flowing at Pale'a'ahu Gulch on November 8, 2019.

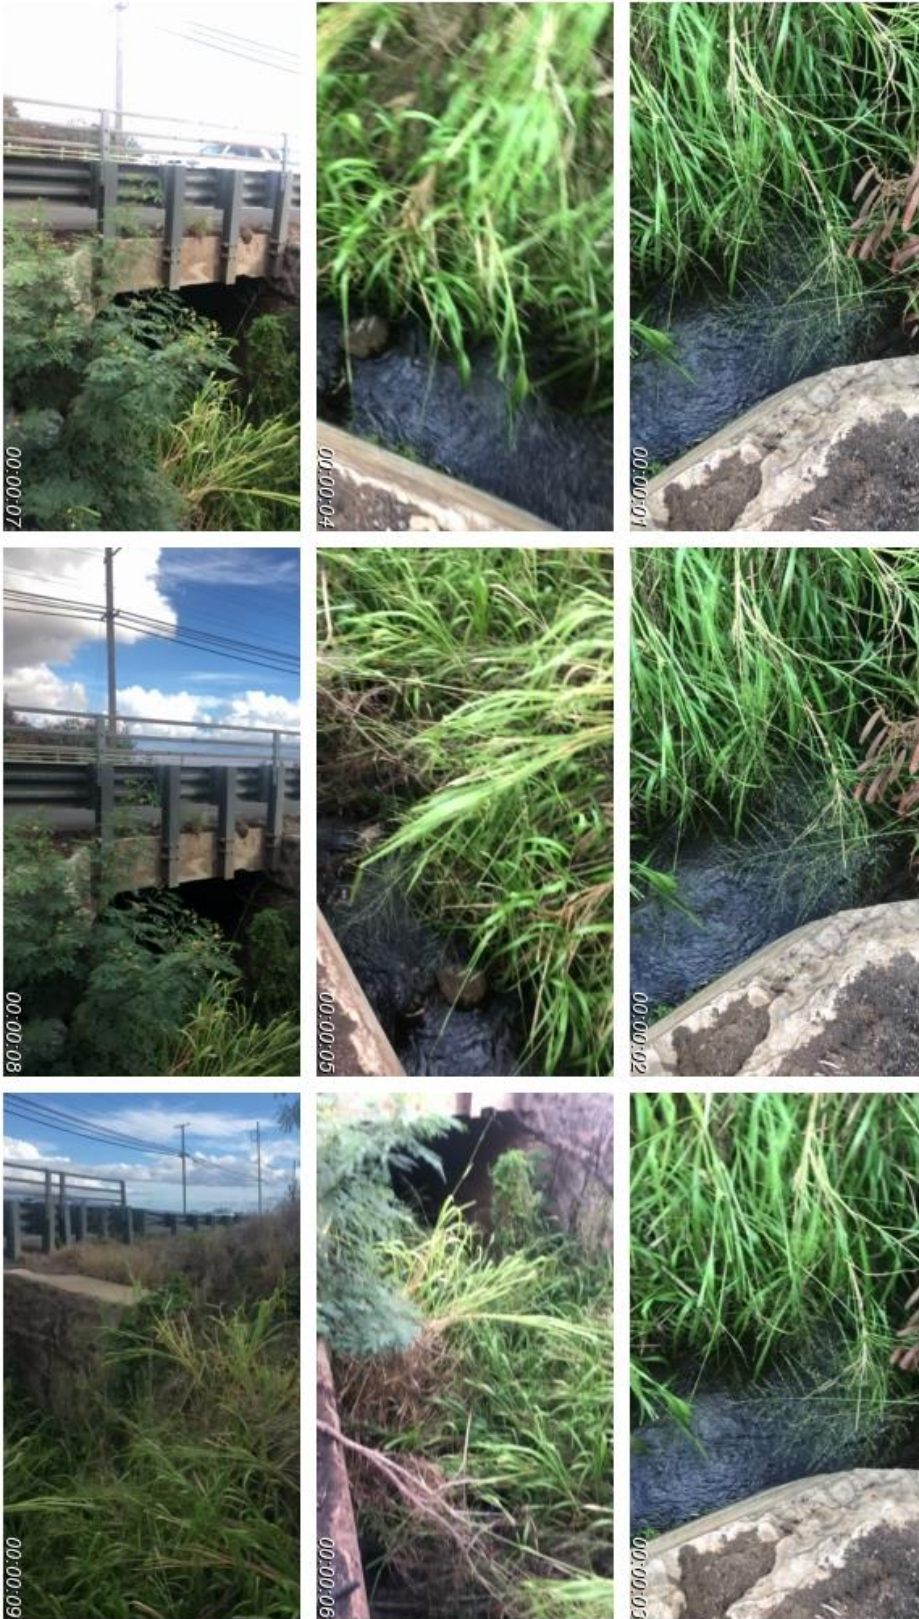
Exhibit 8.15: Thumbnails of 13-second video clip submitted by Hui o Nā Wai 'Ehā of water flowing at Pale'a'ahu Gulch on November 8, 2019.

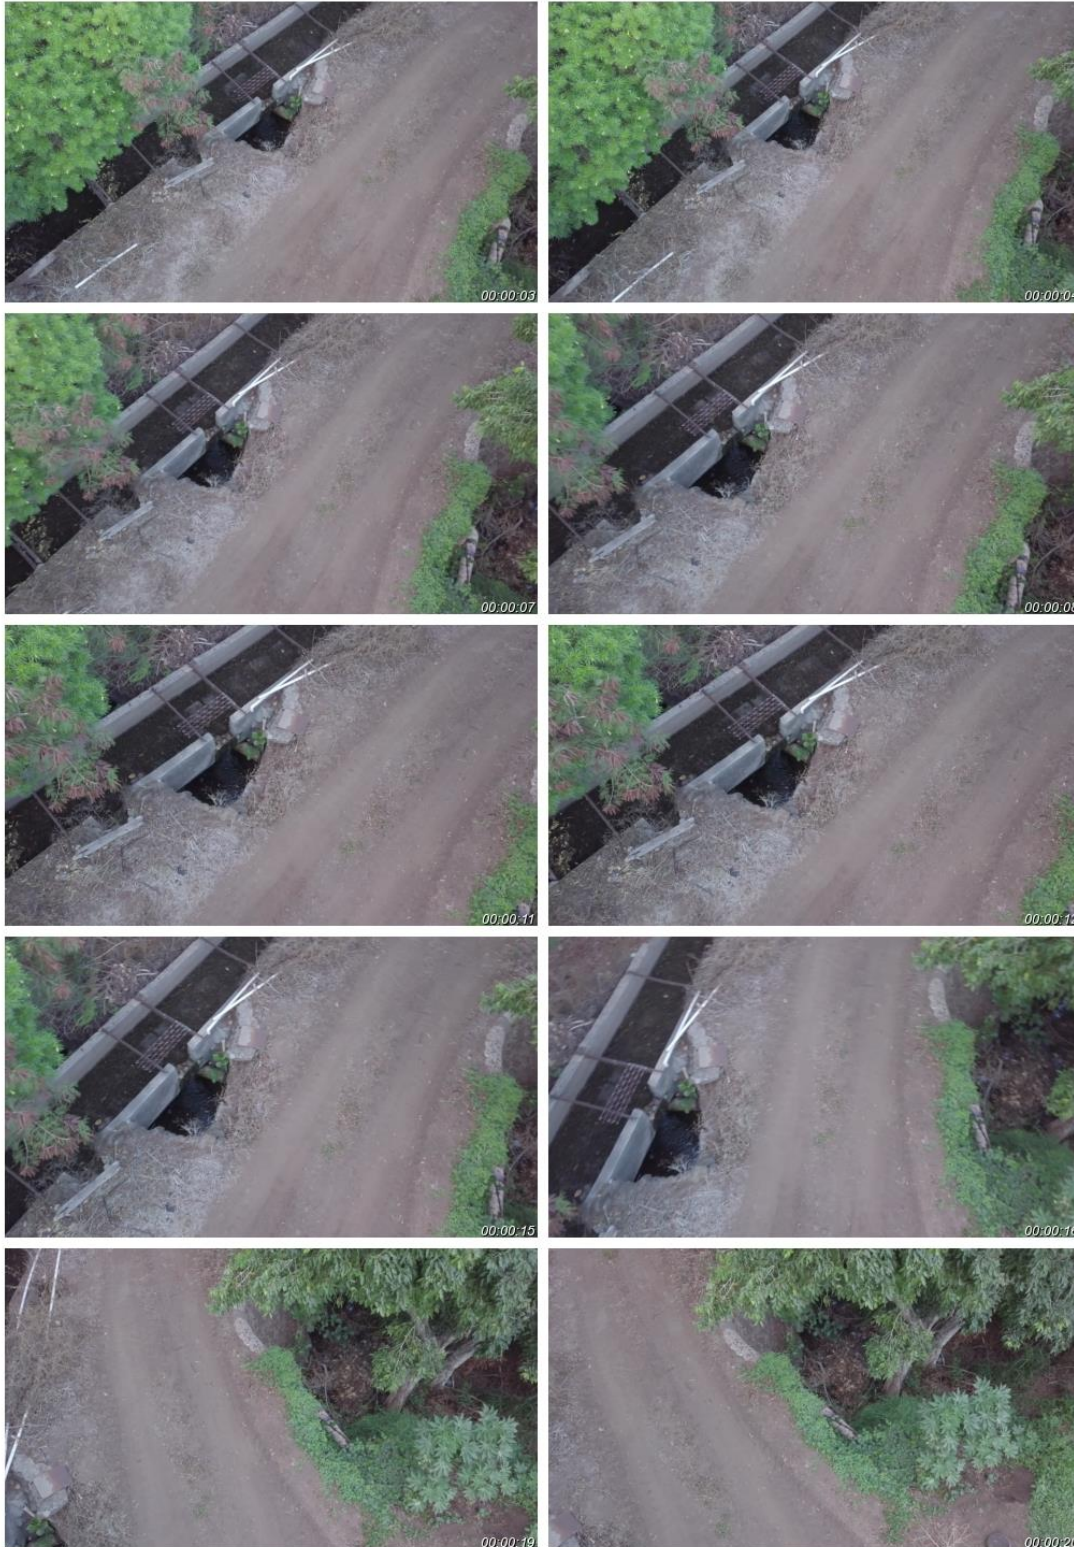
Exhibit 8.16: Thumbnails of 25-second video clip (drone footage) submitted by Hui o Nā Wai 'Ehā of water flowing at Pale'a'ahu Gulch on November 11, 2019.

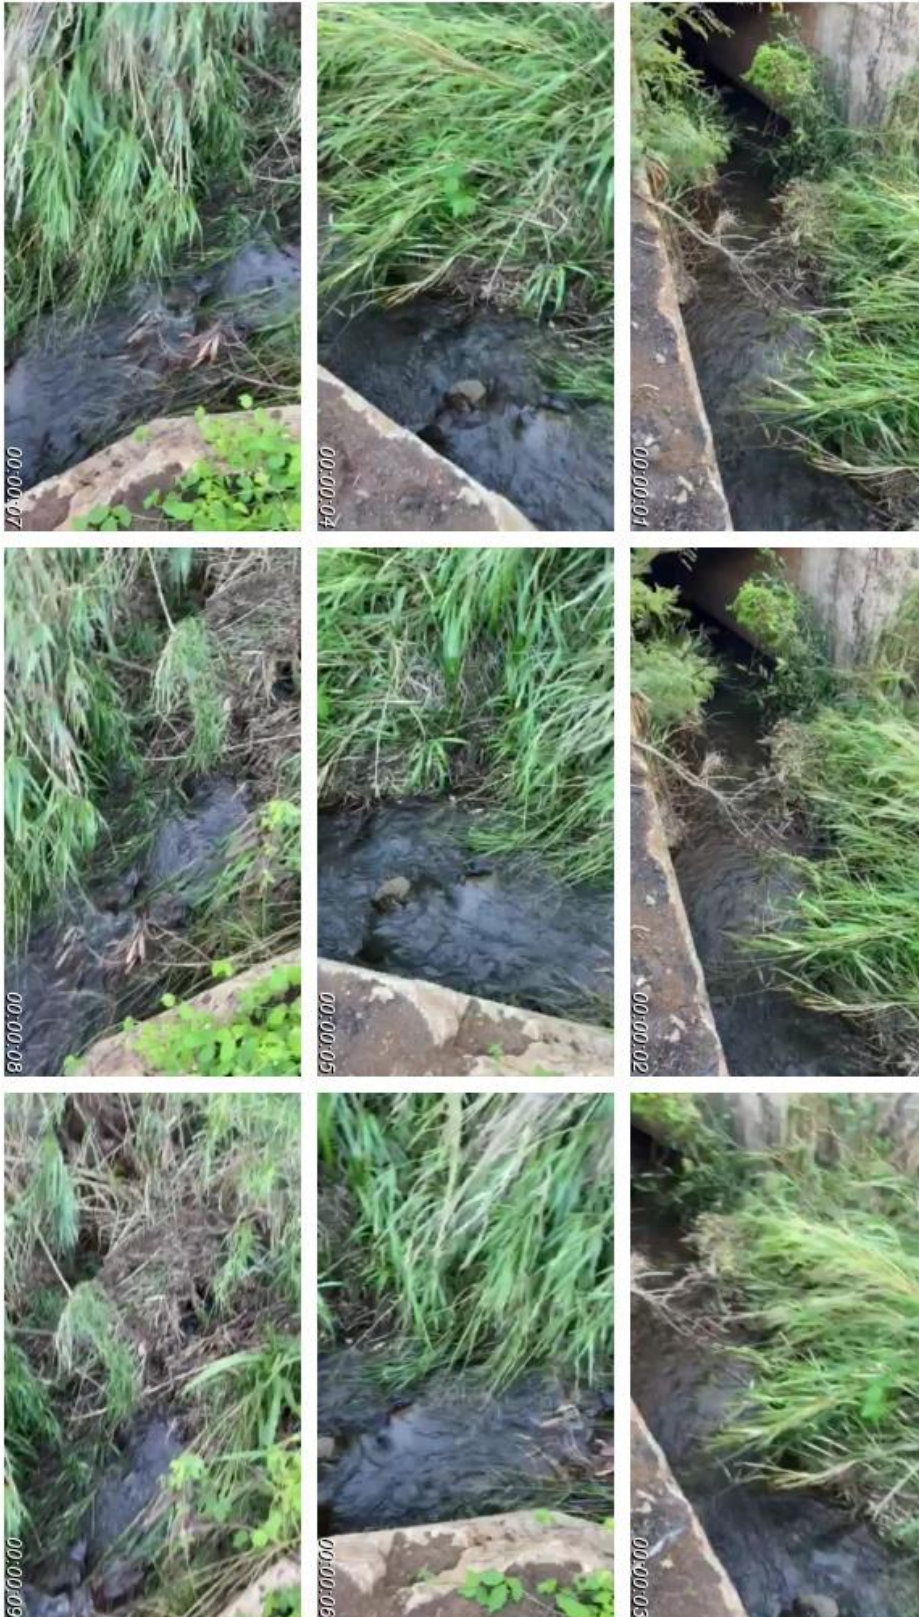
Exhibit 8.17: Thumbnails of 14-second video clip submitted by Hui o Nā Wai 'Ehā of water flowing at Pale'a'ahu Gulch on January 5, 2020.

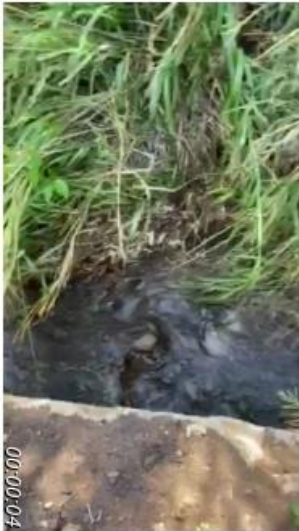
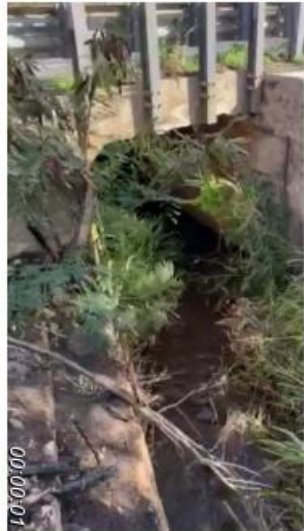
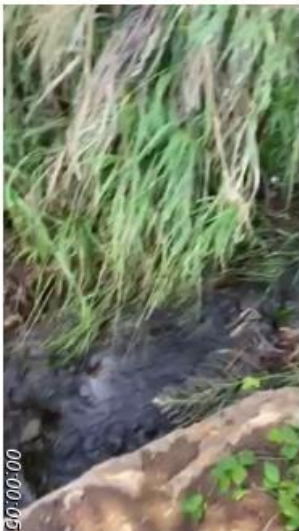
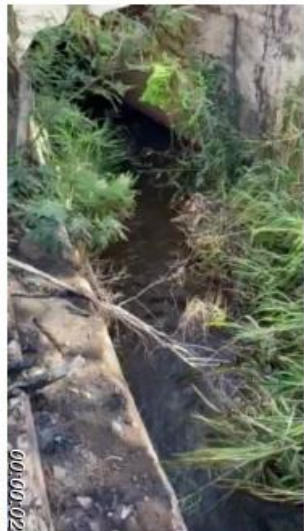
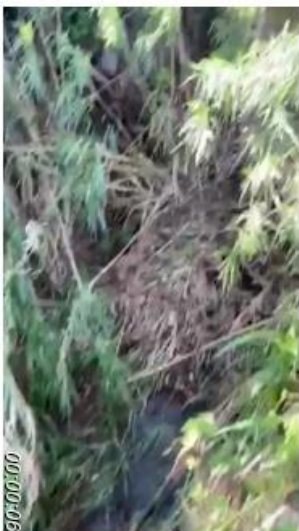
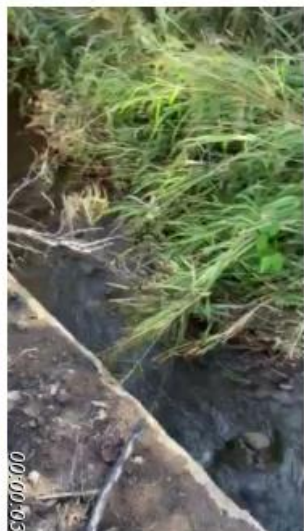
Exhibit 8.18: Thumbnails of 9-second video clip submitted by Hui o Nā Wai 'Ehā of water flowing at Pale'a'ahu Gulch on January 8, 2020.

- a. Seal release gate at Pale'a'ahu Gulch to prevent any future dumping events.
 - b. Repair the intake control gate at the Spreckels Ditch diversion on Waihe'e River.
