STAFF SUBMITTAL

Wailuku Kuleana Town 'Auwai
Nā Wai 'Ehā Surface Water Management Area, Maui

No action. The purpose of this submittal is to present information on the implementation of the Commission on Water Resource Management's (Commission) Decision and Order in contested case hearing CCH-MA15-01, as it relates to issues experienced with users on the Wailuku Town Kuleana 'Auwai (also referred to as Wailuku Town Kuleana Ditch).

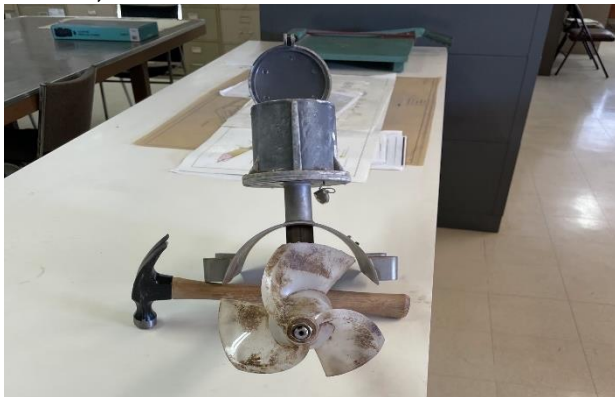
1) Front-view of the propeller flow meter used by WWC.

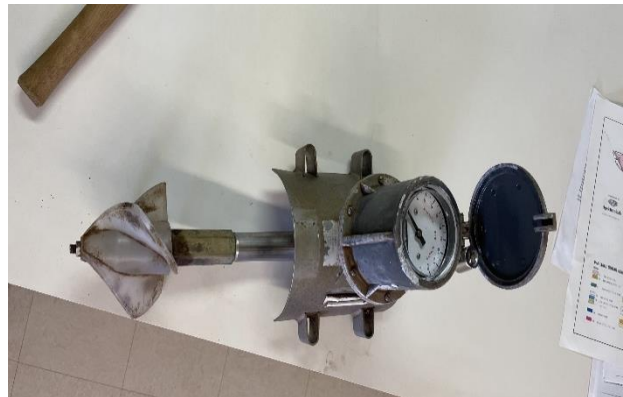
2) Top-view of the propeller flow meter used by WWC.

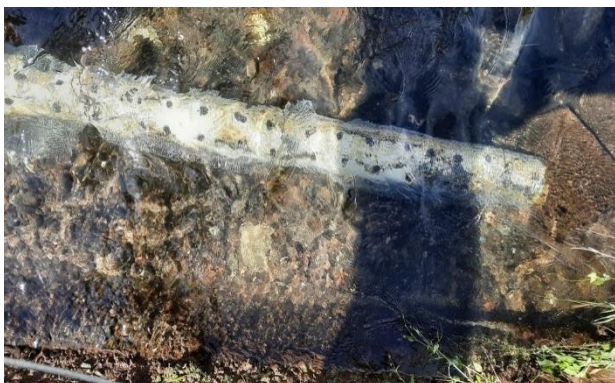
3) Perforated screen installed on intake pipe at Waihe'e Ditch.

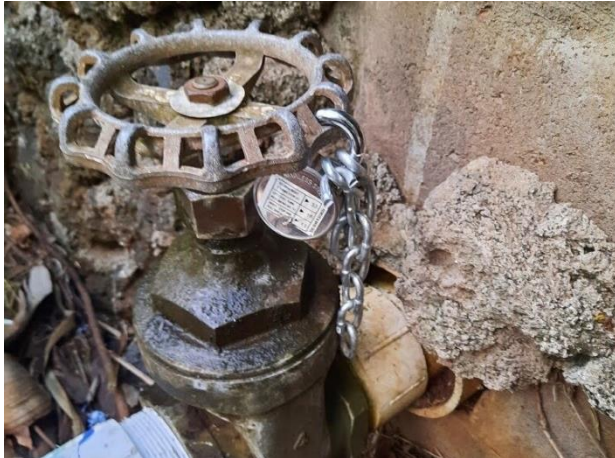
4) Cut chain on distribution pipe valve to the Wailuku Town Kuleana 'Auwai.

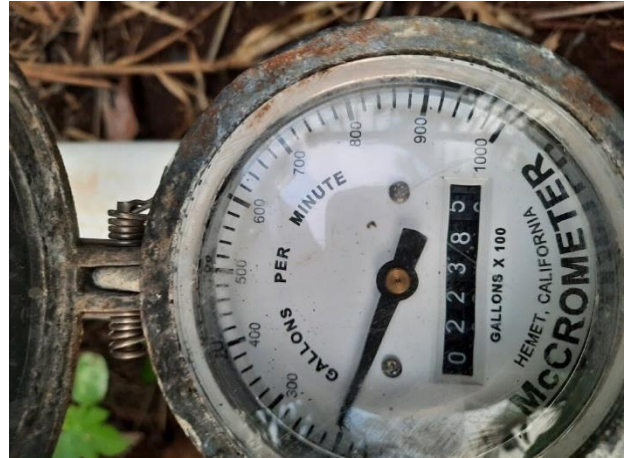
5) Flow meter on the distribution pipe to the Wailuku Town Kuleana 'Auwai. Reading indicates slightly more than 100 gpm, and a total of 2,238,500 gallons.

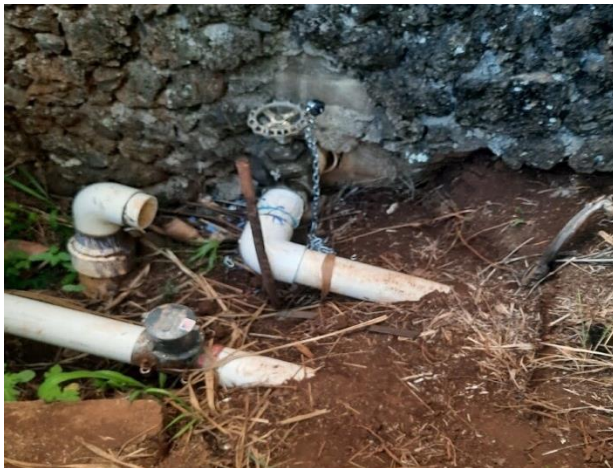
6) Cut chain on distribution pipe valve to the Wailuku Town Kuleana ‘Auwai on October 25, 2021.

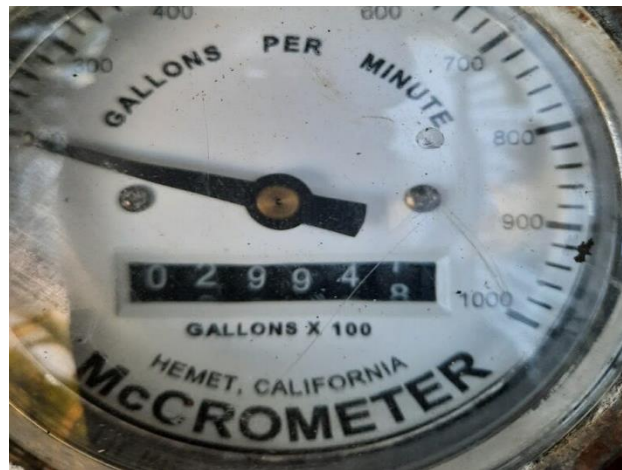
7) Flow meter on the distribution pipe to the Wailuku Town Kuleana ‘Auwai. Reading indicates approx. 200 gpm, and a total reading of 2,994,800 gallons.

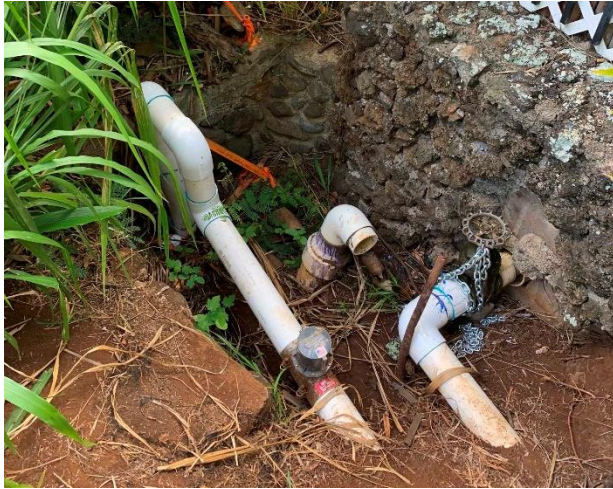
8) Distribution pipe with valve chained and flow meter at center, located on the boundary of Imua Family Services property.

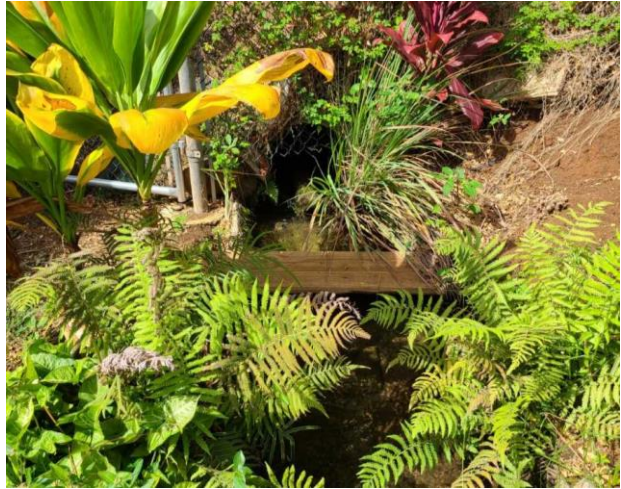
property, the water flows out of a concrete-lined channel and flows for approximately 20 feet (Photo 9), where it continues under a fence and flows through the adjacent property (TMK (2) 3-4-007:010; Photo 10) in a northerly direction. At some point after flowing the width of adjacent parcel, the water goes back underground flowing in an easterly direction. The group walked to Wailuku Public Library and observed the ditch through a concrete lined access point located behind the library (Photos 11 to 13). In 2015, complaints on the Wailuku Town Ditch found that tree roots in the vicinity of the library were clogging the underground channel and impeding flow.

9) Water flows underground from Imua Family Services and drops into an open ditch on the Koeli LLC property.

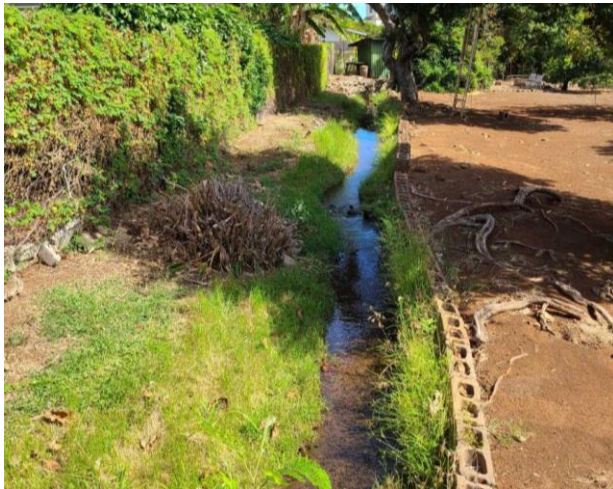
10) Water continues in an unlined ditch from the Koeli LLC property through the adjacent property before entering an underground channel at the northern end of the property.

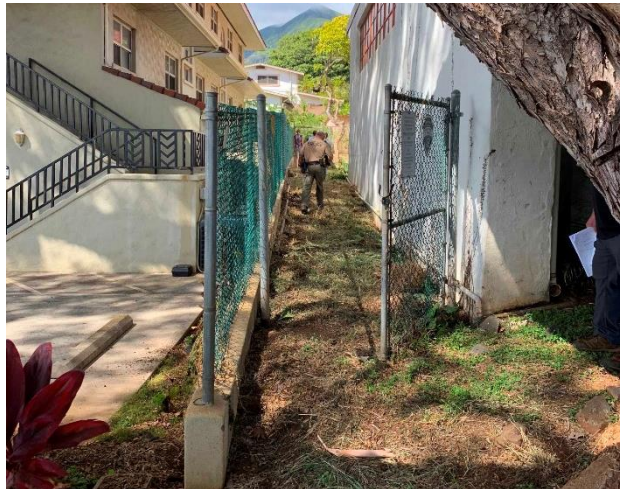
11) The access gate behind the Wailuku Public Library to observe the access point on the underground concrete-lined channel.

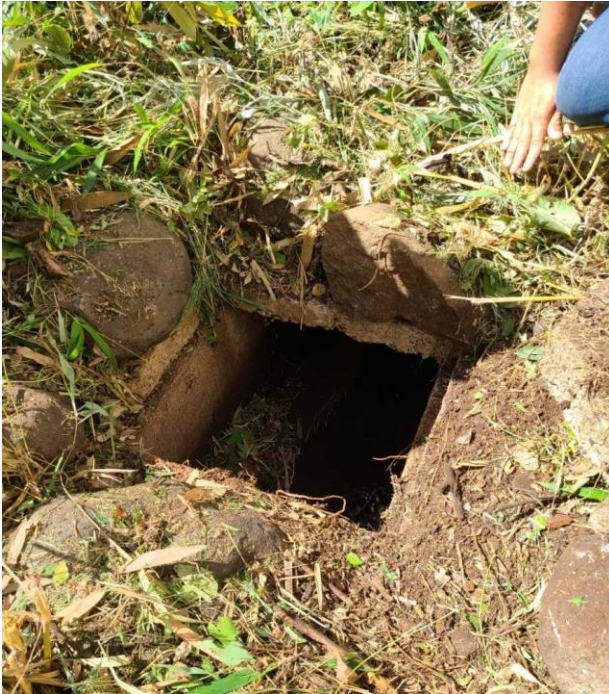
12) Uncovered access point of underground concrete-lined channel behind Wailuku Public Library.

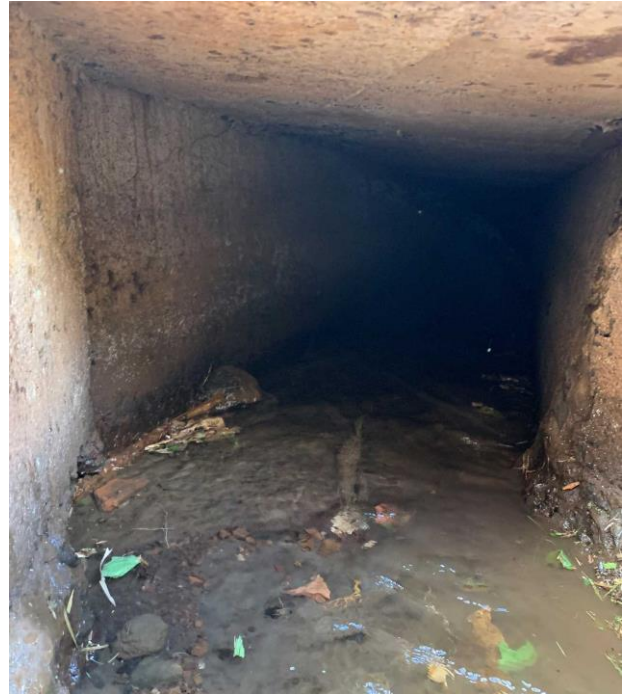
13) Water flow in underground concrete-lined channel behind Wailuku Public Library.

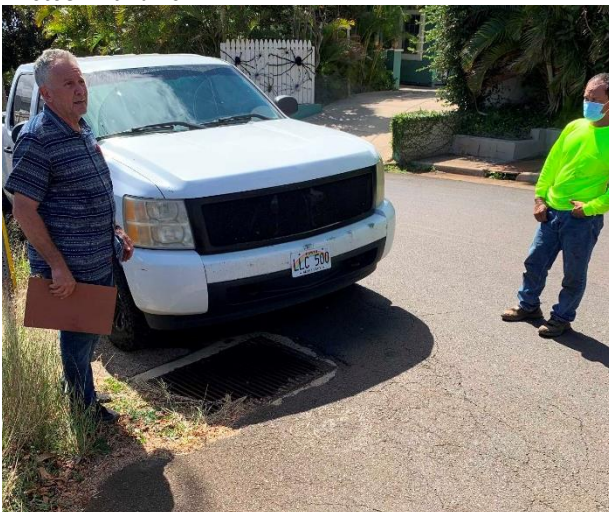
The underground channel continues east under Kaohu Street, then makes a right turn southerly under Kalua Road (Photos 14 and 15). At the corner of this intersection, the ditch can be observed through a steel grate, where it receives storm water runoff from the road. The Commission staff is attempting to work with the Maui County, Department of Environmental Management, to determine if anything can be done to prevent storm water runoff entering the Wailuku Kuleana Town Ditch.

14) Storm drain grate at the corner of Kaohu Street and Kalua Road, where channel continues underground towards the left of the photo along Kalua Road.

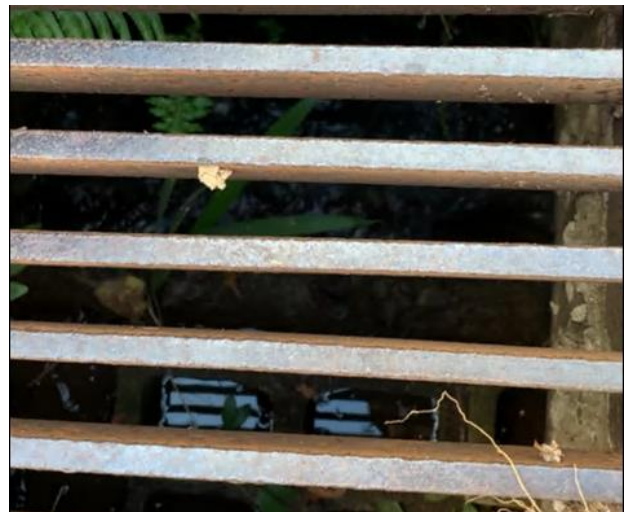
15) Close-up of water flowing in concrete-lined channel approximately six (6) feet underground.

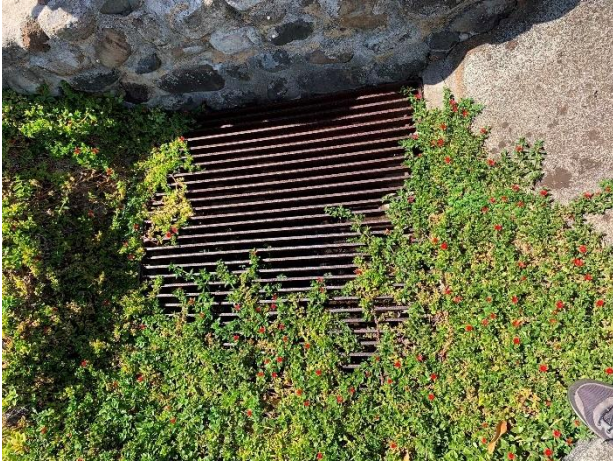
The group continued walking in a southerly direction down Kalua Road. A second storm drain to the Wailuku Town Kuleana ‘Auwai was observed, located at the edge of the driveway of 436 Kalua Road (Photos 16 and 17).

16) Storm drain at 436 Kalua Road.

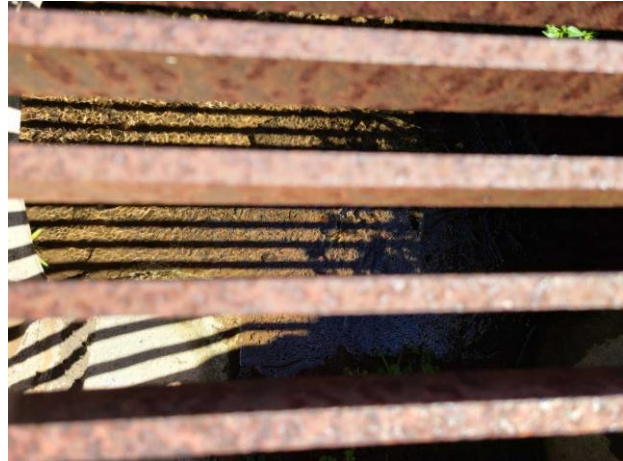
17) Close-up of water flowing ditch at 436 Kalua Road.

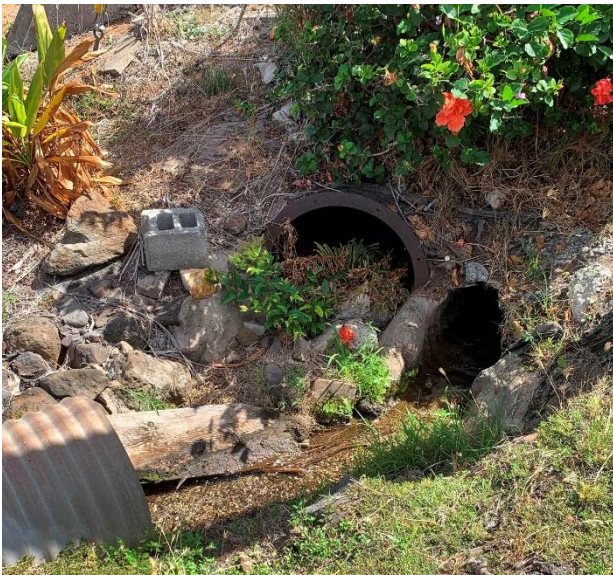
While the Wailuku Town Kuleana ‘Auwai is underground for much of the way along Kalua Road, approximately 1,100 feet, it eventually drops into an unlined channel that flows on the western (mauka) edge of several properties (Photo 18). It flows through culverts under several driveways, before reaching the edge of the Velez (Higa) property (TMK (2) 3-4-004:017) near the end of Kalua Road. At that point, the ditch is concrete-lined and splits in three directions towards the Velez, Ciotti (TMK (2) 3-4-004:019), and Ibara (TMK (2) 3-4-004:020) properties (Photo 19).

18) Water exits underground pipe and flows into an unlined channel and enters a culvert under a driveway.

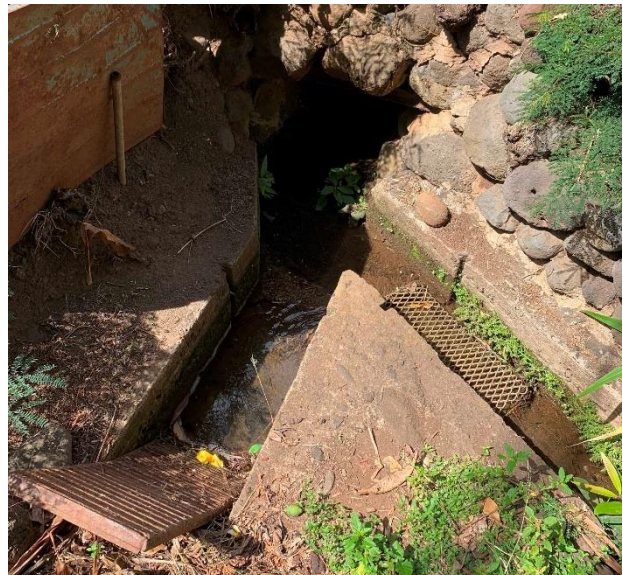
19) Water flows from a driveway culvert at the Velez (Higa) property and splits. The right channel goes towards Velez and Ciotti (Velez pulls water from the channel via a pipe). The left channel continues towards the Ibara property.

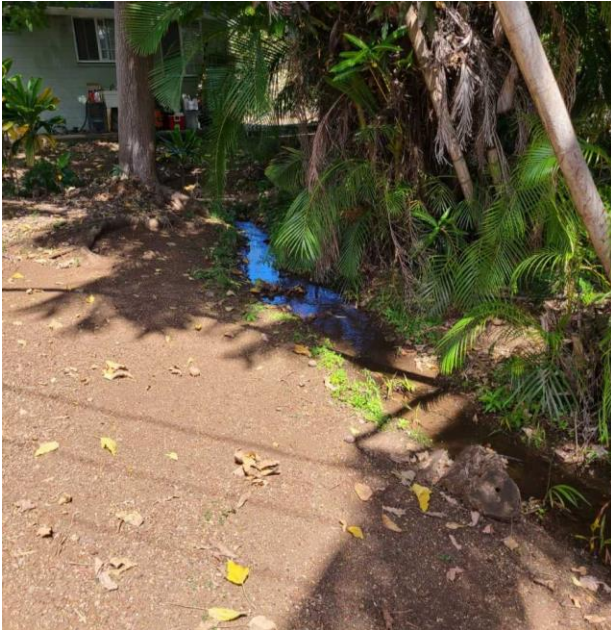
20) Water flows from the Velez property in an unlined ditch towards the Ciotti property.

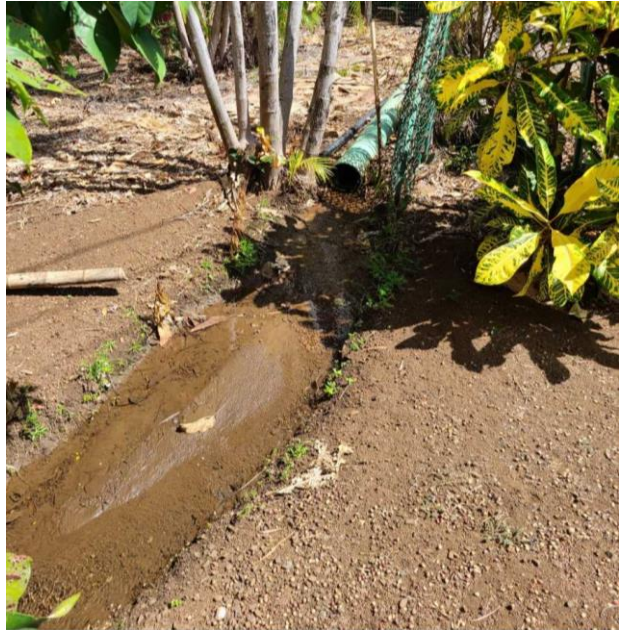
21) The water continues in an unlined ditch onto the Ciotti property where it is piped and distributed to various points on the property

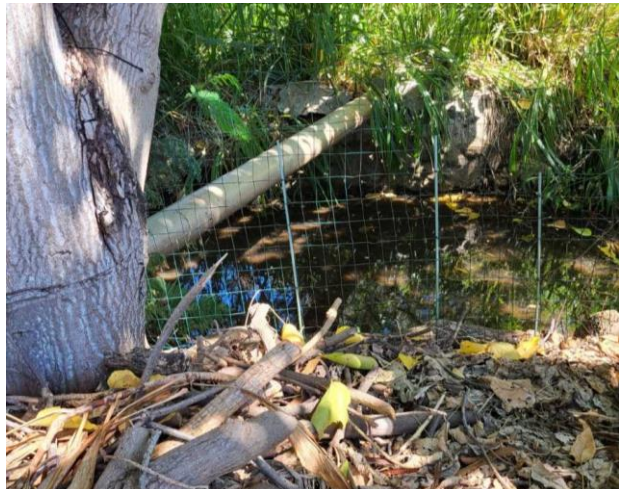
23) Excess water flows through a pipe at the edge of the Ciotti property into Spreckels Ditch.

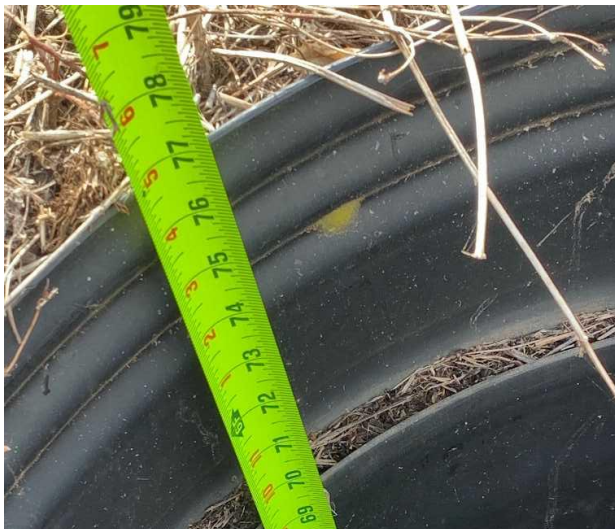
24) Measured depth (approx. 6'6") from ground surface to the bottom of Waihe'e Ditch where the control valve is located.

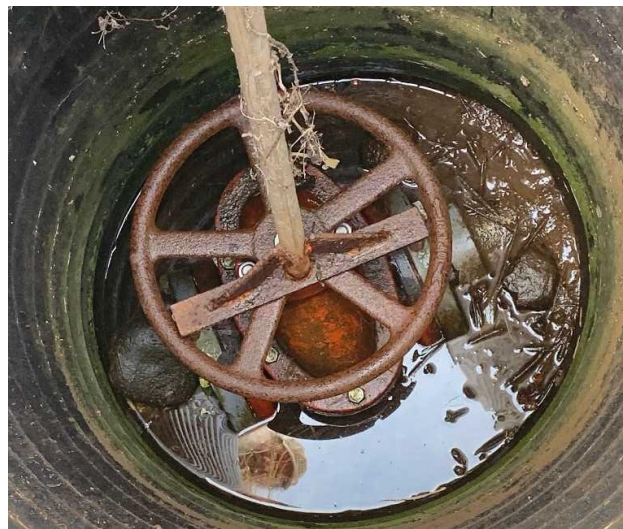
25) Control valve for the intake pipe located on Waihe'e Ditch which feeds the distribution pipe to the Wailuku Town Kuleana 'Auwai.

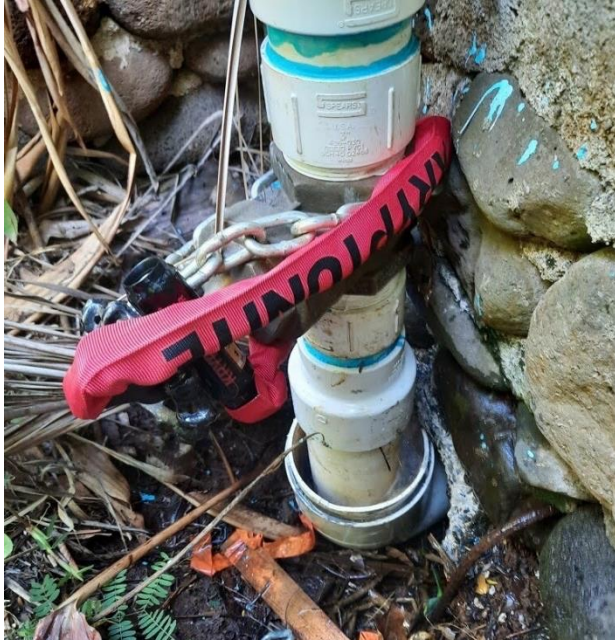
Mr. Chumbley later notified staff that a new Kryptonite lock and chain (Photo 26) was installed on the distribution pipe and valve to prevent further efforts to cut the chain.

26) Kryptonite lock installed on the Wailuku Town Kuleana 'Auwai distribution pipe.

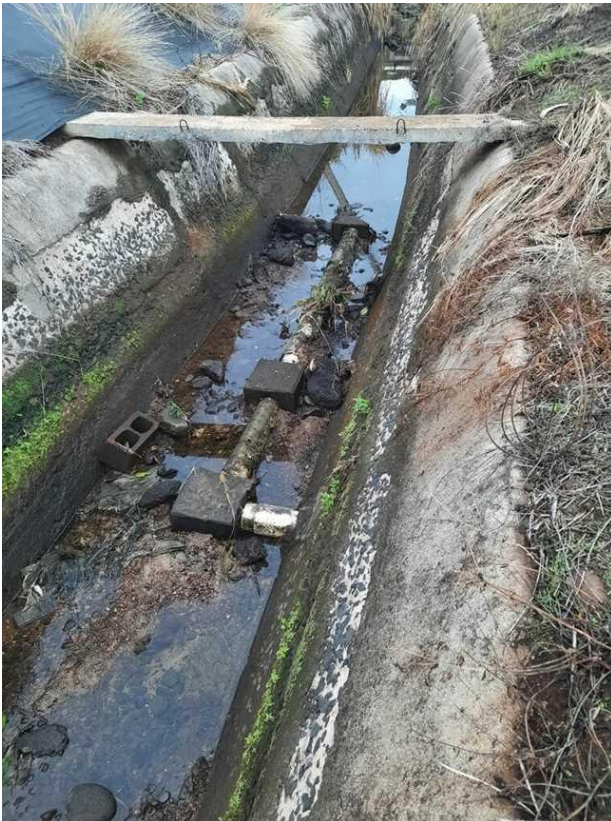
“Below is a picture of the Wailuku Town Kuleana intake as it is positioned in Waihee ditch, as you will see in the picture there is a lot of rock, rubble and debris from the storm, additionally there is no flow in the ditch nor will there be on Wednesday during your scheduled site visit. As soon as it is safe to get into Waihee valley it is our intention to shut down the diversion of the Waihee ditch system and do an inspection of the rupture on the Waihee syphon under Wailuku River. This shut down is necessary to determine the extent of damage and prevent further complete catastrophic failure of the syphon. Depending on the level of damage it may be some time until the Waihee diversion flows can be brought back on line.

29) Photo provided by Mr. Chumbley on December 2, 2021.

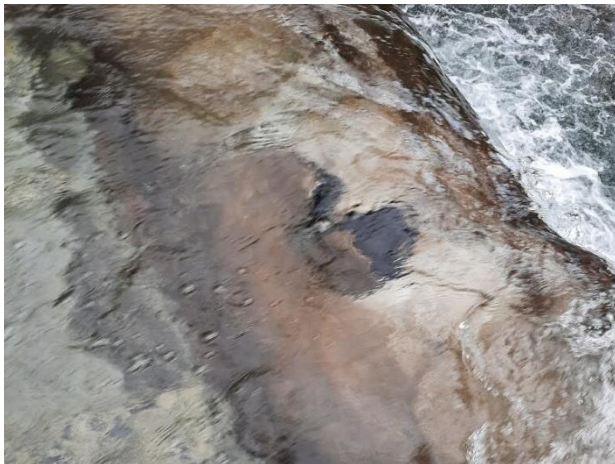
“The Commission on Water Resource Management (Commission) was notified yesterday, December 6, by Wailuku Water Company (WWC) that the Waihe‘e Ditch siphon at Wailuku River (formerly ‘Īao Stream) was damaged during the severe rainfall event experienced on Maui. The siphon was likely damaged by a large boulder that was carried downstream by the high flows.

30) Ruptured siphon at Wailuku River.

On December 13, 2021, Commission staff received an email from Mr. Chumbley detailing his plans to repair the Waihe‘e Ditch siphon (Siphon) where it crosses at Wailuku River, and requesting “immediate emergency approval to proceed with phase 1 repairs.” Mr. Chumbley provided a photo of the ruptured siphon (Photo 30), while the event also made the Hawaii News Now newscast on December 10, 2021 (Photo 31)

Step 1: I have a metal fabricator from Maui coming this morning (Dec 13th) to do a site inspection, he will inspect the pipe based on the K2N engineers proposed repair drawings (see attached PDF), take final measurements and then fabricate a 3/8 inch A-36 metal plate to weld or use Lindapter bolts, depending on the type of metal of the pipe (steel vs- cast iron) over the rupture hole. He will also take a sample of the existing metal pipe which will be sent to the mainland for a metallurgy analysis to ensure the type of welding rods (if welding is to be done) are used to adhere the larger metal bumper plate in the phase 2 steps explained below, are compatible to the old pipe. His certified welder will use a rod that they feel best for the short-term immediate repair if it is to be welded vs- Lindapter bolts. I am calling this Phase 1 Temp repair, this will get the diversion flows back on line quickly.

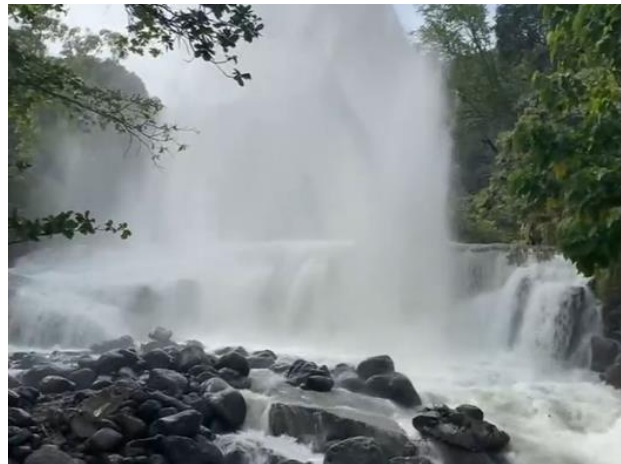
31) Screenshot of damaged siphon from Hawaii News Now newscast on December 10, 2021. Recording was provided courtesy of Hui o Nā Wai ‘Ehā.

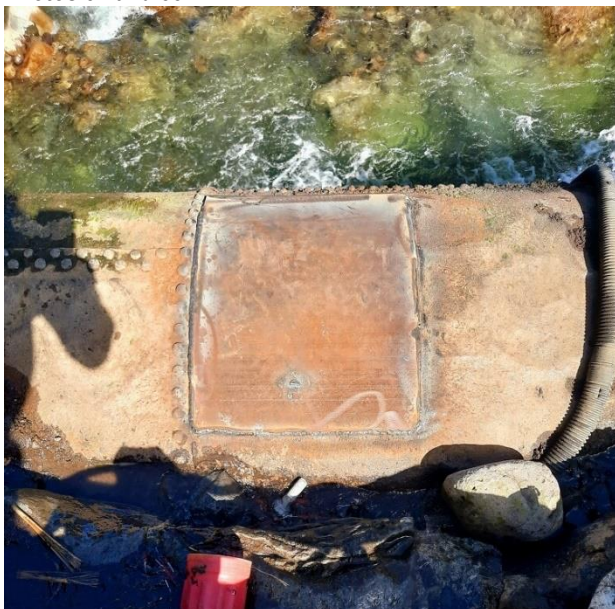
32) Repaired siphon at Wailuku River.

On January 5, 2022, Mr. Chumbley notified Commission staff the WWC was able to successfully complete Phase 1 of the Siphon repairs. The repair consisted of the welding of a steel plate over the ruptured section of the Siphon. Mr. Chumbley indicated that on Wednesday, January 6, WWC would “start walking the water back down the Waihee ditch and should have normal diversions restored by the end of the day.”

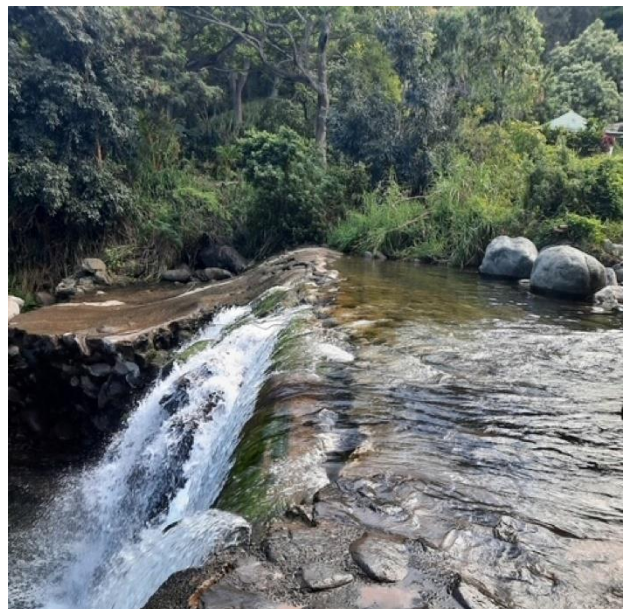
33) Wailuku River following repair of the Siphon, at center.
