Ki'iki'i Stream Biological Surveys
Division of Aquatic Resources¹, DLNR
Commission on Water Resources Management², DLNR

Biological stream surveys were conducted in the lower reaches of Ki'iki'i Stream below Wahiawa Reservoir, Oahu on June 2, 2021 by DAR and CWRM staff to establish Instream Flow Standards (IFS). Methods used in the collection of data included eDNA water sampling, cast net, visual observations, and High Definition Fish Survey (HDFS) using underwater video camera. Five sites were visited with the assistance of Dole Foods, Inc. and private landowners. Site 1 was at the stream road crossing below the reservoir, Site 2 was at the ditch outflow below the reservoir, Site 3 was above Waialua at the 20 feet elevation above Farrington Highway, Site 4 was the stream road crossing in Kaukonahua Gulch at the 70 feet elevation, and Site 5 is also in Kaukonahua Gulch at the 280 feet elevation. The number of throws for the cast net per site depended on the water depth and open areas. At Site 1: 5 throws were made; Site 2: 2 throws were made; Site 3: 8 throws made; Site 4: 2 throws made; and Site 5: 4 throws made. The water clarity was poor and cloudy at all the 5 sites, but did im

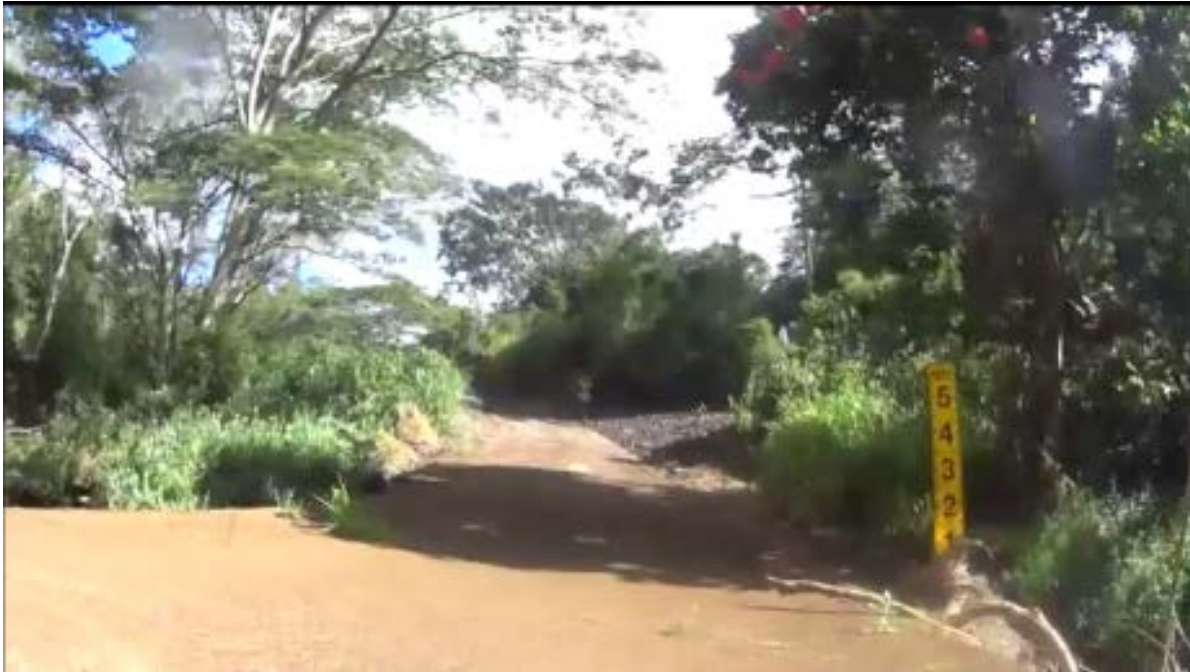
Figure 1. Site 1 stream road crossing below the reservoir. Note water level gauge on the right side of the road.

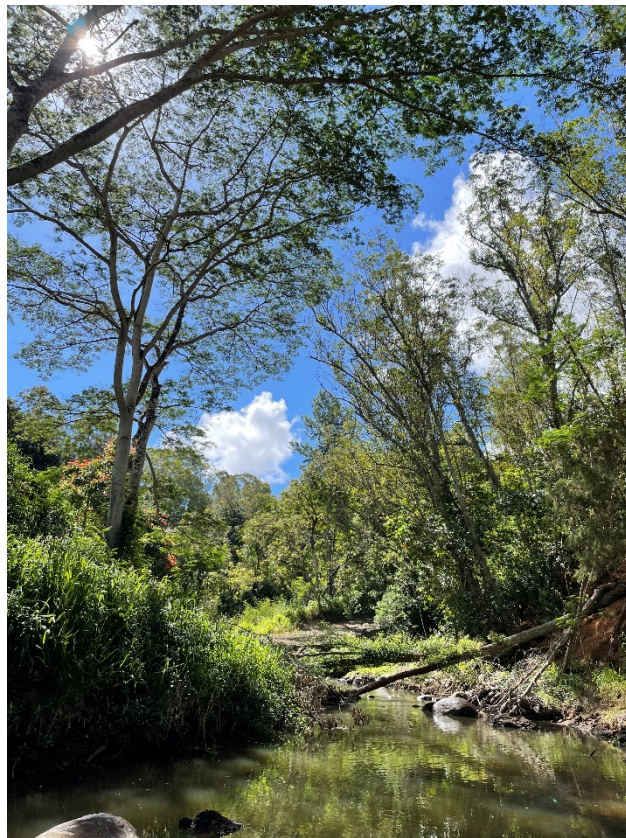
Figure 2. View of Site 1 road crossing from downstream.

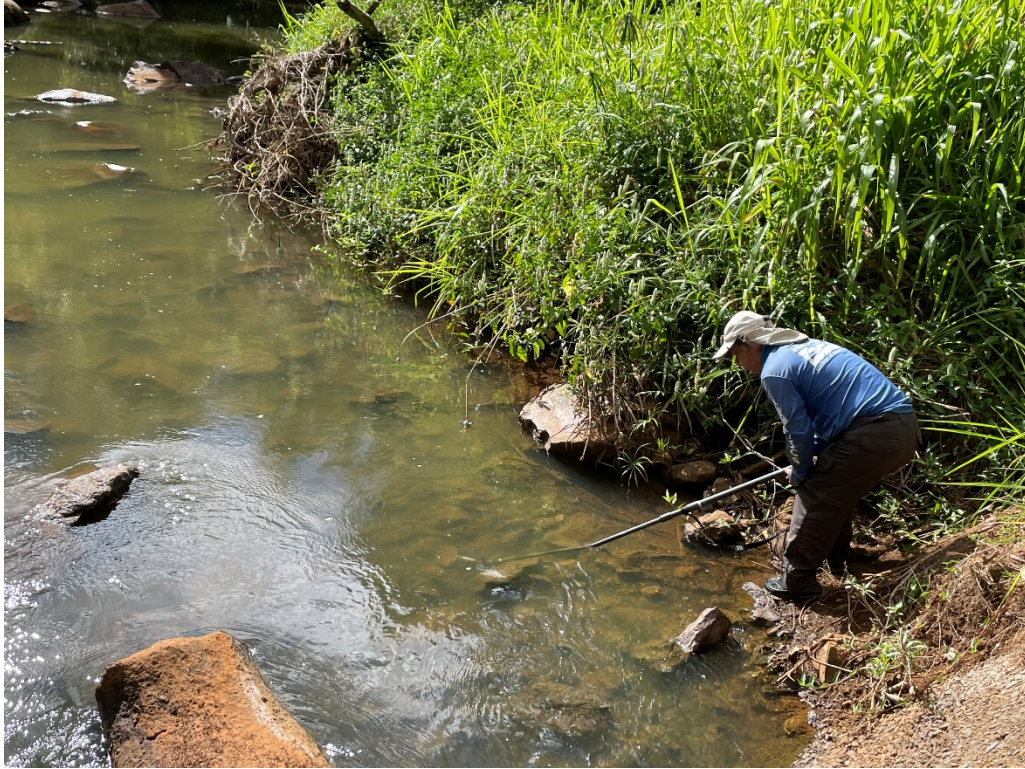
Figure 3. Site 1 above road crossing showing Glenn using video camera for underwater fish surveys (HDFS).

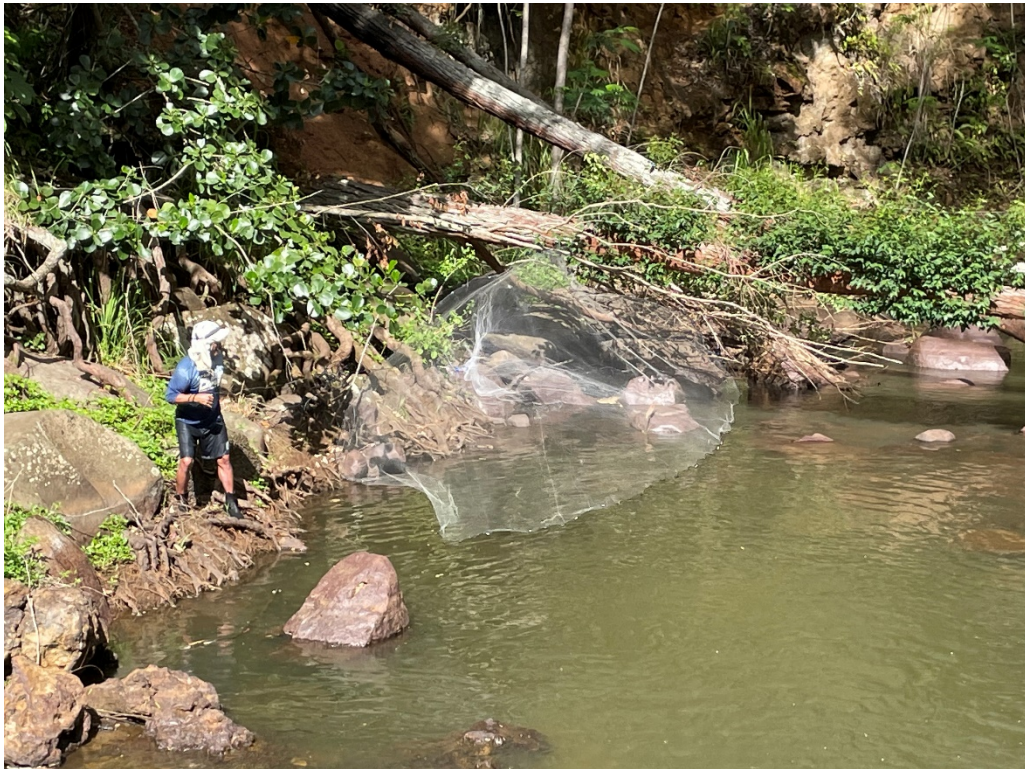
Figure 4. Neal throwing cast net in pool at Site 1 just below the road crossing.

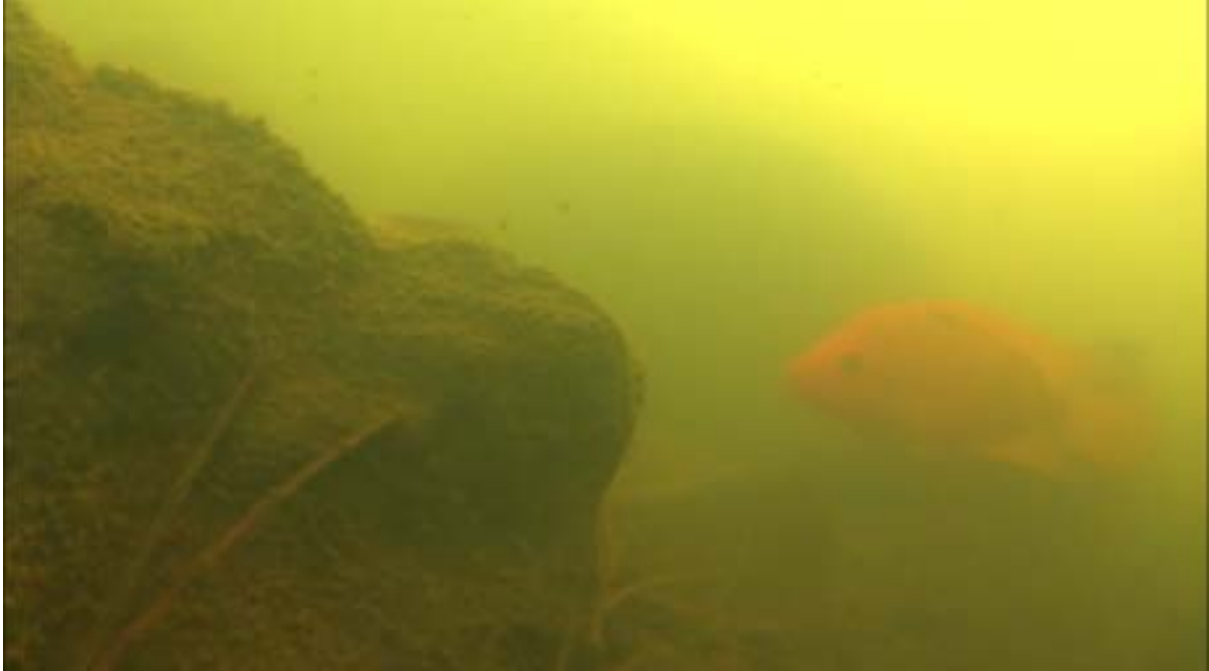
Figure 5. Red devil caught on video camera at site 1. Identifiable even with water cloudiness.

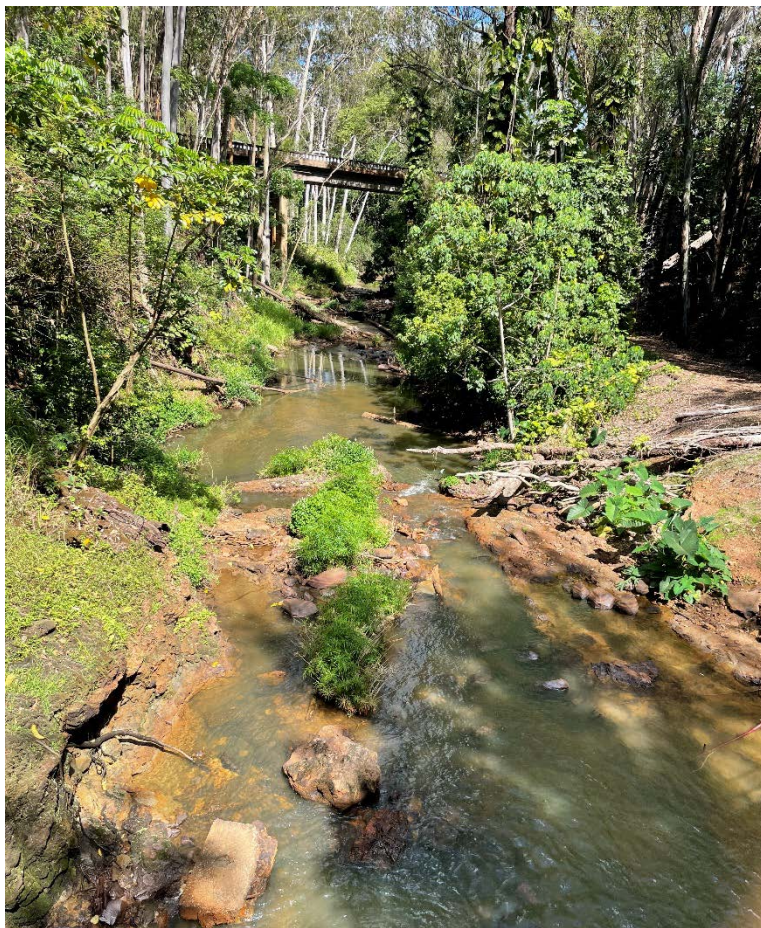
Figure 6. Site 2 at the ditch outflow below the reservoir.

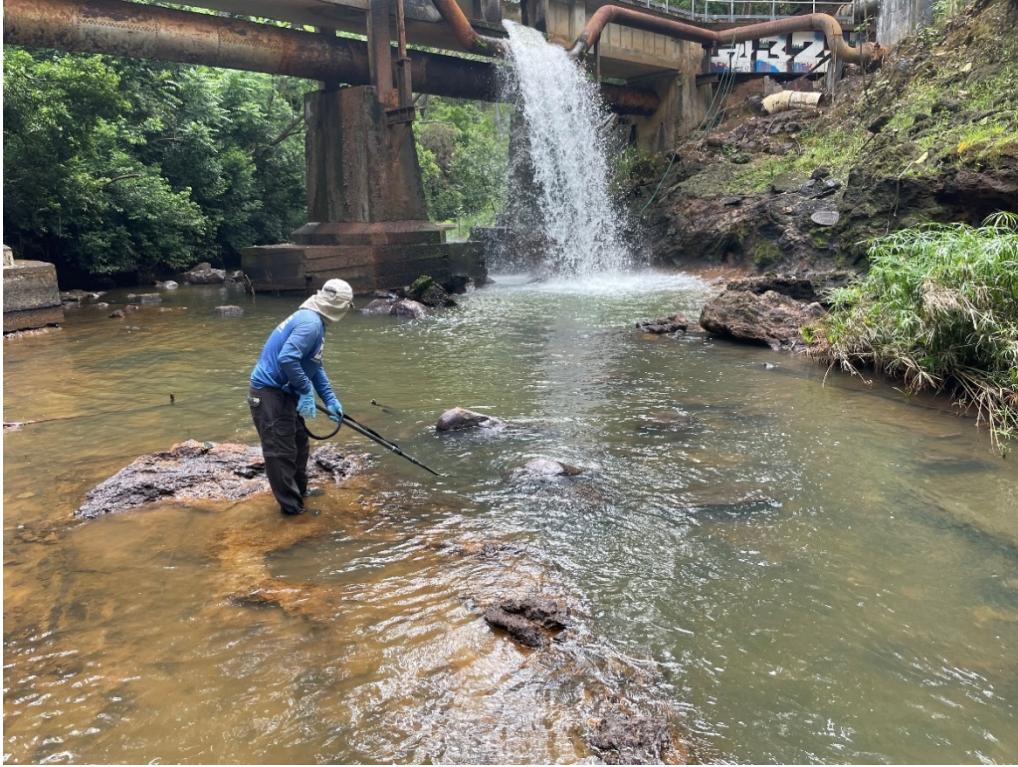
Figure 7. Glenn conducting underwater video survey just below the ditch outflow from the reservoir at Site 2.

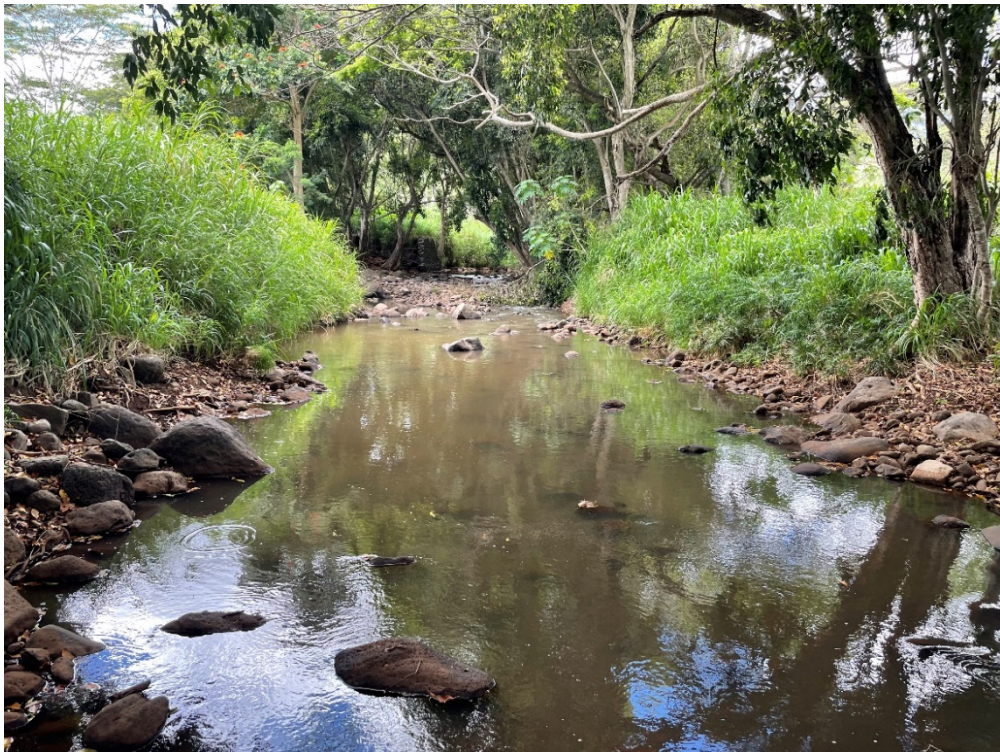
Figure 8. Site 3 located at the 20 feet elevation above Farrington Highway looking upstream.

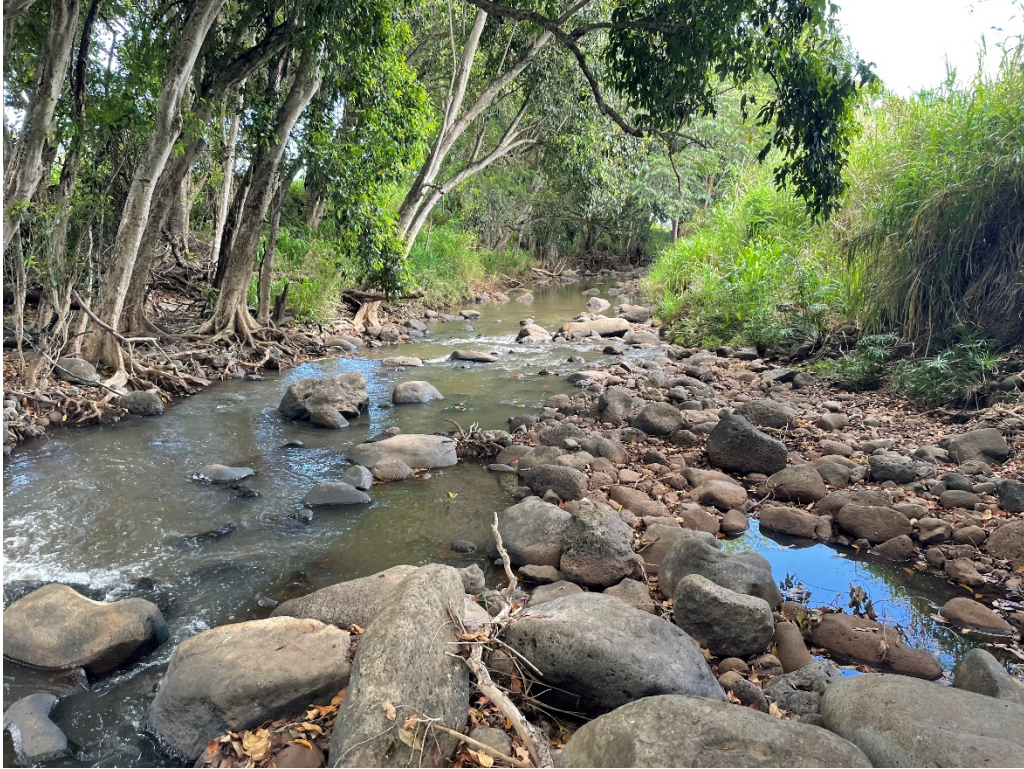
Figure 9. Site 3 looking downstream.

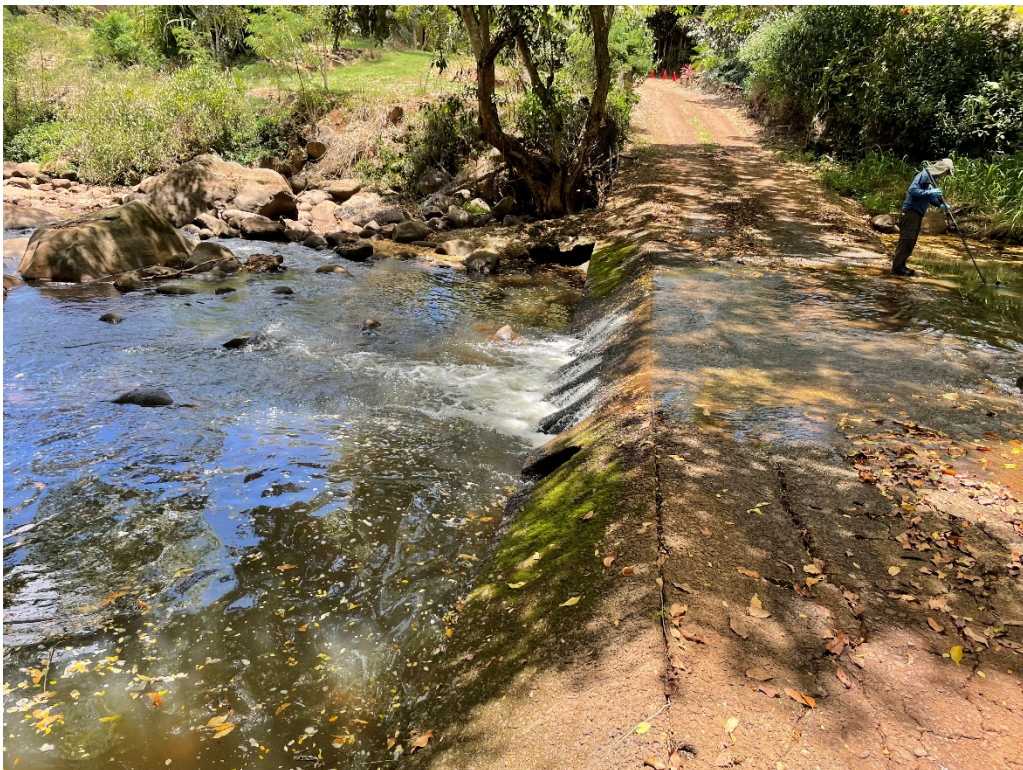
Figure 12. Site 4 road crossing with Glenn conducting HDFS survey.

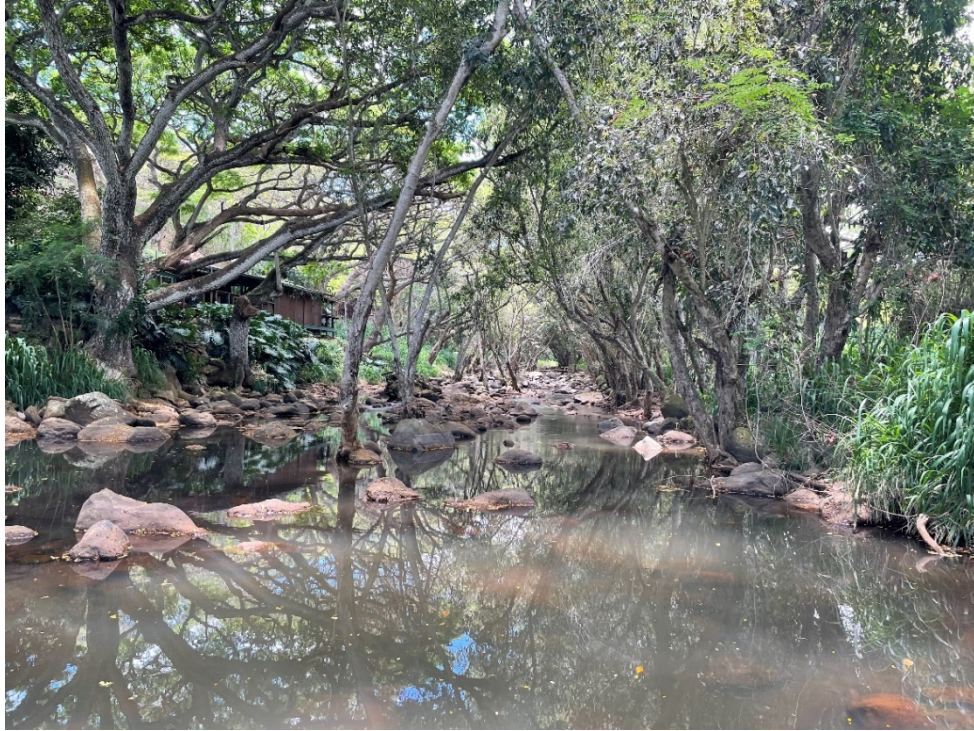
Figure 13. Site 4 looking upstream from road crossing.

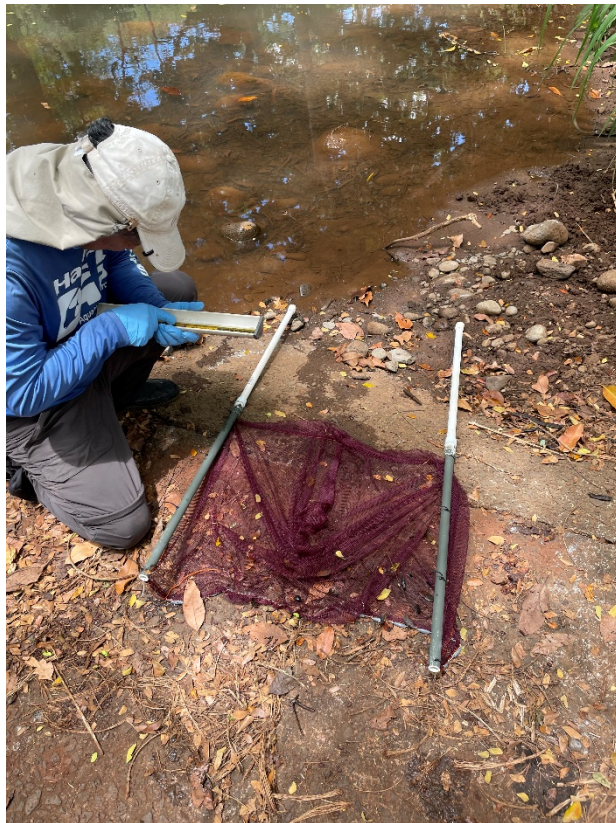
Figure 14. Site 4 with Glenn measuring a juvenile o'opu nakea caught with the opae net.

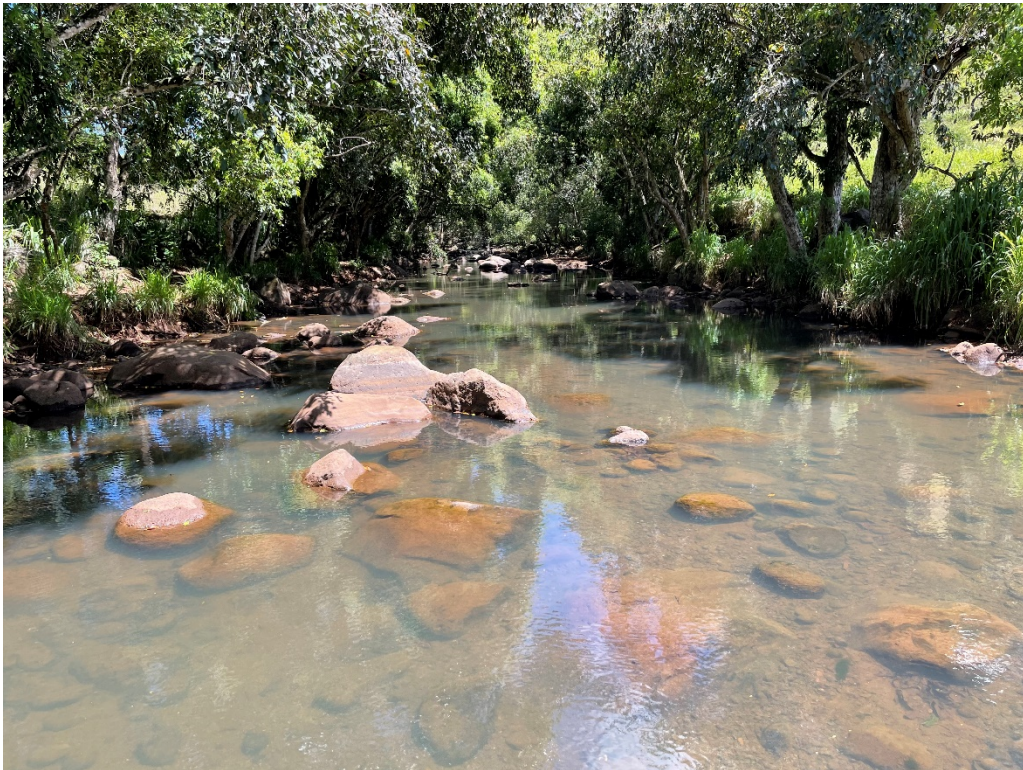
Figure 16. Site 5 with upstream view. Note improvement on water clarity.

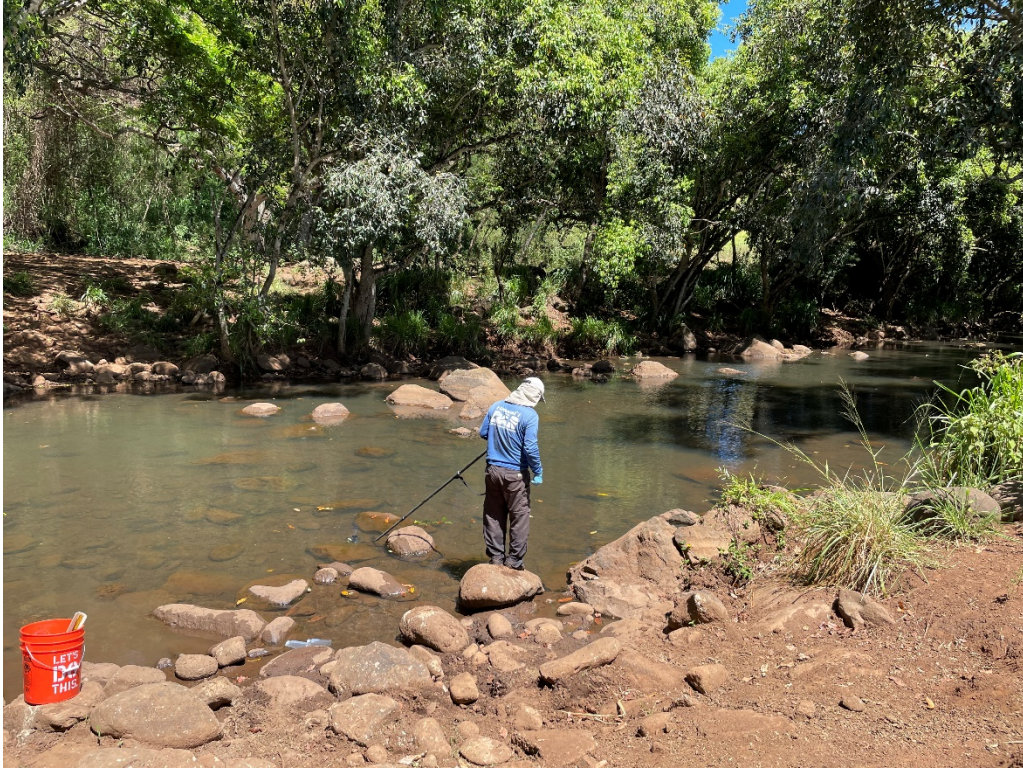
Figure 17. Glenn conducting HDFS survey at Site 5.

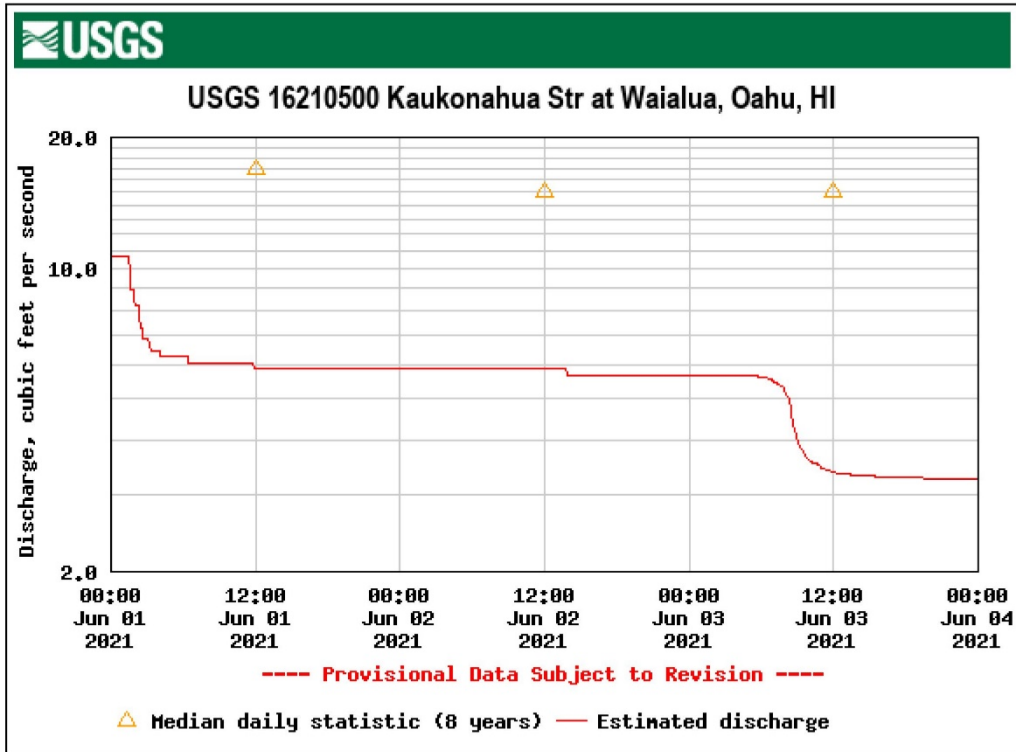
Figure 20. Streamflow from USGS 16210500 stream gage at Waialua, Oahu.

For the week leading up to the survey, water released below Wahiawa Reservoir into Kaukonahua Stream ranged from 8.5 cubic feet per second (cfs) to 25 cubic feet per second (cfs). Streamflow on June 2 was 10.6 cfs until the flow was reduced at 13:30 to 3.76 cfs. The reduction in flow did not affect the surveys at sites 1-4, as the reduced flow had not reached these downstream locations until after the surveys were completed. However, at survey site 5, streamflow had declined noticeably by the time the survey was completed.

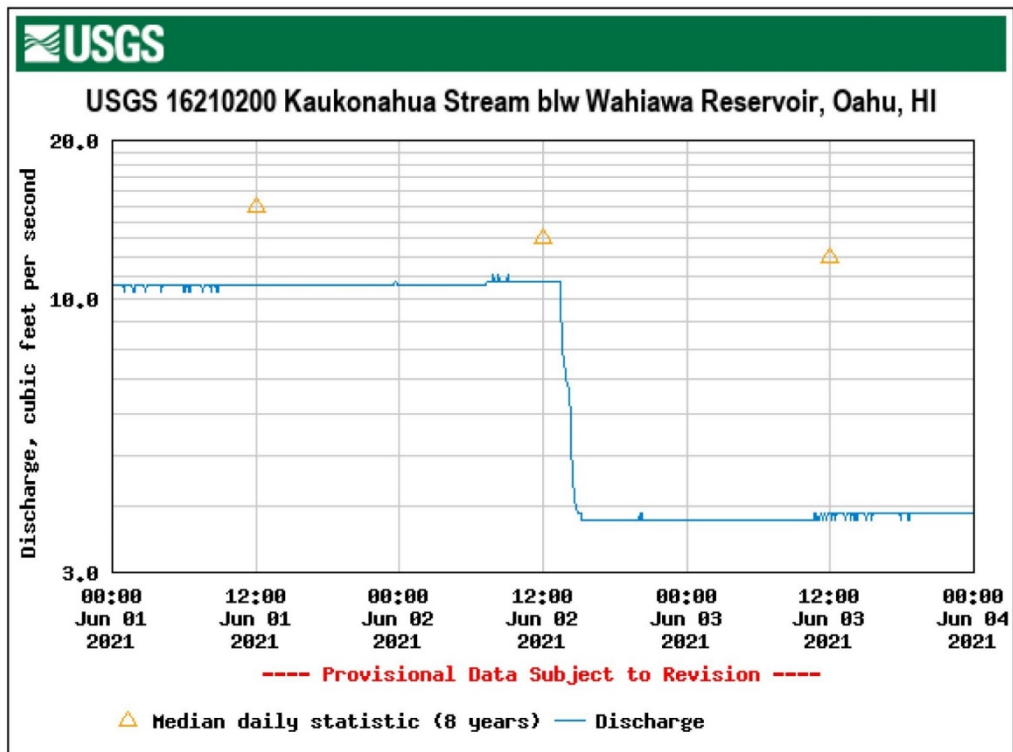
Figure 21. Streamflow from USGS 16210200 stream gage below Wahiawa Reservoir, Oahu.
