**STATE OF HAWAII
DEPARTMENT OF LAND AND NATURAL RESOURCES
OFFICE OF CONSERVATION AND COASTAL LANDS
Honolulu, Hawaii**

REGARDING: Conservation District Use Application (CDUA) MA-3633
Stable Road Beach Restoration Project

APPLICANT: Stable Road Beach Restoration Foundation, Inc.

LOCATION: Spreckelsville Beach Lots, Wailuku, Mau`i
Submerged Land Makai of TMKs: (2) 3-8-002:71, 74, 77 & 78

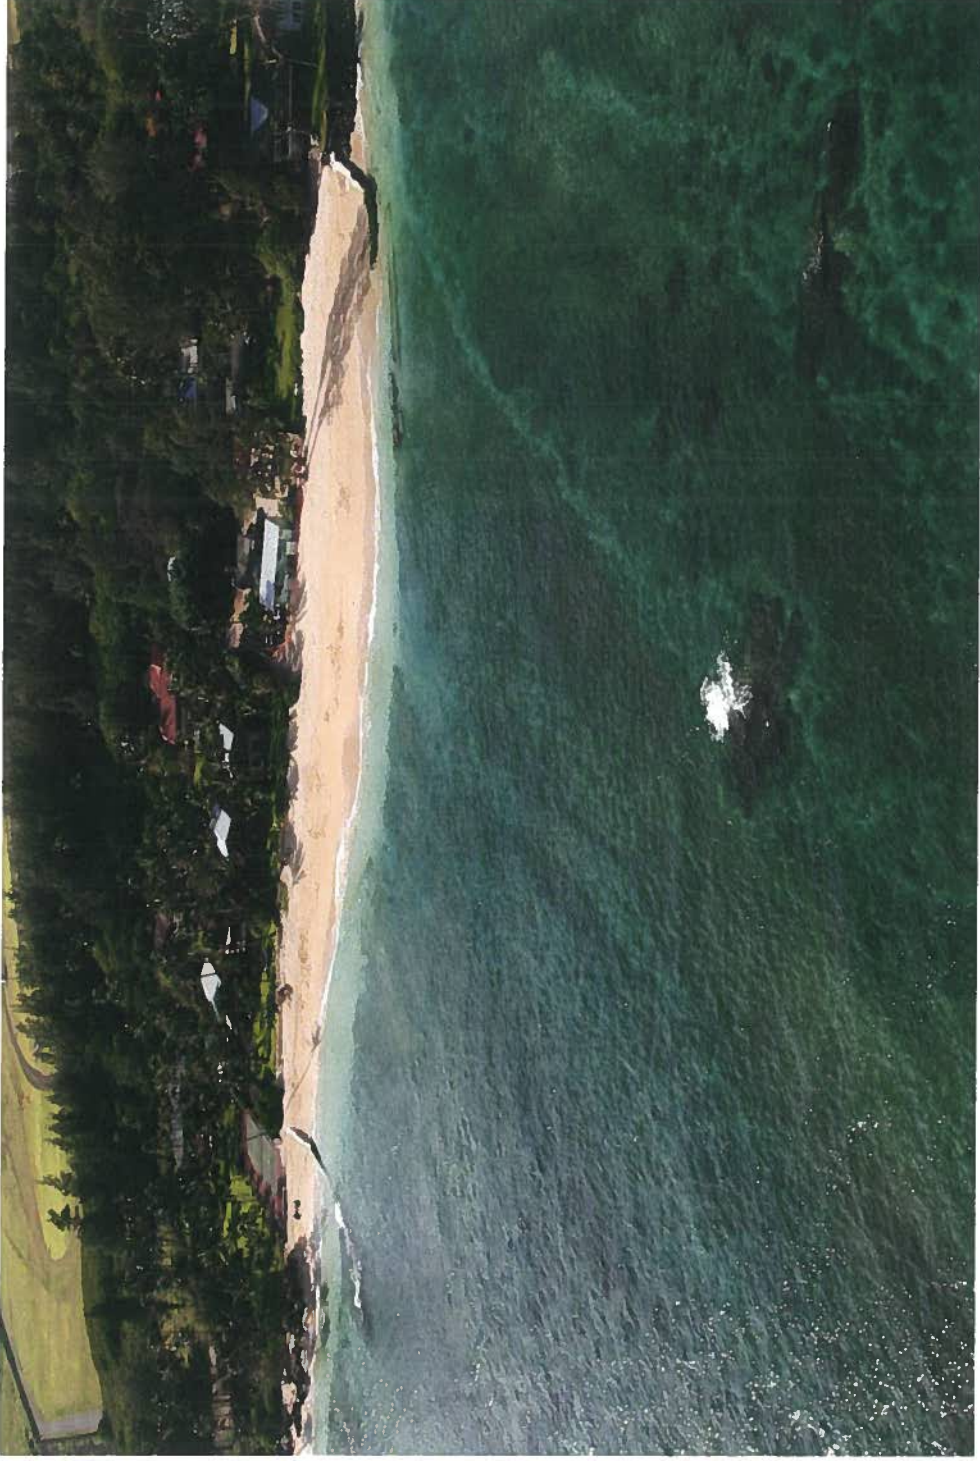
EXHIBIT I

Aerial View of Project Beach Post-Groins, 29 March 2012

2.5 years of performance monitoring indicates that the groin field has sufficiently retained beach sand during all seasons. It appears the temporary groins performed successfully during subsequent seasons retaining naturally accreted beach sand with the continuation of long shore sand transport to down drift beaches. **EXHIBIT 1**

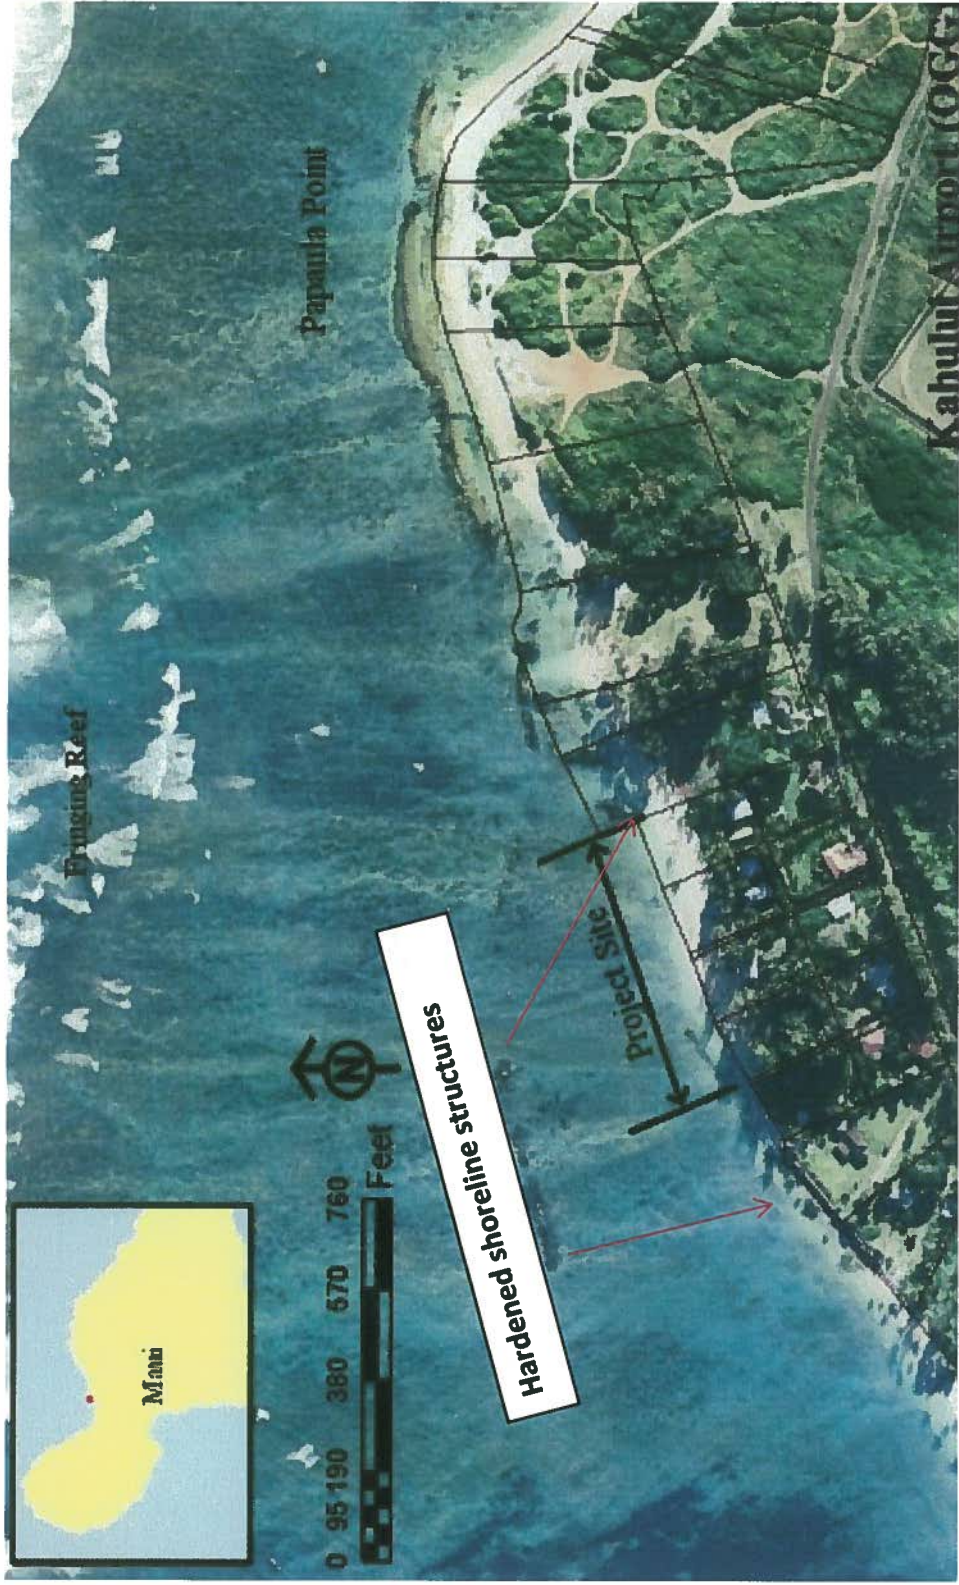
EXHIBIT 2

The Project Beach is located on the north shore of Maui, in Spreckelsville, north of the Kahului Airport (see Figure 1).

Figure 1- Project Location/Area Map

The project site is approximately (\approx) 600 feet long and averages 84-feet wide containing \approx 50,000-ft² of beach sand to the mean sea level. The land behind the beach is developed with seven oceanfront residences. The residential lots consist of sandy soils with clay soil layers. When this land erodes due to beach processes, the land drops into the ocean. The beach site is flanked on each end with existing, hardened shoreline structures. **EXHIBIT 2**

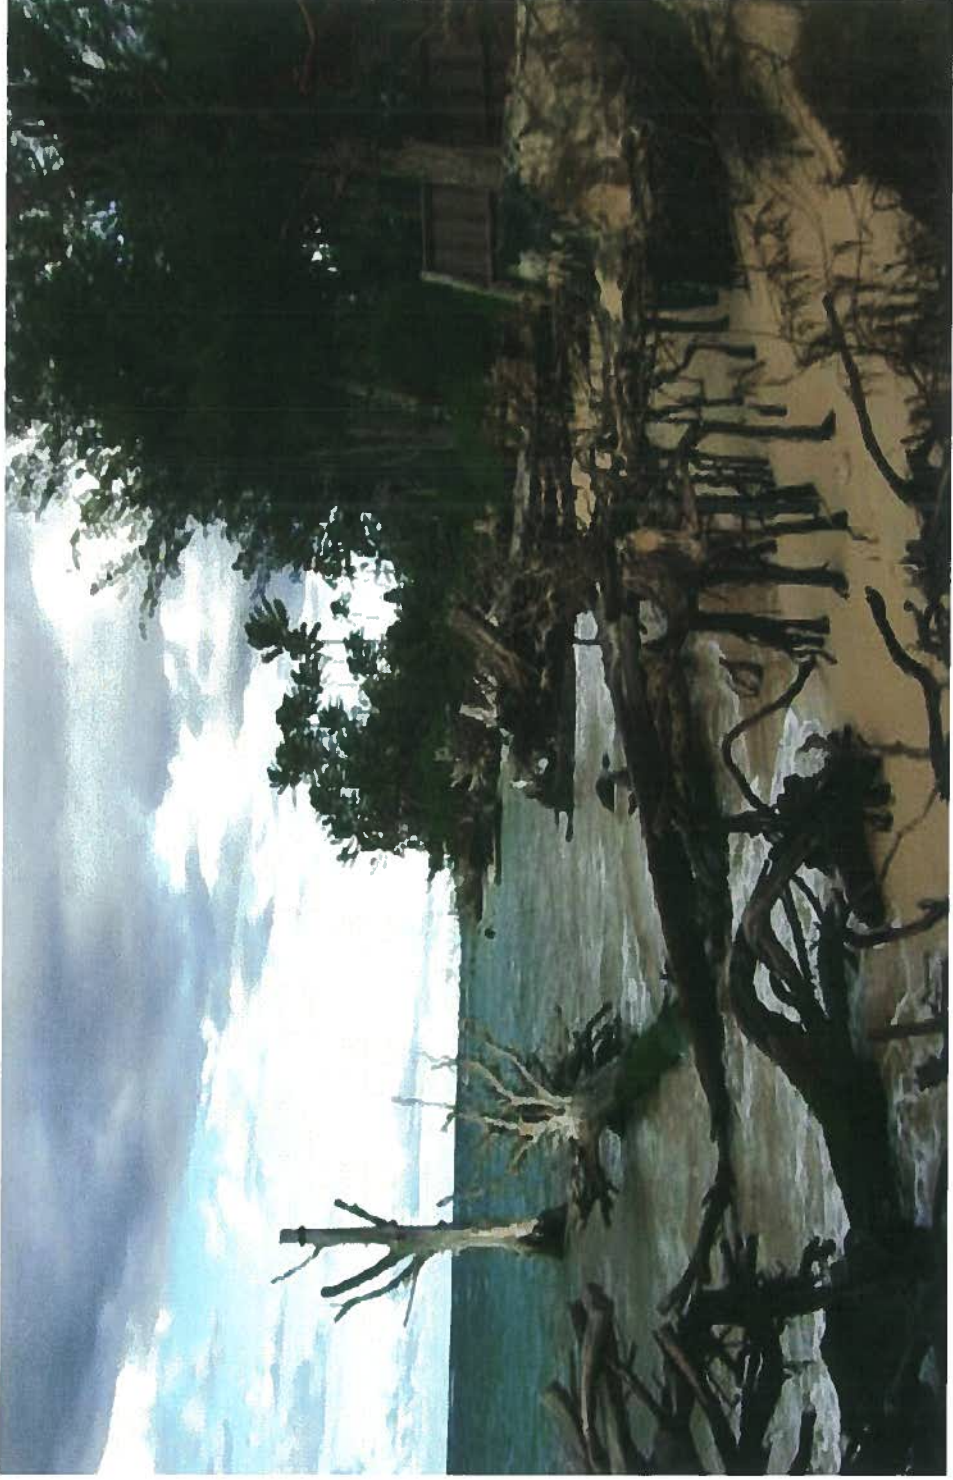
EXHIBIT 4

Beach and Land Erosion Pre - Groins at Project Beach Looking East, 22 August 2006

In 2006, the site started experiencing higher than previous historic rates of beach erosion and land loss exposing upland banks, felling trees and vegetation, releasing sediment in the near shore that increased turbidity and impaired water quality. Long term erosion rates as calculated by the UH Coastal Geology Group vary between 1.0 and 1.5 feet per year. Accordingly, the measured long-term erosion rates indicate that erosion experienced at the site is not temporary or localized. Seasonal high surf can threaten the properties even when the winter beach is at its widest. **EXHIBITS 3 & 4**

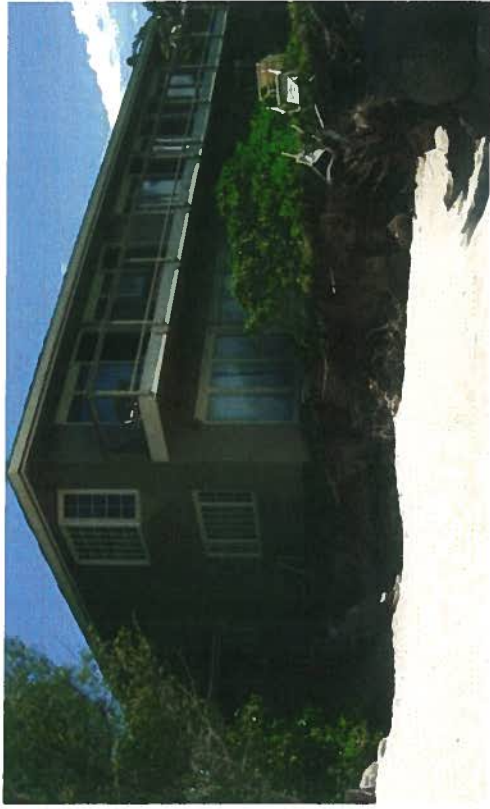
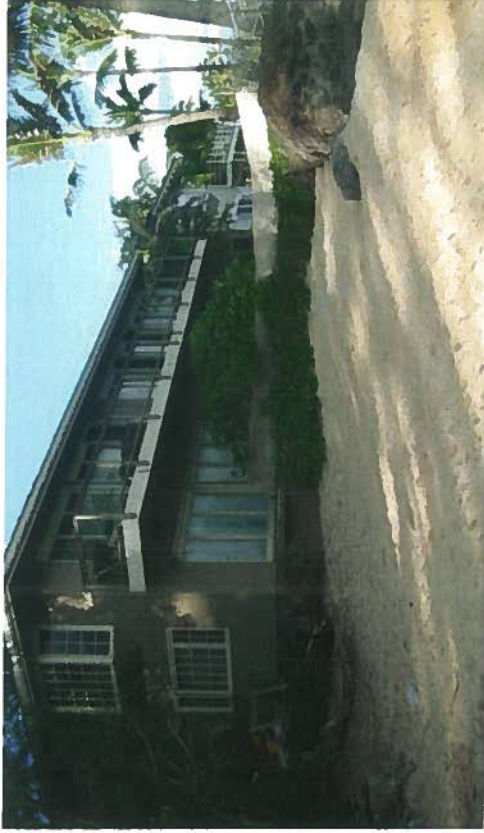
Pre- and Post-Groins Condition at West End of Project Beach, 23 August 2010 and 25 August 2012

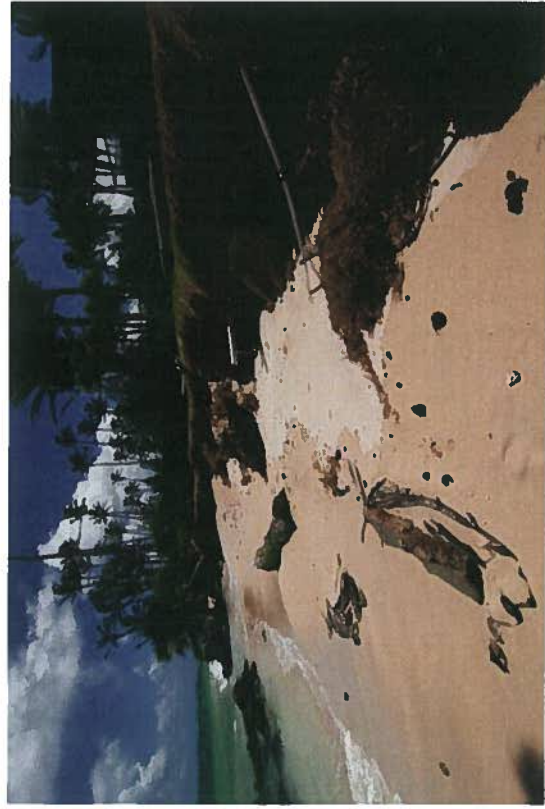
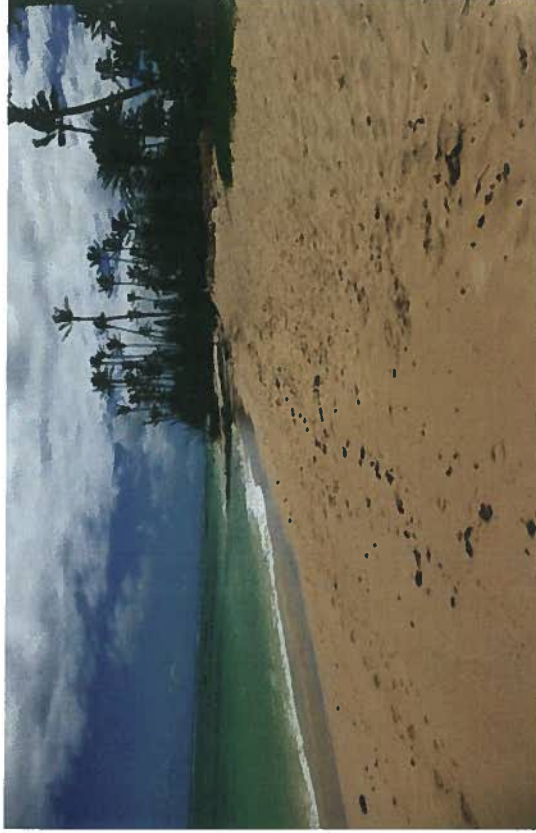
Pre- and Post-Groins Condition at East End of Project Beach, 4 August 2009 and 6 August 2012

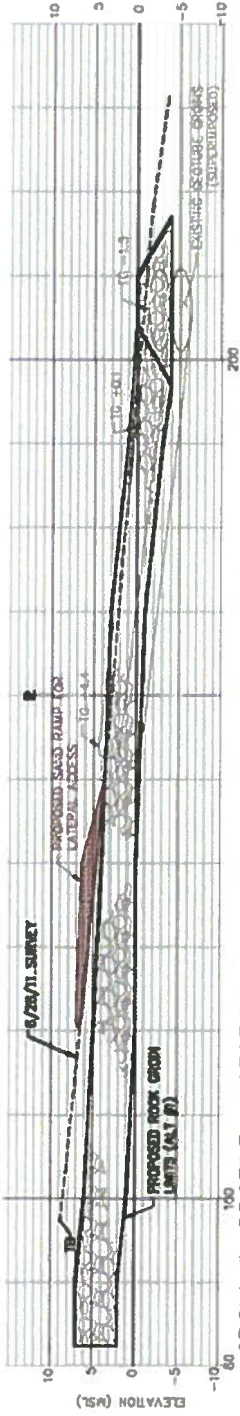
GROIN #1 PROFILE -- SECTION 6
SCALE 1 in. = 10 ft.

The pyramid-shaped replacement groin's exposed length will be significantly less than their actual length as the landward ends are to be buried below the level of the land bank with excavated sand creating a sand ramp over the groin providing lateral beach access and to reduce the apparent groin size and visibility. The mid-section of each groin will be slightly above the beach sand level and slope down along the beach profile and extend into and below sea level. The groins will be low enough to allow waves and water at high tides to flow over and through gaps allowing sediment transport.

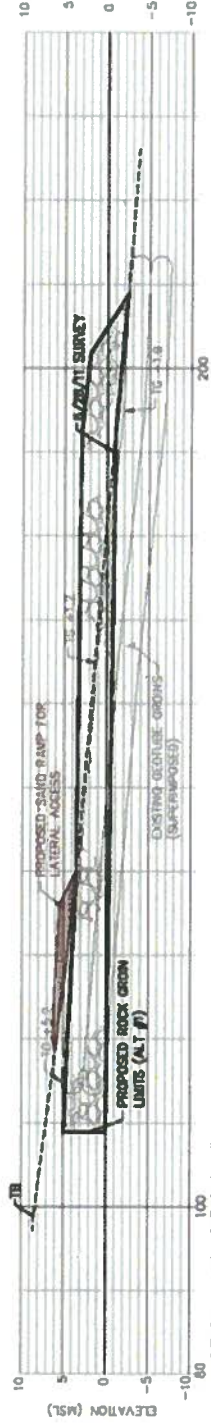
GROIN #2 PROFILE -- SECTION 7
SCALE 1 in. = 10 ft.

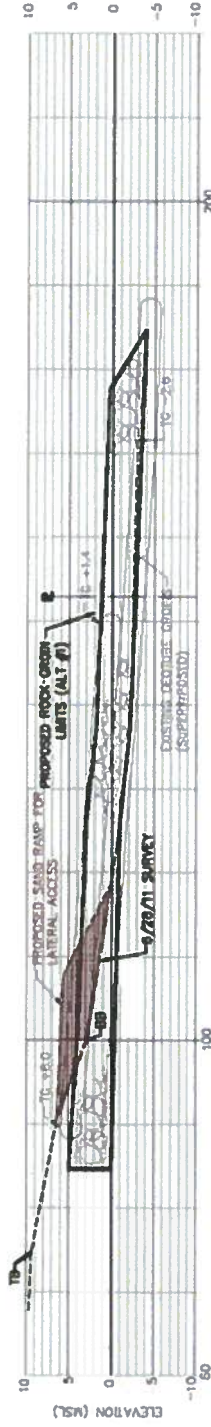
GROIN #3 PROFILE -- SECTION 9
SCALE 1 in. = 10 ft.

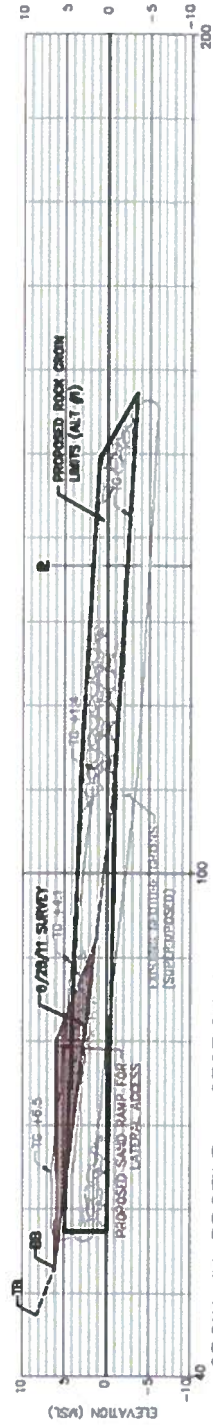
GROIN #4 PROFILE -- SECTION 11
SCALE 1 in. = 10 ft.
