SUBJECT: Enforcement Action against Richard Stewart for Alteration of historic properties during the course of land alteration activities without a permit. Kalaoa Ahupa'a, North Kona Moku, Island of Hawaii
TMK: (3) 7-3-005:015

FIELD REPORT: March 25, 2013, TMK (3) 7-3-005:015

SUBJECT: Report on March 11, 2013 Site Visit in Response to Complaints of Bulldozing Historic Sites.
Kalaoa Ahupua'a, North Kona District, Hawaii Island,
TMK (3) 7-3-005:015

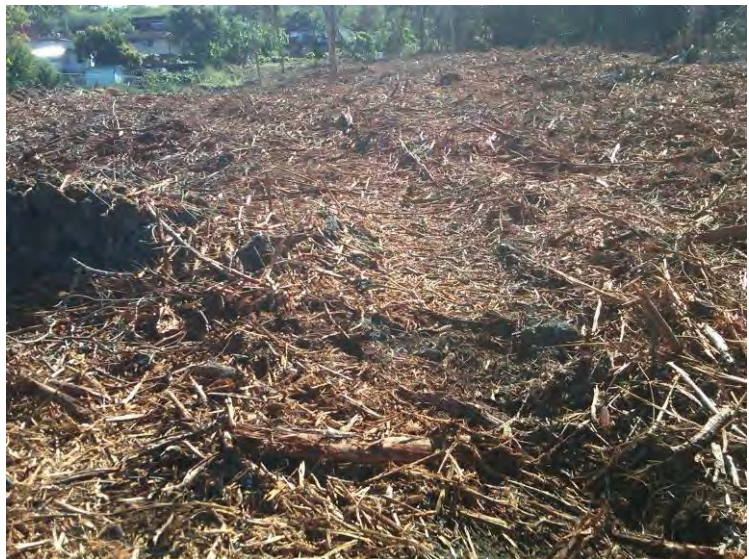
Vitousek observed that there had been extensive land clearing activities in the subject area. As a result, a layer of wood chips, broken branches, leaves, and other organic debris covered the ground throughout the area. This thick layer of debris severely limited ground visibility in this area. Vitousek conducted a limited pedestrian survey of the subject parcel without the use of formal transects. When historic properties were encountered they were minimally cleared of debris and assessed for recent impacts. Historic properties that had been impacted were further cleared of debris and photographed.

Figure 2. Overview of land clearing activities on subject property. View to NE

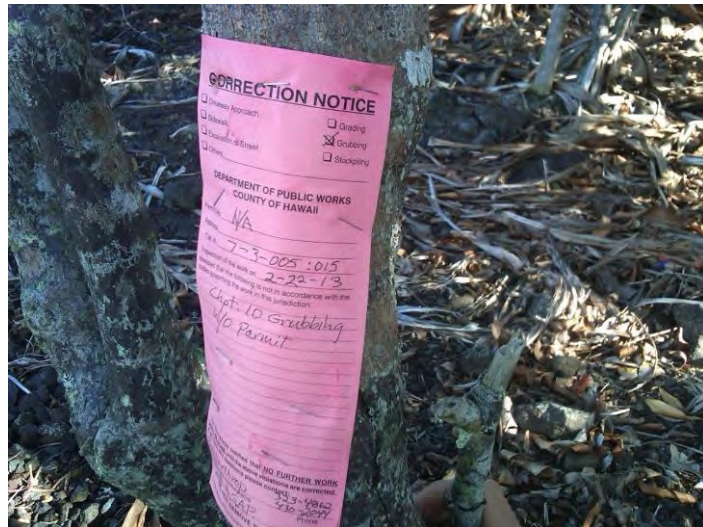
The land clearing activities on the subject property were carried out without a County of Hawaii grubbing permit. Figure 3 shows a County of Hawaii correction notice that was posted at the subject property, which indicates that a County of Hawaii grubbing permit was, in fact, needed for the land clearing activities that were carried out at the subject parcel. According to **HRS §6E-42 Review of proposed projects.**

Figure 3. Correction Notice on subject property reads “Chapt. 10 Grubbing w/o Permit” View to N

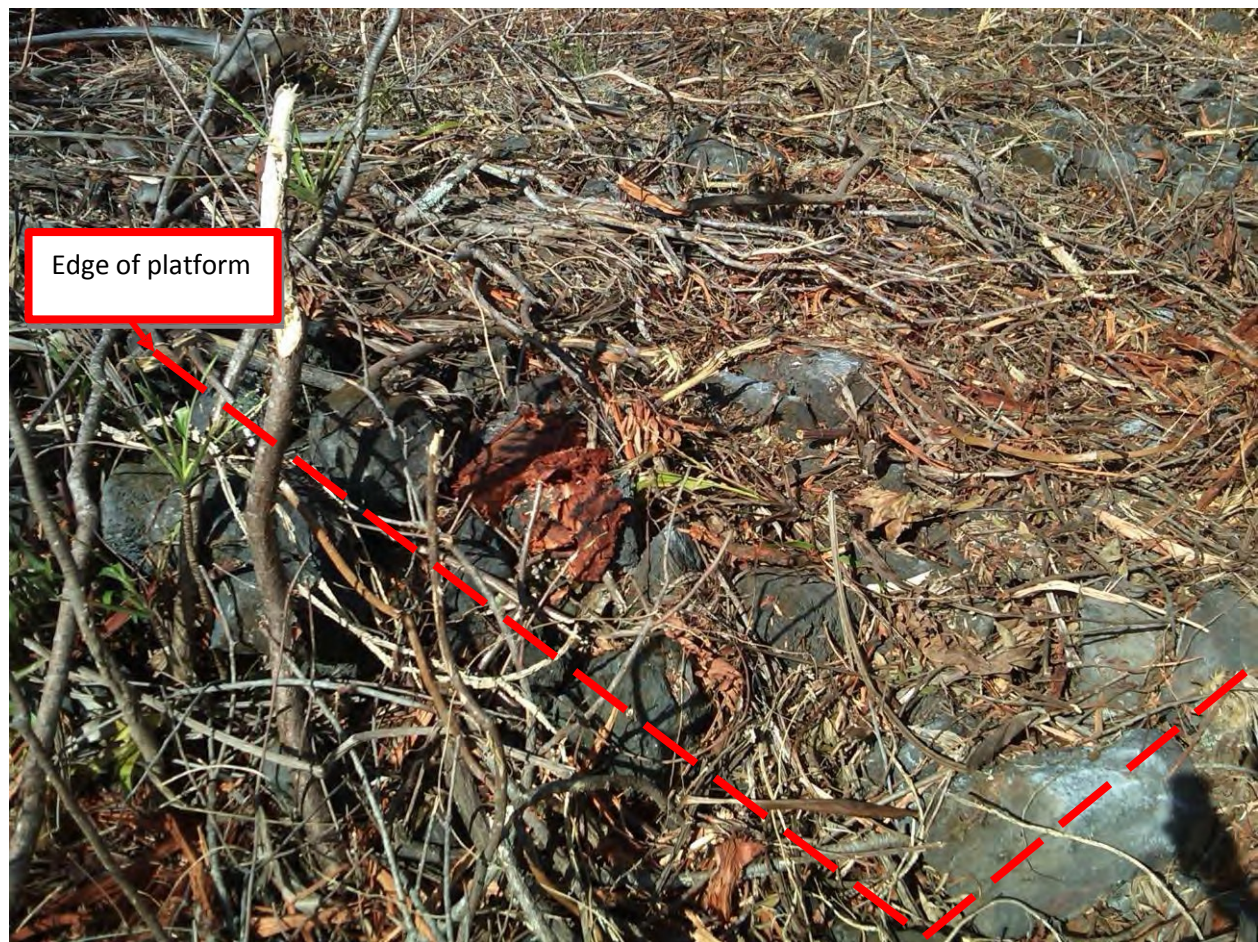
Apparent HRS § 6E-11(c) Violation #1: Alteration of Historic Stone Platform:

Figure 4. View to west. Historic platform with recent mechanical scarring.

This photograph depicts a dry stacked stone platform that is located in the makai, southwest, portion of the property. This platform is a historic property that likely represents a pre-contact or historic habitation site. Although it is obscured by the wood debris that covers the ground it is apparent that this historic property was altered by the land clearing activities. The observable alterations include recent scarring on the rocks that is likely the result of the steel track excavator passing over it. In addition, the stones that were in the face of the platform have been pushed over. This impact constitutes an alteration and destruction of a portion of the site.

1. Possible pre-contact habitation site, altered by land clearing activities. Observable alterations include recent scarring on rocks likely caused by a steel track excavator passing over it. Additionally, stones in the face of the platform were pushed over. See Exhibit A, Figure 4

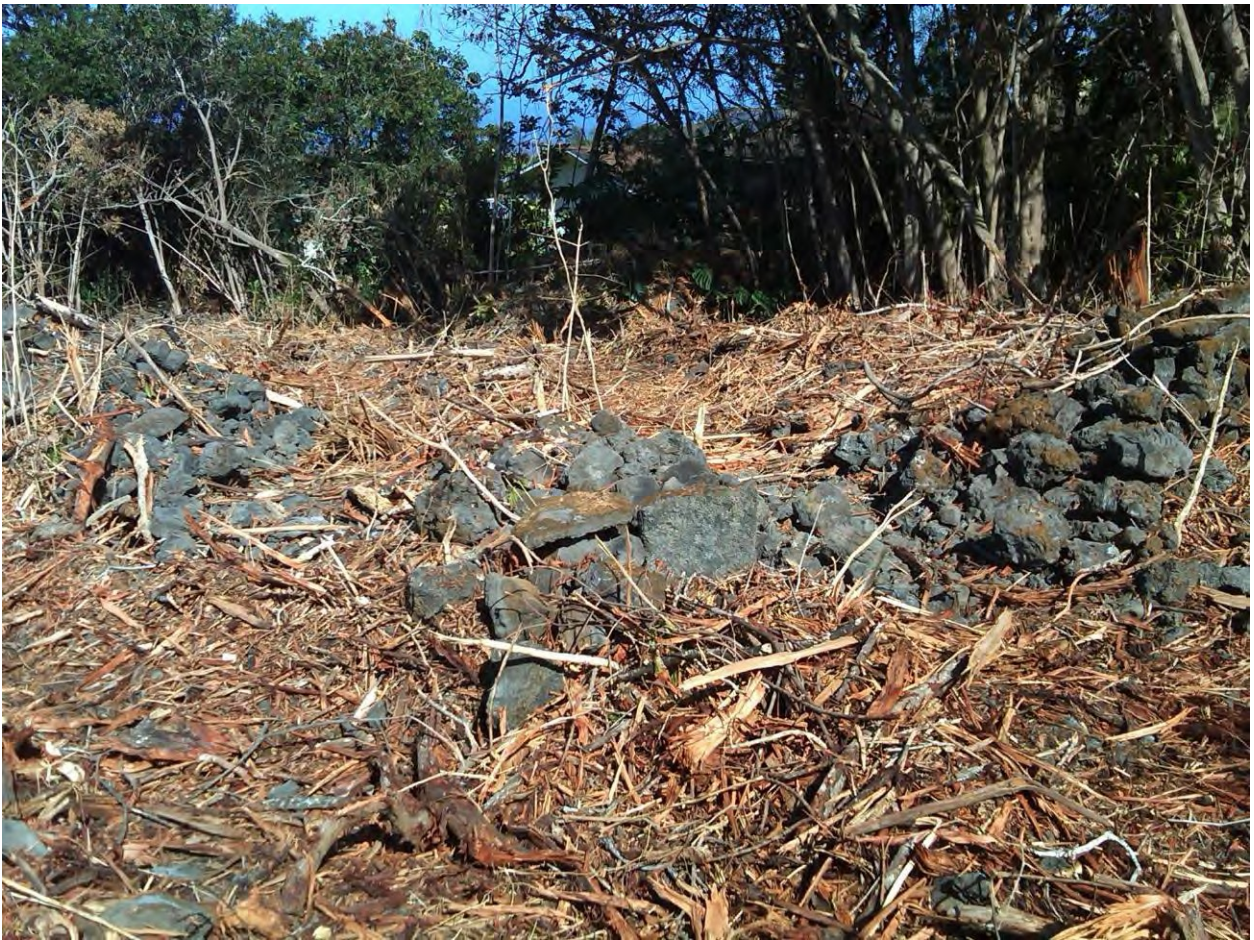
Apparent HRS § 6E-11(c) Violation #2: Impact to Large Enclosure

Figure 5. View to NW. Corner of the historic enclosure where the excavator breached the wall

This is a photo of the corner of a large dry stacked stone enclosure that is located in the makai northwest corner of the subject parcel. It appears as though this is the location where the steel track excavator breached the wall in order to clear the land within the enclosure. As figure 5 indicates, there are two large depressions in the wall where the tracks of the excavation passed over the wall. These two sections of the wall have been reduced to rubble. It is apparent that this is a recent impact because the intact portions of the wall have a layer of moss covering it, and the disturbed portions have no moss growth. This enclosure was significantly altered by the passage of heavy machinery through the wall during land altering activities.

2. Large dry-stacked stone enclosure located in the makai northwest corner of the subject parcel. There are two large depressions in the wall where the excavator appears to have passed over the wall to enter the enclosure. The stones in the area of the depressions have been reduced to rubble. It was apparent to the archaeologist that the walls had been recently impacted because the intact portions of the wall had a layer of moss covering them, and the disturbed portions did not. This site was significantly damaged. See Exhibit A, Figure 5.

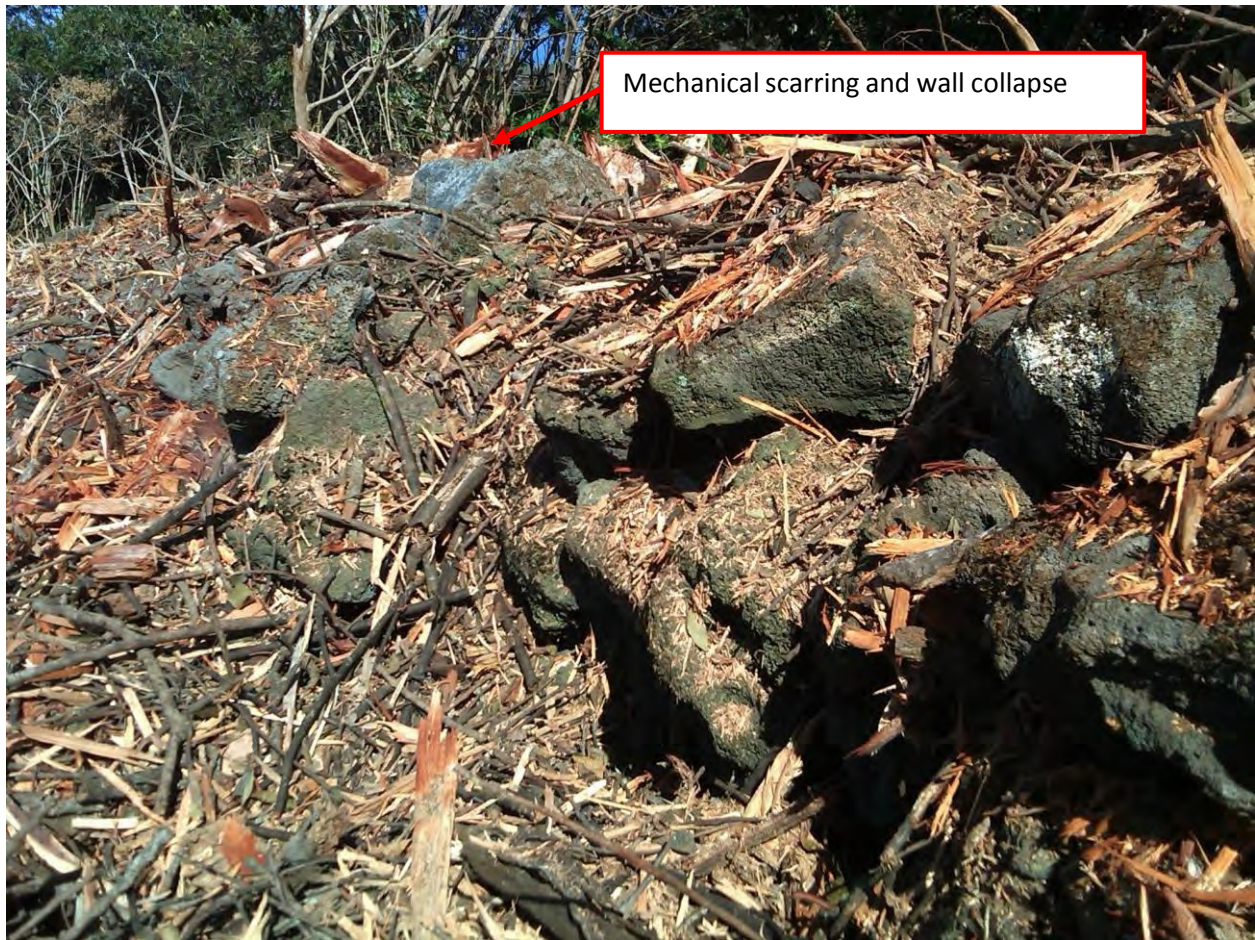
Apparent HRS § 6E-11(c) Violation #3: Impact to Historic Wall

Figure 6. View to NW. Impact to historic wall.

This is a photo of a historic dry-stacked stone wall located in the lower northern portion of the property. This photograph shows an intact portion of the wall in the foreground, with an impacted area in the background. The impacted section has mechanical scarring, and the faced portion of the wall has collapsed. This impact likely constitutes an alteration or and damage to this historic property.

3. Impact to historic dry-stacked rock wall. Faced portion of the wall has collapsed. Rocks show mechanical scarring. See Exhibit A, Figure 6.

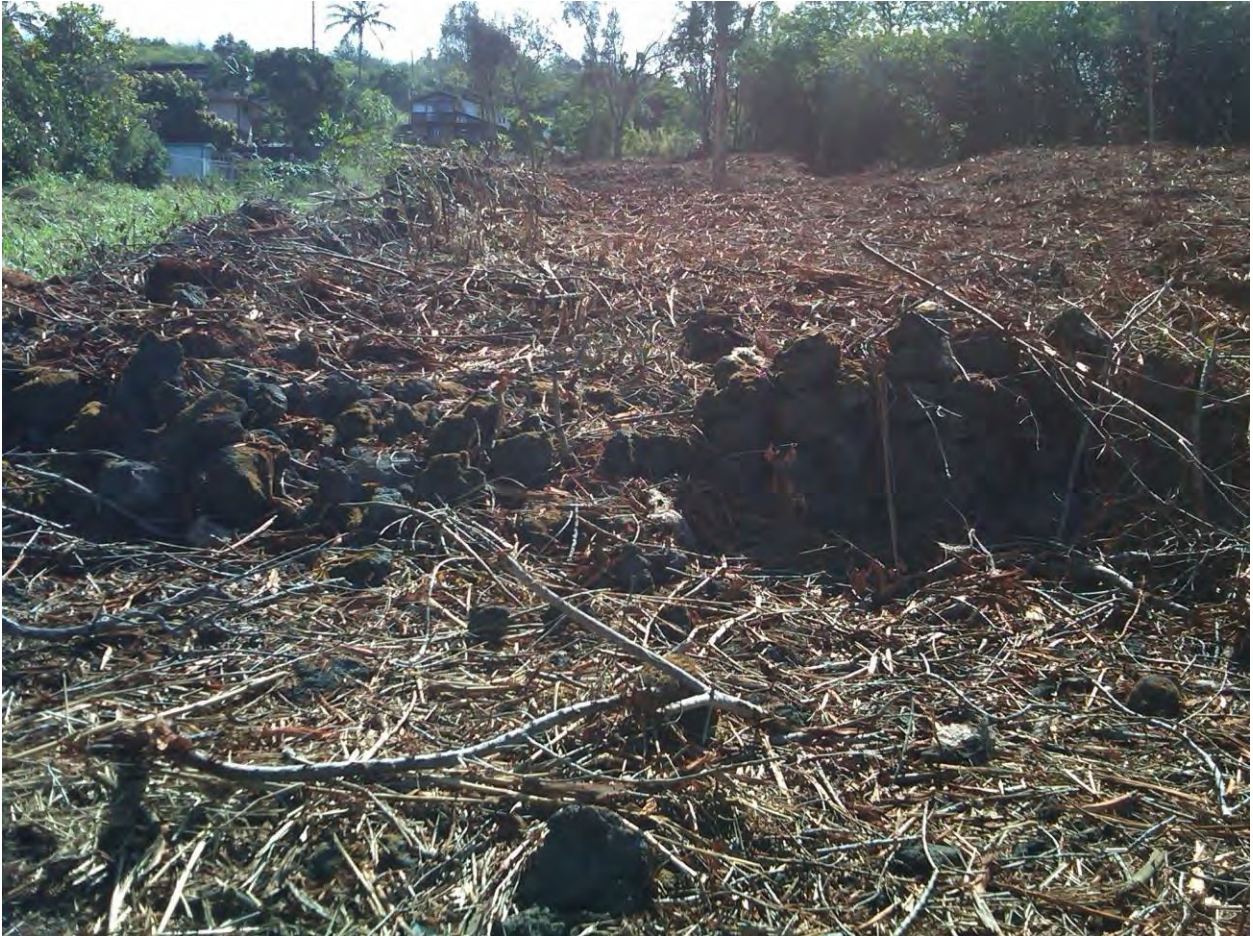
Apparent HRS § 6E-11(c) Violation #4: Impact to Historic Wall

Figure 7. View to East. Impact to historic rock wall

The photograph indicates a separate incident of impact to another historic dry-stacked stone wall located in the lower to middle and northern portion of the property. This photograph shows an intact portion of the wall on the right side of the photo with a disturbed portion on the left. The scattered mixture of dozer scarred and moss covered stones on the left represent the collapsed remnant of the stone wall that was likely impacted by the described land altering activities.

4. Impact to historic rock dry-stacked rock wall resulting in the partial collapse of the wall. Rocks show mechanical scarring. Non-impacted rocks are moss covered. See Exhibit A, Figure 7.

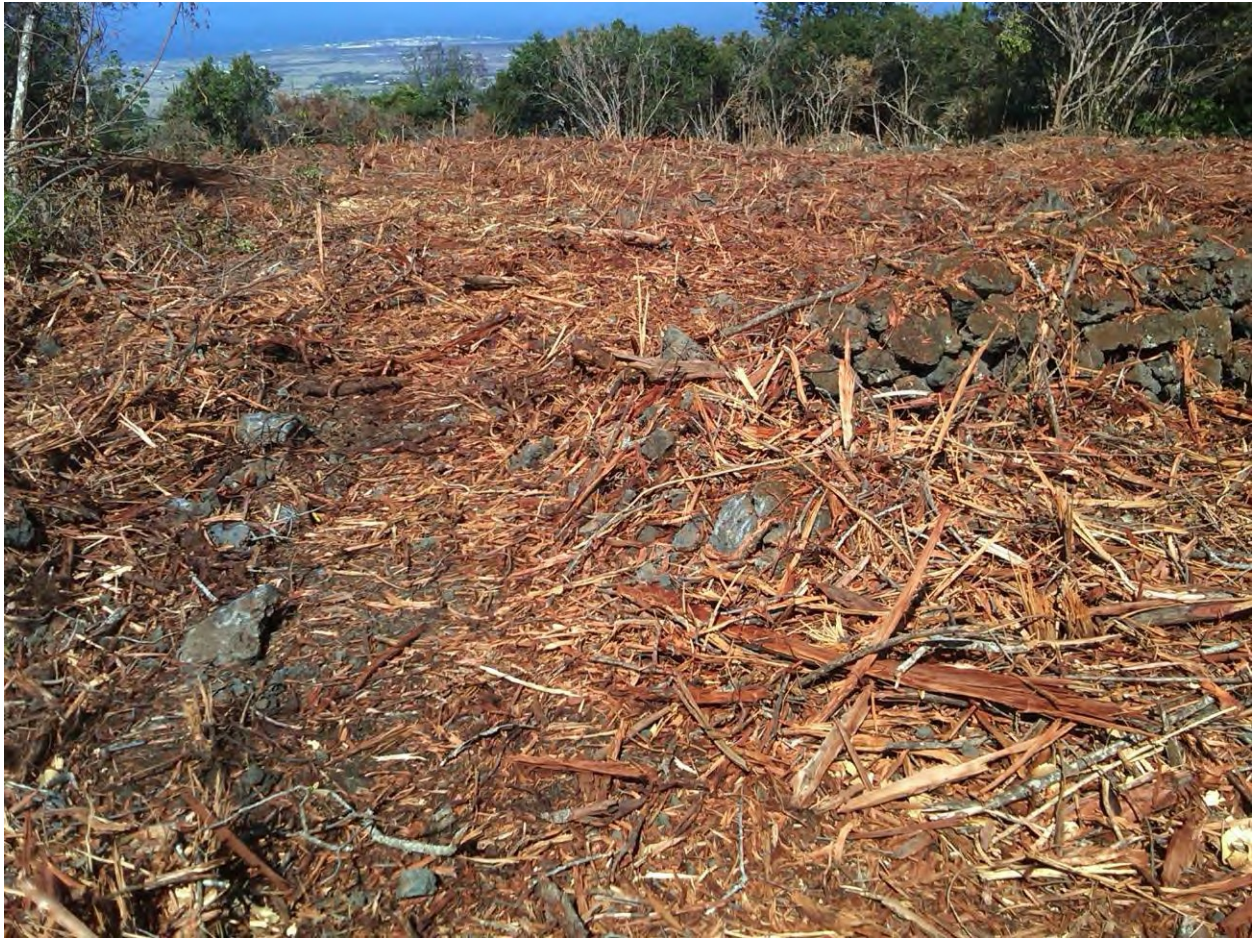
Apparent HRS § 6E-11(c) Violation #5: Impact to Historic Wall

Figure 8. View to West. Impacts to historic wall

This photo indicates the location where another historic wall was impacted by the mechanical land clearing activities. This impacted segment is in the mid-level on the southern portion of this property. This photograph indicates an intact portion of the wall on the right side with a completely destroyed section of the wall on the left. The mechanical scarring and track marks in the destroyed section indicate that this is the area where the excavator breached this historic wall. This impact likely constitutes the destruction of a portion of this property.

5. Impact to historic rock wall. Wall is collapsed where excavator completely destroyed a section of the wall. See Exhibit A, Figure 8.

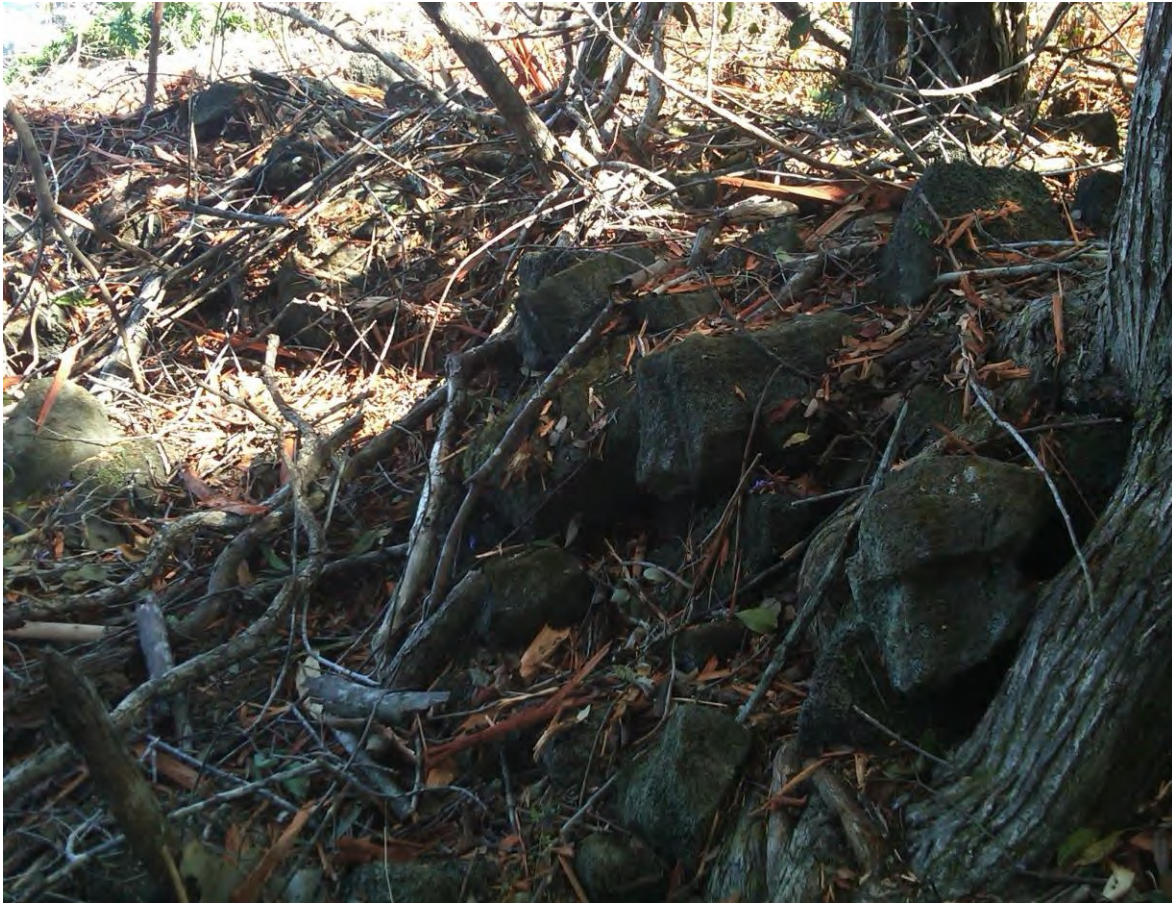
Apparent HRS § 6E-11(c) Violation #6: Impact to Historic Wall

Figure 9. View to NE. Impact to historic retaining wall in background with unaltered portion in foreground

This photograph represents yet another example of a historic, dry-stacked, stone wall that was altered by the land clearing activities on this parcel. This photo shows an unaltered portion of the wall in the foreground with an altered and collapsed portion of the wall in the background. Although it is obscured by wood chips and debris, mechanical scars were visible on the collapsed portion of the wall. Given the absence of track marks or a large breach in the wall, it is likely that this section of the wall was damaged by the mechanical arm of the excavator.

6. Impact to pre-contact dry stacked retaining wall. Partial wall collapse is probably caused by mechanical arm of the excavator. See Exhibit A, Figure 9.

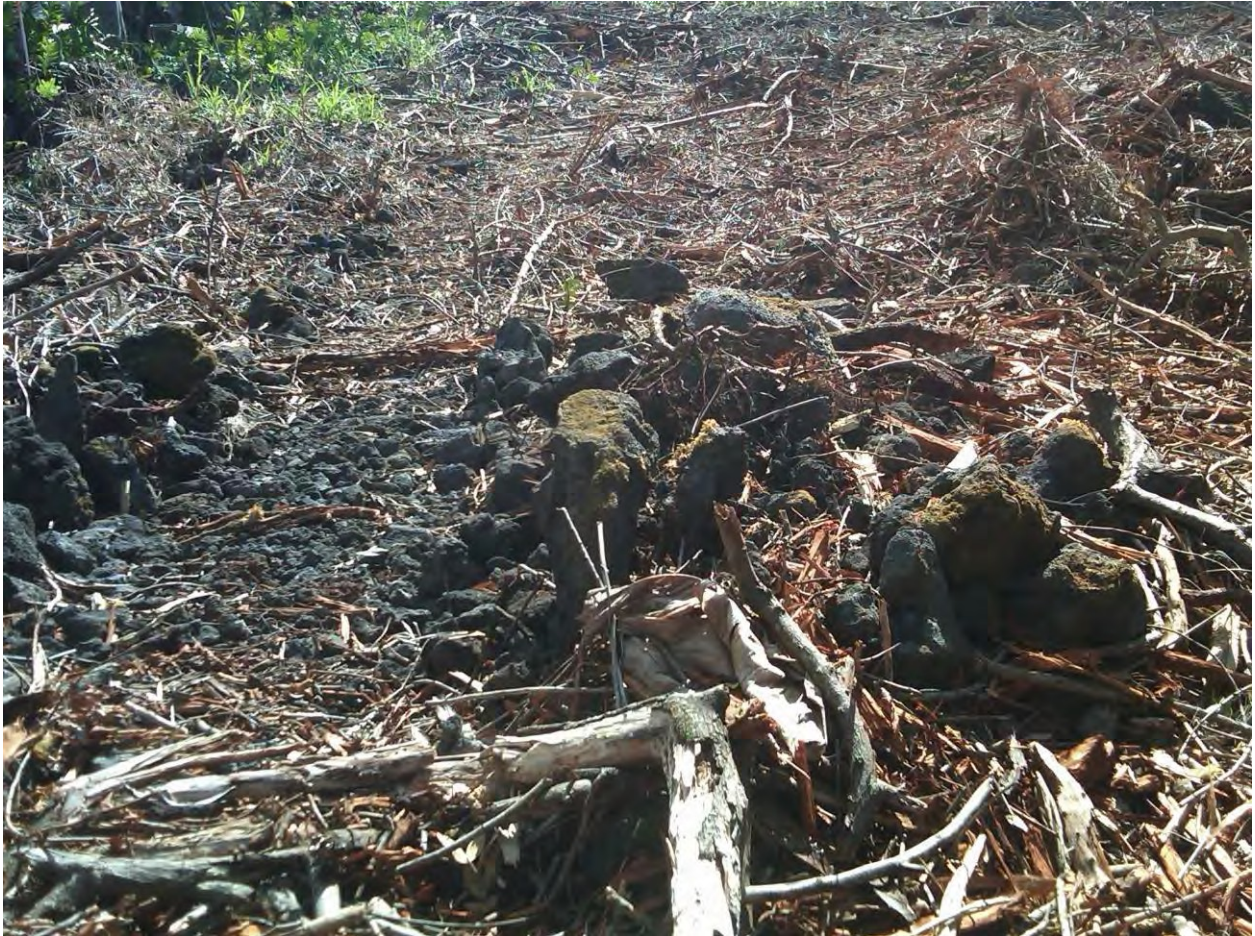
Apparent HRS § 6E-11(c) Violation #7: Alteration of Historic Agricultural Mound

Figure 10. View to East. Destruction of Historic Mound

This photograph displays the remnants of what was likely a pre-contact or historic agricultural clearing mound located in the upper northern portion of this property. The photograph clearly indicates where a track of the excavator passed directly over this agricultural mound and flattened it out. The intact portion of the mound that was missed by the excavator is visible on the right side of the photograph.

7. Destruction of Pre-contact agricultural mound. Excavator ran over the mound and flattened it. See Exhibit A, Figure 10.

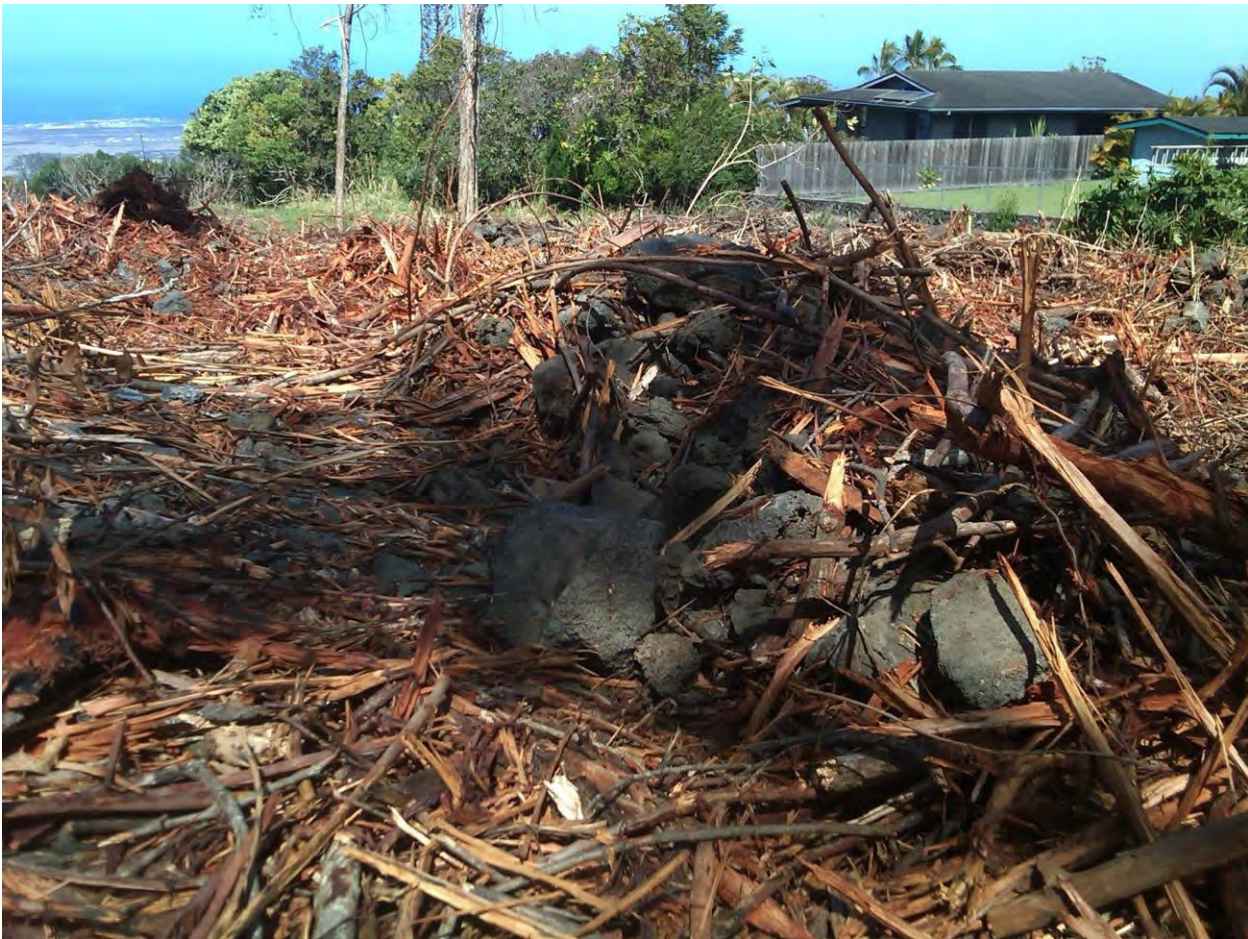
Apparent HRS § 6E-11(c) Violation #8: Alteration of Historic Agricultural Mound

Figure 1. View to West. Destruction of Historic Mound

This photograph depicts the alteration of a separate a pre-contact/historic agricultural clearing mound that is located in the upper northern portion of this property. The photograph also clearly indicates where a track of the excavator passed directly over this agricultural mound and destroyed a portion of it. The intact portion of the mound that was missed by the excavator is visible on the right side of the photograph. The area of impact shows recent mechanical scarring and track marks.

8. Destruction of a Pre-contact agricultural mount. Excavator ran through the mound and destroyed a large segment of it. See Exhibit A, Figure 1.
