SUBJECT: Chapter 343, Hawaii Revised Statutes
Draft Environmental Assessment (DEA)

Project: Krueger Residence Seawall Modification and Repair
Applicants: David and Terri Krueger
Agent: G70 (Jeff Overton)
Location: 1226A Mokulua Drive - Kailua
Tax Map Key: 4-3-005: 056
Request: Shoreline Setback Variance and
Special Management Area Use Permit
Chapters 23 and 25, Revised Ordinances of Honolulu

REPAIR OF EXISTING SHORE PROTECTION FOR 1226A MOKULUA DRIVE

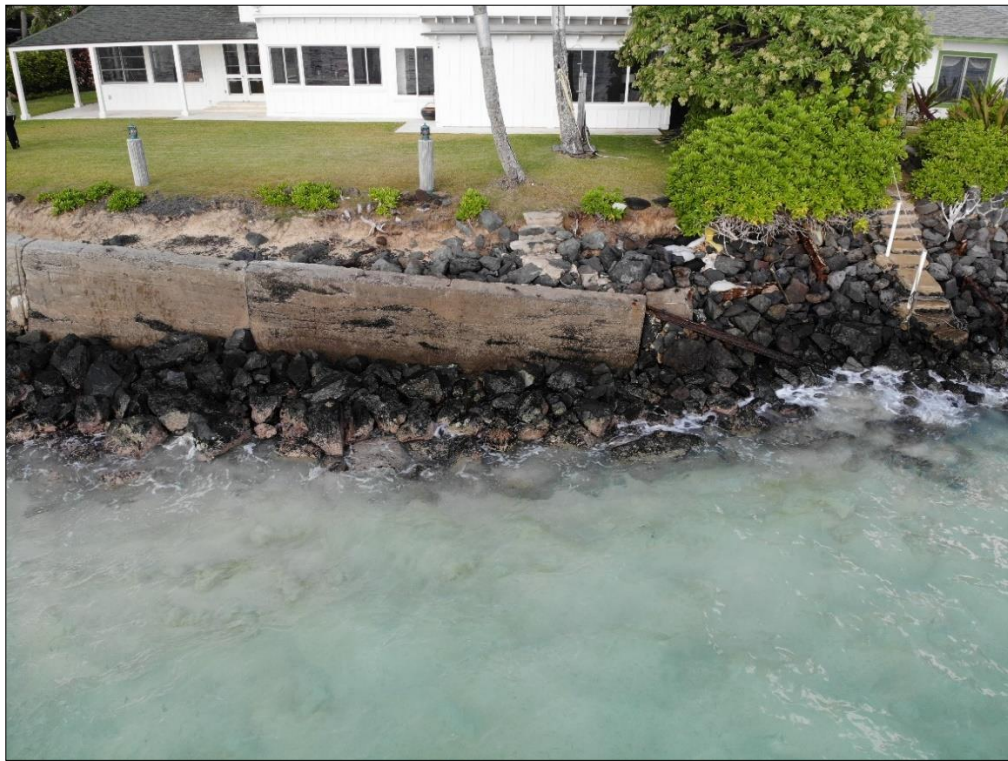
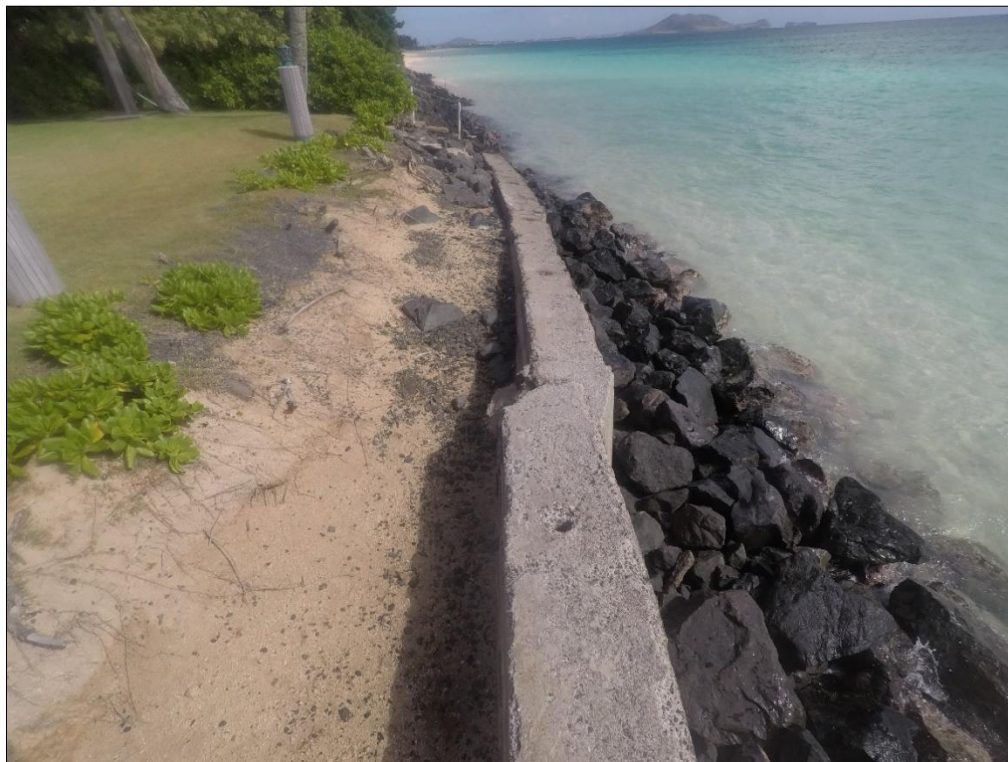
Figure 2-2

Existing Conditions – North End of Shoreline (SEI)

The seawall appears to have been constructed in six segments, or panels. Vertical joints are visible between each panel section. There is evidence of concrete repairs at several of the panel joints. An approximately 1 to 2-inch-wide gap was observed at the panel joint between the subject seawall and the south adjacent seawall.

Settlement was observed along the northern portion of the seawall, which is likely due to the loss of subgrade support from erosion of the underlying substrate. In the areas where settlement was observed, outward rotation of the wall has also occurred. Most noticeable failure is at the return on the north end of the seawall which has disconnected from the main wall structure. The outward rotation of the wall may be attributed to a loss of bearing support fronting the wall and/or an increase in the active lateral forces due to saturated soil conditions. See *Appendix F* for additional photos depicting the existing conditions and deterioration of the seawall.

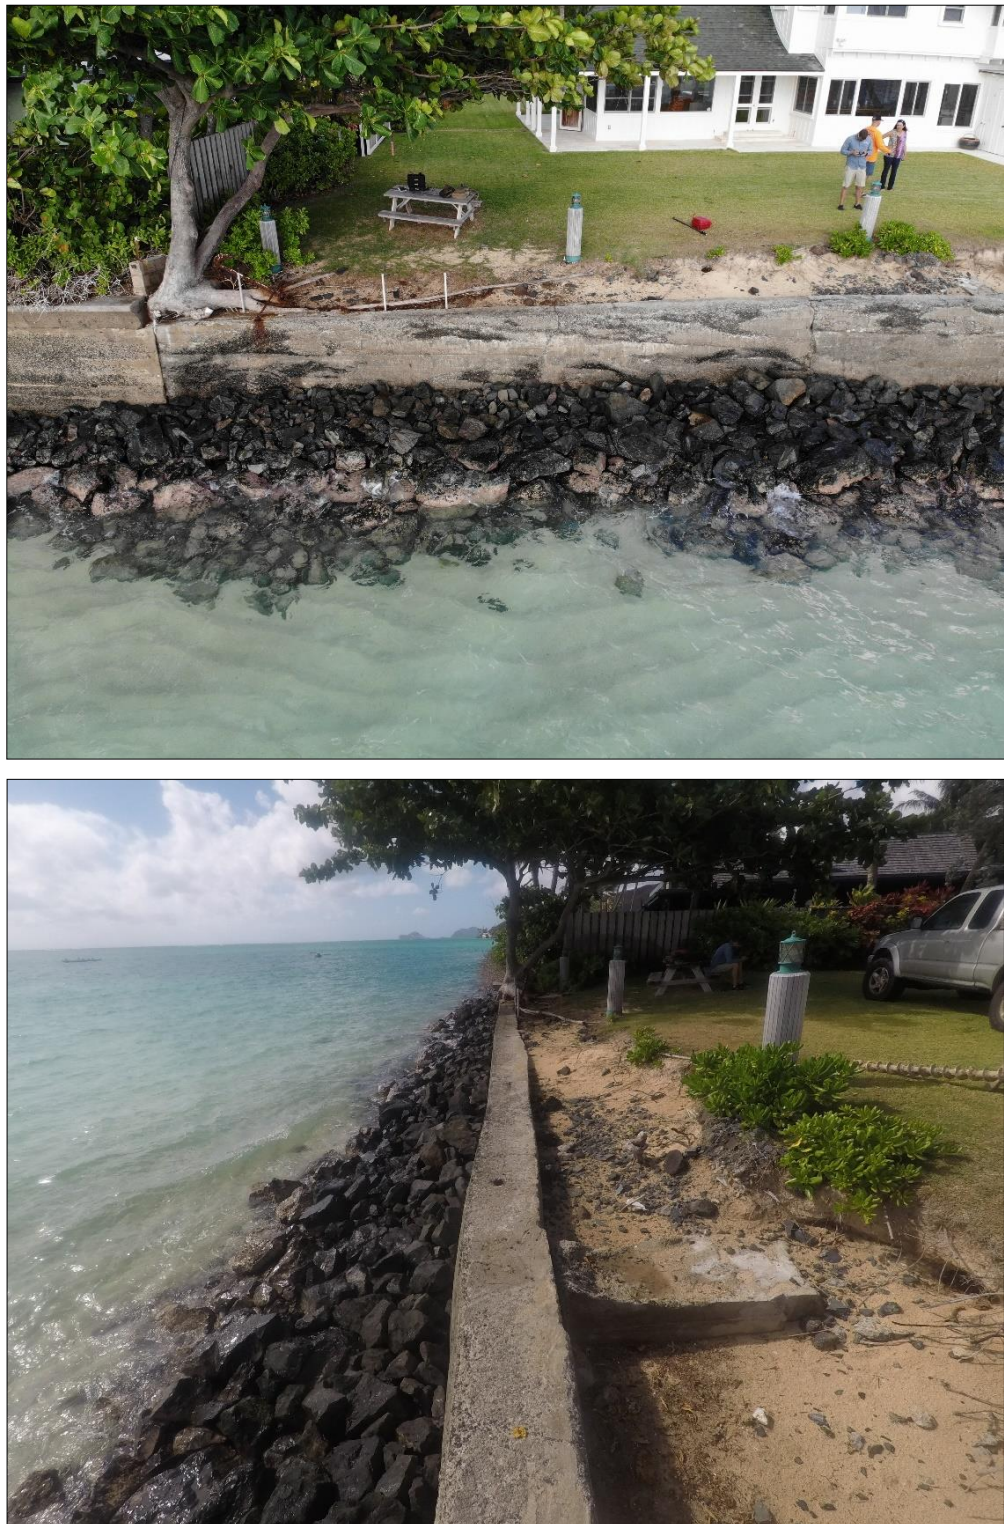
Existing Conditions – South End of Shoreline (SEI)

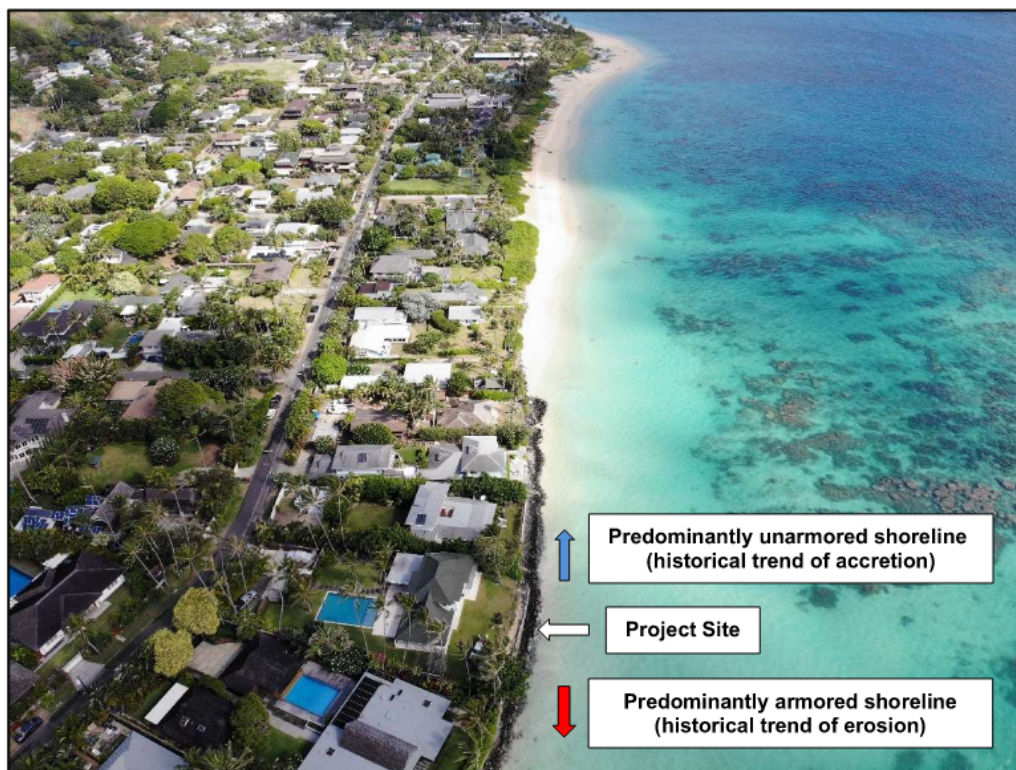
Project Site and Surrounding Shoreline Characteristics (SEI)

Prior to the late 1970's, Lanikai Beach showed a trend of accretion. This trend reversed causing erosion along the shoreline and, in response, property owners constructed seawalls and other hardened shoreline protection structures (Romine and Fletcher, 2012). The project site is located at the north end of a predominantly armored shoreline that extends approximately 4,000 feet south to Wailea Point. The shoreline north of the project site transitions to a wider, dry beach with backshore dune formation and stable vegetation. Many of the properties in this area are fronted by shore protection structures that have been buried as the shoreline has accreted over time. The beach extends approximately 2,500 feet north of the project site. The remaining 1,200 feet of shoreline extending to Alāla Point is fronted by shore protection structures. See *Figure 2-4*.

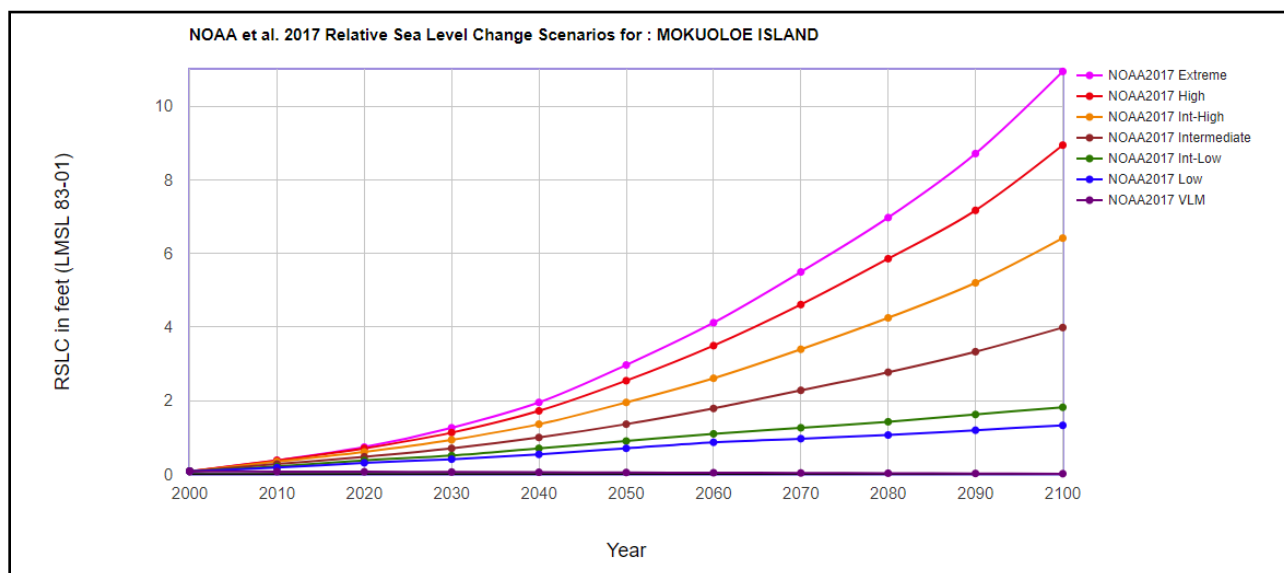
Hawai'i Sea Level Rise Projections (adapted from NOAA, 2017)

The National Oceanic and Atmospheric Administration (NOAA) recently revised their sea level change projections through 2100 considering up-to-date scientific research and measurements. Mean SLR scenarios for Hawai'i based on NOAA projections are depicted in *Figure 3-5*. An important conclusion of this regional climate assessment is that NOAA recommends the revised *Intermediate* rate for planning and design purposes in Hawai'i. The *Intermediate* rate projects that sea level in Hawai'i will rise 2.3 feet by 2070. Given the recent upwardly revised projections and the potential for future revisions, consideration may also be given to the *Intermediate-High* rate for planning and design purposes, which projects that sea level in Hawai'i will rise 3.4 feet by 2070.

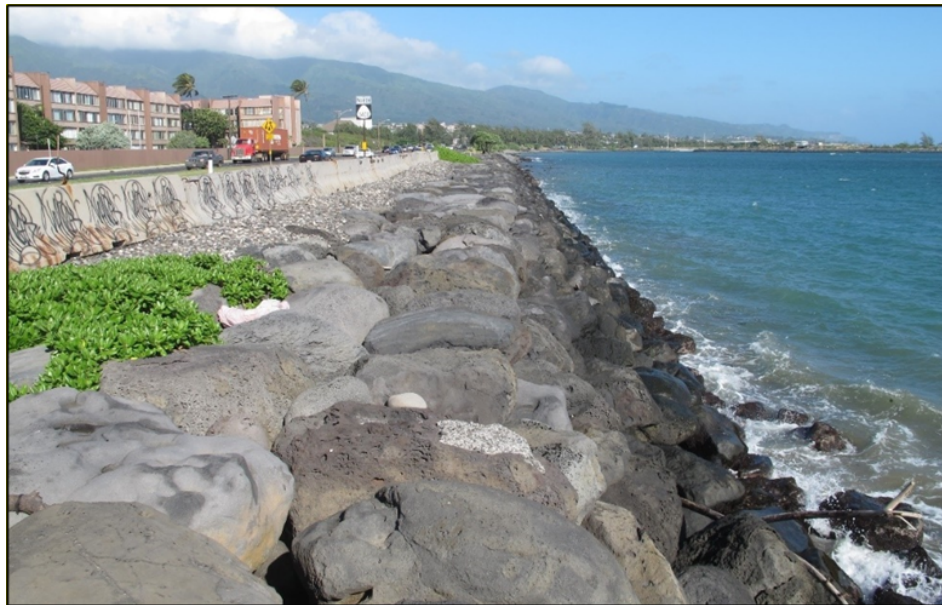
Rock Revetment at Kahului Harbor (Kahului, Maui, Hawai'i)

The design of a rock revetment is dependent on sea level elevation, design wave height, and scour depth. Additionally, it is preferred that the toe of the revetment be founded on hard, non-erodible substrate to prevent scour and undermining of the structure.

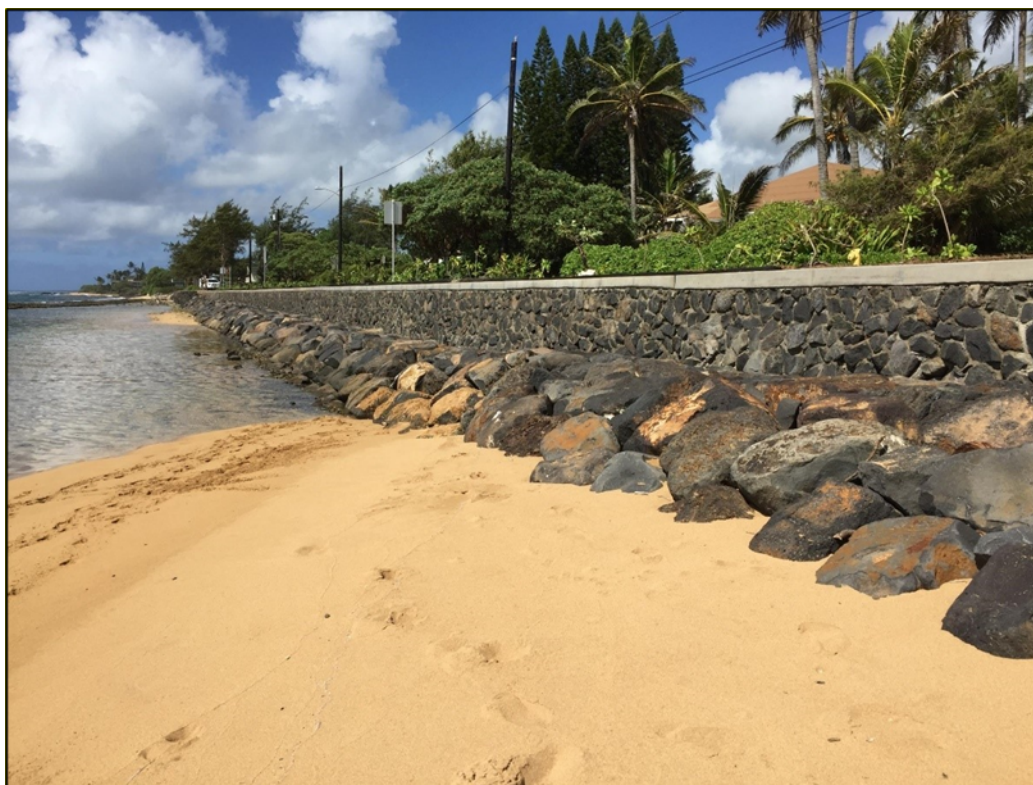
Hybrid Seawall-Revetment (Kapa'a, Kaua'i, Hawai'i)

SEI evaluated two options for a hybrid seawall-revetment at the project site. Both designs incorporate a 2.3-foot higher than present sea level, with consequent increases in predicted wave exposure and scour depth. Utilizing 2.3 feet of sea level rise, which is currently projected for 50 years in the future, provides suitable design criteria within the effective life span of similar structures. Structure maintenance, improvements, or replacement would be appropriate at the end of the structure's projected life span or when the environment changes beyond design conditions. Adaptation to rising sea levels and its resulting impacts predicted at time frames beyond the structure's design life should be incorporated at that time. The armor and underlayer stone size and placement would be the same as for the rock revetment options. Like the rock revetment option, a hybrid seawall-revetment would extend beyond the limits of the easement area and would require demolition and removal of the existing seawall and rock apron. Return walls within the shoreline setback area would also be required to stabilize and protect the adjacent properties and existing shore protection structures.

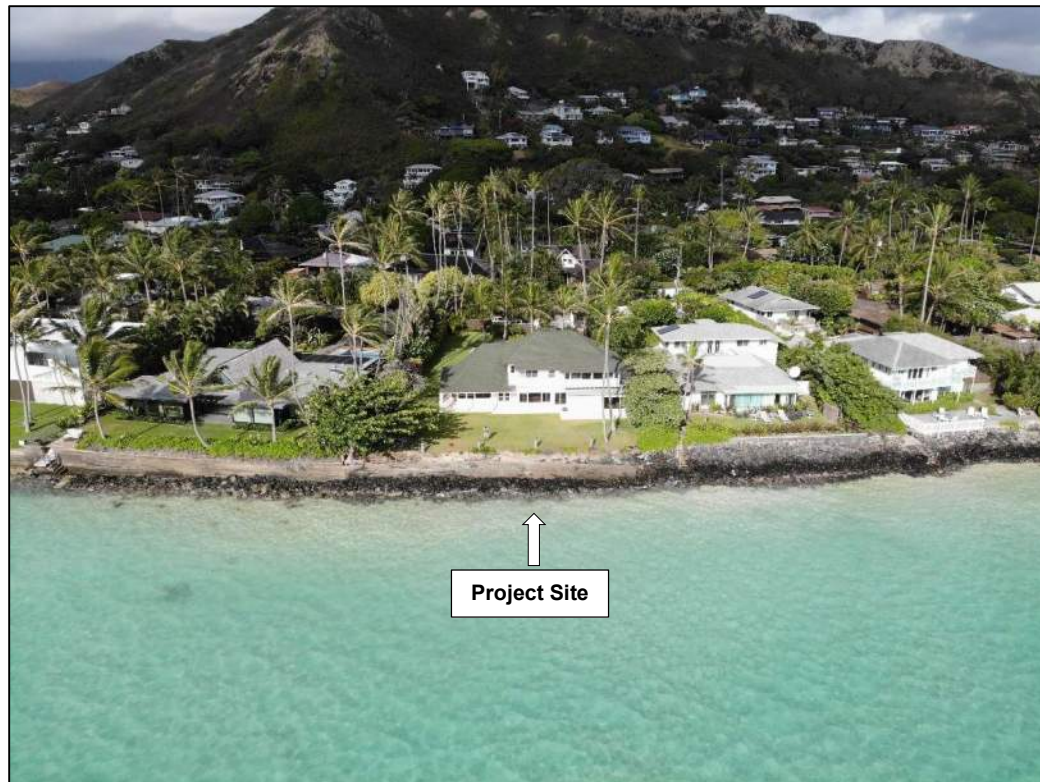
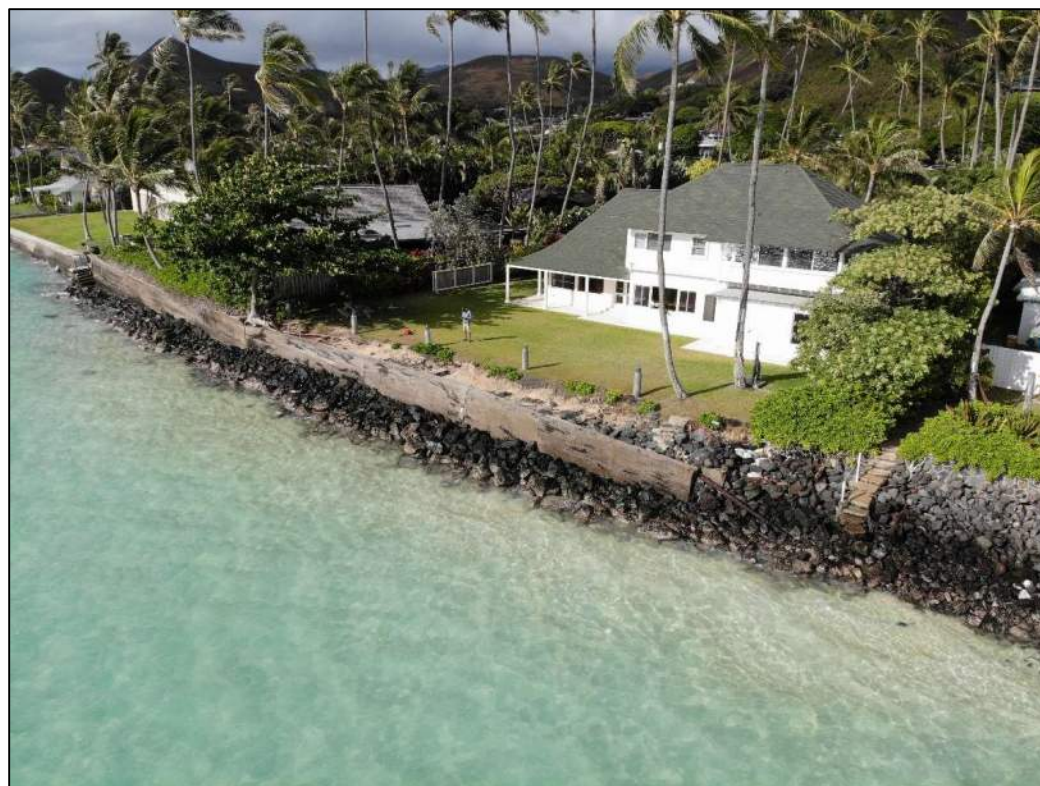
Figure 2-1 Existing conditions (July 2020)

The seawall appears to have been constructed on loose sand that is highly susceptible to scour and erosion. At a portion of the wall about 30 feet from the north end, where the bottom of the wall was visible, sandy substrate was visible under the wall. Sinkholes are apparent along the entire length of the seawall (Figure 2-11). The sinkholes likely formed due to internal erosion of the sandy substrate from beneath and behind the seawall foundation.

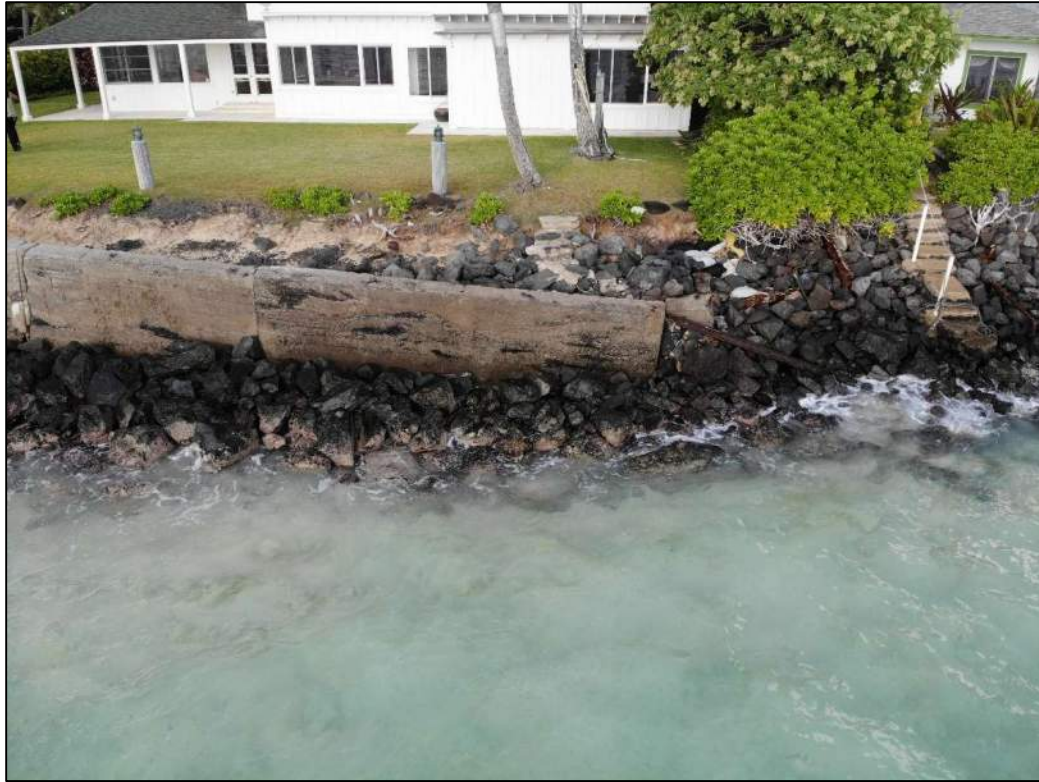
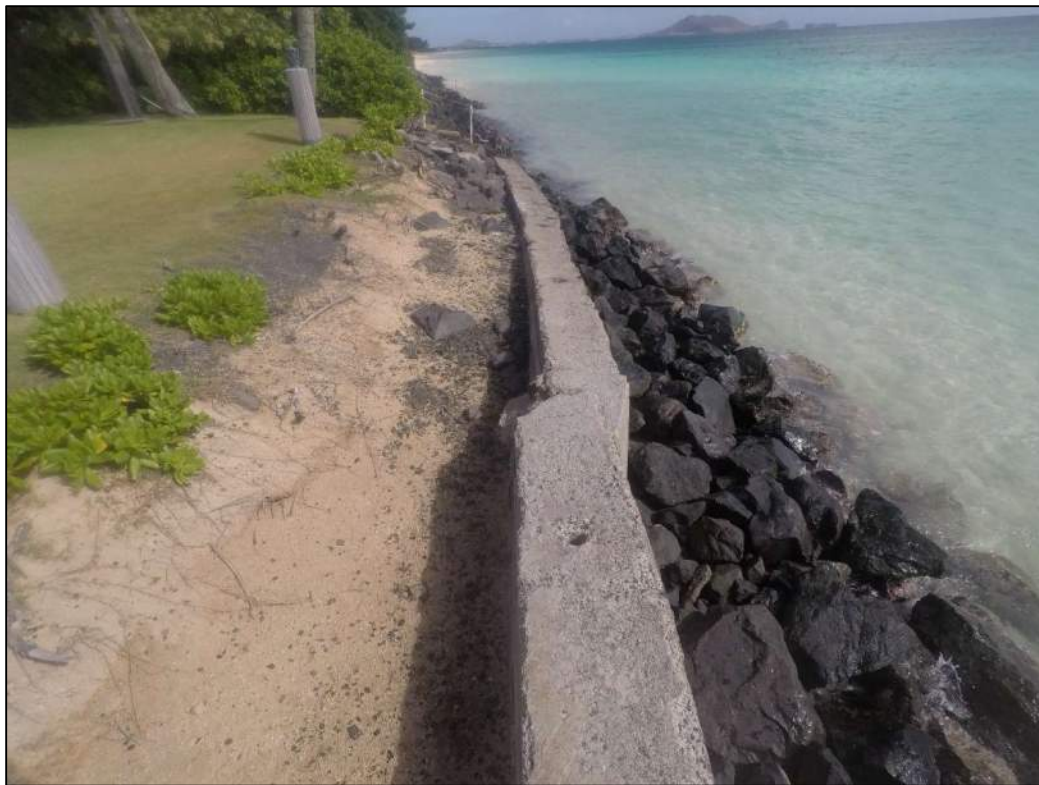
Figure 2-2 Existing conditions – north end of shoreline (July 2020)

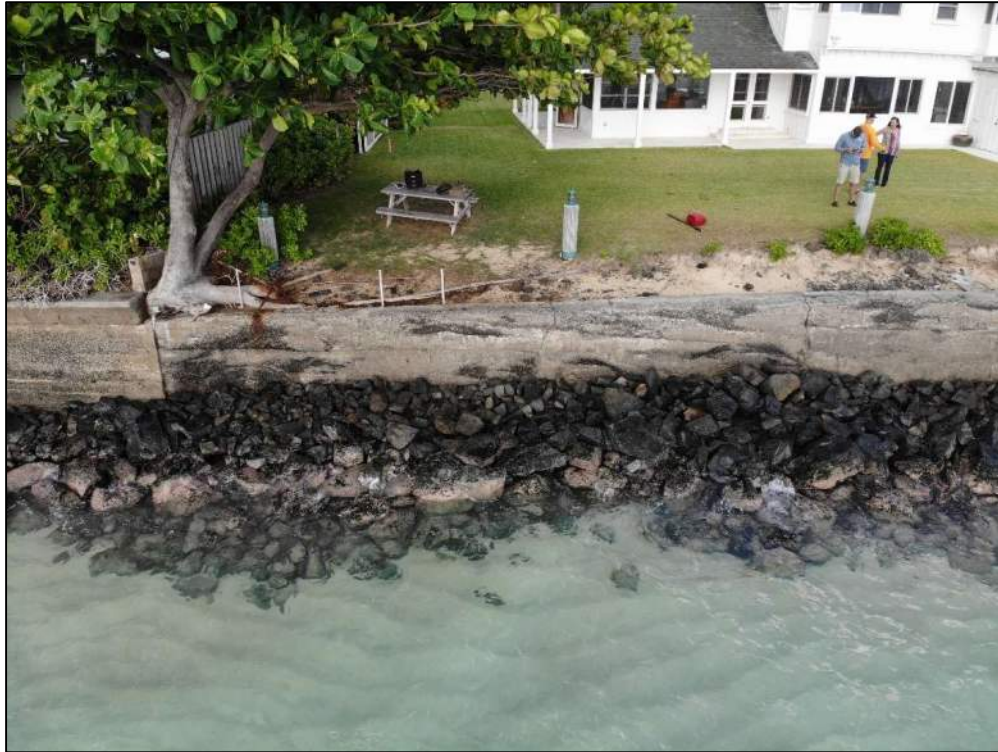
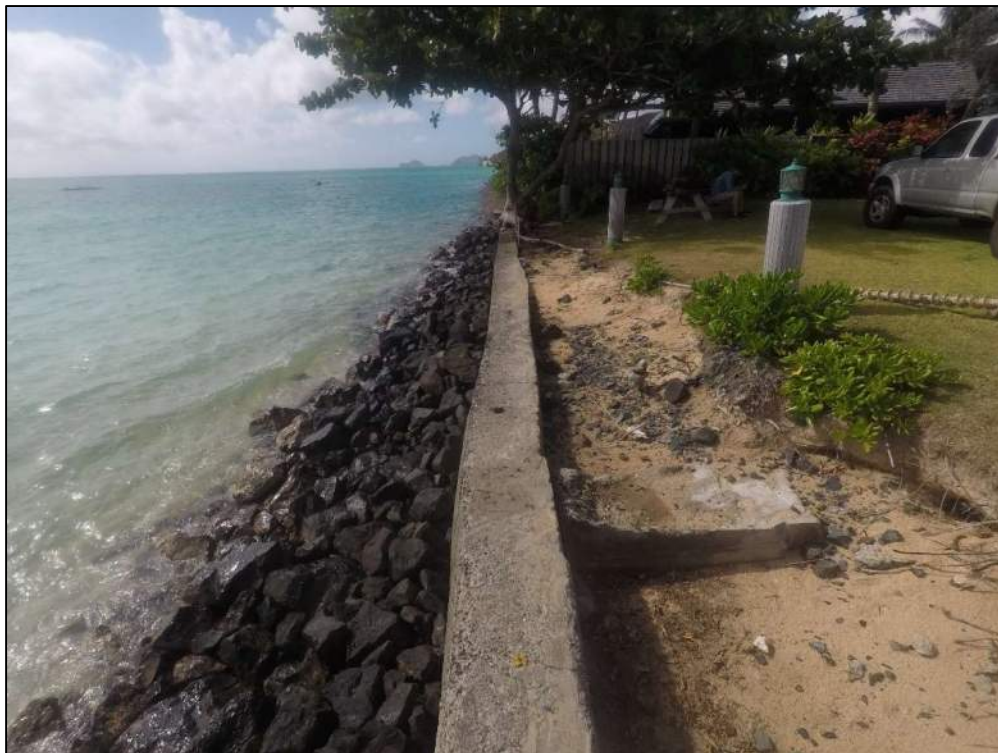
Figure 2-3 Existing conditions – south end of shoreline (July 2020)

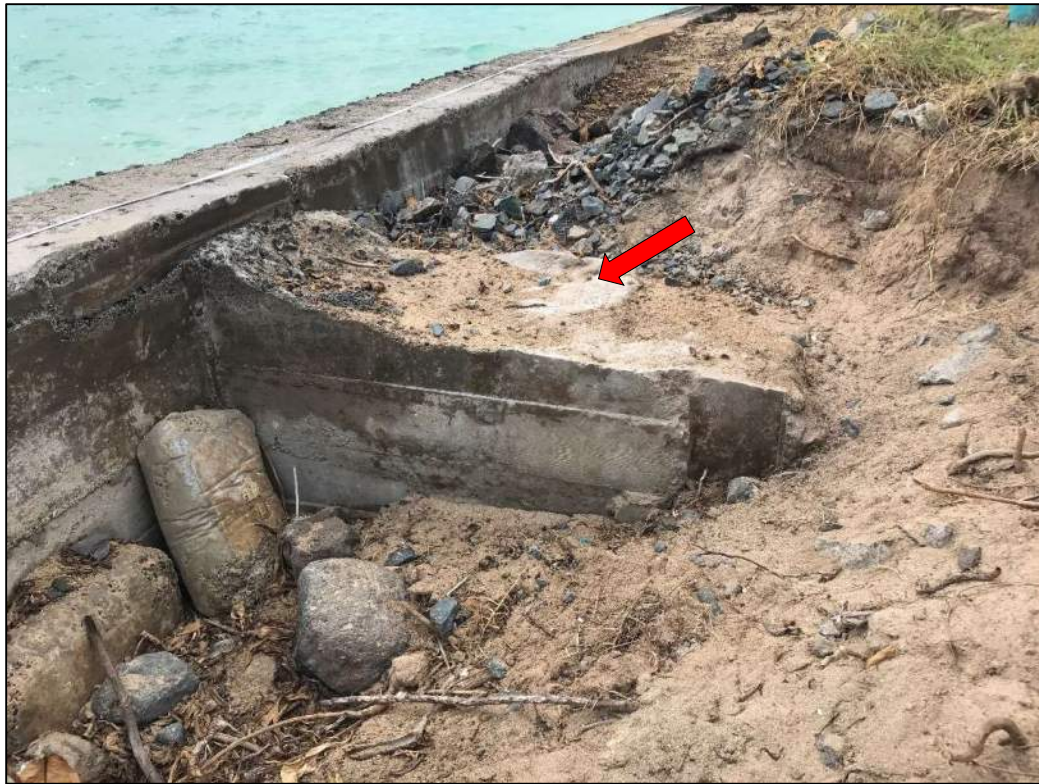
Figure 2-4 Counterfort on inshore side of seawall (July 2020)

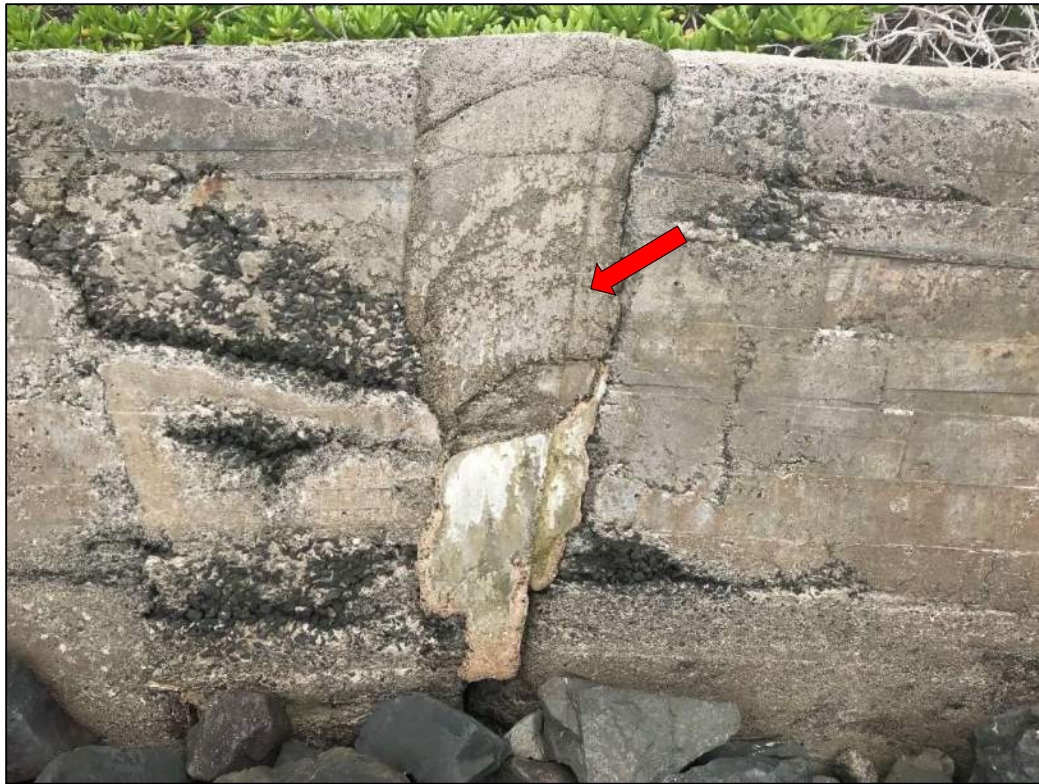
Figure 2-6 Concrete repairs at panel joint (July 2020)

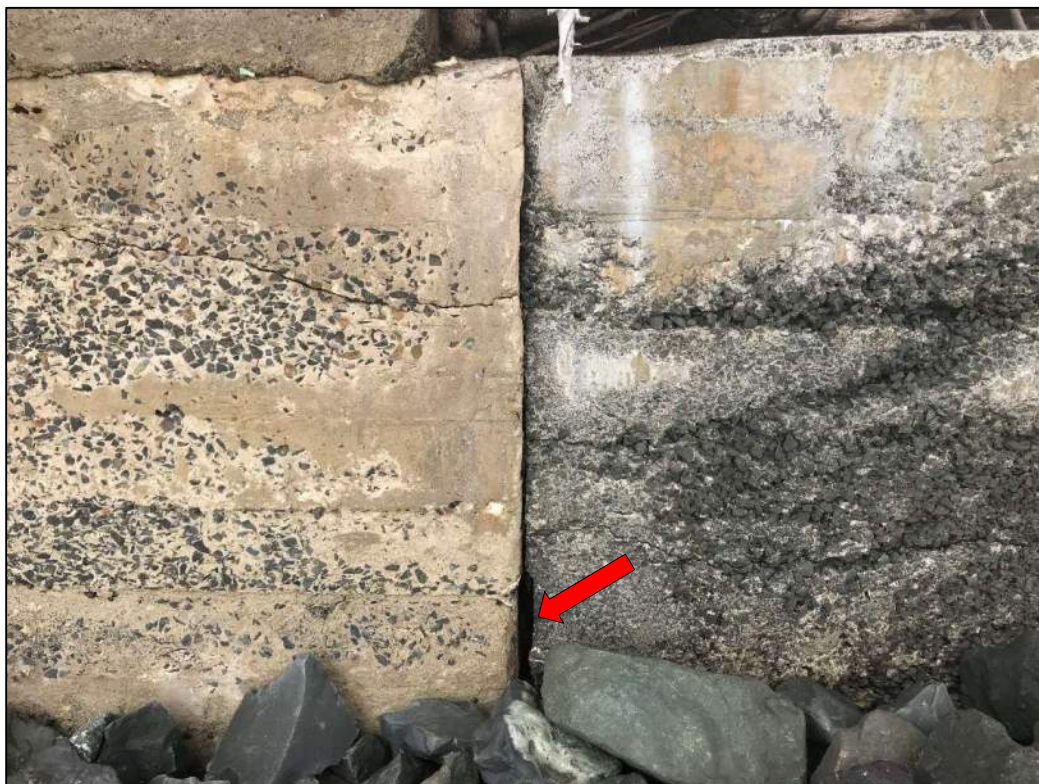
Figure 2-7 Gap between subject seawall and south adjacent seawall (July 2020)

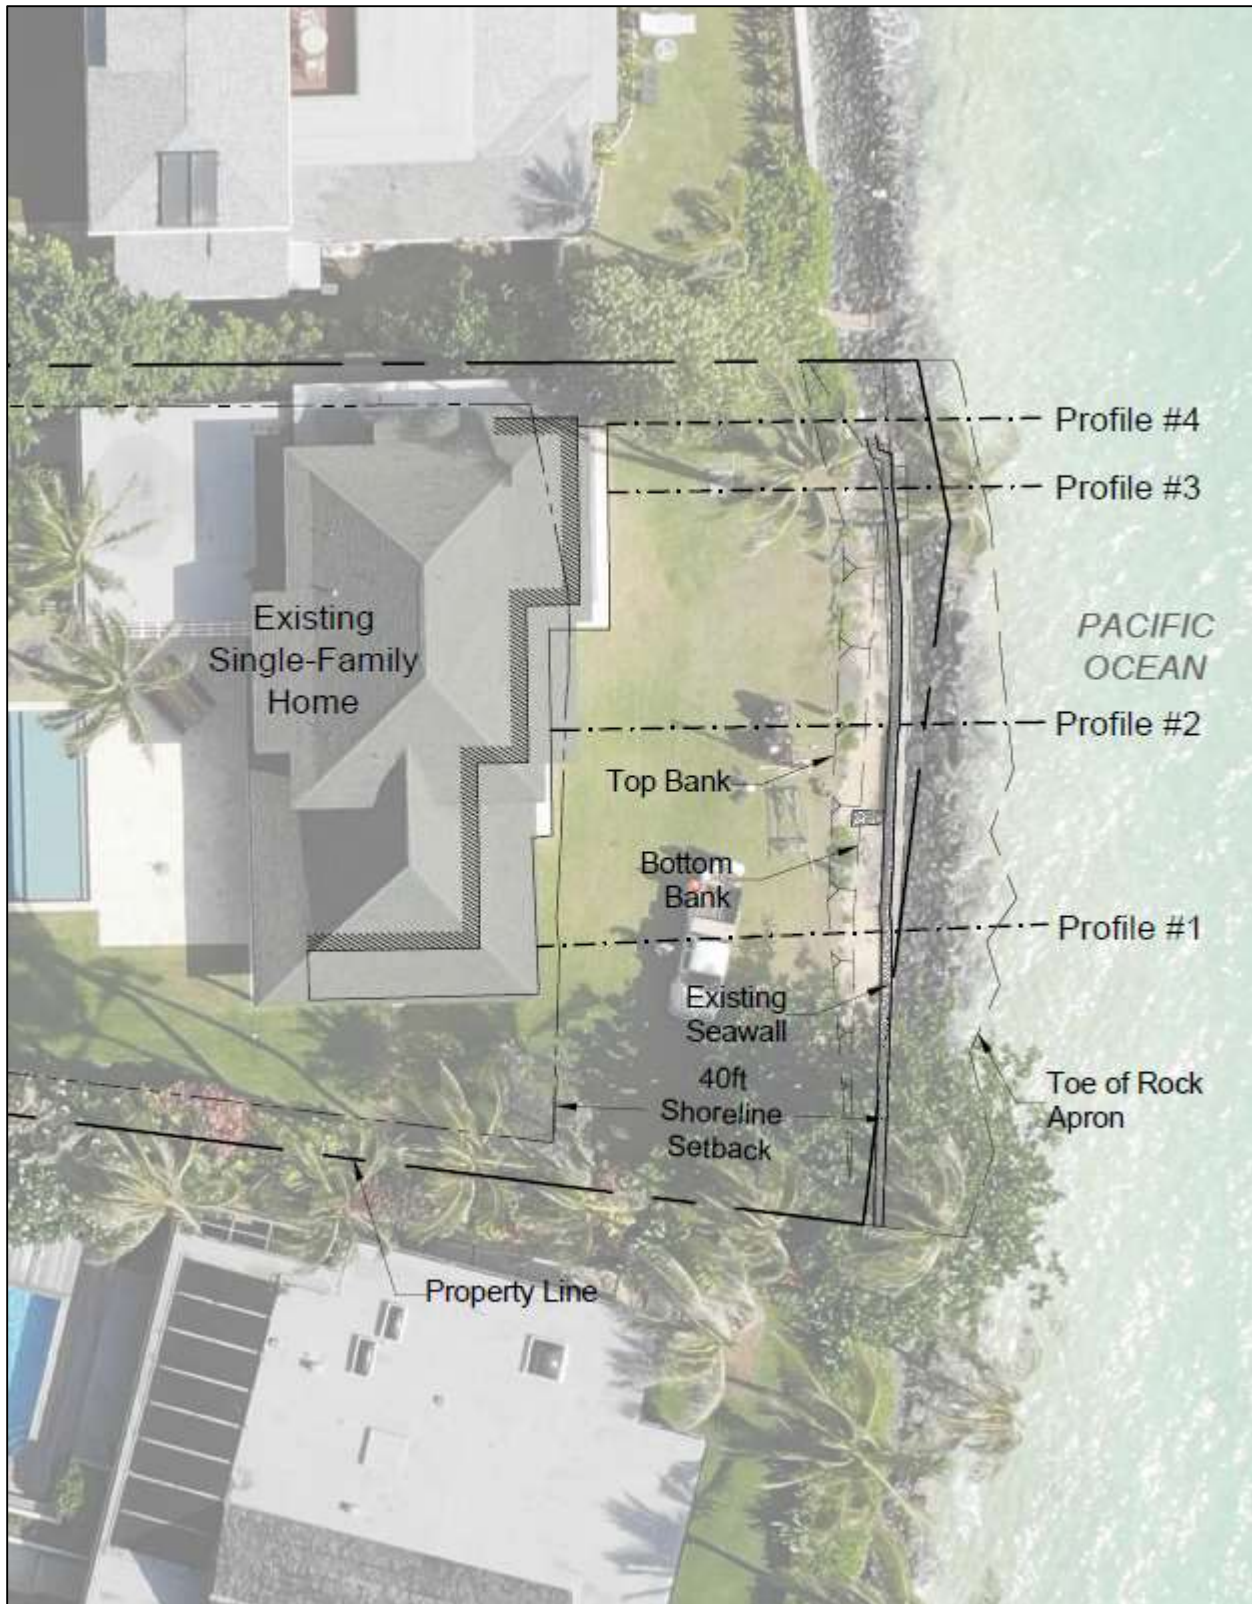
Figure 2-14 Profile transect locations

SEI conducted a topographic survey in July 2020 to collect elevation data of the backshore, foreshore, and nearshore waters fronting the project site. Four (4) shoreline profiles were generated through the topographic survey data to show the cross-shore profile of the seawall and rock apron (Figure 2-14 and Figure 2-15). Elevations are relative to mean sea level (msl). There is no seawall present at Profile 4.

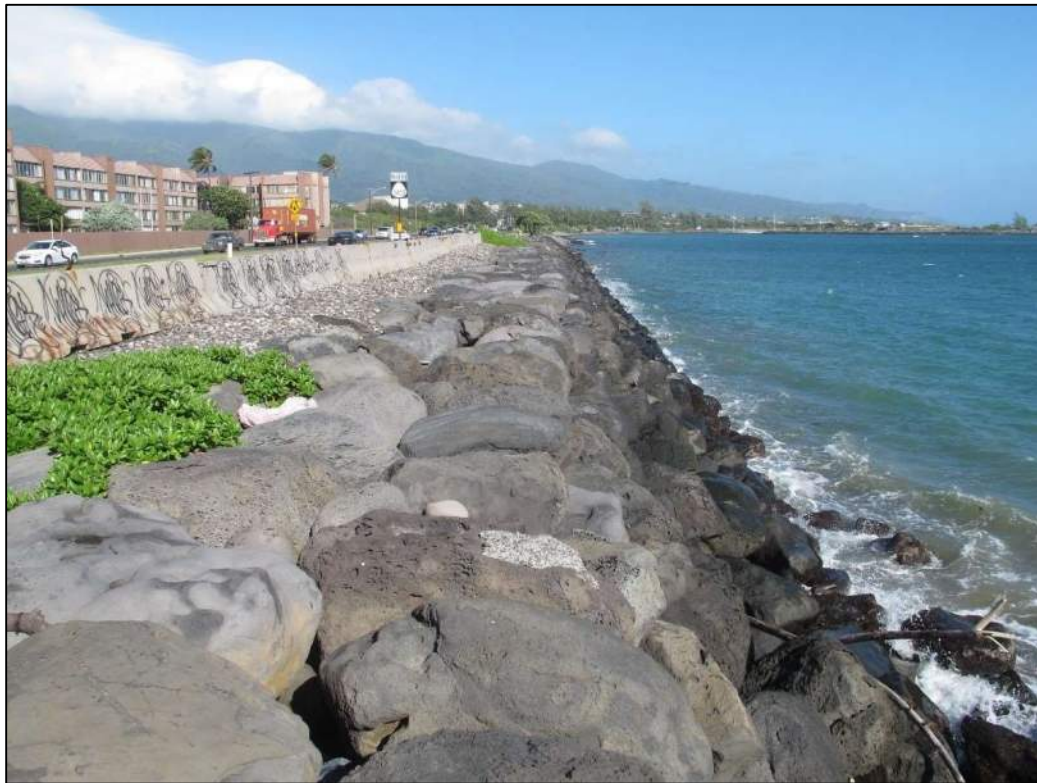
Figure 6-2 Rock revetment at Kahului Harbor (Kahului, Maui, Hawaii)

A revetment is a sloping, un-cemented structure constructed of wave-resistant material. The most common method of revetment construction is to place a layer of armor stone, sized according to the design wave height, over an underlayer of smaller rock that sits atop geotextile filter fabric. The underlayer is designed to distribute the weight of the armor layer and to prevent loss of fine material through voids in the revetment. An example of a rock revetment is shown in Figure 6-2.

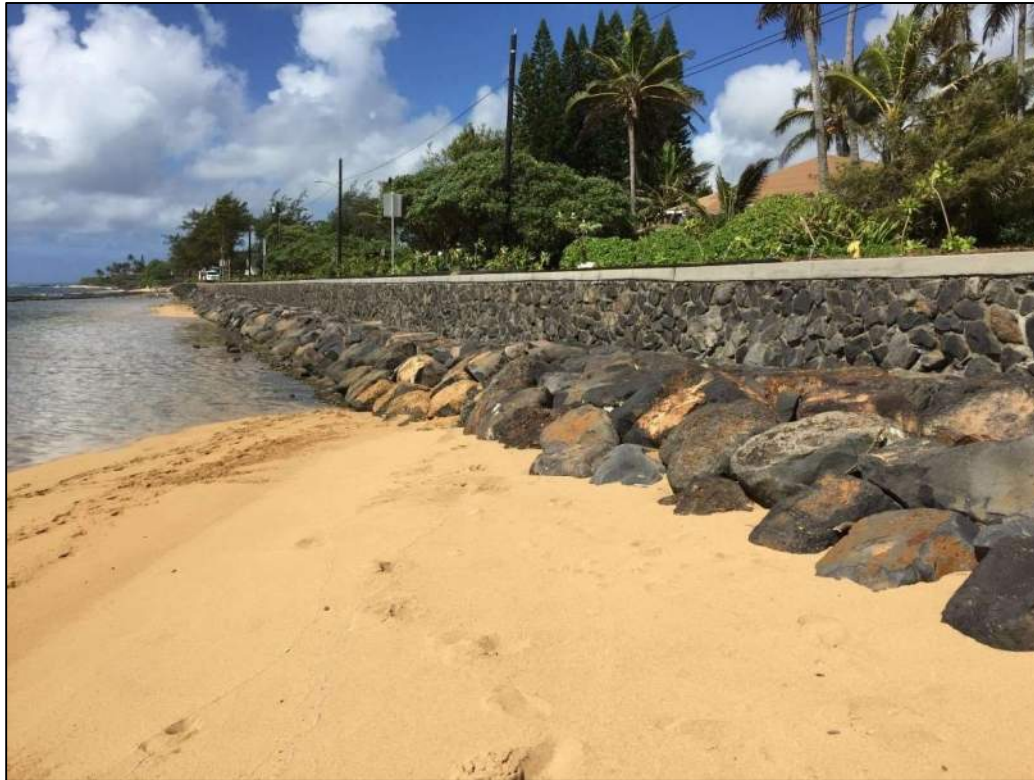
Figure 6-7 Hybrid seawall-revetment (Kapaa, Kauai, Hawaii)

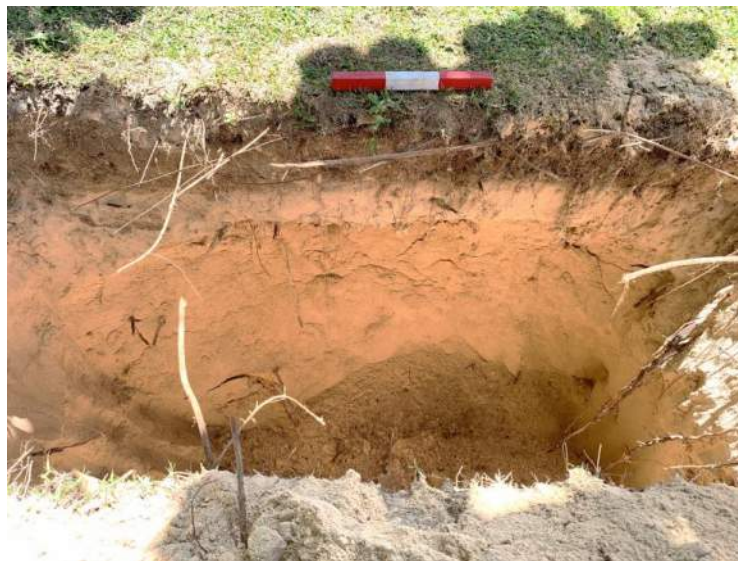
Figure 17. TR 3 southwest face photo.
