SUBJECT: Draft Environmental Assessment and Anticipated Finding of No Significant Impact
Spillover Rehabilitation and Vegetation Clearing at the Decommissioned Tai Lee Reservoir; Waimānalo, O'ahu

Spillway Rehabilitation and Vegetation Clearing at the Decommissioned Tai Lee Reservoir

Draft environmental assessment and anticipated finding of no significant impact (DEA-AFNSI)

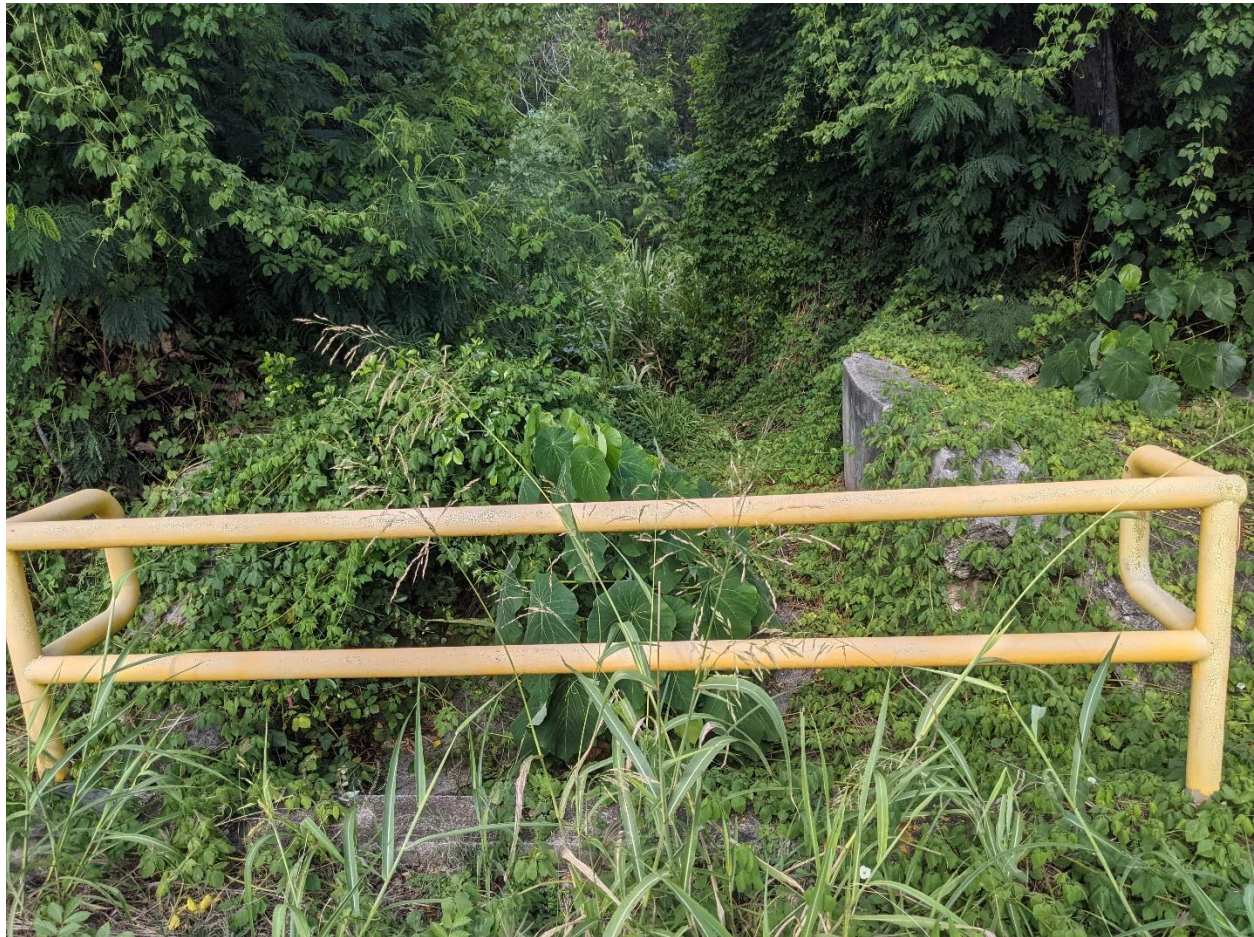
View of spillway from Mokulama Street facing west

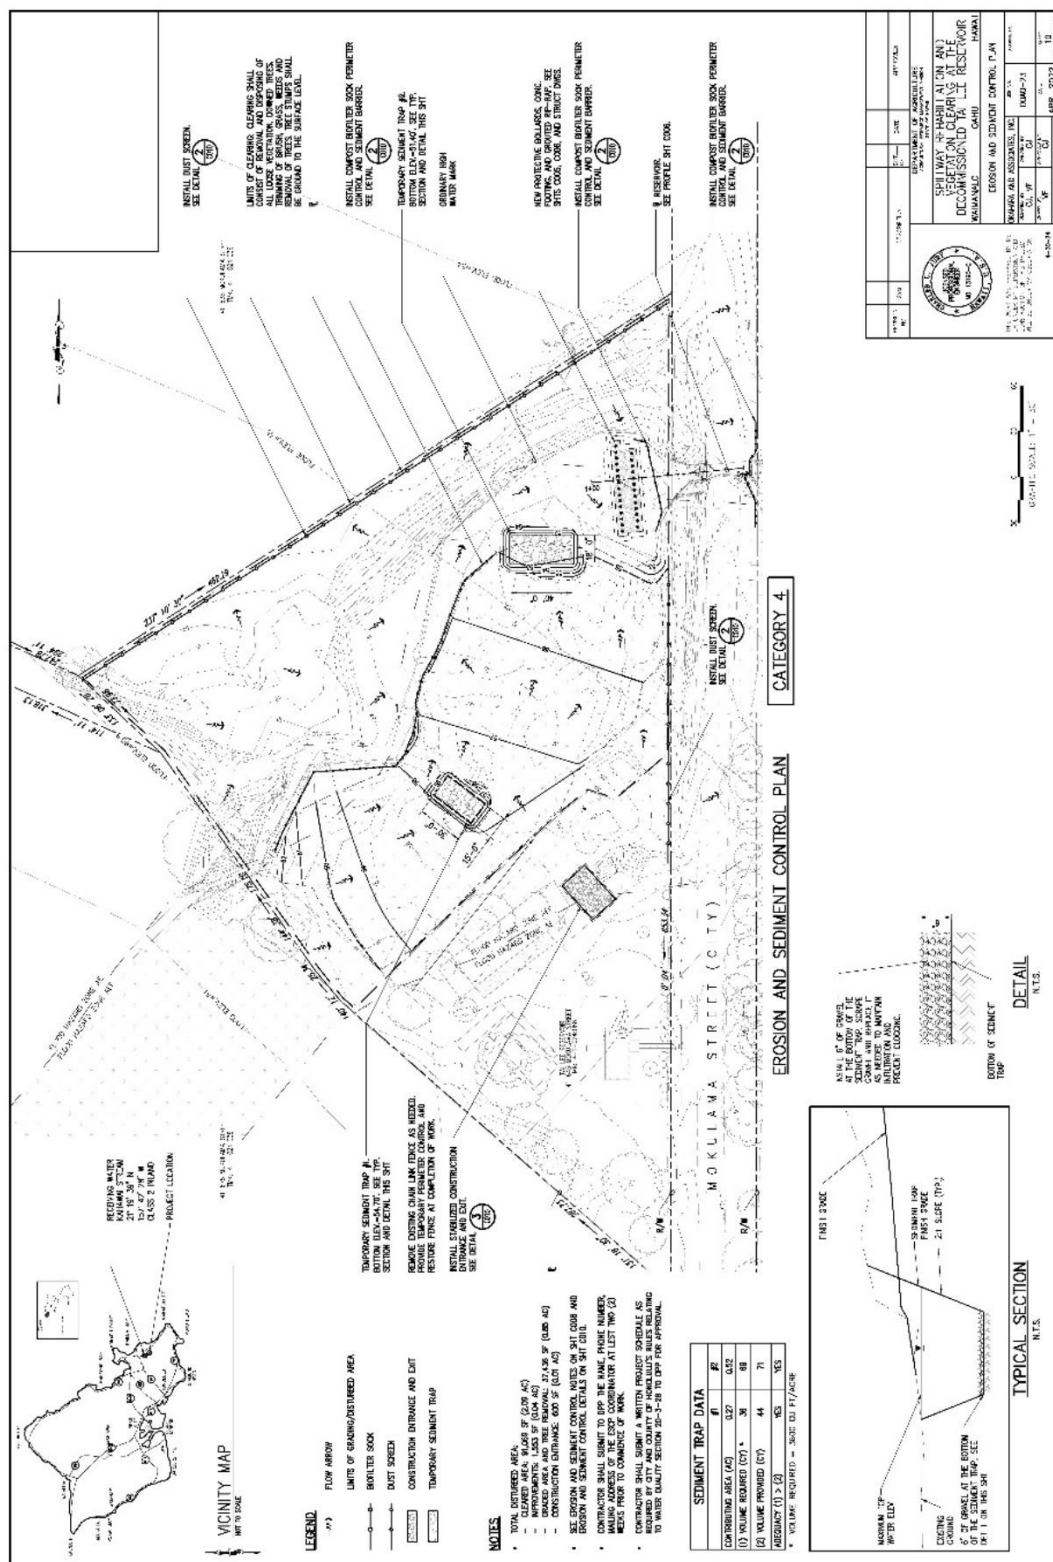
Figure 9. Erosion and Sediment Control Plan (from Okahara and Associates, Inc., 2022)

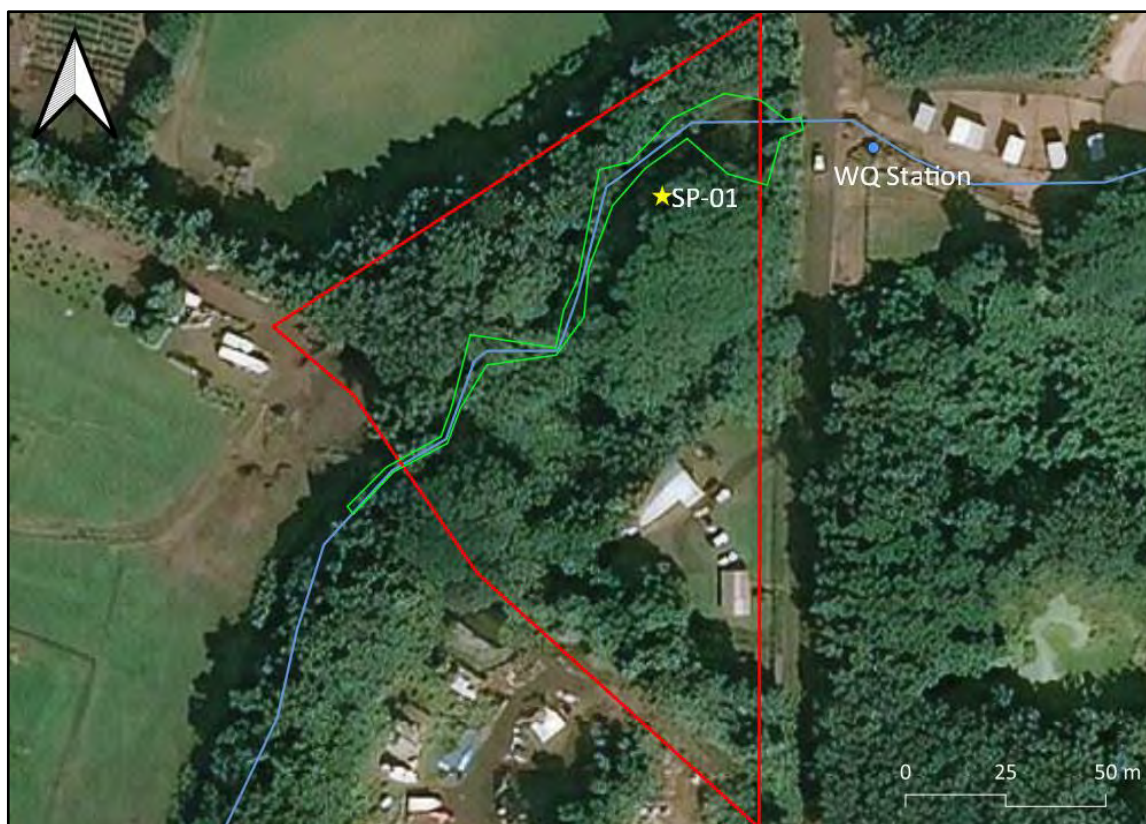
Figure 7. Ordinary high water mark (in green) indicating the delineation of Kahawai Stream within the Tai Lee Reservoir (outlined in red).

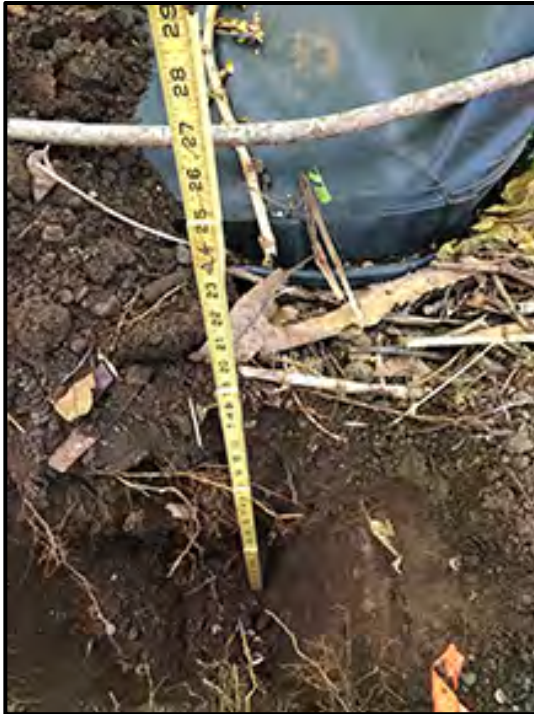
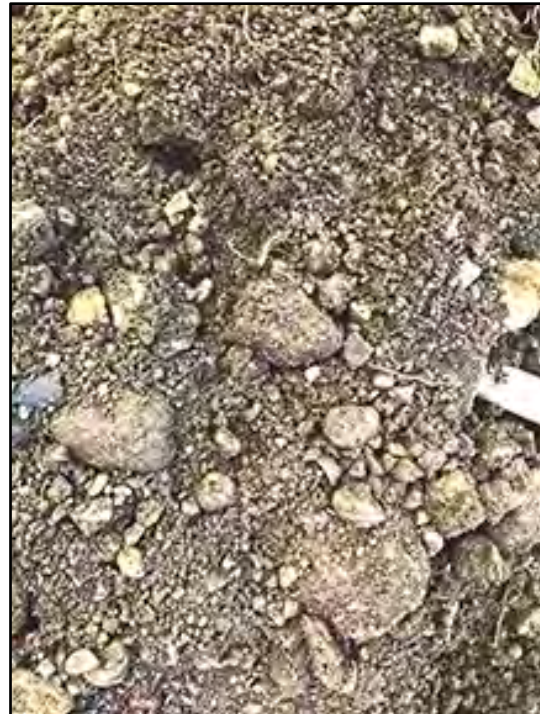
Figure 8a (left) SP-01 located in the reservoir; soil not indicative of wetland. Figure 8b (right) presence of cobble and gravel on surface.

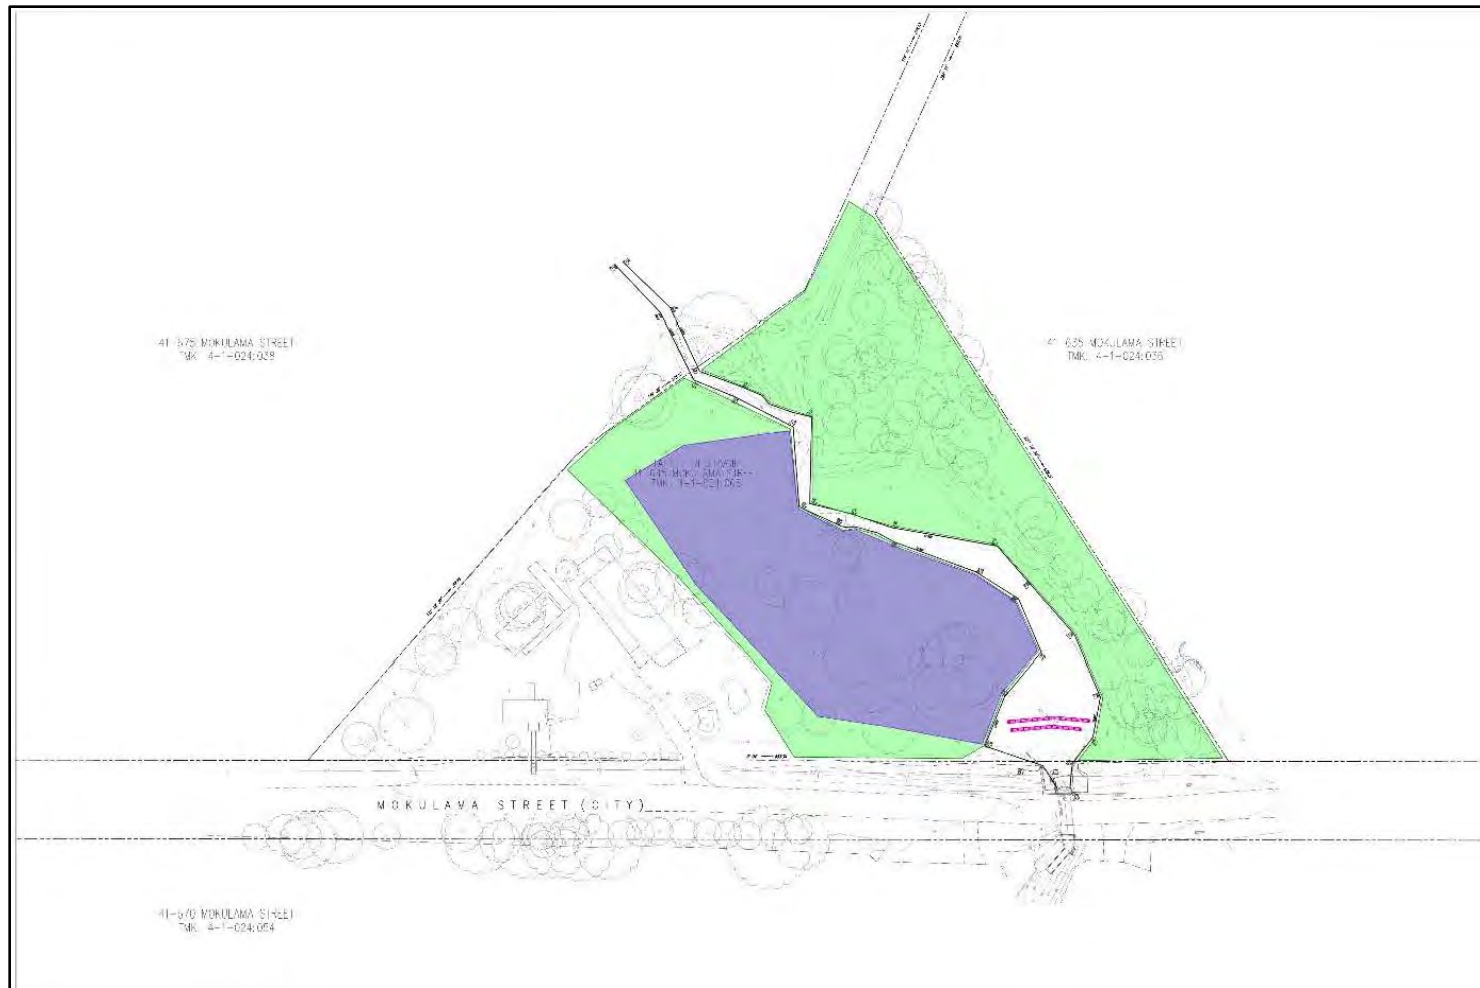
Figure 4. Project map (supplied by Okahara and Associates, Inc. 2022) with north to the right and Mokulama Street, which is to the east, at bottom. Grading will be required in the area highlighted purple within the interior of the reservoir which will then be grassed and maintained. Vegetation, including all trees within the property, will be cleared within the area highlighted green. Two rows of staggered bollards intended to capture debris are proposed and depicted with the magenta lines near the reservoir spillway (close to Mokulama Street).

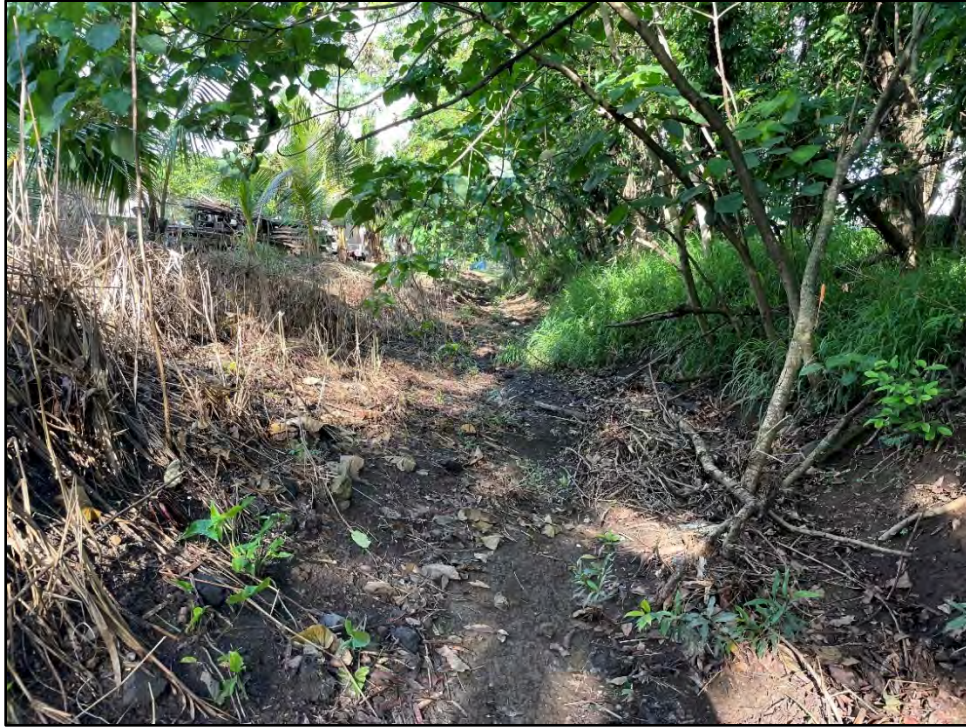
Figure 31. Photo A: View of earthen Pump Ditch as it enters the west corner of the project area, view to northwest

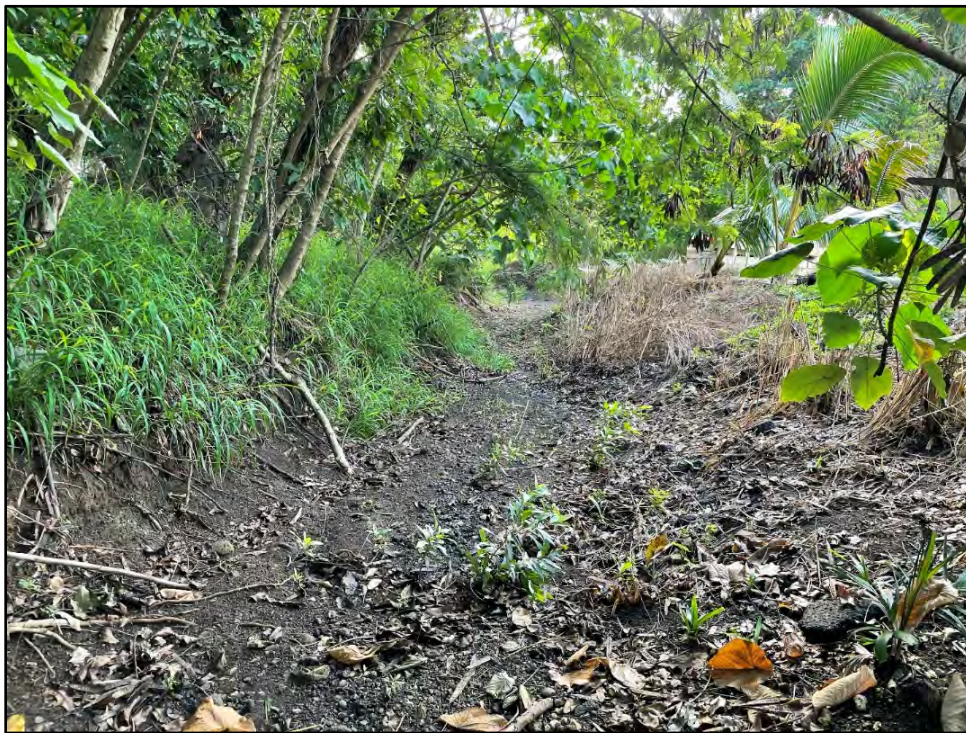
Figure 32. Photo B: View of earthen Pump Ditch as it enters the west corner of the project area, view to east

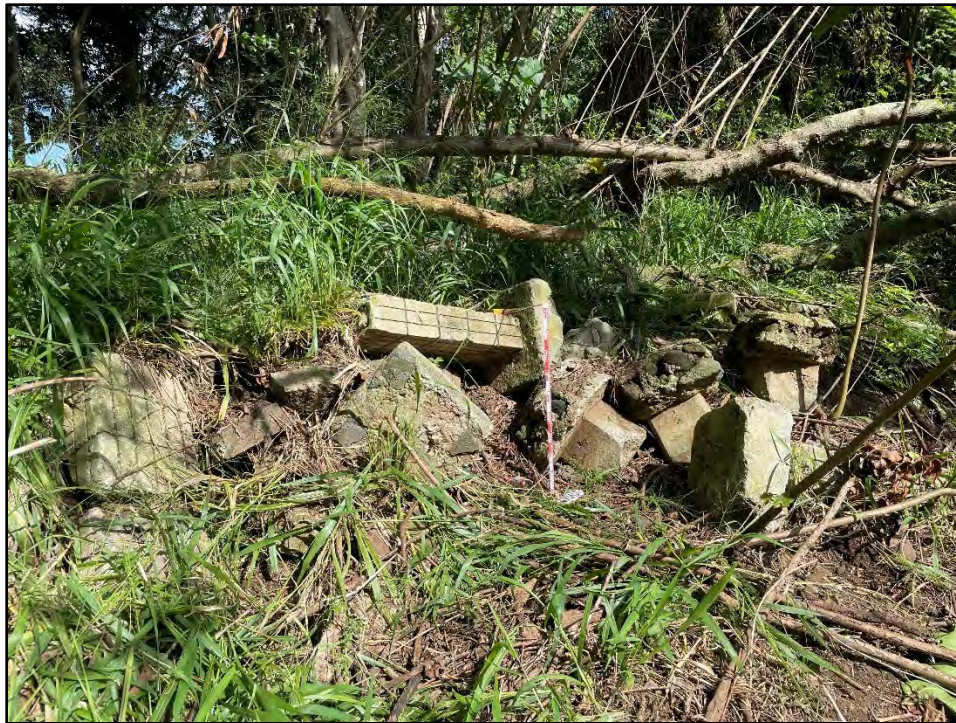
Figure 33. Photo C: View of Concrete remnants believed to have been related to water control as the Pump Ditch entered the Tai Lee Reservoir, view to northwest

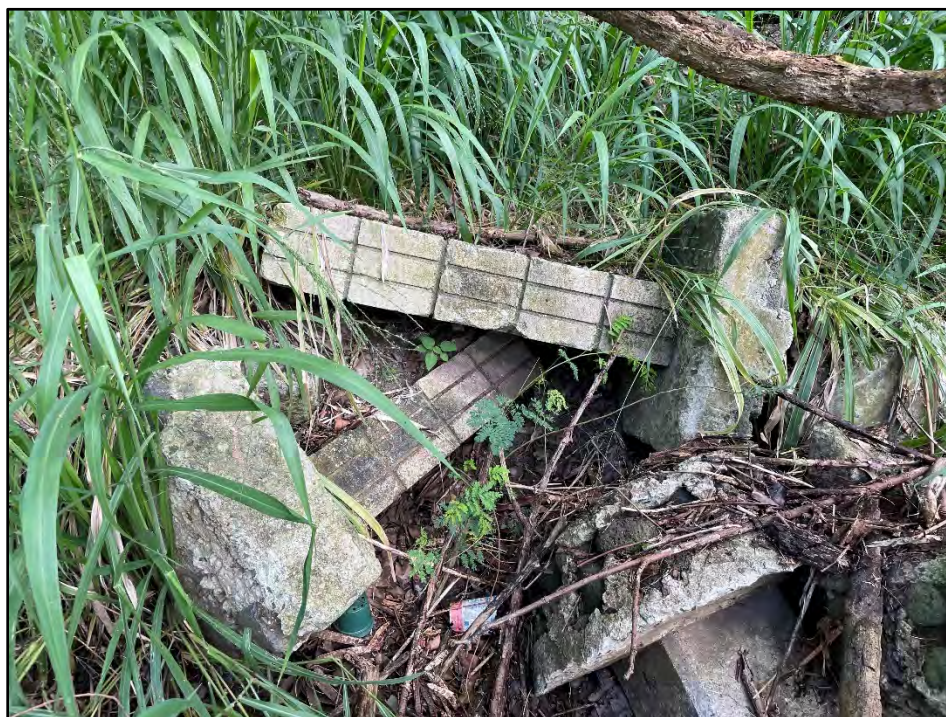
Figure 34. Photo D: Close-up view of concrete remnants believed to have been related to water control as the Pump Ditch entered the Tai Lee Reservoir, view to west

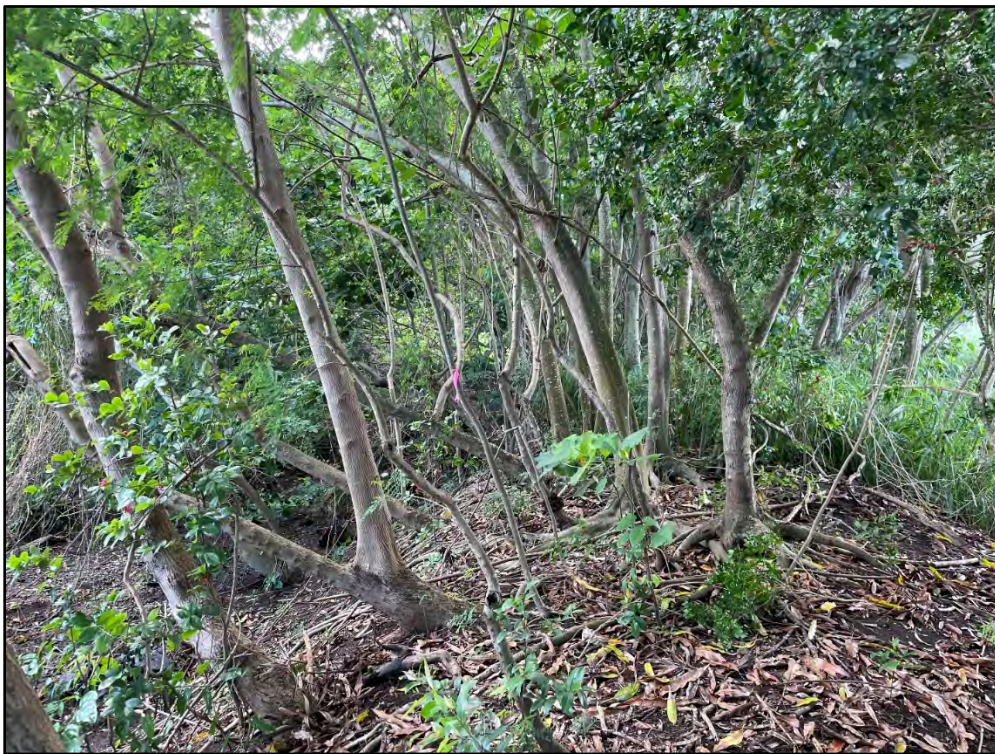
Figure 36. Photo F: View along dam berm along northwest side of reservoir (reservoir at left), view to northeast

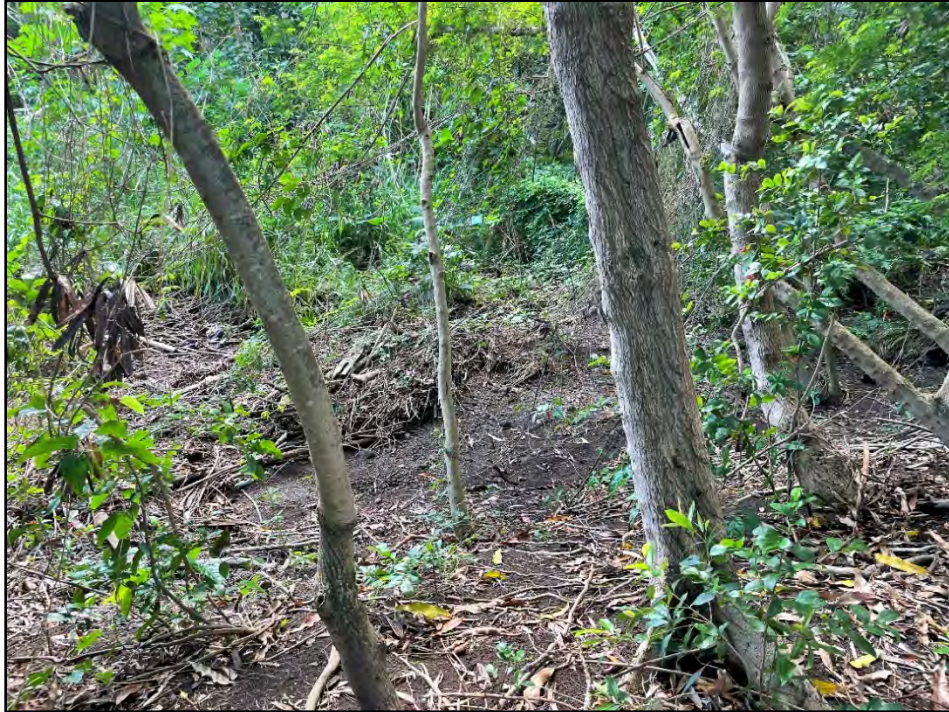
Figure 37. Photo G: Overview of dam berm from on top of the berm looking into the reservoir, view to south

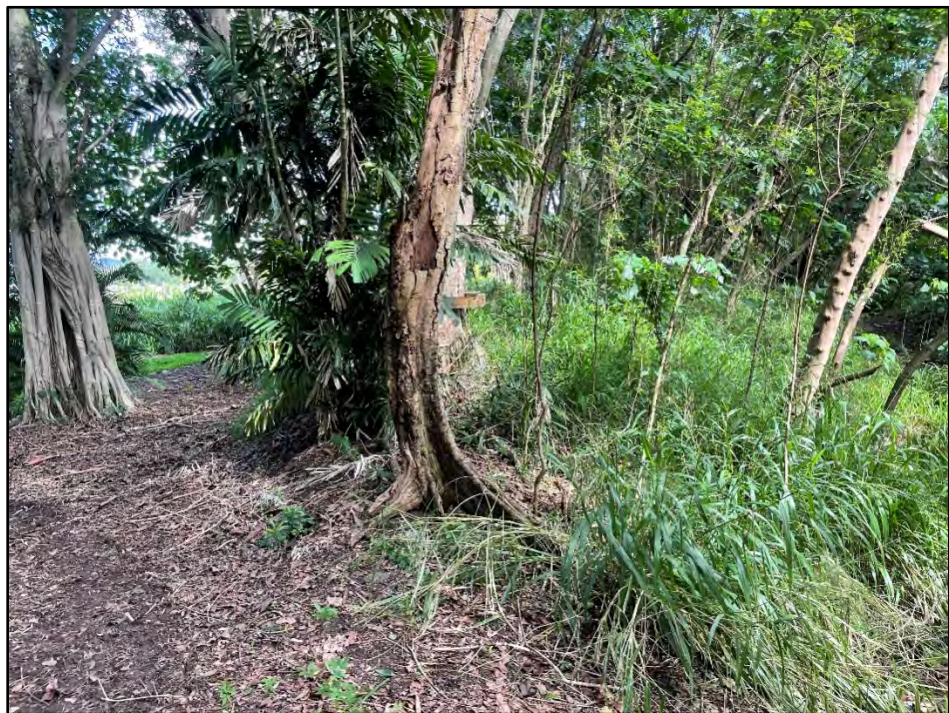
Figure 38. Photo H: Overview of reservoir berm along northwest side of reservoir (reservoir at right), view to northeast

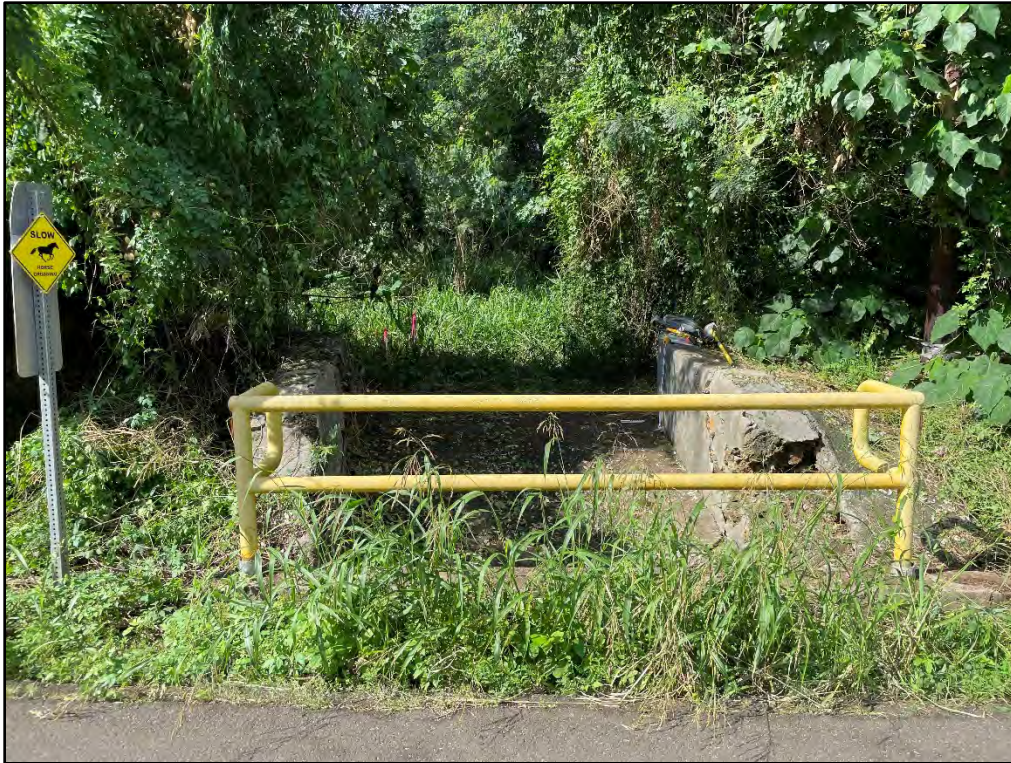
Figure 39. Photo I: Photo of spillway from Mokulama Street, view to west

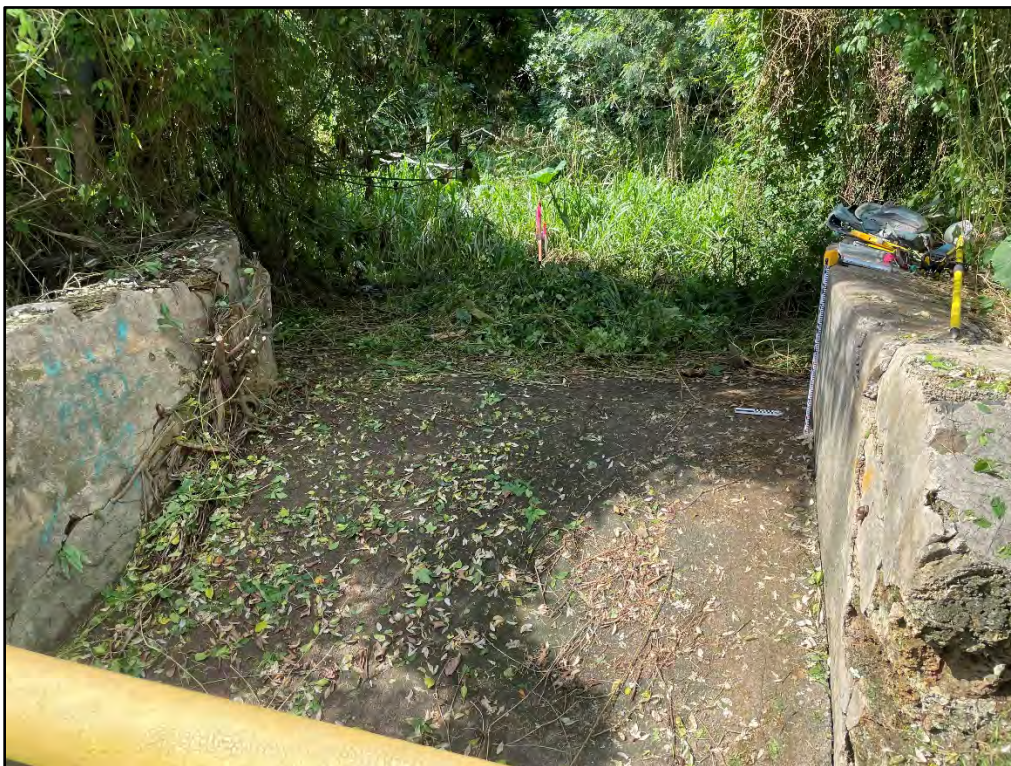
Figure 40. Photo J: Close-up of spillway from Mokulama Street, view to west

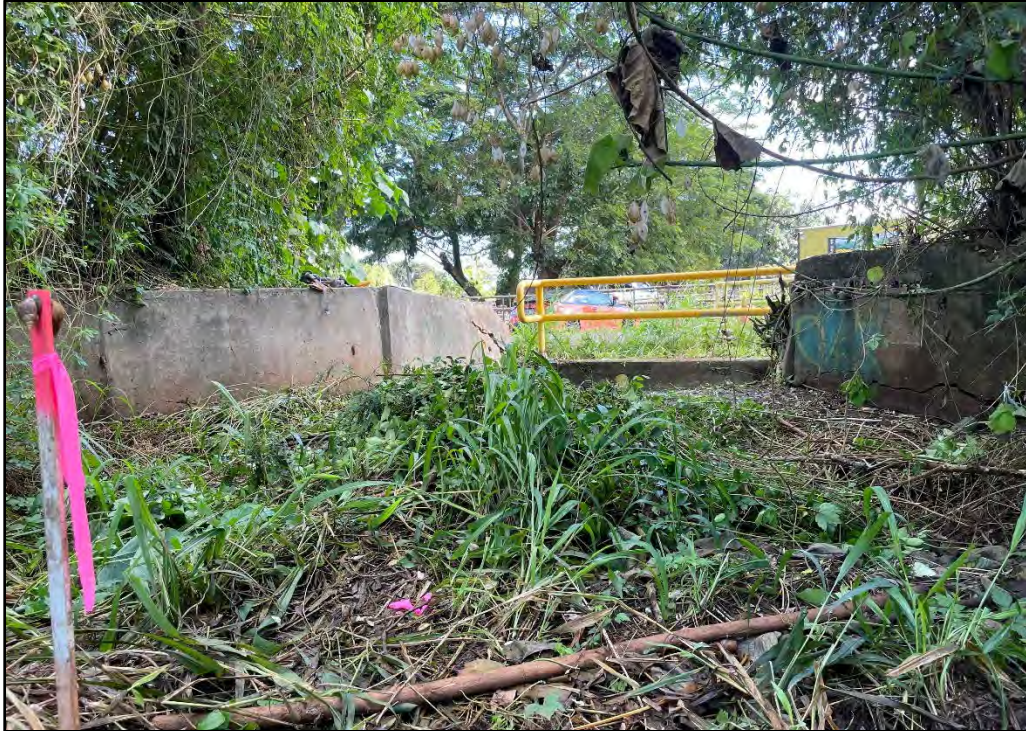
Figure 41. Photo K: View of spillway, view to northeast (Mokulama Street in background)

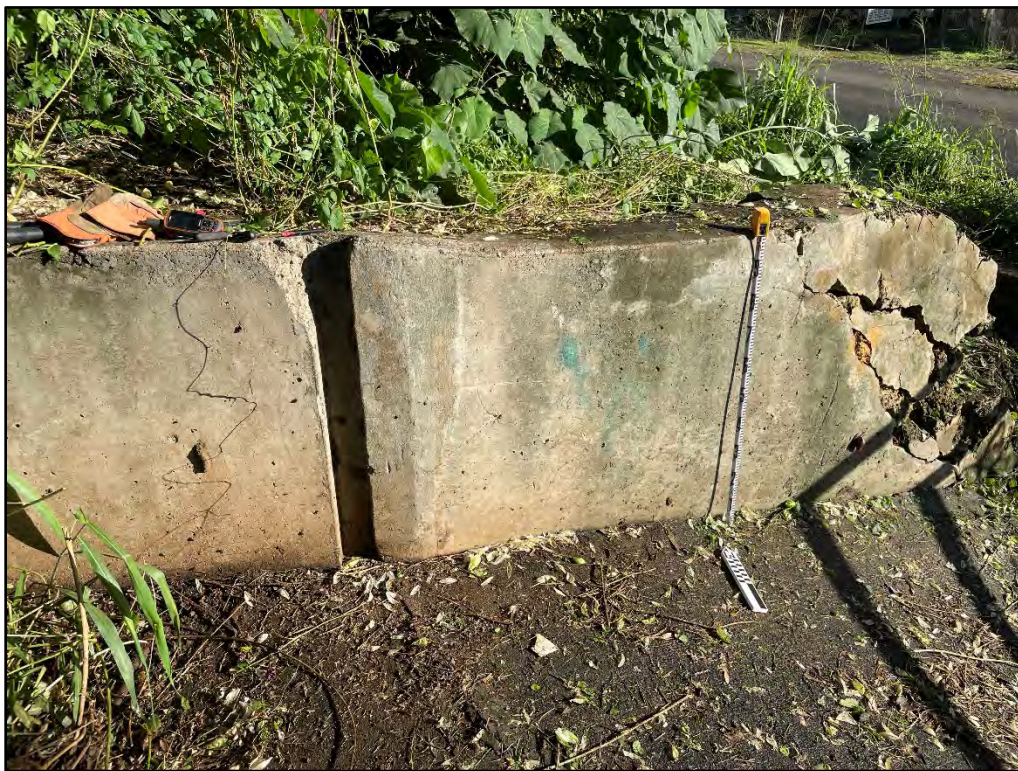
Figure 42. Photo L: View of the north side of the spillway with sluice gate slot, view to north

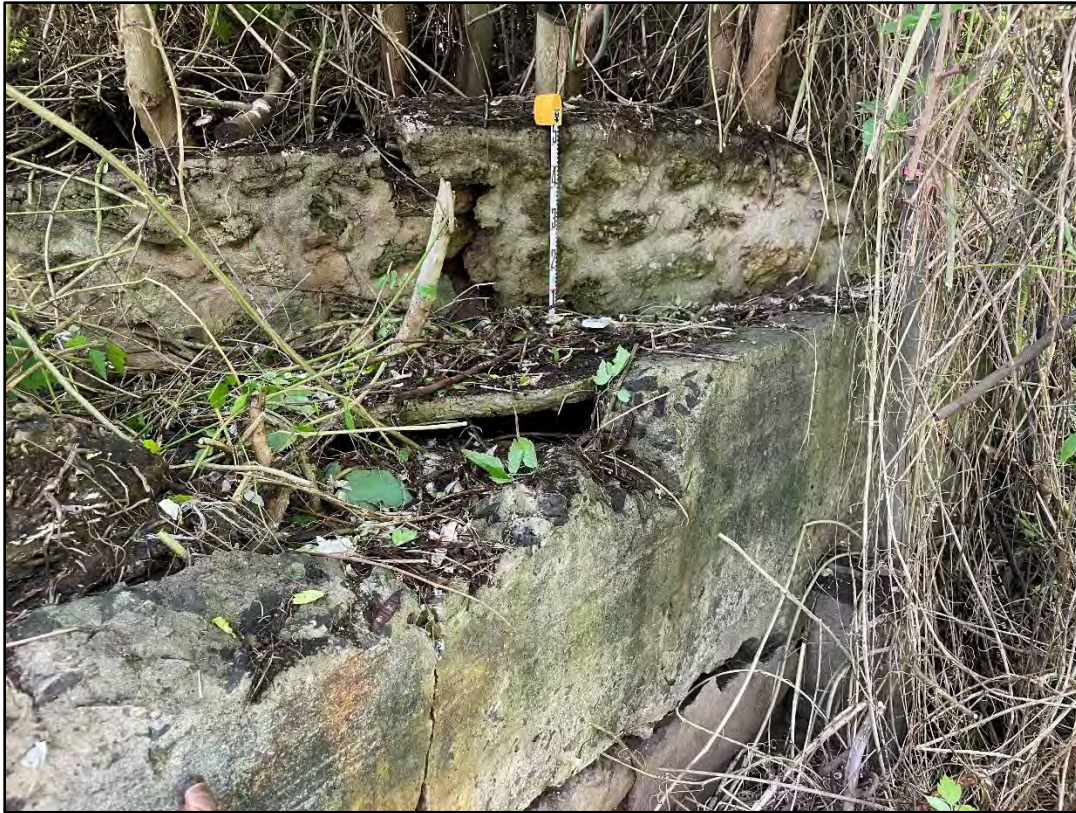
Figure 43. Photo M: Retaining wall(s) on south side of spillway, the upper wall is believed to be older and relate to the original construction of the reservoir and the lower wall is believed to relate to renovations ca. 1950, view to south
