SUBJECT: Environmental Assessment for Helen C. Texeira for  
Access and Utility Easement Over a Portion of  
Government Land at Pohakuhaku-Kemau, Hamakua, Hawaii

ENVIRONMENTAL ASSESSMENT OF ROADWAY ACCESS EASEMENT AT POHAKEA-KEMAU HAMAKUA, HAWAII  
TAX MAP KEY 3rd. 3/ 4-3-06:4 & 16.

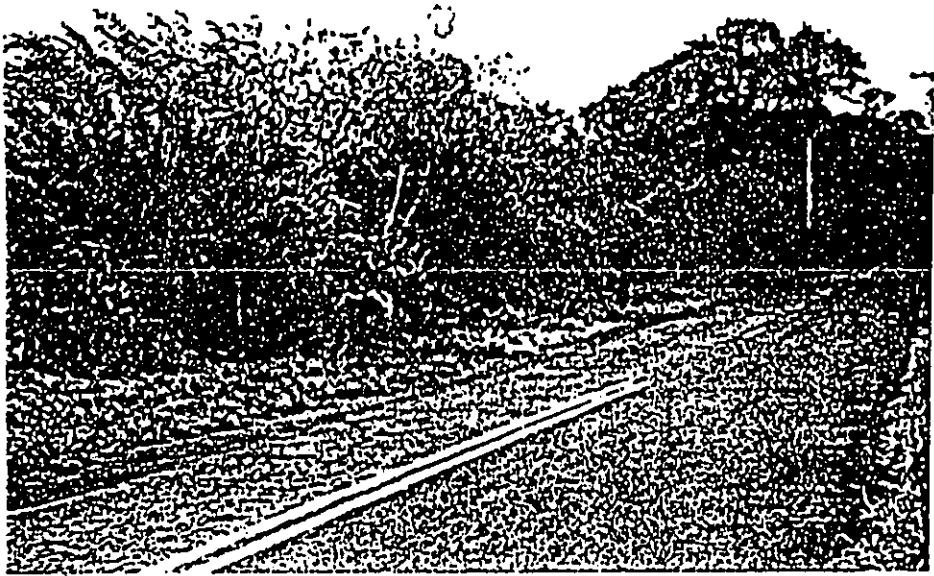
Site of proposed  
alternate access,  
which is situated at  
the end of the knoll.

The area of proposed easement is level entrance access off Pohakea Homestead Road

thus no excavation is necessary. The road will then pass along the back side of the knoll, and drop into the applicant's property. At present, the subject easement site is overgrown with sugar cane. This proposed access will have no effect on the surrounding environment.
