Oceanit Coastal Corporation

**ENVIRONMENTAL ASSESSMENT FOR A
SHORE PROTECTION STRUCTURE AT
57-521 KAMEHAMEHA HIGHWAY
TMK 5-7-05: 10**

submitted to:
**THE DEPARTMENT OF LAND UTILIZATION
CITY AND COUNTY OF HONOLULU**

MARCH 1990

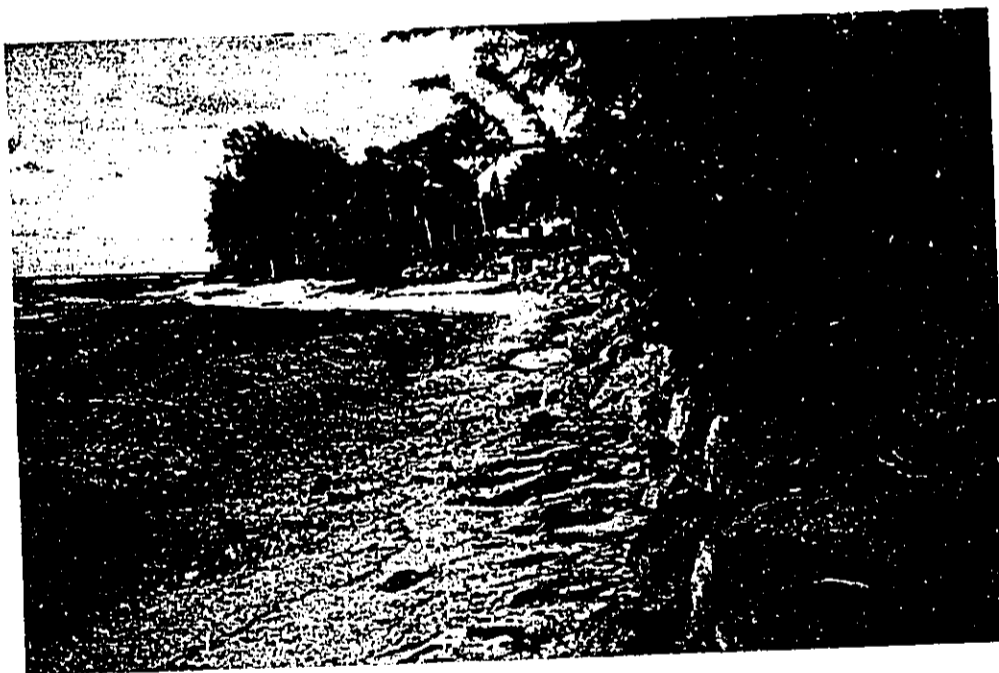
FIGURE 3 EXISTING REVETMENT AT 57-521 KAM HIGHWAY
IN OCTOBER 1989

REVETMENT AND EMBANKMENT

VIEW OF COASTLINE TO THE EAST

A shoreline survey is included as Appendix B. Photographs taken in 1986 prior to installation of the existing revetment are shown in Figure 2. Photographs of the existing rubble structure are shown in Figure 3.

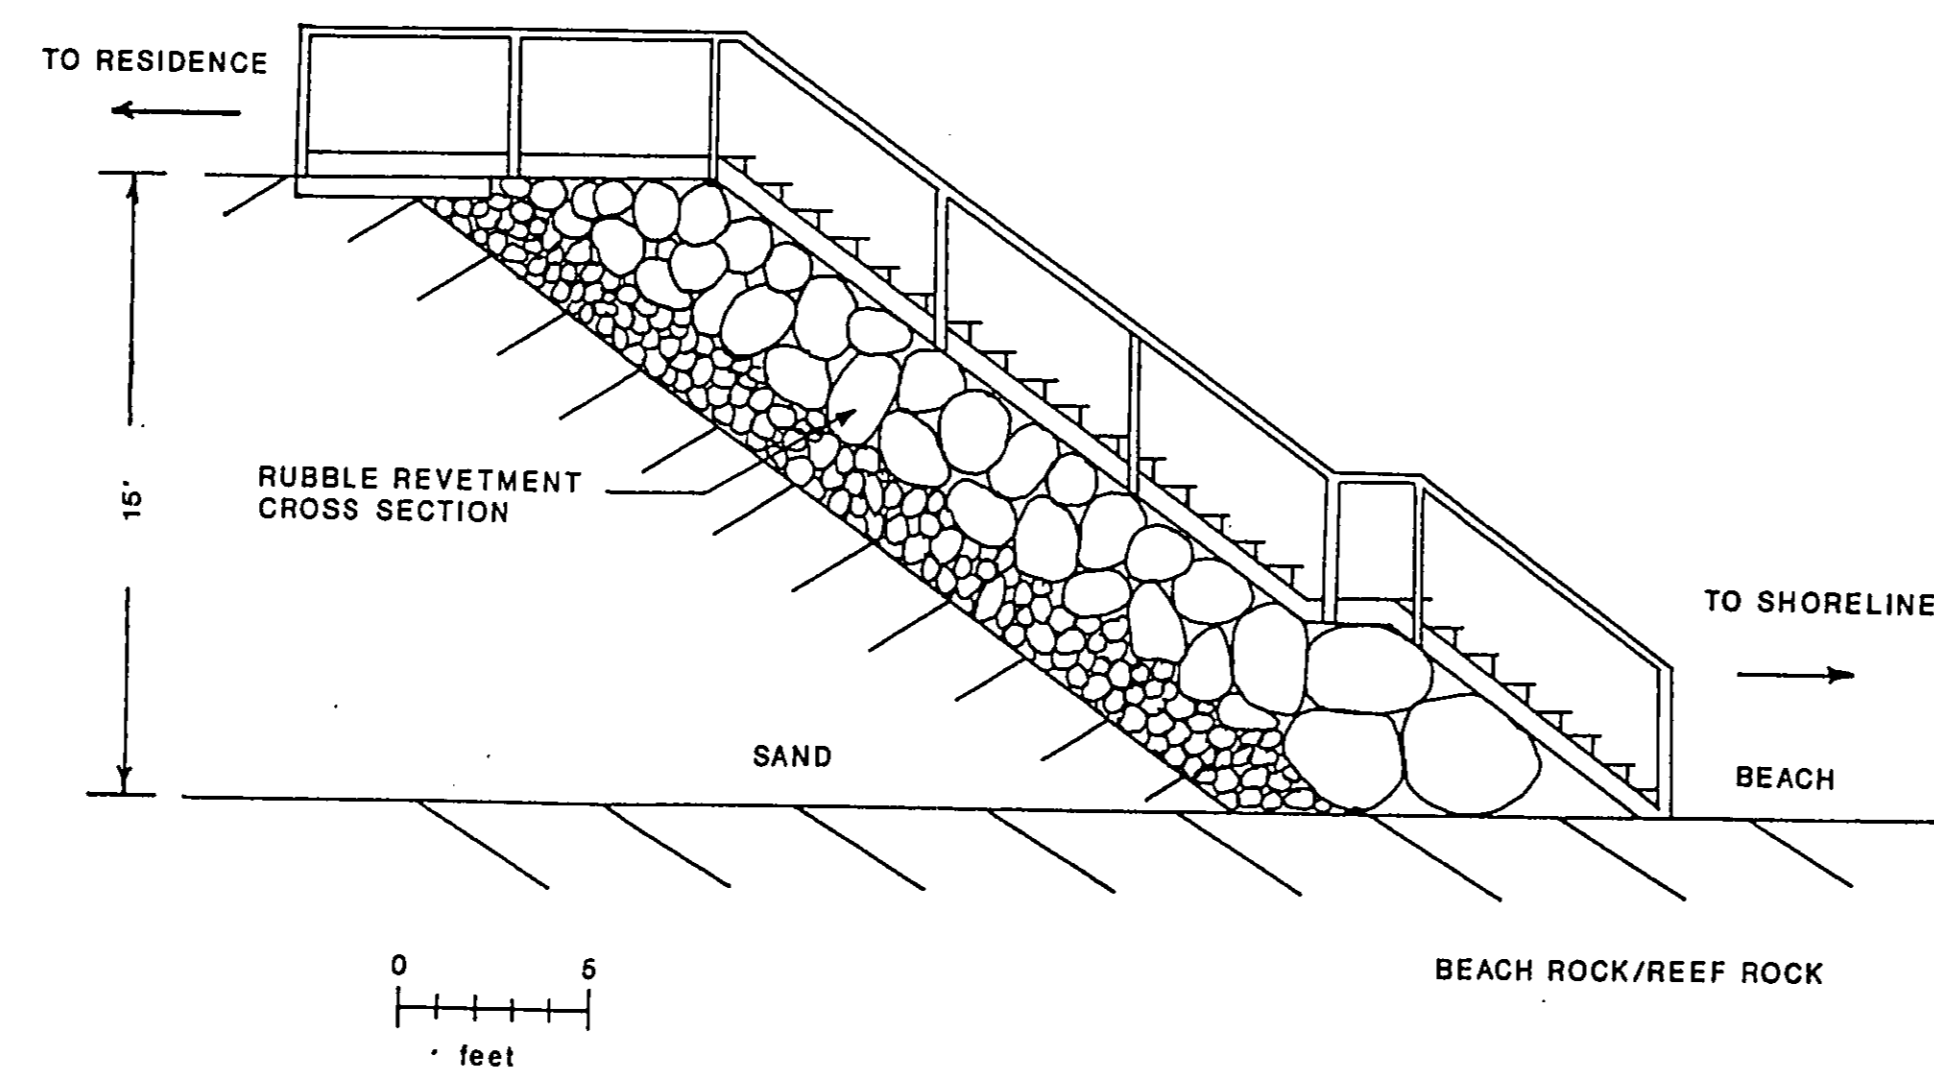
STAIRWAY AND REVETMENT SIDE VIEW

1. THIS IS A PRELIMINARY CONCEPTUAL DESIGN OF A STAIRWAY OVER THE REVETMENT. THIS DESIGN HAS NOT BEEN STRUCTURALLY ANALYZED AND SHOULD NOT BE USED AS A CONSTRUCTION DRAWING.
2. THE STAIRWAY WOULD BE ANCHORED AT THE TOP AND BOTTOM AND WOULD REST ON CONCRETE FOOTINGS ON THE REVETMENT.
3. THE STAIRWAY WOULD BE CONSTRUCTED OF STEEL WITH WOOD STEPS. THIS TYPE OF CONSTRUCTION WILL REQUIRE REGULAR MAINTENANCE FOR CORROSION AND WEATHERING.
4. THIS TYPE OF STAIRWAY SHOULD NOT BE INSTALLED UNTIL SEVERAL MONTHS AFTER THE REVETMENT HAS BEEN CONSTRUCTED TO GIVE THE ARMOR STONES TIME TO SETTLE IN PLACE.

A stairway over the revetment is proposed to provide access to the beach for residents. (See Figure 6. and Appendix C) The design presented herein is preliminary and should not be used for construction. No structural analysis of this design has been done. This stairway should be redesigned and constructed only after the revetment is completed and the armor stones have had time to settle. It is not an integral part of the revetment structure. A steel structure with wood steps appears to be practical; however, this type of stairway will require periodic maintenance for corrosion. Other types of materials such as aluminum or wood may also be feasible.
