SUBJECT: DOCUMENT FOR PUBLICATION IN THE OEQC BULLETIN -  
ENVIRONMENTAL ASSESSMENT FOR CONSERVATION DISTRICT USE  
APPLICATION OA-2455 for a portion of an existing seawall  
TMK: 4-3-3: 75, 4-3-4, 83 and 87

#### ENVIRONMENTAL ASSESSMENT FOR A SEAWALL LOCATED AT 1426 MOKULUA DRIVE, LANIKAI, KAILUA, HAWAII

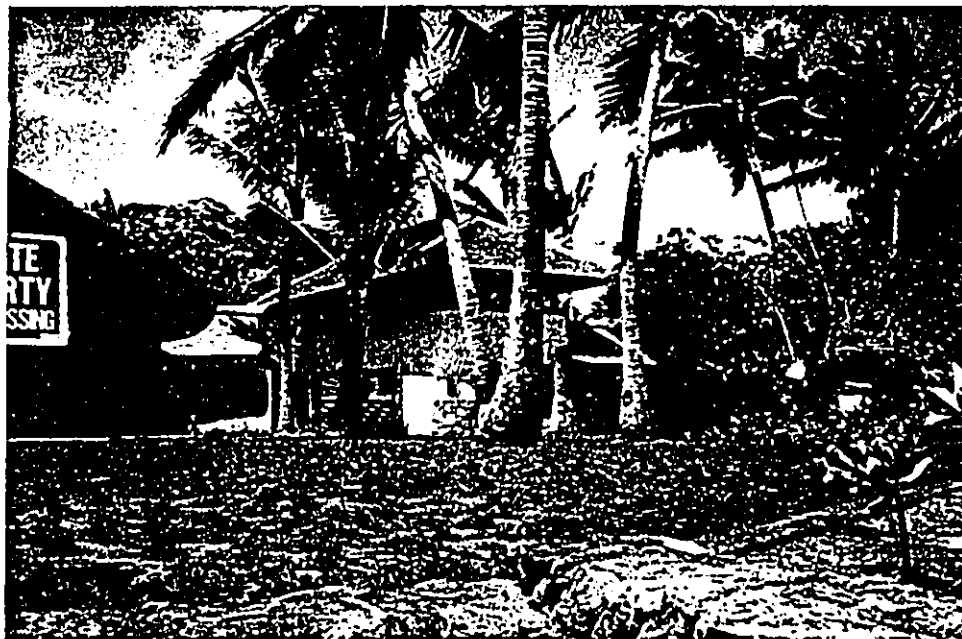
EXHIBIT A-5  
(Land area mauka of seawall, Kailua end  
of property)

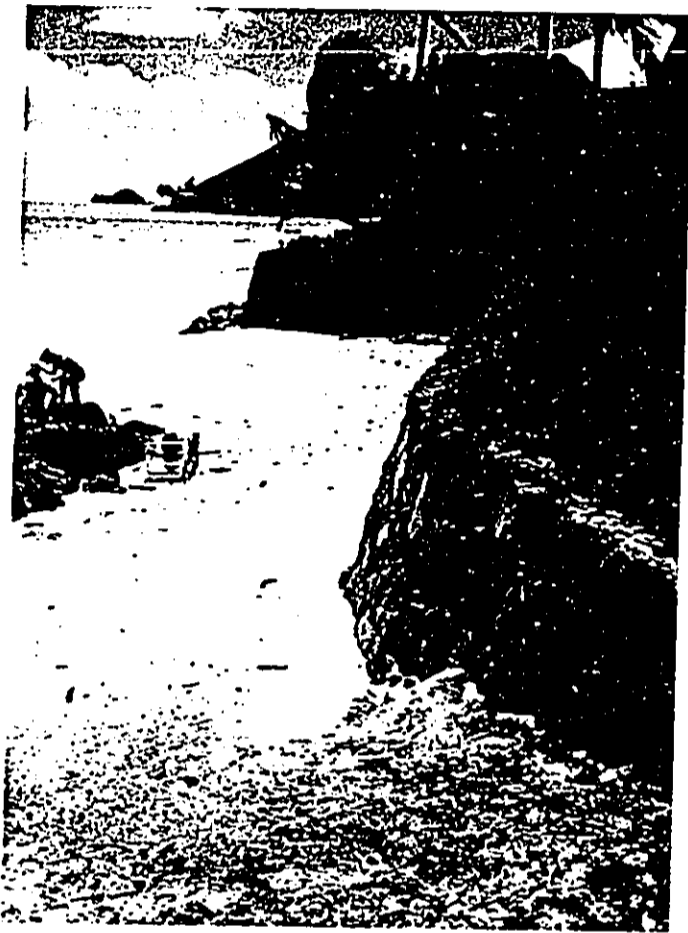
EXHIBIT A-6  
(Land area makai of seawall, facing  
toward Waimanalo)

seawall in 1989, there are no significant adverse effects on the environment. The beach area remains unaffected after the seawall was demolished and reconstructed.<sup>8</sup>

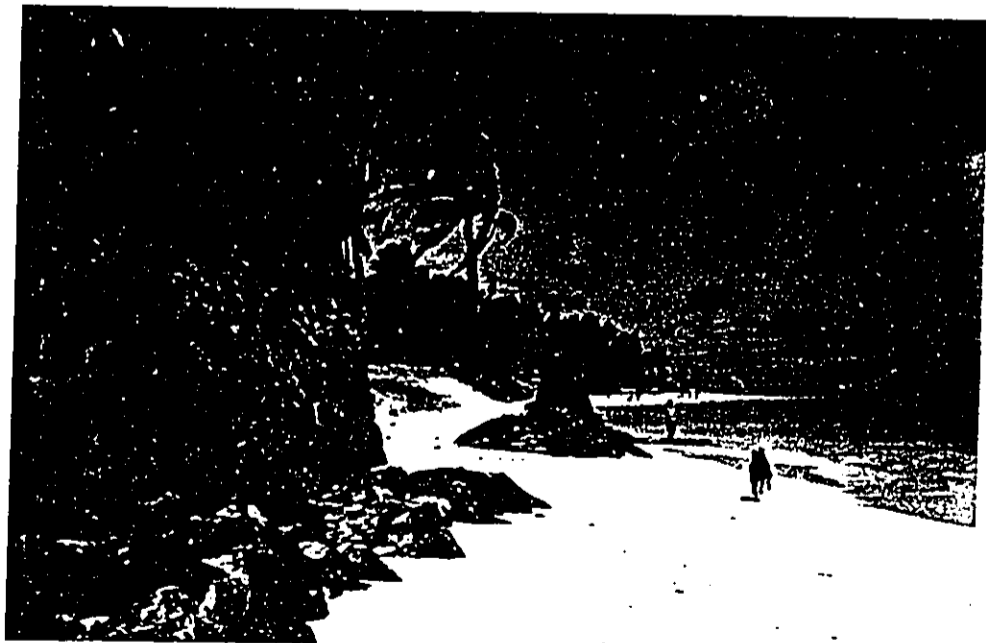
EXHIBIT A-7  
(Land area makai of seawall, facing toward  
Kailua)

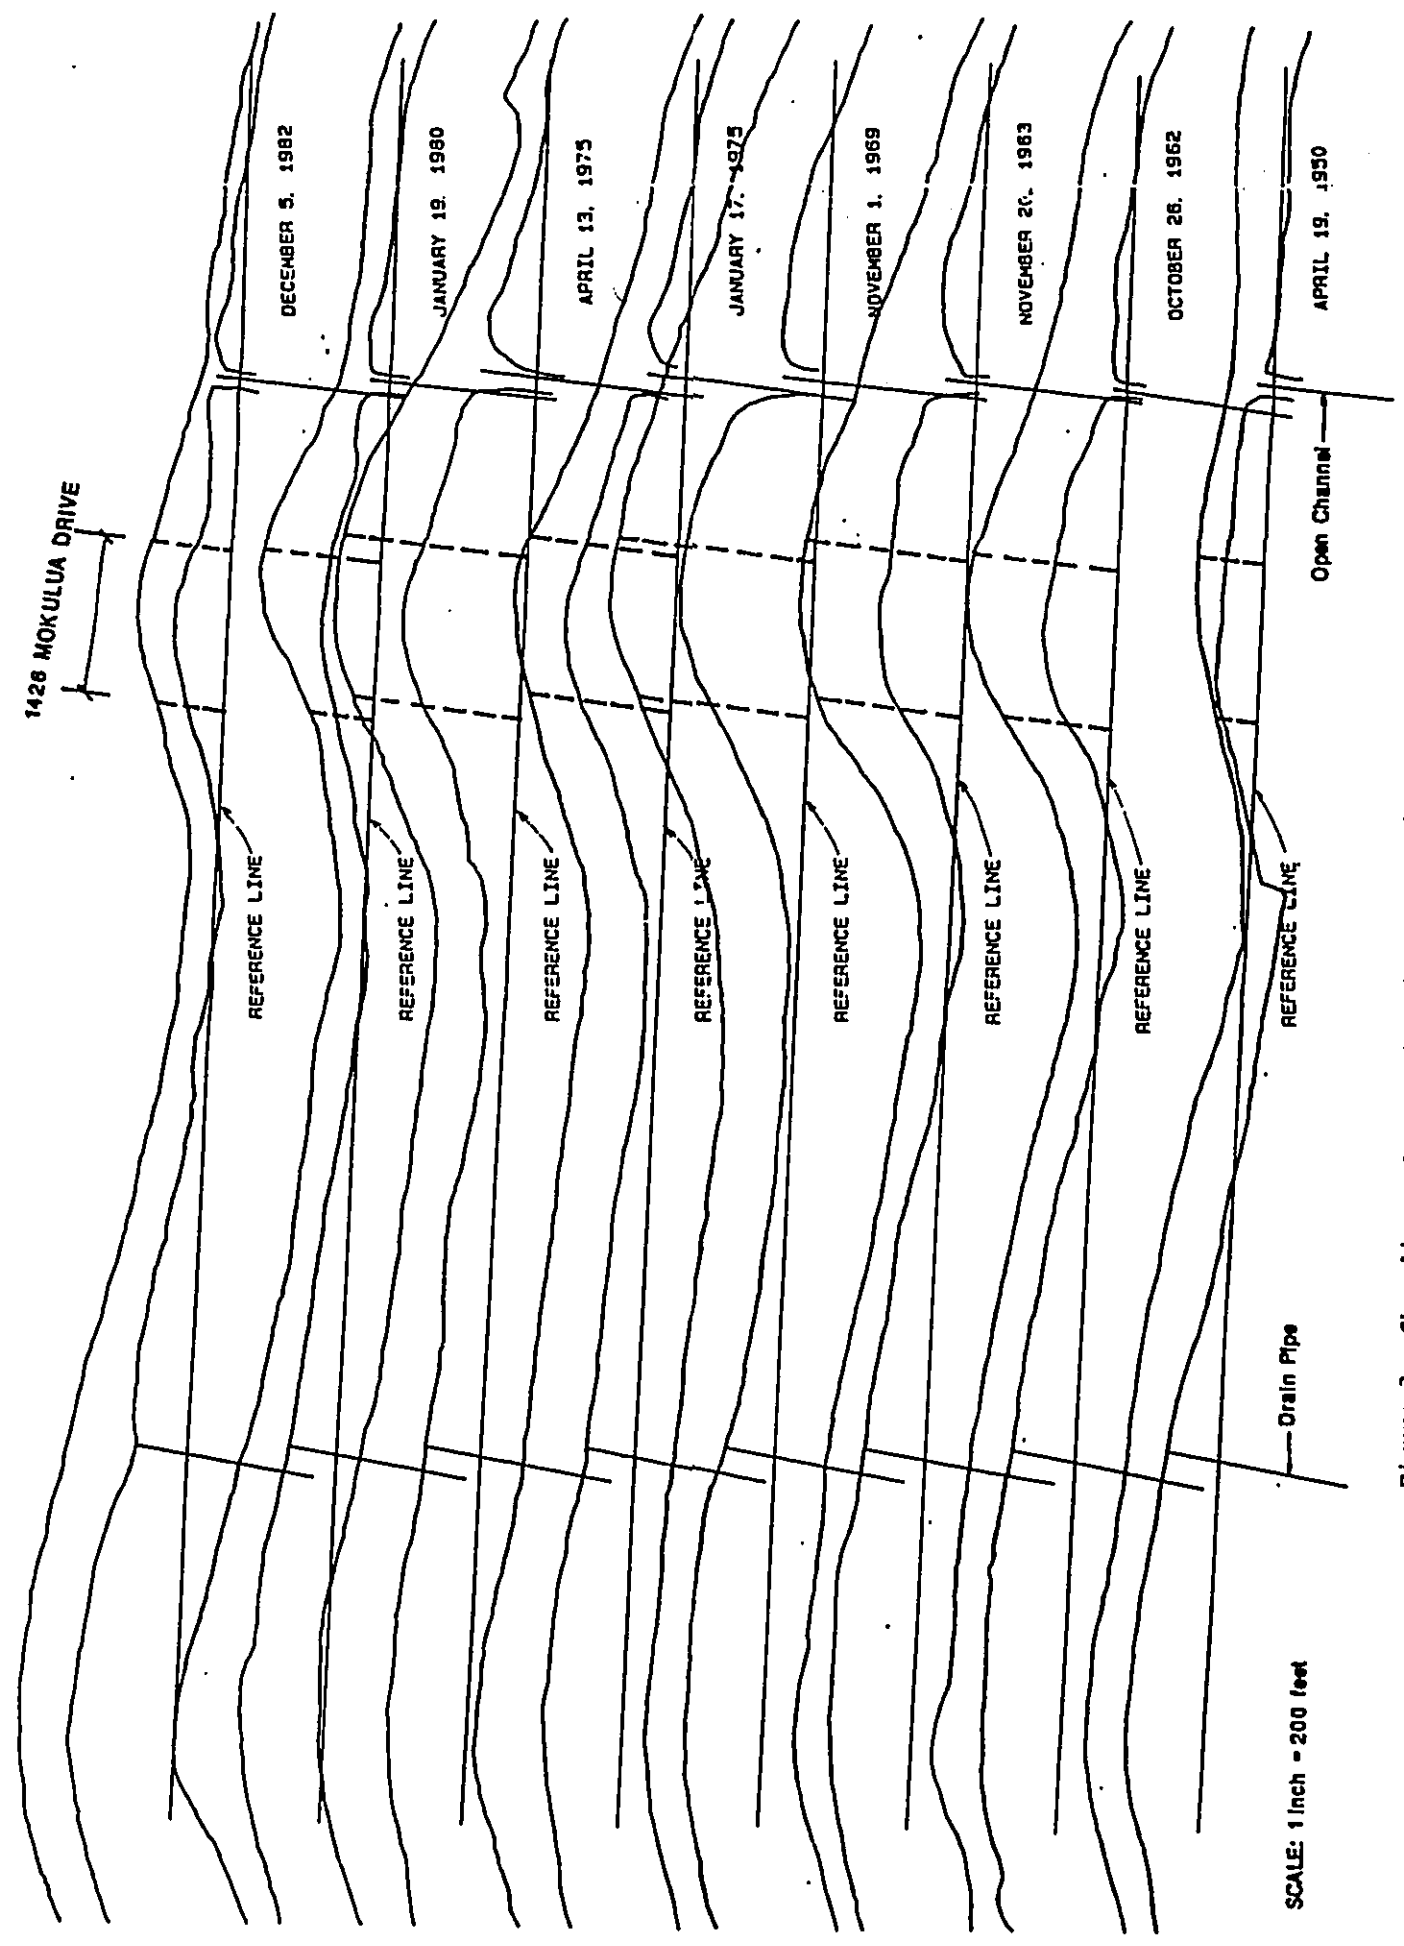
Figure 3. Shoreline and Waterline Along Project Reach from Aerial Photos.

were determined by analysis of aerial photos spanning the period April 1950 to December 1982. Figures 1, 3, and 4 (Inclosures 3, 4, and 5, respectively) are reproduced from the Flood Control Project study report, and show the approximate location of the subject property. The analysis revealed dramatic fluctuations in the shoreline and beach width during this time frame. In 1950, the vegetation line was at about the same location as it is presently. From 1950 to 1969, the vegetation line moved seaward about 140 feet and the beach width between the vegetation line and the beach toe was about 100 feet wide. From its most accreted state in 1969, the vegetation line and beach width eroded back to its present state and the line of seawalls fortressing this shore presently prevents further shoreline recession. With the present seawalls, it is still possible that another major accretion cycle could result in seaward movement of the shoreline and increase in dry beach width.

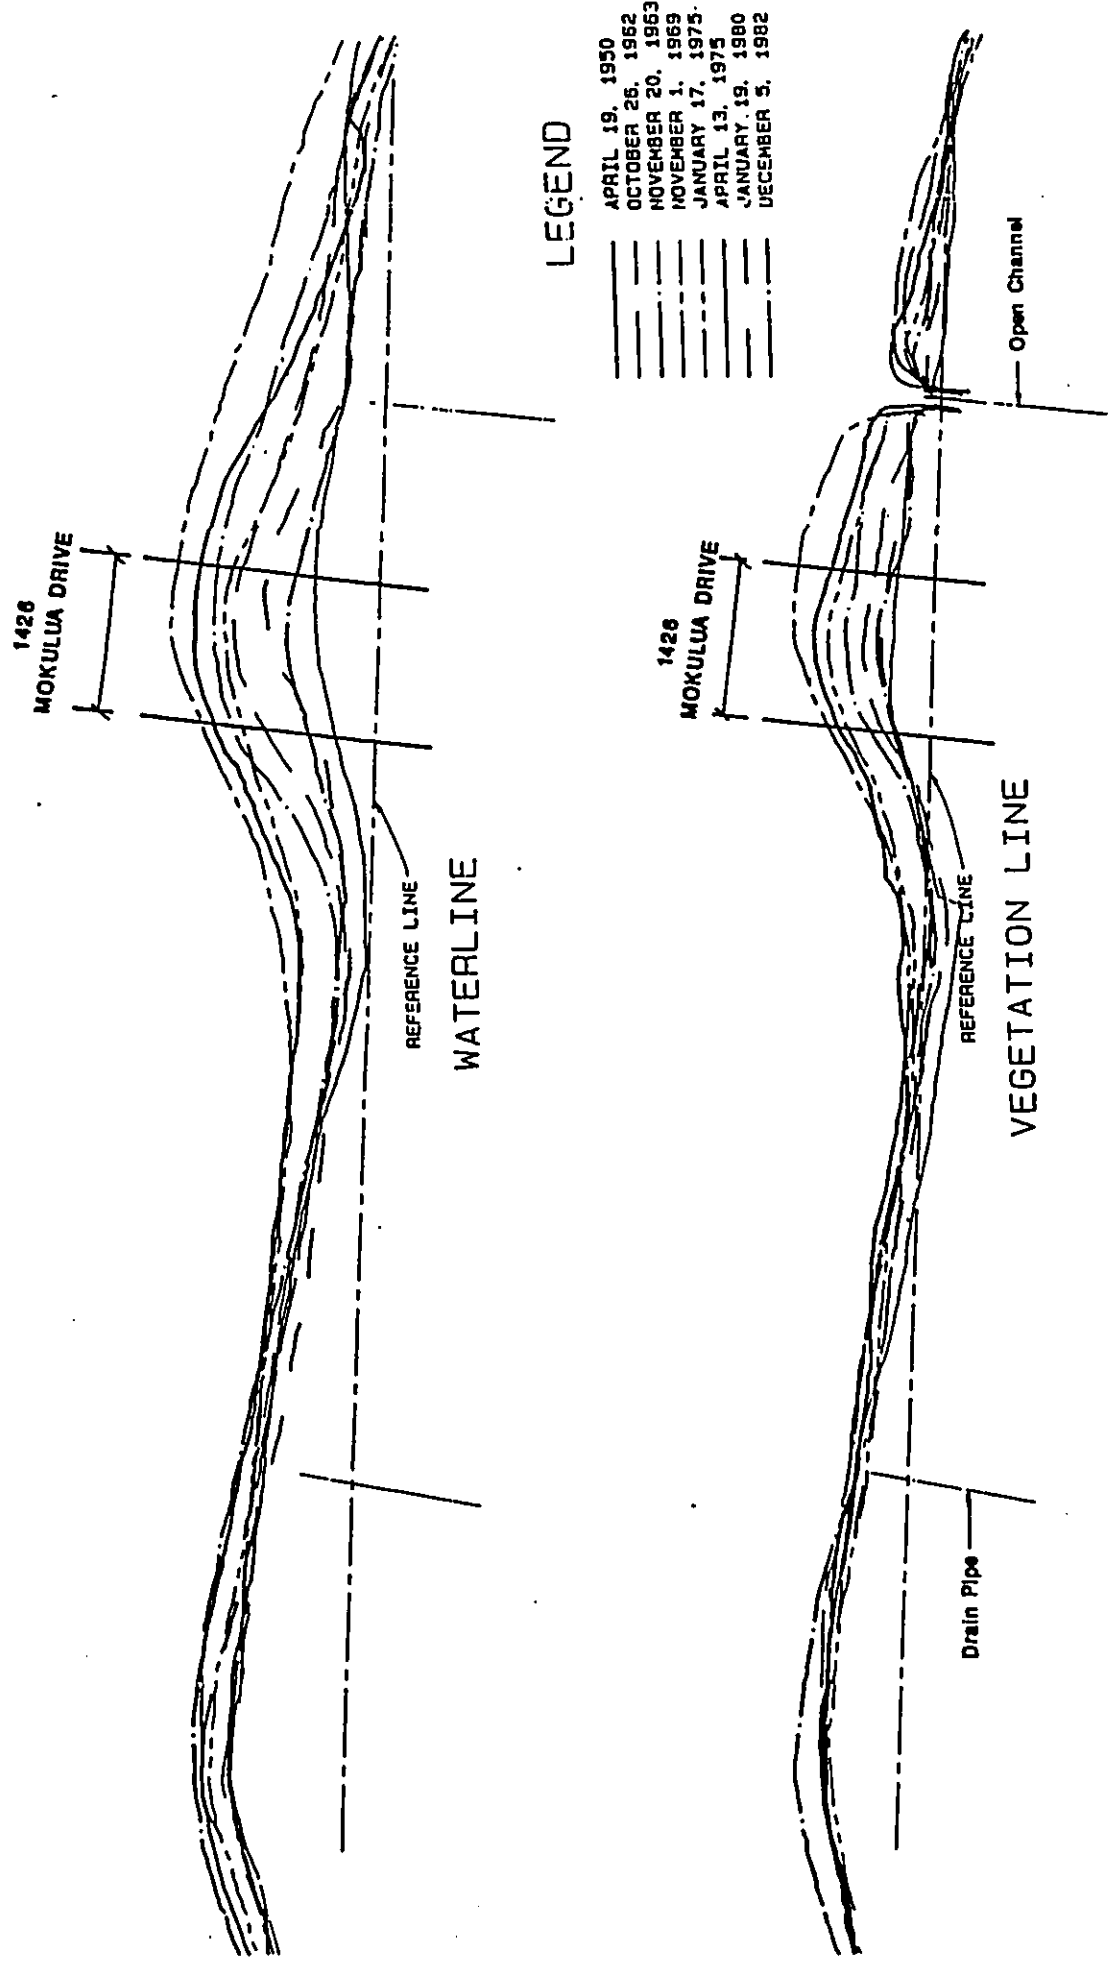
Figure 4. Overplots of Shoreline and Waterline from Aerial Photos.

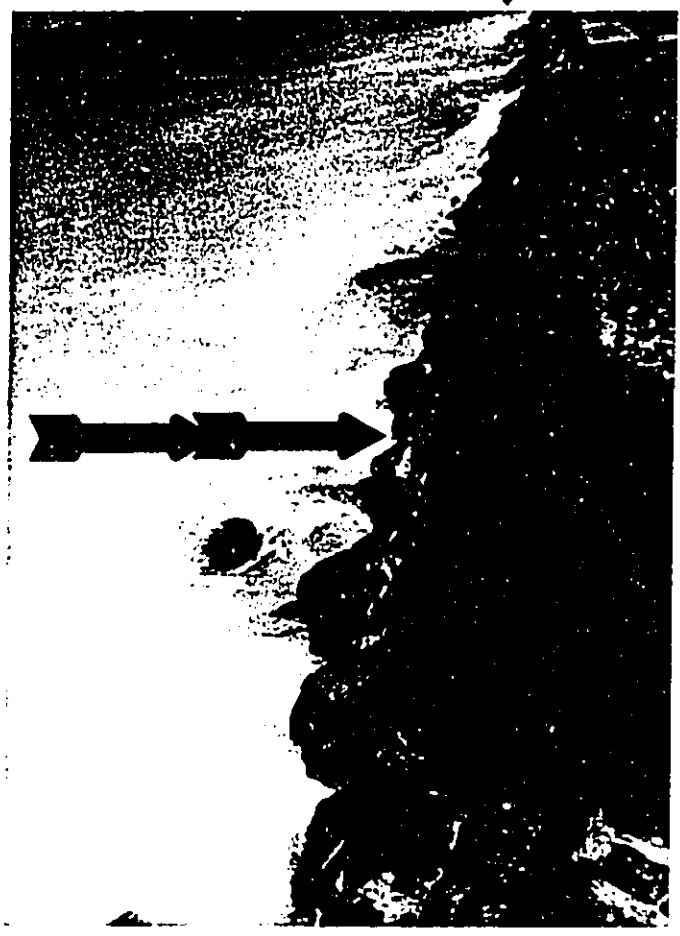
Aligned with neighboring seawall

Rebuilt on old foundation

(Waimanalo end of seawall (facing toward Waimanalo) prior to demolition)

CDUA No. OA-2173 was initiated because Applicant's contractor initially rebuilt the seawall upon the original foundation, thus aligning with the neighboring seawall. Portions of the original foundation are makai of the June 1, 1986 certified shoreline, which resulted in locating portions of the reconstructed seawall within the State Conservation District.<sup>9</sup>

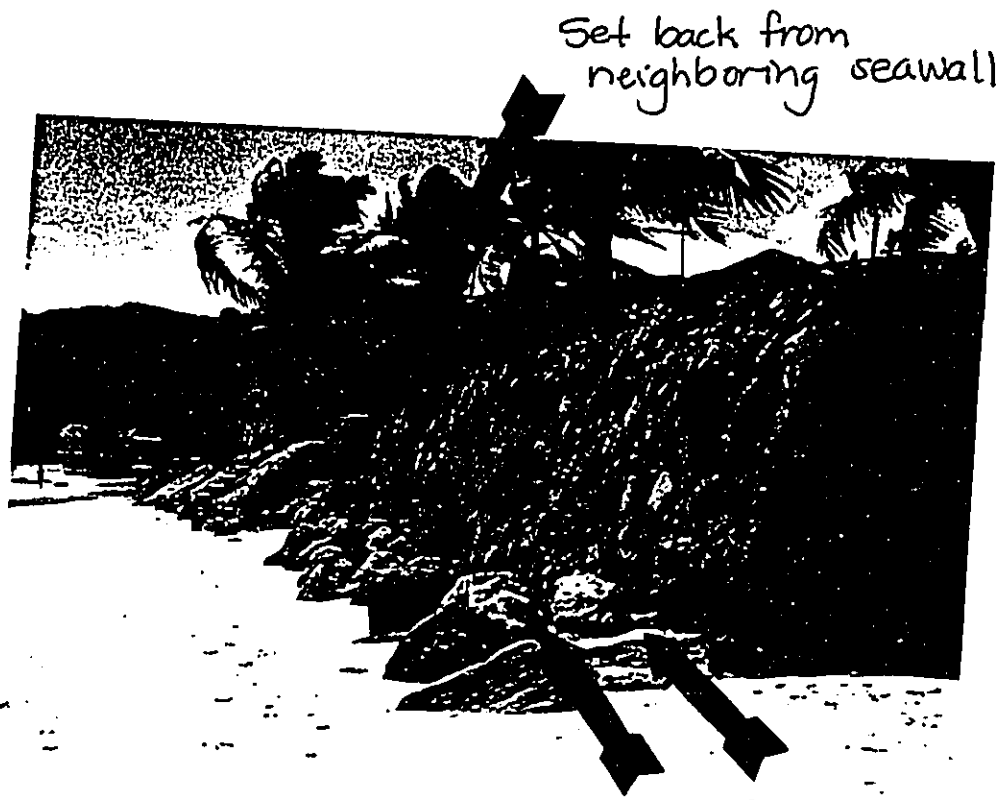
Set back from neighboring seawall

Old foundation exposed

(Waimanalo end of seawall (facing toward Waimanalo) after demolition and reconstruction)

Applicant has expended in excess of \$70,000 to comply with DLNR's order to remove the seawall from the State Conservation District and to mitigate its first reconstruction efforts.<sup>10</sup> A survey drawing comparison of the first and second reconstruction areas demonstrates the results of Applicant's efforts to mitigate the encroachment.<sup>11</sup> A comparison of "before" and "after" photographs of the second reconstruction also demonstrates these efforts.<sup>12</sup>
