1.0 LOCATION AND PROBLEM DEFINITION

This coastal engineering evaluation and environmental assessment is prepared in support of an application for a Shoreline Setback Variance for a shore protection structure, and in accordance with Ordinance No. 4631 Shoreline Setback Rules and Regulations.

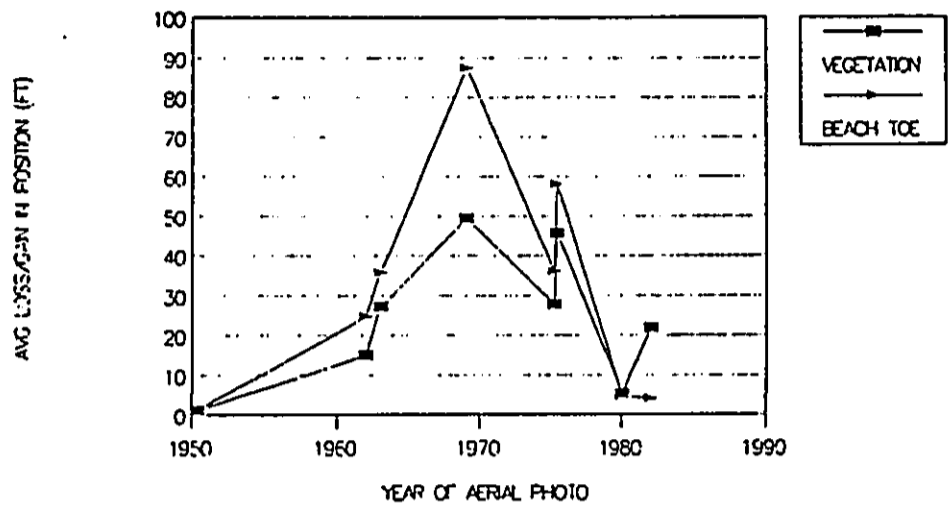
FIGURE 3a. Average cumulative movement for a 2,500-foot stretch of shoreline from Wailea Point northward past the project site.

This southeast end of Lanikai had experienced considerable accretion and subsequent erosion over a long-term period from 1950 to the 1980s. Figure 3a shows the average cumulative movement of the shoreline over a 2,500 feet length along the southern third of the Lanikai coastline.¹ Between 1950 and 1970, this shoreline reach accreted substantially, a maximum of about 200 feet near the drainage channel. Many of the property owners legally extended their property boundaries seaward by claiming these accreted fastlands. From 1970 to the early 1980s, the shoreline eroded back to the approximate 1950s position. Most of the seawalls were constructed in response to this erosion cycle. Presently, the entire +2,000-foot reach at the southeast end of Lanikai is armored with shore protection structures.

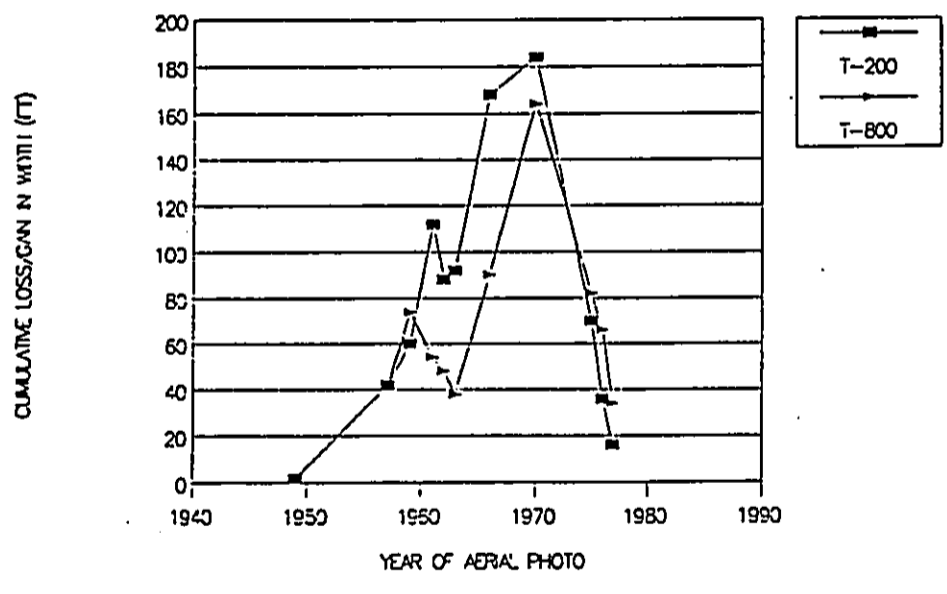
FIGURE 3b. Cumulative movement of the shoreline at Kailua Beach Park at locations 200' and 800' from the boat ramp.

The long-term accretion and erosion cycle was a natural process, possibly caused by shifts in wind and wave patterns. The southern Lanikai shore displayed similar historical accretion-erosion trends as the Kailua Beach Park shoreline (which was and still is unprotected). Figure 3b shows the historical shoreline movement at Kailua Beach Park. The Lanikai seawalls were constructed in response to the erosion cycle to protect existing residential improvements, and were not the cause of the erosion trend. Their influence now, however, is to discourage sand buildup if there is a return to an accretionary phase of the cycle. With the increase in reflectivity due to the seawalls, there is little chance for sediment to be re-deposited and for the beach to build back naturally in the near future.

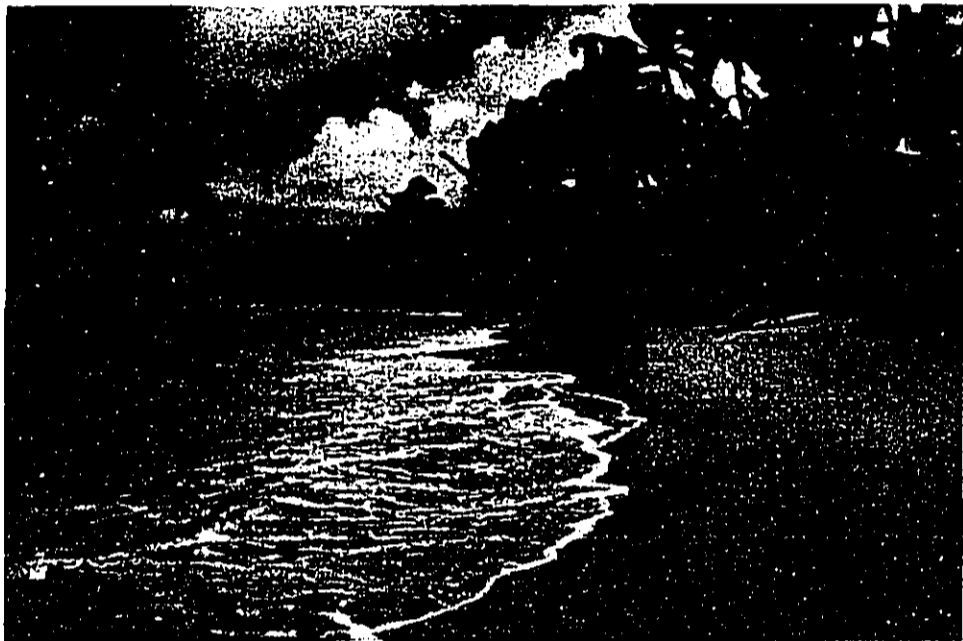
Photo 1. View of
shoreline southward of
project site. Photo date
6-17-90, tide +1.6' MLLW.

The project site is in the transition zone between the southeastern end of Lanikai that historically has undergone a dramatic accretion-erosion cycle, and the middle segment of Lanikai that historically has been relatively stable. The extreme southeast Lanikai shoreline has experienced net long-term erosion since 1970, and deficit of sand along this southeastern shoreline reach may be causing a gradual shift of the erosion trend towards the shoreline reach north of the project site. Photo 1 shows a view of the shoreline reach southward from the project site, and Photo 2 shows a view northward of the project site.

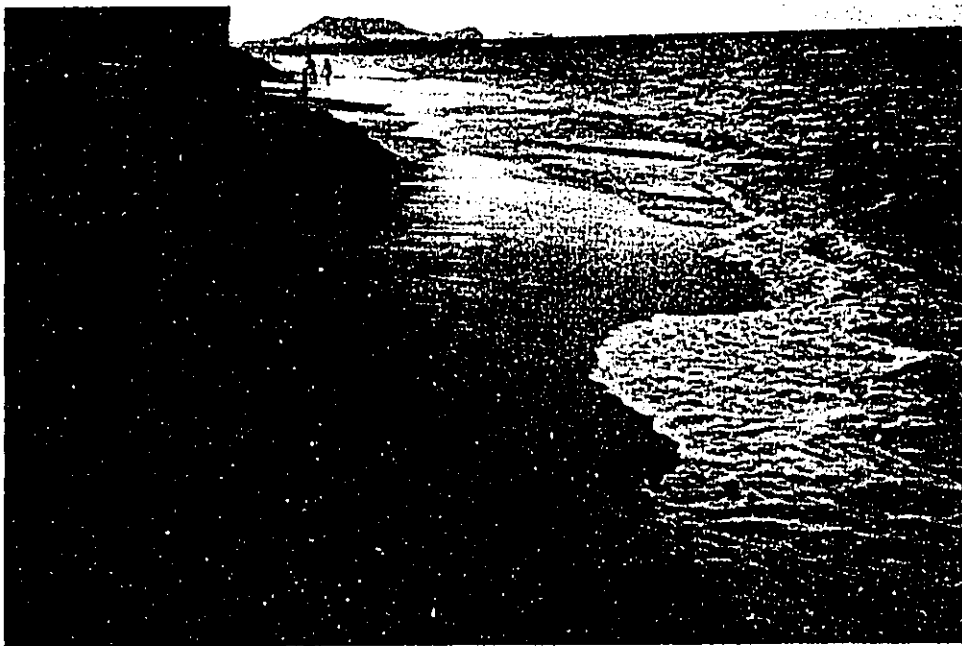
Photo 4. Typical minimum beach width. Photo date 8-8-90, tide +1.9' MLLW.

There is generally a narrow dry beach fronting the subject parcel towards the beginning of the summer season after winter northerly swell activity transports sand from beach areas north of the project site (Photo 3). By the end of the summer season however, tradewind waves transport much of this sand back to the beaches north of the project site (Photo 4).
