1991-08-08-0A-PEA - Perry Revetment CDA

CONSERVATION DISTRICT USE APPLICATION
FOR REVETMENT AT 622 KAIMALINO ST.
KAILUA, HAWAII

APPLICANT: Michael W. Perry
Address: 622 Kaimalino St.
Kailua, Hawaii 96734

SUBMITTED: APRIL 16, 1991

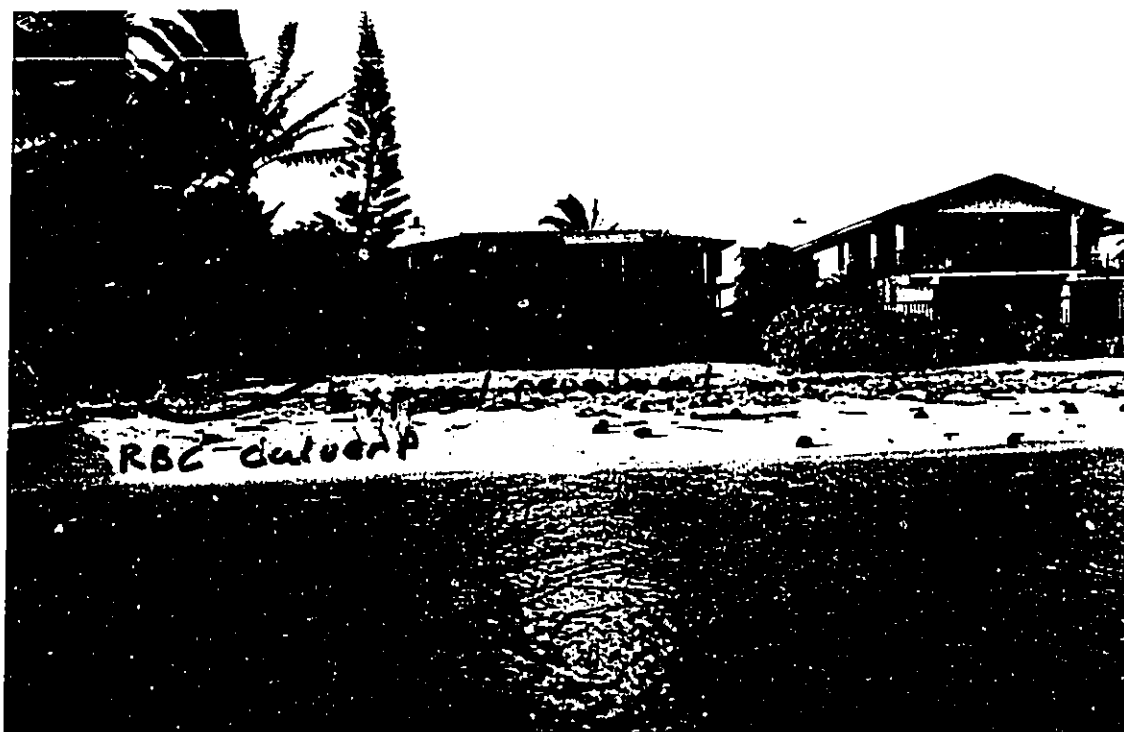
PLATE 1: OVERALL PLAN VIEW OF SUBJECT PROPERTY
Low to Mid Tide; March 28, 1991; 17:30 hrs.
(Natural litter due to storm of March 23-24, 1991)

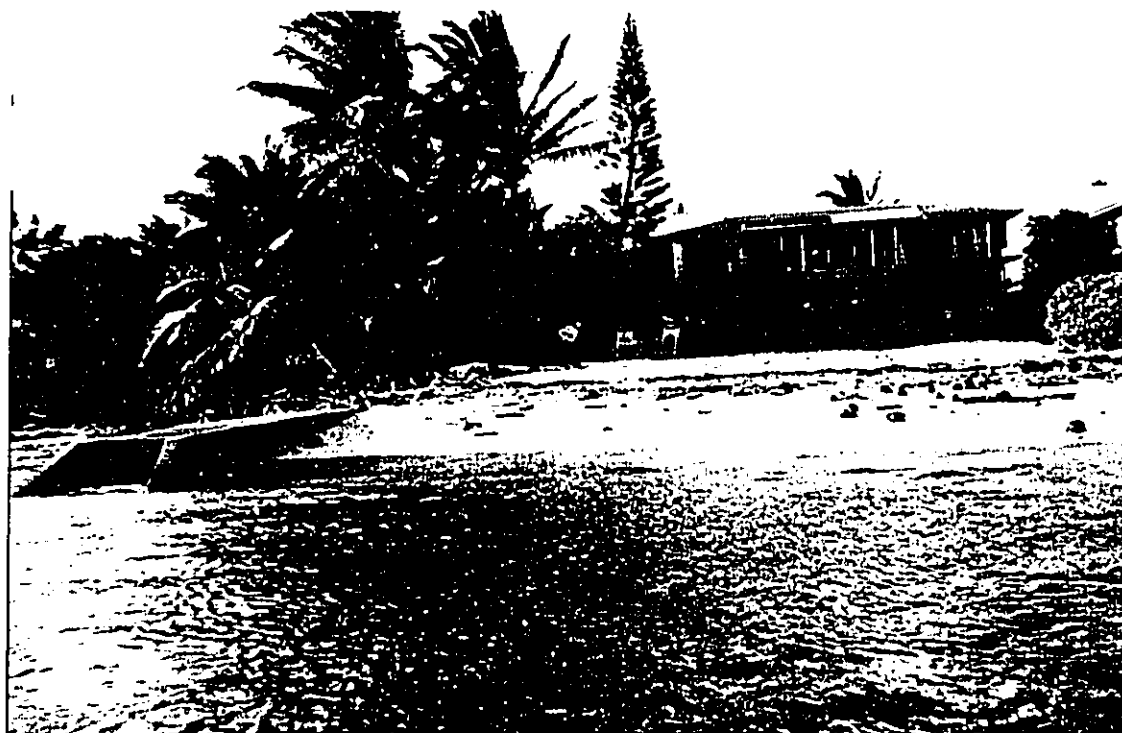
PLATE 2: OVERALL VIEW OF SUBJECT PROPERTY AND RBC CULVERT
Low to Mid Tide; March 28, 1991; 17:30 hrs.
(Natural litter due to storm of March 23-24, 1991)

B. Plate 2 shows the City & County 3.5 feet x 2.5 feet reinforced concrete storm drain which projects about 40 feet into the water at an angle nearly perpendicular to the shoreline. This structure was constructed in 1976 to replace an 18" culvert in the same easement. Increasing the size of this storm drain was needed when the subdivision was developed. The top of this concrete box is at elevation 2.9 at the present shoreline and 2.8 close to the discharge end. All elevations shown on Figure 2 and in the narrative of this report are based on mean sea level (msl) and are determined from City bench marks. City plans show an invert elevation at the drain outlet of +0.5 and probing on October 24, 1988 indicated several inches of sand fill in the bottom. This structure functions as a small groin with classic sand deposit on one side only as shown on Plates 9 and 10. There is a rather direct relationship of the City & County storm drain to the extent of this beach. The Kailua Beach Park erosion control report reveals

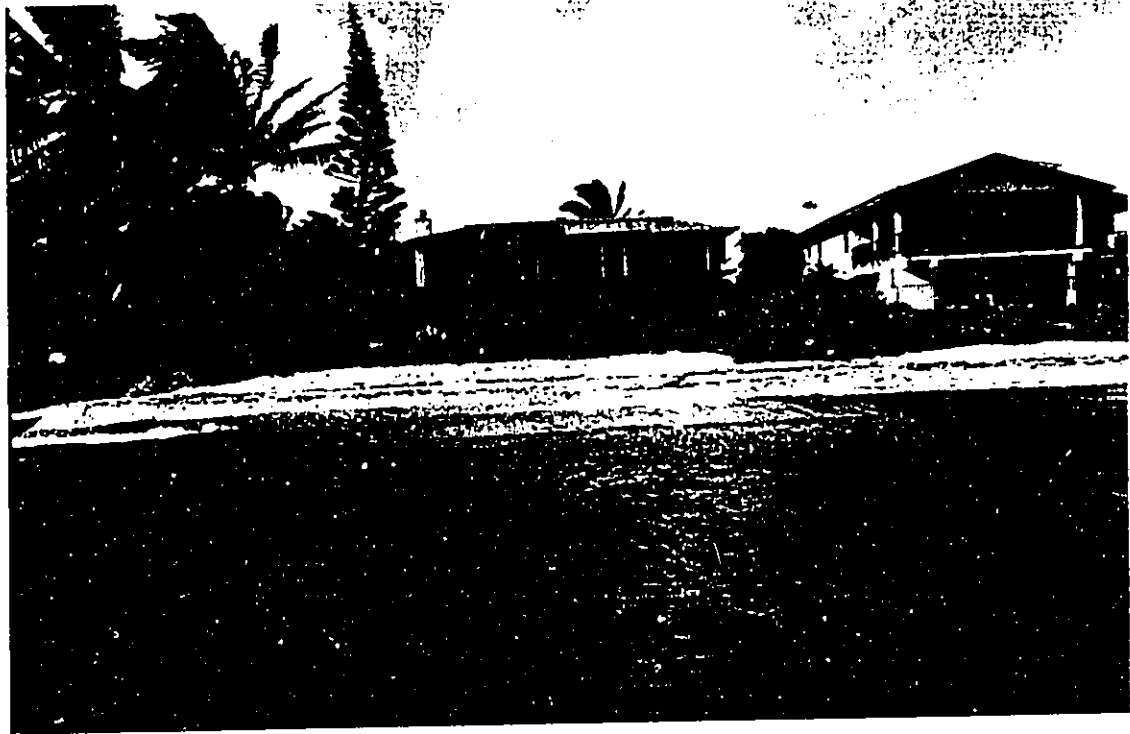
PLATE 3: OVERALL PLAN VIEW OF SUBJECT PROPERTY
High Tide (+1.8 msl); April 2, 1991; 16:30 hrs.

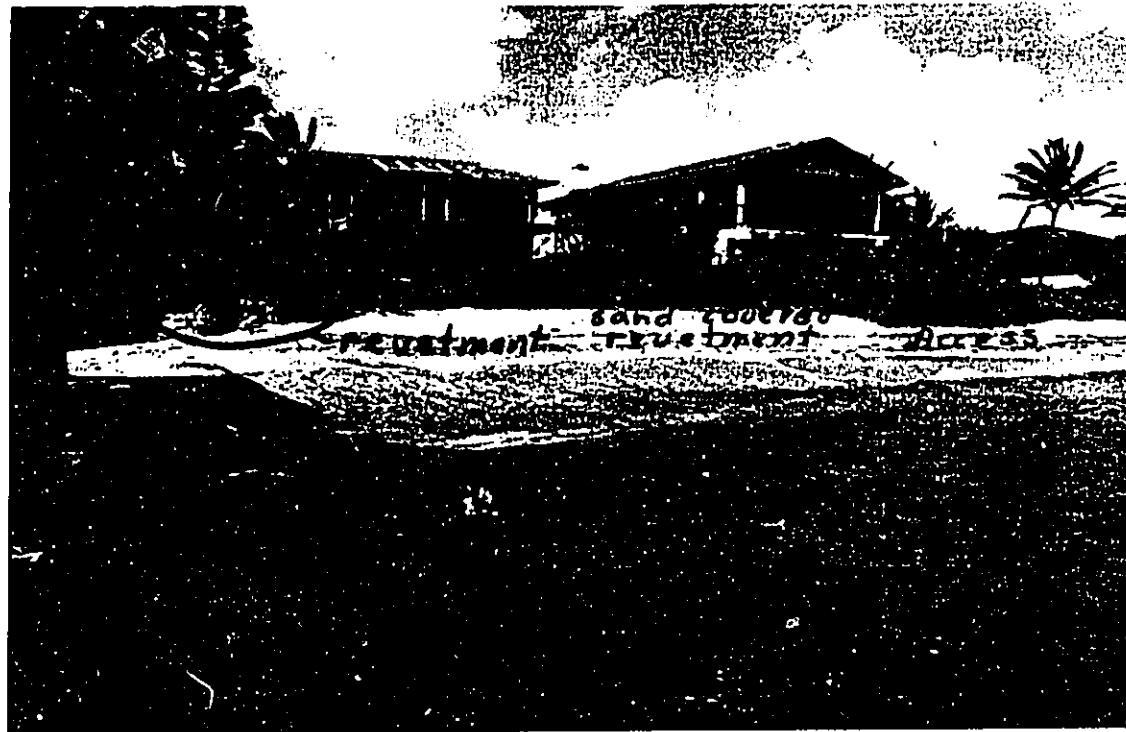
PLATE 4: OVERALL VIEW OF SUBJECT PROPERTY AND RBC CULVERT
High Tide (+1.8 msl); April 2, 1991; 16:30 hrs.

The land area on the makai side of the revetment is gently sloping sandy beach. The revetment is almost entirely covered by the sand. The sandy beach remains partially exposed at high tides. Plates 4,7 and 9 clearly show the unrestricted access and beach exposure at high tide (+1.8 msl).

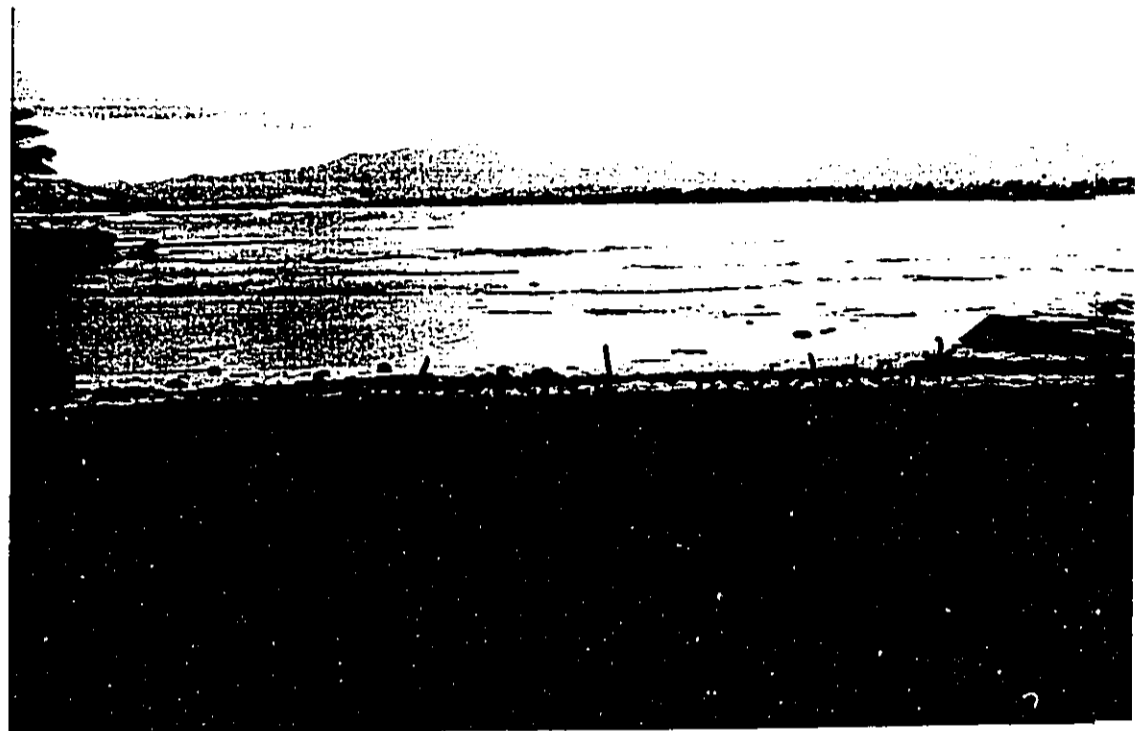
PLATE 5: VIEW FROM PROPERTY TO MAKAI
Low tide; March 28, 1991; 17:30
(Natural litter due to storm of March 23-24, 1991)

The ocean area adjacent to the applicant's property consists a shallow reef flat area. The area is apparently a turtle feeding area due to the rich nutrients entering from Kaiwainui stream. Turtles are frequently seen frequenting the area. Plates 5 and 11 provide a view of the nearshore waters adjacent to the subject property.

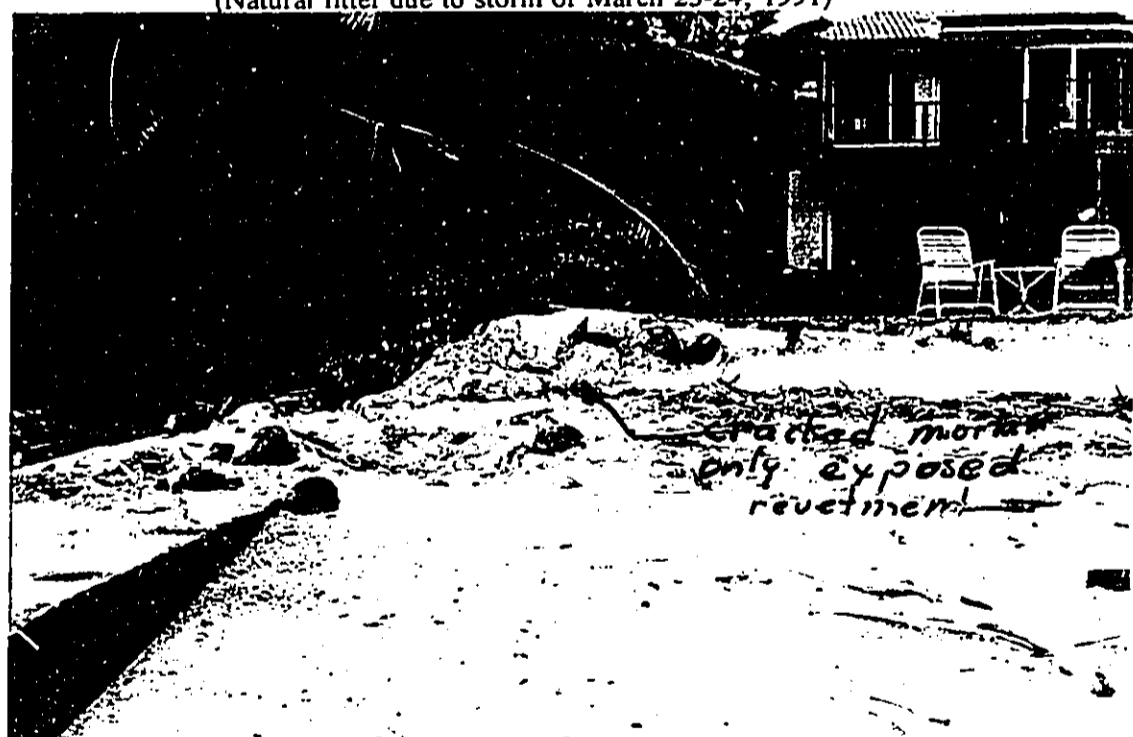
PLATE 6: EXPOSED PORTION OF REVETMENT, WEST END OF
PROPERTY; LOOKING MAUKA
Note damaged mortar; March 28, 1991; 17:30 hrs
(Natural litter due to storm of March 23-24, 1991)

The subject structure is a loose stone revetment with a damaged mortar covering. It is approximately 46 foot long, five foot wide and is located along the shoreline boundary of the property. It is approximately 2.5 feet high with a facing slope varying from 1(v):1.5(h) to 1(v):3(H). It is composed of 20 to 50 pound stones and backfill. Please see Exhibits A-4 and A-5. The revetment has a history dating back to the construction of the Oneawa Channel Flood Control Project by the U.S. Army Corps of Engineers, Honolulu District in 1966. This may have been the first time that stone was placed for the purposes of erosion control on the shoreline area under study. It is not certain if, and to what extent, stone was placed at the site of the existing revetment. In 1982 the then owners hand placed stone to prevent erosion on what they mistakenly believed was their own property. A chronology of the history of this revetment is included in Attachment B.

(1). This structure is a revetment with a thin top of mortar which was placed after the owners found that children could move the stone they had placed by hand too easily. From discussions by Mr. Bail with the owners, City & County maintenance personnel, and Corps of Engineers personnel it appears that a fairly large shoal in the same area as the presently existing one in the right side of the canal near the outlet was removed by City & County personnel in 1981. Annual reports by the Corps refer to such a shoal for several years through early 1981 but do not mention it in the early 1982 report. City & County equipment coming in from North Kalaheo Avenue along the right bank removed the shoal and this was observed in progress by Corps representatives.

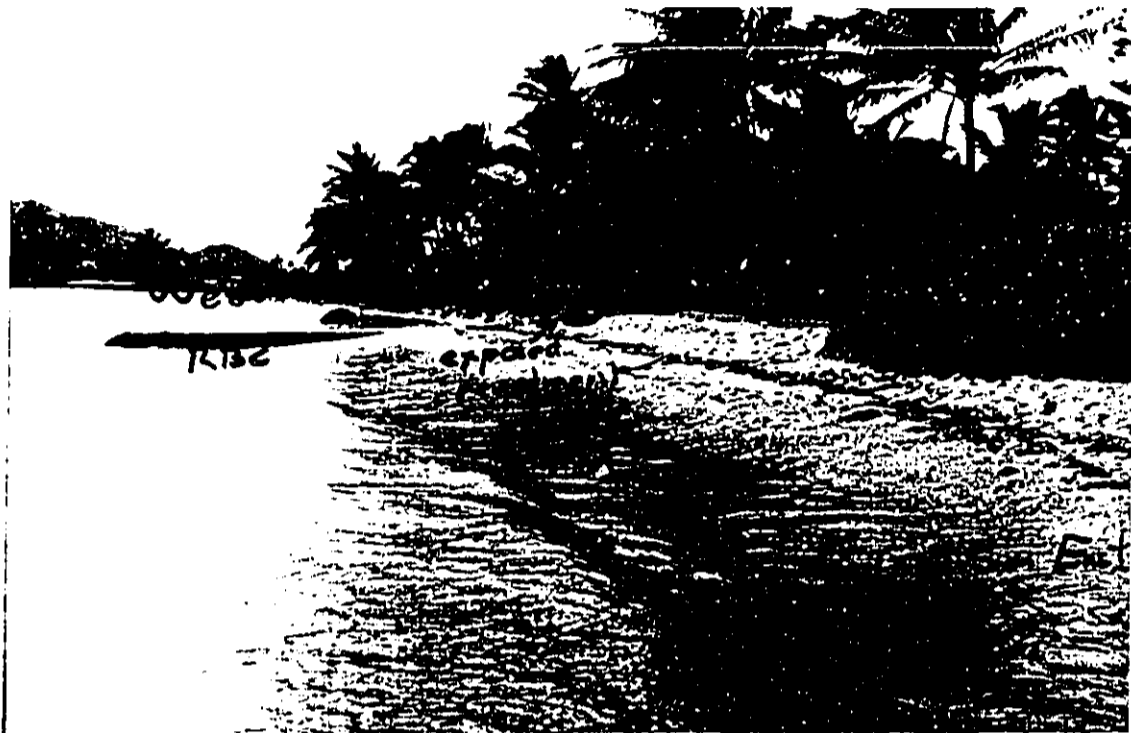
PLATE 7: SHORELINE AT SUBJECT PROPERTY AT HIGH TIDE
LOOKING EAST TO WEST
Note unrestricted access; April 2, 1991; 16:30 hrs.

Public access to the beach and shoreline is possible at all tide conditions. Photographs taken on March 28 and April 2, 1991 respectively show the width of beach at high and low tides (Plates 7 and 8). These conditions are similar to those described by the present and previous owners, adjacent property owners, and previous studies (Bail, 1989) Assessment through varied seasons and years.

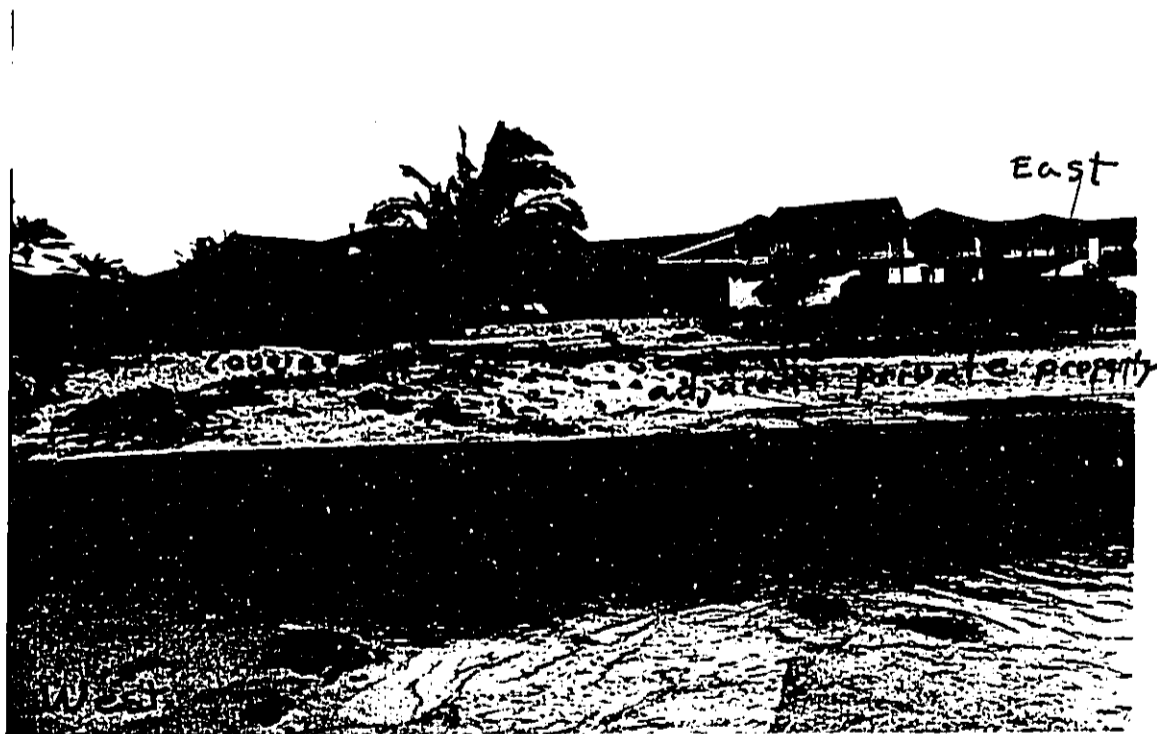
PLATE 8: AREA SHORELINE AT LOW TIDE
March 28, 1991; 16:30 hrs.
(Natural litter due to storm of March 23-24, 1991)

current which seems to affect the longshore transport of sand. Tradewind conditions result in a current toward the northwest. A wind shift to the west combined with a North West Pacific swell causes the longshore current to shift to toward the southeast. Under either current condition sand accretion would occur at this lot. Tradewinds prevail approximately 70 per cent of the time. The dominant feature of the shoreline affecting the accretion and erosion of sand is the City and County RCB drain. The drain acts as a groin and interrupt the longshore current causing the deposition of sand on the east side of the drain. This groin effect is clearly shown in Plates 8,9, and 10.

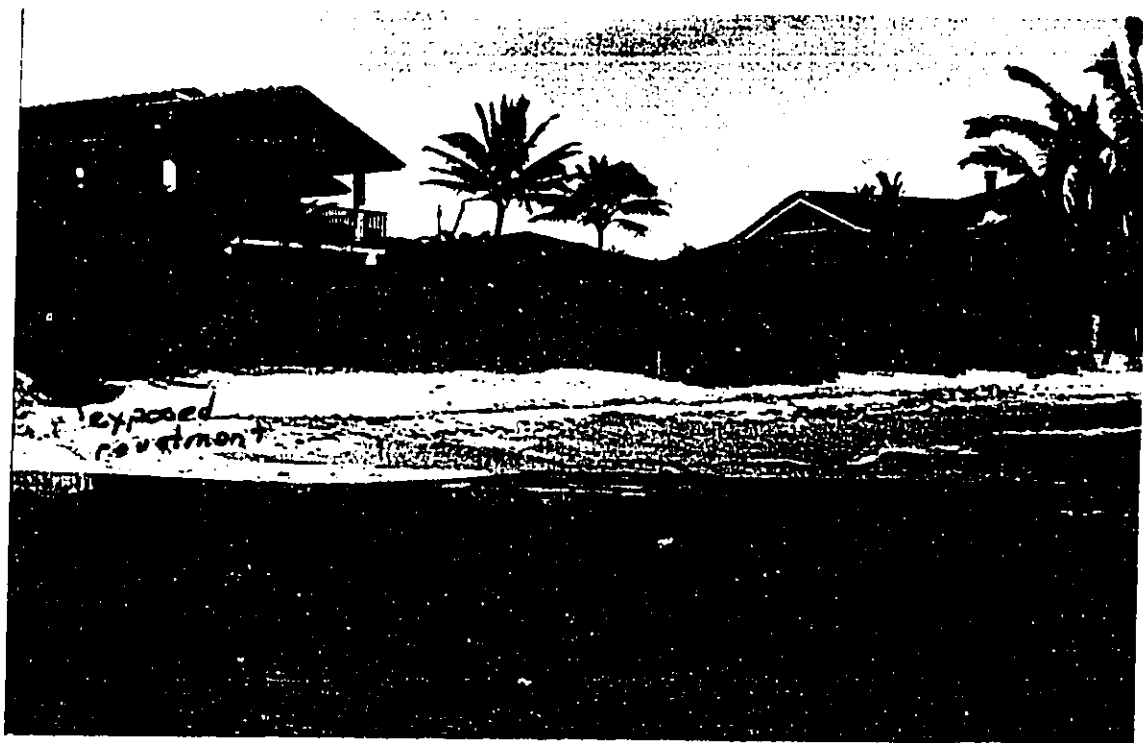
PLATE 9: RBC CULVERT AT HIGH TIDE
LOOKING EAST AND MAUKA
Note groin effect unrestricted access; April 2, 1991; 16:30 hrs.

Immediately west of the three parcels under consideration a 3-1/2 foot by 2-1/2 foot reinforced concrete box (RCB) drainage pipe, extends approximately 40 feet seaward of the shoreline fronting parcel 34. The RCB drainage pipe acts as a groin interrupting longshore transport of sand to the west, and trapping sand on its east side in front of parcels 33 and 34. West of the RCB drainage pipe, there are three parcels which have some form of shoreline protection. The two parcels immediately west of the RCB drainage pipe have loose rock revetments. Further west, the third parcel abuts the Kawainui Channel; a rock revetment protects its east side, and a coral seawall protects its west edge along the mouth of Kawainui Channel.

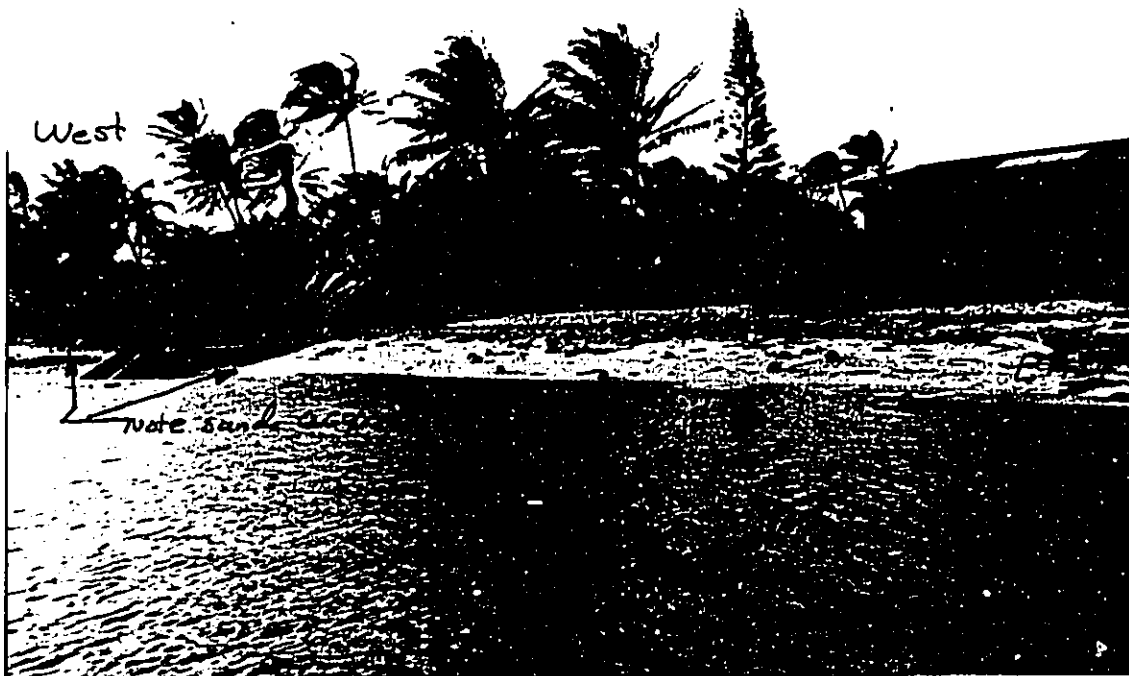
PLATE 10: RBC AREA SHORELINE AT LOW TIDE
March 28, 1991; 16:30 hrs.
(Natural litter due to storm of March 23-24, 1991)

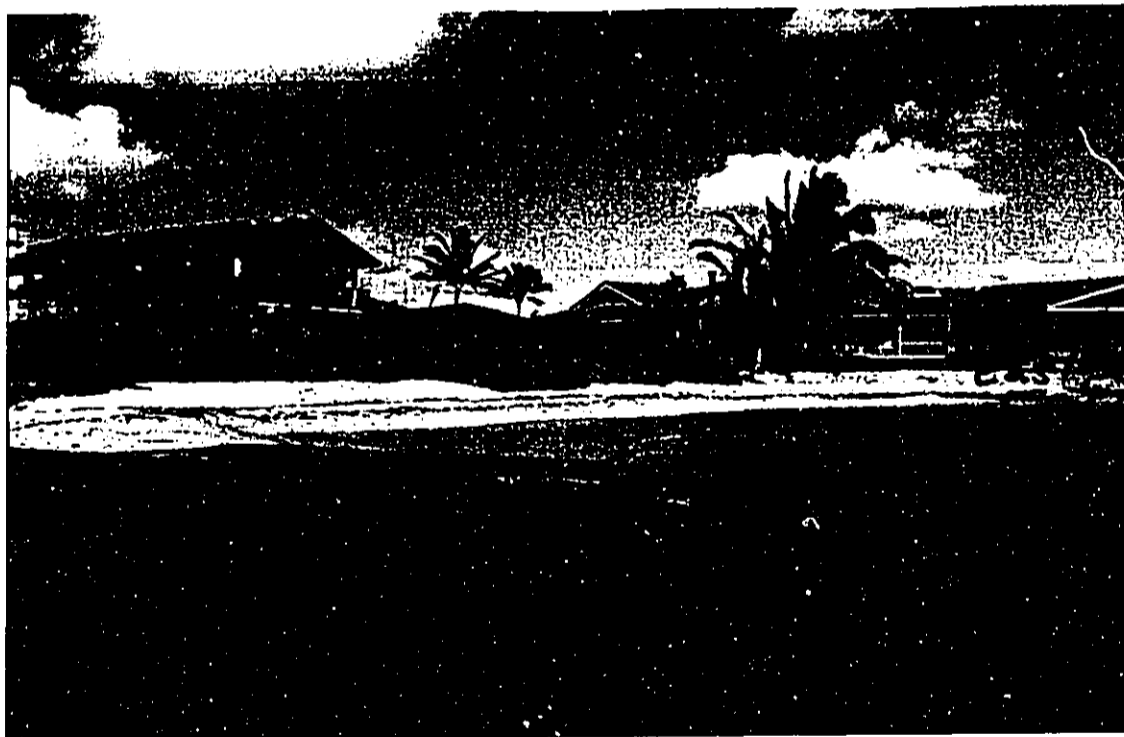
PLATE 12: AREA SHORELINE AT HIGH TIDE
Note: Unrestricted access, seawalls on adjacent properties
April 2, 1991; 16:30 hrs.
