#### NEGATIVE DECLARATION FOR KAUNAKAKAI TOWN DRAINAGE SUBJECT: IMPROVEMENTS, FINAL ENVIRONMENTAL ASSESSMENT 5-3-01,02,09, VARIOUS 5-4-07, 08 VARIOUS TAX MAP KEY: KAUNAKAKAI, MOLOKAI, HAWAII

## FINAL ENVIRONMENTAL ASSESSMENT NEGATIVE DECLARATION for the KAUNAKAKAI TOWN DRAINAGE IMPROVEMENTS KAUNAKAKAI, MOLOKAI

WILSON OKAMOTO & ASSOCIATES, INC. 1907 SOUTH BERETANIA STREET HONOLULU, HAWAII 96826 WOA: 2931-02

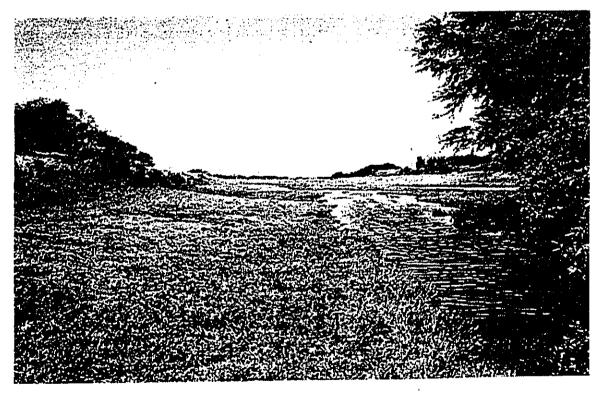
Fig. 2.2

Downstream view of Kaunakakai Stream the day after heavy rains.

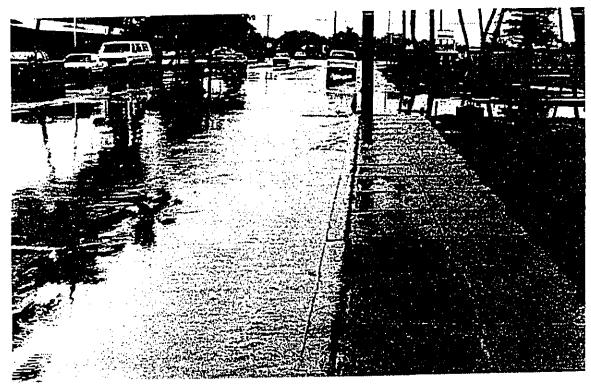
Ala Malama Avenue after a heavy rain

Within the town, an inlet/catch basin system is located at the intersection of Kamehameha V Highway and Ala Malama Avenue. Water is conveyed from this system under the highway through a 24-inch RCP culvert, "CE4", into a grassed ditch running along the south side of the highway (see bottom photo on Figure 2.4).

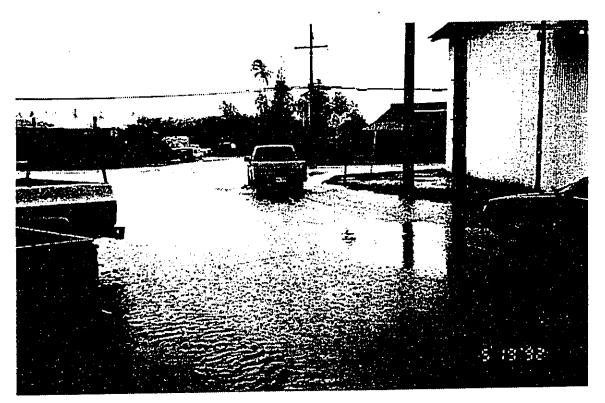
Mohala Street after a heavy rain.

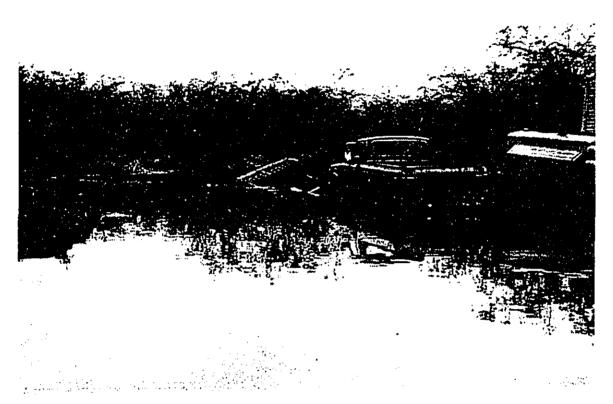
Flooded lot on Mohala Street, just south of Kamehameha V Highway.

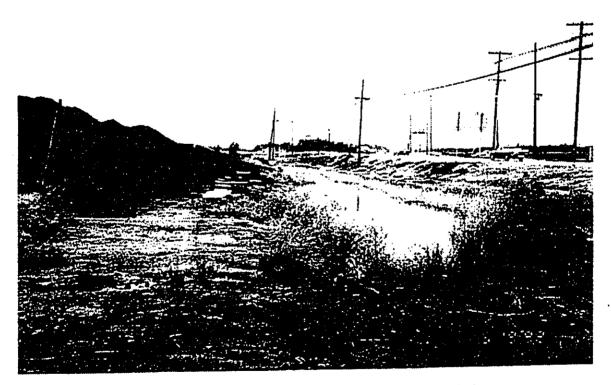
Roadside ditch on the south side of Maunaloa Highway.

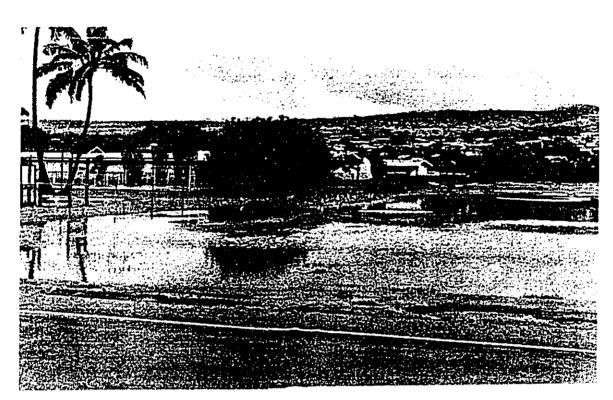
East boundary of Kaunakakai Elementary School with flooded area on adjacent playing field.

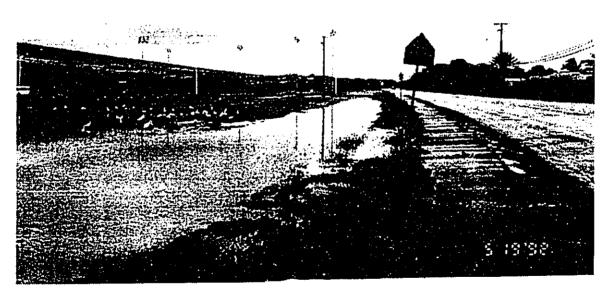
Swale and ditch along Kamehameha V Highway.

After the 90 degree turn to the east, the swale transitions to "DE6", which is 4-foot wide and 6 inches deep and lined with concrete. This lined swale runs for approximately 850 feet before becoming a grassed trapezoidal ditch, "DE7", with a top width of 16 feet and depth of 3 feet. At the time of the survey, a heavy growth of grass in the ditch had reduced the capacity by about half. The photograph on the bottom of Figure 2.5 shows storm runoff overtopping the ditch after a heavy rain in May 1992.

Ditch "DE7" drains to a 10-foot wide x 3-foot high RC box culvert, "CE12", which conveys flow to the south side of the highway. However, when surveyed in May 1992, the midpoint of this culvert was partially clogged with a thick layer of silt and dead vegetation. A 24-inch RCP culvert, "CE13", serves as a second highway crossing for the swale, but because the inlet invert of the pipe is approximately 1 foot above the invert of the swale, the culvert serves as a ditch relief line.

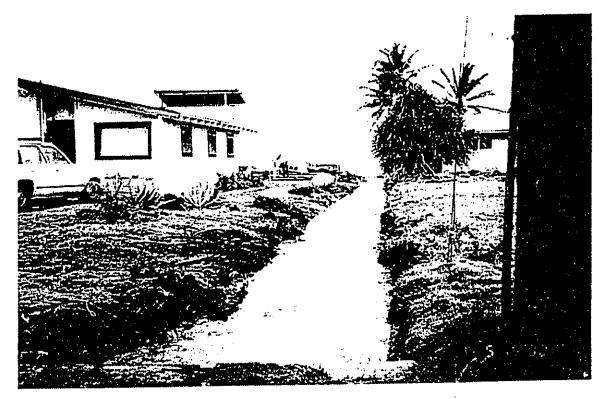
Fig. 2.6,...

Channel DE8 where it outlets to the ocean.

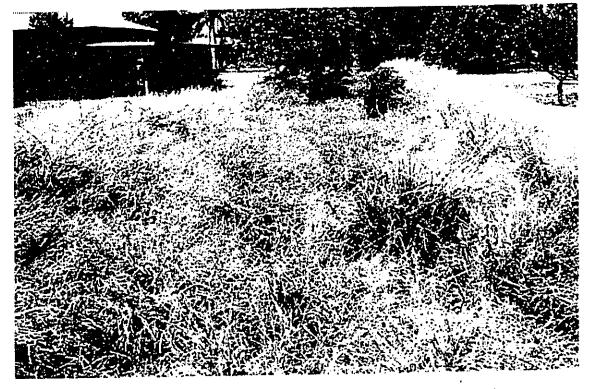
Fig. 2.7

A heavy overgrowth of grass in ditch "DE10" on the south side of the highway.

The grassed ditch, "DE10", draining the 8-foot x 3-foot box culvert is trapezoidal in shape with a top width of 12 feet and a depth of 2 feet. As observed in May 1992, a heavy overgrowth of grass had reduced the capacity of the ditch by more than 50 percent. Both ditches "DE9" and "DE10" do not have culvert crossings to pass water through the Kapaakea Loop before outletting into the ocean. Thus, during times of heavy rainfall, runoff flows over the roadways to the ocean.

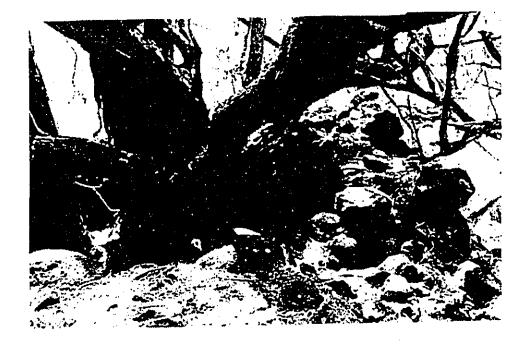
Figure 13 Site 50-60-03-895. Feature A Enclosure, Showing Interior with Large Knows Tree (View to South)

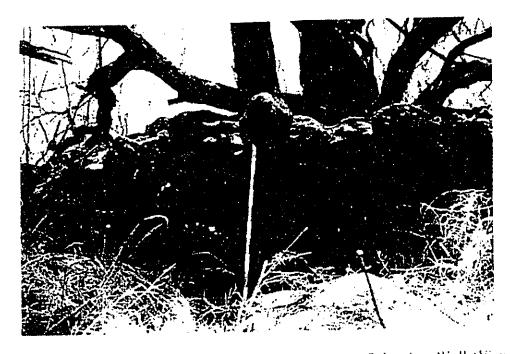
Figure 14 — Site 50-60-03-895, Feature A. Showing Exterior of Souther Wall (View to North)

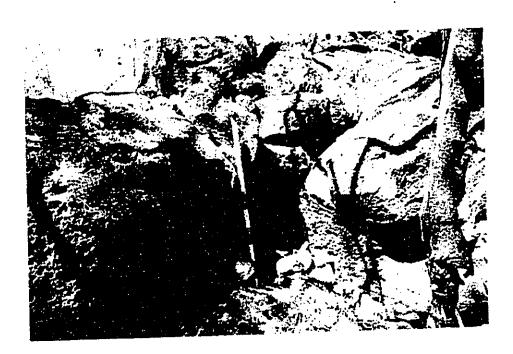
Figure 18

Site 50-60-03-895. Feature C. Showing Boulder Stacking Between Bedrock Boulders (View to West)
