Re: Negative Declaration to Retain a Rock Wall at the
Napili Sunset Condominium, TMK: 4-3-2:54, Napili,
Lahaina, Maui

1995-04-23-MA-PEA-Napili Sunset Condominium APR 23 1995
Setback Variance to Retain a Rock Wall

Maui Planning Department's Report
for the
Maui Planning Commission Meeting on
March 28, 1995

Environmental Assessment (EA)
Review

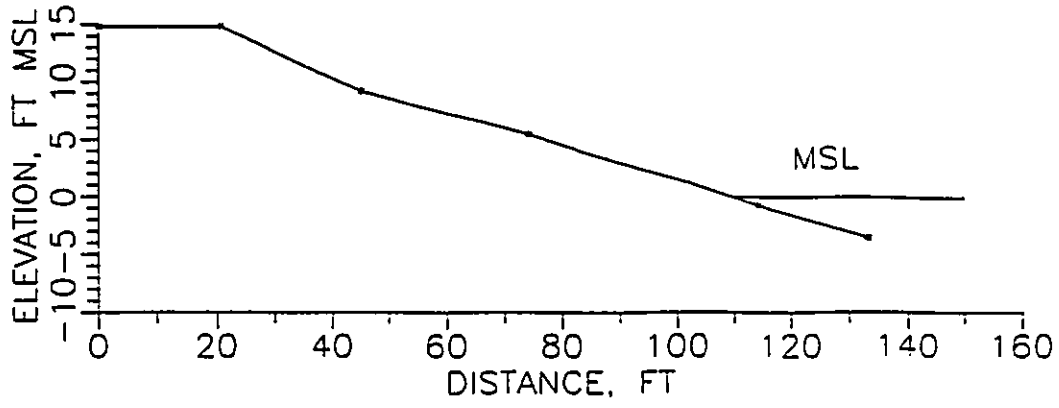
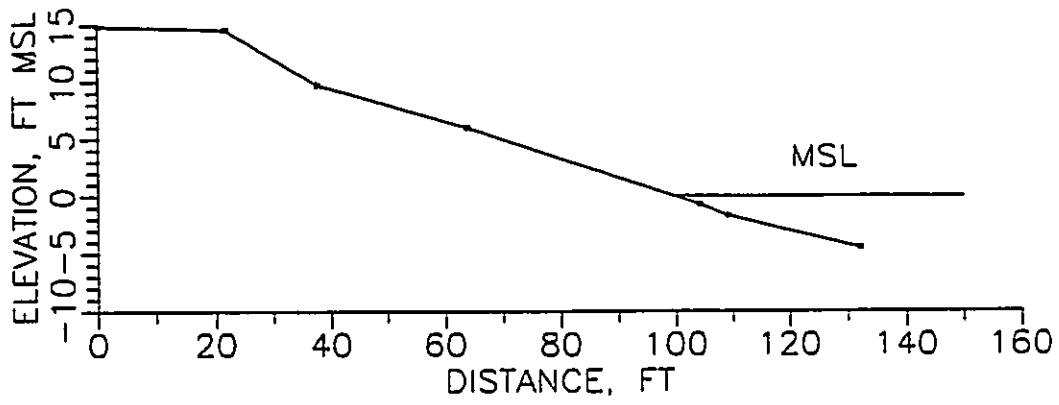
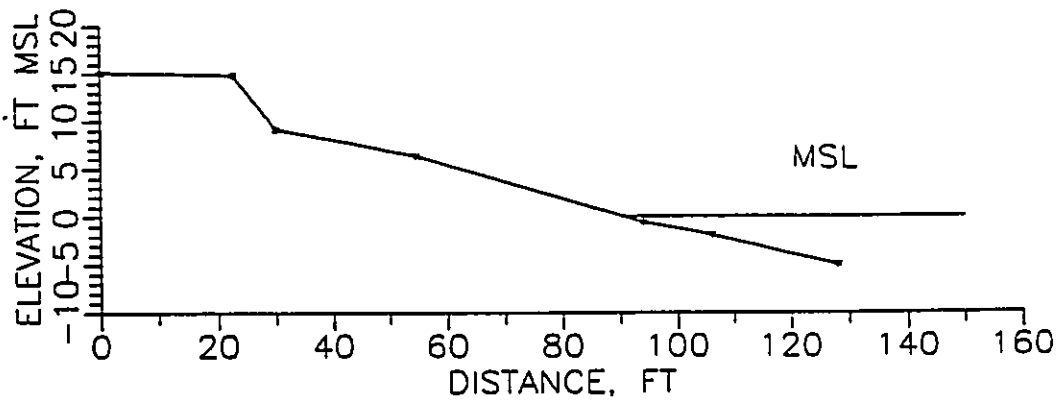
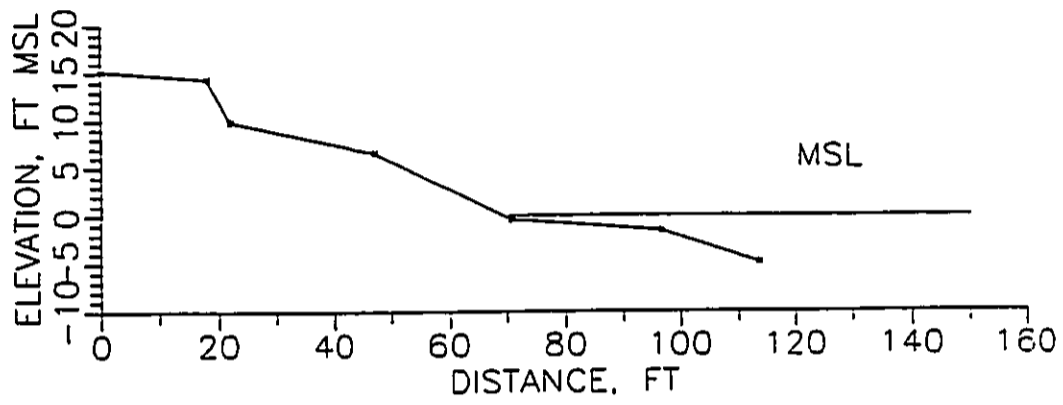
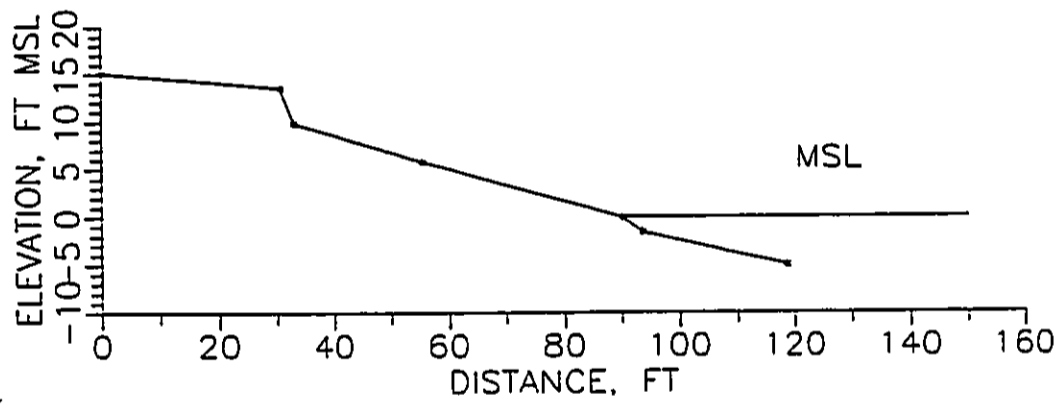
Figure 5. Beach Profiles

Beach profiles were measured at five locations shown in Figure 5. Beach slopes are approximately 1:6 to 1:7, which is within the expected range for Hawaiian beaches. Beach slopes depend on wave conditions and are typically steeper in winter than summer. Beach sand size gradation is shown in Figure 6. Median grain size is 0.5 mm in the wave swash zone, typical for Hawaiian beaches. Sand size at the top of the beach is smaller than in the swash zone indicating onshore transport has occurred.
