1995-09-08-NO-FAA-Kaupoa House Reconstruction

# **Final Environmental Assessment**

## **Kaupoa House Reconstruction**

**MUNEKIYO &  
ARAKAWA, INC.**

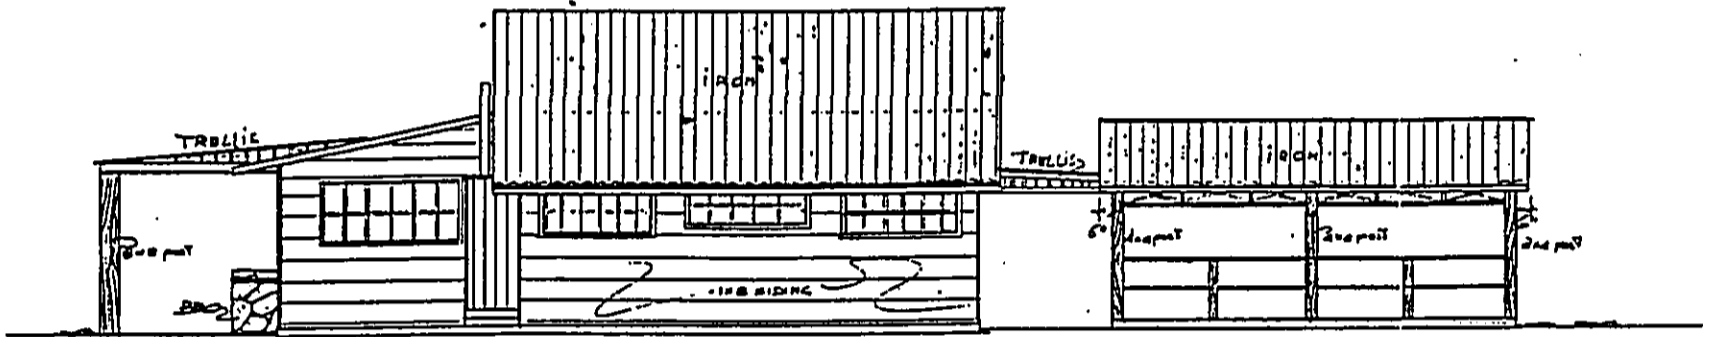
**Kaupoa House Reconstruction  
Special Management Area Map**

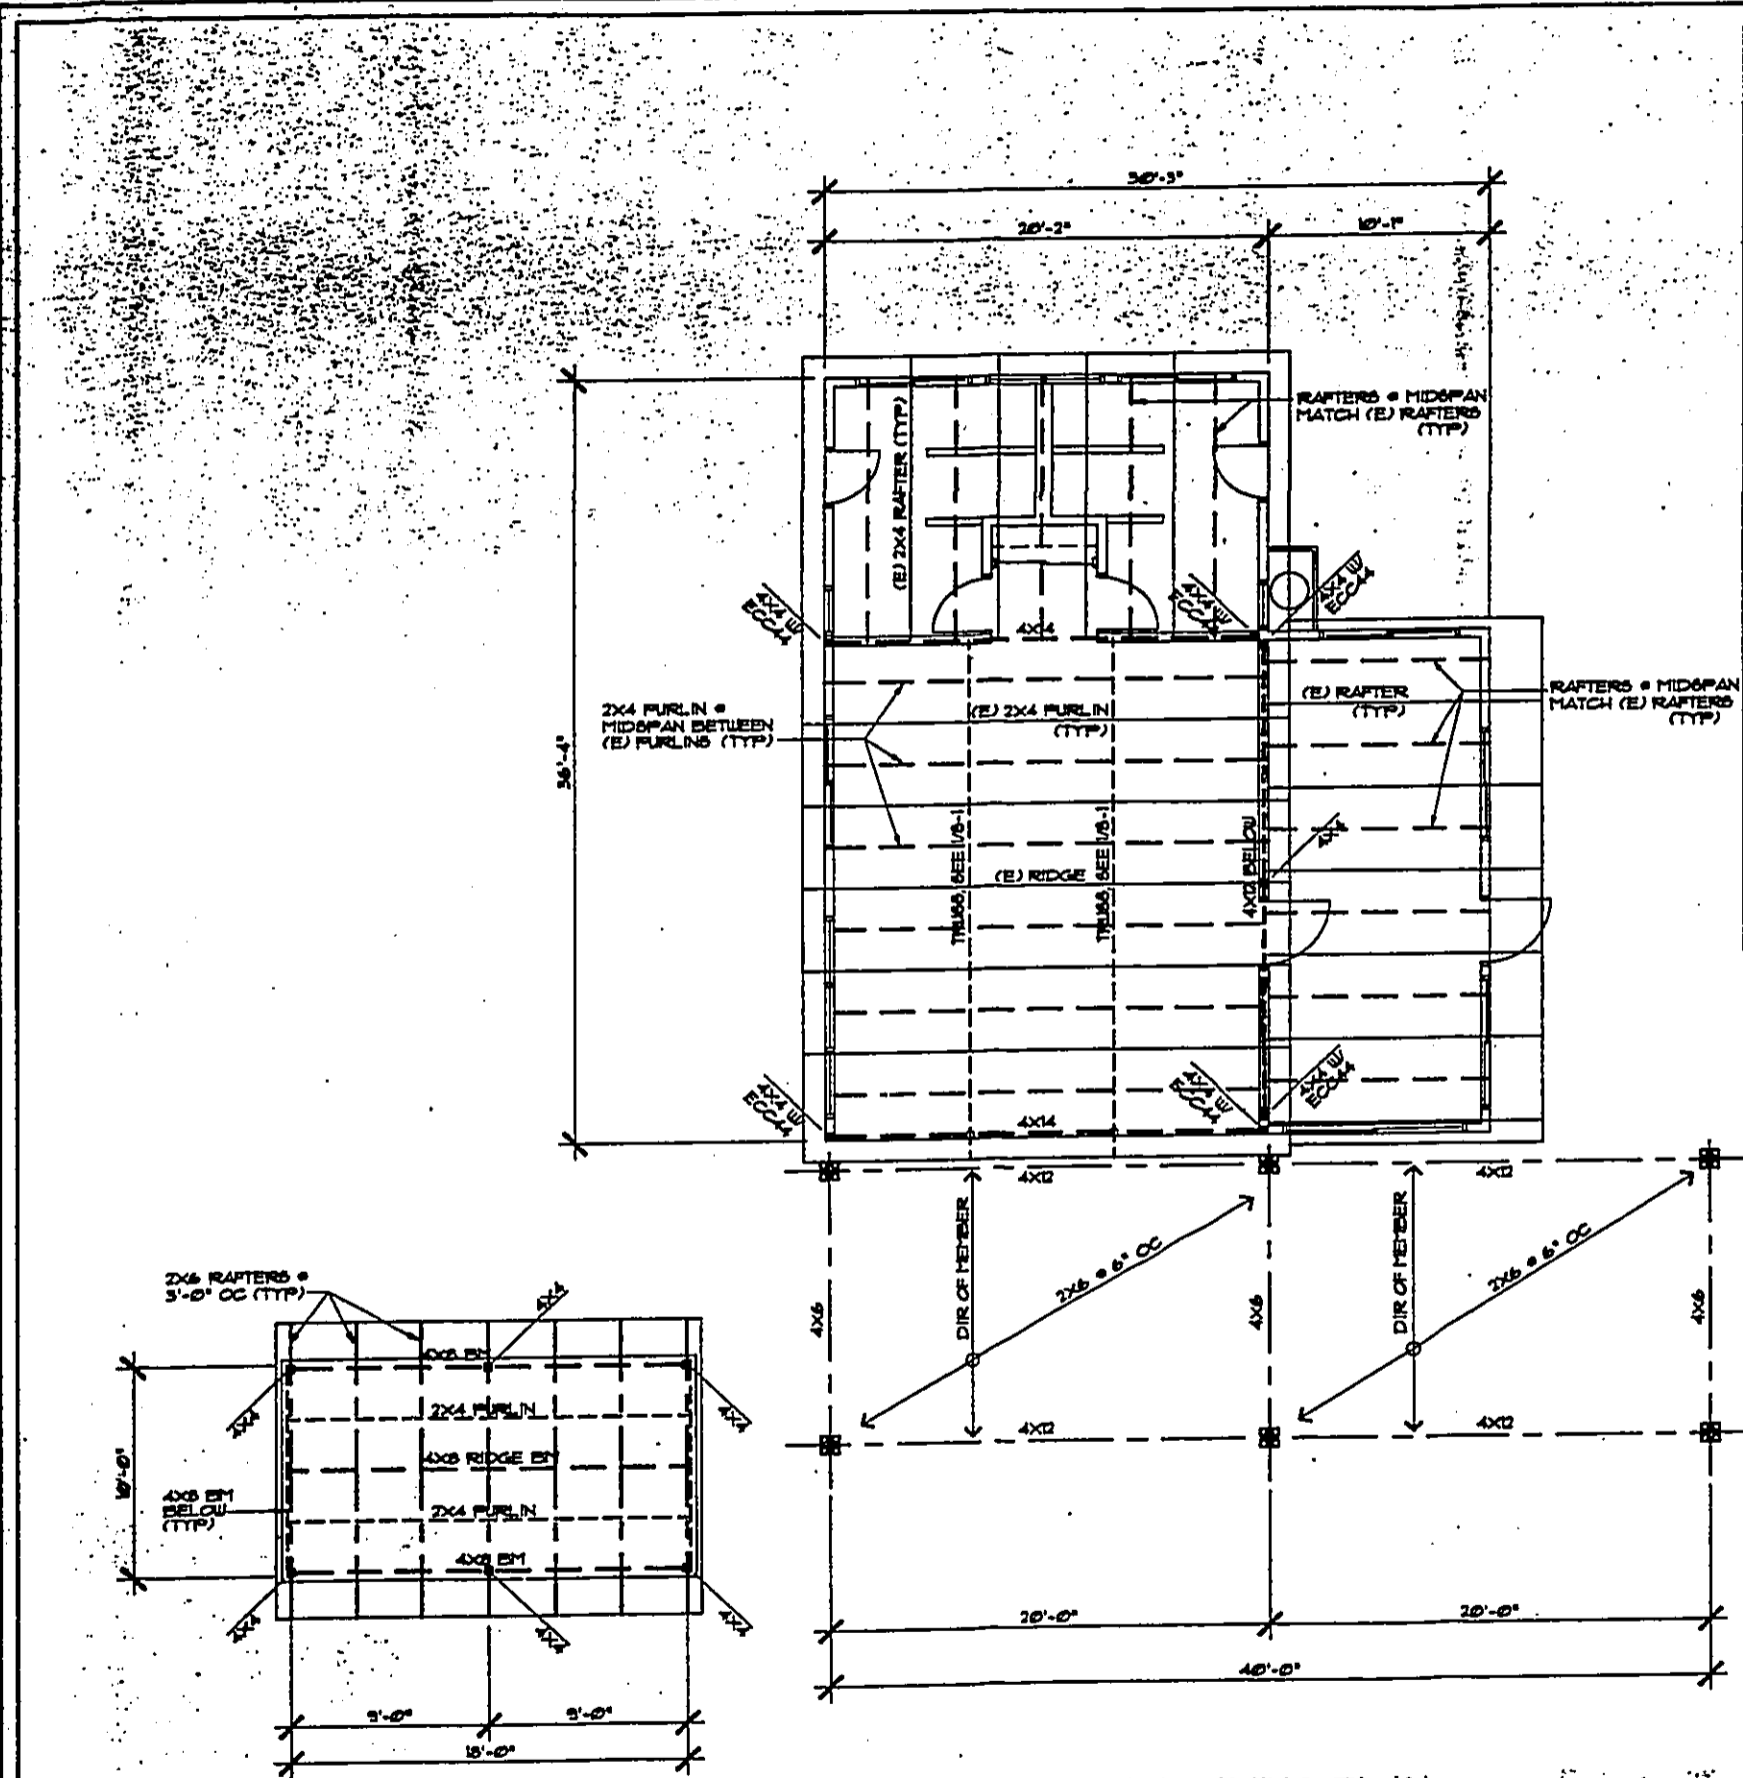
With regard to man-made environmental considerations, the subject site had been previously cleared when the original improvements were constructed. Construction activities were confined to the structure's original footprint. Ground disturbing activities have not and will not be undertaken with the reconstruction and use of Kaupoa House. As previously noted, an archaeological inventory

---
