Re: Final Environmental Assessment/Negative Declaration Croft Residence Rock Revetment Shoreline Setback Variance SSV-95-2 TMK: 4-1-2-13:35 Kekaha, Kauai

FINAL

ENVIRONMENTAL ASSESSMENT FOR SHORE PROTECTION AT CROFT RESIDENCE, 4470 MAMO ROAD KEKAHA, KAUAI, TMK 1-2-13:35

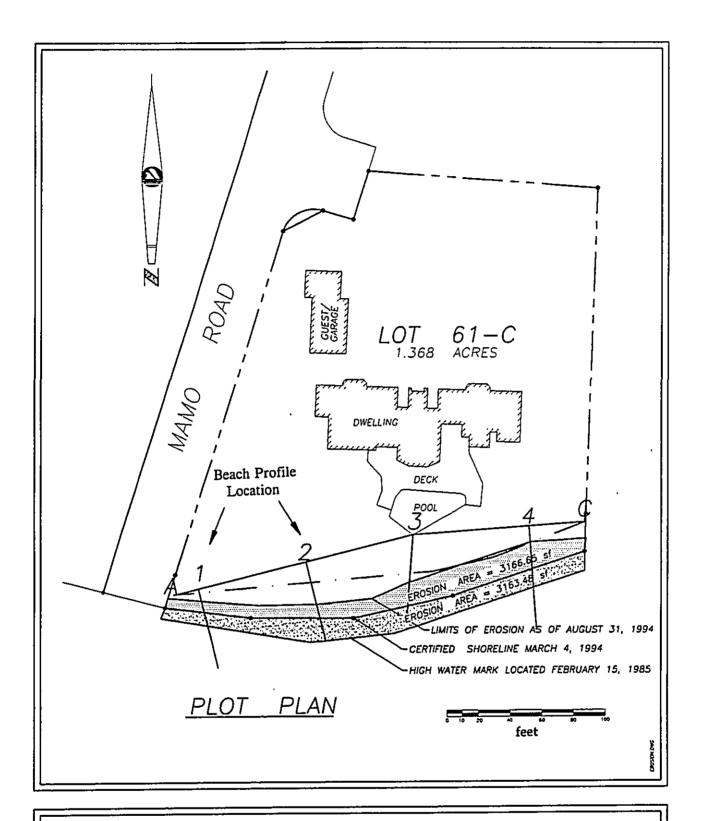
### FIGURE 2 SHORELINE POSITION

A certified shoreline survey map is included in Appendix A. The site plan is shown in Figure 2.

The eroded shoreline as measured on August 31, 1994 is shown on a copy of the certified shoreline map in Figure 2. Also shown is the high water mark of 1985. The recession of the shoreline indicates long-term erosion at 1.4 feet per year. However, between March 1994 and August 1994, the shoreline has receded at an average of 2.1 feet per month, a much greater rate. Erosion at the Croft property has been aggravated at the east end by a neighboring rock wall that caused flanking erosion over 24 feet from the certified shoreline. Much of this erosion is reportedly recent. Table 1 gives the estimated areas and quantities of material lost. Figure 8 shows the beach profiles measured on August 31, 1994. Instead of a smooth sloping beach between the property and the waterline, there was an abrupt escarpment 4-5 feet high where topsoil and vegetation fell into the water. The escarpment is shown in the photographs of Figure 9a-b-c.

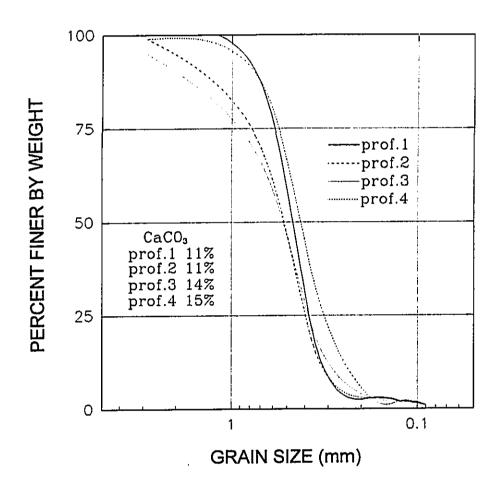
FIGURE 3 SAND SIEVE CURVES

The shoreline at Kikiaola Beach consists of a narrow sand beach, composed primarily of volcanic sand mixed with white calcareous sand. The volcanic sand is denser than the white sand and is probably eroded from inland deposits and washed into the sea by rivers. The Waimea River located east of the project site is probably the primary source of volcanic sand found along the Kekaha shoreline. Median sand size in front of the Croft property is in the range of 400 - 500  $\mu$ m and the percentage of calcareous sand is about 11 - 15% as shown in Figure 3.

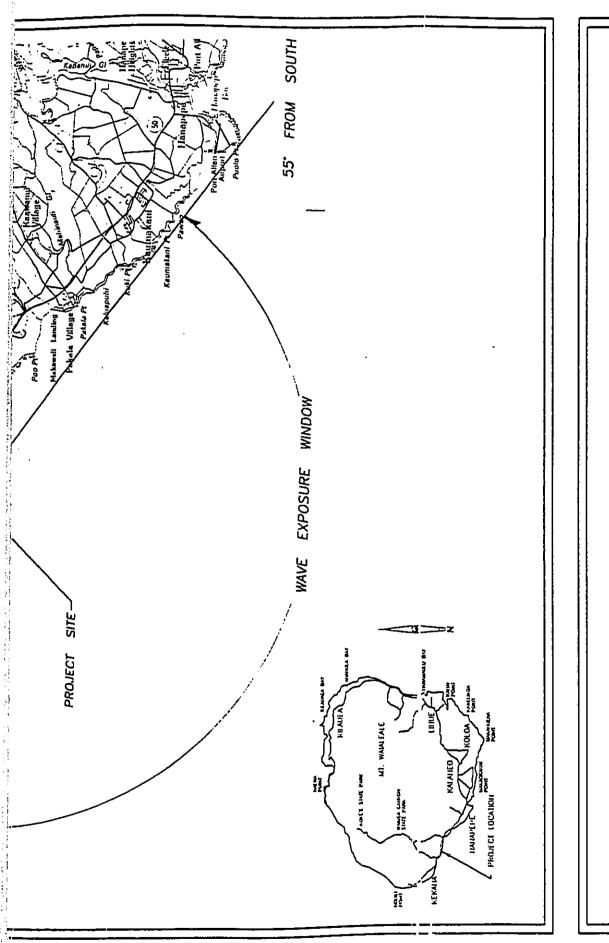
FIGURE 4	MAP OF WAVE EXPOSURE	SURE
4470 MAM TM	4470 MAMO ROAD, KEKAIIA, KAUAI TMK : (4)-1-2-13:35	Oceanil Coastal Corporation

The Kekaha shoreline of Kauai is subject to deepwater waves that are predominantly from the south (S) and southwest (SE) with the most probable wave height of 3 feet and period of 12 to 14 seconds (Figures 4 and 5). In addition to direct exposure to south swell and Kona storm waves, the shoreline is indirectly exposed to refracted tradewind waves from the east and North Pacific swell from the west. As these waves approach the shoreline they are transformed by refraction, friction, and shoaling until they strike the beach. The site is fronted by a reef that is slightly shallower than surrounding areas. Many waves break when they hit the reef; however, the water becomes deeper inside the reef so that waves can reform before reaching the beach.

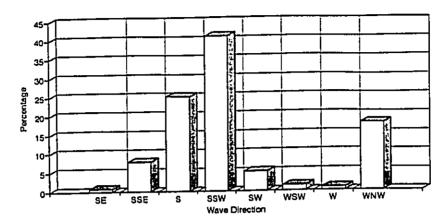
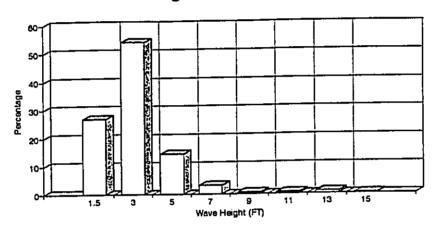
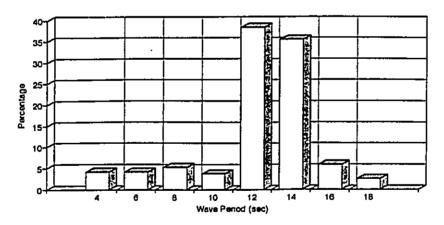
FIGURE 5 WAVE STATISTICS

### Histogram of Wave Direction

Histogram of Wave Height

Histogram of Wave Period

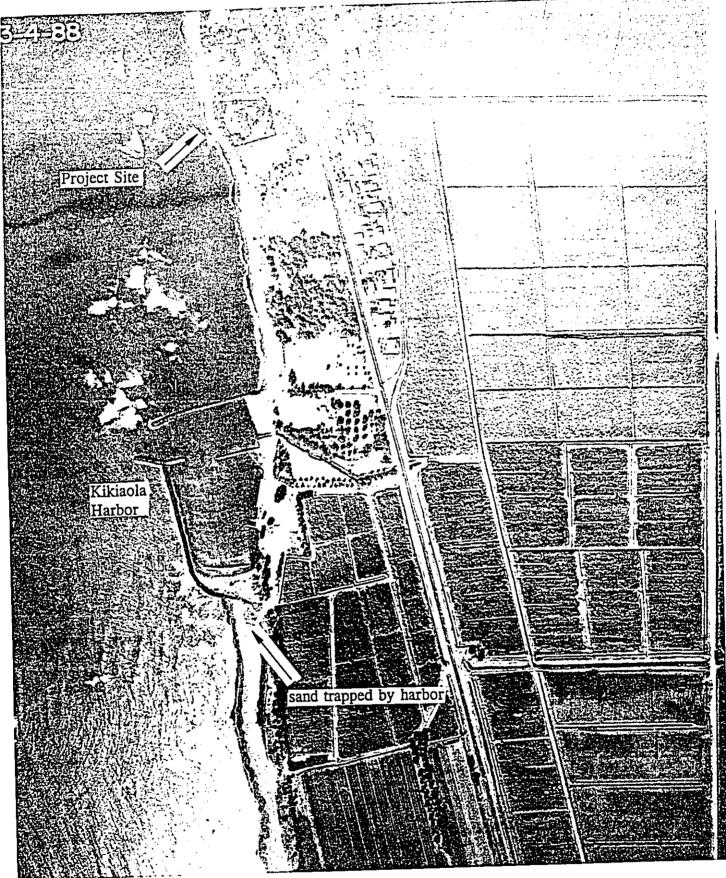
FIGURE 6 AERIAL PHOTOGRAPH

from the harbor to Oomano Point. The former section has accreted and the latter section has had intensified erosion since the construction of the harbor (Makai Ocean Engineering Inc. and Sea Engineering Inc., <u>Aerial Photograph Analysis of Coastal erosion on the Islands of Kauai, Molokai, Lanai, Maui and Hawaii,</u> 1991). The erosion patterns can also be seen in aerial photographs (Figure 6).

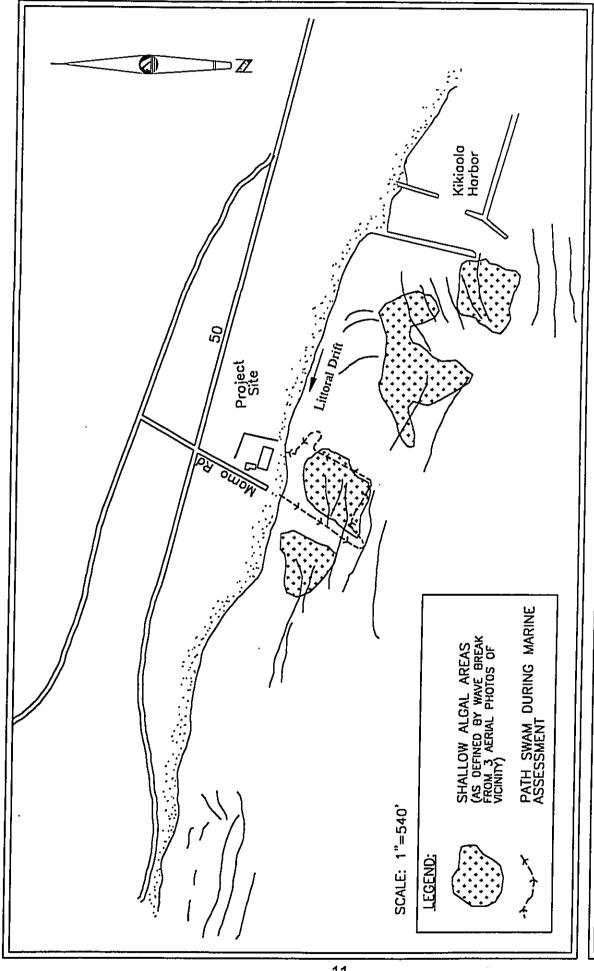
# FIGURE 7 WAVE REFRACTION/DIFFRACTION PATTERN

Although the wave climate varies seasonally, the predominant littoral drift is to the west, as indicated by typical wave refraction/diffraction patterns taken from aerial photographs (Figures 6 and 7). The angle that the wave front makes with respect to the shoreline will generate a westward longshore current and thus cause westward sediment transport. According to the U.S. Army Corps of Engineer Division (Hawaii Regional Inventory of the National Shoreline Study, 1971) and Campbell (Erosion and Accretion of Selected Hawaiian Beaches, 1962-1972), the shoreline immediately west of the Waimea River has eroded steadily since the early 1900's. The construction of the Kikiaola Boat Harbor in 1959 divided the shoreline into two sections. One of them is Waimea Beach from Waimea River to the Boat Harbor, and the other is Kikiaola Beach

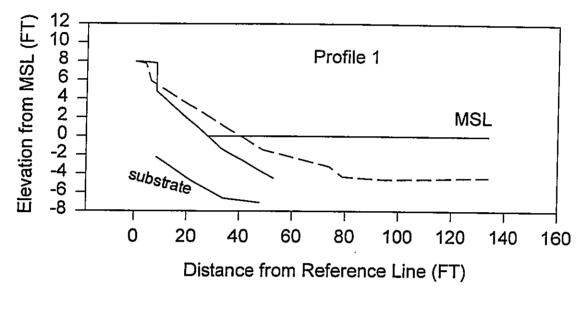
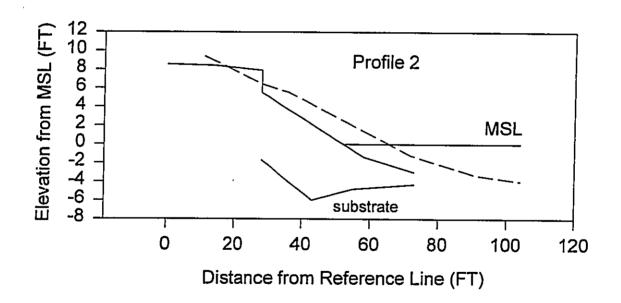
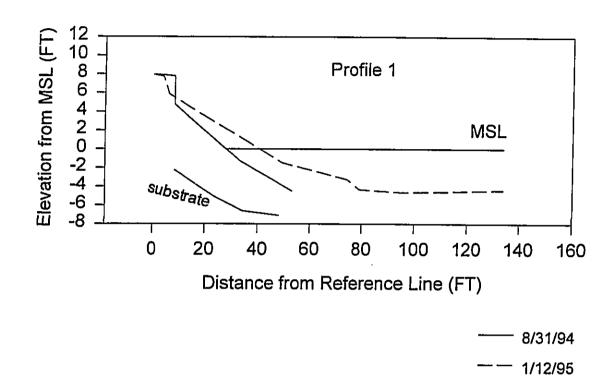
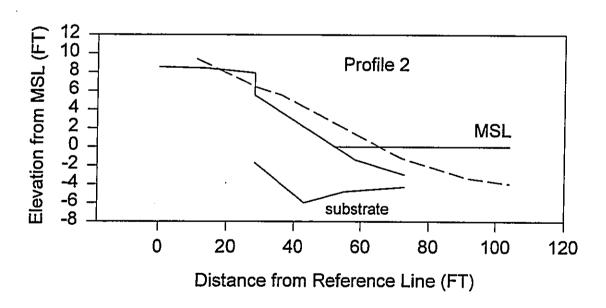
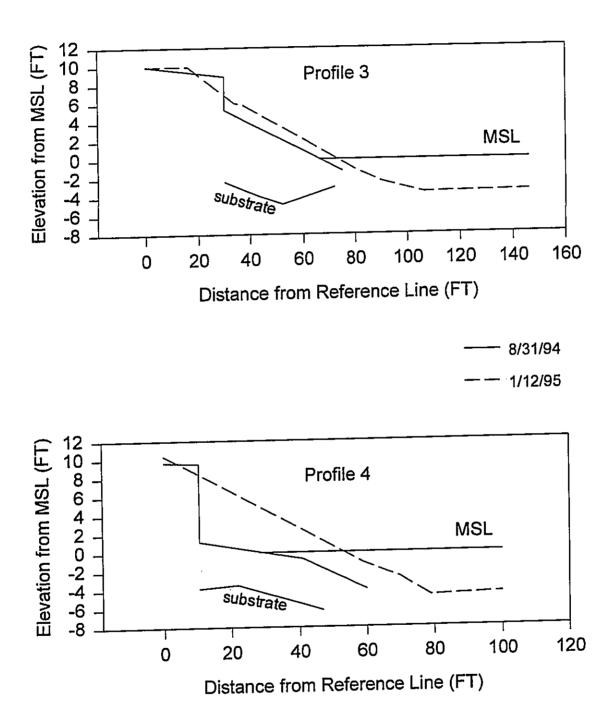
FIGURE 8 BEACH PROFILES

Also shown in Figure 8 are the profiles measured on January 12, 1995 after the completion of the revetment construction. The increase in beach width and sand accretion in front of the revetment is apparent in post construction photographs (Figures 11a-b and 12a-b). The condition of the beach after construction indicates that the revetment is performing well, dissipating wave energy and encouraging beach growth.

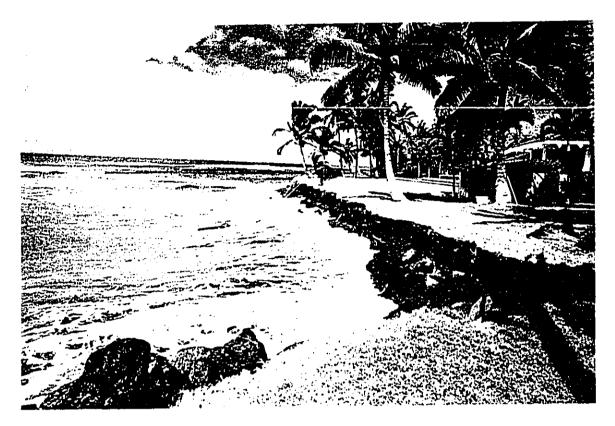
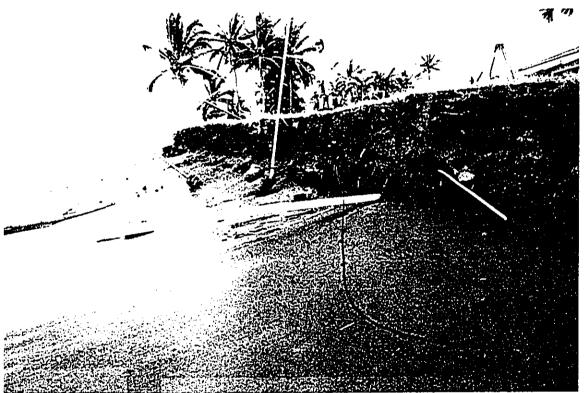
FIGURE 9 PHOTOGRAPHS BEFORE CONSTRUCTION
a. EAST EDGE OF PROPERTY
b MIDDLE SECTION OF PROPERTY

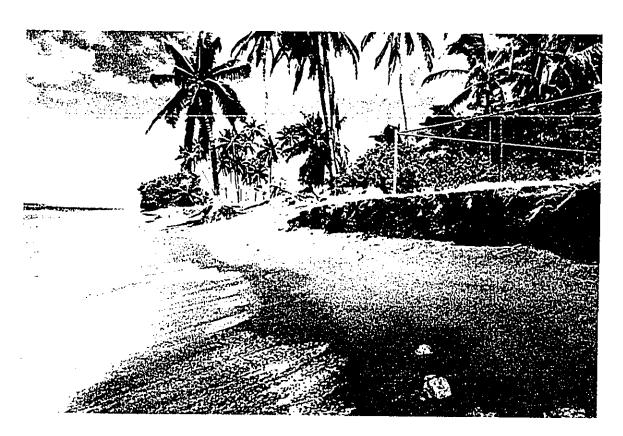
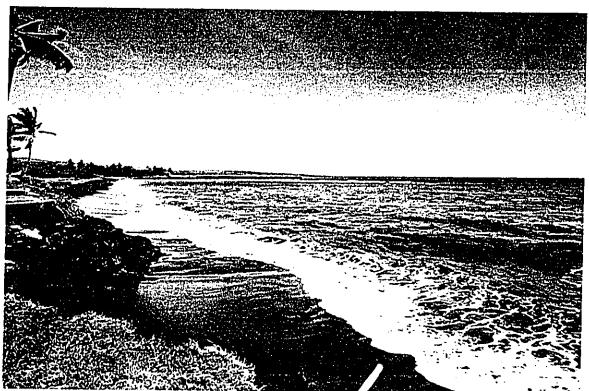
FIGURE 9 (CONTINUED) PHOTOGRAPHS BEFORE CONSTRUCTION
c. WEST EDGE OF PROPERTY AND NEIGHBORING PROPERTY
d. SEDIMENT PLUME AND KIKIAOLA HARBOR TO EAST

Oceanit Coastal Corporation (OCC) was contracted by Mr. Chuck Croft to assess the nature and extent of the coastal erosion, to provide preliminary recommendations on alternatives for remedial action, and to design proper erosion control structures. OCC evaluated the erosion problem and concluded that the long-term erosion of the shoreline at Kekaha together with accelerated erosion during 1994 resulted in recession that finally reached the property of coastal landowners, including Mr. Croft (Figure 2). Based on beach profile measurements and the fact that the property was not protected by a beach to the top elevation of the property, large amounts of erosion would have continued before an equilibrium beach profile was established. This loss would have endangered structures including a swimming pool and house on the property. In addition, several large coconut trees were also threatened. The erosion of large amounts of topsoil created an offshore sediment plume that was detrimental to marine life, especially coral or other benthic organisms (Figure 9d).

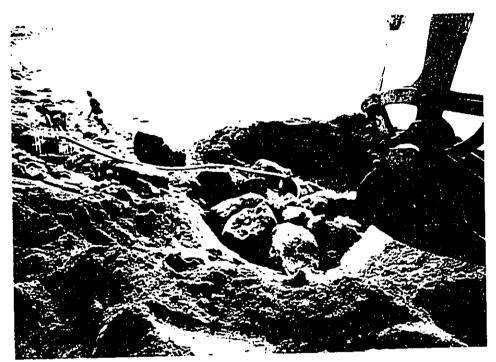
FIGURE 10 PHOTOGRAPHS DURING CONSTRUCTION

a. FILTER FABRIC PLACEMENT

b. TOE STONE PLACEMENT

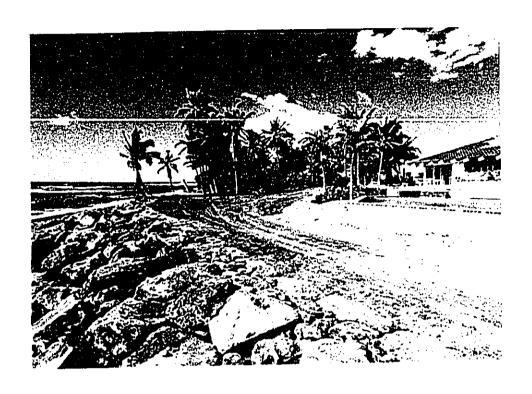
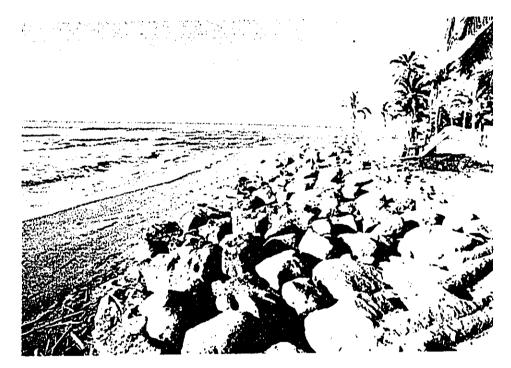
FIGURE 11 PHOTOGRAPHS AFTER CONSTRUCTION (11/29/94)

a. FRONT YARD AND REVETMENT

b. BEACH AND REVETMENT

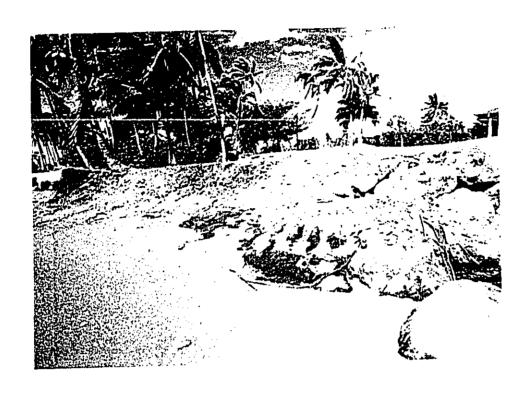
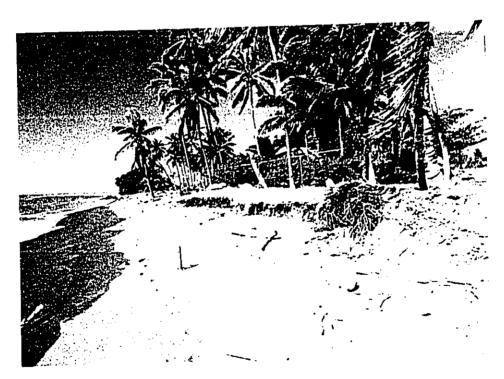
The unprotected shoreline at the western end of the property exhibits continuous erosion and trees in the shoreline are in danger of being lost (Figures 11c-d and 12d). By comparing Figures 11d and 12d, it may be concluded that some erosion occurred between November 29, 1995 and January 12, 1995 along the unprotected section, at least around the endangered trees. Either rainfall runoff or wave runup could have caused this erosion. In case of bad weather and high surf conditions in the foreseeable future, this section of the shoreline will be a potential problem and merits immediate attention. Although the whole unprotected shoreline shows slight recession, there is no sign of flank erosion at the western end of the revetment (Figures 11c and 12c). The same is true for the eastern flank protection. This indicates that the flank protection is properly designed and it is unlikely to cause flank erosion to neighboring property.

FIGURE 11 (CONTINUED) PHOTOGRAPHS AFTER CONSTRUCTION c. WEST END OF REVETMENT AND UNPROTECTED SHORELINE d. ENDANGERED TREES AT THE WEST SECTION OF PROPERTY

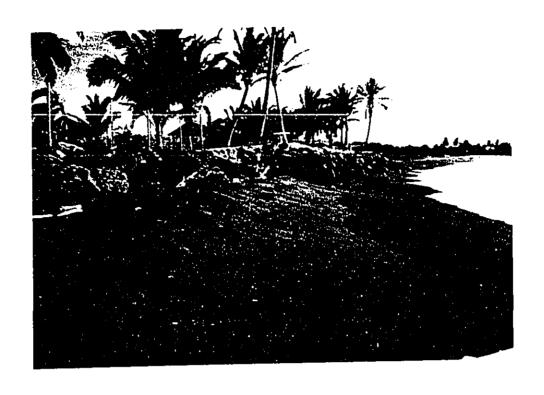
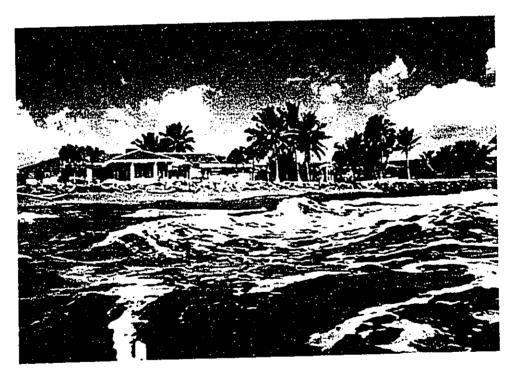
FIGURE 12 PHOTOGRAPHS AFTER CONSTRUCTION (1/12/95)

a. EAST EDGE OF PROPERTY

b. BEACH AND NEIGHBORING SEAWALL

A field trip was made on January 12, 1995 to assess the impact of the revetment. Sand has accreted and a nice beach was observed in front of the property (Figure 12a-b). The waterline moved approximately 10 feet offshore as a result the revetment

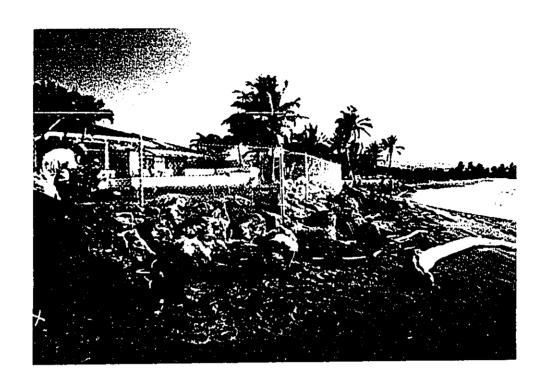
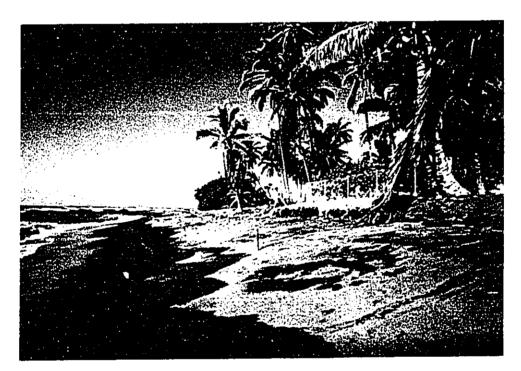
A chain-link fence was also erected along the newly built revetment approximately 5 feet seaward from the top of the revetment (Figure 12c). Construction of the fence is necessary to avoid liability that may be occasioned by unauthorized use of the swimming pool or damage to landscaping. The fence does not block public beach access.

c WEST FLANK OF REVETMENT AND FENCE
d SCARP AND ENDANGERED TREES AT WEST EDGE

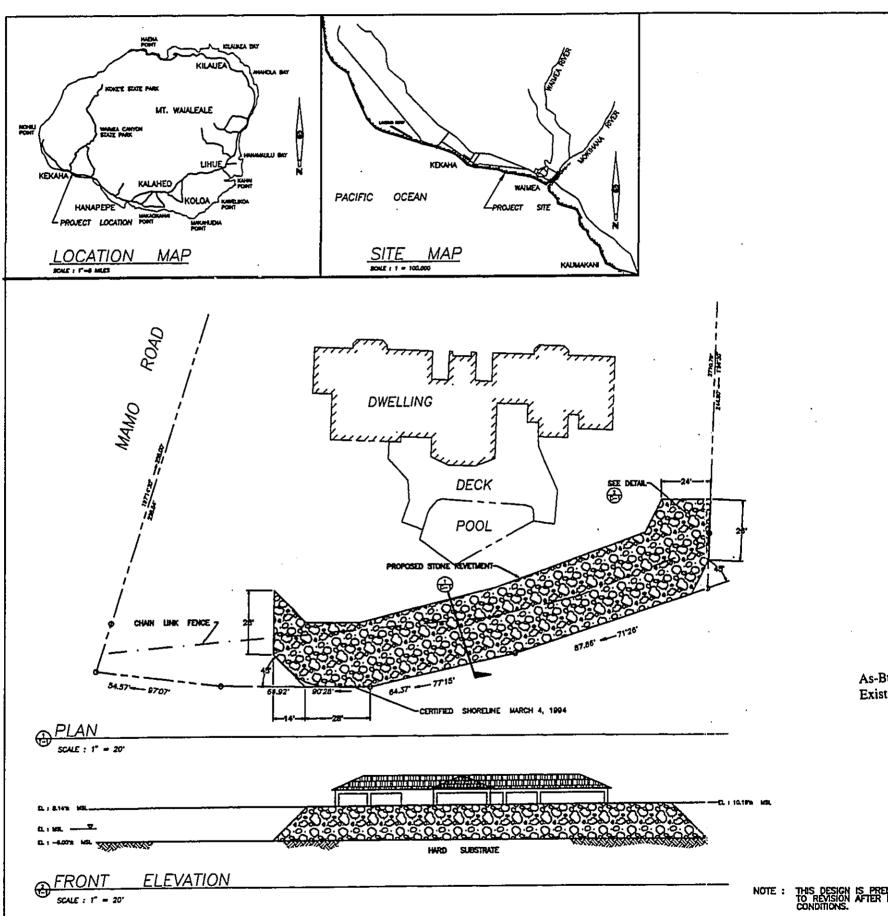
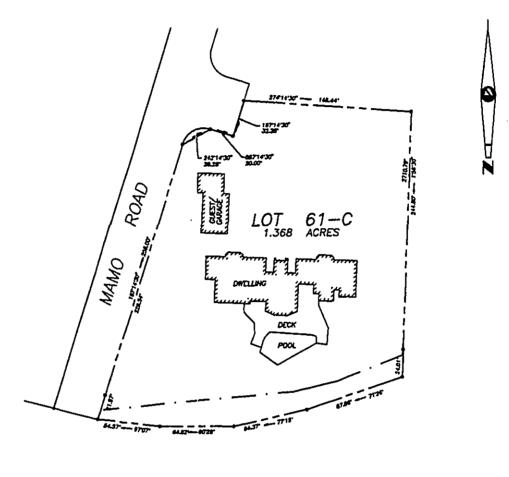
As-Built Drawing of Existing Revetment

Oceanit Coastal Corporation SCALE AS HOTED DESCRIP WEB APPROVED BY DRAWN BY VEB DATE: 9/94 J09 HO. ACAD FREICHOFTI-DRAWING NUMBER FIGURE B-1 T-1

Based on the emergency permit and after consultation with the Planning Department, a rock revetment was designed and constructed (see design drawings in Figures B-1 and B-3). A description and assessment of conditions prior to and subsequent to the construction, and recommendations based on the assessment are contained herein.

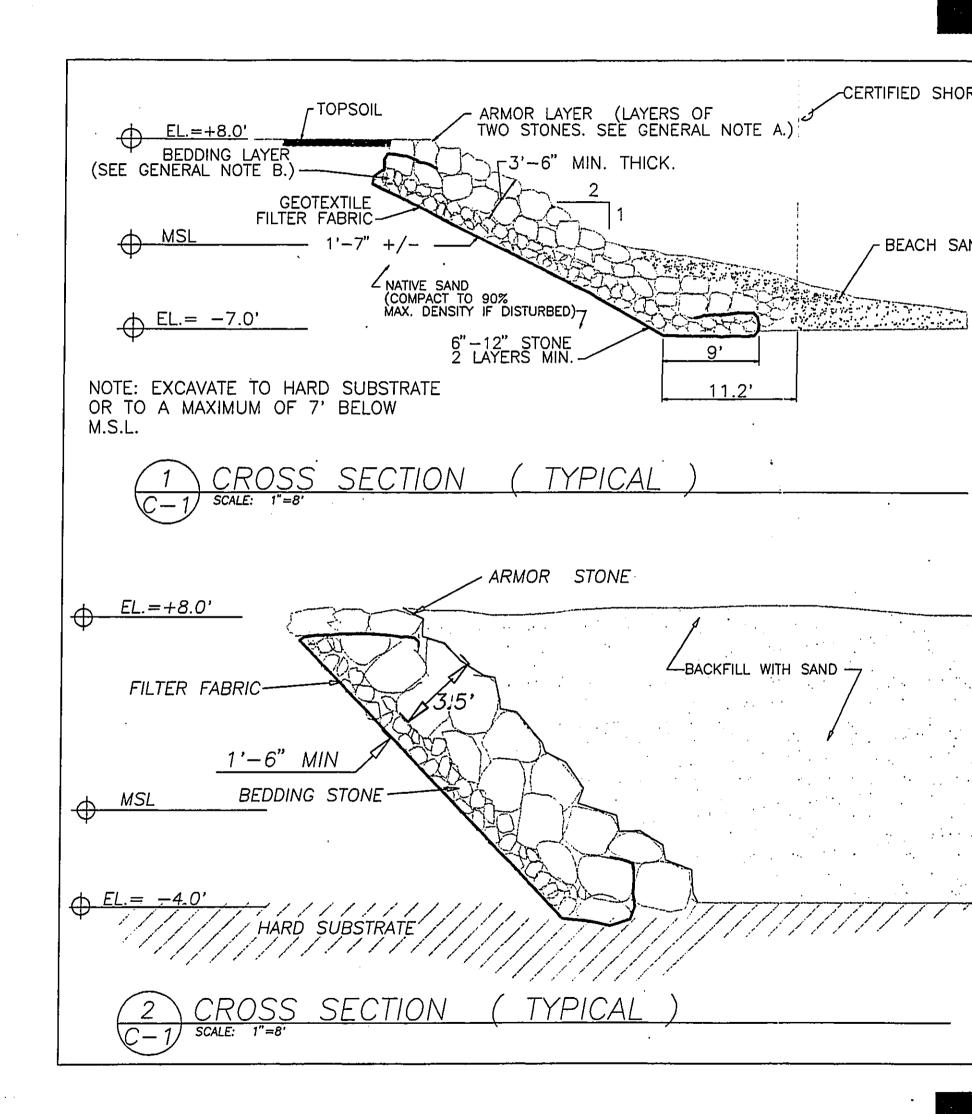
- A geotextile filter fabric shall be placed between the bedding layer and the soil. The filter fabric shall be puncture resistant and shall retain soil particles. The fabric shall be Supac 8NP by Phillips: Fiber Corp. or approved equal.
- The fabric must be placed loosely, not in a stretched condition, but free of wrinkles, crosses, or folds.

- Sand and rubble shall be excavated to hard substrate. If hard substrate is not found, the project engineer must be notified immediately for possible design changes.
- The largest armor stones will be used as toe stones. Toe stones must be placed on hard substrate. No stones shall be placed seaward of the certified shoreline.
- After revetment construction, the beach shall be cleaned of construction debris and returned to the original slope.
- The contractor shall remove all unused material from the site.
- The contractor shall backfill the revetment wall with eand and compact.

Oceanit Coastal	Corporation
	coastal engineer	ring services
	1100 Alakoo Bulking 1100 Alakwa Street, Suite 3100 Honolulu, Hawai'i 96813	Ph: (808) 531-3017 FAX: (808) 531-3177 MCI: OCEANIT
	REVETMENT DES 4470 MAMO ROAD, KEKAHA. TMK: 1-2-13:35	IGN KAUAI
SCALE AS NOTED	APPROVED BY	DESIGNED WEB
DATT: 2/95	7	
	<del></del>	DRAWN BY WTY
ł		JOB NO. 9408
		ACAD FILE: critical.day
FIGURE B-3		DRAWING NUMBER C-1

The shore protection structure is a rubble revetment with a slope of 1:2 (vertical: horizontal). Design drawings are included in Appendix B. The revetment was designed according to accepted coastal engineering practices and Corps of Engineers' guidelines. The top of the revetment is at an elevation of 8 feet MSL. The toe of the revetment follows the certified shoreline. The toe stones were placed on hard substrate where found or buried up to 7 ft below sea level. Armor stones ranged from approximately 700 to 1200 pounds with some larger stones used in the toe. These are quarry stone or field stone with specific gravity approximately 2.65 and nominal size ranges from 1.9 to 2.2 feet diameter. Two layers of armor stones were placed on a bedding layer of 1/10 size stone. The bedding layer is two stones thick with a minimum thickness dimension of 1.6 feet. Filter fabric was placed between the bedding layer and existing soil to prevent sand piping (see Figure 10 for the placement of filter fabric and other construction scenes). Amoco 4553, 4551, or equivalent fabric was used. The filter fabric is puncture resistant with mesh size small enough to retain soil particles. The fabric was placed loosely, not in a stretched condition, but free of wrinkles, creases, or folds. The revetment is flanked on both the east and the west ends by extending the revetment 20 to 30 feet inland (see design drawings in Appendix B).
