SUBJECT: LOWER MAIN STREET TRAFFIC SIGNAL AND INTERSECTION IMPROVEMENTS
AT MILL STREET
FEDERAL AID PROJECT NO. STP-3830(4)

Final
Environmental Assessment

**Lower Main Street
Traffic Signal and Intersection
Improvements at Mill Street**

March 1996

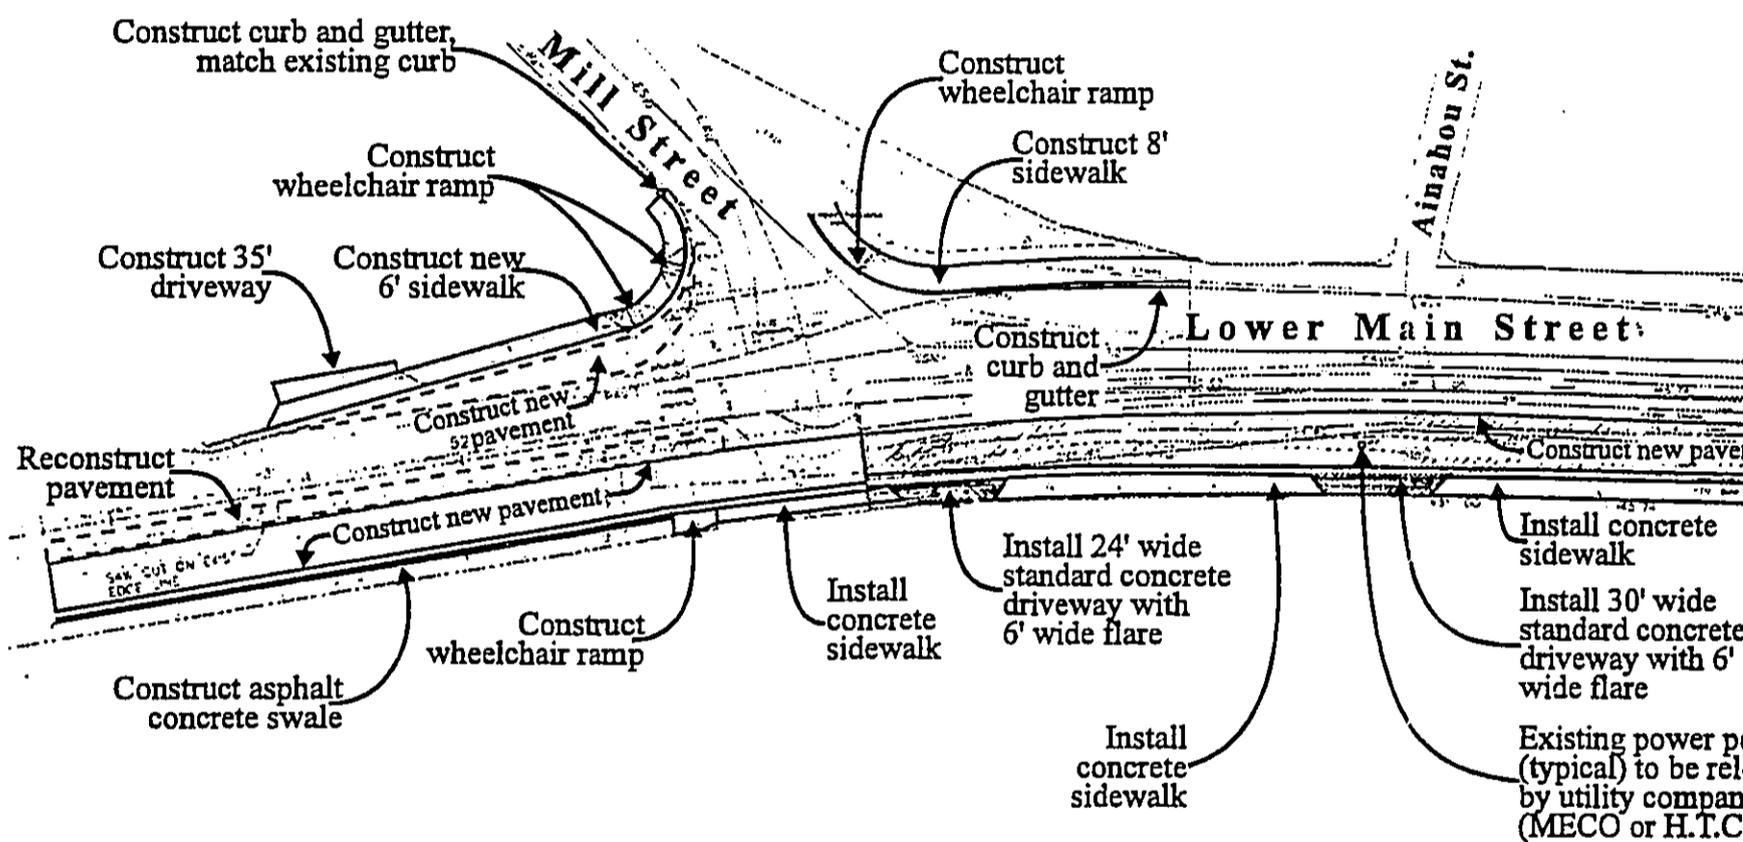
Figure 2

The westbound approach on Lower Main Street involves a lengthening of the separate right turn lane. A through lane and a two-way center left turn lane are also proposed. See Figure 3. The eastbound approach on Lower Main Street would have a left turn lane, a through lane, and a right turn lane. Past the intersection, the right turn lane merges with the through lane. On the Mill Street approach, separate right-turn and left-turn lanes are retained.

New pavement is proposed on the eastern boundary of Lower Main Street. Curb, gutter and sidewalk improvements, as well as wheelchair ramps and driveways to abutting properties, are proposed.

Lower Main Street Traffic Signal and Intersection Improvements at Mill Street Construction Plan

The traffic signal would replace the existing stop control. As noted earlier, the Mill Street approach will be realigned to as close to 90 degrees as possible in order to improve sight distance.

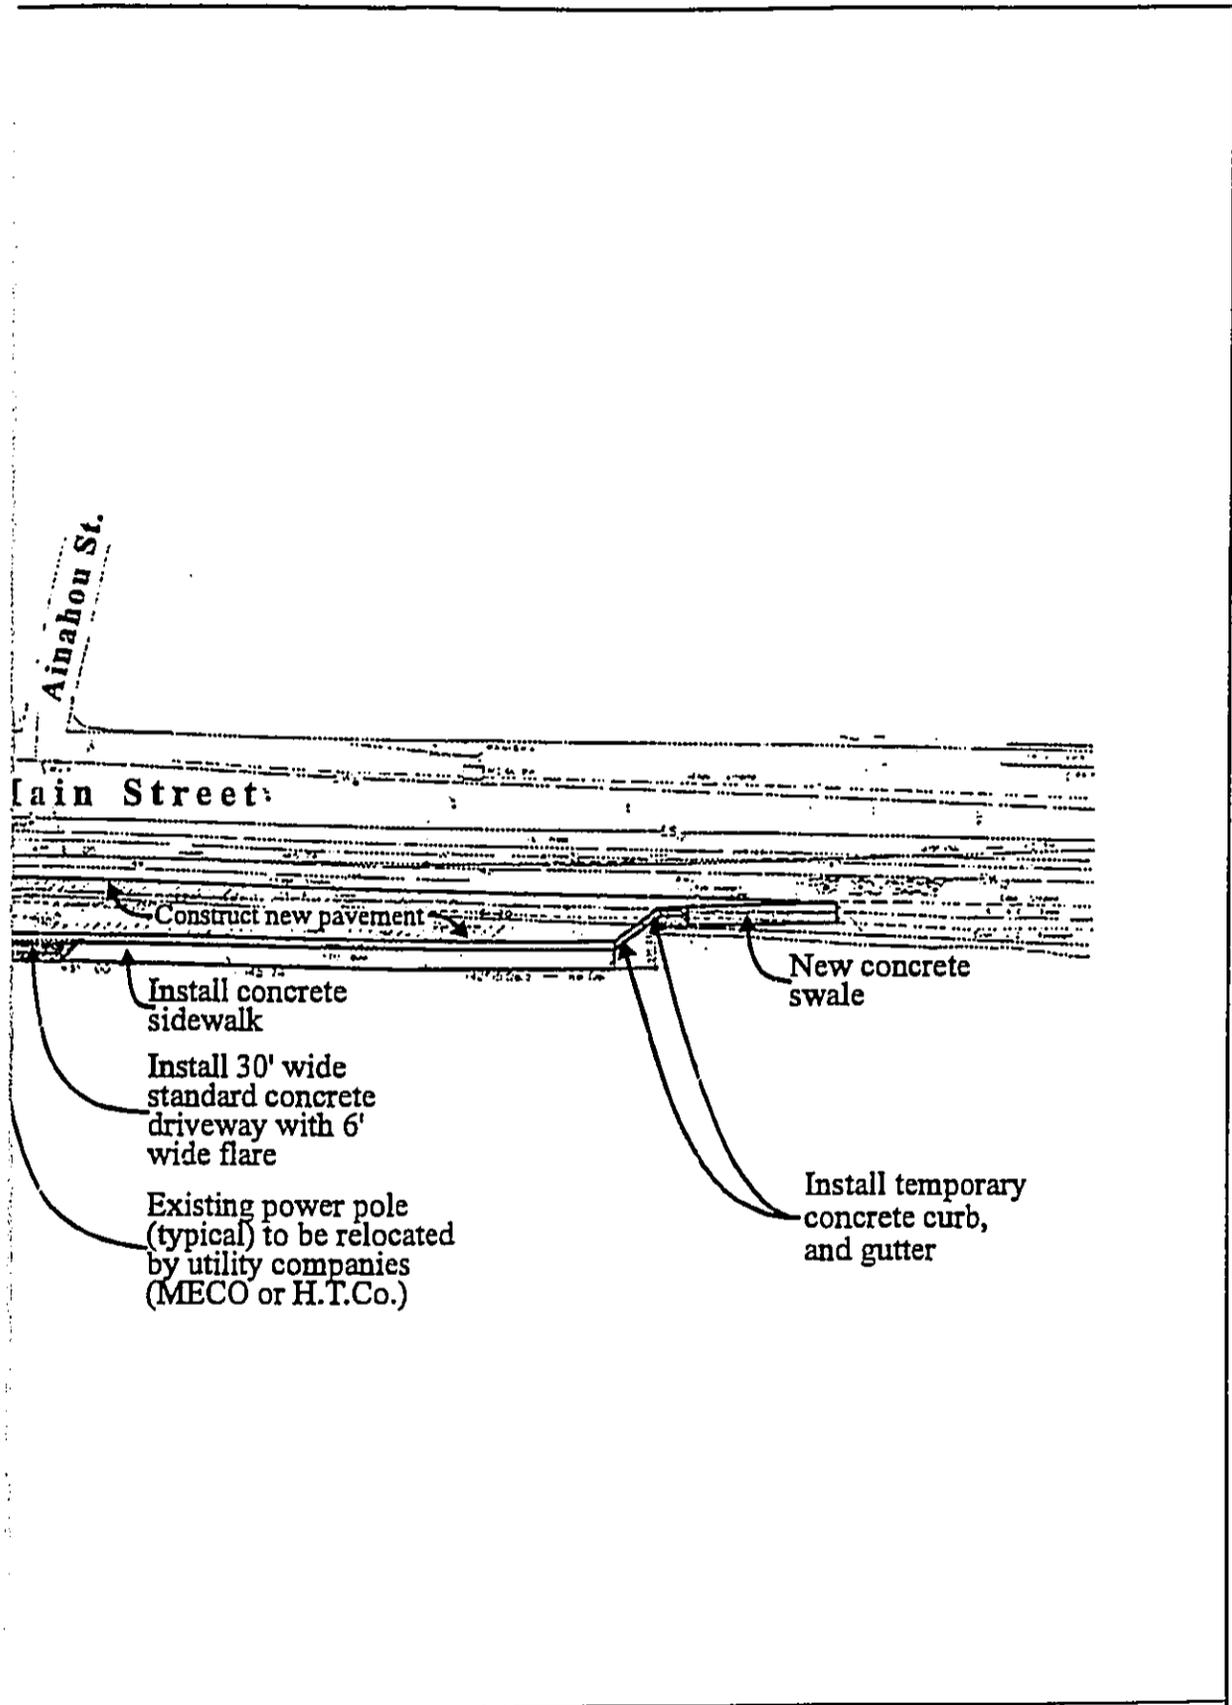
Traffic Signal and
 Signs at Mill Street
 Plan

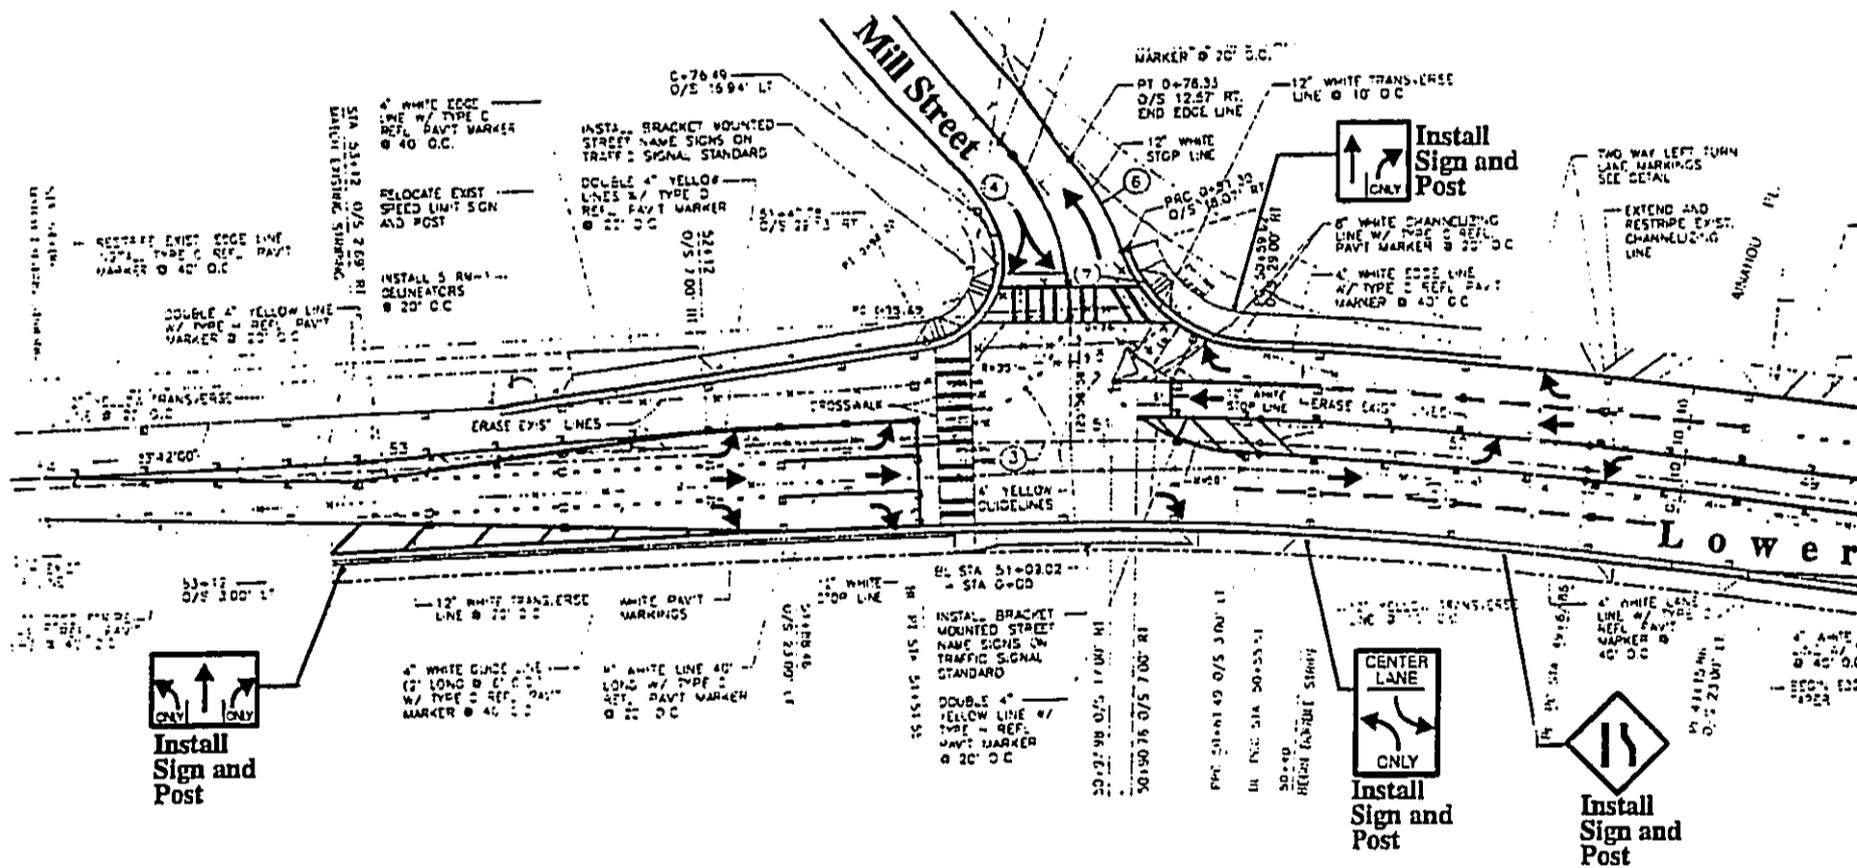
Figure 3

Lower Main Street Traffic Signal and Intersection Improvements at Mill Street Striping Plan

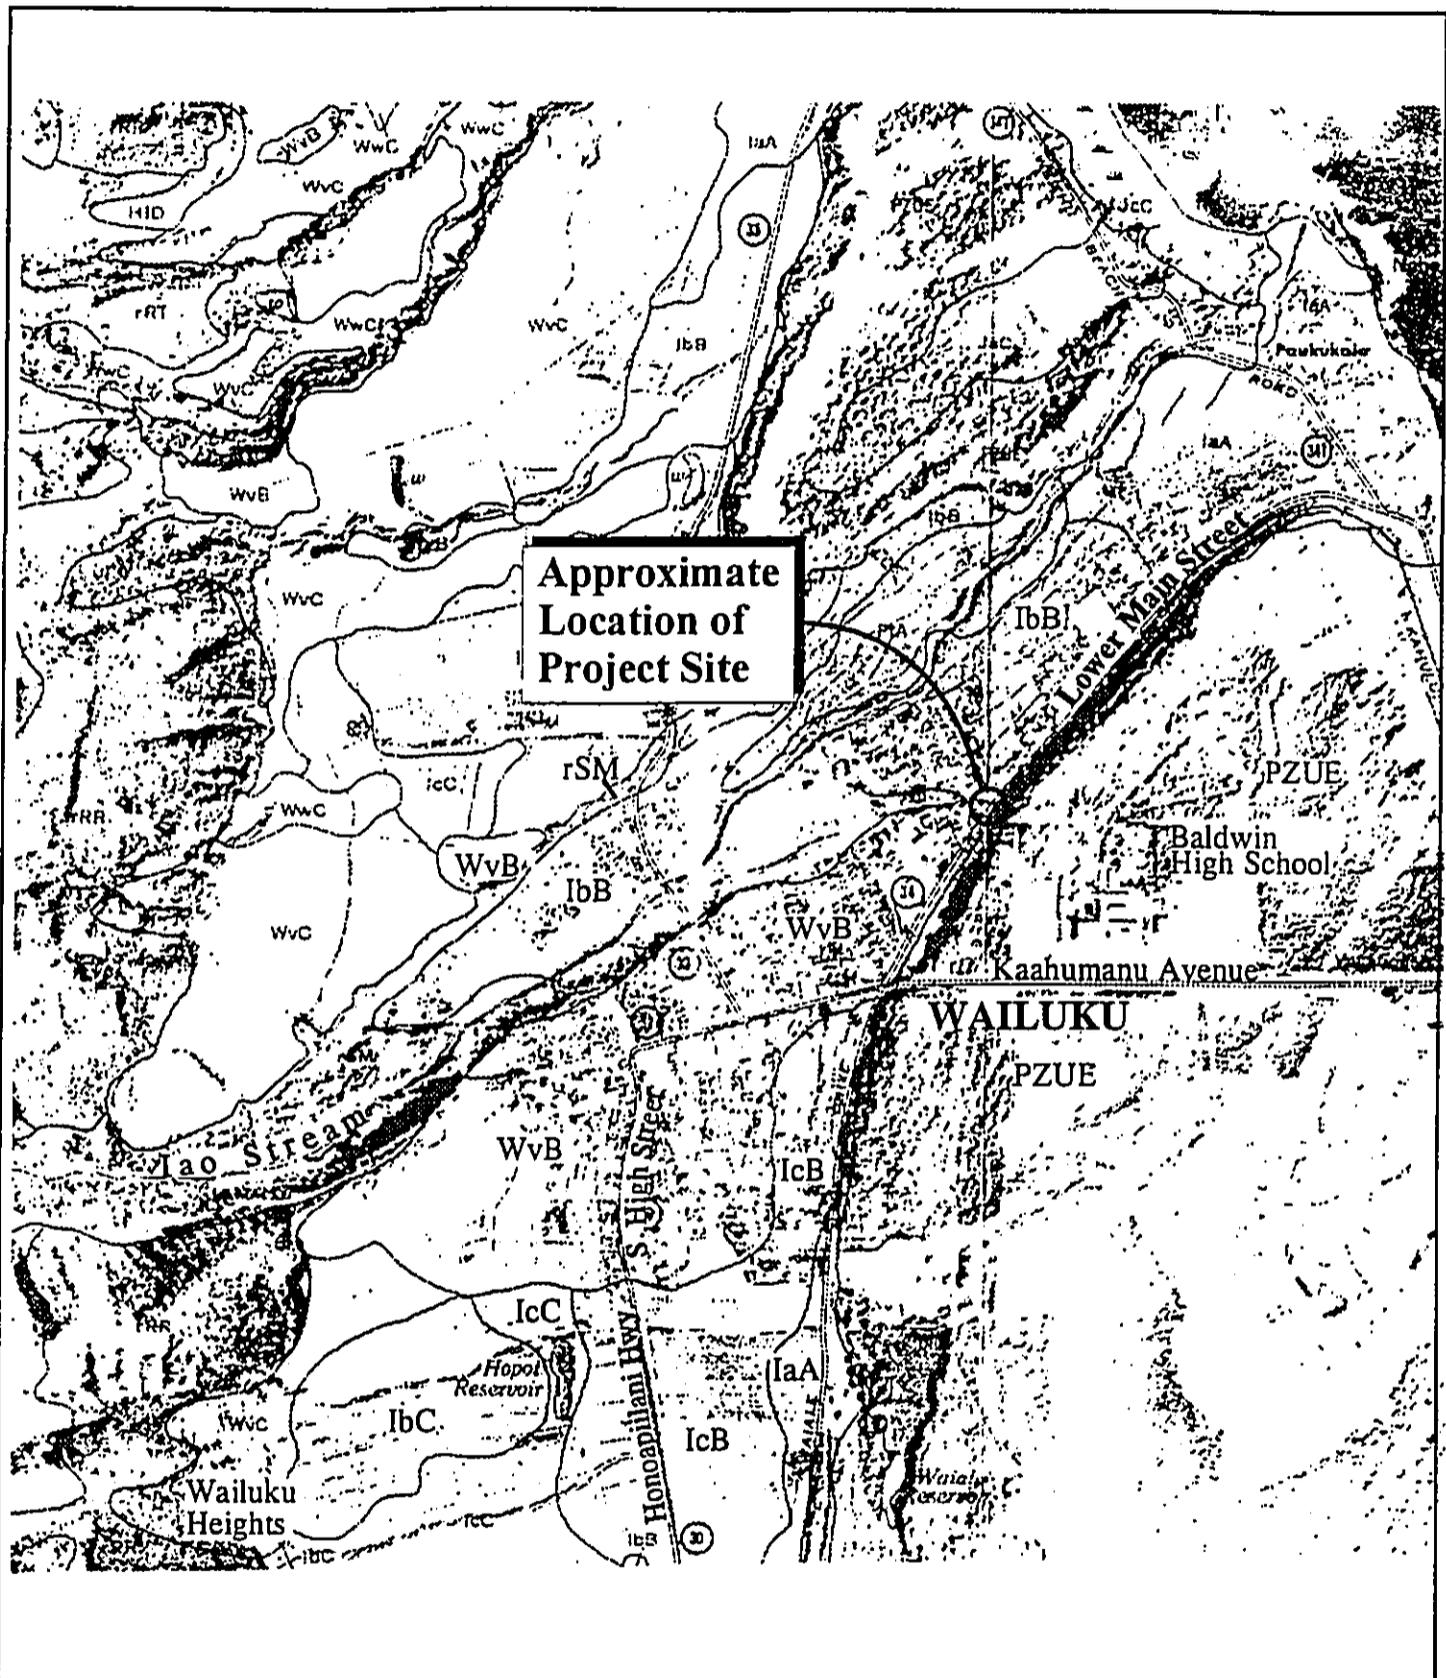
Figure 5 Lower Main St. Traffic Signal and Intersection Improvements at Mill St. Soil Classification Map

The soil types underlying the project site are lao cobbly silty clay, 3 to 7 percent slopes (lbB) and Wailuku silty clay, 3 to 7 percent slopes (WvB). See Figure 5. The permeability of lao cobbly silty clay is moderately slow. Runoff is medium and the erosion hazard is slight to moderate. The permeability of Wailuku silty clay is moderate. Runoff is slow to medium, and the erosion hazard is slight to moderate.

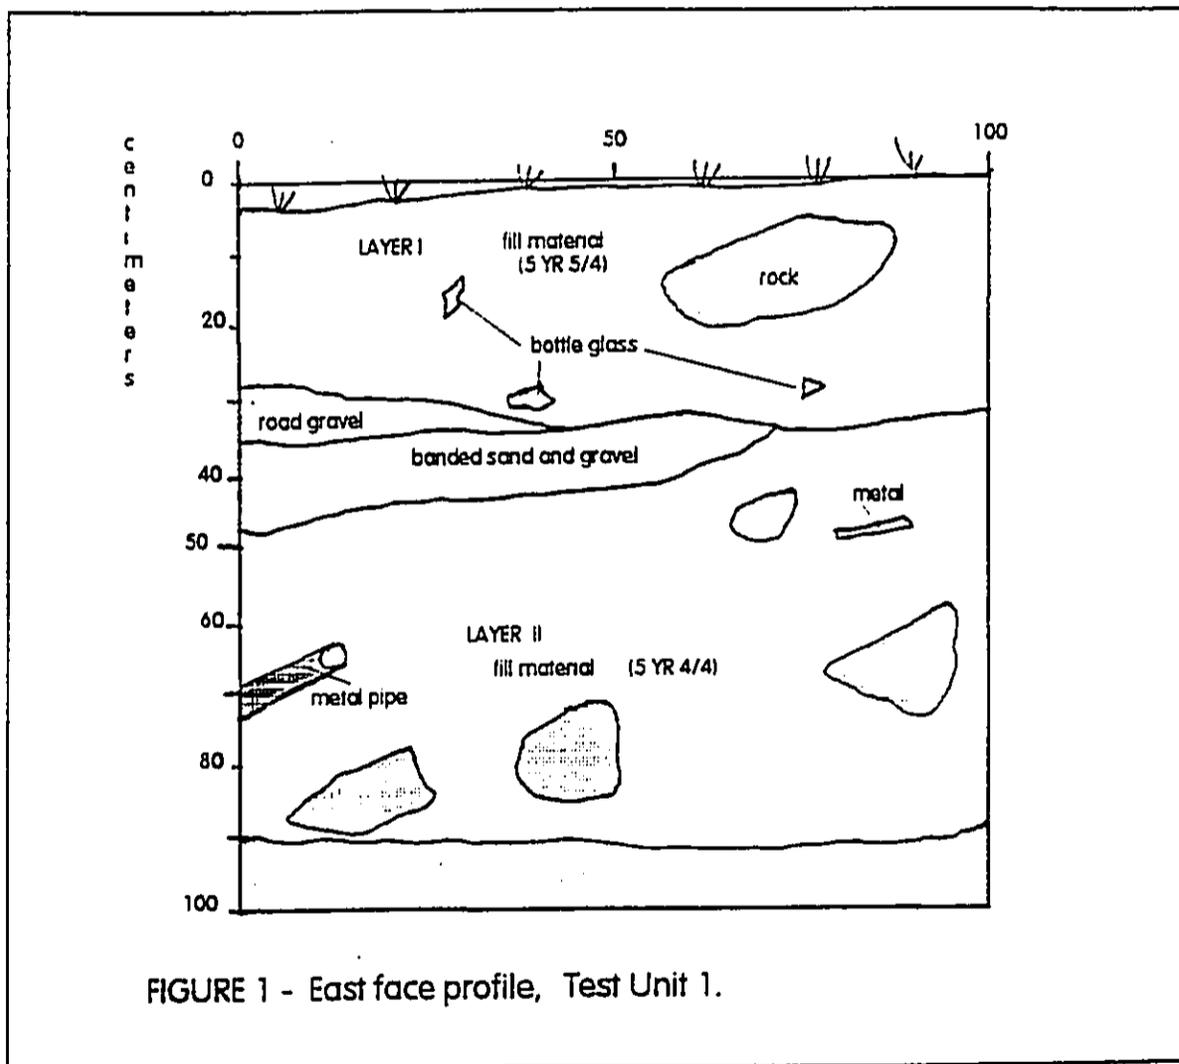
FIGURE 1 - East face profile, Test Unit 1.

Layer I (c. 0 to 0.35 mbs) consisted of reddish brown (5 YR 5/4) sandy clay fill. This fill soil contained modern materials including broken bottle glass, round head nails, rusted metal pieces, a carbon core from an automobile battery, plastic pieces and charred rubber. This layer was partly separated from Layer II by a sterile lens of road gravel and light gray (7.5 YR 7/6) sand.

One hand excavated unit was next placed in the study area in an effort to further explore subsurface conditions. This unit was 0.5 m. wide by 1.0 m. long by 0.9 m. deep. Two reddish brown sandy clay fill layers and a lens of road gravel and sand were encountered in TU 1 (Figure 1). Only historic materials were found in these fill layers.

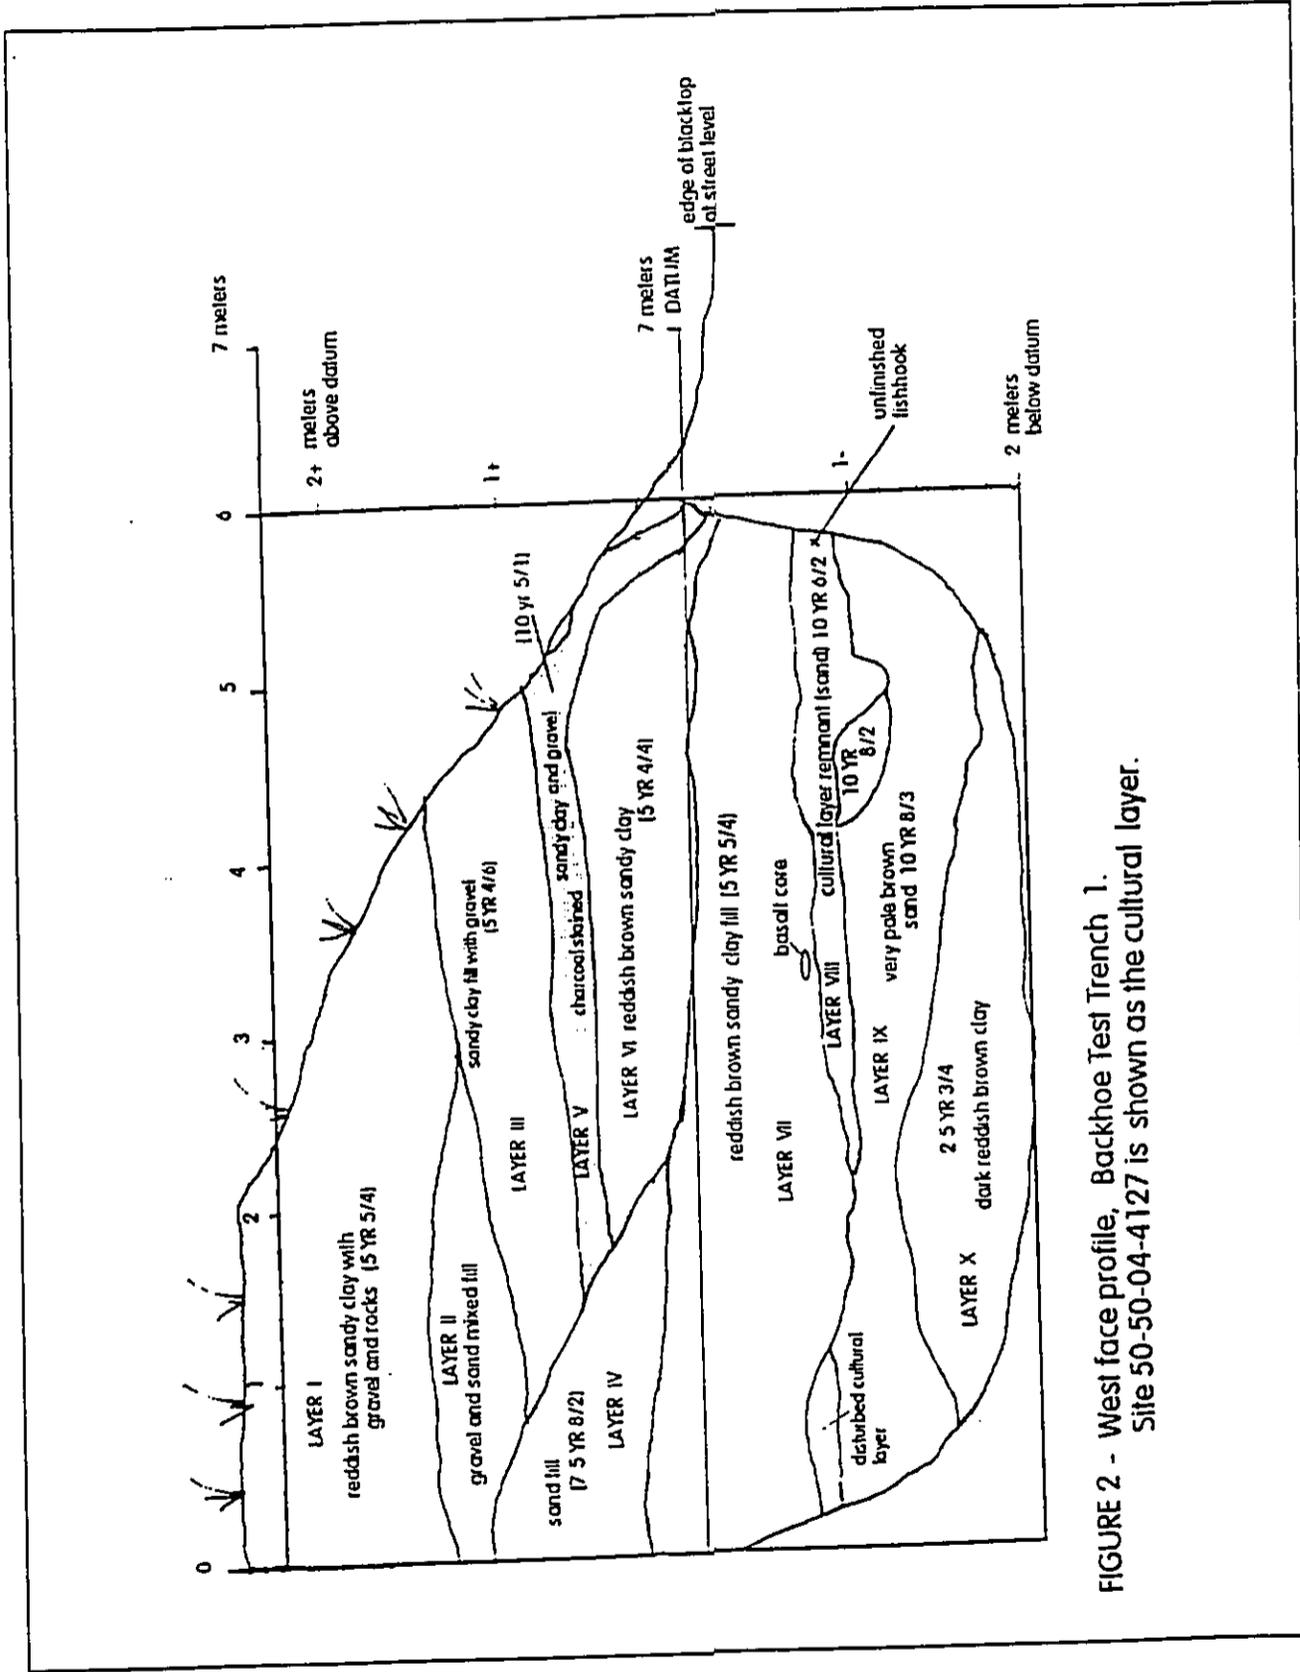
FIGURE 2 - West face profile, Backhoe Test Trench 1. Site 50-50-04-4127 is shown as the cultural layer.

Layer VIII represents a c. 0.1 to 0.2 m. thick cultural stratum. This light brownish gray (10 YR 6/2) cultural layer extended from c. 3.0 mbs to 3.4 mbs a maximum depth. A possible post hole feature was present in the western face of BT 1 in the cultural layer. Material culture remains observed in the profile of the trench included *pipipi* (*Nerita picea*), cowrie (*Cypraea* sp.), cone (*Conus* sp.), bivalves (primarily *Brachidontes* sp.), echinoderm and crustacean. A one piece unfinished bone fishhook was recovered from the profile during inspection. It measures 35 mm. in length and 20 mm. in width (Figure 9).

A total of 7 fill layers and 3 intact soil layers were encountered before excavation was halted at a maximum depth of 4.3 m. below the surface of the berm (Figure 2; Photos 3 & 4). Layer I extended from the surface to a maximum depth of 1.2 mbs. This fill layer consisted of reddish brown (5 YR 5/4) sandy clay mixed with road gravel and angular basalt rocks. Modern materials including brown bottle glass fragments, plastic, metal and metal beverage containers were noted in the backfill. A sterile lens (c. 0.4 m. maximum thickness) of road gravel and pinkish gray (7.5 YR 7/2) sand occurred under a portion of Layer I. Layer II extended to a maximum depth of c. 1.6 mbs. Layer III was composed of yellowish red (5 YR 4/6) sandy clay fill which extended to a maximum depth of 1.8 mbs. This stratum also contained modern historic materials. Layer IV consisted of pinkish white (7.5 YR 8/2) sand fill which contained modern materials such as metal, plastic and brown bottle glass. This layer extended to a maximum depth of c. 2.6 mbs. Layer V consisted of charcoal stained sandy clay and road gravel. This gray (10 YR 5/1) fill layer contained modern material, was c. 0.2 m. thick and extended to a maximum depth of c. 2.2 mbs. Layer VI was composed of reddish brown (5 YR 4/4) clay mixed with road gravel. This stratum was c. 0.6 m. thick and extended to a maximum depth of 2.4 mbs. Material culture remains observed were modern. A c. 0.1 m. thick portion of Layer IV pinkish white sand occurred under Layer VI. The last fill layer was composed of brown (5 YR 5/4) sandy clay. This fill stratum contained what appeared to be mixed historic and indigenous materials in the bottom 0.2 m. of this nearly meter thick fill layer. Layer VII extended to a maximum depth of c. 3.0 mbs. A dense basalt core c. 120 m. long by 85 mm. wide by 25 mm. thick was recovered from the southwest profile of BT 1 near the bottom of Layer VII (Figure 9).

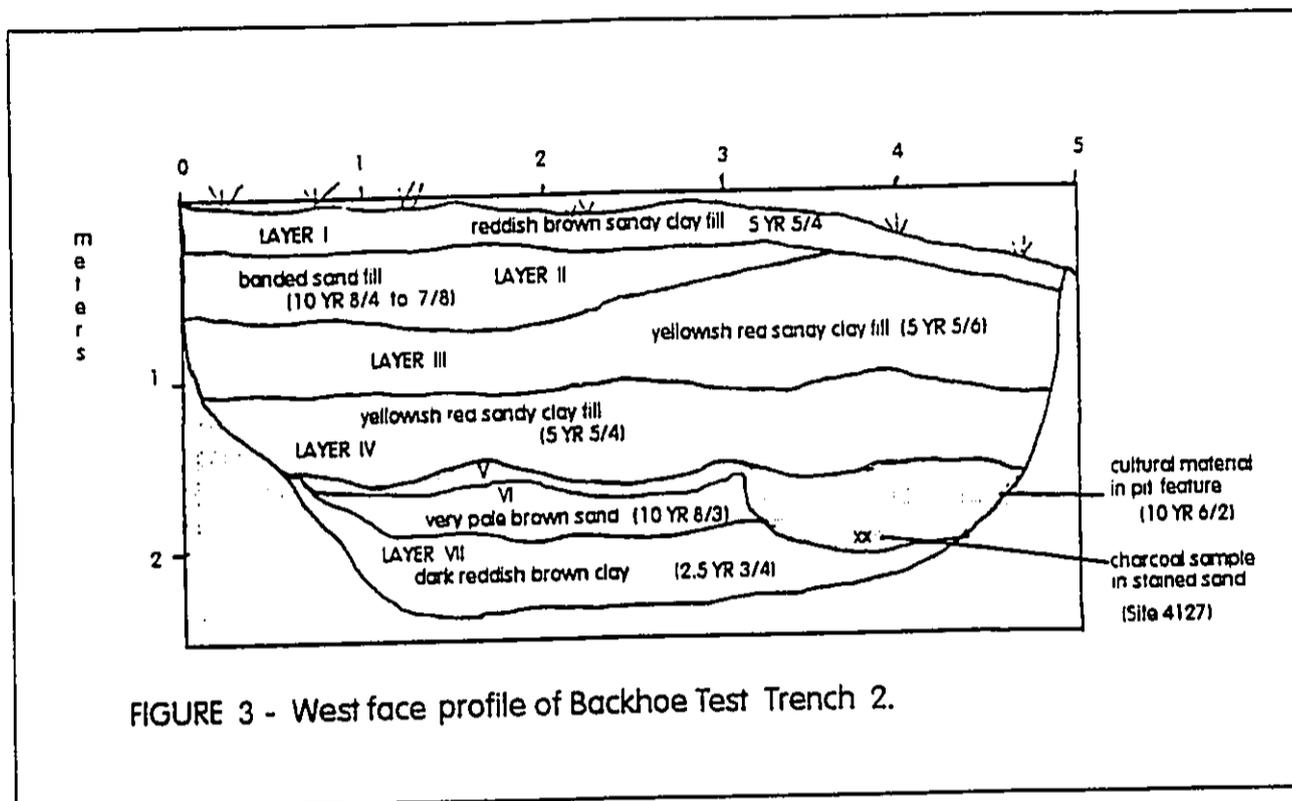
The 4 fill layers totaled c. 1.6 m. in depth. Layer I (0 to 0.4 mbs) consisted of the reddish brown (5 YR 5/4) sandy clay fill found in BT 1. Modern materials including rusted metal, road gravel, brown bottle glass and plastic were observed in the back dirt along with several waterworn cobbles. Layer II (0.3 to 0.8 mbs) consisted of banded very pale brown (10 YR 8/4) to yellow (10 YR 7/8) sand. This fill contained modern materials such as rusted metal, plastic, wood and bottle glass. Layer III fill extended from c. 0.3 to 1.1 mbs. This yellow red (5 YR 5/6) sandy clay stratum contained road gravel, broken brown bottle glass and metal. Layer IV (c. 1.1 to 1.6 mbs) also contained historic materials, including coal, steel beverage containers and broken brown bottle glass. This reddish brown (5 YR 5/4) sandy clay fill layer appeared to have also impacted the underlying cultural stratum and the bottom 0.1 to 0.2 m. of Layer IV contained mixed historic materials and midden.

FIGURE 3 - West face profile of Backhoe Test Trench 2.

Layer V consisted of a light brownish gray (10 YR 6/2) sand stratum similar to the one located in BT 1. In general, Layer V was less than 0.2 m. in thickness. However, a pit feature on the Lower Main Street side (northern end) of the southwestern profile was nearly 0.4 m. thick. This feature contained scattered charcoal flecking along its bottom and measured nearly 1.3 m. across by 0.37 m. at its deepest point (Figure 3). A small charcoal sample was collected from the bottom of the feature and sent to Beta Analytic, Inc. for radiocarbon dating analysis. Unfortunately, this sample proved to be too small to date. It is possible that this feature is a burial pit. Midden observed in the cultural stratum included *pipipi* (*Nerita picea*), cowrie (*Cypraea* sp.), cone (*Conus* sp.), bivalves (primarily *Brachidontes* sp.) and traces of echinoderm. The top of the cultural layer was between 0.2 and 0.4 m. below Lower Main Street.

This trench was located c. 12 m. southwest of BT 1. Unit orientation was 313 degrees magnetic, and BT 2 dimensions were c. 1.6 m. wide by 5 m. long by a maximum of 2.4 m. deep. A total of 4 fill layers and 3 intact soil layers were encountered (Figure 3; Photo 5).

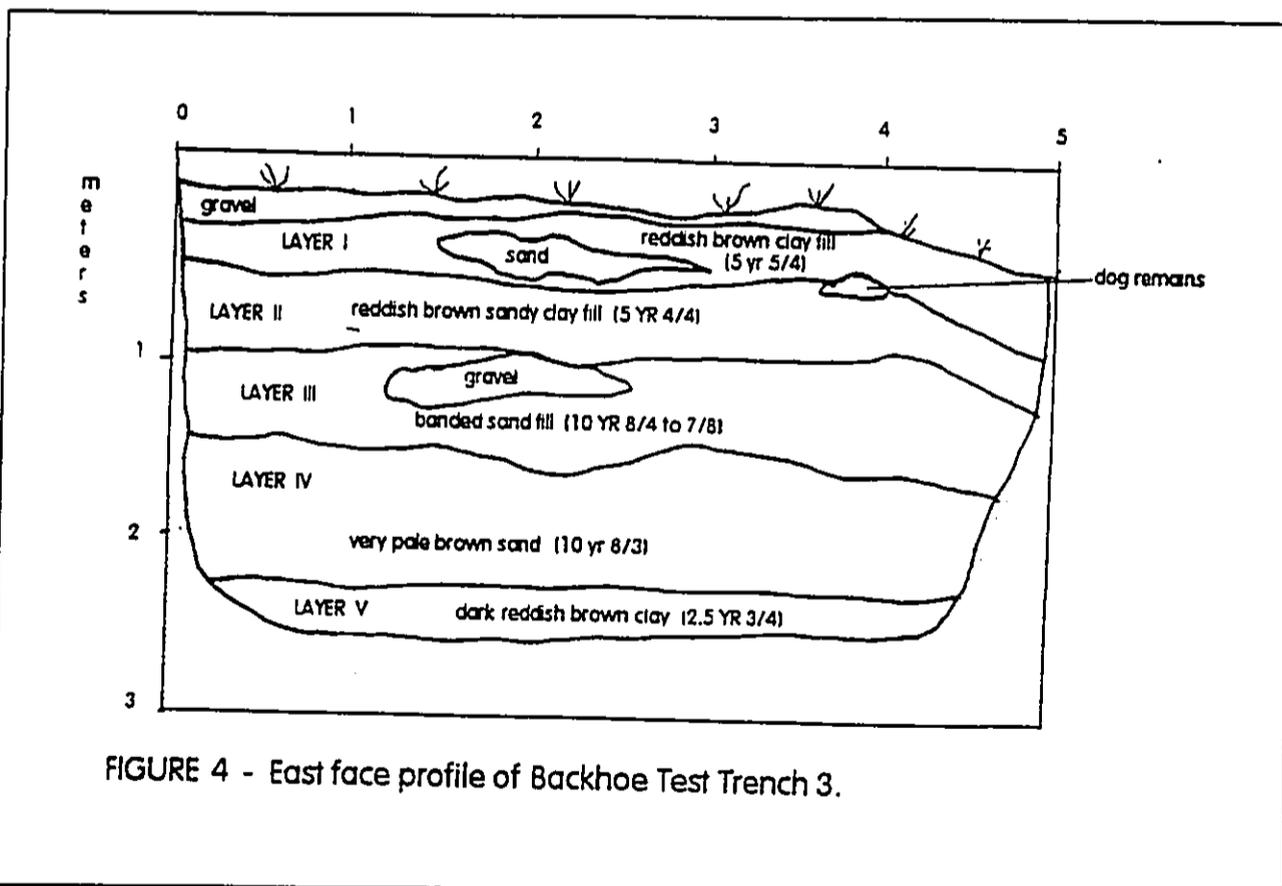
The 3 fill layers extended to c. 1.6 mbs and all contained modern debris. Layer I (0 to 0.5 mbs) consisted of reddish brown (5 YR 5/4) clay fill. This fill contained a concentration of road gravel, concrete and fragments of black top c. 0.3 m. thick near the surface. In addition, a white (10 YR 8/2) sand lens was contained in Layer I. Historic items included broken bottle glass, rusted metal, plastic and a rusted railroad spike. A portion of a dog's jaw was located in the southwestern face of BT 3 between Layers I and II. In addition, scattered skeletal remains (dog) were located in the back dirt pile. Layer II (0.5 to 1.0 mbs) was composed of reddish brown (5 YR 4/4) sandy clay fill. Portions of the canine skeletal remains were also noted in the back dirt pile along with scattered

FIGURE 4 - East face profile of Backhoe Test Trench 3.

fragments of bottle glass, cans, plastic, a "D" cell battery and a piece of PVC pipe. Layer III (c. 0.9 to 1.6 mbs) consisted of banded very pale brown (10 YR 8/4) to yellow (10 YR 7/8) sand fill. This fill layer contained some modern refuse as well as a c. 0.2 m. thick lens of road gravel. Some scattered midden was noted in the profile of BT 3 with 0.2 to 0.3 m. above Layer IV. It is possible that this scattered material represents a portion of a former cultural deposit that was impacted during historic earth moving activities.

This subsurface test was located c. 10 m. southwest of BT 2. Trench dimensions were c. 1.6 m. wide by 5 m. long by 2.5 m. maximum depth and BT 3 was oriented to 300 degrees magnetic. A total of 3 fill layers and 2 undisturbed layers were encountered before excavation of BT 3 was halted due to very compact and rocky clay subsoil (Figure 4).

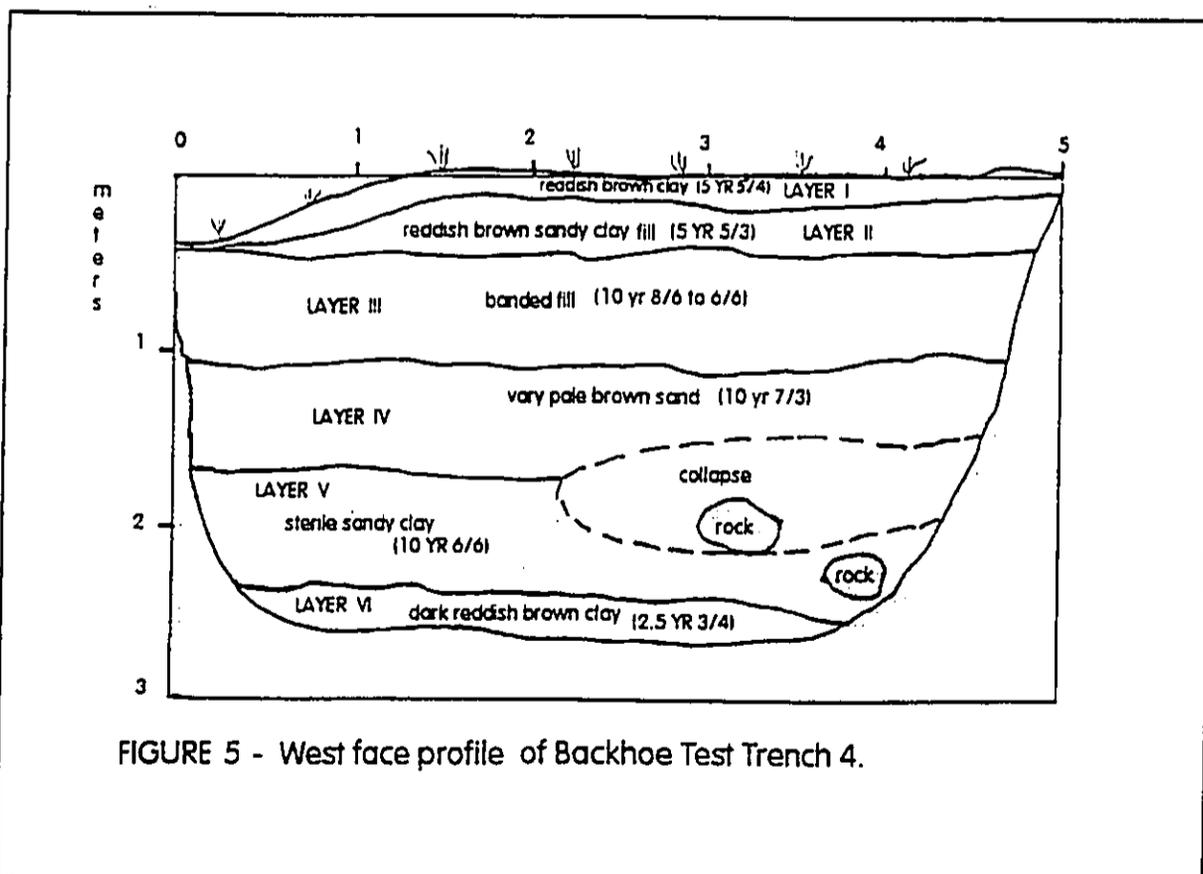
FIGURE 5 - West face profile of Backhoe Test Trench 4.

The five fill layers totaled c. 1.6 m. in thickness. Layer I (0 to 0.2 mbs) was composed of reddish brown (5 YR 5/4) clay which contained modern debris. It was underlain by Layer II which extended to c. 0.5 mbs. This reddish brown (5 YR 5/3) sandy clay also contained modern debris. Layer III (c. 0.5 to 1.1 mbs) was composed of banded yellow (10 YR 8/6) to brownish yellow (10 YR 6/6) sand fill. Historic materials observed included 2 railroad spikes, several pieces of coal, 2 round head nails, broken brown bottle glass, 2 steel beverage containers and paper. Several waterworn shells were also noted in this fill material. Layer IV (c. 1.1 to 1.7 mbs) consisted of very pale brown (10 YR 7/3) sand. This stratum contained a few pieces of coal, a drawn square nail and a few cone (*Conus* sp.) and cowrie (*Cypraea* sp.) shell fragments. This stratum was relatively homogenous and did not exhibit much evidence of historic disturbances. However, it was underlain by what appeared to be a fill layer. Layer V (c. 1.7 to 2.5 mbs) was composed of brownish yellow (10 YR 6/6) sandy clay which contained several large subangular "blue rock" cobbles and small boulders ranging from 0.5 to 0.9 m. in diameter. These rocks were not incorporated into an architectural feature and randomly occurred in Layer V soil. Layer V appeared to be sterile. However, two of the boulders possessed what appeared to be heavy equipment surface scars.

This trench was located c. 15 m. southwest of BT 3 near a utility pole support. Unit orientation was 310 degrees magnetic and BT 4 dimensions were 1.6 m. wide by 5.0 m. long by 2.7 m. at maximum depth. This unit contained 5 fill layers and one intact layer (Figure 5).

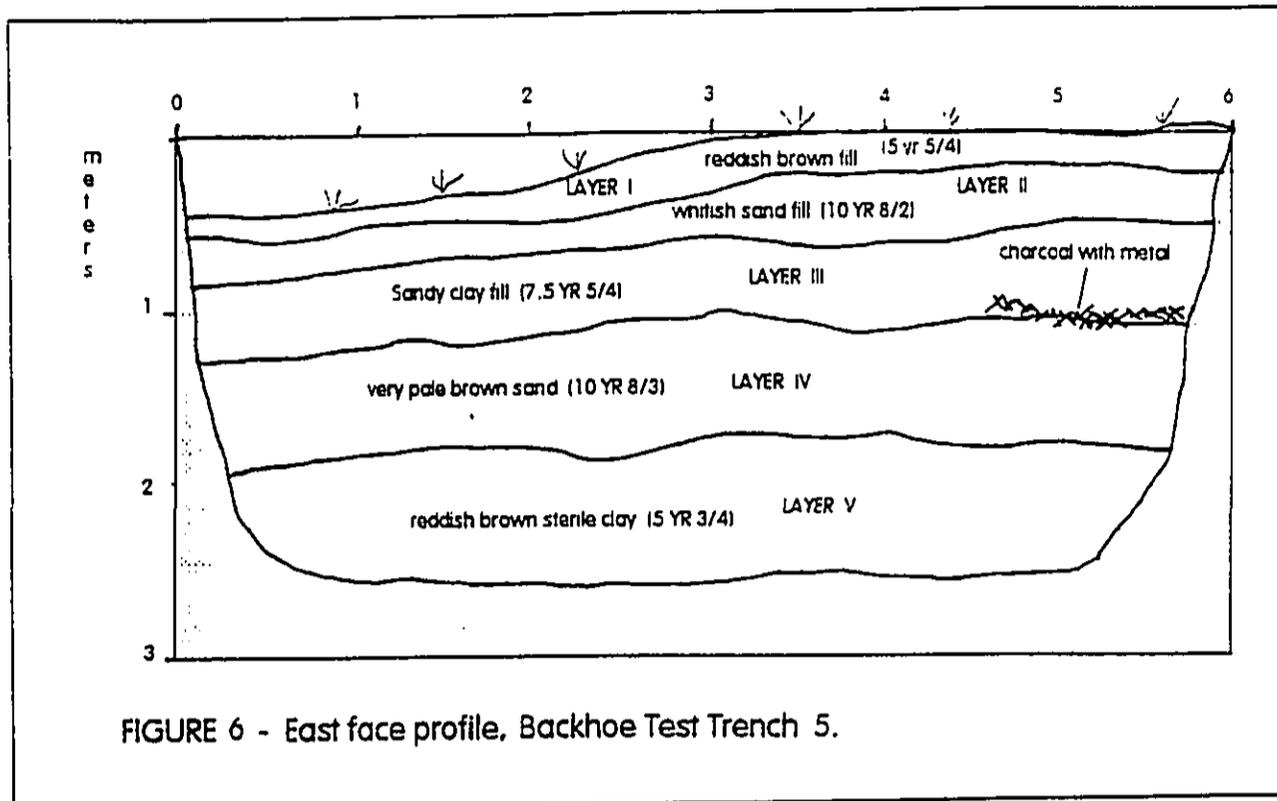
The upper 3 soil layers were a total of 1.2 m. deep at their thickest. Layer I (c. 0 to 0.3 mbs) consisted of reddish brown (5 YR 5/4) sandy clay fill. This layer contained modern debris such as rusted metal, brown bottle glass, road gravel and plastic. Layer II (c. 0.3 to 0.7 mbs) was composed of whitish (10 YR 8/2) sand fill which contained modern debris. Cultural materials observed in Layer III (c. 0.7 to 1.2 mbs) brown (7.5 YR 5/4) sandy clay fill included road gravel, modern debris, coal, one drawn square nail, and a few pieces of midden. In addition, a charcoal lens c. 1.2 m. long by 0.1 m. thick was present in the northwest profile of BT 5 at the interface between Layers III and IV. Several pieces of rusted metal were observed in this lens. It appears possible that earth moving activities associated with Layer III may have impacted a formerly intact cultural stratum.

FIGURE 6 - East face profile, Backhoe Test Trench 5.

Both Layers IV and V appeared to be undisturbed strata. Layer IV (c. 1.2 to 1.8 mbs) was composed of very pale brown (10 YR 8/3) sand. This layer did not contain any evidence of material culture remains. Layer IV was underlain by Layer V reddish brown (5 YR 3/4) clay. This sterile subsoil contained fragments of decayed bedrock and extended to the bottom of BT 5 at a maximum of c. 2.6 mbs.

This subsurface test was located c. 20 m. southwest of BT 4. Trench orientation was 280 degrees magnetic and BT 5 dimensions were 0.8 m. wide by 6.0 m. long by a maximum depth of 2.6 mbs. This unit contained 3 fill layers and 2 in place layers (Figure 6).

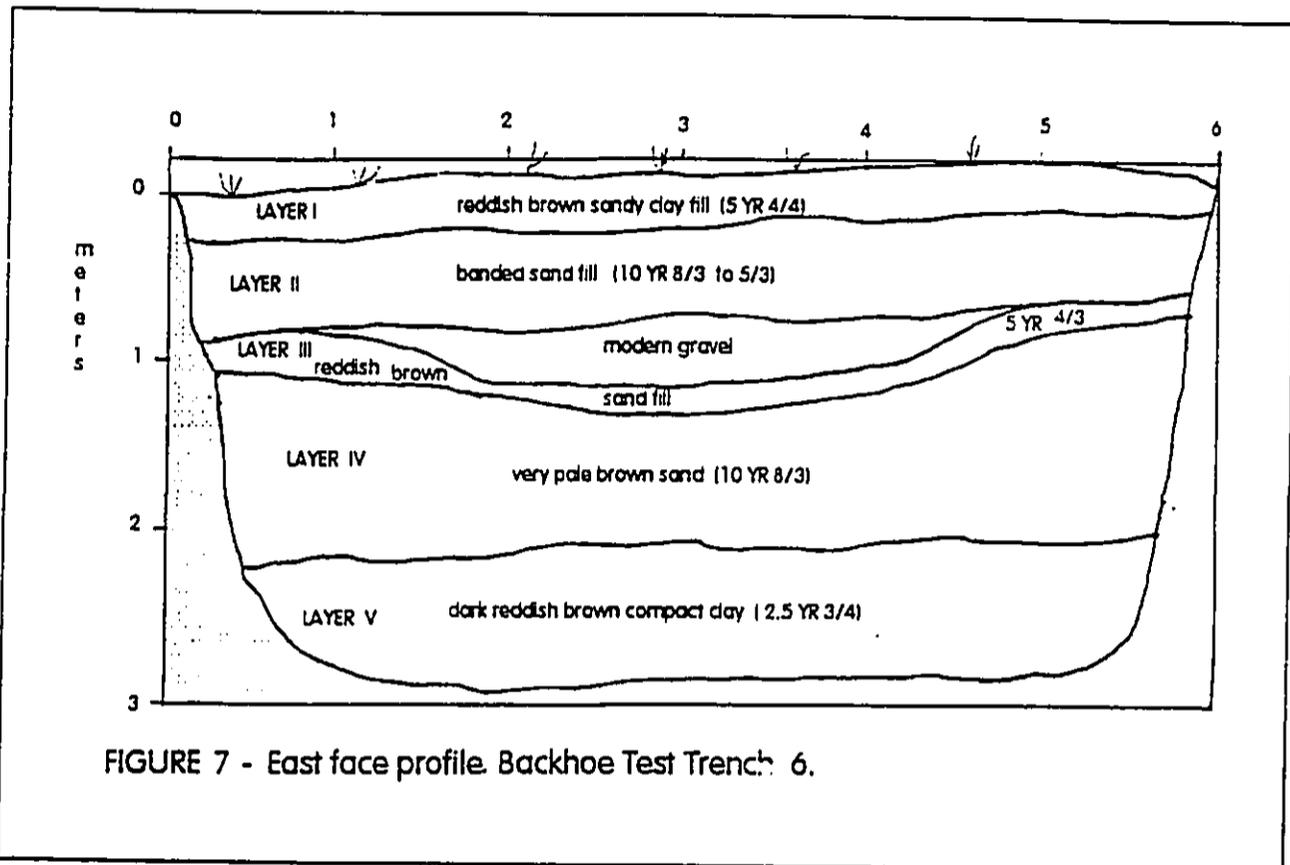
The 4 fill layers were a maximum of 1.4 m. thick. Layer I (c. 0 to 0.4 mbs) was composed of reddish brown (5 YR 4/4) sandy clay fill. This stratum contained modern debris. It was underlain by banded very pale brown (10 YR 8/3) to brown (10 YR 5/3) sand fill. Modern historic materials noted in Layer II (c. 0.4 to 0.9 mbs) include charred rubber, pieces of black top, road gravel, broken bottle glass, wood and aluminum foil. In

FIGURE 7 - East face profile. Backhoe Test Trench 6.

addition, scattered pieces of coal ranging from c. 10 to 30 mm. in diameter were also noted. Layer II was underlain by a broad lens of road gravel c. 3.5 to 4.0 m. wide by a maximum of 0.4 m. thick. This gravel lens rested on top of a c. 0.2 m. thick reddish brown (5 YR 4/3) sand fill layer. Layer III extend to a maximum depth of 1.4 mbs. This layer contained scattered pieces of coal ranging from 10 to 25 mm. in diameter.

It appeared that both the gravel lens and Layer III intruded into Layer IV which was composed of very pale brown (10 YR 8/3) sand. This stratum appeared to be partly intact and extended to a maximum depth of 2.2 mbs. No evidence of *in situ* material cultural materials was noted. This apparently sterile stratum overlaid Layer IV which extended to the bottom of BT 6 at 2.9 mbs. The compact, dark reddish brown (2.5 YR 3/4) clay' subsoil layer appeared to be sterile. Excavation at BT 6 was halted due to very compact, rocky soil conditions.

Backhoe Trench 6 was excavated c. 10 m. to the southwest of BT 5. Unit orientation was 330 degrees magnetic and BT 6 dimensions were 0.8 m. wide by 6.0 m. long by a maximum depth of 2.9 mbs. A total of 4 fill layers which overlaid 2 intact strata were located before excavation was halted at very hard subsoil (Figure 7).

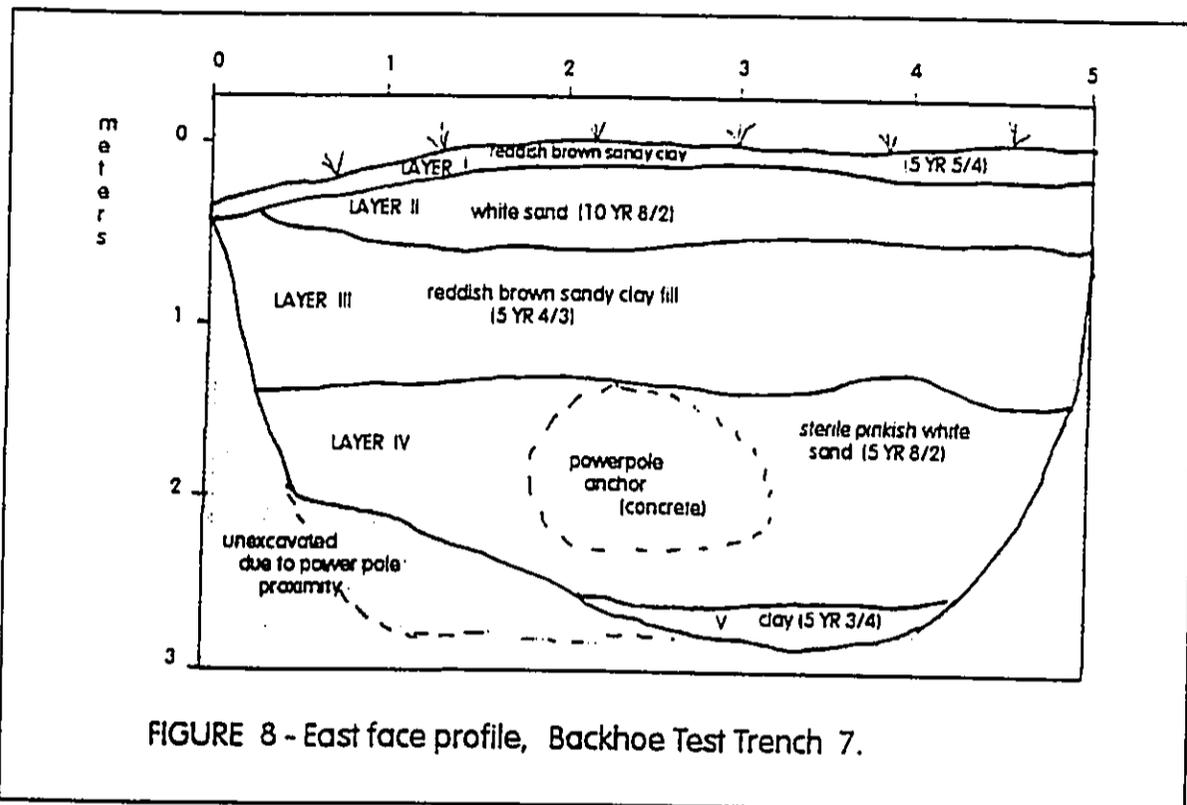
FIGURE 8 - East face profile, Backhoe Test Trench 7.
