Higa Seawall at Ewa Beach

**COASTAL ENGINEERING EVALUATION
AND ENVIRONMENTAL ASSESSMENT
FOR A SEAWALL AT
EWA BEACH, OAHU, HAWAII
(TMK: 9-1-07:72)**

Edward K. Noda and Associates, Inc.
615 Piikoi Street, Suite 300
Honolulu, Hawaii 96814

MAY 1996
FINAL

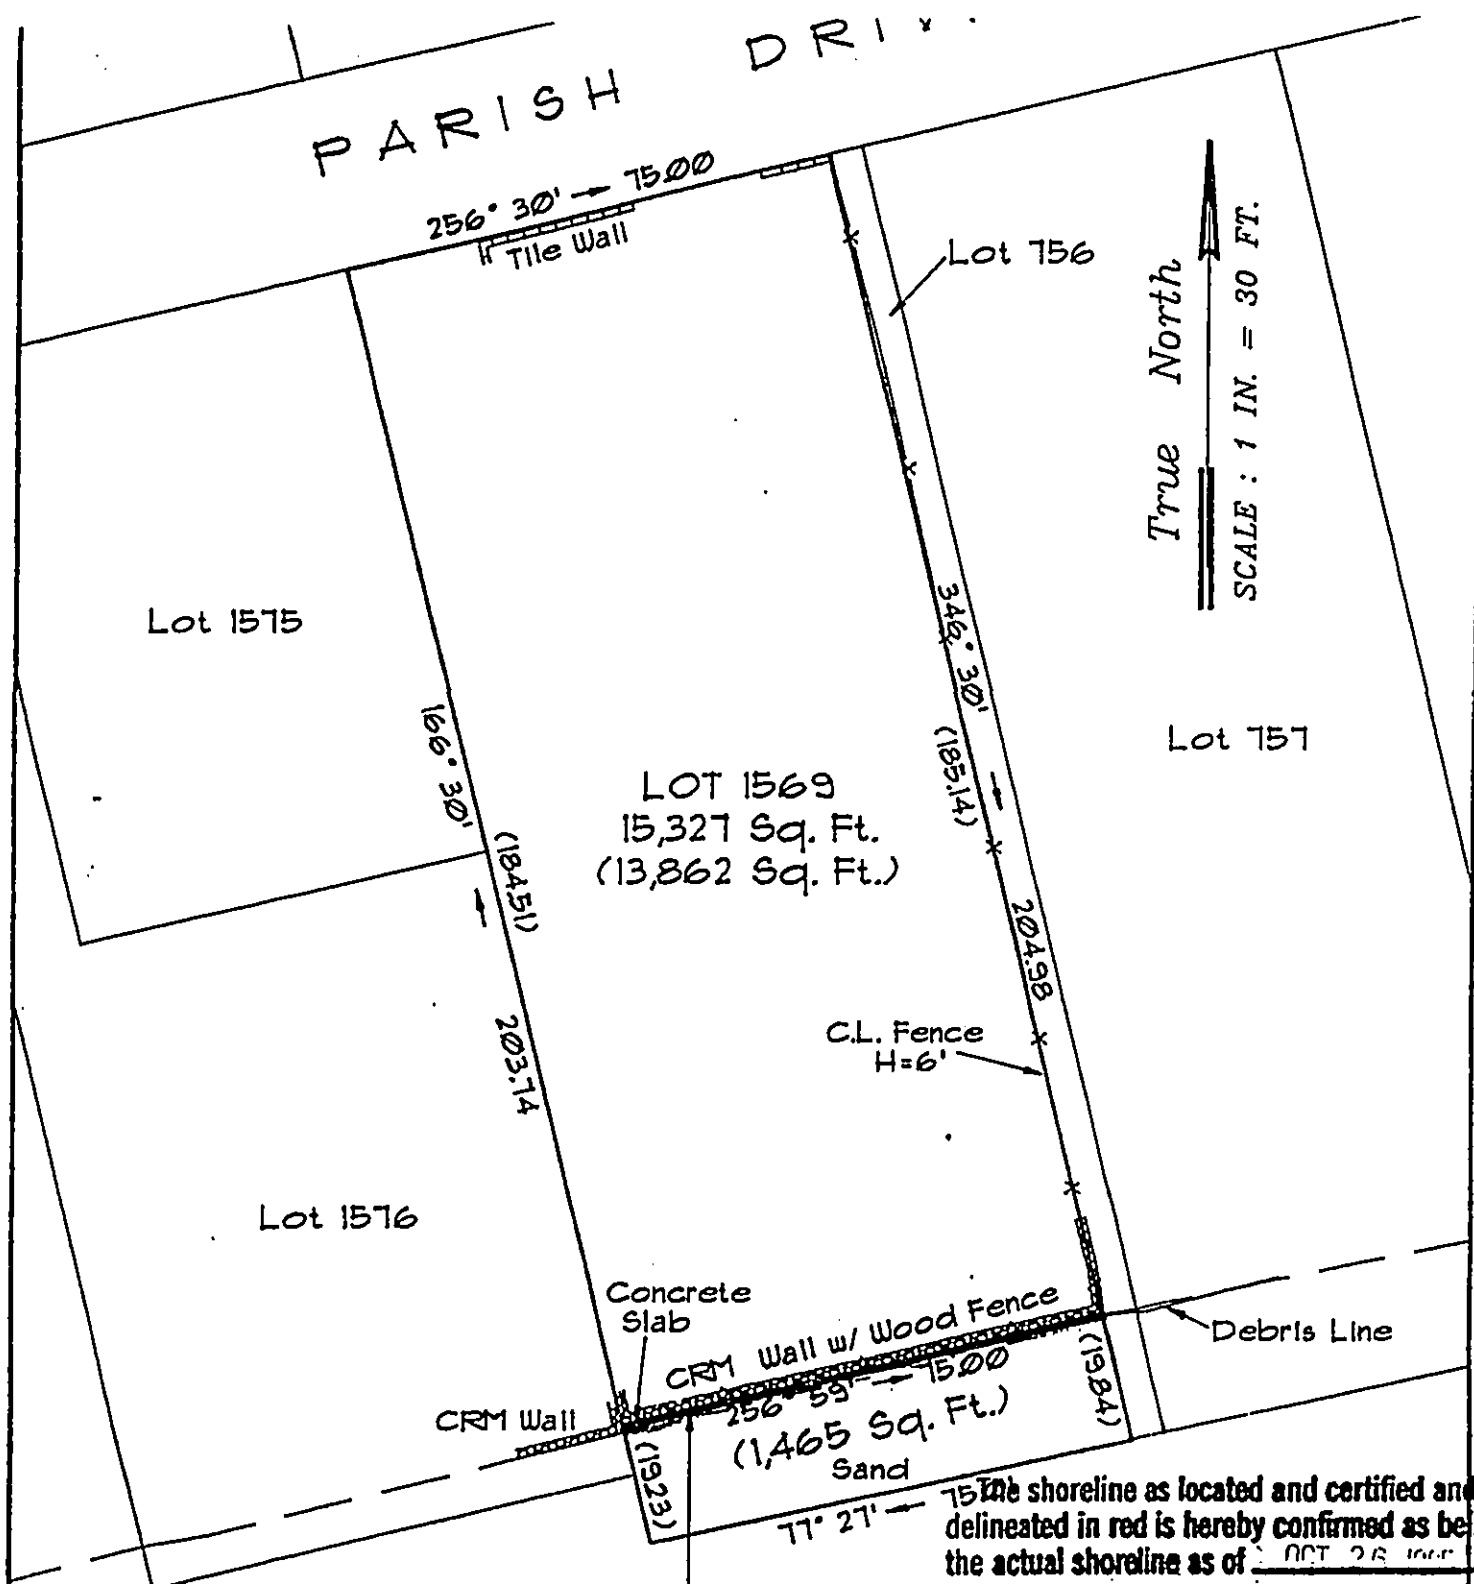
Owner: James H. Higa
Address: 91-049 Parish Dr.
Purpose: Wall Constr FIGURE 4

Shoreline follows face of seawall as allocated on August 19, 1986

Shoreline Survey
of Lot 1569
of Land Court Application 242 (Map 204)
at Ewa, Honolulu, Oahu, Hawaii
T.M.K. : 9-1-07 : parcel 72

The existing seawall was constructed after Hurricane Iwa caused significant erosion and wave overtopping damage to this shorefront. A shoreline survey on file with the State Surveyor shows the shoreline following the face of the seawall as located on August 19, 1986 (Figure 3). The current certified shoreline also follows the face of the seawall as located on August 7, 1995 (Figure 4). The seawall is located about 19.5 feet landward of the seaward property boundary (effectively reducing the usable property area by about 1,460 square feet).

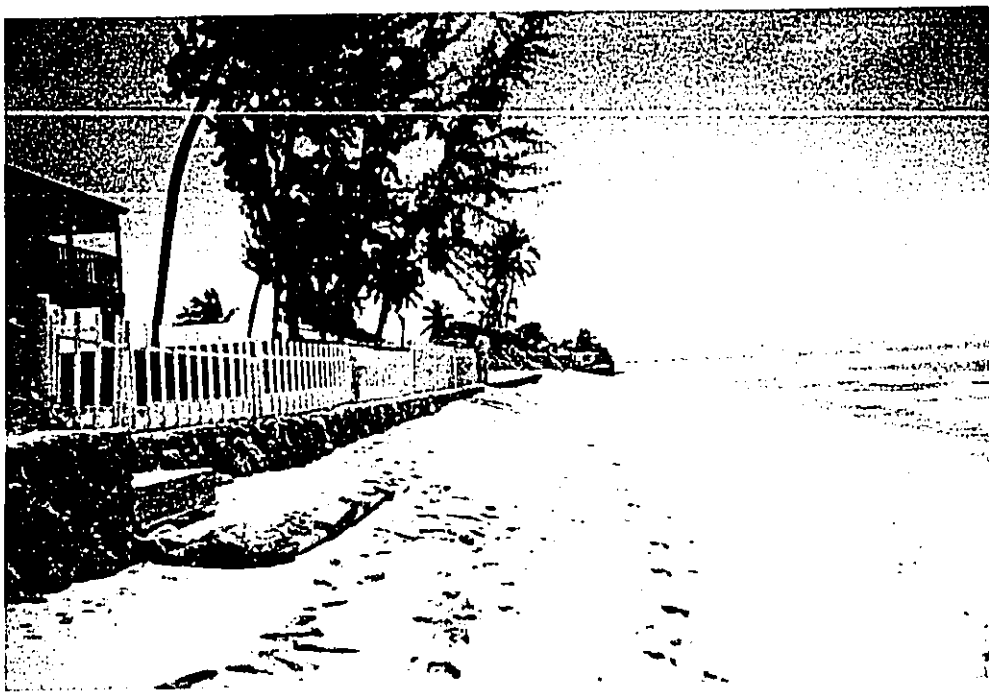
Photo 1. Condition of beach and seawall in July 1995.

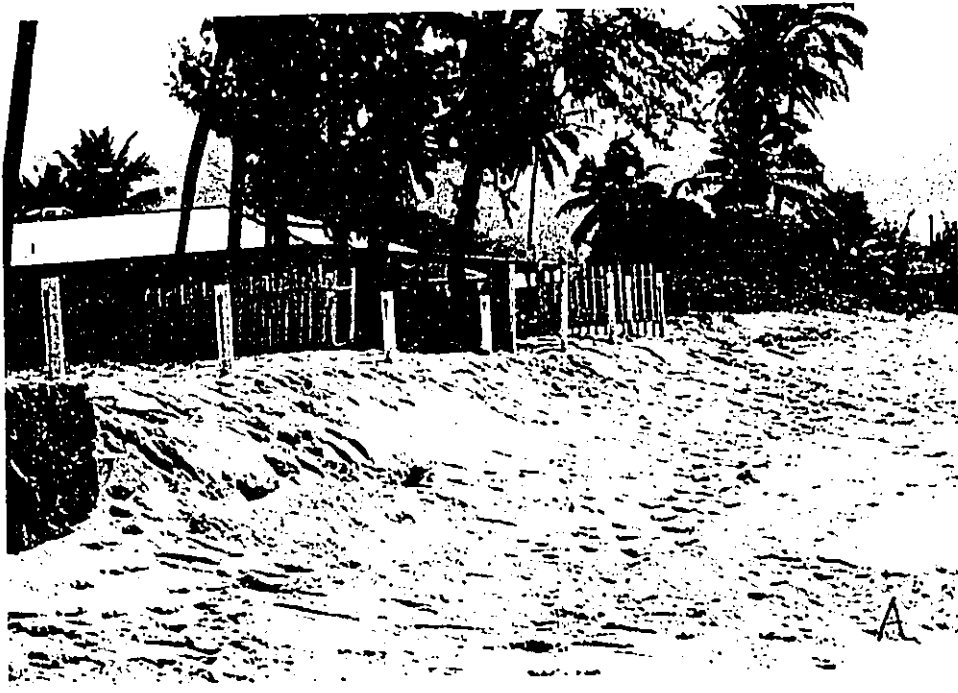
Photo 2. Condition of beach and seawall in August 1995.

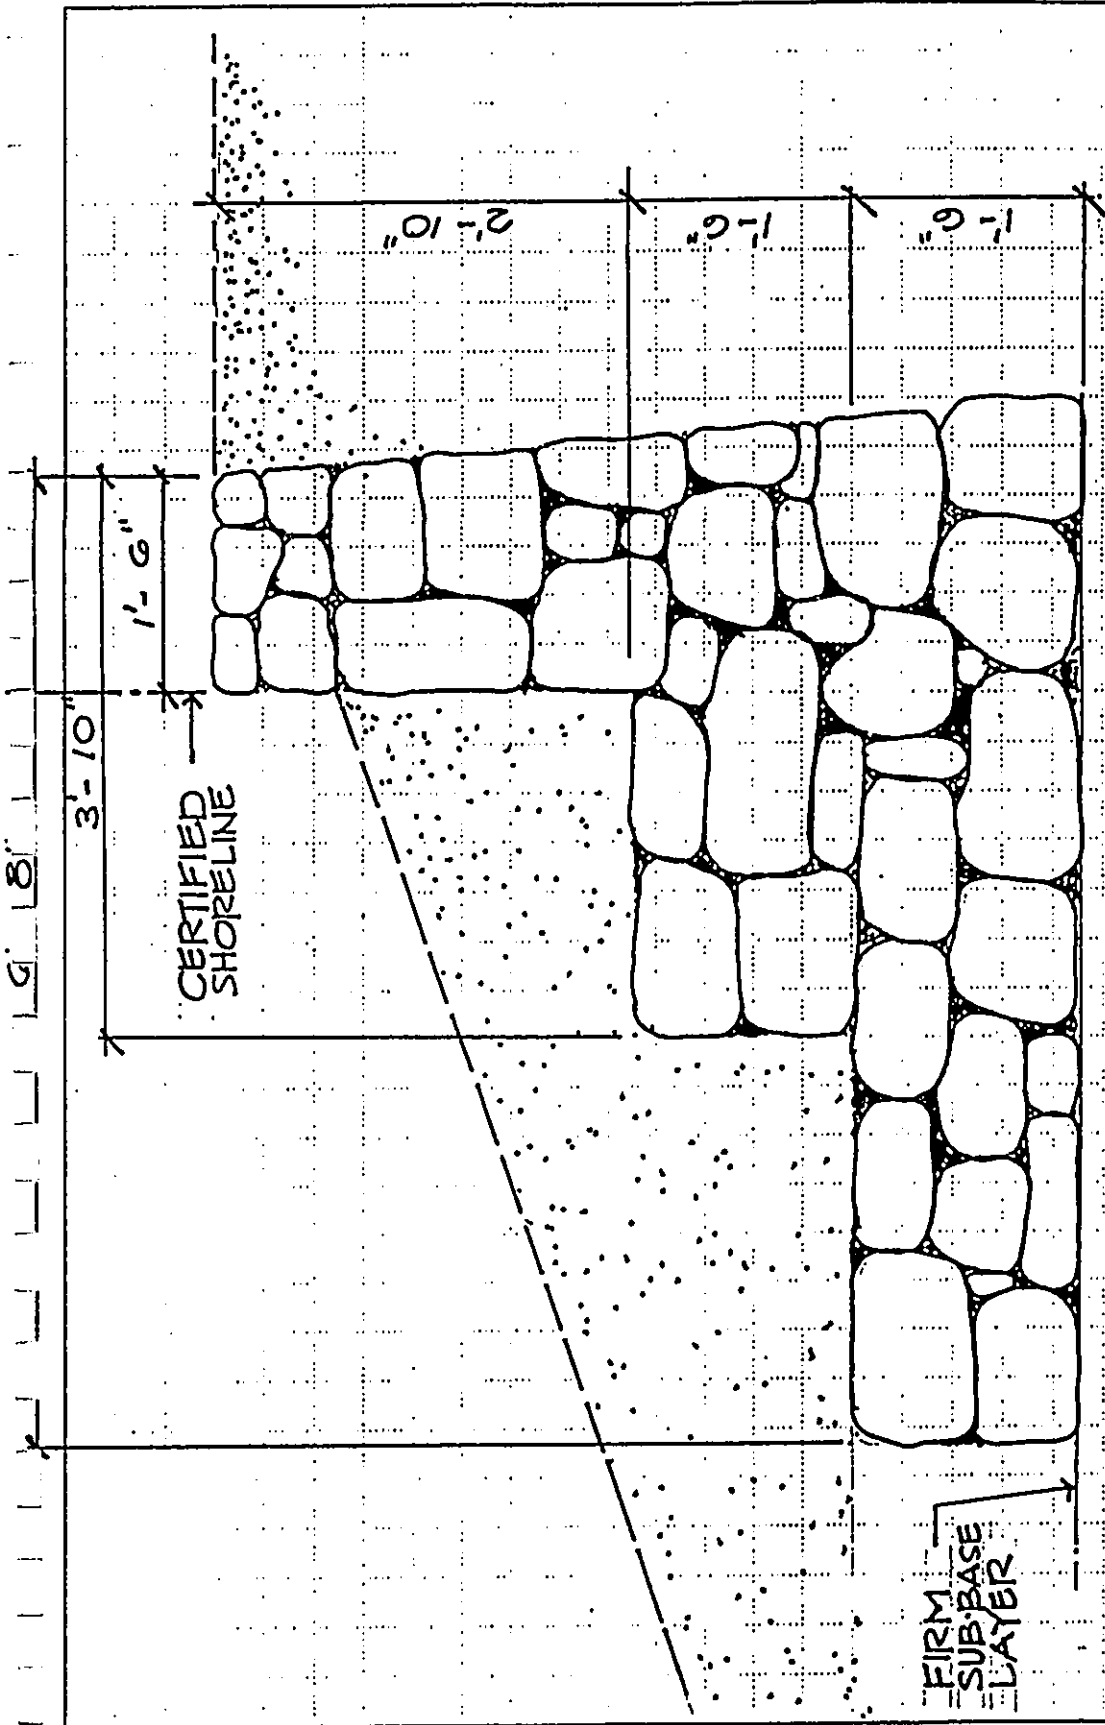
FIGURE 6

'AS BUILT'

A TYPICAL SECTION OF EXISTING SEAWALL

The seawall is constructed of rock set with cement mortar, with a crest width of 18 inches. The bottom width of the seawall is estimated to be about 7 feet.¹ The structural integrity of the wall is adequate to withstand storm wave runup and overtopping, especially since the wall is almost entirely buried. The footing of the wall, keyed to the limestone platform underlying the beach, will prevent wave scour and undermining of the seawall should it become exposed during extended duration of storm wave attack. However, the stepped face and low profile of the wall will minimize reflectivity, allowing sand to be redeposited on the beach. According to the property owners, in the past 10 years or so that the seawall has been in place, the face of the seawall has never been fully exposed. In fact, because the seawall is low enough to allow substantial wave overtopping during high water level and large wave conditions, sand is usually washed over the beach crest and seawall and deposited in the yard and patio areas. Photos 3 and 4 show the condition of the shoreline after periods of high surf in October and November 1993. Note that the wall is completely buried and substantial quantity of sand has been deposited in the backyard area landward of the wall (the white picket fence is located along the top of the seawall).

¹The base (bottom tier) of the wall may extend farther landward than indicated on the drawings. At the time the as-built condition of the seawall was verified in the field, only the seaward side was excavated to the base of the wall.

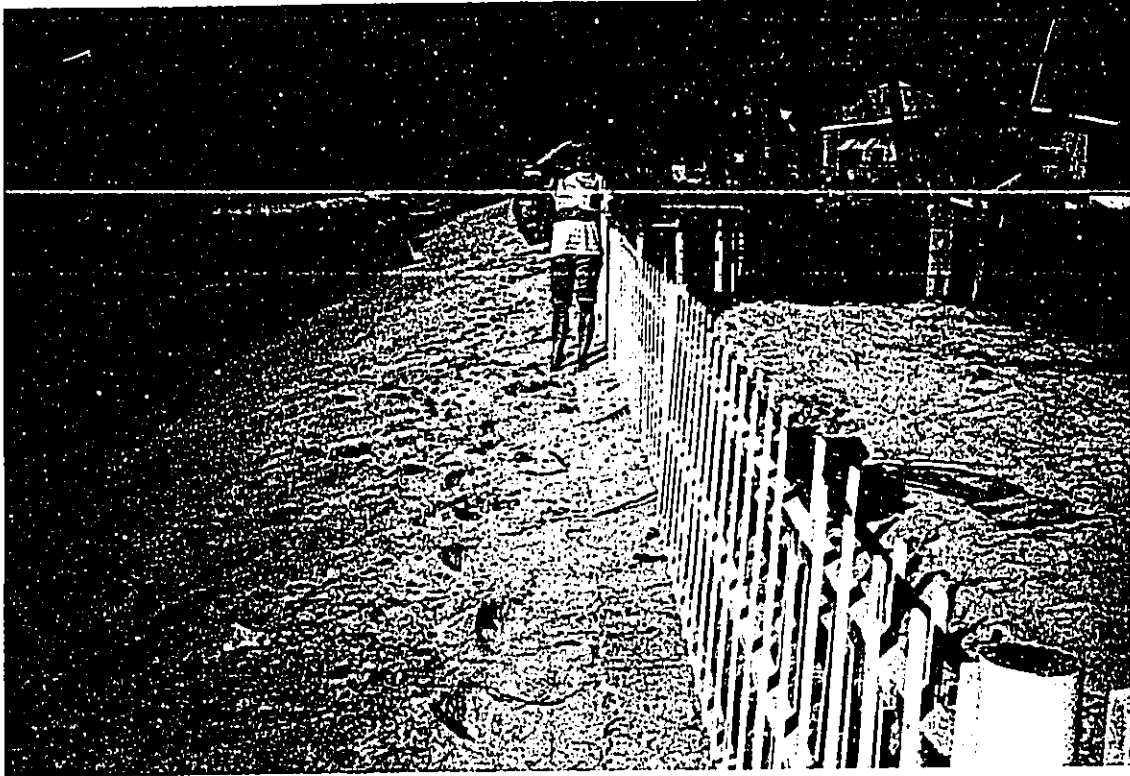
Photo 3. Condition of beach and seawall in October 1993.

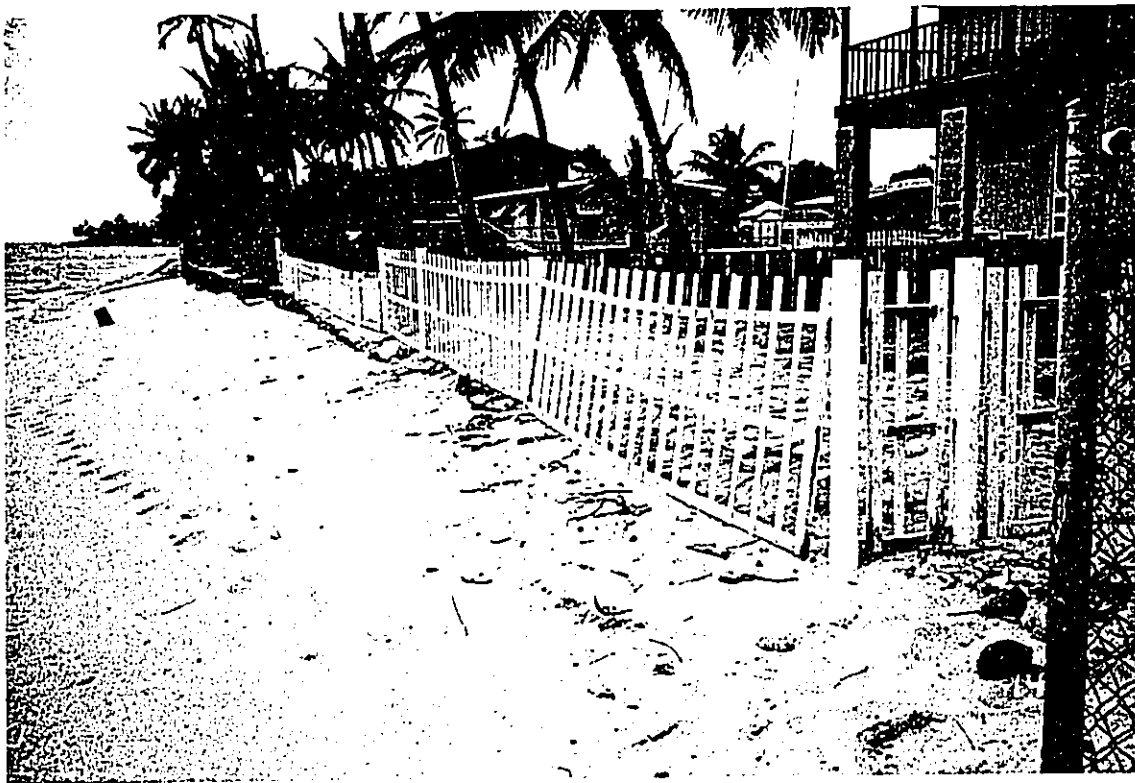
Photo 4. Condition of beach and seawall in November 1993.
