CHAPTER 343, HRS  
Environmental Assessment (EA)/Determination  
Finding of No Significant Impact

1997-07-08-0A-**FEA**  
Amjadi After-the-Fact  
Revetment

**APPLICATION FOR SHORELINE SETBACK VARIANCE  
AND  
FINAL ENVIRONMENTAL ASSESSMENT**

Existing Shoreline Revetment and Walkway  
Amjadi Residence, TMK (1) 5-5-2:86 (Lot 116-B)  
55-321B Kamehameha Highway, Laie, Oahu, Hawaii

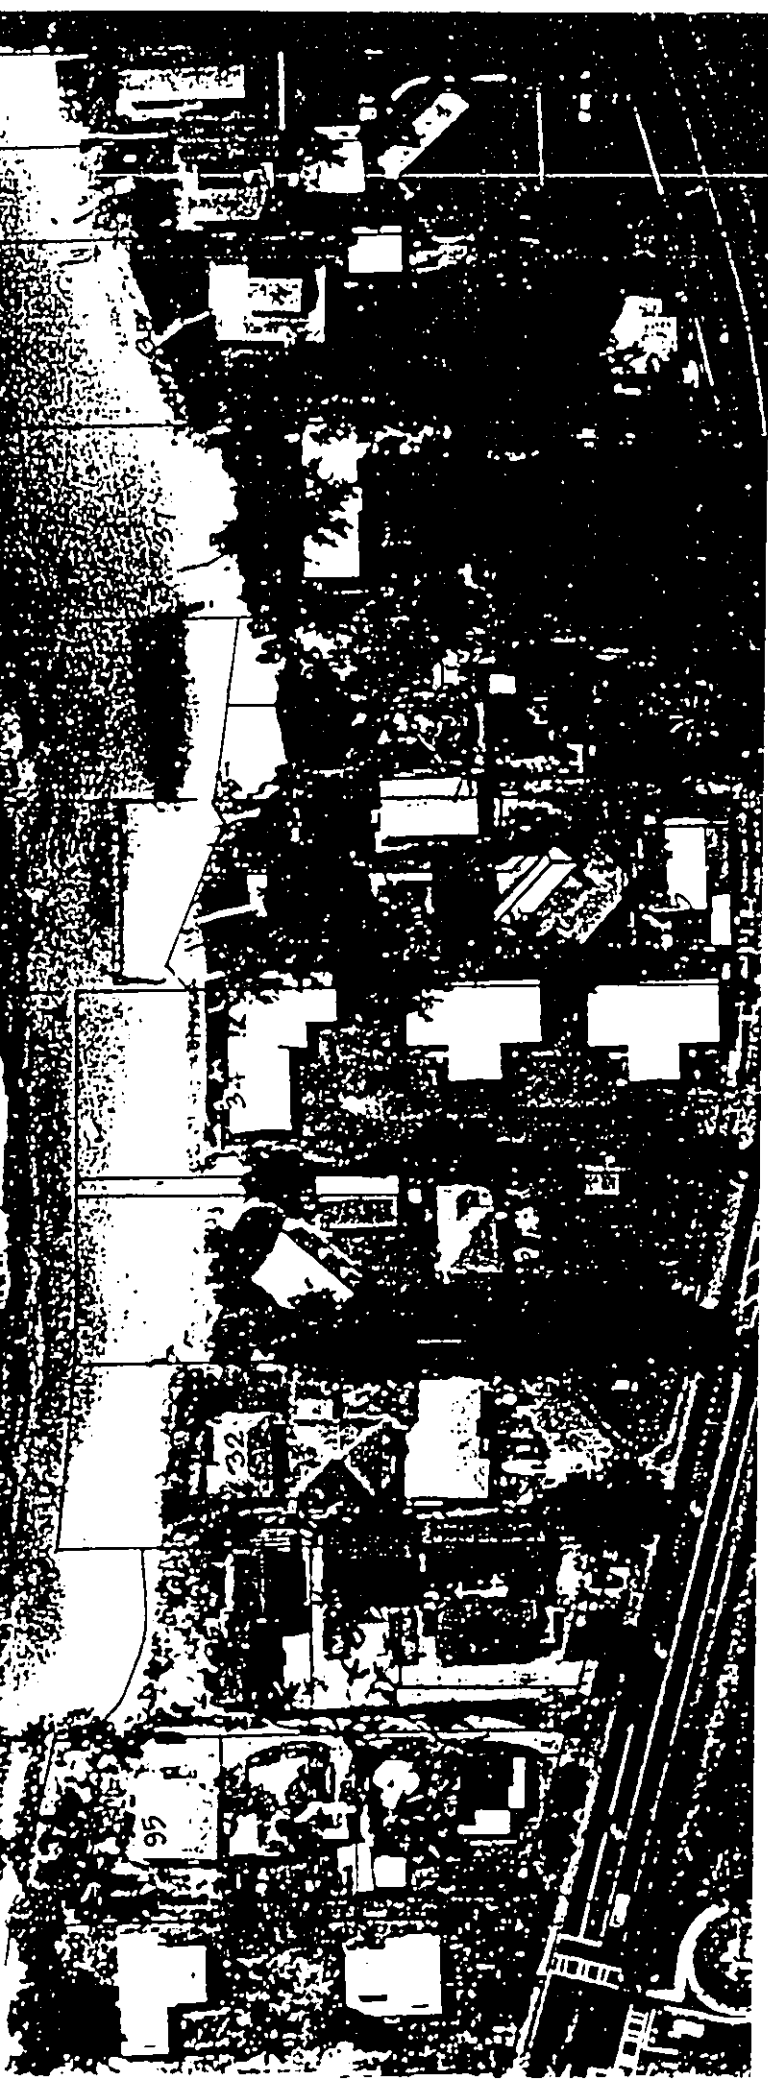
In general, the 1949 aerial photo in Appendix B depicts a smooth, arcuate-shaped shoreline which is devoid of any protective structures for the 1100-foot length of the shoreline covered by the photo. Nine years later in the 1958 photo (Appendix C), the pattern of erosion which has continued into the 1990s had been set in motion. The rock revetments at TMKs 5-5-02:95 and 05, which are at the north and south ends of the 1958 photo, were in place. These revetments have held those portions of the shoreline in place until the present time, while the 900 feet of shoreline between these two protruding revetments has retreated progressively inland. Notably, the low-lying, rectangular-shaped wall offshore of TMKs 5-5-02:86 & 77 (Segment 3) was in place at the time of the 1958 photo. Also the loose boulders in the nearshore waters in front of TMKs 5-5-02:92 and 93 (Segment 4) were in place in 1958. Despite these modest efforts at shoreline protection, erosion continued to occur at these four lots at about the same rate as the lots to the north and south.

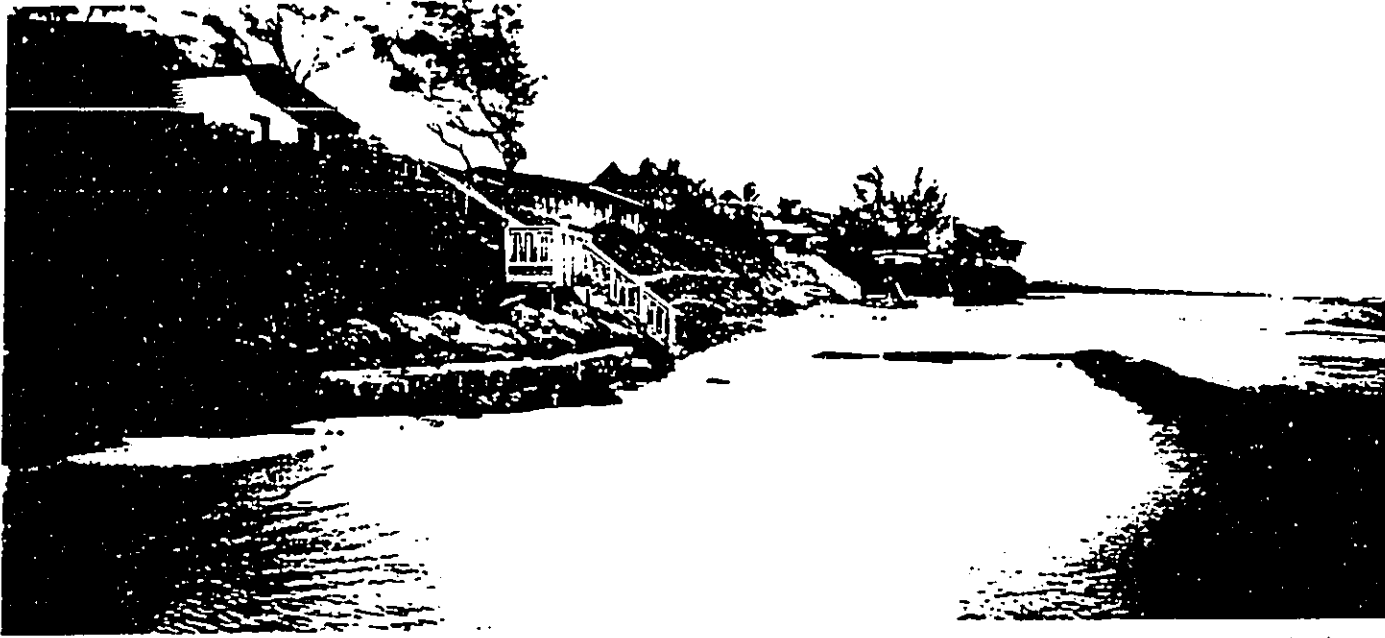
Photo No 3. This view of the revetment at TMK 5-5-02:86 shows the relationship of the collapsing wall at the foot of the revetment and boulders behind it.

**Low Grouted Wall.** The low grouted wall is entirely beneath the limestone boulders. As an integral part of the structure, it will not be removed. On the south side, the wall is broken into three pieces of significant size. The owner would prefer to not remove the remnants of this wall, since it provides additional protection at the toe of the revetment.

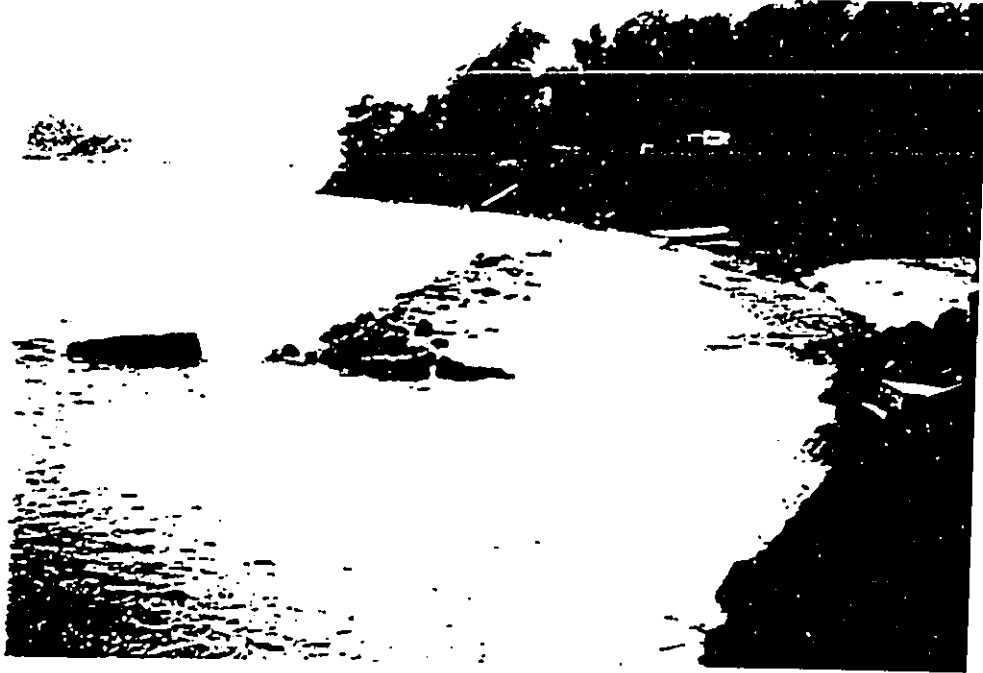
Photo No 6. View of the basalt boulders in front of TMKs 5-5-02:92 & 93 taken at mid-tide.

- Immediately to the south of the offshore wall and directly in front of TMKs 5-5-02:92 and 93, there is a line of loose basalt boulders in the nearshore waters (Photo Nos. 6 and 7). Available aerial photographs indicate that these boulders were also placed sometime between 1949 and 1958.

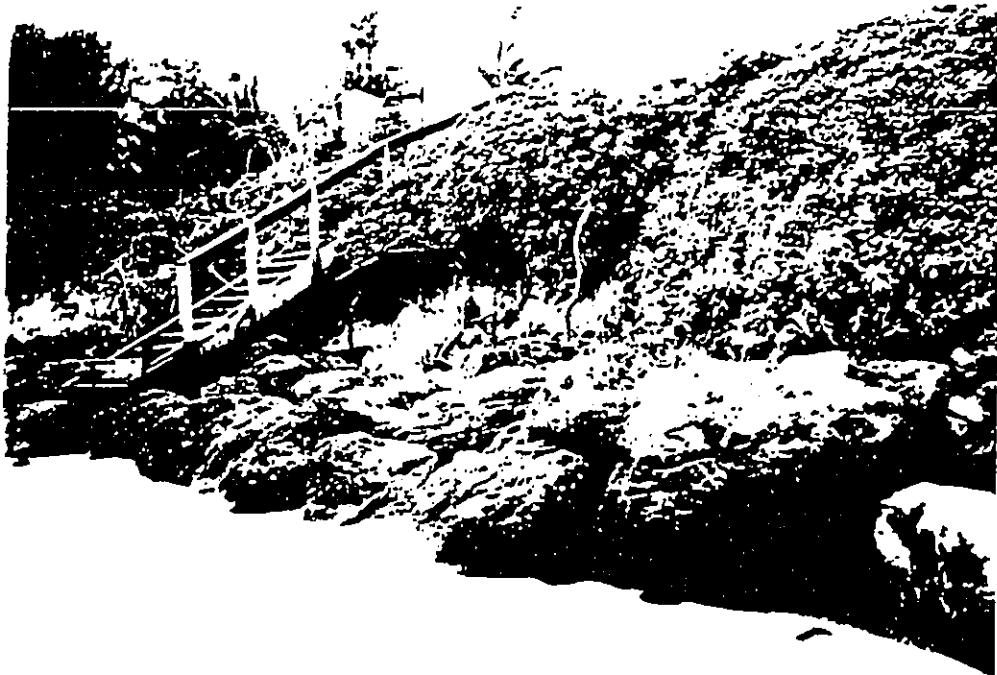
Photo No. 8. This erosion behind the revetment in front of TMK 5-5-02:77 occurred in November 1996.

1. At the north end of the revetment where the top of the grout cap is at 7 to 8 feet (msl), there was no loss of sand on the inland side of the revetment during the high waves of November 1996.
2. Beginning at the wooden stairs and proceeding to the south end, the top of the revetment declines from 6.2 to 4.8 feet. At the lower end, overtopping by the November 1996 waves did scour the sand behind the boulders. The top of the revetment continues to decline further moving south in front of TMK 5-5-02:77. The loss of sand behind this lower portion of the revetment was more substantial in November 1996 (Photo No. 8).

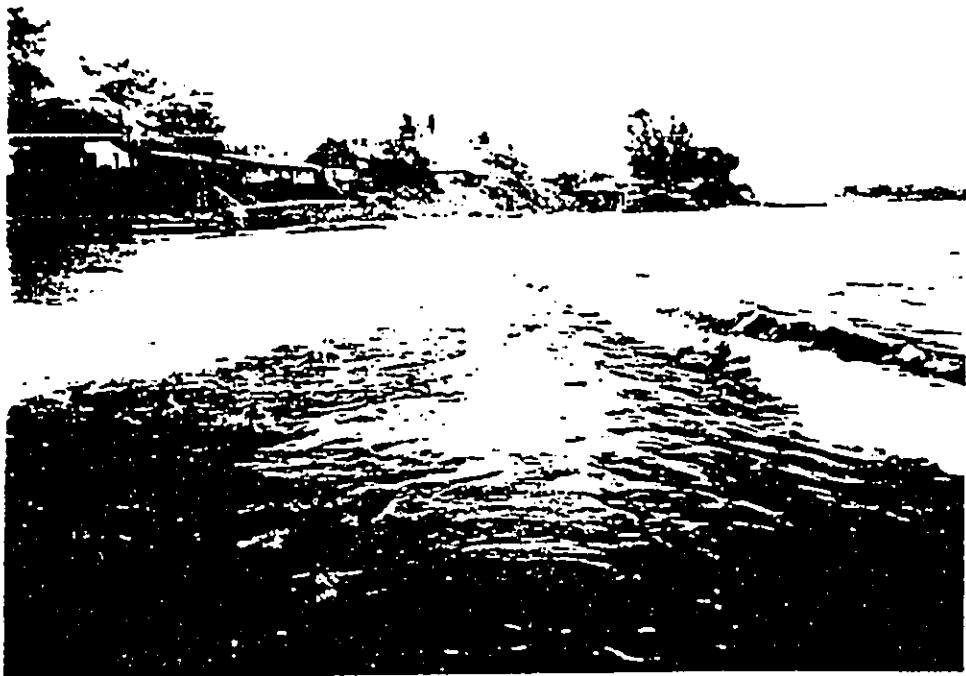
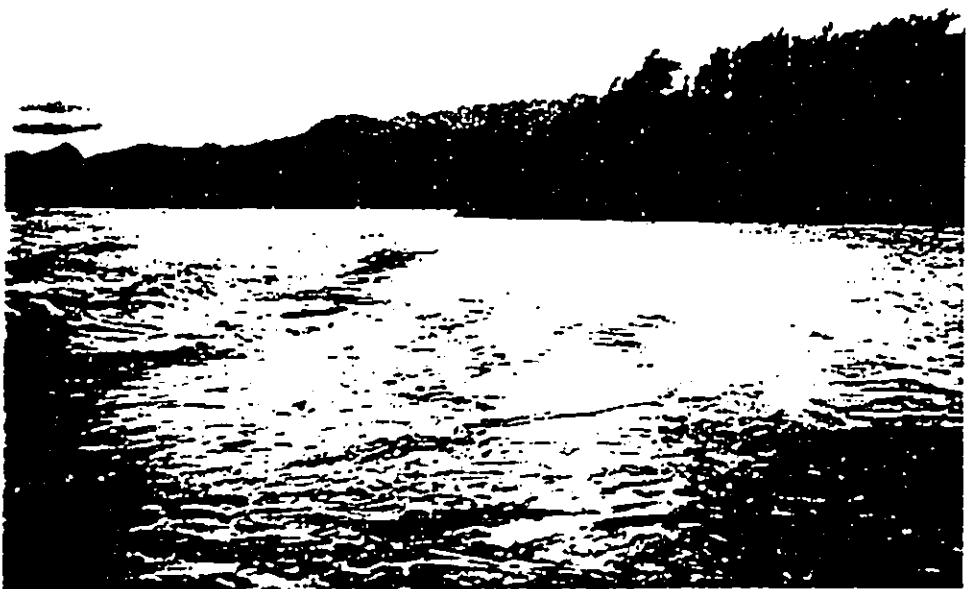
Photo Nos. 12 & 13. These views of the nearshore sill were taken at mid-tide. The top photo is looking north and the bottom is looking south. At low tide, the sill is fully emerged.

- A partially emerged sill runs parallel to the shoreline (Photo Nos. 12, 13, and 16). For the 400 feet to the north of Lot 116-B, the sill is 60 to 80 feet offshore. For the 400 feet to the south, the sill is generally 120 to 140 feet offshore. It is comprised primarily of lithified sand and coralline algae. Its top is 15 to 20 feet wide and most high tides, the top is entirely submerged. Conversely, on most low tides, it is fully emerged. There is a relatively abrupt drop of 3 to 4 feet on the land and seaward sides of the sill. Based on the sill's orientation and composition, it undoubtedly is a former location of the shoreline.

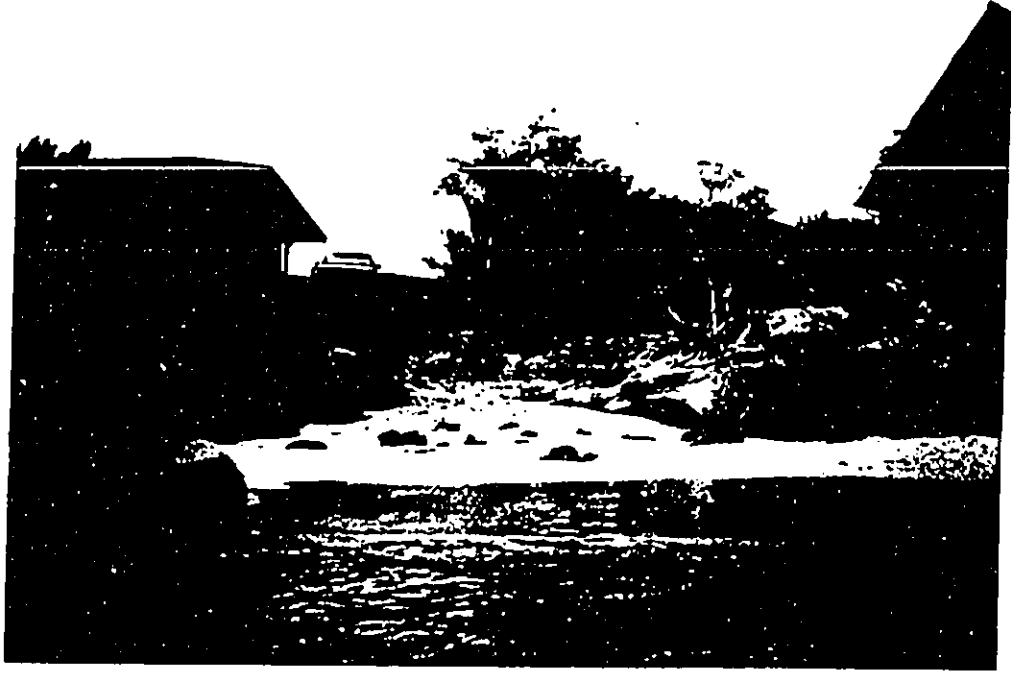
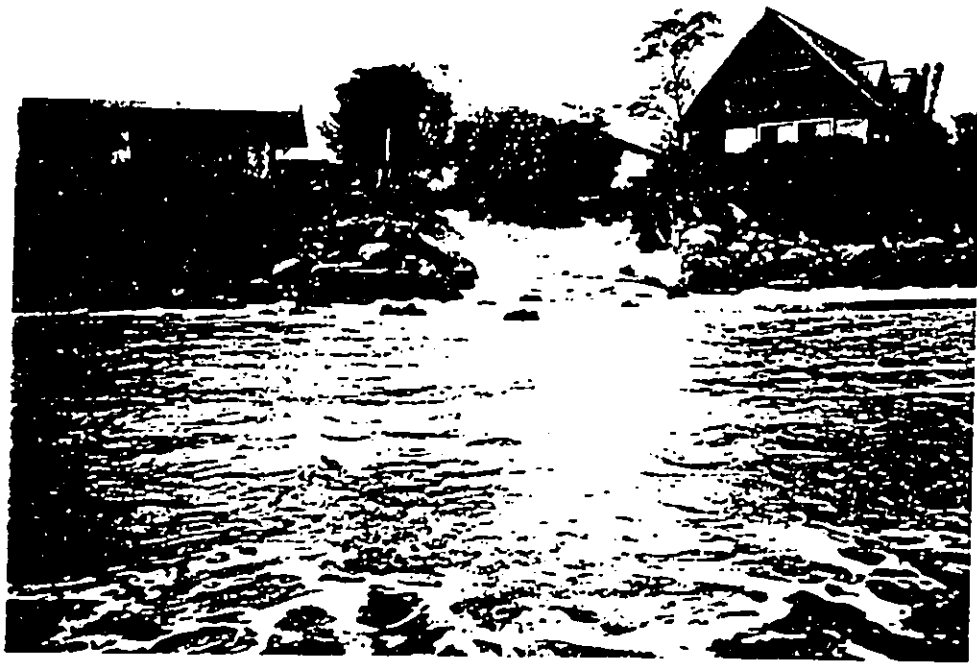
Photo Nos. 14 & 15. This gap in the shoreline revetments is for the 10-foot wide shoreline access for TMK 5-5-02:67. TMK 5-5-02:34 is on the left and TMK 5-5-02:32 is on the right. This is the only break in shoreline protection to the north of the subject property.

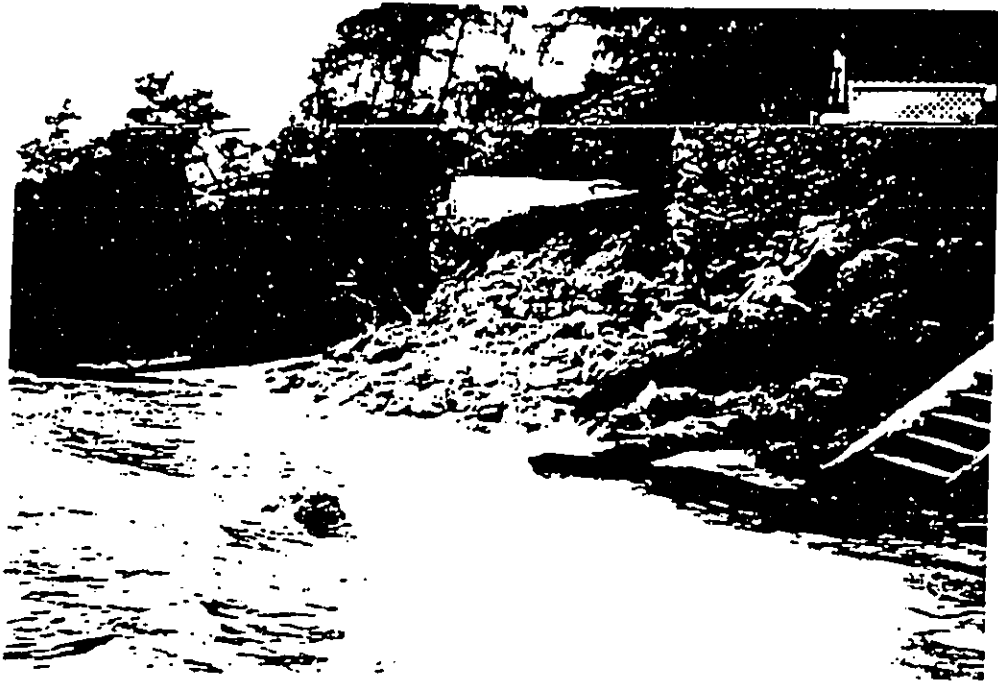
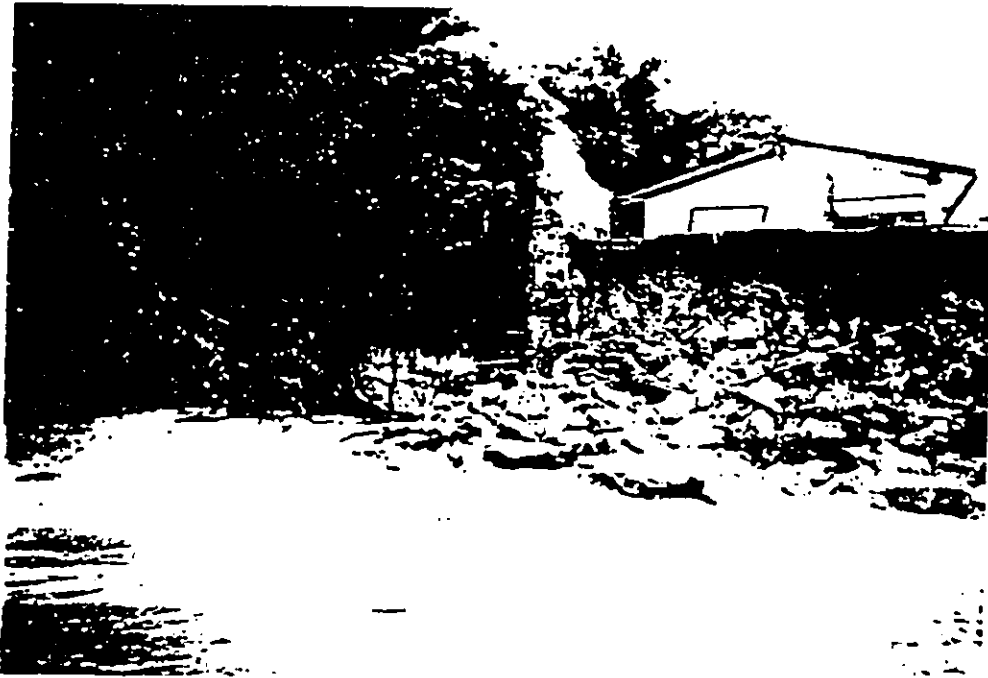
Photo Nos. 19 & 20. Views of the collapsed wall in front of TMK 5-5-02:81. Heavy rains during the week of November 5, 1996 created cracks. Subsequent high waves caused the wall to collapse.

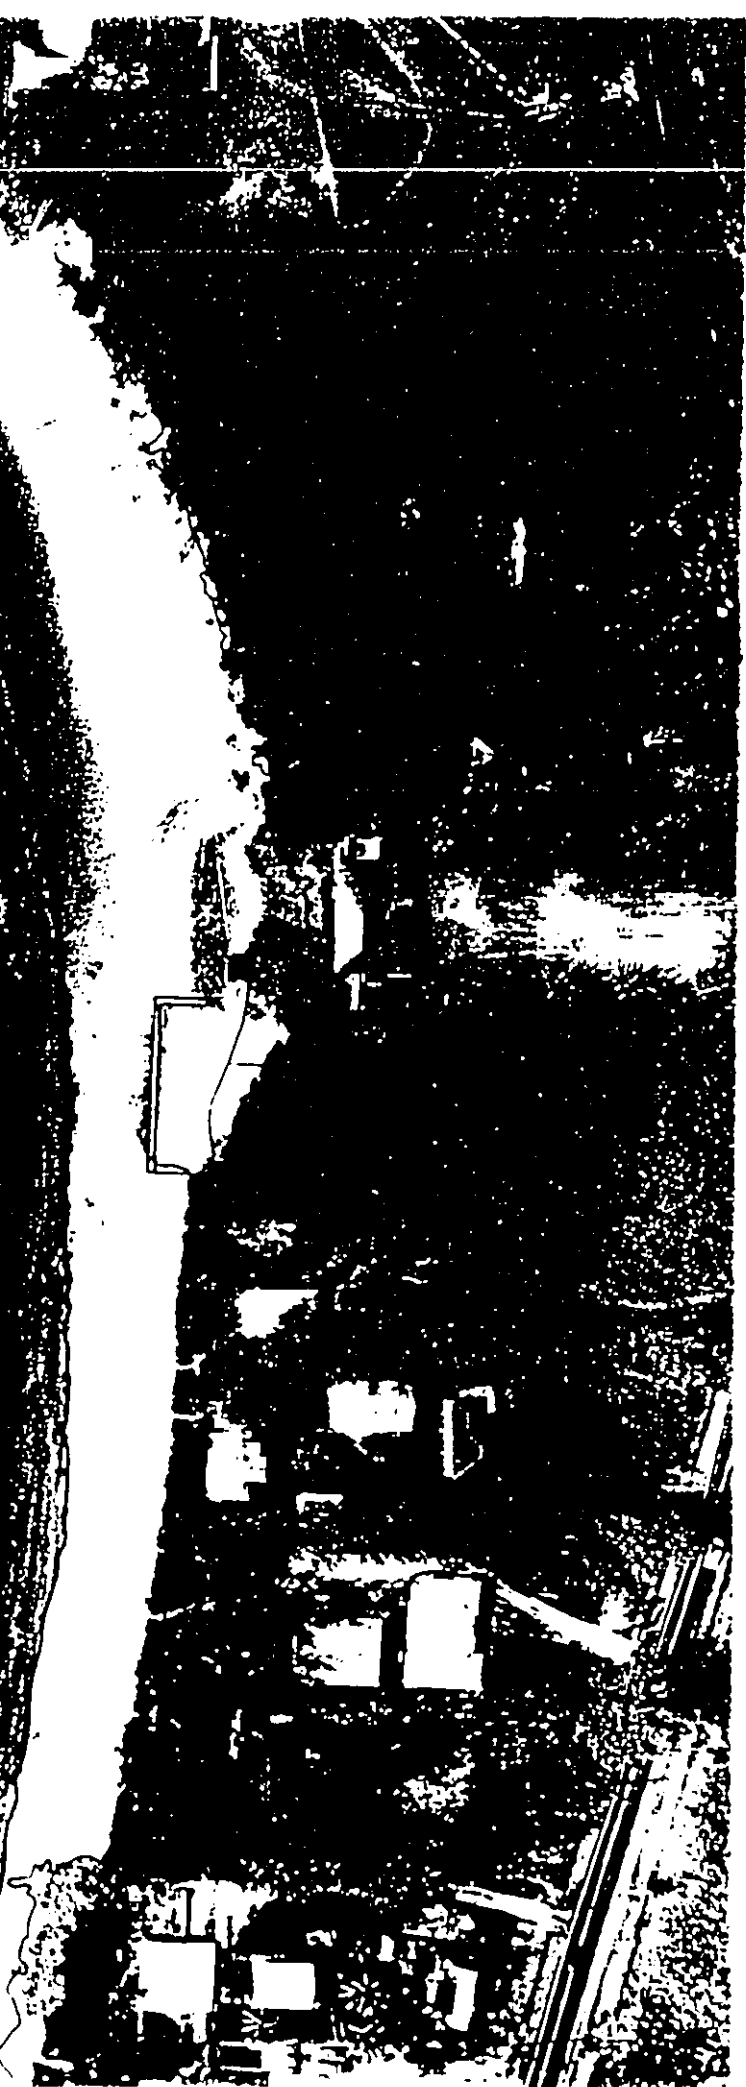
Appendix D

April 23, 1967 Aerial Photo With  
Overlay of the 1995 Shoreline

In addition to the September 1995 aerial photo which is the base for Figures 1 and 2, five other aerial photos were used to identify shoreline changes over the last 40 to 50 years. Dates of these photos are as follows: May 1949; June 1958; April 1967; May 1972; and December 1982. The photos, each with an acetate overlay of the shoreline in 1995, can be found in Appendices B to F. Changes to each of the five shoreline segments in the years between each of the six aerial photos are summarized on Table 2.

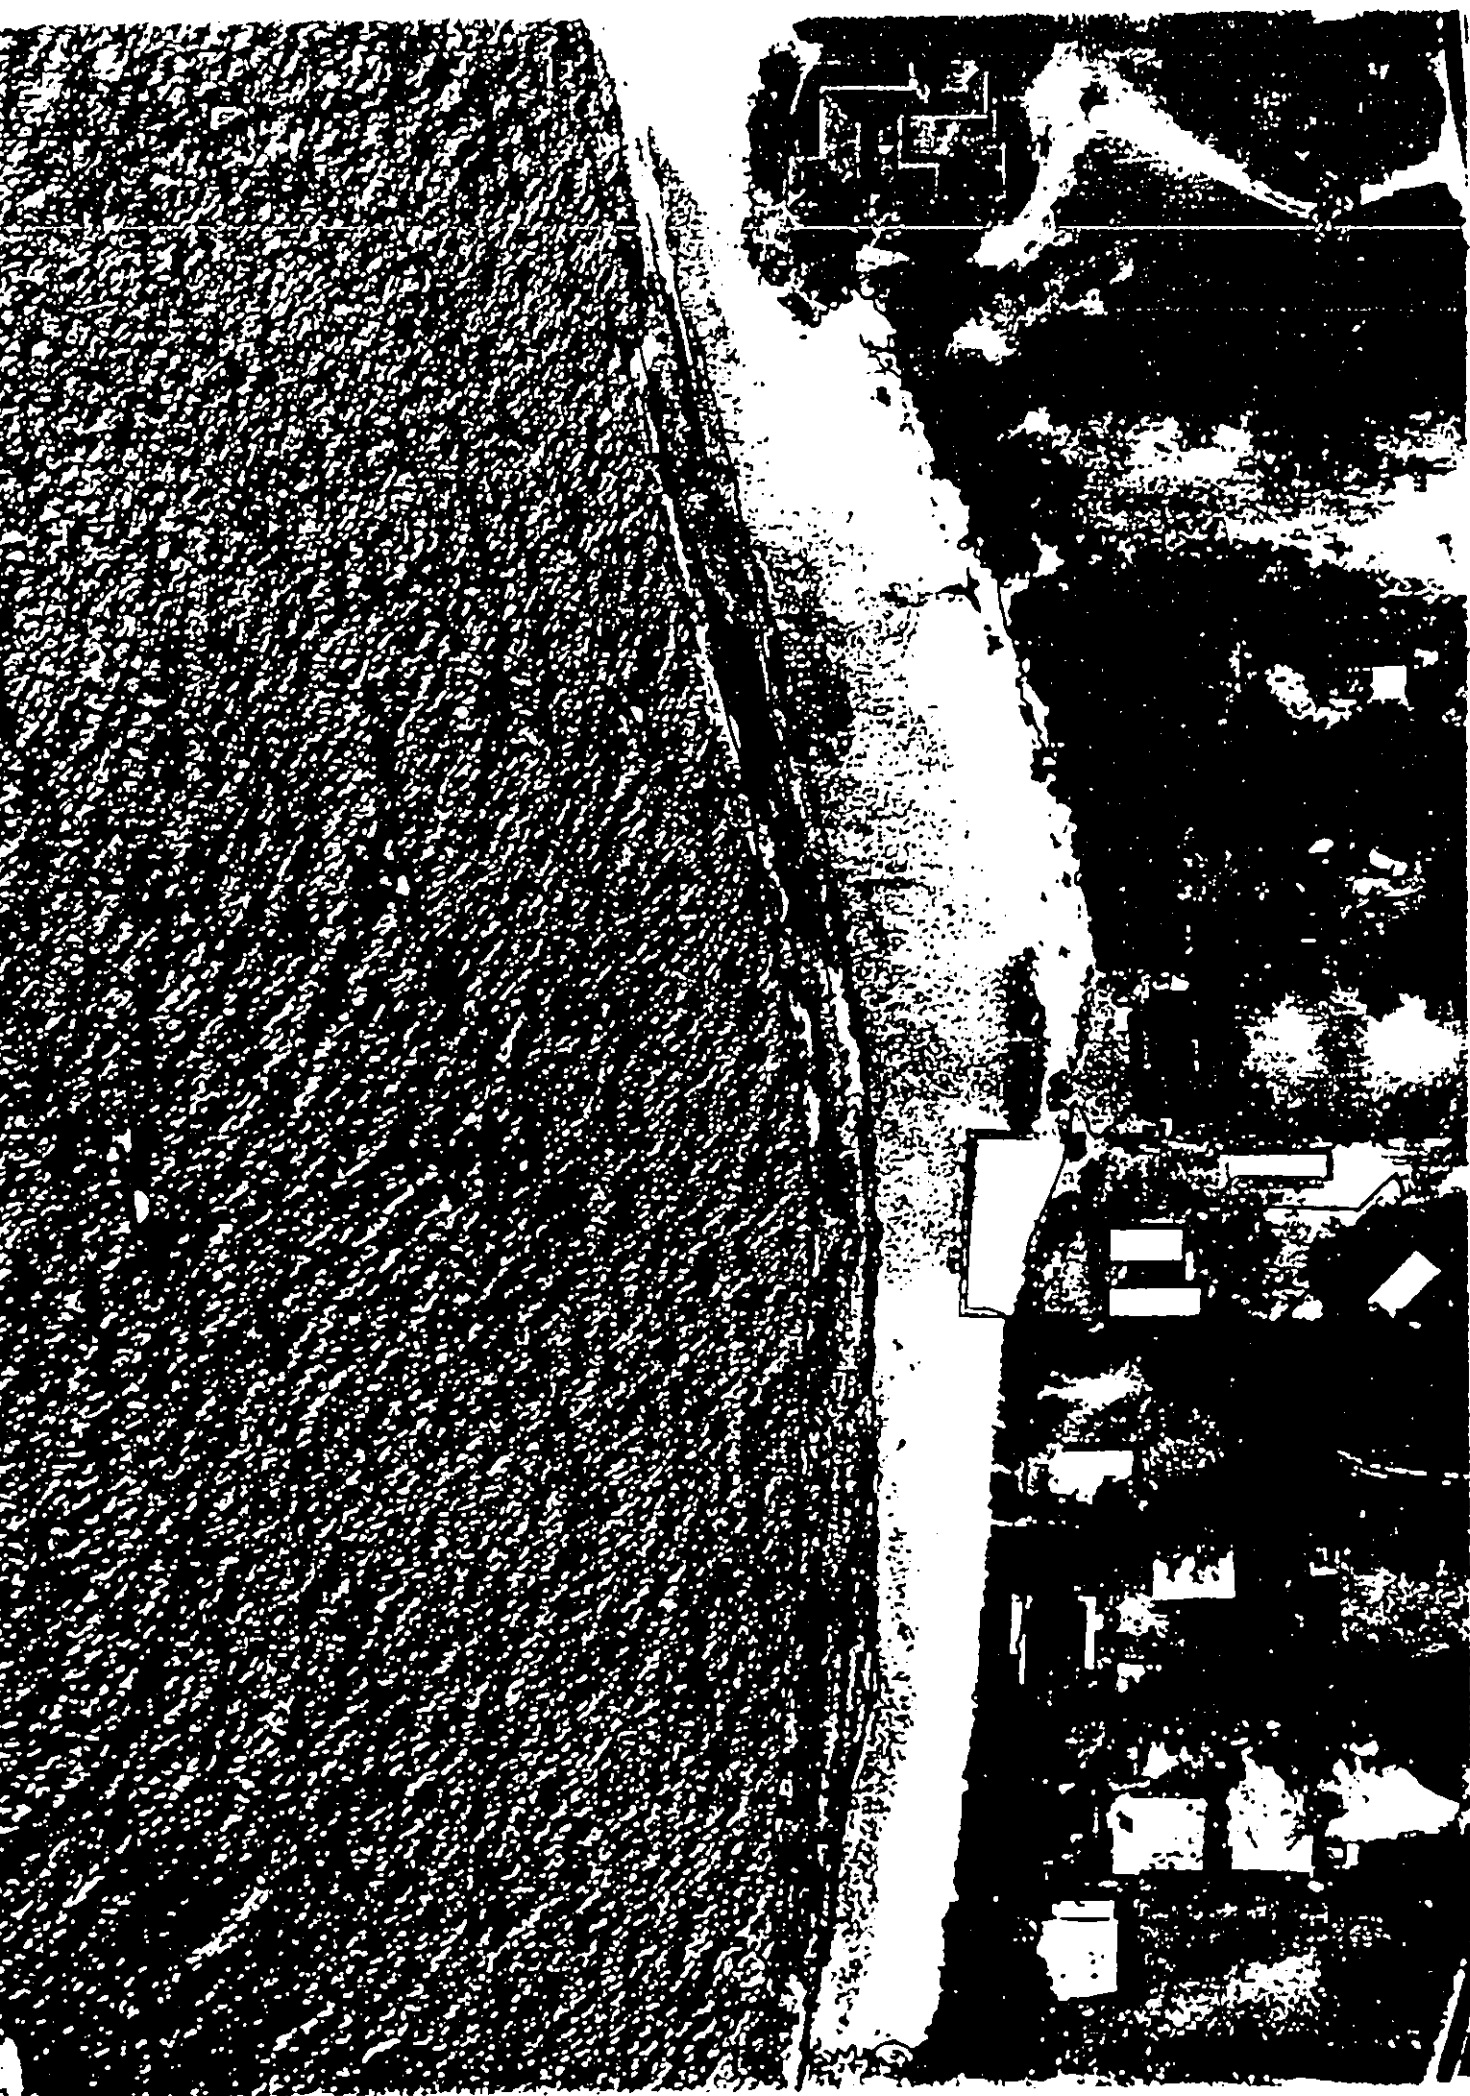
Appendix E

May 26, 1972 Aerial Photo With  
Overlay of the 1995 Shoreline

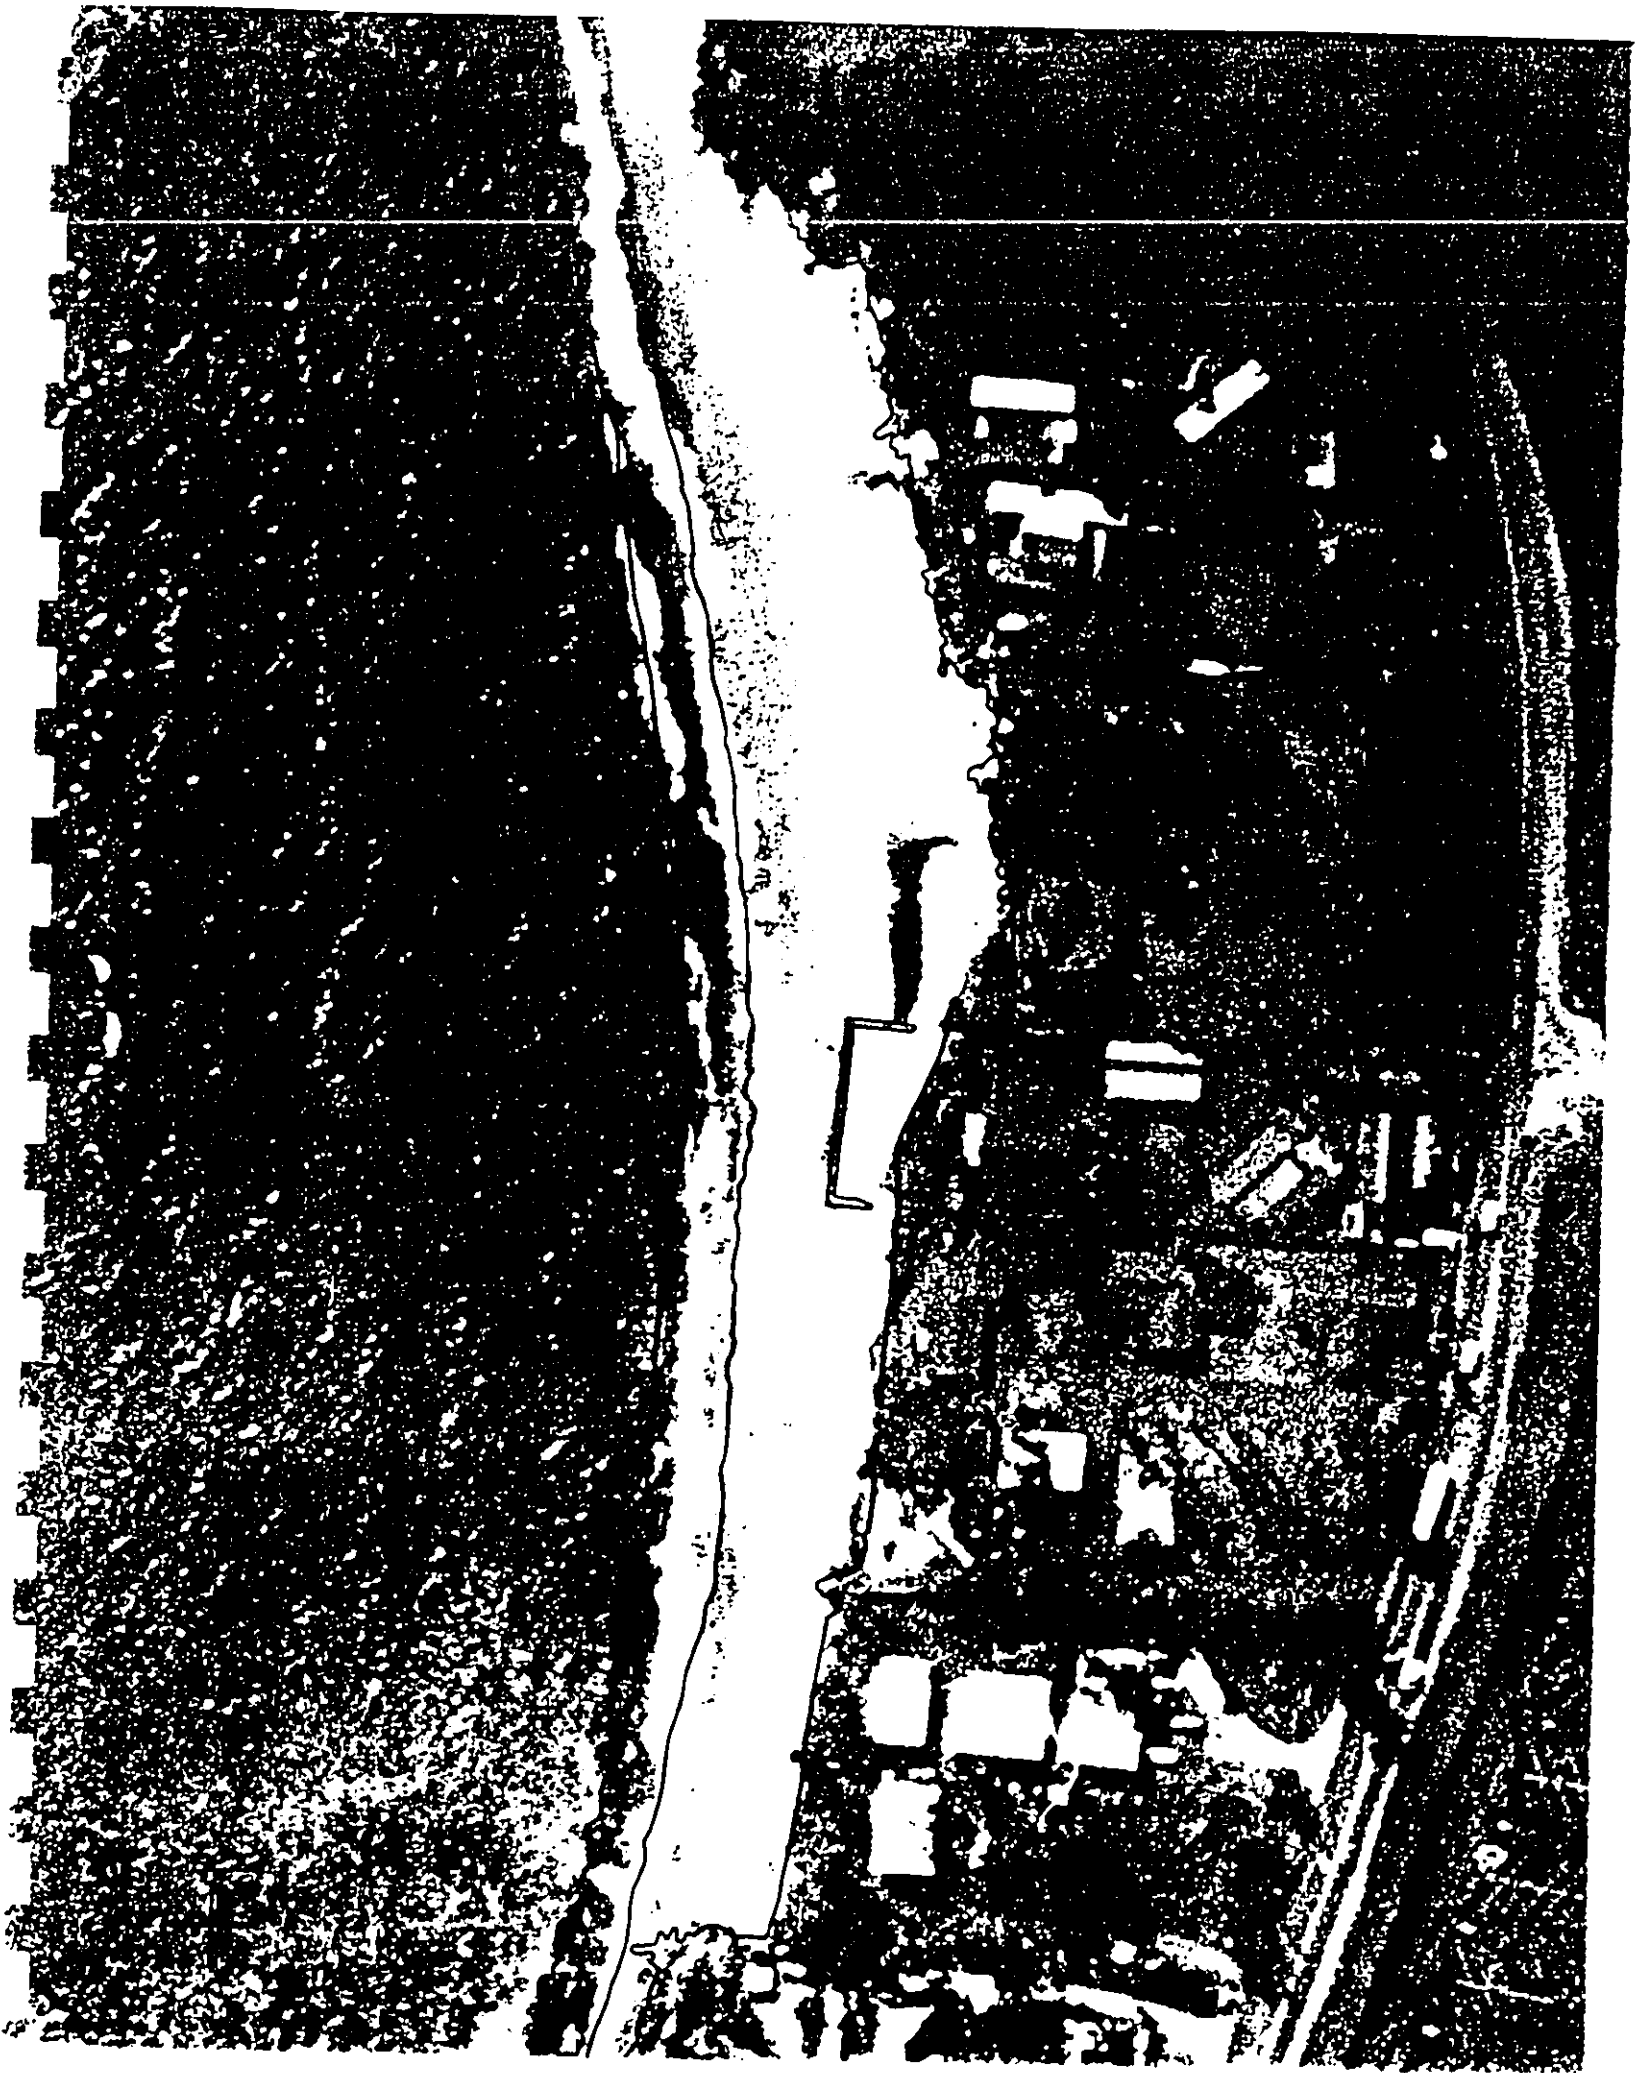
Appendix F

December 5, 1982 Aerial Photo With  
Overlay of the 1995 Shoreline
