# 1997-12-23-OA-FEA-Frost Seawall Reconstruction

Frost Property, TMK (1) 6-8-10:24 (Lot 13) 68-697 Farrington Highway, Mokuleia, Oahu, Hawaii

Reconstruction of Existing Seawall Structure
Frost Property, TMK (1) 6-8-10:24 (Lot 13)
68-697 Farrington Highway, Mokuleia, Oahu, Hawaii

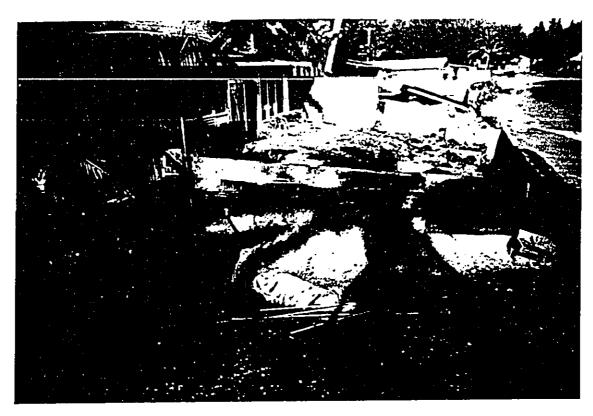
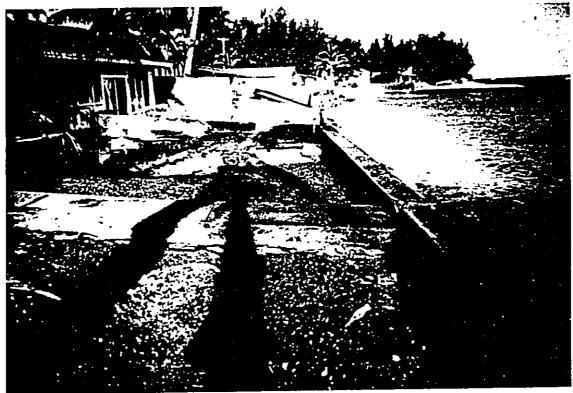
Photo Nos. 3 & 4. These photos illustrate the stop gap measures to stabilize the wall at TMK 6-8-10:23 and counteract the undermining occurring mostly at the west end.

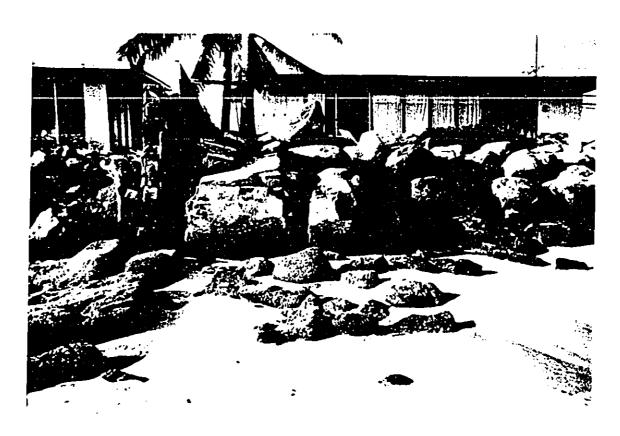
Photo Nos. 11 & 12. These details of the remnants of the seawall at TMK 6-8-10:25 show the top of the foundation to be well above sea level.

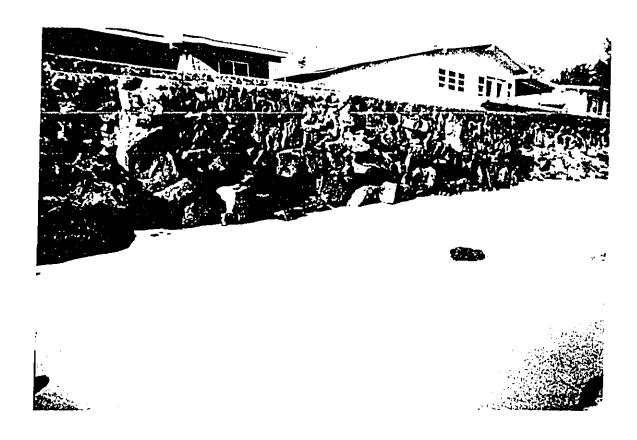
Photo Nos. 15 & 16.

The top photo shows the extent of undermining of the rubble-rock seawall at TMK 6-8-10:26. Concrete has been poured on the landward side to avoid undermining there (photo at right). A second wall set 14 feet behind the seawall has been constructed to contain overtopping waves.
