Stubenberg After-the-Fact
Seawall

APPLICATION FOR SHORELINE SETBACK VARIANCE

FINAL ENVIRONMENTAL ASSESSMENT

Existing Shoreline Revetment, Wood Fence and Walkway

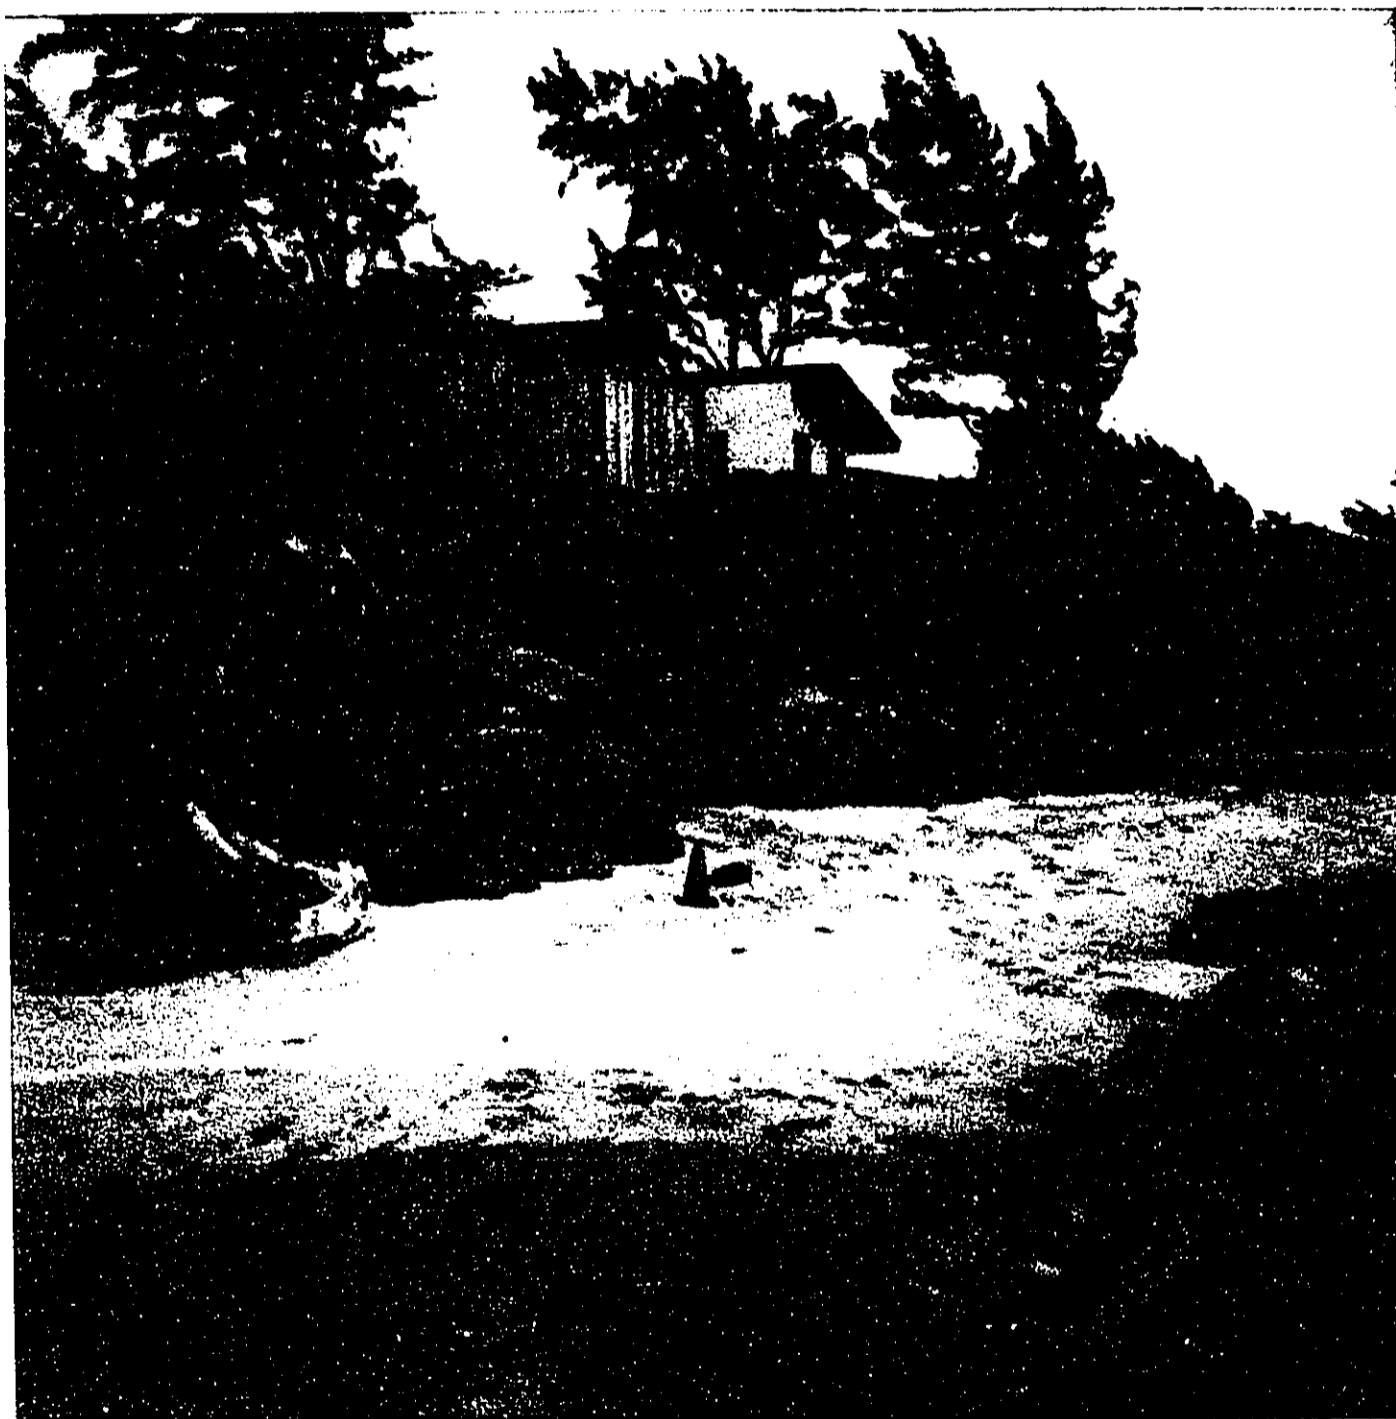
PHOTO OF REVETMENT

55-321C KAM HWY

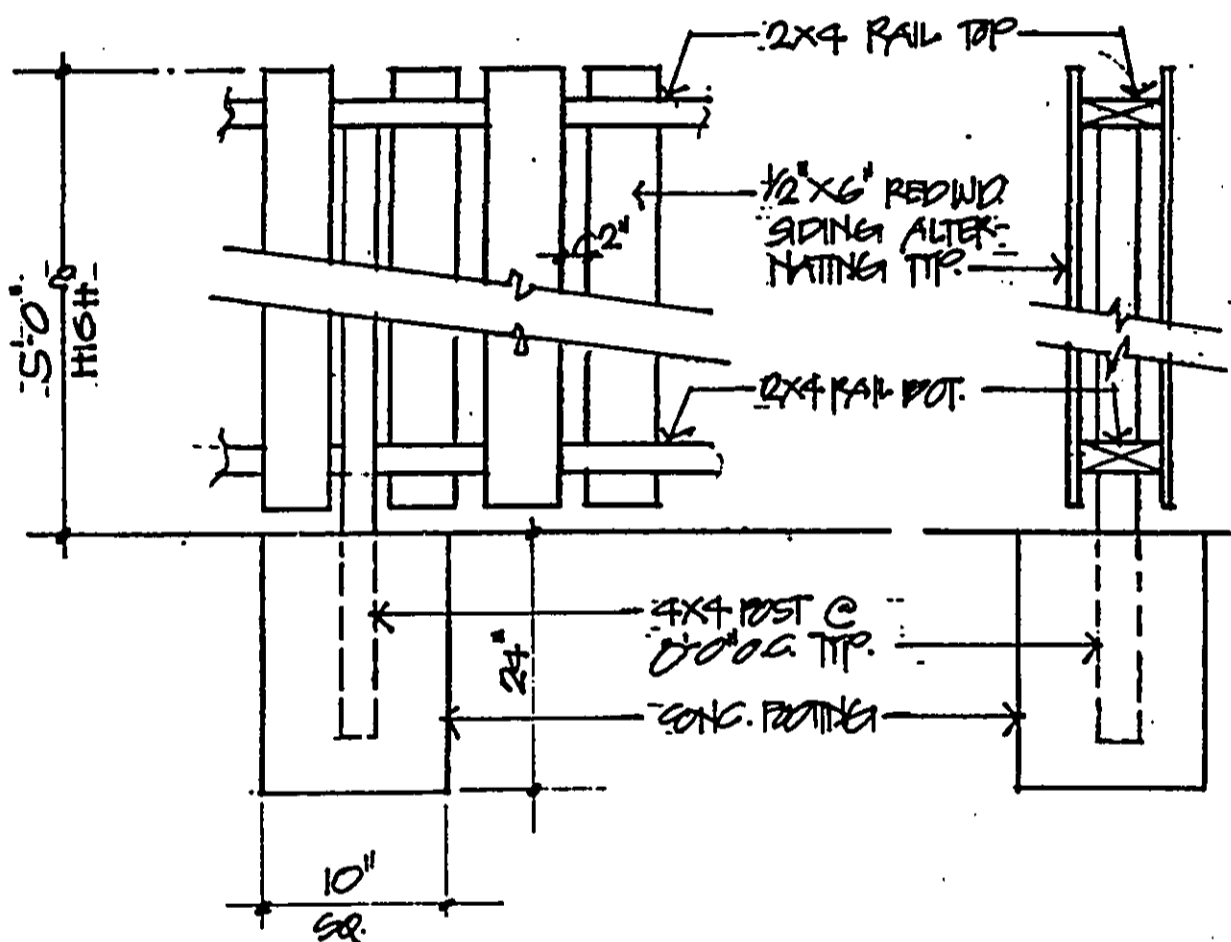
SHEET

1 - TYP. FENCE DETAIL
 A-2 SCALE: N. I. S.

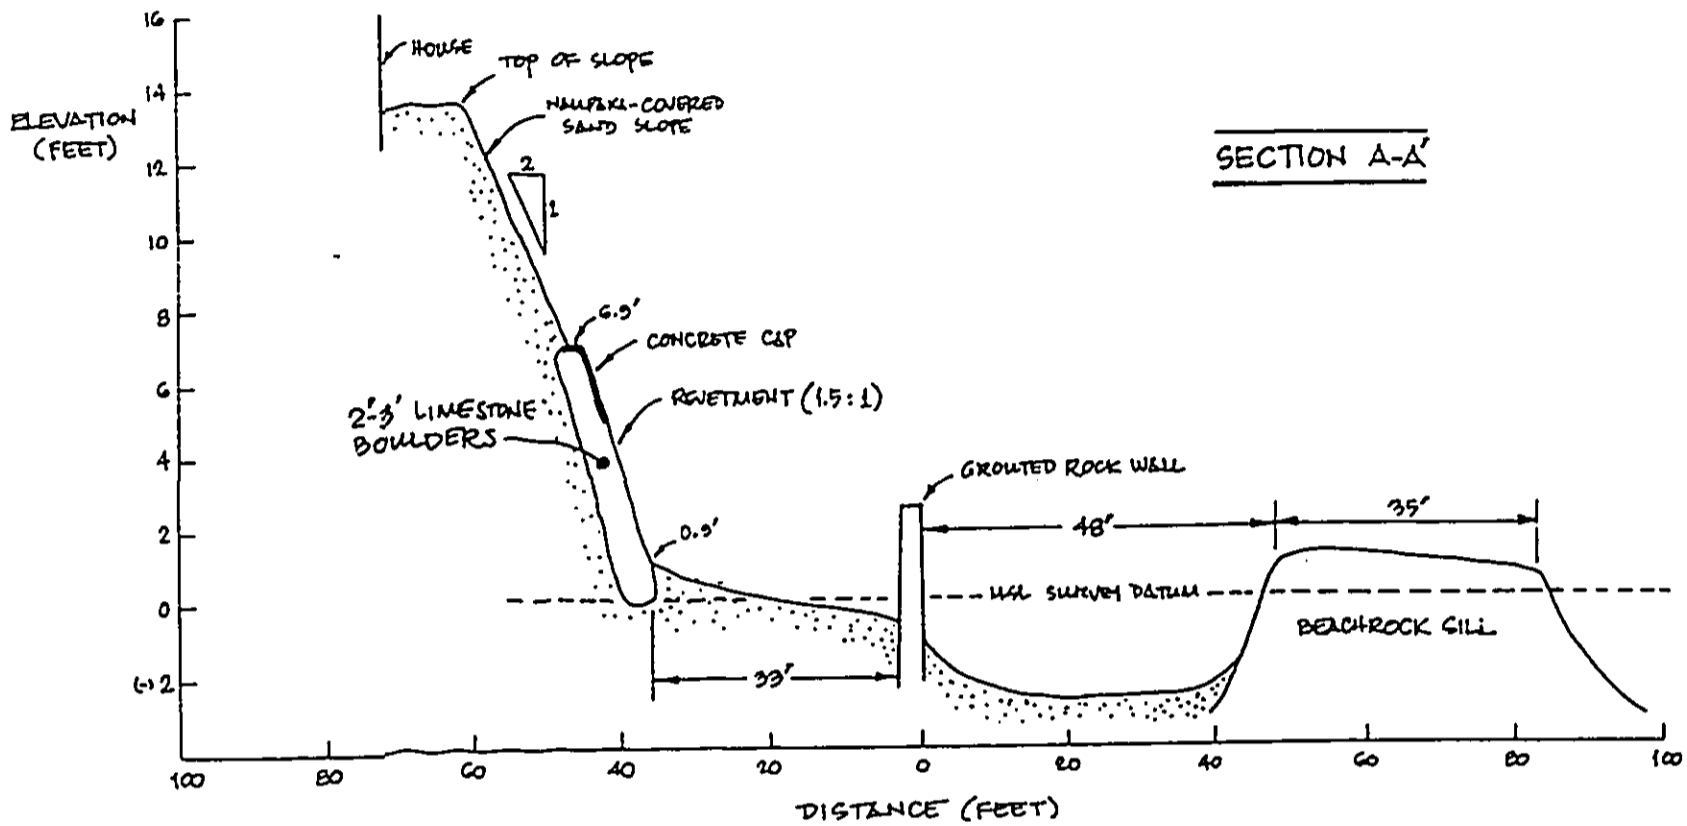
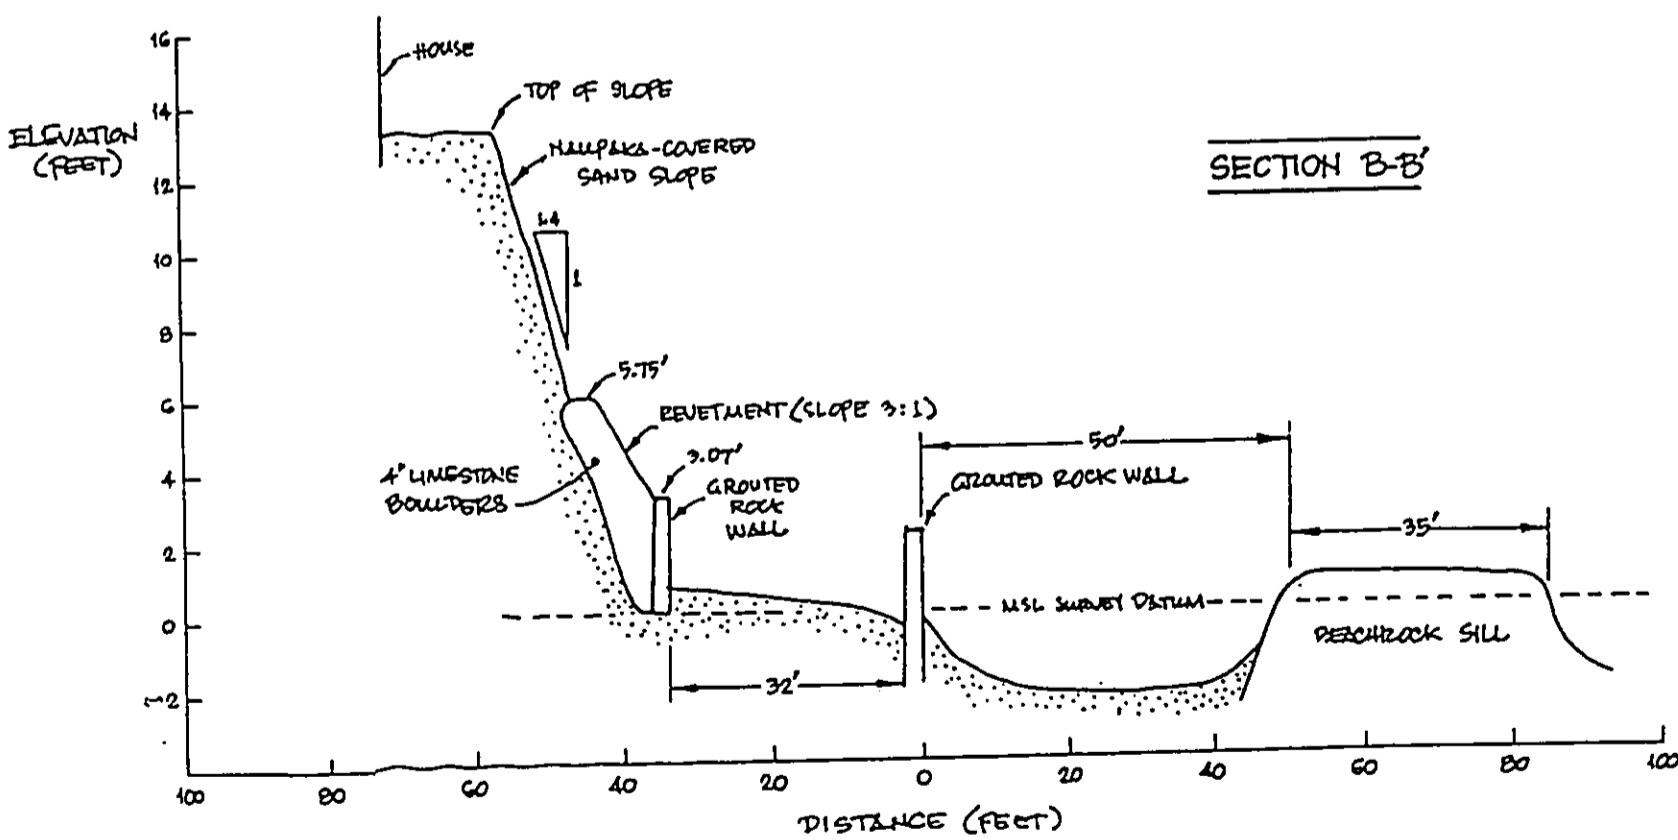
- Notes:
1. Refer to Figure 3 for the locations of the cross sections.
 2. Topographic survey by ESH was supplement with spot elevations by TNWRE.
 3. Both cross sections are shown with a five-fold vertical exaggeration.

Figure 5
Cross Sections of the Shoreline
Revetment at TMK 5-5-02:86

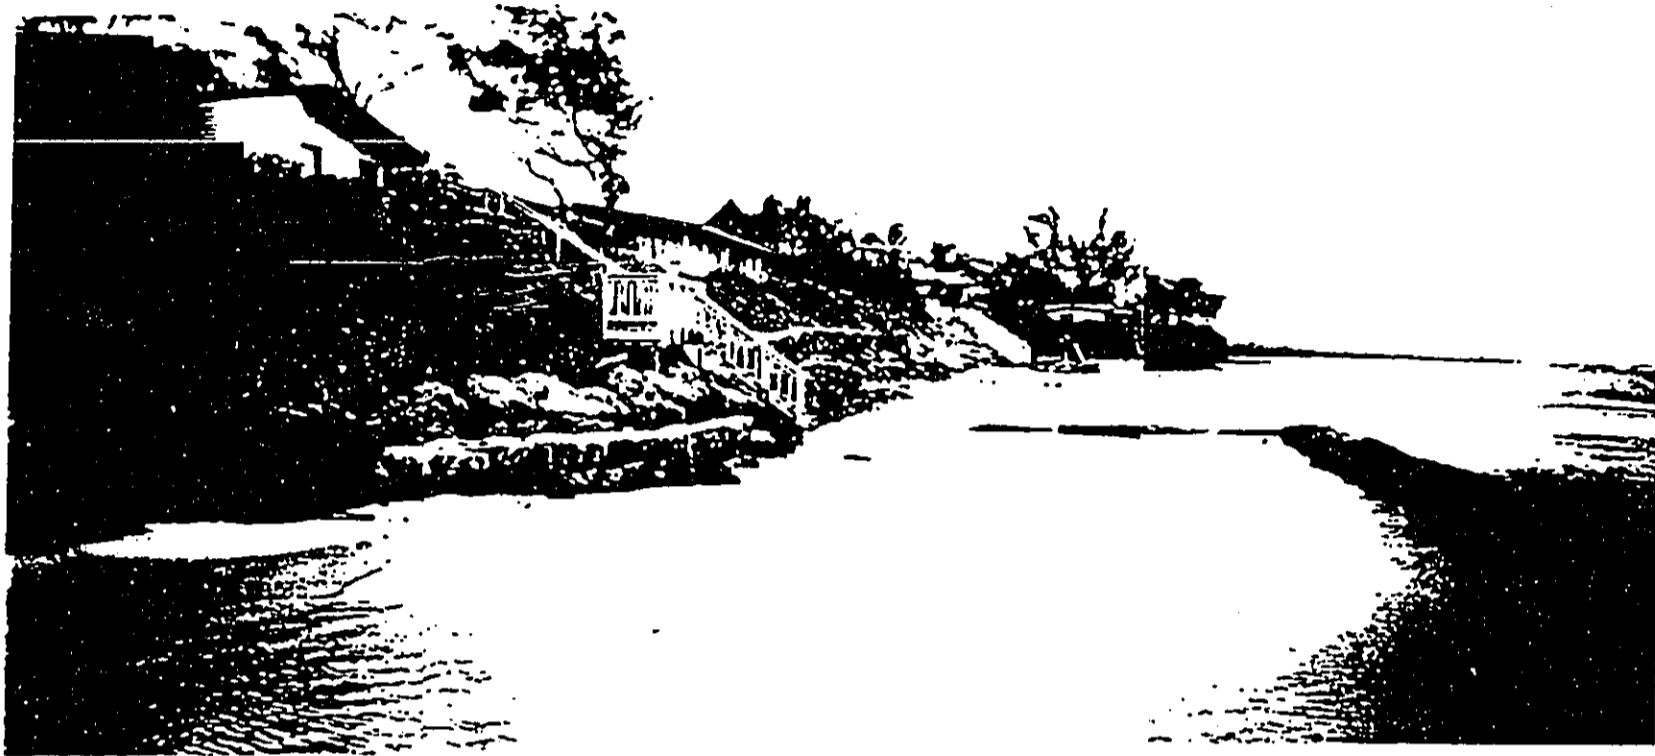
Photo No 3. This view of the revetment at TMK 5-5-02:86 shows the relationship of the collapsing wall at the foot of the revetment and boulders behind it.

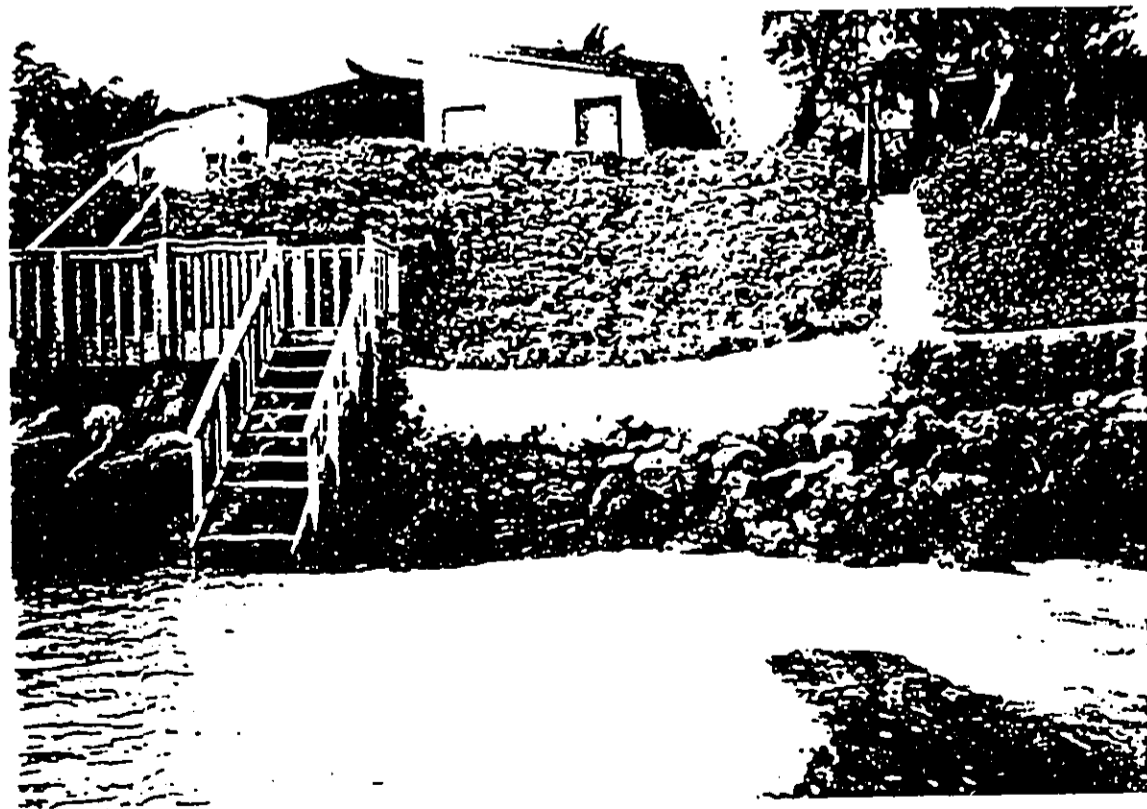
Photo No 4. The north end of the revetment at TMK 5-5-02:86 has a grout cap.

1. At the north end of the revetment where the top of the grout cap is at 7 to 8 feet (msl), there was no loss of sand on the inland side of the revetment during the high waves of November 1996.
2. Beginning at the wooden stairs and proceeding to the south end, the top of the revetment declines from 6.2 to 4.8 feet. At the lower end, overtopping by the November 1996 waves did scour the sand behind the boulders. The top of the revetment continues to decline further moving south in front of TMK 5-5-02:77. The loss of sand behind this lower portion of the revetment was more substantial in November 1996 (Photo No. 8).

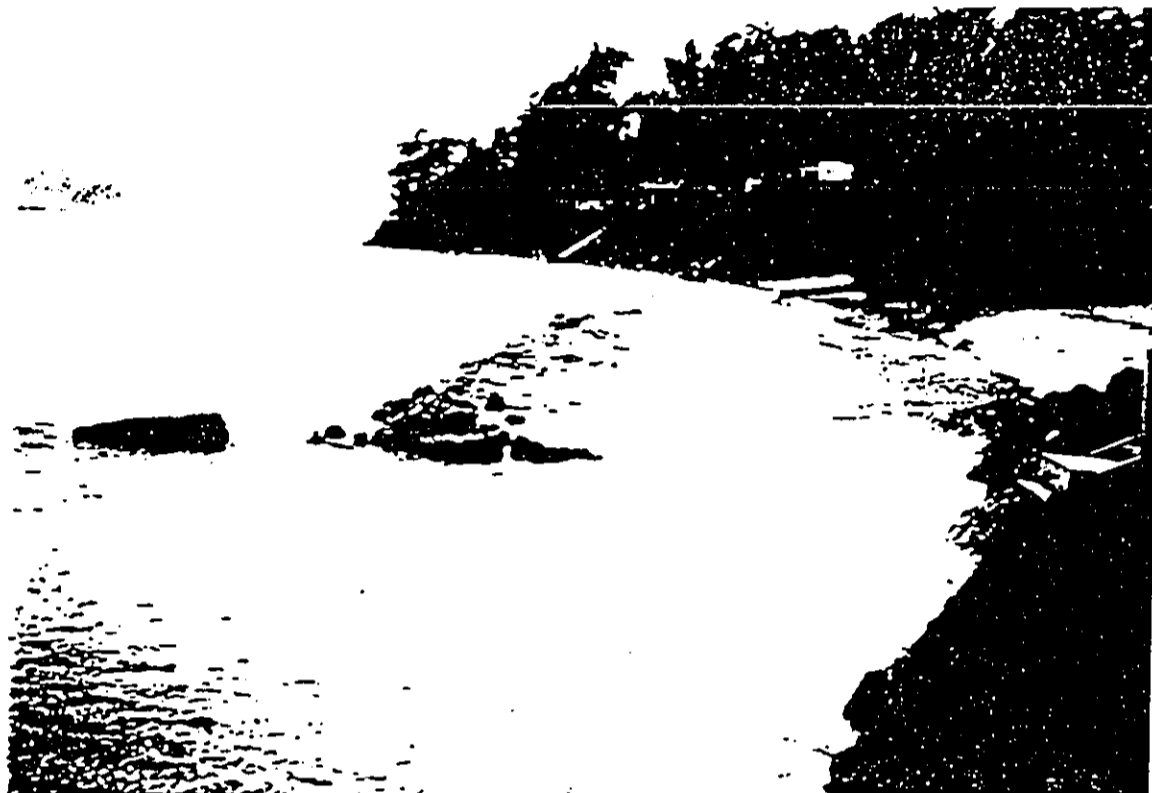
Photo No 6. View of the basalt boulders in front of TMKs 5-5-02:92 & 93 taken at mid-tide.

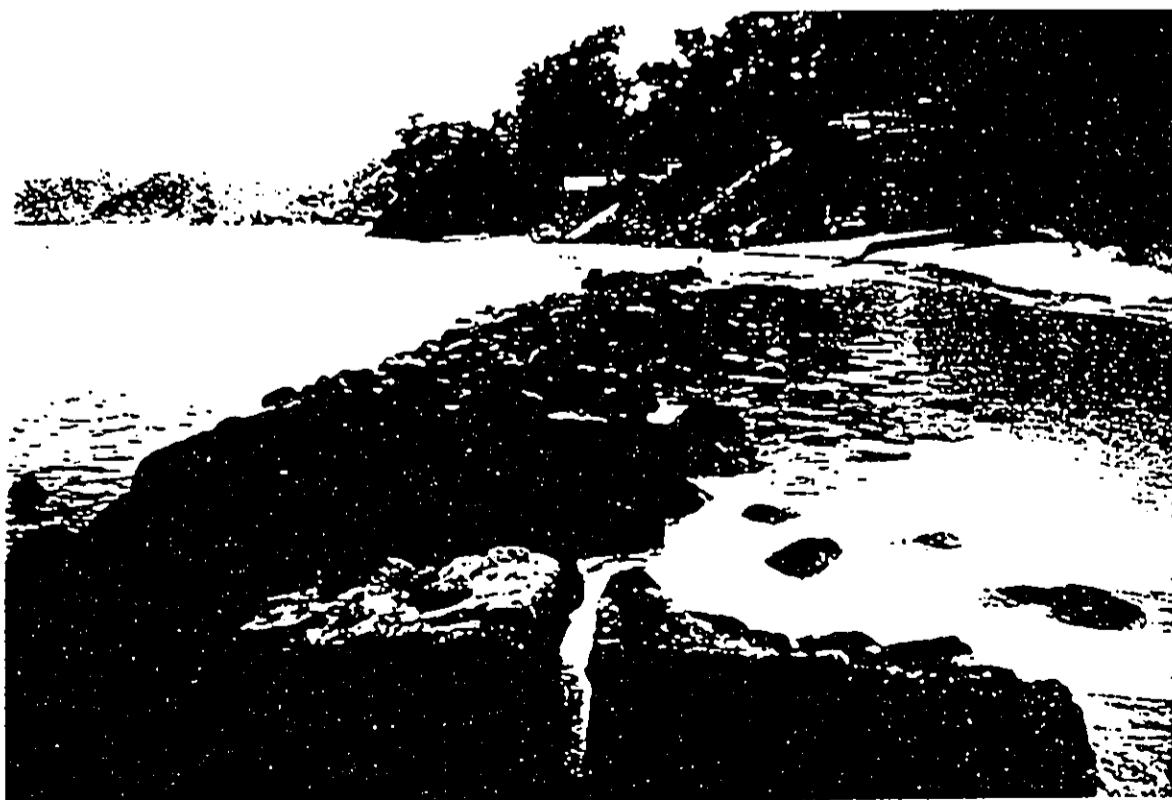
Photo No. 7. Close up of the basalt boulders at low tide. These were placed sometime prior to 1958.

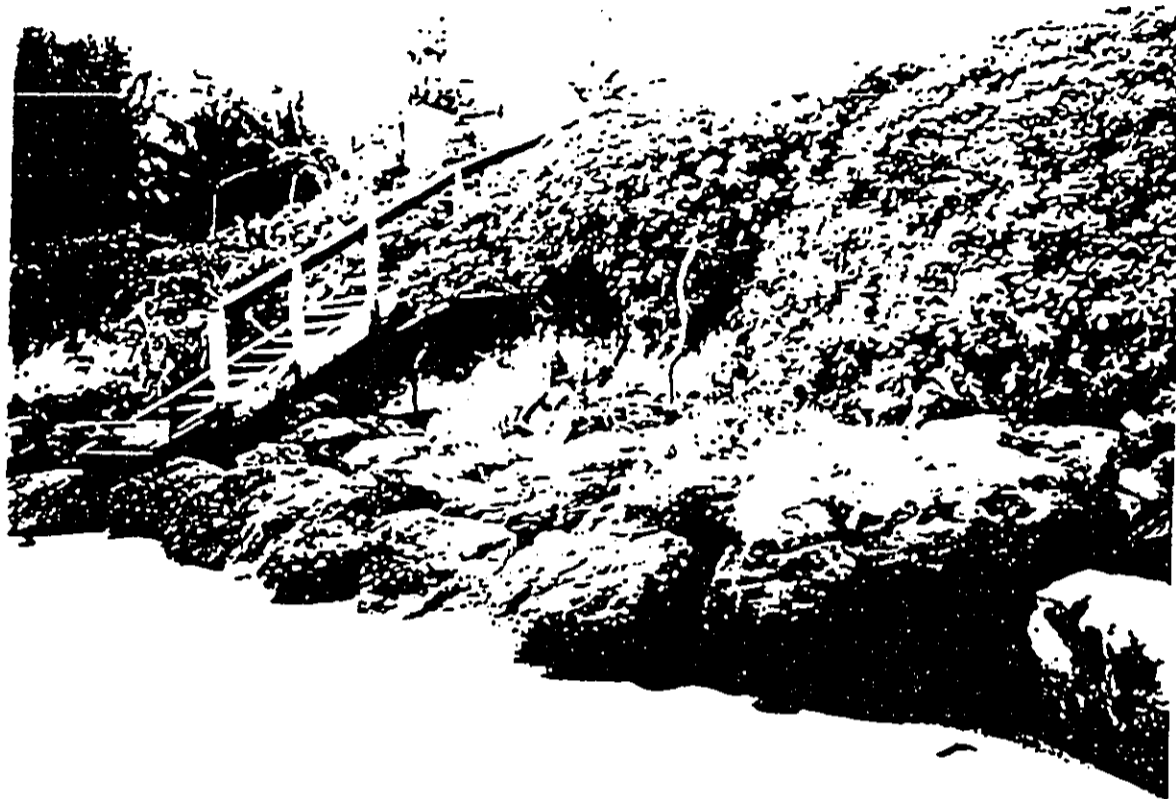
Photo No. 3. This erosion behind the revetment in front of TMK 5-5-02:77 occurred in November 1996.

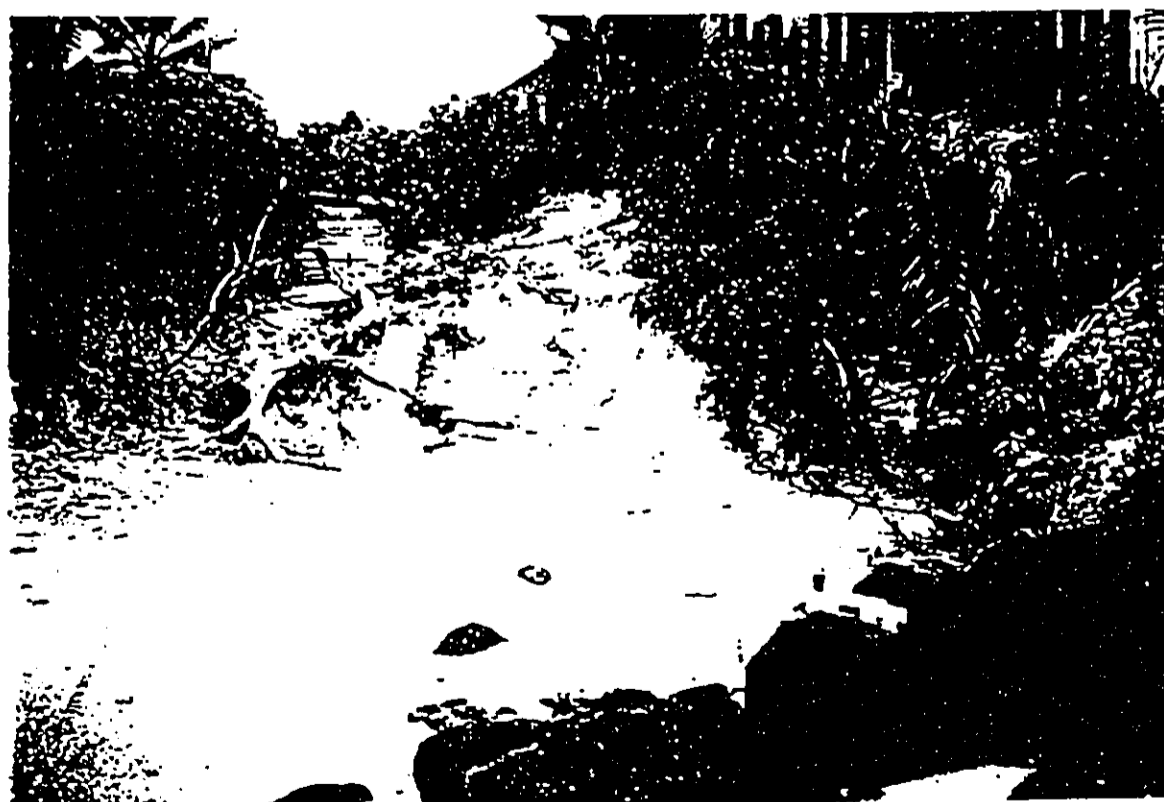
Photo No. 9. Most of this erosion at the north end of TMK 5-5-02:92 also occurred in November 1996.

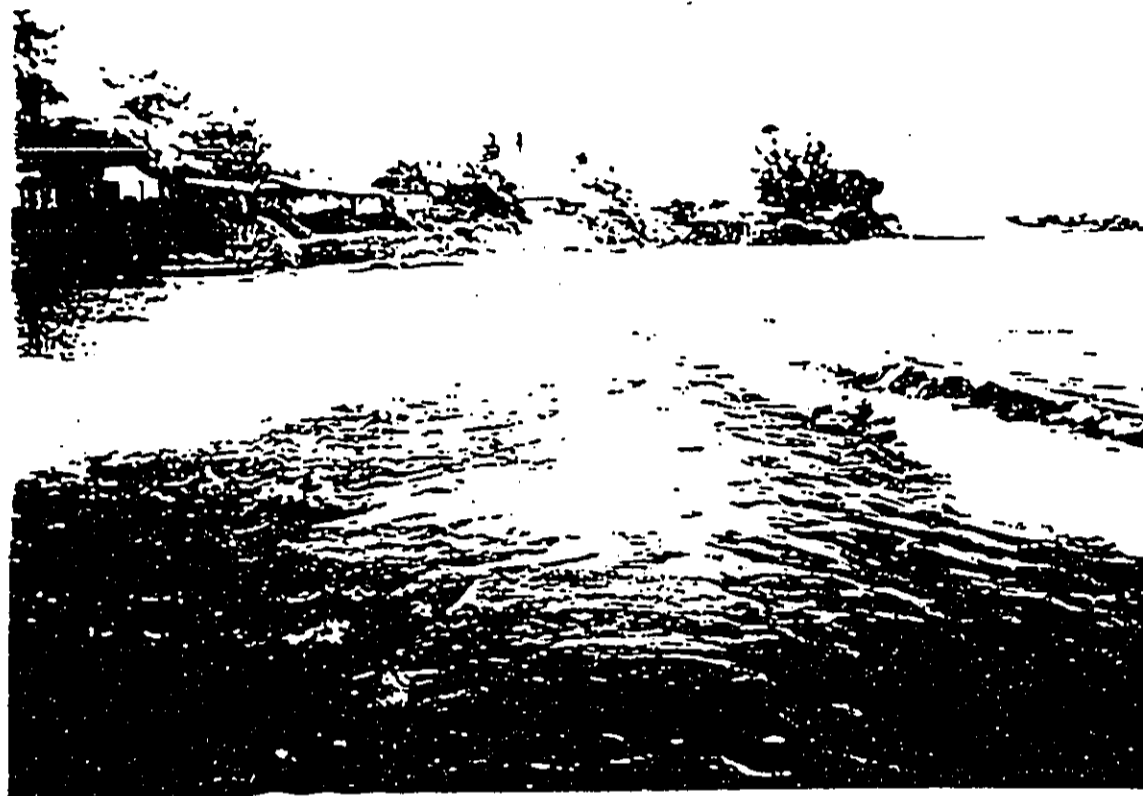
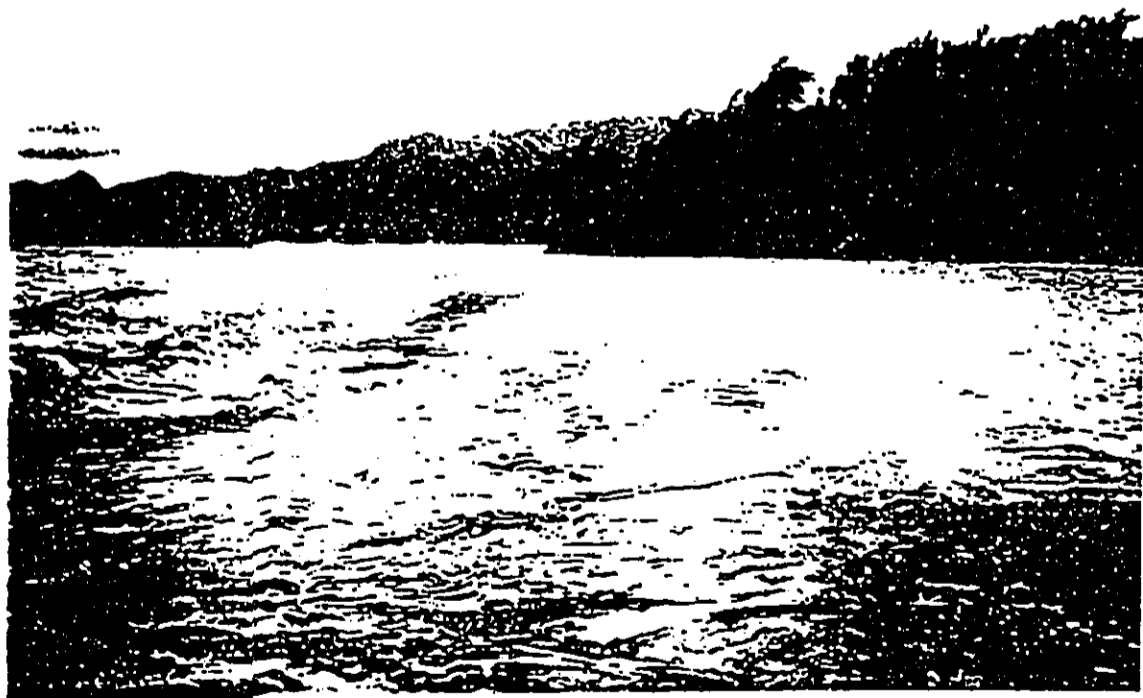
Photo Nos. 12 & 13. These views of the nearshore sill were taken at mid-tide. The top photo is looking north and the bottom is looking south. At low tide, the sill is fully emerged.

- A partially emerged sill runs parallel to the shoreline (Photo Nos. 12, 13, and 16). For the 400 feet to the north of Lot 116-B, the sill is 60 to 80 feet offshore. For the 400 feet to the south, the sill is generally 120 to 140 feet offshore. It is comprised primarily of lithified sand and coralline algae. Its top is 15 to 20 feet wide and most high tides, the top is entirely submerged. Conversely, on most low tides, it is fully emerged. There is a relatively abrupt drop of 3 to 4 feet on the land and seaward sides of the sill. Based on the sill's orientation and composition, it undoubtedly is a former location of the shoreline.

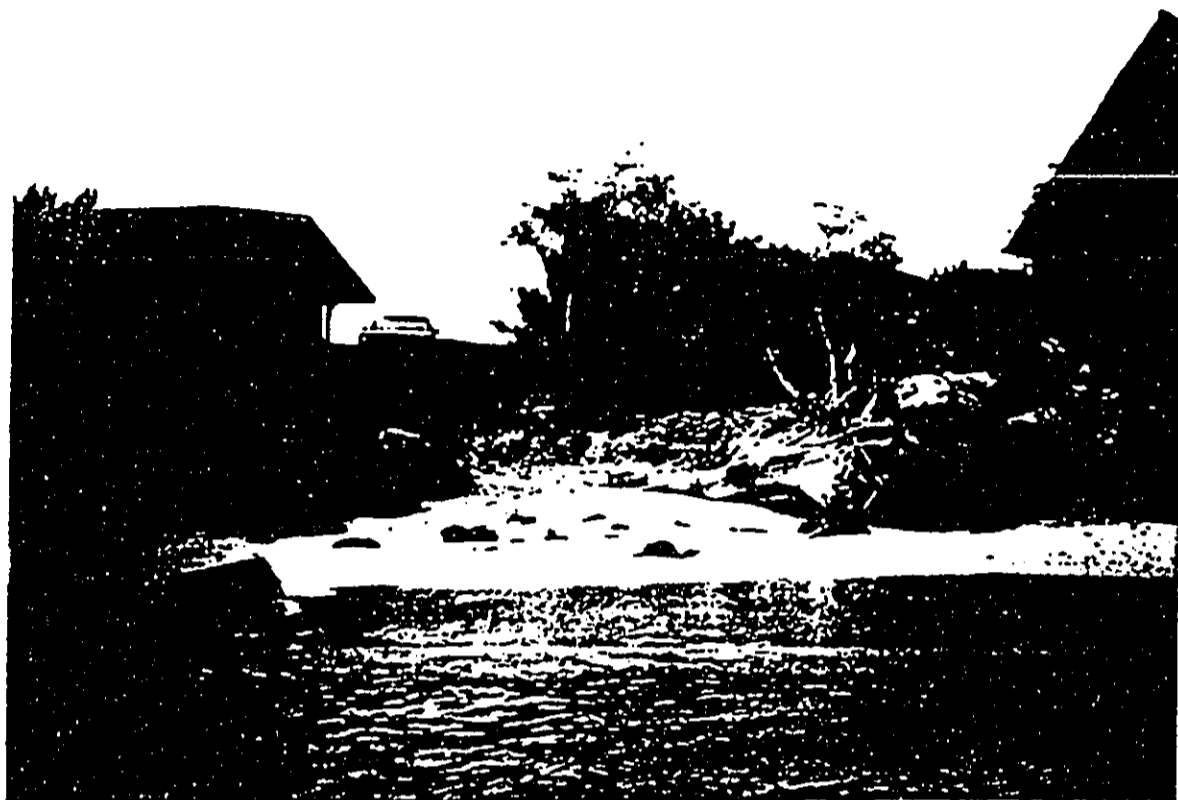
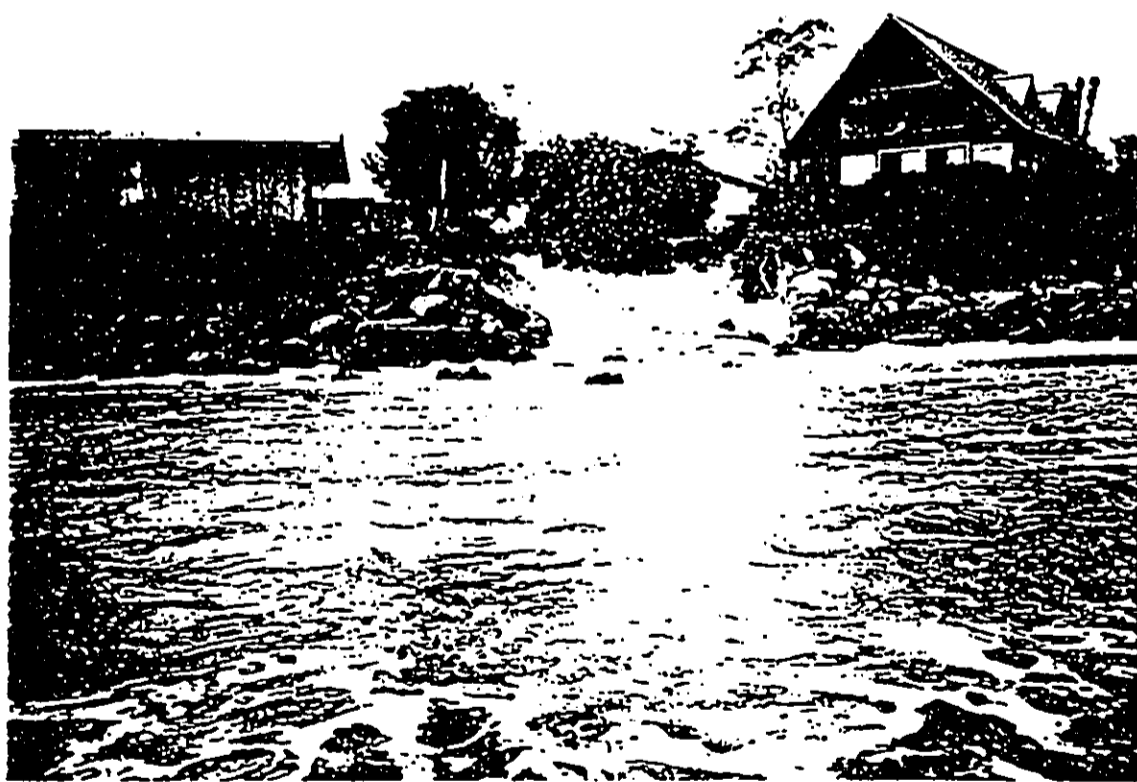
Photo Nos. 14 & 15. This gap in the shoreline revetments is for the 10-foot wide shoreline access for TMK 5-5-02:67. TMK 5-5-02:34 is on the left and TMK 5-5-02:32 is on the right. This is the only break in shoreline protection to the north of the subject property.

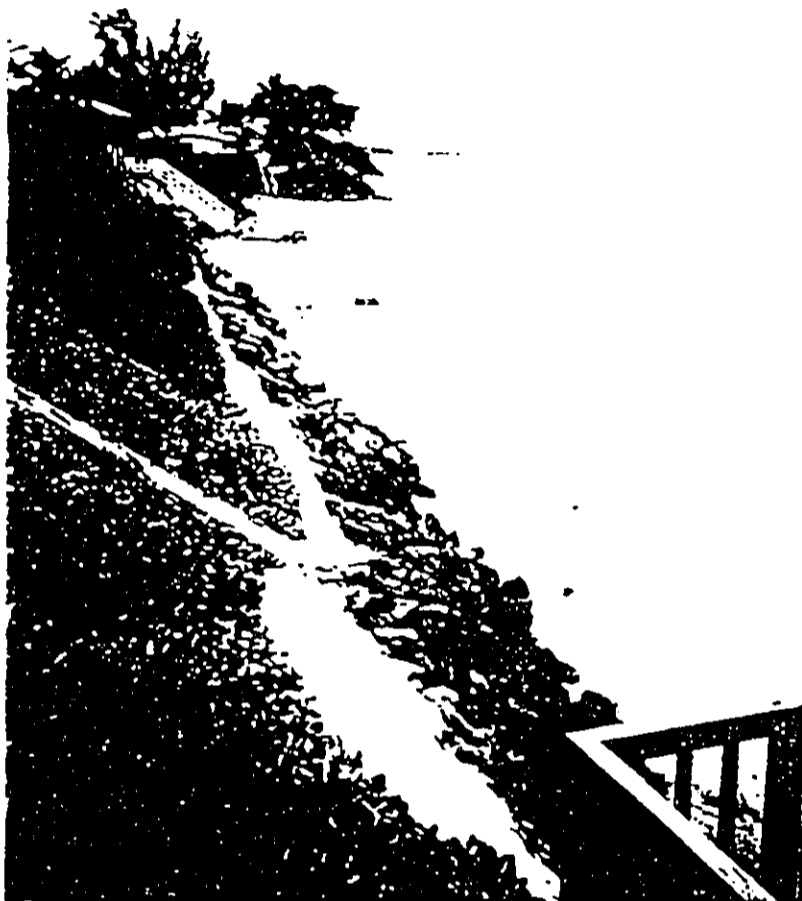
Photo No 16 Views of the shoreline to the n
of the subject property. The s
almost of the shoreline in fro
TMK 5-5-02:95

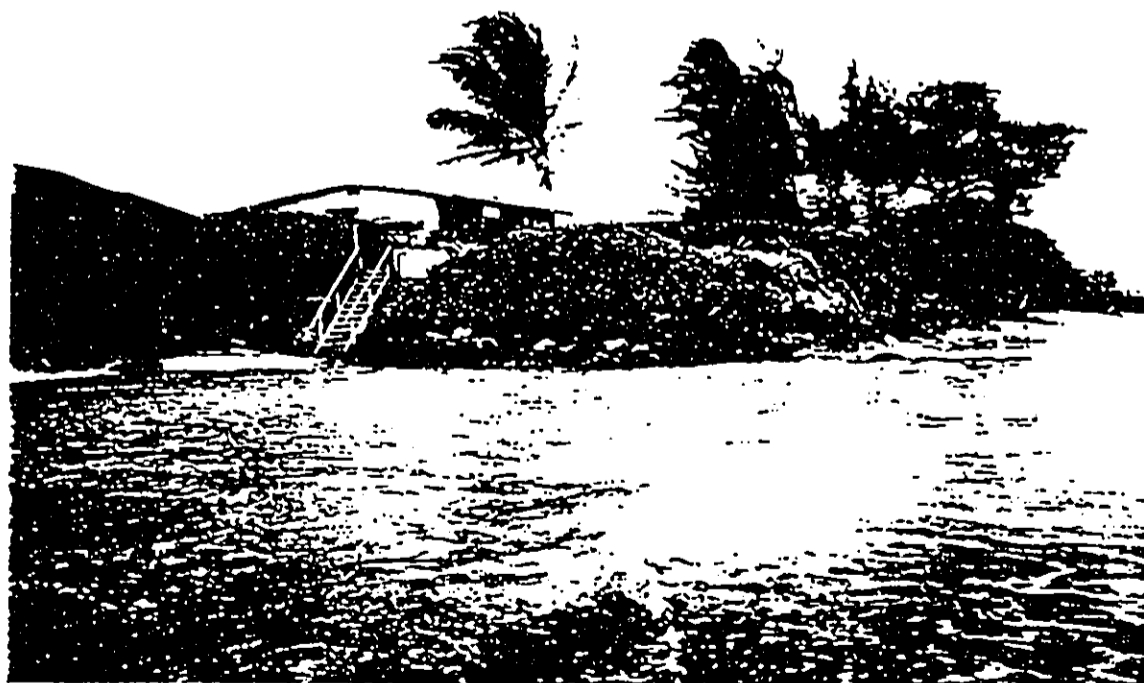
Photo No 17. Boulder revetment in front of TMK 5-5-02:95 which was con-
structed sometime prior to 1958.

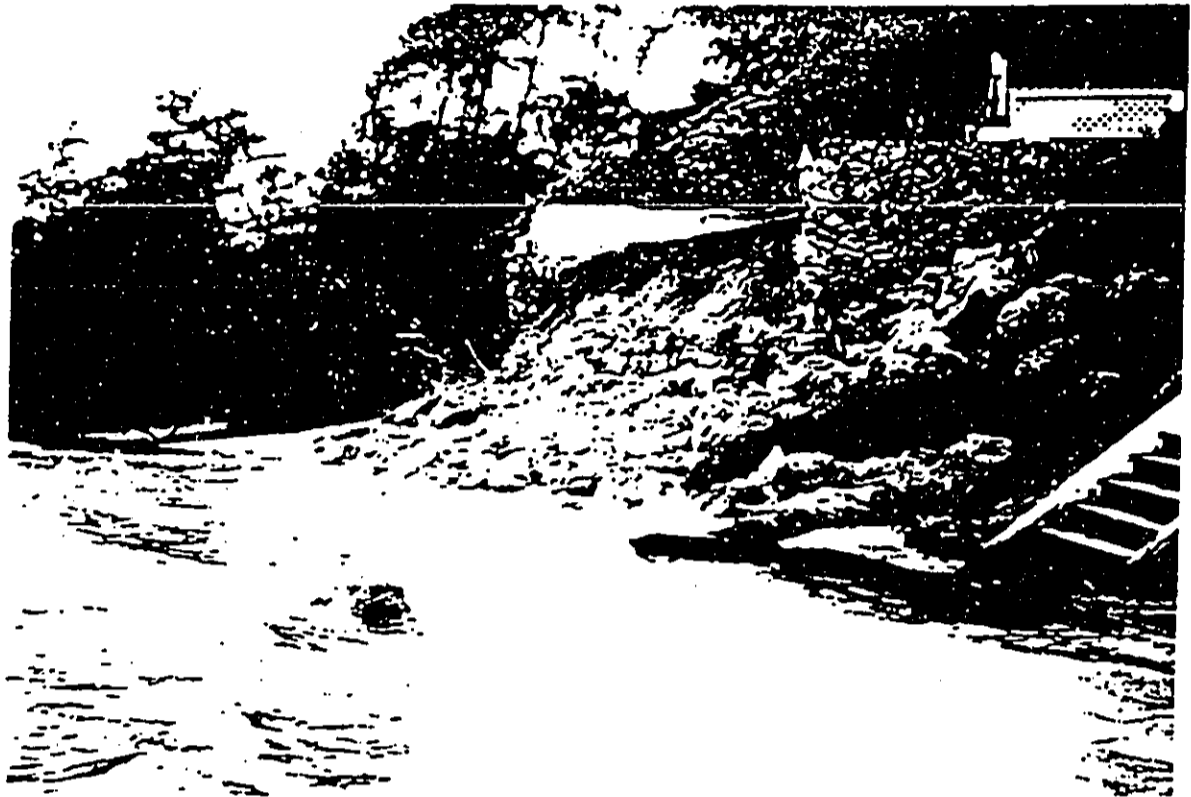
Photo Nos. 19 & 20. Views of the collapsed wall in front of TMK 5-5-02:81. Heavy rains during the week of November 5, 1996 created cracks. Subsequent high waves caused the wall to collapse.

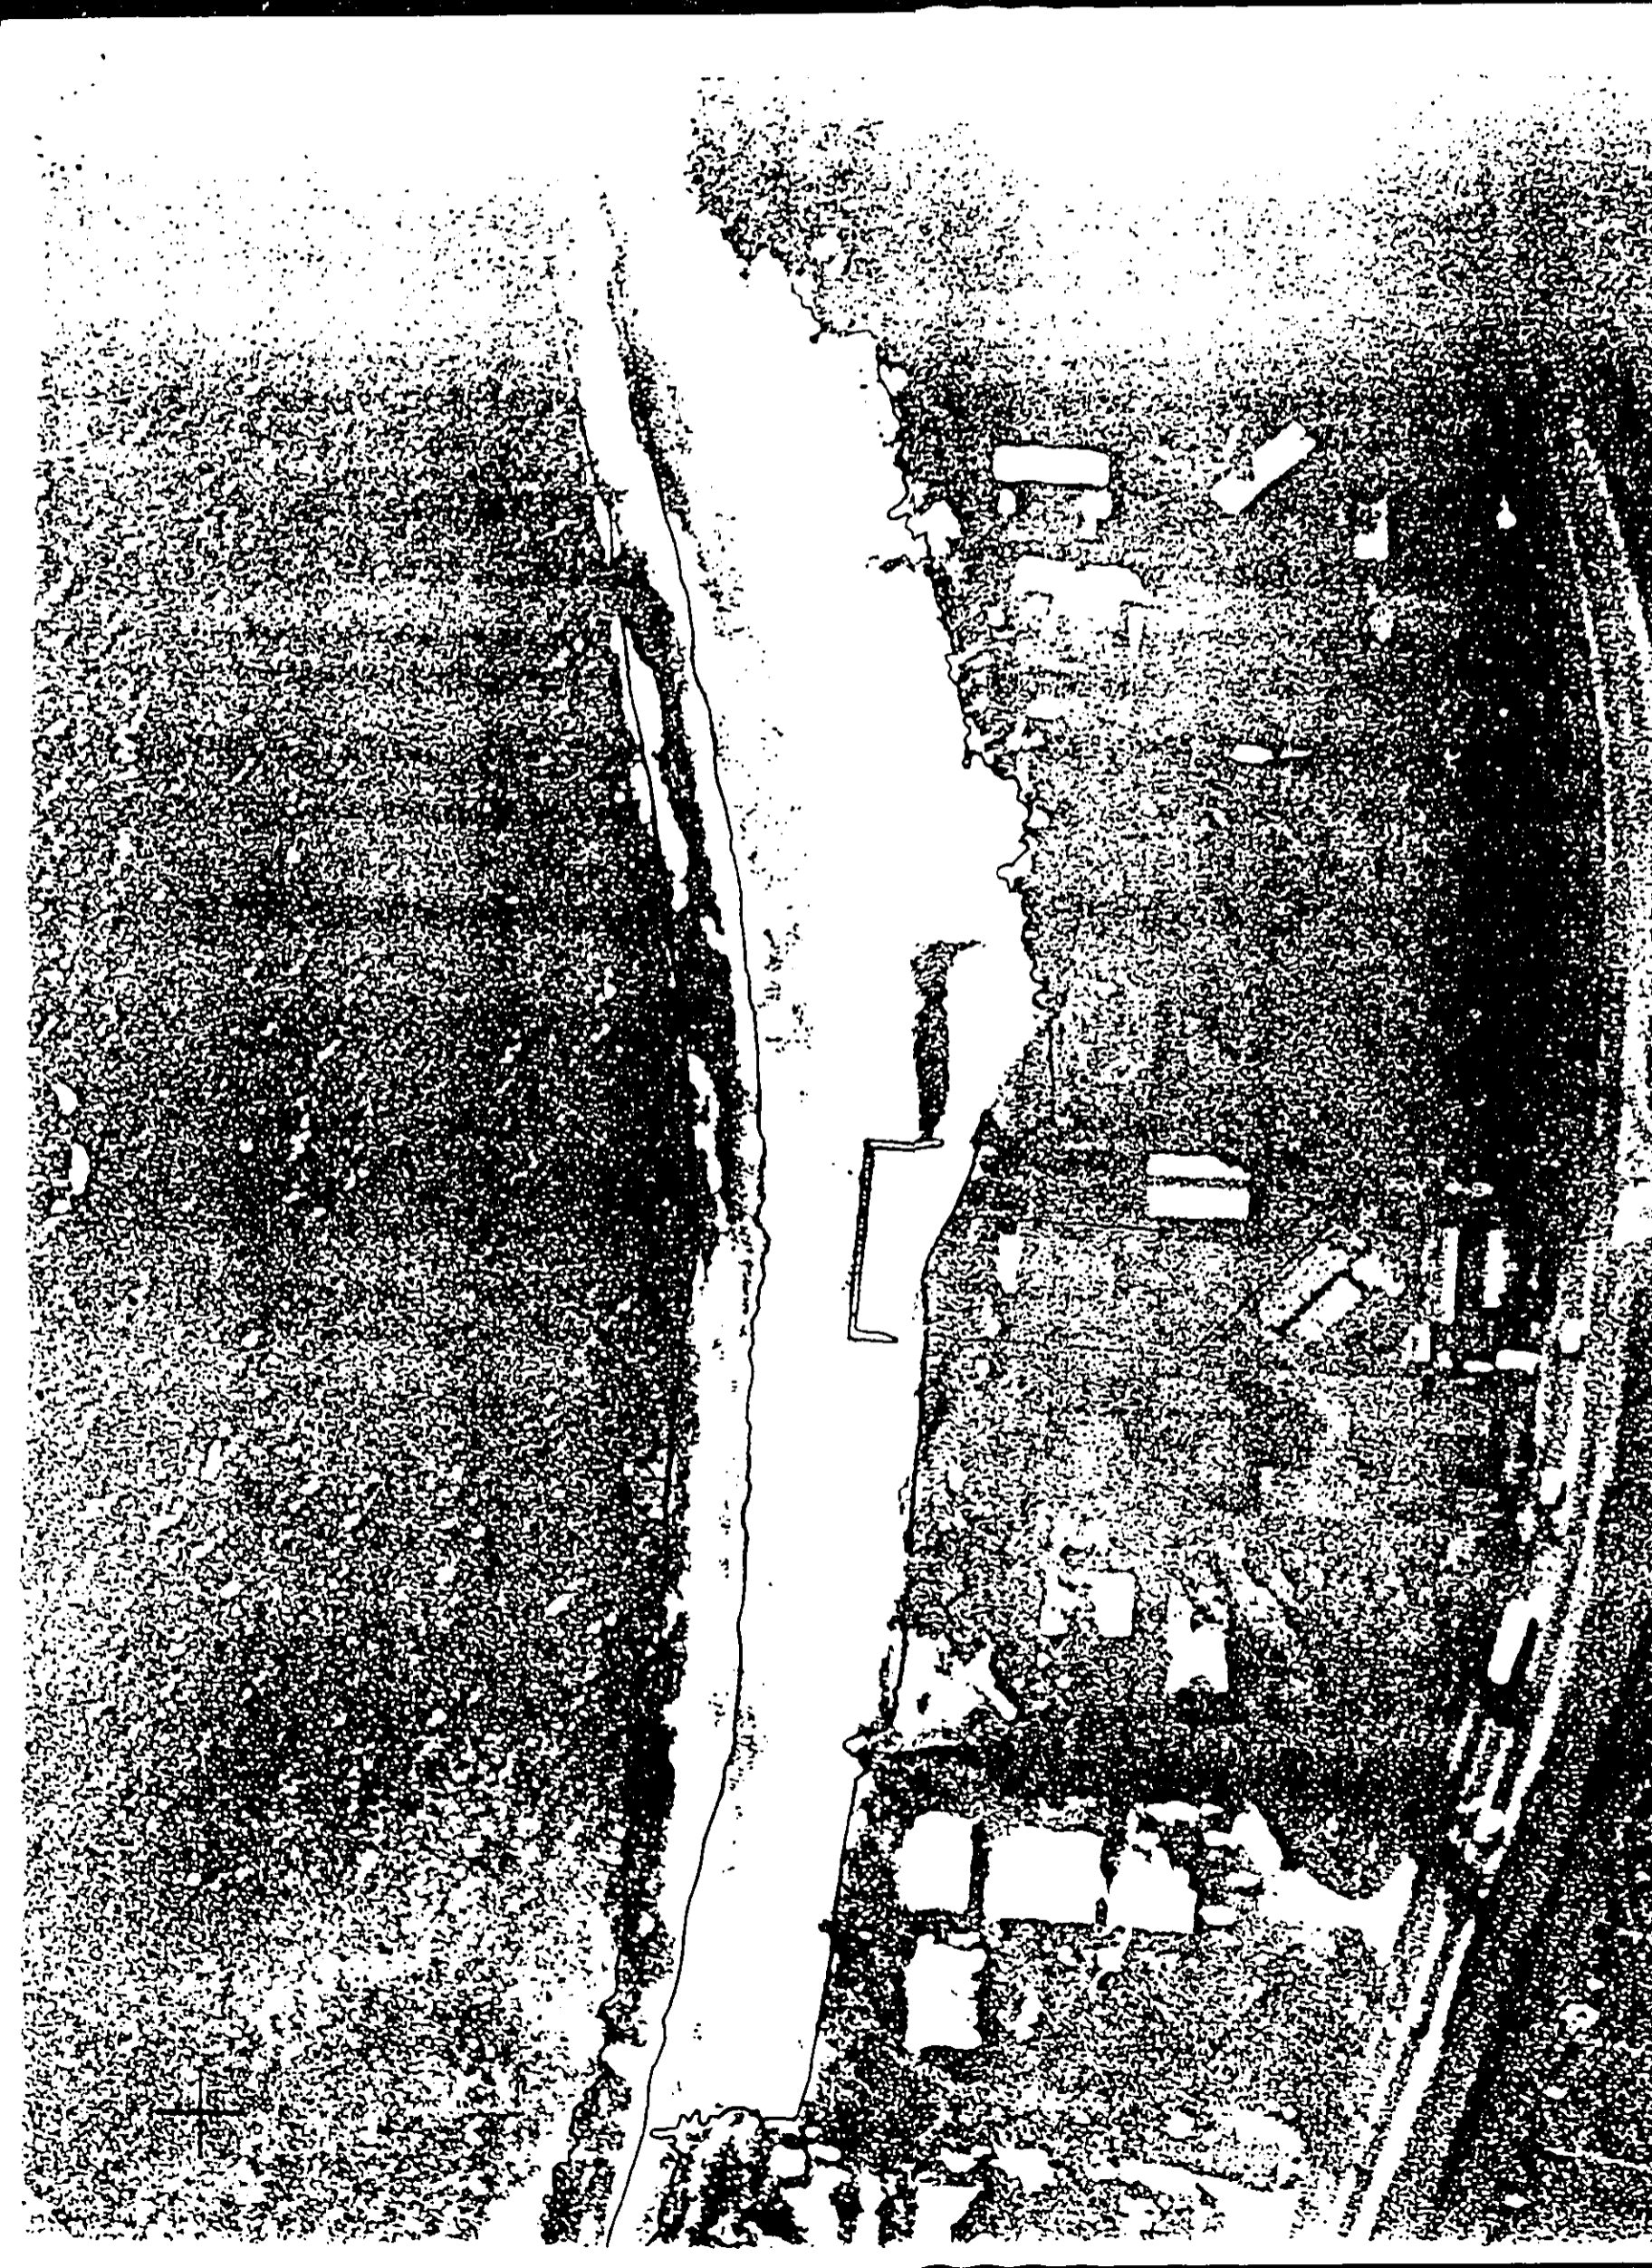
Appendix F

December 5, 1982 Aerial Photo With
Overlay of the 1995 Shoreline
