Subject: Final Environmental Assessment and Finding of no  
Significant Impact (FONSI) to the Environment for the  
Subdivision of Olowalu Lands, Olowalu, Maui

**\*SUBDIVISION OF  
LOWALU LANDS\***

Olowalu Elua Associates, LLC

MUNEKIYO, ARAKAWA & HIRAGA, INC.

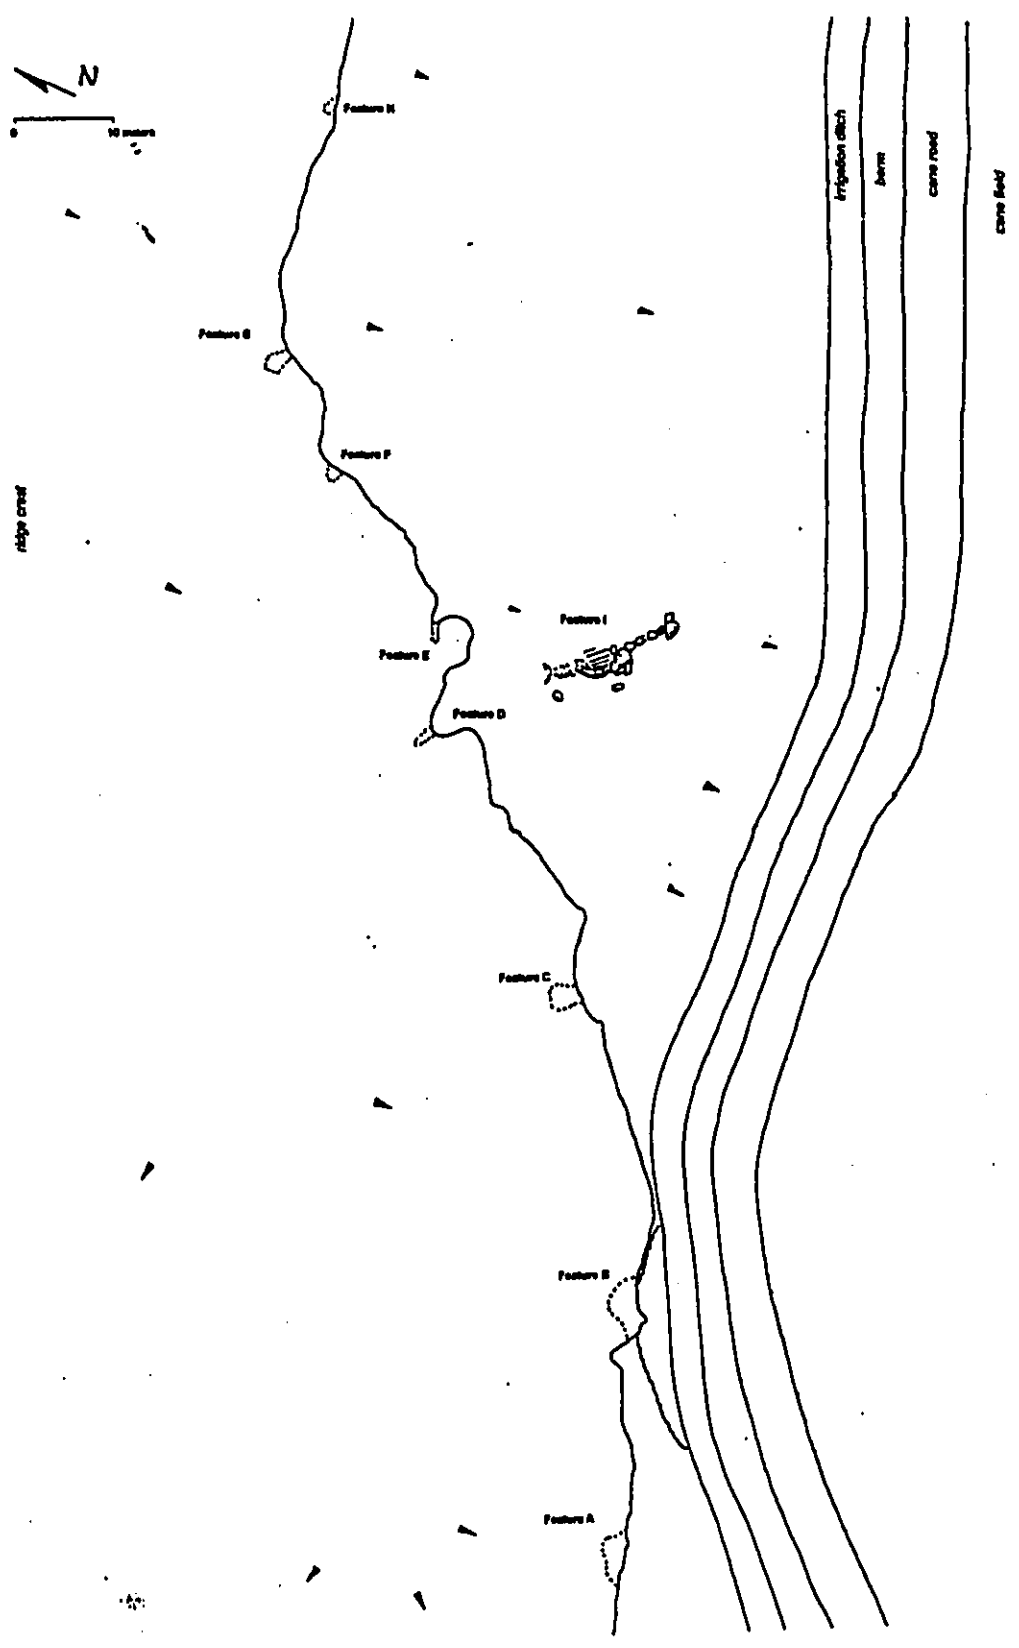
Figure A1 - Plan view of Site 4699.

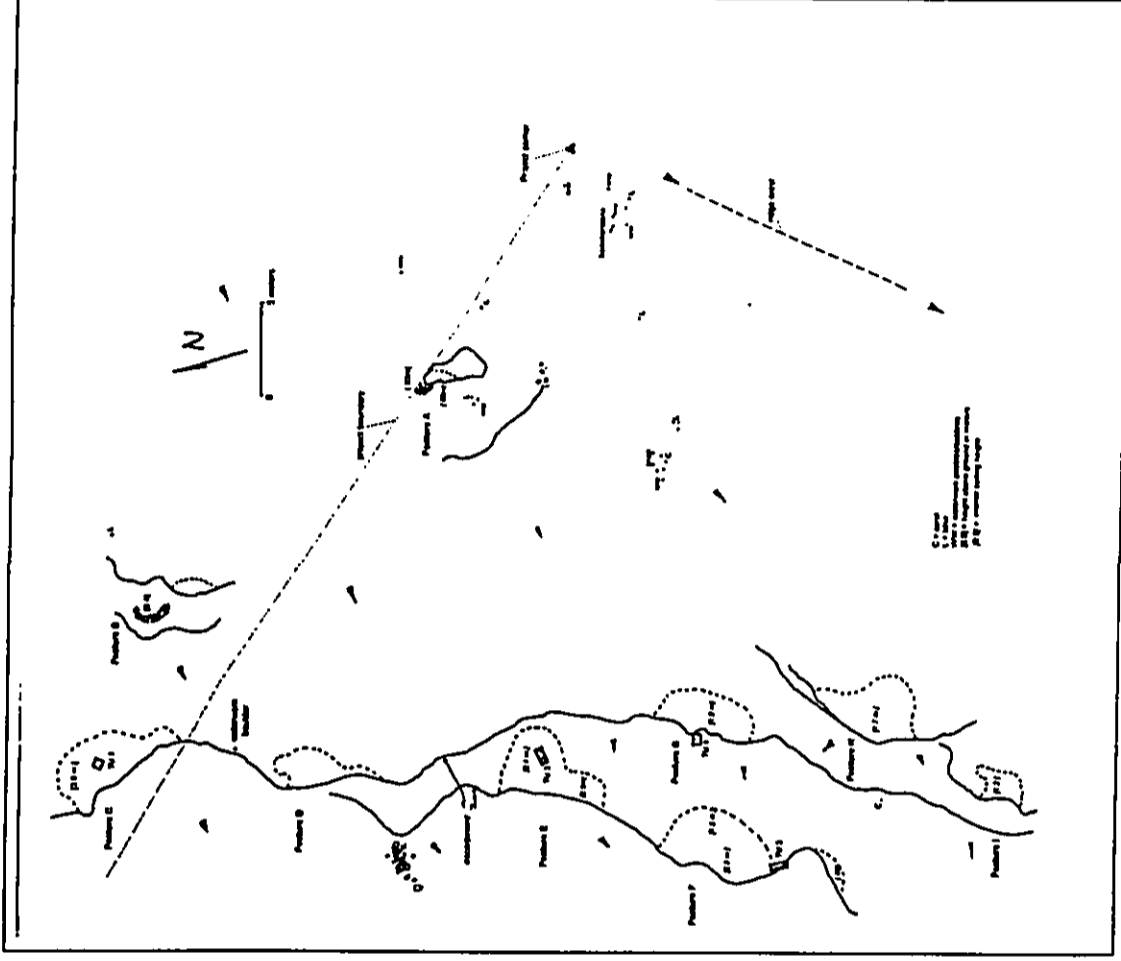
Figure A3 - Plan view of Site 4700.

Test units contained shallow deposits. Matrix was primarily very loose silt with a powdery consistency (aeolian deposit). Marine shell counts were high in Features C, E, and F. Lithic and volcanic glass debitage was common, as well as fire-cracked rocks. One potential hearth remnant (HF 1) was present in TU 3, Feature F.

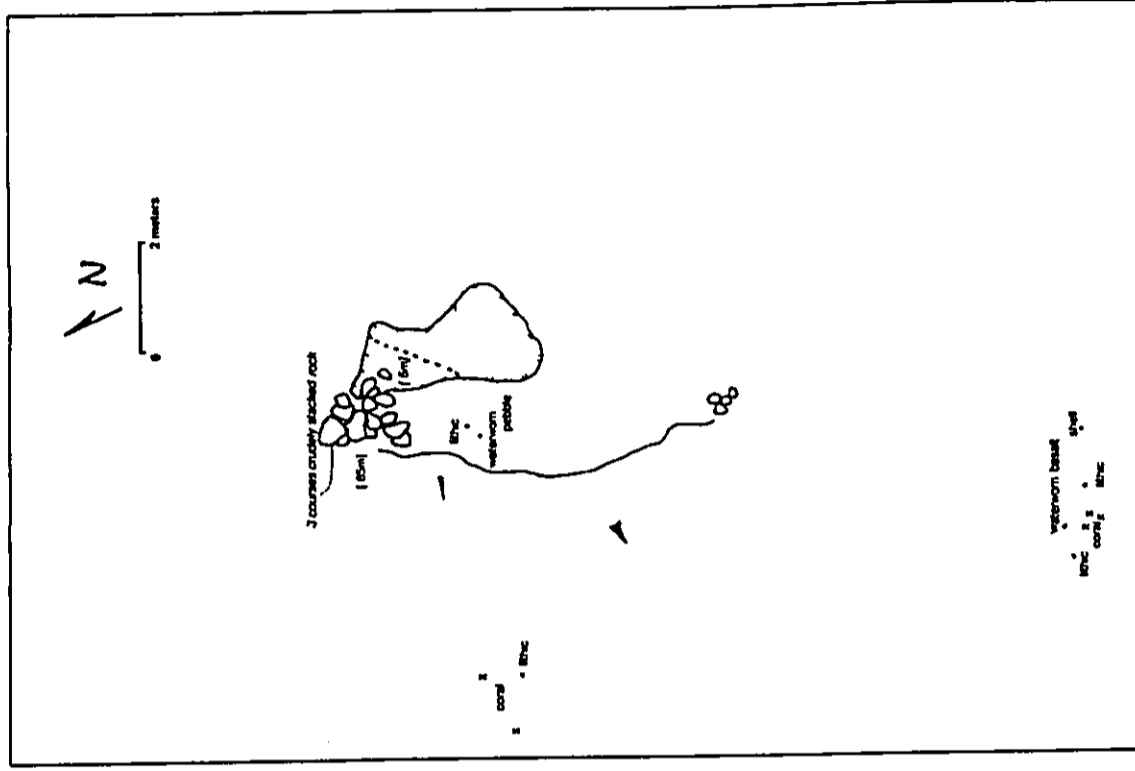
Figure A4 - Plan view of Feature A—rock shelter with possible windbreak.

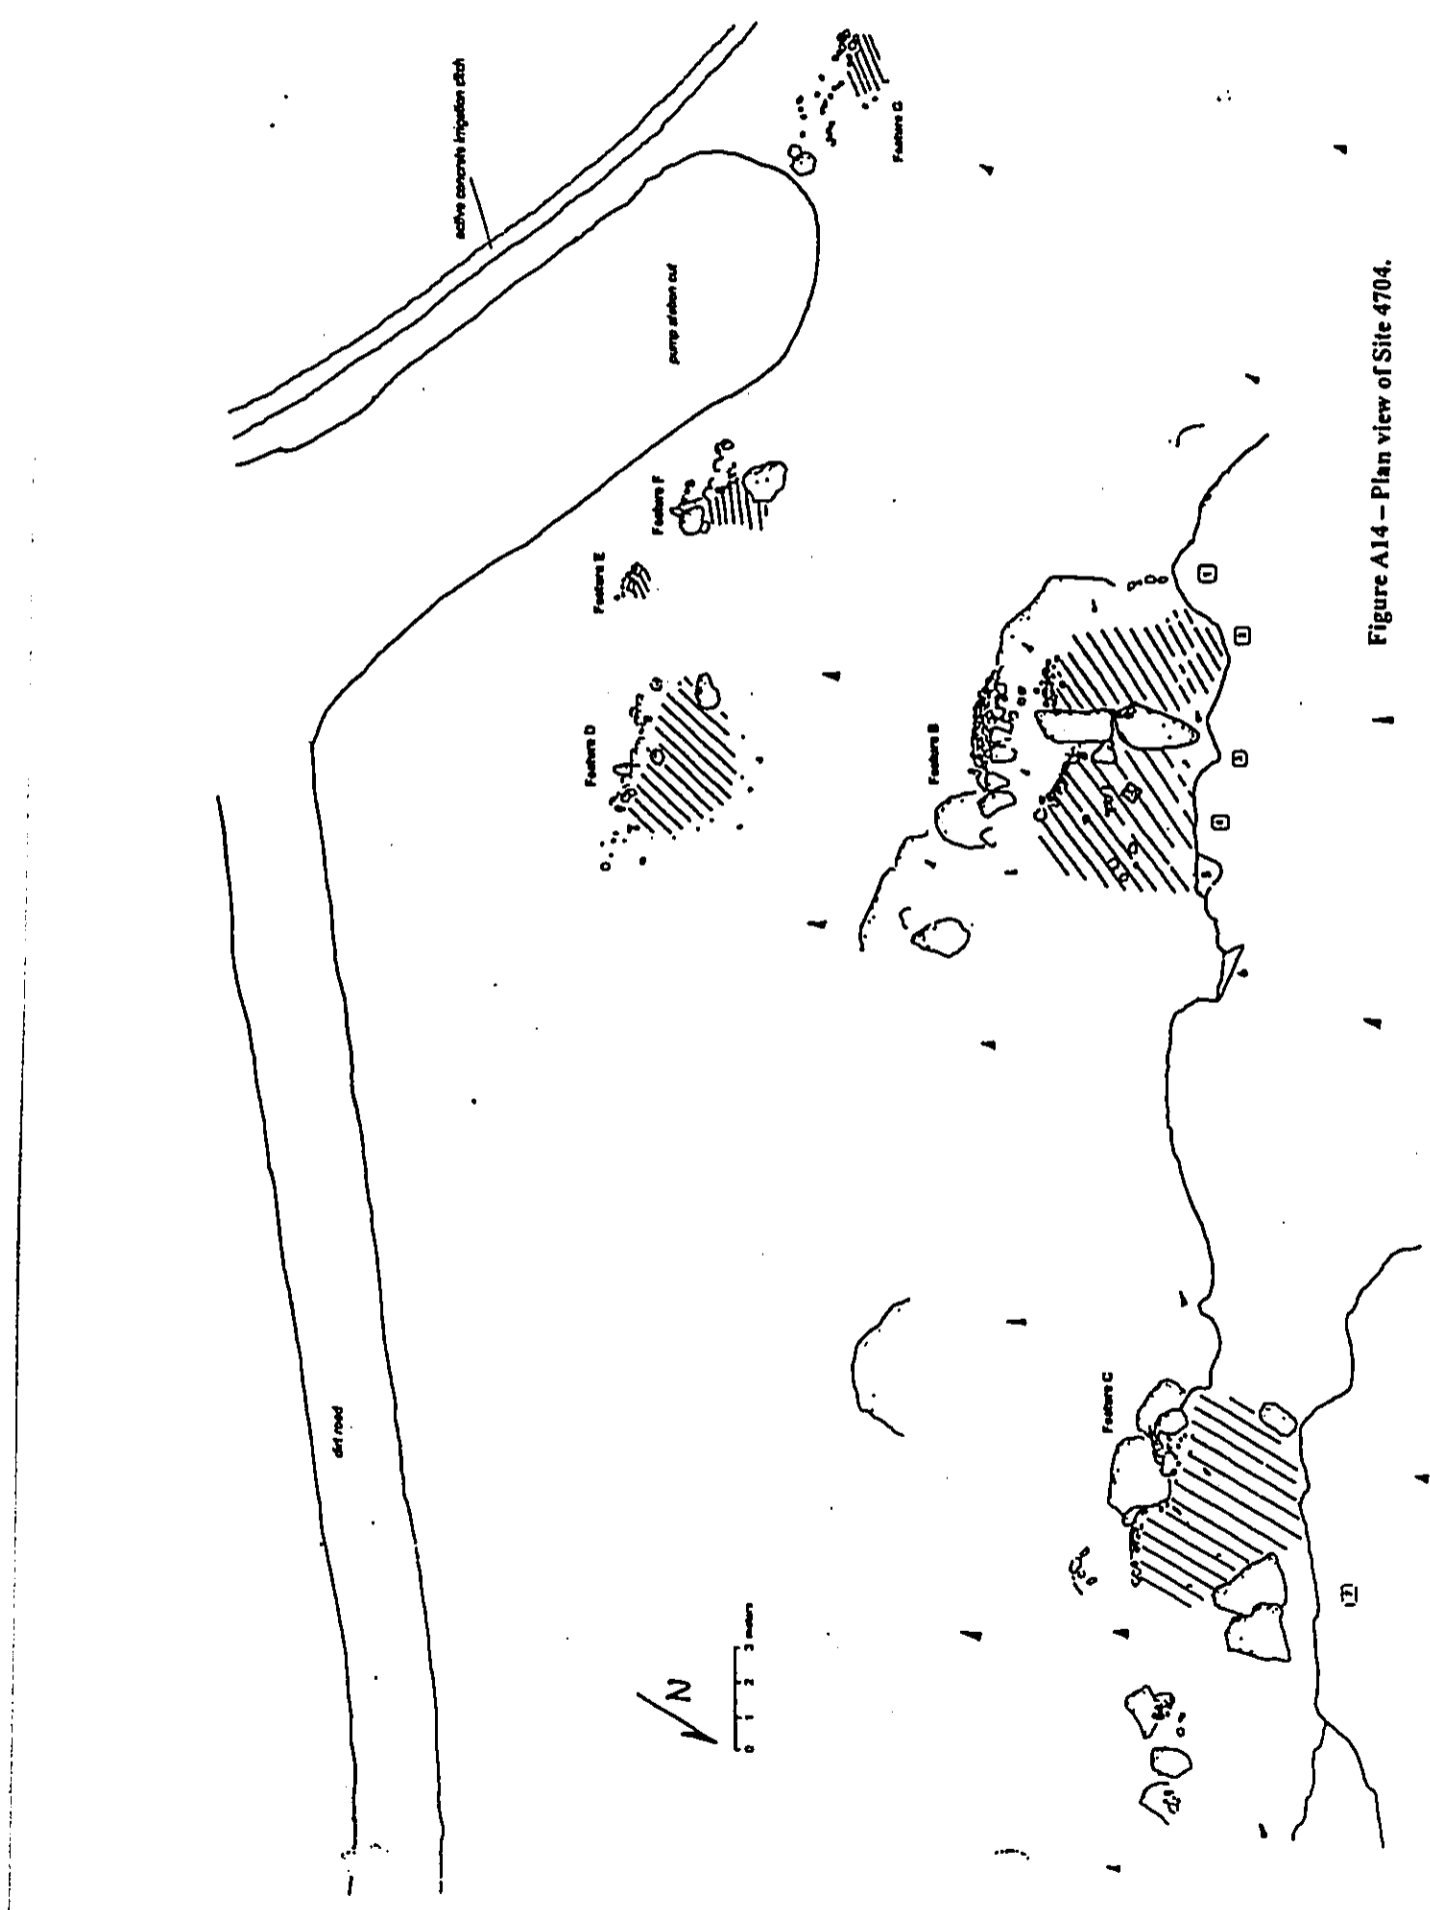
Figure A14 - Plan view of Site 4704.

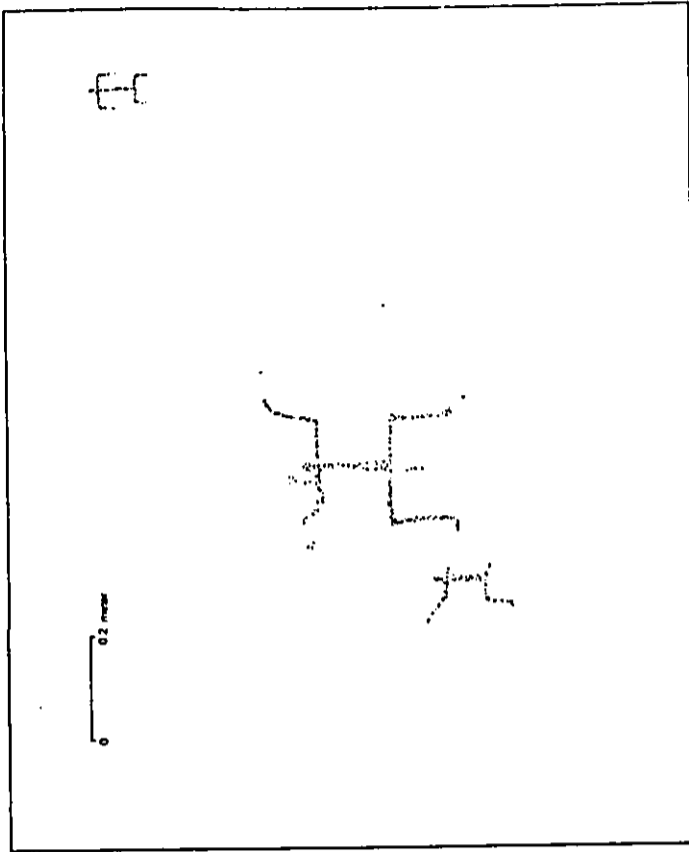
Comments: At least 27 separate images occur on this panel.

Figure A15 - Feature A—petroglyph panel number 2—Site 4704.

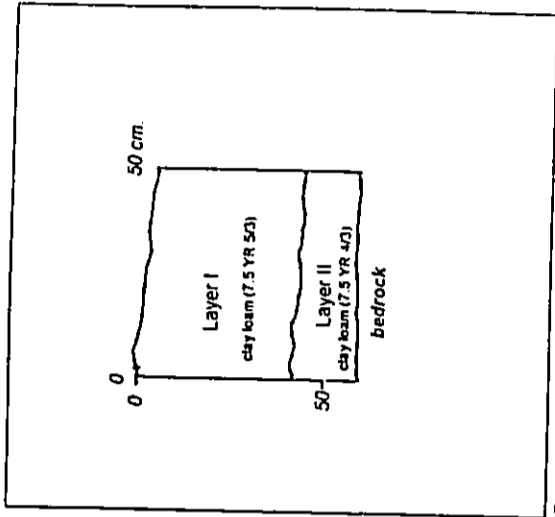
**Comments:** This terrace consists of a stacked, faced retaining wall of angular basalt boulders 5 to 13 courses high that is constructed parallel to the vertical basalt face with petrophylphs on it. Two small retaining walls of 1 to 3 courses create 2 level areas of 9 square meters and 25 square meters on top of the terrace. These level areas are separated by large boulders that have fallen from the basalt face.

Figure A 17 - East wall profile of Test Unit 1—Feature B.

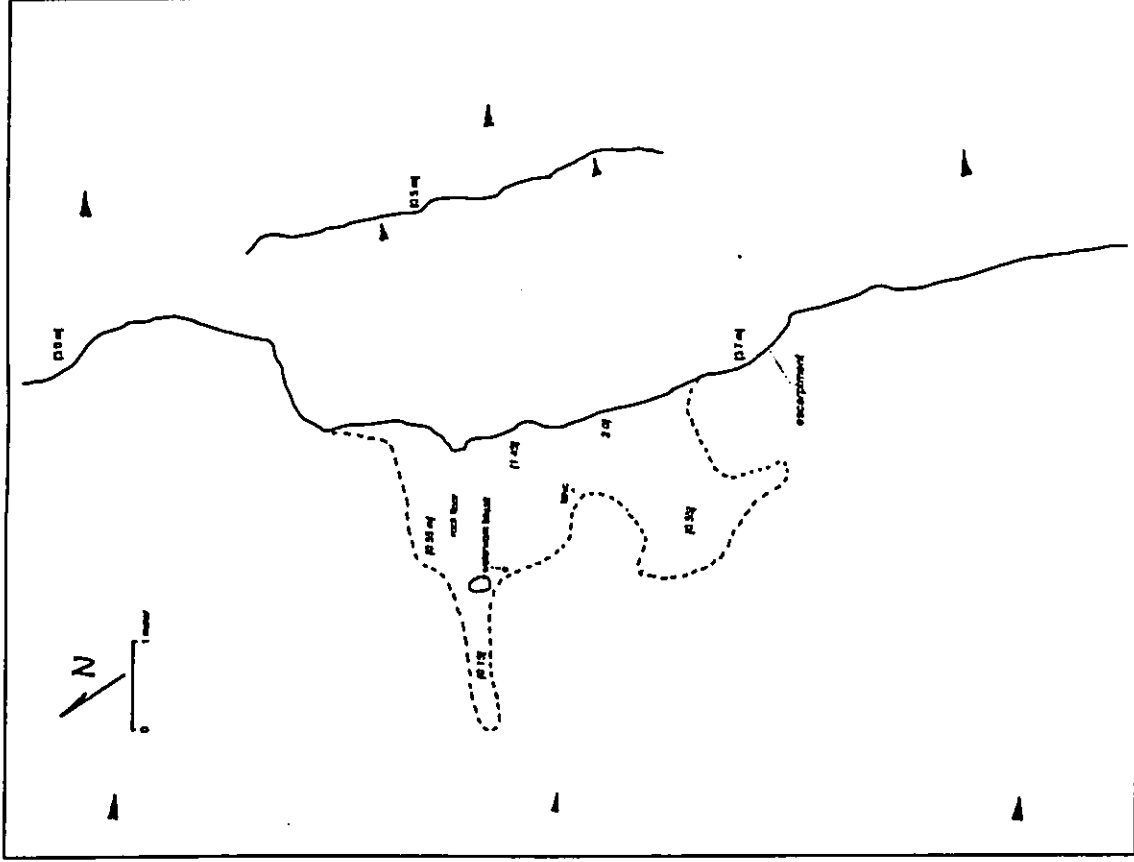
Comments: Average height of ceiling is 0.55 meters. There is narrow deep niche in the back of the shelter where a waterworn cobble has been placed on top of some partially burned stalk-like plant material. The south half of this shelter has a level soil deposit, while the north half is uneven bare rock. Feature B is 43 meters to the northeast.

Figure A18 - Plan view of Feature A—Site 4705.

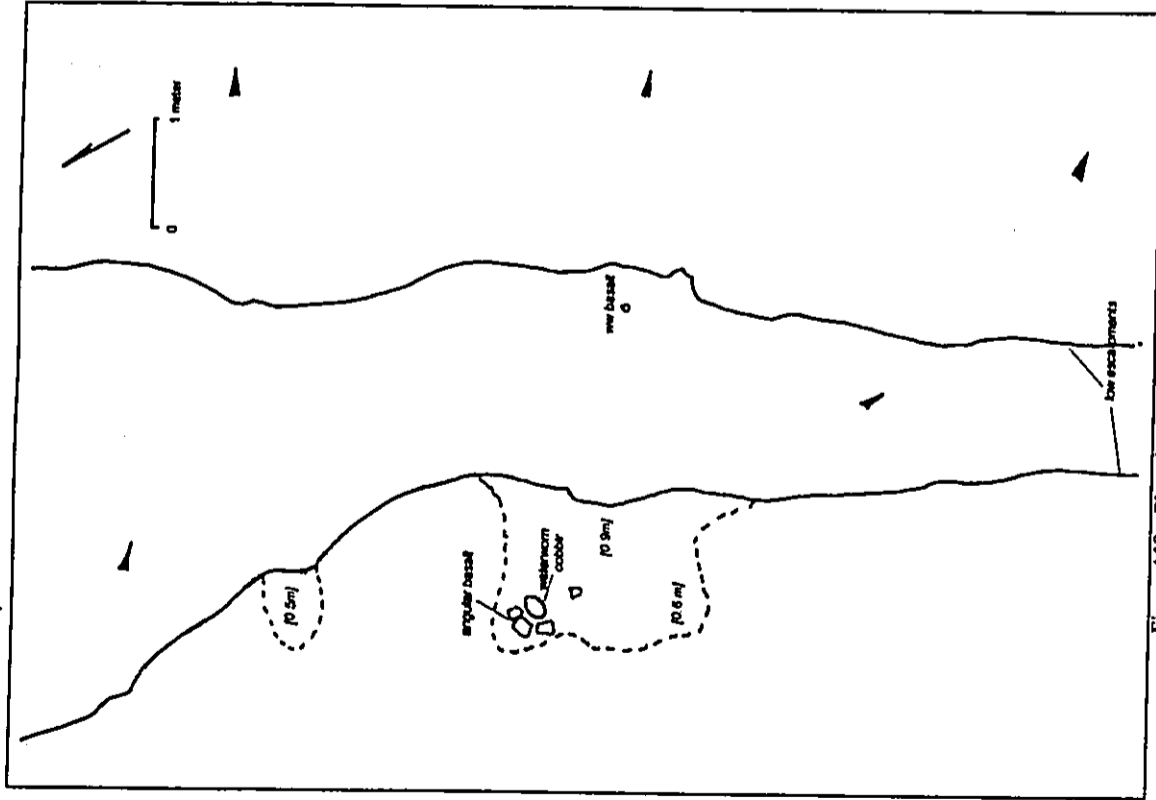
Figure A19 - Plan view of Feature B—Site 4705.

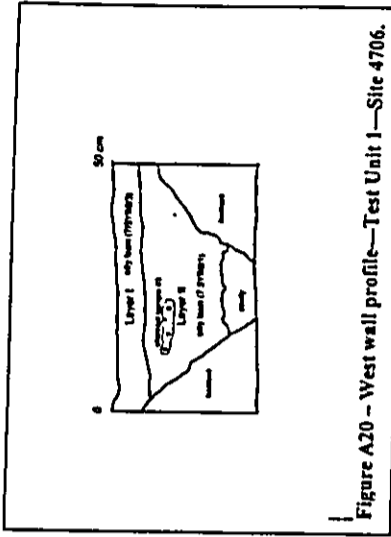
Figure A20 - West wall profile—Test Unit 1—Site 4706.

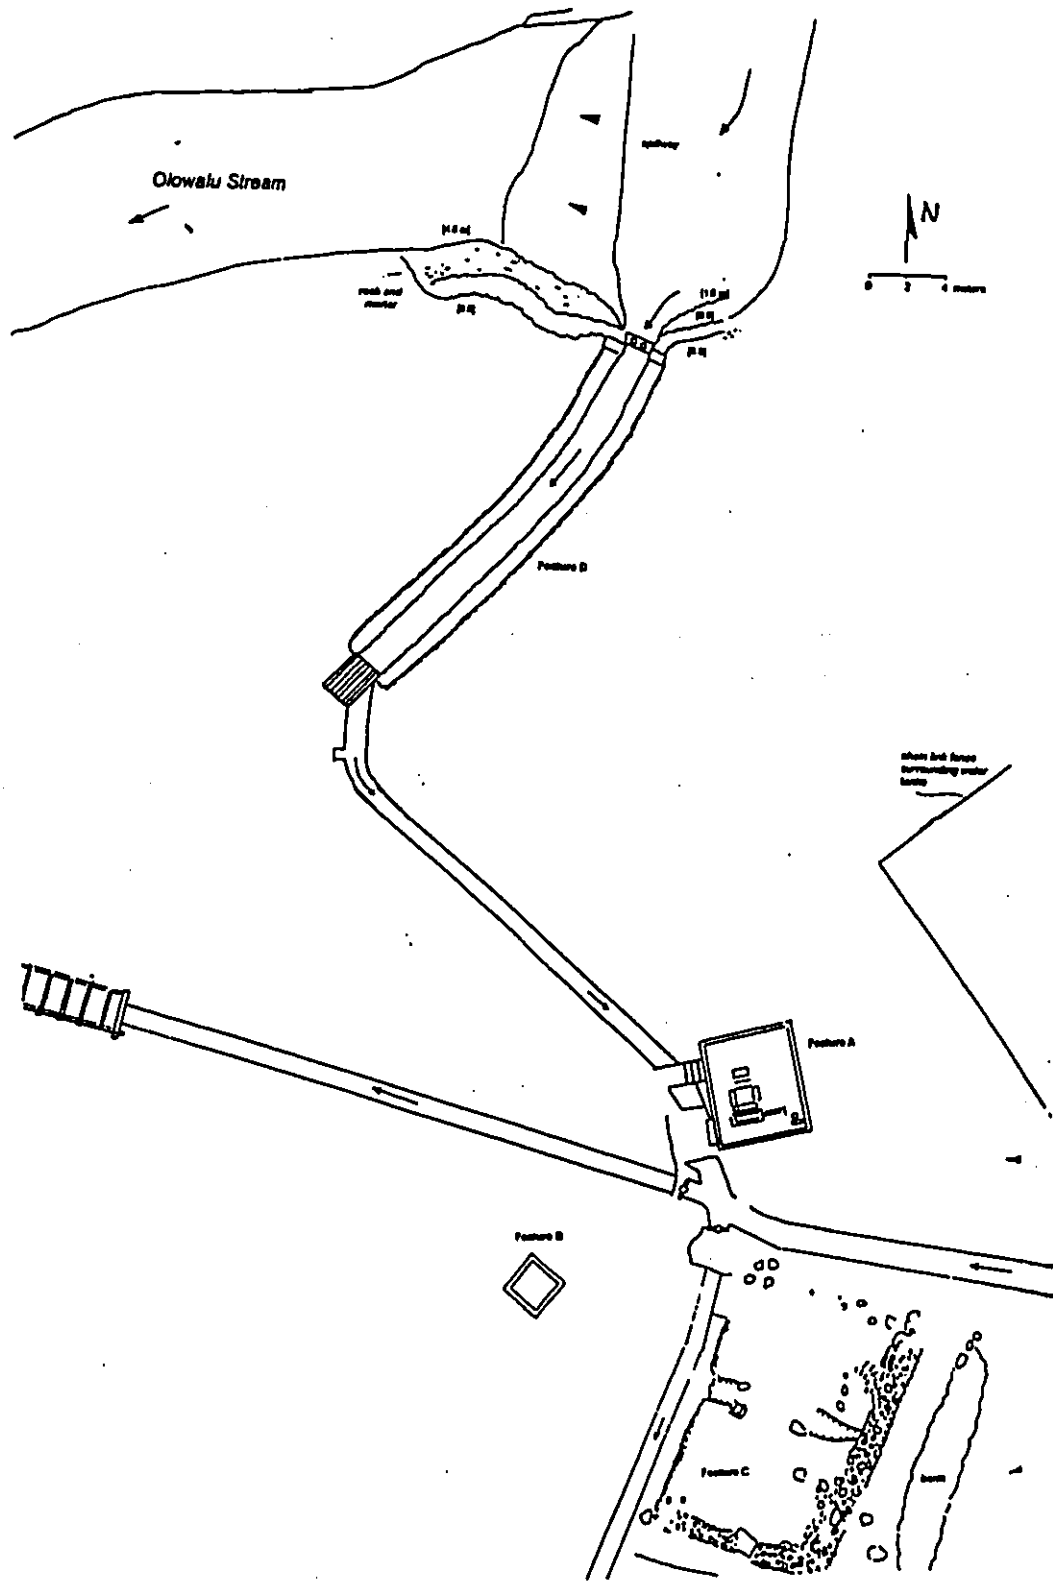
Site type: complex—concrete foundations, stacked rock wall, irrigation ditches  
Environmental setting: Located within the mouth of the Olowalu Stream valley, c. 30 meters east of the stream. Flora is buffelgrass with *Kiawe* and *Klu* trees interspersed  
Dimensions: 29 meters N-S by 23 meters E-W  
Function: historic hydro-electric plant  
Subsurface potential: good  
Tested: no  
Integrity: altered by salvage of equipment

Figure A25 - Plan view of Site 4709.

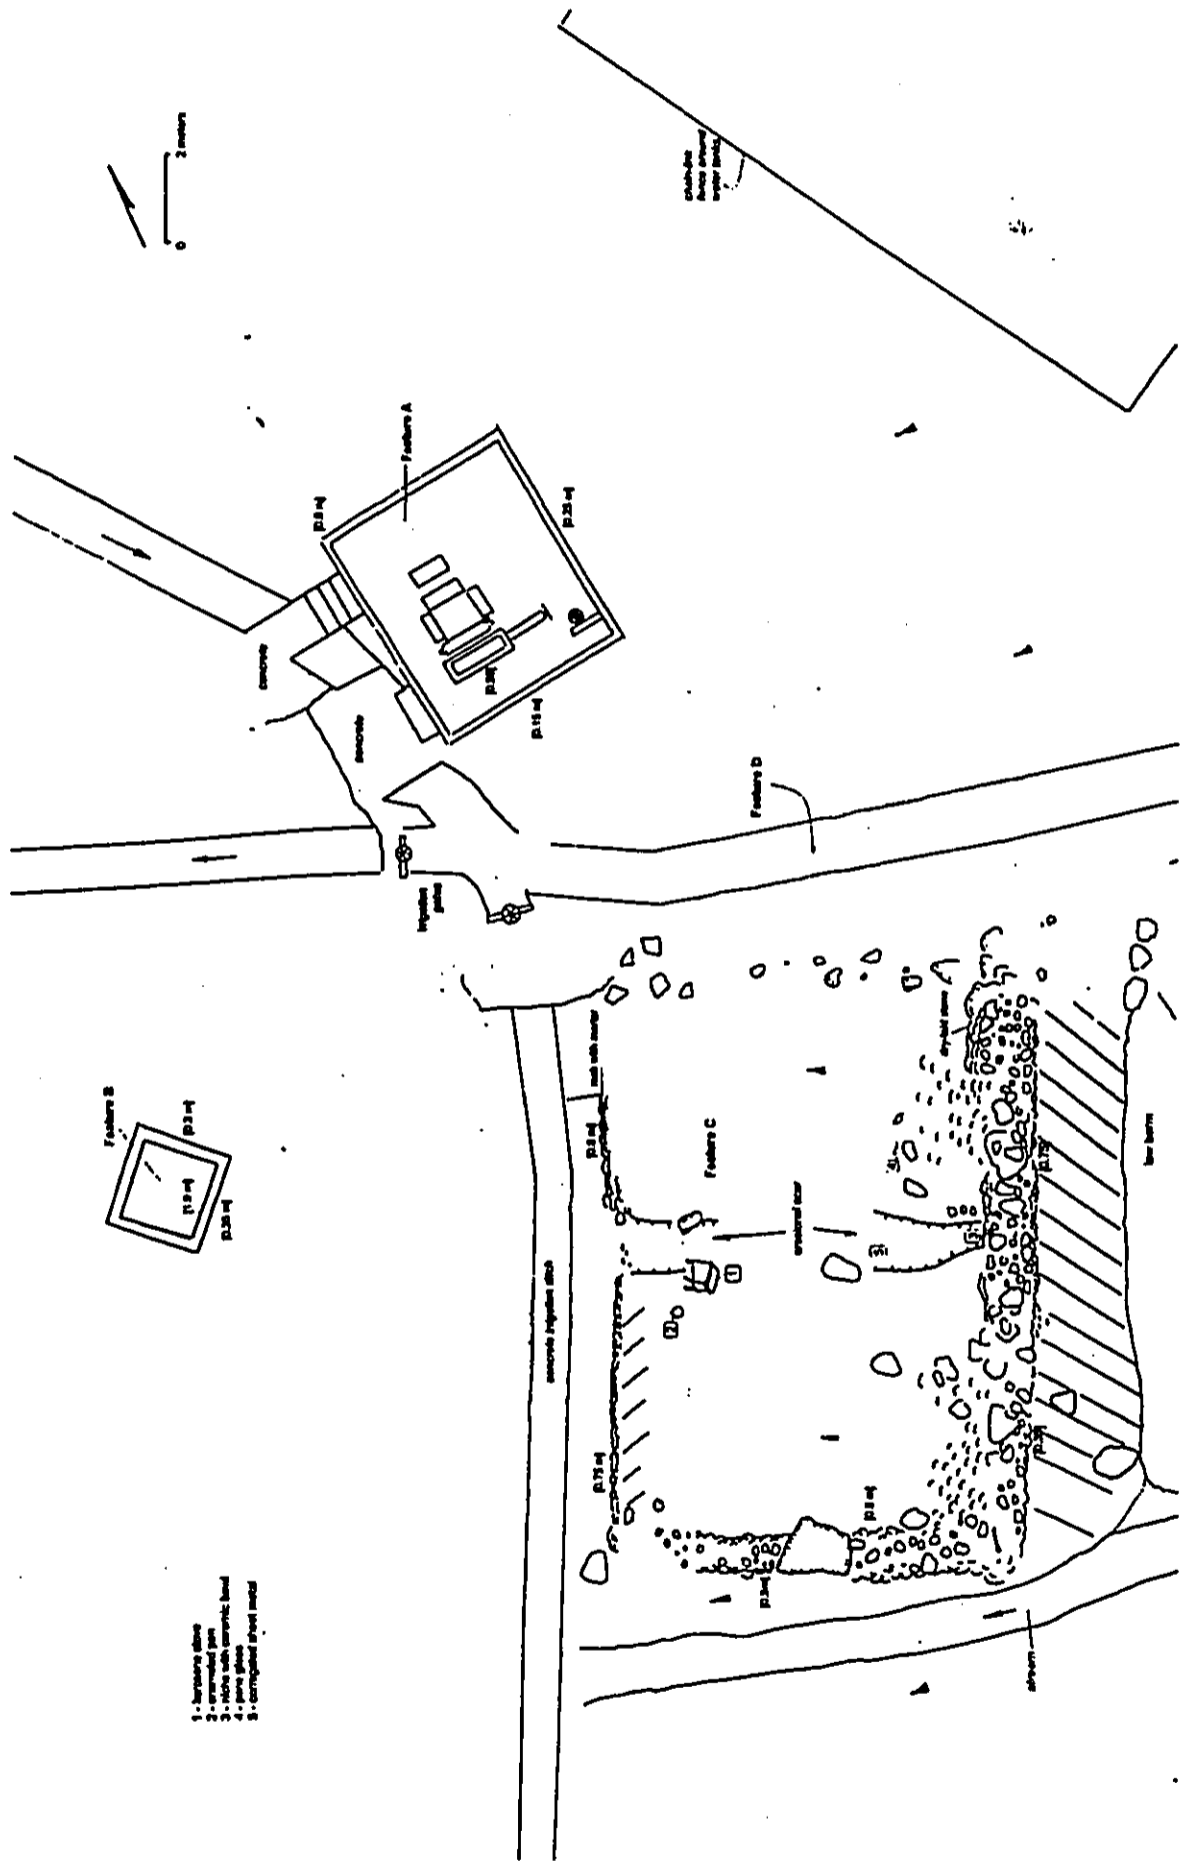
Comments: Poured concrete walls are 8" thick and rise 40 cm. above ground surface. A 6" entrance pipe is 1 meter below the NE inside wall. A 4" exit pipe is 1.7 meters below the SE wall.

Figure A26 - Plan view of Features A, B, and C—Site 4709.

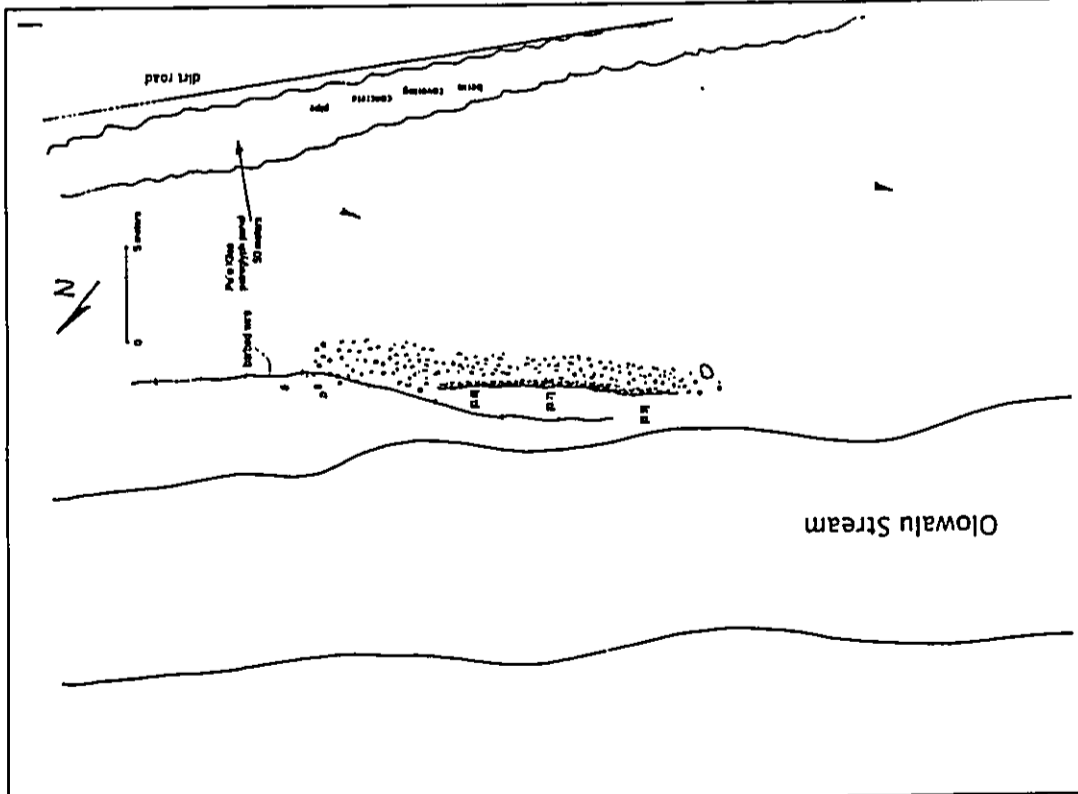
Figure A36 - Plan view of Feature C - Site 4717.

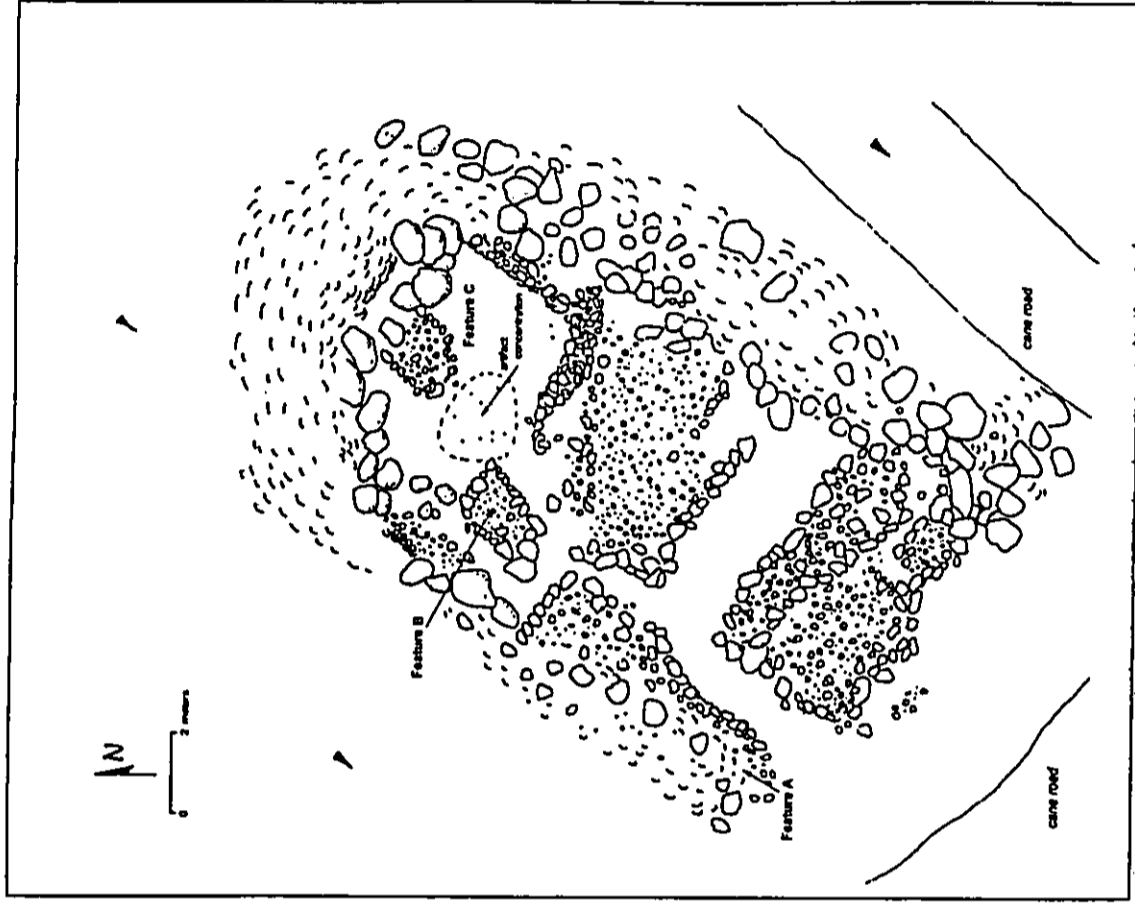
Figure A37—Plan view of Site 4718—*heiau* remnant.

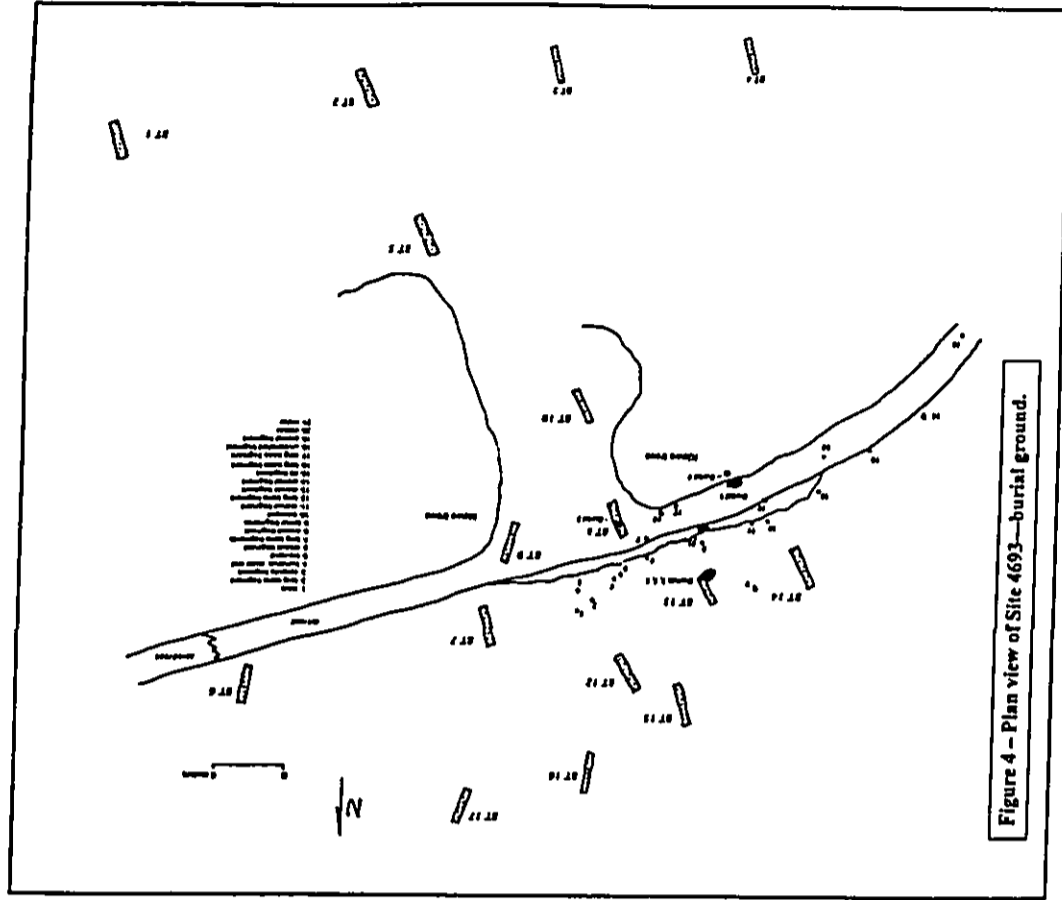
Figure 4 - Plan view of Site 4693—burial ground.

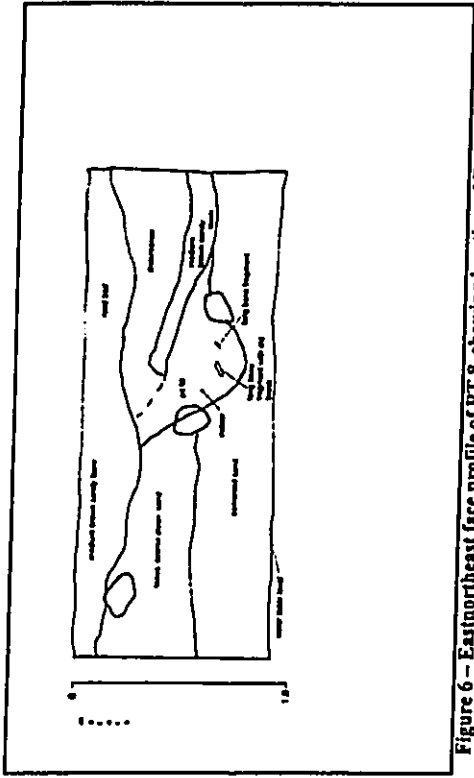
Figure 6 - East-northeast face profile of BT 8, showing location of Burial #2.

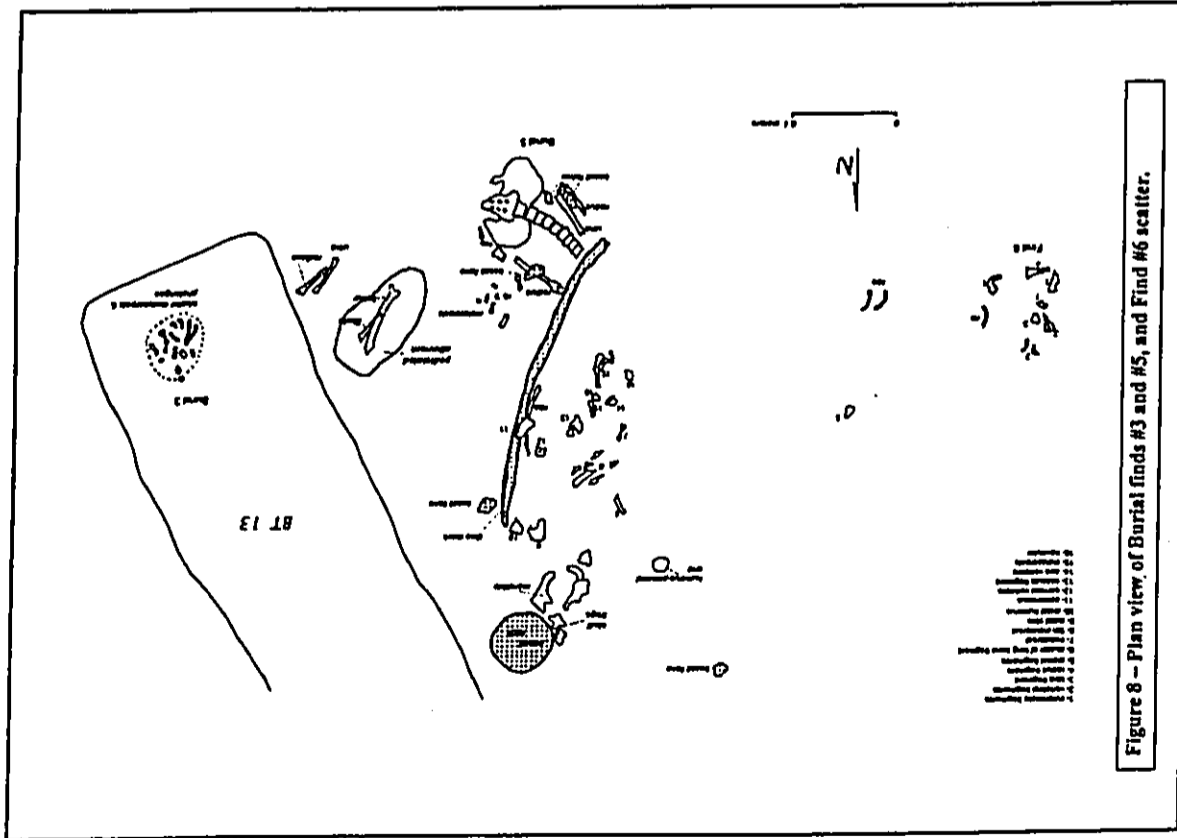
Figure 8 - Plan view of Burial finds #3 and #5, and Find #6 scatter.

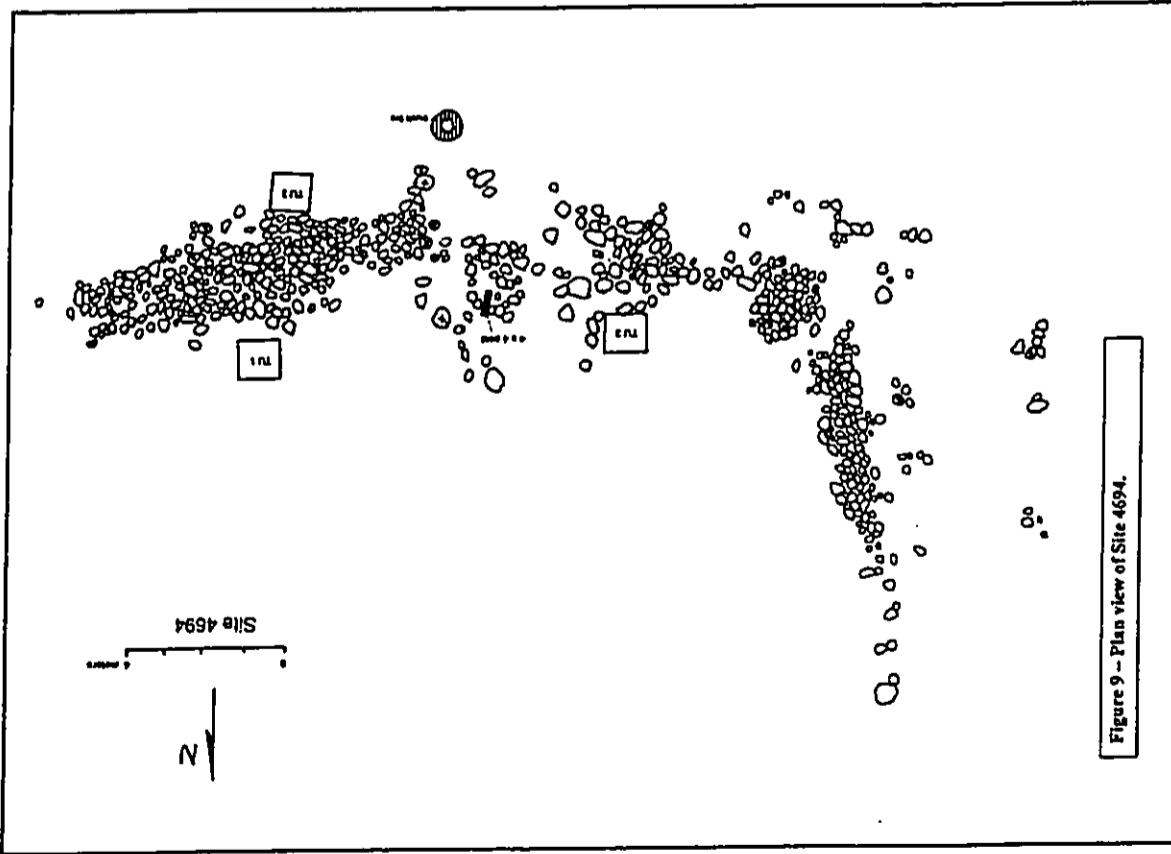
Figure 9 - Plan view of Site 4694.

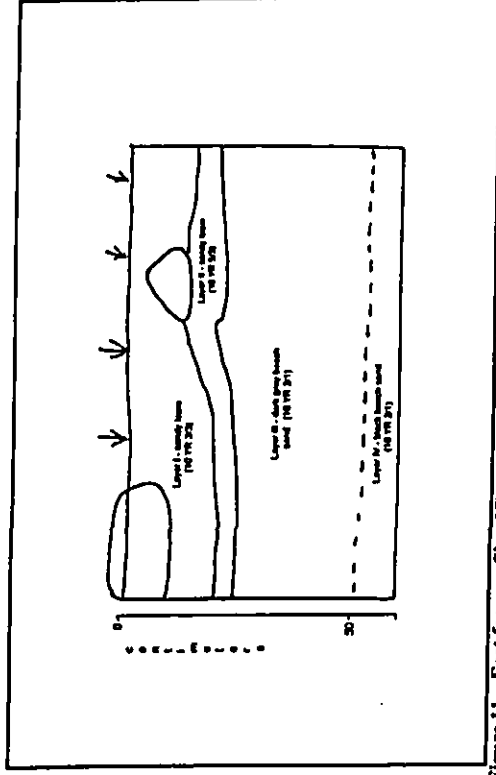
Figure 11 - East face profile of Test Unit 2—Site 4694.

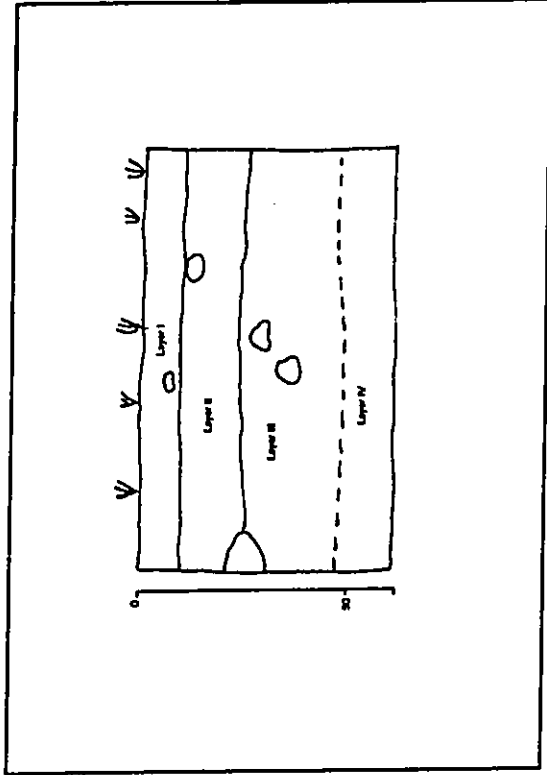
Figure 13 - East face profile of Test Unit 3—Site 4694.

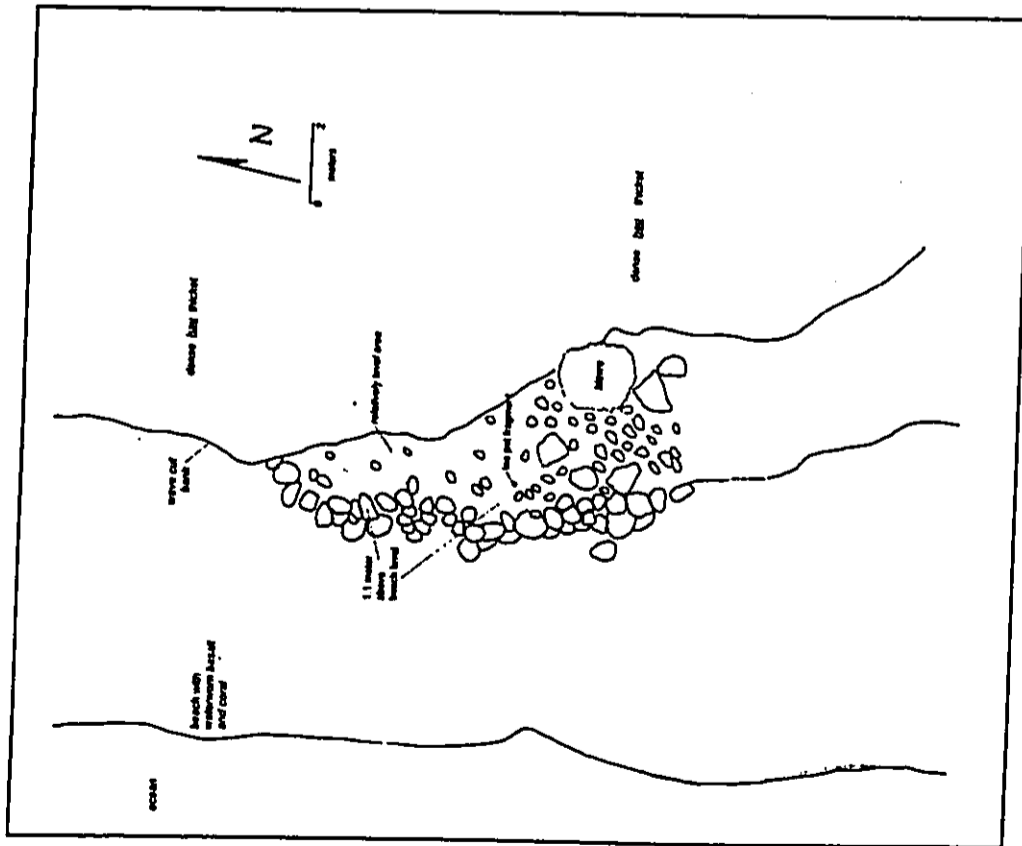
Figure 14 - Plan view of Site 4695.

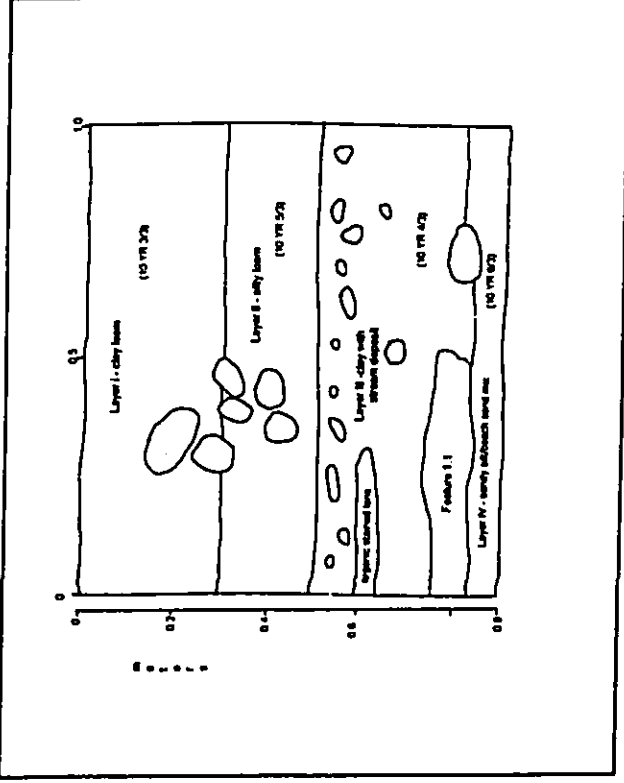
Figure 17 — West face profile of Test Unit 1—Site 4698.

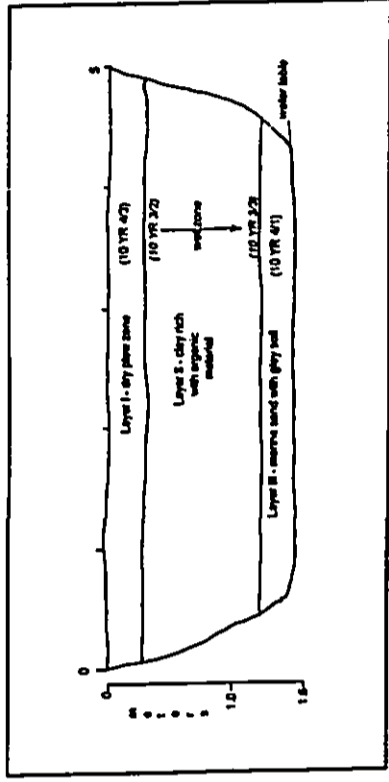
Figure 19 - West face profile of Backhoe Trench 21.

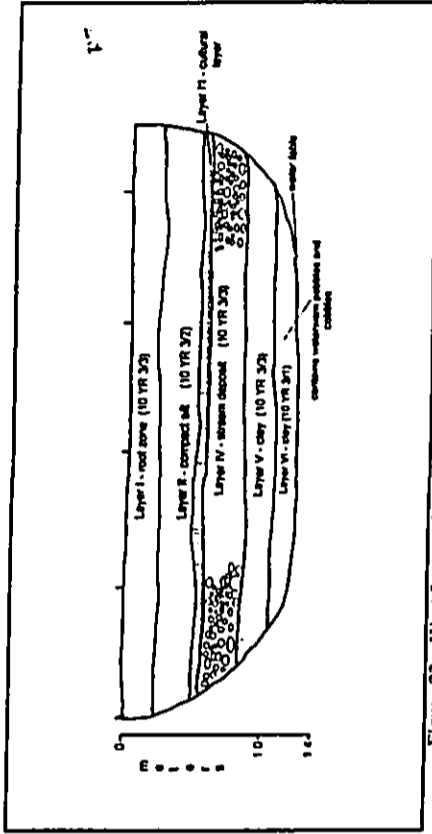
Figure 22 - West face profile of Backhoe Trench 59.
