## STATE OF HAWAII DEPARTMENT OF HAWAIIAN HOME LANDS

Minal Environmental Assessment

Lower Kula and Waiohuli Water System Improvements Tax Map Keys: (2) 2-2-02: 56 (Portion) and 2-3-06: 32

Kula, Island of Maui, Hawaii

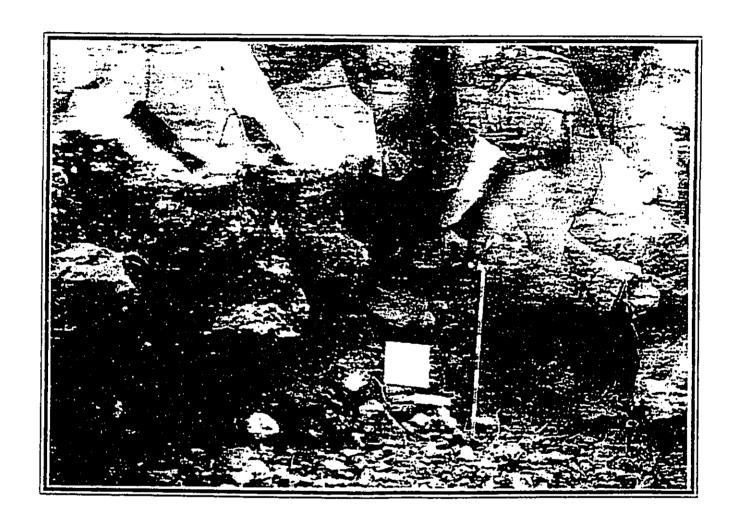
Figure D-12. SITE W-90, ENTRANCE TO HISTORIC BURIAL.
VIEW TO SOUTHEAST. (PHRI Neg.1145-3)

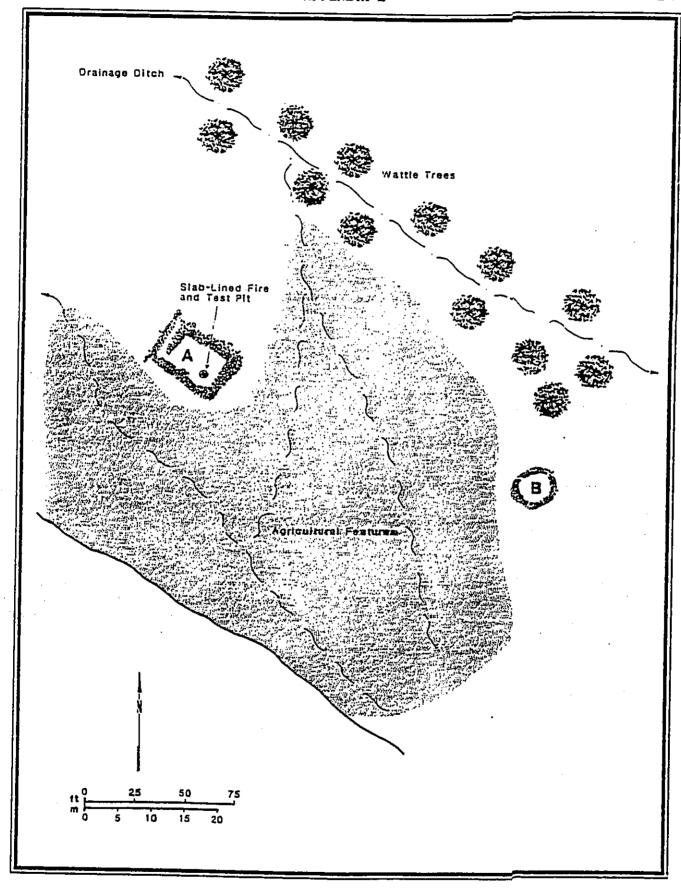
Figure E-1. SITE K-7, FEATURES A AND B.

**DESCRIPTION:** Complex consists of two enclosures, one rectangular and one oval. Surrounding the enclosures are numerous agriculture features.

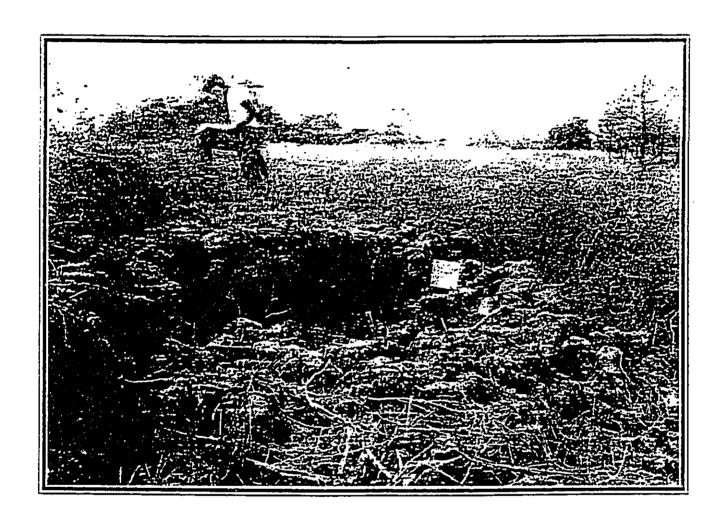
Figure E-2. SITE K-27, OVERHANG. VIEW TO WEST-NORTHWEST. (PHRI Neg. 1143-10a)

DESCRIPTION: Feature consists of two adjacent overhangs with associated walls on top of an outcrop. The south edge of the outcrop abuts the rock wall of Site K-12. The northern overhang is 3.0 m long, 2.5 m deep, and 1.5 m high. The southern overhang is 1.3 m long, 1.2 m deep, and 1.5 m high. Although no cultural remains noted on the surface of the overhangs their association with Feature B and size indicate possible use as shelters. Testing would be necessary to verify prehistoric use.

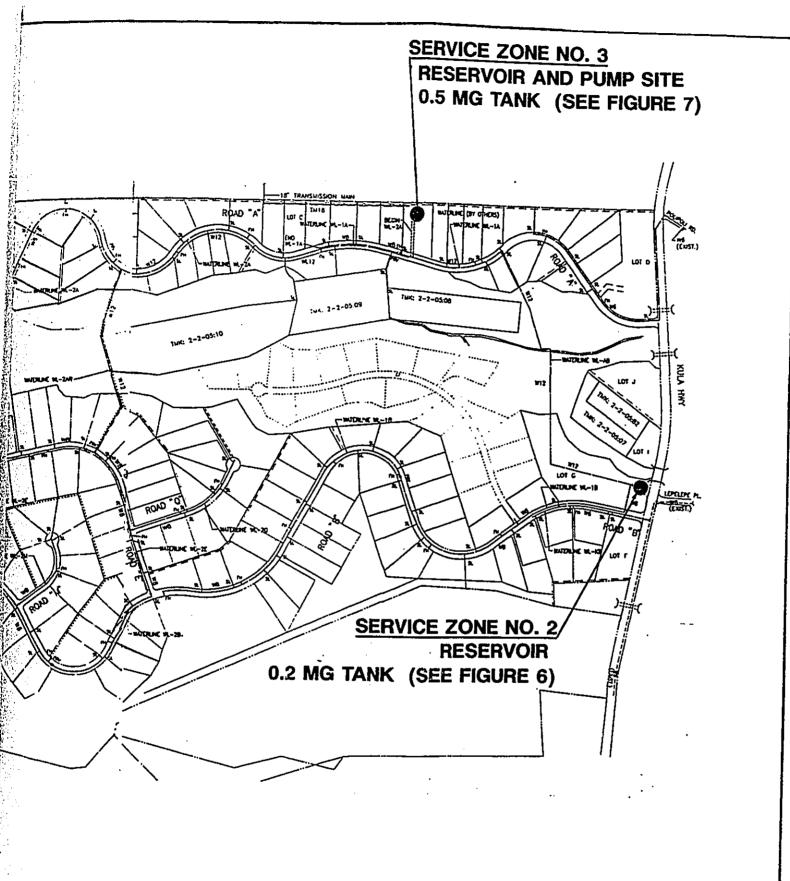
FIGURE 4

RIBUTION MAP CE LOTS - UNIT I

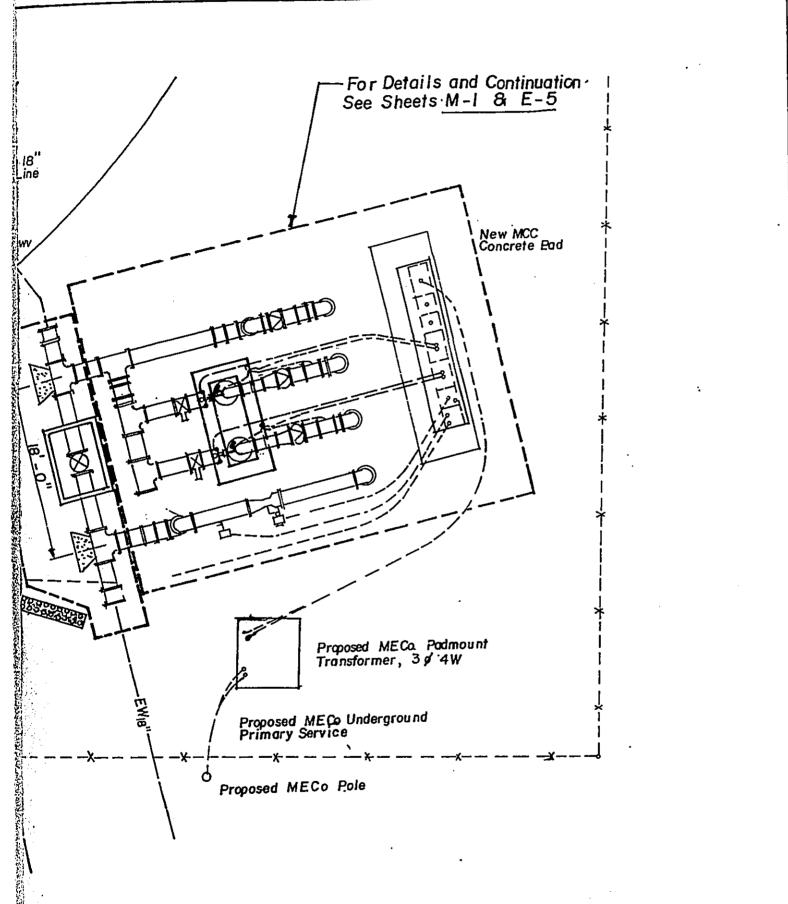
FIGURE 5

## TER PUMP SITE PLAN

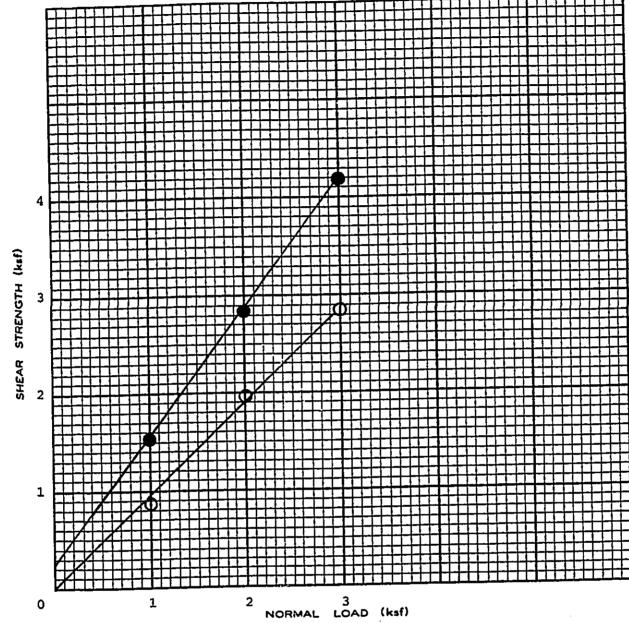
# DIRECT SHEAR TEST

LOCATION	DEPTH (ft.)	COHESION (psf)	ANGLE OF	TEST CONDITIONS
~	B-1, S-2	2.5'	250	53°	Field Density - Peak Strength
$\frac{1}{c}$	B-1, S-2	2.5'	0	44°	Field Density - Residual Strength
<u> </u>

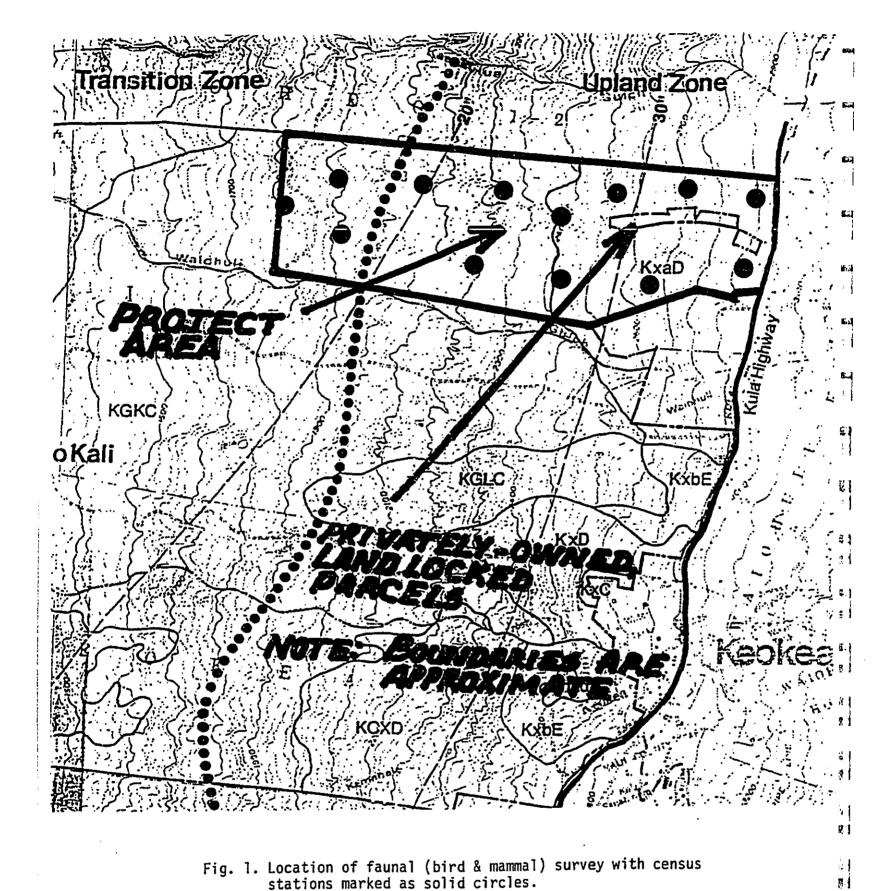
Fig. 1. Location of faunal (bird & mammal) survey with census stations marked as solid circles.

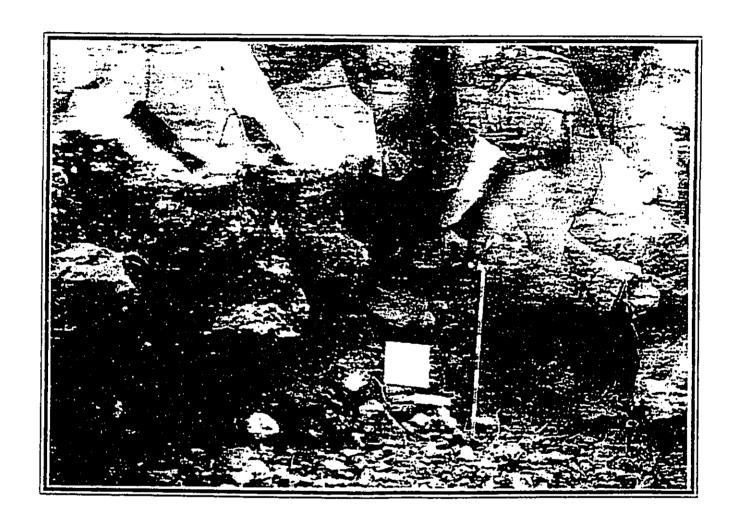
Figure D-12. SITE W-90, ENTRANCE TO HISTORIC BURIAL.
VIEW TO SOUTHEAST. (PHRI Neg.1145-3)

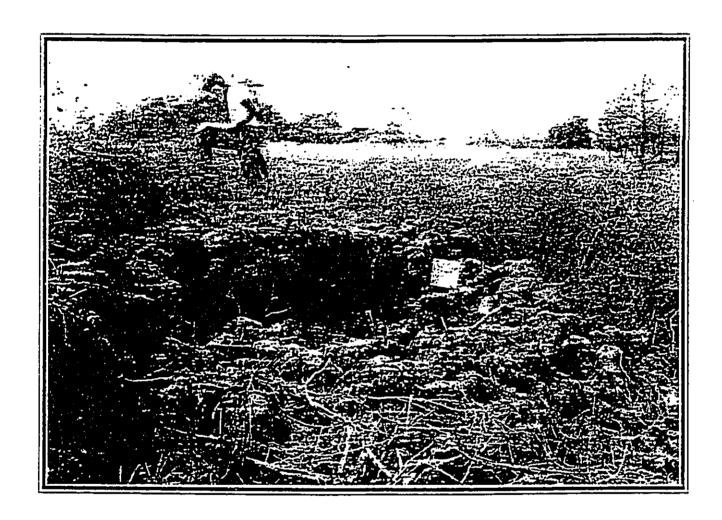
Figure E-2. SITE K-27, OVERHANG. VIEW TO WEST-NORTHWEST. (PHRI Neg. 1143-10a)

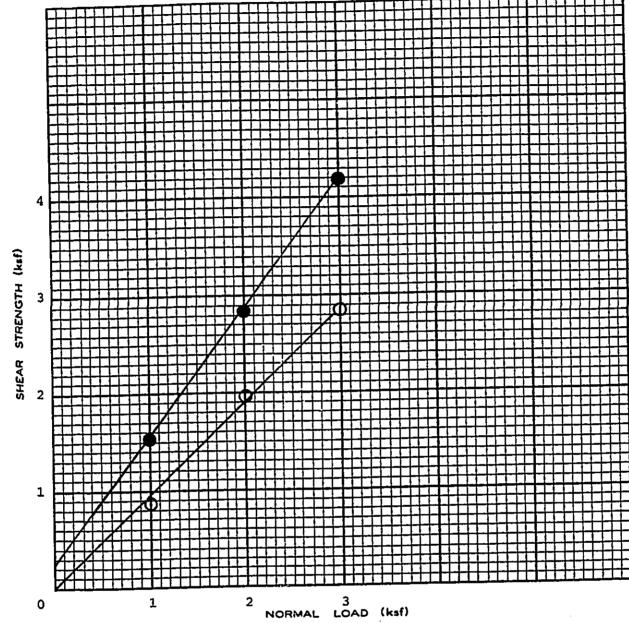
## DIRECT SHEAR TEST

LOCATION	DEPTH (ft.)	COHESION (psf)	ANGLE OF	TEST CONDITIONS
~	B-1, S-2	2.5'	250	53°	Field Density - Peak Strength
$\frac{1}{c}$	B-1, S-2	2.5'	0	44°	Field Density - Residual Strength
<u> </u>
