Owner/Applicant: Edward and Ann Dewey
Agent : Edward Dewey
Location : 1280 Mokulua Drive, Kailua, Oahu
Tax Map Key : 4-3-5: 60
Request : Shoreline Setback Variance (SV)
Proposal : Construct a concrete seawall and stairs
landward of the existing loose rock
revetment
Determination : A Finding of No Significant Impact is
Issued

**ENVIRONMENTAL ASSESSMENT
CONSTRUCT A SEA WALL
MAUKA OF EXISTING REVETMENT**

Lanikai, Oahu, Hawaii

Tax Map Key: 4-3-05:60

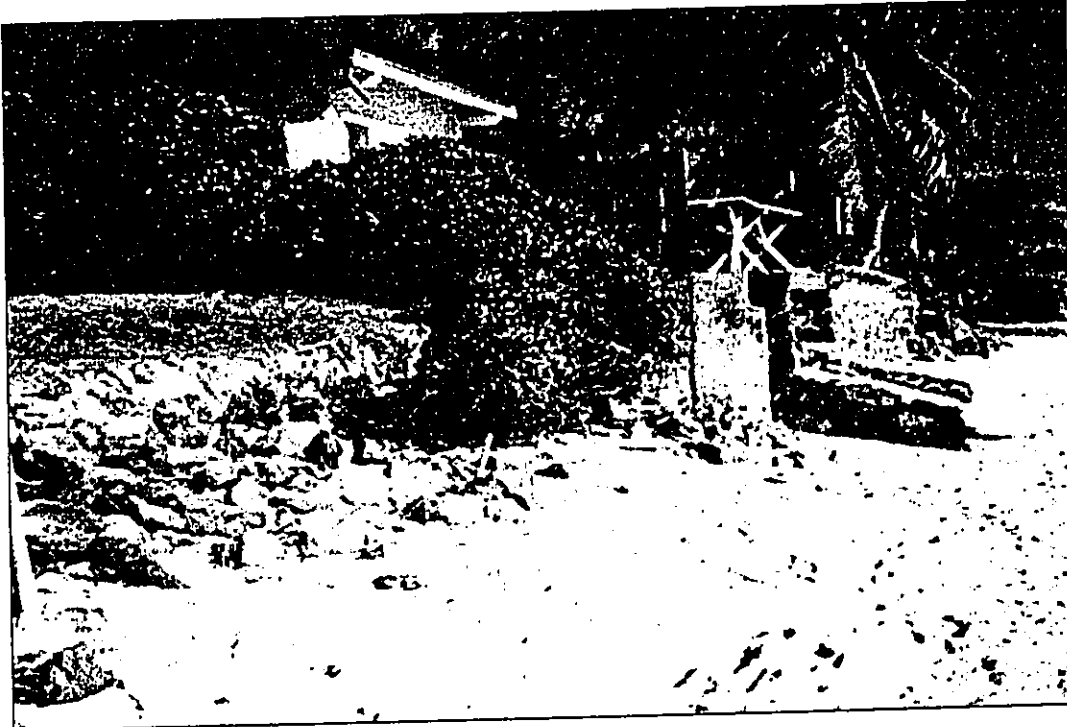
Photo 2
June 1997

← *Note only
6" of drain
headwall showing
at Right of Way.
See photo 14

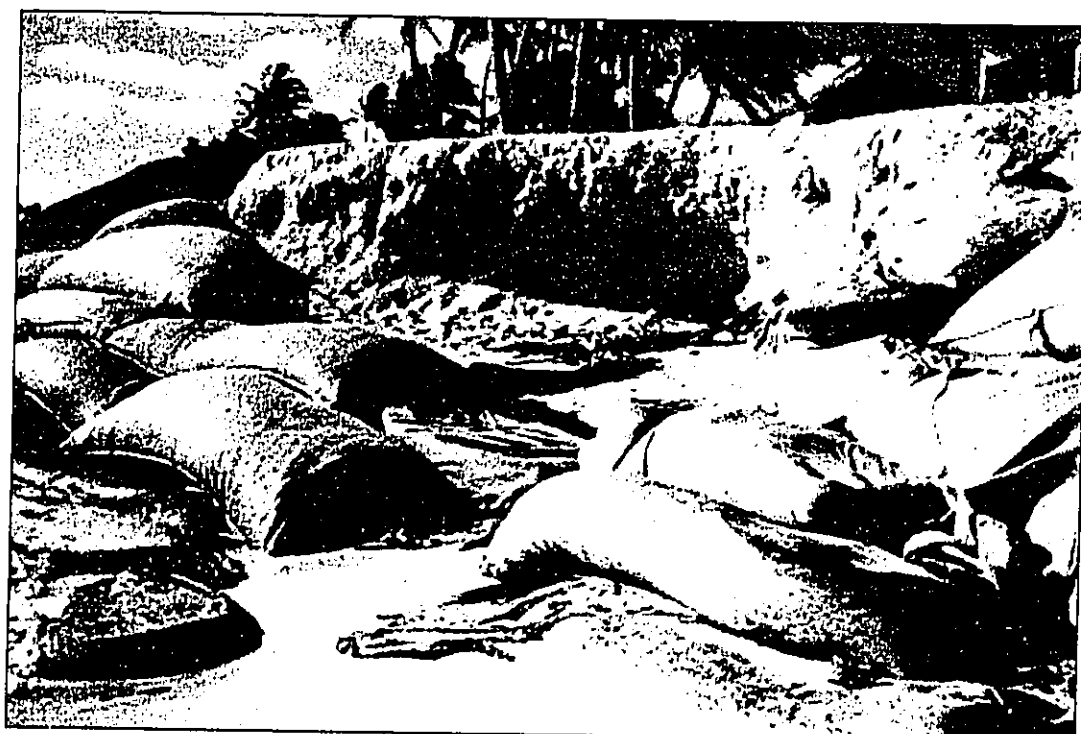
Photo 10
Sept. 4, 2001

Structural Failure

Sand Bag Beach Deterioration

Sand Bag Beach is continuing to deteriorate under the ocean's relentless assault. Even in protected Lanikai, the sand bag structures are not strong enough to survive long term. See Photos 10, 11, 12. The property owners and the community are not happy with the situation. Government policy needs to be changed. The large rock revetment built on the south side of the right of way, south of Sand Bag Beach has performed very well. See Photo 13.

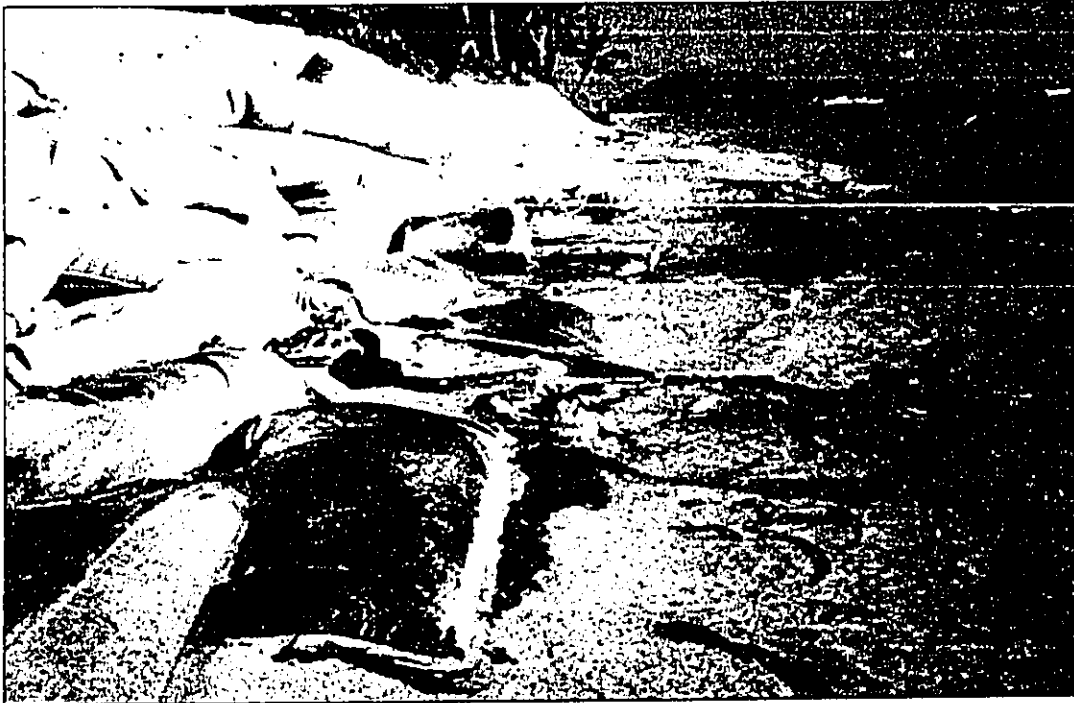
Photo 11
Sept. 4, 2001

View North

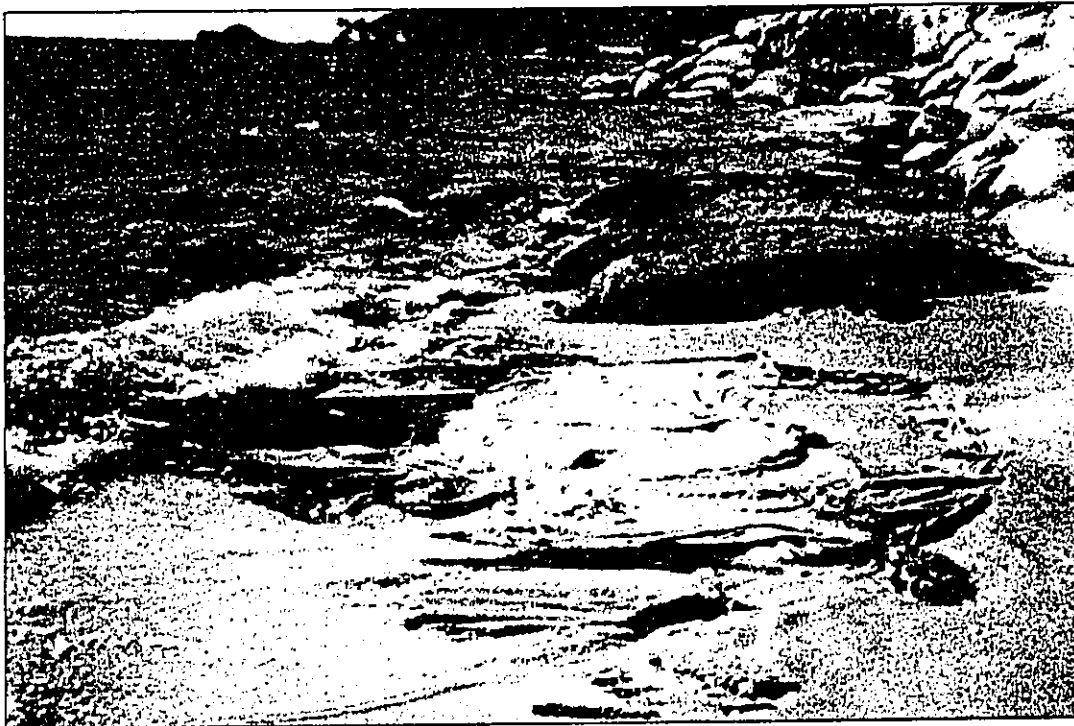
Photo 12
Sept. 4, 2001

View South

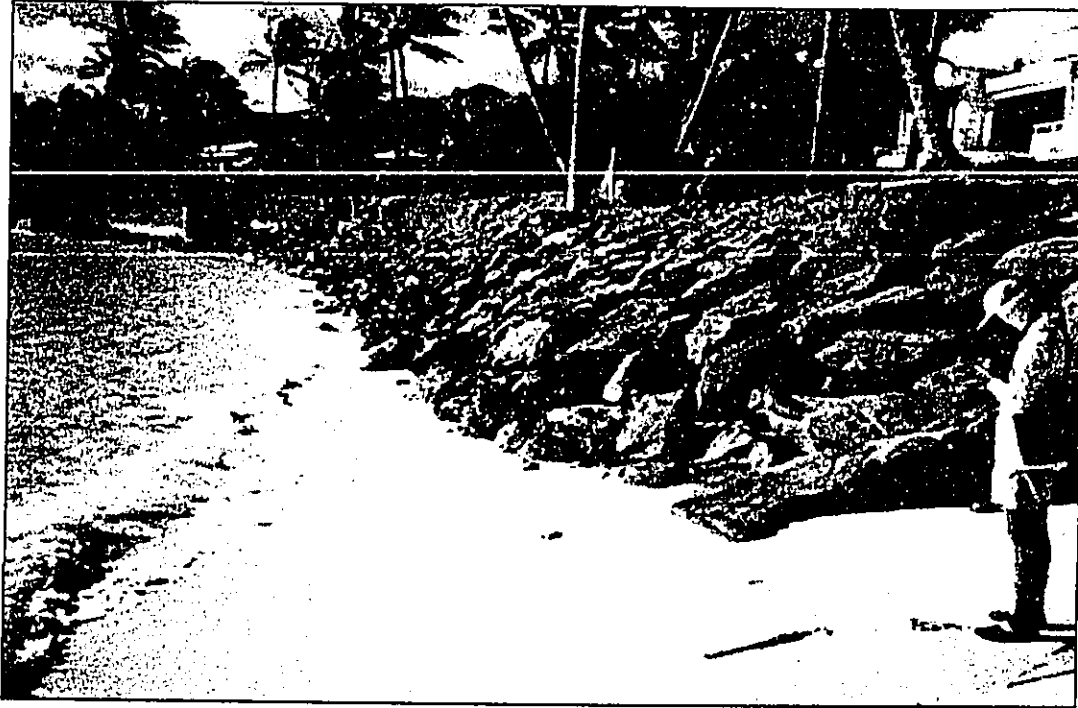
Photo 13
Sept. 4, 2001

Engineered, sloping large rock revetments directly South of Sand Bag Beach right of way are effective shoreline protection, fisherman / lateral access friendly, attractive and less reflective than sand bags.

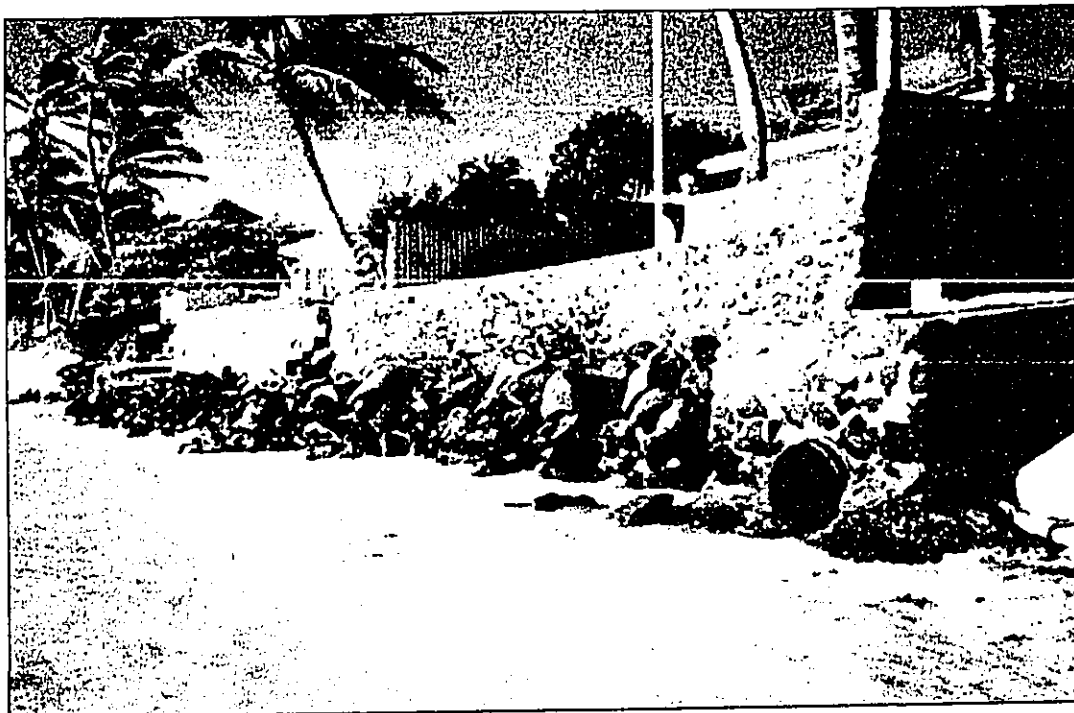
Photo 14
Sept. 4, 2001

54" vertical sand loss measured at headwall of drainage out let since June 1997.
Right of way is over drainage way, now unsafe to use.

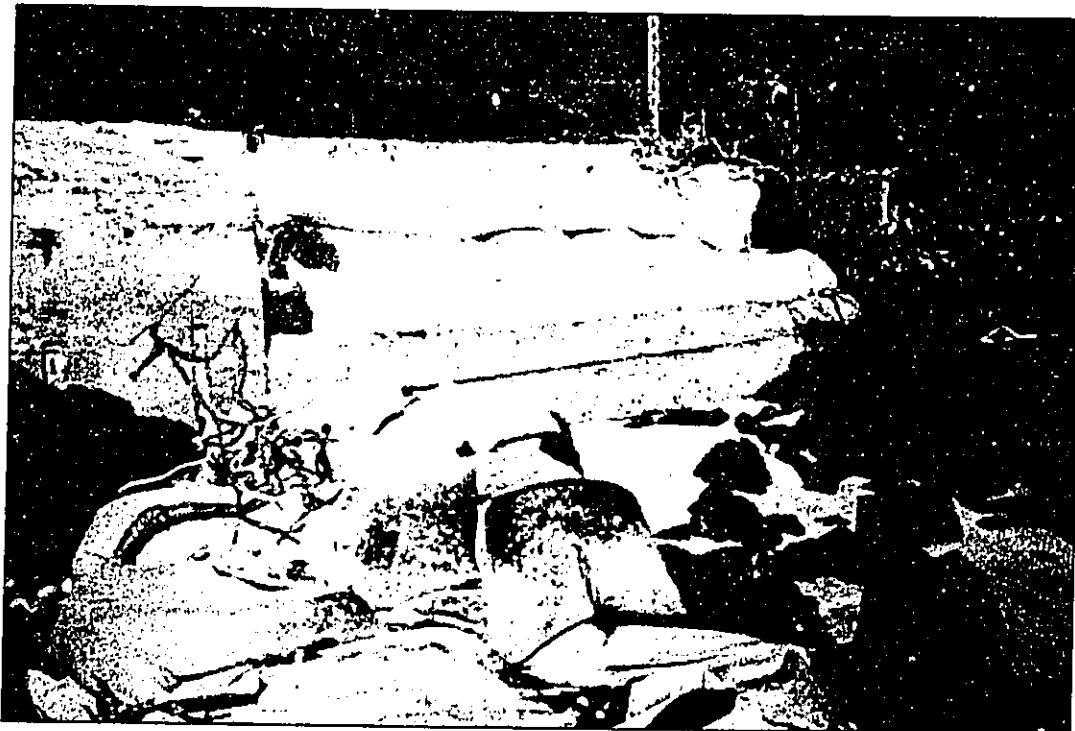
Photo 17
Sept. 4, 2001

150 ft poured in place reinforced concrete vertical seawall with boat ramp and loose rock dissipater now exposed North of new sand bag site.

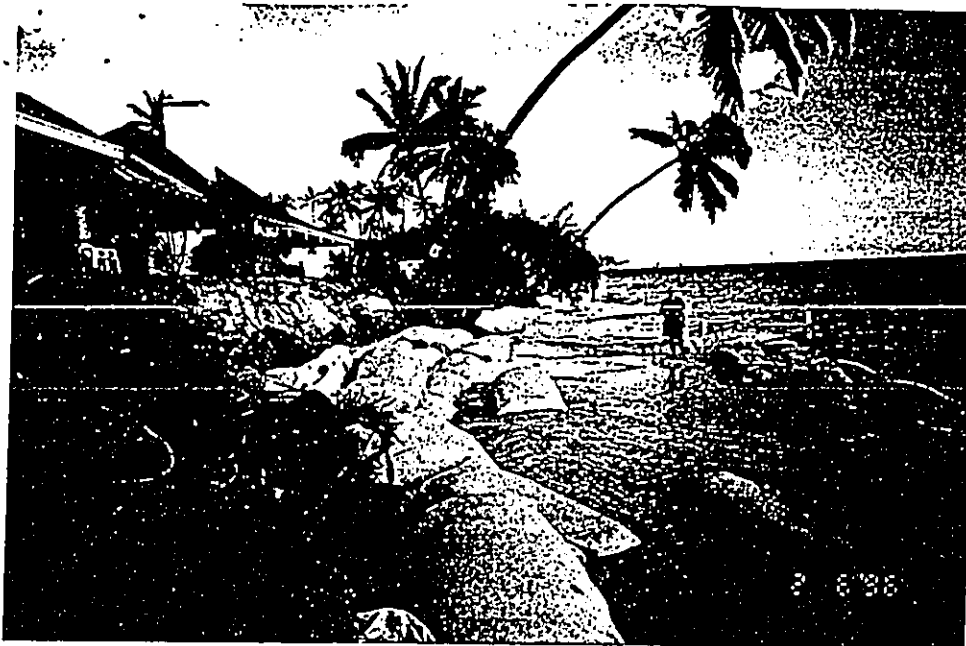
Photo 4: View northward showing damaged condition of sandbags fronting adjacent parcel 98 (Carpenter).

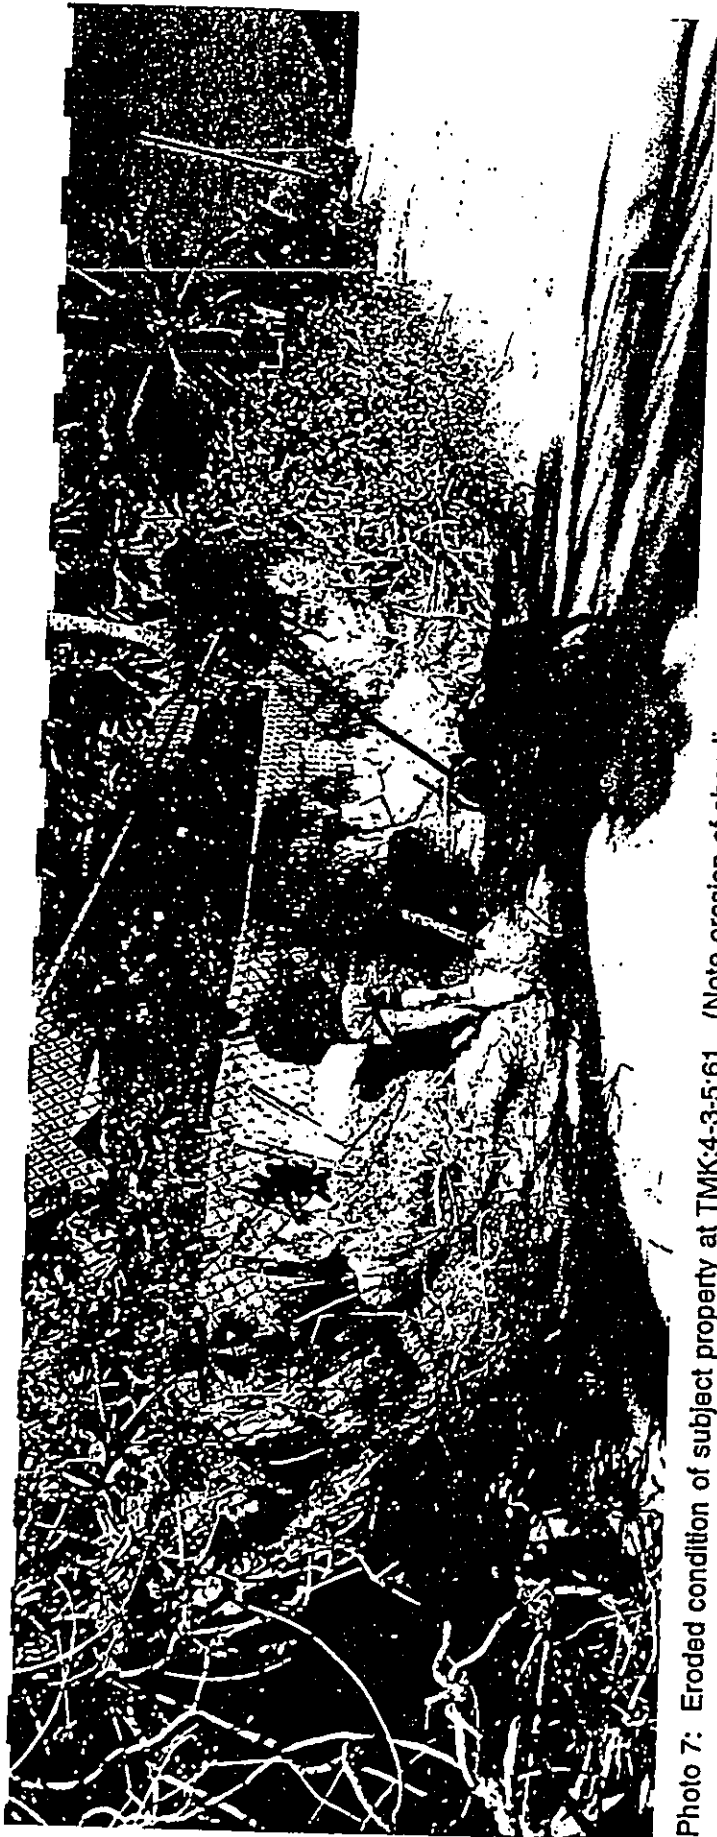
Photo 7: Eroded condition of subject property at TMK:4-3-5:61. (Note erosion of shoreline vegetation and undermining/collapse of fence.)
