**2004-03-23 FONSI
LANIKAI SHORE PROTECTION STRUCTURES**

Final Environmental Assessment

Proposed Shore Protection -- Two Residences, Lanikai

**Lanikai, Oahu
TMKs: 4-3-005: 088 and 059**

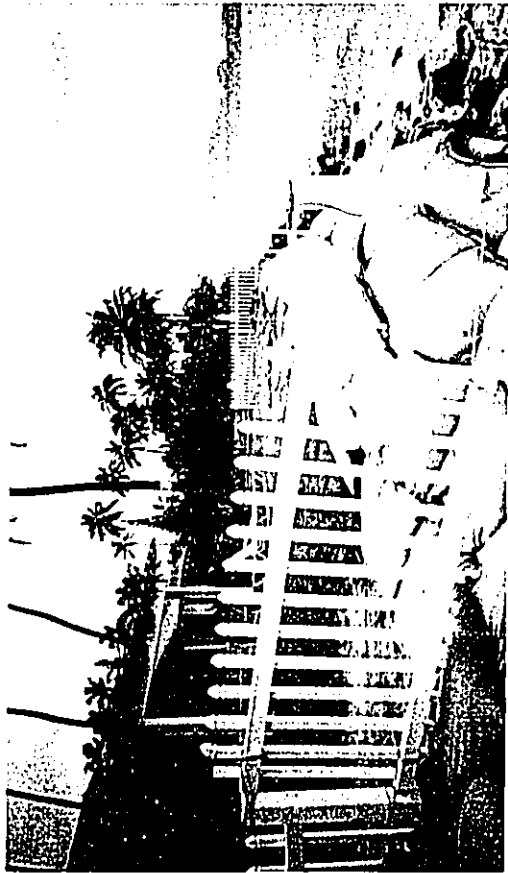
Photo A: View looking north (toward Makapu) across parcel 88. The white fence in the foreground marks the boundary between parcels 59 and 88. The white fence in the distance marks the north boundary of parcel 88.

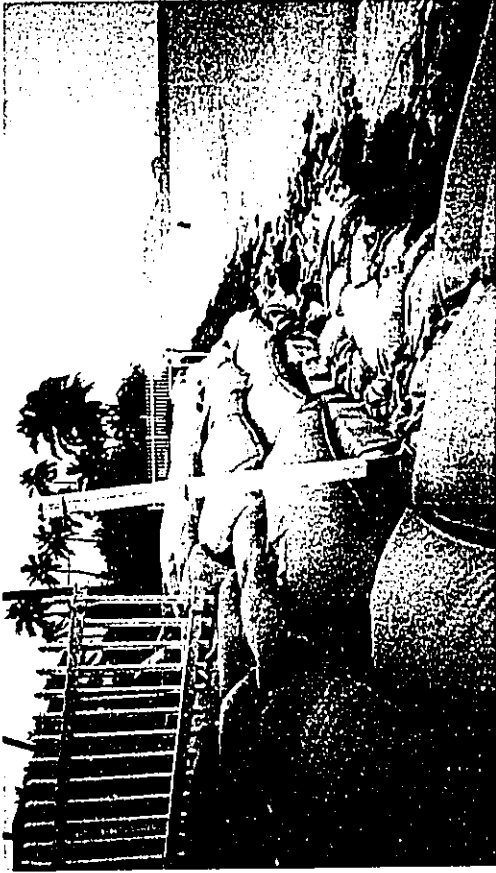
Photo B: Looking in the same direction as Photo A at the base of the SEAbags. The top edge of the nonconforming seawall is visible, starting at the bottom of the white post. The rocks lying on the seaward side of the wall are part of a "rock blanket" intended to protect the toe of the wall. The rock blanket was permitted in 1958 by the City Planning Department, the Department of Land and Natural Resources, and the U.S. Army Corps of Engineers.

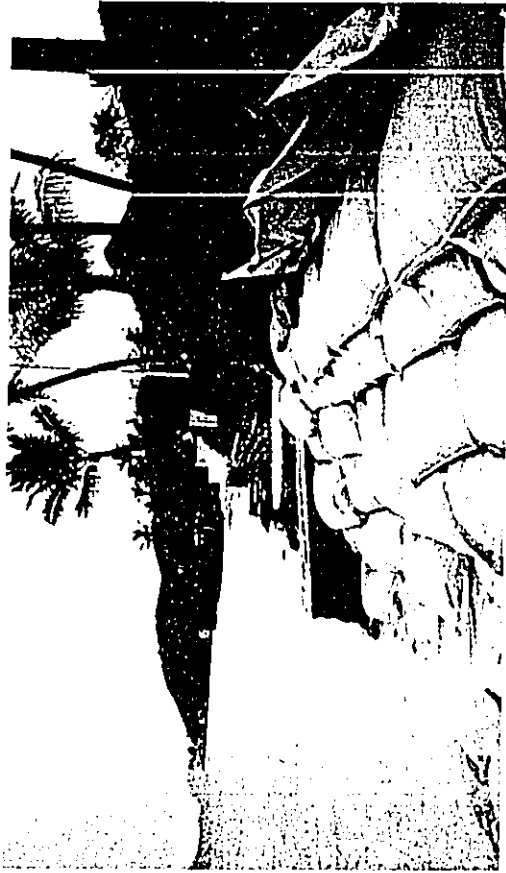
Photo C: View from the middle of parcel 59's shoreline, looking south toward Waimanalo. The protruding CRW groin wall houses the end of a City drainage line and marks the southern end of parcel 59. A public beach right-of-way abuts the southern boundary of parcel 59.

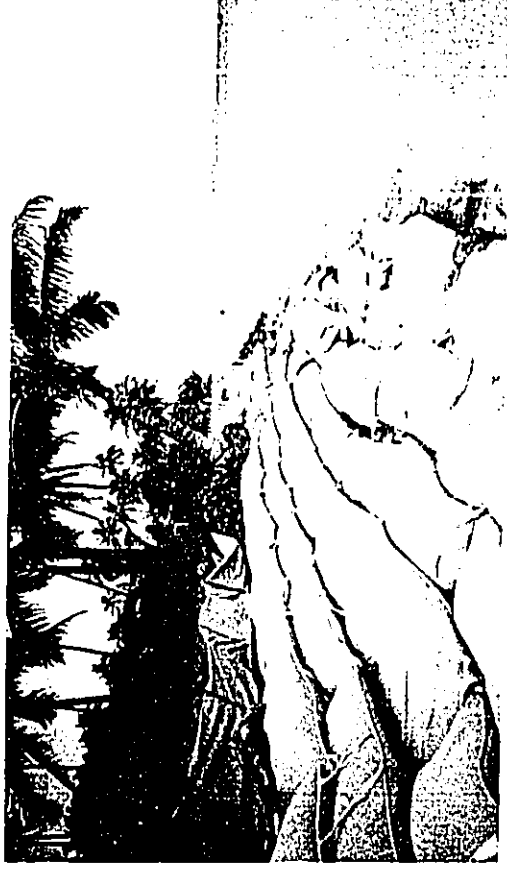
Photo D: View from the south corner of parcel 59 looking north along the shoreline.

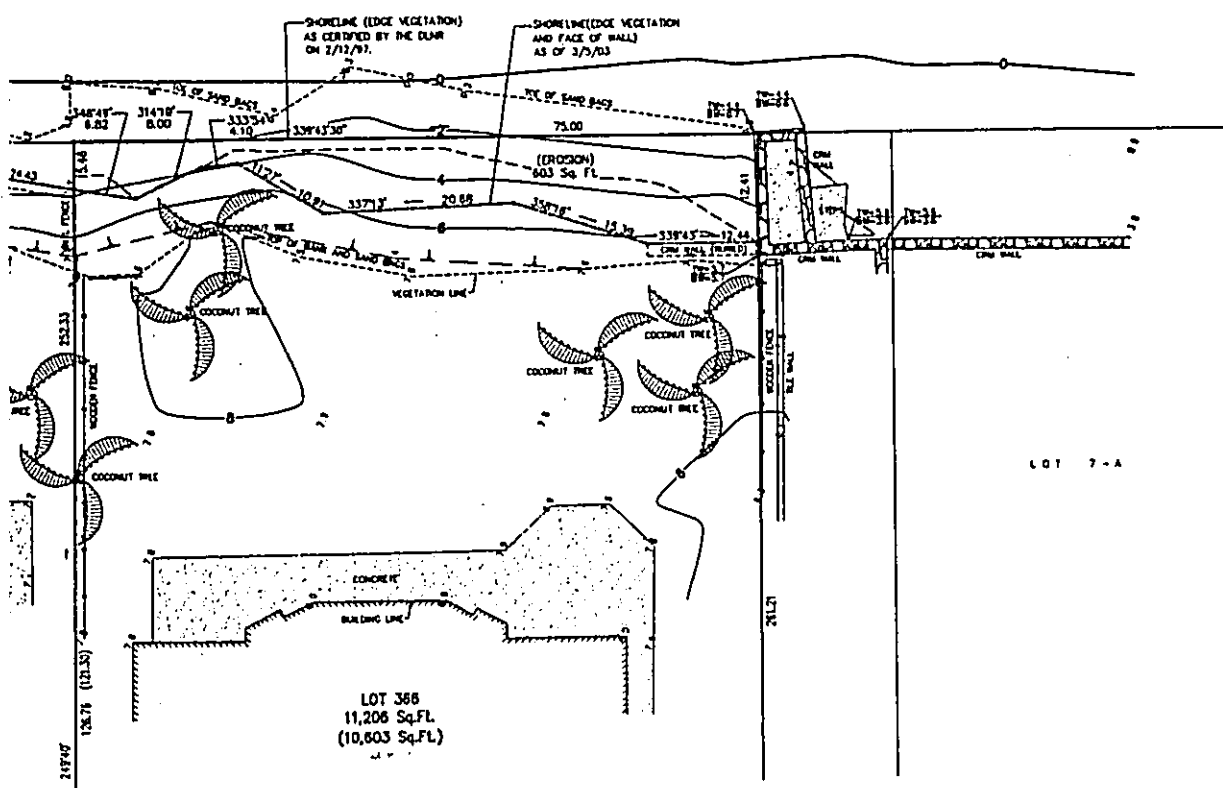
FIGURE 4

TOPOGRAPHIC SURVEY
PORTION LOTS 366 AND 373
LAND COURT APPLICATION 616
AT LANIKAI, KAILUA, KOOLAUPOKO, OAHU, HAWAII

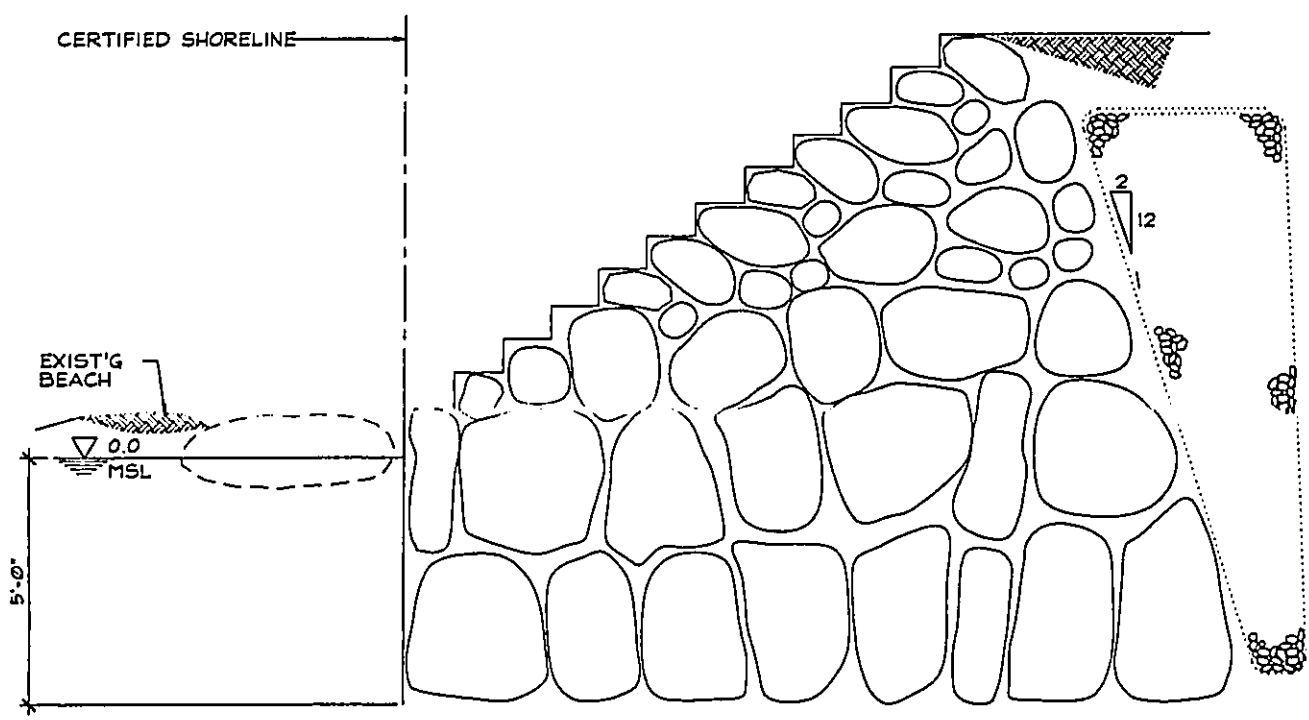
SECTION THRU STAIRS

*EMBED 5'-0" MIN. BELOW MEAN SEA LEVEL UNLESS FOUNDED ON SOLID NON-ERODIBLE SUBSTRATA

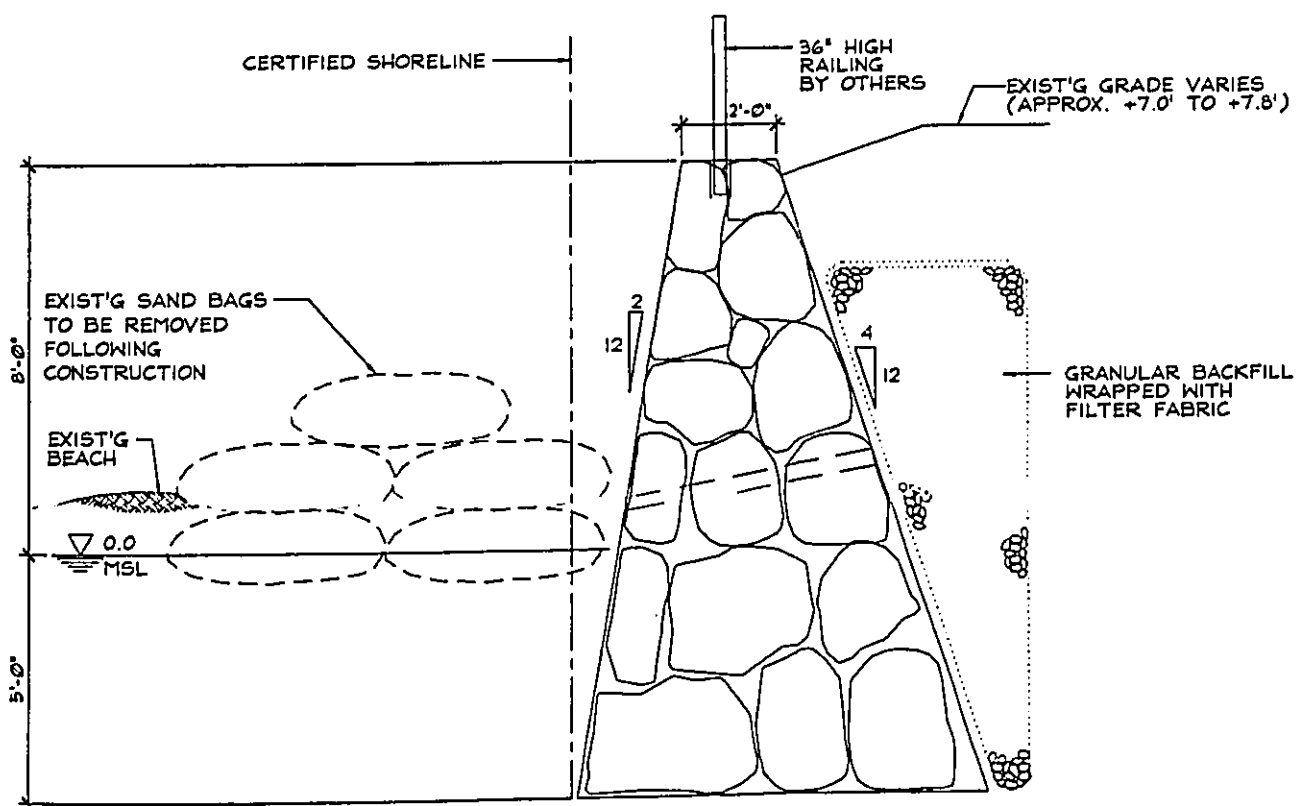
SECTION THRU NEW CRM SEAWALL
 SC 1/4" = 1'-0"

3. EMBED BASE OF WALL 3'-0" MIN. BELOW MEAN SEA LEVEL UNLESS SOLID NON-ERODABLE STRATA IS ENCOUNTERED AT A HIGHER ELEVATION.
4. ALL STONES SHALL BE CLEAN AND FREE FROM DIRT OR LOOSE MATERIAL.

7. BACKFILL SHALL CONSIST OF CLEAN SAND, 3B FINE OR OTHER APPROVED NON-EXPANSIVE GRANULAR MATERIAL. COMPACTION SHALL NOT EXCEED 95%. BACKFILL SHALL BE WRAPPED IN A GEOTEXTILE FABRIC SUCH AS SUPAC 4NP. LAP FILTER FABRIC 5'-0" MIN.

Figure 5a is a reduced version of the structural engineering plans for the project, including the wall layout plan and sections. Structural calculations are provided in **Figure 5b**. As shown in the drawing “Section Thru New CRM Wall,” the proposed structure is a typical gravity wall design, with a foundation set five feet below mean sea level (MSL). The wall will be approximately 9.5 feet wide at the base, tapering to two feet wide at the top. The top of the wall will be at or slightly above the grade of the rear yards, which varies from +7.0 to +8.0 MSL. The area behind the wall will be excavated and backfilled with granular backfill wrapped in geotextile filter fabric. The backfill and weep-holes will allow for relief of

hydrostatic pressures created when the wall is over-topped by high tides and storm waves; the filter fabric will prevent escape of fine soil material into shore waters. Following construction, the existing SEAbags will be removed, and a safety railing will be installed on top of the seawall.

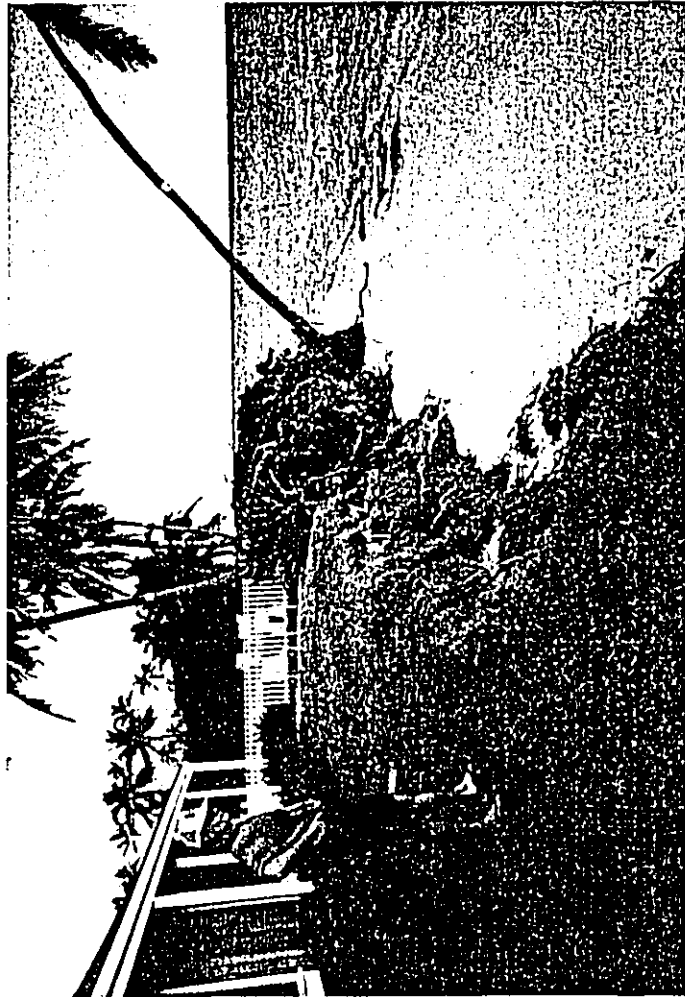
Photo 2: View northward showing eroded condition of subject property.

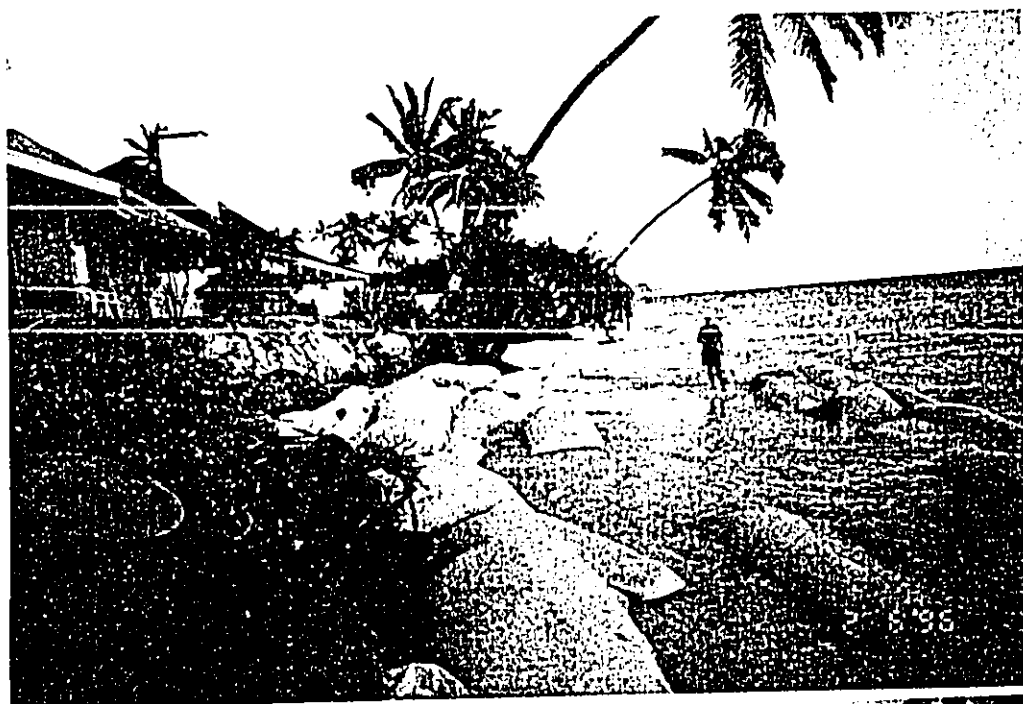
Photo 4: View northward showing damaged condition of sandbags fronting adjacent parcel 98 (Carpenter).

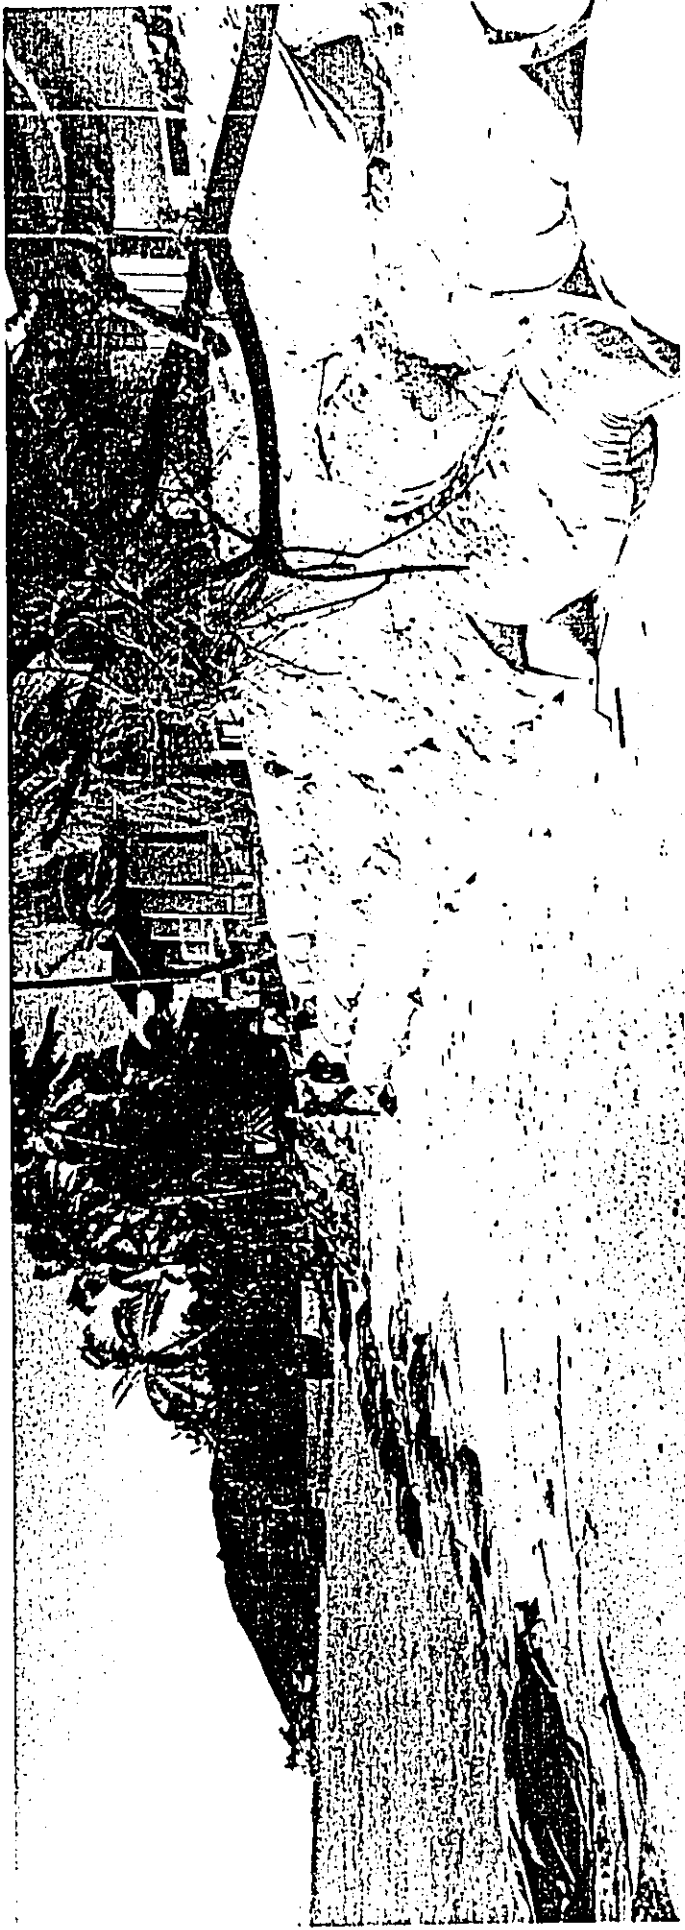
Photo 8: View southward showing rebuilt sand bag revetment on adjacent parcel 98 (Carpenter).

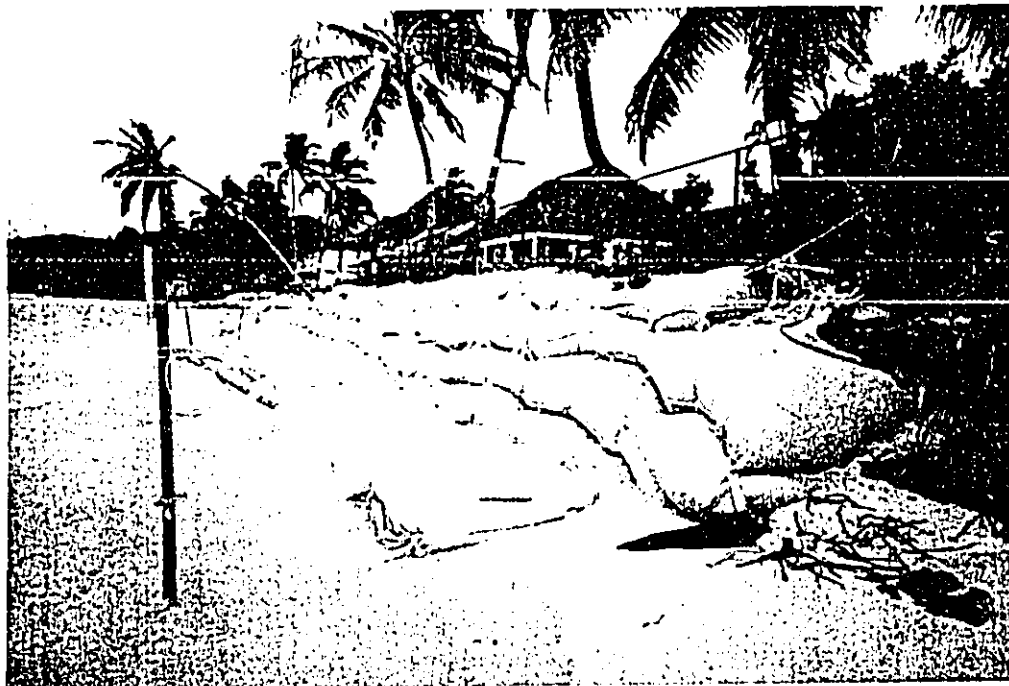
Photo 9: View southward showing completed sand bag revetment on subject property TMK:4-3-5:61.

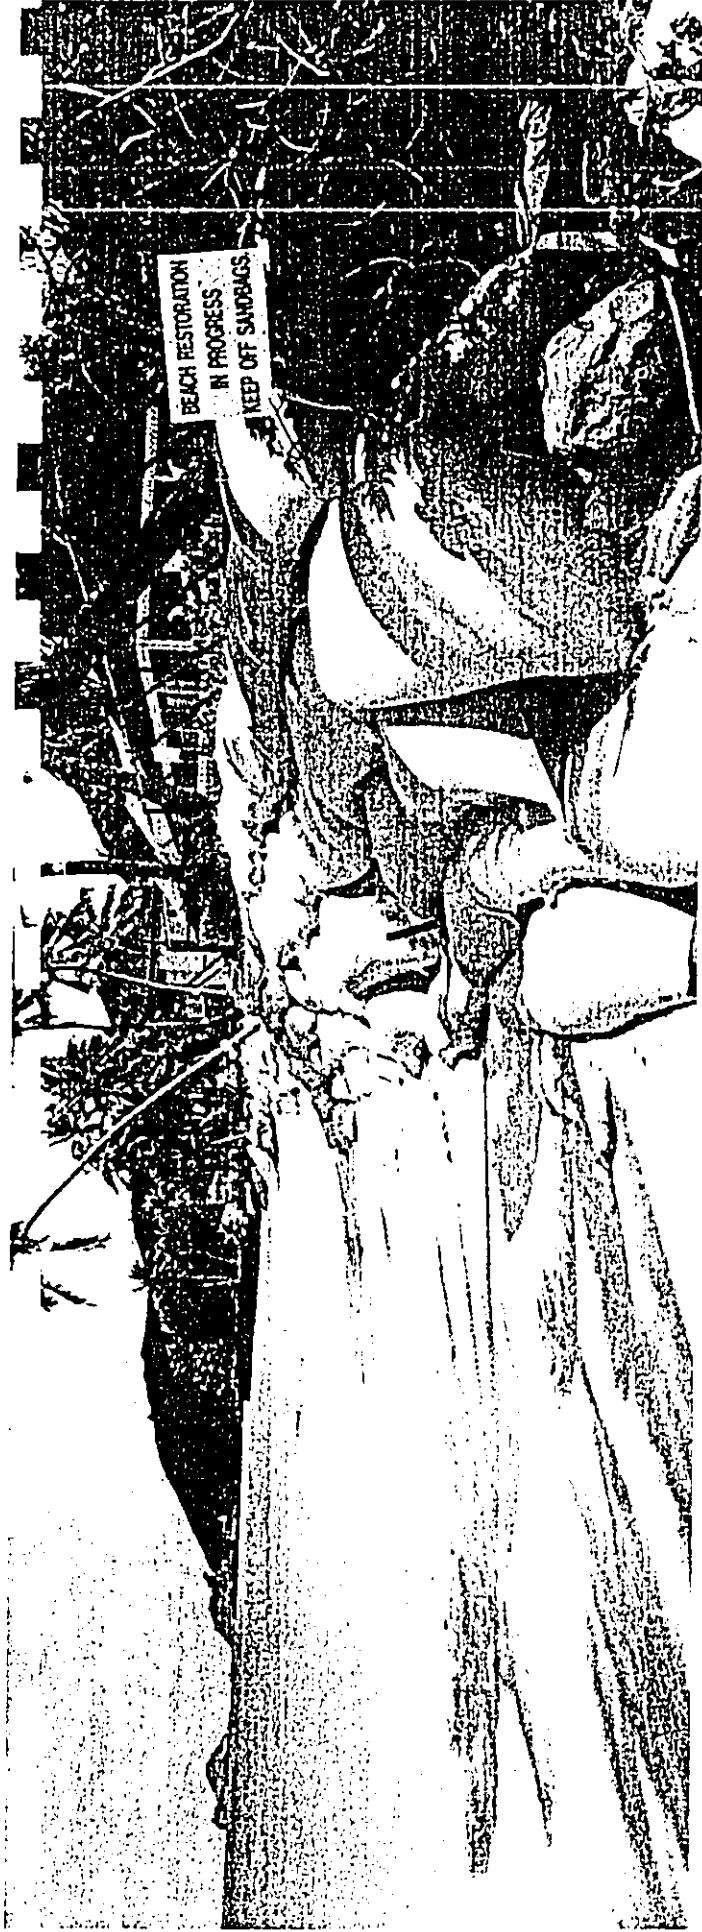
Photo 12: View southward fronting subject property TMK:4-3-5:61 showing condition of sand bag revetment after repairs completed.

Photos 12 through 17, taken in May 1997, show the existing condition of the SEAbag revetment on the subject parcels and the condition of adjacent properties. Note that the shoreline fronting the adjacent properties to the south is continuing to be modified by placement of SEAbags, removal of prior SEAbags that were damaged, placement of additional beach sand obtained from offsite source(s), and possibly mechanical redistribution of sand in the nearshore area. While the details are unclear, apparently the work is being done as part of a demonstration pilot project for beach replenishment by the Lanikai Beach Management Committee.⁴ A Departmental Permit for use within the Conservation District was issued by the Board of Land and Natural Resources on June 3, 1996 for the demonstration beach replenishment project. A condition of the permit was the requirement to perform pre-, during-, and post-construction beach profile monitoring and topographic monitoring for at least a year. The first monitoring report for the "Pilot Research Project" was filed in September 1997 by David Lipp, the coastal engineer who is monitoring the project on a volunteer basis. The report

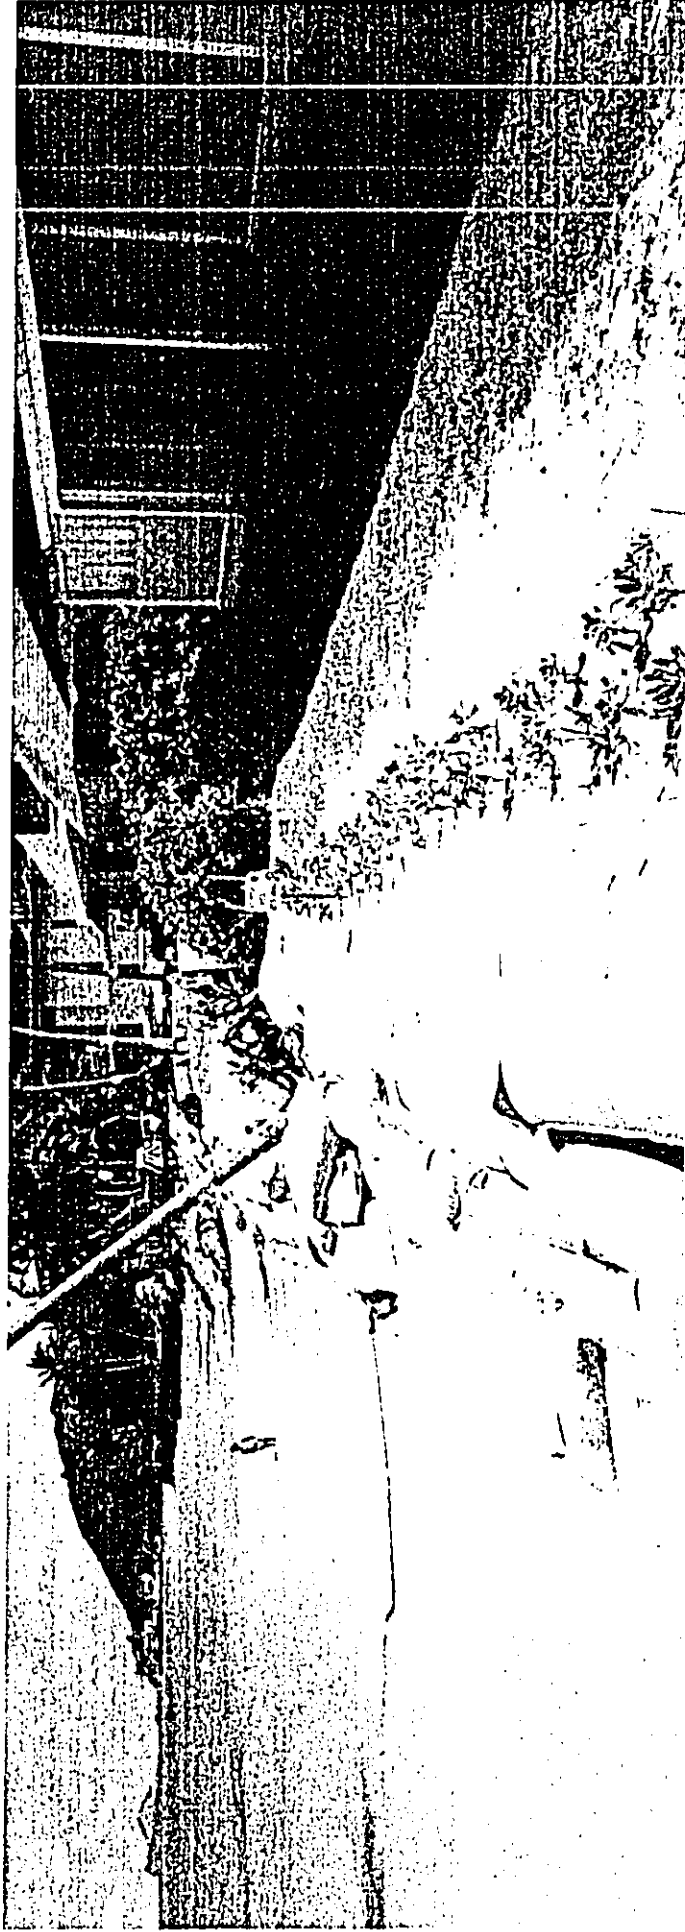
Photo 13: View southward showing shoreline condition in front of the house on subject parcel TMK:4-3-4:74.

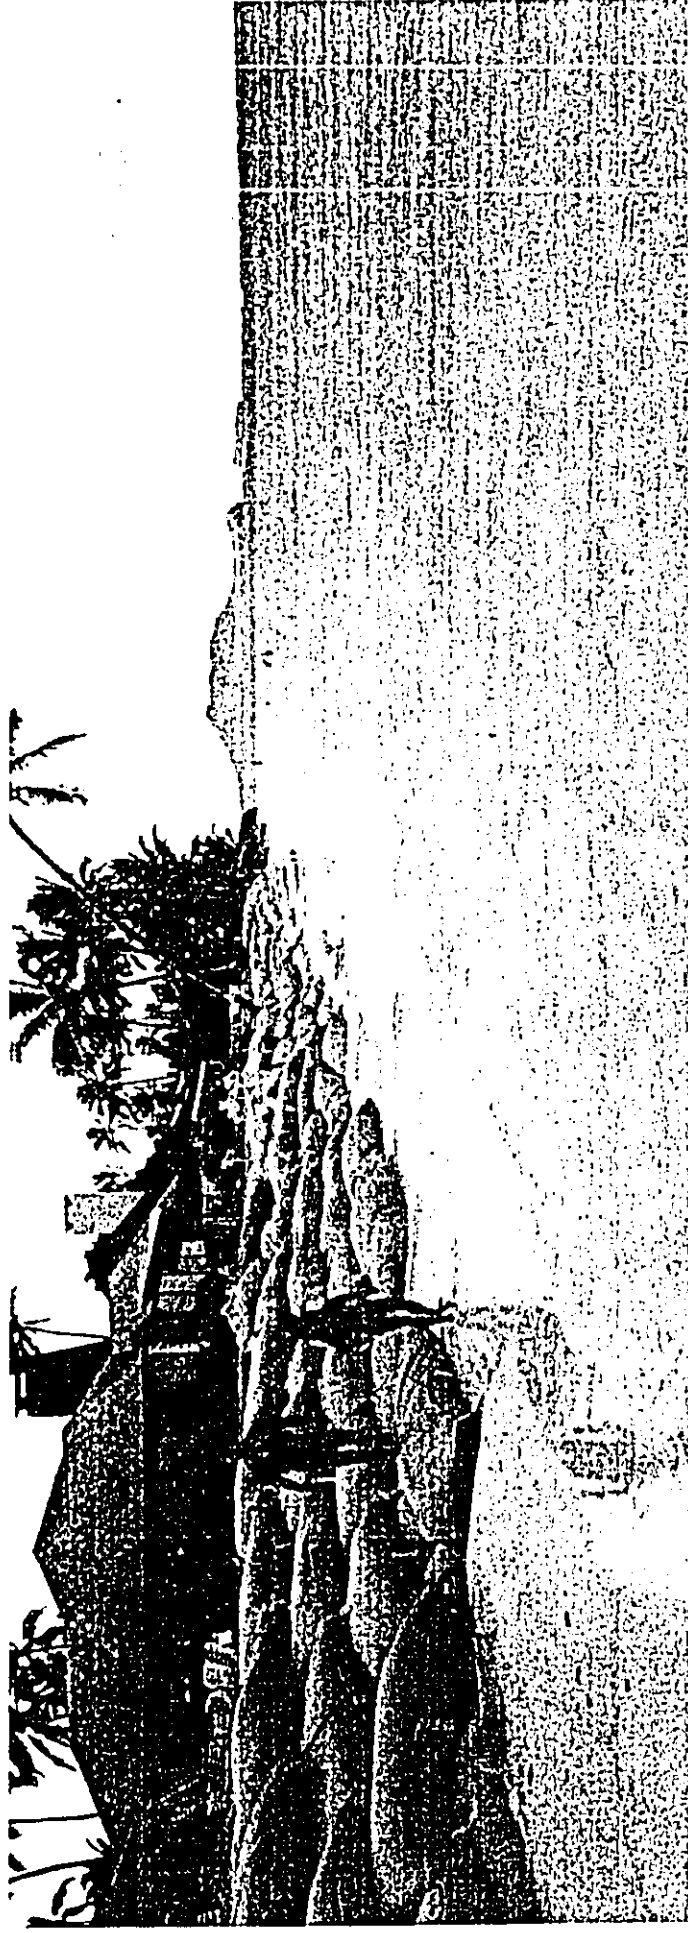
Photo 14: View northward showing condition of shoreline fronting adjacent parcels 76 (Olds) & 98 (Carpenter). Subject parcel is in background.

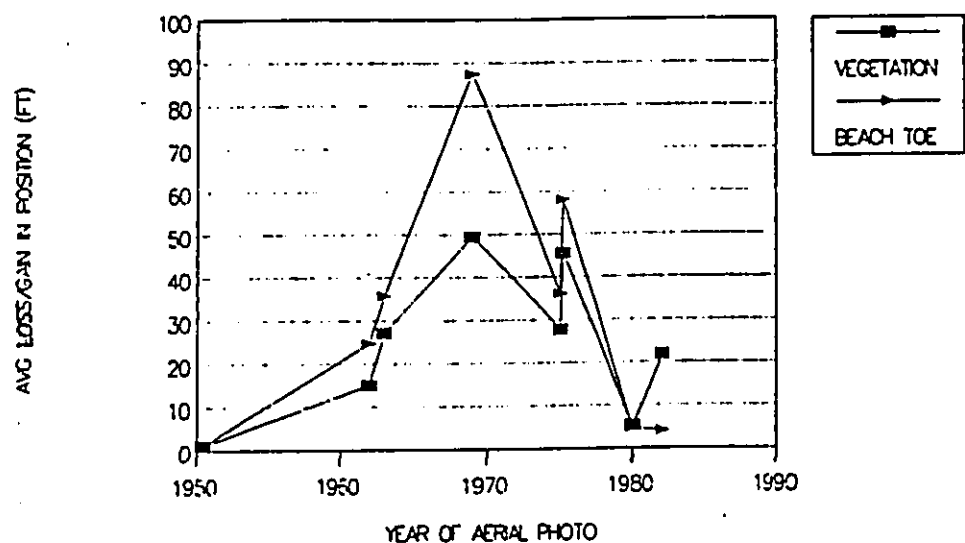
Figure 4a: Average cumulative movement for a 2,500-foot stretch of shoreline from Wailea Point northward to the project site.

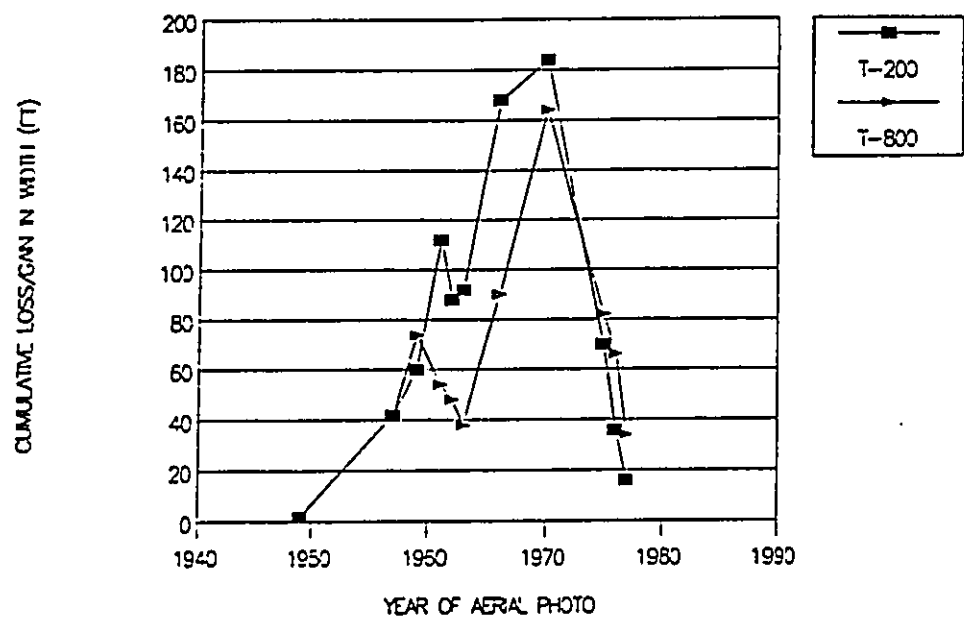
Figure 4b: Cumulative movement of the shoreline at Kailua Beach Park at locations 200' and 800' from the boat ramp.

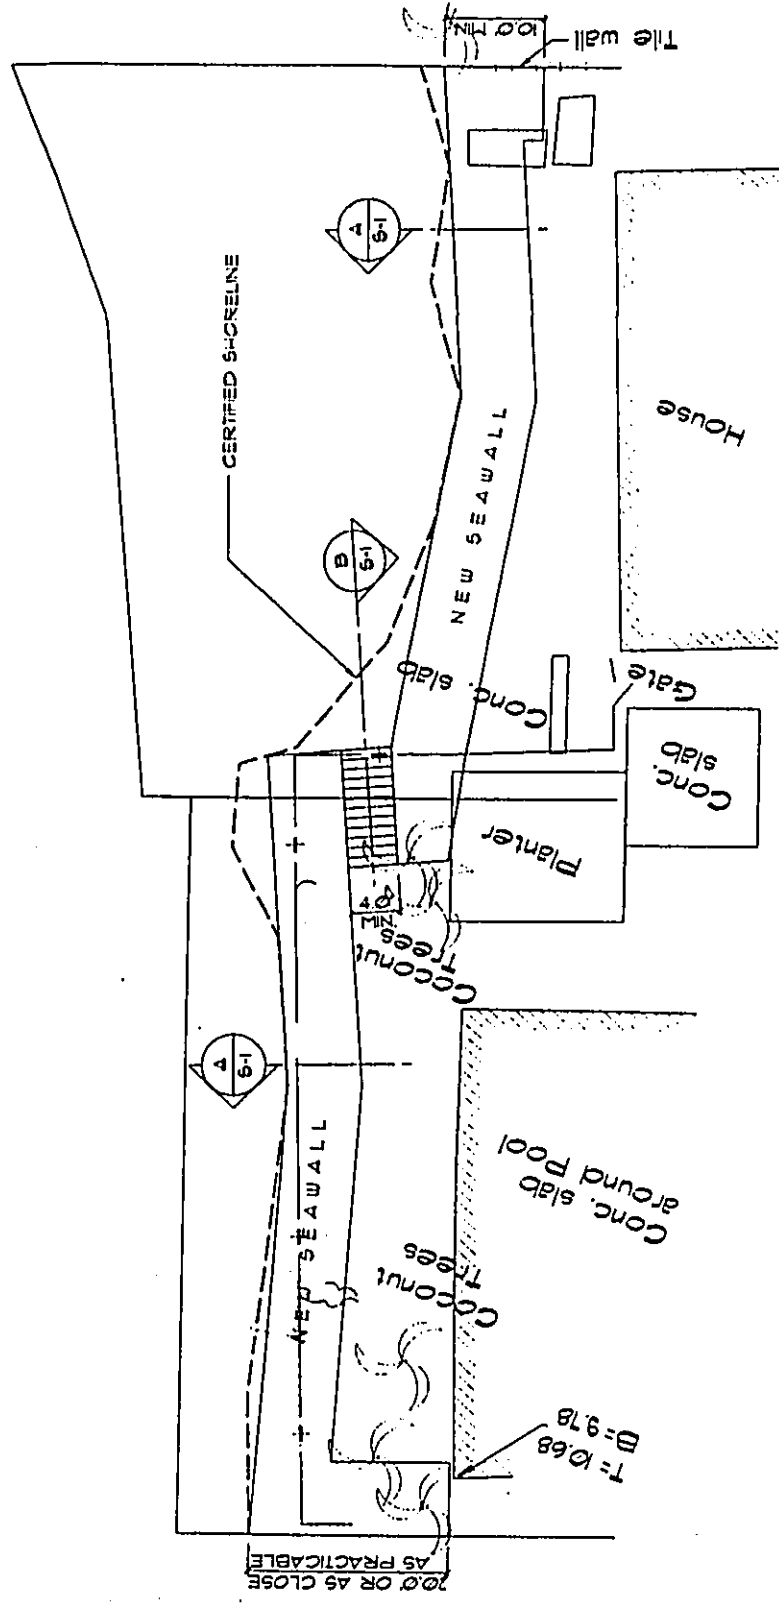
FIGURE 5

WALL LAYOUT PLAN

The "Wall Layout Plan" (Figure 5a) shows that the seaward edge of the wall foundation follows the existing seaward Land Court boundary or the certified shoreline, whichever is farther inland. On parcel 88, the seaward edge of the seawall follows the existing Land Court seaward boundary. (Note: The above description and the Wall Layout Plan relative to parcel 88 have been changed from those contained in the Draft EA. The plan described in the Final EA is based on the current property boundary for parcel 88.) In the event that Land Court approves Mr. Long's petition to relocate the seaward boundary contiguous with the 2002 certified shoreline on parcel 88 (see Section 2.1 above), then the makai edge of the seawall foundation would be relocated seaward. In any event, no portion of the seawall will be constructed on State land.

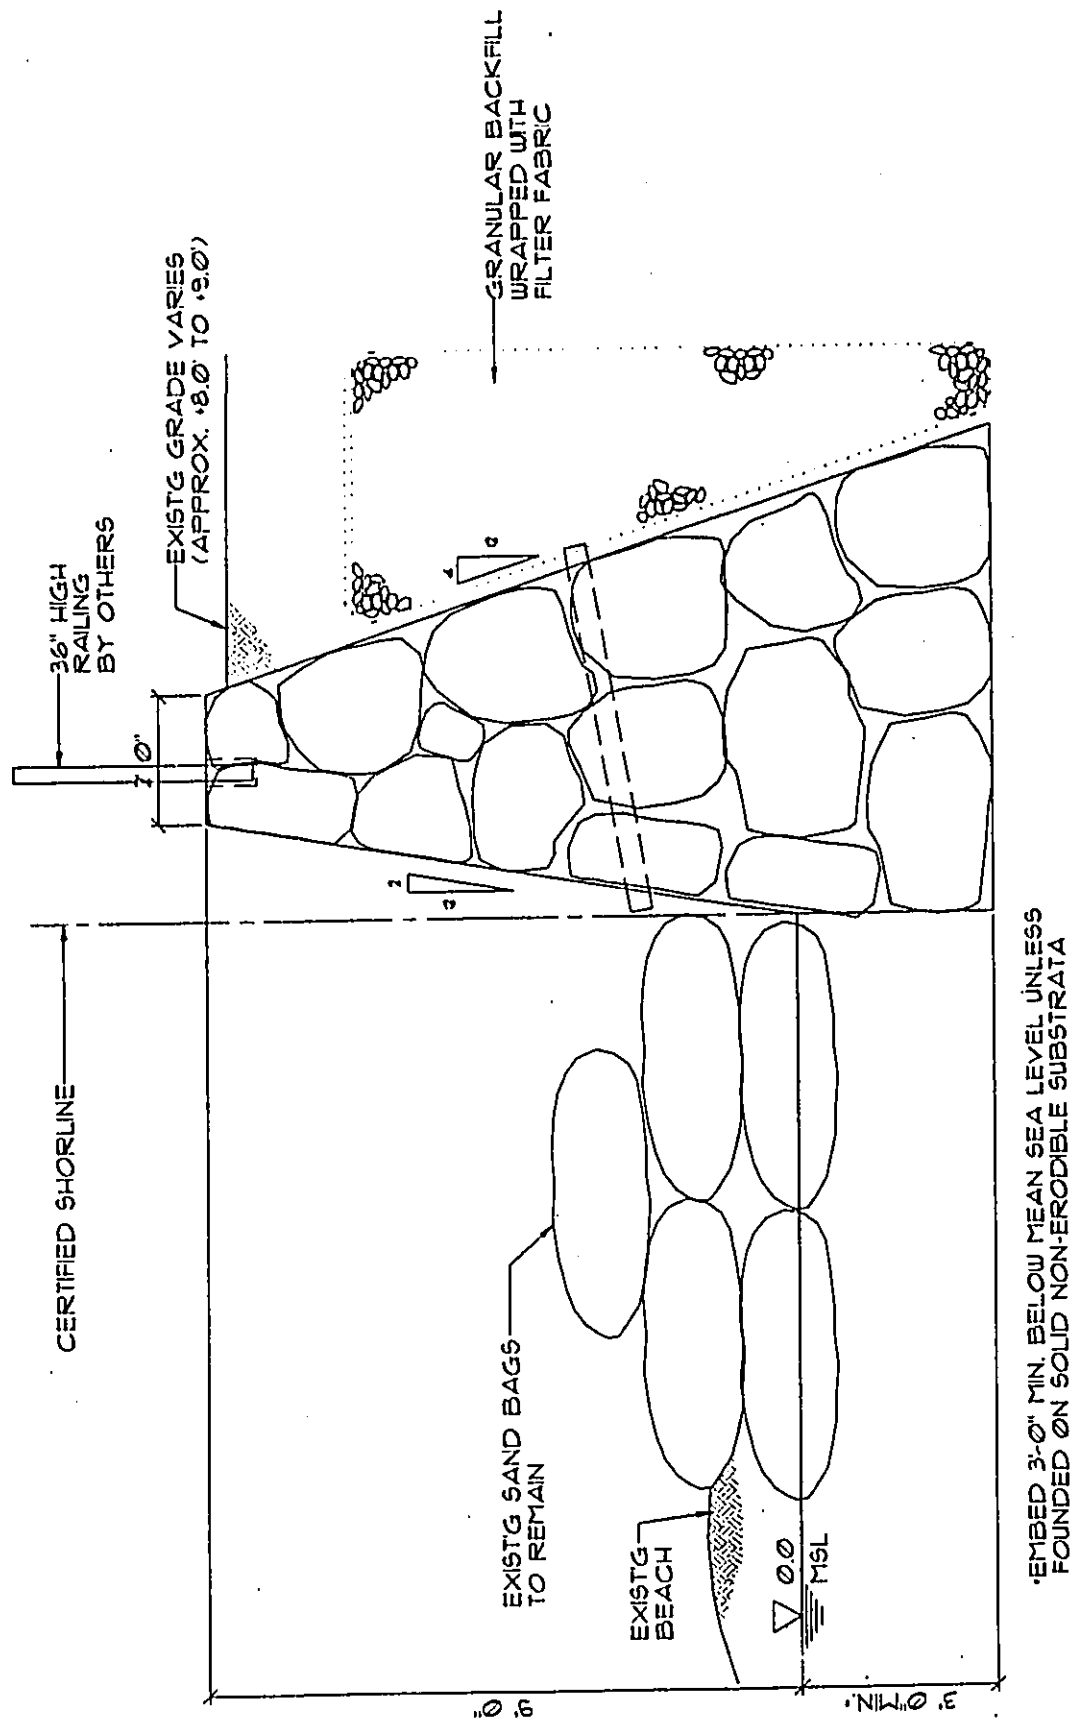
SECTION THRU NEW CRM SEAWALL

The seawall would be constructed of rock set with cement mortar, using very large rocks at the base of the wall and smaller rocks near the top. The bottom width of the wall would be 7.5 feet. Because of the requirement to build the seawall entirely landward of the certified shoreline, the landward base of the wall would be within about 8 feet of the foundation of the house at its closest point, and within about 10 feet of the concrete slab of the pool. Temporary shoring may be required to stabilize the excavation side slope during construction.

Because the top of the wall would not extend much above the existing shoreline elevations, wave overtopping can occur during high tides and storm wave attack. Therefore, weepholes would be provided to relieve hydrostatic pressures that could result in damage to the wall or formation of sinkholes landward of the wall.

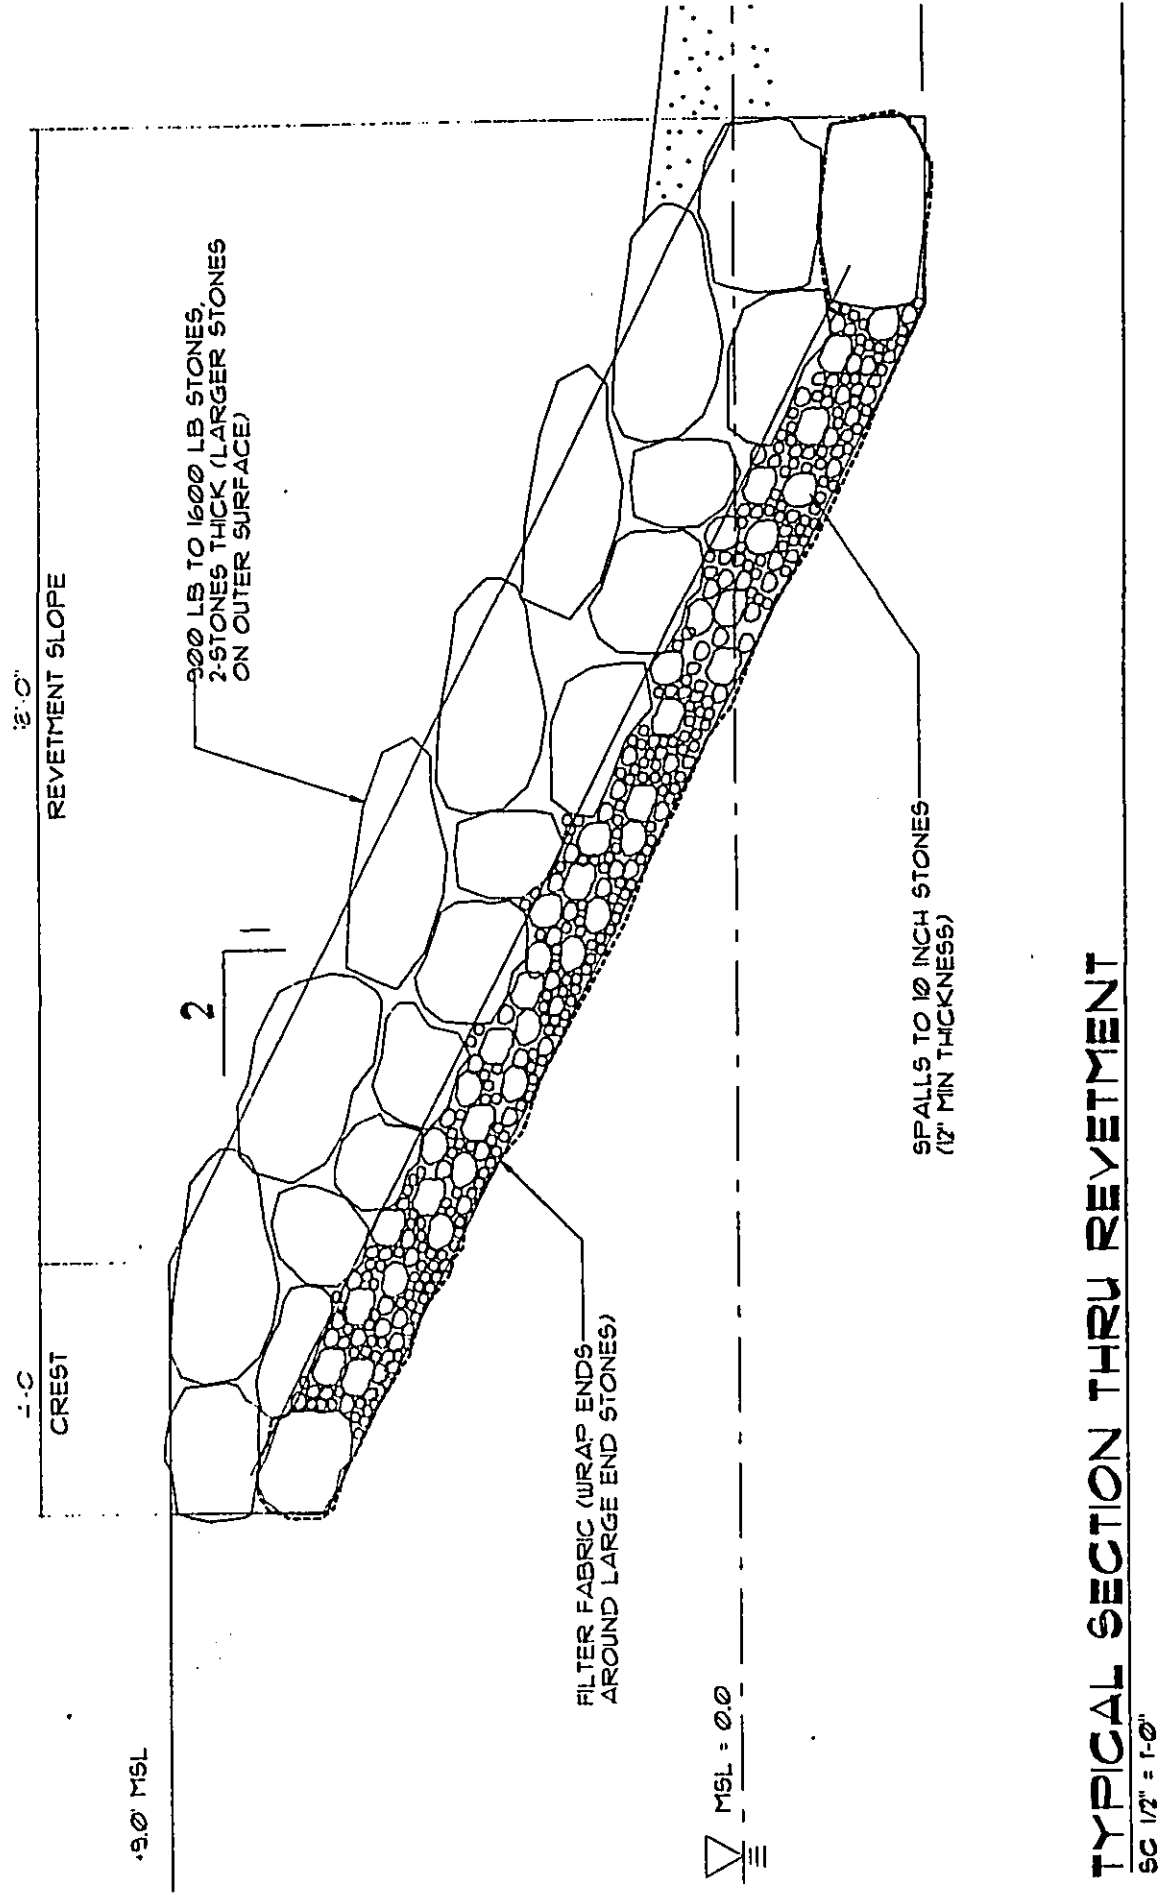
TYPICAL SECTION THRU REVETMENT

Sloping Revetment. A conceptual plan for a sloping revetment is shown in Figure 6, “Layout Plan – Revetment Alternative.” The toe of the revetment would be placed at -5.0 MSL and would rise at a 2:1 slope – 2 horizontal to 1 vertical – to the elevation of the rear yard, +7 to +8 MSL. With a four-foot-wide crest at the top, the revetment would be 28 to 30 feet deep across the shoreline frontage of the two lots. As shown in the Layout Plan, the structure would be located as far landward as possible, while allowing space for construction equipment and avoiding damage to the dwelling foundations. Because of the depth of the revetment, it would need to encroach into the Conservation District by 6 to 12 feet, extending seaward of the adjacent seawall to the north. In 1997, the City Department of Land Utilization queried the Department of Land and Natural Resources about allowing a revetment at the Dilks property four lots to the south. DLNR’s response stated the following conclusion: “. . . DLNR would not support the construction of any portions of a revetment on the makai side of the shoreline, where there are alternatives available.” In the letter, DLNR explicitly recognizes a vertical seawall as a viable option, if it is constructed mauka of the shoreline. (Letter dated November 19, 1997, a copy of which is included below in Appendix C, “Comments and Responses to the Draft EA.”)

- Filter fabric and a bedding layer of spalls to 10-inch stones placed on a slope of 2H: 1V. The filter fabric/ bedding layer serves as a foundation for the armor stones to prevent differential settlement into the sand.
- A 2-stone-thick layer of armor stones 900-1,600 pounds in weight (stones of approximately 2-foot diameter), which are large enough to prevent dislocation by storm waves. The larger rocks would be placed on the outer surface. The ends of the filter fabric would be wrapped around large end stones at the crest and toe of the revetment.

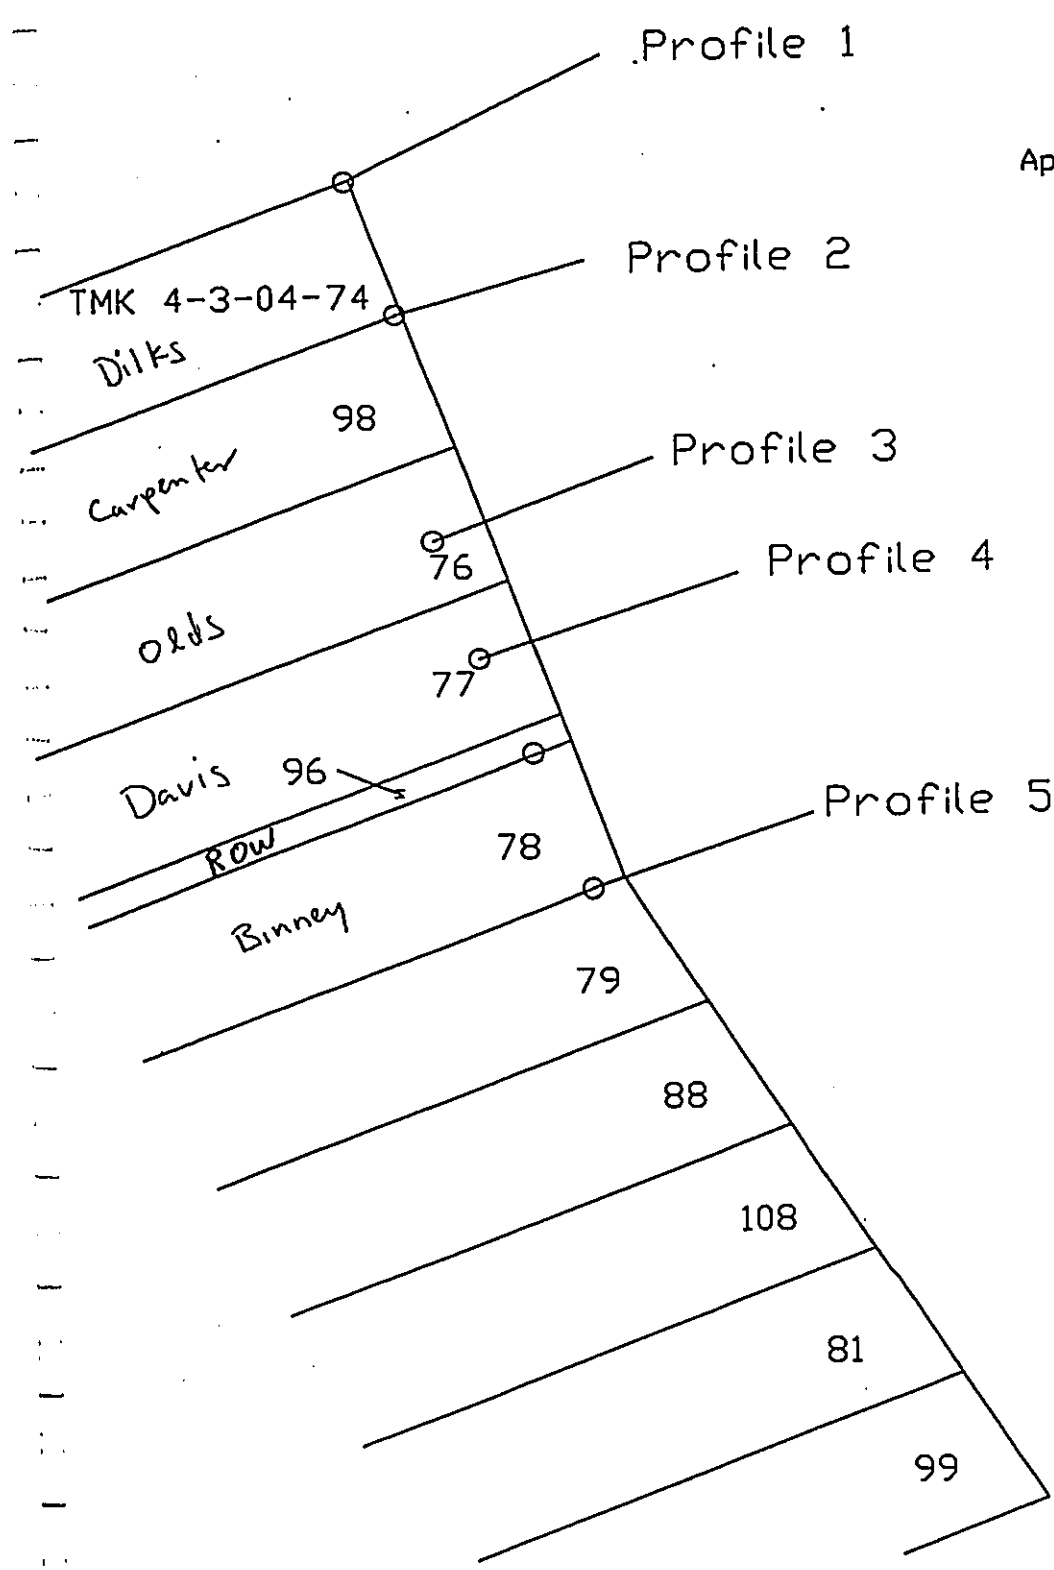
Profile 1 Dilks Property

includes time series graphs of beach profiles for five transects along the shoreline. Each graph shows data from four observations made between September 1995 and June 1997. Attached as Appendix A, Lipp's report states that sand movement into the area over time is due to environmental conditions, not the SEAbags themselves. According to Lipp, *"What is important to note is that the sandbags did not prevent the beach from reforming."*
