Shoreline Setback Variance  
Chapter 343, Hawaii Revised Statutes  
Environmental Assessment (EA)/Determination  
Finding of No Significant Impact

FINAL ENVIRONMENTAL ASSESSMENT FOR A  
SHORELINE SETBACK VARIANCE APPLICATION

**EXISTING SEAWALL**

68-003 Laau Paina Place, Waialua, Hawaii

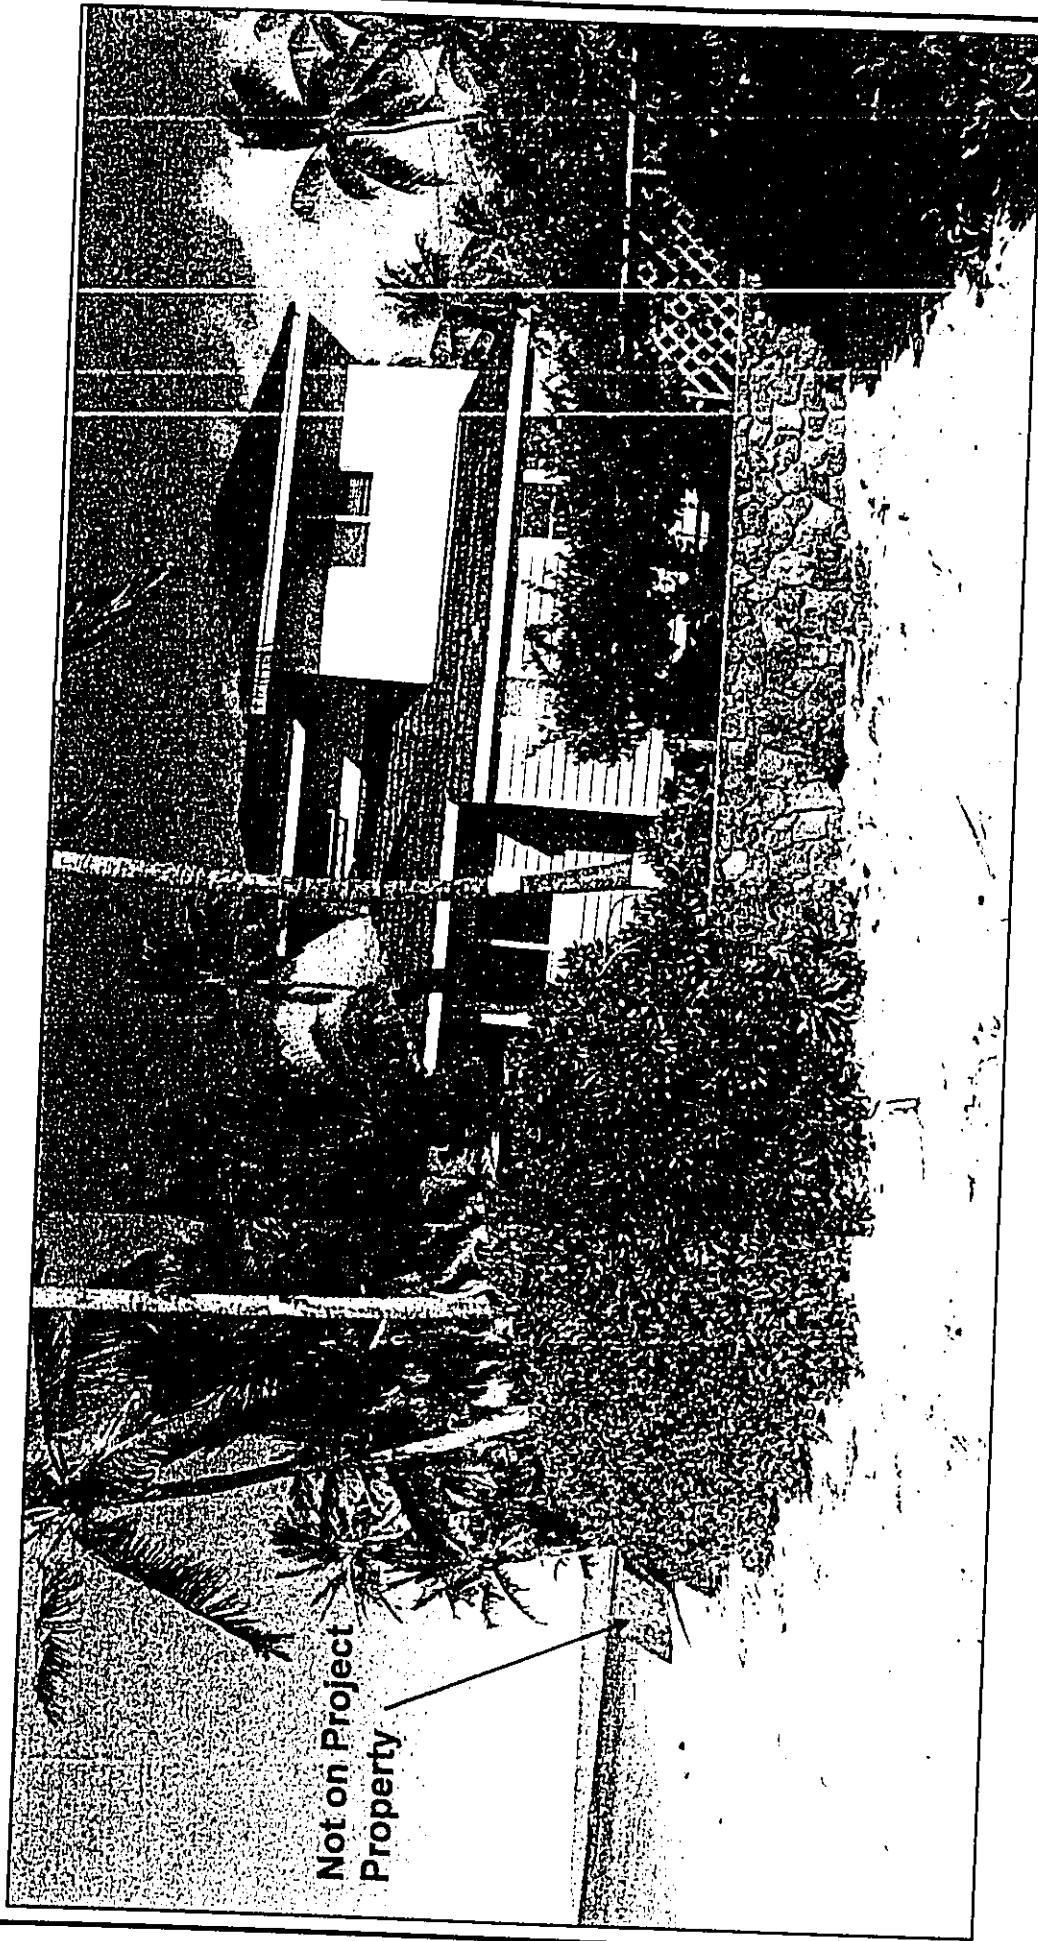
Figure 4  
VIEW OF SEAWALL COVERED IN NAUPAKA LOOKING TOWARD WAIALUA (September 2003)  
(Exposed/visible seawall beyond naupaka vegetation is not on the Project Property)  
68-003 Laau Paina Place, Waialua, Oahu, Hawaii

Not on Project  
Property

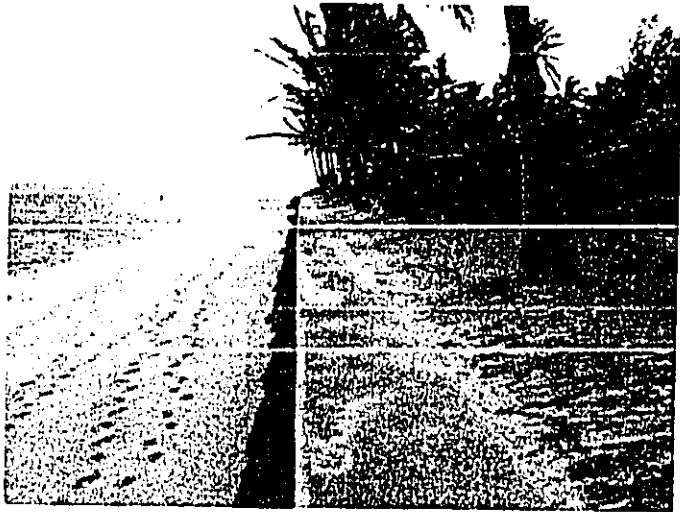
View eastward along the top of the seawall fronting the Mokuleia Beach Colony. Note the narrow beach.

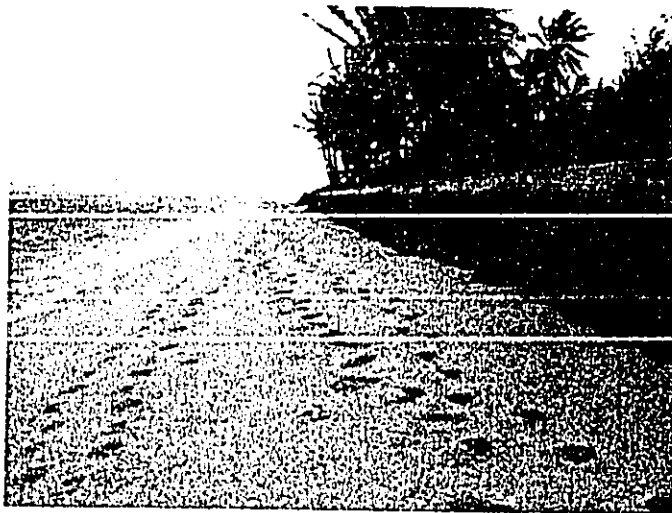
View eastward along the beach fronting the Mokuleia Beach Colony seawall. Note the narrow and steep beach profile.

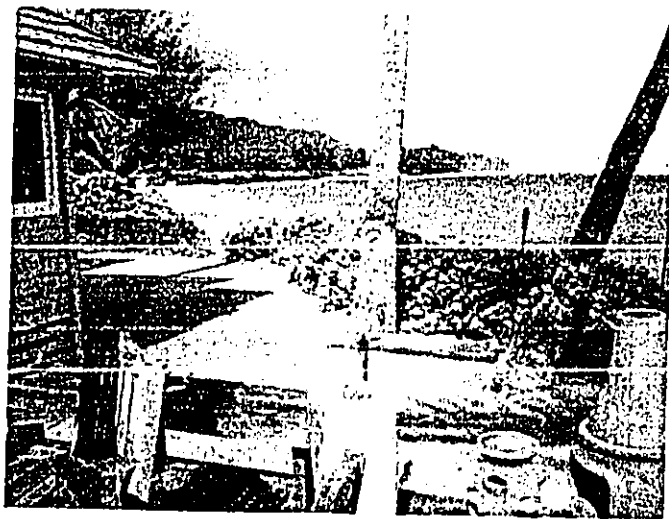
View westward from porch on Parcel 11.

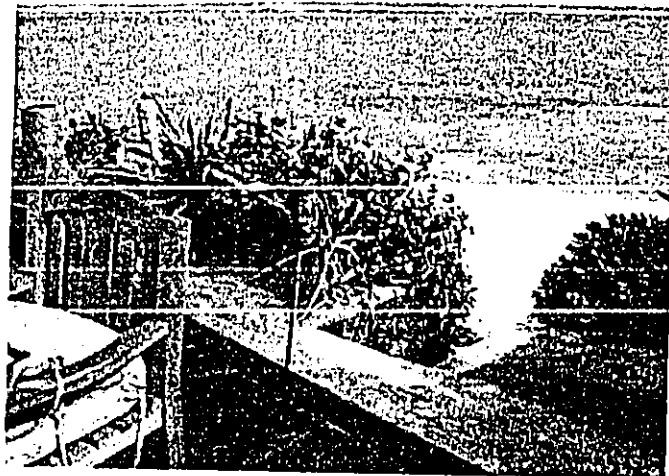
View offshore from porch on Parcel 11.  
Steps in seawall lead down to the beach.

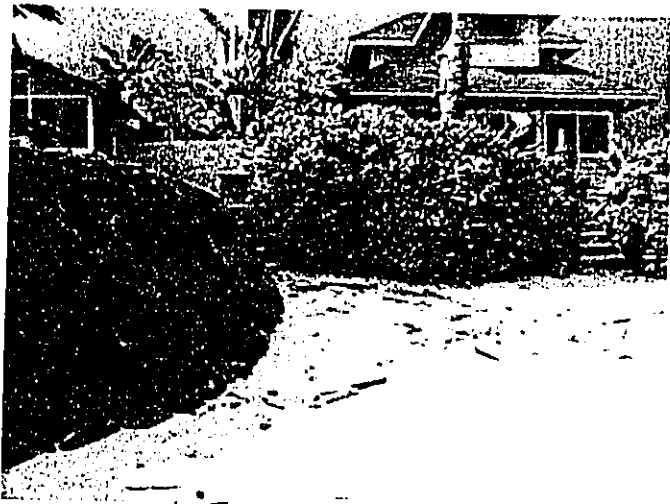
View of Parcel 11 seaward frontage. Seawall is hidden by naupaka vegetation. Curved seawall on left fronts Parcel 10.

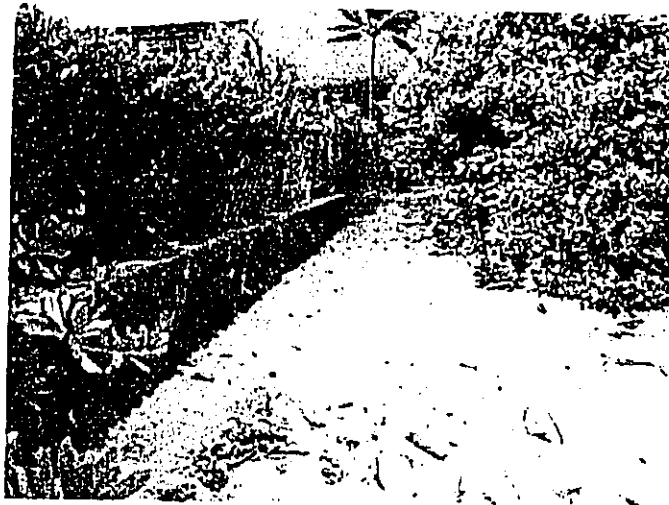
View mauka along private right-of-way. The CRM wall on left is Parcel 11's return wall.

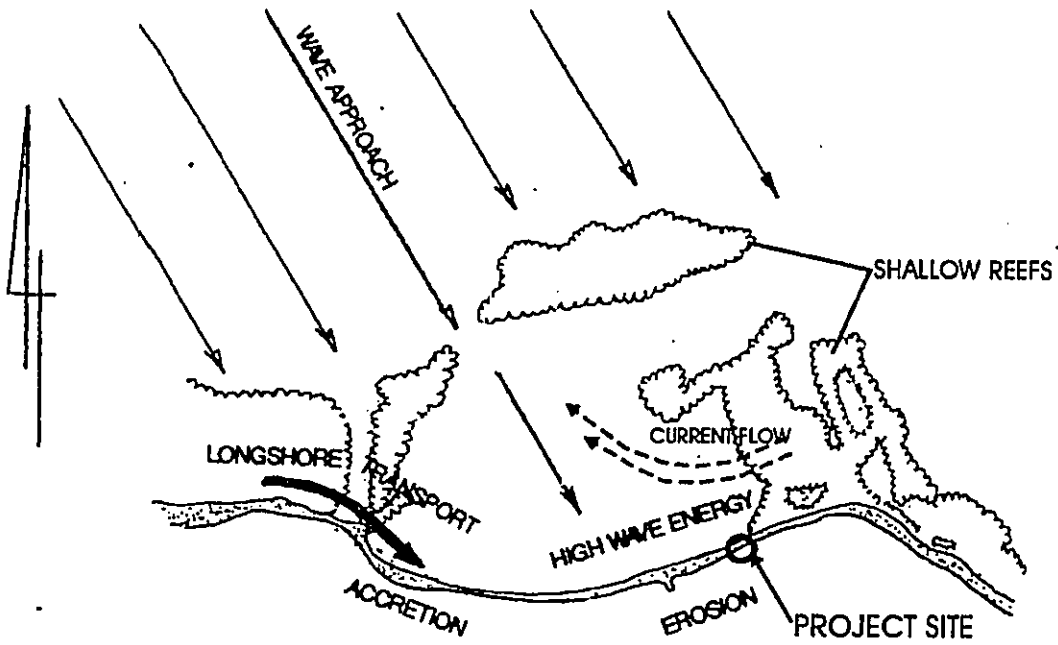
WINTER NORTHWEST SWELL CONDITIONS

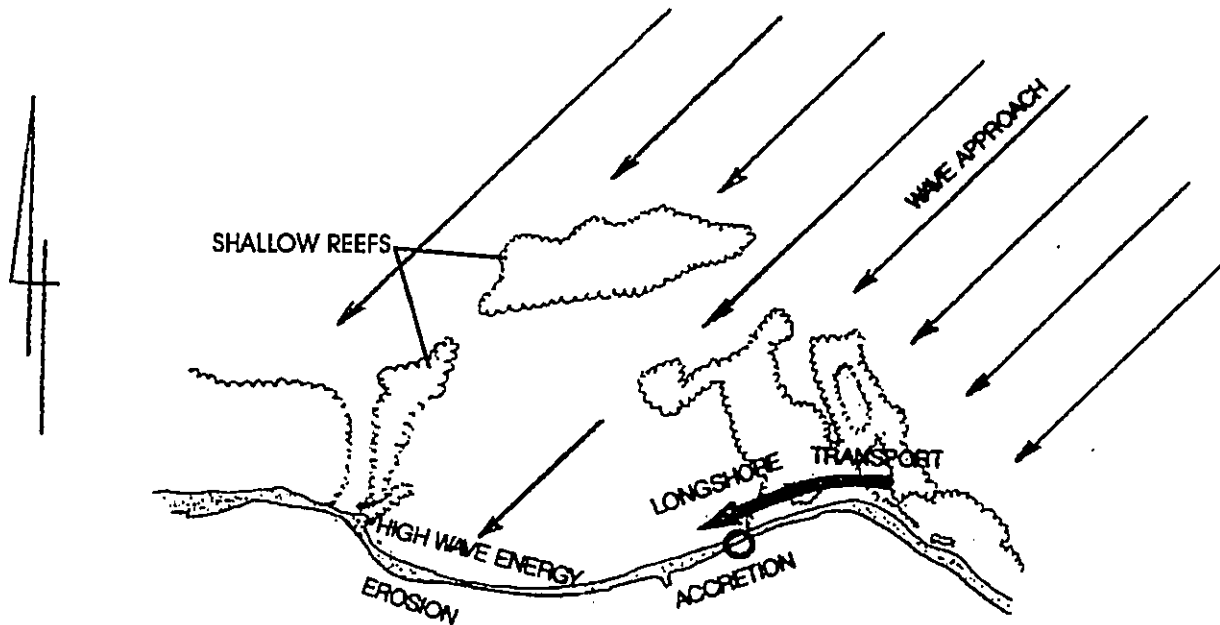
SUMMER NORTHEAST TRADEWIND CONDITIONS

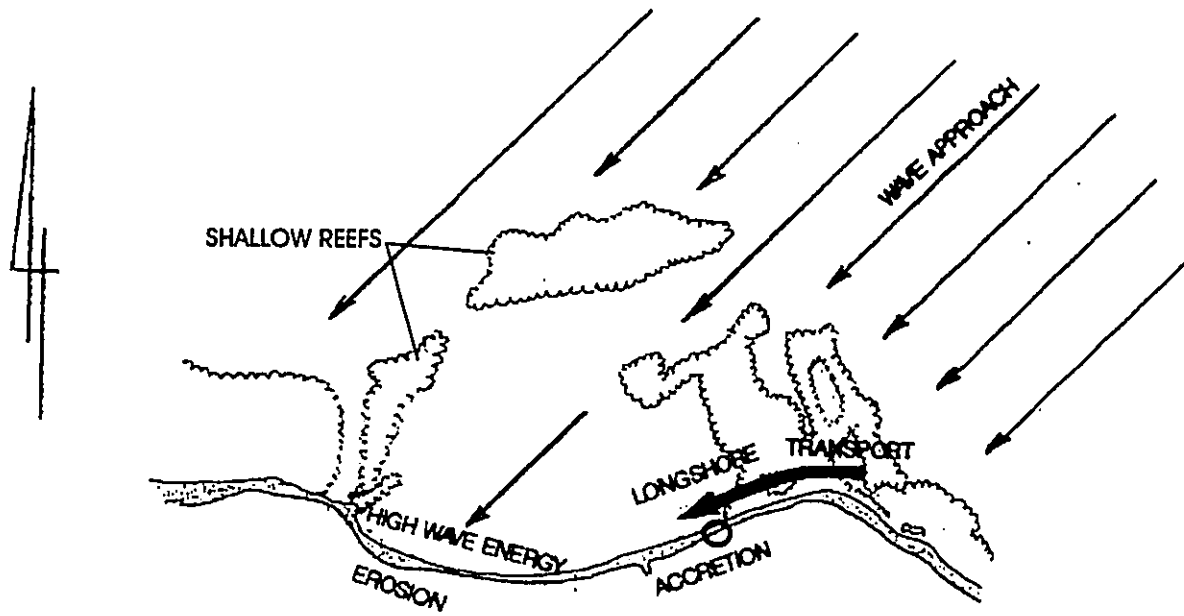
SUMMER NORTHEAST TRADEWIND CONDITIONS

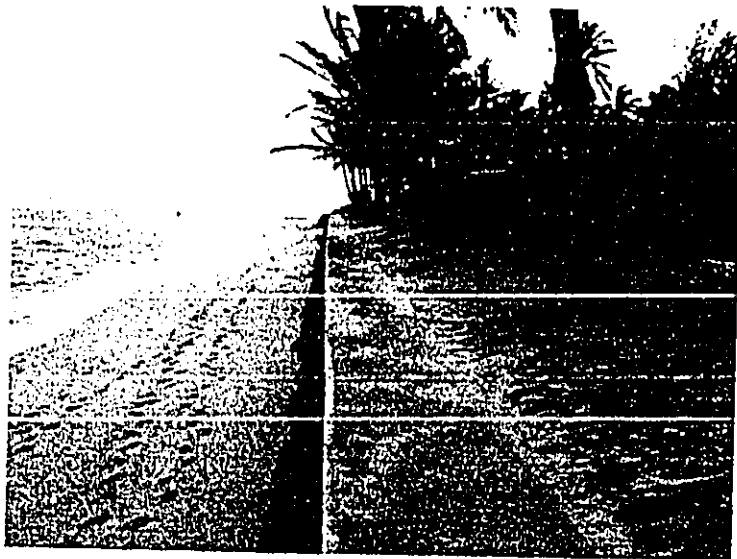
View eastward along the top of the seawall fronting the Mokuleia Beach Colony. Note the narrow beach.

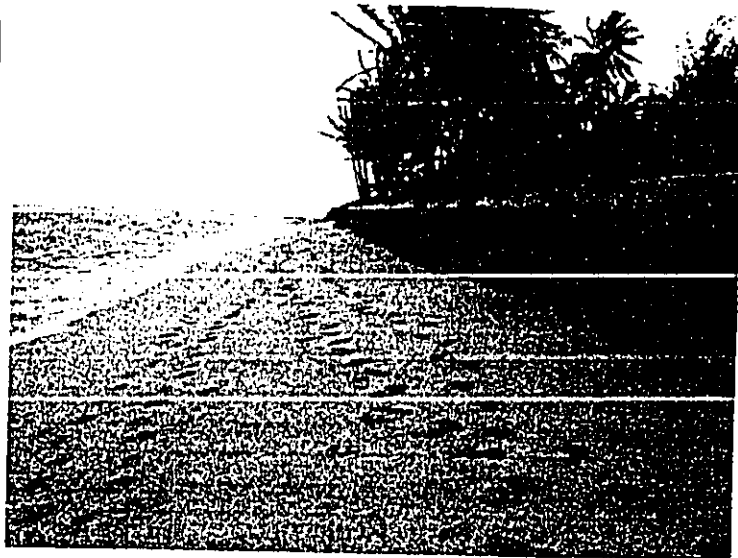
View eastward along the beach fronting the Mokuleia Beach Colony seawall. Note the narrow and steep beach profile.

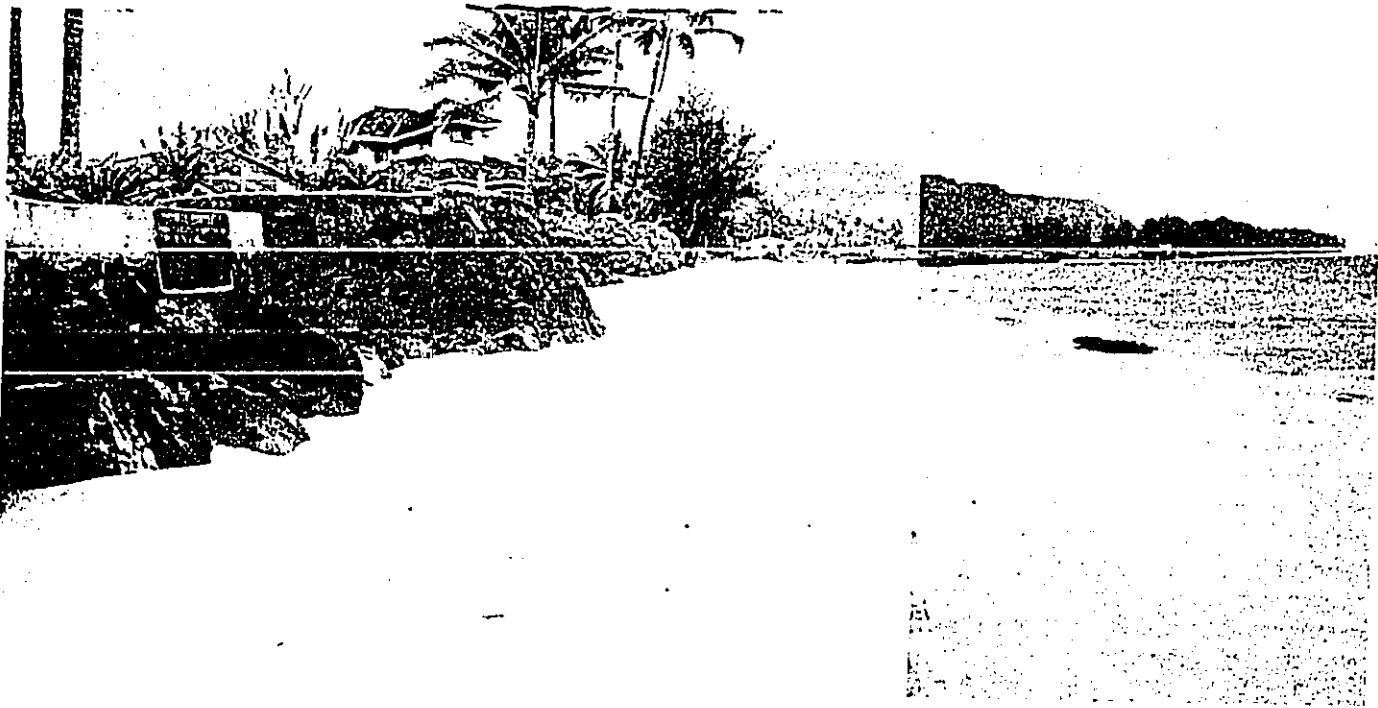
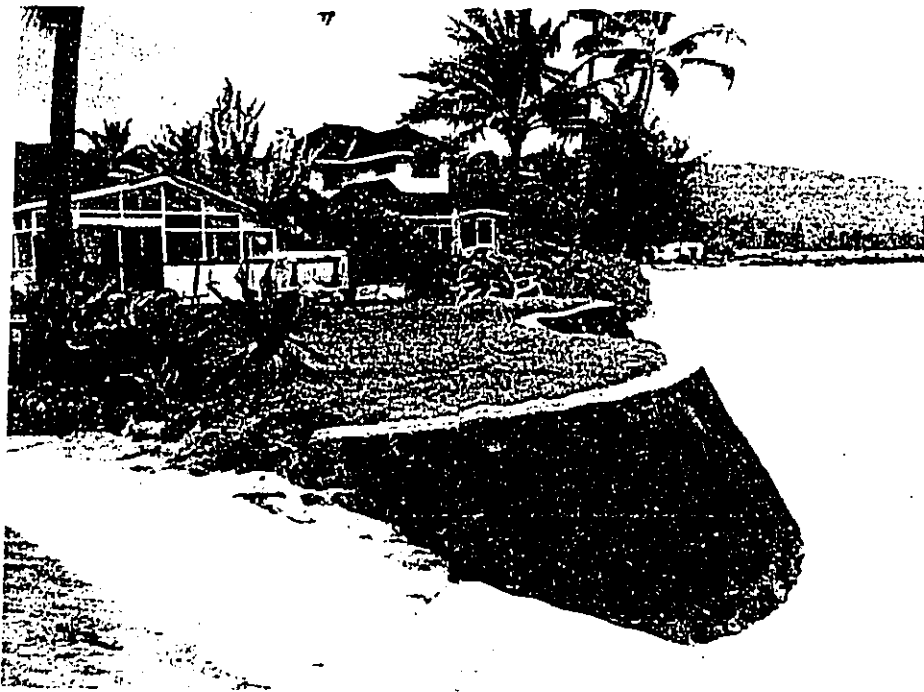
PHOTO page-2

Views westward from west end of Mokuleia Beach Colony seawall. Parcel 10 is in the foreground. Parcel 11 is next to Parcel 10. (Sign is on the west end of the Mokuleia Beach Colony seawall. The sign permits the public to walk on the top of the seawall.)

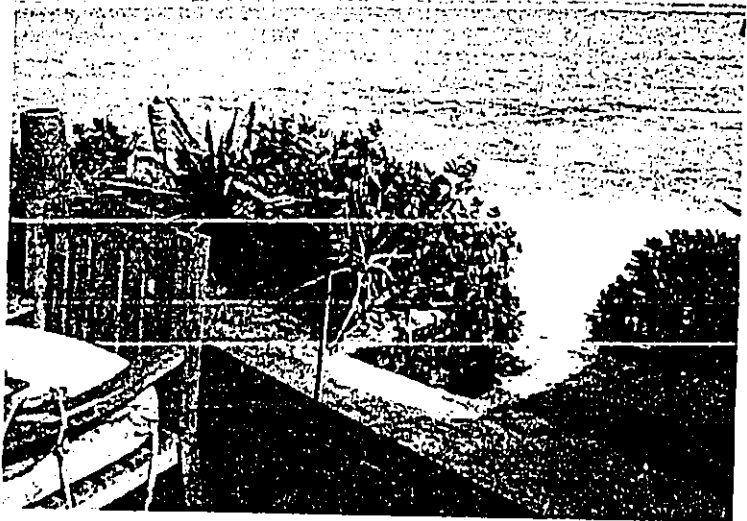
View offshore from porch on Parcel 11.  
Steps in seawall lead down to the beach.

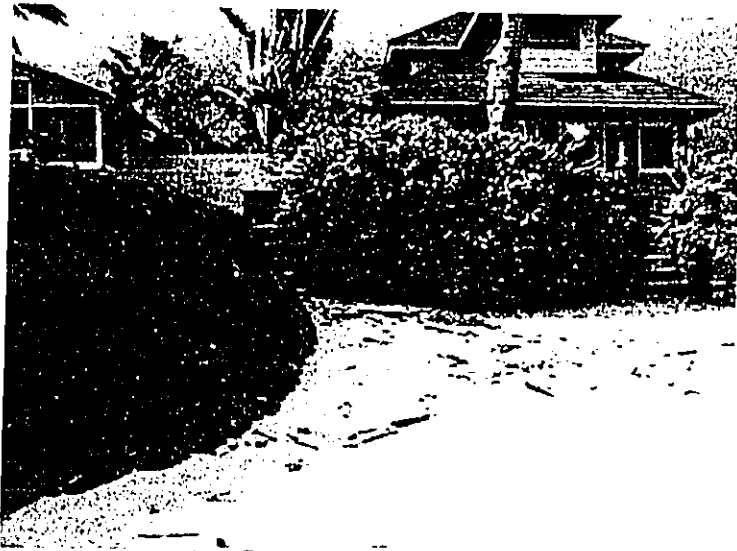
View of Parcel 11 seaward frontage. Seawall is hidden by naupaka vegetation. Curved seawall on left fronts Parcel 10.

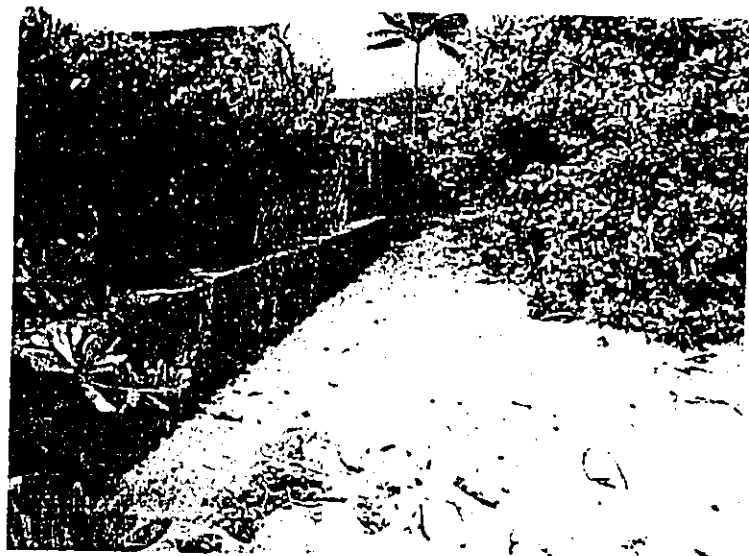
View mauka along private right-of-way. The CRM wall on left is Parcel 11's return wall.

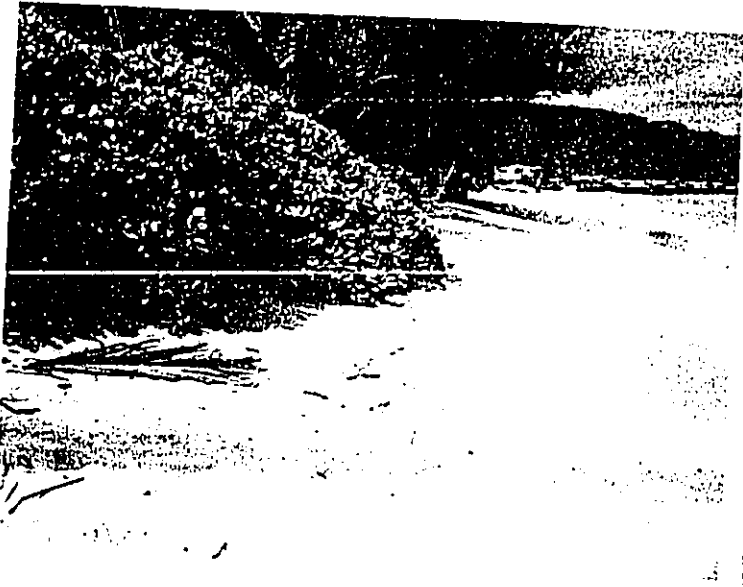
View westward from private right-of-way.  
Naupaka vegetation fronts Parcel 12.

Photo page-4 shows the parcels westward to the stream. The parcel on the west side of the right-of-way (Parcel 12) is obscured by naupaka vegetation, and the adjacent parcel (Parcel 13) is fronted by a CMU wall. The large parcel on the east side of the stream (Parcel 20) is unprotected. Photo page-5 shows the stream and adjacent shoreline reach to the west. The parcel on the west side of the stream mouth shows obvious erosion damage, and a nearly continuous line of seawalls protect the remaining shoreline within the embayment.

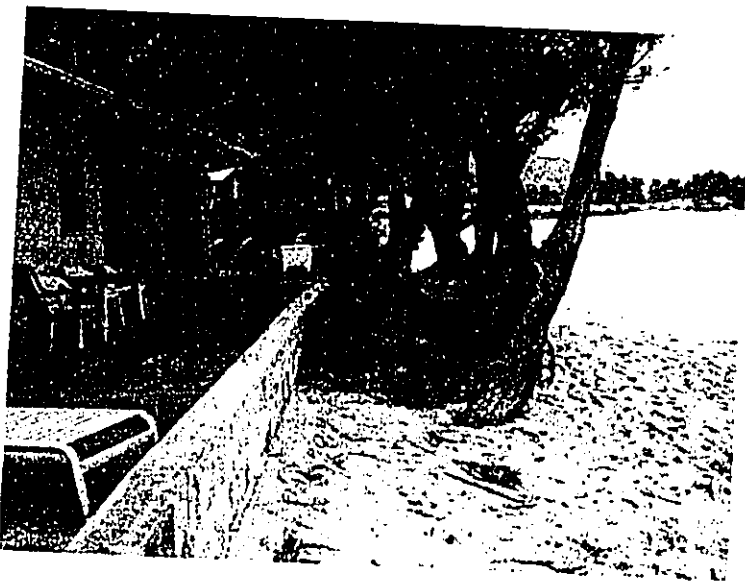
CMU wall fronts Parcel 13 .

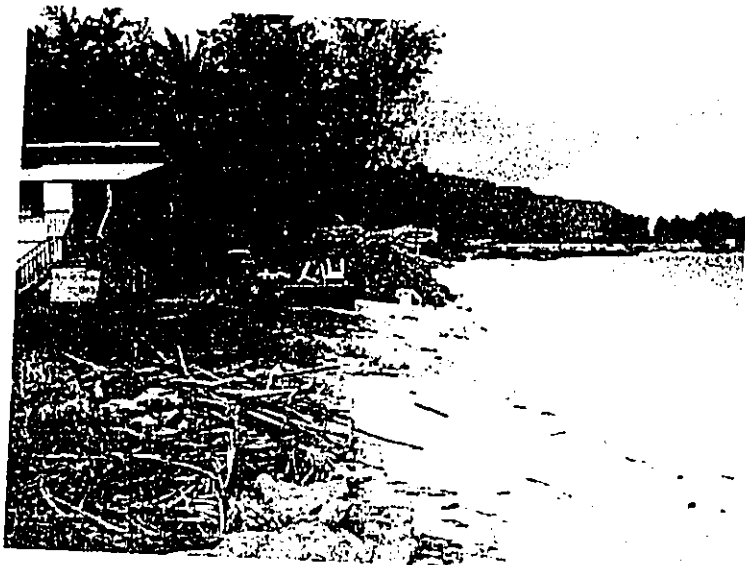
Shoreline fronting Parcel 20 on east side  
of stream. Note debris line at edge of  
vegetation.

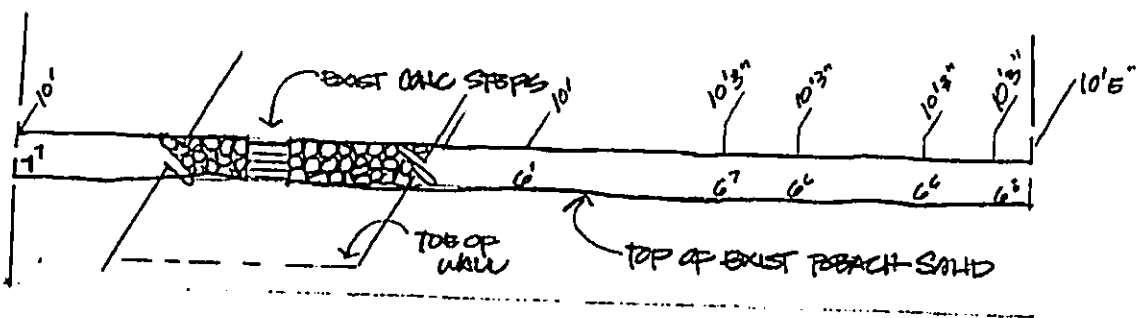
OCEAN ELEVATION

NOTE: ELEV FOR TOP SURVY  
 DINS SURVYING DRAWING #95016  
 & DLNR SHORELINE CERTIFICATION  
 DATED APRIL 26, 1995  
 LOT A-15

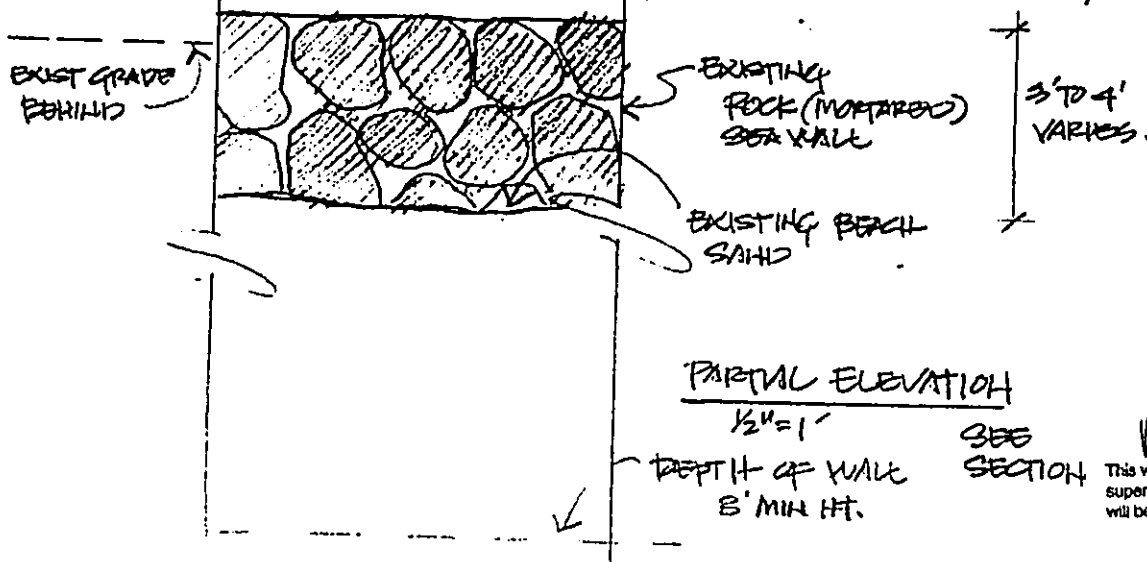
PARTIAL ELEVATION

1/2" = 1'  
 SEE SECTION
