**ALEXANDER DAM
IRRIGATION DITCH RESTORATION
FINAL ENVIRONMENTAL ASSESSMENT**

Applicant:
Kauai Coffee Company

Prepared By:
**Wilson Okamoto Corporation
Engineers and Planners
1907 South Beretania Street, Suite 400
Honolulu, Hawaii 96826**

February 2006

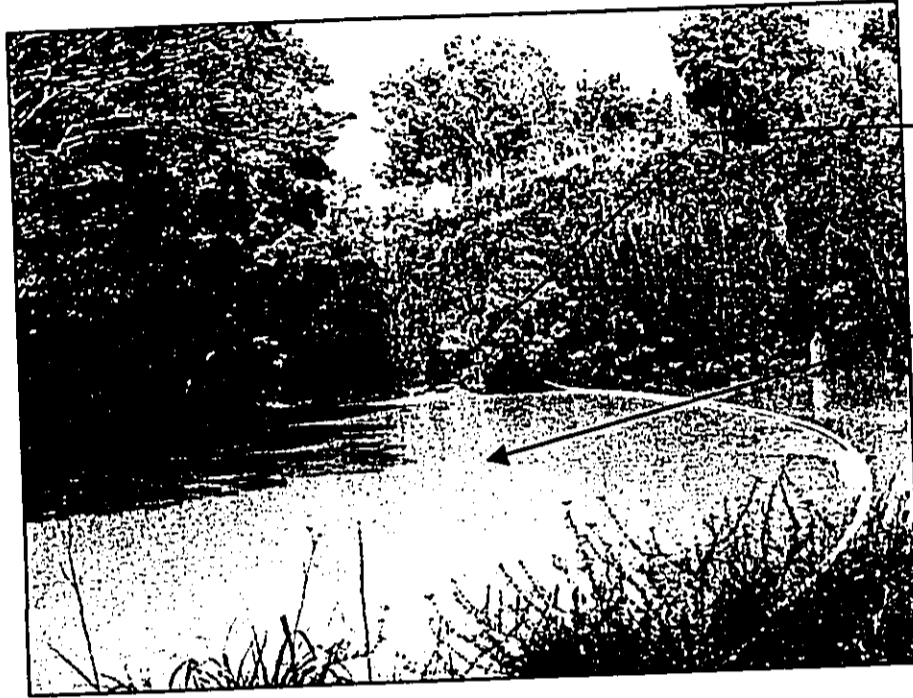
Photo 1: Restored irrigation ditch discharging into forebay.

Irrigation ditch outlet

Forebay

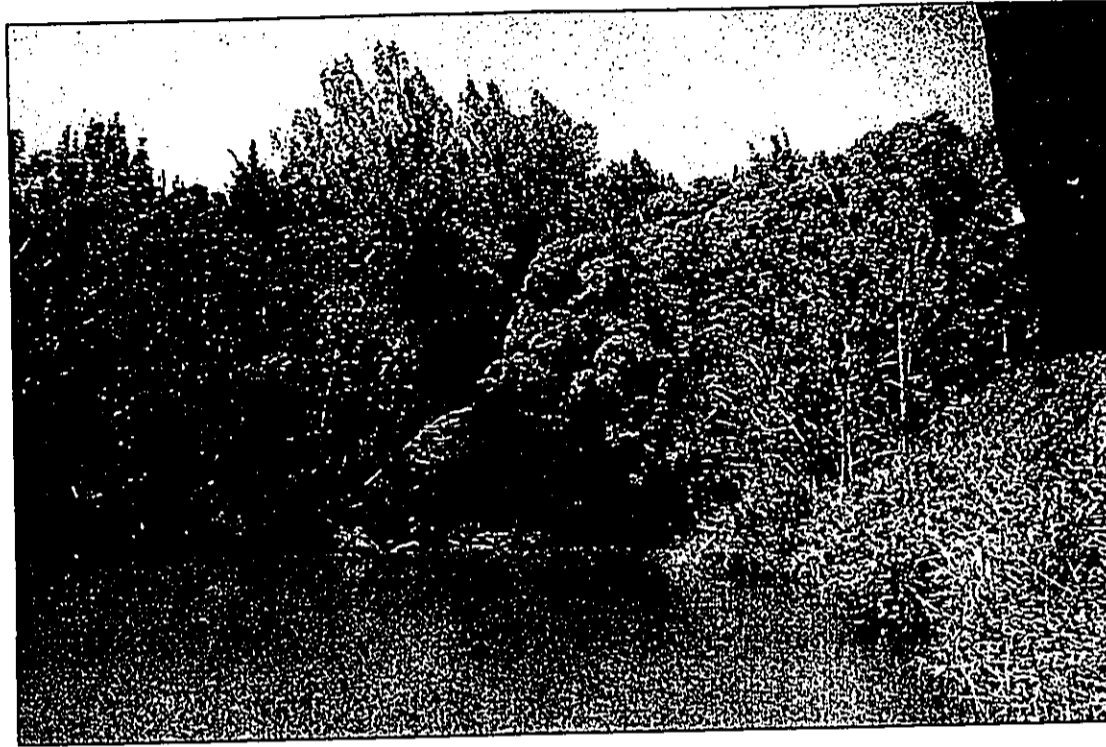
Figure 19. Top of forebay, view north

DESCRIPTION: The forebay is an excavated earth water impoundment facility situated downslope from Alexander Dam (Figure 19, Figure 20). Prior to collapse in 2001, a tunnel from the reservoir carried water from the dam and fed the northeast end of the forebay. At the southeast corner a metal riveted pipe called a penstock (Figure 21) carries water from the forebay to the Kalāheo hydroelectric station and KCOF coffee tree fields as irrigation water. The forebay site is about 1.65 acres in area. Along the western edge, a new entry has been excavated to allow water from the newly realigned and refurbished ditch to drain into the forebay (see Figure 11 and Figure 20).
