SUBJECT: Final Environmental Assessment (FEA)/Finding of No Significant Impact (FONSI) for Conservation District Use Application (CDUA) MA-3382

The Department has reviewed the Final Environmental Assessment (FEA) for the proposed commercial use of the grounds of the former Plantation Mill at Olowalu, Lahaina, Maui, TMK (2) 4-8-03:5. The applicant has added an appendix that includes his responses to comments received. The original CDUA has not changed.

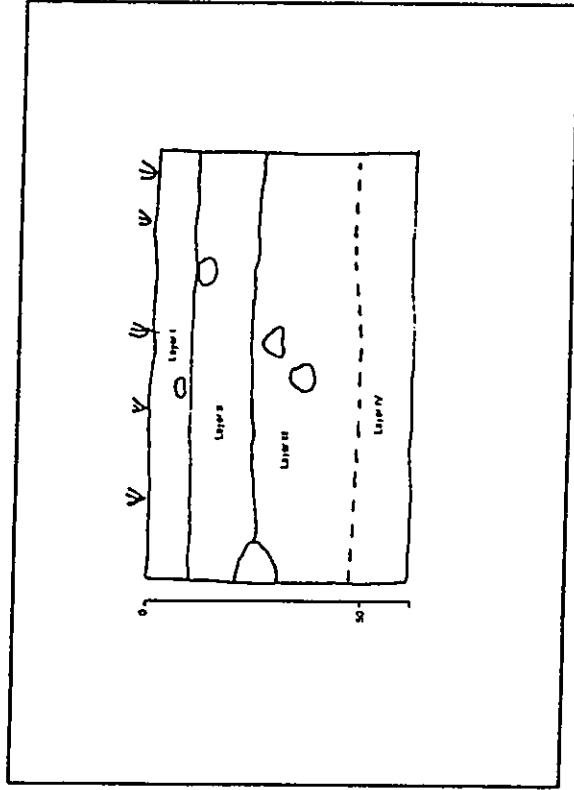
Figure 13 - East face profile of Test Unit 3—Site 4694.

This last unit was placed on the *mauka* or north side of the structure. Test Unit 3 was excavated in an attempt to recover a charcoal sample. A moderate amount of material culture remains were recovered. The same soil layers were present as were encountered in the other test units (Figure 13).

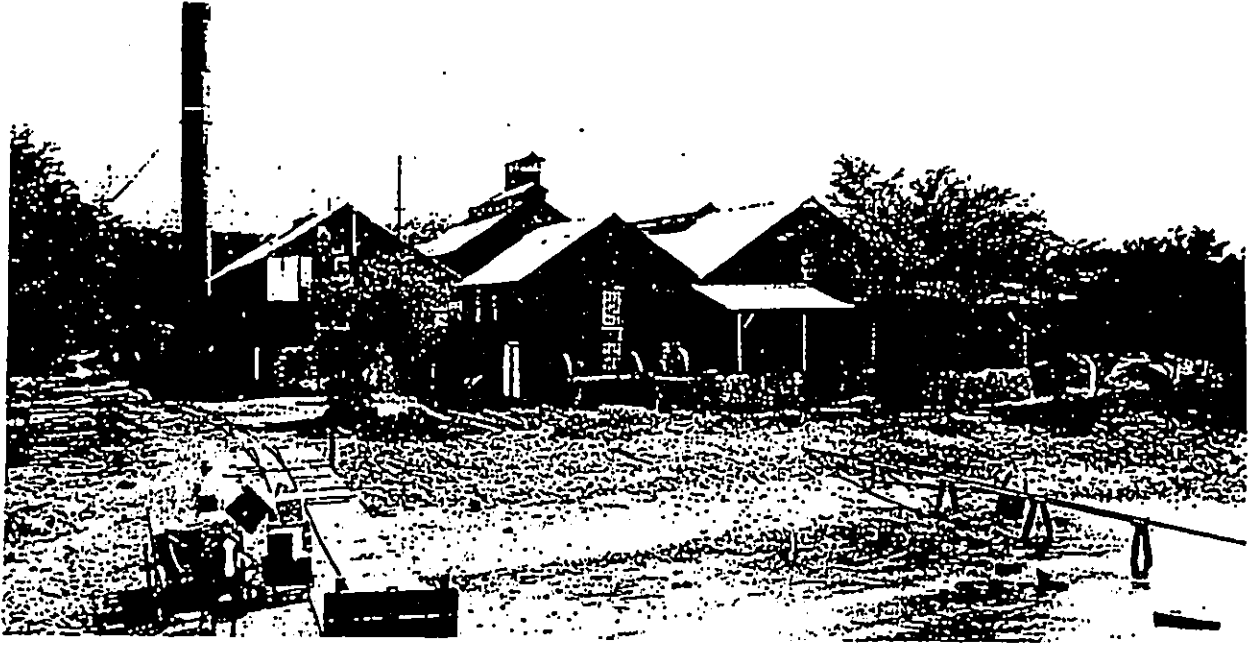
The Olowalu Sugar Company mill between 1870 and 1890.

The historic photo on page 50 (Figure 18a) shows the Mill in the latter part of the 19th century. A boardwalk appears to be extending onto the jetty. Directly behind is the smokestack that would have extended from the brick structures that made up the boiling room at the *makai* end of the large concrete slab. We were not able to find anyone who had knowledge about the specific designation of the various parts of the remaining ruins. It is hoped that this information will be forthcoming with Ms. Bartholomew's continuing research.

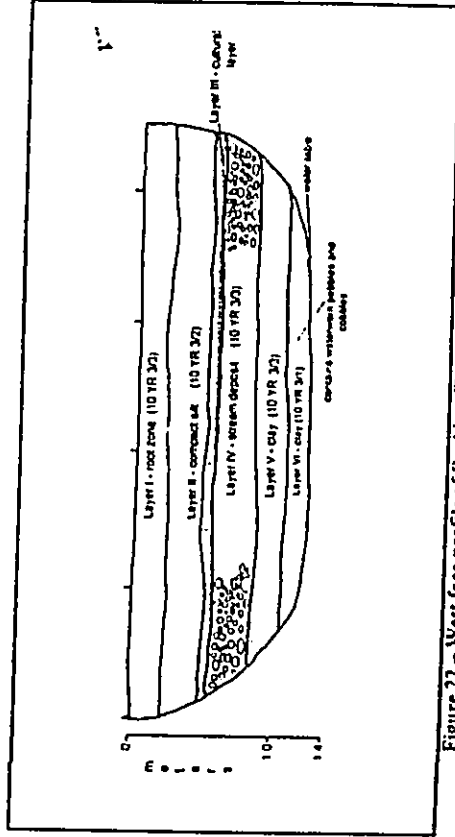
Figure 22 - West face profile of Backhoe Trench 59.

appeared to be the case in BT 83. Backhoe Trench 59 (Figure 22) revealed a thin cultural layer, while BT 60 uncovered 19th century historic debris. Backhoe Trench 75 indicated a heavy water-flow area, by the presence of a high density of waterworm pebbles and cobbles. Backhoe Trench 97 had a 50%-50% marine and terrestrial sand deposit at the very bottom of the trench, which may indicate another possible tributary section, where during high tide, the marine-terrestrial sand mixing occurred.

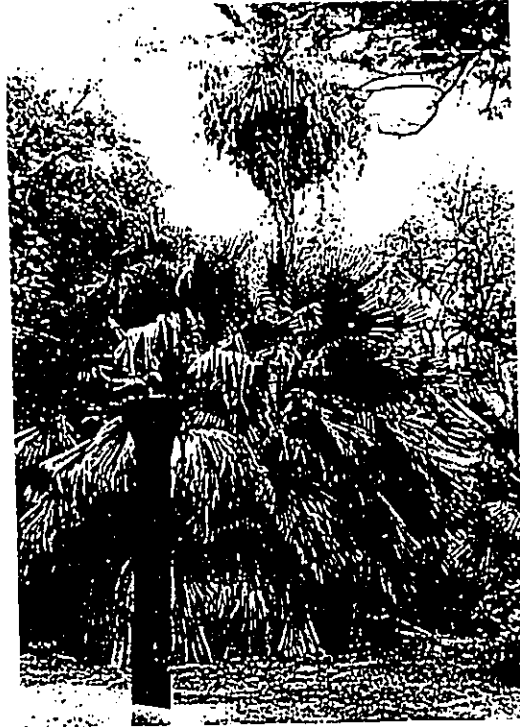
Photo 21 - Iron post with rigging and eye on top. Ruins of the mill are behind thick vegetation.

The Olowalu Mill was probably constructed in the 1870s. A photograph is reproduced in Maui Remnants (Bartholomew and Bailey, 1994, p. 45), and is one of the few in existence.⁹ It shows the iron pole, which still remains (Photo 21) that was probably used to guide cables or ropes, to boats tied to the pier. It may be part of a type of loading system that was used in the sugar industry at other mills.

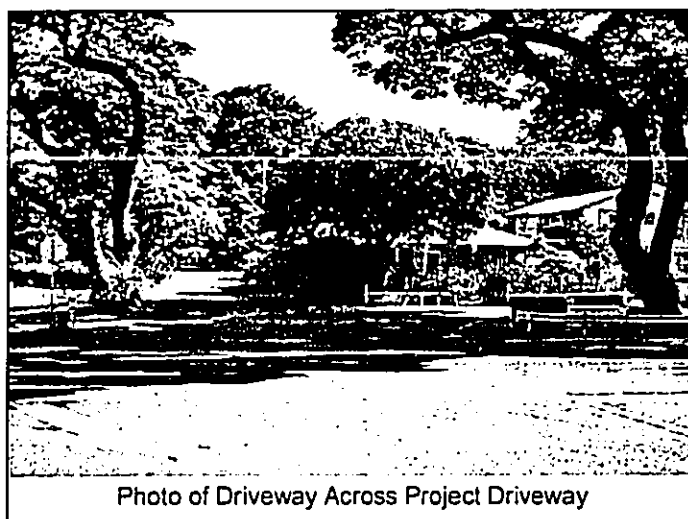
Photo of Driveway Across Project Driveway

There are no other highly urbanized developments located in the immediate vicinity south of Olowalu. The area is generally undeveloped and consists of former agricultural lands mauka of Honoapi'ilani Highway. Some existing residential lots are located in the area generally situated along the highway corridor. The Olowalu General Store and Chez Paul Restaurant are located across (mauka) of the project site. One of the driveways serving these uses along with a few residences is situated across the project driveway as shown on the photo exhibit.

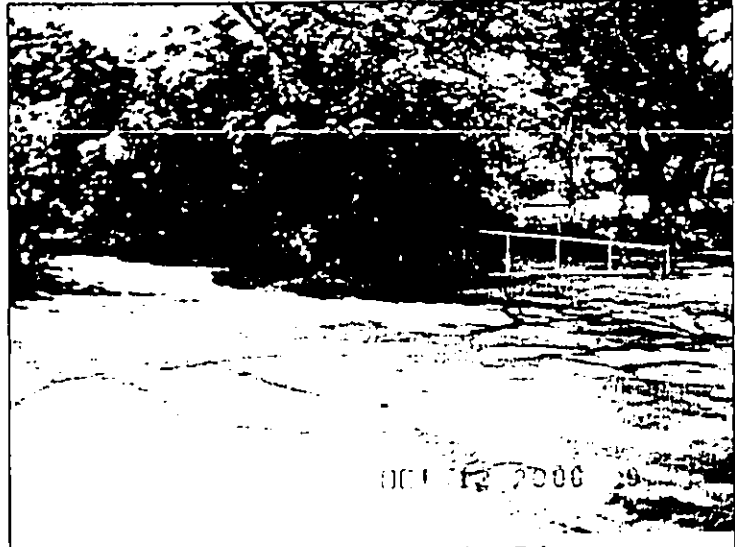
Photo 2 - Beach access road and Project Driveway

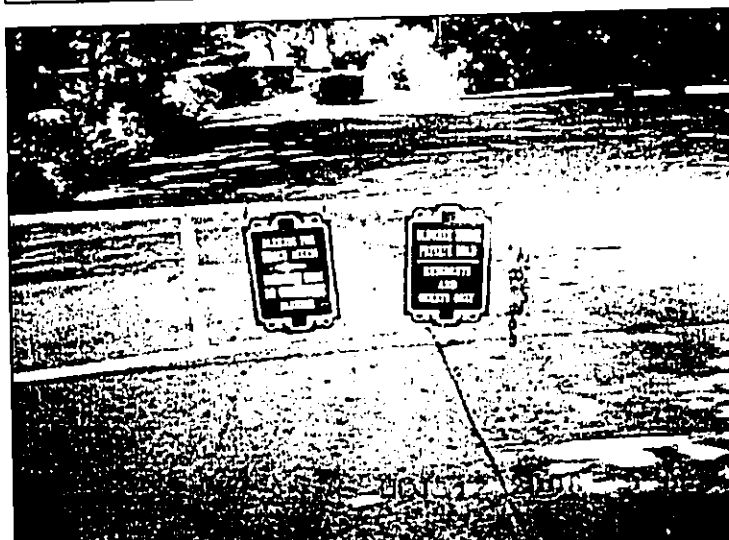
Photo 10 - Close-up of signs at entrance of Project Driveway

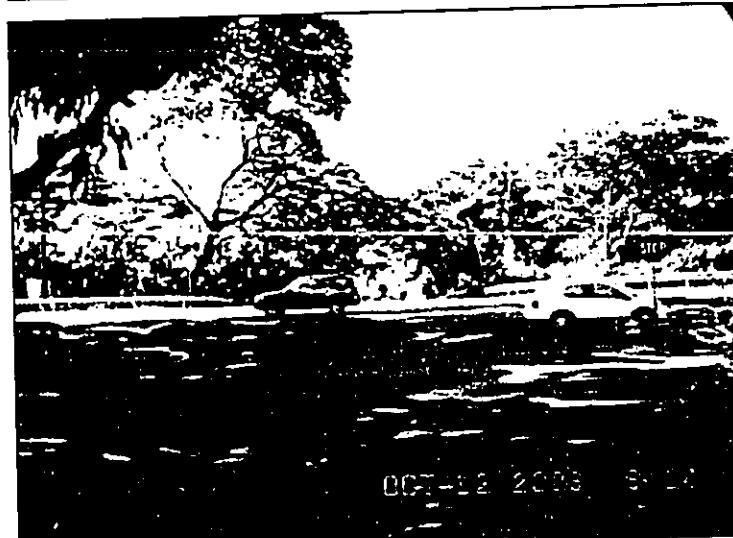
Photo 12 - Facing South on Olowalu General Store Driveway to Study Intersection
