**SUBJECT: FINAL ENVIRONMENTAL ASSESSMENT (DEA) FOR THE  
DEMOLITION OF TWO (2) COUNTY OF MAUI HOUSES  
LOCATED AT 578 FRONT STREET, LAHAINA, MAUI,  
HAWAII, TMK: (2) 4-6-007:003 (EA 2005/0010)**

## **FINAL Environmental Assessment**

### **For the demolition of two houses built circa 1962 Lahaina, Maui, Hawaii (EA 2005/0010)**

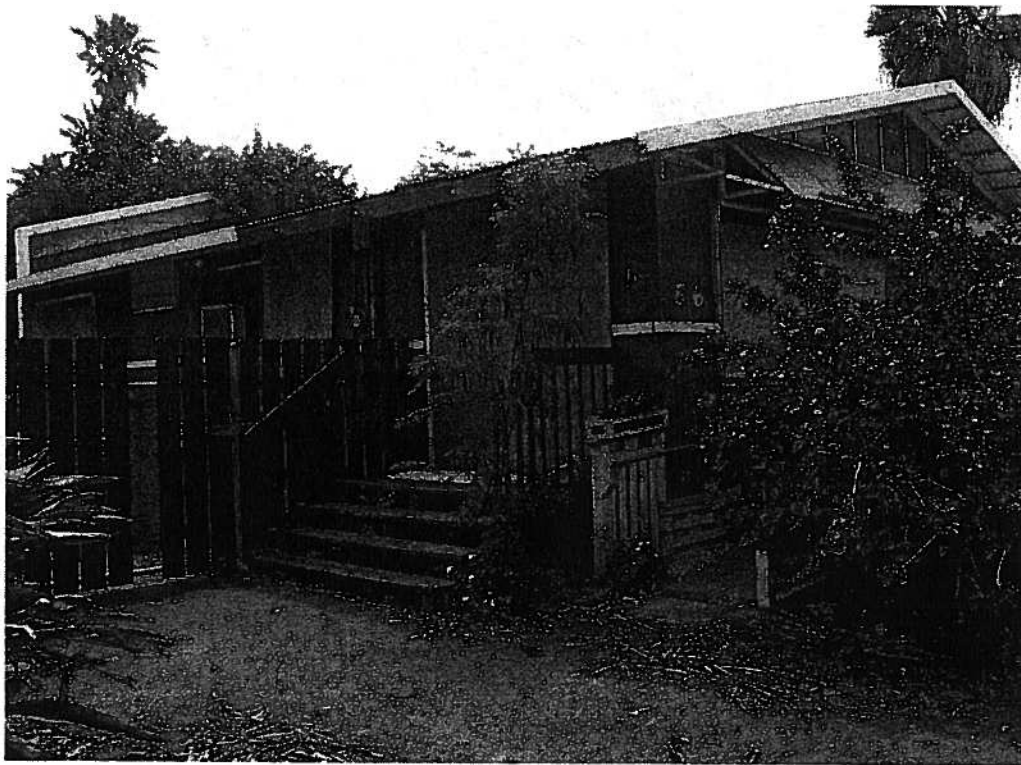
Northwest corner of southernmost building

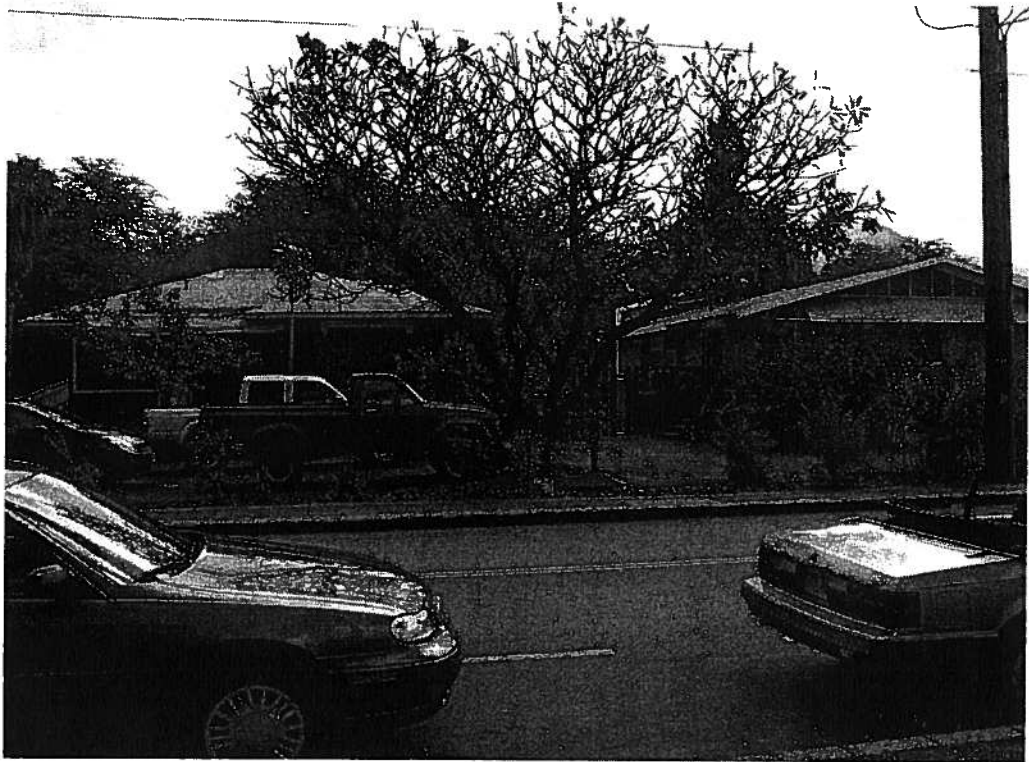
Both subject buildings - taken from school across Front Street
