Subject: Shoreline Setback Variance  
Chapter 343, Hawaii Revised Statutes  
Environmental Assessment (EA)/Determination  
Finding of No Significant Impact

**Environmental Assessment  
Shoreline Setback Variance for an  
Existing Seawall and Revetment  
Lanikai, Oahu, Hawaii**

**1586-B Mokulua Drive (Tax Map Key: 4 - 3 - 001: 013)**

**Wil Chee - Planning & Environmental**

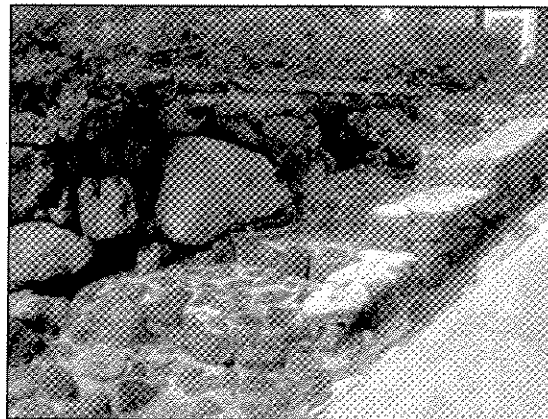
Plate 6: CRM Wall and Rock Steps.

The narrow set of steps is located along the northern boundary of the project site.

A wide center stairway provides direct access to the shoreline from the makai edge of the property (refer to Plate 3). The existing seawall and revetment are not expected to accelerate erosion on neighboring properties which are already armored by seawalls or revetments (refer to Plates 1, 2 and 4). The return at the northern end of the seawall where it meets a narrow set of steps reinforces the wall system (refer to Plates 5 and 6).

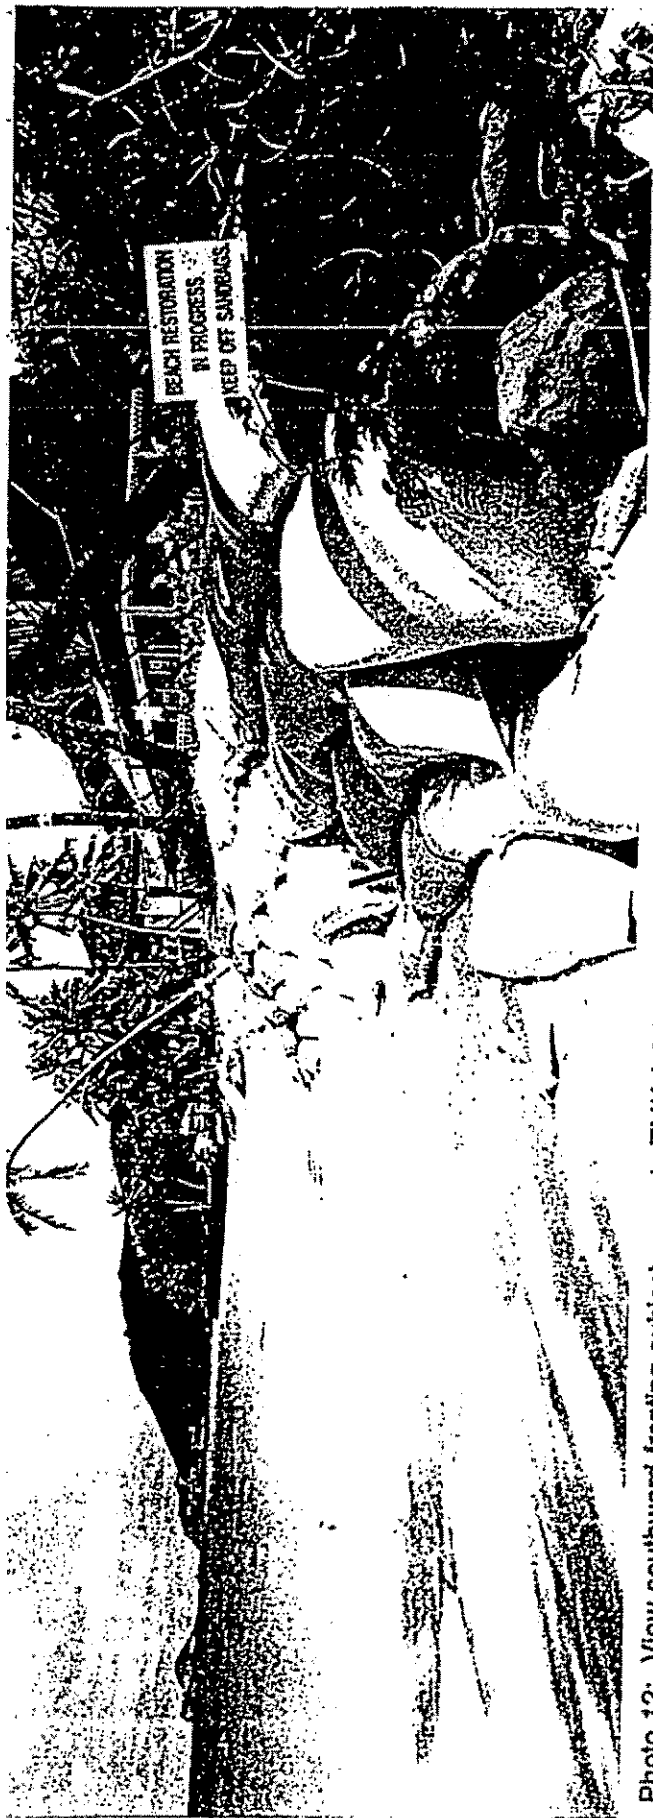
Photo 12: View southward fronting subject property TMK-4-3-5:61 showing condition of sand bag revetment after repairs completed.

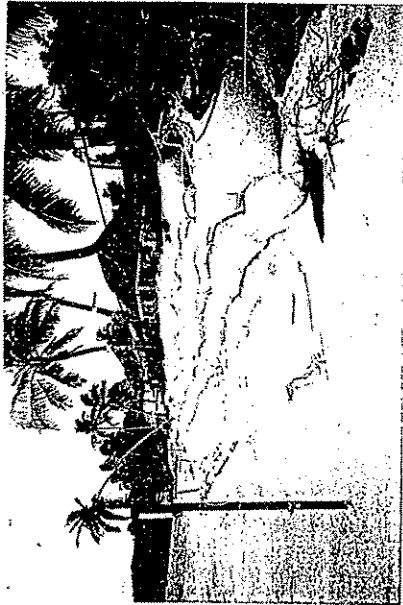
Photo 9: View southward showing completed sand bag revetment on subject property TMK-4-3-5.61.

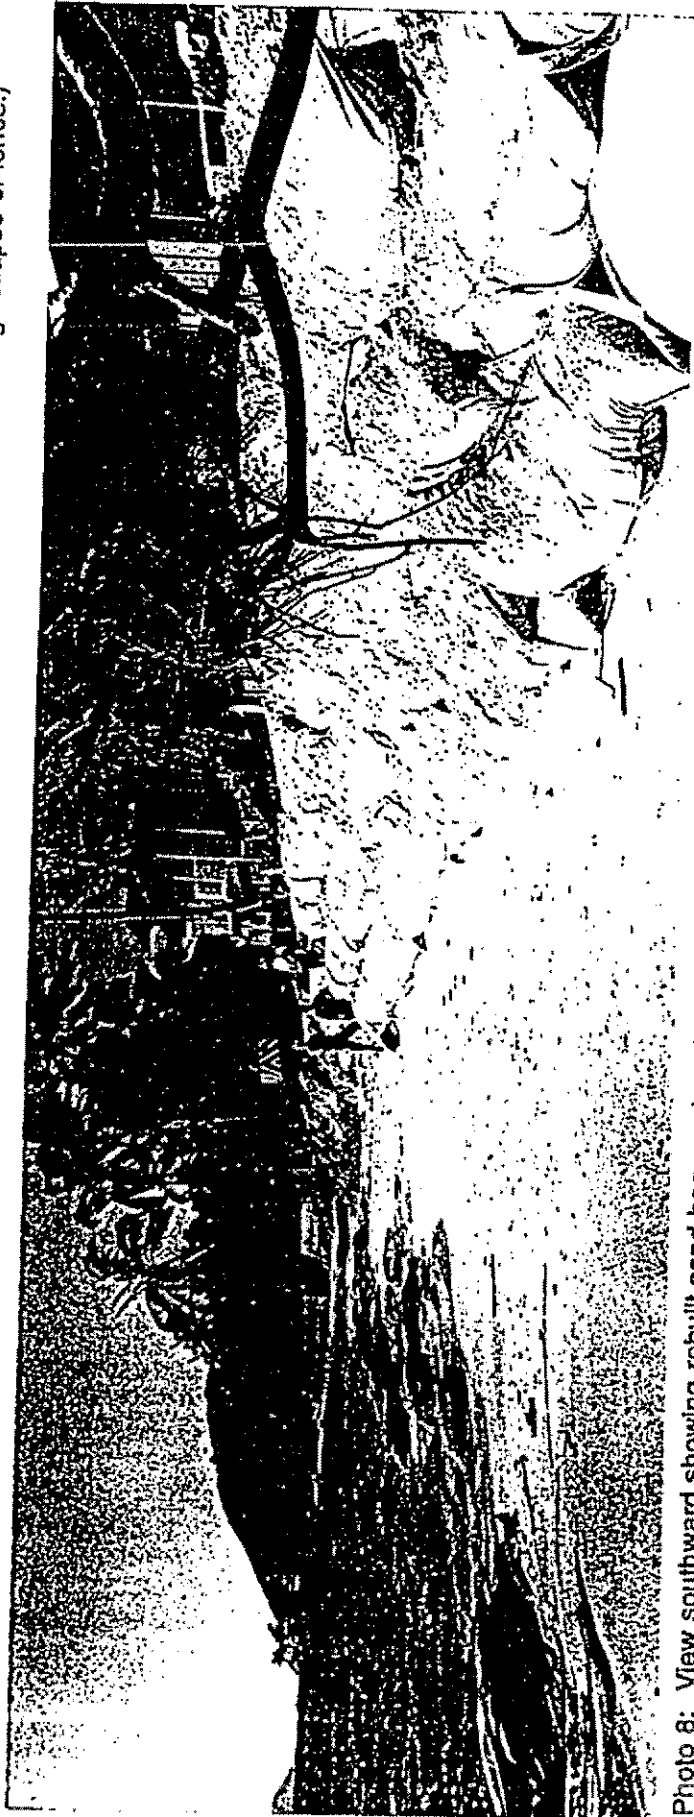
Photo 8: View southward showing rebuilt sand bag revetment on adjacent parcel 98 (Carpenter).

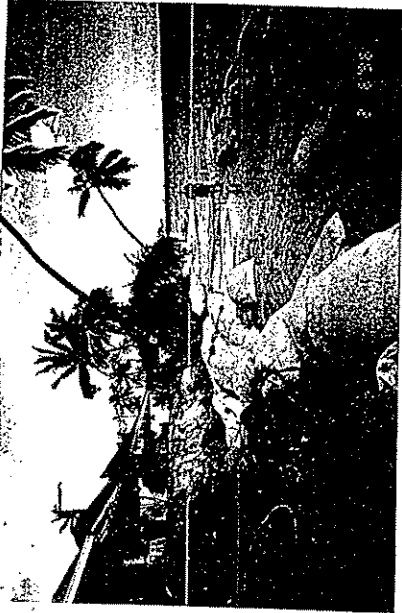
Photo 4: View northward showing damaged condition of sandbags fronting adjacent parcel 98 (Carpenter).

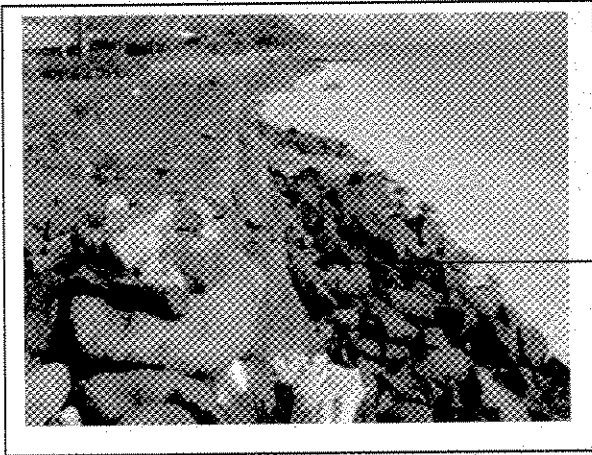
Wall has thickness and batter with large interlocking stone, Note seaward rubble protection.
