FINAL ENVIRONMENTAL ASSESSMENT

KAPOHO BAY FISHPOND RESTORATION PROJECT
KAPOHO, PUNA, HAWAI'I ISLAND, HAWAI'I

FEBRUARY 2008

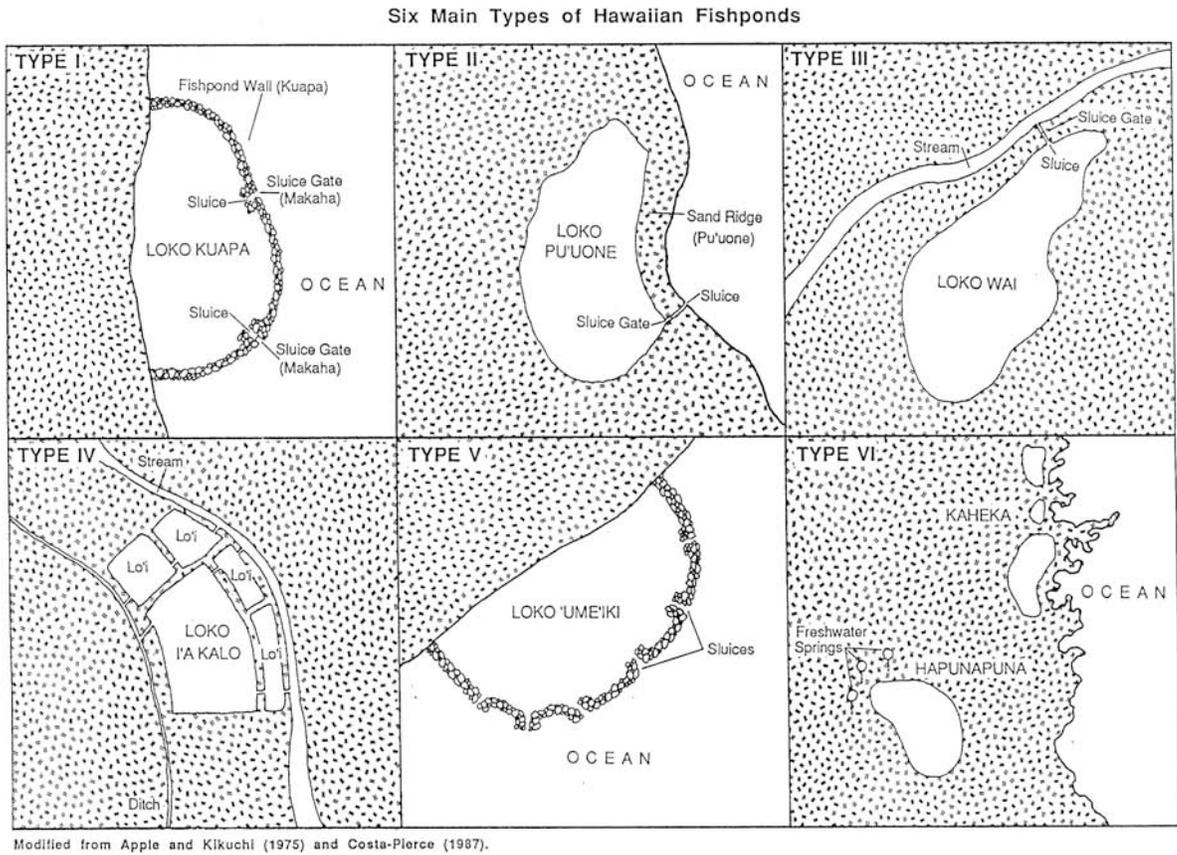
Figure 1 - Six Main Styles of Hawaiian Fishponds (DHM Planners, Inc 1989).

The style of fishponds constructed is closely related to the topographical features of an area. For instance Moloka'i and O'ahu contain the highest number of *loko kuapā* in the state (48% and 30%, respectively) due to the deep bays and presence of shallow fringing reefs that protect the walls from high surf. Hawai'i island has few *loko kuapā* (14%) but the largest number of *loko pu'uone* (50%), *kāheka/hāpunapuna* fishponds (79%). This is because the island is geologically the youngest of the major islands, with ongoing volcanic activity producing an irregular coastline and lacking a fully developed fringing reef, but with many depressions, lava tubes and freshwater pools.

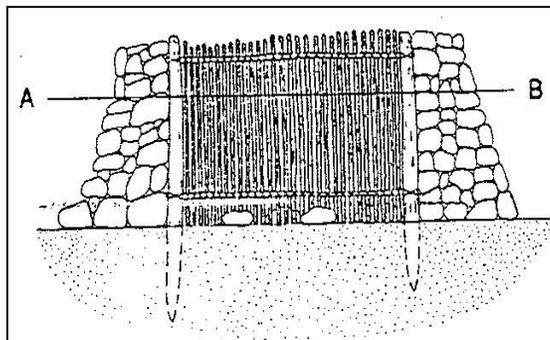
Figure 2:
Side View of *Mākāhā*. Line A-B
Indicates water level (Summers 1964).

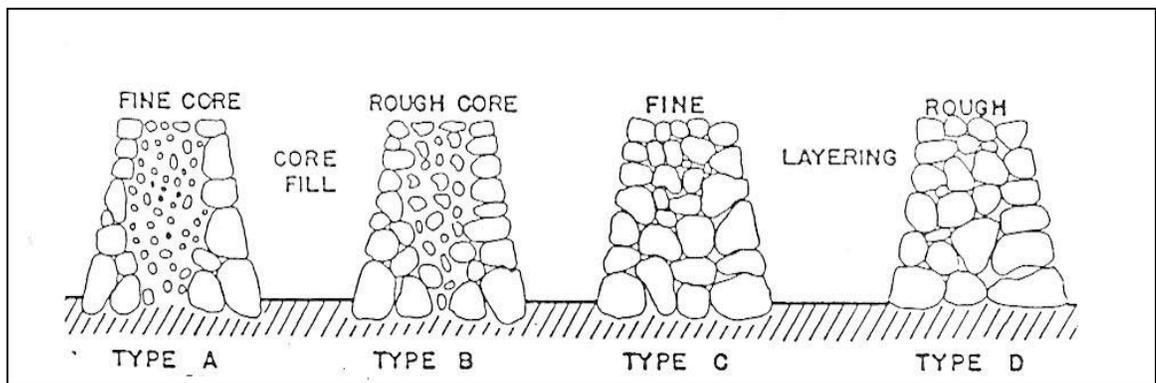
Figure 5: Cross-sections of double-wall construction with fill (Kikuchi 1975).

The *loko kuapā* wall consisted of basalt, coral boulder and rocks. The walls are double faced with smaller rocks and coral fragments (*'ili 'ili*) used to fill the interior between the inner and outer wall facings. The facing rocks were placed in an interlocking fashion (*ho 'oniho*) to form the two facings of the wall. Kikuchi (1973) noted that fishpond wall lengths varied from 150 feet to 6,300 feet, with the highest frequency between 1,200 and 2,000 feet. The walls of a *loko kuapā* are

not submerged at high tide; the water may approach the top of the wall, but it never covers it completely (Ibid.). Wyban (1995) states that the ancient fishponds have wall facings that are usually one rock thick. A prevalent characteristic of the rock walls was their sloping faces. Kikuchi (1973) notes, that the seaward walls have a larger slope than the inner face. This enabled the wall to withstand wave energy more efficiently. Another technique in the reduction of wave energy is the wall's semi-permeable construction. Fishpond rock walls are solid but porous and do allow for percolation of seawater, allowing wave energy to be absorbed and dissipated.

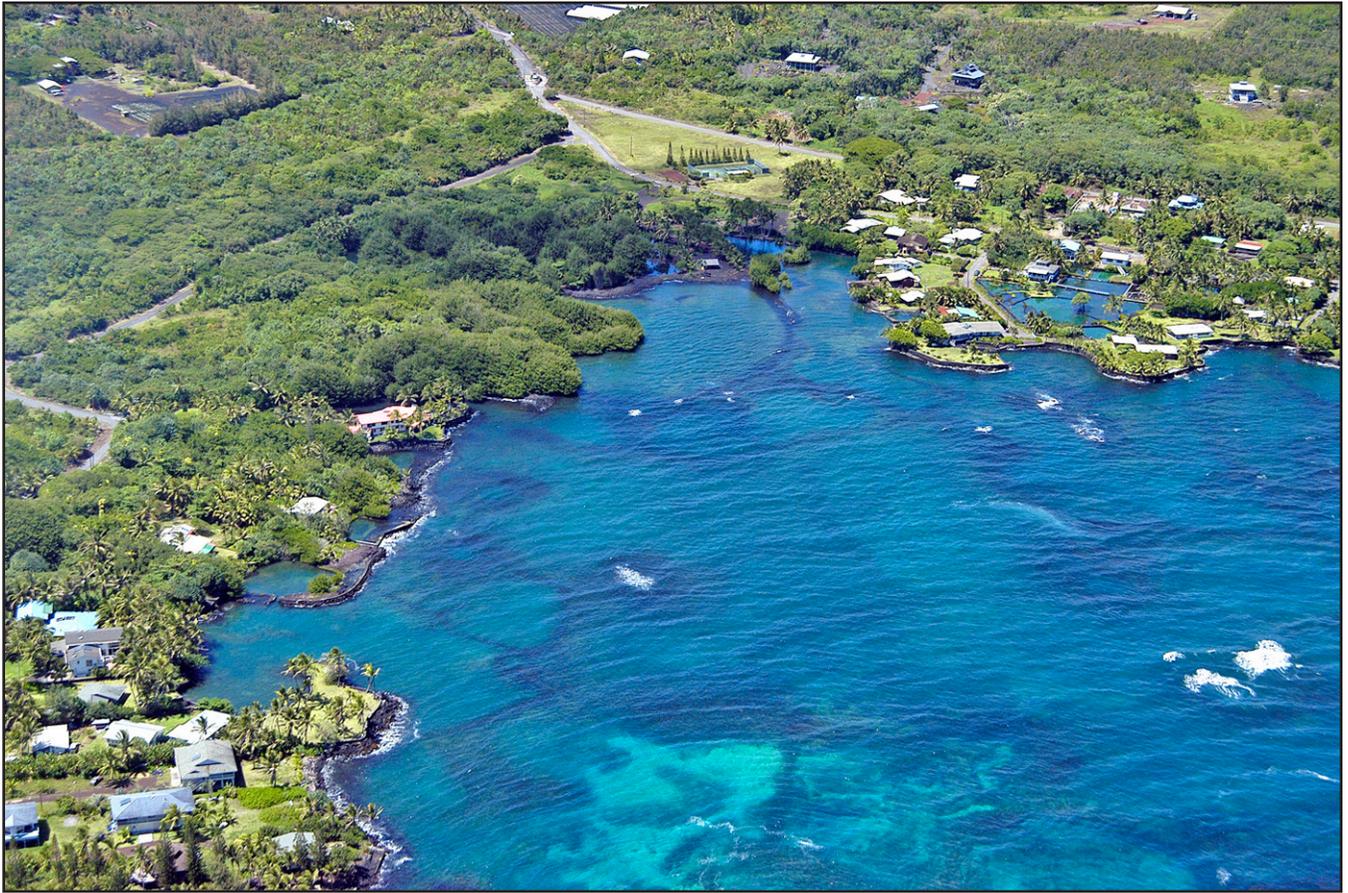
Figures 7 & 8. Aerial View of Southern Kapoho Bay and Close-up of Subject Fishpond at High Tide (Brian Powers/Hawaiian Images Photography).

Note that there are numerous submerged remains of other wall alignments adjacent to the relatively intact main fishpond wall (these remains can be seen in the aerial picture, figures 7 and 8, page 13). This indicates the probability that the existing fishpond wall alignment has been modified over time and or may

Not mentioned in the draft EA is the existence of a network of submerged man-made walls in the waters of the bay outside of the fishpond. Many of these walls can be seen in Figure 7 of the EA. When we snorkeled around these features in the early 50's, especially in the area to the northeast of the fishpond, my brother and I found 3 or 4 broken and intact poi pounders and several dense worked rocks like adze-heads. (Neither my brother or I remember what happened to those artifacts.) A few oldtimers (don't remember who) in the 50s told us that the walls were remnants of old fish ponds and possibly house platforms/enclosures. It was said that these structures were submerged in subsidence events of the 1800's and 1924. It would be interesting to find out if those wall structures were indeed submerged in 1924, as it would possibly shed additional light on the history of the Kapoho fishpond. Note that increased surf action since 1975 has done significant damage to these walls....they are rapidly getting smeared out and in another decade or two may not be recognizable as being man-made. A final thought on these walls is that when you look at them in the aerial photo of Fig. 7, it looks as though they might have been a complex of fishponds...after they were lost to subsidence, maybe Kapoho fishpond was built as a partial replacement? When was the original bay actually formed?

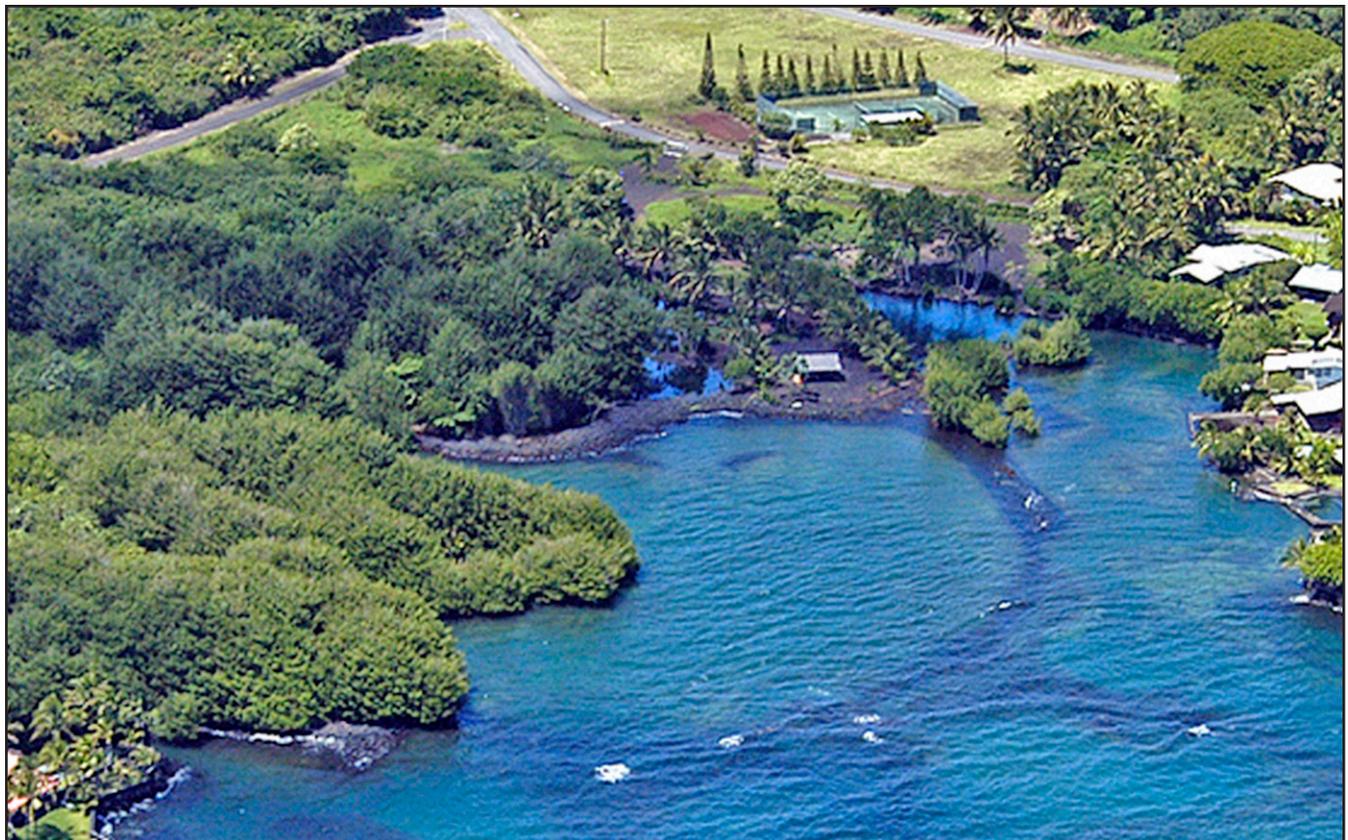
Figure 9. Aerial View of Kapoho Fishpond Circa 1970. Note intact wall and islets that are now covered in mangrove (Ford 1973).

There is no mention in the DEA of the nursery/pua ponds that used to exist the back area of the main pond. These ponds are clearly visible in Figure 9 of the DEA. As mangrove clearly progresses, care should be taken to preserve/restore the walls to these ponds.

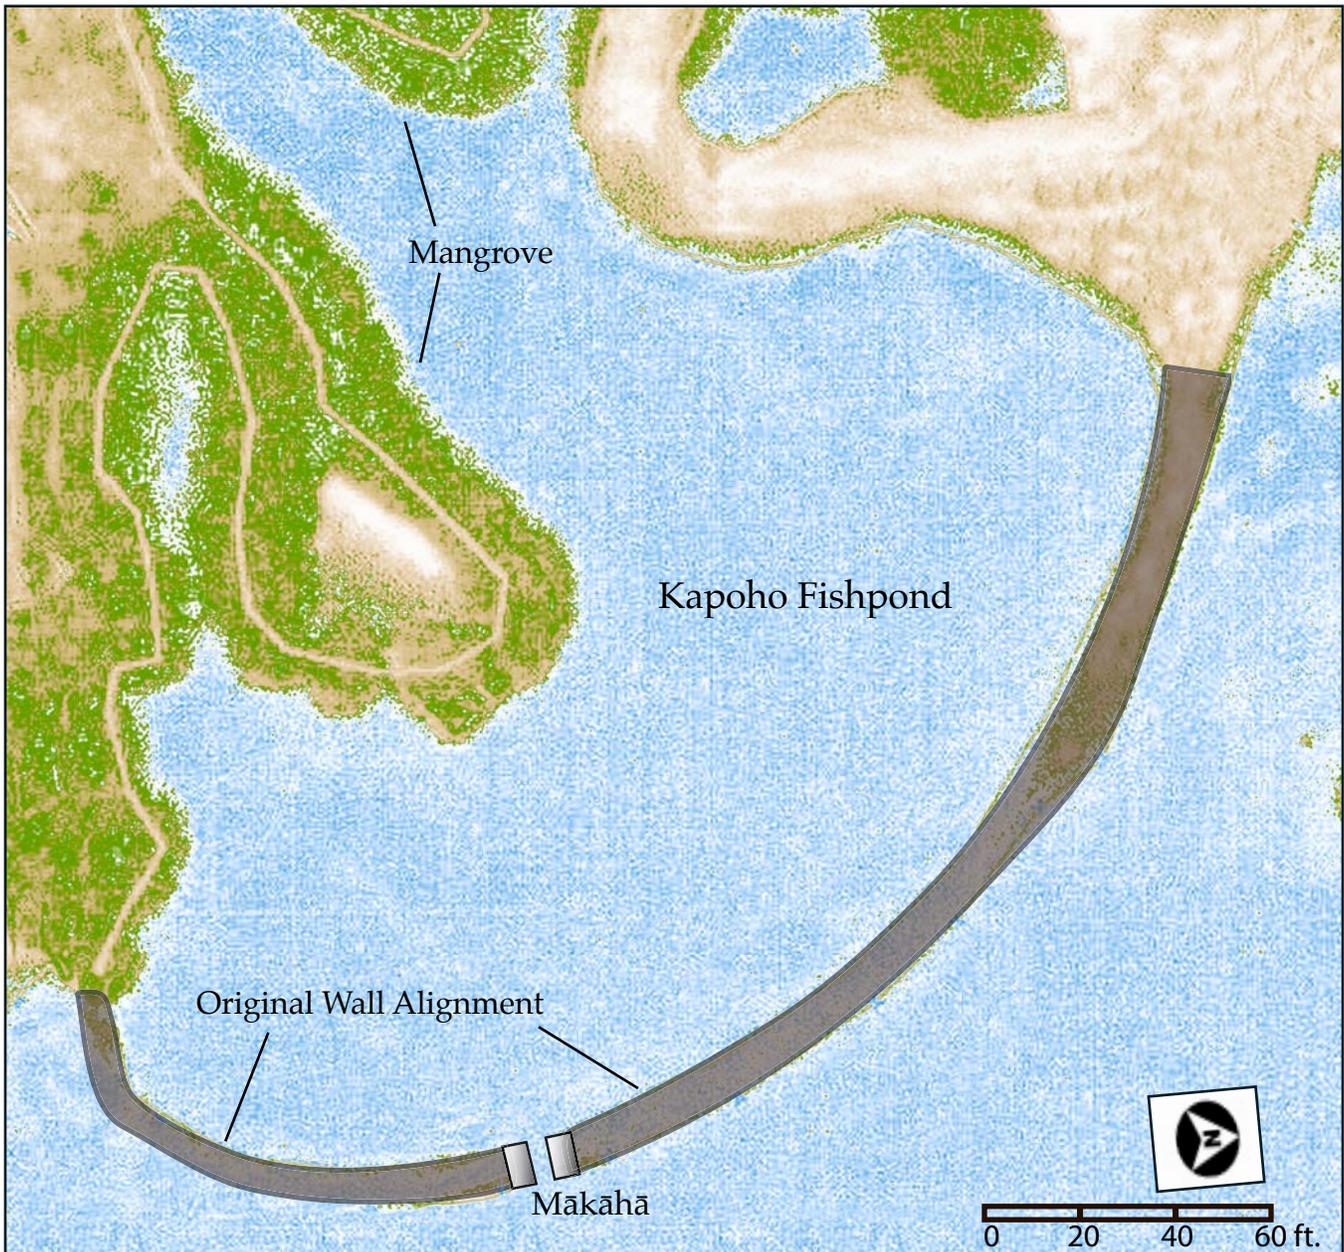
SITE PLAN

Kapoho Fishpond. Size: 4.3 acres, wall length 1,250 feet.

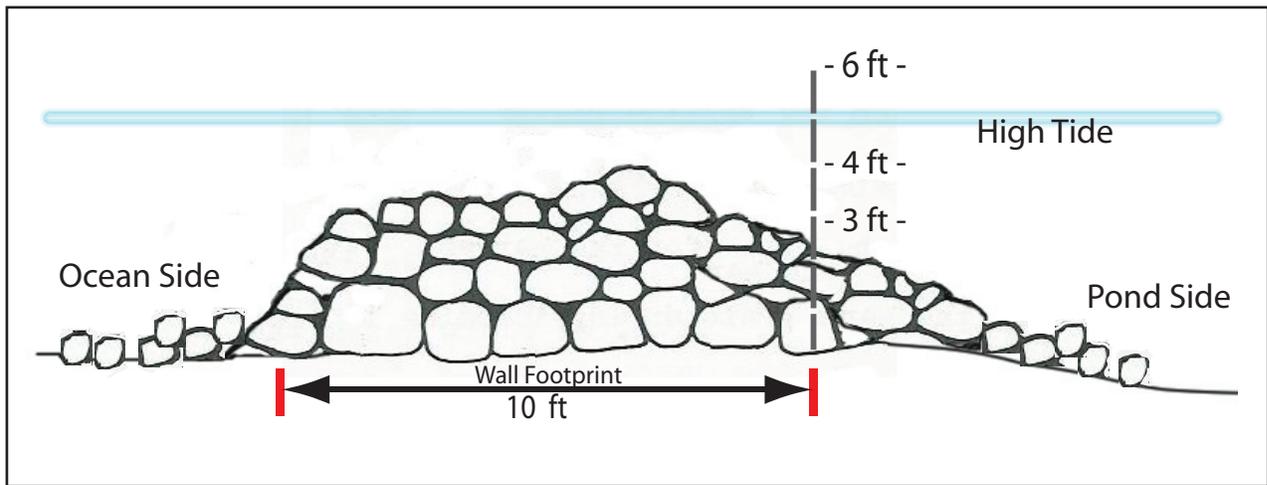
Figure 16. Kapoho Fishpond . Cross-section of Existing Wall.

Fishpond Description. The fishpond is delineated on its *makai* (seaward) side by a deteriorating 1,246-foot long wall that encloses about 4.3 acres of water, depths of which range from 3 to 5 feet. The first 75 feet of the wall, from the north curving around to the south, is in poor to fair condition, a broad flattened wall with rocks scattered along both sides of the original fishpond wall's

footprint at a width of about 27 feet. The next portion of the wall to the *mākāhā* is in good condition with a width of just over 5 feet at the crown and about 10 feet at the base. Wall height is about 3 feet at the low water marking. The facing on seaward portions of the rock wall here are in good condition. Rocks are scattered about 3 feet out from the footprint on both sides. The opening in the wall is an intact *mākāhā* of basalt rocks reinforced with concrete. The *mākāhā* has a base width of about 10 feet tapering on both sides to a crown width of 5.5 feet. It is 5 feet high. The height of the wall on both sides of the *mākāhā* is about 3 feet. From the *mākāhā*, the remaining southern portion of the wall is in poor condition with rocks scattered along the footprint of the wall and on portions of the reef and rock outcroppings. This condition can be attributed to the fact that this portion of the wall lies furthest *makai*, seaward, and closest to edge the reef flat, thus it is exposed to more wave energy and currents relative to the rest of the wall. The wall footprint ends into a thick grove of mangrove.

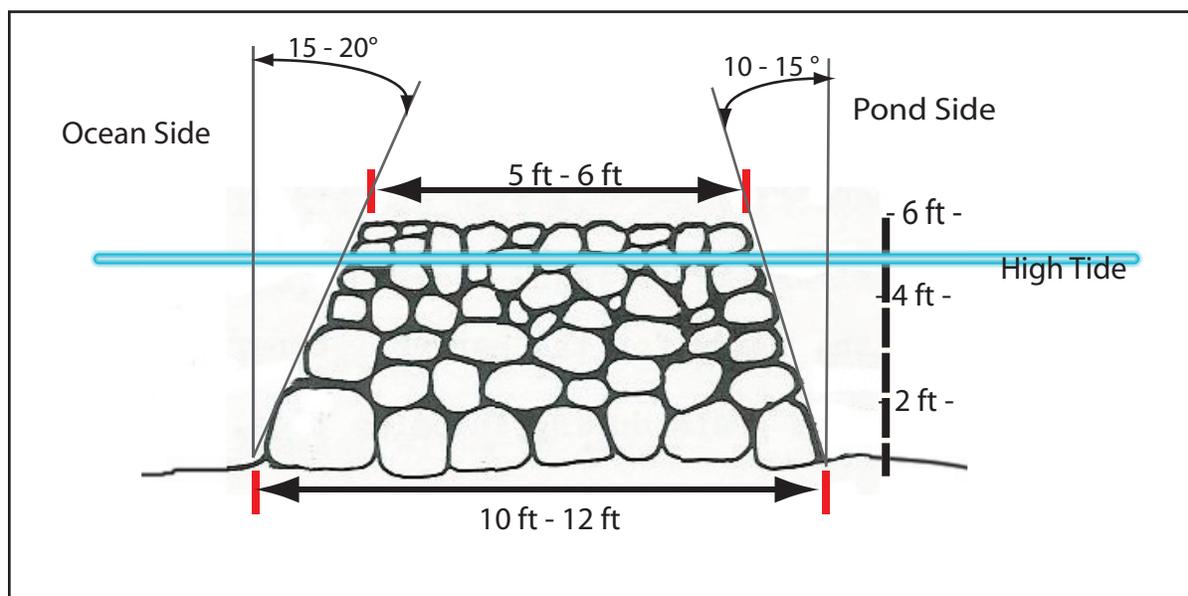
Figure 17. Kapoho Fishpond . Cross-section of Restored Wall.

2. The manual movement of 'ili 'ili (smaller rocks, pebbles, loose coral) within the fishpond basin;
3. Restore and rebuild the fishpond wall using the existing onsite rock and 'ili 'ili, in the traditional method of dry-stack rock wall construction without mortar, *uhau humu pohaku*. Additional rock needed to complete the wall will come from local quarries and be of the same general size found at the fishpond wall.

4. The existing alignment and wall design will be followed and replicated. Where there is little or no wall footprint or foundation stones, the wall will be rebuilt in similar design and boulder size consistent with archaeological findings and the surrounding fishpond wall.

Most of the fishpond wall is 3 to 4 feet high. The wall is proposed to be restored and rebuilt at a uniform height of 6 feet.

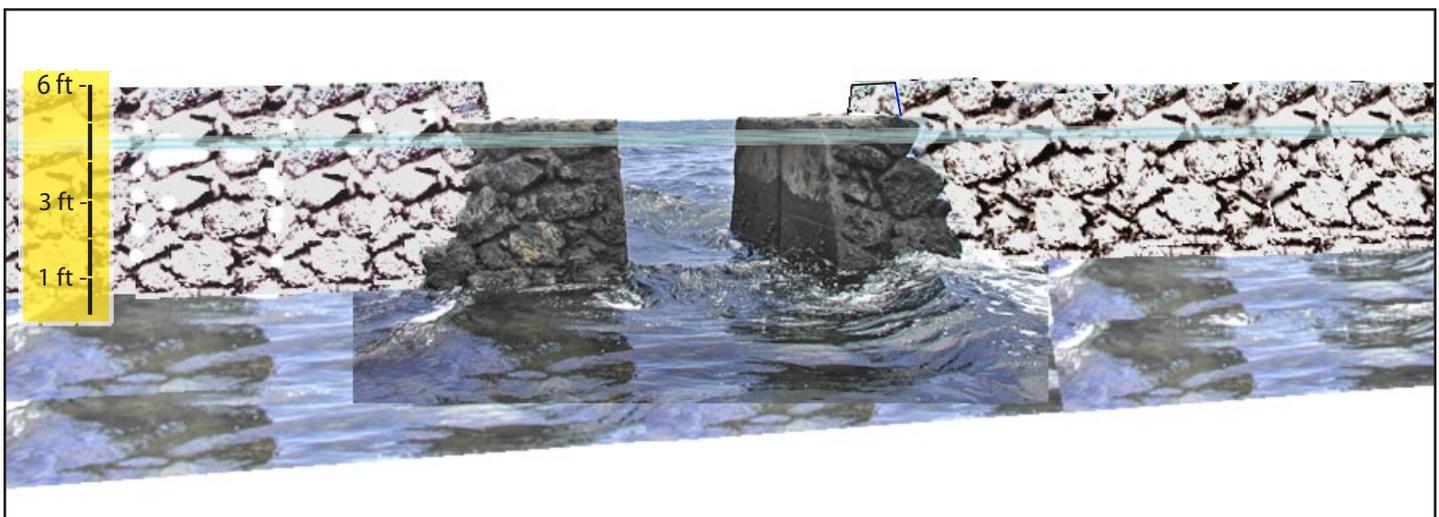
Figure 18. Kapoho Fishpond . Restored Wall at Mākāha Looking Makai. Note that the wall will be rebuilt one foot higher than the existing mākāhā to assure the wall will be exposed at high tide (blue line is approximate high tide).

The existing *mākāhā* is in excellent shape a result of having been reinforced with concrete. The excellent condition of the *mākāhā* and adjoining walls provide valuable information as to the original wall dimensions and style. This information will be used as the template to replicate how the wall will be rebuilt. The intact *mākāhā* dimensions are 5 feet high, base of about 10 feet wide, crown 5.5 feet wide (see pictures page 35).

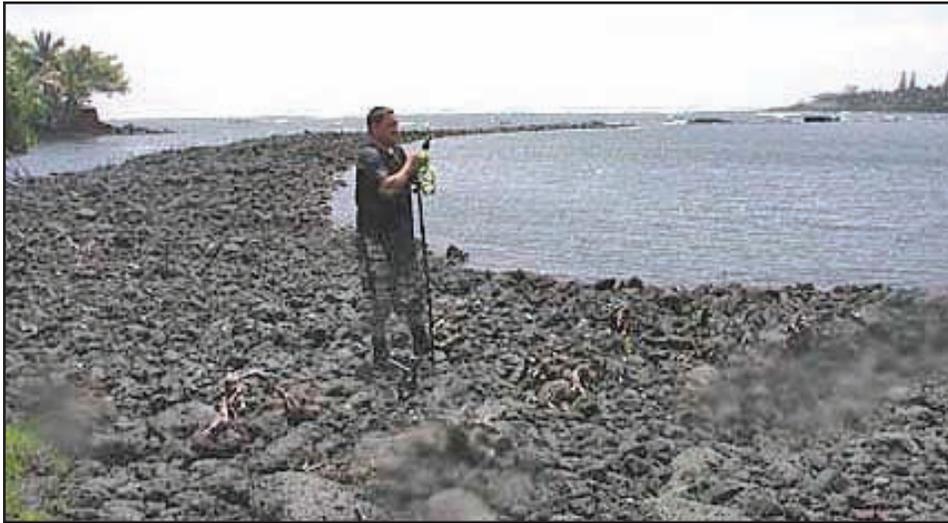
Three Views of Fishpond Wall Moving from North to South at Low Tide.

Fig 19. Beginning of Fishpond Wall at Northern End Where it Meets the Shoreline.

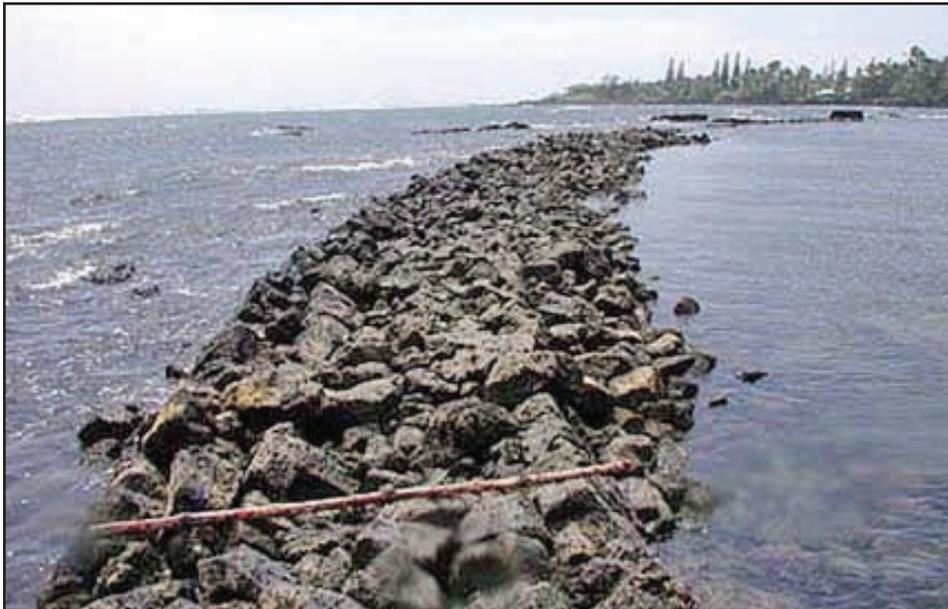
Figure 20. Next Portion of Wall Moving South. This section of the wall is the best preserved. Note the uniformity of the outer wall line.

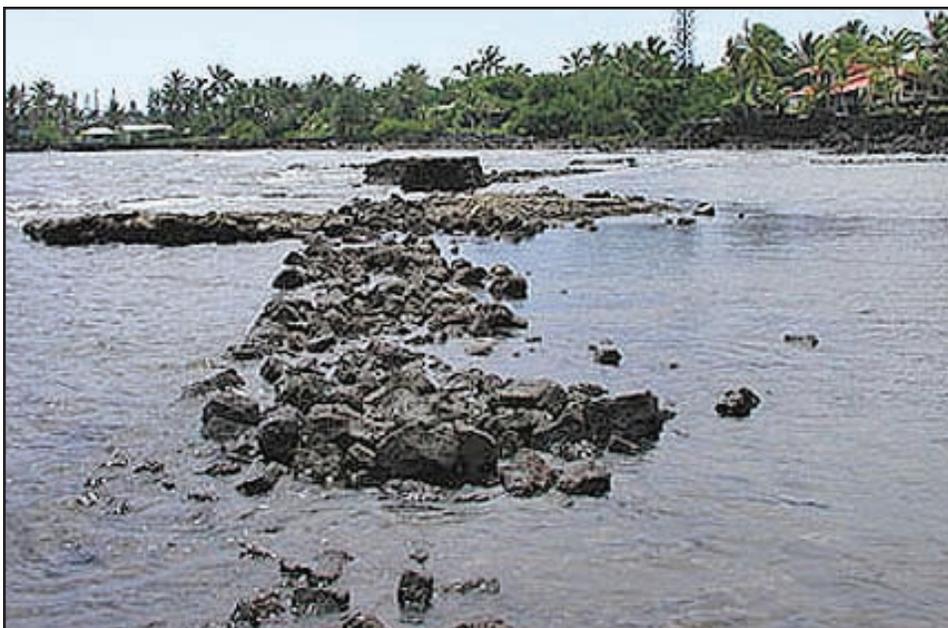
Figure 21. Wall with Mākāhā in the Background. This Section of wall is exposed to high wave energy thus many of the wall stones are found inside the fishpond basin. The horizontal rock formation in the background right before the makaha is exposed reef.

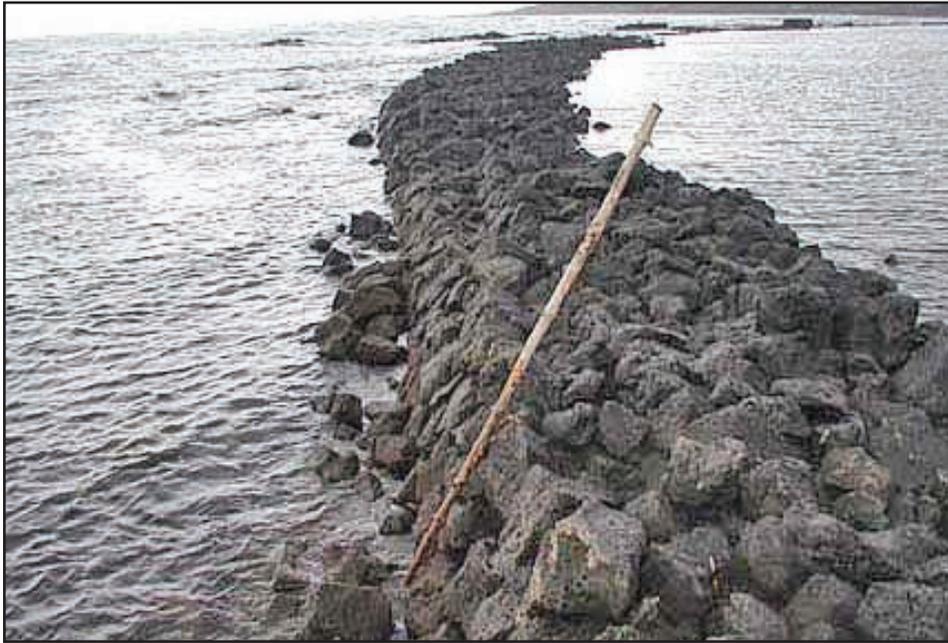
Fig 22. Outside Wall Facing. Note wall angle and alignment relatively intact.

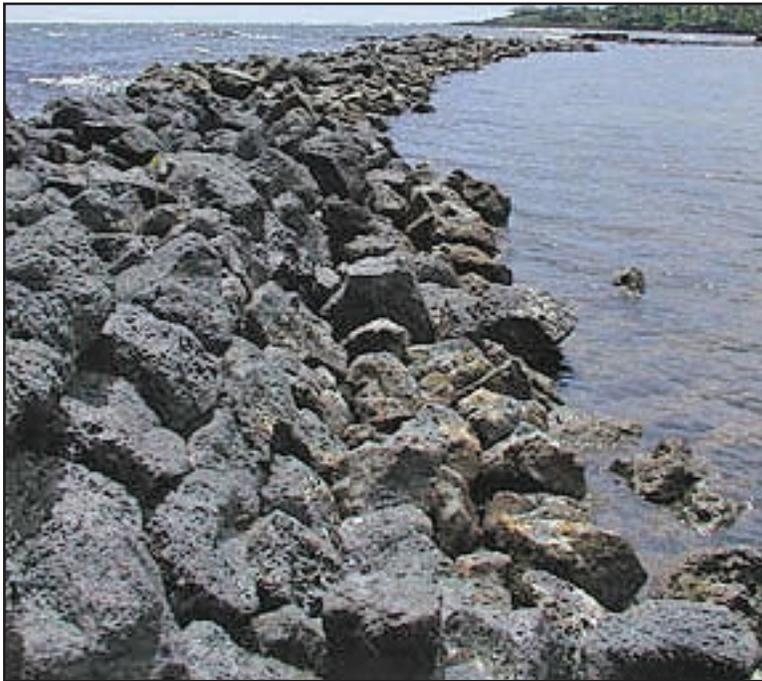
Figure 23, left, Inside Wall Facing. Inside wall alignment much less defined than outer wall. Many of the rocks have tumbled off the wall and are in the fishpond basin due to storm surges and wave action.

Figure 24, right, Wall Footprint, Outside. Numerous wall rocks are scattered about three feet on both sides the fishpond wall. These rocks will be reused to repair the wall.

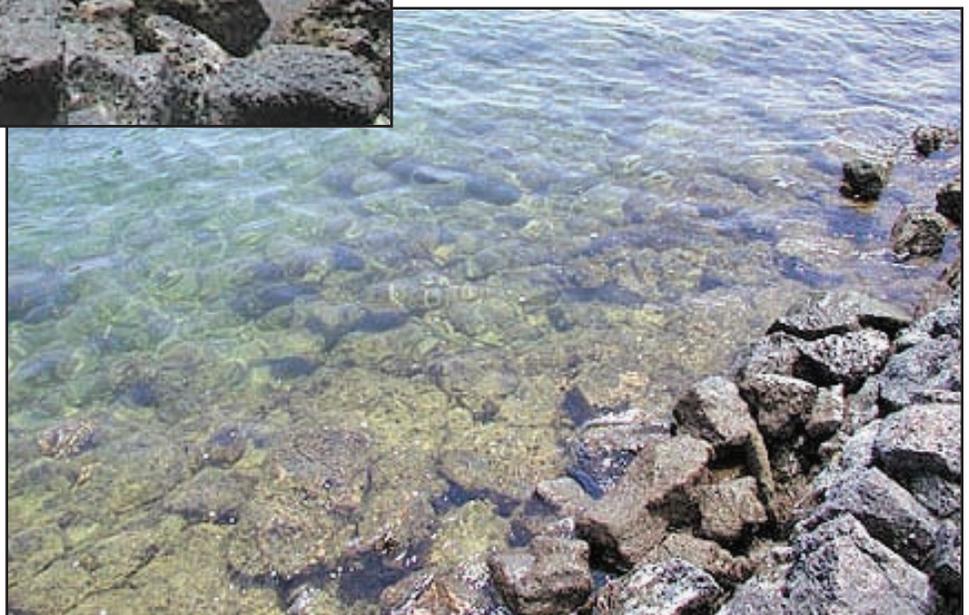
Fig 25. Mākāhā at Low Tide. Note at high tide mākāhā is completely submerged.

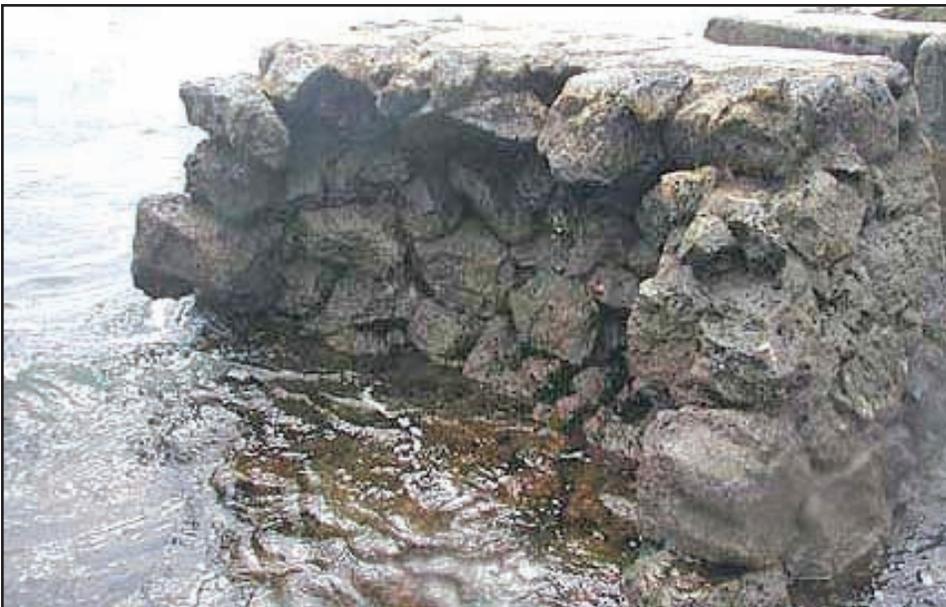
Figure 26. Detail of Northern Mākāhā.

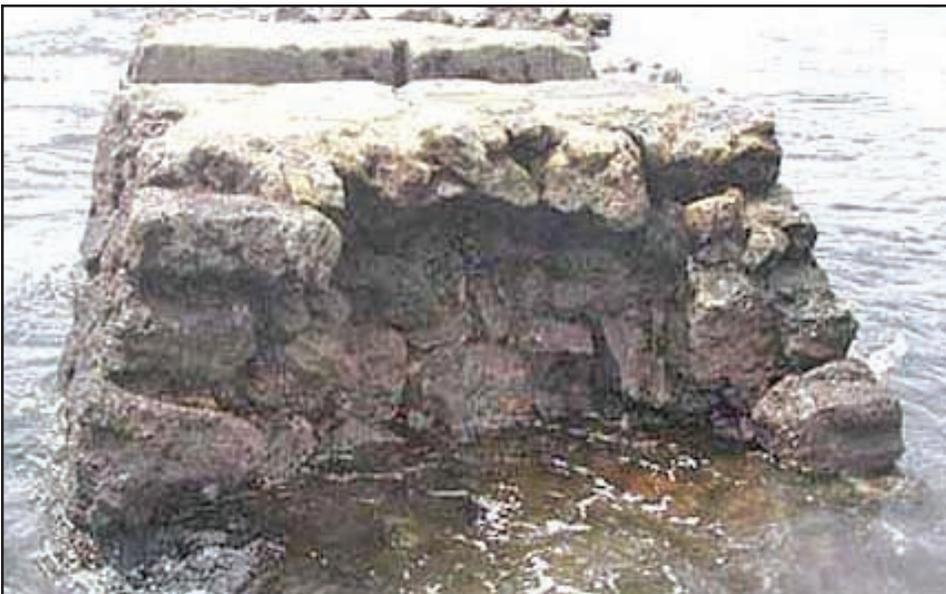
Figure 27. Detail of Southern Mākāhā.

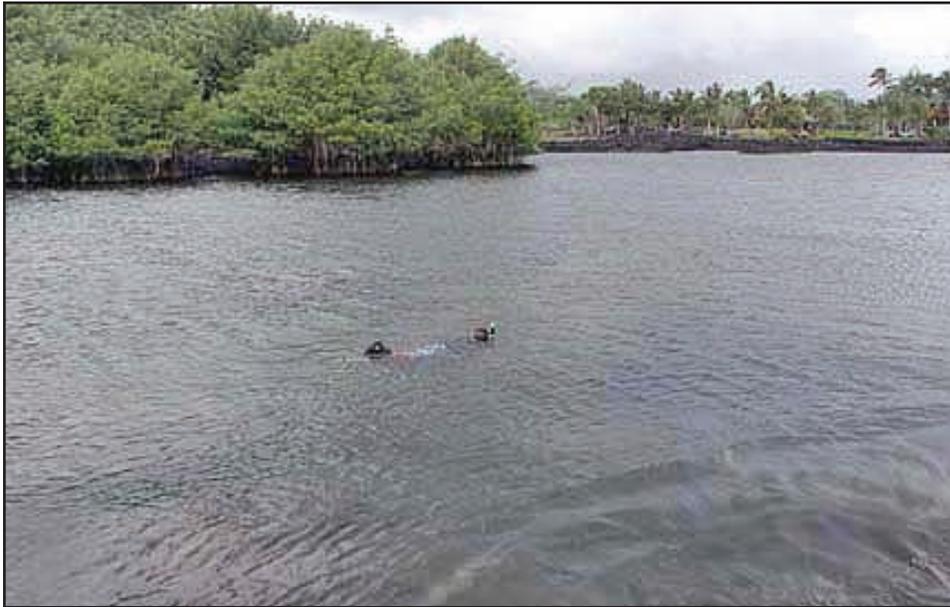
Fig 28. View of Fishpond Waters Looking West from the Makaha. Note extensive mangrove infestation in the foreground. Applicant's home is just barely visible on the far right.

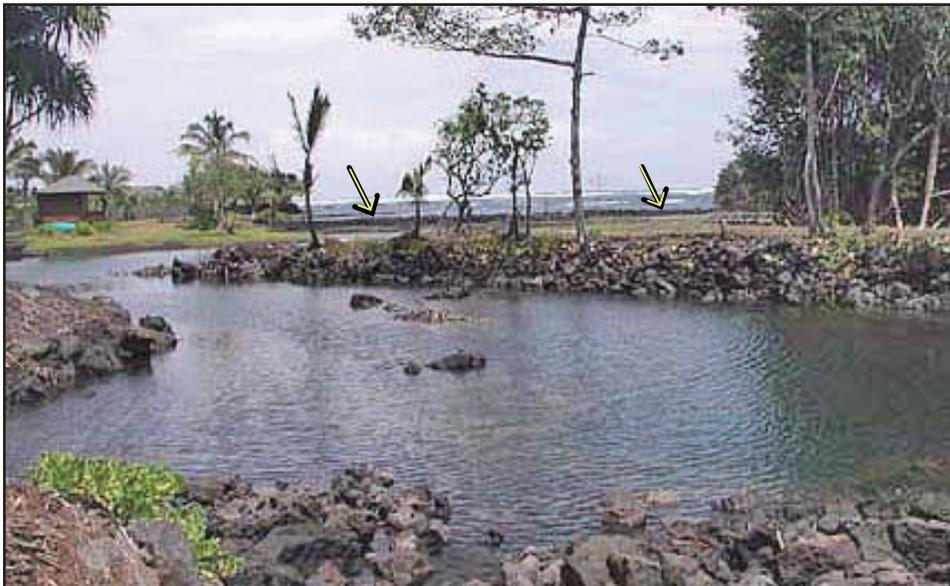
Figure 29. Interior of Fishpond Basin, North West Corner. The peninsula in the foreground has been cleared of heavy mangrove infestation. The fishpond wall is just visible in the background (arrows).

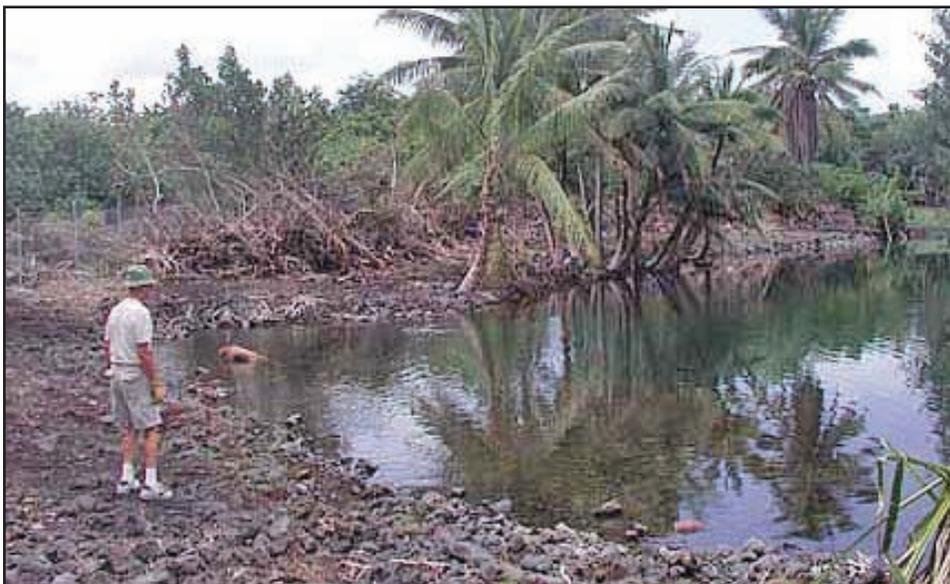
Figure 30. Back of Fishpond. Fishpond basin west end. Percolating springs are visible in this area of the fishpond basin. Note western property line delineated by chain link fence (right above gentleman's hat).

along this coastline including the subject property. Basal ground water is found in wells, at springs along the coast at low tide, or where features such as cracks have exposed the water table. At coastal discharge points, basal water is brackish. On the far landward side of the fishpond basin, fresh water seepage can be observed during low tide periods (see photo, Figure 30, page 36).

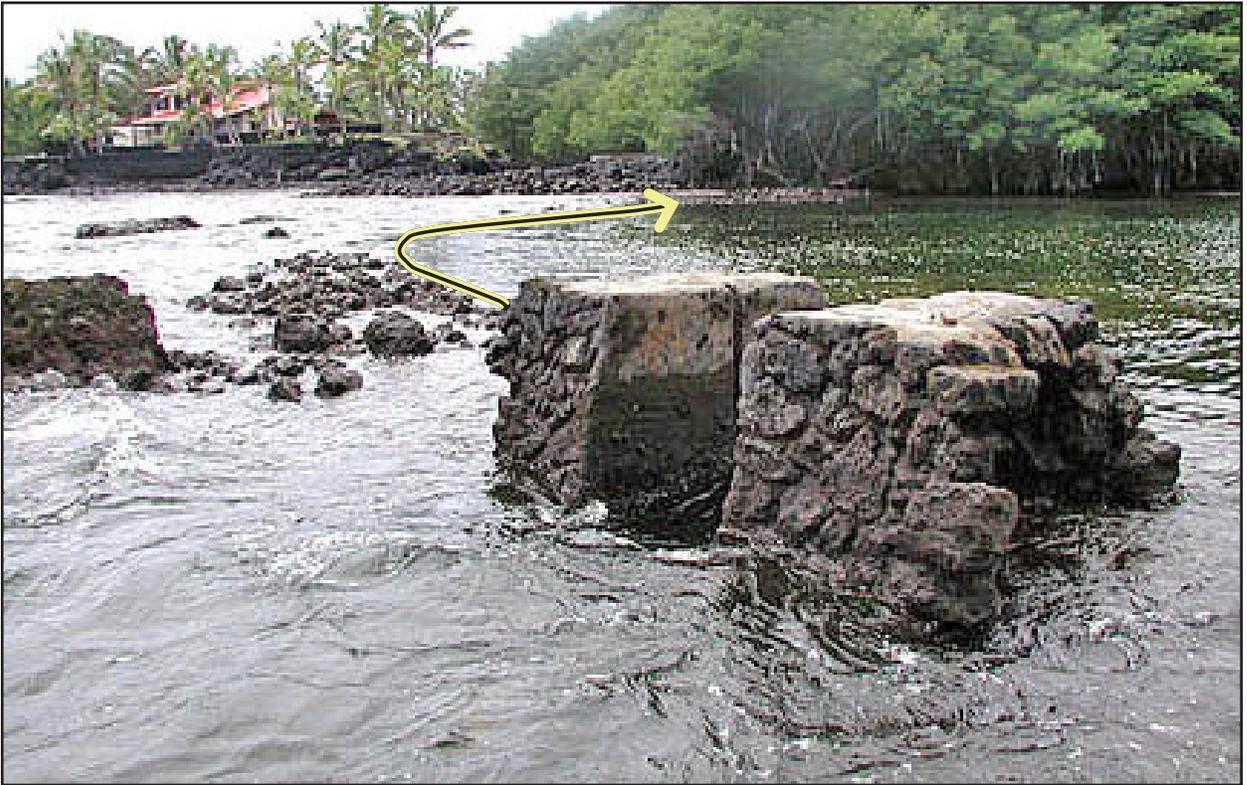
Figure 31, above, View of Mākāhā and Southern Portion of Fishpond Wall. Inside wall footprint is discernible as an arch containing the calm waters of the fishpond basin (yellow line). The southern terminus of the wall is at the edge of the mangrove (arrow).

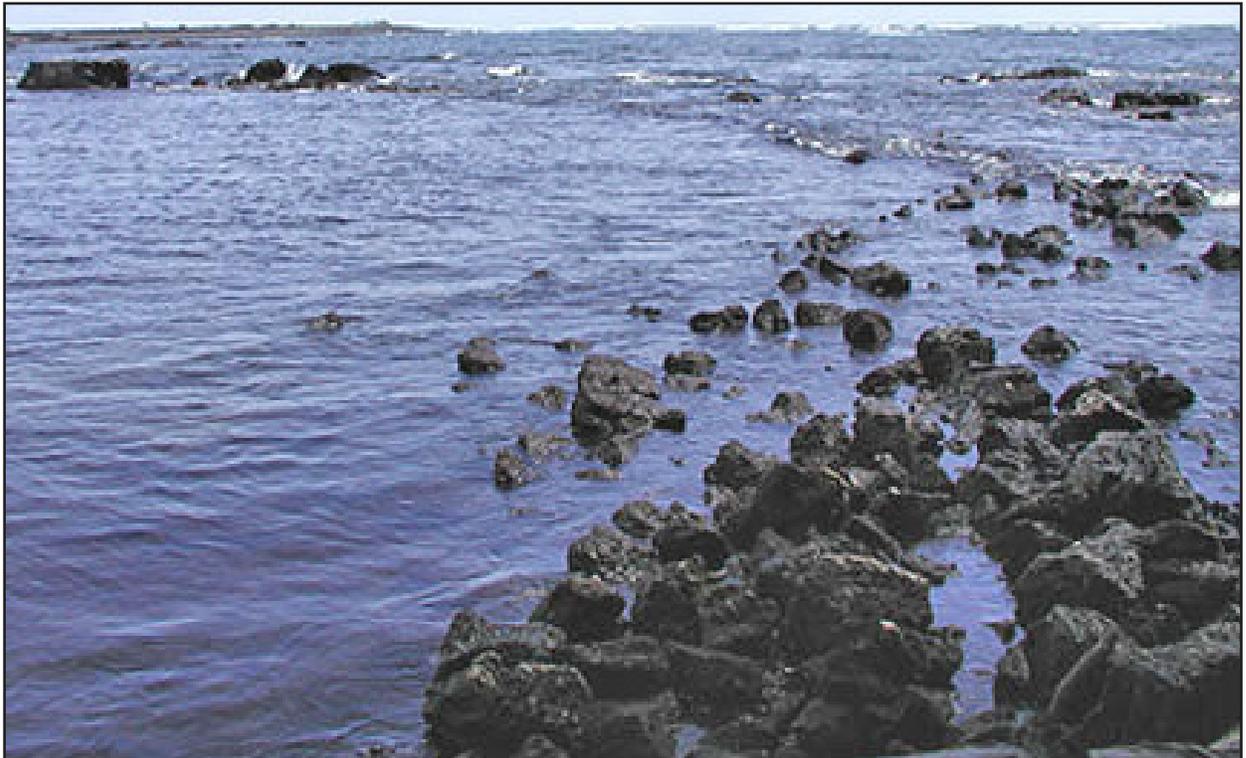
Figure 32, below, View from the Southern Terminus of the Wall towards the mākāhā. Wall is in poor condition due to exposure to heavy wave energy and currents.

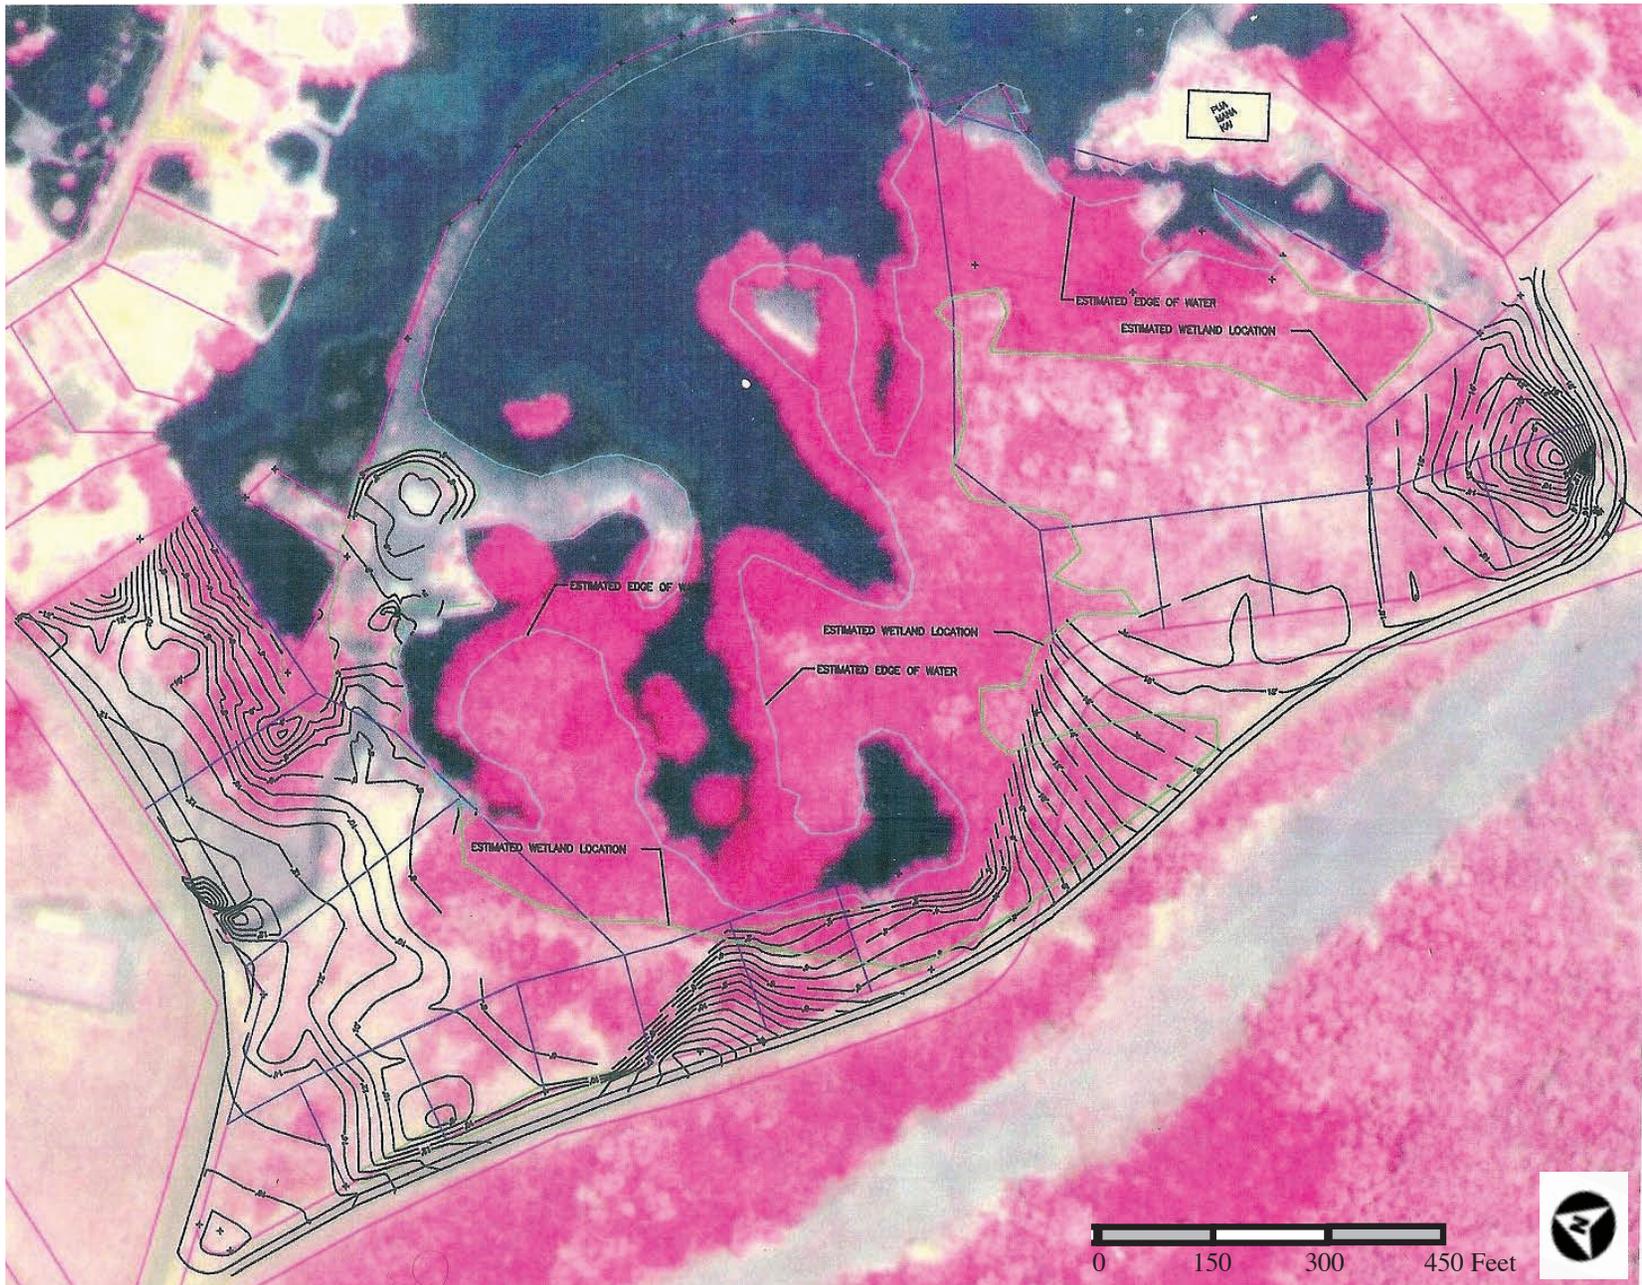
Figure 34
 Shoreline Survey and Topographic Map
 Source: R.M. Towill Corp.
 Farber & Associates, 8/2007.

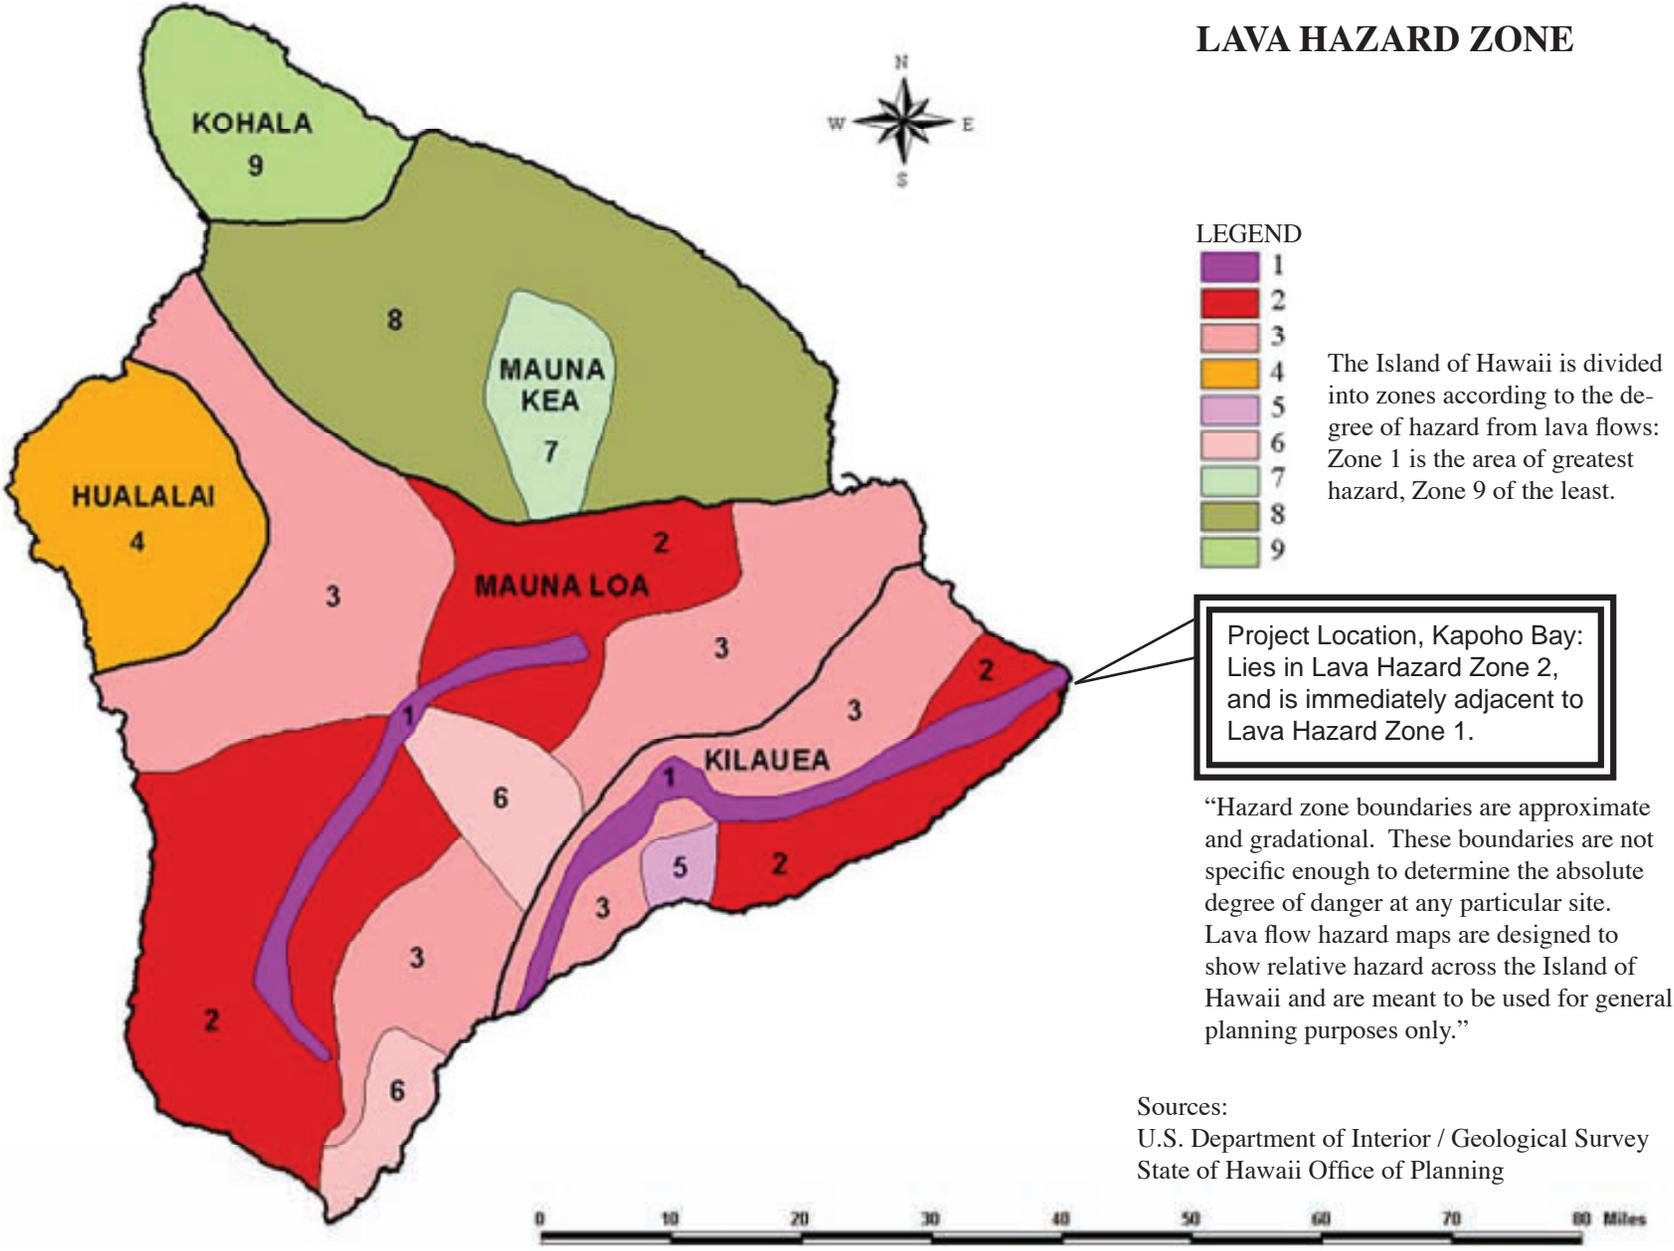
FIGURE 35
 Lava Hazard Zone
 Source: State of Hawai'i GIS
 Farber & Associates, 8/2007

According to the Lava Hazard Zone Map (see Figure 35, page 44) the subject property straddles hazard Zones 1 and 2, Zone 1 being the area of the greatest hazard to volcanic activity (the island is divided into nine zones). The lava flow hazard zones are based on past lava events, past eruption events, past lava coverage and topography.
