FINAL ENVIRONMENTAL ASSESSMENT

KAPOHO BAY FISHPOND RESTORATION PROJECT
KAPOHO, PUNA, HAWAI'I ISLAND, HAWAI'I

FEBRUARY 2008

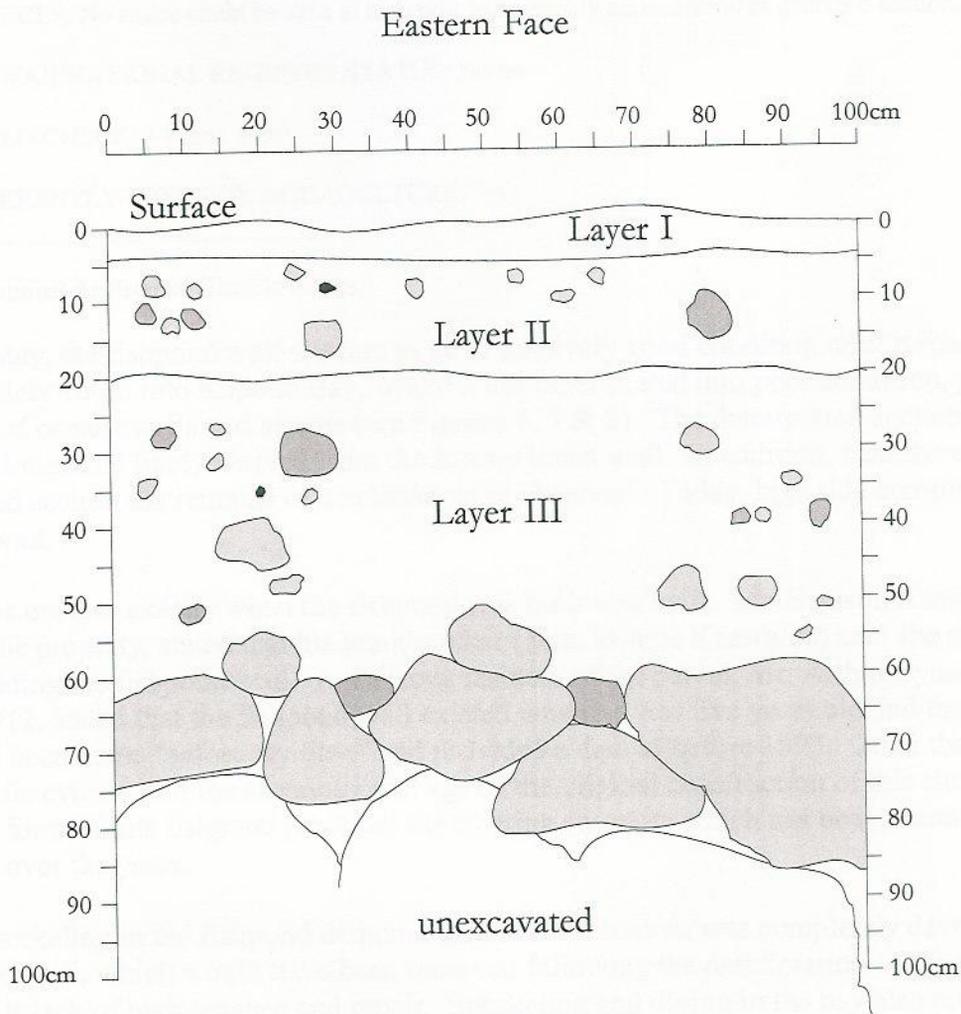
Figure 5: Profile of STU 1

- Layer I: Very dark grayish brown (10YR 3/2) cinder-stony silt
- Layer II: Very dark brown (10YR 2/2) stony silt loam
- Layer III: Very dark grayish brown (10YR 3/2) cinder-stony silt

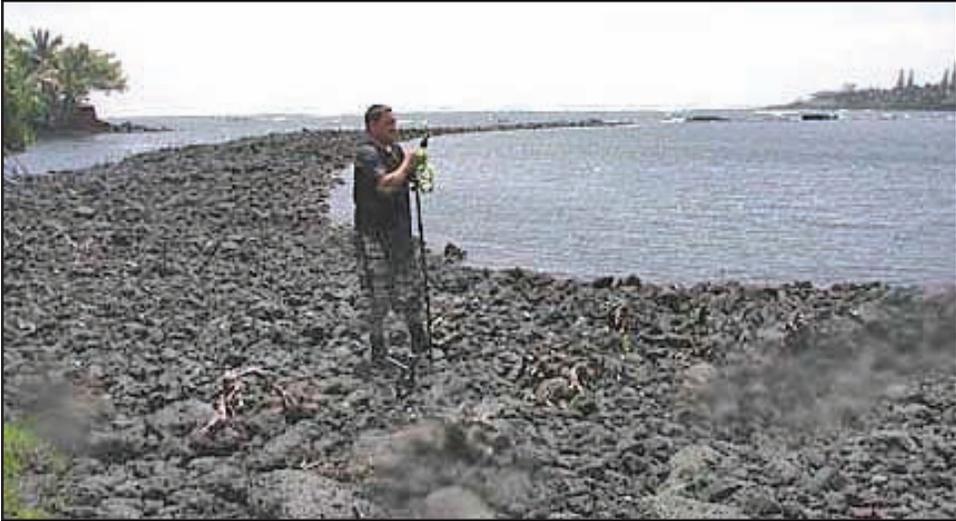
Fig 19. Beginning of Fishpond Wall at Northern End Where it Meets the Shore-line.

Fig 19. Beginning of Fishpond Wall at Northern End Where it Meets the Shoreline.

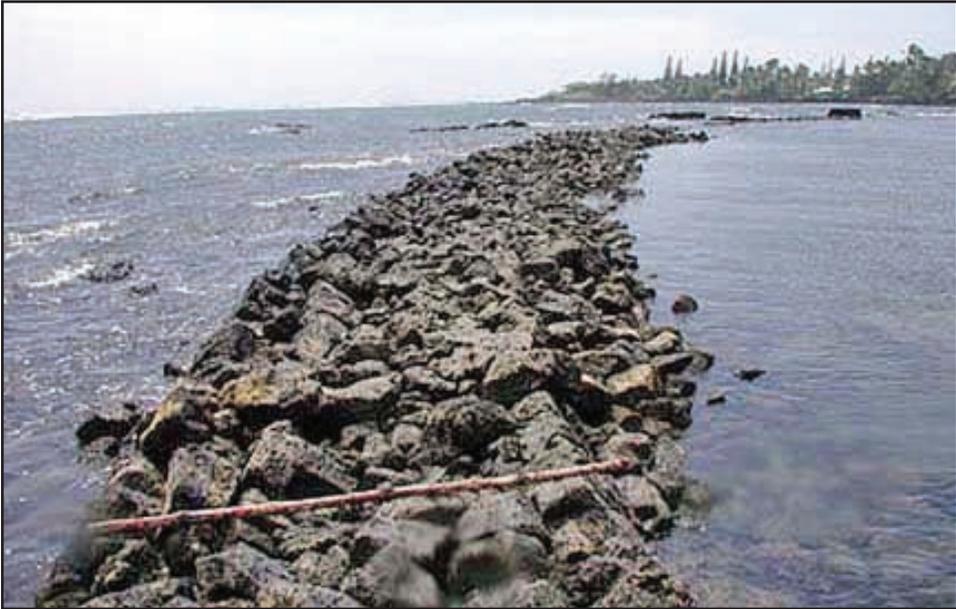
Figure 20. Next Portion of Wall Moving South. This section of the wall is the best preserved. Note the uniformity of the outer wall line.

Figure 20. Next Portion of Wall Moving South. This section of the wall is the best preserved. Note the uniformity of the outer wall line.

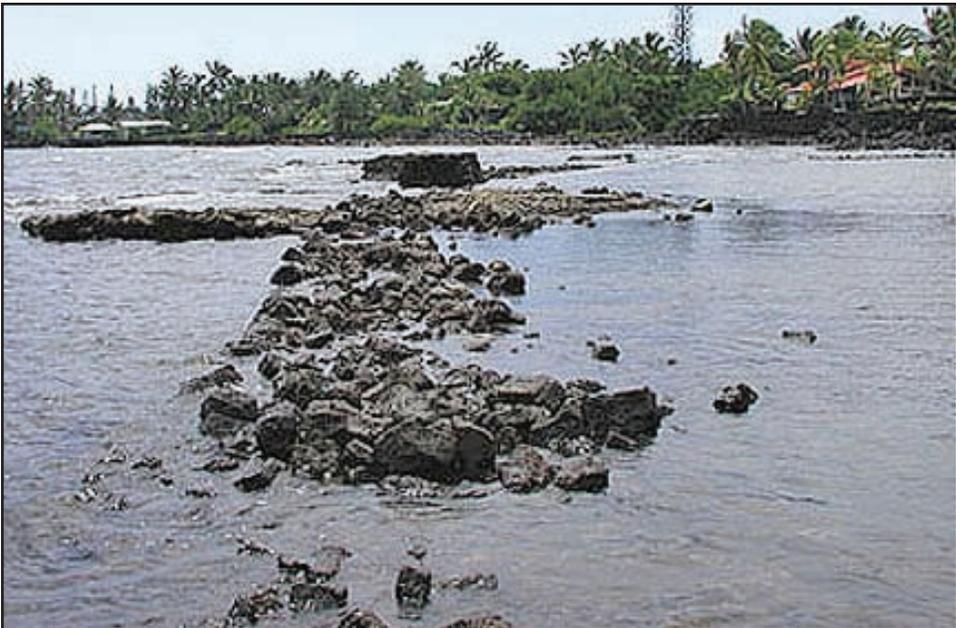
Figure 21. Wall with Mākāhā in the Background. This Section of wall is exposed to high wave energy thus many of the wall stones are found inside the fishpond basin. The horizontal rock formation in the background right before the makaha is exposed reef.

Figure 21. Wall with Mākāhā in the Background. This Section of wall is exposed to high wave energy thus many of the wall stones are found inside the fishpond basin. The horizontal rock formation in the background right before the makaha is exposed reef.

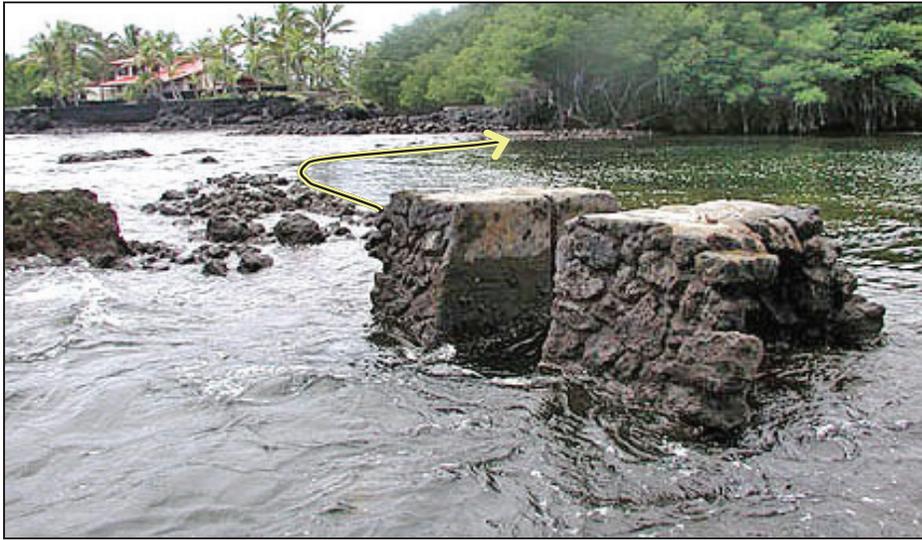
Figure 31, View of Mākāhā and Southern Portion of Fishpond Wall. Inside wall footprint is discernible as an arch containing the calm waters of the fishpond basin (yellow line). The southern terminus of the wall is at the edge of the mangrove (arrow).

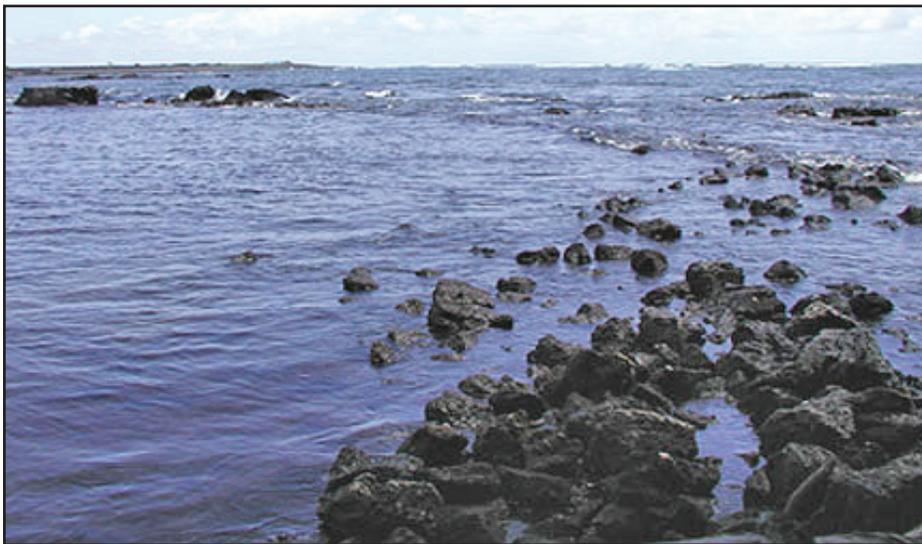
Figure 32, View from the Southern Terminus of the Wall towards the mākāhā. Wall is in poor condition due to exposure to heavy wave energy and currents.

7. Figure 32 on page 37 discusses the poor condition on the southern terminus of the wall “due to exposure to heavy wave energy and currents.” How will the wall construction mitigate against strong ocean surge and tidal energy? Please discuss measures to address this.

4. *Ref. Figure 32 on page 37 - Discusses the poor condition of the southern terminus of the wall due to exposure of heavy wave energy and currents. "How will the wall construction mitigate against strong ocean surge and tidal energy?"*

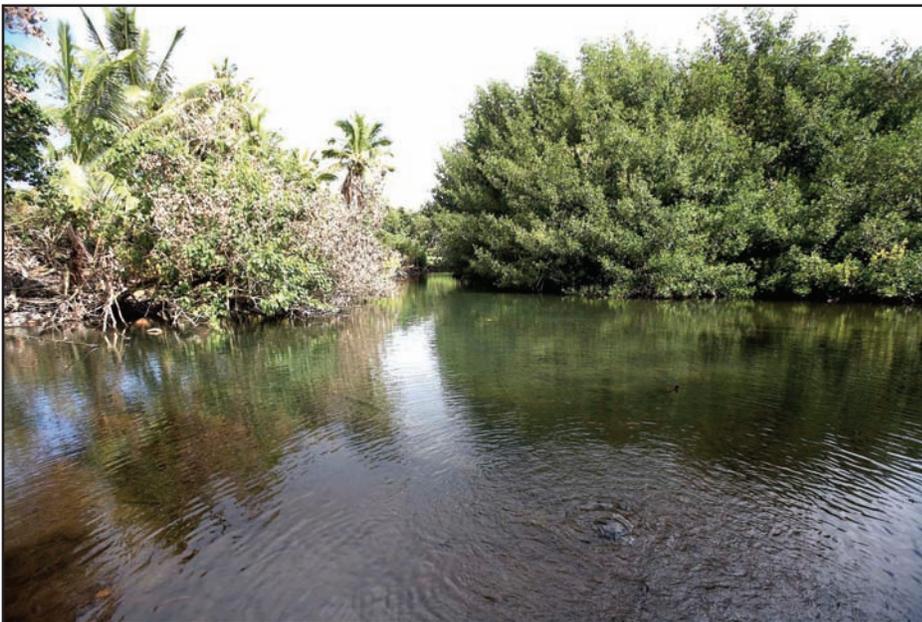
Figure 39, View from Western Edge of Fishpond Basin Looking North-east. Note heavy mangrove encroachment, springs in foreground.

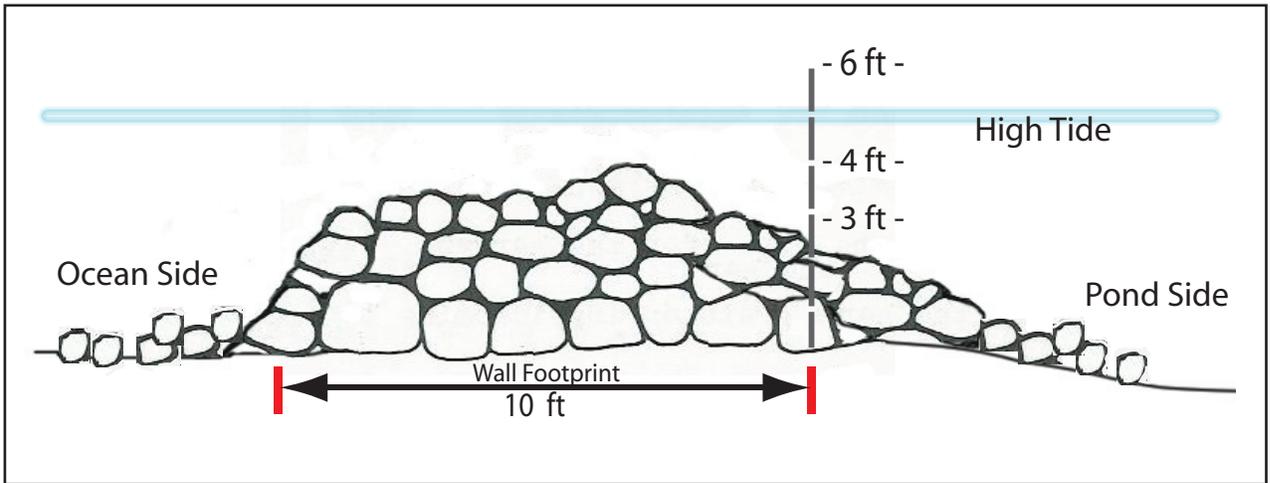
Figure xx. Kapoho Fishpond . Cross-section of Existing Wall.

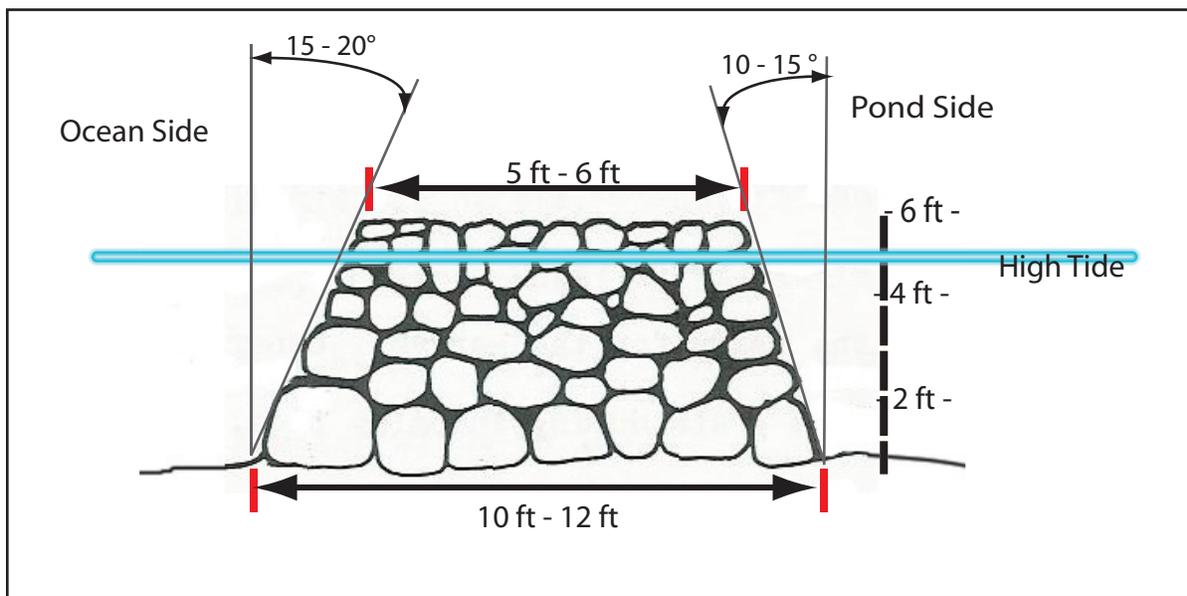
Figure xx. Kapoho Fishpond . Cross-section of Restored Wall.

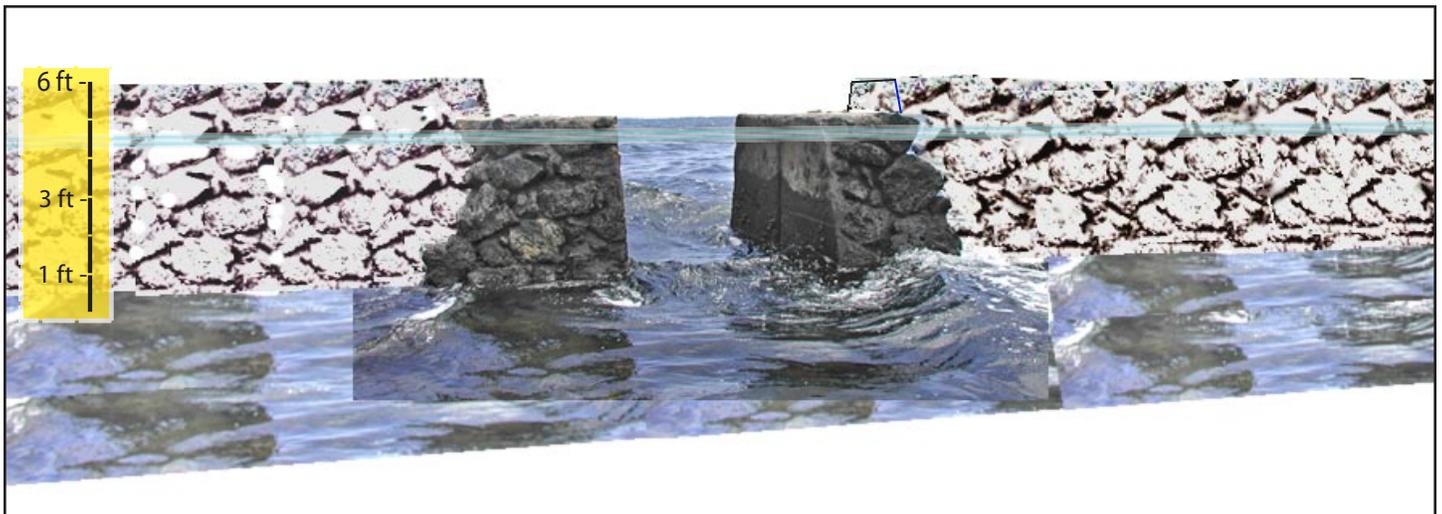
Figure xx. Kapoho Fishpond . Restored Wall at Mākāha Looking Makai. Note that the wall will be rebuilt one foot higher than the existing mākāha to assure the wall will be exposed at high tide (blue line is approximate high tide).
