Kona View Estates Subdivision

Final Environmental Assessment

TMK (3rd) 7-4-026:001-030
Honokōhau 1st, North Kona, District, Hawai‘i Island, State of Hawai‘i

April 2008

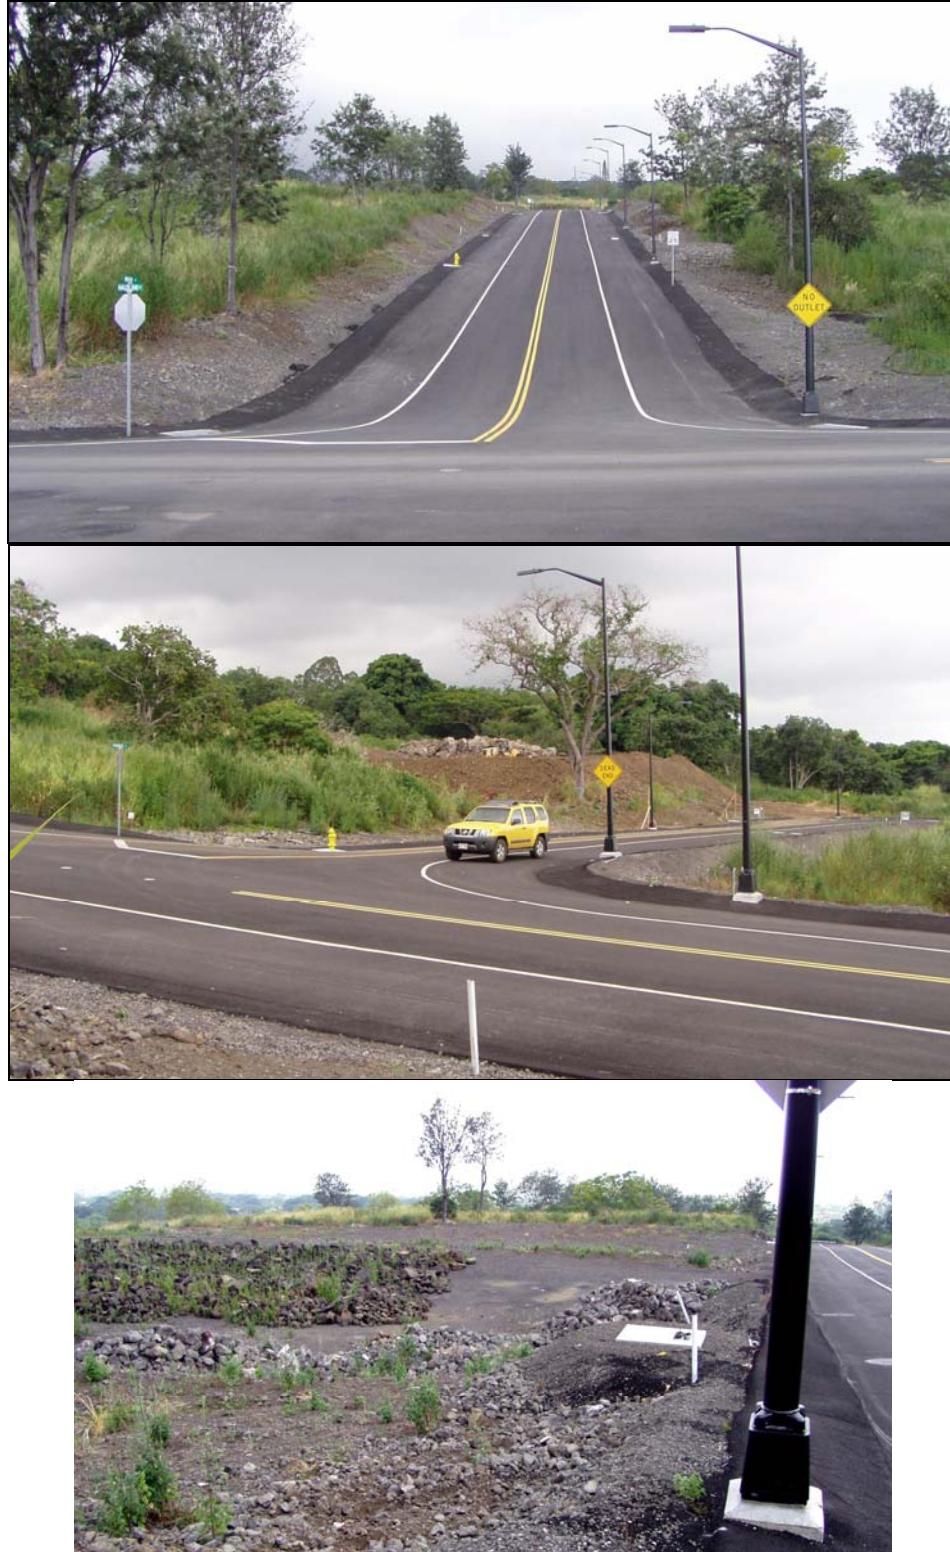
Figure 3. Project Site Photographs

Top: Entrance to Subdivision; Middle: Completed Streets; Bottom: Typical Lot

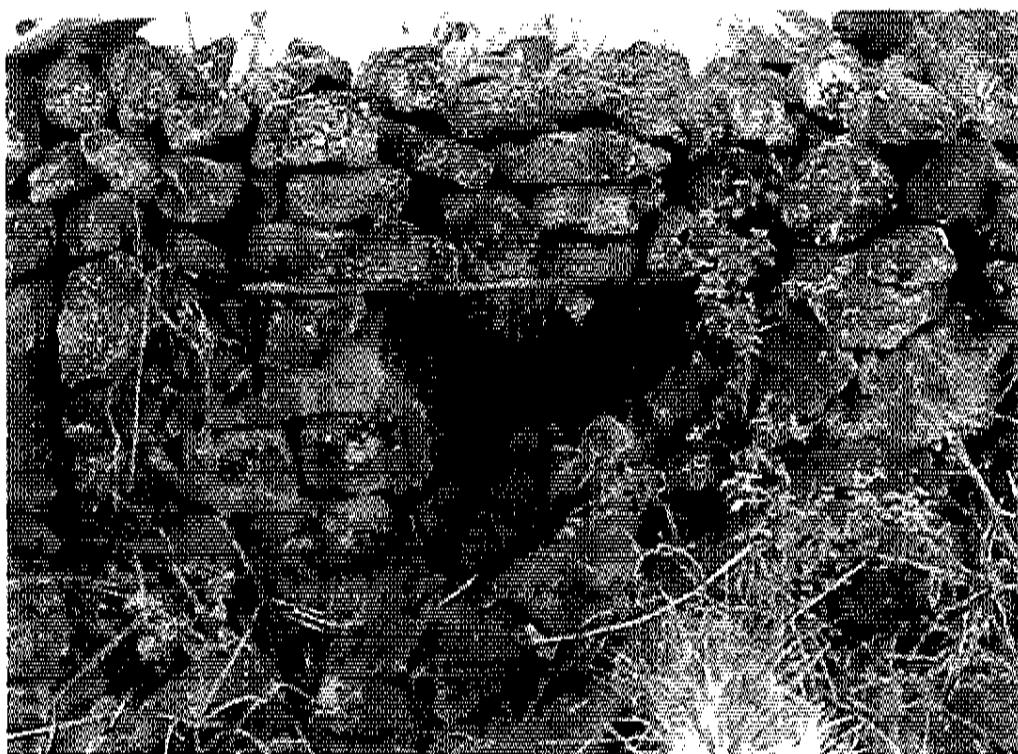
Figure 8. Pig Gate in Site 18115 Wall, view to south

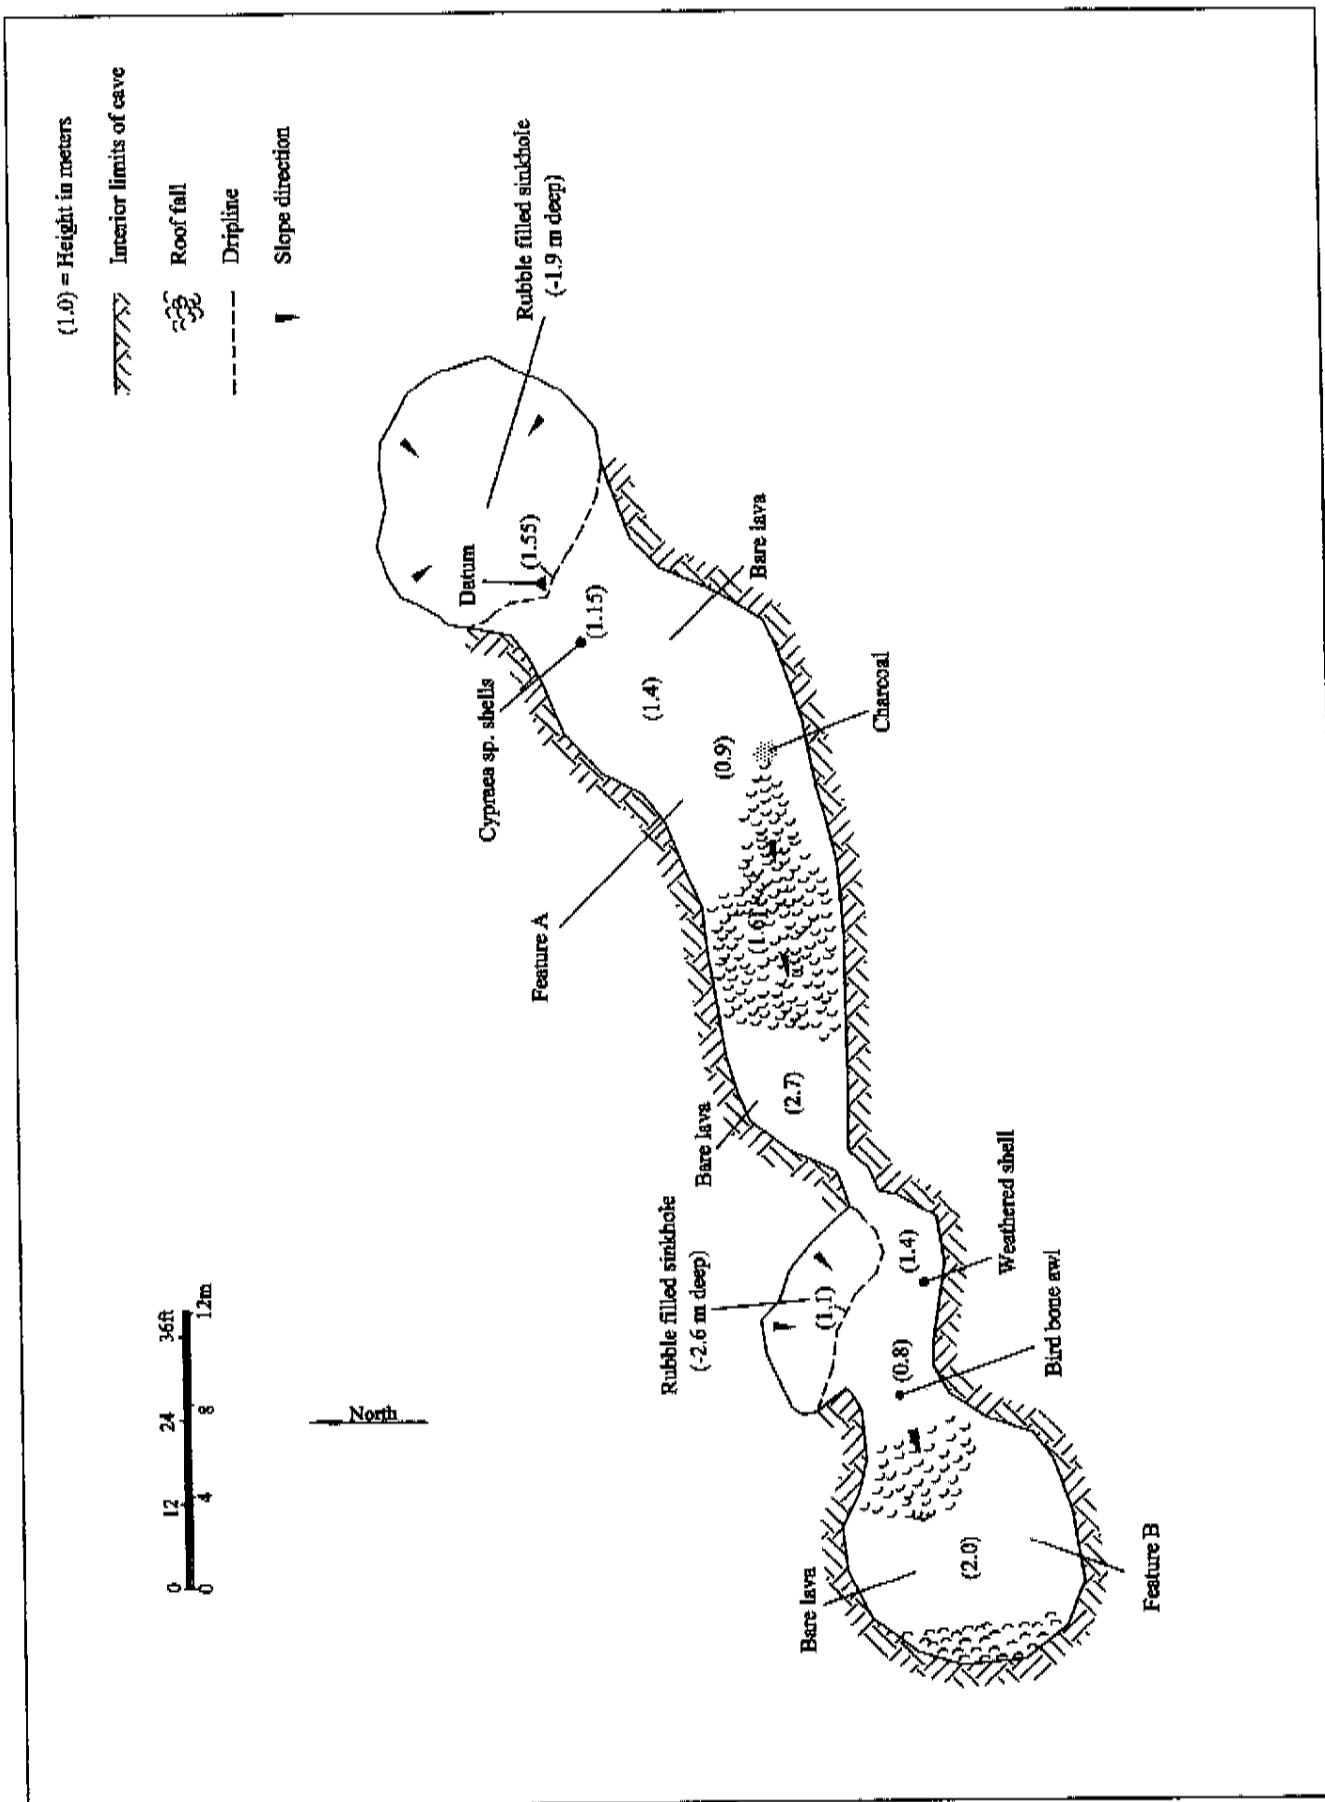
Figure 13. Site 24379 Plan Map

Site 24379 is a large lava tube with two entrances located in the northwestern portion of the project area at elevations ranging from 1,073 to 1,109 ft. The inland entrance (Feature A) consists of an oval-shaped, rubble filled sinkhole that is 11.2 m long (northwest by southeast), 10.5 m wide and 1.9 m in depth,

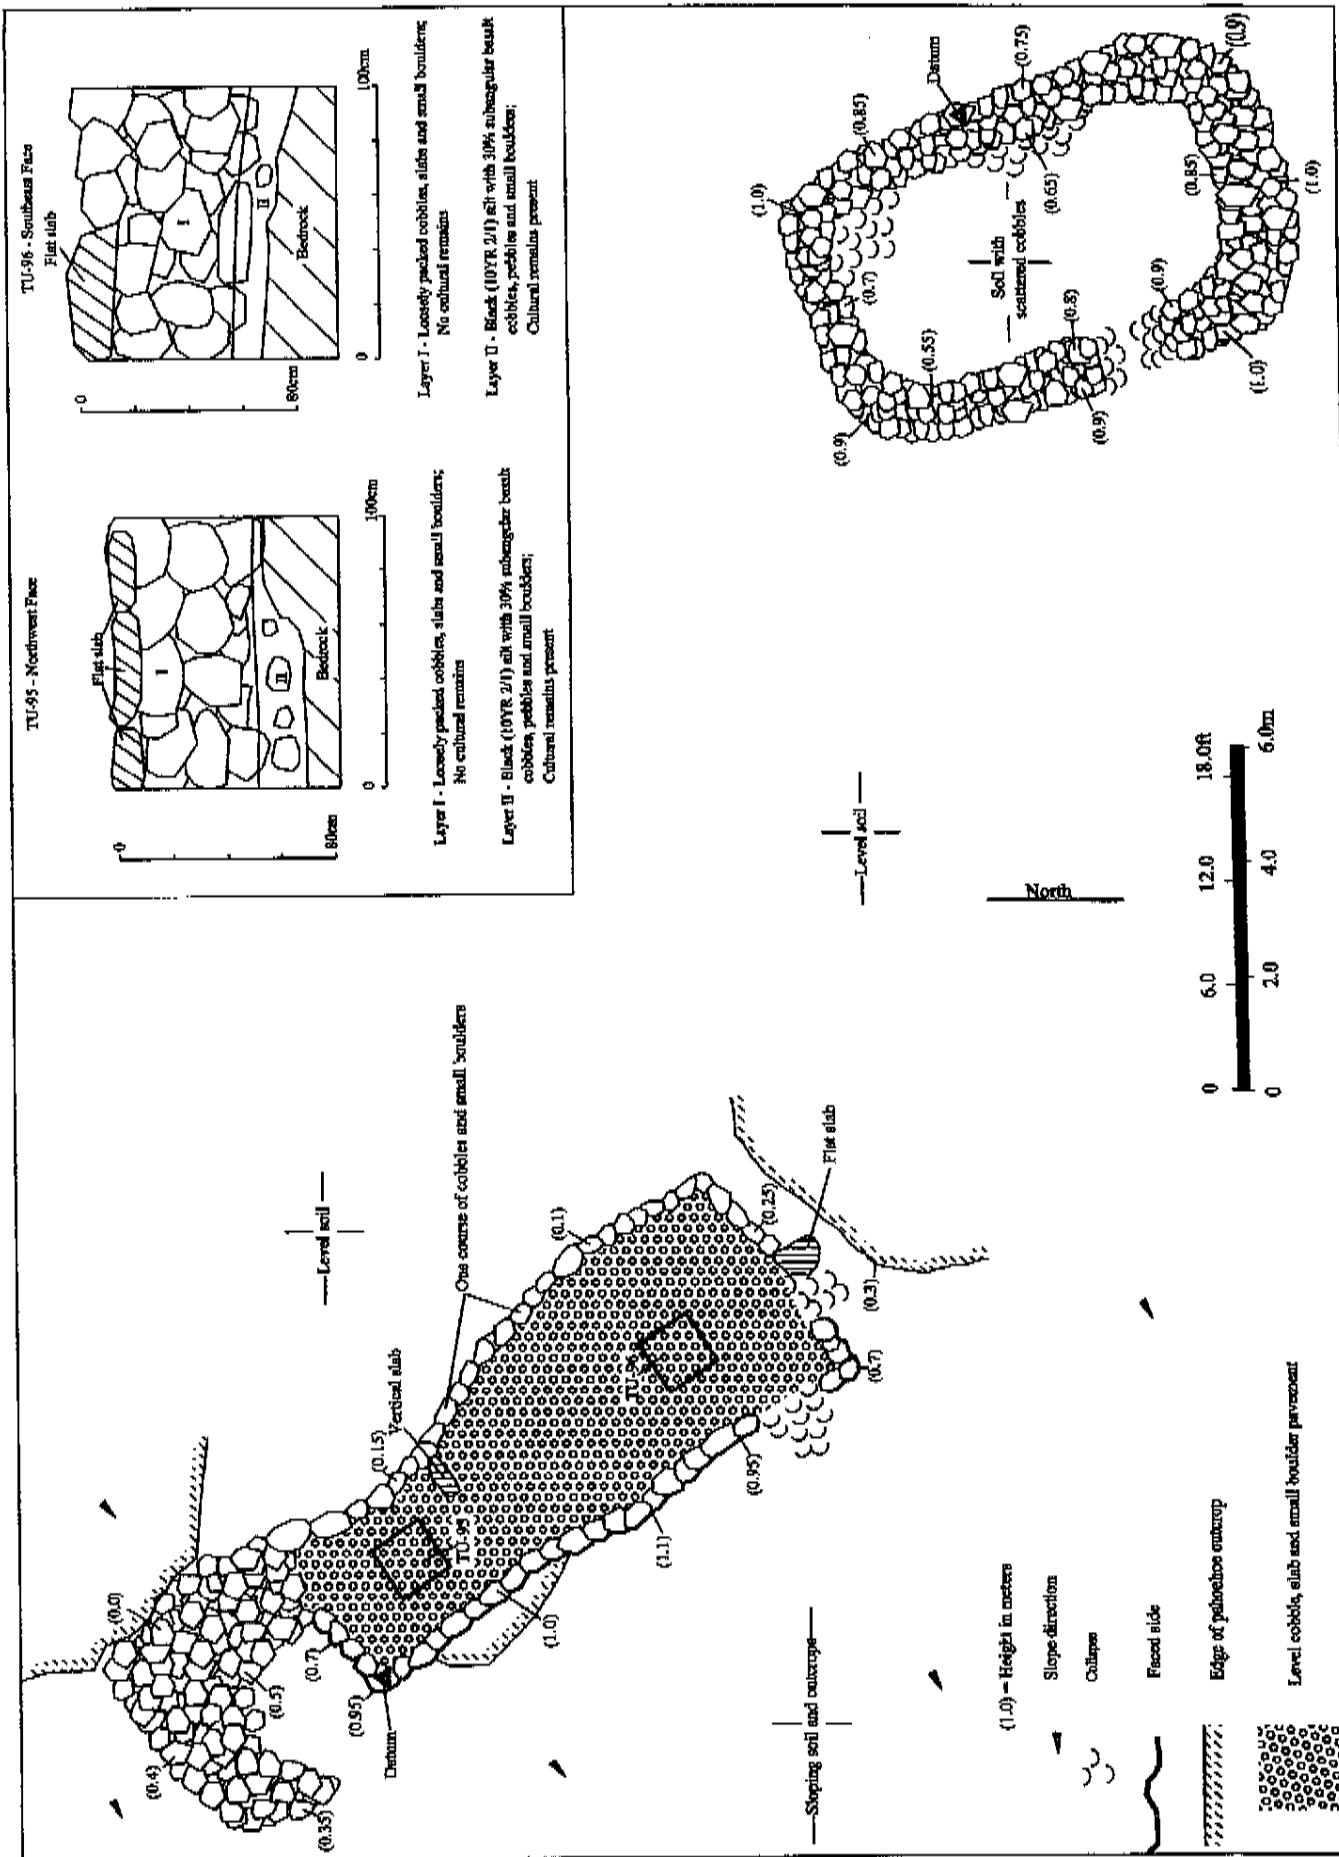
Figure 19. Site 24385 Plan Map and TUs 95 and 96 Profiles

The Layer II deposit consisted of 0.04 to 0.18 m of a black (10YR 2/1) silt with 30% subangular basalt cobble, pebble and small boulder inclusions. Cultural remains from Layer II consisted of a basalt

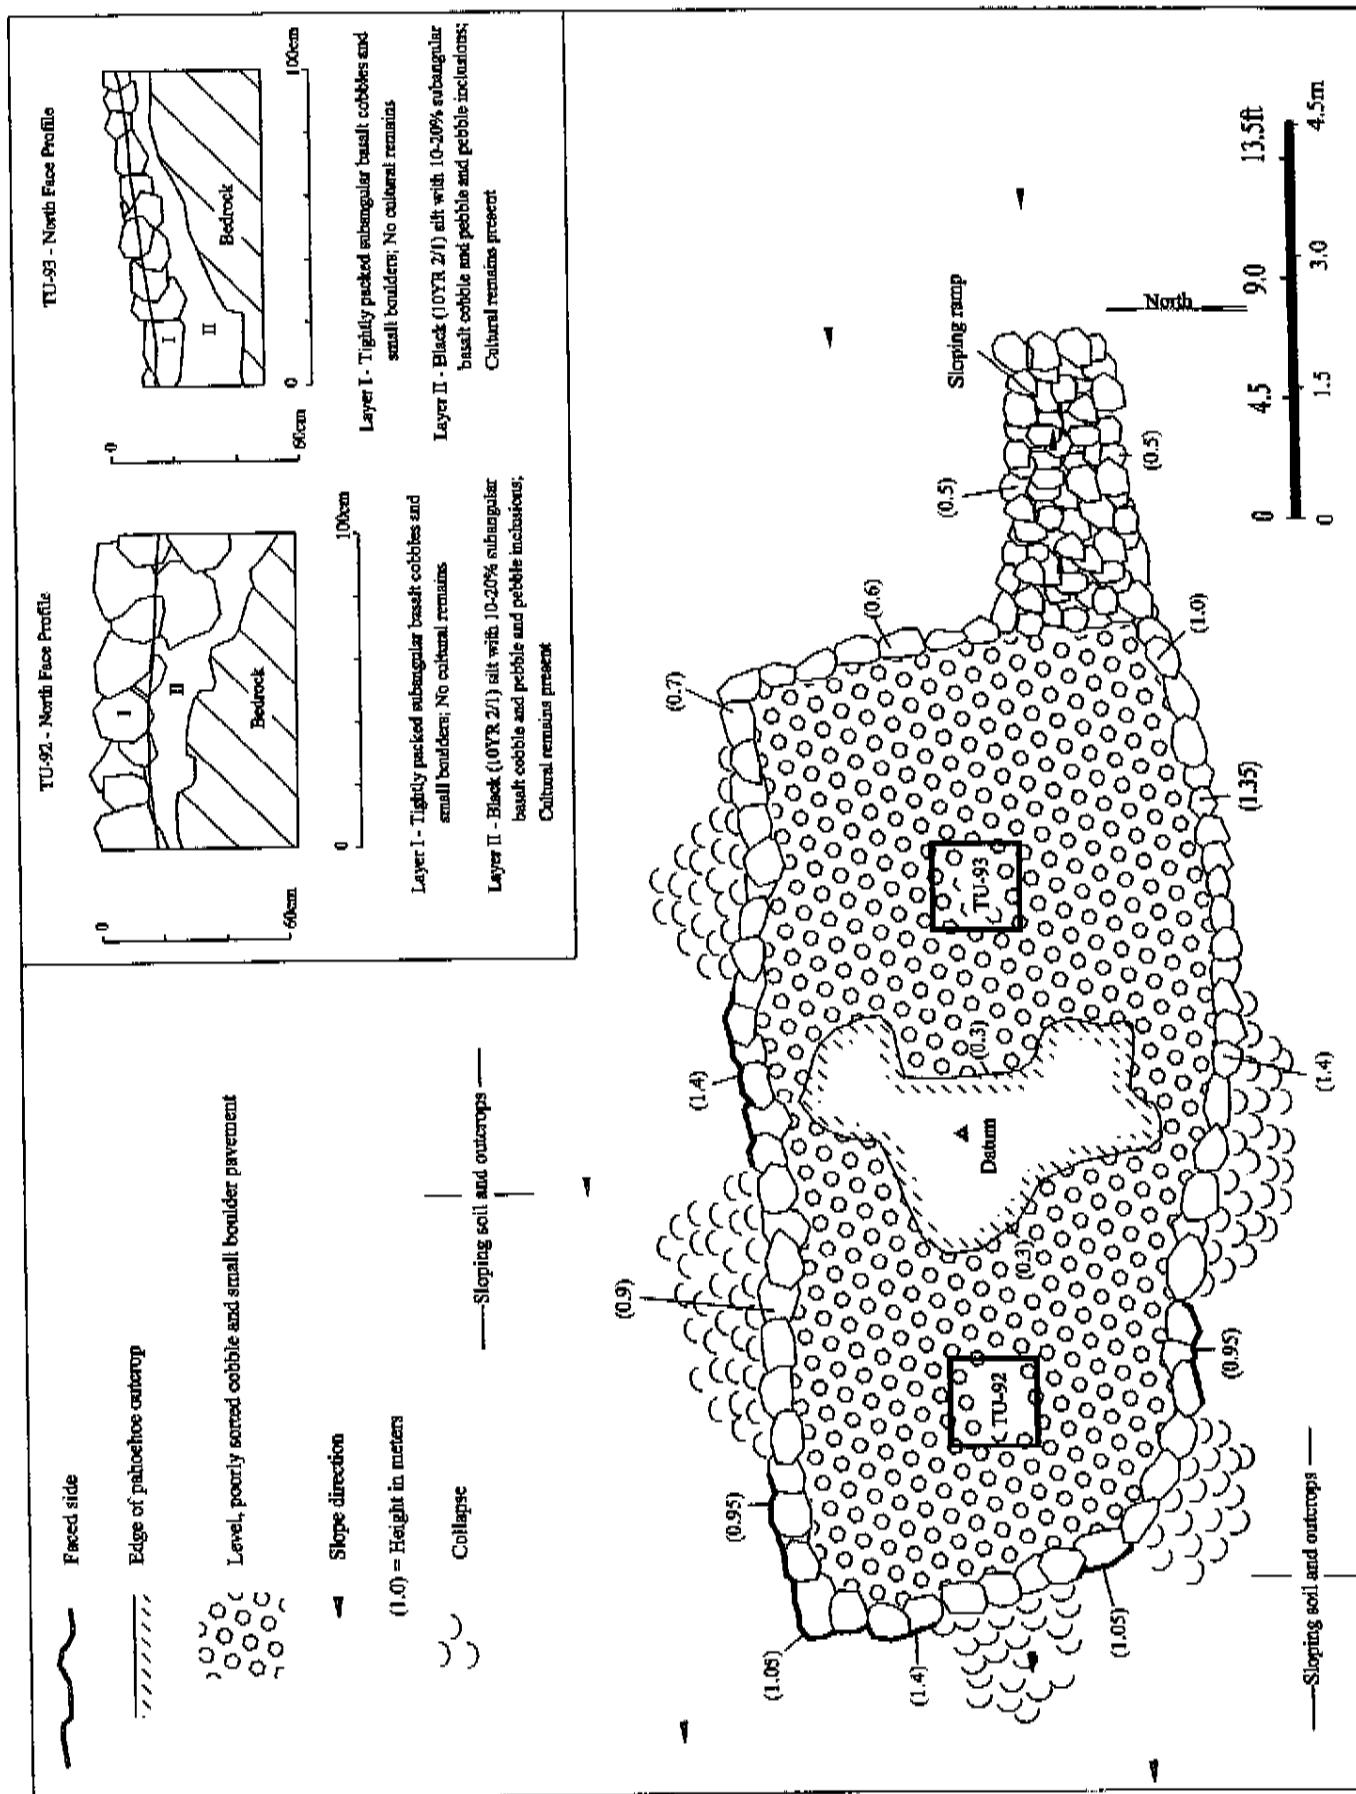
Figure 22. Site 24388 Plan Map and TUs 92 and 93 Profiles

TU-93 was located in the eastern portion of the platform. The excavation of this unit revealed identical stratigraphy to that observed in TU-92 (see Figure 22). Layer I consisted of 0.1 to 0.13 m of tightly packed subangular basalt cobbles and small boulders with no cultural remains. Layer II was comprised of 0.07 to 0.19 m of a black (10YR 2/1) silt with 10-20% subangular basalt cobble and pebble inclusions.

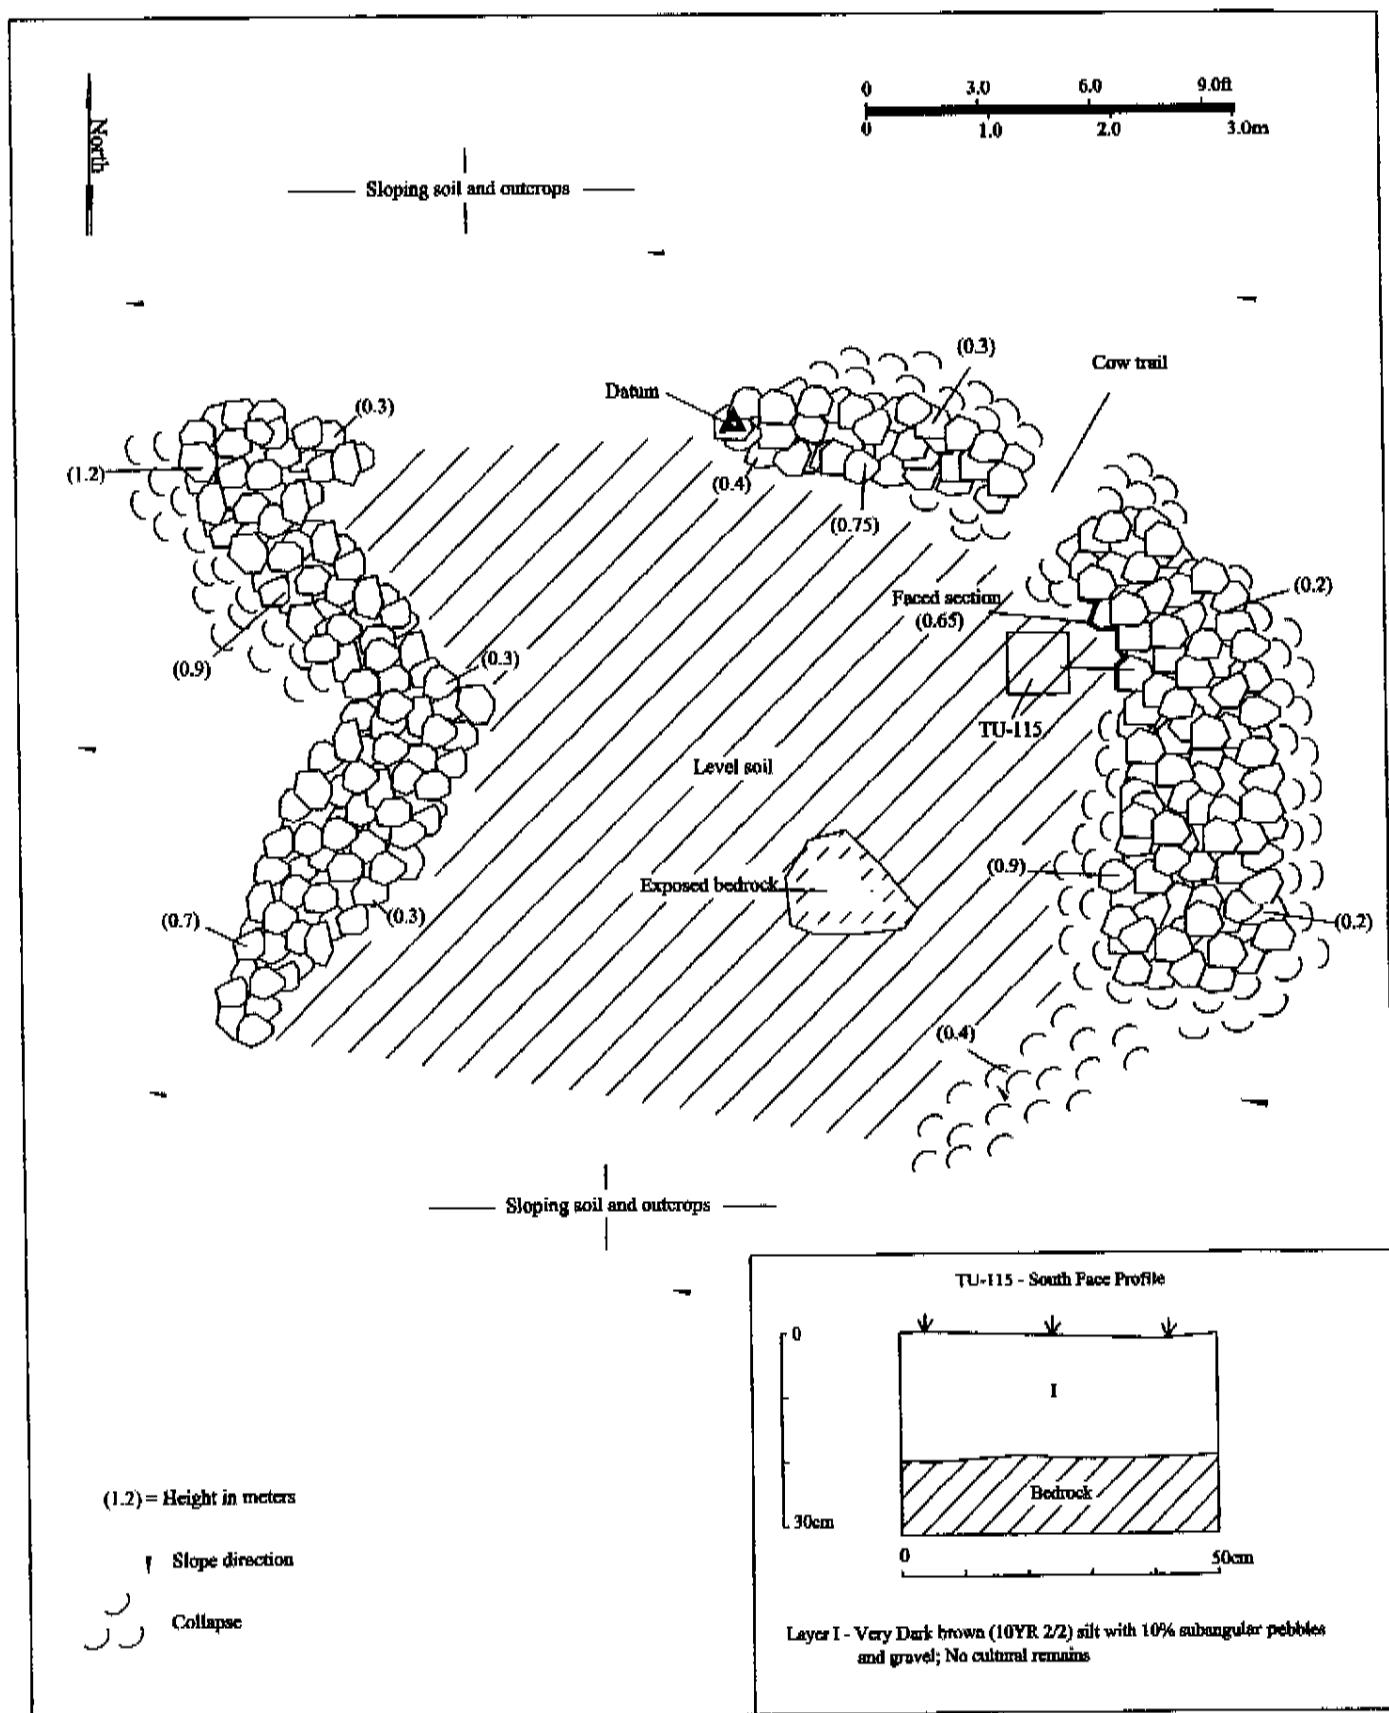
Figure 40. Site 24397, Feature DA Plan Map and TU-115 South Face Profile

A 0.5 by 0.5 m test unit (TU-115) was excavated into the surface of the terrace adjacent to the faced section (see *Figure 40*). This excavation revealed a single soil layer over bedrock. Layer I was comprised of 0.1 to 0.2 m of a very dark brown (10YR 2/2) silt with 10% subangular pebble and gravel inclusions. No cultural remains were present. Feature DA was assigned an agricultural function based on the generally informal construction and absence of cultural remains. It is in fair condition and is unaltered.
