FINAL ENVIRONMENTAL ASSESSMENT
REPLACEMENT OF OLA‘A RESERVOIR NO. 2

TMK: (3rd) 1-6-002: 87 & 98, 1-6-03:27
Kea‘au, Puna District, Hawai‘i Island, State of Hawai‘i

May 2008

Hawai‘i County
Department of Water Supply
345 Kekuanaoa Street, Suite 20
Hilo, Hawai‘i 96720

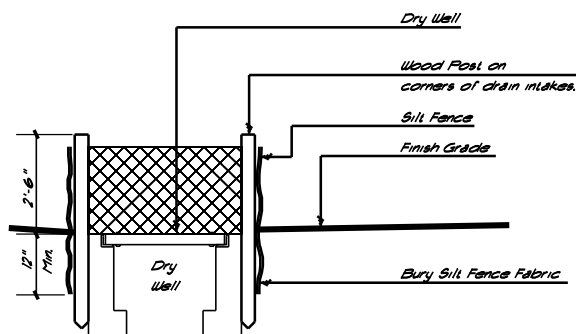
D **LI** **Silt Fence Detail**
Not to scale

Install Silt Fence at Drywell

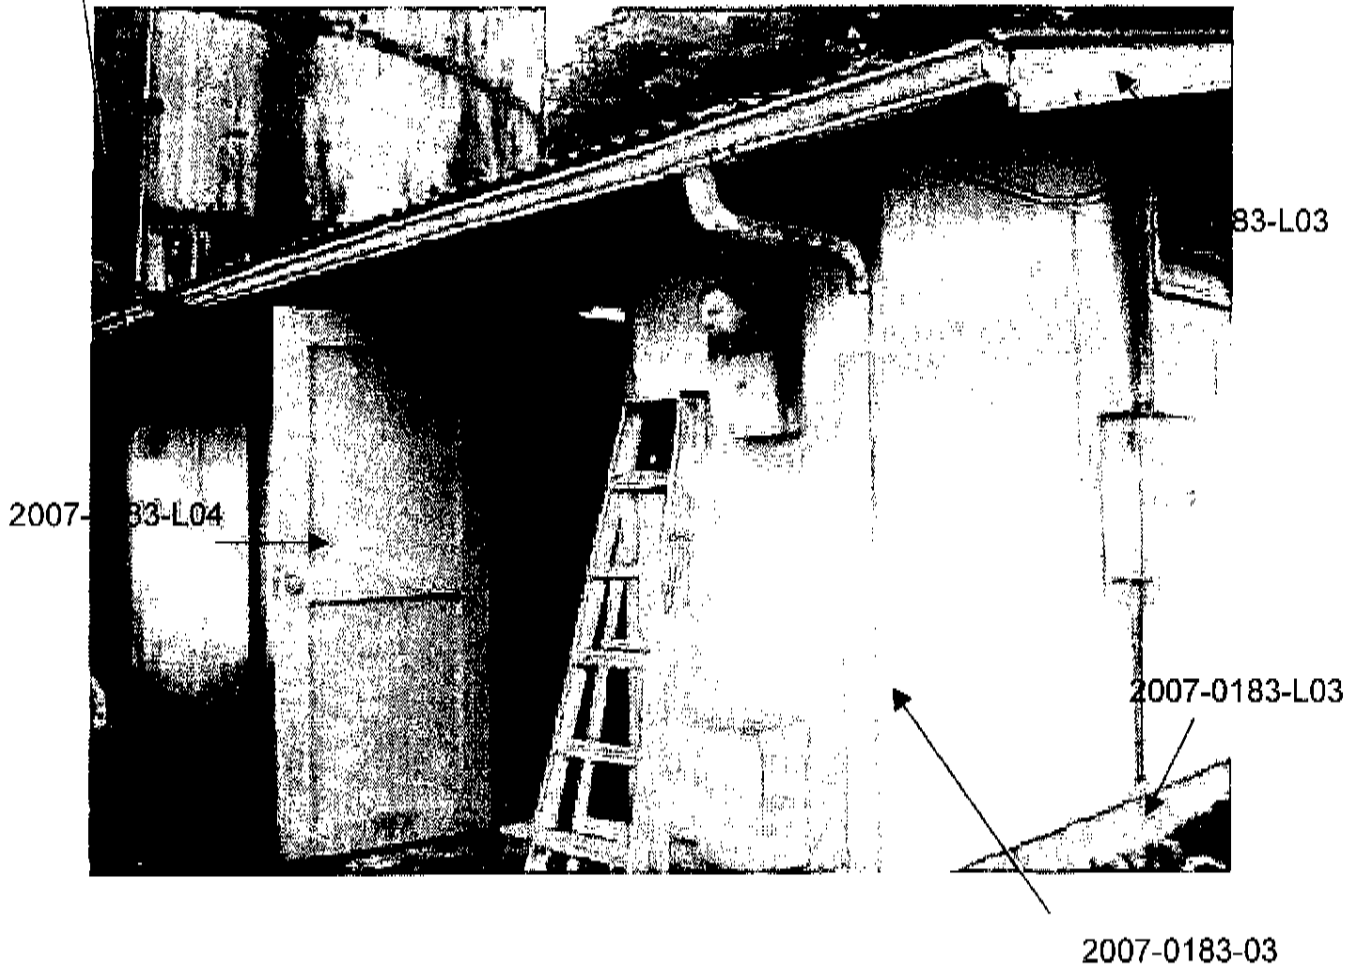
Photo No. 1: Photo of the control station. The transite walls and transite roof of the building contained Asbestos. The green paint on the door and foundation and roof edge contained lead.

The existing reservoir's control building was found to contain asbestos in four interior transite walls, the transite roof, and gaskets of the pump piping within the control building. Lead-containing paint was found on the green paint of the water tank, the pumps at the control station, and miscellaneous other locations.

Concerning the hazardous materials in the existing reservoir, the following mitigation measures will apply. When lead-containing paint or asbestos-containing materials are disturbed during demolition work, regulations including those of the Environmental Protection Agency (EPA), Occupational Safety and Health Administration (OSHA), and the State Department of Health (DOH), among others, must be complied with. All lead-containing paint must undergo testing to determine if it may be disposed of in a municipal landfill. Metal debris coated with lead paint may be sent to recyclers as scrap metal without removing the paint. For asbestos, an abatement crew will set up a containment and wearing personal protective equipment will abate the asbestos. The material will be double-bagged and then shipped off-island in appropriate containers for disposal in a landfill permitted to receive this substance.

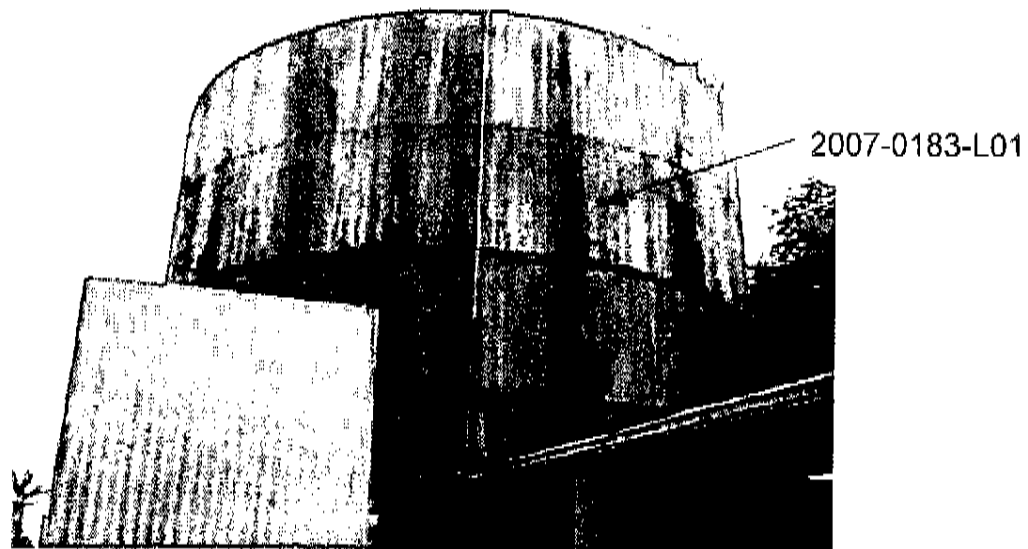
Photo No. 4: View of the water tank. The green paint on the water tank contained lead.

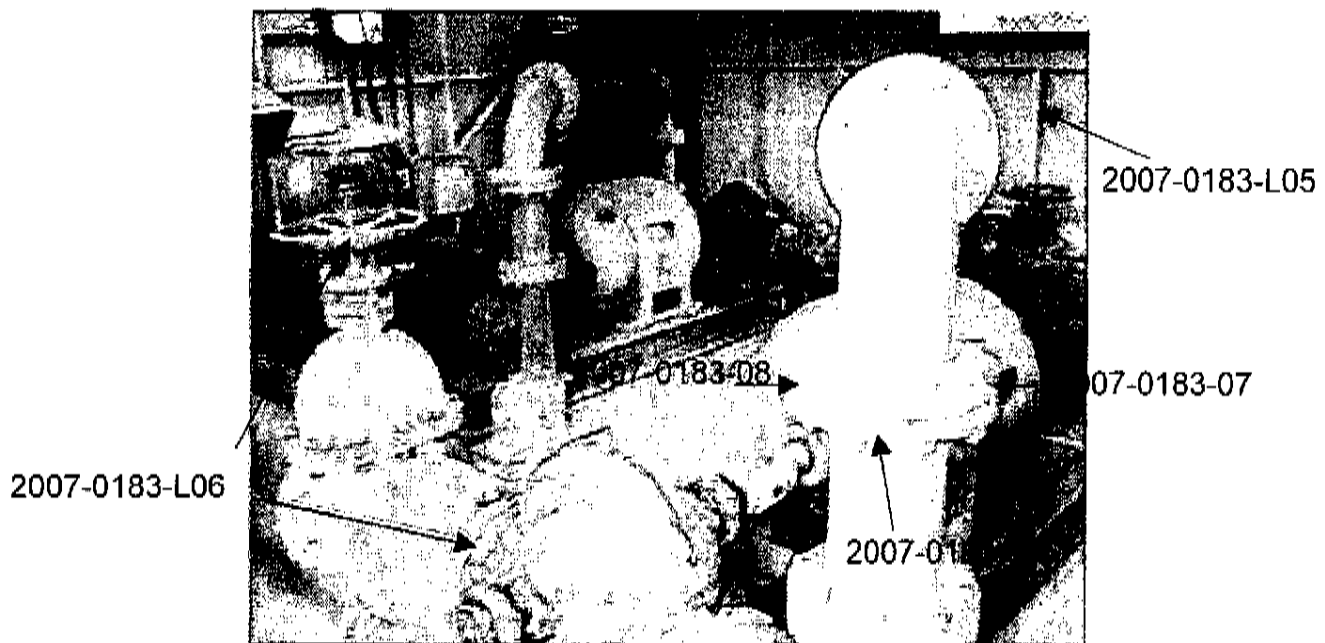
Photo No. 5: View of the pump inside the control station. The red paint on the valves and green paint on the pump contained lead. The gaskets contained asbestos.
