***Draft Environmental Assessment***

***Appendices:  
Intersection Improvements  
Dillingham Ranch  
Agricultural Subdivision***

Waialua, Island of O'ahu, Hawai'i  
Tax Map Key: (1) 6-8-003: 015

July 2008

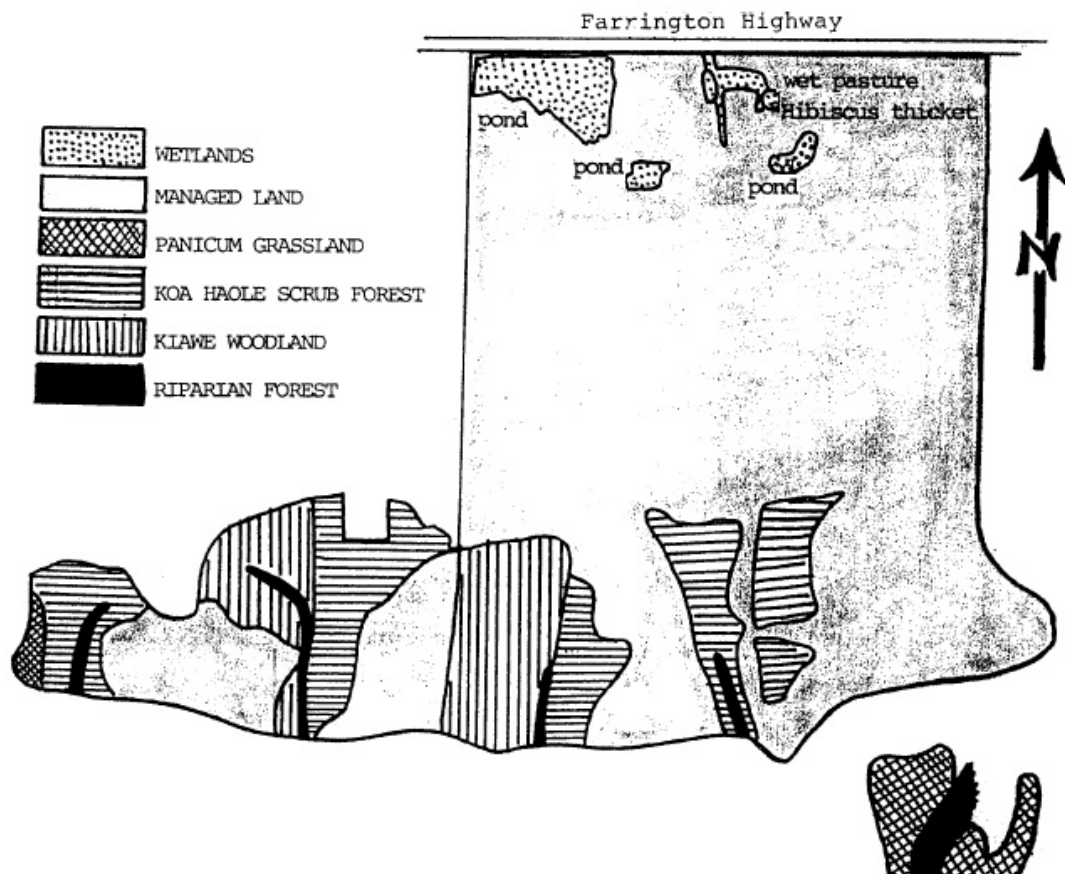
Figure 3. Vegetation map of the Dillingham Ranch property prepared by Whistler based on a 1991 botanical survey (altered from the original with respect to orientation).

Whistler prepared a map of vegetation zones that he defined based upon his field observations. Six vegetation types were recognized: (1) Wetlands; (2) Managed land; (3) *Panicum* grassland; (4) Koa haole scrub forest; (5) Kiawe woodland; and (6) Riparian forest. Whistler further divided the wetlands category into *Hibiscus* thicket, coastal marsh, and pond margins. The 1991 map of these vegetation zones on the Dillingham Ranch property is presented herein as Fig. 3. Shown on this map (lower right) is a portion of a *mauka* parcel that was part of the 1991 survey area but not included in the agricultural subdivision area.

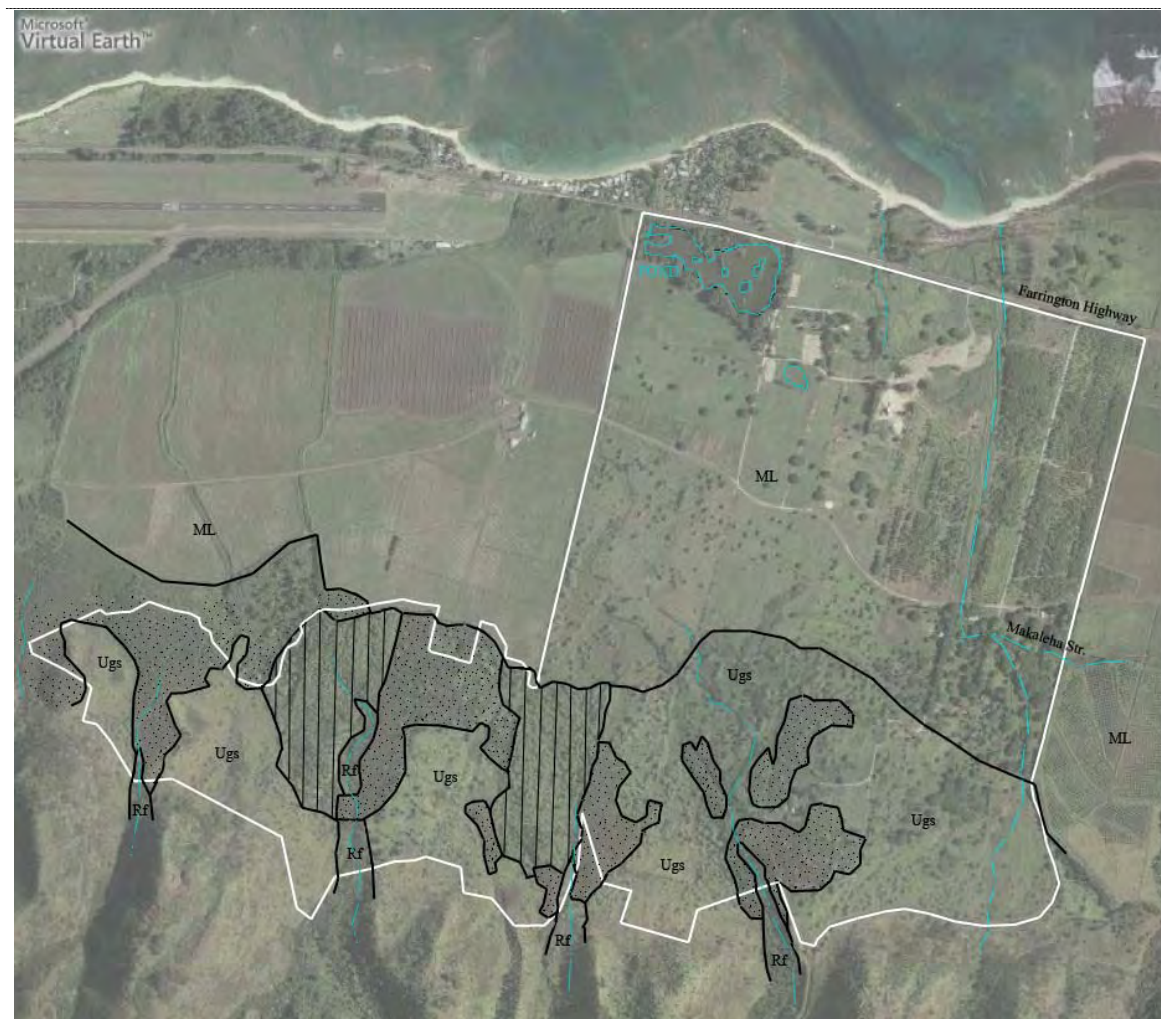
Figure 4. Vegetation zones as mapped for the present survey. ML = managed land; Ugs = *Urochloa* grassland/savanna; Rf = Riparian forest; stippled = koa-haole forest and scrublands; vertical stripes = kiawe woodland.

The Koa haole scrub forest (stippled in Fig. 4) occupies scattered areas across the property that are dominated by koa haole (*Leucaena leucocephala*) growth. The plants tend to be scrubby at the higher elevations and moderately tall trees (Fig. 7) in the lowlands and along the swale bottoms. Some areas of Koa haole scrub forest correspond to archaeological reserves, suggesting that fencing cattle out has encouraged the growth of this alien species. In fact, damage to koa haole is very evident in the *Urochloa* grassland/savanna where cattle continue to be grazed on a limited basis. Thus, it is not surprising that this vegetation type in particular has expanded at the expense of pasture as ranching on the property has declined.

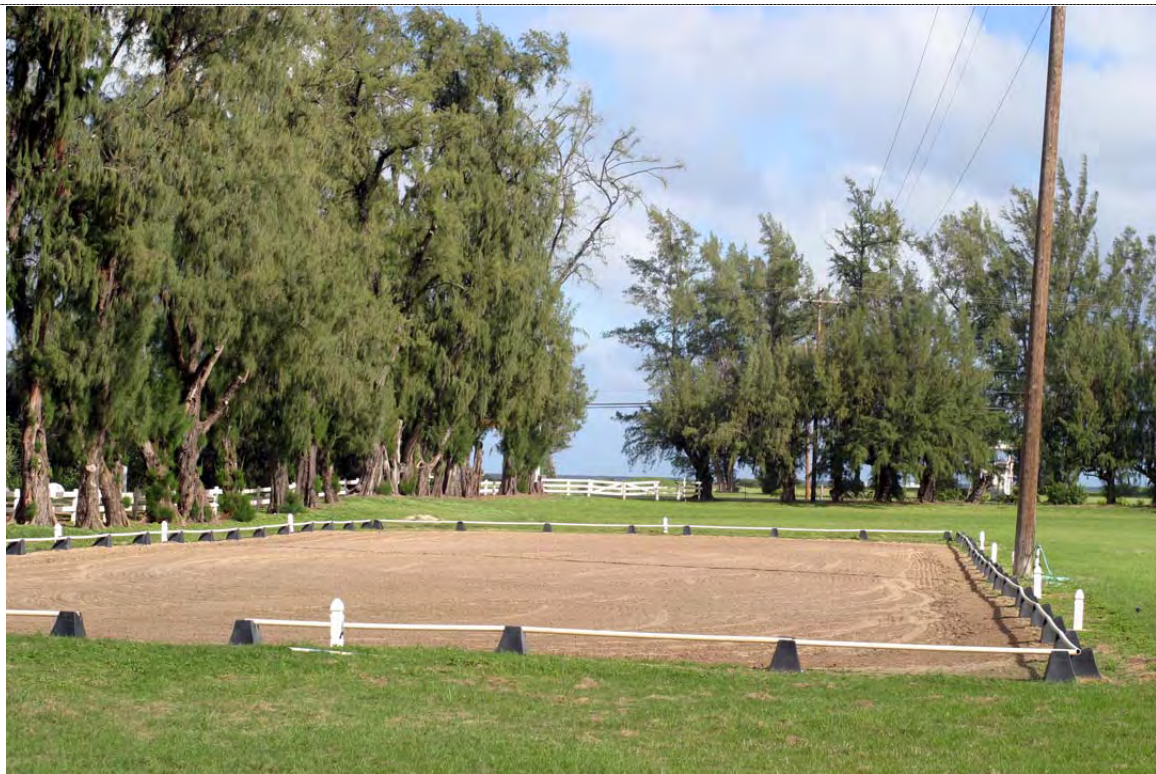
Figure 5. View north towards the intersection of the ranch entrance road (left) and Farrington Highway (background).

One area of managed land was looked at more carefully: the proposed intersection of the access road improvements with Farrington Highway. The access road would follow the existing ranch entrance road seen in Fig. 4 skirting the east side of the large pond. The pond itself is a depression presumably created by an old sand mining operation (i.e., a quarry; Warren Corporation, 1973). The jurisdictional status of the water body may need to be established if roadway improvements impinge on the shore, although sufficient room exists for this not to occur. The intersection consists of a tree-lined (ironwoods; *Casuarina equisetifolia*) verge (Fig. 5, above) that is maintained (mowed) on both sides of the highway (the Mokule'ia Polo Field occupies land across the highway from the ranch entrance).

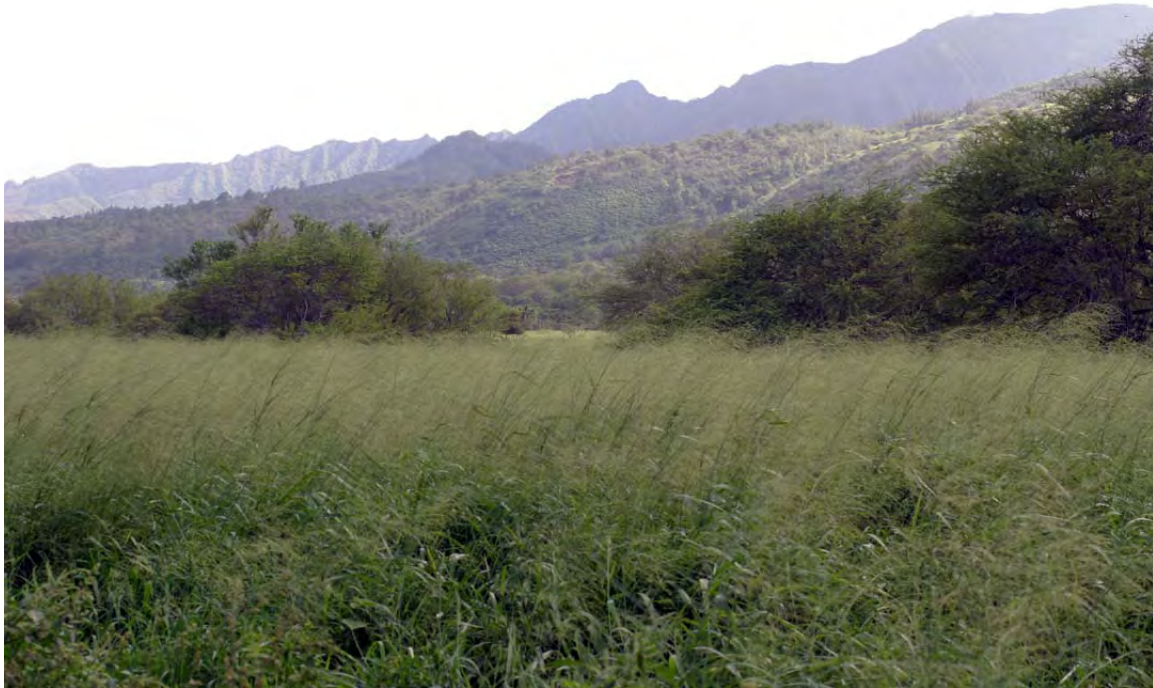
Figure 6. *Urochloa* grassland/savanna showing tall (to 2 m or 6 ft) Guinea grass and scattered kiawe trees on formerly managed land.

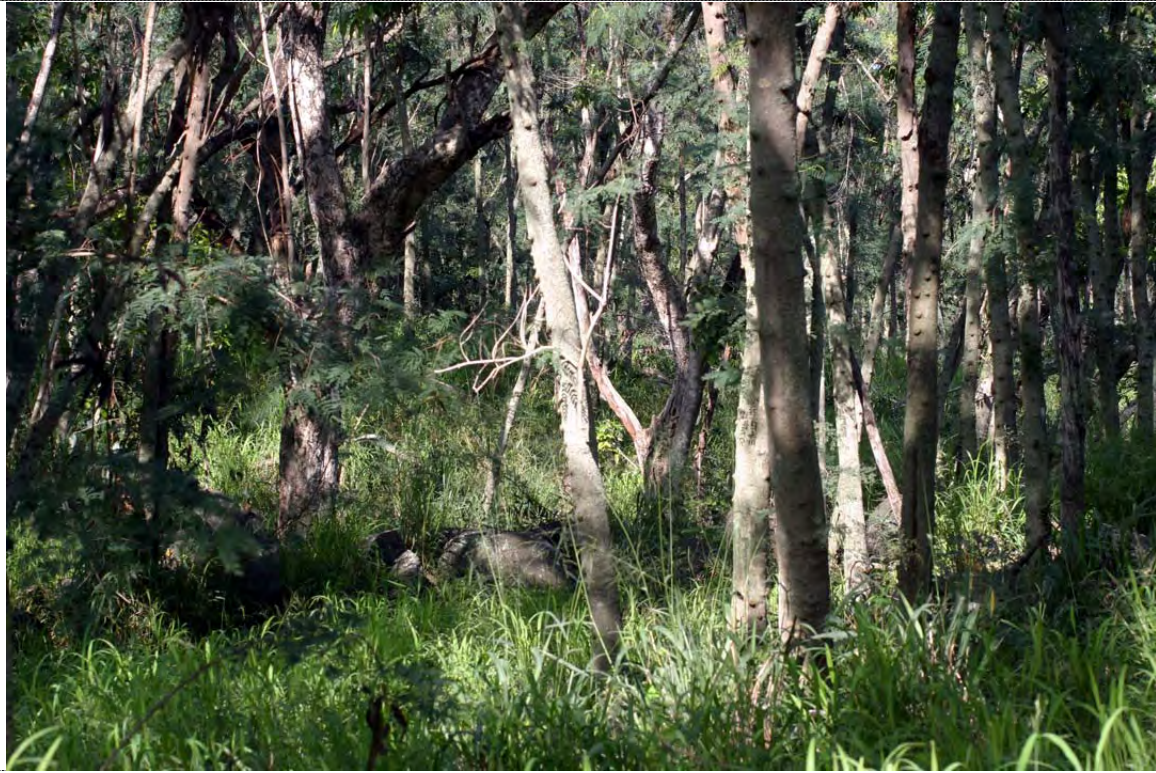
Figure 7. Koa haole forest. Note the stunted but high cover of Guinea grass on the rocky forest floor.

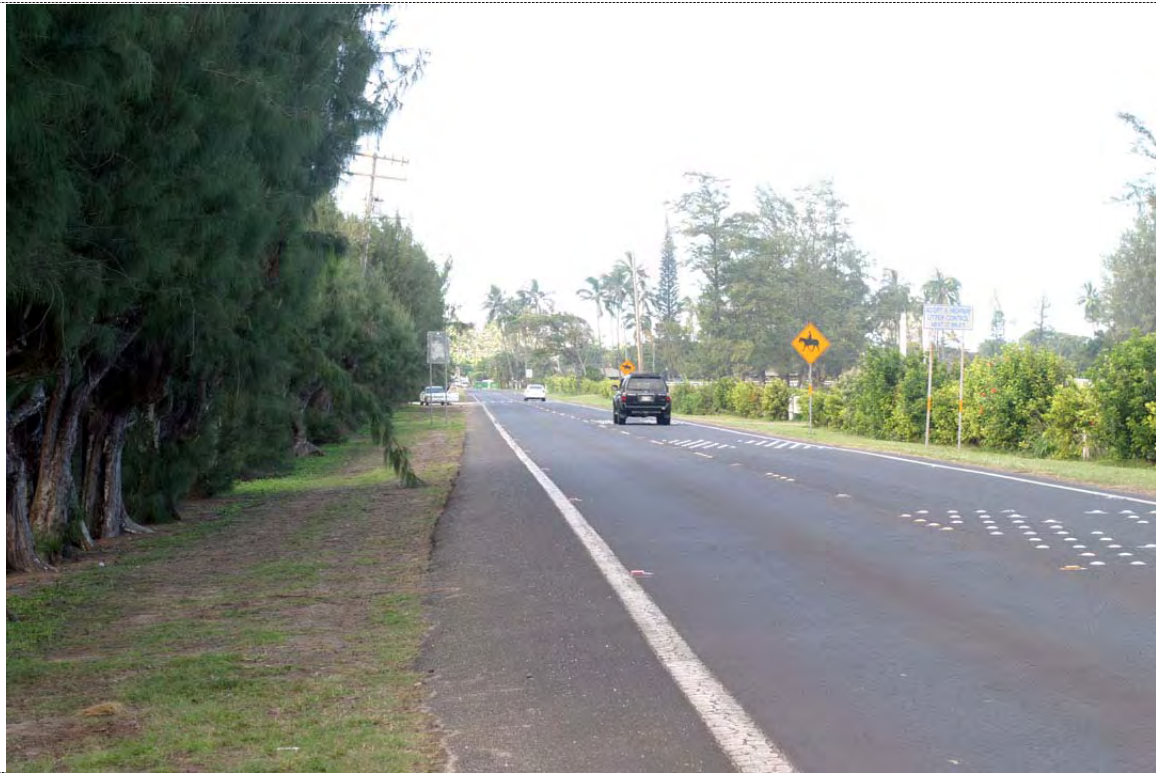
Figure 8. Farrington Highway looking west in the area of the proposed intersection improvements. The white car on the left marks the ranch entrance.

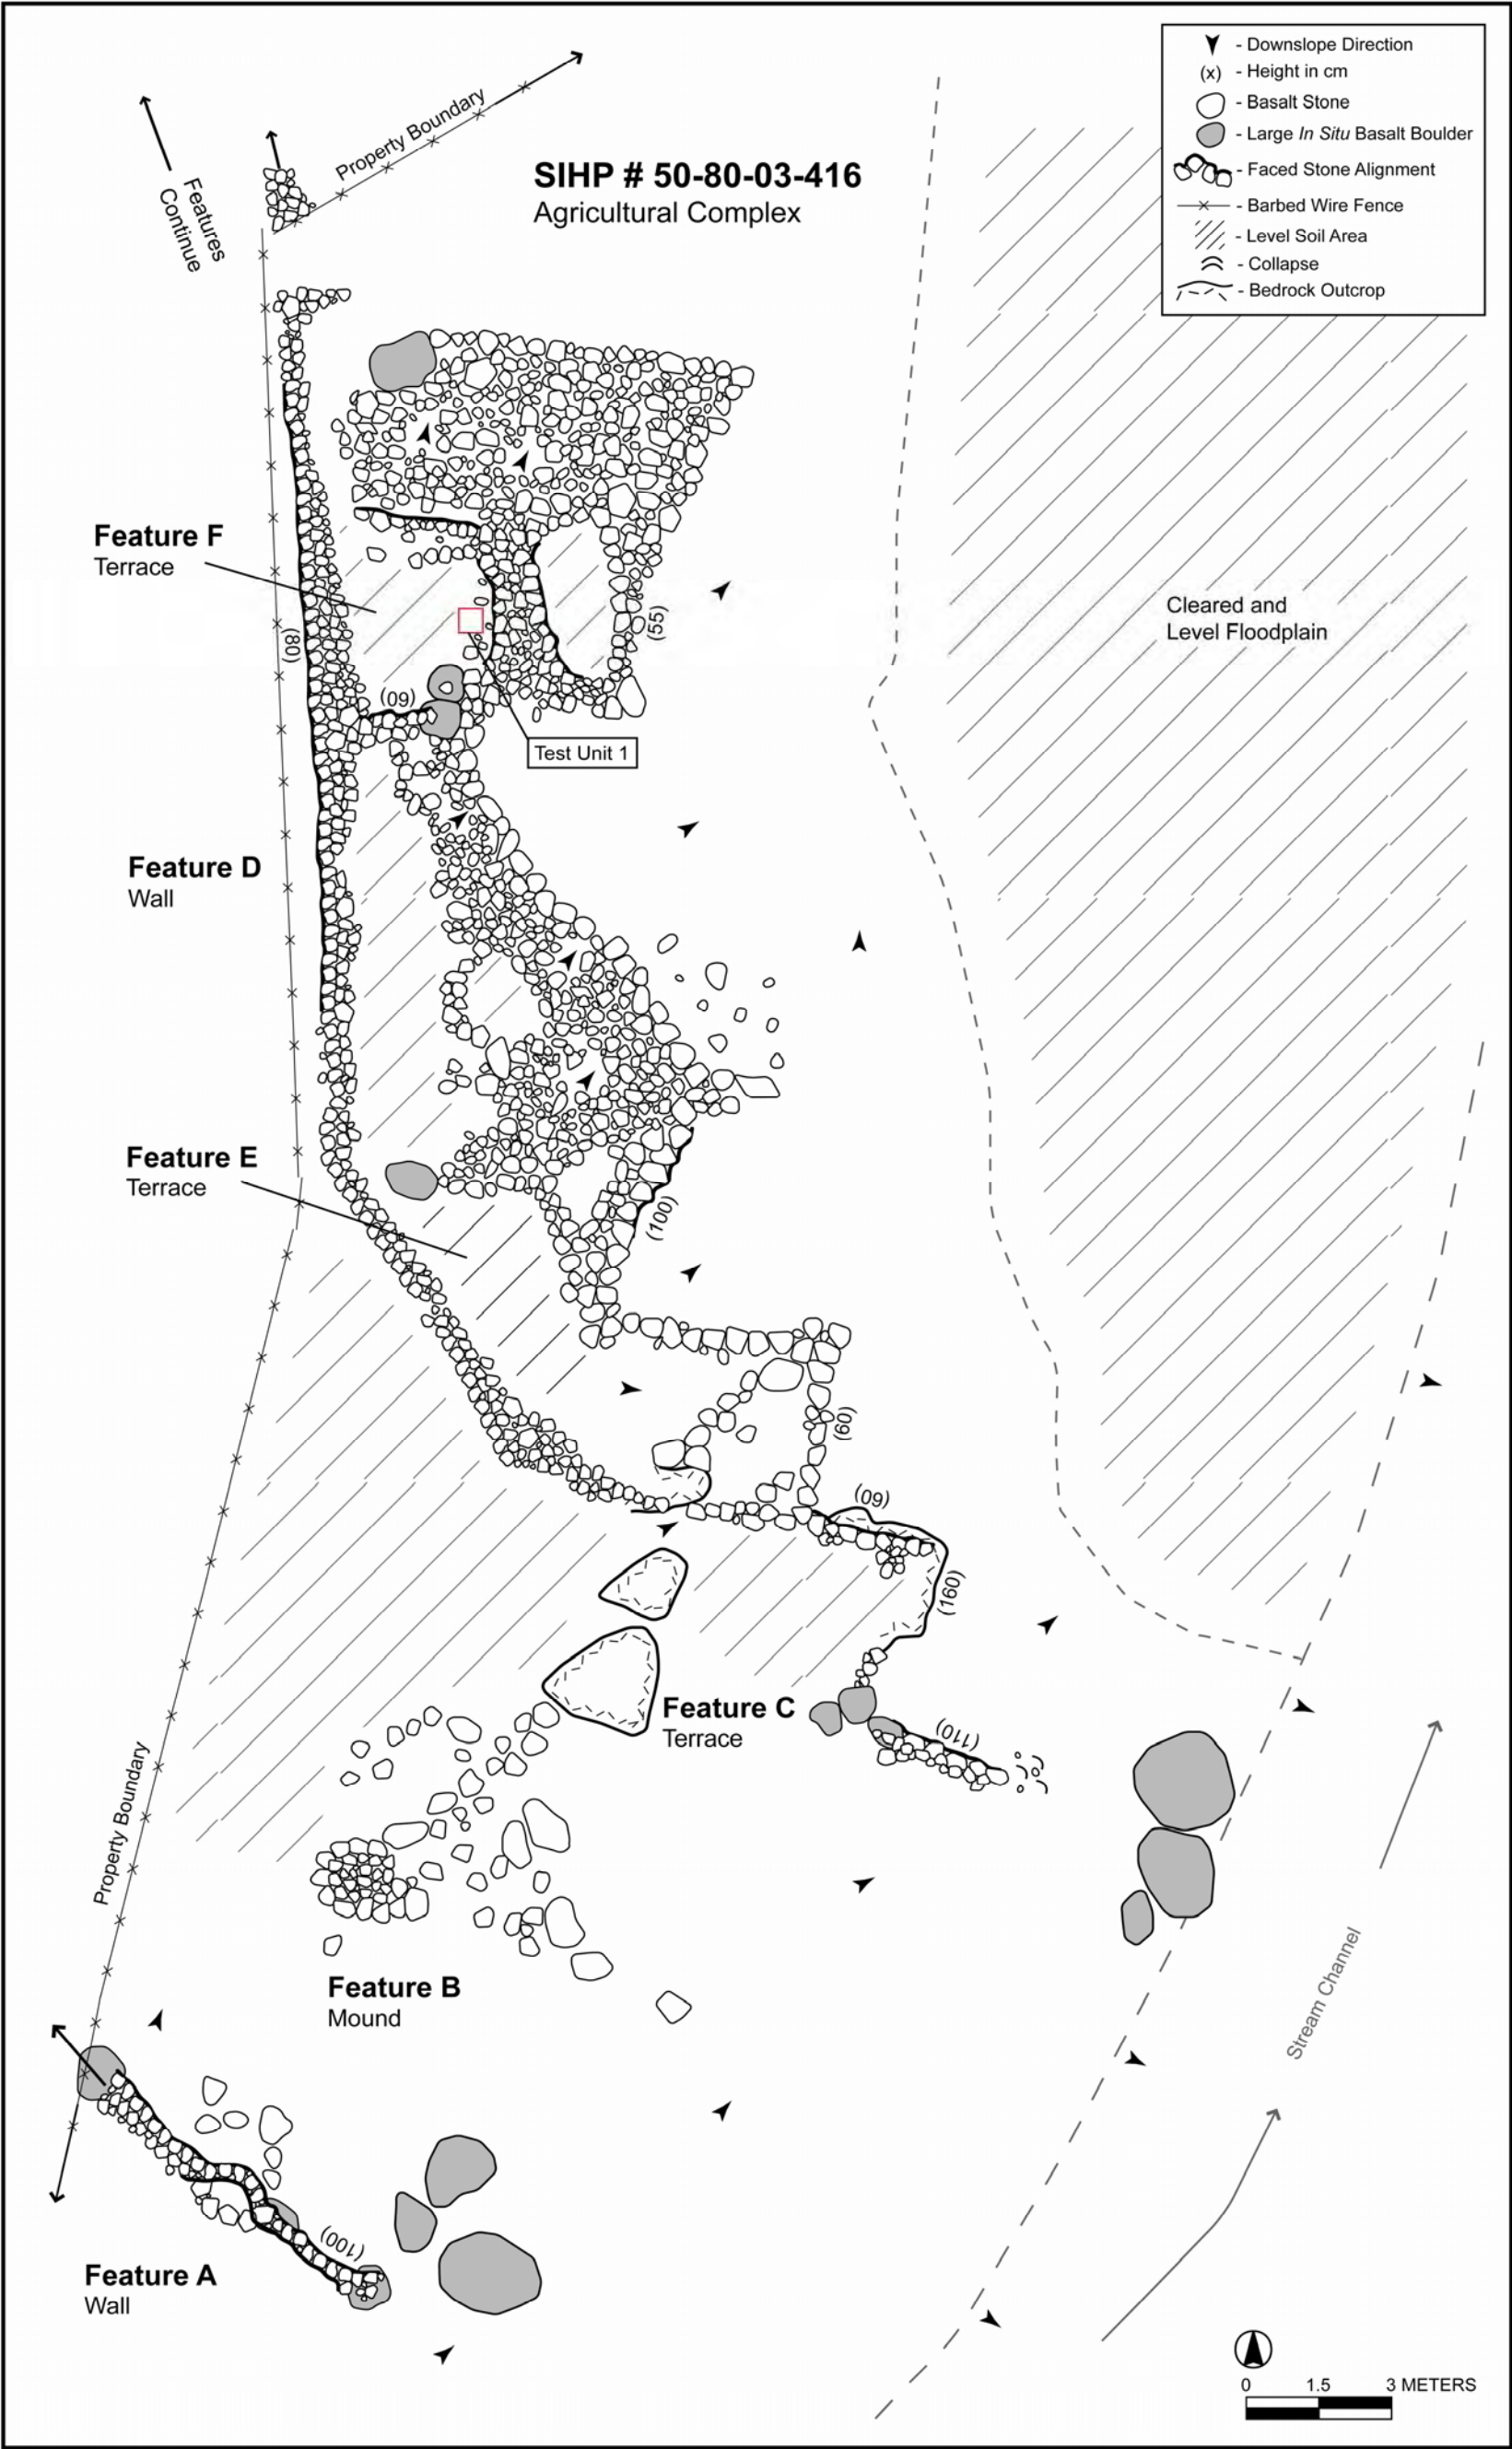
Figure 19. Plan view diagram of SIHP 50-80-03-416: agricultural/habitation complex

Feature D is a stacked-stone wall located along the western edge of this portion of the SIHP # 50-80-03-416 site complex (Figure 19). The wall begins at the western edge of the Feature C terrace and runs roughly north-south and forms the western boundary of the Feature E and F terraces. The wall measures 1.2 m wide, 0.2 m to 0.8 m in height, and approximately 28 m in length within the current study area. The wall continues to the north outside of the study area. Feature D is constructed of loosely stacked basalt boulders and cobbles, with the southern portion of the wall 1 to 2 courses high, and the northern portion 3 to 4 courses high (Figure 22). Stones comprising the wall construction average approximately 30 cm in diameter. The wall is faced along the western edge and of a mounded-type construction along the eastern edge.

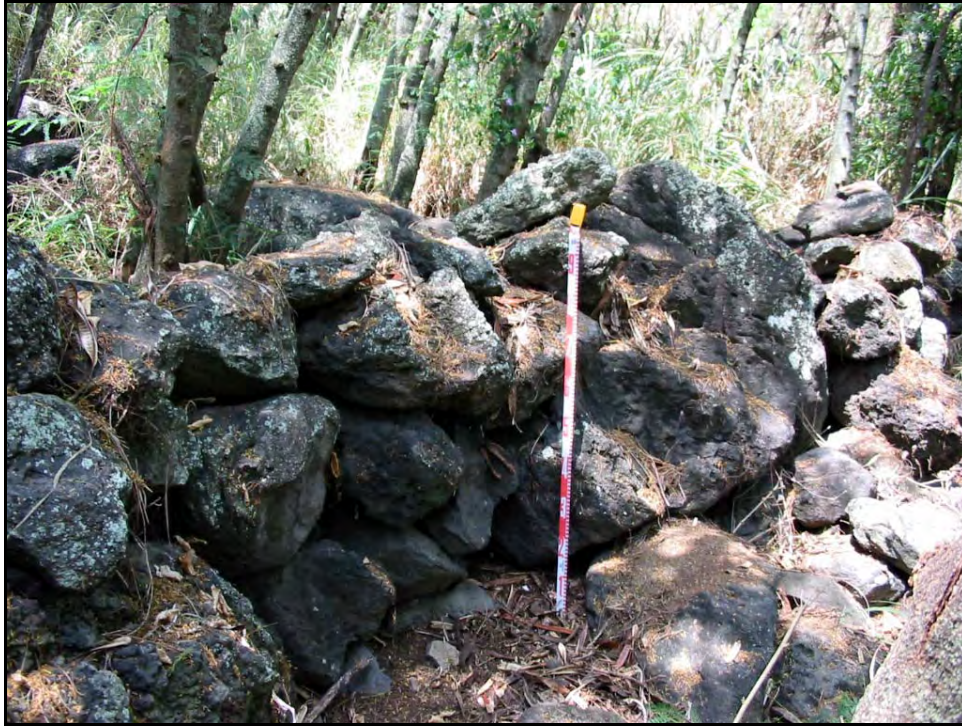
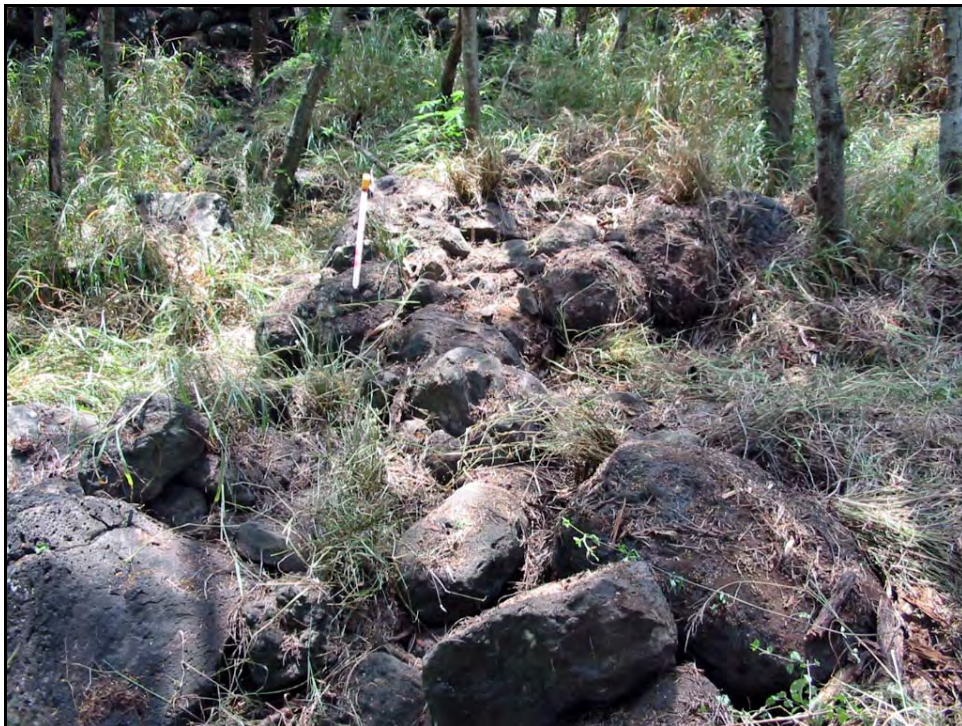
Figure 20. Photographs of SIHP # 50-80-03-416 Feature A wall (above, view to southwest) and Feature B mound (below, view to southwest)

Feature A is a stacked-stone wall located at the southern end of the SIHP # 50-80-03-416 site complex. The wall is oriented roughly east-west, along the contour of the gently sloping terrain. The well-faced wall is constructed of loosely stacked basalt boulders and cobbles, 3 to 4 courses high, and incorporates several large, *in situ* basalt boulders into the wall construction (Figure 20). Stones comprising the wall construction average approximately 50 cm in diameter. The base of the wall is 2 to 3 courses wide, and tapers to 1 course wide at the top of the wall. Feature A measures approximately 1.0 m in height, 1.5 m wide, and 8.8 m in length within the current study area. The wall continues to the northwest outside of the study area. Feature A may have served as a boundary marker, delineating the *mauka* (southern) extent of the site complex.

Feature B is a mound located between the Feature A wall and Feature C terrace (Figure 19). The mound is constructed of crudely piled basalt boulders and cobbles, with large boulders around the perimeter and infilling with small boulders and cobbles (Figure 20). Feature B measures 2.7 m by 1.6 m wide, with a maximum height of 0.6 m. Feature B may have functioned as a clearing mound, associated with agricultural activities in the vicinity. An approximately 20 m by 13 m wide area relatively level and cleared of surface stones is located immediately northwest of the Feature B mound.

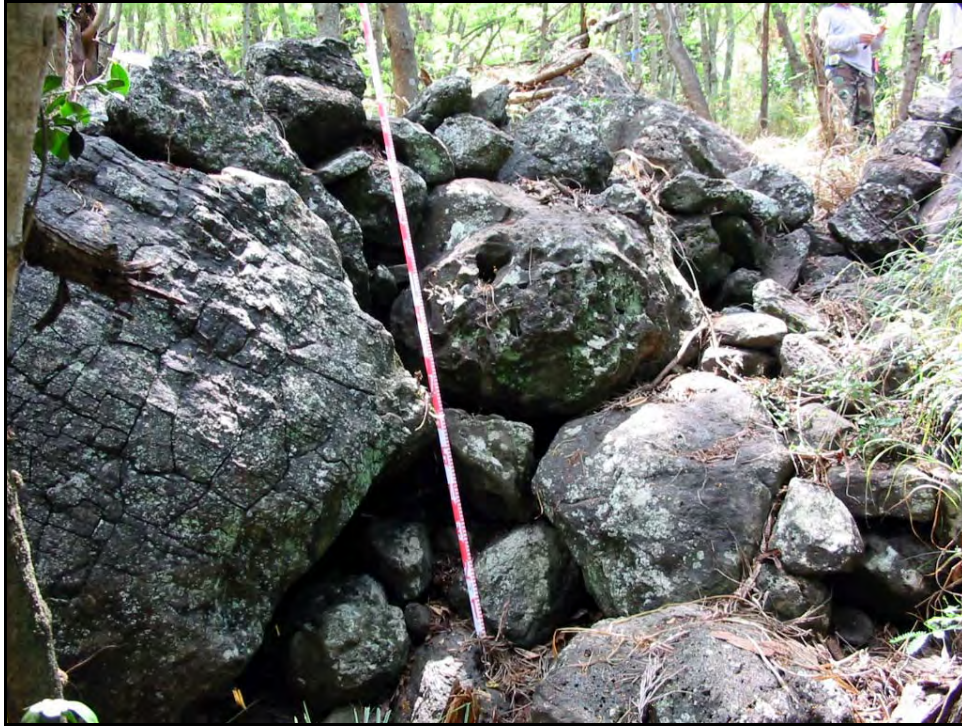
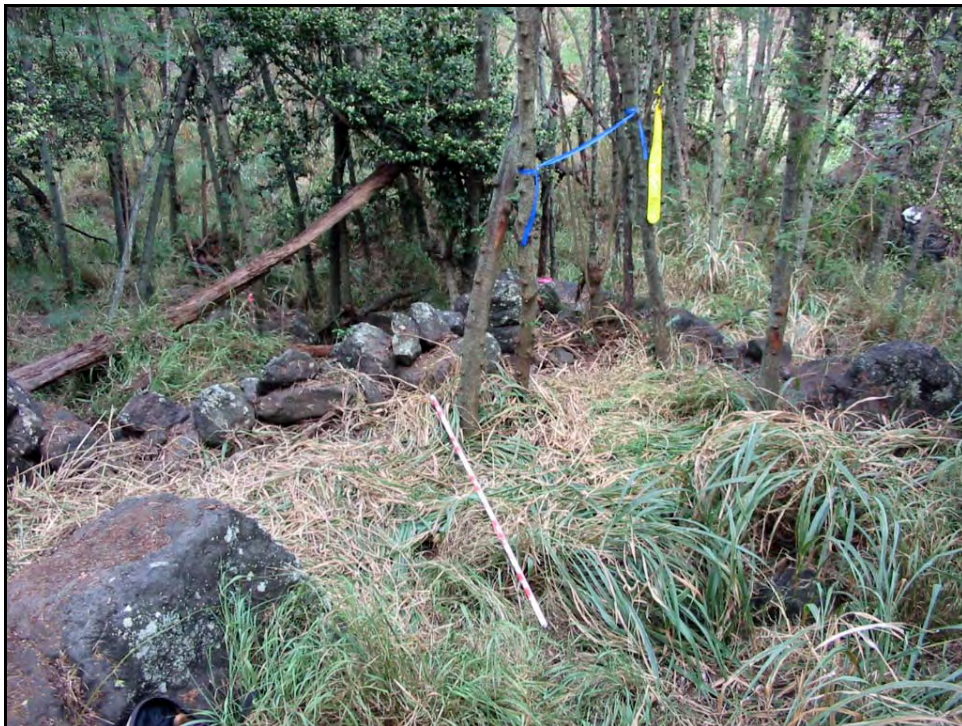
Figure 21. Photographs of SIHP # 50-80-03-416 Feature C terrace retaining wall (above, view to south) and level soil area (below, view to northeast)

Feature C is a well-constructed terrace. The terrace retaining wall is situated along the edge of a low bluff, immediately upslope of a wide floodplain west of the unnamed stream channel (Figure 19). The well-faced retaining wall is constructed of stacked basalt boulders and cobbles, 3 to 7 courses high, and incorporates bedrock outcrops and large, *in situ* basalt boulders into the wall construction (Figure 21). Stones comprising the retaining wall construction range from approximately 0.2 m to 1.0 m in diameter. The Feature C terrace retaining wall measures approximately 11 m in length, 0.8 m wide, with a maximum height of 1.6 m. The wall retains a level soil terrace upslope, measuring 4.2 m by 3.3 m wide. Feature C is interpreted to function as an agricultural planting terrace.

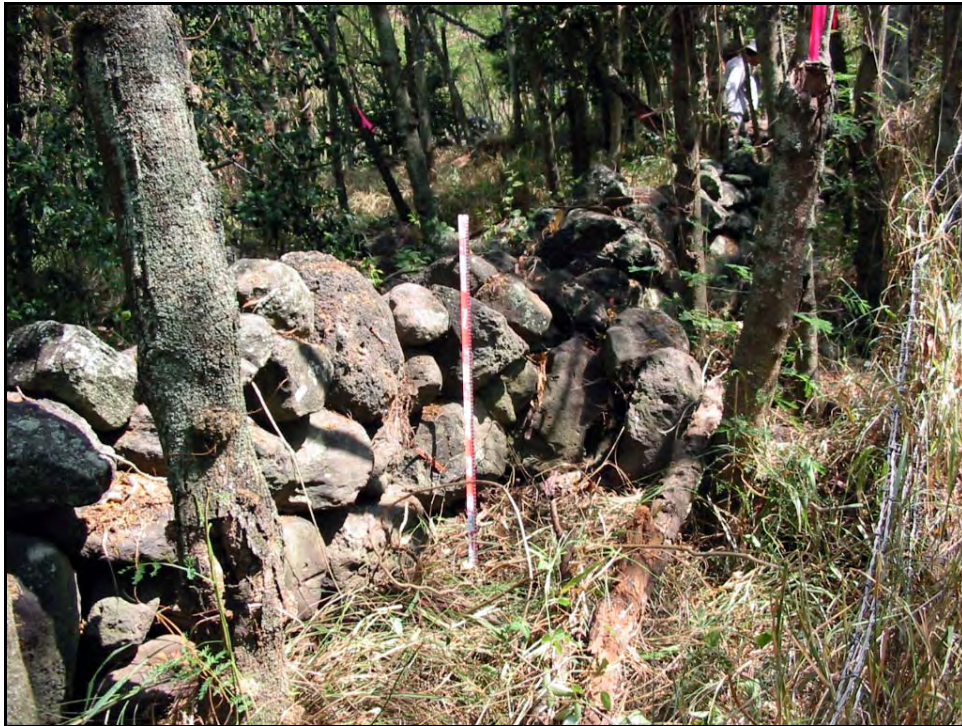
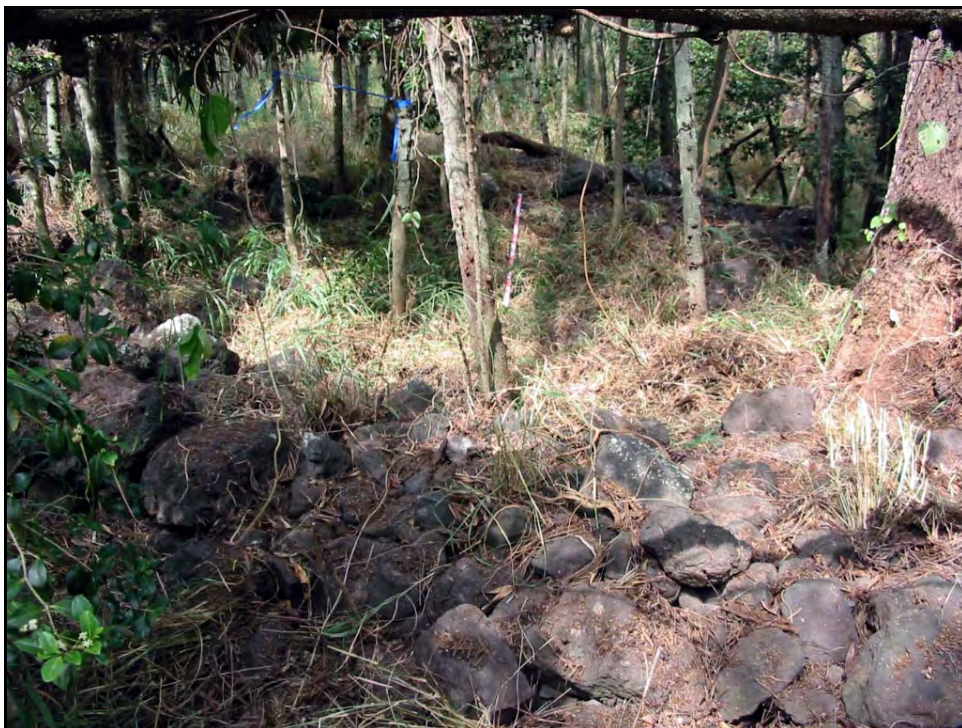
Figure 22. Photographs of SIHP # 50-80-03-416 Feature D wall (above, view to southeast) and Feature E terrace (below, view to northeast)

Features E and F consist of adjoining terraces located immediately northwest of the Feature C terrace (see Figure 19 above). The terraces are situated along the edge of a low bluff, immediately upslope of a wide floodplain west of the unnamed stream channel. The Feature E and F terraces are bounded along the upslope (western) edge by the Feature D wall. The retaining wall along the downslope edge of the Feature E and F terraces is of a mounded-type construction, consisting of basalt boulders and cobbles crudely piled against the edge of the natural bluff (Figure 23). The modified portion of the bluff measures approximately 23 m long, 2 to 4 m wide, and 2 to 3 m in height. The wall retains level soil areas upslope, between the retaining wall and the Feature D wall. The level soil terraces are divided by low, mounded walls, 1 to 2 courses high. Feature E includes two soil terraces, measuring 4.5 m by 2.3 m and 7.8 m by 1.8 m wide. Feature F also includes two soil terraces, one at the base of the bluff and one on the top surface. The terrace at the base of the bluff measures 3.3 m by 1.2 m wide, with intact facing along the western edge of the wall bounding the terrace. The upper terrace is circular in shape and measures 4.5 m by 3.2 m. The north, south, and eastern walls bounding the terrace have intact facing and are better constructed than the walls around the Feature E terraces (Figure 23). Features E and F are interpreted to function as agricultural planting terraces. However, the more careful construction of the Feature F terrace may indicate an associated habitation function.

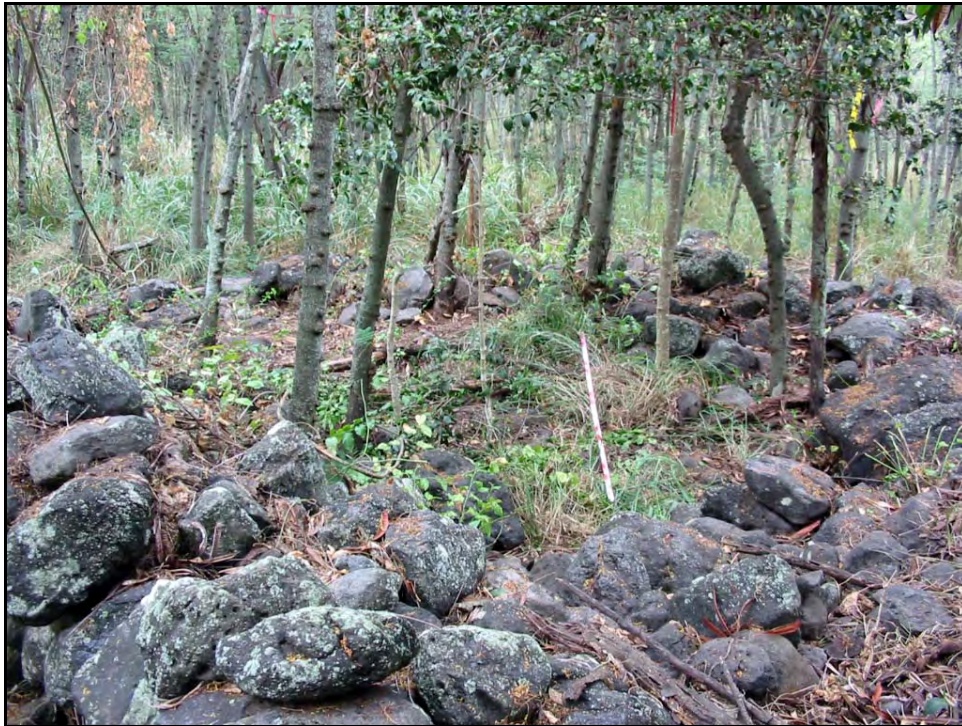
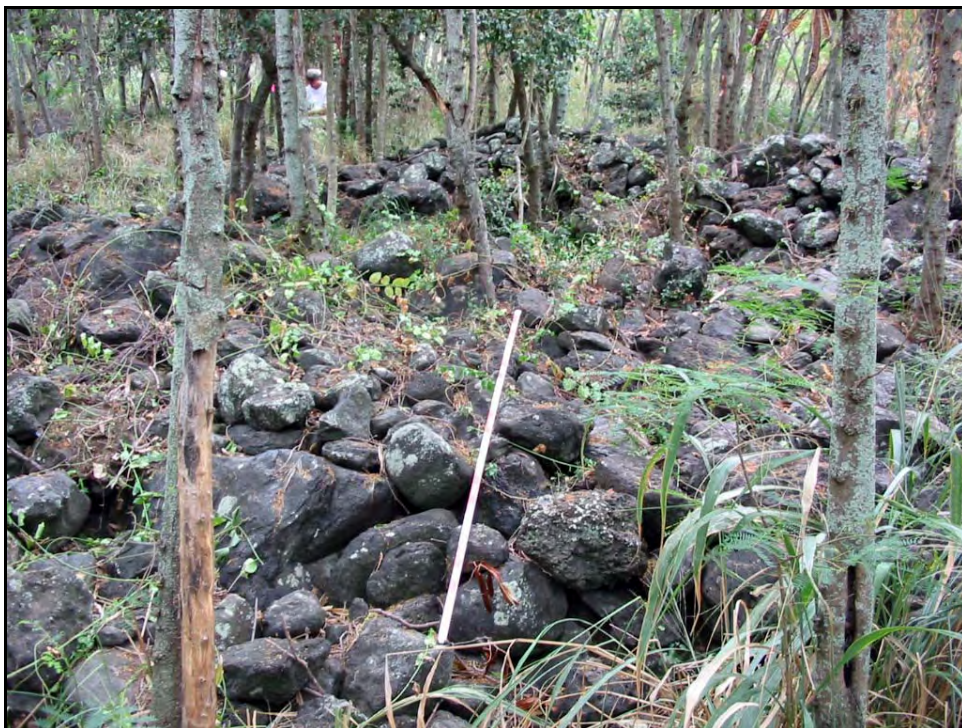
Figure 23. Photographs of SIHP # 50-80-03-416 Feature F terrace, (above, view to north) and sloping retaining wall along Features E and F (below, view to south)

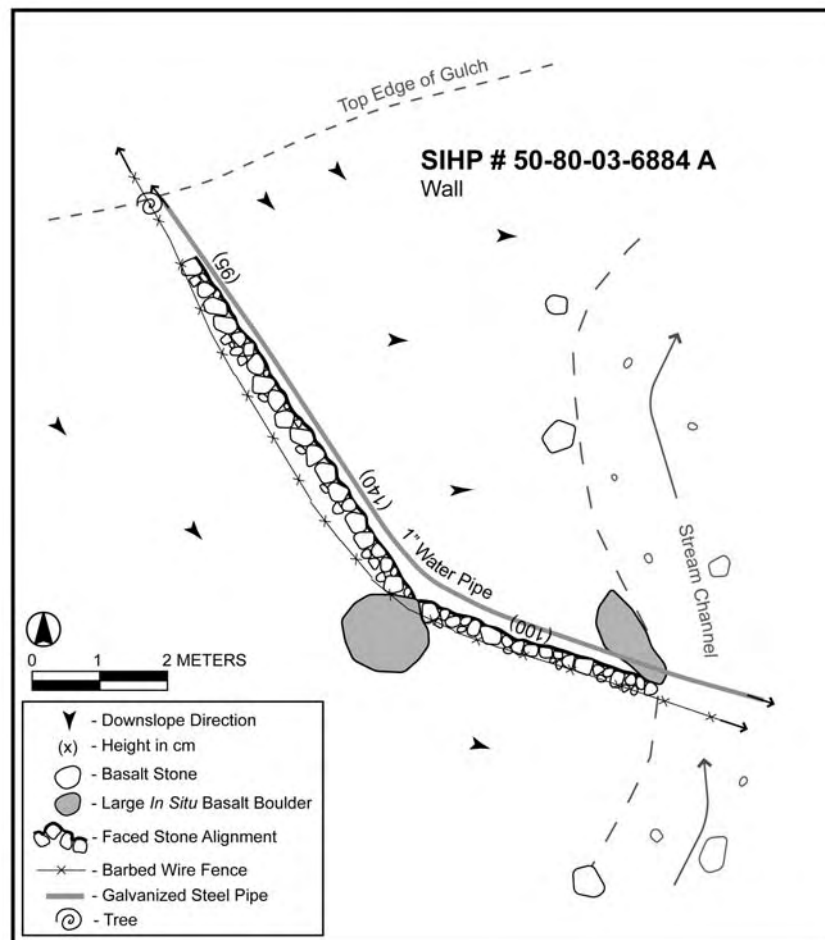
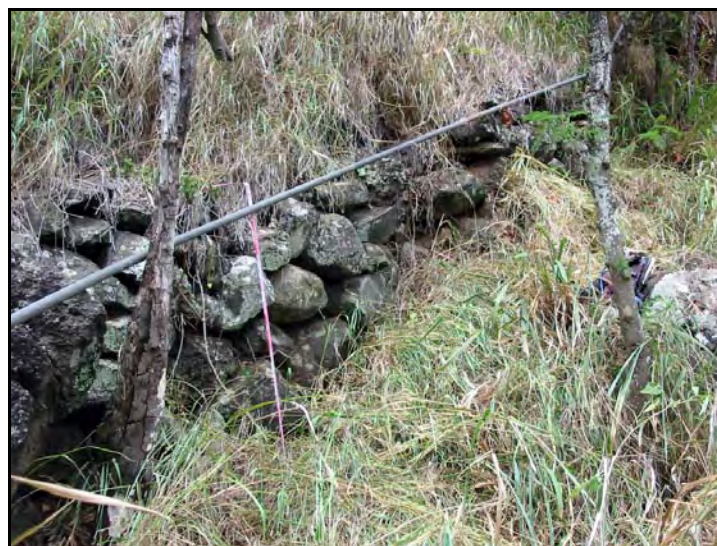
Figure 24. Plan view diagram (above) and photograph (below, view to west) of SIHP # 50-80-03-6884 Feature A: wall

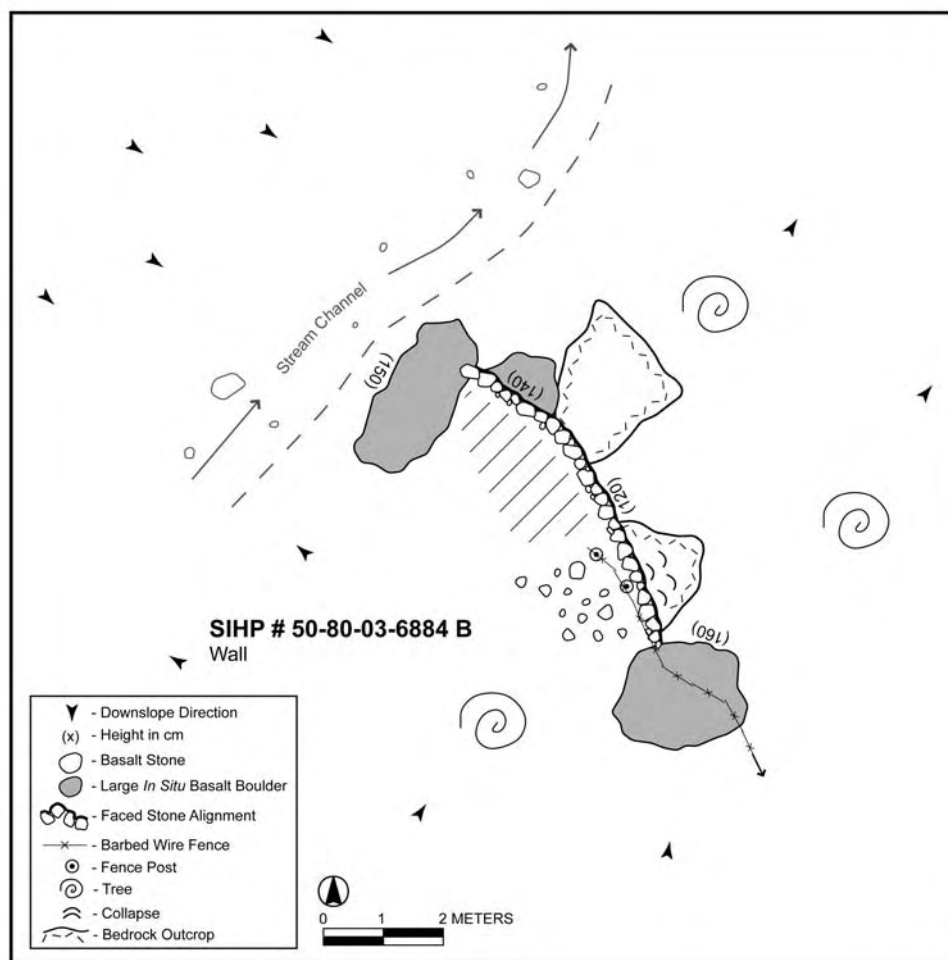
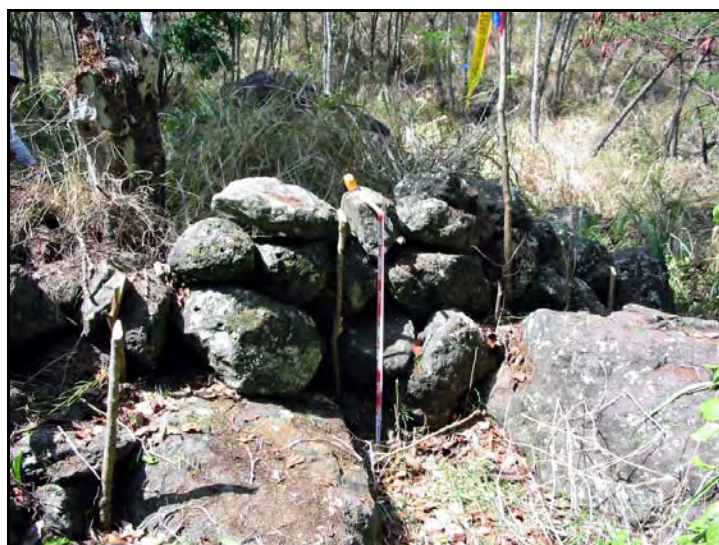
Figure 25. Plan view diagram (above) and photograph (below, view to west) of SIHP # 50-80-03-6884 Feature B: wall,

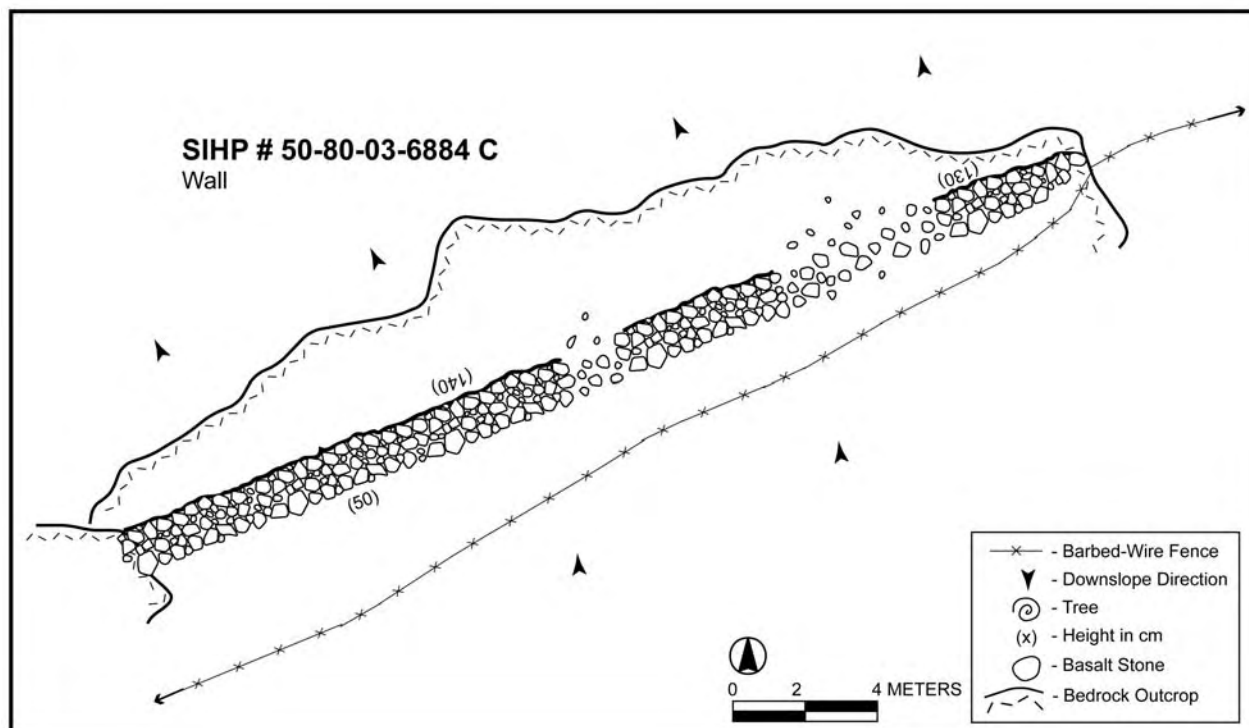
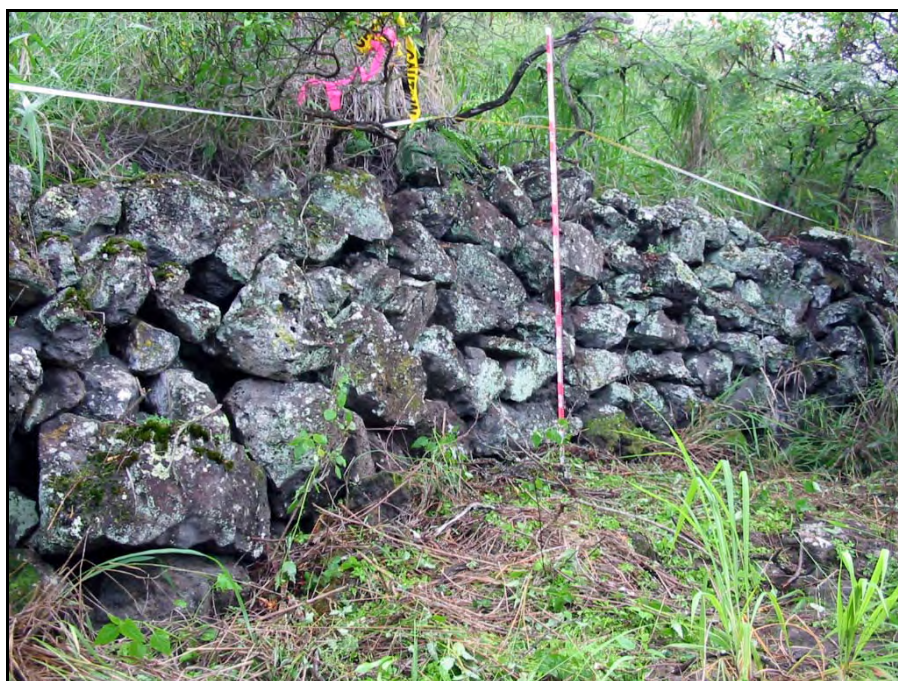
Figure 26. Plan view diagram (above) and photograph (below, view to south) of SIHP # 50-80-03-6884 Feature C: wall
