***Draft Environmental Assessment***

***Appendices:  
Intersection Improvements  
Dillingham Ranch  
Agricultural Subdivision***

Waialua, Island of O'ahu, Hawai'i  
Tax Map Key: (1) 6-8-003: 015

July 2008

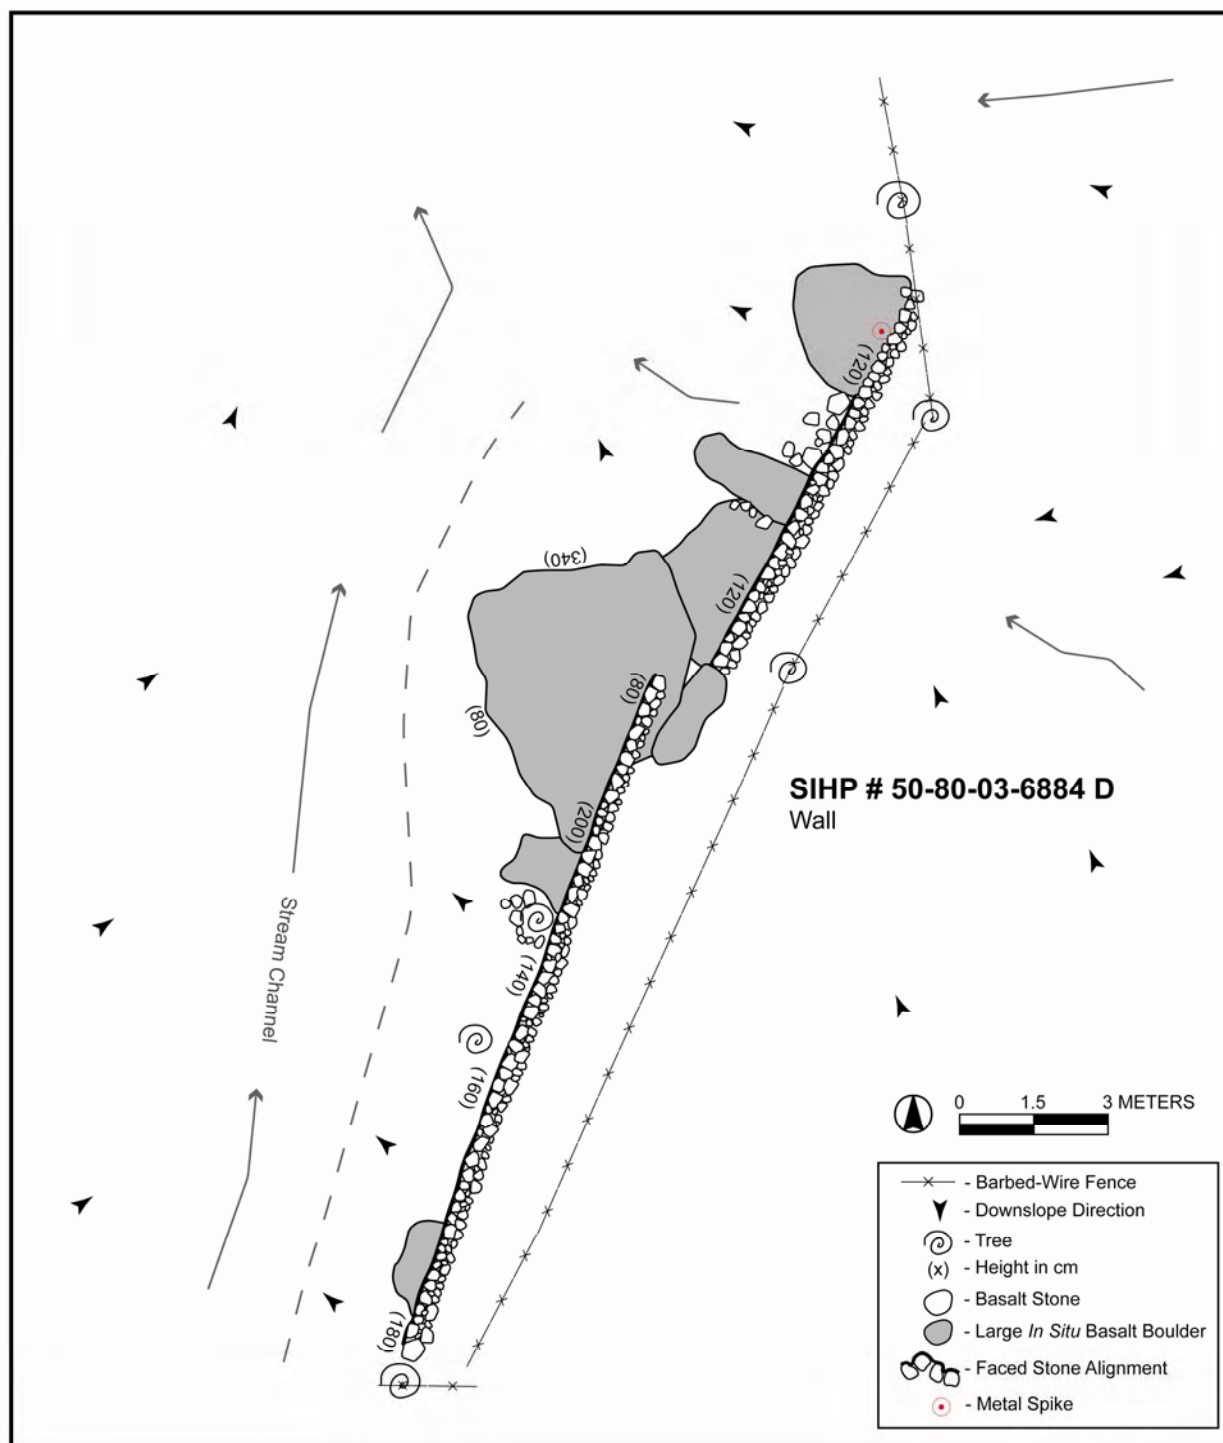
Figure 27. Plan view diagram of SIHP # 50-80-03-6884 Feature D: wall

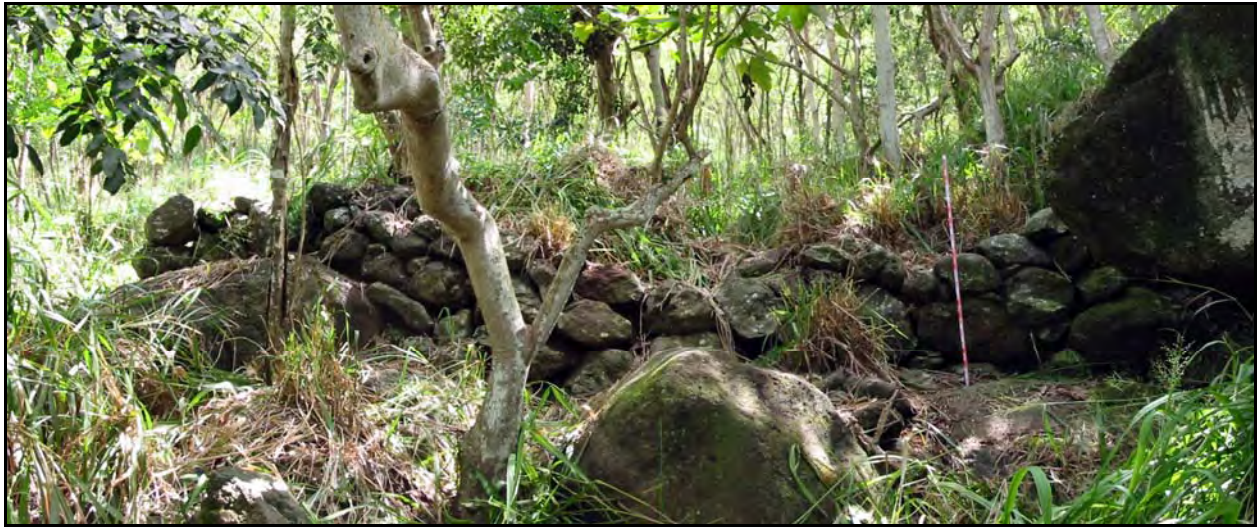
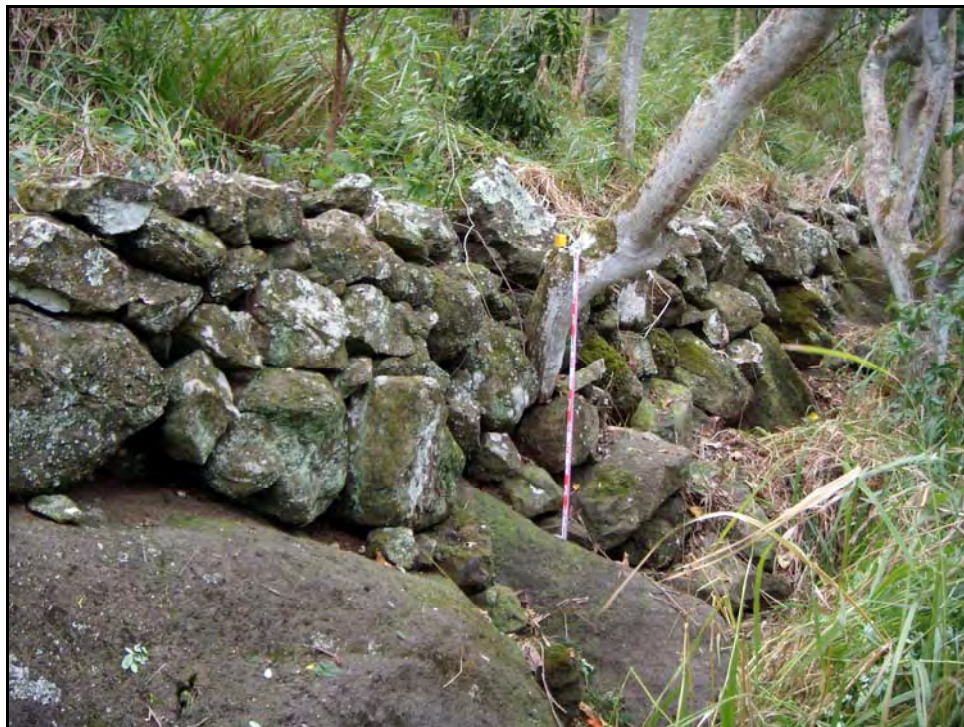
Figure 28. Photographs of the northern (above, view to southeast) and southern (below, view to southeast) portions of SIHP # 50-80-03-6884 Feature D: wall

SIHP # 50-80-03-6884 Feature D consists of two stacked-stone wall segments located within the central portion of the 75-acre inventory survey area (see Figures 16 and 17 above). The stone wall segments are constructed across a natural, seasonal drainage channel and alluvial terrace, within the same unnamed gulch as SIHP # 50-80-03-6884 Feature C. The stone wall segments are oriented roughly northeast-southwest, together measuring approximately 24 m in length (Figure 27). The wall segments are constructed of loosely stacked basalt boulders and cobbles, 2-5 courses high, with a maximum downslope height of 1.7 m on the northern segment and 1.4 m on the southern segment (Figure 28). The wall constructions are comprised of stones ranging from 20-80 cm in diameter, with larger boulders used for the base course and smaller stones in the upper courses. The wall segments are also constructed over and incorporate large, *in-situ* basalt boulders. The northern segment of the SIHP # 50-80-03-6884 Feature D wall is constructed across the base of a natural drainage channel, with the southern end of the northern wall segment terminating at the edge of an extremely large *in-situ* basalt boulder. A metal spike was observed to be supporting the base of a portion of the northern wall segment. The southern wall segment begins on top of the extremely large basalt boulder and continues southwest along the edge of a natural alluvial stream terrace within the gulch. The southern end of the southern wall segment terminates at the southern slope of the unnamed gulch, where water flow has washed out the end of the wall. The SIHP # 50-80-03-6884 Feature D wall is well-faced along the downslope edge, and nearly level with the sloping hillside along the upslope edge. A remnant barbed-wire fence is located immediately upslope of the wall, running roughly parallel to the wall and continuing north and southwest beyond the wall construction.

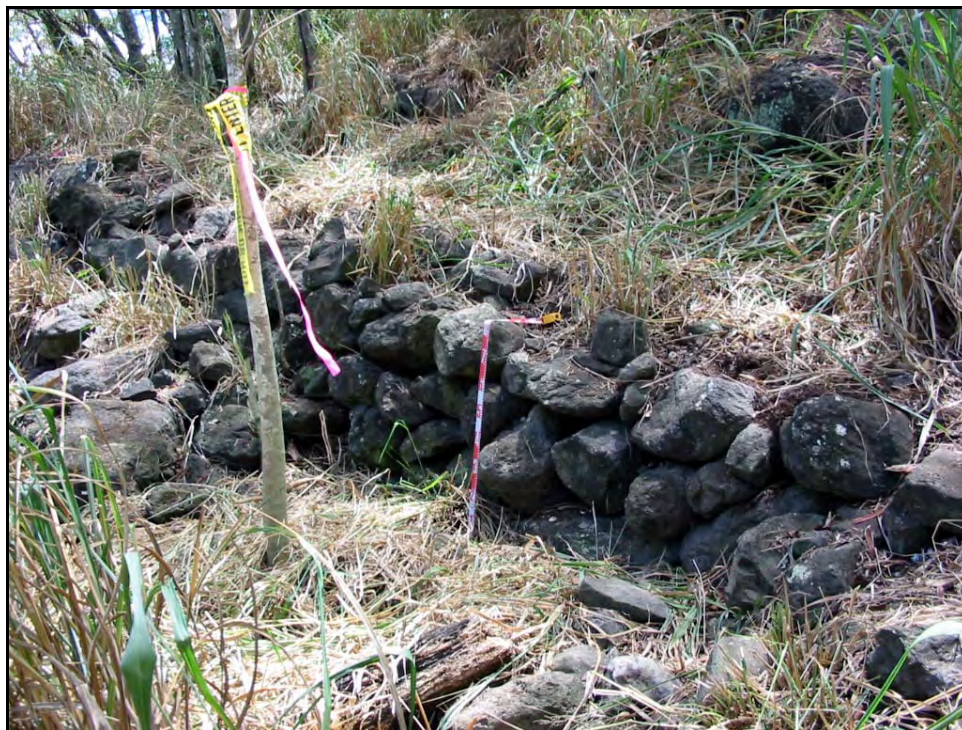
Figure 33. Photograph of SIHP # 50-80-03-6885 Feature B: retaining wall, view to east

terrace below. The Feature B retaining wall may also define the *mauka* (upslope) edge of a possible 'auwai (irrigation ditch) leading from the stream channel to the Feature D terrace discussed below.

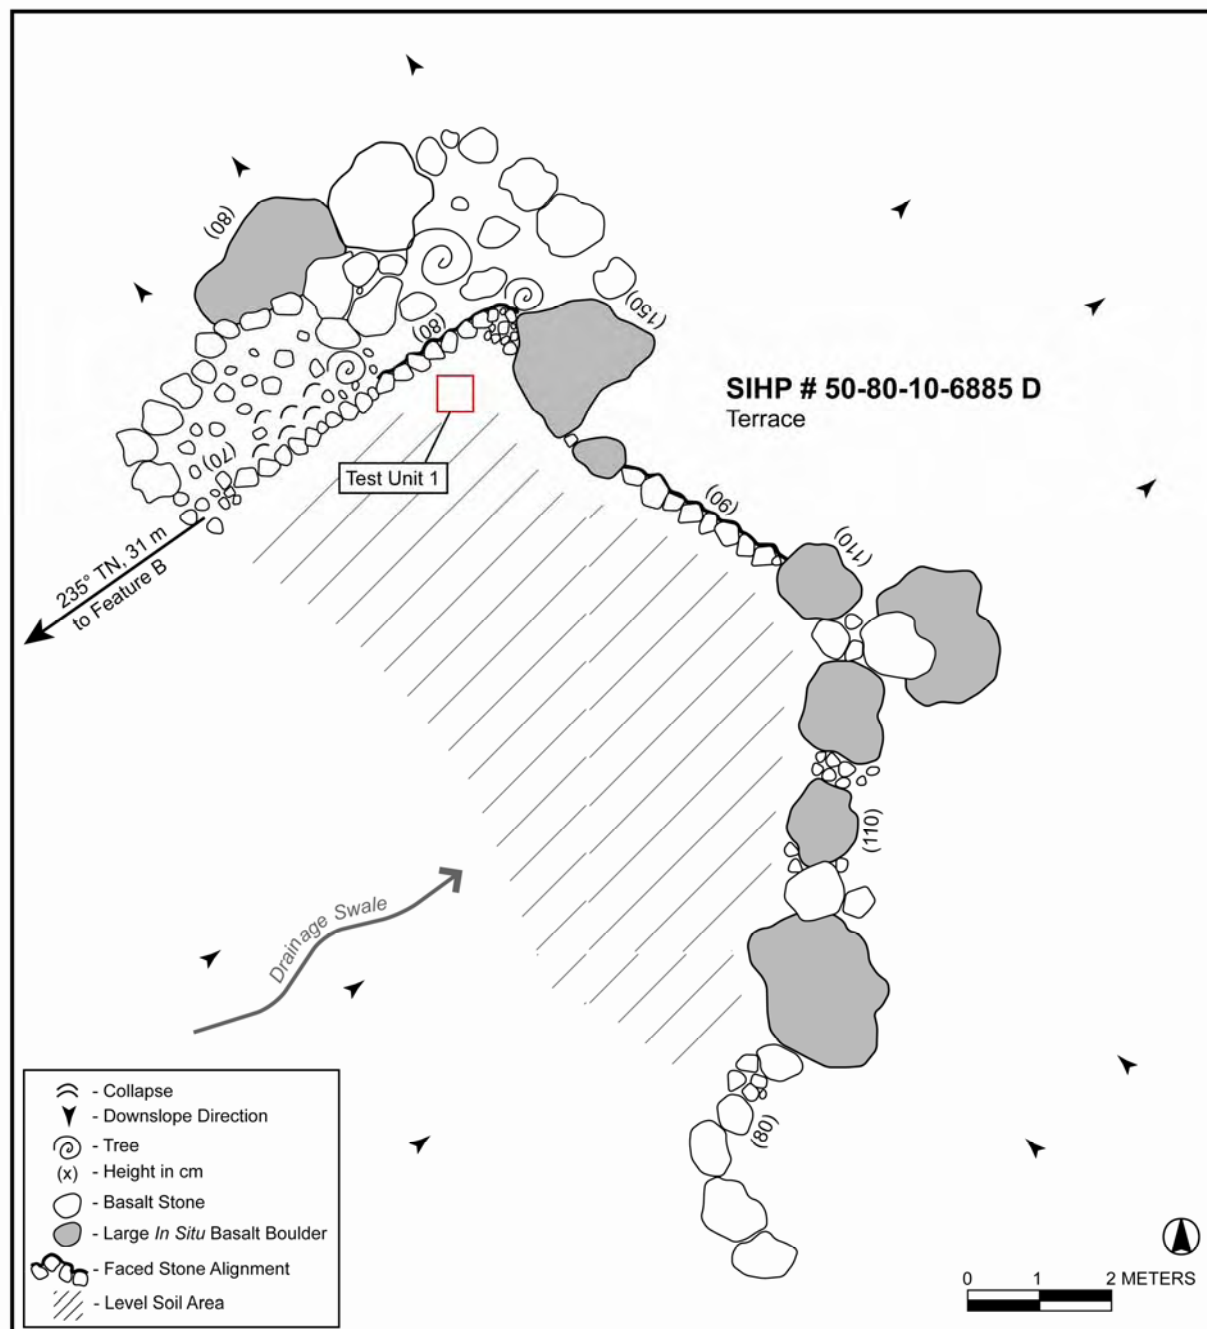
Figure 35. Plan view diagram of SIHP # 50-80-03-6885 Feature D: terrace

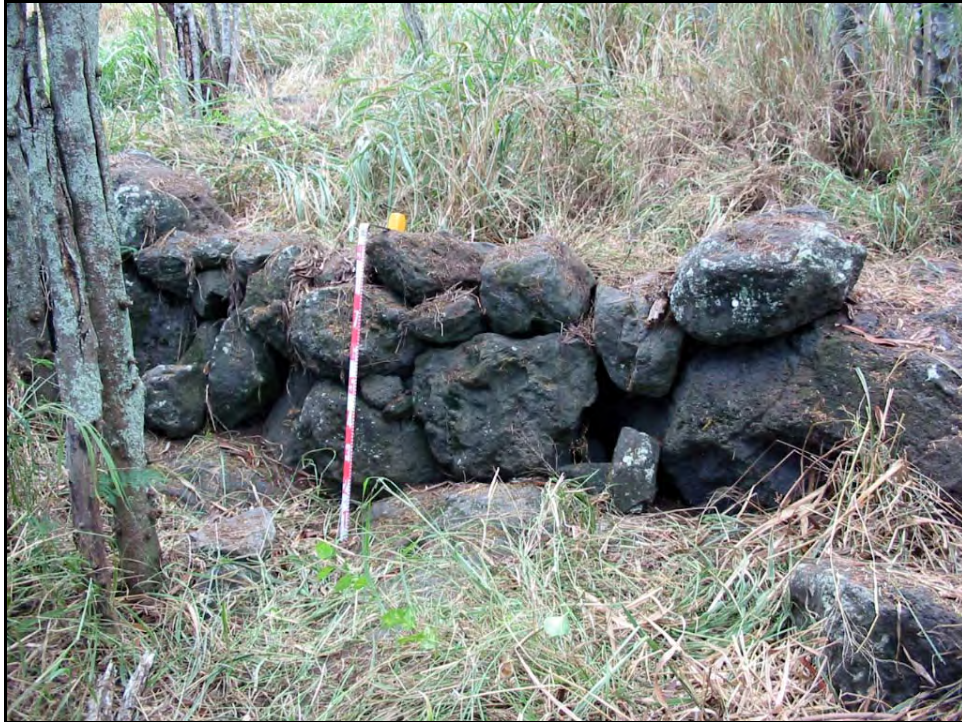
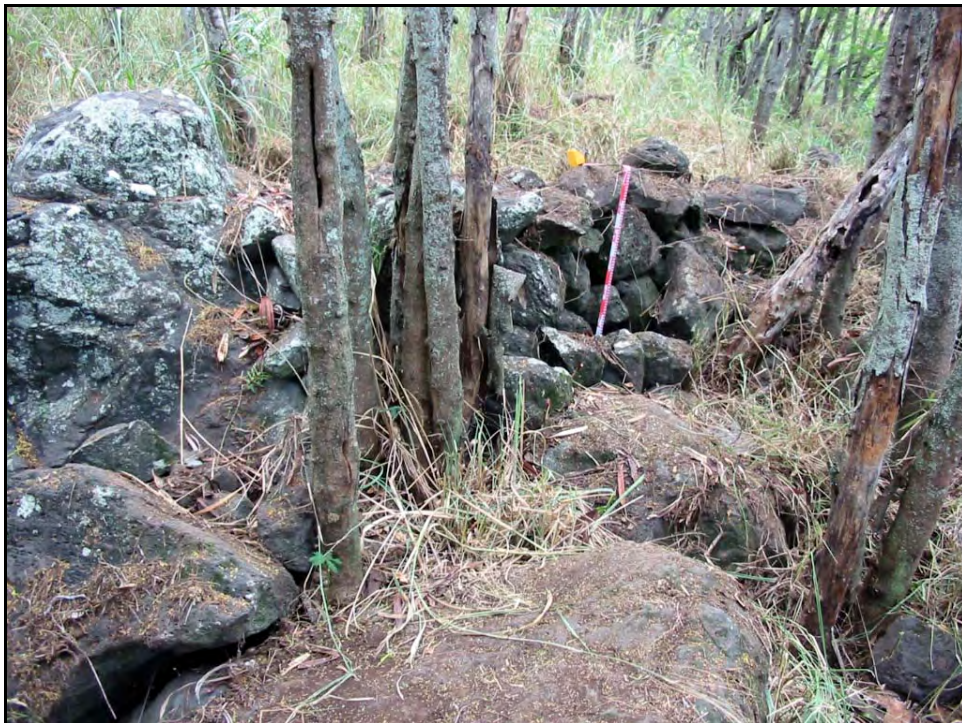
Figure 36. Photographs of the eastern (above, view to southeast) and western (below, view to southwest) portions of SIHP # 50-80-03-6885 Feature D: terrace

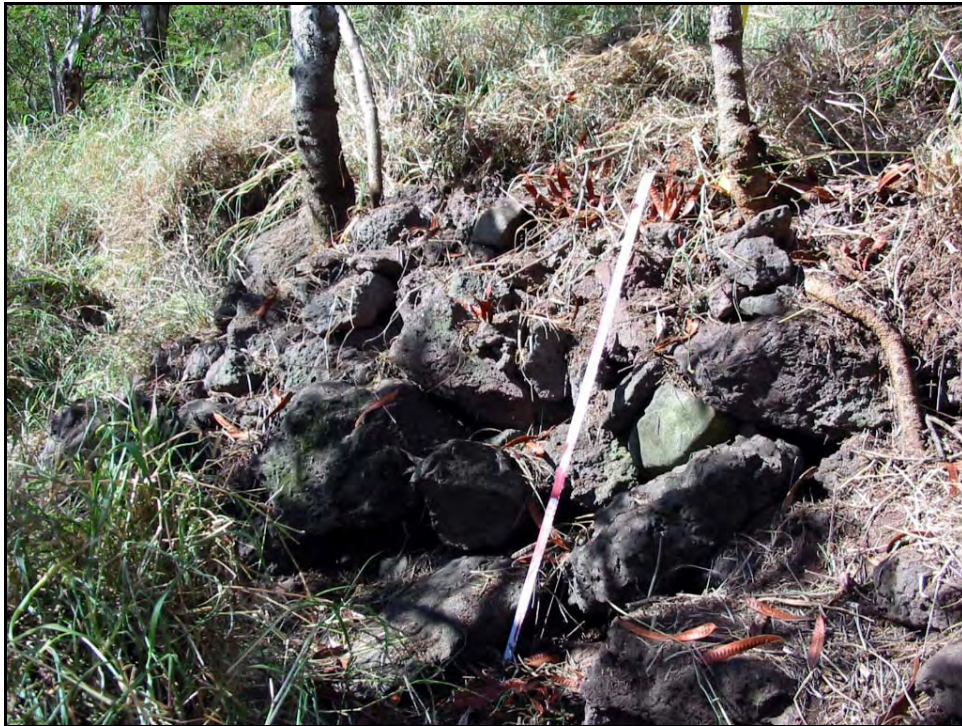
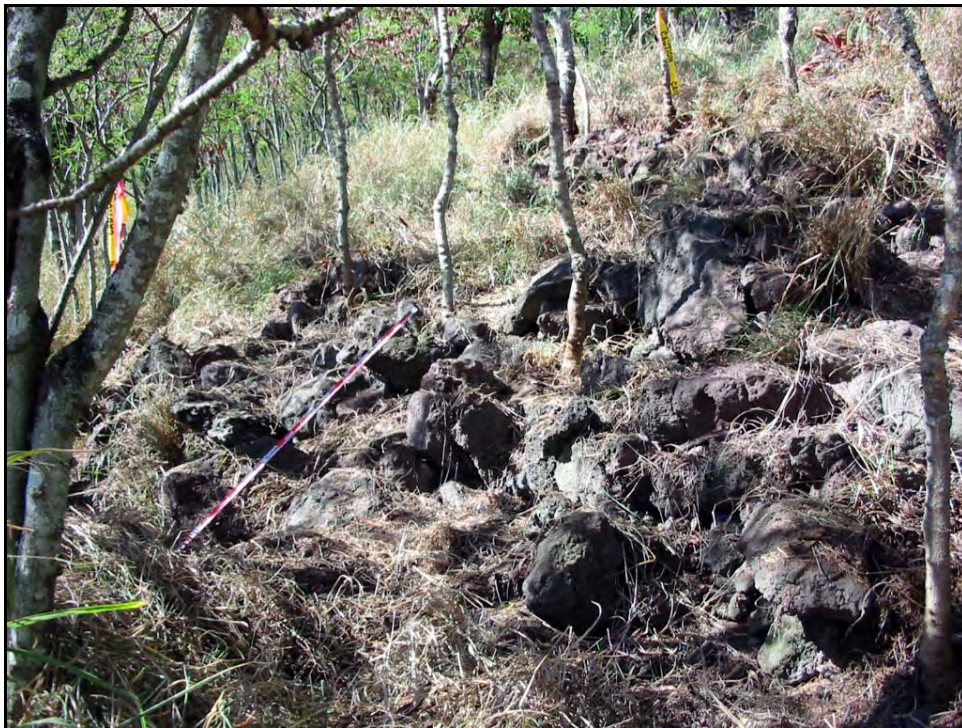
Figure 39. Photographs of SIHP # 50-80-03-6886 Feature A mound (above, view to south) and Feature B mound (below, view to south)

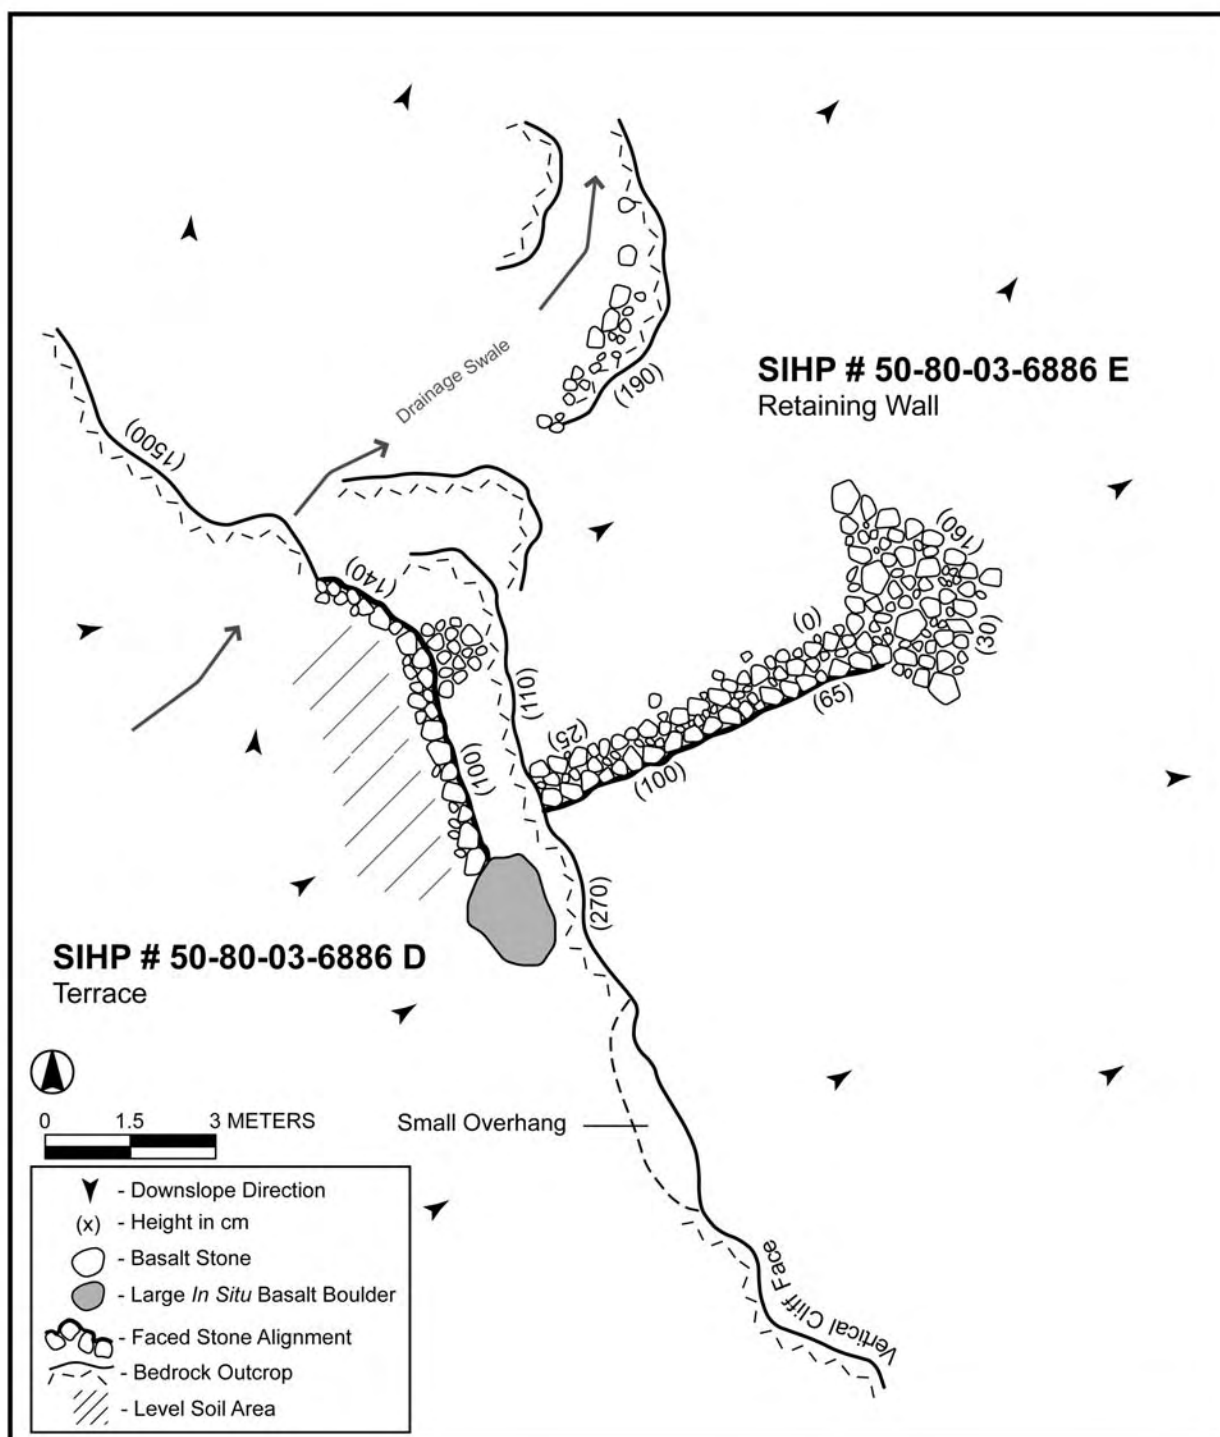
Figure 41. Plan view diagram of SIHP # 50-80-03-6886 Feature D terrace and Feature E retaining wall

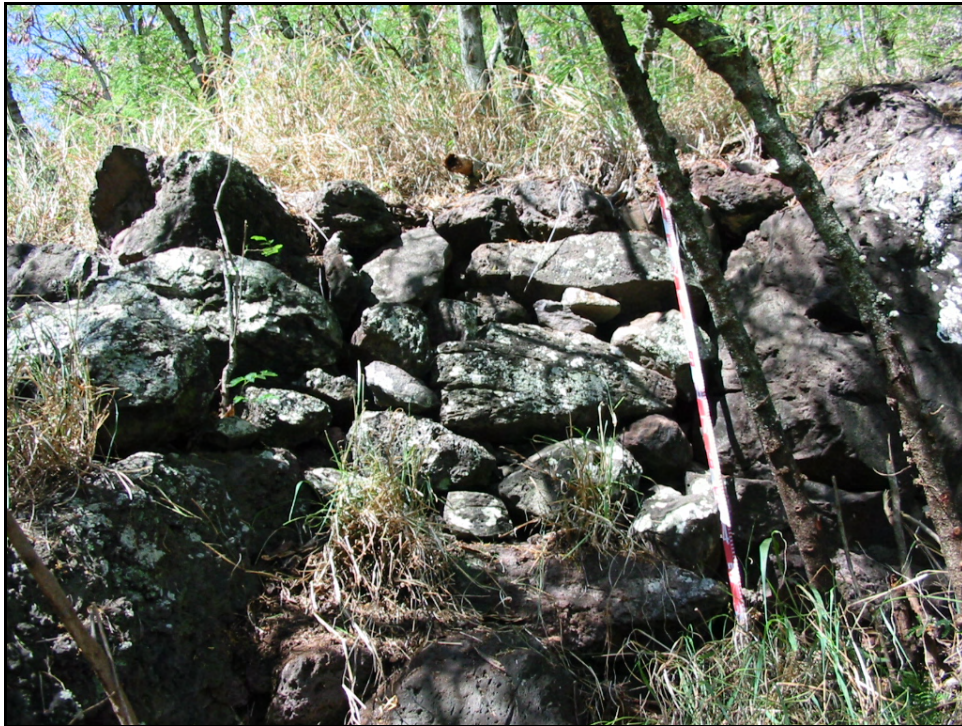
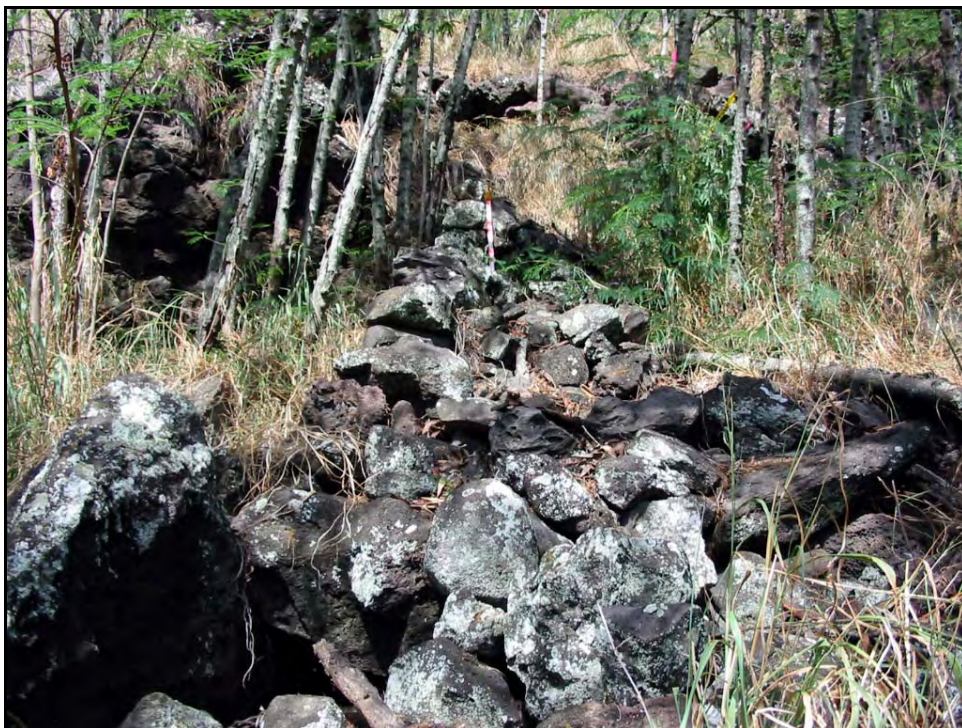
Figure 42. Photographs of SIHP # 50-80-03-6886 Feature D terrace (above, view to southwest) and Feature E retaining wall (below, view to west)

Feature E is a well-constructed retaining wall located immediately downslope of the Feature D terrace, oriented parallel to the prevailing slope. The retaining wall is constructed against the edge of an exposed basalt cliff face and extends approximately 9 m downslope. The wall is constructed of stacked basalt boulders and cobbles, 2 to 4 courses high, with a maximum height of 1.0 m and average width of 0.8 m. The wall is well-faced on the southern edge, and nearly flush with the ground surface on the northern edge. The wall fans out at the downslope end, resembling a crudely constructed mound similar to Features A-C.

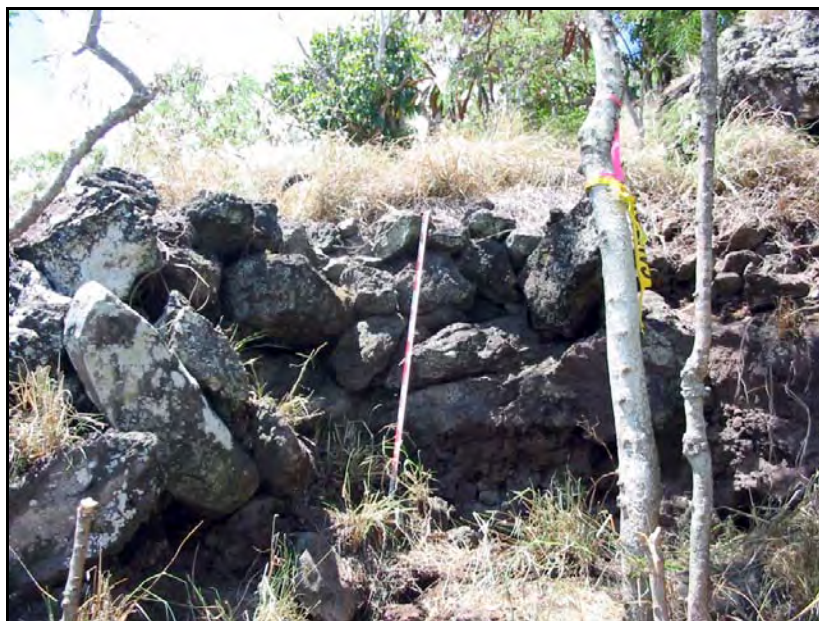
Figure 43. Plan view diagram (above) and photograph (below, view to southwest) of SIHP # 50-80-03-6886 Feature F: terrace

wide rocky soil area is retained upslope of the retaining wall. The Feature F terrace retaining wall measures 3.6 m long, 0.6 m wide, with a maximum height of 1.4 m (Figure 43). The faced retaining wall is constructed of stacked basalt boulders and cobbles, 2 to 4 courses high. An approximately 1.8 m by 0.5 m wide rocky soil area is retained upslope of the retaining wall. Immediately downslope of the Feature F terrace is a single-course alignment of basalt boulders and cobbles measuring 2.2 m long, 0.2 m wide, and 0.6 m high. The alignment is oriented roughly parallel to the prevailing slope and is situated along the western edge of the natural drainage channel. The alignment appears to function in directing water flow toward the Feature A and B mounds downslope. The Feature G terrace retaining wall measures 2.0 m long, 0.3 m wide, with a maximum height of 0.6 m (Figure 44). The faced retaining wall is constructed of stacked basalt boulders and cobbles, 3 courses high. An approximately 1.3 m by 0.4 m wide rocky soil area is retained upslope of the retaining wall.

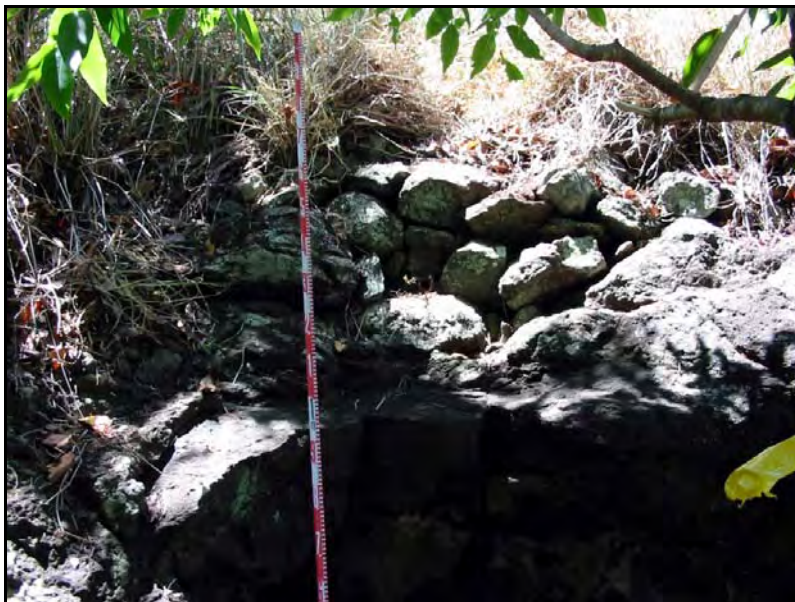
Figure 44. Plan view diagram (above) and photograph (below, view to west) of SIHP # 50-80-03-6886 Feature G: terrace

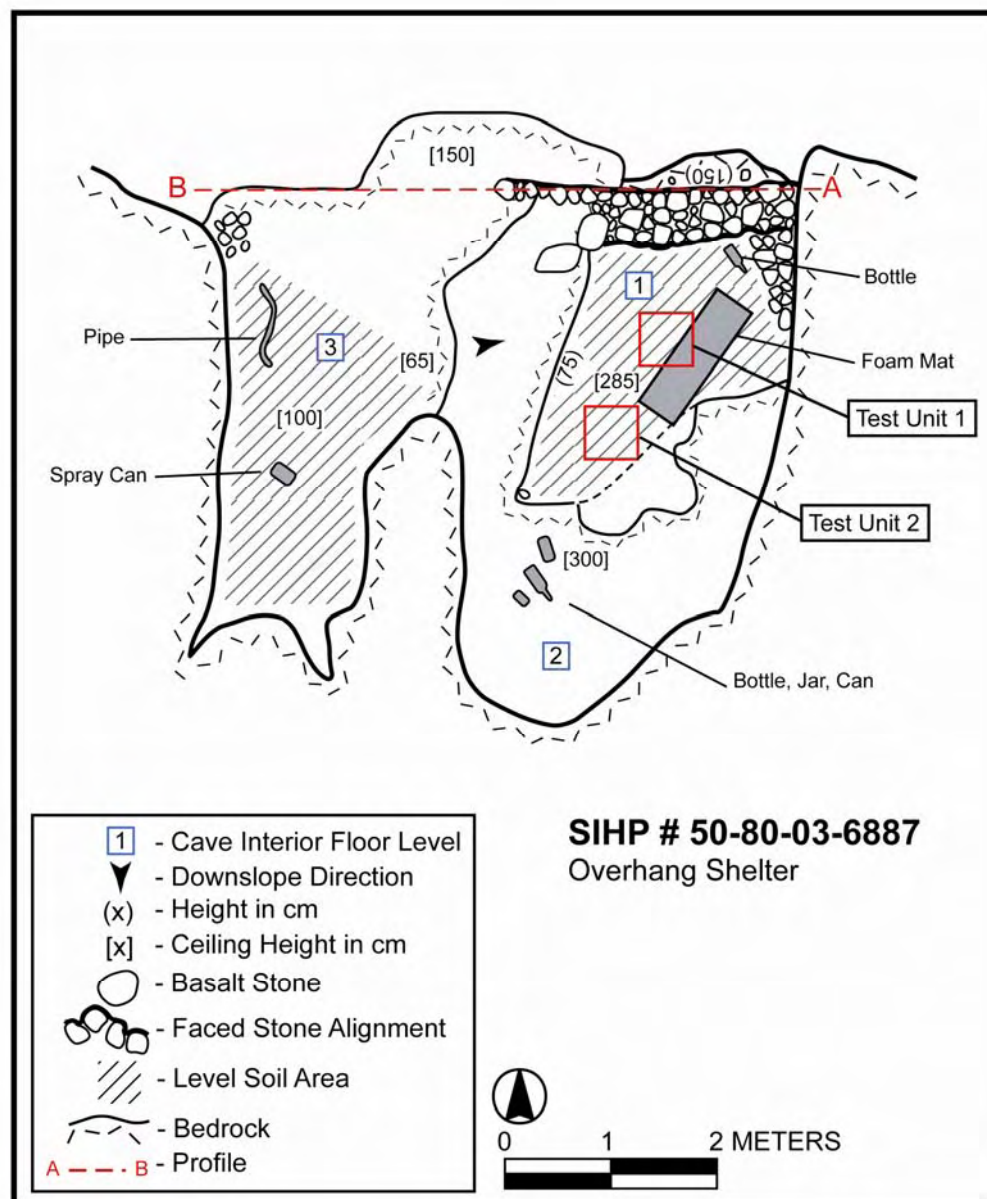
Figure 45. Plan view diagram of SIHP # 50-80-03-6887 overhang shelter

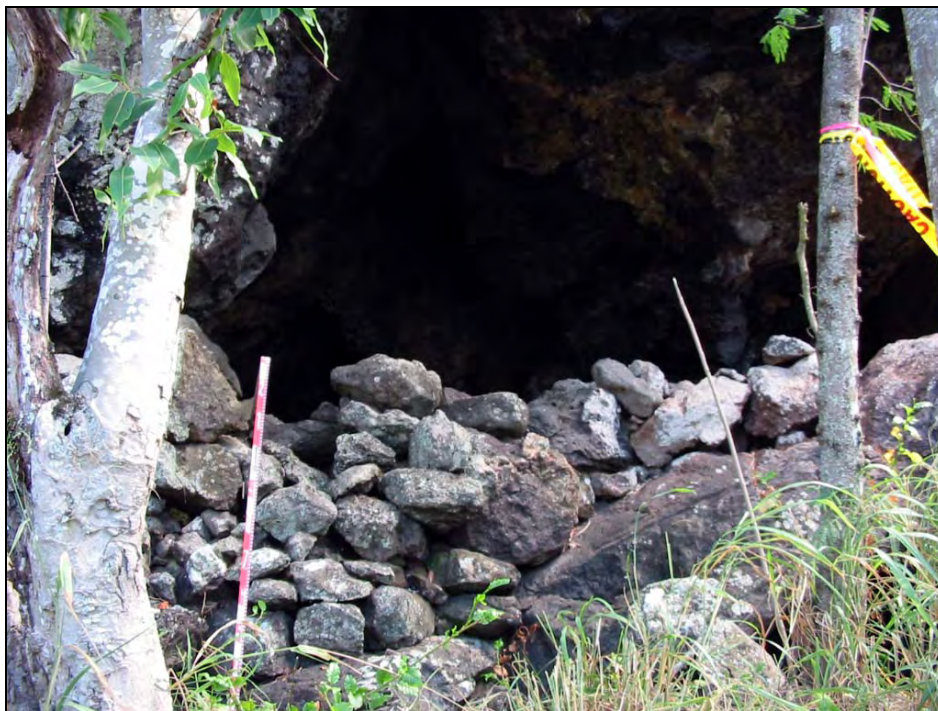
Figure 47. Photograph of SIHP # 50-80-03-6887: modified overhang shelter, exterior, showing retaining wall across the overhang entrance, view to south

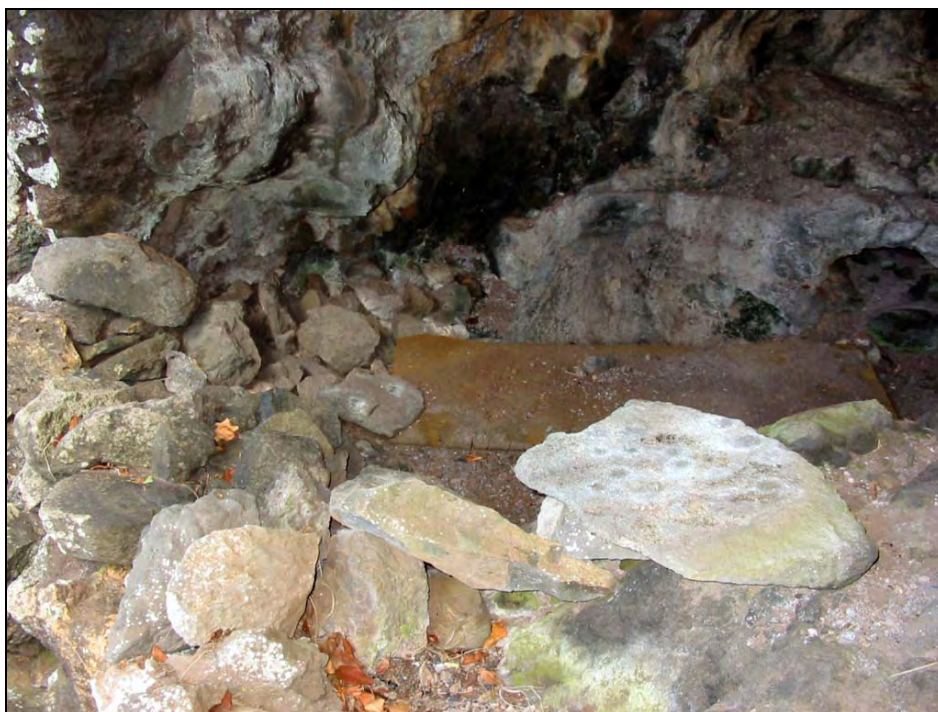
Figure 48. Photograph of SIHP # 50-80-03-6887: modified overhang shelter, interior, showing level terrace area within the overhang and foam mat, view to east.

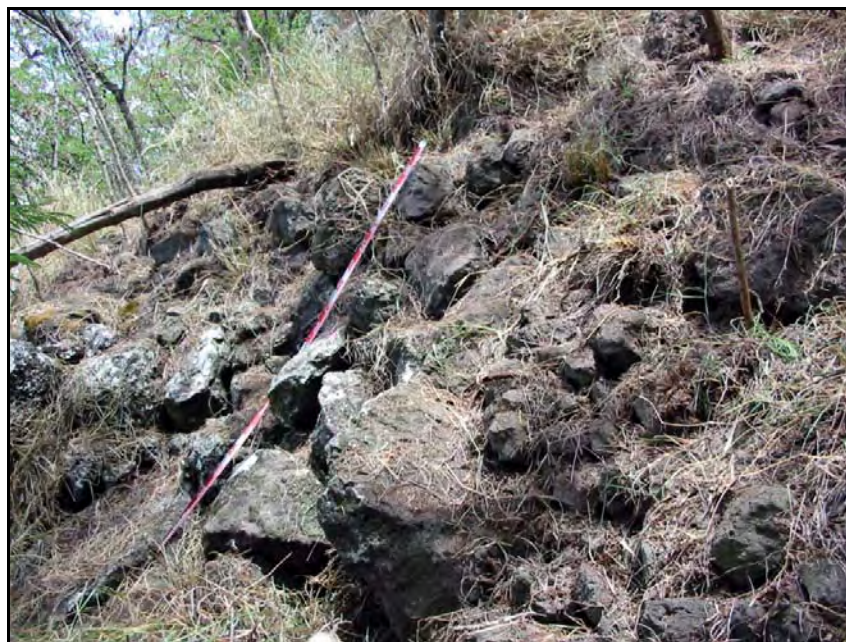
Figure 49. Plan view diagram (above) and photograph (below, view to southeast) of SIHP # 50-80-03-6888 Feature A: mound

Feature A mound measures 6.0 m long, 2.5 m wide, with a maximum height of 2.0 m (Figure 49). The mound is constructed immediately upslope of a bedrock outcrop and includes larger stones along the downslope edge and smaller stones on the upslope edge. Feature C mound measures 5.4 m long, 3.0 m wide, with a maximum height of 1.6 m (Figure 50). The mound is constructed across a natural drainage swale, with larger stones incorporated into the base of the mound and smaller stones piled on top. Feature D mound measures 4.5 m long, 1.5 m wide, with a maximum height of 1.1 m (Figure 51). The mound is constructed immediately upslope of a bedrock outcrop, primarily composed of basalt boulders, with few cobbles along the upslope edge. Feature E measures 3.5 m long, 2.2 m wide, with a maximum height of 1.7 m (Figure 52). The mound is constructed against the upslope edge of a large, *in situ* basalt boulder, with basalt boulders and cobbles evenly distributed throughout the construction. Feature F consists of two adjacent mounds, measuring 4.5 m long, 1.4 m wide, 1.6 m high and 2.1 m long, 1.5 m wide, 1.3 m high (Figure 53). The adjacent mounds are constructed with evenly distributed basalt cobbles and small boulders.

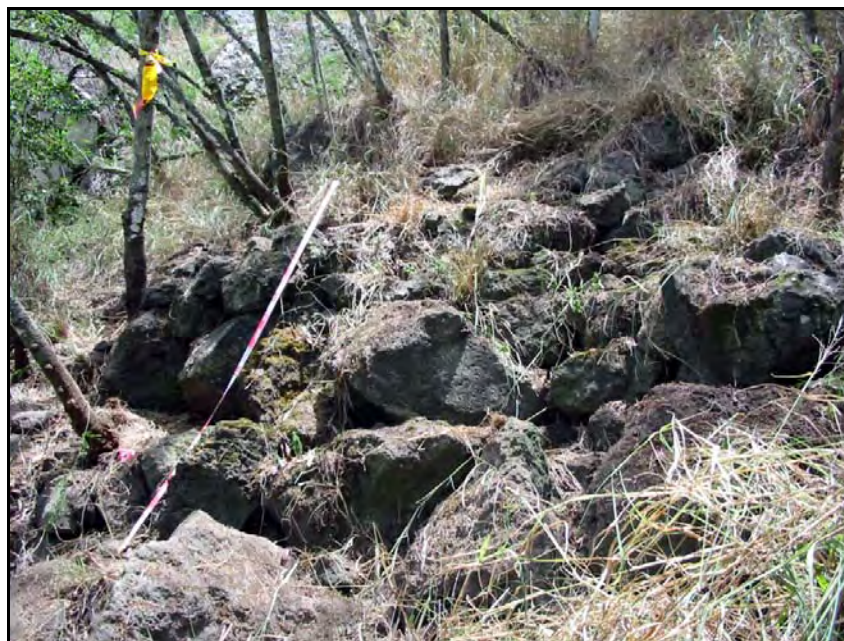
Figure 50. Plan view diagram (above) and photograph (below, view to southeast) of SIHP # 50-80-03-6888 Feature C: mound

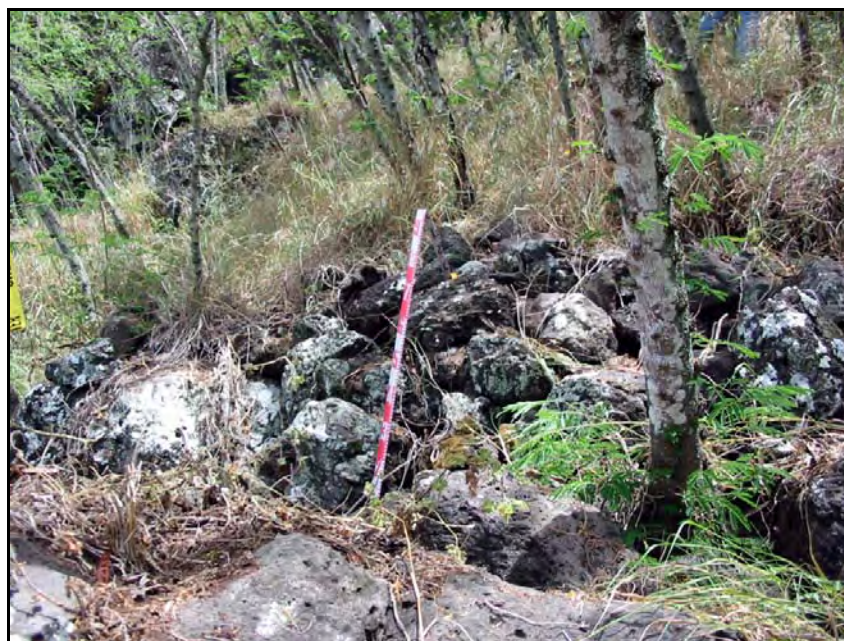
Figure 51. Plan view diagram (above) and photograph (below, view to southeast) of SIHP # 50-80-03-6888 Feature D: mound

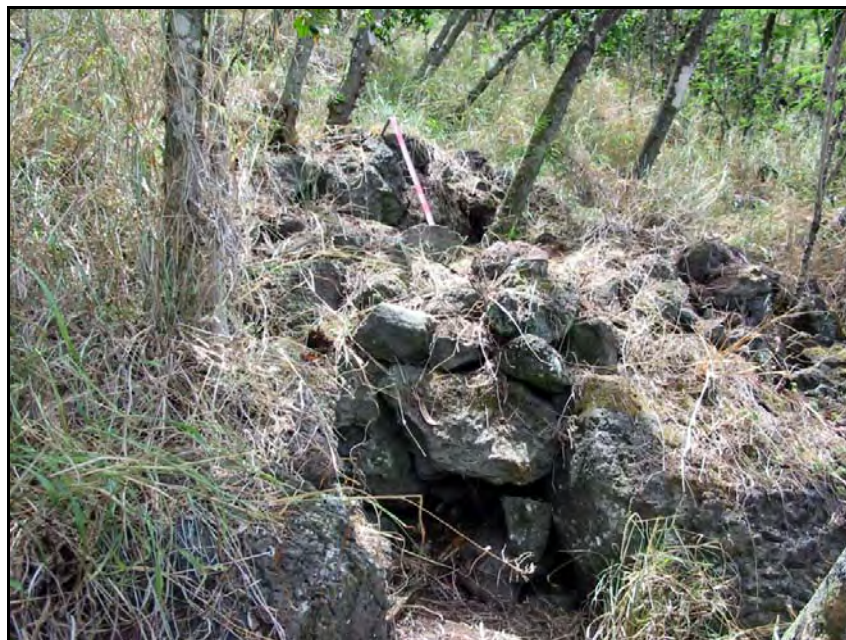
Figure 52. Plan view diagram (above) and photograph (below, view to southwest) of SIHP # 50-80-03-6888 Feature E: mound

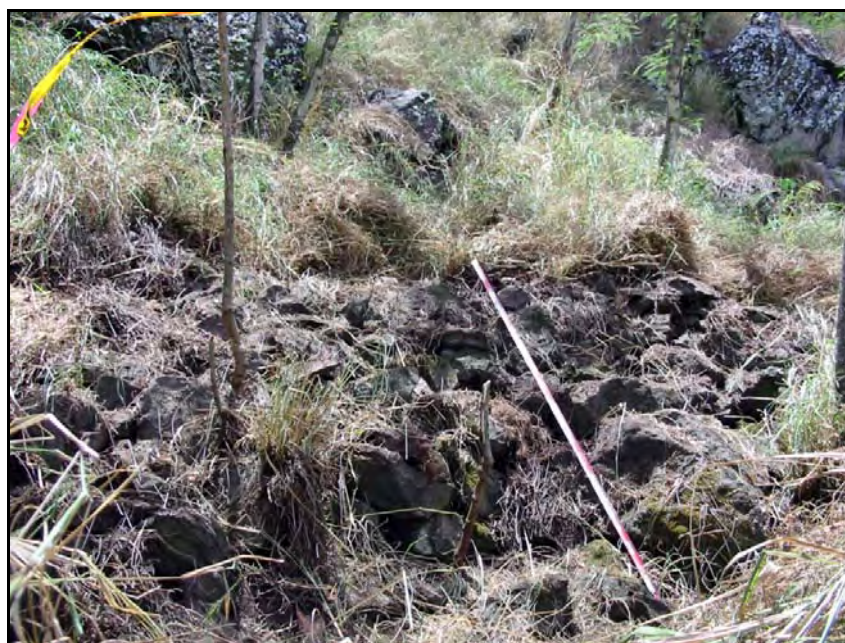
Figure 53. Plan view diagram (above) and photograph (below, view to southwest) of SIHP # 50-80-03-6888 Feature F: mound

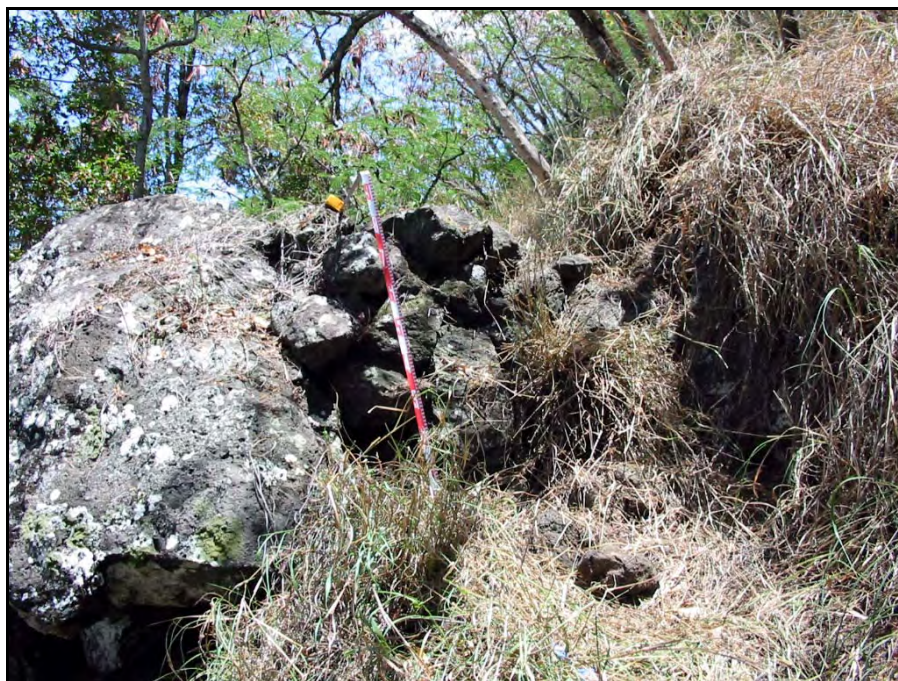
Figure 54. Plan view diagram (above) and photograph (below, view to east) of SIHP # 50-80-03-6888 Feature B: terrace

Feature B is a small terrace feature within the SIHP # 50-80-03-6888 complex. The terrace is constructed with a small, loosely stacked basalt boulder and cobble retaining wall (Figure 54). The retaining wall is oriented parallel to the prevailing slope and is constructed between a large, *in situ* basalt boulder downslope and a bedrock outcrop upslope. The retaining wall measures 1.3 m long, 0.4 m wide, with a maximum height of 0.7 m along the downslope edge. The retaining wall is faced on the downslope side and retains a level soil terrace between the large boulder and bedrock outcrop, measuring 1.1 m by 1.0 m wide.

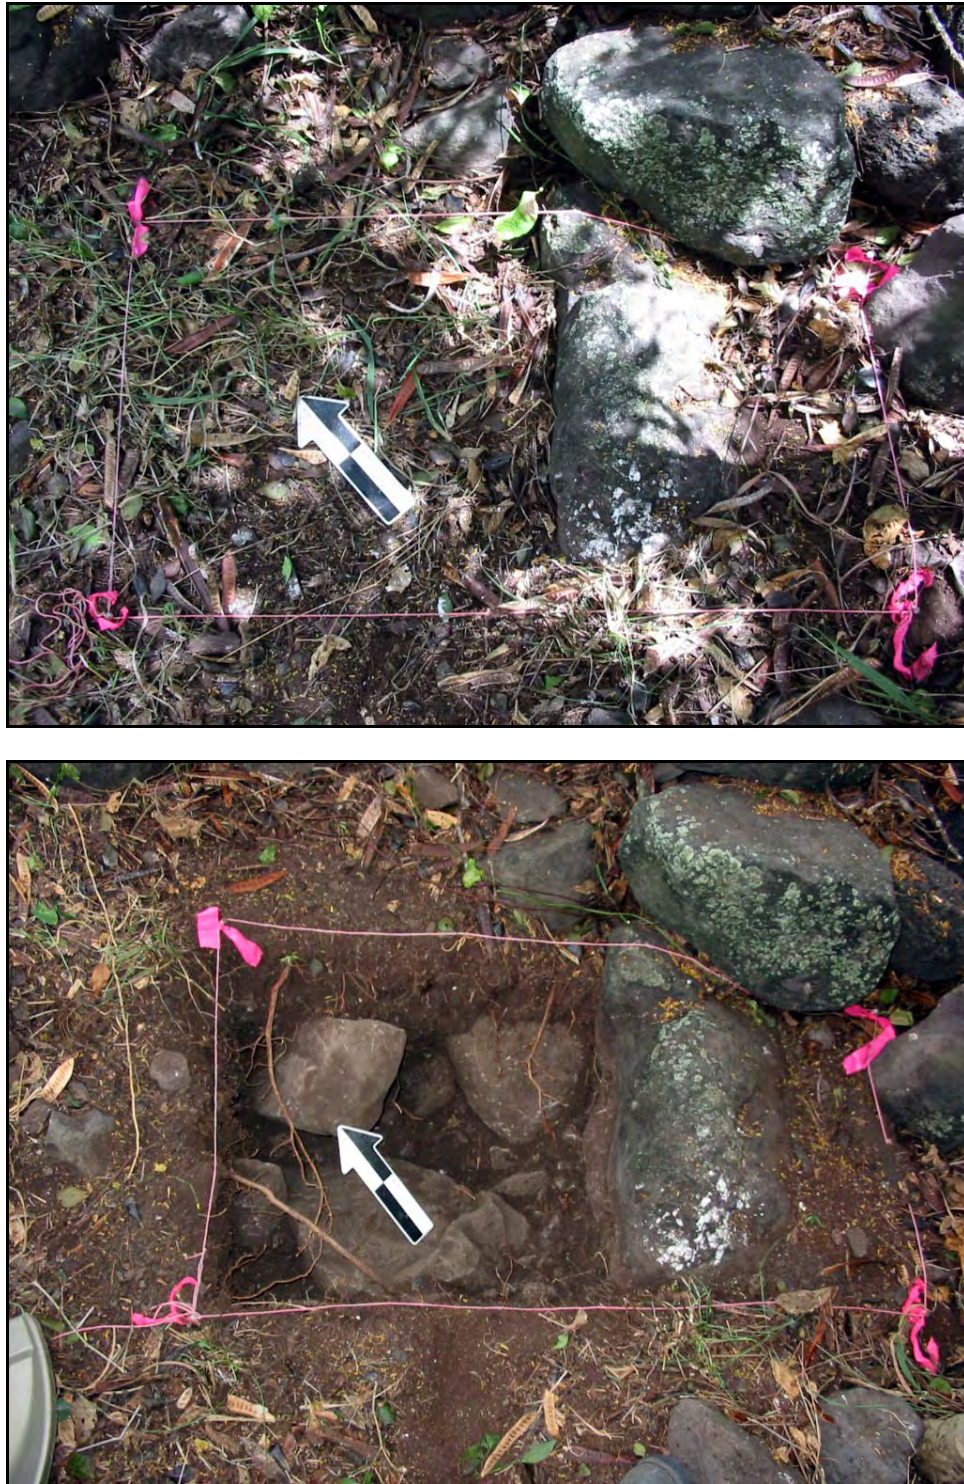
Figure 55. Pre-excavation (above) and post-excavation (below) photographs of SIHP # 50-80-03-416 Feature F Test Unit 1

Strata	Depth (cmbs)	Description
Stratum I	0-5	10YR 2/2 very dark brown silt loam; weak, fine blocky structure; dry, loose consistency; non-plastic; no cementation; terrestrial origin; includes leaf litter and abundant roots and rootlets, no cultural material observed; Lower Boundary (LB) is clear, smooth.
Stratum II	5-BOE	10YR 3/2 very dark grayish brown silt loam; moderate, fine blocky structure; dry, slightly hard consistency; non-plastic; no cementation; terrestrial origin; includes 30% basalt pebbles and cobbles, abundant roots and rootlets, contains light charcoal flecking and a small amount of marine shell midden; Lower Boundary (LB) below base of excavation.

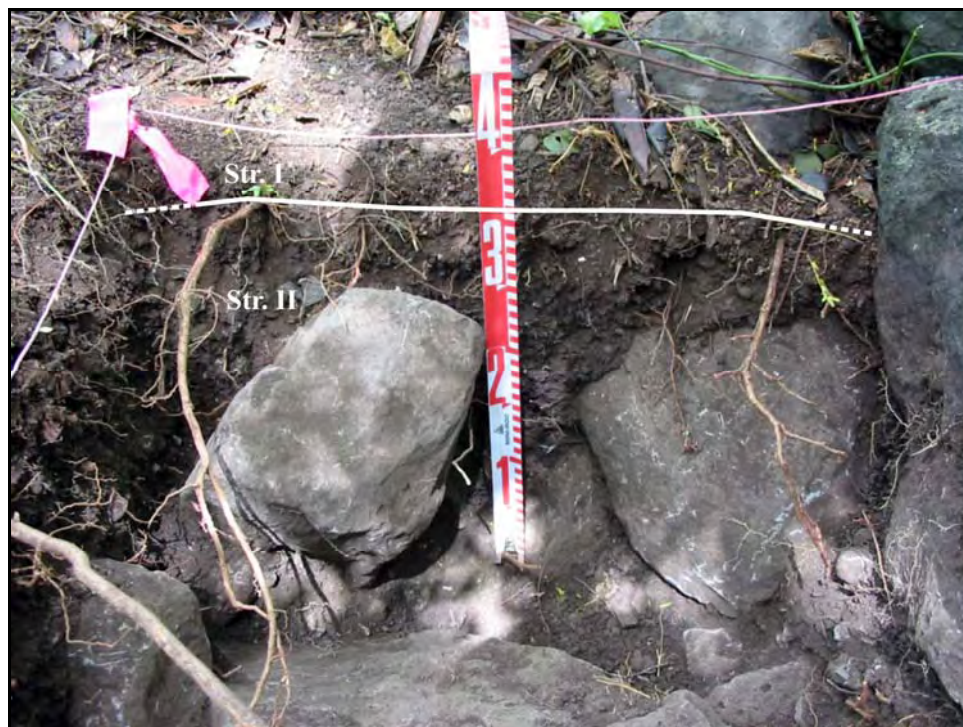
Figure 56. Photograph (above) and stratigraphic profile (below) of the northeast wall of SIHP # 50-80-03-416 Feature F Test Unit 1
