***Draft Environmental Assessment***

***Appendices:  
Intersection Improvements  
Dillingham Ranch  
Agricultural Subdivision***

Waialua, Island of O'ahu, Hawai'i  
Tax Map Key: (1) 6-8-003: 015

July 2008

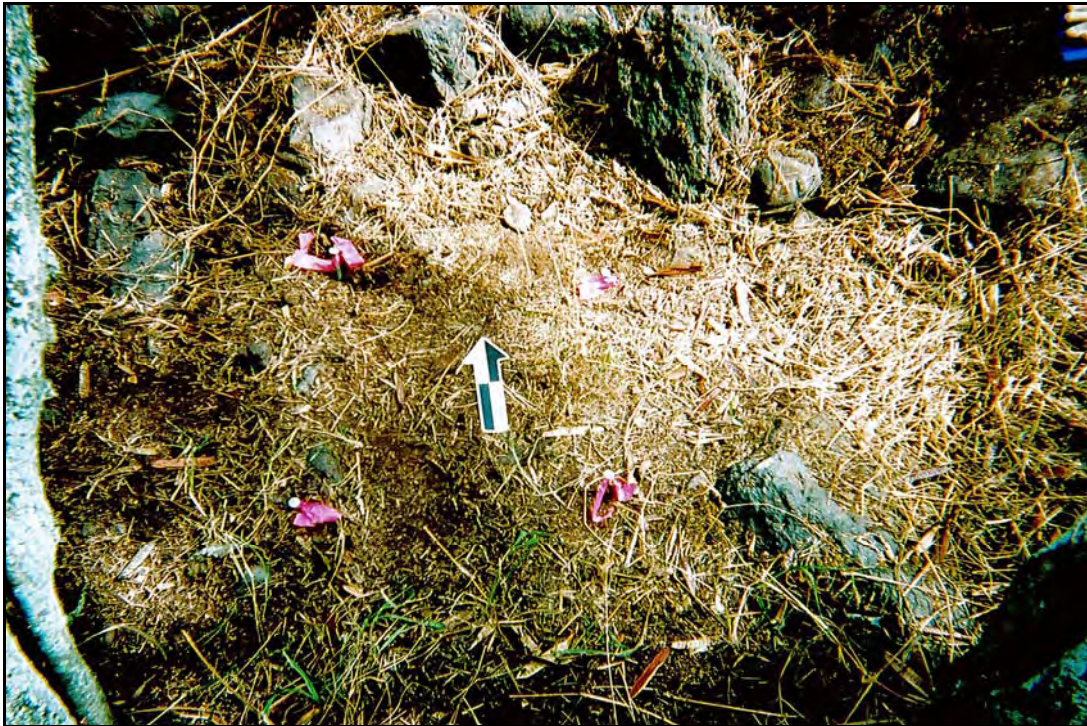
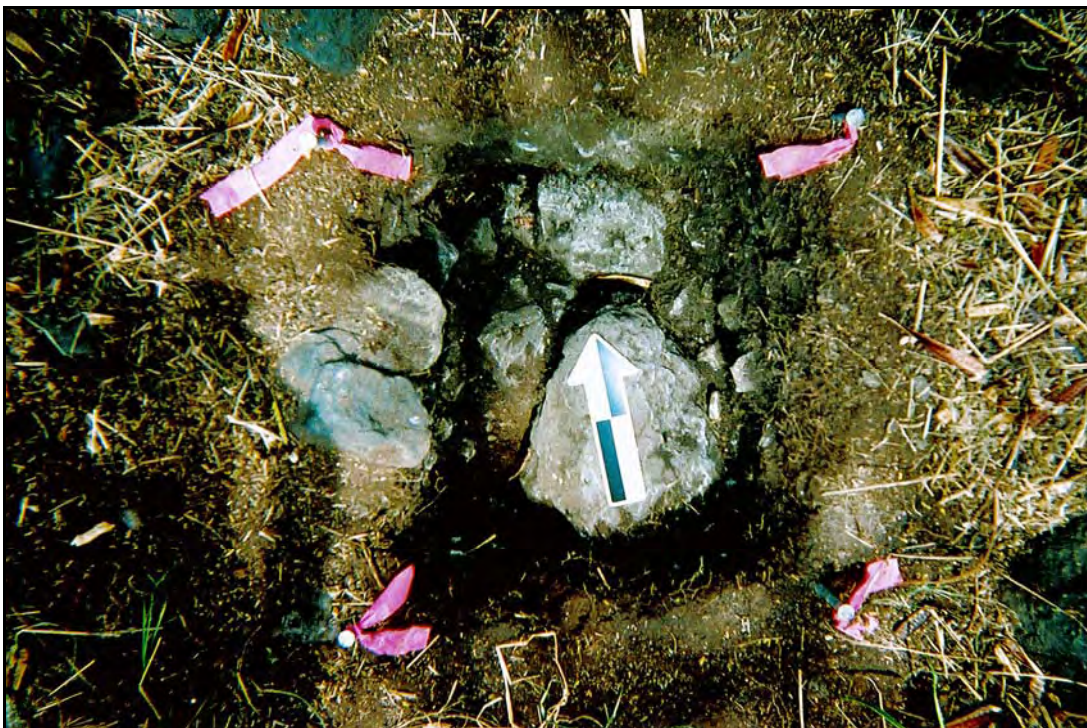
Figure 57. Pre-excavation (above) and post-excavation (below) photographs of SIHP # 50-80-03-6885 Feature D Test Unit 1

<u>Strata</u>	<u>Depth (cmbs)</u>	<u>Description</u>
Stratum I	0-10	10YR 3/2 very dark grayish brown silt loam; weak, medium crumb structure; dry, loose consistency; slightly plastic; no cementation; terrestrial origin; includes plentiful roots and rootlets, few angular basalt pebbles; no cultural material observed; Lower Boundary (LB) is clear, smooth.
Stratum II	10-BOE	10YR 3/3 dark brown silt loam; weak, fine granular structure; dry, loose consistency; slightly plastic; no cementation; terrestrial origin; includes a small pocket of charcoal, abundant roots and rootlets, and plentiful angular basalt pebbles and cobbles; LB is below base of excavation.

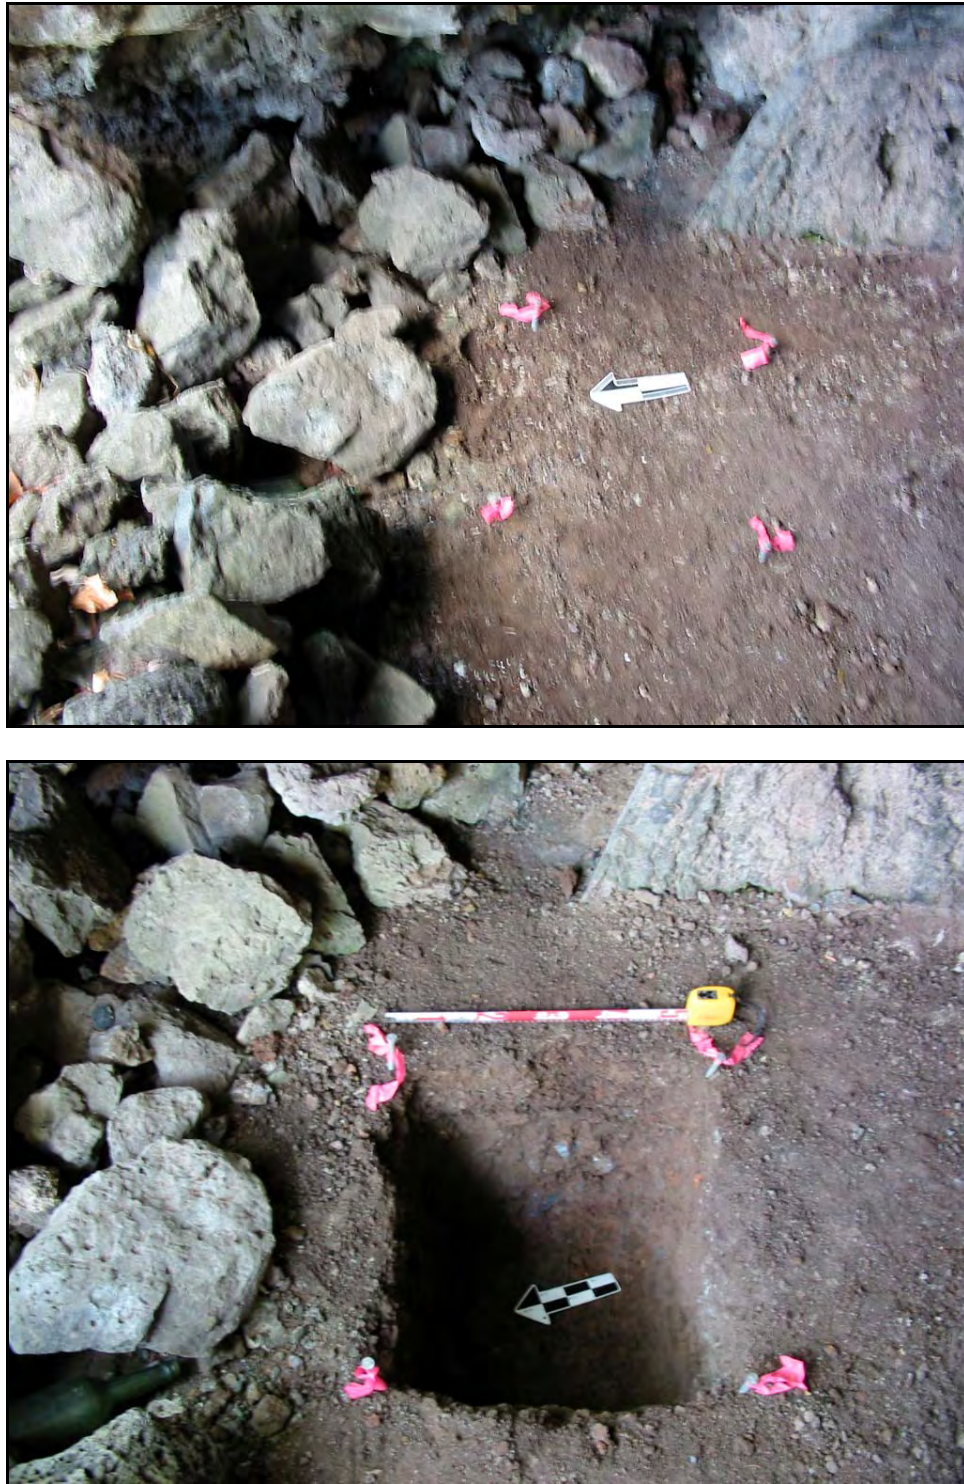
Figure 59. Pre-excavation (above) and post-excavation (below) photographs of SIHP # 50-80-03-6887 Test Unit 1

The surface of the test excavation consisted of level soil, clear of surface stones, with historic and modern garbage, including a foam sleeping mat (Figure 59). Two sediment strata were observed through the excavation of Test Unit 1 (Figure 60). Stratum I consisted of a slightly hard, dark brown clay loam sediment, representing continued sediment buildup within the overhang. Stratum II consisted of a very hard, dark brown clay sediment. Stratum II included plentiful decomposing basalt pebbles and cobbles incorporated into the sediment matrix. Stratum II represents sterile sediment accumulation behind the constructed terrace wall. The test excavation was terminated at bedrock, at a depth of 46 cmbs. No cultural material was observed through the excavation of Test Unit 1.

<u>Strata</u>	<u>Depth (cmbs)</u>	<u>Description</u>
Stratum I	0-15	7.5YR 3/2 dark brown clay loam; moderate, medium crumb structure; dry, slightly hard consistency; slightly plastic; no cementation; terrestrial origin; no cultural material observed; Lower Boundary (LB) is abrupt, smooth.
Stratum II	15-BOE	7.5YR 3/2 dark brown clay; structureless; dry, very hard consistency; plastic; no cementation; terrestrial origin; no cultural material observed; Lower Boundary (LB) is at bedrock.

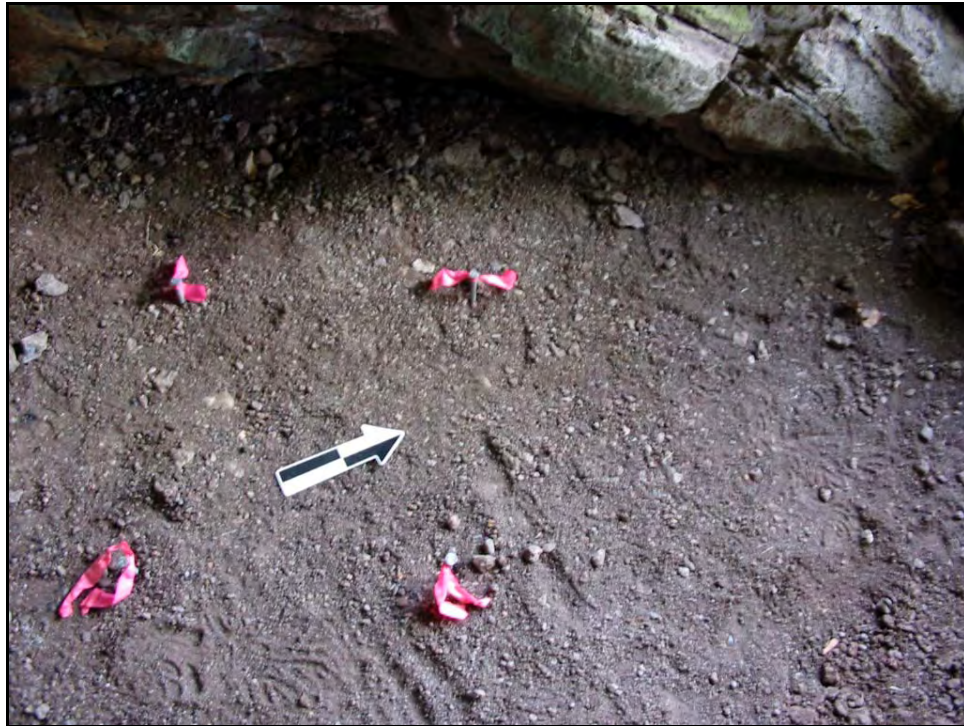
Figure 61. Pre-excavation (above) and post-excavation (below) photographs of SIHP # 50-80-03-6887 Test Unit 2

The surface of the test excavation consisted of level soil, clear of surface stones, with historic and modern garbage, including a foam sleeping map (Figure 61). Two sediment strata were observed through the excavation of Test Unit 2 (Figure 62). Stratum I consisted of a slightly hard, dark brown clay loam sediment, representing continued sediment buildup within the overhang. Stratum II consisted of a very hard, dark brown clay sediment. Stratum II included plentiful decomposing basalt pebbles and cobbles incorporated into the sediment matrix. Stratum II represents sterile sediment accumulation behind the constructed terrace wall. A portion of a hearth, or fire pit, was encountered in the northeastern portion of the test excavation. The Feature A hearth was observed to have been excavated into the Stratum II sediment and was capped by the undisturbed Stratum I sediment, indicating a period of sediment buildup within the overhang shelter following the disuse of the hearth. The Feature A hearth contained abundant charcoal, including large chunks, burnt fish bones, and fire-cracked basalt cobbles. 81.1 g of charcoal and 0.4 g of marine vertebrate midden were recovered from Test Unit 2. A 40.1 g charcoal sample was submitted for radiocarbon dating analysis. The test excavation was terminated at a depth of 30 cmbs, within clearly sterile Stratum II sediments.

<u>Strata</u>	<u>Depth (cmbs)</u>	<u>Description</u>
Stratum I	0-10	7.5YR 3/2 dark brown clay loam; moderate, medium crumb structure; dry, slightly hard consistency; slightly plastic; no cementation; terrestrial origin; includes few basalt pebbles and small cobbles; no cultural material observed; Lower Boundary (LB) is abrupt, smooth.
Stratum II	15-BOE	7.5YR 3/2 dark brown clay; structureless; dry, very hard consistency; plastic; no cementation; terrestrial origin; includes a hearth (Feature A) excavated into Str. II sediment, containing abundant charcoal, burnt rocks, burnt bone midden; LB is below base of excavation.

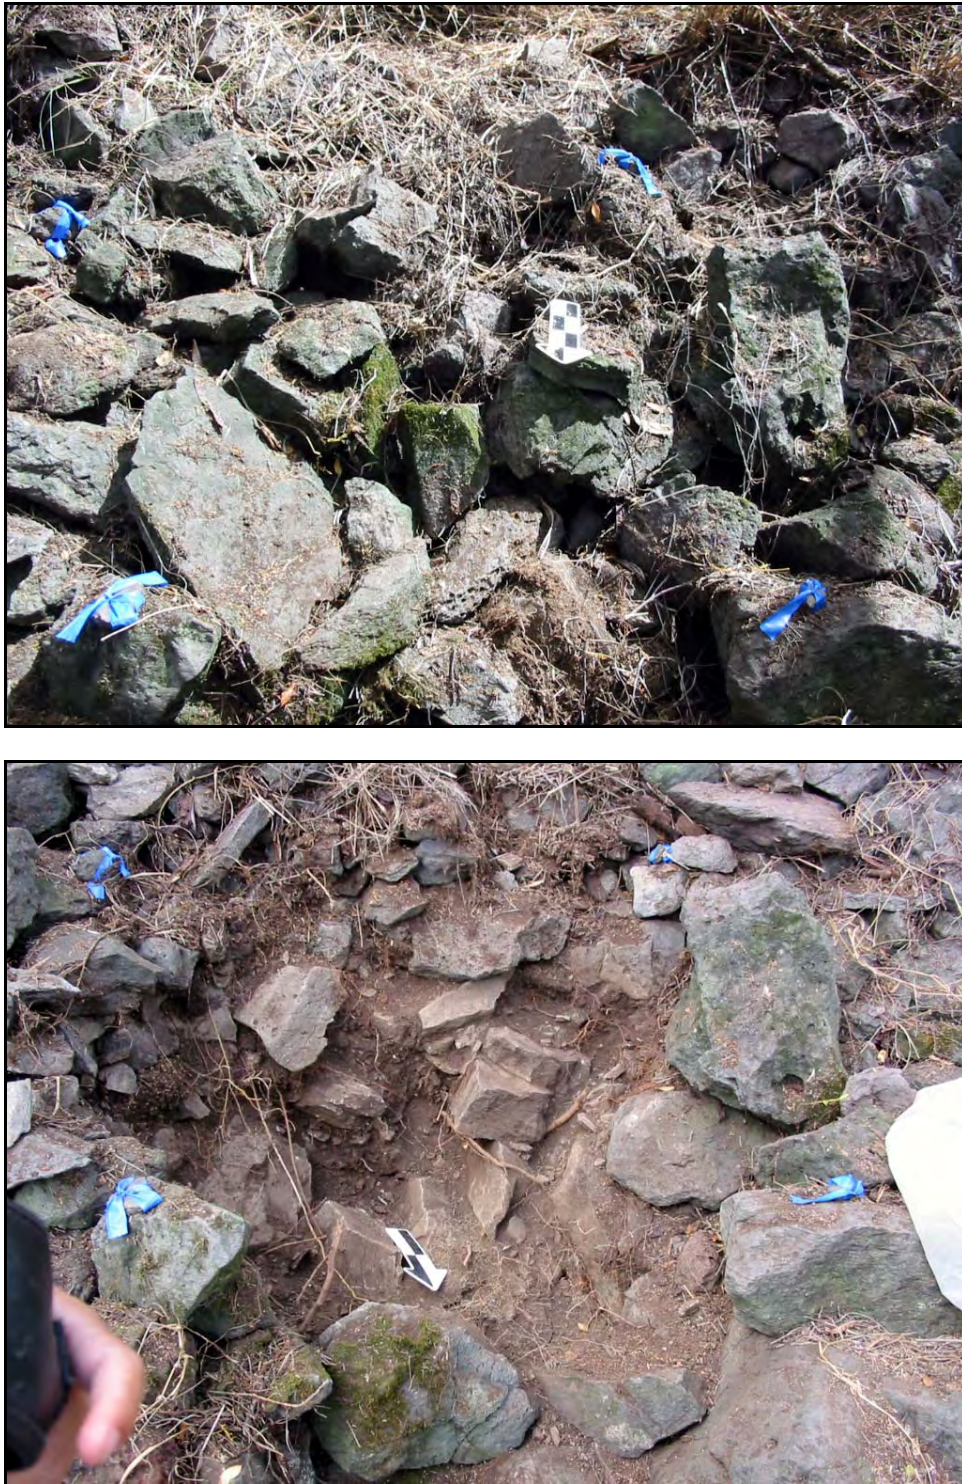
Figure 63. Pre-excavation (above) and post-excavation (below) photographs of SIHP # 50-80-03-6888 Feature F Test Unit 1

The sloping surface of the test excavation consisted of piled basalt boulders and cobbles, covered with a layer of leaf litter and humus (Figure 63). Deconstruction of the mound feature revealed the stones were loosely piled approximately 20-30 cm above the current soil surface, with a mixed soil and stone matrix extending to the base of excavation. This soil buildup in the lower portion of the rock matrix indicates the lower courses of the mound structure function in retaining soil. The stones comprising the mound structure were unsorted, with boulders, cobbles, and pebbles distributed throughout the construction. Several flat, plate-like stones were also incorporated into the mound construction. These stones were unlikely to have rolled down the hillside, and therefore provide further evidence the mounds are man-made constructions, rather than natural rockfall accumulations.

<u>Strata</u>	<u>Depth (cmbs)</u>	<u>Description</u>
Stratum I	0-5	7.5YR 4/3 brown silt loam; moderate, fine blocky structure; dry, weakly coherent consistency; non-plastic; no cementation; terrestrial origin; includes leaf litter and abundant roots and rootlets, no cultural material observed; Lower Boundary (LB) is clear, wavy.
Stratum II	5-BOE	7.5YR 4/4 brown silt loam; moderate, fine blocky structure; dry, hard consistency; non-plastic; no cementation; terrestrial origin; includes abundant roots and rootlets; Lower Boundary (LB) is below base of excavation.

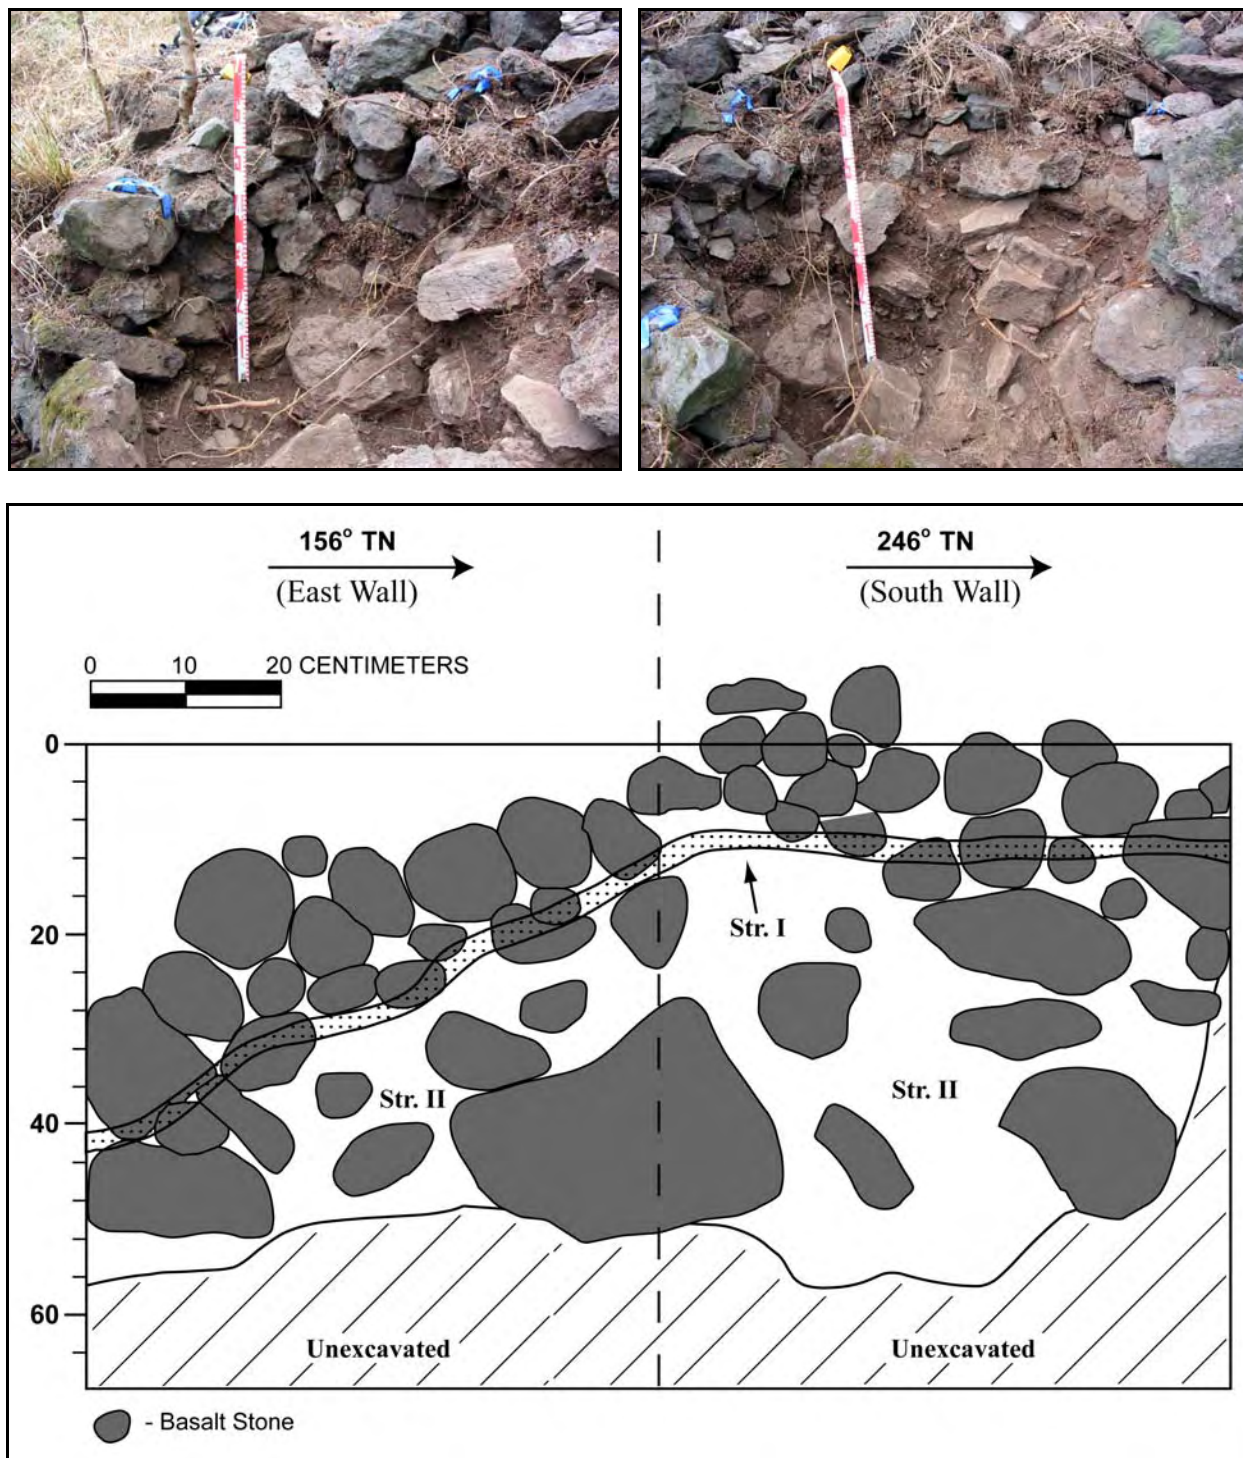
Figure 64. Photographs (above) and stratigraphic profile (below) of the east and south walls of SIHP # 50-80-03-6888 Test Unit 1

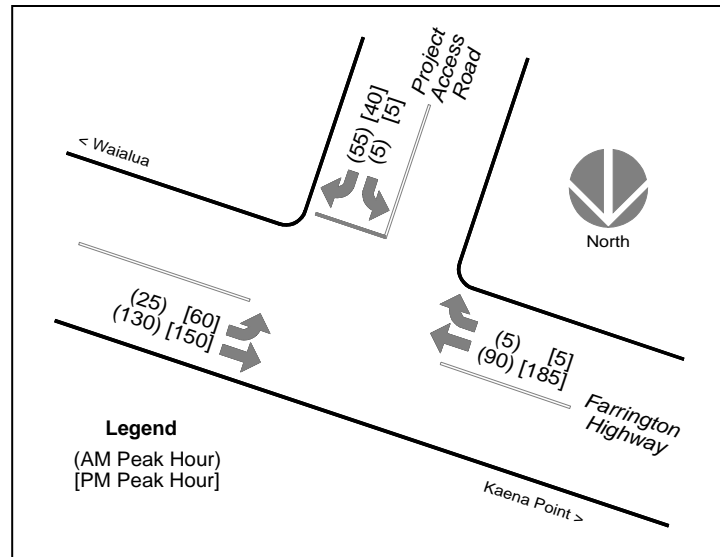
**Figure 2 – Traffic Assignments (2030)**

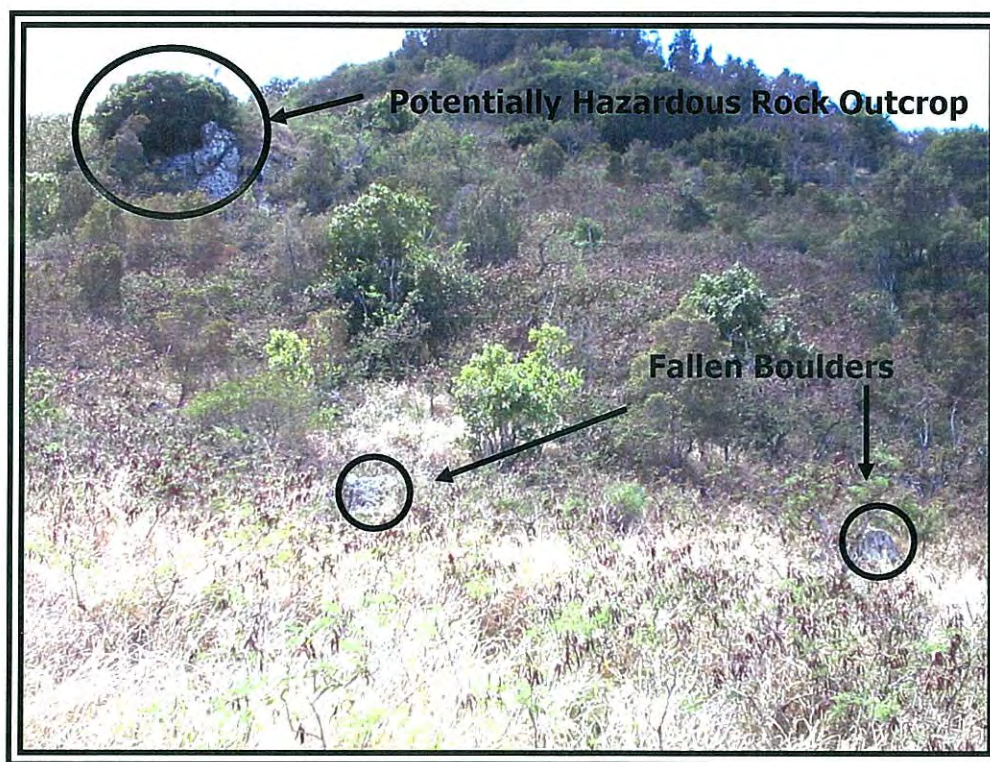
**Photograph No. 5:** Proposed vacant land upslope of Lot Nos. 64 and 65, and westerly of Lot No. 63. Large potentially hazardous rock outcrop located well above the development boundary. (1459)

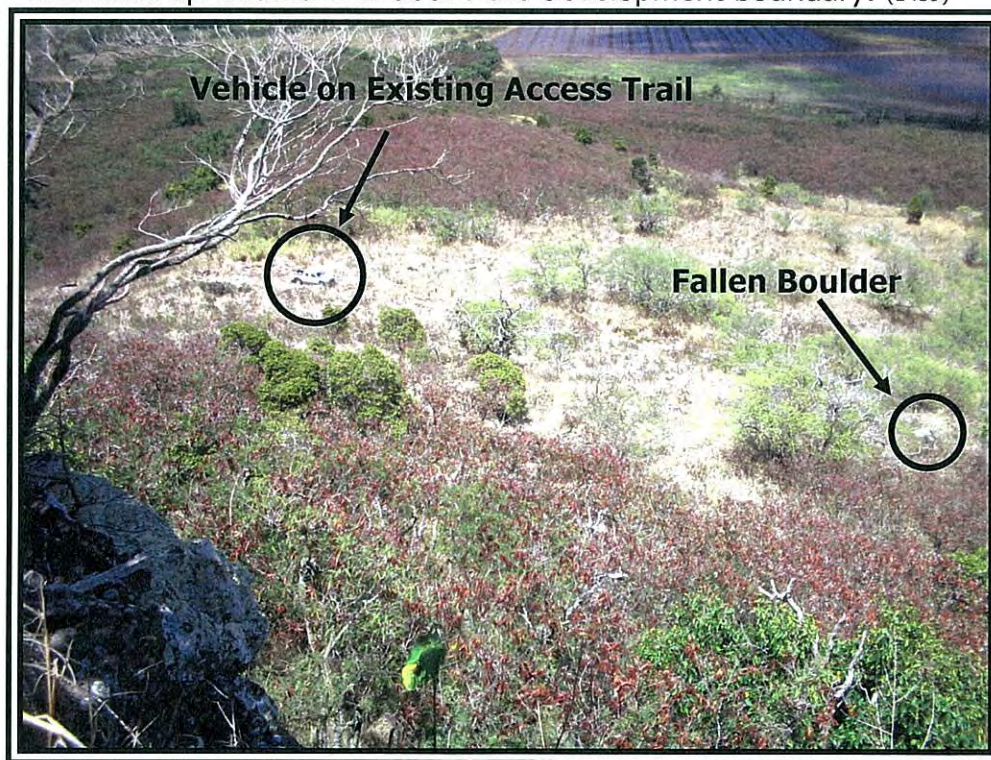
**Photograph No. 6:** View down slope of Lot No. 63 from existing rock ledge outcropping above the development boundary. Note vehicle located on existing access trail at about the lot midpoint elevation. Also note fallen boulder at right edge of photo. (1474)

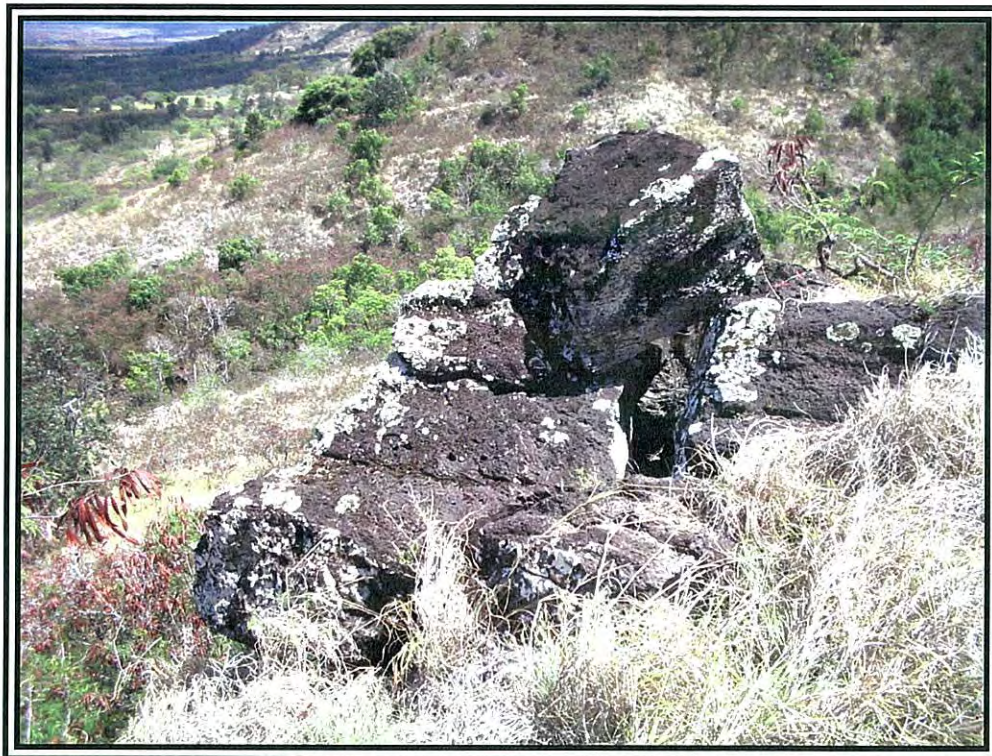
**Photograph No. 7:** Existing boulder cluster above about Lot No. 63. (1480)

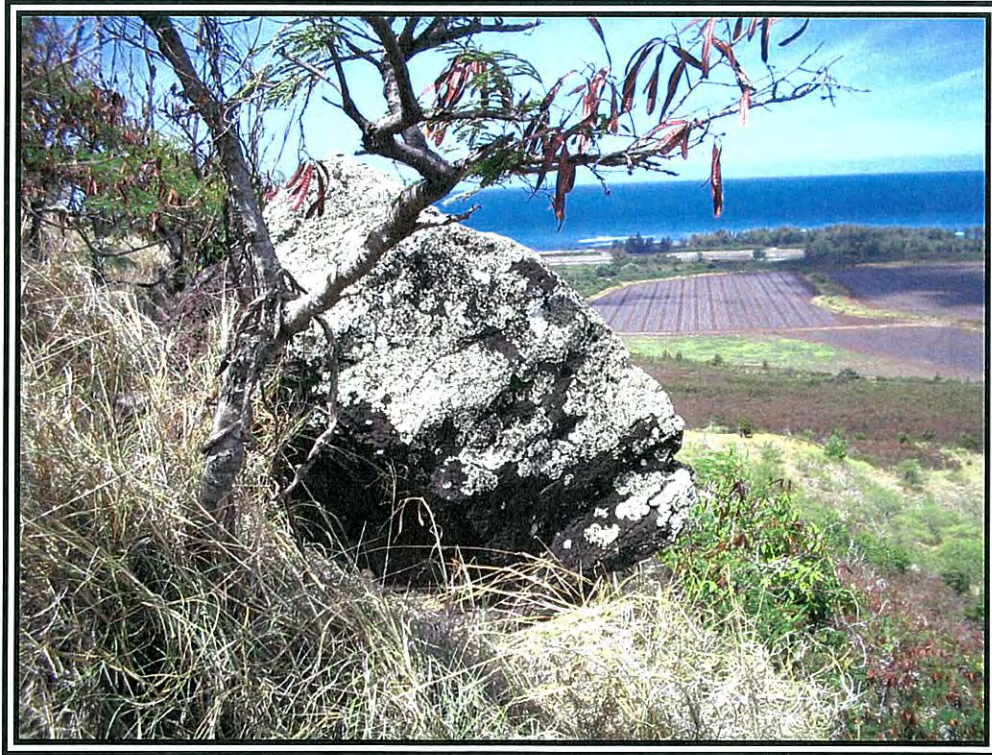
**Photograph No. 8:** Existing surface boulder above about Lot No. 63. (1481)

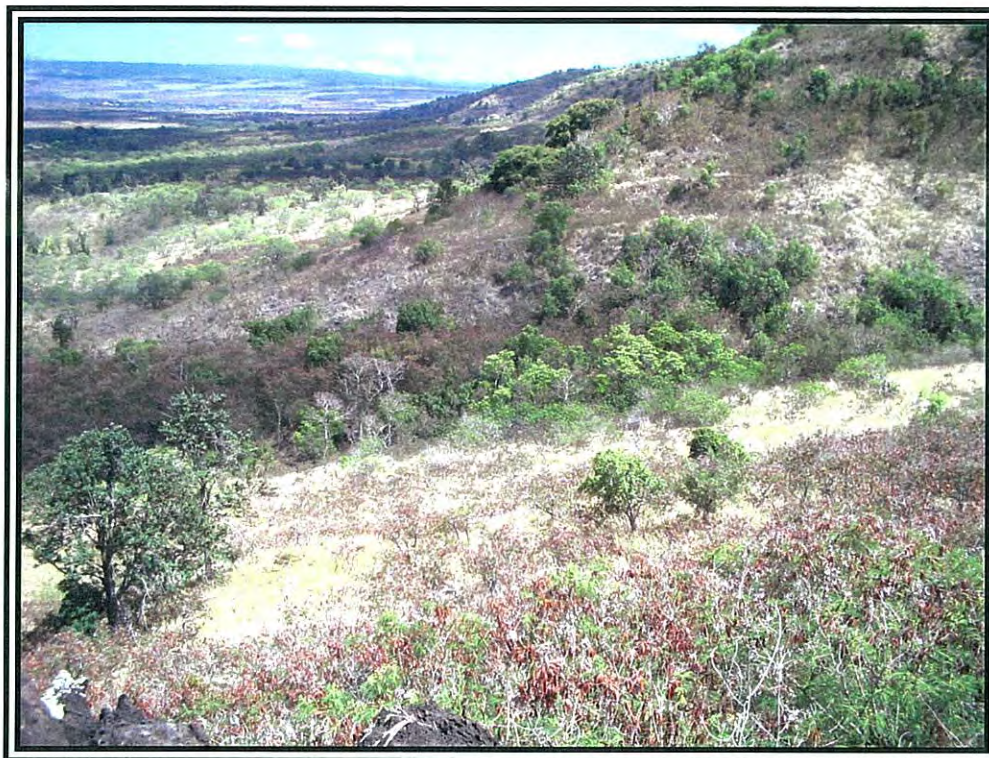
**Photograph No. 9:** Typical conditions with view down slope toward ravine and Lot No. 62 from existing rock outcroppings above about Lot No. 63. (1483)

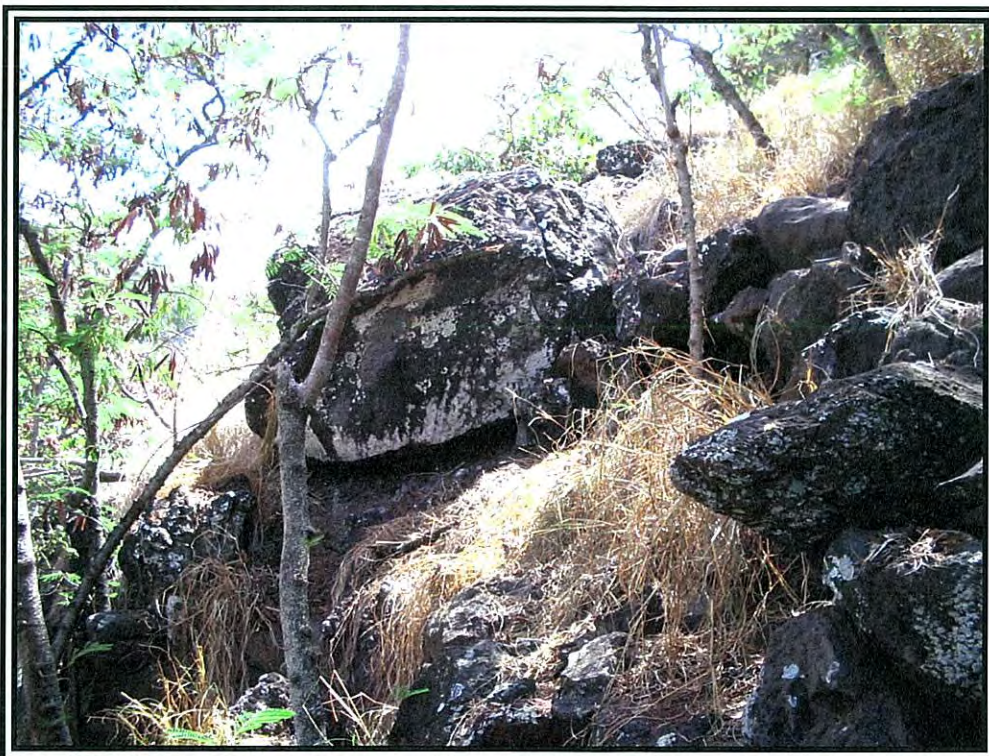
**Photograph No. 10:** Existing boulders on slope above about Lot No. 61. (1485)

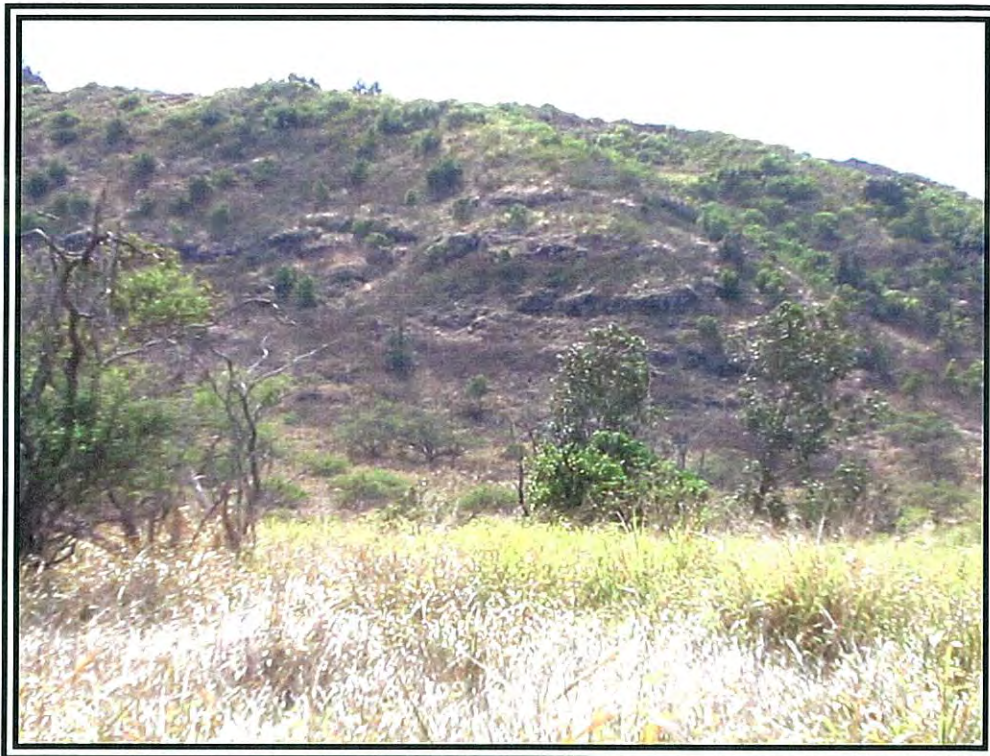
**Photograph No. 11:** View from Lot No. 58 of rock outcroppings on hillside above about Lot Nos. 58 and 59. (1490)

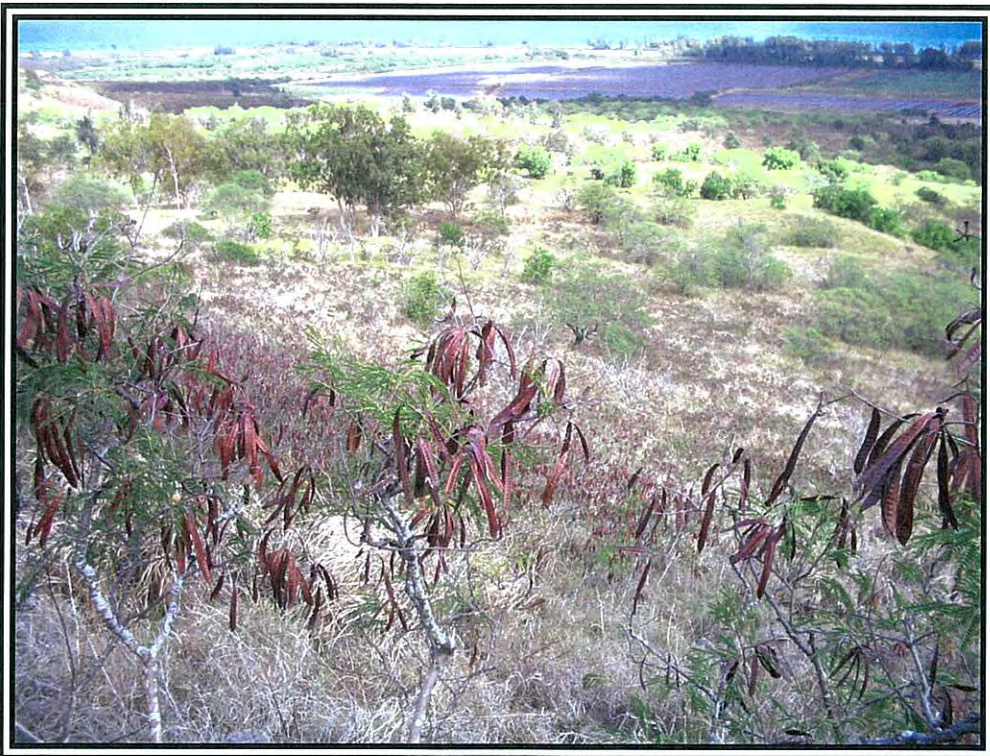
**Photograph No. 12:** View down slope toward about Lot Nos. 49 and 50 showing typical conditions with generally few rockfall hazards. (1511)

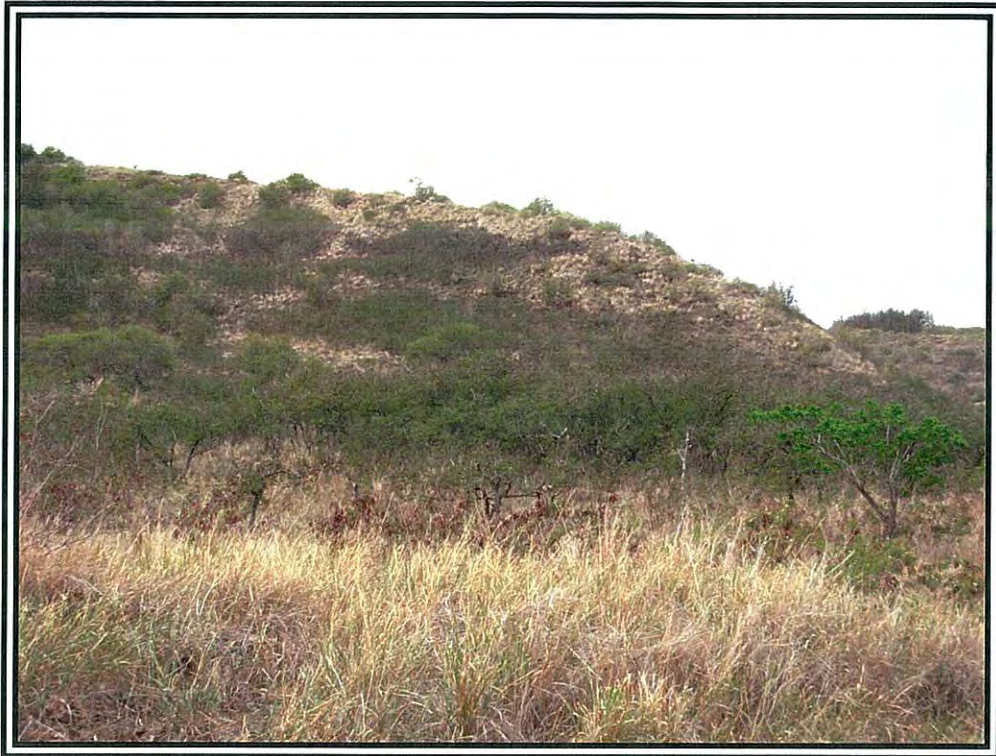
**Photograph No. 13:** View upslope from Lot No. 47 showing the east facing hillside containing widely scattered boulders and rock outcroppings above the western side of Lot No. 47. (0606)

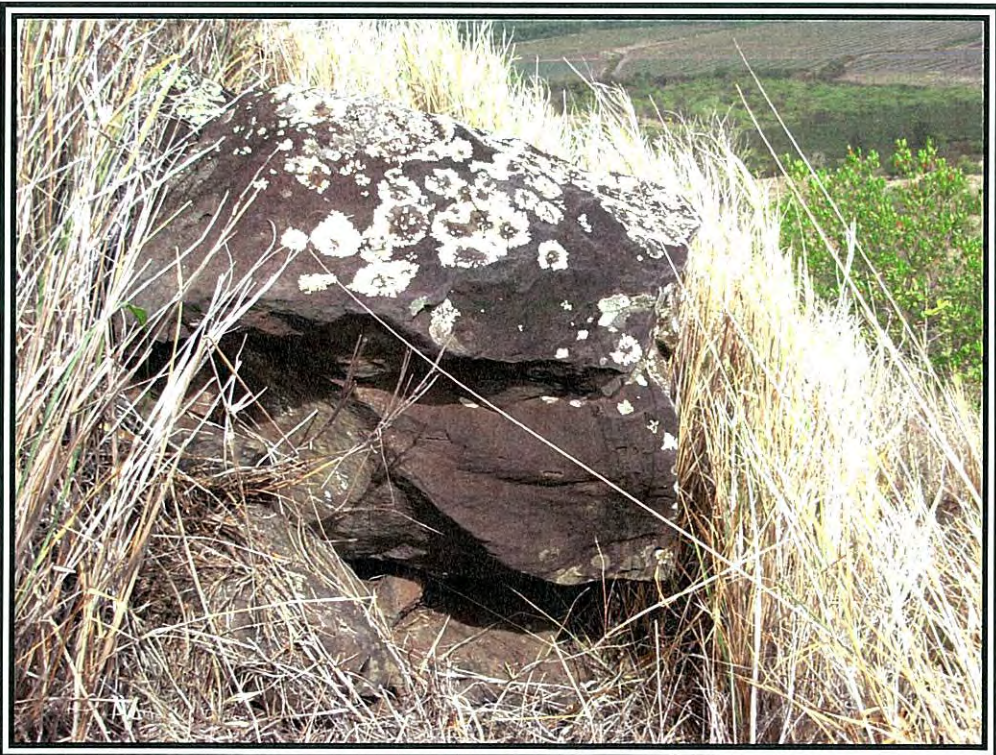
**Photograph No. 14:** Typical condition of existing widely scattered boulders on steep hillside above Subdivision Road "D". (0603)

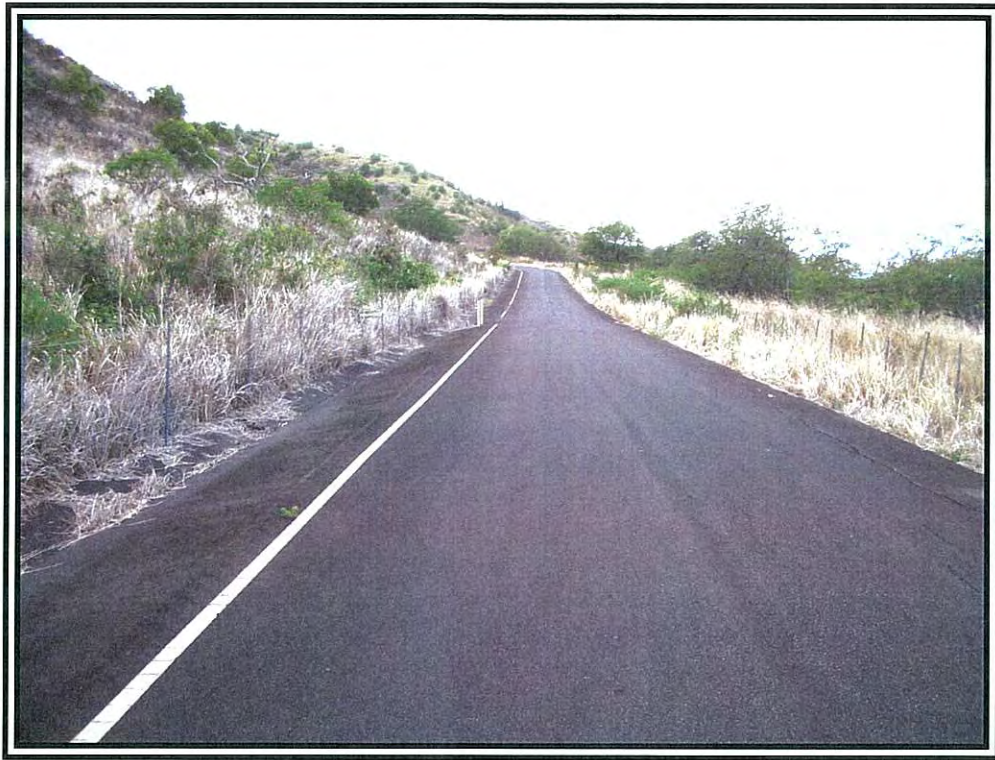
**Photograph No. 15:** Existing Peacock Flats access road traversing above Lot Nos. 30 thru 35. (1533)
