FINAL ENVIRONMENTAL ASSESSMENT

SHORELINE SETBACK VARIANCE

TMK: 6-8-10: 021
68-689 Farrington Highway
Mokuleia, Oahu, Hawaii

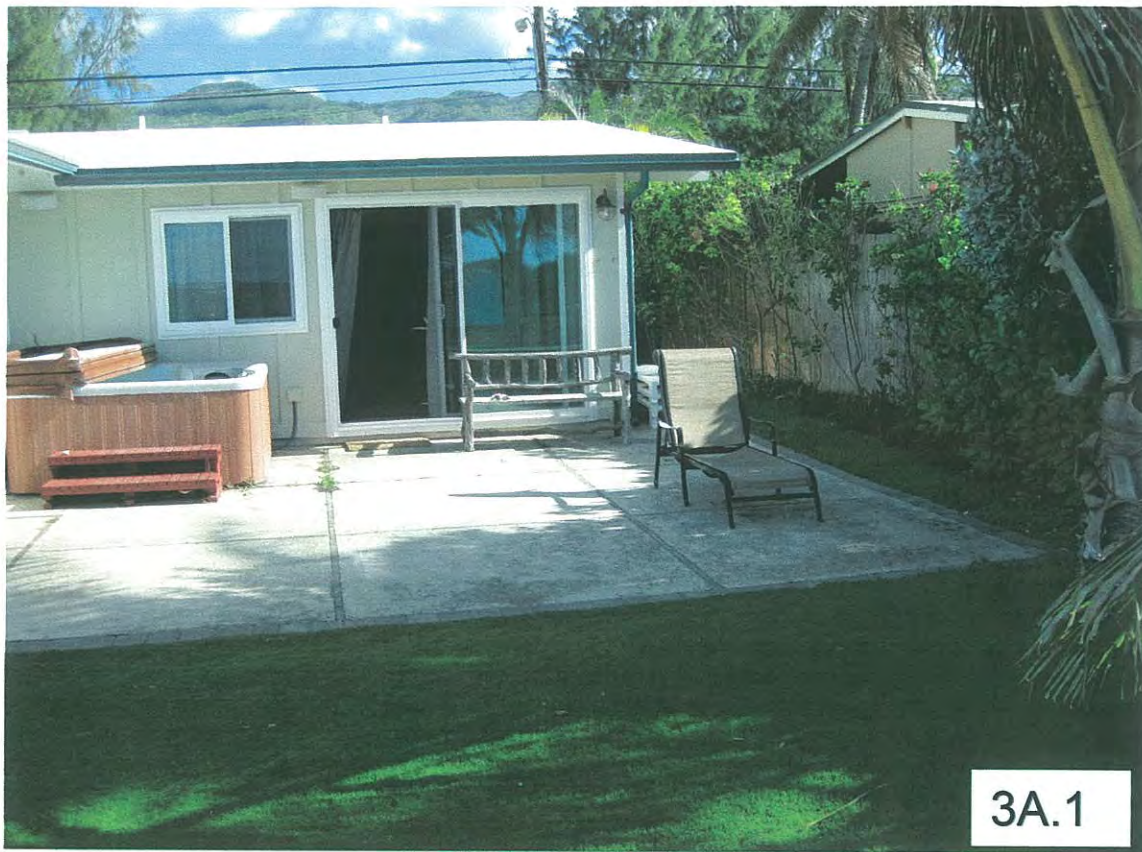
3A.1

(Photo 9
shown on
2008 site
survey)

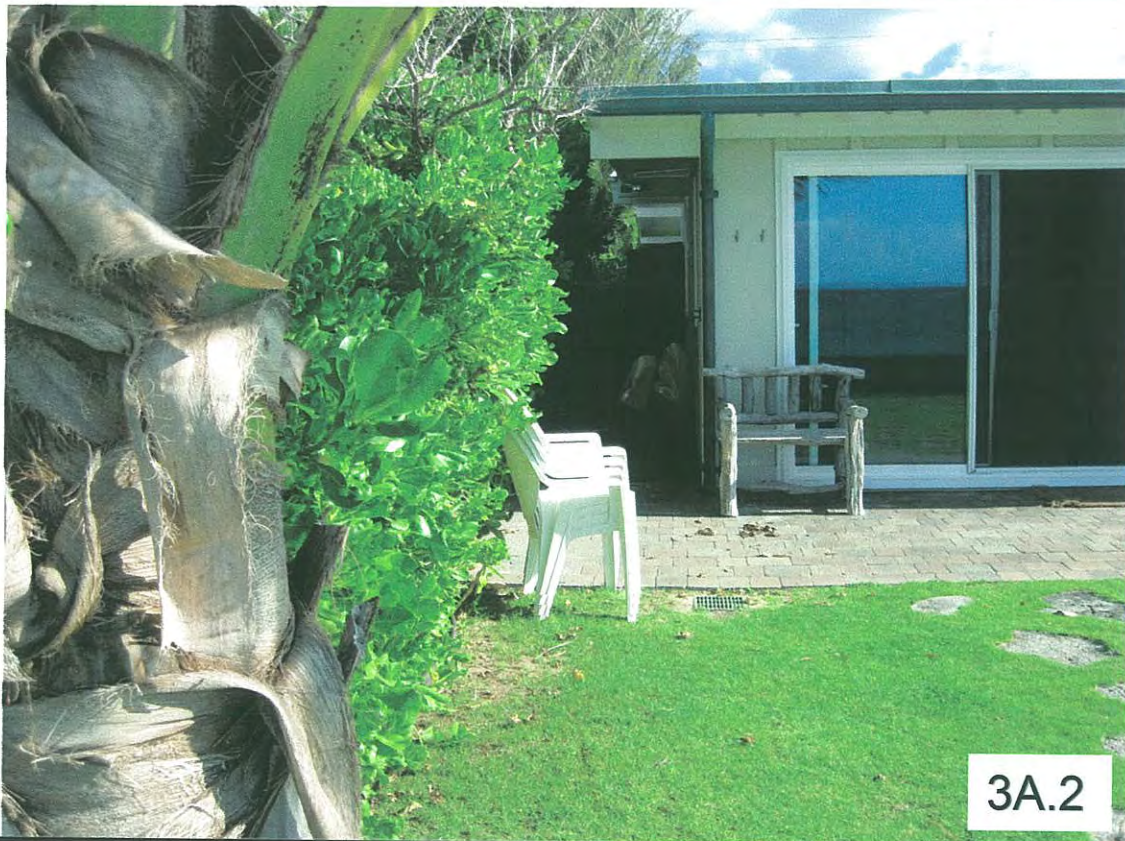
3A.2

(Photo 10
shown on
2008 site
survey)

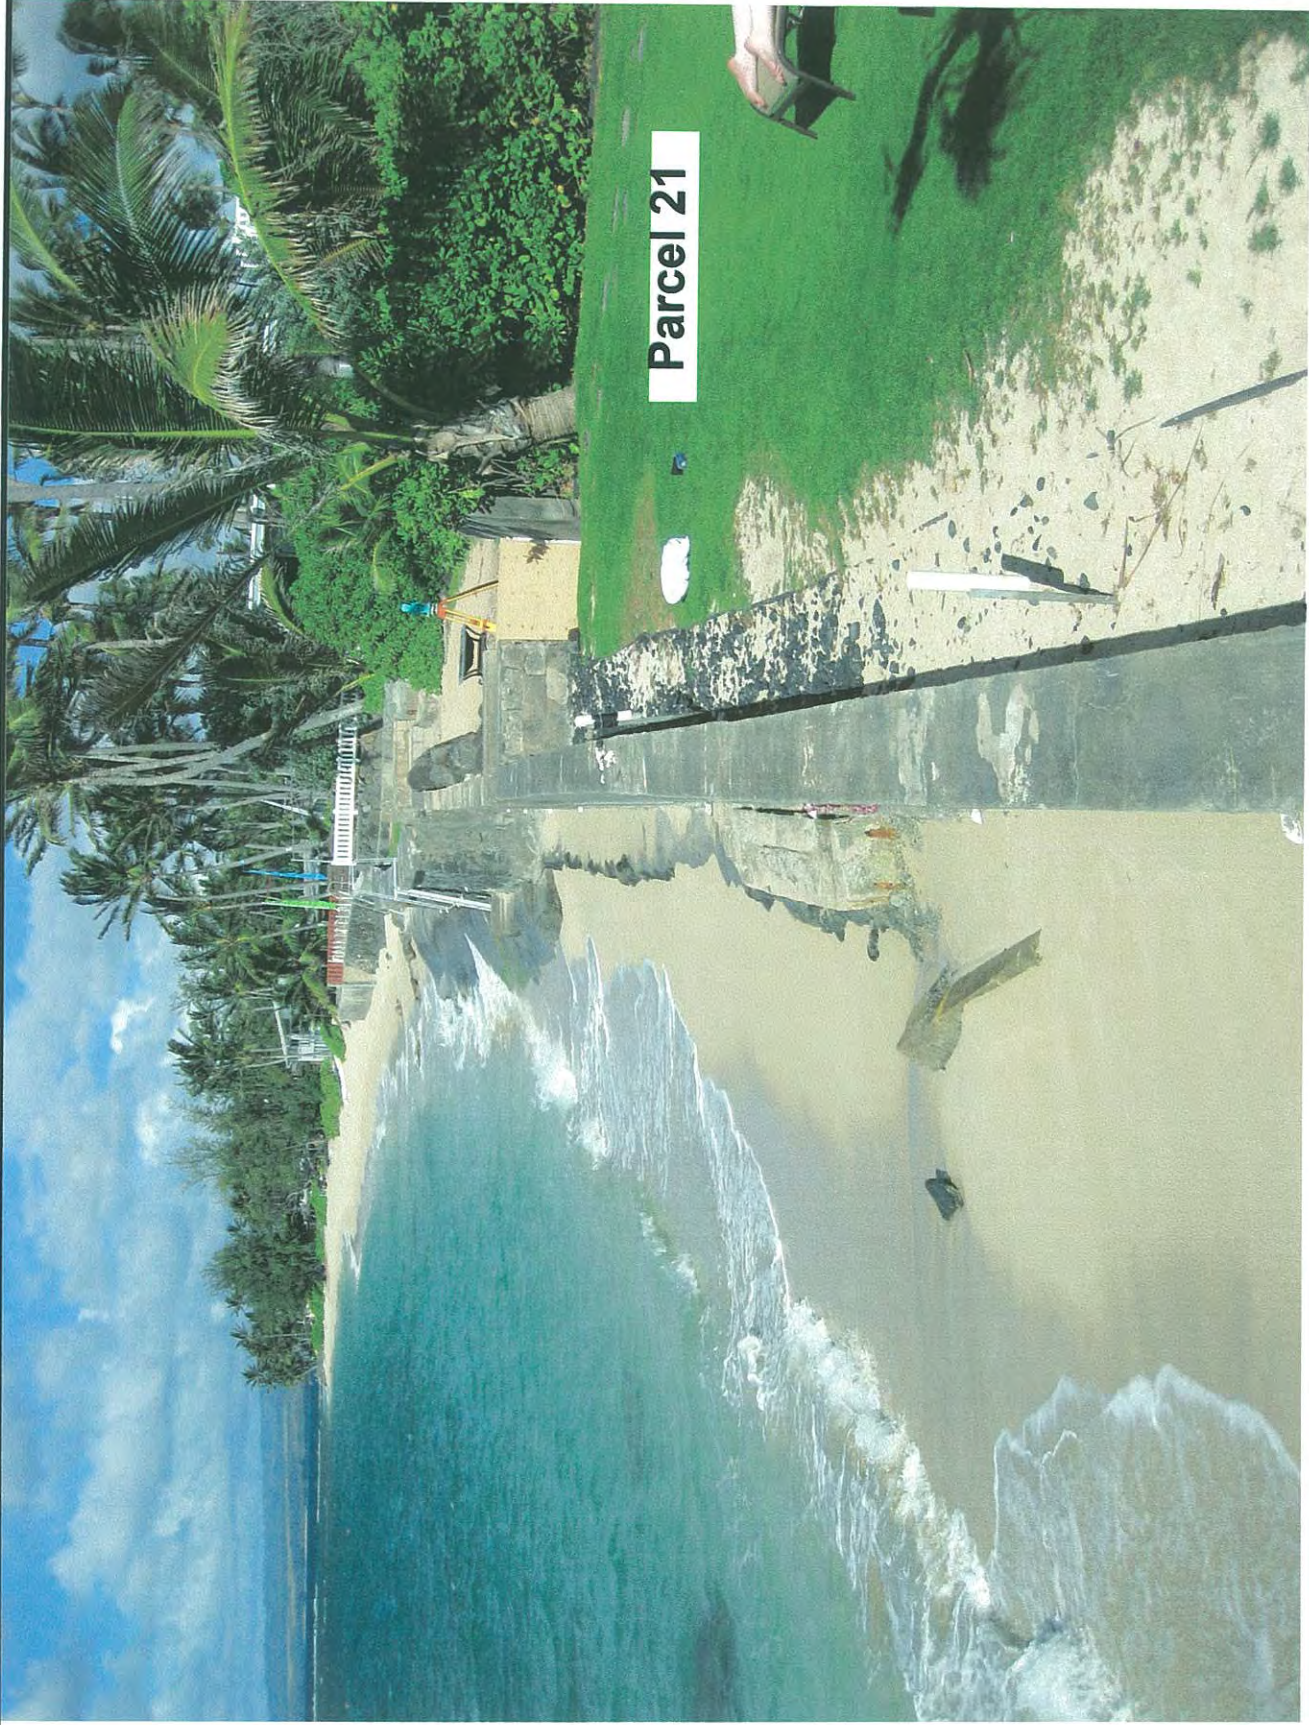
Figure 3A.3

(Photo 5 shown on 2008 site survey)

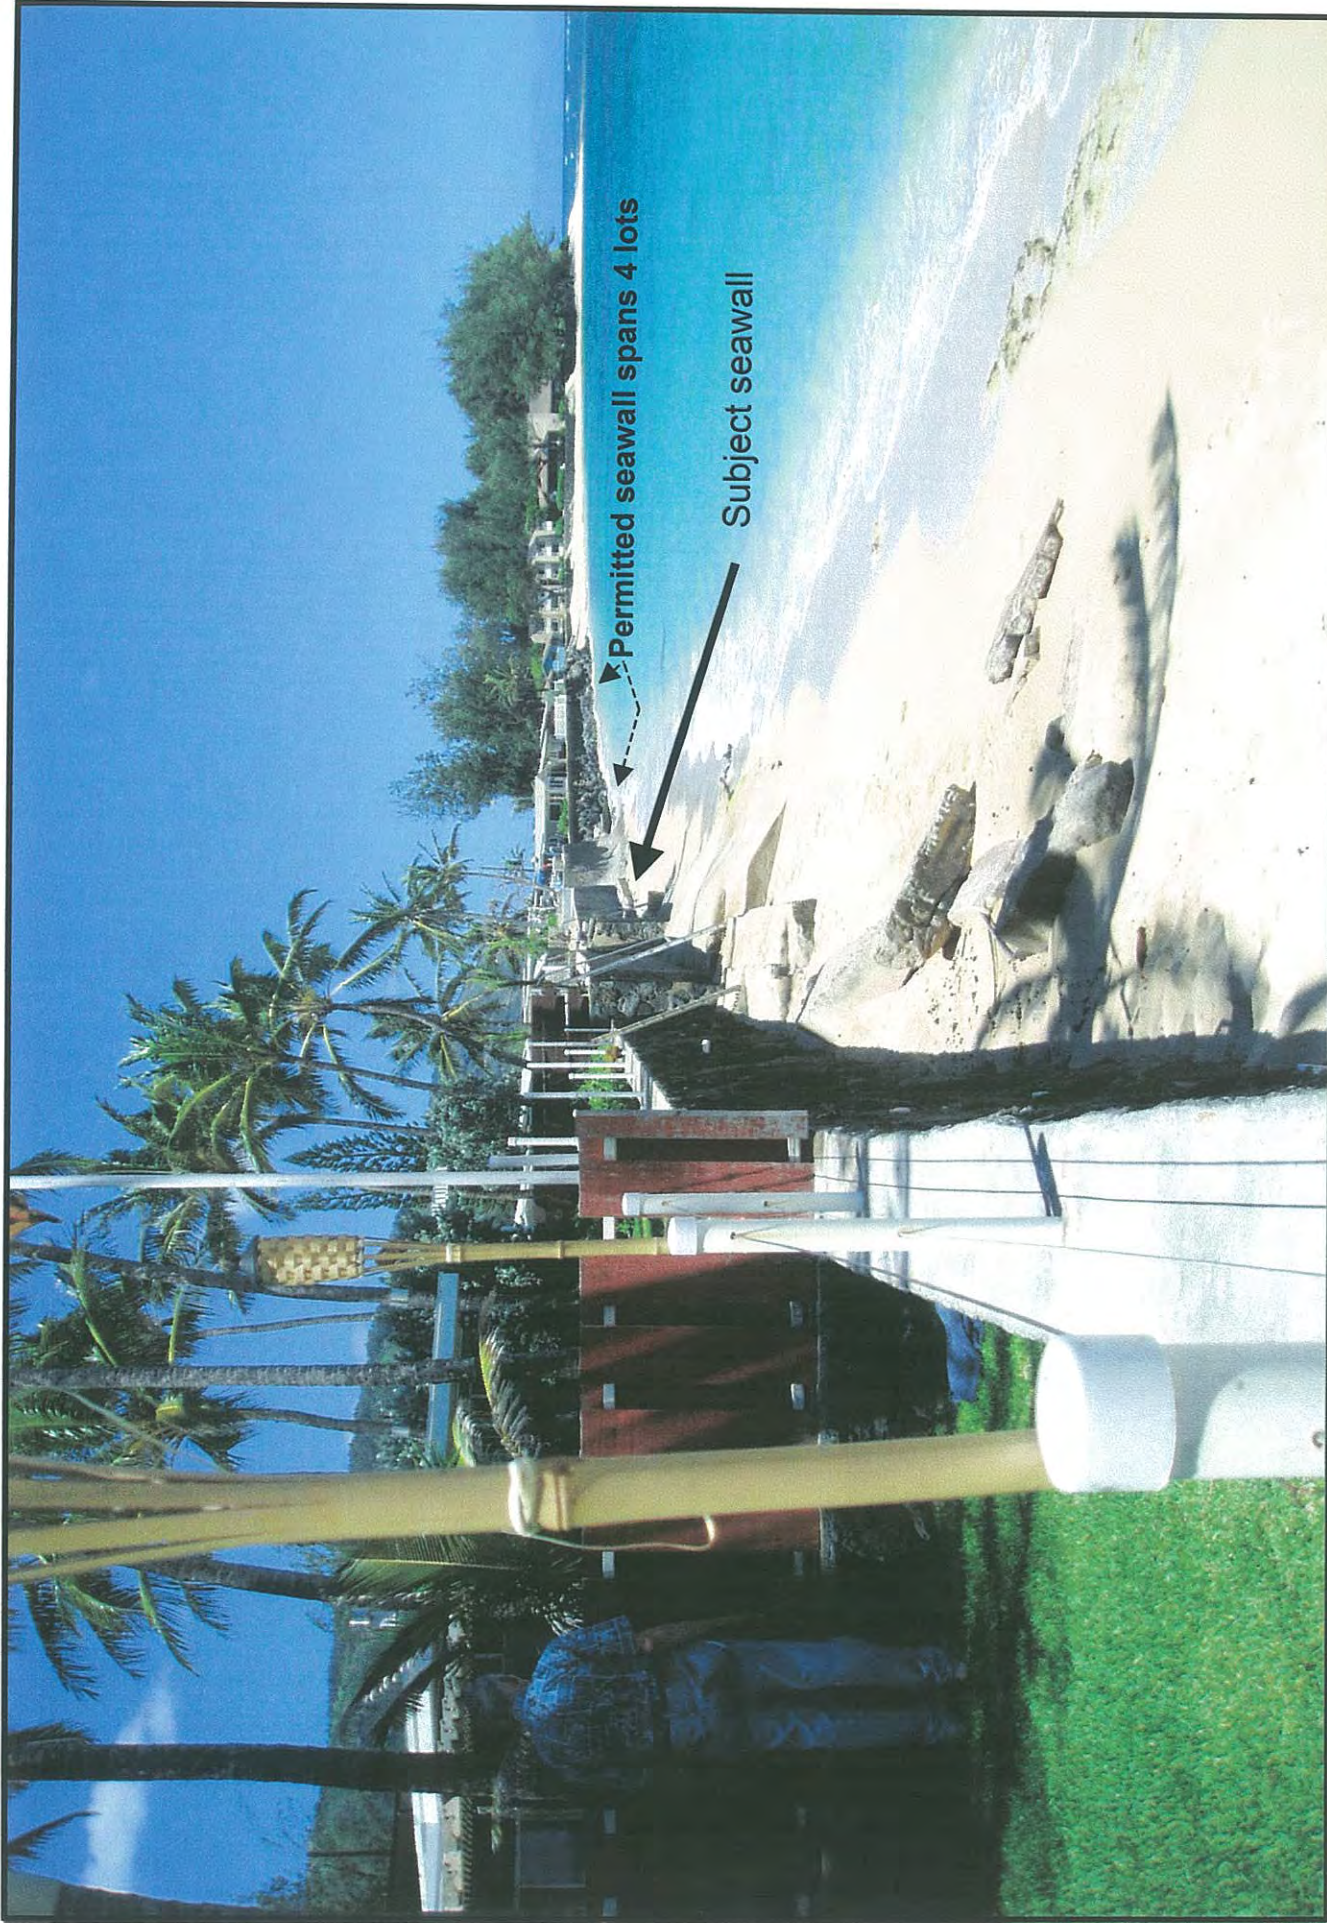
Figure 11

EXISTING CONTINUOUS SEAWALLS ALONG EMBAYMENT

Note: It appears that, over time, seawalls in the area have been replaced and/or repaired and strengthened and the original foundations left to support the walls. The walls that were repaired and strengthened remained on the original foundations. For those walls which were reconstructed, it appears that the walls were placed slightly landward of the original foundation making the base of the wall look as if it has been extended makai, when in fact the foundations have remained in place and the re-constructed seawalls re-built landward. In these cases, the original foundations remain. This is the case with the subject property.

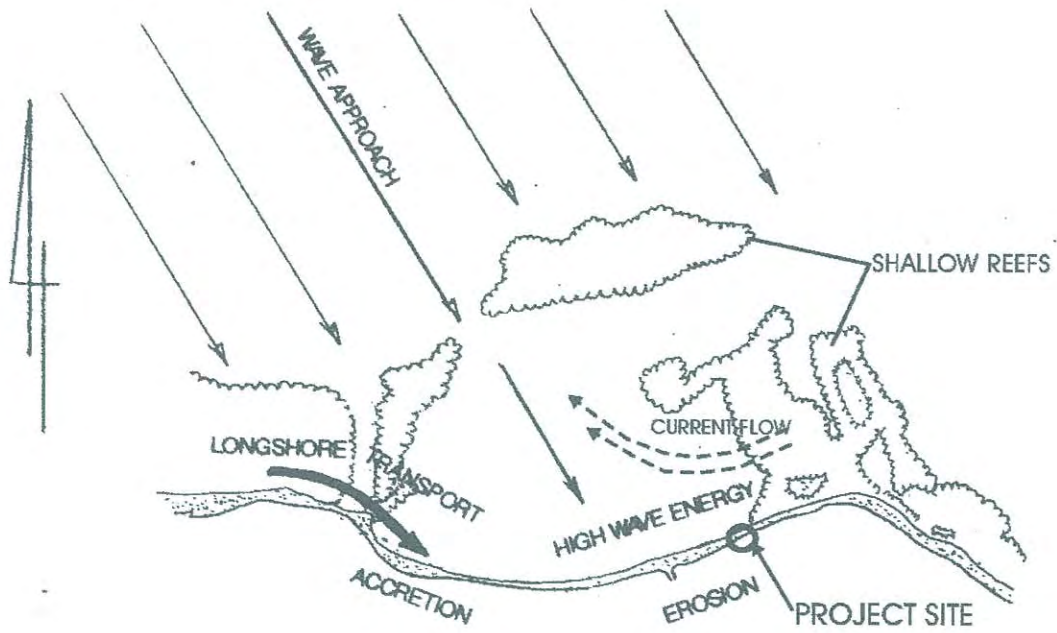
WINTER NORTHWEST SWELL CONDITIONS

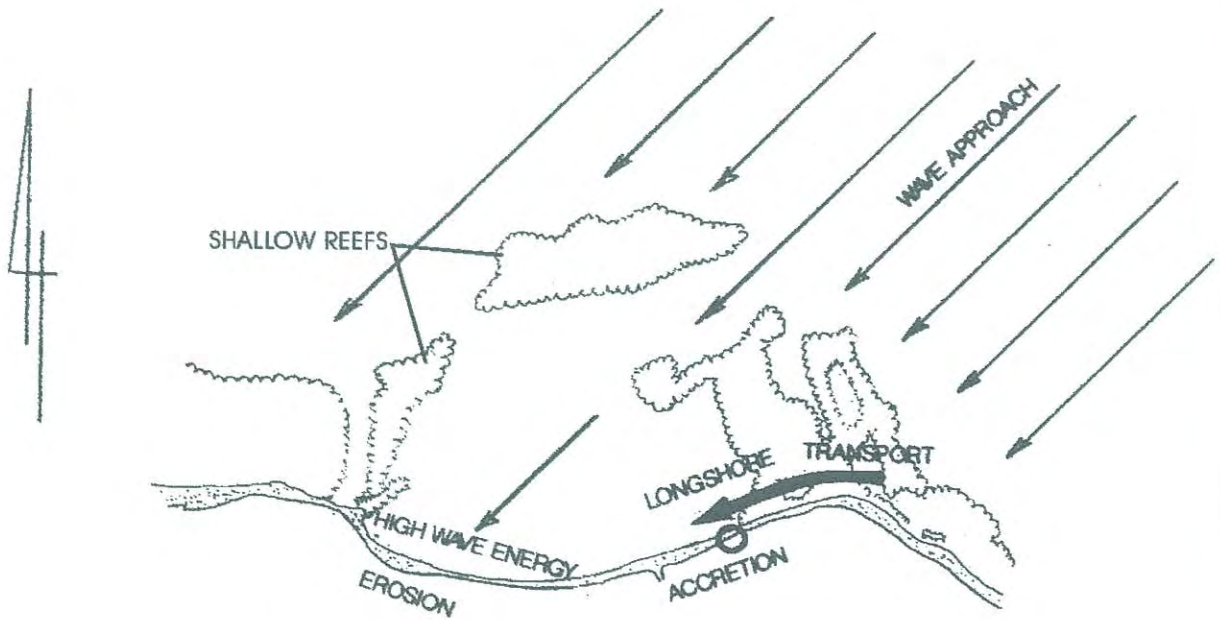
SUMMER NORTHEAST TRADEWIND CONDITIONS

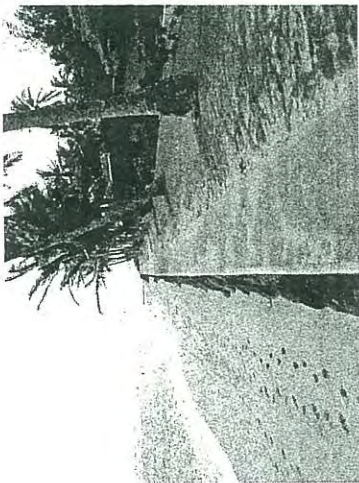
View eastward along the top of the seawall fronting the Mokuleia Beach Colony. Note the narrow beach.

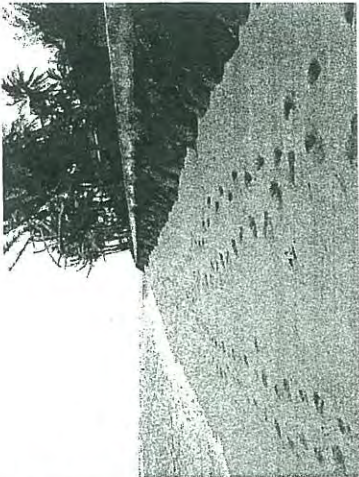
View eastward along the beach fronting the Mokuleia Beach Colony seawall. Note the narrow and steep beach profile.

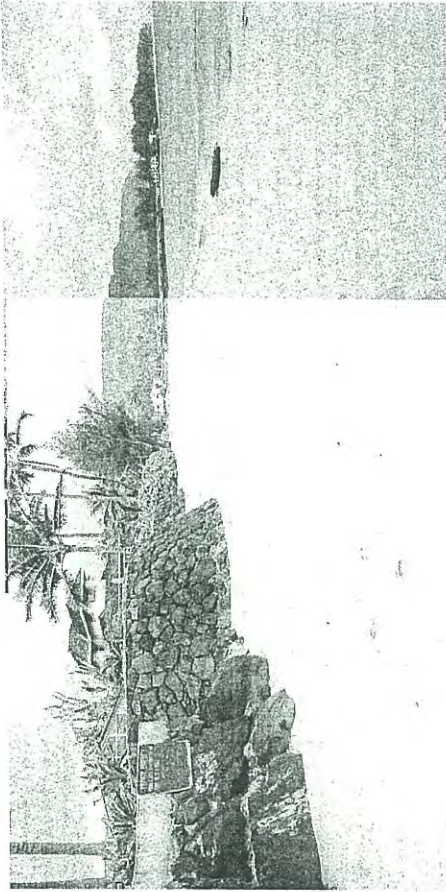
Views westward from west end of Mokuleia Beach Colony seawall. Parcel 10 is in the foreground. Parcel 11 is next to Parcel 10. (Sign is on the west end of the Mokuleia Beach Colony seawall. The sign permits the public to walk on the top of the seawall.)

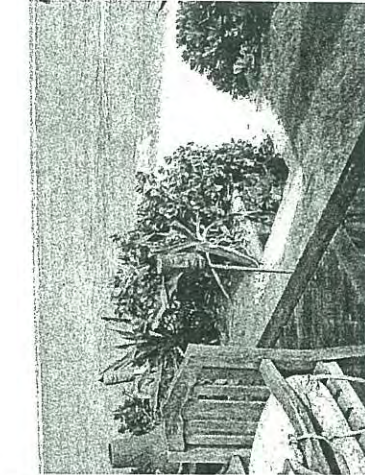
View offshore from porch on Parcel 11. Steps in seawall lead down to the beach.

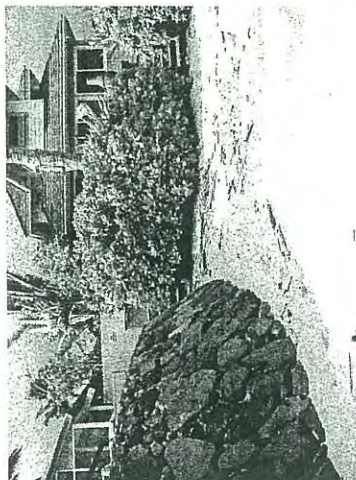
View of Parcel 11 seaward frontage. Seawall is hidden by Naupaka vegetation. Curved seawall on left fronts Parcel 10.

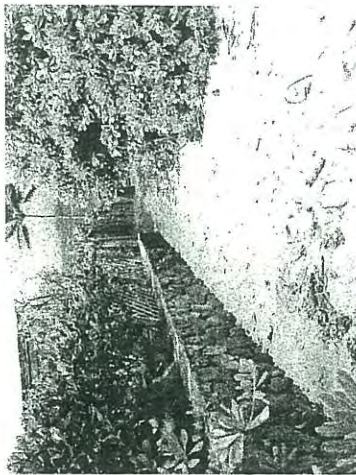
View mauka along private right-of-way. The CRM wall on left is Parcel 11's return wall.

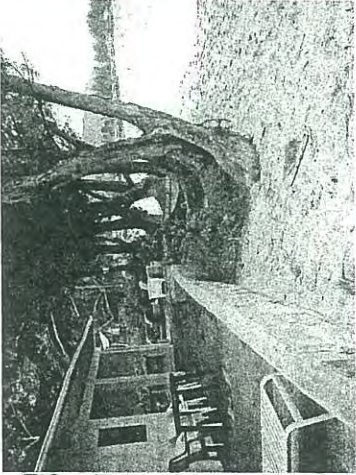
CMU wall fronts Parcel 13.

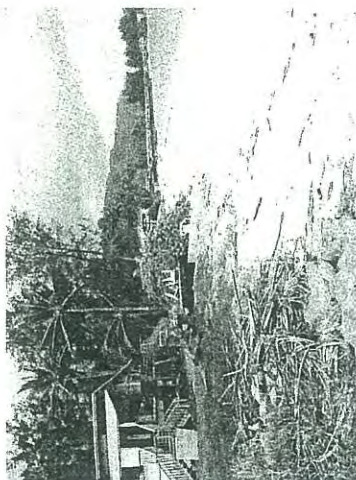
Shoreline fronting Parcel 20 on east side of stream. Note debris line at edge of vegetation.

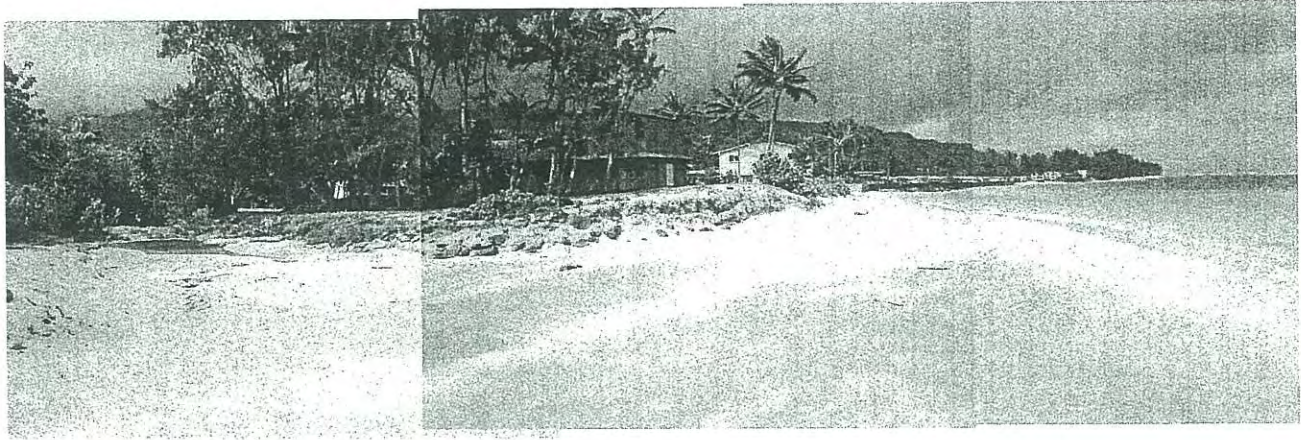
View westward from stream mouth. Note eroded condition of embankment on west side of the stream.
Continuous line of seawalls protect entire central shore frontage within the embayment.
