SUBJECT: Finding of No Significant Impact (FONSI) and
Final Environmental Assessment (FEA) for
Aliomanu Road Repair
TMK: 4-8-18: 028, 029, Anahola, Kauai

Final Environmental Assessment For 'Aliomanu Road Repair

Department of Public Works
County of Kaua'i

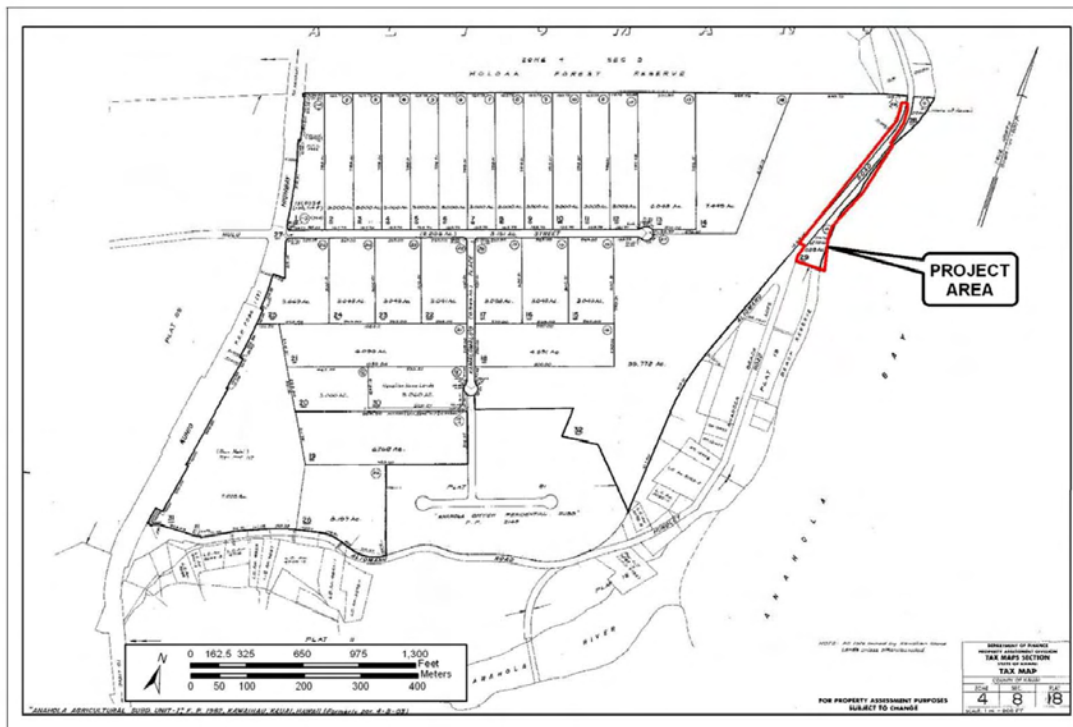
Figure 1-1. TMK of Project Site

The tax map key numbers for this project are 4-8-18: 028, 029 (see Figure 1-1). The State of Hawai'i is the owner of these parcels, but the road repair section is under the jurisdiction of the County of Kaua'i.

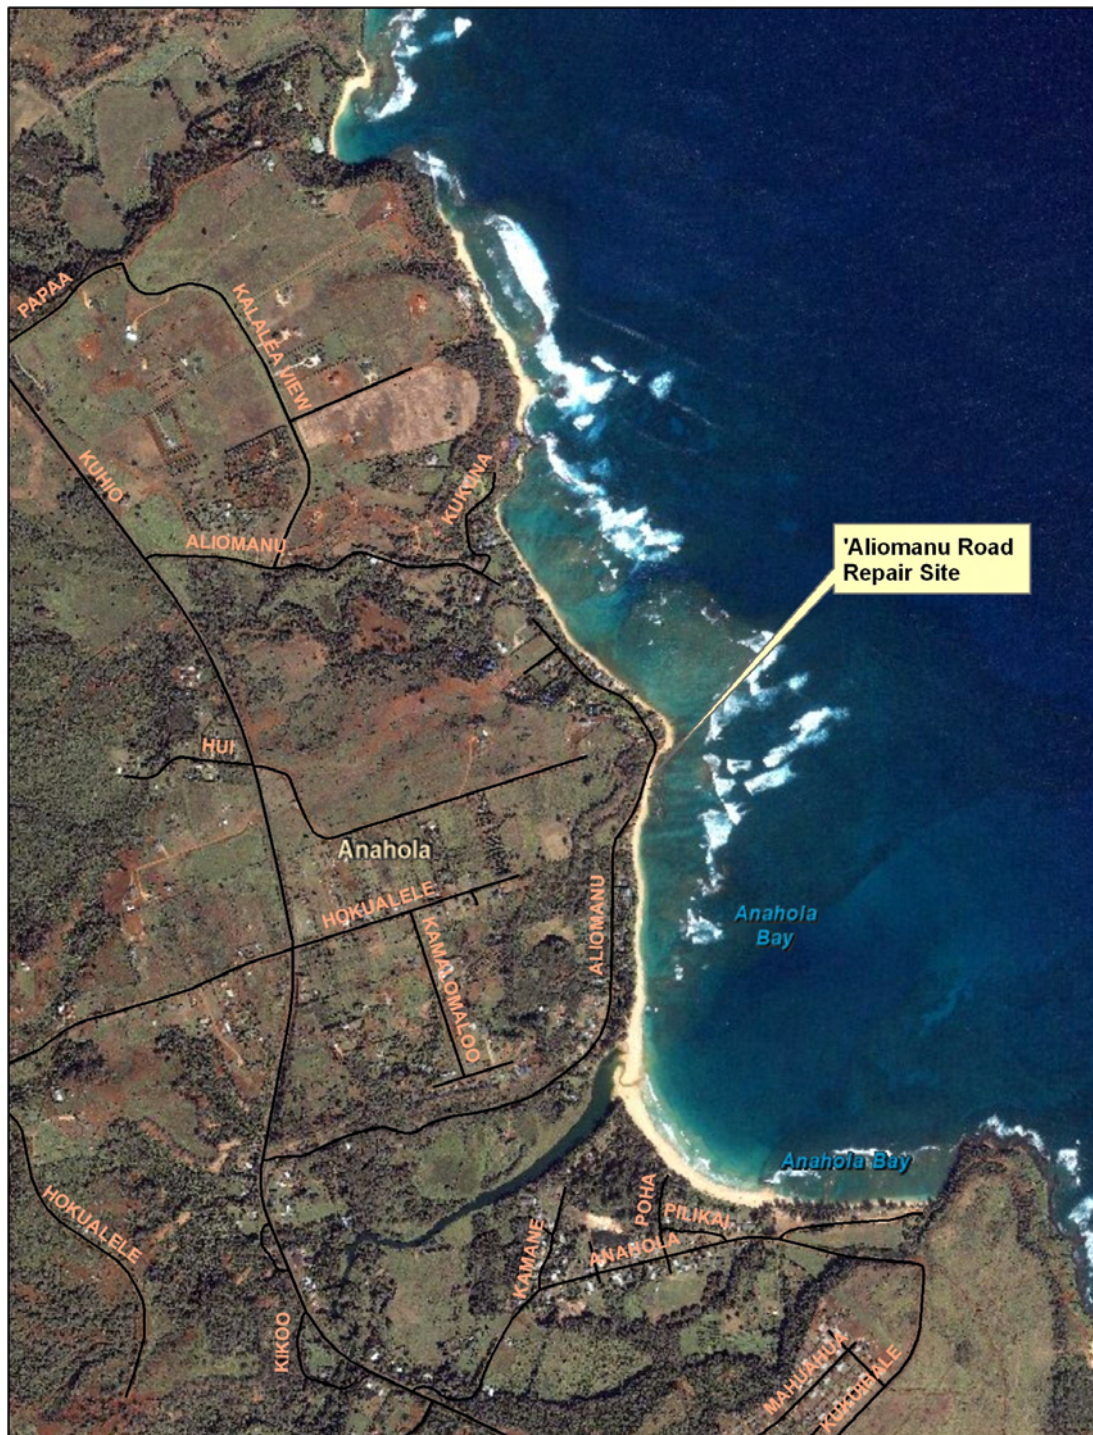
Figure 1-2. Location of 'Aliomanu Road Repair Site

The project area is shown in Figure 1-2 below. Photos showing the deteriorating road are shown in Figures 1-3 and 1-4.

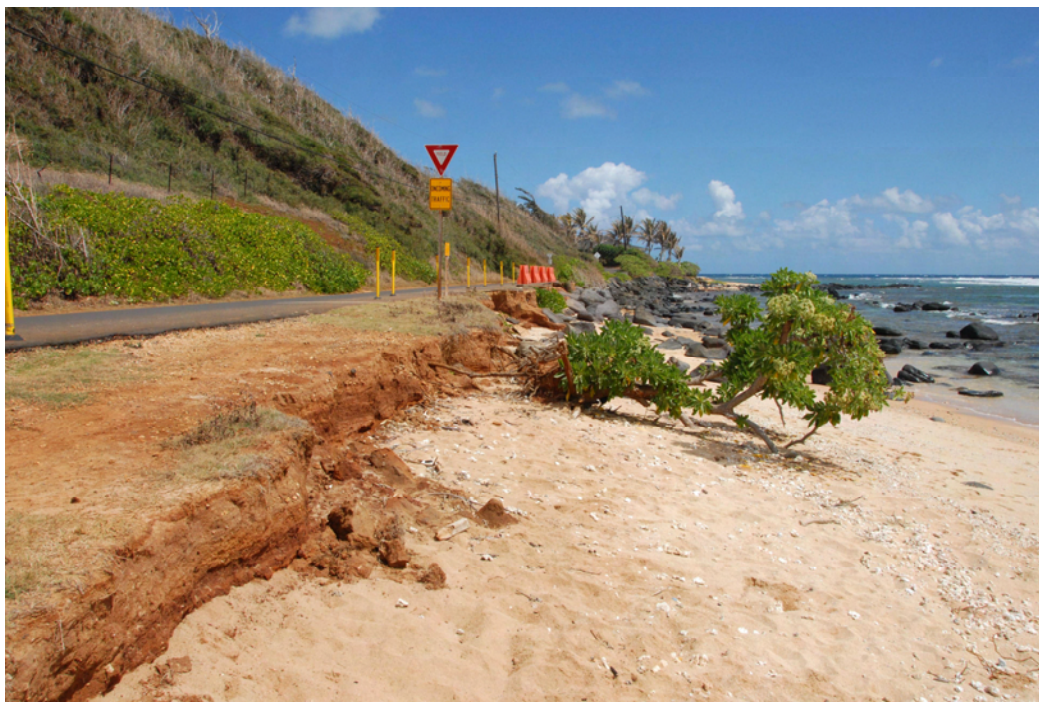
Figure 1-3. View of 'Aliomanu Road looking north

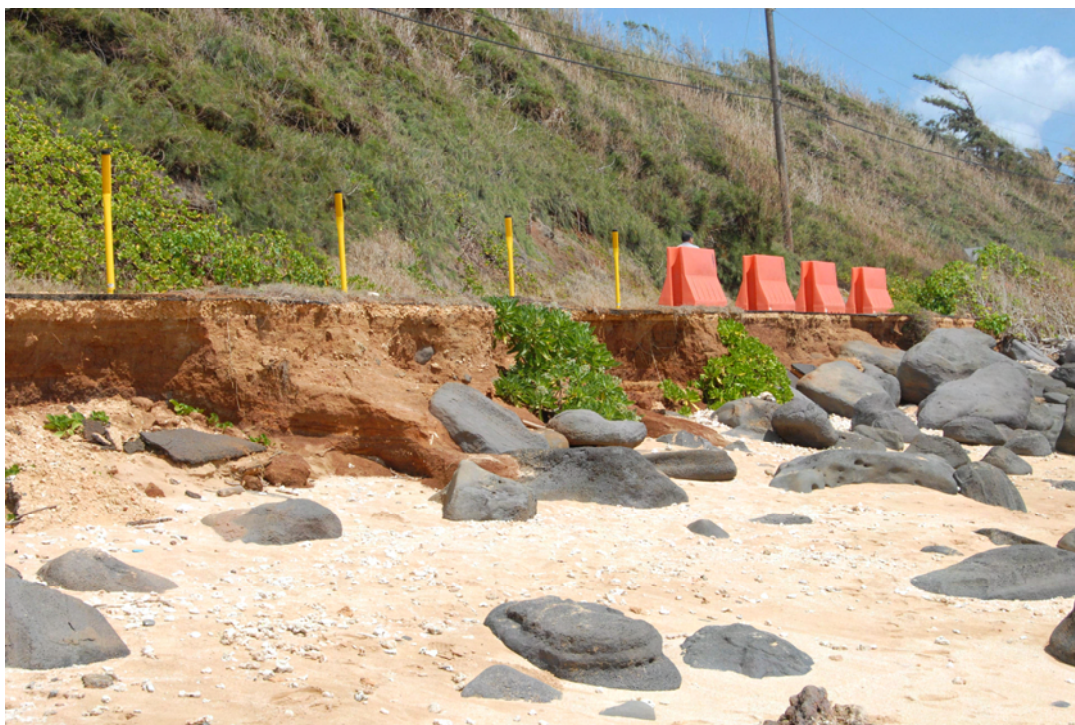
Figure 1-4. Undermining of the road

This environmental assessment is being prepared by Department of Public Works (DPW) of the County of Kaua'i, to repair 'Aliomanu Road located along the shoreline in Anahola. This road is being undermined by shoreline erosion, causing part of the road to collapse into the ocean. This project will require County of Kaua'i funding to repair the road and reinforce the makai side of the road with a rock revetment on lands owned by the County and the State of Hawai'i.

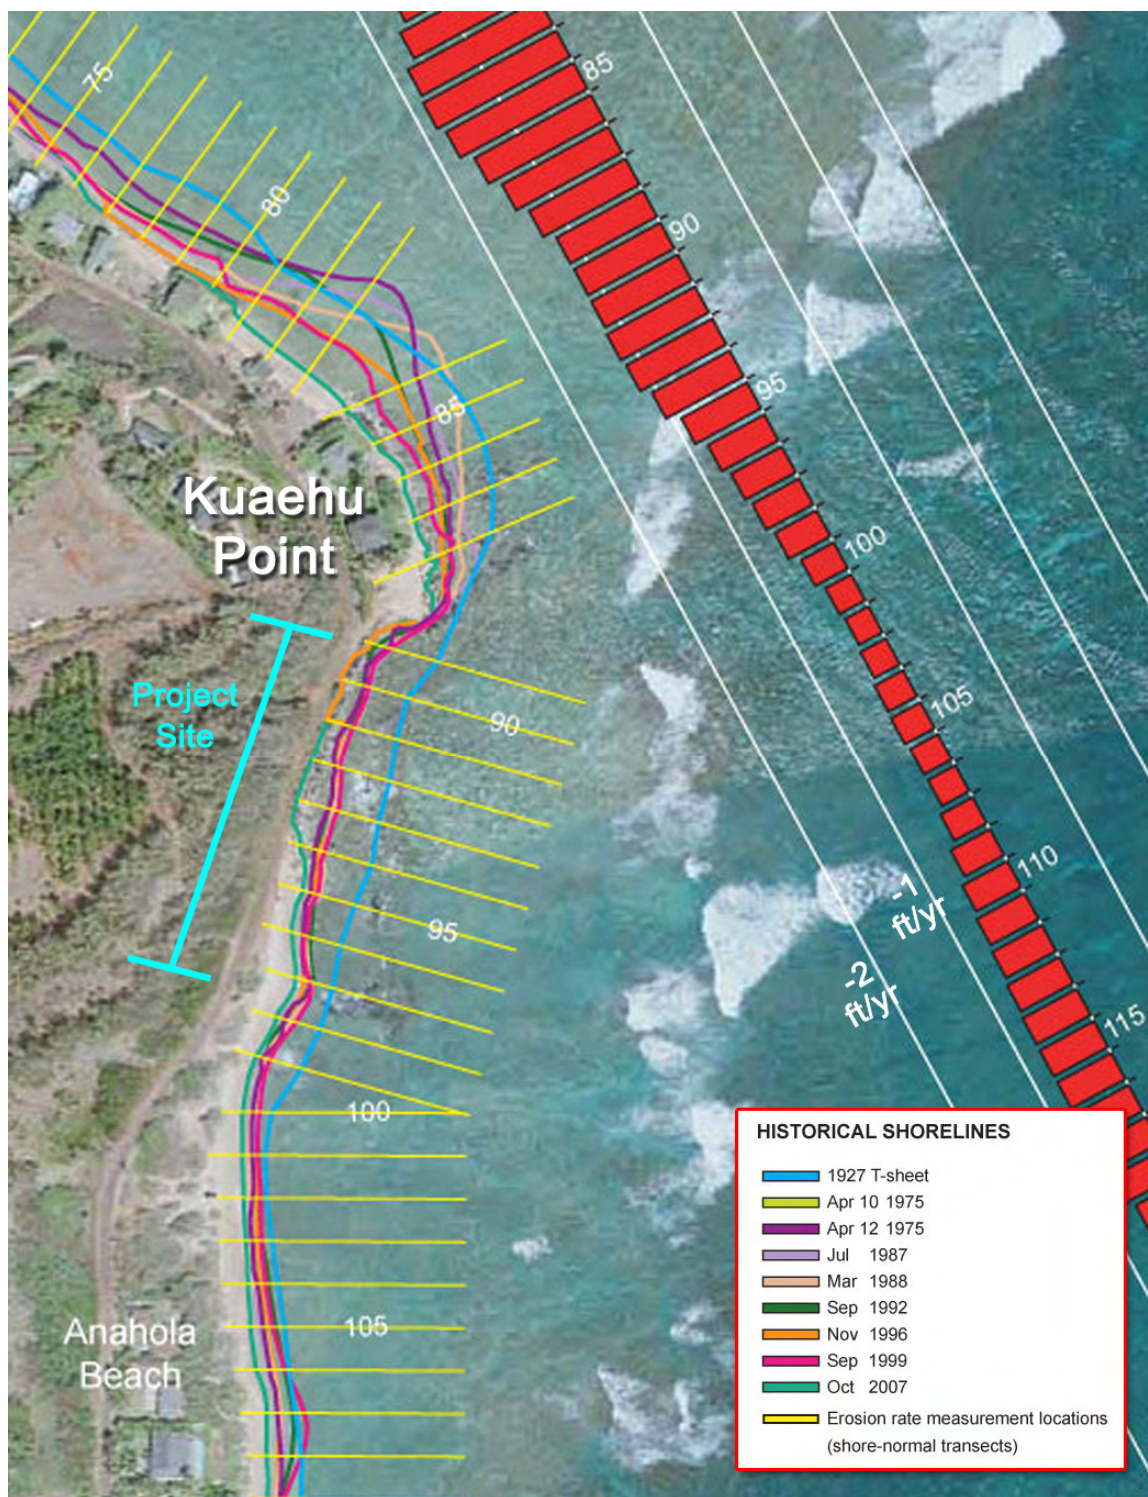
Figure 2-1. Map showing historical erosion

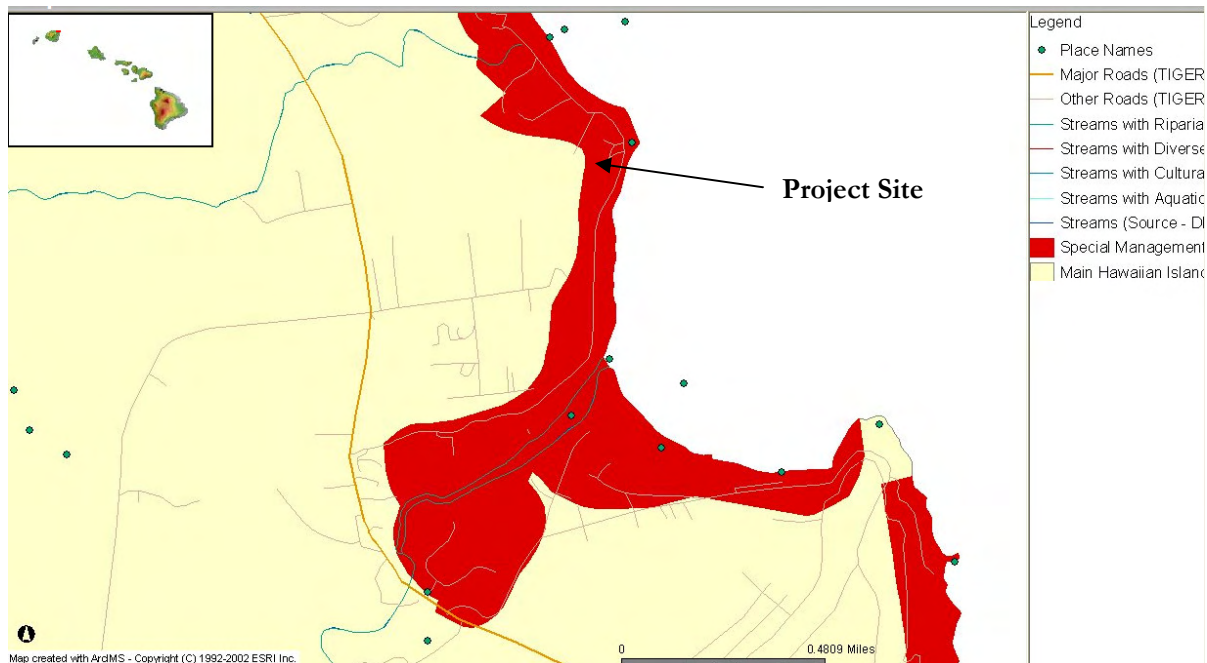
Figure 2-2. Special Management Area Map

The project site is within the Special Management Area as shown in Figure 2-2. Therefore a Special Management Area Permit will be required. A shoreline setback variance will also be needed for this project.

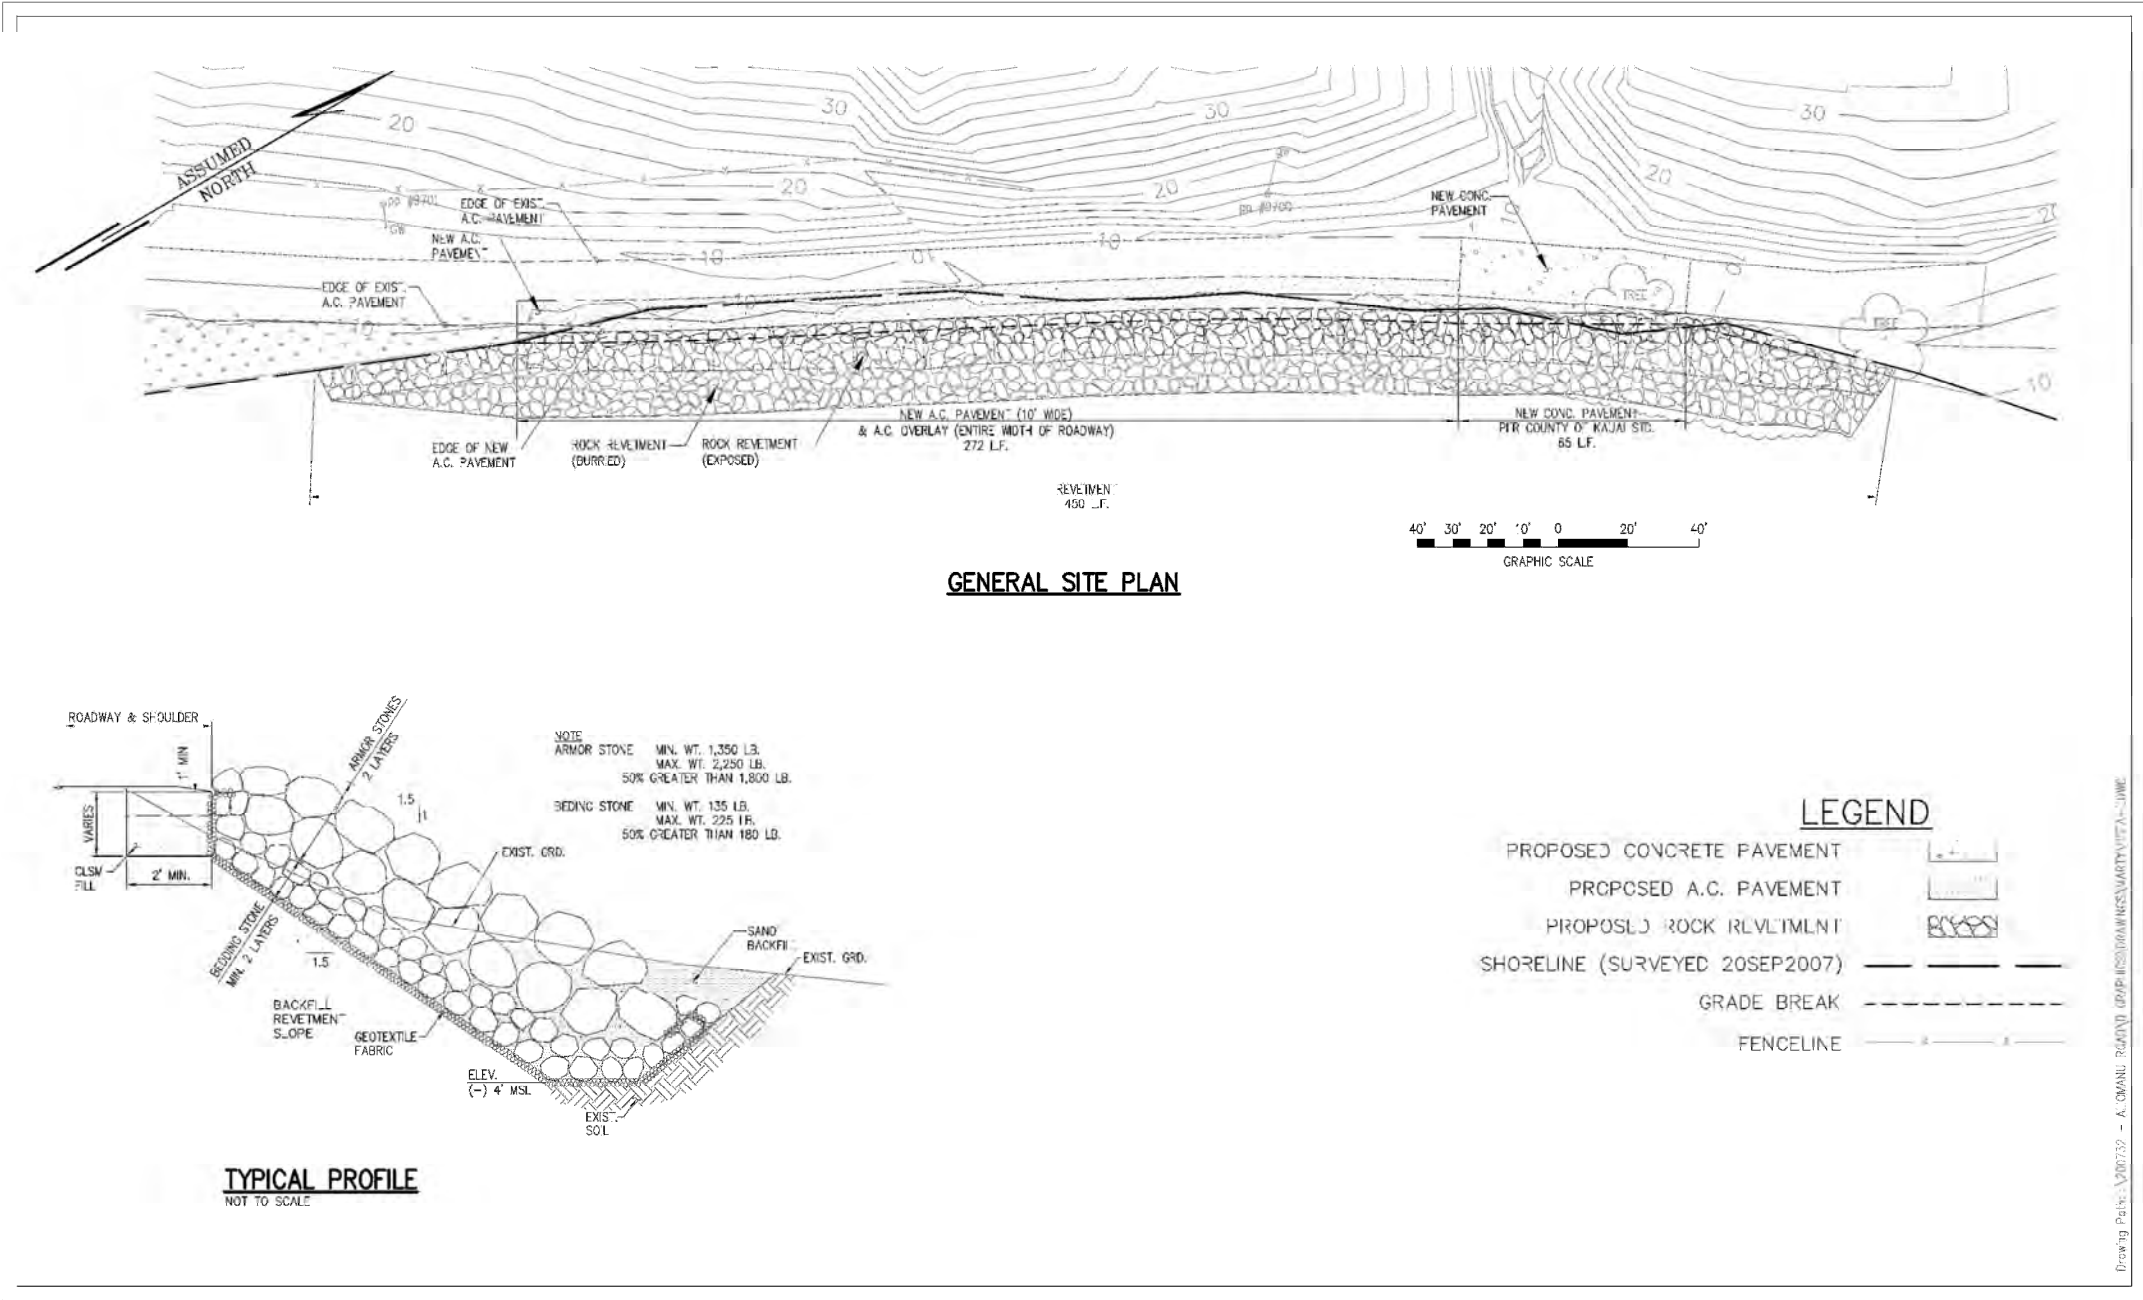
FIGURE 3-1
ALIOMANU ROAD REPAIR CONCEPT

Figure 3-1. Plan and Profile of Road Repair and Rock Retention

The scope of the repair work is to reconstruct the damaged portion of the road to pre-erosion conditions. Therefore, the proposed project is to rebuild the existing roadway to include a 2-foot wide paved shoulder to pre-erosion conditions and stabilize the road with a new rock revetment to prevent future erosion of the roadway (see Figure 3-1). The rock revetment was designed using Corps of Engineers' methods given in the Shore Protection Manual (U.S. Army Corps of Engineers, 1984).

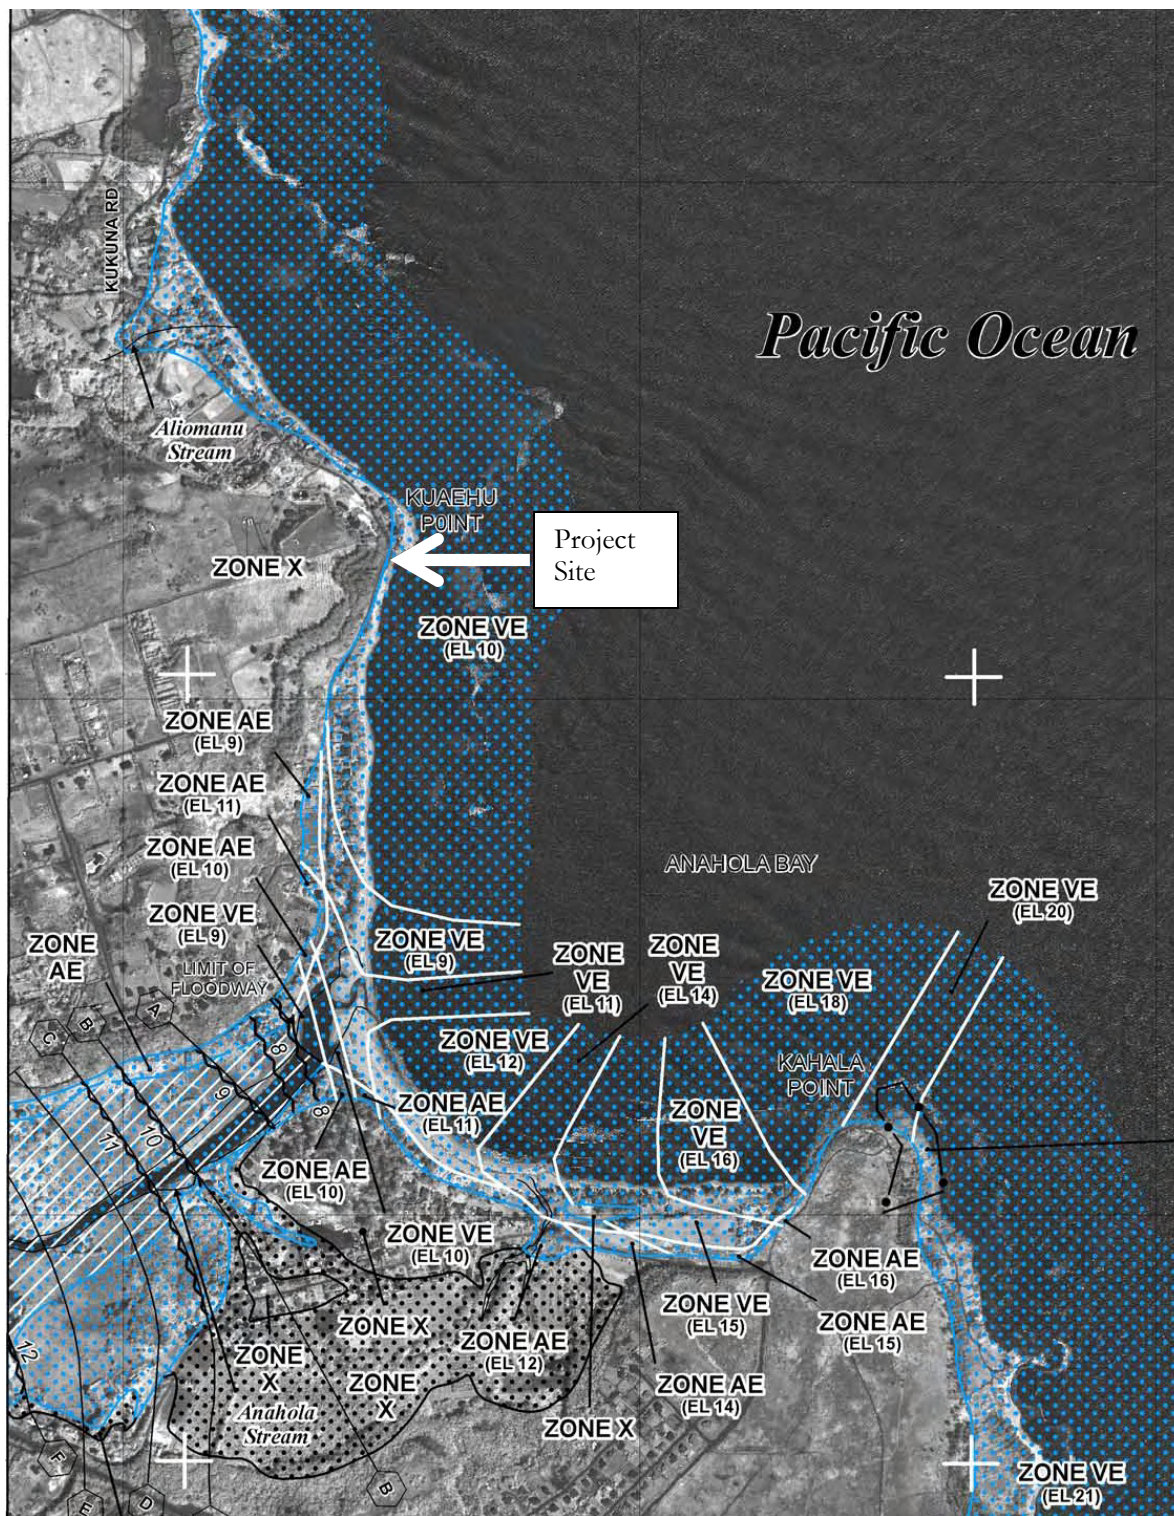
Figure 4-1. FEMA Flood Map

According to the Flood Insurance Rate Map (FIRM), ‘Aliomanu Road from Anahola Stream to Kuaehu Point is within the VE Zone with a flood elevation of 10 feet (see Figure 4-2). The VE designation means that this area is in the coastal flood zone with velocity hazard (wave action) where base flood elevations have been determined.

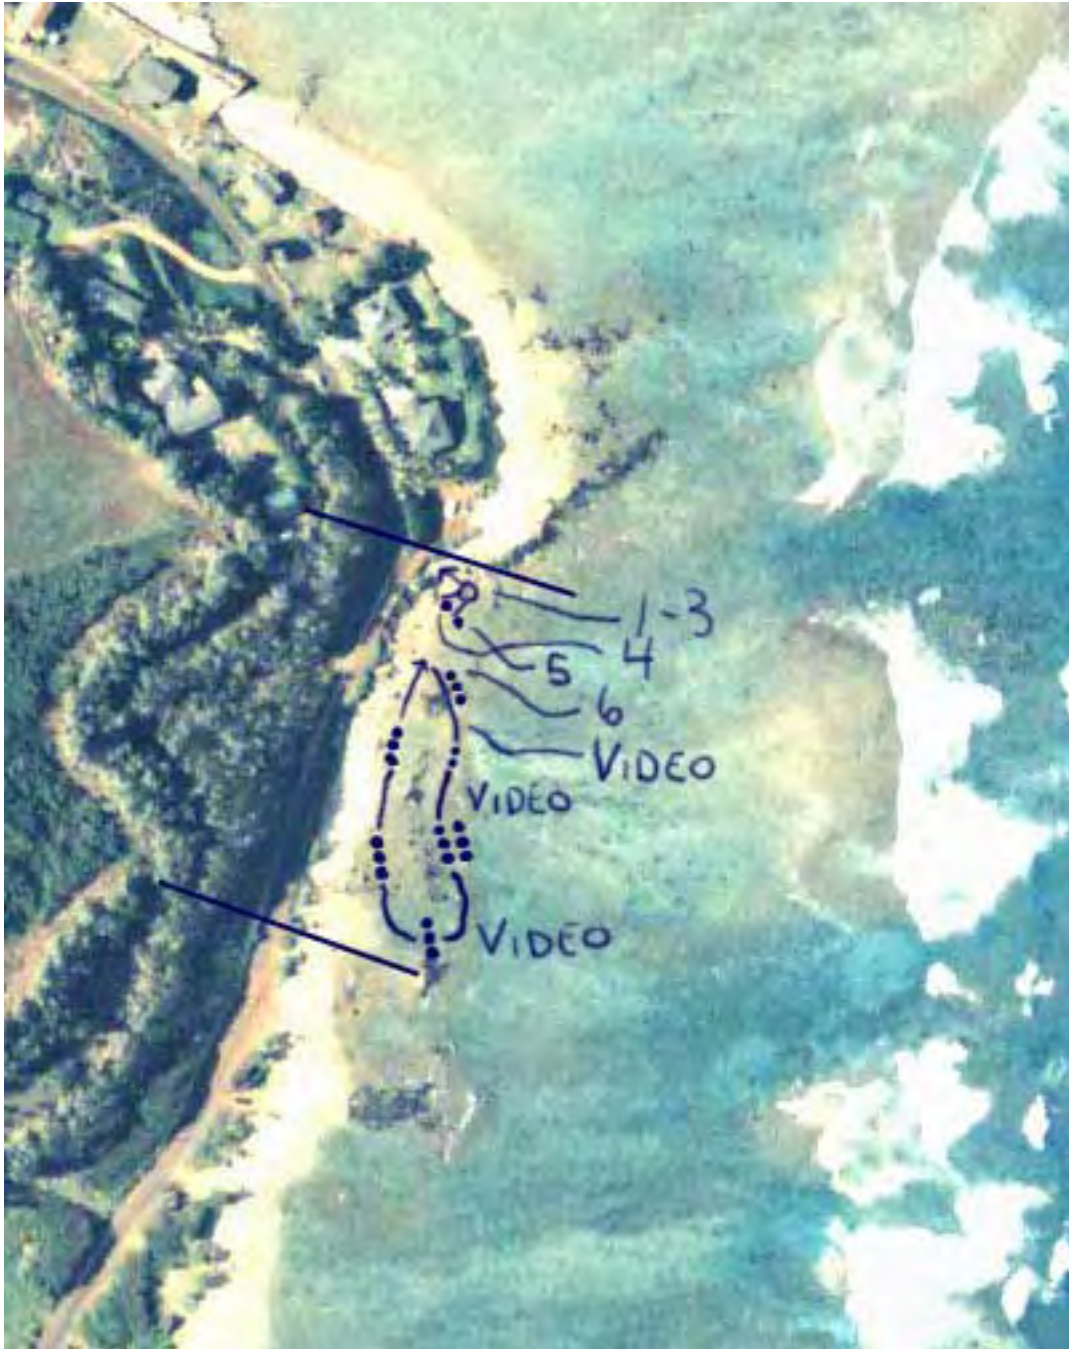
Figure 1 – Area studied in this survey. Approximate project area is within the linear markings. The loop represents the course of the in-water survey, dots indicating photo-points, solid lines indicating video recording.

- 17. *Section 4.3. Aquatic Resources.* Please reference Figure 1 of Appendix A for this section. A more detailed map of the exact locations of these corals may be helpful for avoiding impact to these features. What type of habitat will the new rocks provide?

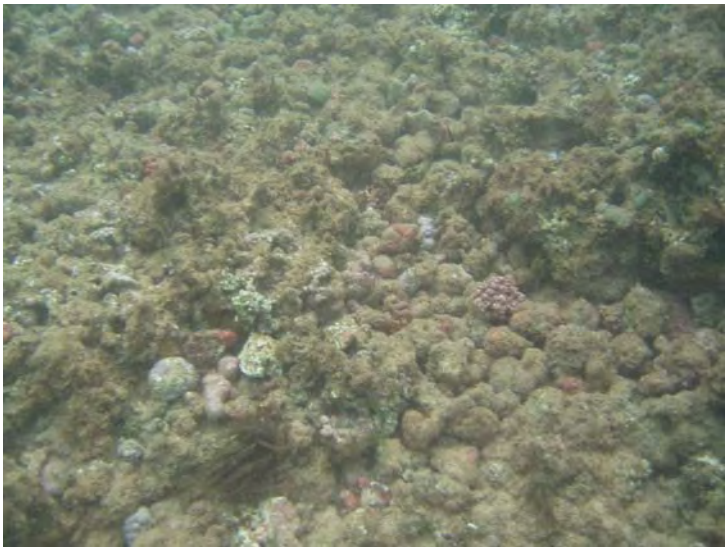
1. Benthic algae mat over hard substrate nearshore at northern extent of project site.

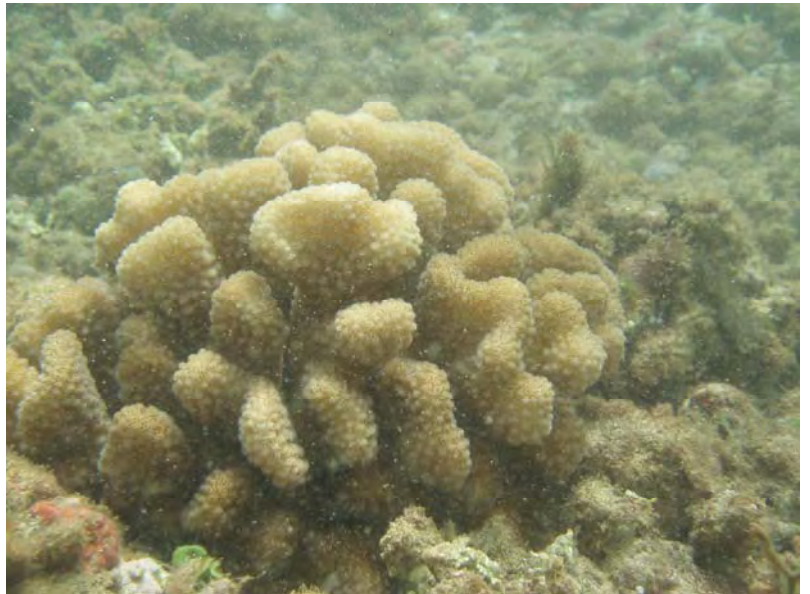
2. Rose coral (*Pocillopora meandrina*) on uplifted hard substrate approximately 75 feet off shore.

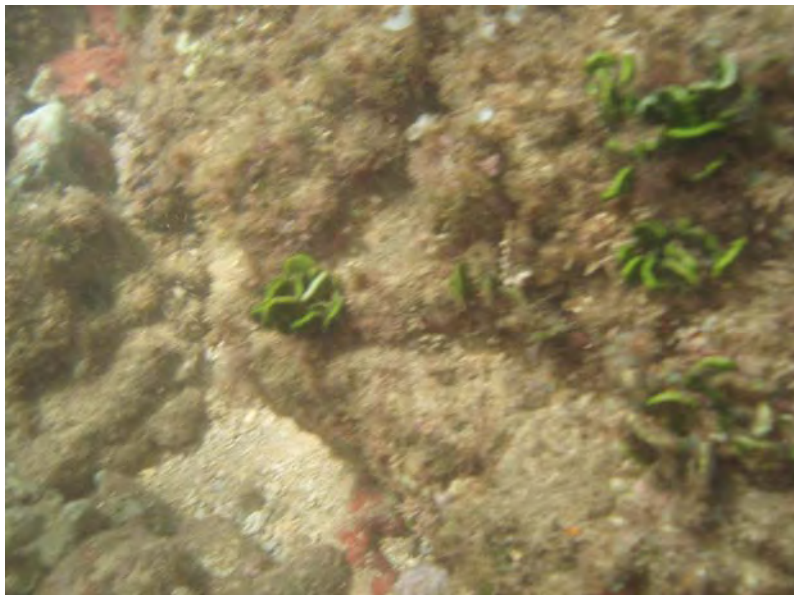
3. Mixed algae mat, including green *Halimeda* species, located approximately 75 feet offshore.

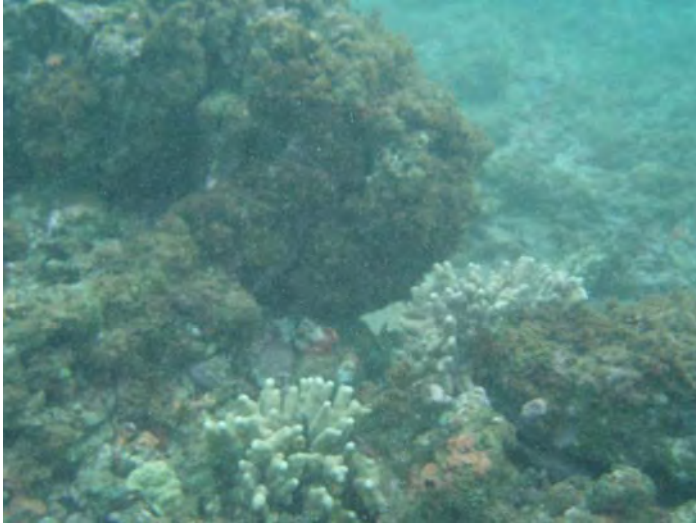
4. Finger coral (*Porites compressa*) colonies in crevasse protected by larger rocks and uplifted benches approximately 100 feet off shore in 3-4 feet of water.

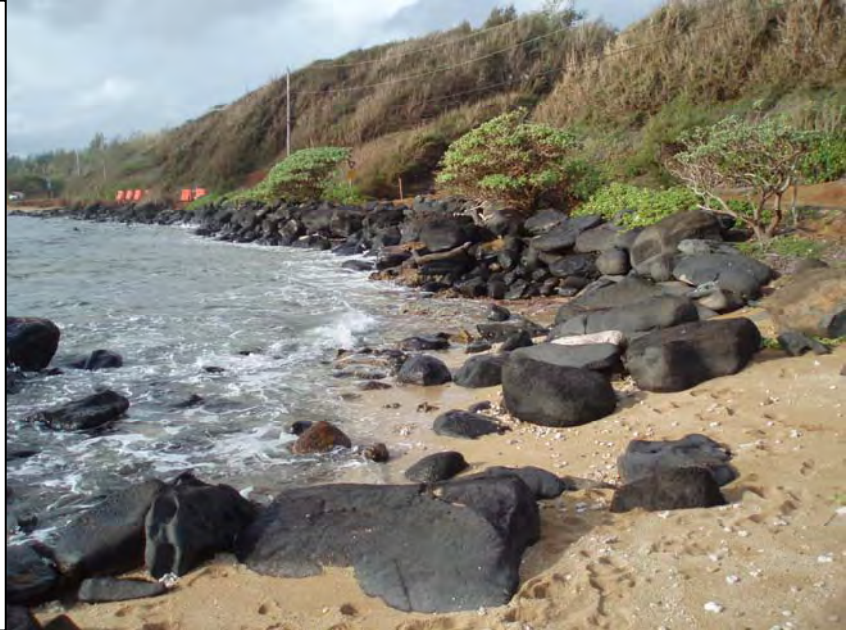
7. A tree heliotrope (*Tournefortia argentea*) individual recently topple due to erosion.

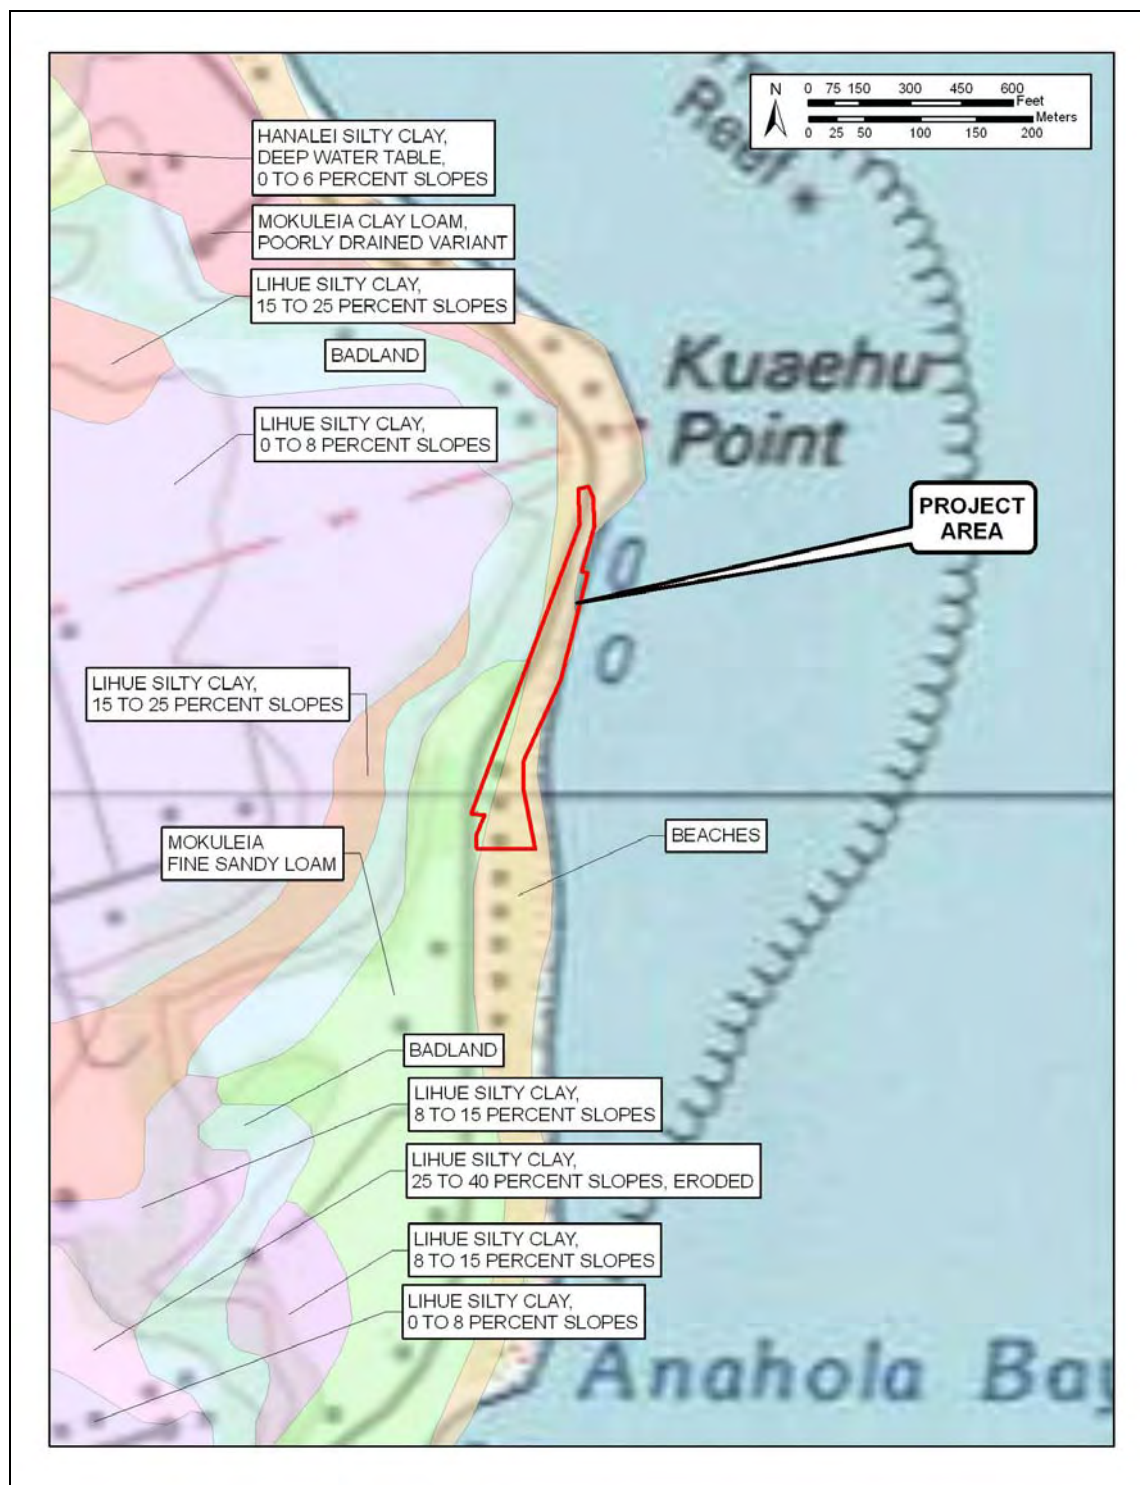
Figure 4. Overlay of the Soil Survey of the State of Hawai'i (Foote et al. 1972), indicating the soil type within the project area

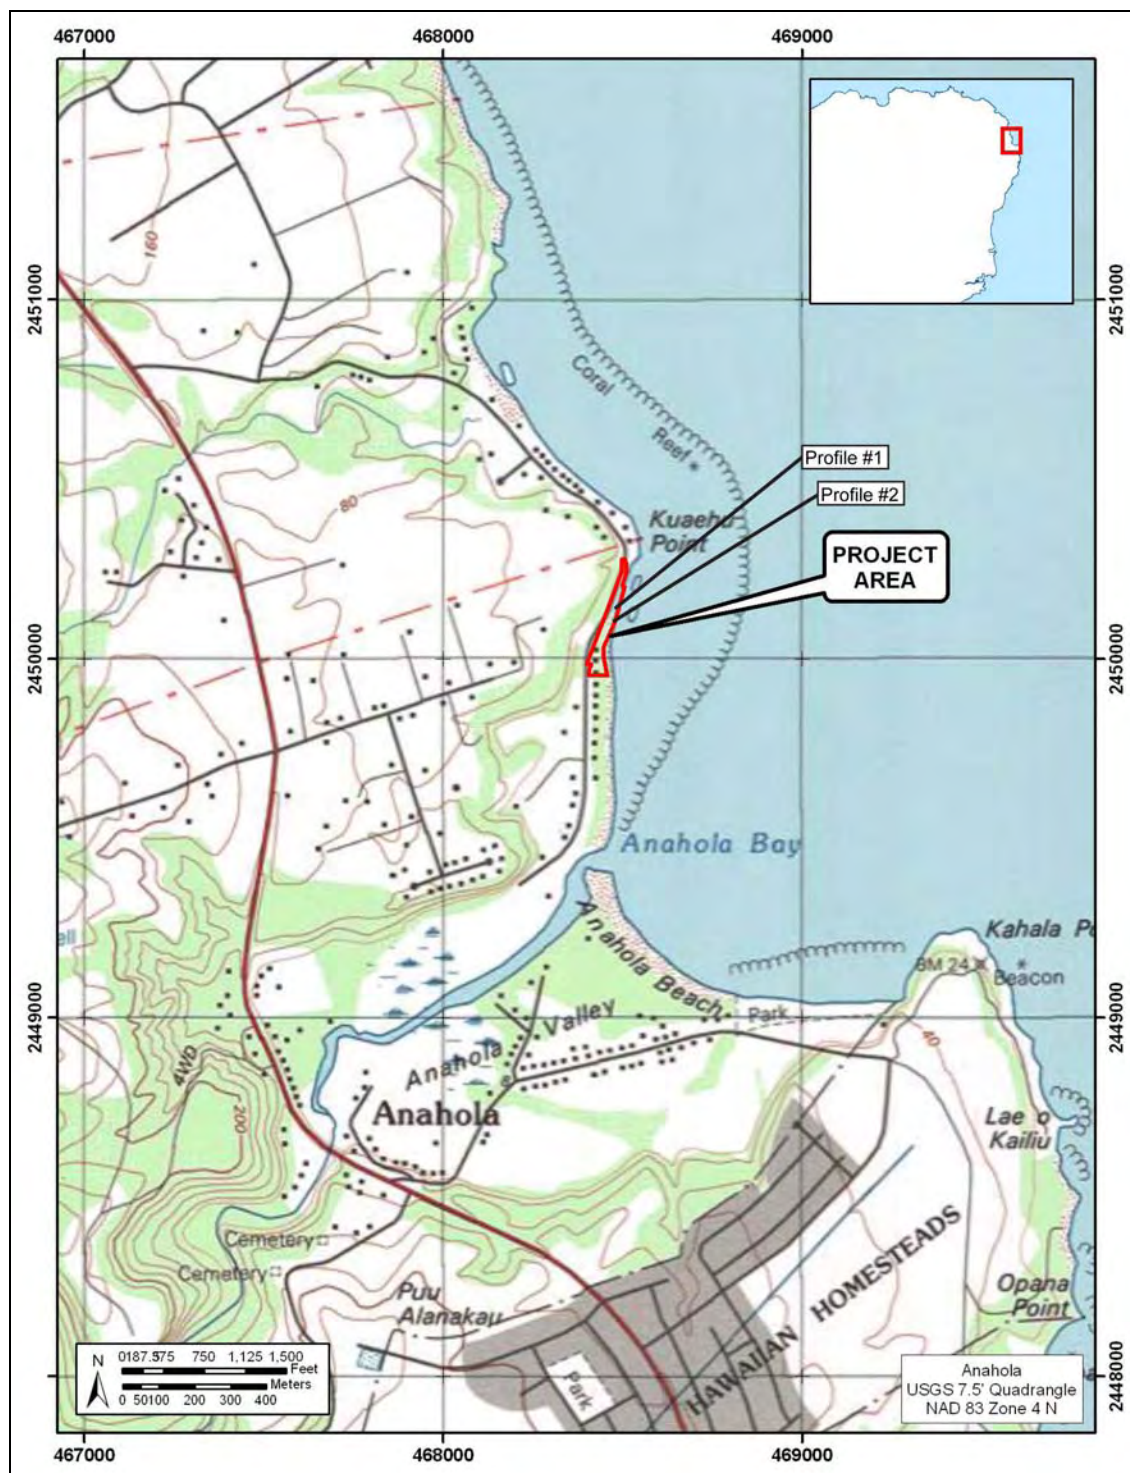
Figure 10. Portion of USGS Topo Map, Anahola Quad (1998), showing project area and locations of profiles

Two representative profiles were recorded within exposed areas of the project area to document the stratigraphy. Profile #1 of the wave-cut bank was recorded in the northern, more seriously eroded stretch (Figure 10); this was the north-most portion of the project area that was accessible without having to stand in the ocean record the stratigraphy. This northern portion of the project area contained asphalt road surface with an underlying coral cobble base and varying layers of imported sands and fill (Figure 13 and Figure 14).

Profile #2 was recorded further south, where the waves have cut only into the road grade, not the asphalt road itself. This profile was recorded adjacent to and *makai* of a surveyor’s pipe, and a sign post holding the signs “YIELD” and “ONCOMING TRAFFIC” (Figure 15). Profile #2 is 20.2 m south of Profile #1. This portion of the project area contained wave and wind deposited beach sand overlying multiple layers of sand and sediments with coral pebbles, glass fragments, and pieces of metal. This fill layer appears to be compacted.

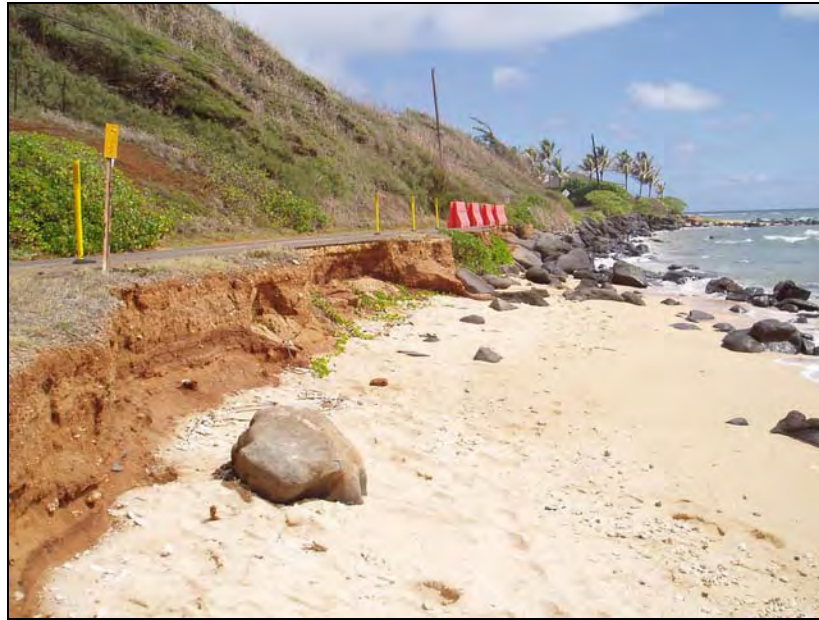
Figure 11. General view of the wave cut bank *makai* of 'Aliomanu Road, view to north-northwest

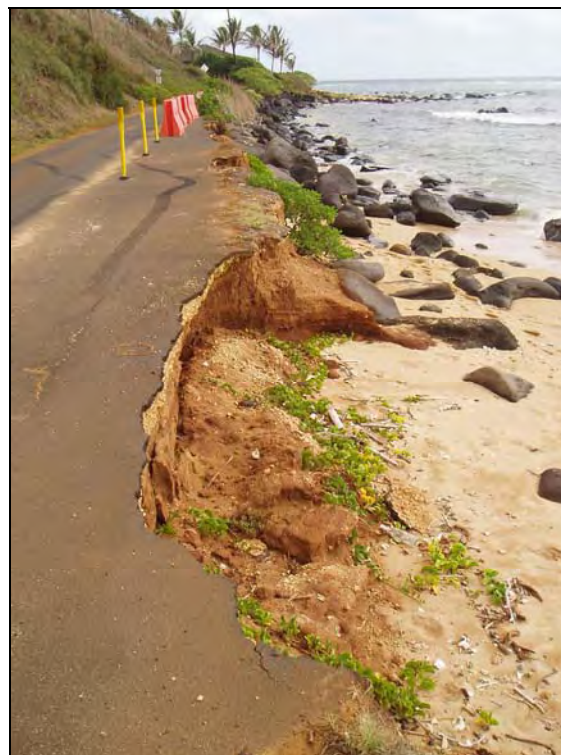
Figure 12. 'Aliomanu Road showing asphalt damage, view to north

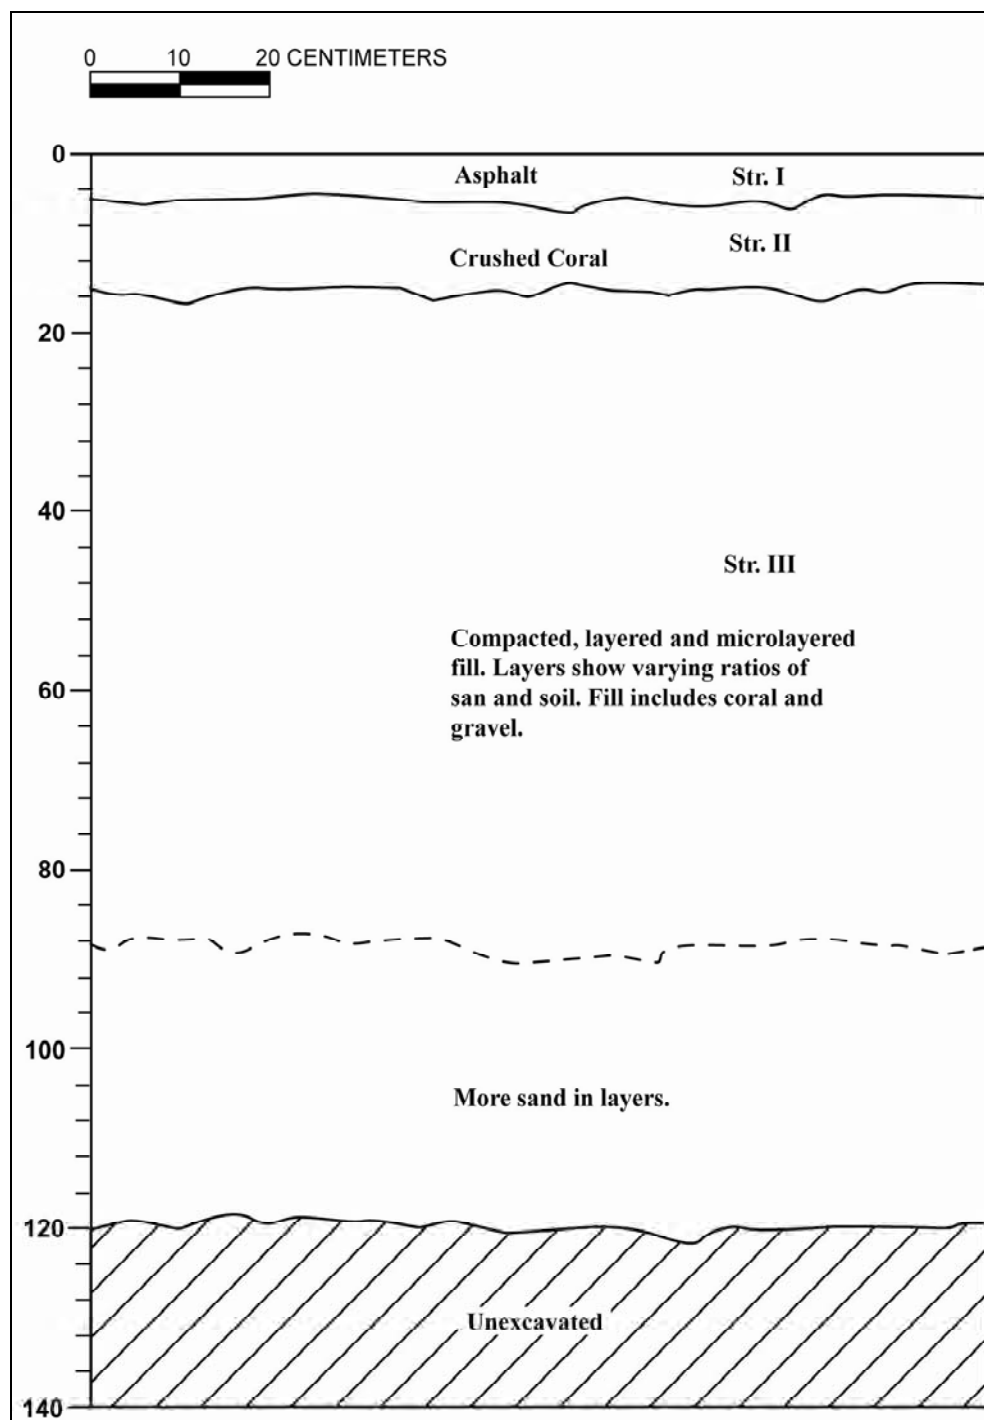
Figure 13. Stratigraphy of Profile 1

Strata	Depth (cmbs)	Description
Stratum I	0-6	Asphalt
Stratum II	5.0-16	Fill Horizon; crushed coral base course
Stratum III	15-90	Compacted layered and micro-layered fill that appears to be compacted. Layers show varying ratios of sand and soil with various colors. Various textures, strong grade, various sizes, dry very hard consistency, strong cementation, mixed origin of sediments, abrupt boundary distinctness, smooth topography

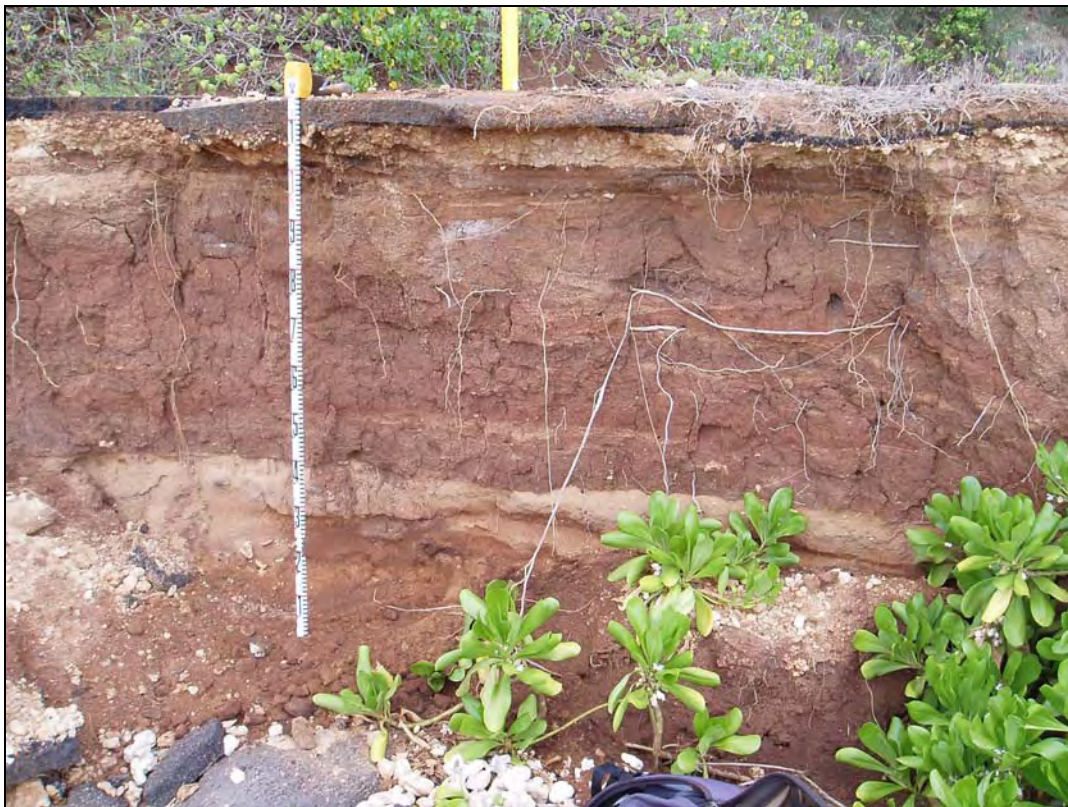
Figure 14. Profile 1, view to west
