SUBJECT: Finding of No Significant Impact (FONSI) and
Final Environmental Assessment (FEA) for
Aliomanu Road Repair
TMK: 4-8-18: 028, 029, Anahola, Kauai

Final Environmental Assessment For 'Aliomanu Road Repair

Department of Public Works
County of Kaua'i

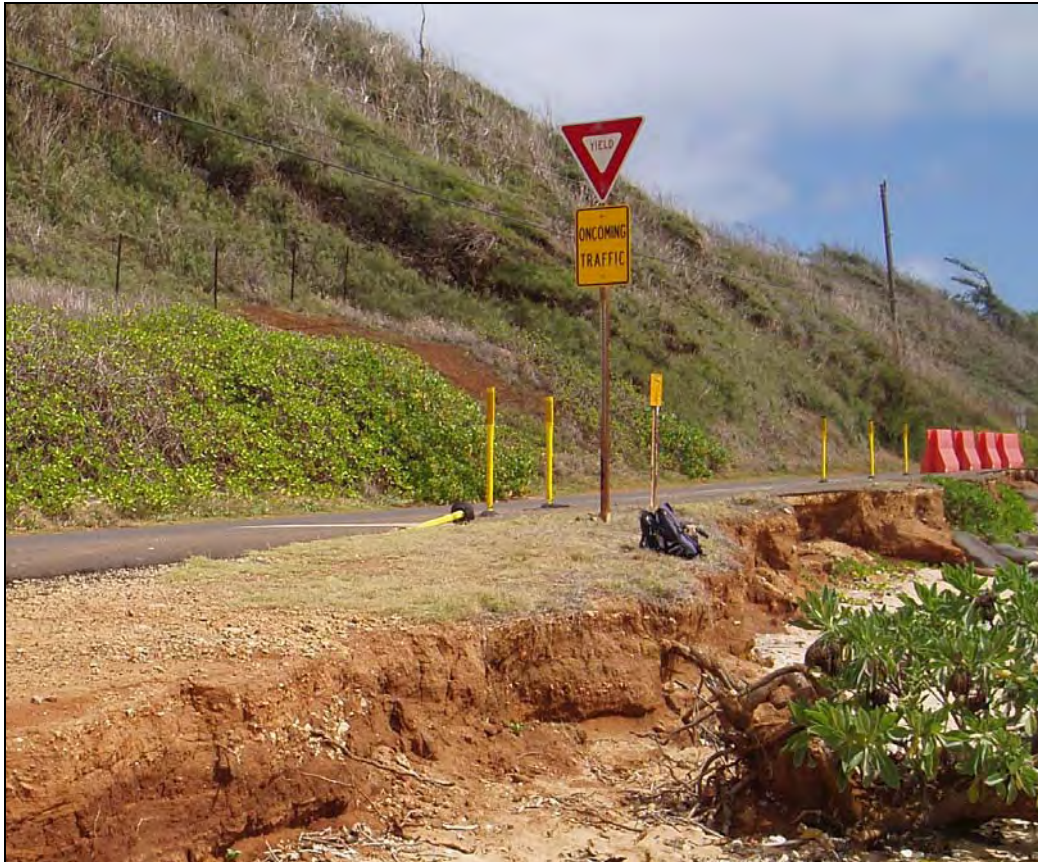
Figure 15. Location of Profile 2, view to northwest

Profile #2 was recorded further south, where the waves have cut only into the road grade, not the asphalt road itself. This profile was recorded adjacent to and *makai* of a surveyor’s pipe, and a sign post holding the signs “YIELD” and “ONCOMING TRAFFIC” (Figure 15). Profile #2 is 20.2 m south of Profile #1. This portion of the project area contained wave and wind deposited beach sand overlying multiple layers of sand and sediments with coral pebbles, glass fragments, and pieces of metal. This fill layer appears to be compacted.

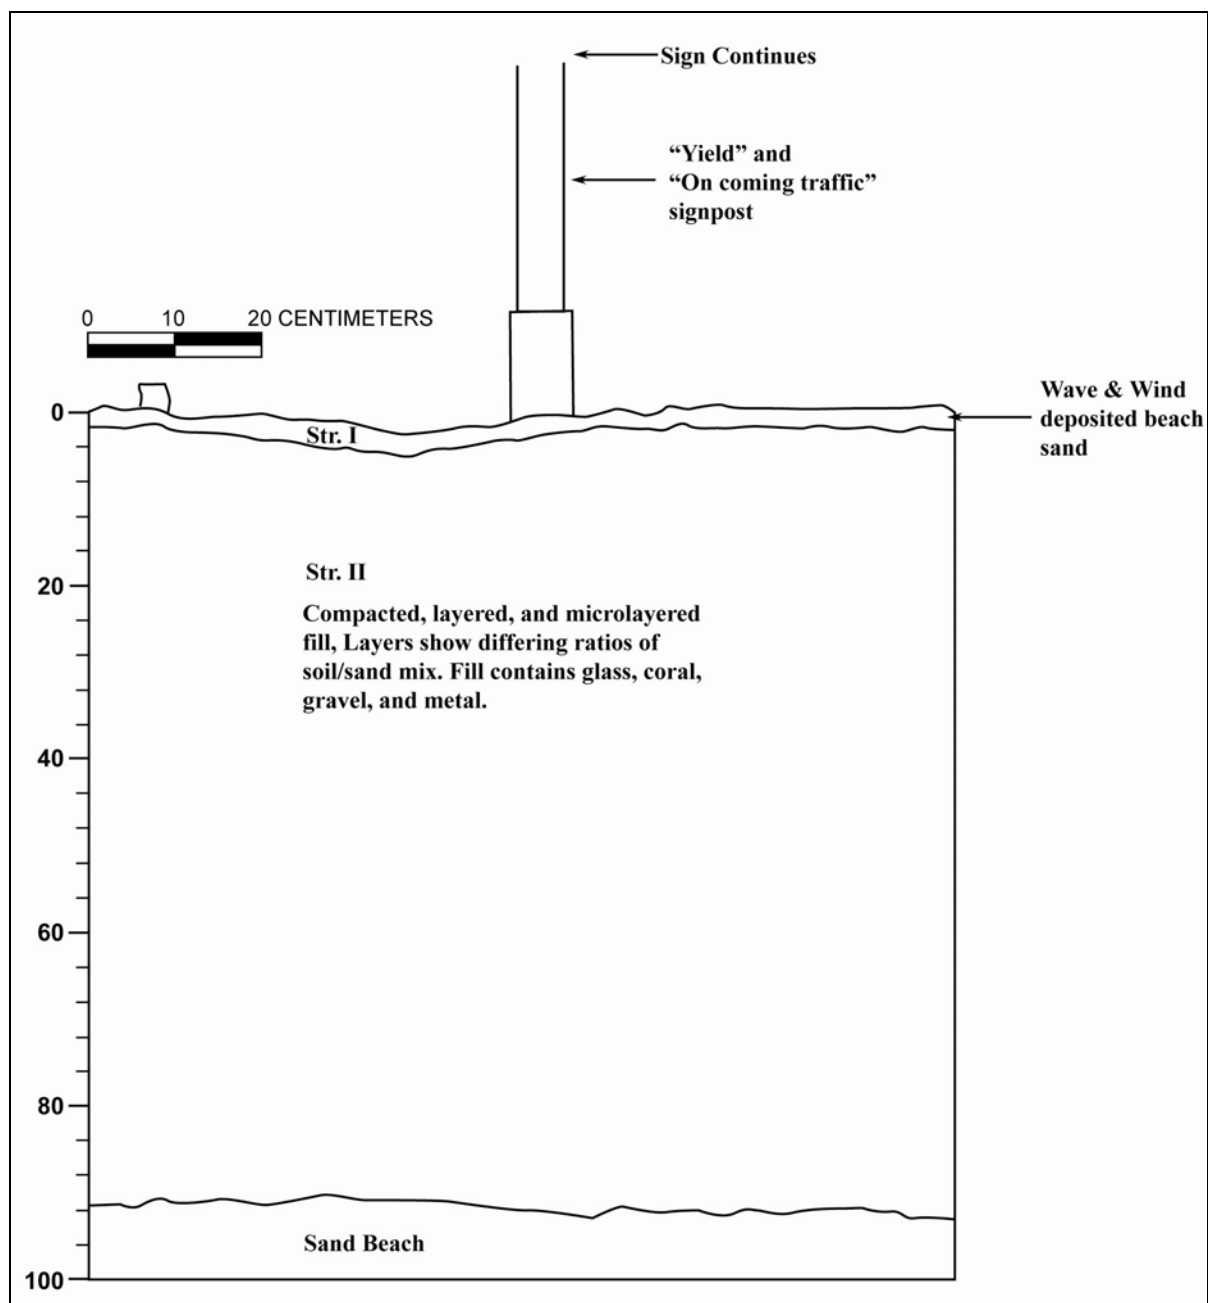
Figure 16. Stratigraphy of Profile 2

Strata	Depth (cmbs)	Description
Stratum I	0-3	Wave and wind deposited beach sand. Yellowish brown sand, medium size, weak grade, medium size, single grain, dry, loose consistency, non-plastic, no cementation, marine origin, abrupt boundary, smooth topography
Stratum II	2-94	Compacted layered and micro-layered fill that appears to be compacted. Layers show varying ratios of sand and soil with various colors. Layers consist of sand and sediment with coral pebbles, gravel, glass fragments, and pieces of metal. Dry, very hard consistency, non-plastic, strong cementation, mixed origin, abrupt boundary, smooth topography.
Stratum III	90-100	Beach sand. Natural sand that underlies fill layer and has been exposed by wave action. Similar coloring to Stratum II

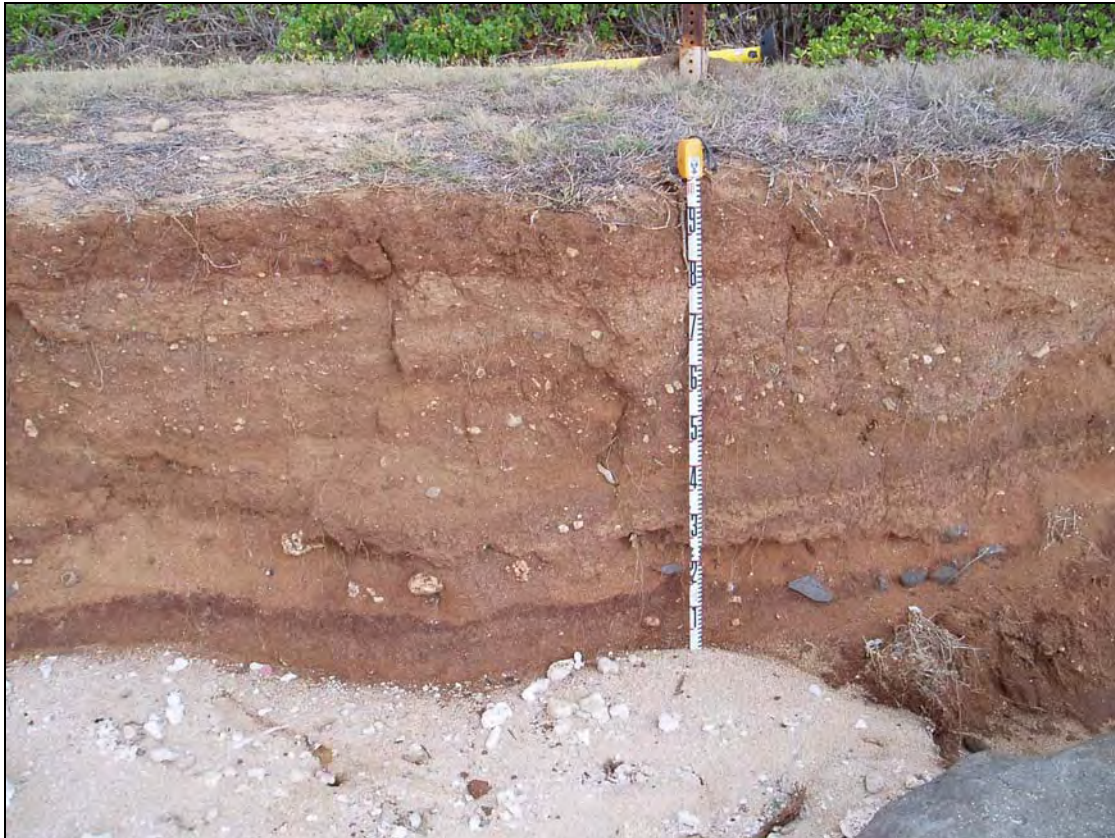
Figure 17. Profile 2, view to west

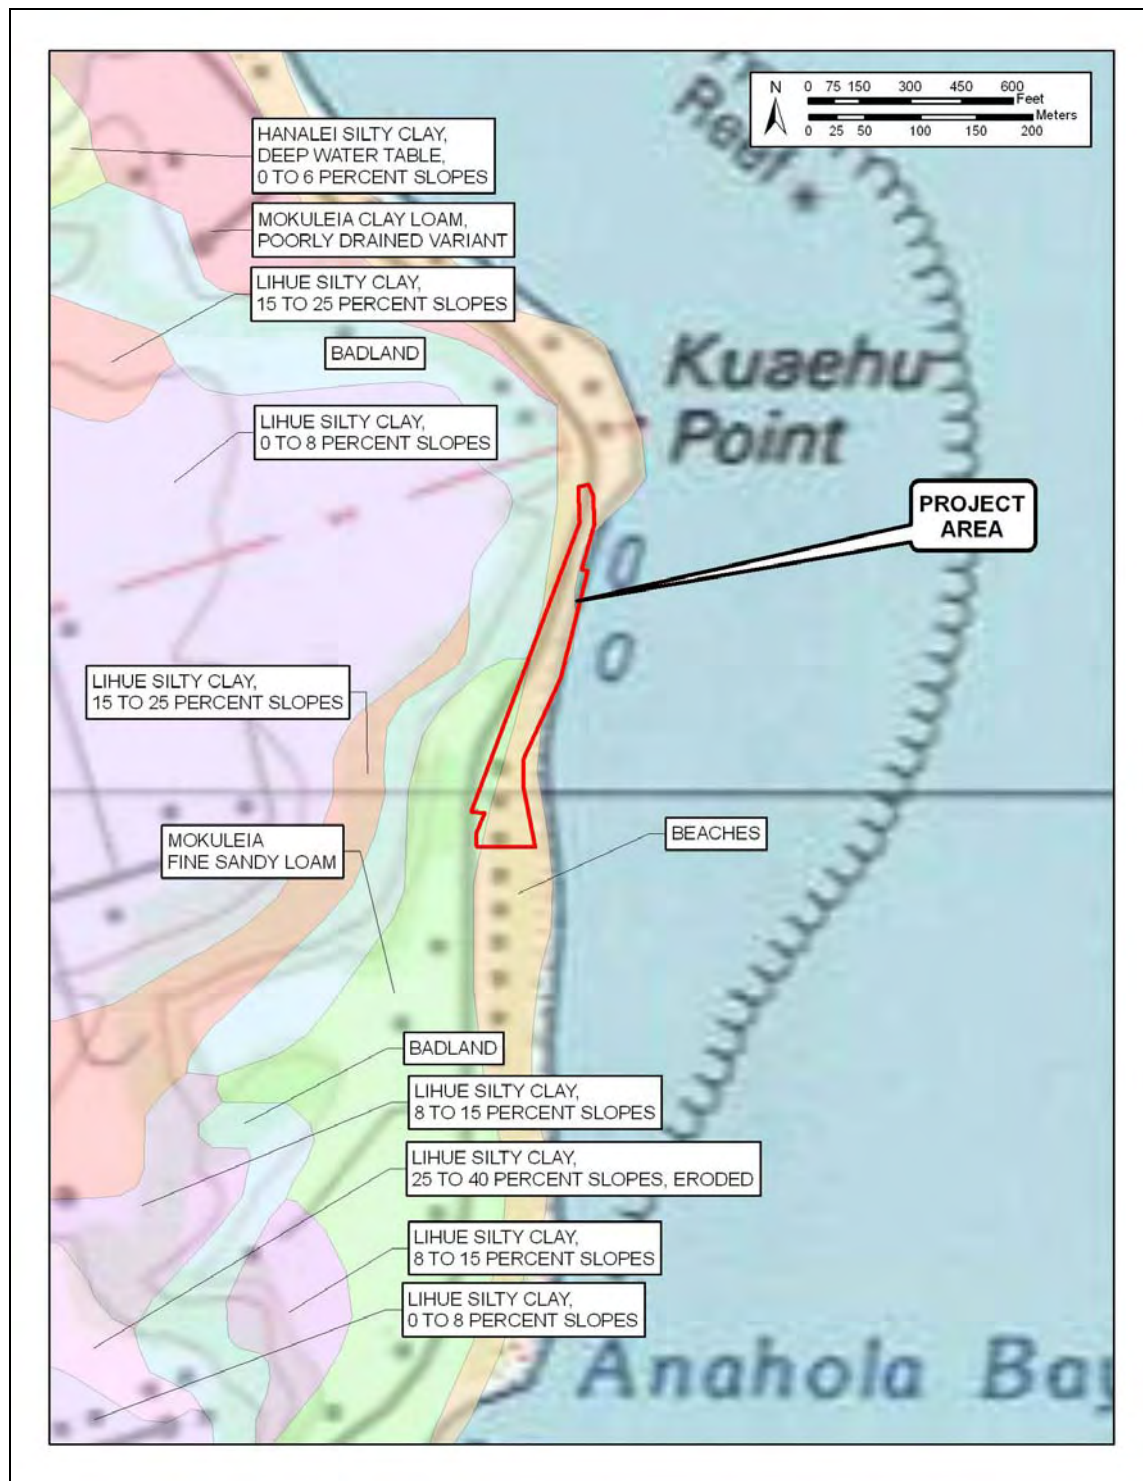
Figure 4. Overlay of the Soil Survey of the State of Hawai'i (Foote et al. 1972), indicating the soil type within the study area

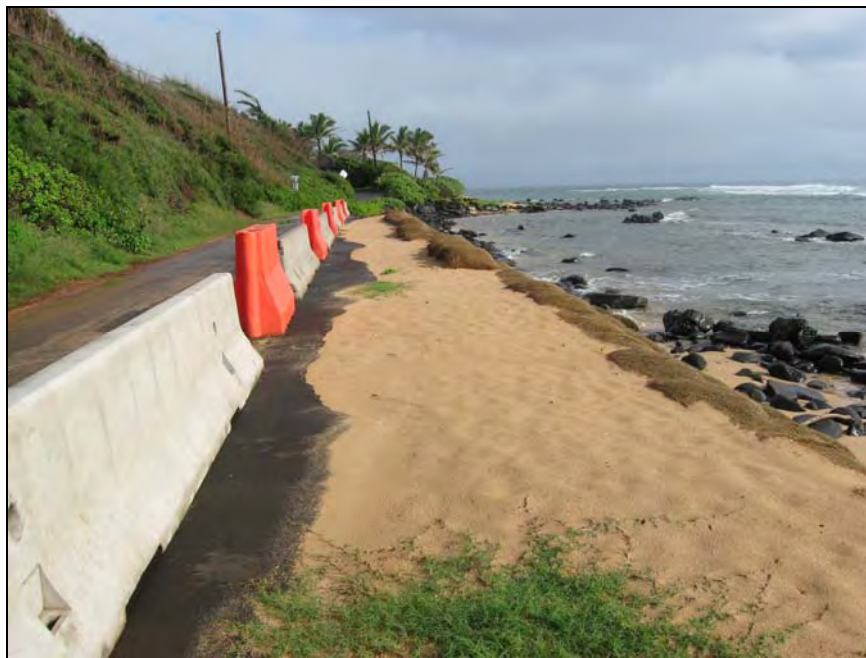
Figure 15. Project site with roadblocks

Closer to the project area, he pointed out the roadblocks along the erosion line, making travel unsafe on both sides of the road.

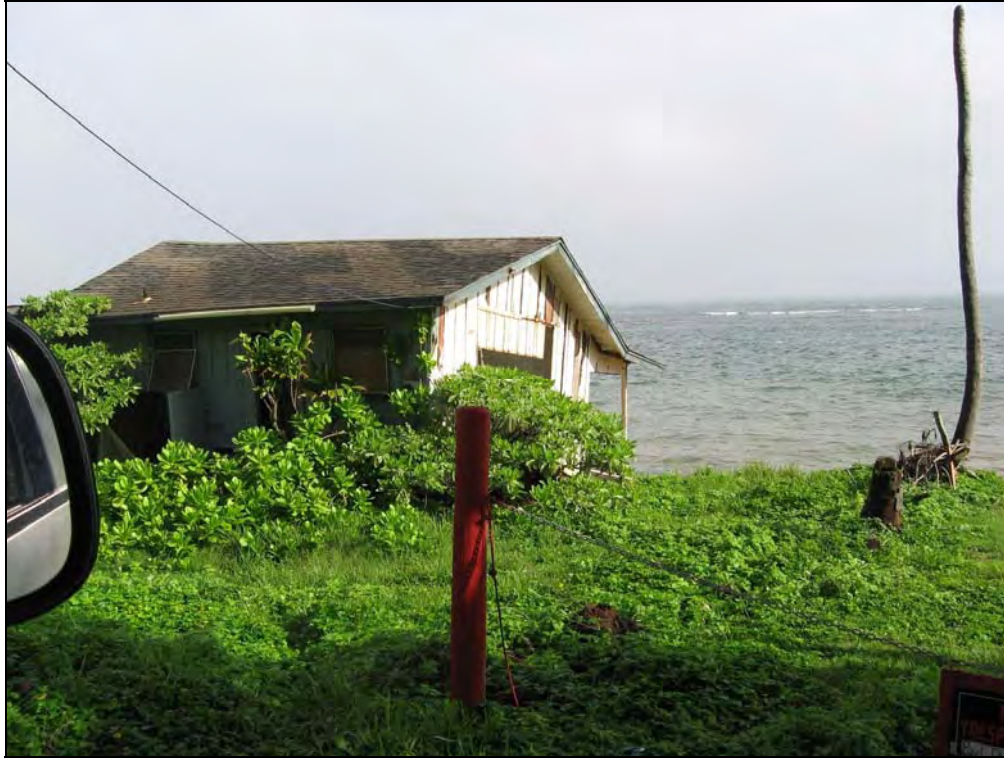
Figure 17. The neighboring property by the project site contains a home that is falling into the water because of coastal erosion.
