**FINAL ENVIRONMENTAL ASSESSMENT**  
and Application for a Shoreline Setback Variance &  
Minor Shoreline Structure Permit

**TMKs**  
**3-5-003:008**  
**3-5-003:009**  
**3-5-003:010**

**Kahala, O'ahu**

Prepared for: WF Coastal Properties  
Prepared by: PlanPacific, Inc.

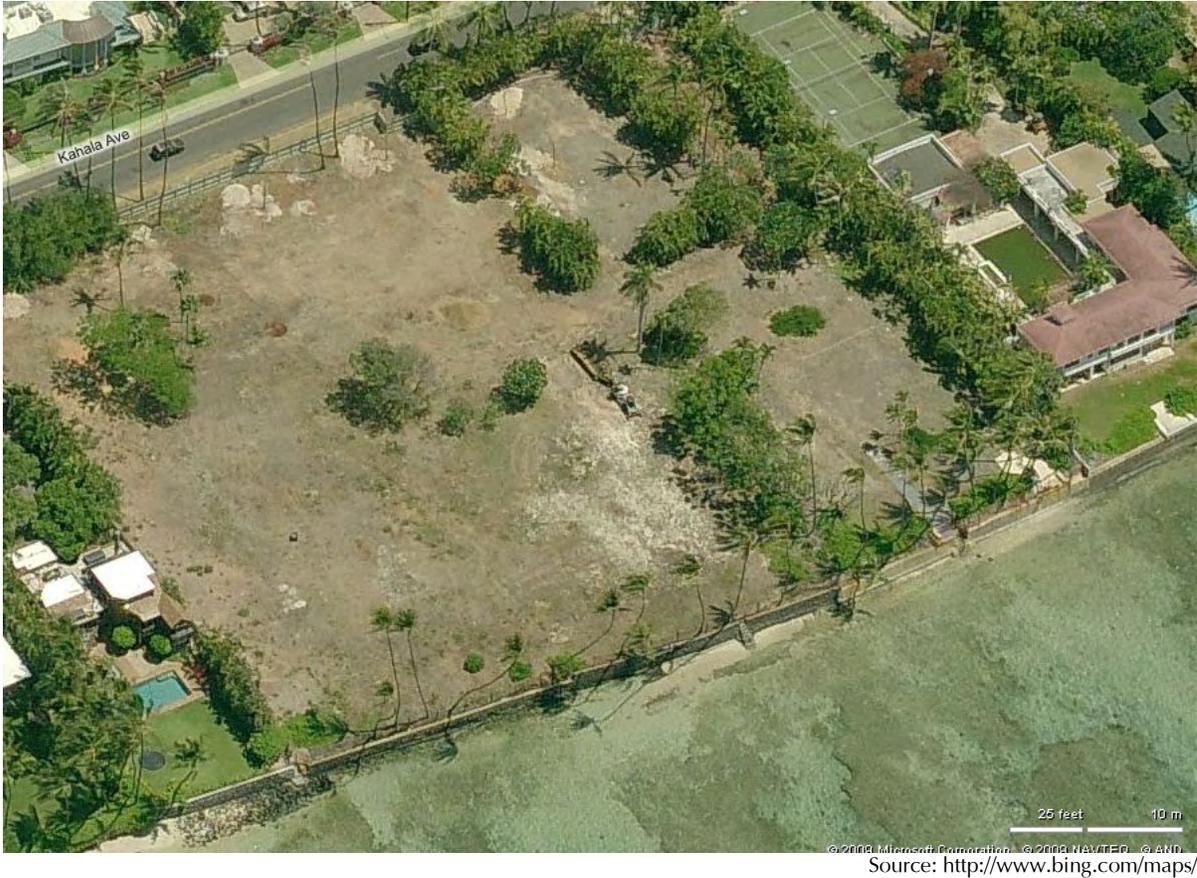
**Figure 3: Aerial Photo, Low-Angle Oblique**

The seawall on parcel 10 was the chief subject of the Draft EA as it was most prone to undermining, but a more recent study prepared by IMH Engineering, Inc. recommends reinforcement of all three walls. The applicant proposes to reinforce and repair the seawalls with a range of masonry work as described in the following section 2.2.1 and Appendix B.

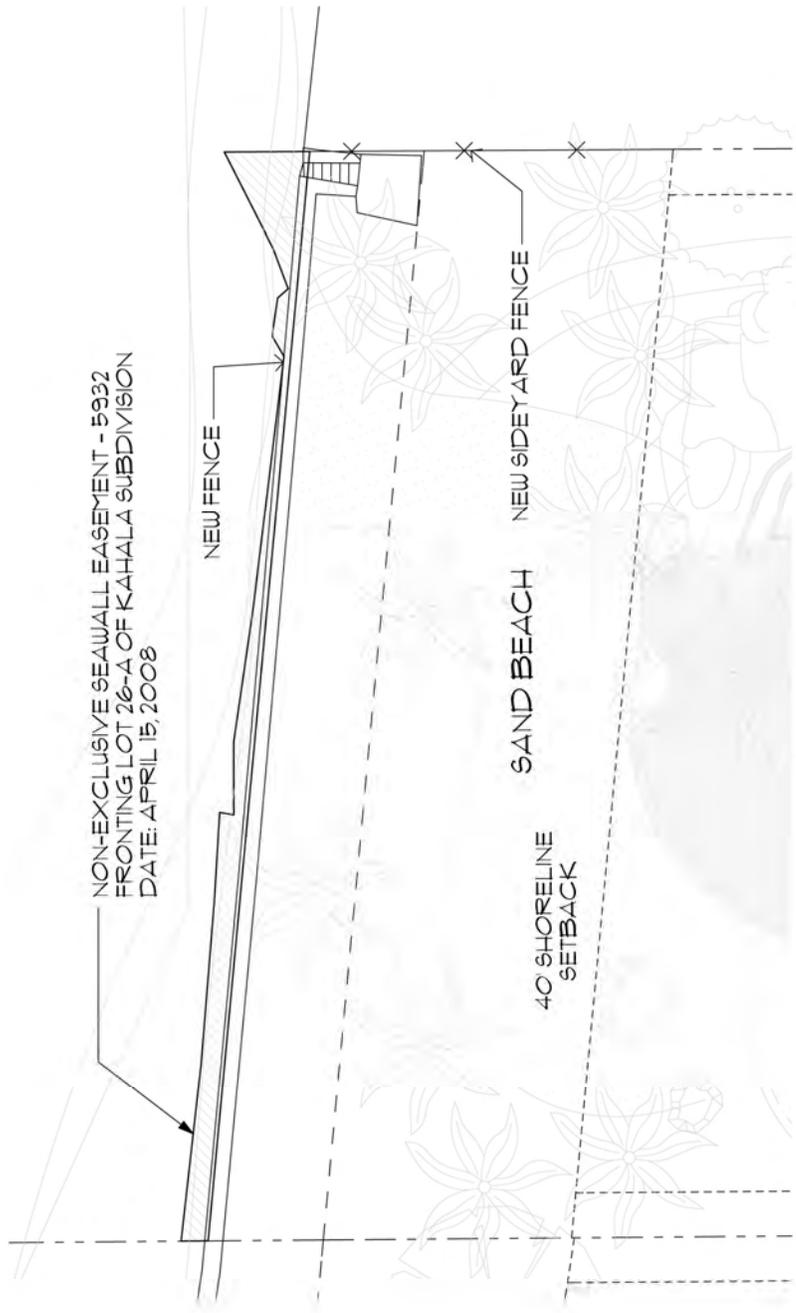
**Figure 4A: Site Plan, Parcel 10**

The most significant work involves the construction of a new support structure inland of the existing seawalls to stabilize the walls and prevent undermining and failure (referred to as Wall Retrofit Type I). The existing wall on parcel 10 will require this type of work. It is constructed of concrete rubble masonry (CRM). It spans the shoreline property boundary measuring 6.25-feet above Mean Sea Level (MSL) and 121.04 feet long. See Appendix H, Figure 1-4. Only portions of the wall extend down to the solid coral ledge, making it susceptible to undermining by high surf and tidal events. Soil erosion mauka of the seawall gives evidence of previous undermining. The eroded area has been filled with coarse gravel. Lot elevations range from six to eight feet MSL. The seawall extends the length of the seaward property boundary. A set of stairs providing beach access from the property is incorporated in the west end of the wall.

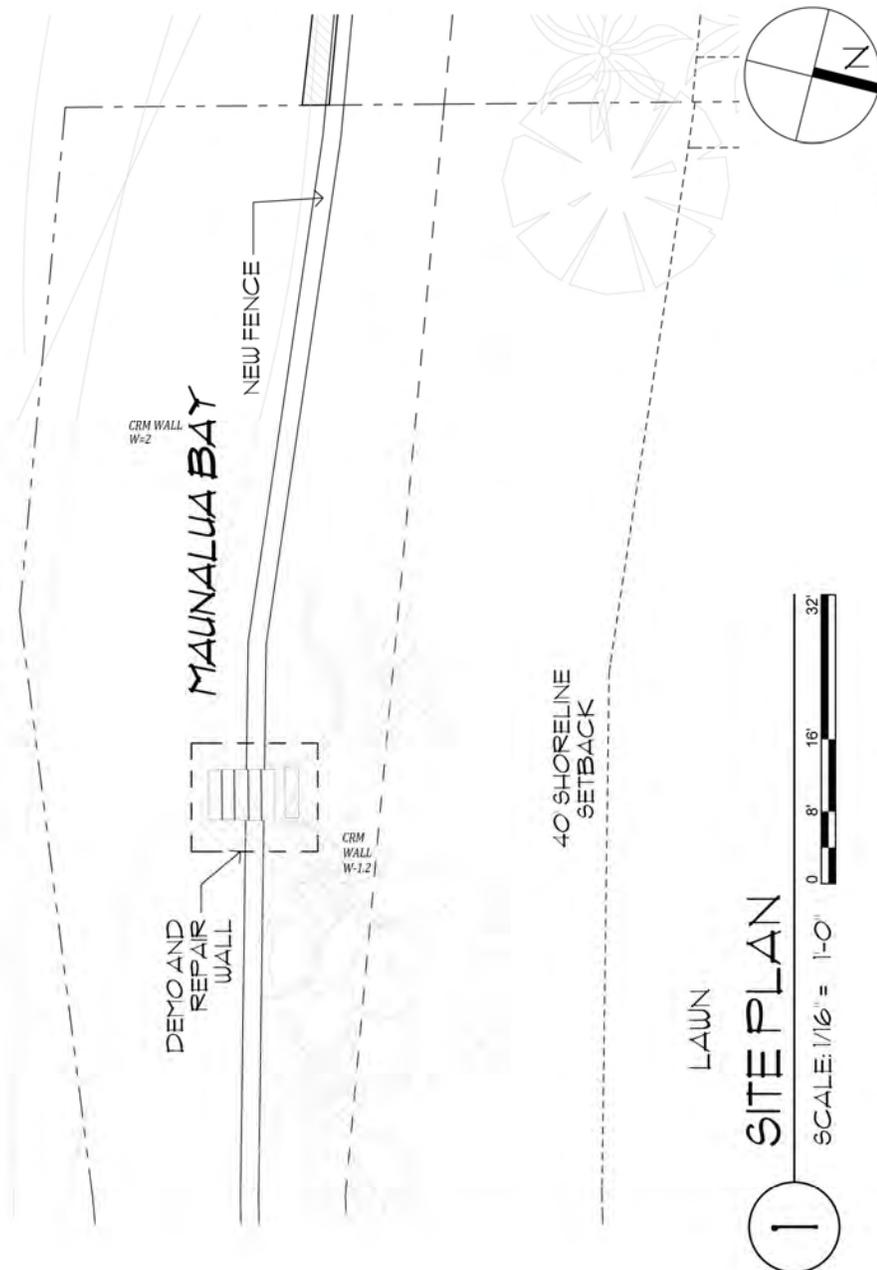
Figure 4B: Site Plan, Parcel 9

The seawall on parcel 9 is also constructed of CRM, but appears less damaged. Excavations will be done to determine if a support wall and/or solid footing will need to be constructed to maintain the wall's structural integrity. The seawall on parcel 9 has concrete steps crossing through that lead from the property to the adjacent beach. The applicant is proposing to remove these steps and fill the gap to complete the wall (Wall Retrofit Type V). The gap would be filled with CRM to match the existing wall, see Appendix B, Detail E.

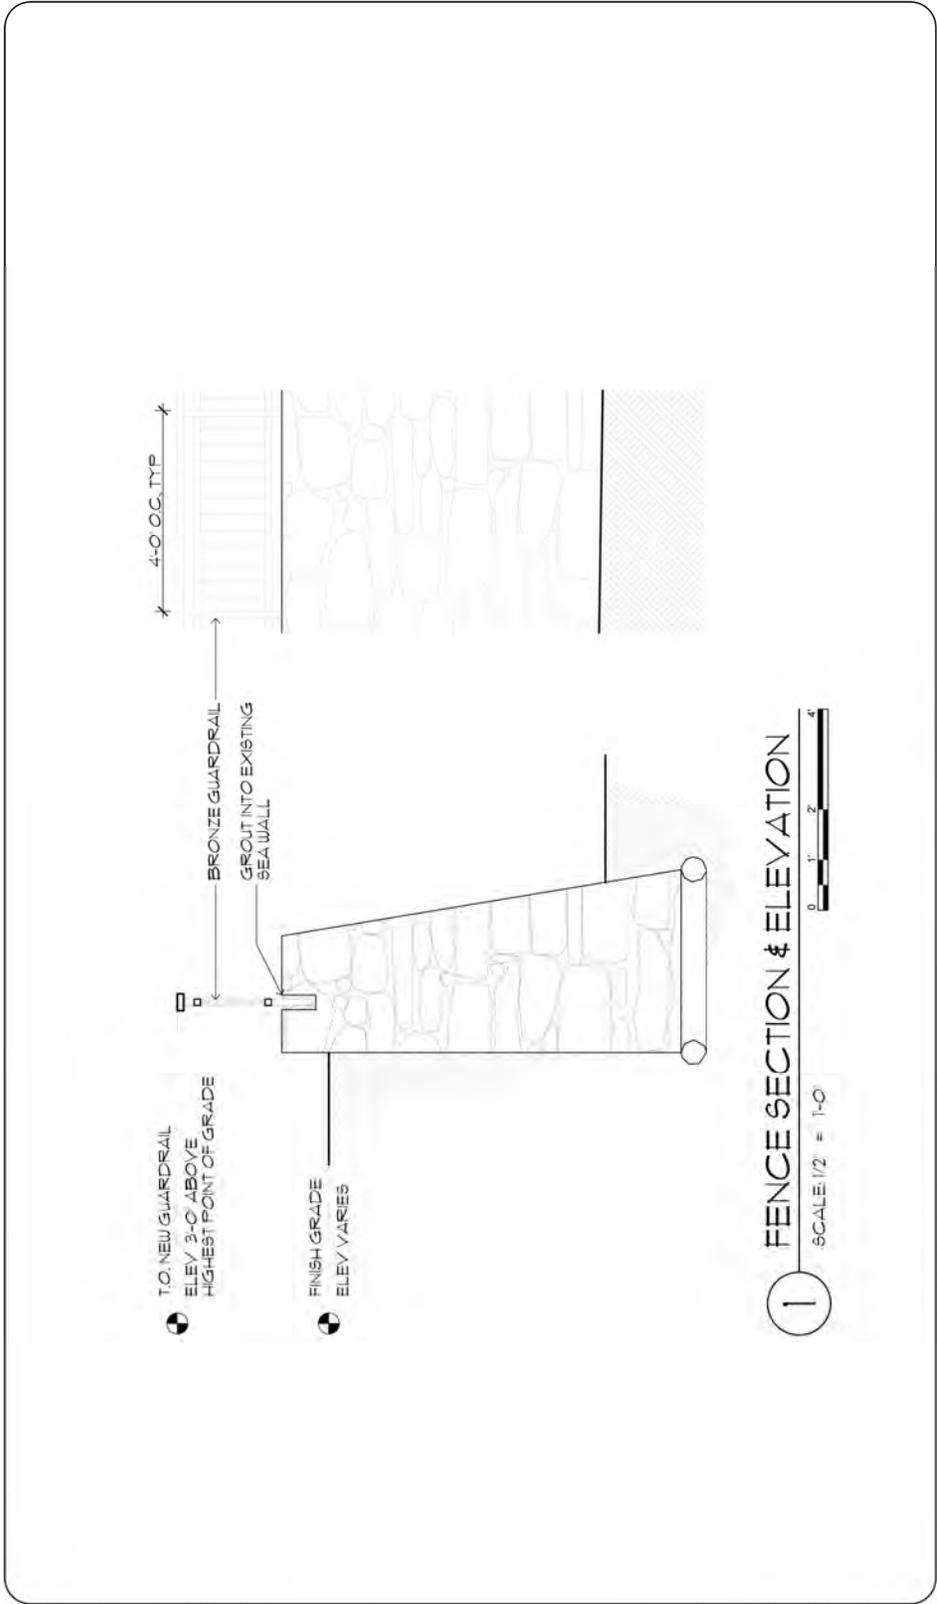
Figure 5: Fence Detail, Seawall

Drawing: Sea Wall fence  
 Date: 21 January 2010  
 Scale: As Noted  
 Ref. Dwg:

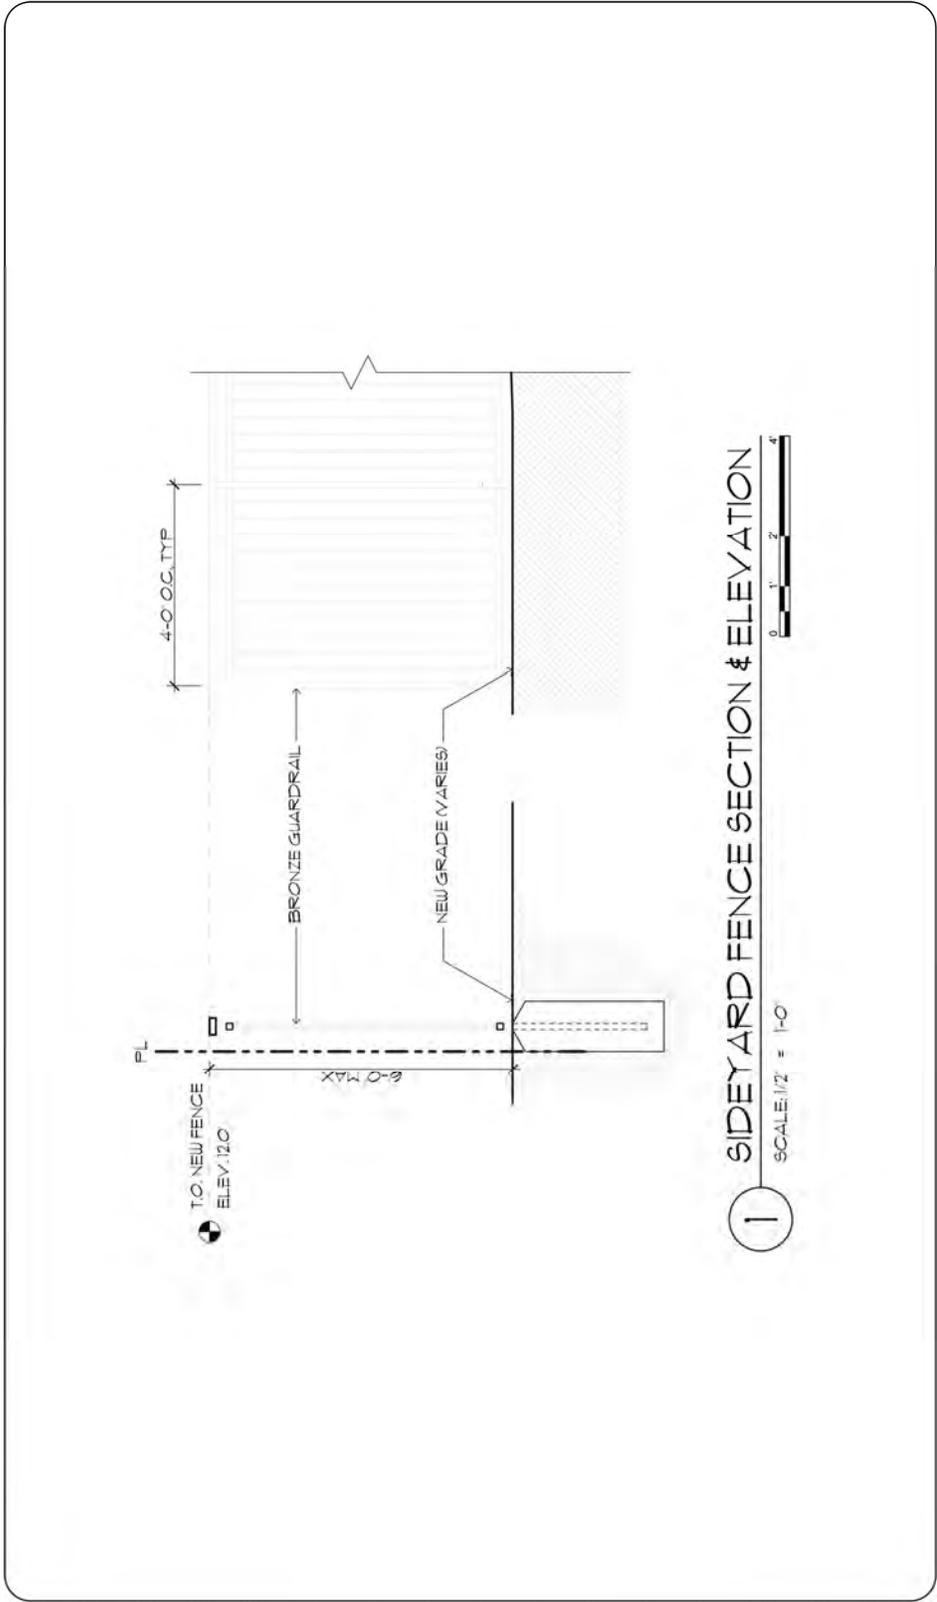
<b>WF Coastal Properties Sea Wall</b> Construction Documents 4423, 4433, and 4439 Kalia Avenue Honolulu, HI 96815	<b>Drawing:</b> Sideyard fence <b>Date:</b> 21 January 2010 <b>Scale:</b> As Noted <b>Ref. Dwg:</b>	Page
--	--	------

A Minor Shoreline Structure Permit is requested for the proposed replacement of an existing chain-link sideyard fence on parcel 10 with an open metal fence, and the replacement of a portion of an existing hollow tile wall on parcel 8 with an open metal sideyard fence. See Section 2.2.2.

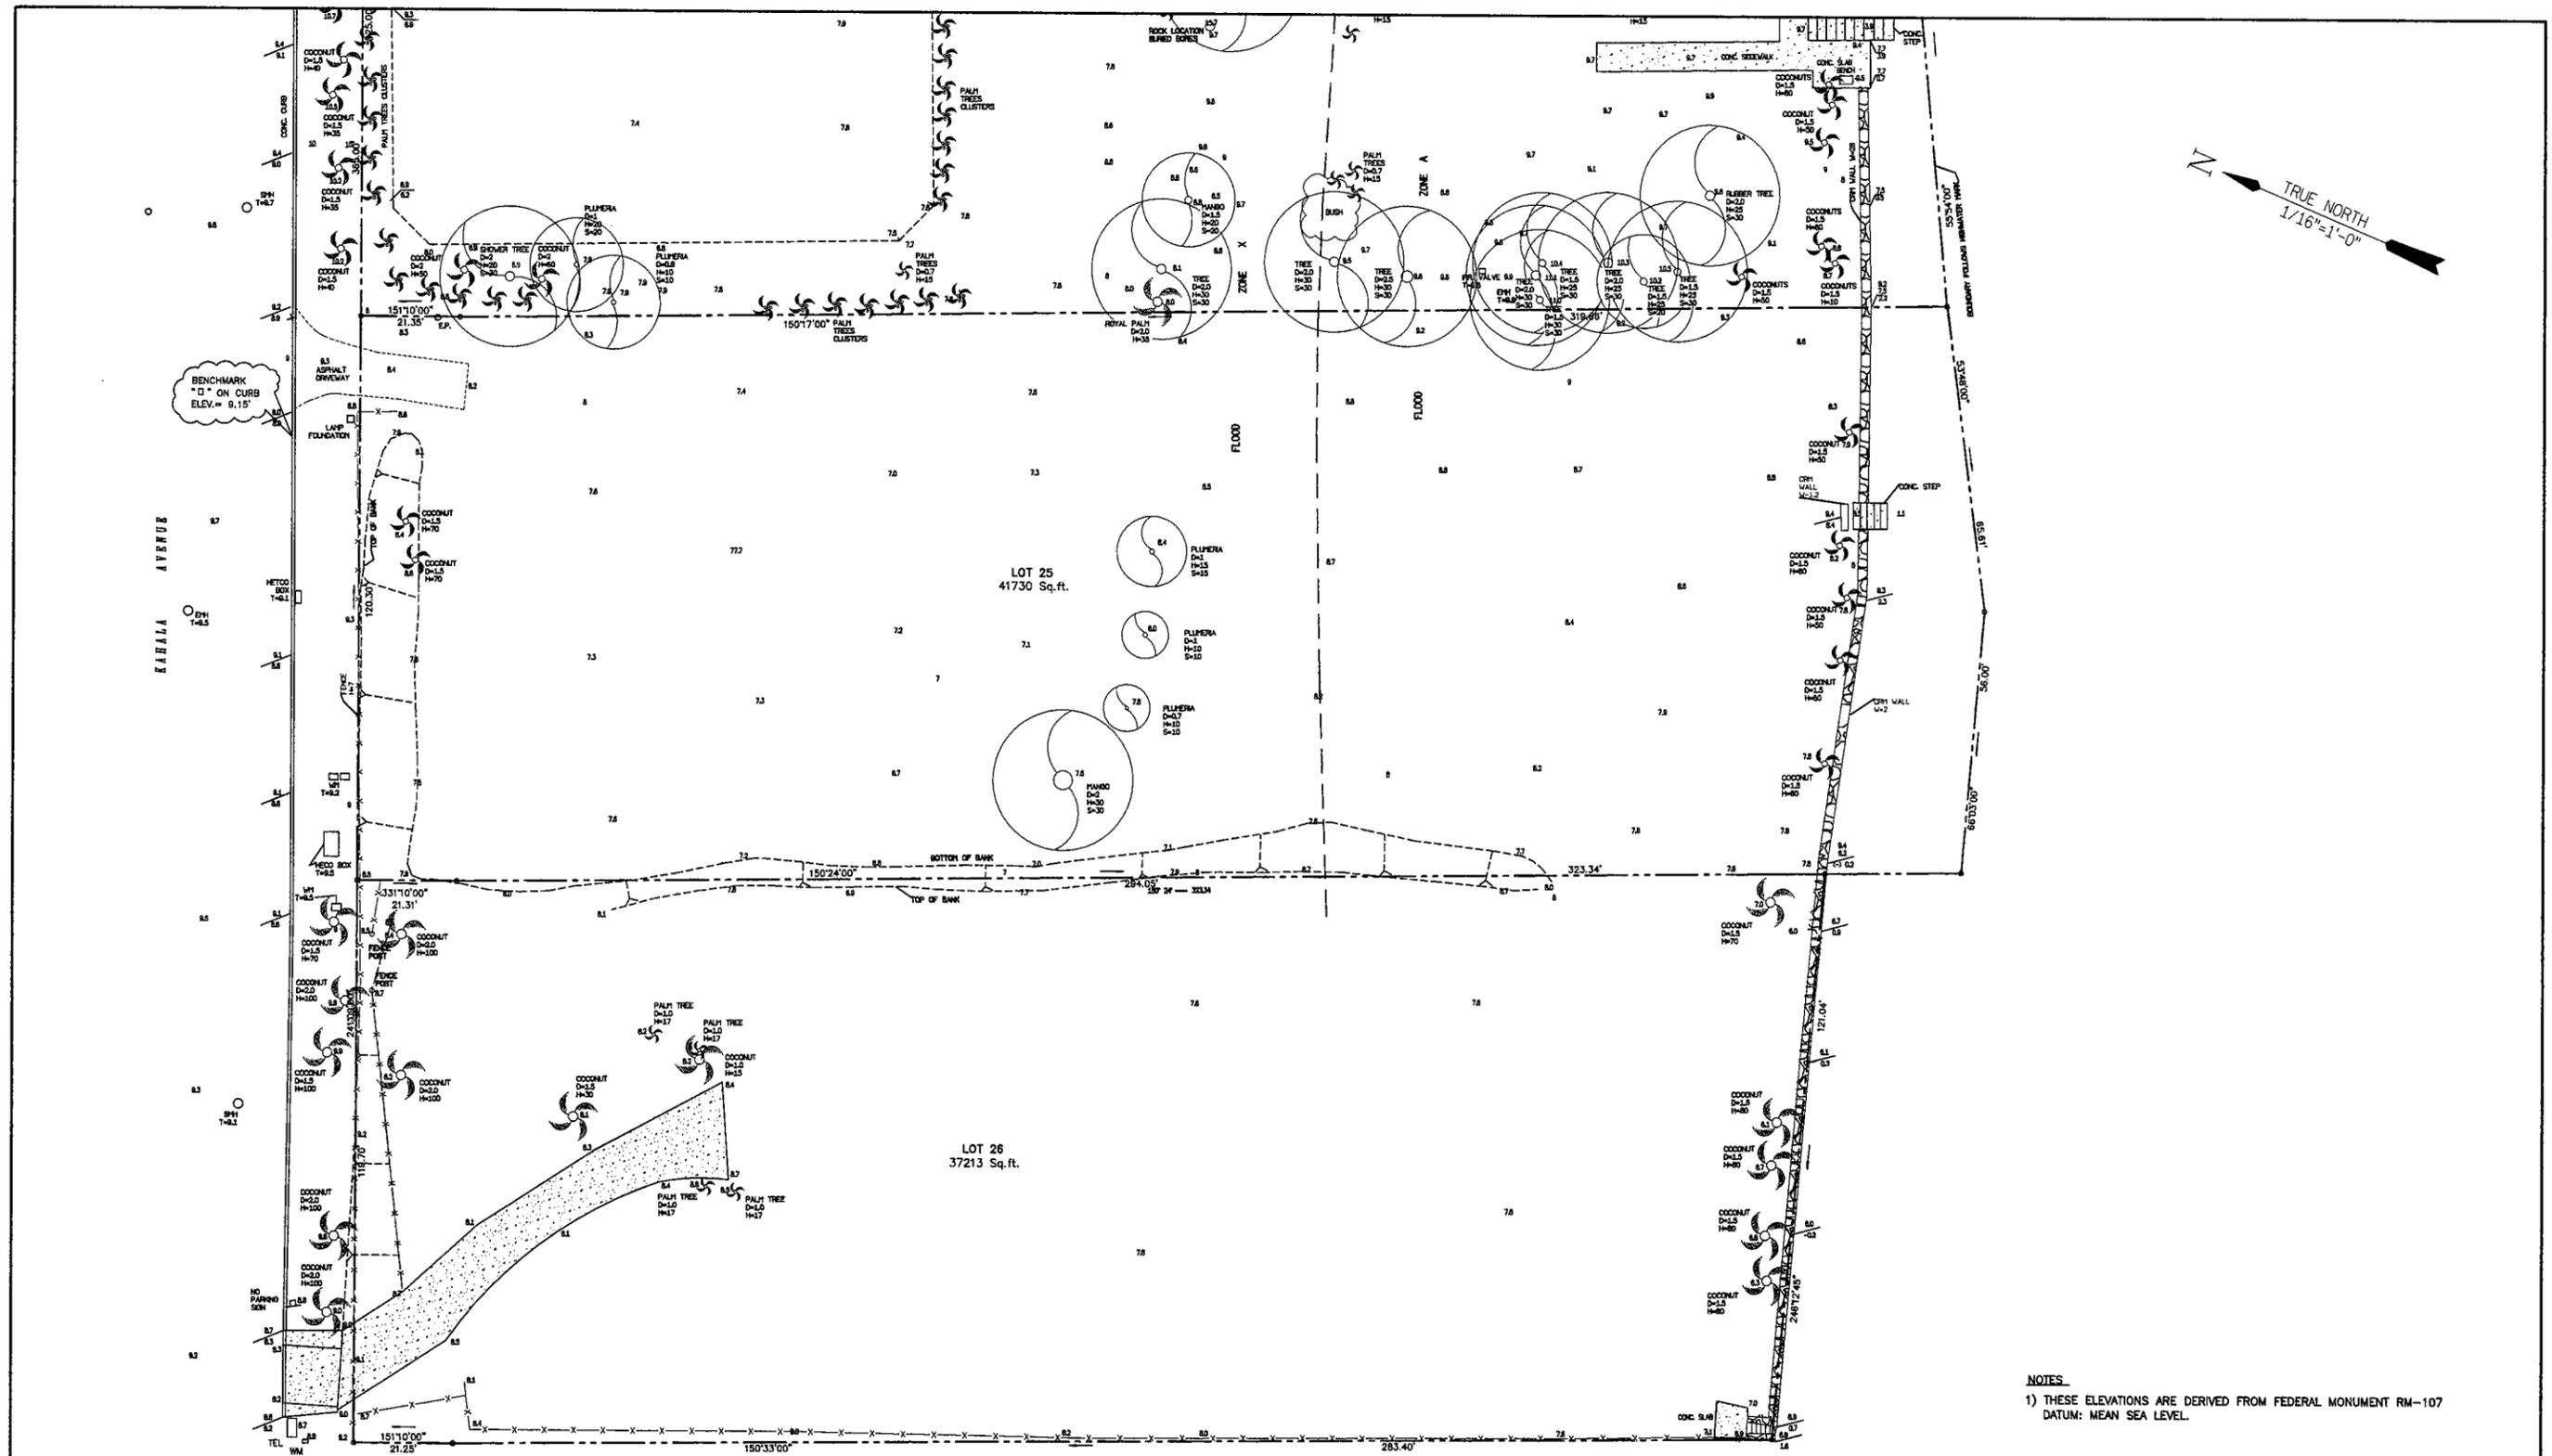
NOTES  
1) THESE ELEVATIONS ARE DERIVED FROM FEDERAL MONUMENT RM-107  
DATUM: MEAN SEA LEVEL.

TOPOGRAPHIC SURVEY			
TAX MAP KEY: 3-5-03: 8, 9, & 10			
SCALE: 1/16"=1'-0"	APPROVED BY:	DRAWN BY: NMH	
DATE: AUG. 20, 2007		REVISED:	
HONOLULU, OAHU, HAWAII			
FIELD BOOK DATA COLLECTOR, 411-54, 440-54			
DUNS SURVEYING & MAPPING, INC.			DRAWN BY: NMH
P.O. BOX 25636 HONOLULU, HAWAII 96825			03677

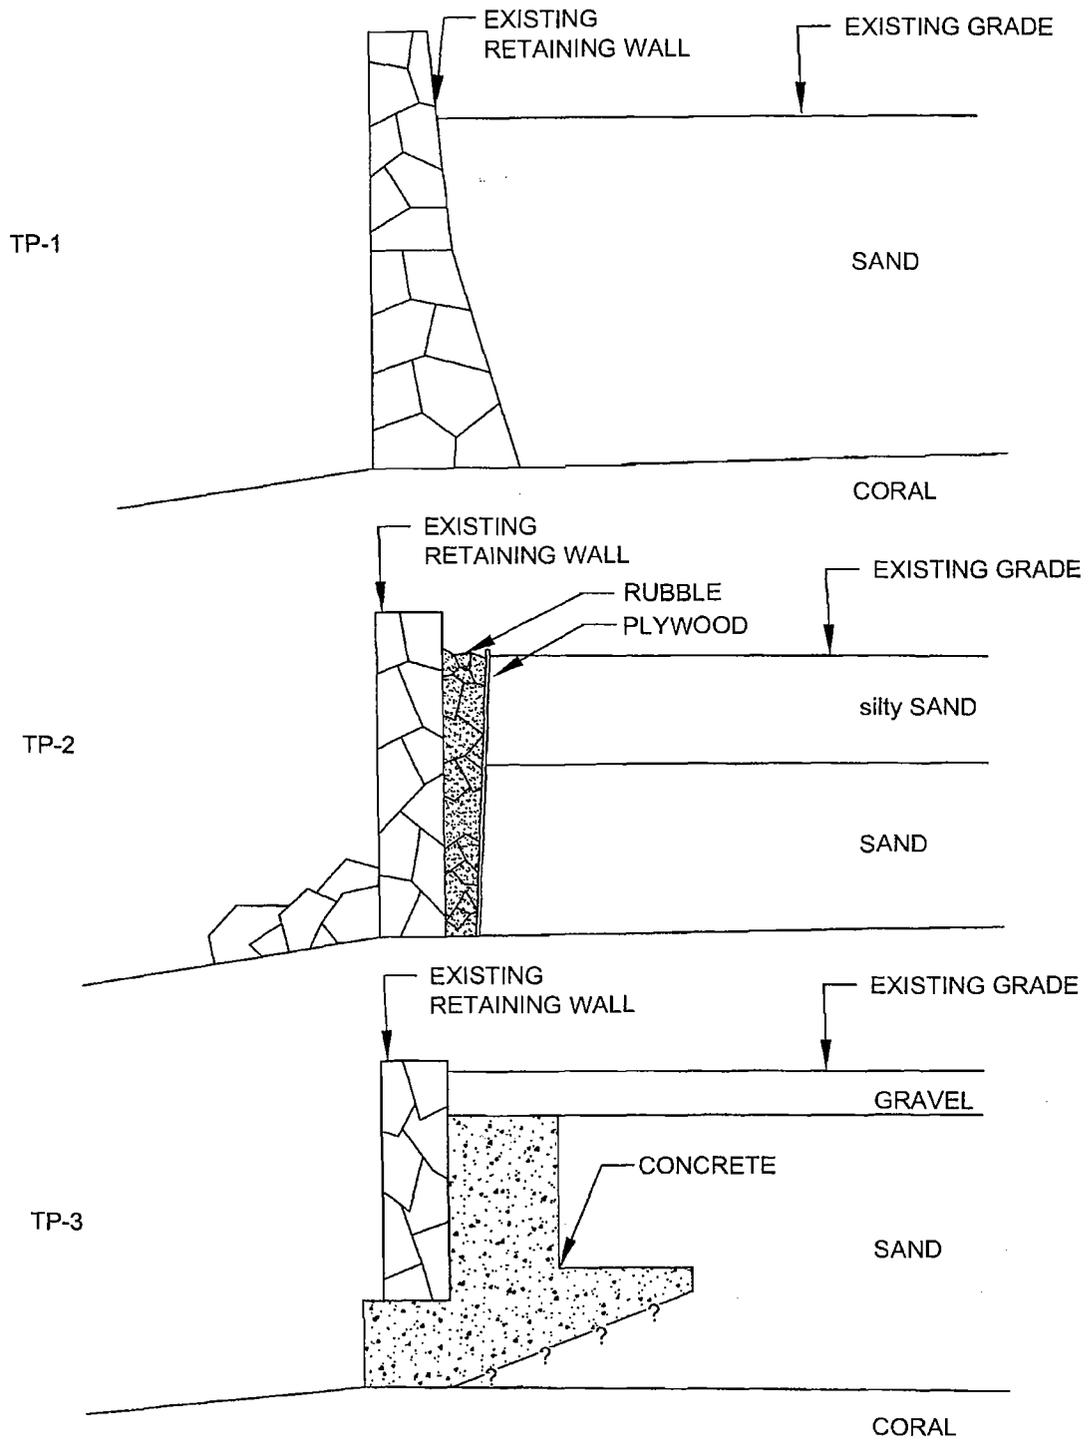
**RETAINING WALL SECTIONS**  
 SCALE: 1" = 4'

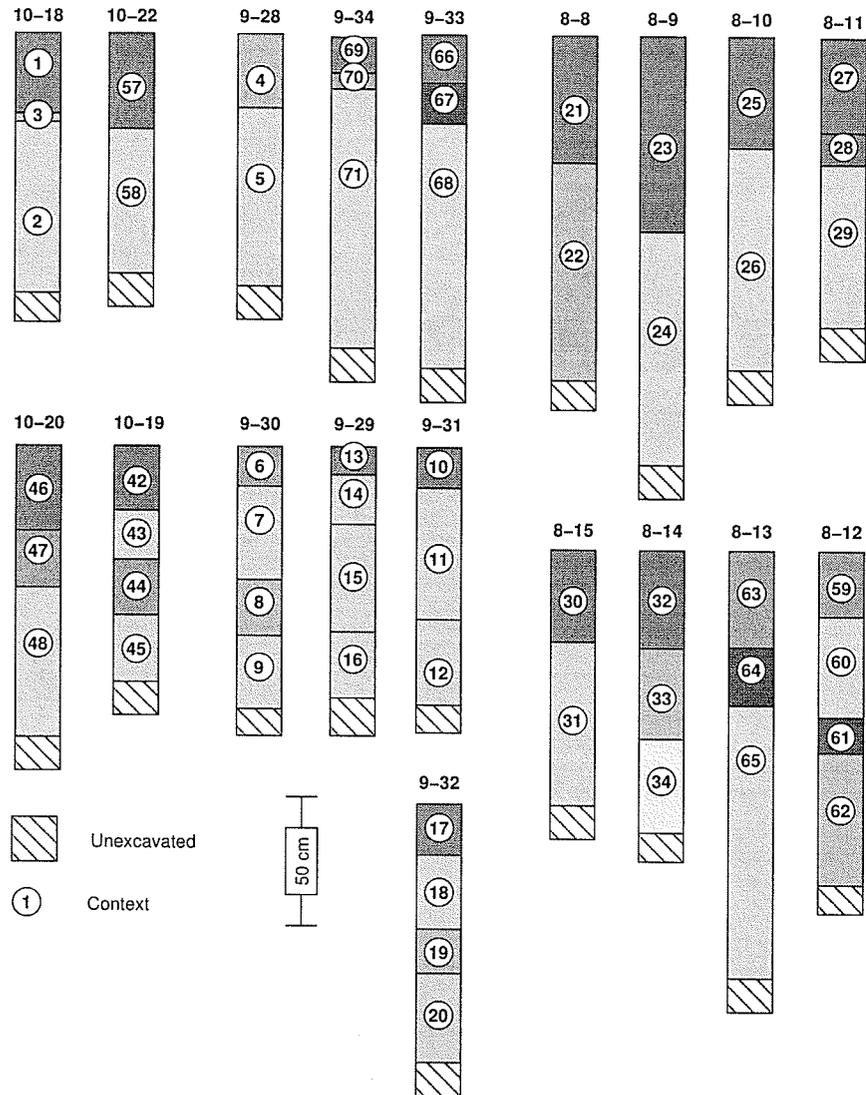
Figure 4. Stratigraphic profiles of shovel test units. See figure 3 on page 12 for locations of shovel test units.

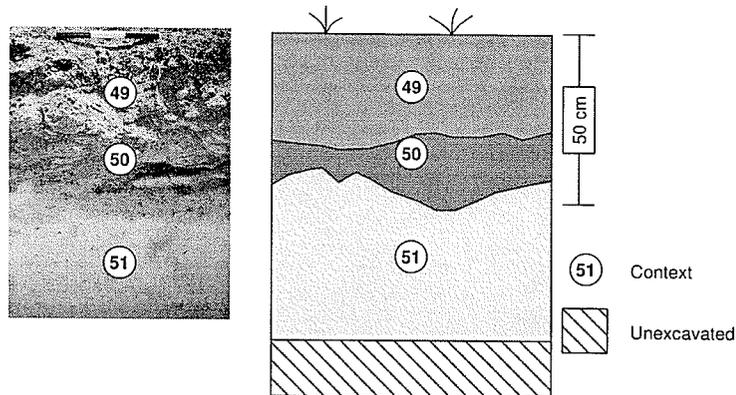
Figure 6. Stratigraphic profile of block 1 sondage. Note the disturbance evident in the paleosol, context 50. The scale bar in the photograph is marked in 10 cm increments.

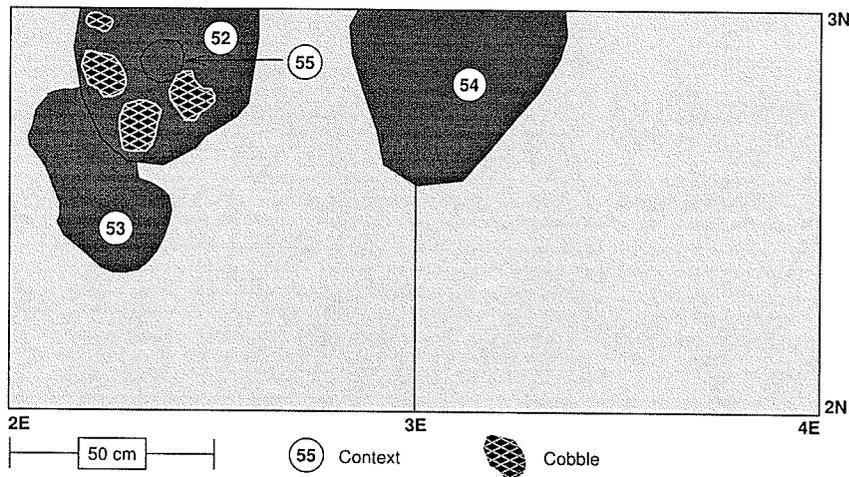
**Figure 7.** Plan view of features 1–4 in block 1. Note: Feature 1, context 52, is shown at 21 cm below surface; Feature 2, context 53, is shown at 34 cm below surface; Feature 3, context 54, is shown at 24 cm below surface; and Feature 4, context 55, is shown at 48 cm below surface.

Four subsurface features, all cut from the paleosol into the underlying calcareous sand, were identified (fig. 7). Feature 1, excavated as context 52, was a shallow, bowl-shaped pit filled with angular coral cobbles and a charcoal-rich sand matrix. The feature was approximately 40 cm in diameter when it was first identified at 20 cm below surface and was about 16 cm deep. Charcoal identified from the feature consisted of native shrubs and trees and coconut, which was introduced to the islands by Polynesians; no historically-introduced taxa were identified (see section 4). Feature 2, excavated as context 53, was an irregularly shaped, 1.5 cm thick deposit of charcoal-rich sand first discovered at 34 cm

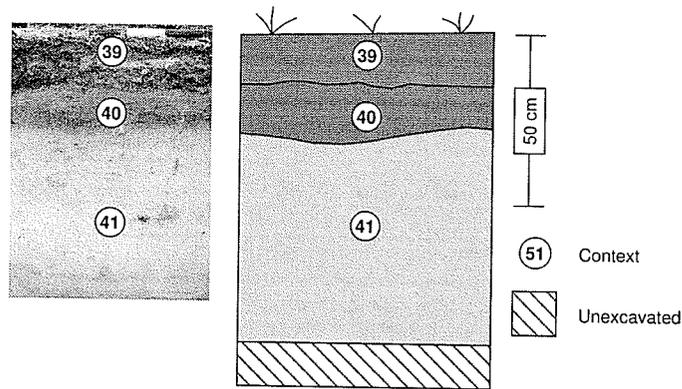
Figure 9. Stratigraphic profile of block 2 sondage. The scale bar in the photograph is marked in 10 cm increments.

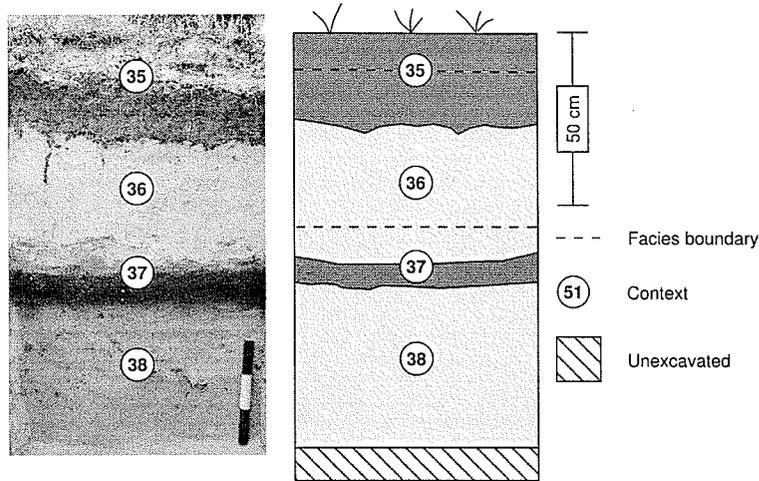
Figure 11. Stratigraphic profile of block 3 sondage. The scale bar in the photograph is marked in 10 cm increments.

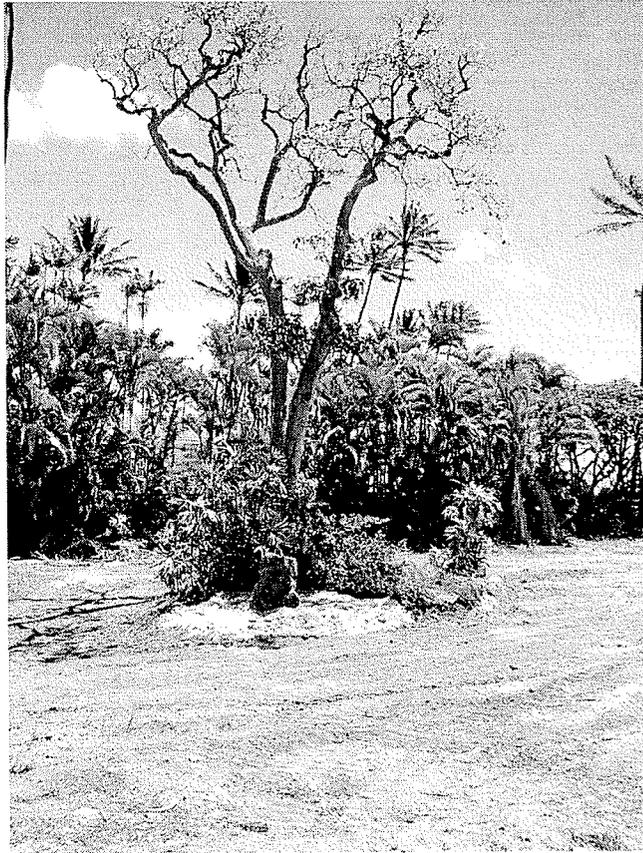
Figure 12. Location of the re-interment site marked by white sand and an upright boulder, looking east. Note the *kukui* tree. The scale is marked in 10 cm increments. See figure 3 on page 12 for the location of the reinterment site at site 50-80-14-5320 in parcel 8.

The Archaeological Inventory Survey, prepared by T.S. Dye & Colleagues, Archaeologists, Inc., verifies the location of State site 50-80-14-5320, as well as the moderate- to high-probability of encountering burials all along Kahala Avenue. The burial site on the subject properties is a reburial of the remains of three historic era (19<sup>th</sup> century) individuals that were discovered inadvertently during construction activities that took place in the 1990s. The State site is located on parcel 8, see Figure 3 of Appendix E, and is marked by an elongate basalt boulder located directly above, see Figure 12 of Appendix E.

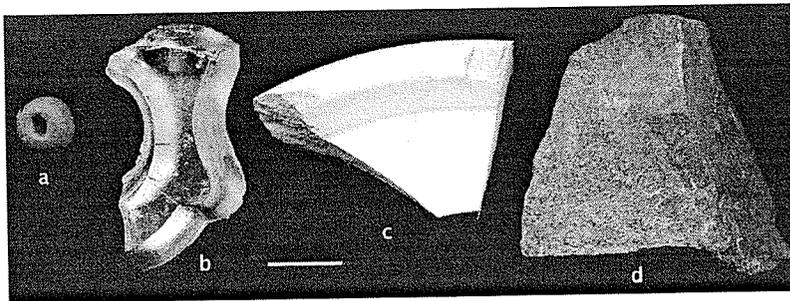
Figure 13. Artifacts from phase 2 deposits: *a*, glass bead, block 2; *b*, glass pitcher or vase handle(?), block 2; *c*, white ware plate base sherd, block 3; *d*, possible basalt flake, block 1. The scale bar is 1 cm.

Forty-nine artifacts were collected during the excavations (table 5). Except for a possible basalt flake (fig. 13*d*), which might possibly be a traditional Hawaiian artifact, the other 48 artifacts are all made of modern materials and belong to the historic era. Most of these are housewares, such as ceramic plates (fig. 13*c*) and glassware (fig. 13*b*), and other items that are typically found around modern homes. Most of these items probably derived from activities that took place in the twentieth century, after Kāhala became a residential neighborhood in the 1930s. The one possible exception to this generalization is a red glass bead (fig. 13*a*) that is similar to beads that were popular in Hawai'i in the nineteenth century. The bead is not sufficiently distinct that it can be dated more precisely, but it might provide some evidence for use of the survey area prior to the 1930s.

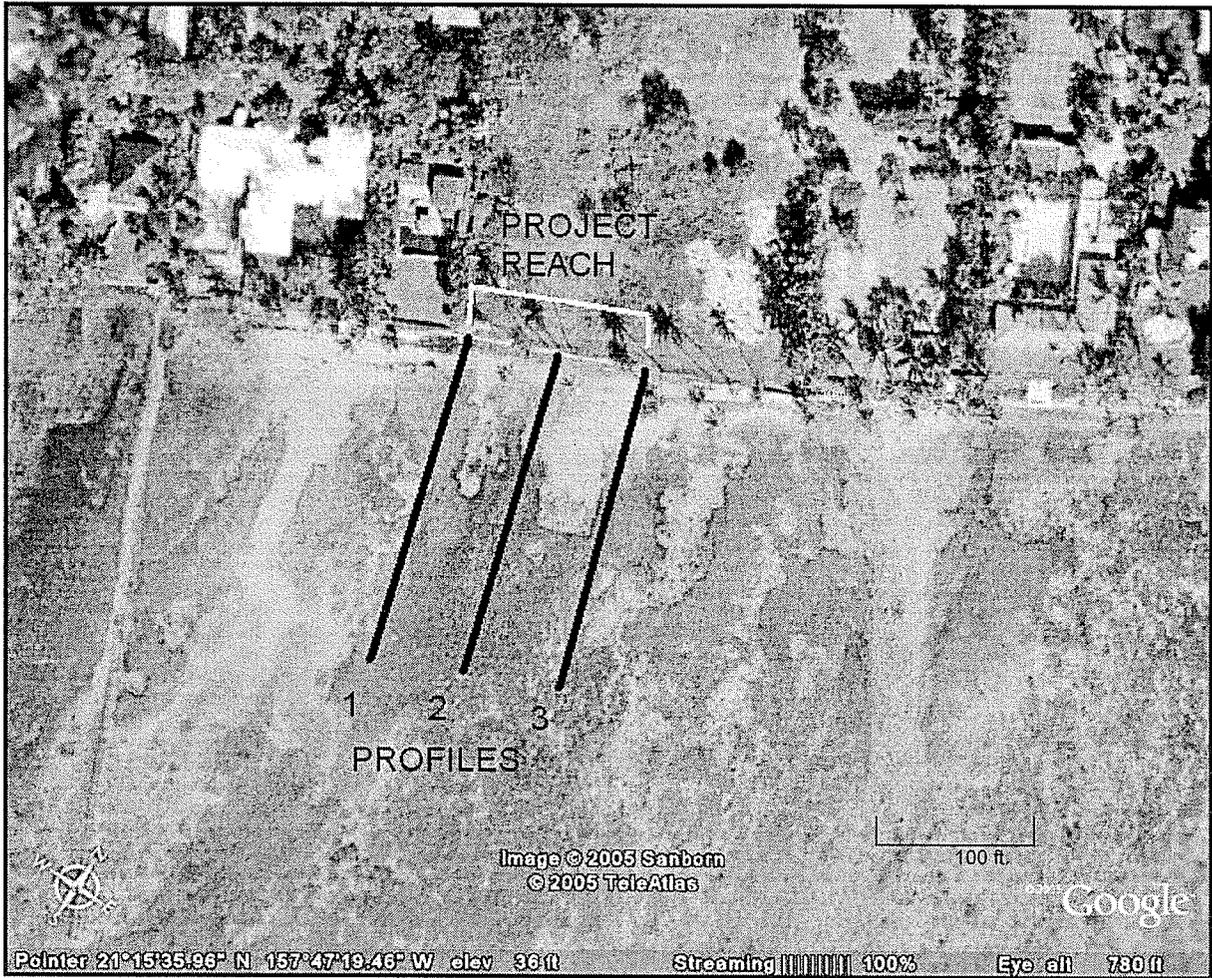
Figure 1-3. Aerial Photograph of Project Site (2) showing the project reach and profile locations (from Google Earth)

This coastal engineering assessment has been prepared as part of a project to repair a seawall fronting a shoreline lot in Kahala on the south shore of Oahu. The project site is located east of Diamond Head at 4415 Kahala Avenue, between Elepaio St. and Kala St. Three adjacent properties at 4415, 4423, and 4433 Kahala Avenue (TMK 3-5-059, parcels 10, 9, and 8, respectively) are proposed for development. Although similar protective seawalls front all three properties, repairs are necessary at only the western-most lot (parcel 10). The regional location of the project is shown in Figure 1-1. Figures 1-2 and 1-3 are aerial photographs of the site.

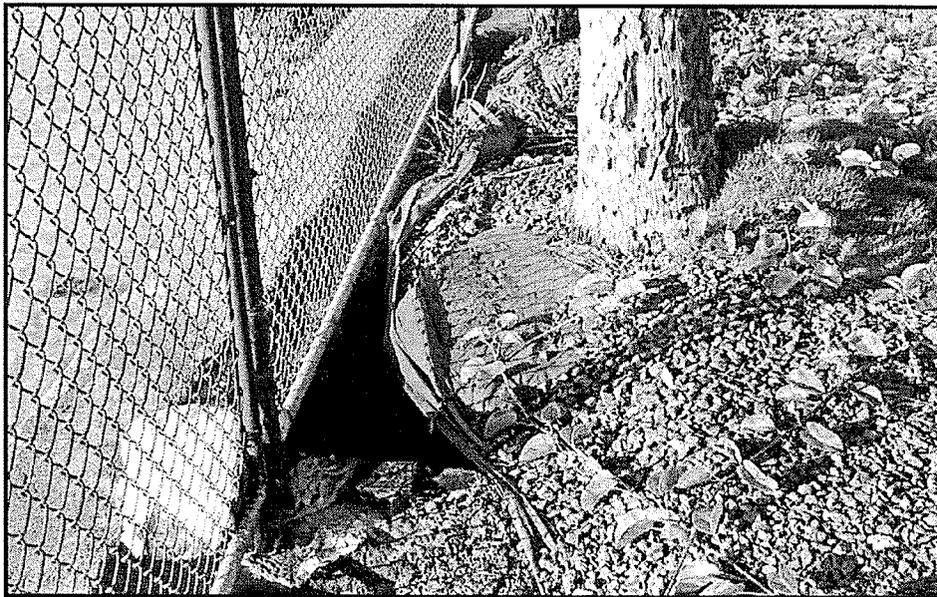
**Figure 1-5. Sinkhole formation behind the seawall**

According to the coastal engineering report, “the no action alternative would result in the gradual deterioration of the existing seawall.” The existing sinkholes which are evidenced by large depressions adjacent to the seawall would continue to expand and deepen until eventual failure of the wall. If the wall were allowed to fail, large amounts of soil and debris would spill into the nearshore area. Erosion of the property would persist endangering the adjacent properties. High wave events would make erosion particularly severe causing high turbidity. Property loss would result.

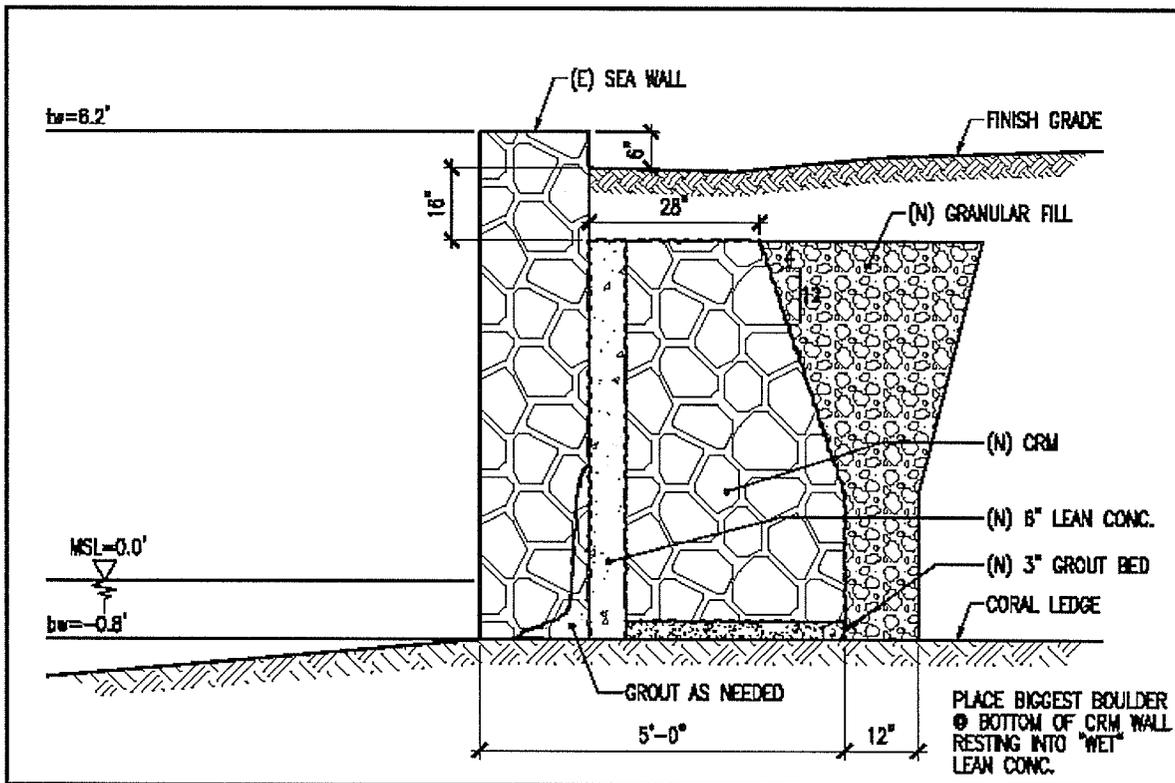
Figure 1-6. Typical seawall repair (N indicates new work)

A typical section for seawall repair is shown in Figure 1-6. Repairs vary somewhat at different sections of the wall, however all construction for the repairs will take place on the landward side of the wall.

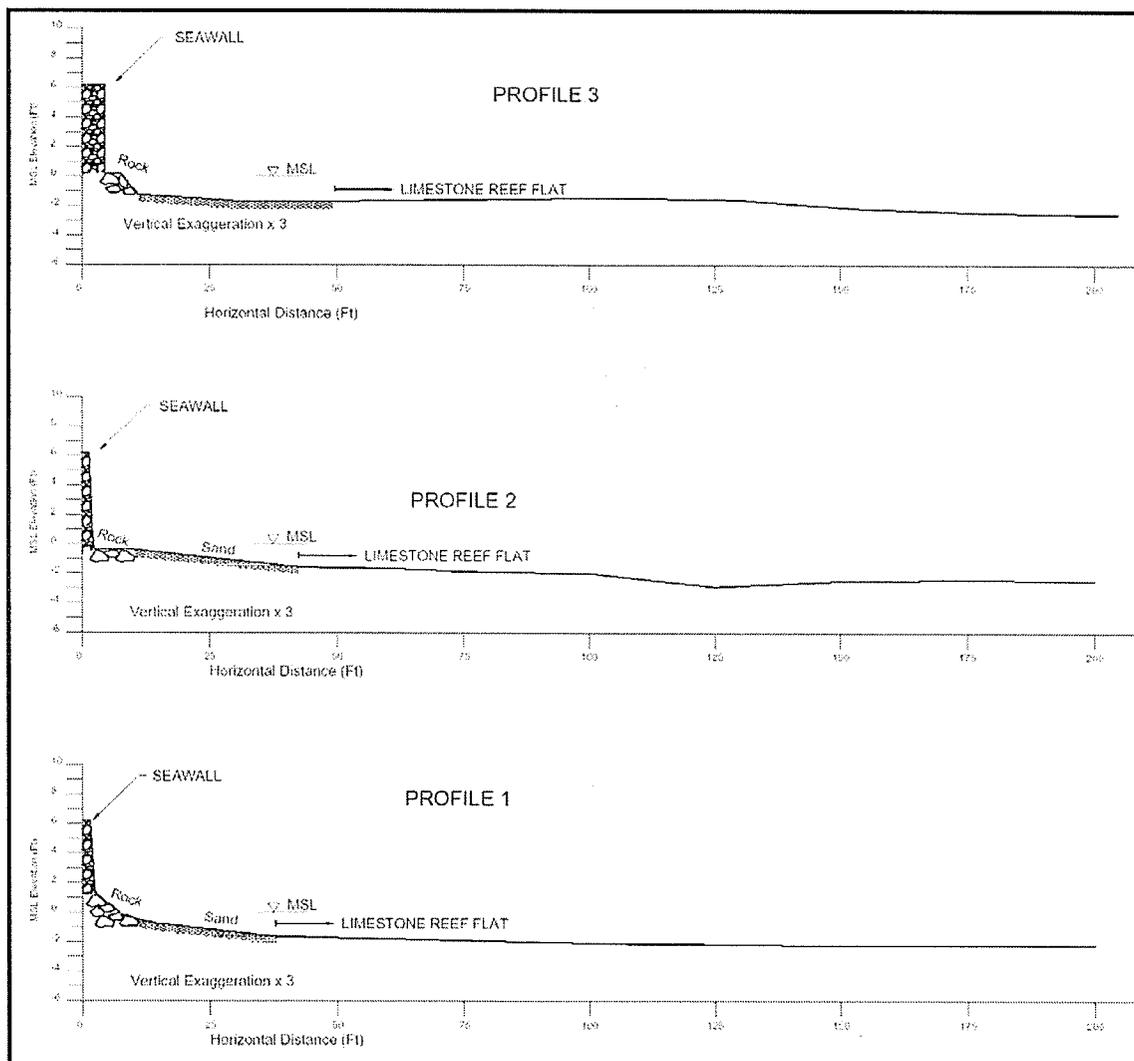
Figure 2-3. Beach profiles

Three beach profiles were taken at the project site, at either end and at the middle of the property shoreline, extending 200 feet offshore. The locations of the profiles are shown in Figure 1-3. The profiles are shown in Figure 2-3. All profiles are similar, showing a near vertical seawall with an elevation just over 6 feet msl, some form of hard rock adjacent to the wall, a short sandy section less than 50 feet in width, and a wide expanse of limestone reef without appreciable elevation change. The sand is typically a few inches or less in thickness. The limestone reef flat has a typical relief less than 0.5 feet. Some areas in the reef flat appear to have been excavated on the order of 1 foot. These areas can be seen in the aerial photographs (e.g. Figure 1-3) and are often delineated by straight excavation edges and corners. The reef flat elevation is typically about -1.5 feet msl 50 feet offshore, and grades to about -2.5 feet at 200 feet offshore.

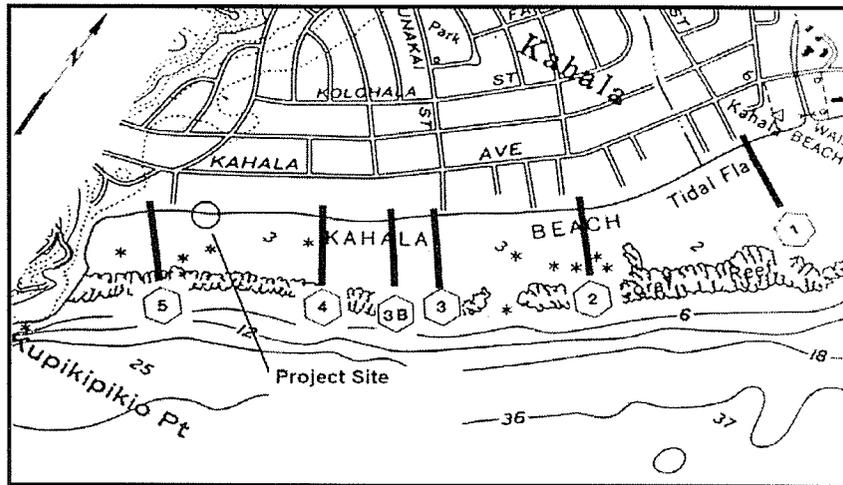
Figure 2-4. Erosion study transect locations (SEI 1988)

The SEI study shows transects on either side of the project site. Transect 5, west of the site, showed a net erosion of 8 feet between 1949 and 1988. Transect 4, east of the site showed a net accretion of 3 feet during the same time period. There does not appear to have been a statistical regional trend of erosion or accretion during the study period at the west end of Kahala Beach, although the prolific seawall construction indicates a probable erosion hazard.
