Draft Environmental Assessment  
for a  
Shoreline Setback Variance Application for a Seawall  
Makaha, Oahu, Hawaii  
TMK: 8-4-006:007

September 2010

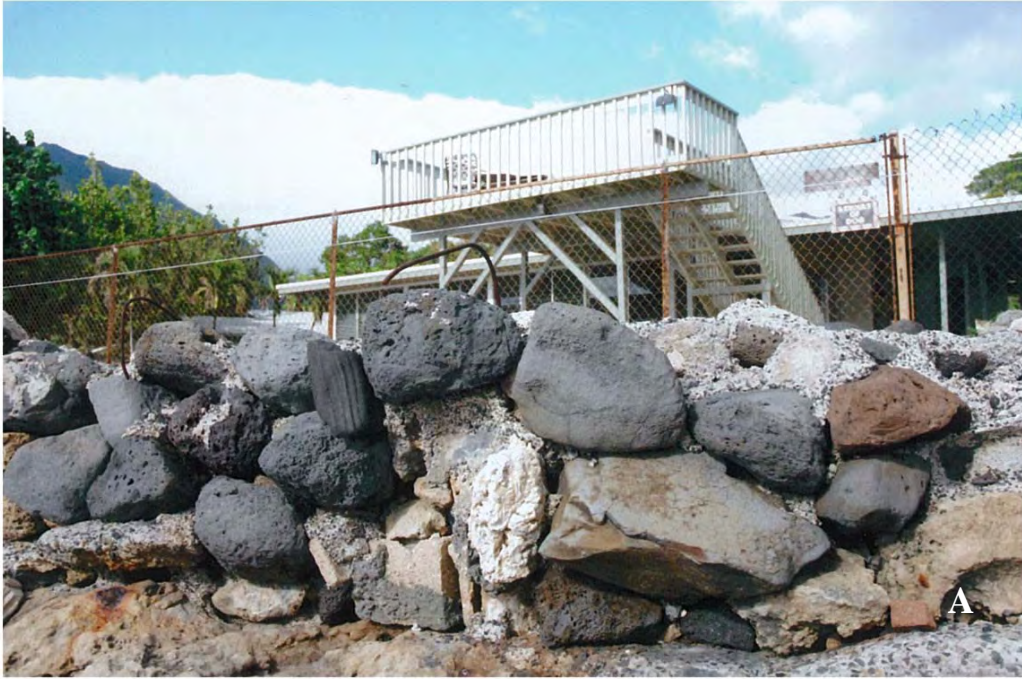
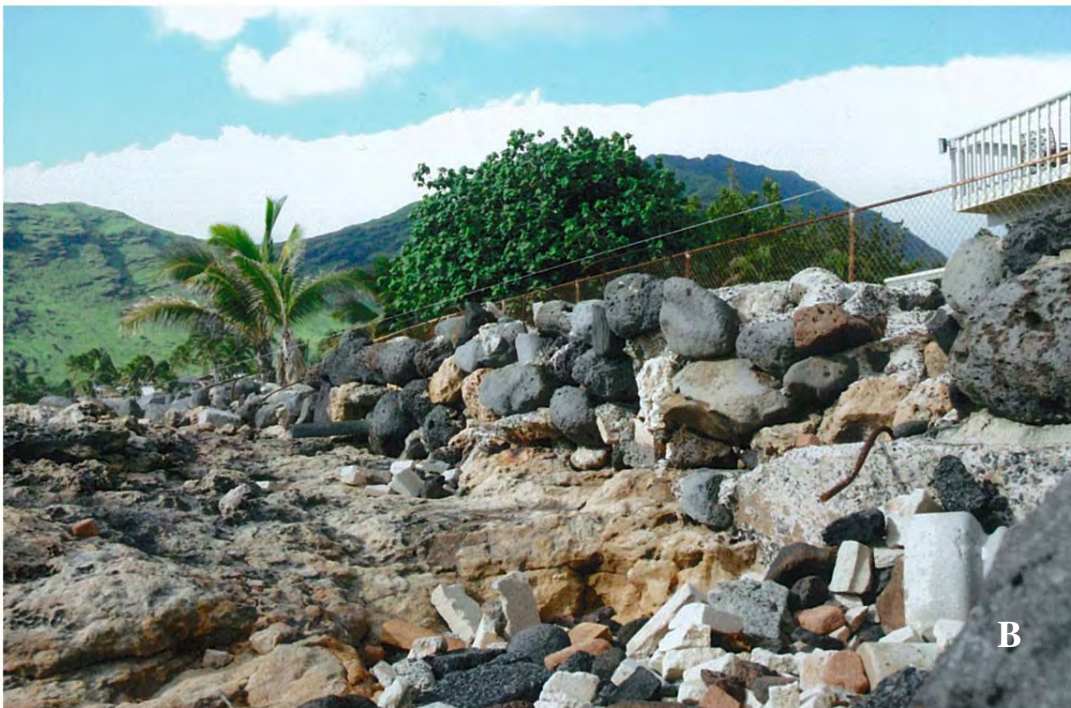
**Figure 1. Shoreline Structures in 2005**

A. 2005 rock and concrete rubble seawall on the makai side of a rusty chainlink fence

B. 2005 rock and concrete rubble seawall

When the Ochis purchased the property in 2005, there was rusty chainlink fence and a rock and concrete rubble seawall along the makai property boundary. Photos taken in 2005 and presented in this EA as Figures 1, 2, and 3 show a rock and concrete rubble seawall on the makai side of a rusty chainlink fence. Evidence of weathering visible in the photo indicates that the rock and concrete rubble seawall and the rusty chainlink fence had been there for some time and were possibly built before 1966. No evidence indicating when the original rock and concrete rubble seawall was emplaced or when it was permitted has been found in records at the DPP.

Due to wear and tear by the elements (waves moving the rocks and corrosion of the metal posts and fencing), the rusted chainlink fence and rock and concrete rubble seawall were in a state of disrepair when the Ochis purchased the property in 2005. In 2006, the Ochi's removed the fence and replaced the rock and concrete rubble seawall with a substantial concrete, rock, and masonry (CRM) seawall. A renter in a neighboring house reported to DPP that the Ochis were repairing their existing seawall. Later that year, the Ochis received a notice of violation from the DPP dated May 9, 2006. The notice stated that "the existing seawall at the rear of the property was being reconstructed without first obtaining a building permit." The Ochis tried to obtain a permit, but the permit was not granted because there was no documentation on the original wall.

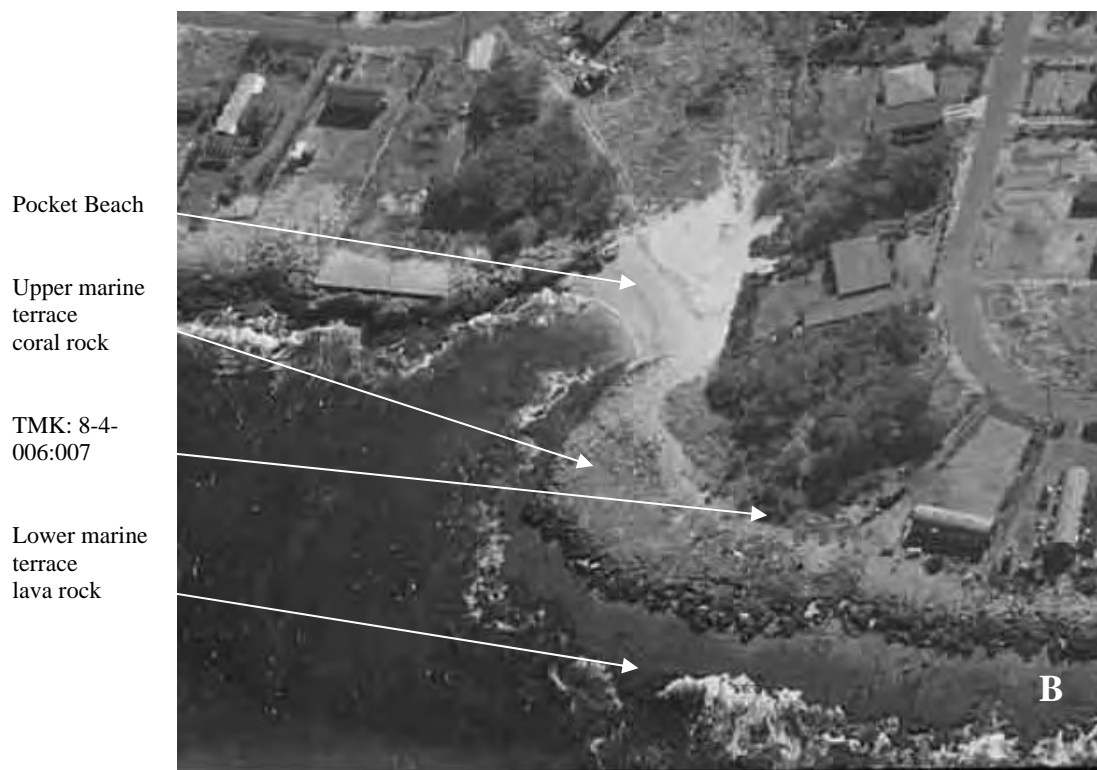
**Figure 2. Aerial Photos**

B. Aerial View 1951

To the north, the marine terraces are wide enough to provide public access parallel to the sea and the seawalls. To the south, there is no safe access that runs parallel to the shoreline. The wave-cut terraces are very narrow in places and lateral coastal access appears to be impossible without trespassing onto private property (Figures 2, 4 & 5).

All the adjacent and other nearby properties are fronted by shoreline protection structures such as seawalls and fences (see Figures 2 & 5). Most of the seawalls in the vicinity are permitted, and the parcels have received certified shorelines (Table 1).

The shoreline in the project area consists of a rocky, basalt lower marine terrace that extends seaward from under a limestone upper marine terrace (Figures 2, 5 & 8). The lower marine terrace averages 2.45 feet above mean sea level, and at low tide, the face of the lower terrace receives most wave impacts. The lower marine terrace is covered with brown marine algae and tide pools. The upper marine terrace is a limestone fossil reef that slopes gently toward the sea. The elevation of the upper terrace averages from 3.12 to 8.11 feet amsl. These rocky marine terraces are resistant to erosion, and standard sources give no erosion rate for the area (Fletcher et. al. 2002, Fletcher et. al, 2009, Hwang 1981). In spite of the fact that the rocky outcrops themselves are resistant to erosion, soil, vegetation and structures on the upper marine terrace can be impacted by wave action.

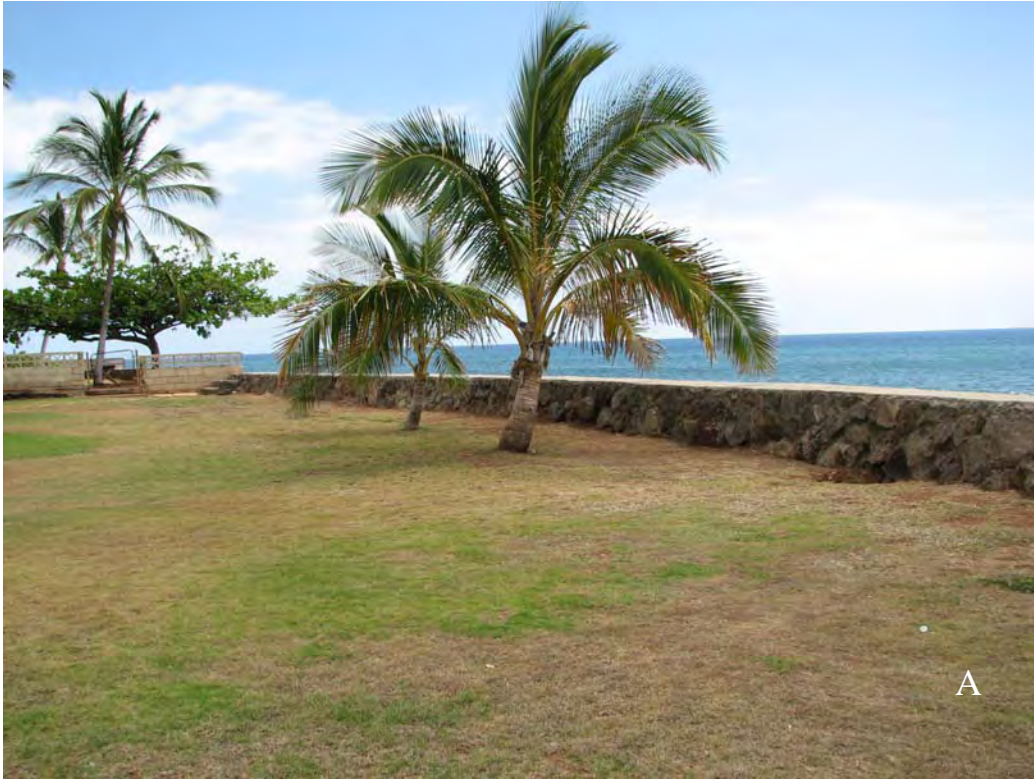
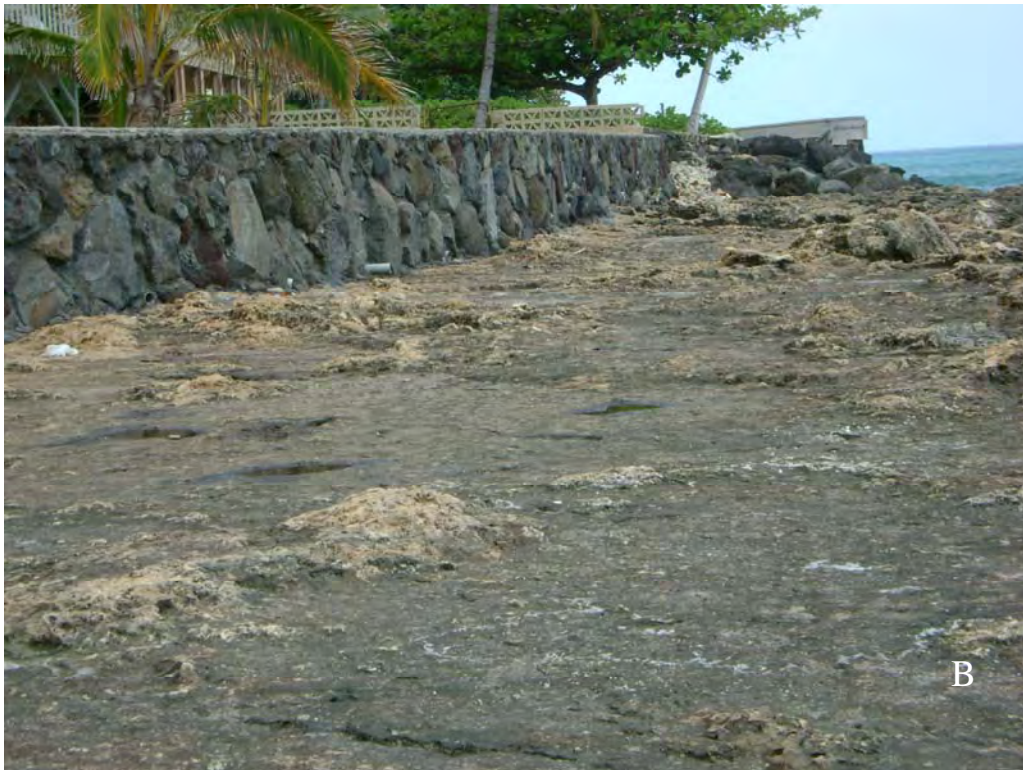
**Figure 7. Existing CRM Wall**

A. Mauka side of the existing CRM seawall

B. Makai side of the existing CRM seawall

Tom Tanimura, P.E., of Tanimura & Associates, Inc., consulting structural engineers, inspected the seawall on October 5, 2009, to determine if the seawall was structurally sound. Next, he prepared an engineered drawing showing the dimensions of the seawall and depicting its condition (Appendix D). The structure is a one-level CRM seawall with a width of 2 feet 10 inches and a height that varies due to irregularities of the surface of the marine terrace. On the makai side of the wall, the maximum height is 6 feet above the marine terrace, and the average height of the entire wall is 5.75 feet. On the mauka side, the maximum height above ground level is 2.64 feet, and the average height is 2.42 feet.

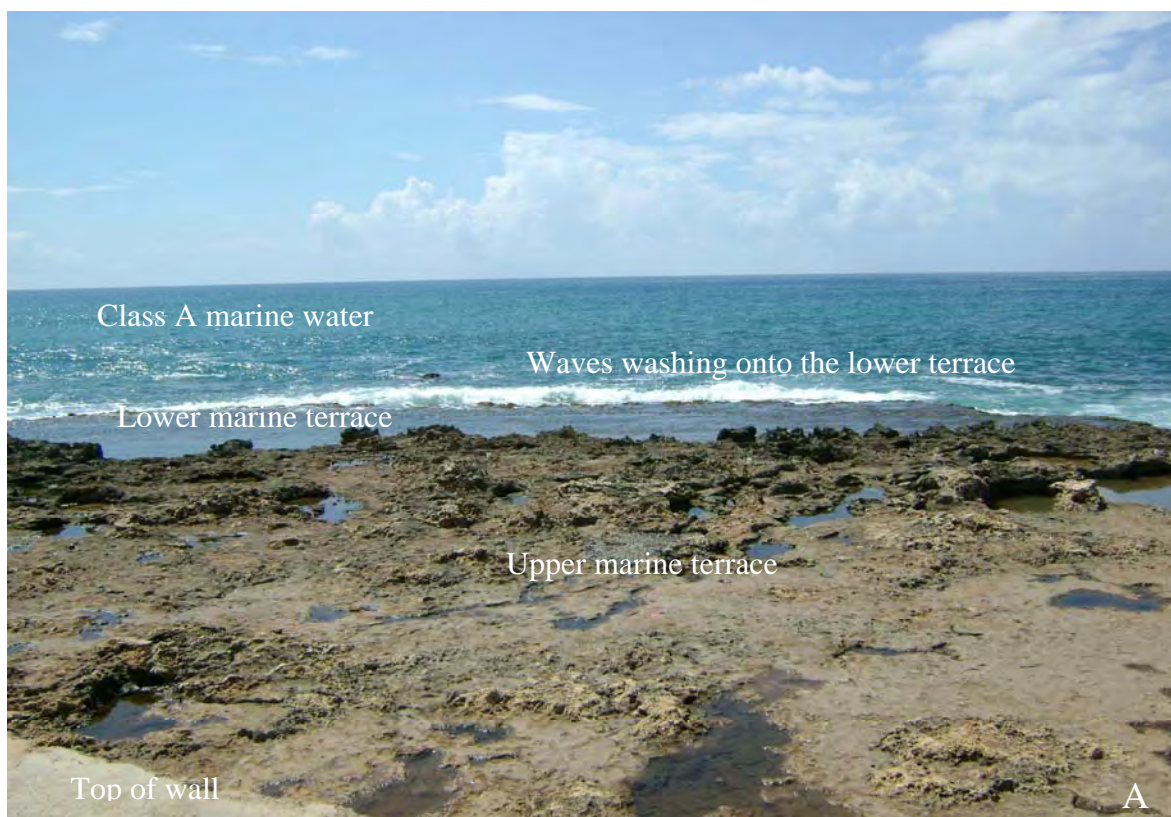
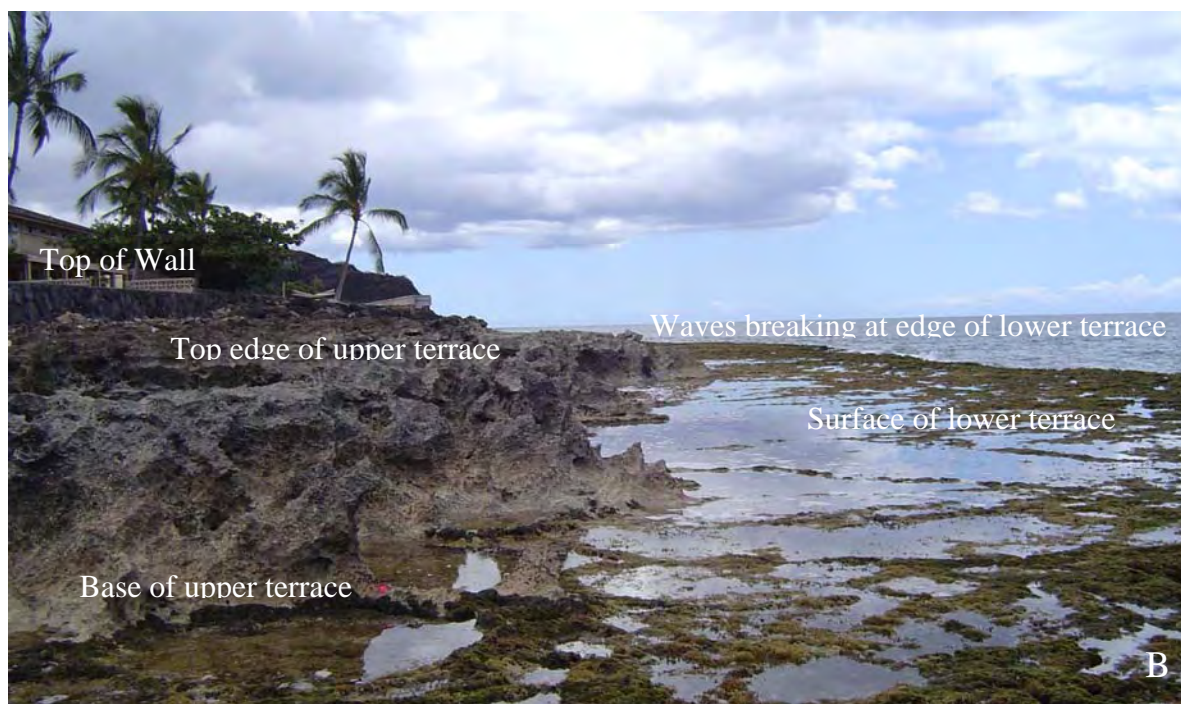
**Figure 8. Marine Terraces**

A. Marine terraces with a falling tide washing onto the lower terrace

B. Marine terraces at a low tide with waves breaking at the edge of the lower terrace.

At low tide, during normal sea conditions, waves hit the face of the lower terrace, and water washes over its upper surface, reflects off the face of the upper terrace, and flows seaward again. When tides are exceptionally high, the waves wash over the upper rocky outcrop and flow back off the marine terraces to the sea. At the Ochi's property, during episodes of high surf, storm surges, and other extreme conditions, waves hit the rock faces of both terraces with such force that the water is propelled onto the surface of the upper terrace and travels 40 feet or more inland, where it strikes the seawall and is reflected back along the surface of the terraces, into the ocean. If the seawall were not in place, the waves would erode the property by removing soil, vegetation, and other debris from the parcel and transporting it into the Class A Marine Waters offshore.

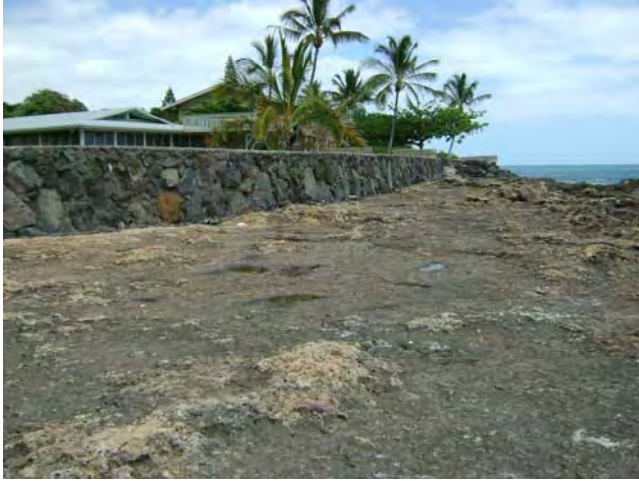
Photograph 1: Wall along TMK 8-4-006:007

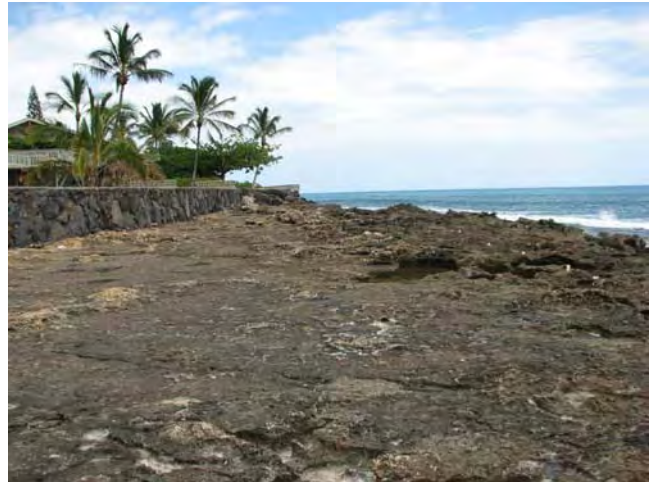
Photograph 2: The coralline limestone platform fronting the wall

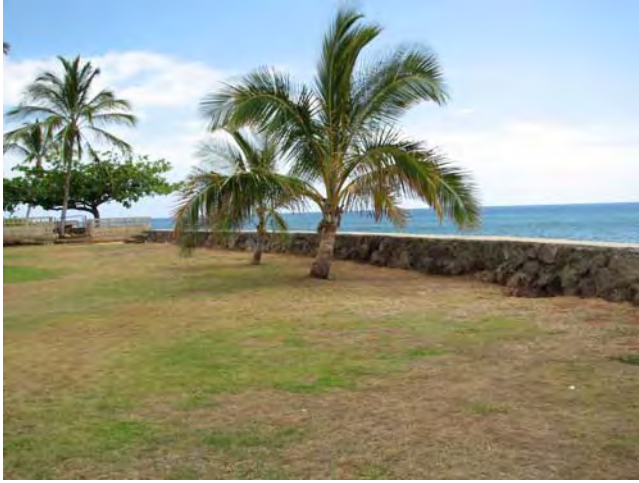
Photograph 4: The wall fronting the property

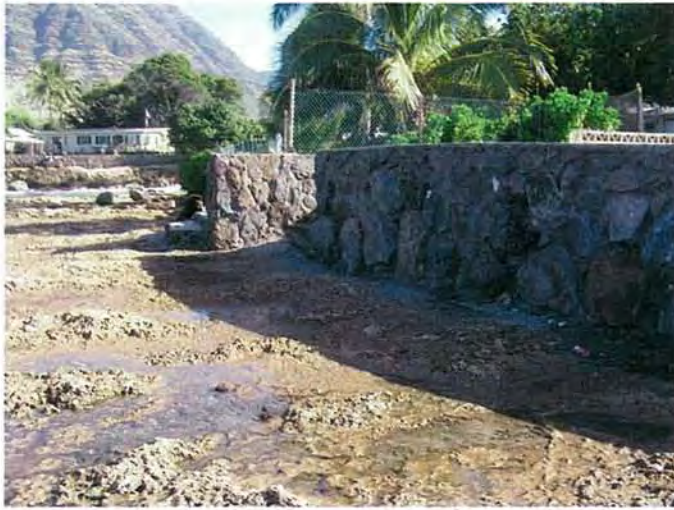
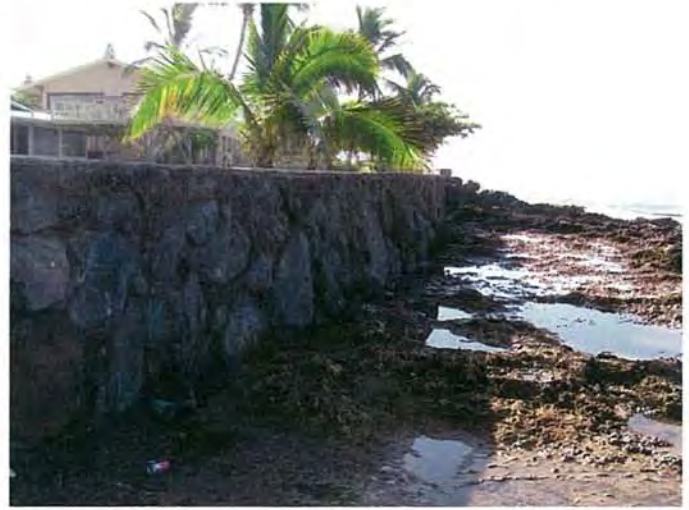
Attachment 1 – Ground photographs from the 1/12/2007 shoreline certification site inspection.

Top left: Looking north at the north end of the seawall and stairs. Seawater has ponded on the carbonate bench, up to the face of the seawall, due to wash of the waves. Top right: Looking south at the south end of the seawall. Seawater has ponded on the carbonate bench, up to the face of the seawall, due to wash of the waves.

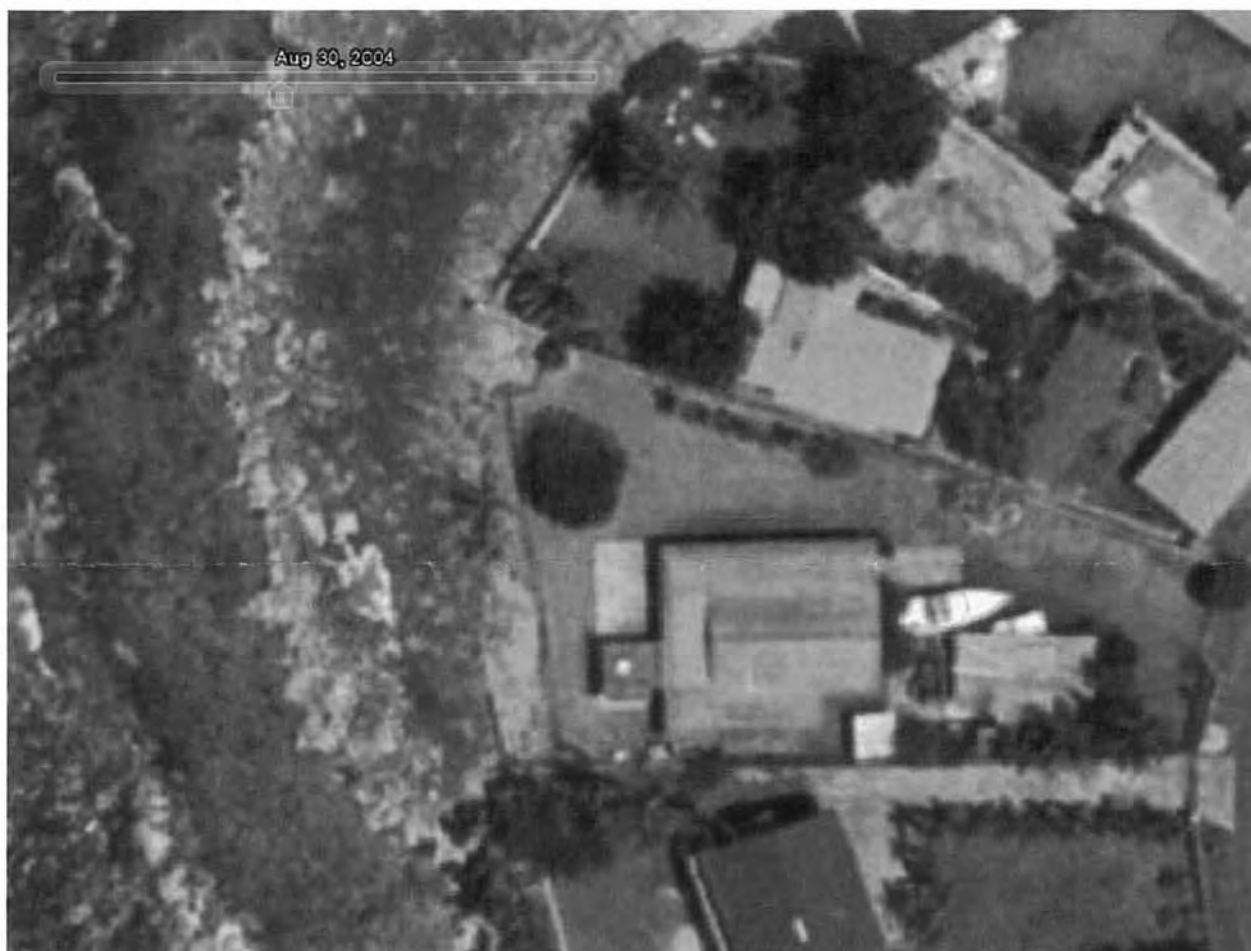
Attachment 3 – Aerial Photograph with date (8/30/2004) from Google Earth. No wall is present in the location of the new seawall.

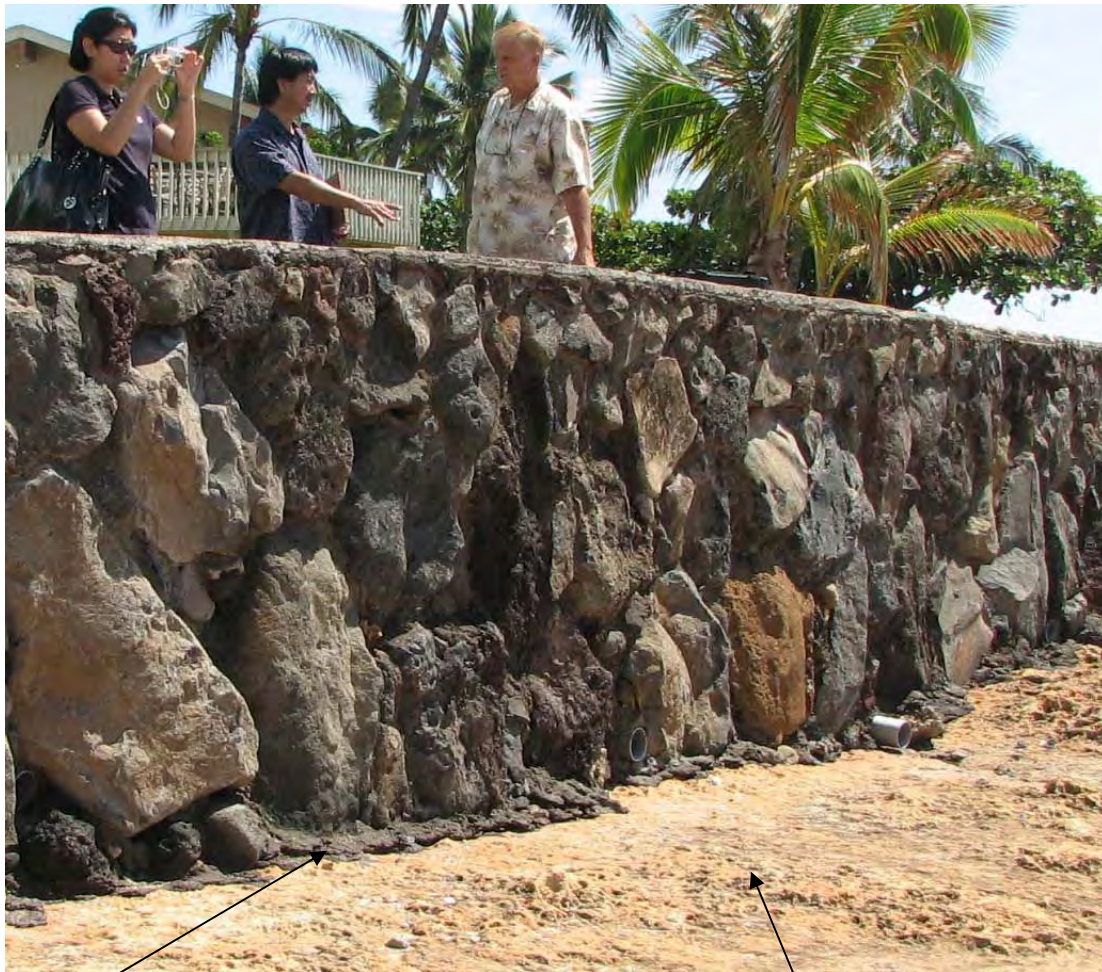
Mortar layer that cements the rock at the base of the wall to the upper rocky marine terrace

The base of the new wall rests on the rocky marine terrace and is cemented (grouted) to the terrace (see Figure 7 on page 8 of the DEA). We will include in the draft EA a photograph that more clearly illustrates the fact that the base of the existing CRM wall is cemented to the rocky marine terrace.

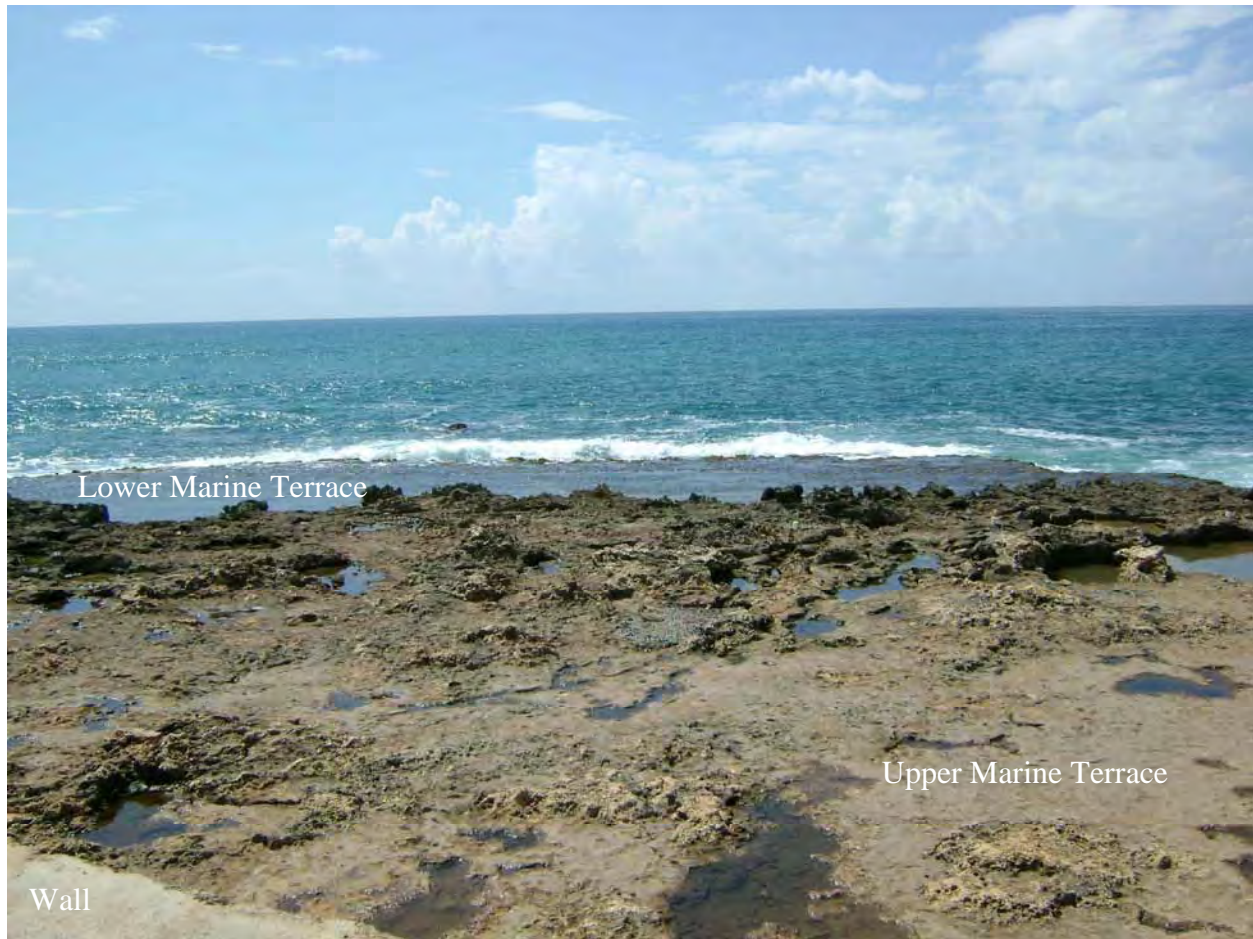
The photo was taken on 10/5/09 at 1:19 p.m., is of waves washing up the lower marine terrace during a low tide. During high tide the waves wash up and over the upper marine terrace and often reach the base of the wall. The puddles are sea water that was left in the low spots earlier as the high tide receded.

At the Ochi's property, during storm surges and other extreme conditions, waves hit the lava-rock face with such force that the water is propelled onto the surface of the upper rock outcrop and travels 40 feet or more inland, where it strikes the wall and is reflected back along the surface of the rock outcrop, from where it falls back into the ocean. If the wall were not in place,

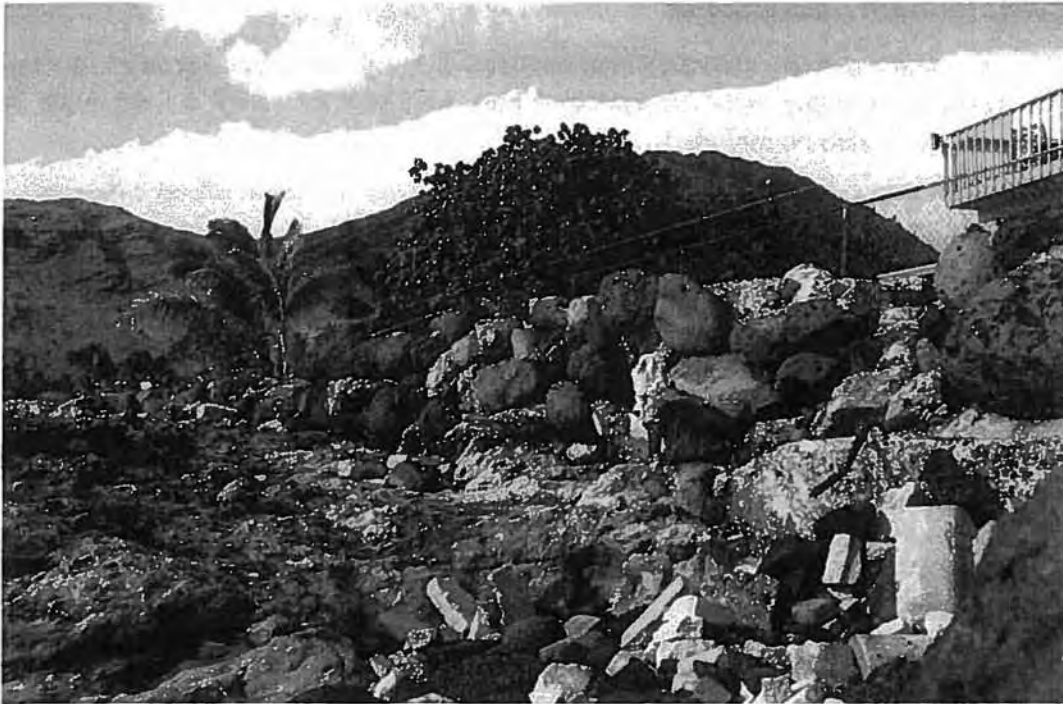
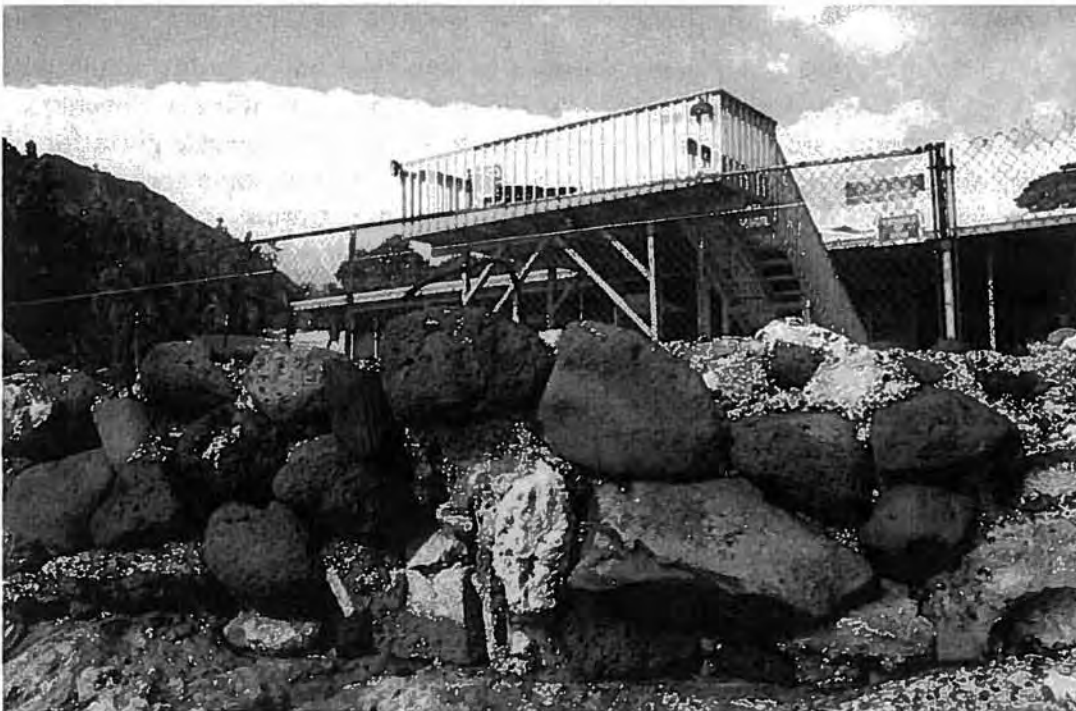
The owners purchased the property in 2005 and they have provided photographs of the shoreline taken just after they purchased the property and prior to rebuilding the wall in 2006. The photos below indicate that there was a cement rock rubble wall on the makai side of a rusty chain link fence topped with barbed wire. It appears that the debris wall had been there for some time and possibly constructed prior to 1966, however, there is no documentation of when the original wall was built.
