DRAFT ENVIRONMENTAL ASSESSMENT

University of Hawai‘i at Hilo Acquisition of Student Housing Complex

TMK: (3rd) 2-4-057:024 & 028
South Hilo District, Hawai'i Island, State of Hawai'i

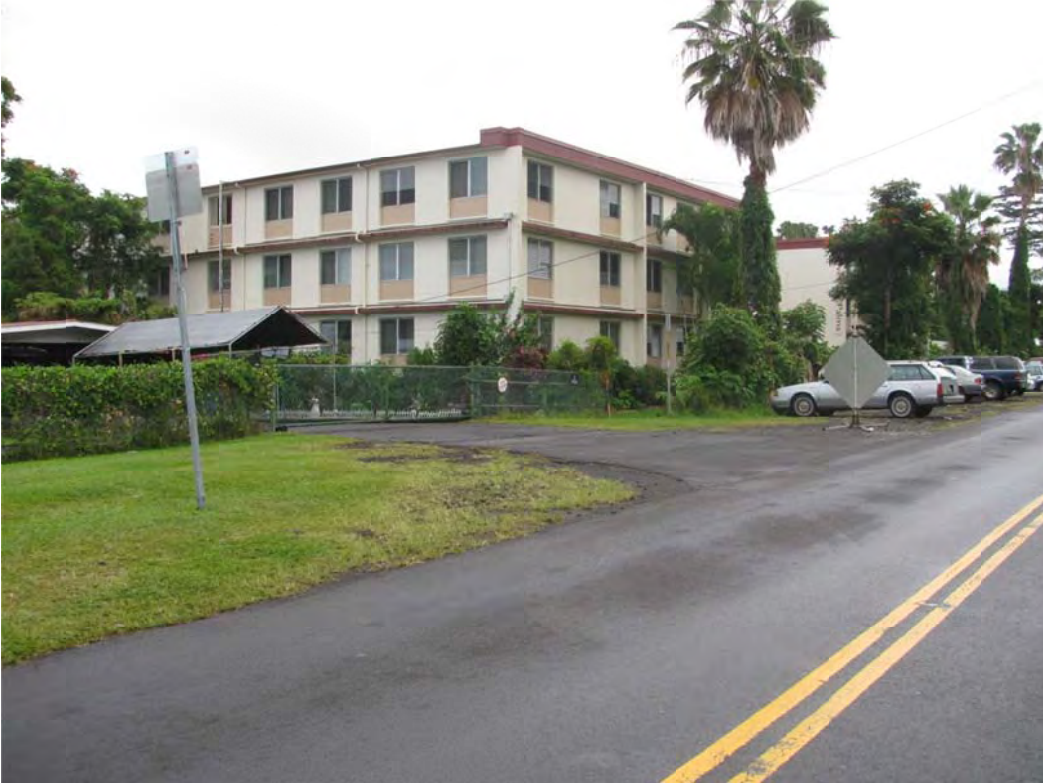
Figure 3 – Project Site Photographs

The University Palms Apartment complex is approximately 37 years old and appears to be in generally good condition (see Figure 3). The primary construction consists of concrete masonry units for the exterior walls and pre-stressed precast concrete planks for the ceiling/floor and ceiling/roof decks. Windows are aluminum frame jalousie units and exterior doors are painted solid-core wood. Some components including the roof, roof drainage, and exterior passage decks require repair. The interior of resident units is in fair to good condition but requires attention to paint, floors, and kitchen appliances and other

details. The acoustical spray-on ceiling material is in good condition but should be removed, as it has been identified as a Regulated Asbestos-Containing Material (RACM) (see Section 3.1.5 for discussion).

Drainage, parking and sidewalk/walkway improvements will also be required for the University Palms facility. In general, the interior plumbing and fixtures appear to be in fair condition, with water supply, water heaters, water pressure and drainage all appearing to be adequate. However, most of the mechanical ventilation systems are in poor condition and require repair or replacement. Electric and telephone services are provided via an underground infrastructure system from overhead public utilities along Kapiolani Street. CATV service is provided by overhead service drop. The entire building is powered through a single meter system from Hawaii Electric Light Co. (HELCO) with a service voltage of 240/120 volts, 1 phase, 3 wires, with a capacity estimated to be 300 amperes and with a measured use about 100 amperes. The lighting fixtures, wireless internet system and fire alarm system do not conform to current codes and standards. A Closed-Circuit-TV (CCTV) with cameras on roof and monitoring equipment in Manager's office was added in recent times. Landscaping infrastructure and plantings will require attention.
