SUBJECT: DRAFT ENVIRONMENTAL ASSESSMENT (DEA) FOR  
HAWAII BELT ROAD  
REHABILITATION OF UMAUMA STREAM BRIDGE  
FEDERAL AID PROJECT NO. BR-019-2(61)

**REHABILITATION OF UMAUMA STREAM BRIDGE  
PROJECT**

**District of North Hilo, Island of Hawai'i  
Federal Project No. BR-019-2(61)**

**October 2011**

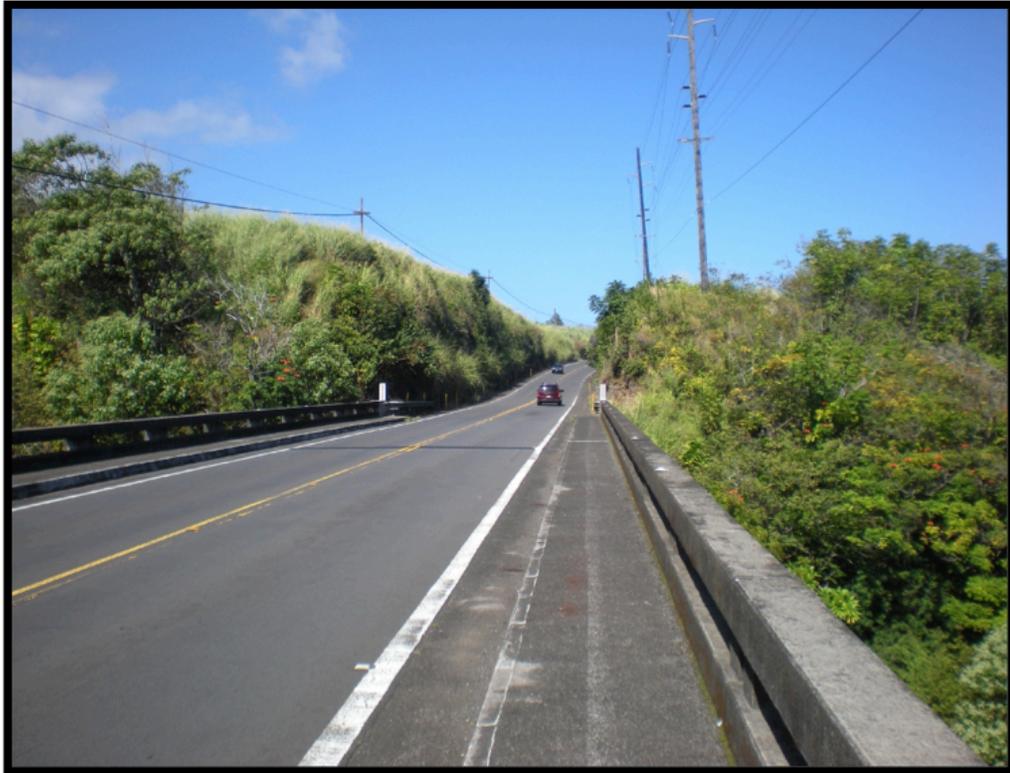
**Photo 1: View of bridge along roadway**

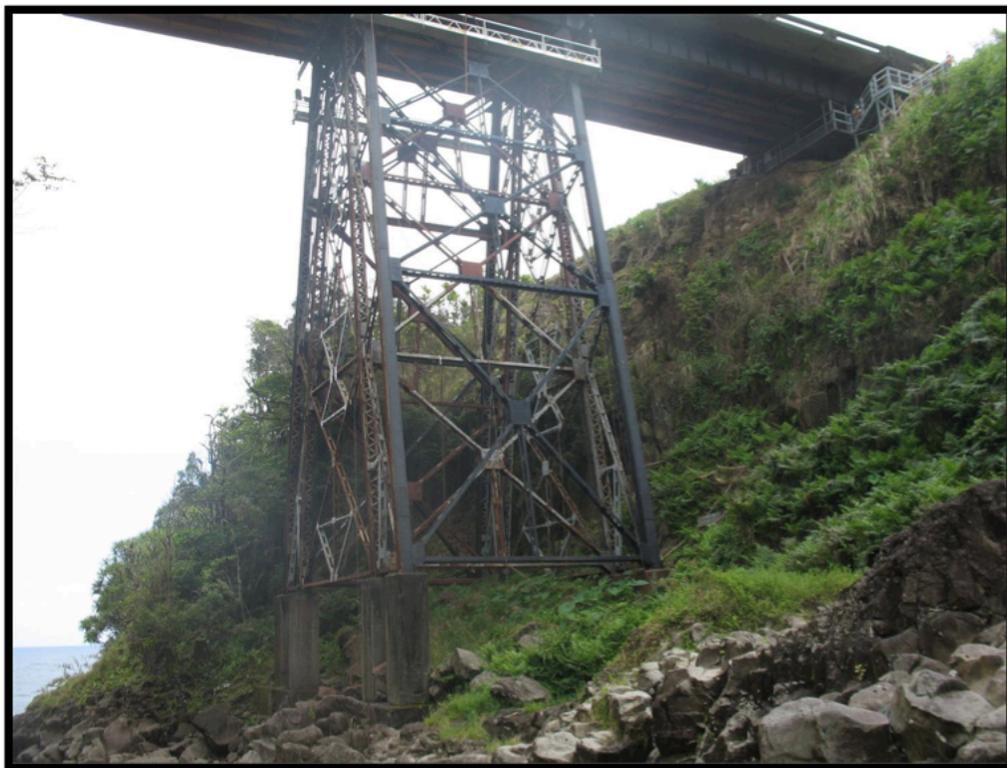
**Photo 2: Steel girder and trestle**

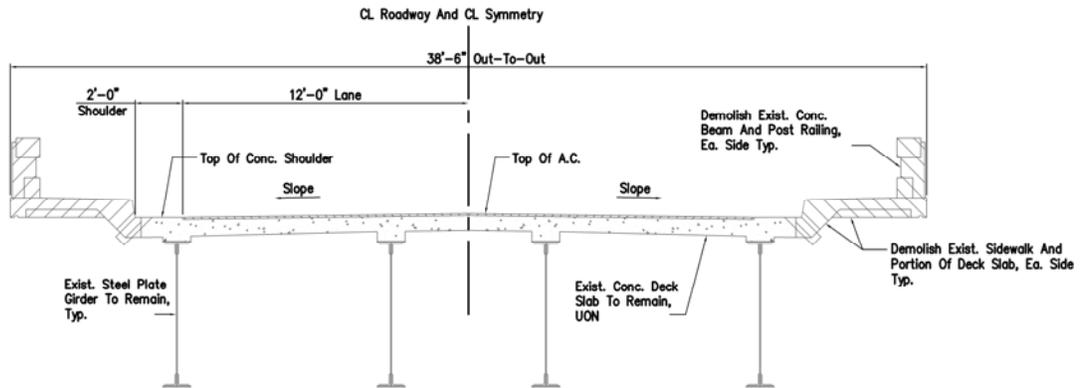
**EXISTING CROSS SECTION**

Note:  
Section Symmetrical About BL, UON  
(See Note 1)

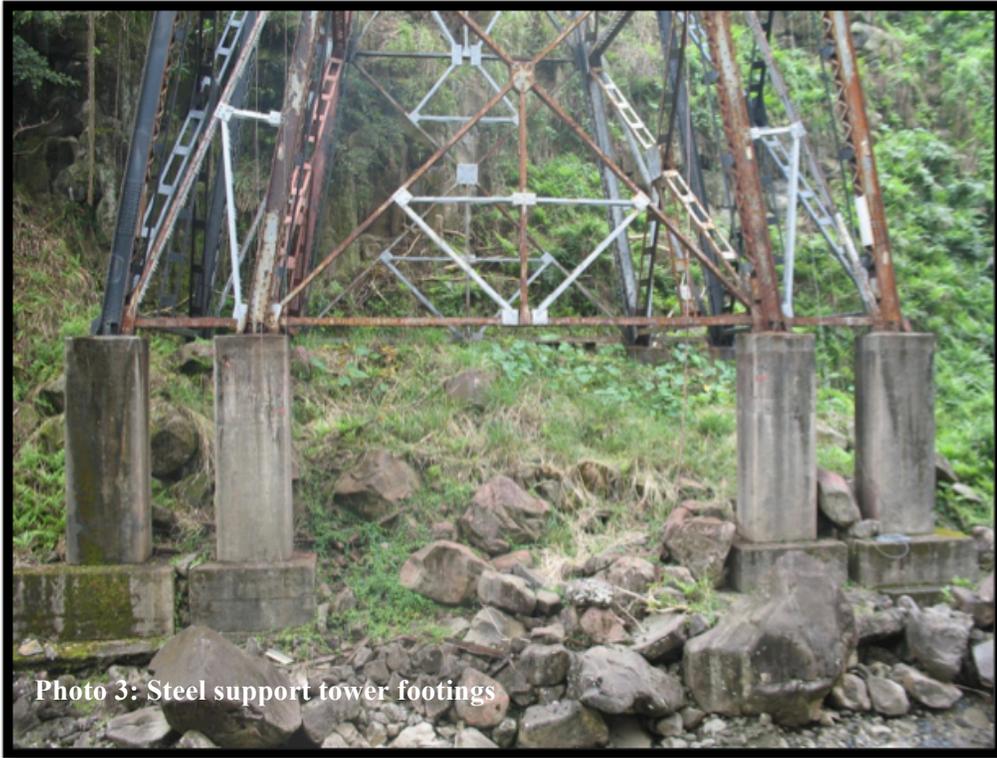
Photo 3: Steel support tower footings

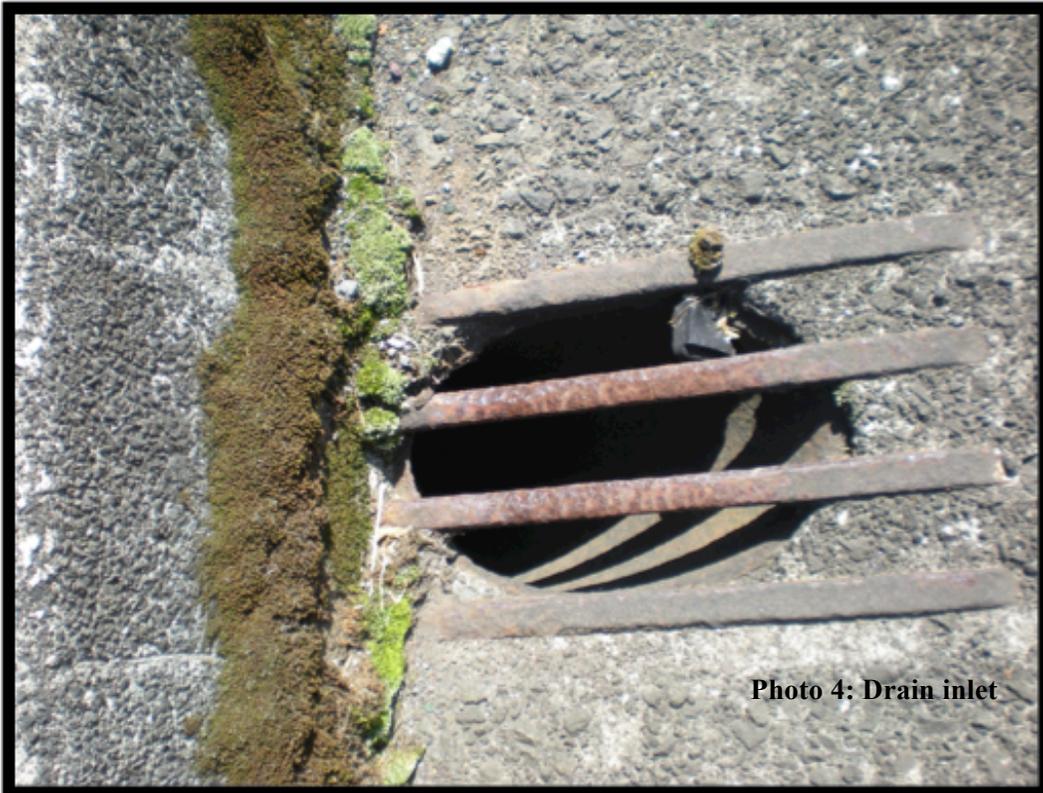
Photo 4: Drain inlet

4-inch pipe with an outlet approximately 4-feet below the bridge deck, allowing stormwater to discharge to the atmosphere and fall to the ground/stream below (see Photos 4 and 5). The proposed project would replace the drain inlets with deck drains placed at certain locations to prevent stormwater from falling directly into the stream. By doing so, storm runoff would be filtered through natural vegetation on the stream bank before entering into the stream.

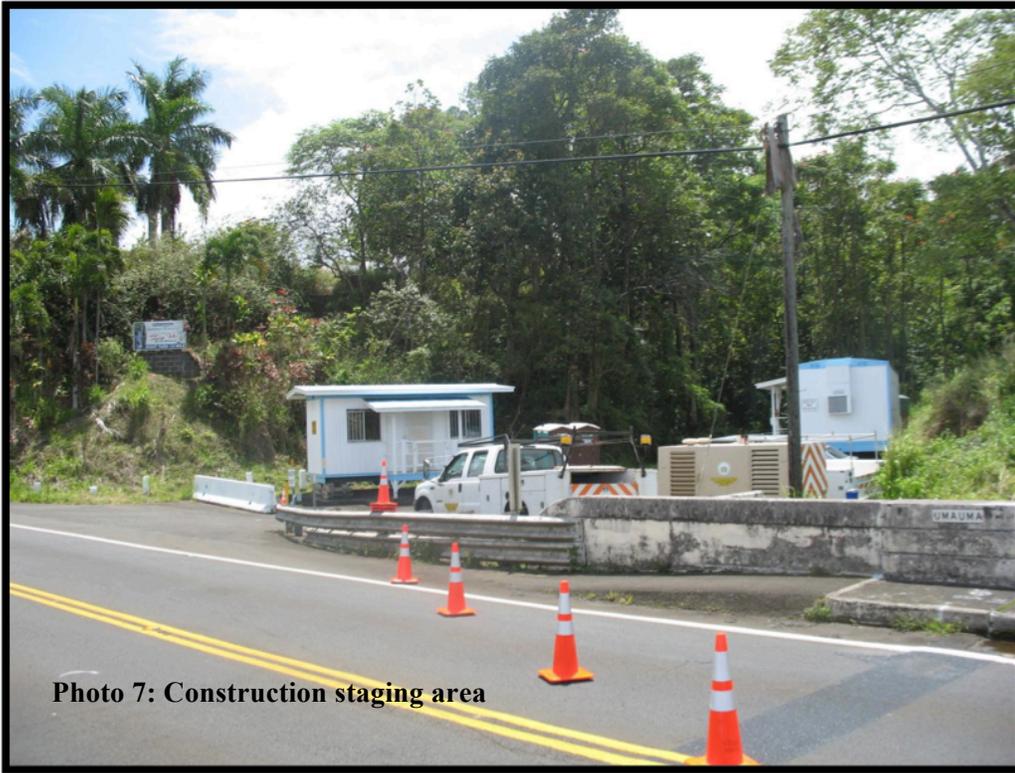
**Photo 7: Construction staging area**

The construction staging area is proposed to be located on the Hilo side of the bridge, *mauka*<sup>2</sup> of the roadway, on an adjacent property to the bridge (TMK (3) 3-1-01:15) (see Figure 6). The Department of Transportation (DOT) currently has several trailers in this staging area for bridge maintenance use (see Photo 7). Construction equipment would also be staged adjacent to the bridge footings and would be within State right-of-way.

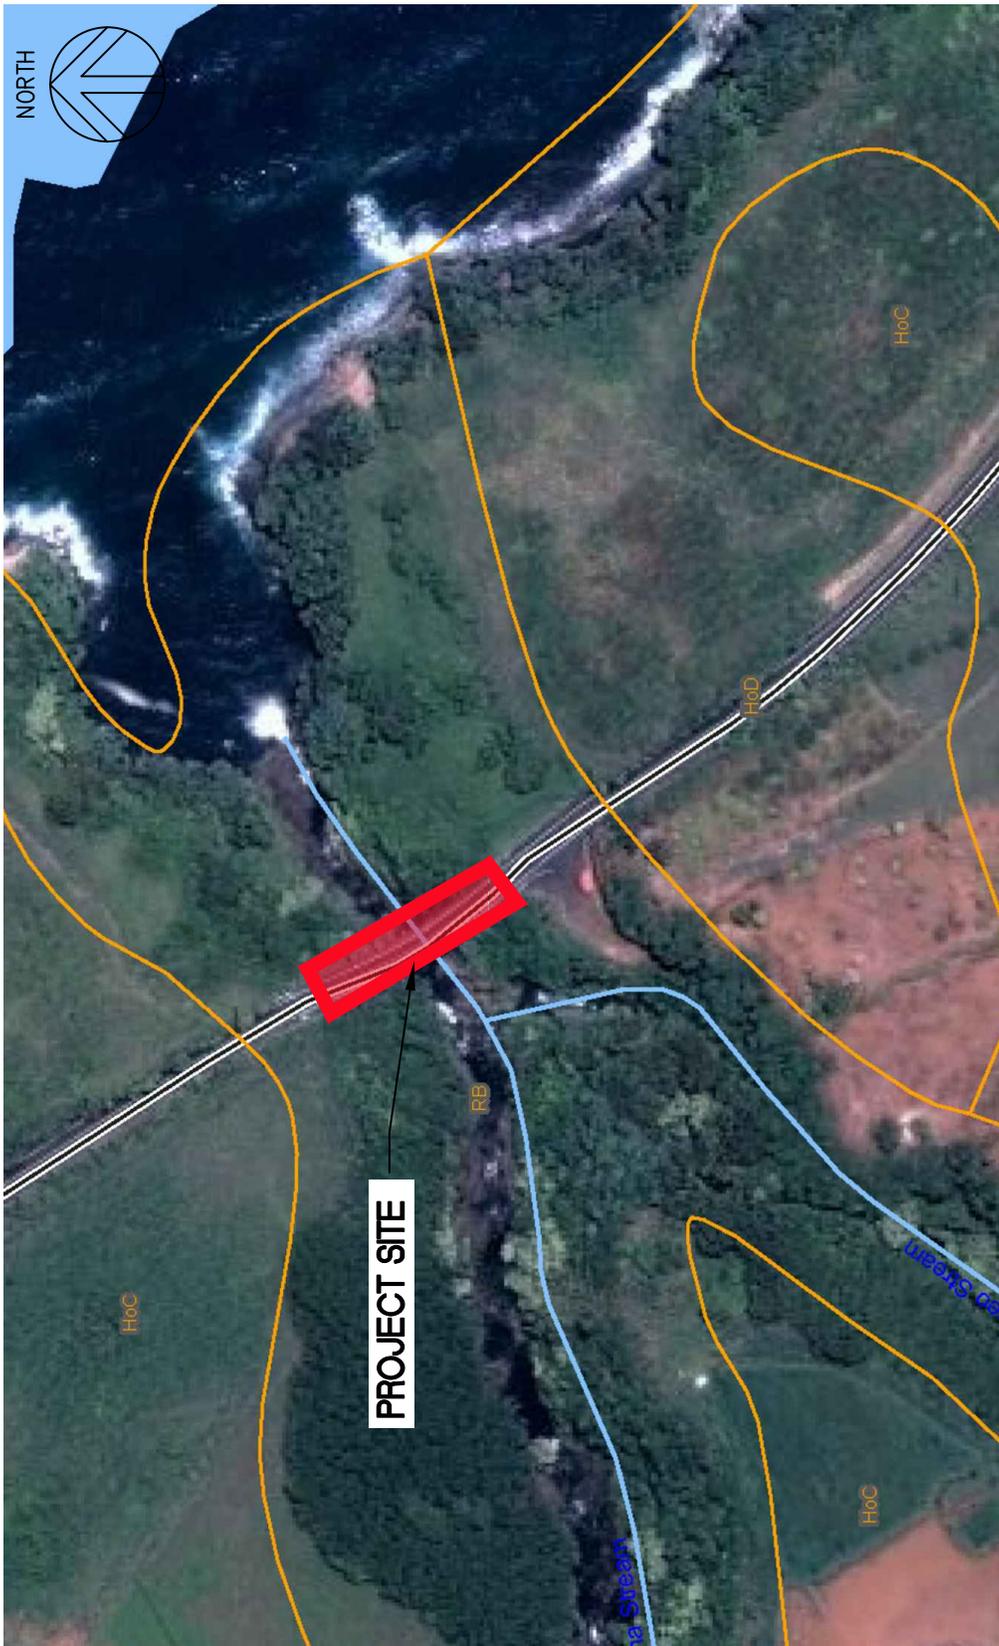
Predominant soils in the area of the project site as classified by the Natural Resources Conservation Service (NRCS) consist of rough broken land (RB) (see Figure 7). Rough broken land is used to characterize gulches, with slopes 35 to 70 percent (NRCS 2009). Based on soil suitability, the State of Hawai'i, Department of Agriculture has established the Agricultural Lands of Importance to the State of Hawai'i (ALISH) system to identify areas of prime farmland. The ALISH system classifies three types of land suitable for agriculture: Prime Lands, Unique Lands, and Other Lands. The project site is located within State right-of-way, and is not considered as agricultural lands of importance (see Figure 8).

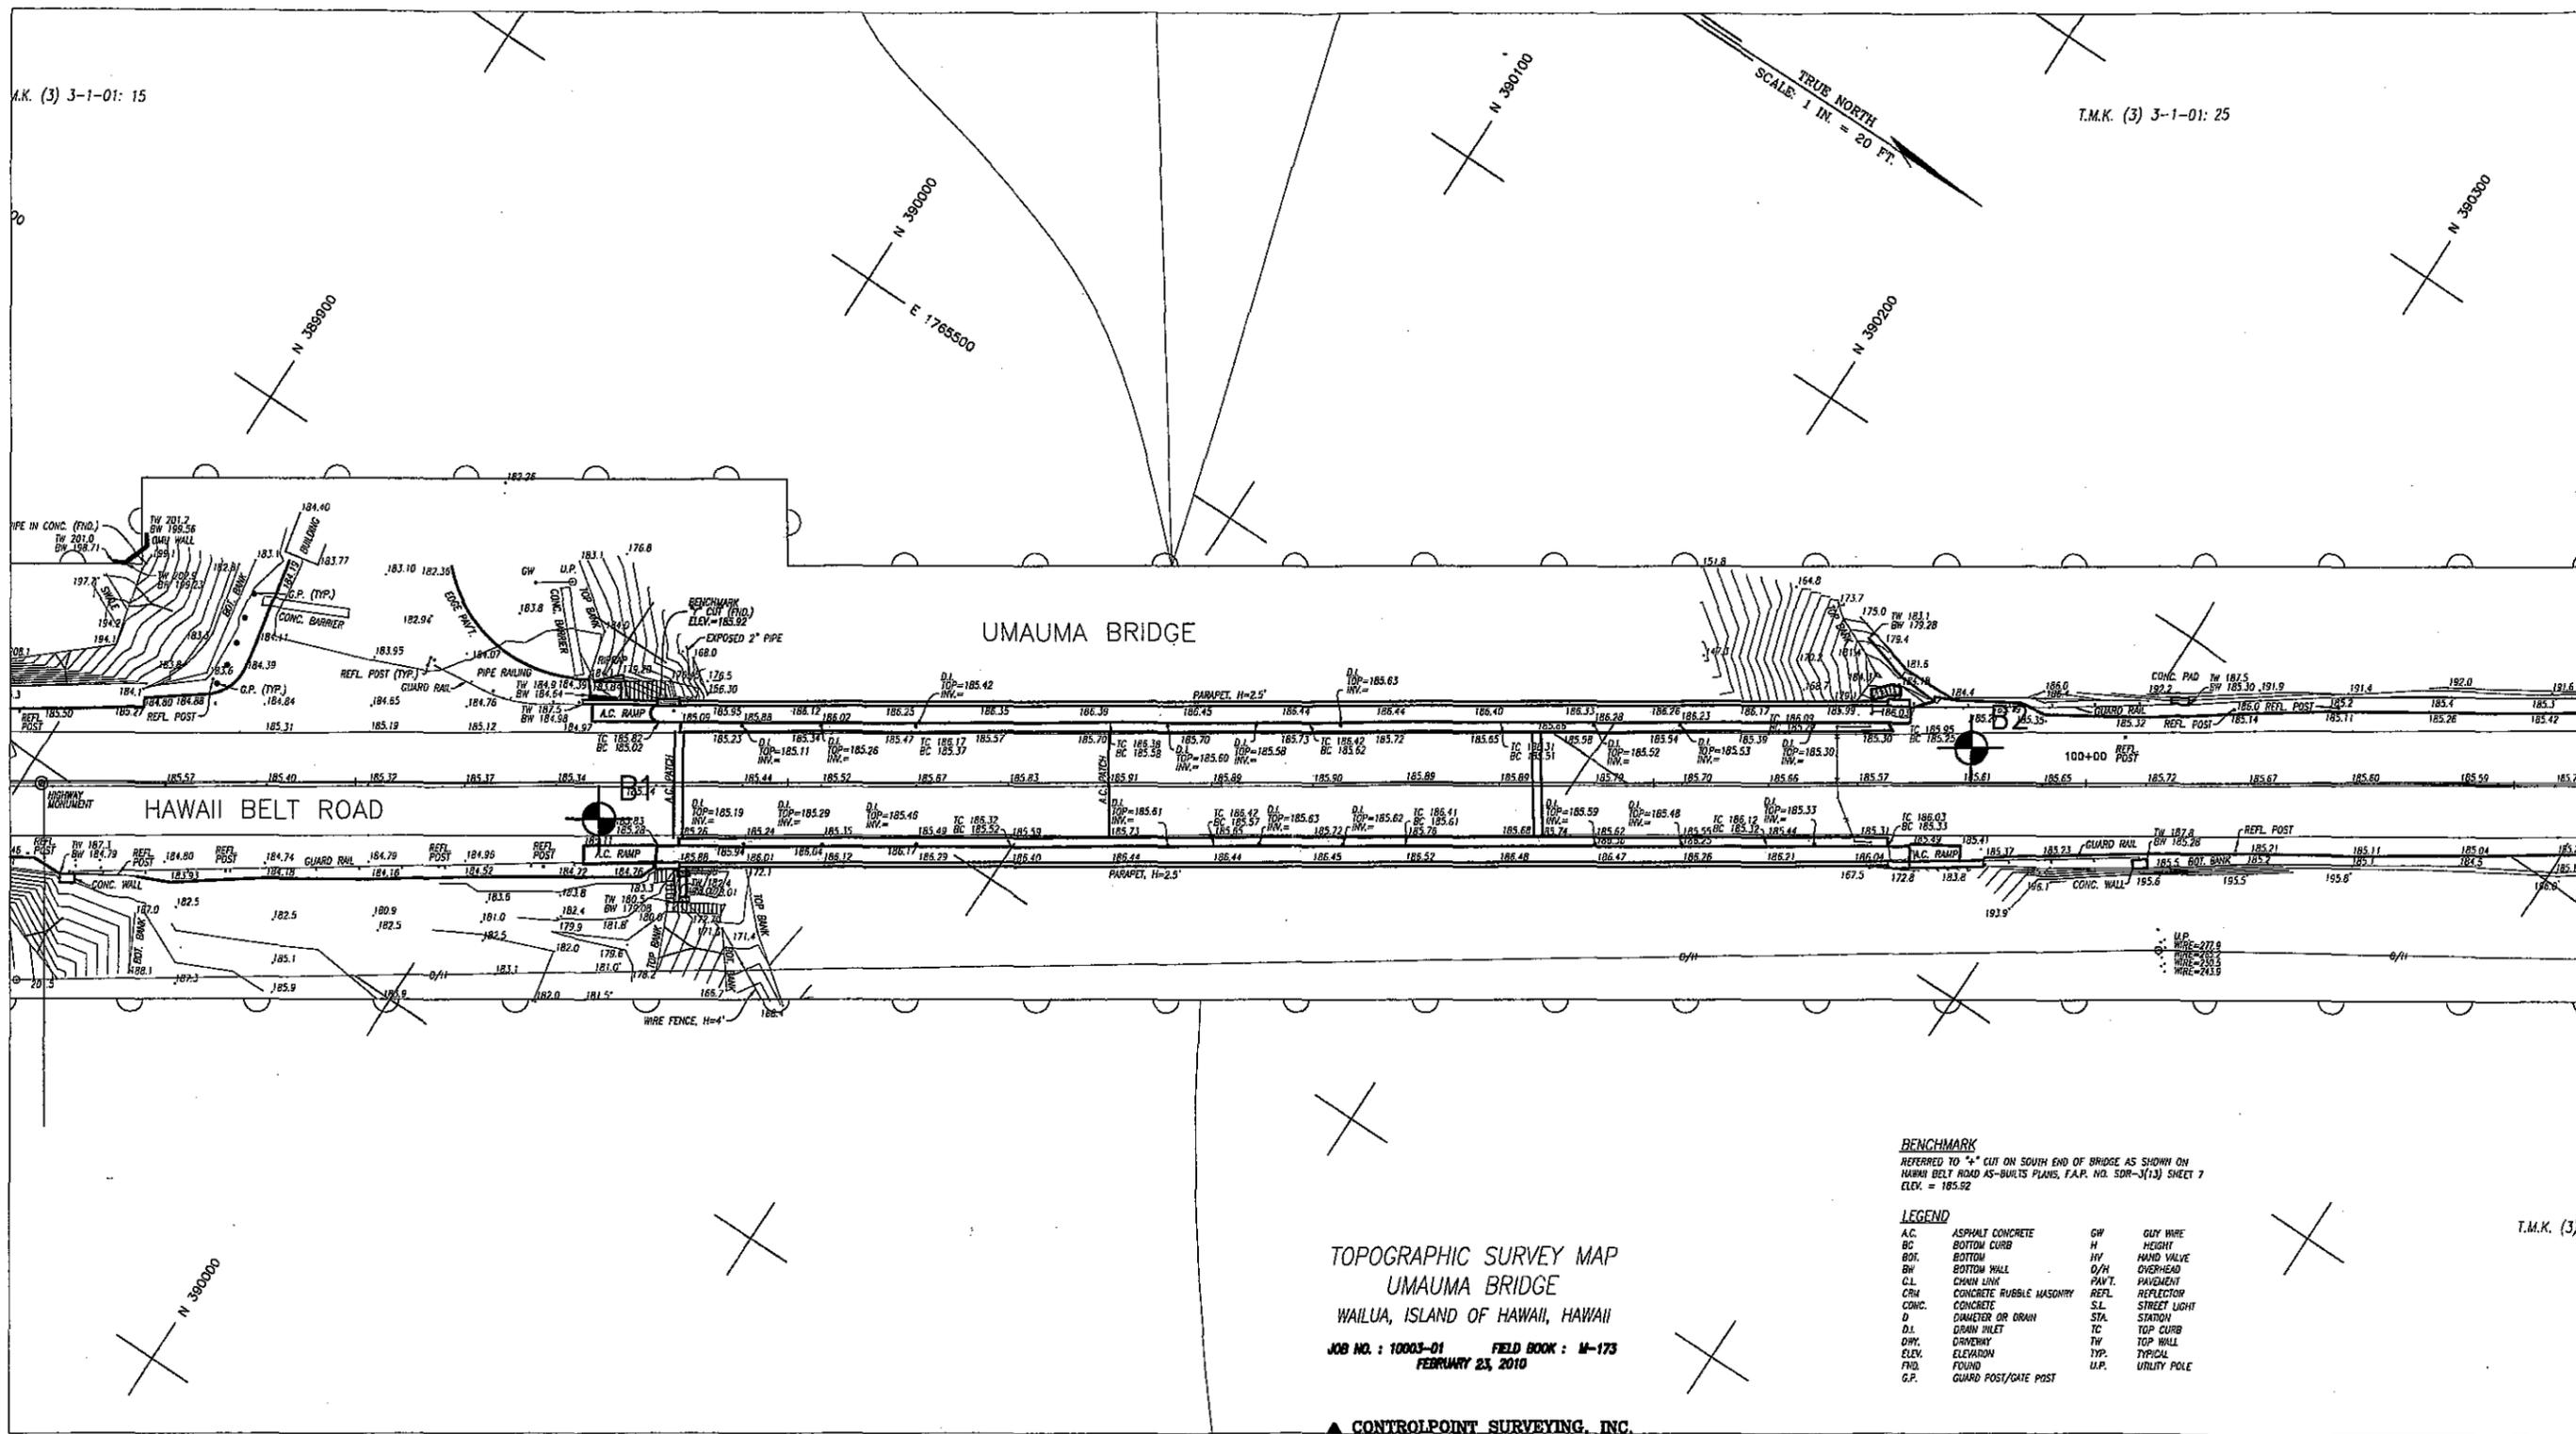
Plate A2.2

Umauma Stream Bridge Rehabilitation, North Hilo  
**BORING LOCATION PLAN**

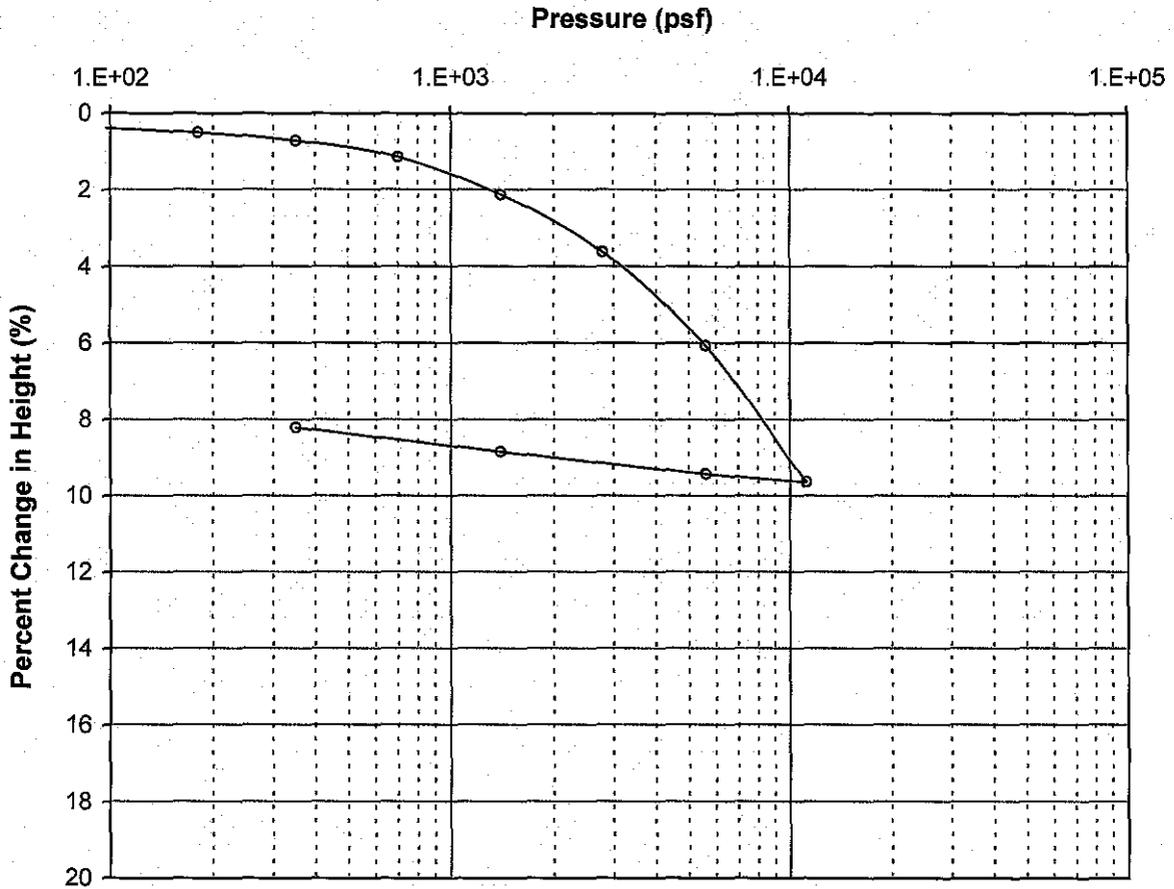
Boring No.: B1    Depth (ft): 28  
 Soil Description: Mottled brown clayey silt

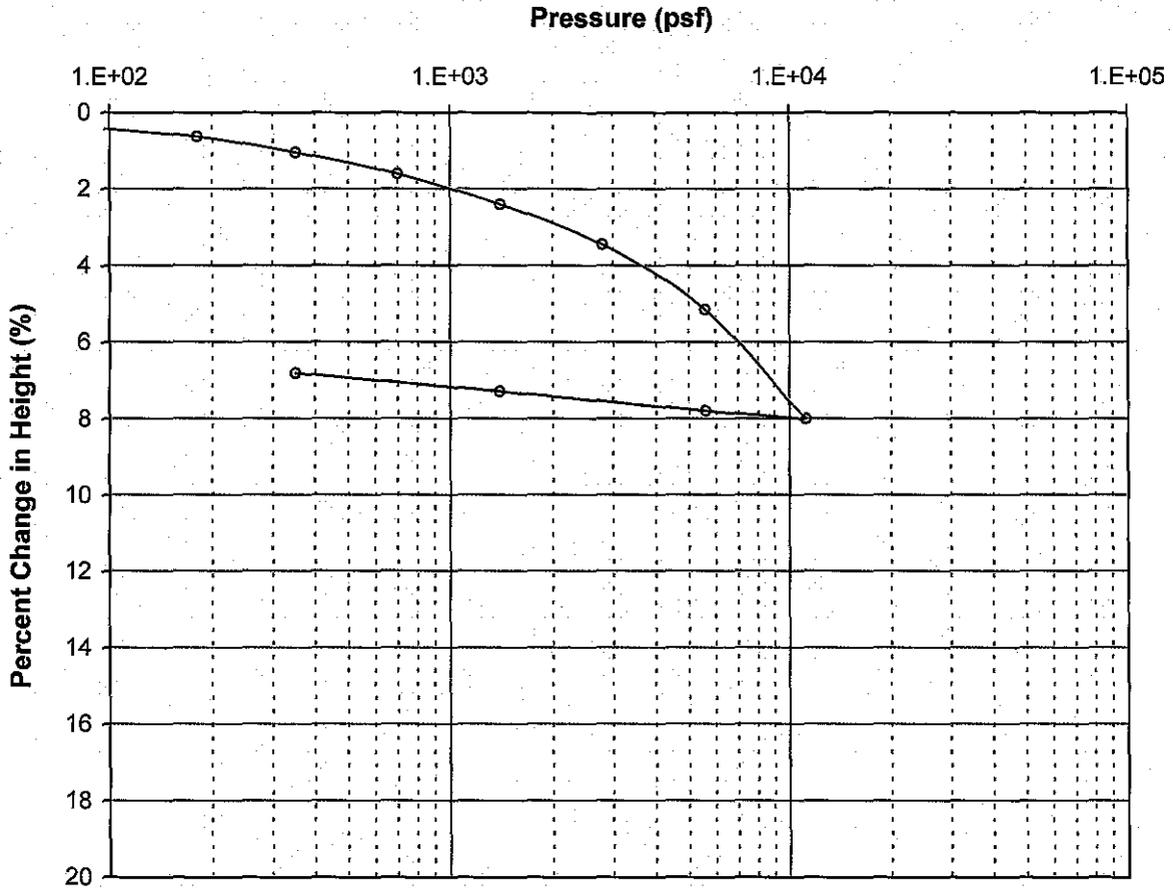
Boring No.: B2    Depth (ft): 13  
 Soil Description: Mottled brown completely weathered rock

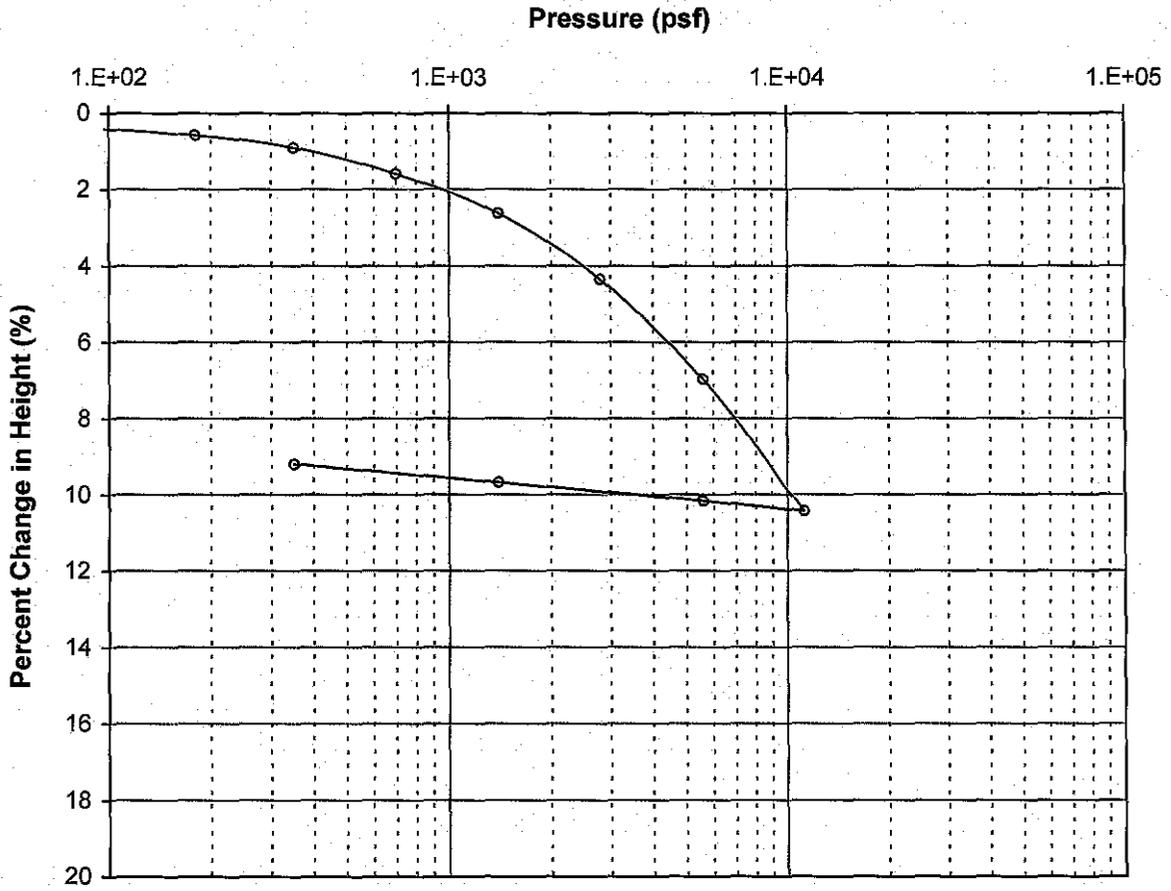
Boring No.: B4    Depth (ft): 4  
 Soil Description: Brown clayey silt

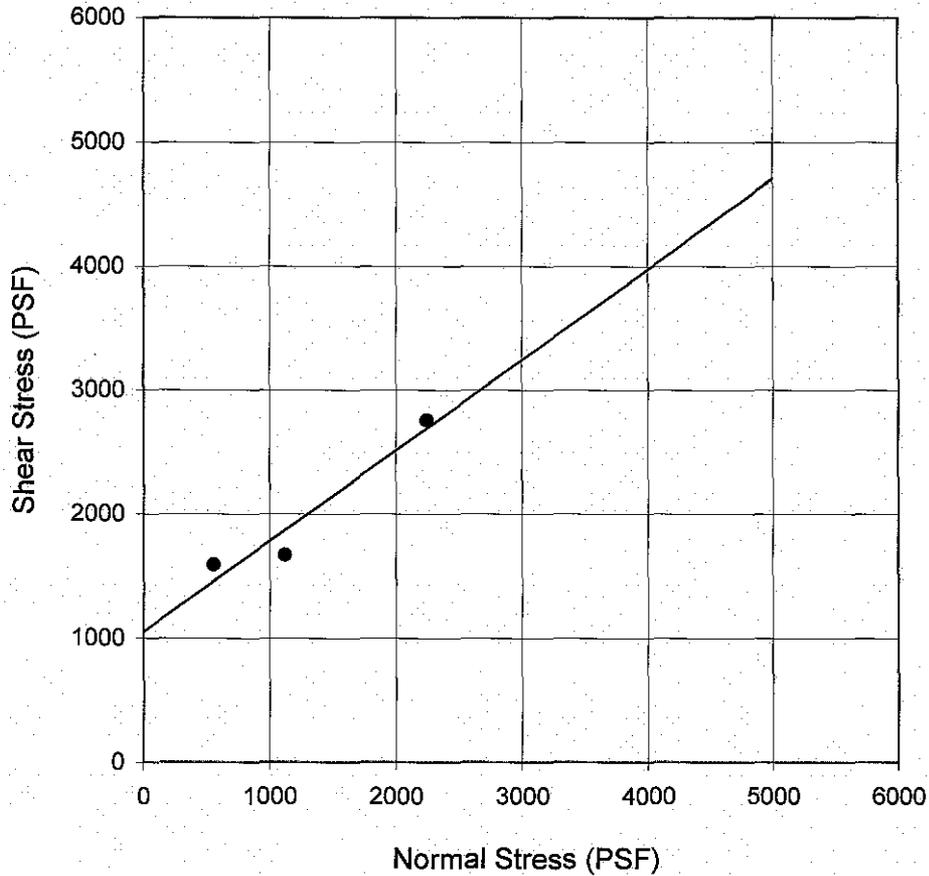
Boring No.: B1                      Depth (ft): 13  
 Soil Description: Mottled brown clayey silt with sand and gravel  
 Strength Intercept (C): 1052.4 PSF  
 Friction Angle ( $\phi$ ): 36.2 DEG

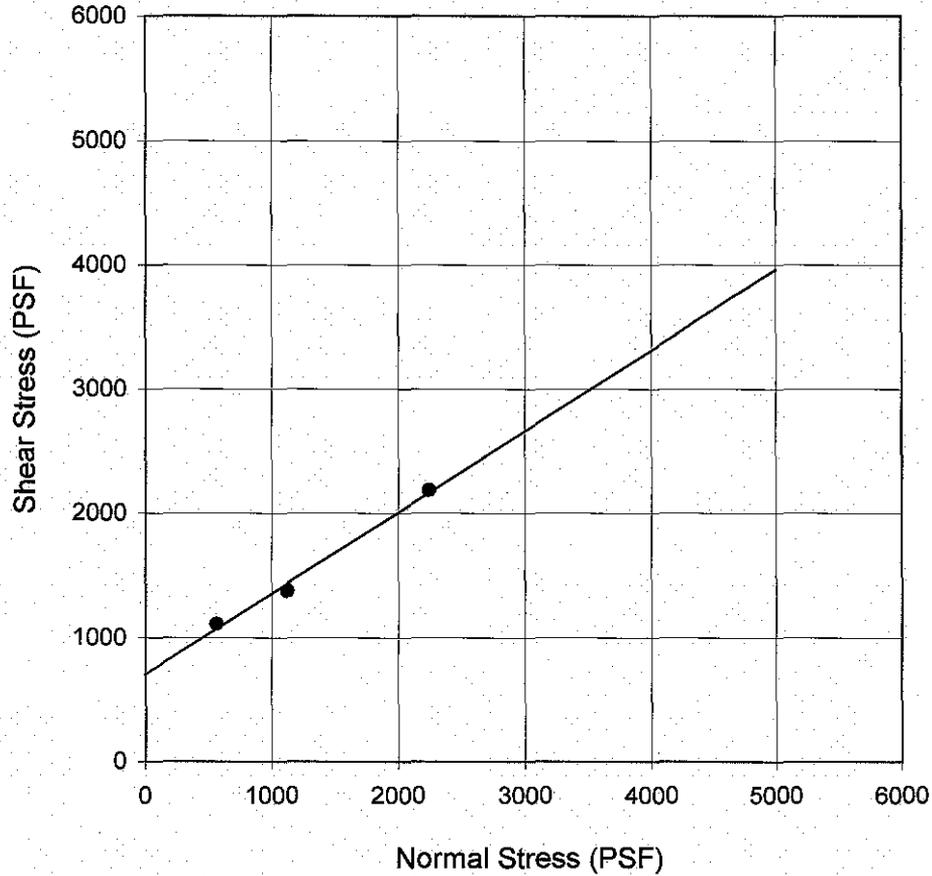
Boring No.: B1                      Depth (ft): 33  
 Soil Description: Mottled brown clay silt  
 Strength Intercept (C): 705.0 PSF  
 Friction Angle ( $\phi$ ): 33.1 DEG

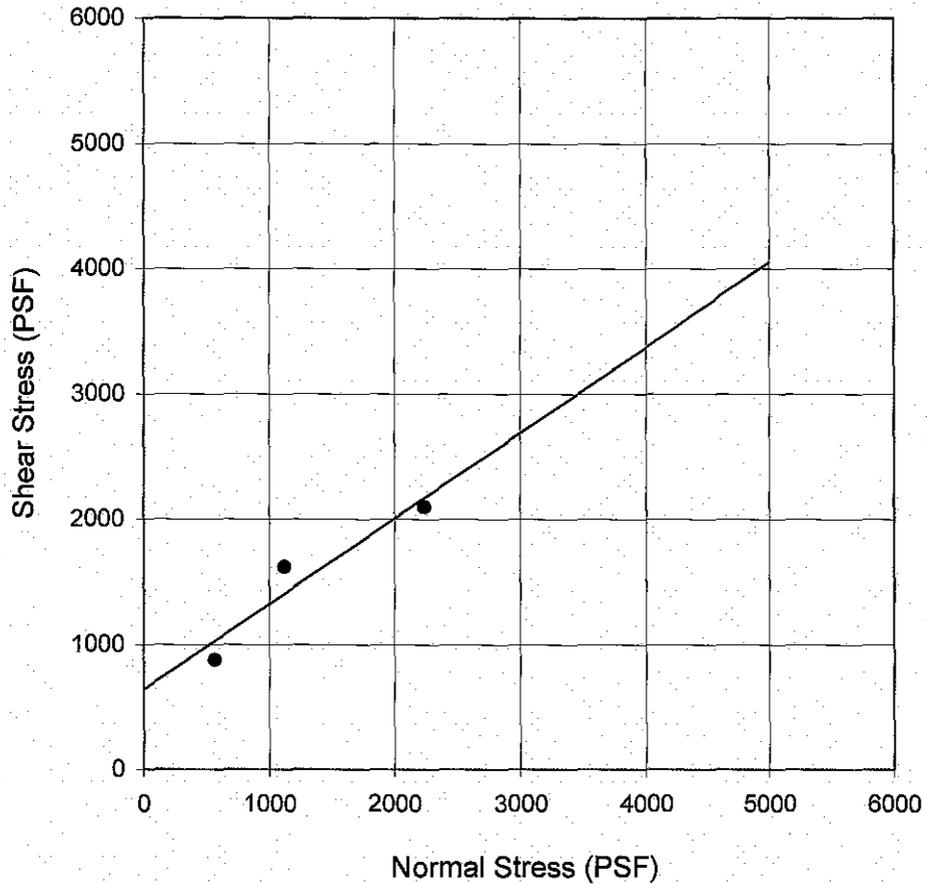
Boring No.: B2                      Depth (ft): 4  
 Soil Description: Mottled brown clayey silt with gravel  
 Strength Intercept (C): 643.1 PSF  
 Friction Angle ( $\phi$ ): 34.3 DEG

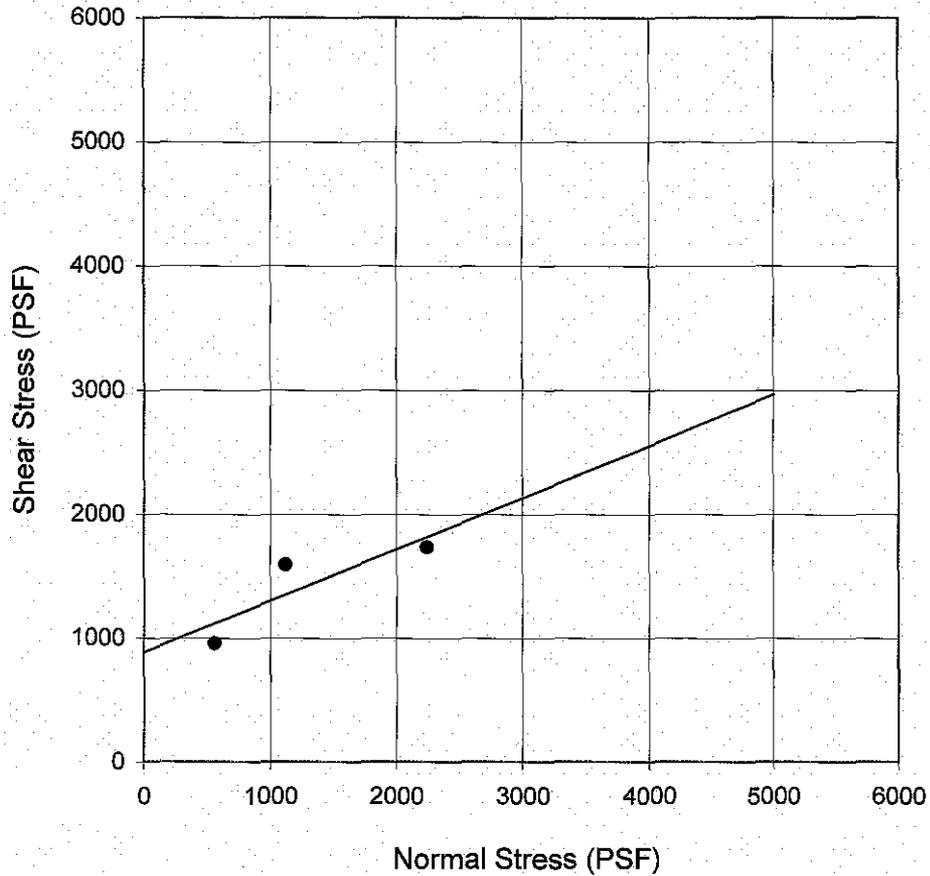
Boring No.: B2                      Depth (ft): 28  
 Soil Description: Mottled brown completely weathered rock  
 Strength Intercept (C): 885.8 PSF  
 Friction Angle ( $\phi$ ): 22.6 DEG

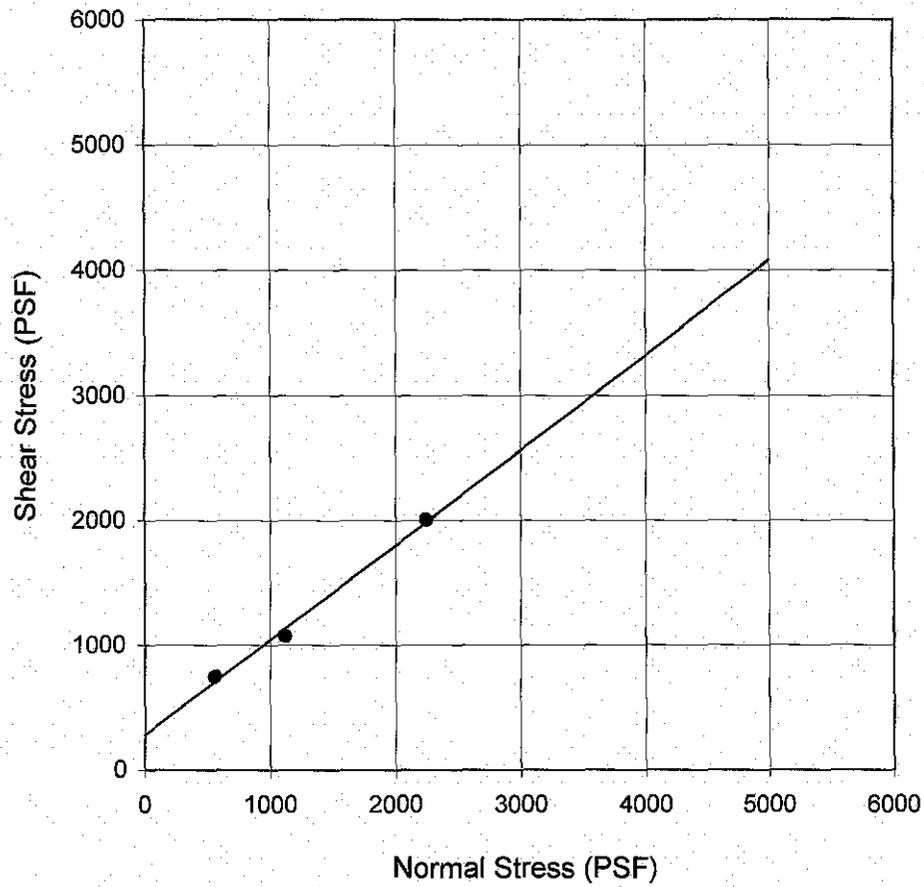
Boring No.: B4                      Depth (ft): 2  
 Soil Description: Brown clayey silt with gravel  
 Strength Intercept (C): 281.4 PSF  
 Friction Angle ( $\phi$ ): 37.2 DEG

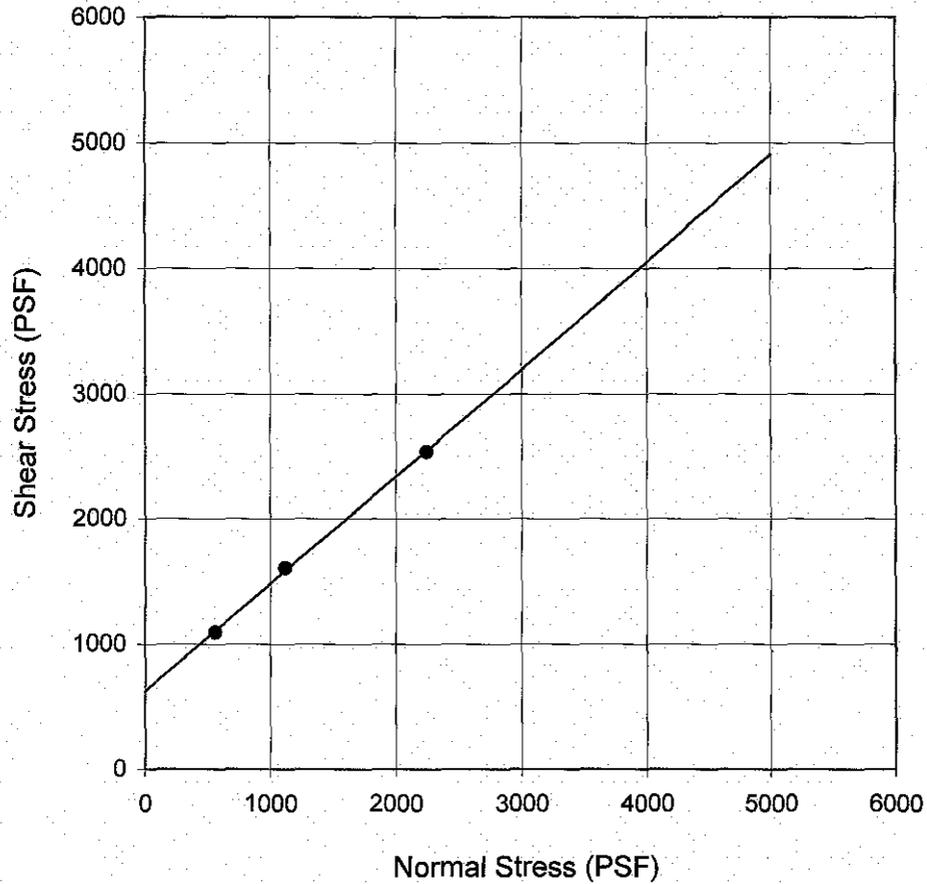
Boring No.: B5                      Depth (ft): 2  
 Soil Description: Mottled brown clayey silt with gravel  
 Strength Intercept (C): 624.1 PSF  
 Friction Angle ( $\phi$ ): 40.6 DEG

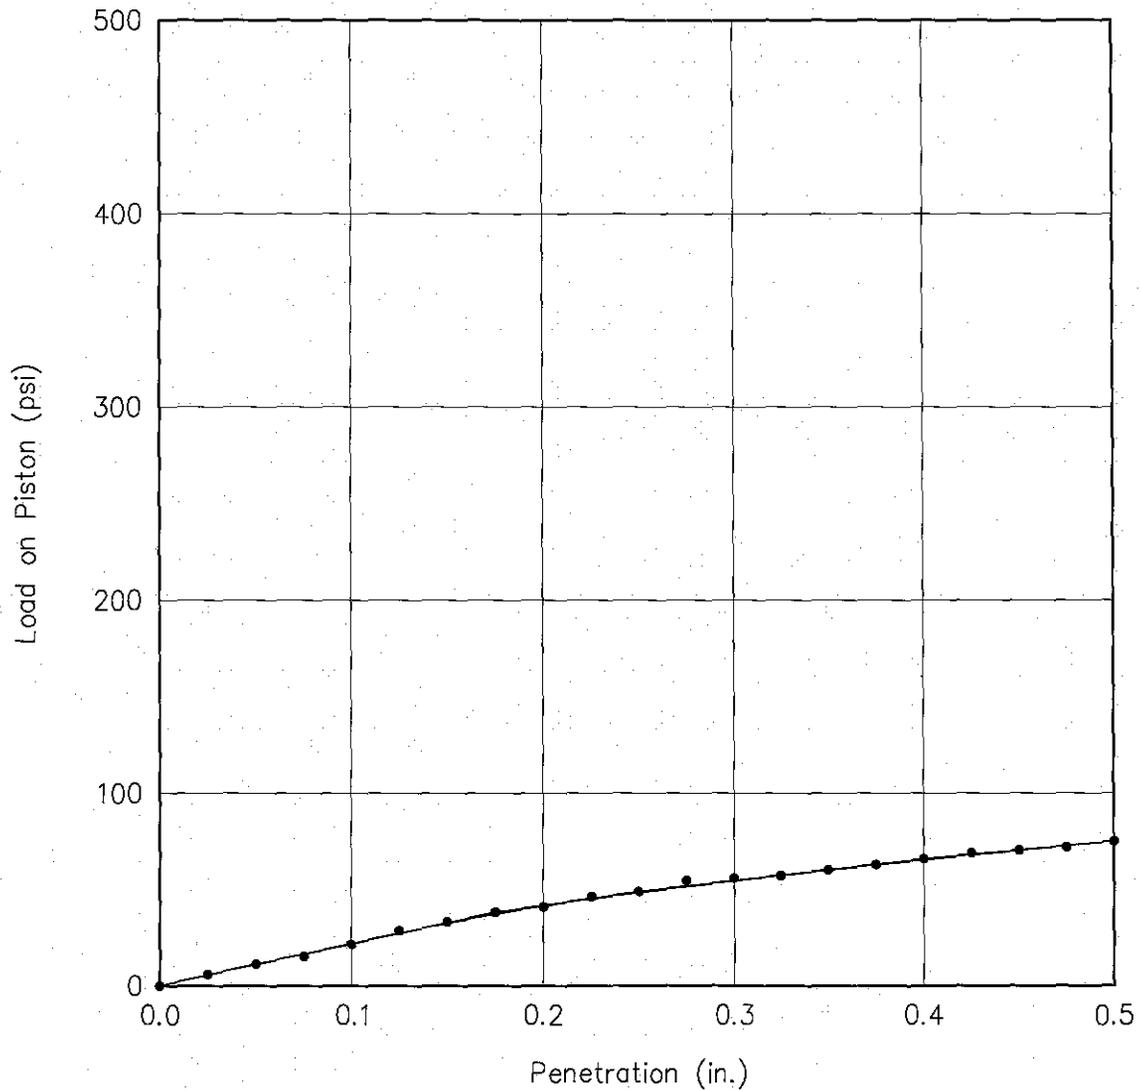
Location: Boring B1 at 2 to 4 ft  
 Description: Brown clayey silt  
 Sample Dry Density: 74 pcf  
 Sample Moisture Content: 45%

W.O. 10-4890	Umauma Stream Bridge Rehabilitation, North Hilo
Hirata & Associates, Inc.	<b>CBR STRESS PENETRATION CURVE</b> Plate B5.1

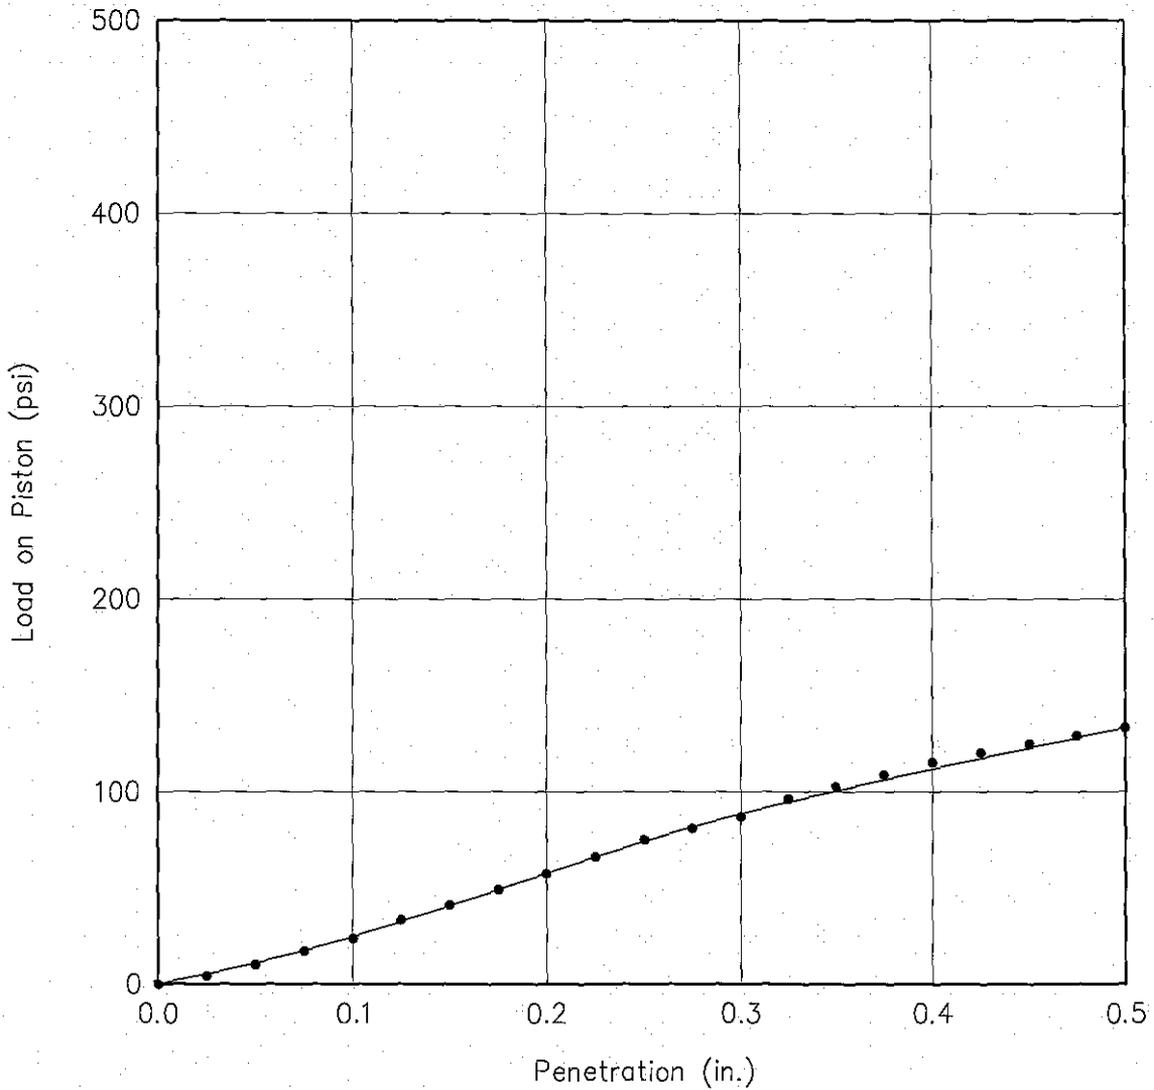
Location: Boring B2 at 2 to 4 ft  
 Description: Brown clayey silt  
 Sample Dry Density: 74 pcf  
 Sample Moisture Content: 43%

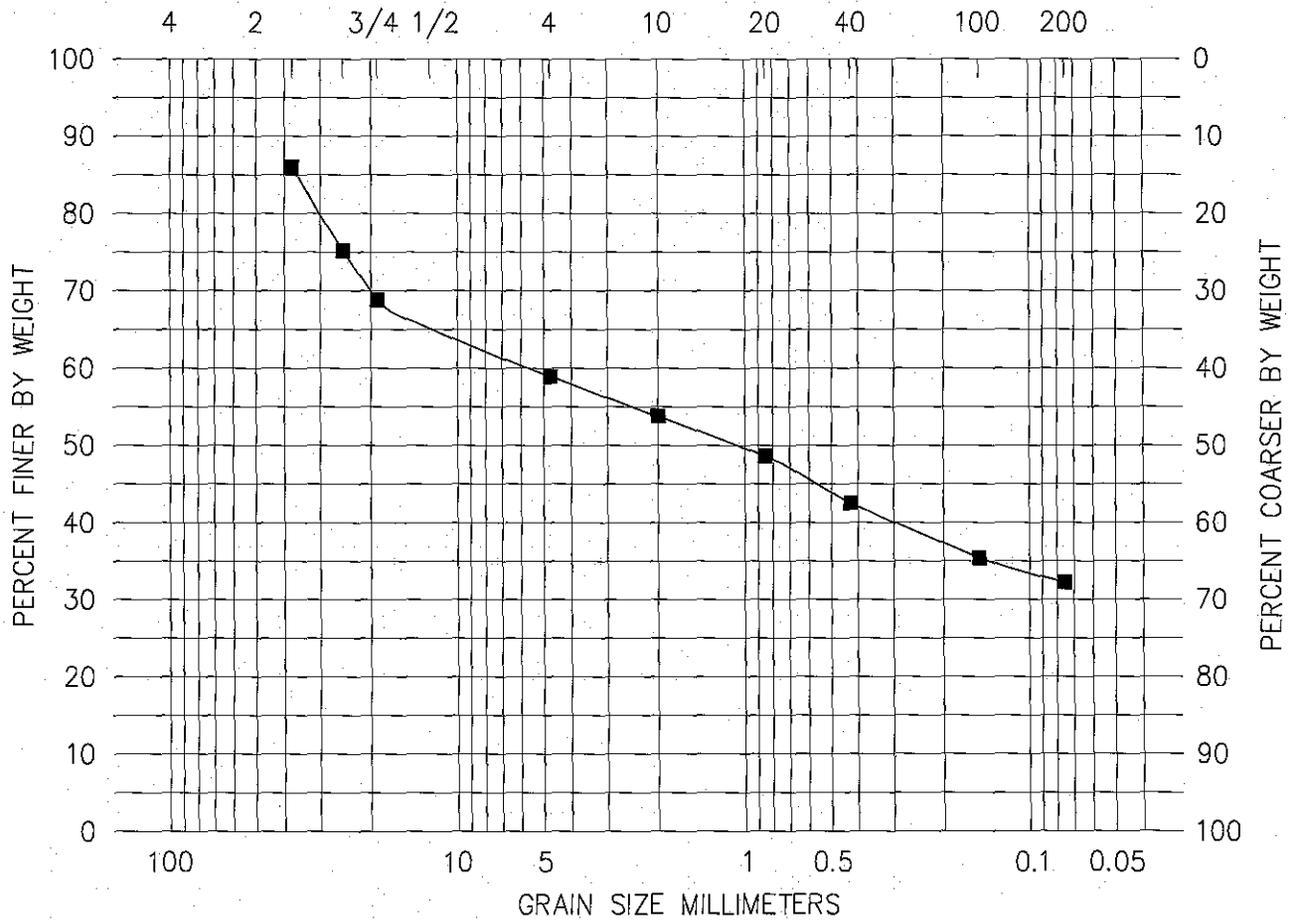
Location	Description
■ Sample #2	Boring B4 at 8 ft	Brown clayey silt with sand and gravel
