SUBJECT: DRAFT ENVIRONMENTAL ASSESSMENT (DEA) FOR  
HAWAII BELT ROAD  
REHABILITATION OF UMAUMA STREAM BRIDGE  
FEDERAL AID PROJECT NO. BR-019-2(61)

**REHABILITATION OF UMAUMA STREAM BRIDGE  
PROJECT**

**District of North Hilo, Island of Hawai'i  
Federal Project No. BR-019-2(61)**

**October 2011**

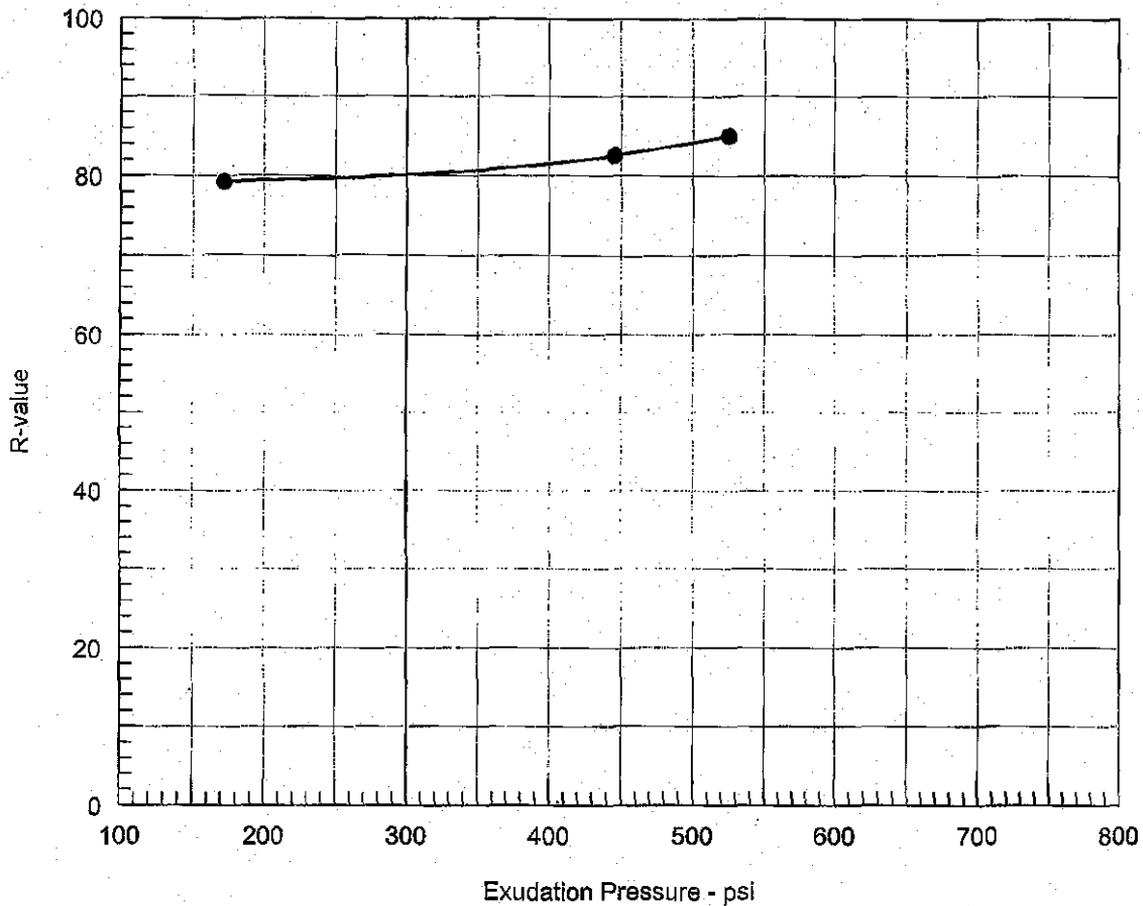
Test Results	Material Description
R-value at 300 psi exudation pressure = 80	Reddish brown gravelly sandy silt, B2, sample received 4/22/2010
<b>Project No.:</b> 0020078 <b>Project:</b> <b>Location:</b> Umauma Stream Bridge Rehab, WO #10-4890 <b>Sample Number:</b> 2110-2 (SL397) <b>Depth:</b> 2'-4' <b>Date:</b> 4/28/2010	<b>Tested by:</b> DTN <b>Checked by:</b> LKL <b>Remarks:</b> B2
R-VALUE TEST REPORT <b>SIGNET TESTING LABS, INC.</b>	Figure B7.2

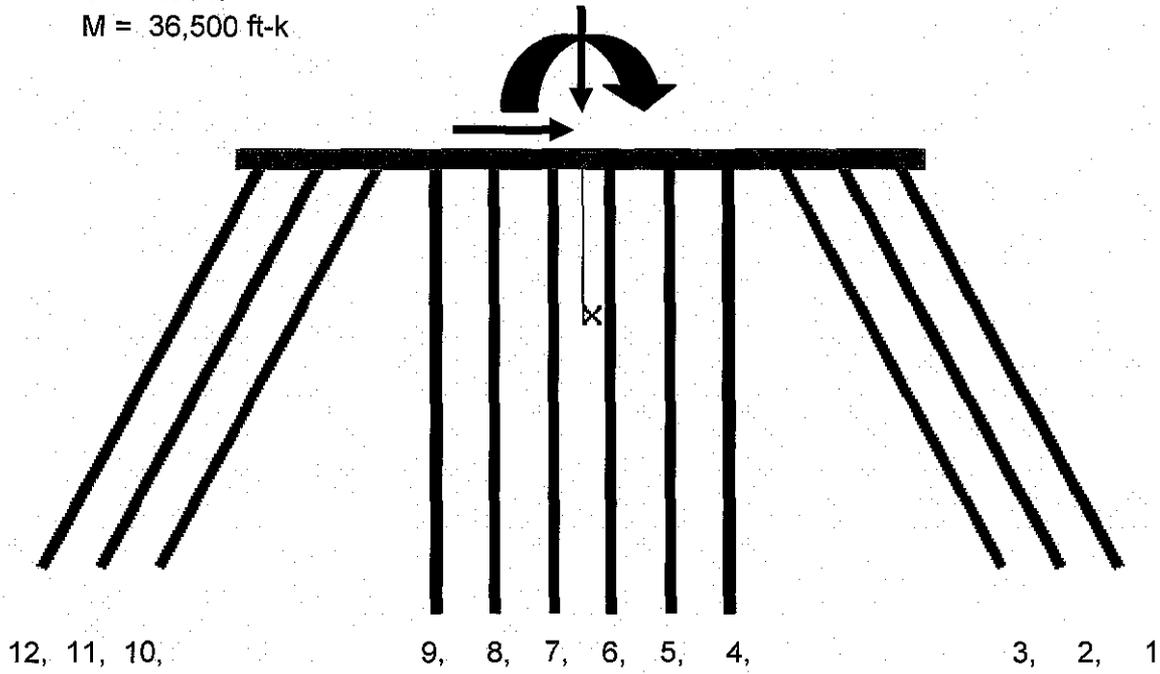
Note: each row has 4 (7-in diameter) micropiles

Row No.	Verical Load (kips)	Lateral Load (kips)	Axial Load (kips)	Shear (kips)	Bending Moment (ft-kips)
1	157	80.9	176.6	2.2	3.37
2	144.7	75	163	2.4	3.83
3	132.5	69.1	149.4	2.5	4.28
4	91.1	4	91.1	4	8.04
5	75.9	4	75.9	4	8.04
6	60.7	4	60.7	4	8.05
7	45.5	4	45.5	4	8.05
8	30.3	4	30.3	4	8.05
9	15.2	4	15.2	4	7.97
10	-47	27.8	-54.5	3.8	7.28
11	-59.3	33.7	-68.1	3.7	6.86
12	-71.5	39.7	-81.7	3.5	6.44

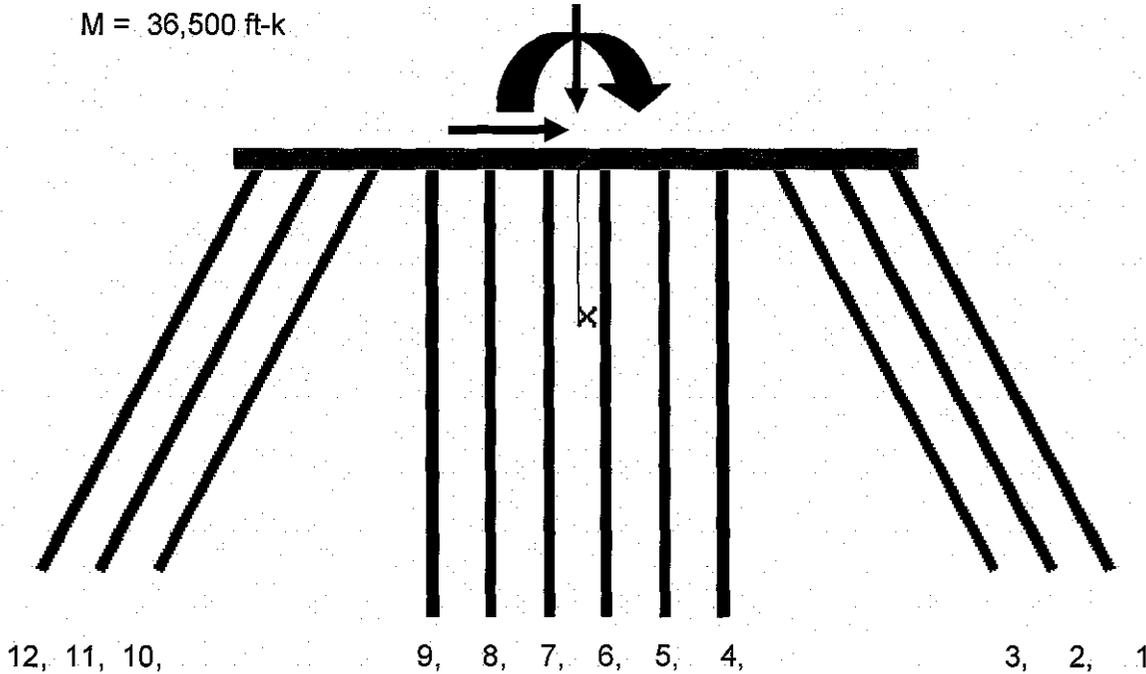
Applied Load at Pile cap in transverse direction  
 P = 1500 k  
 V = 1400 k  
 M = 36,500 ft-k

Note: each row has 4 (7-in diameter) micropiles

Row No.	Vertical Load (kips)	Lateral Load (kips)	Axial Load (kips)	Shear (kips)	Bending Moment (ft-kips)
1	142.1	73.7	160.0	2.4	3.90
2	129.8	67.8	146.4	2.6	4.35
3	117.6	61.8	132.8	2.7	4.79
4	72.7	4	72.7	4	8.02
5	57.5	4	57.5	4	8.02
6	42.3	4	42.3	4	8.02
7	27	4	27	4	8.02
8	11.8	4	11.8	4	8.02
9	-3.3	4	-3.3	4	8.03
10	-61.9	35	-71	3.6	6.74
11	-74.1	40.9	-84.6	3.5	6.32
12	-86.4	46.9	-98.2	3.3	5.89

Pile Cap Deflection = 0.06 inch

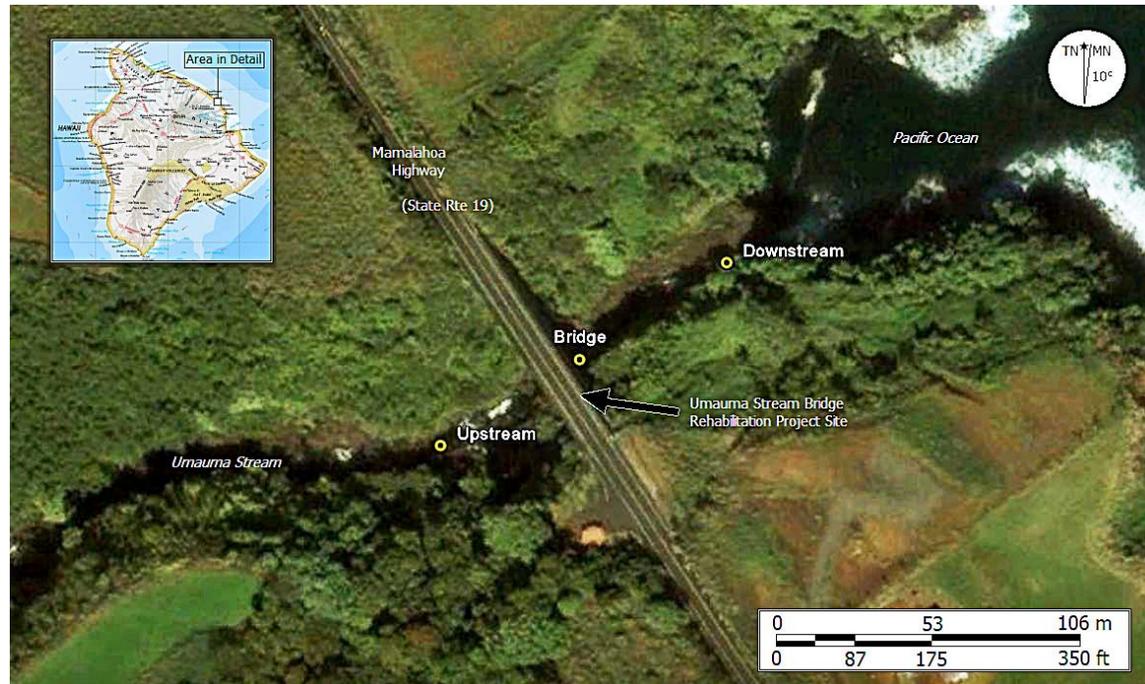
Figure 2. Location of water quality stations (yellow circles) sampled on July 21, 2010.

Station “Upstream” was located in a large pool approximately 175 ft (53 m) upstream of the Māmalahoa Highway bridge, upstream from the Umauma-Hanapueo confluence. Station “Bridge” was located a few meters downstream from the bridge. Station “Downstream” was located in a pool just above the waterfall near the ocean shore, about 200 ft (60 m) downstream from the bridge. All water samples were collected on July 21, 2010 and delivered to AECOS, Inc. in Kane’ohe, O’ahu for laboratory analyses (AECOS Log No 26469).

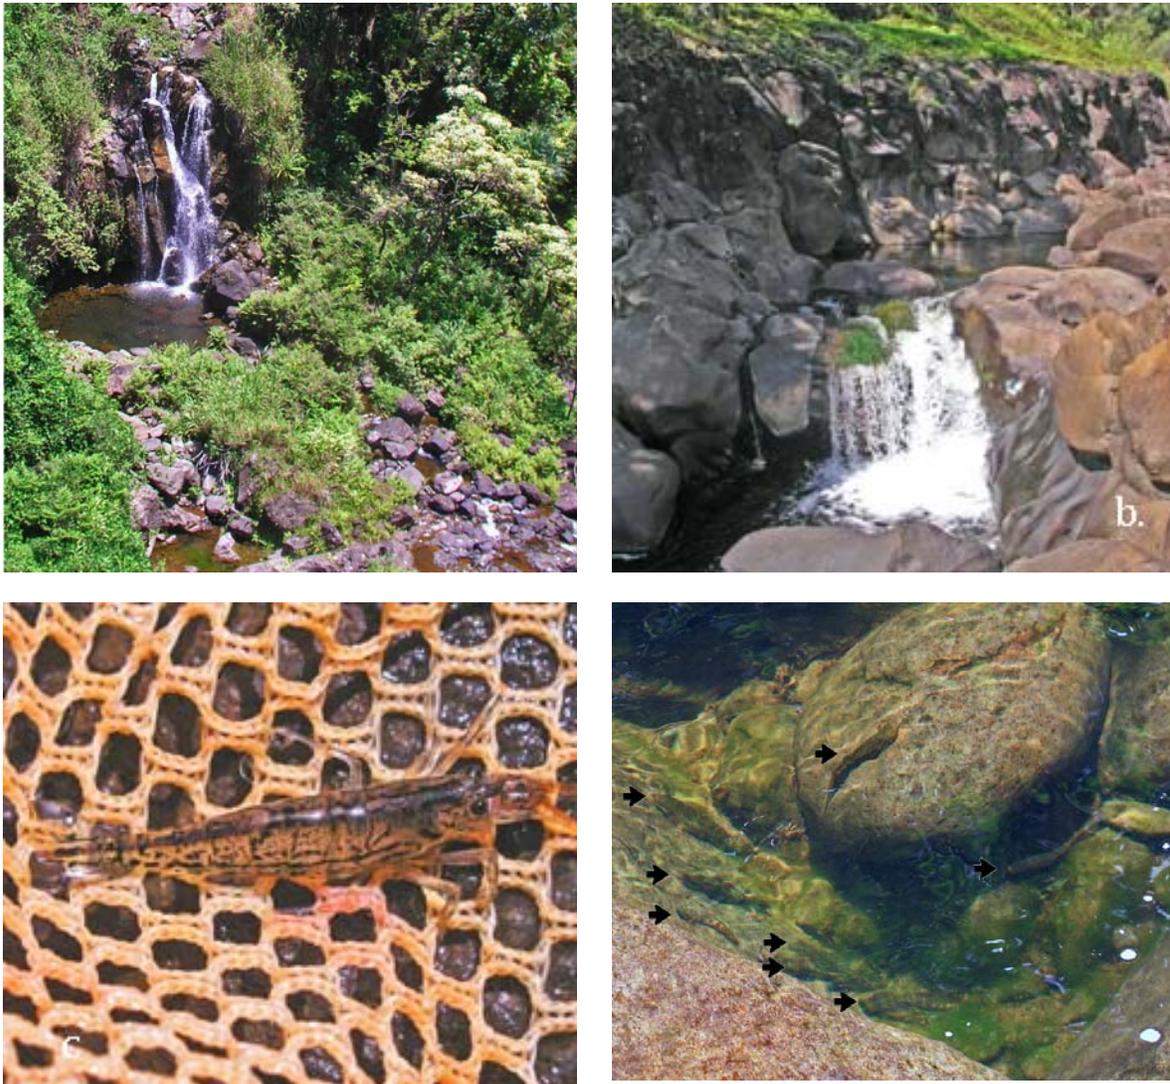
Figure 3. (Clockwise from top left) Hanapueo confluence with Umauma Stream just upslope from highway bridge; Stream flow and chlorophyte growth downstream from project site; Endemic 'ōpae kālā'ole from Umauma stream; Numerous 'o'opu 'nakea and 'o'opu 'alamo'o in a large pool upstream from the project site.

Upstream from the project site native gobies are quite common in large pools. 'O'opu nākea (*Awaous guamensis*) and 'o'opu 'alamo'o (*Lentipes concolor*) comprise most of the gobies sighted but a few 'o'opu nōpili (*Sicyopterus stimpsoni*) are present as well (Fig. 3). Native goby densities as high as 14/m<sup>2</sup> were noted in a large pool 800 ft (m) upstream of the bridge slated for rehabilitation. Native crustaceans are also present upstream of the project. Mountain 'ōpae or 'ōpae kala'ole (*Atyoida bisulcata*; Fig. 3), are occasional while Hawaiian prawn or 'ōpae 'oeha'a (*Macrobrachium grandimanus*) are rare in large pools.

Near the project site, the Hanapueo Stream enters from the south side (left bank) of the stream as a waterfall into a small pool (Fig. 3). Swordtails (*Xiphophorus helleri*) are occasional in the brief segment of Hanapueo between the waterfall and the confluence with Umauma. A few small, shallow pools in the segment are overgrown with chlorophytes, from the genera *Rhizoclonium* and *Spyrogyra*, and diatoms, including *Synedra ulna*.
