SUBJECT: Draft Environmental Assessment (EA) for Conservation District Use Application (CDUA) MA-3633 for the Stable Road Beach Groins Project Located Upon Submerged Land Offshore of Spreckelsville, Maui, Makai of TMK:(2) 3-8-002:71, 74, 77 & 78

DRAFT ENVIRONMENTAL ASSESSMENT WITH FINDING OF NO SIGNIFICANT IMPACT

STABLE ROAD BEACH GROINS REPLACEMENT PROJECT

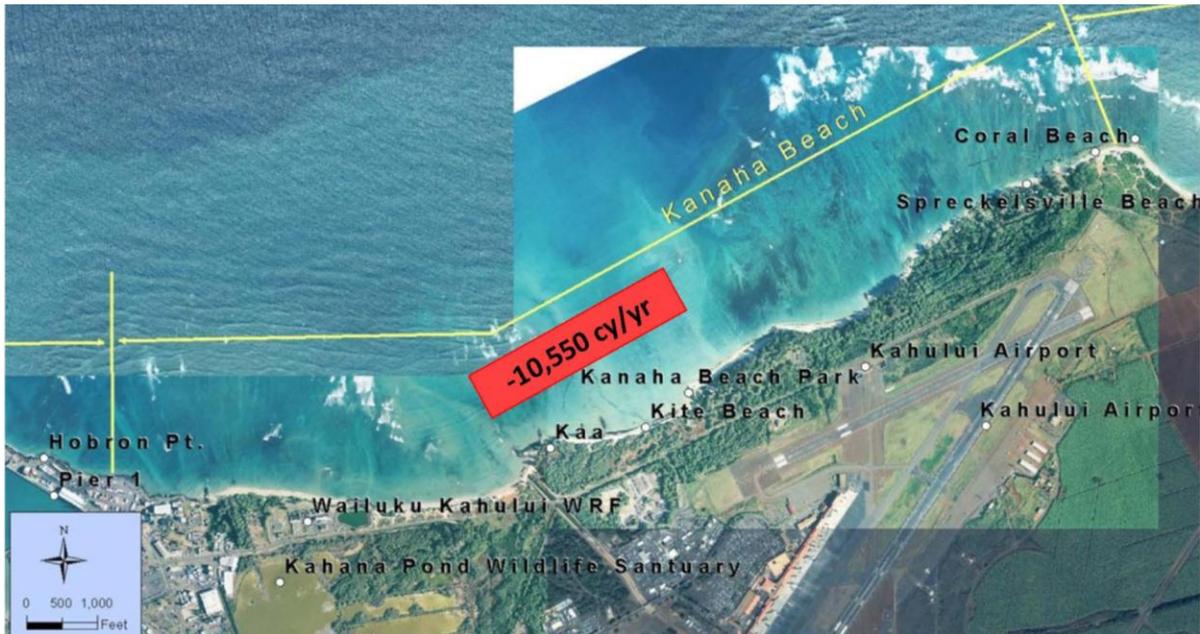
Figure 4 - Regional Annual Sediment Loss Map

A recent Regional Management Study by the U.S. Army Corps of Engineers of Maui's north shore region identified the Kanaha Littoral Cell, which includes the Project Area at its east end, as the fastest eroding cell on Maui's north shore with an annual sediment loss of 10,500 cubic yards for approximately 15,000 feet of shoreline (see Figure 4); whereas the next fastest eroding area is the updrift Baldwin Park cell, which has an annual loss of only 2,400 cubic yards. The theory for the high rate of erosion at the Kanaha cell is that after seven decades of sand mining of this coastal zone and updrift beaches 2.5 miles to Paia, the cell has a diminished, natural sediment supply updrift to sufficiently nourish its beaches.

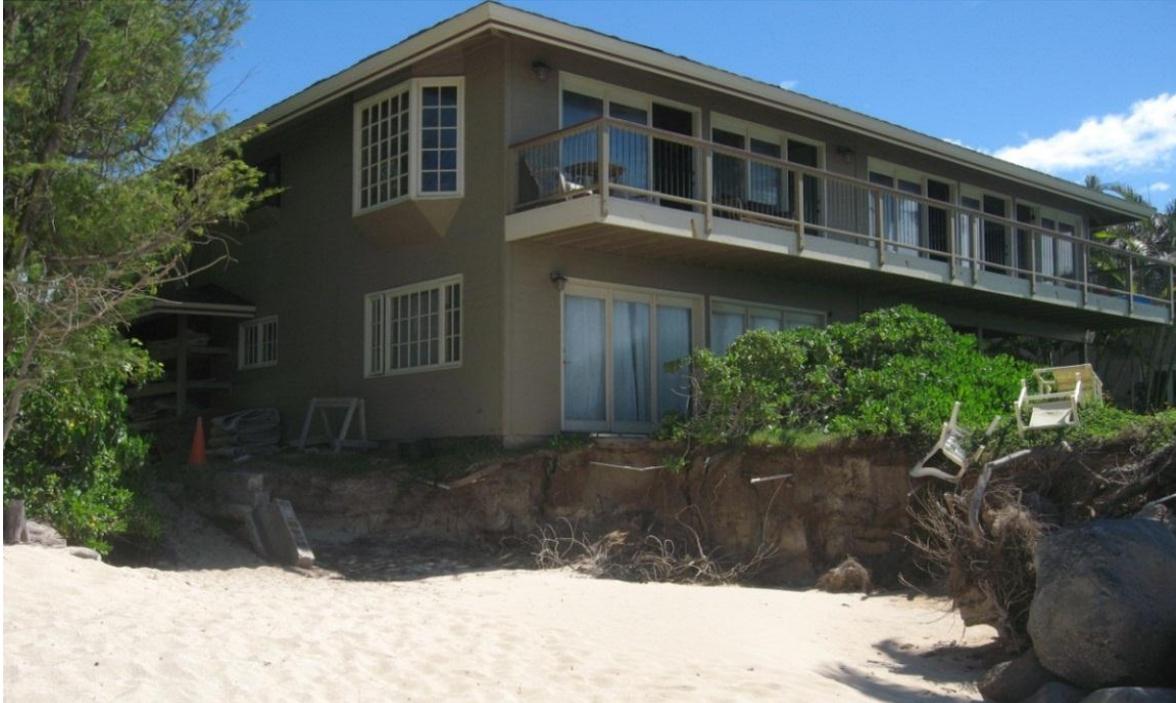
Photo 5 – Beach and Land Erosion at West End of Project Beach (Lot 3), 23 August 2010

During the fall and winter seasons, the Project Beach typically has experienced beach erosion and land loss starting at its far west end due to large surf from north Pacific swells combined with high tides plus from the adverse effect of the adjacent rock revetment and concrete seawall. The safety of the home on Lot 3 at this location is threatened (see Photo 5).

Photograph 9 shows the west end of the Project Beach, which has naturally gained sand over time without a significant fall and winter seasons' loss from large, north Pacific swells (compare to Photo 5, page 18 prior to the SSBN Evaluation Project).

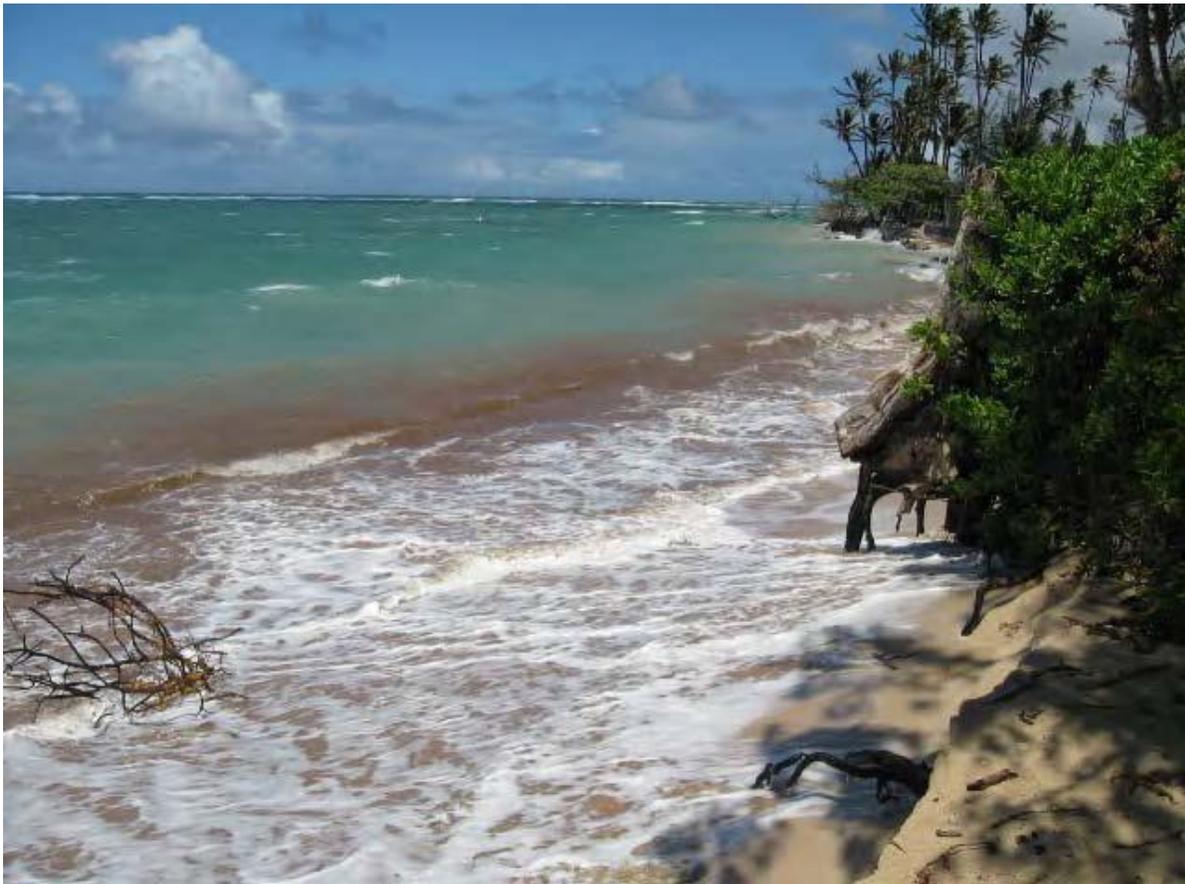
Photo 6 – Beach and Land Erosion Causing Pollution at Project Beach, August 2008

As beach sand erodes and is eventually lost, upland banks and vegetation are left exposed. The upland bank provides little or no resistance to erosion causing land, trees and vegetation to fall onto the beach and into the ocean. The dead vegetation restricts beach use and lateral beach access in addition to creating a safety hazard, especially during times of high tides and large waves (see Photo 4). The erosion of these historically terrestrial soils releases fine sediment and organic matter in the nearshore, increasing turbidity and impairing water quality (Photo 6).

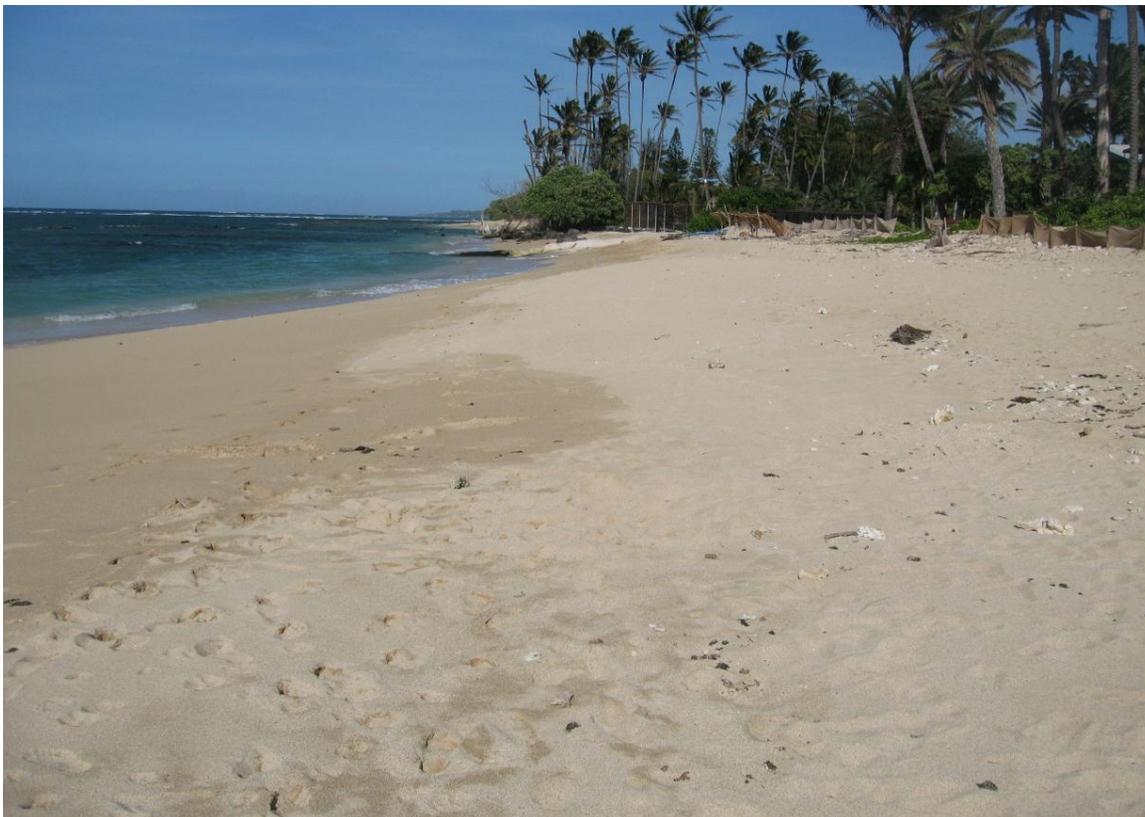
Photo 8 - East End of Project Beach, 2 April 2012 (compare to Photos 4, 6, 7, pages 17-19)

Visual analysis of the Project Beach indicates the success of the temporary groins in preventing beach erosion and land loss.

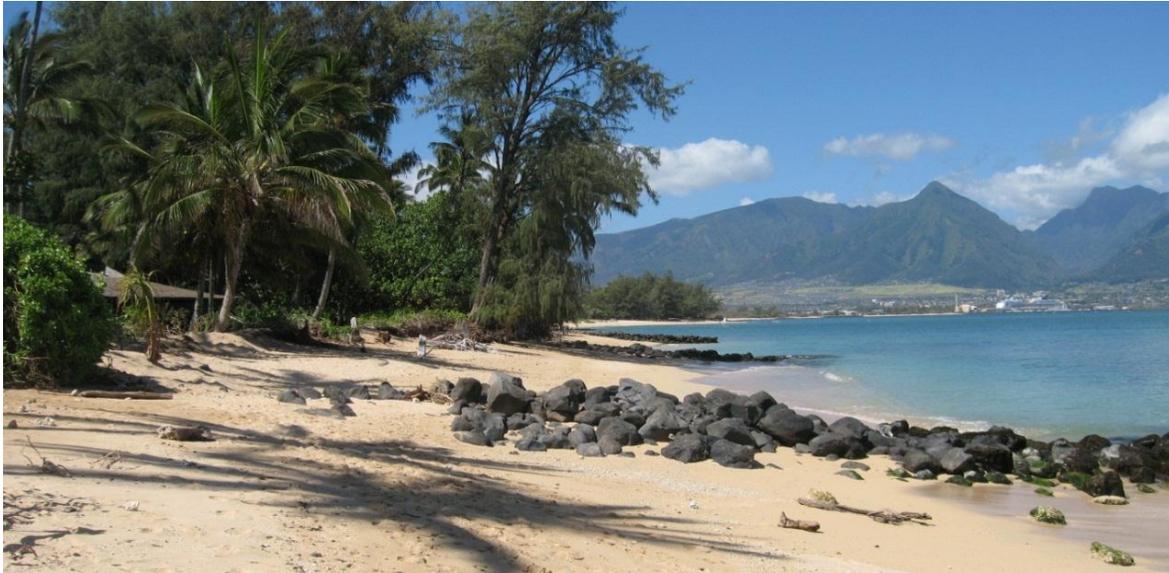
Photo 11 - Existing Rock Groins Downdrift of Project Beach.

The replacement groins are proposed to be constructed with 1.5 ton (2 foot diameter +/-) rocks placed around a longitudinal core of smaller rocks for long-term groin stability (see Replacement Groin Cross Section in Figures 12 and 13). This design approach is consistent with the U. S. Army Corps of Engineers' standards which have been developed after many groin installation assessments.

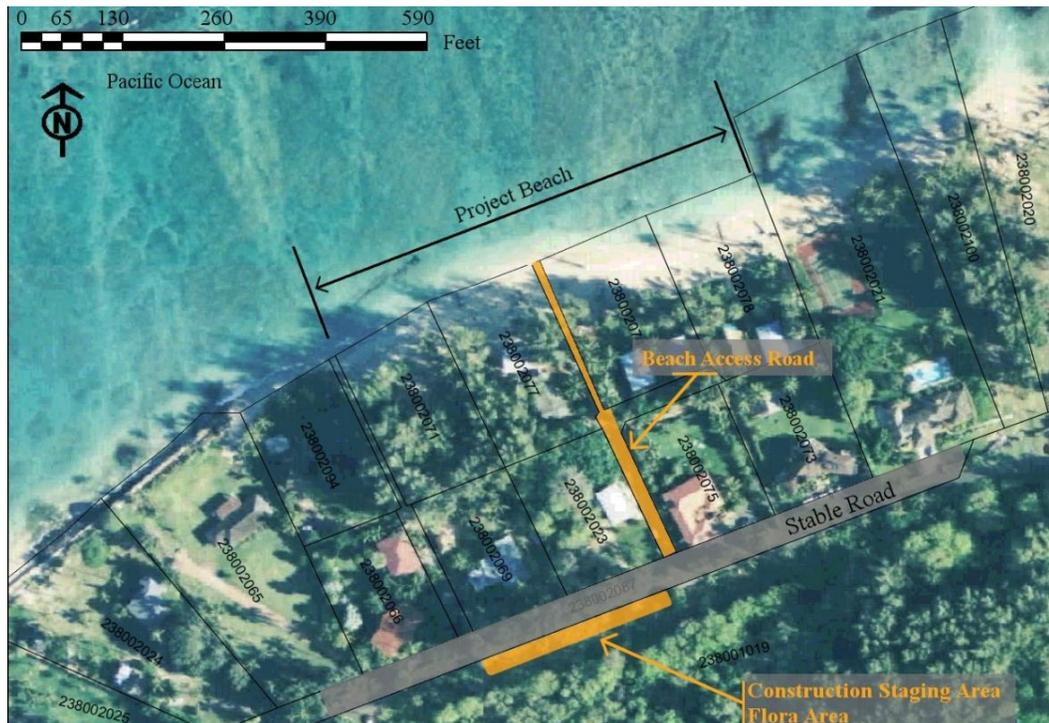
Figure 16 - Proposed Construction Staging Area, Beach Access Road, Existing Access, Flora Area and Resources Map

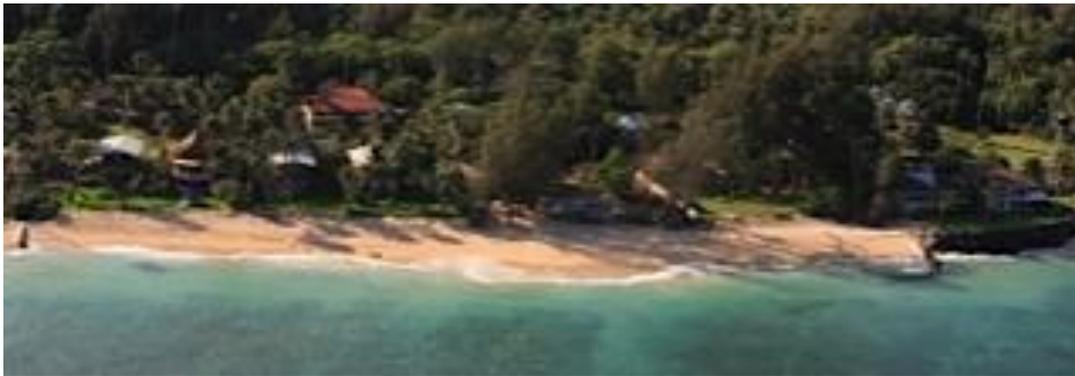
Photo 12 – Project Beach Aerial Photograph, 5 October 2011

Figure 7, page 25 indicates during the first year after the one year equilibrating period that Project Beach Width was stable during the 2011 summer. Photo 12 taken 5 October 2011 shows the SSBN Evaluation Project groin field full of sand since the middle groins are buried and sand is at the top of the terminal groins at their updrift side.

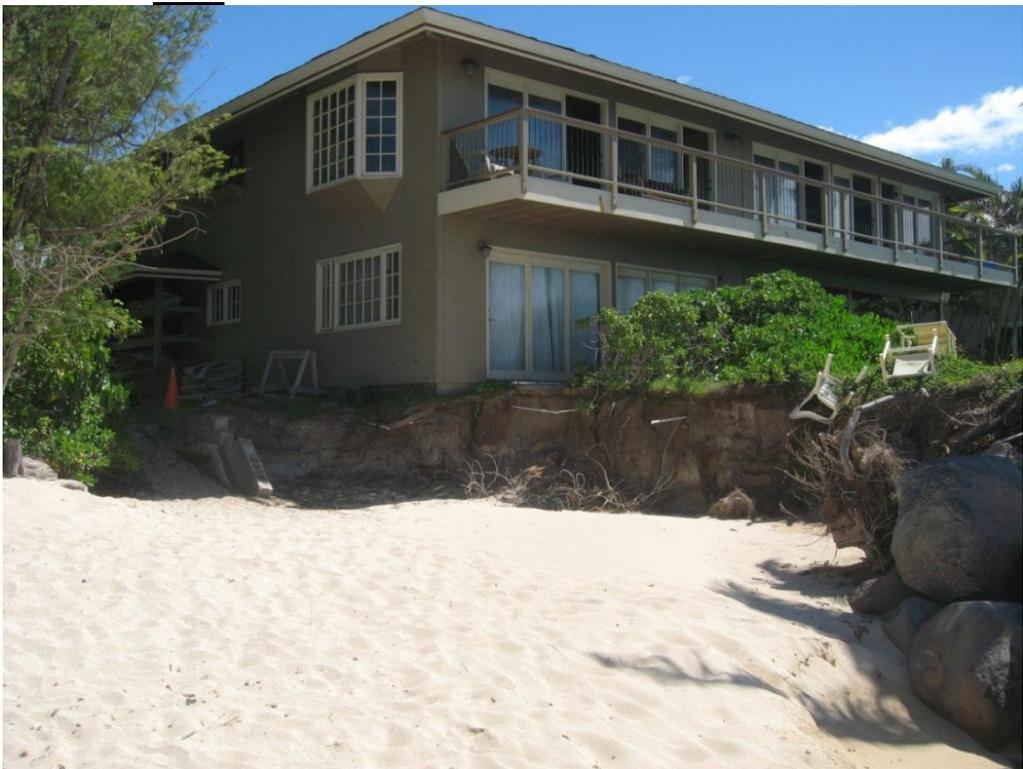
Photo 4- Beach and Land Loss at West End of Project Beach, 23 August 2010

- A loss of beach and shoreline, thus a loss of habitat to endangered species including the Hawaiian Monk Seal, Green and Hawksbill Sea Turtles plus shore birds (see Photo 3).
- The land of a home at the west end of the Project Beach has eroded to expose the building foundation, thus jeopardizing the home's safety and environment (see Photo 4).

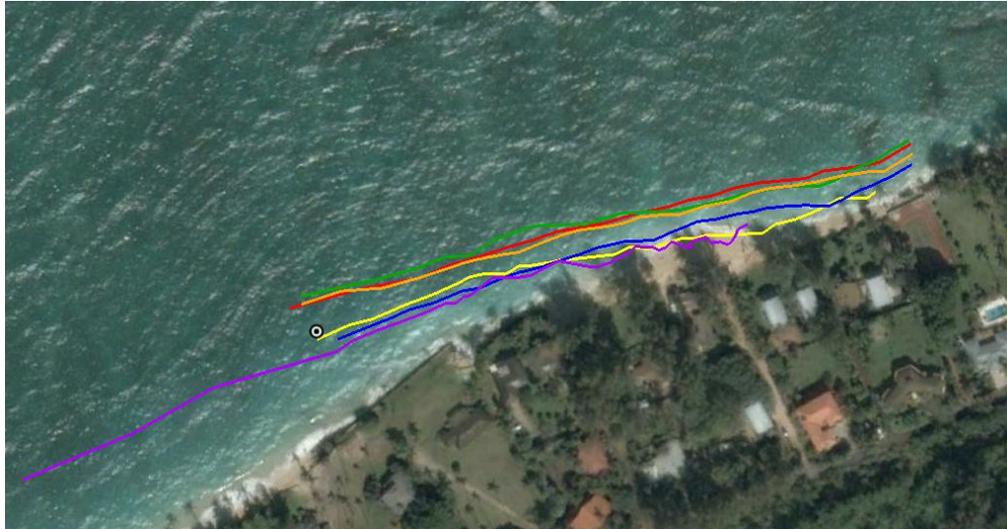
Figure 13 – Nearshore Current Direction

- Nearshore Current Direction - A study of nearshore ocean currents indicated the direction of current downdrift of the Project Area is divergent from the downdrift shoreline (see Figure 13), thus indicating the downdrift area may not receive much of the longshore transported sand from within and updrift of the Project Area, since most of the transported sand may bypass the downdrift beaches.

This study was performed when wind swells from trade winds were not significant. When the trade winds and swells increase typically in the afternoons during the spring and summer season, waves reflect from the downdrift seawall causing rebounding waves in an offshore direction and turbulence suspending sand longer, thus reducing the ability of the small, beach to receive and retain sand from updrift beaches via longshore transport.

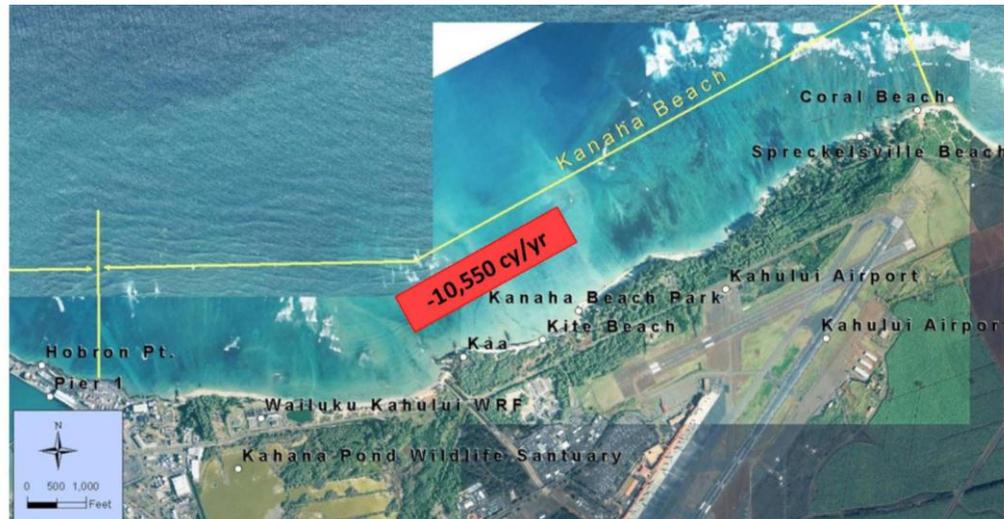
Figure 16 – Kanaha Littoral Cell Annual Beach Sediment Loss

the U.S. Army Corps of Engineers stated that based on more recent 2007 aerial photographs, the long-term Annual Beach Erosion Rate for the Kanaha Littoral Cell, which includes the Within and Outside Project Areas, has significantly increased with a significantly increased annual beach sediment loss of -10,550 cu. yd. per year (see Figure 16).

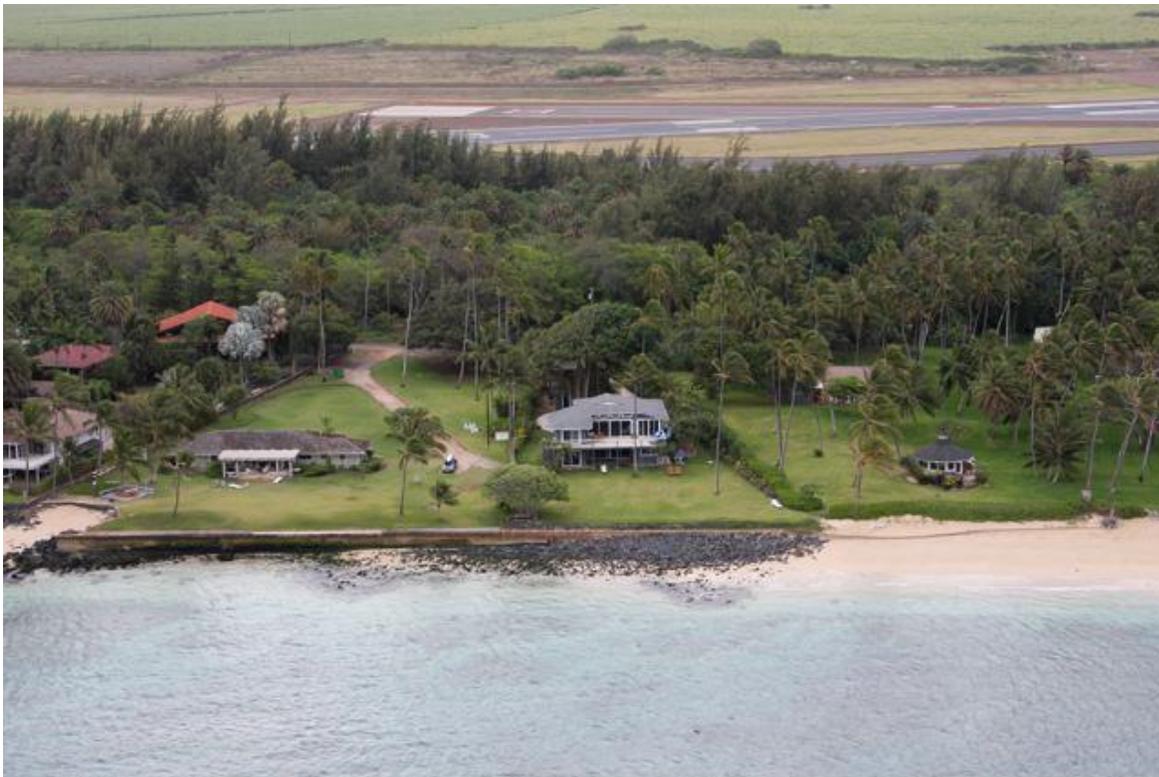
Photo 11 - Aerial View of Downdrift Area Pre-Construction Showing Lot 2 Seawall at Left and Lot 1 Seawall at Center with Rock Piles and at Right, 15 April 2010

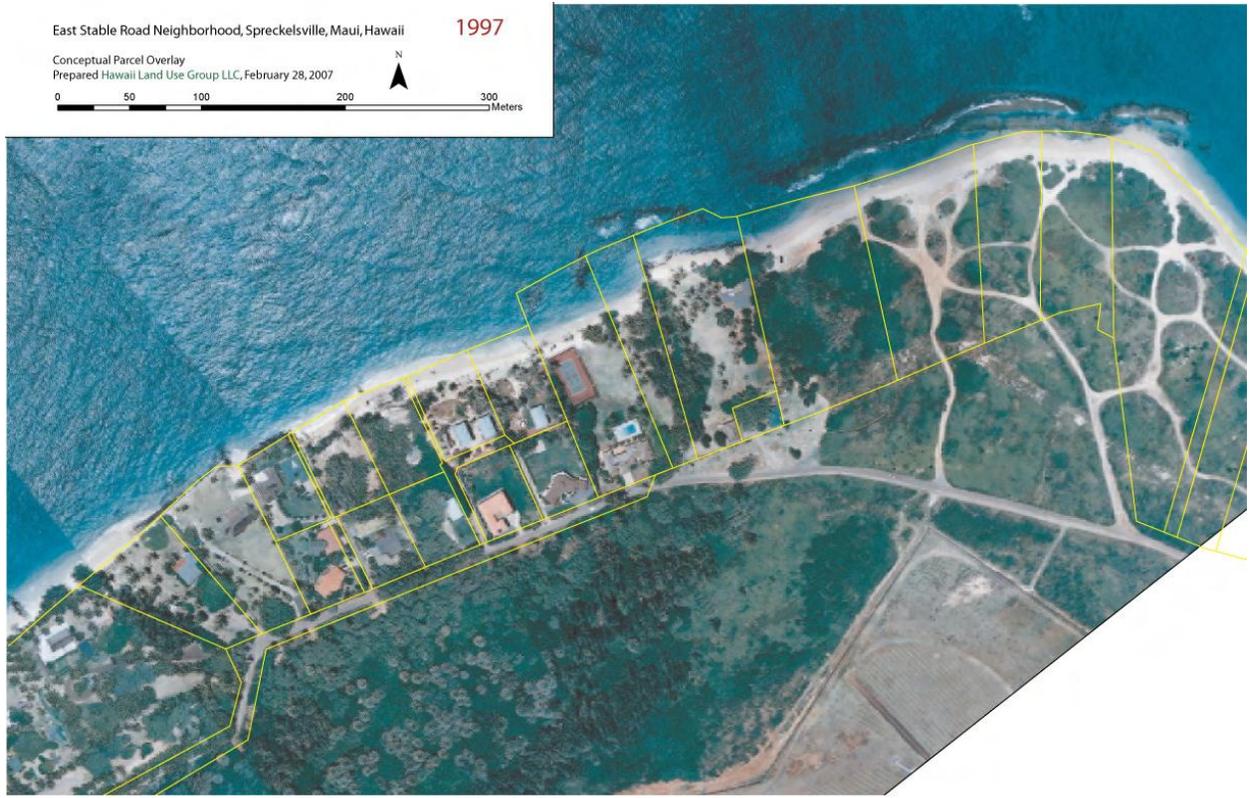
Photo 18 - Aerial View Showing No Beach in Front of Downdrift Lot 2 Seawall, May 1997

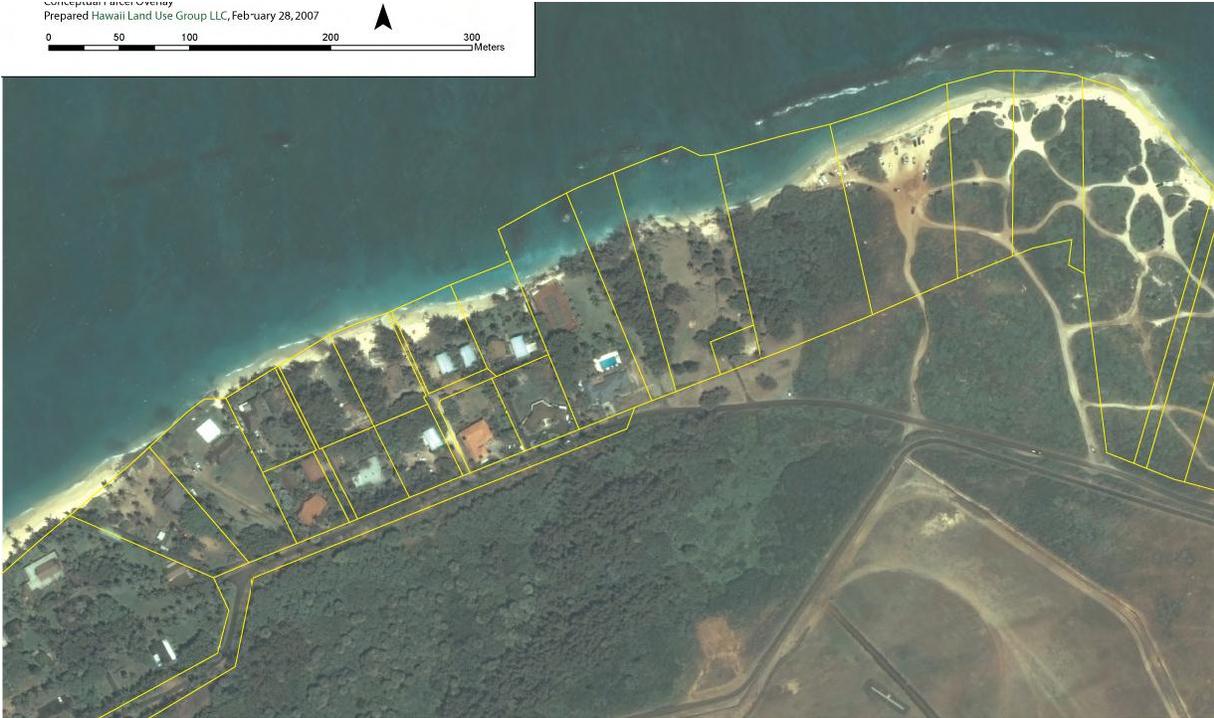
Photo 20 - Aerial View Showing No Beach at DOWNDRIFT Lot 2 and East Half of Lot 1, 2005

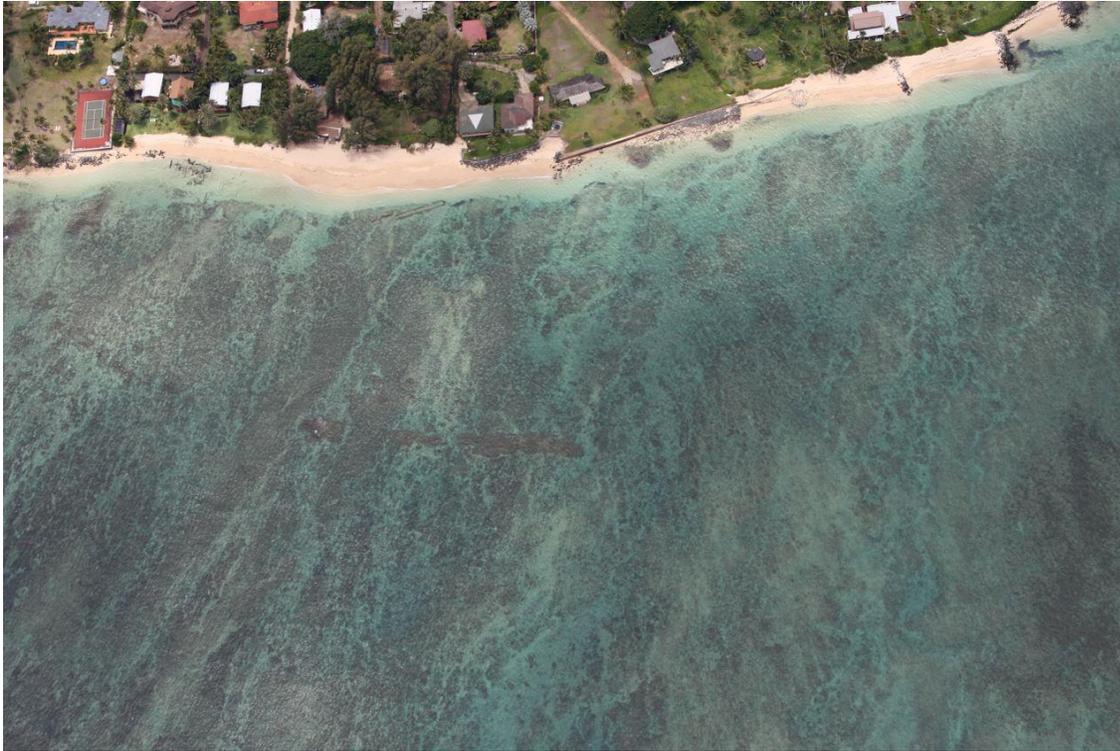
Photo 22 - Aerial View Showing Beach Beginning of Summer Season Erosion, Scouring, Exposed Seawall Portion in Front of Downdrift Lot 1 at Right, 19 July 2009

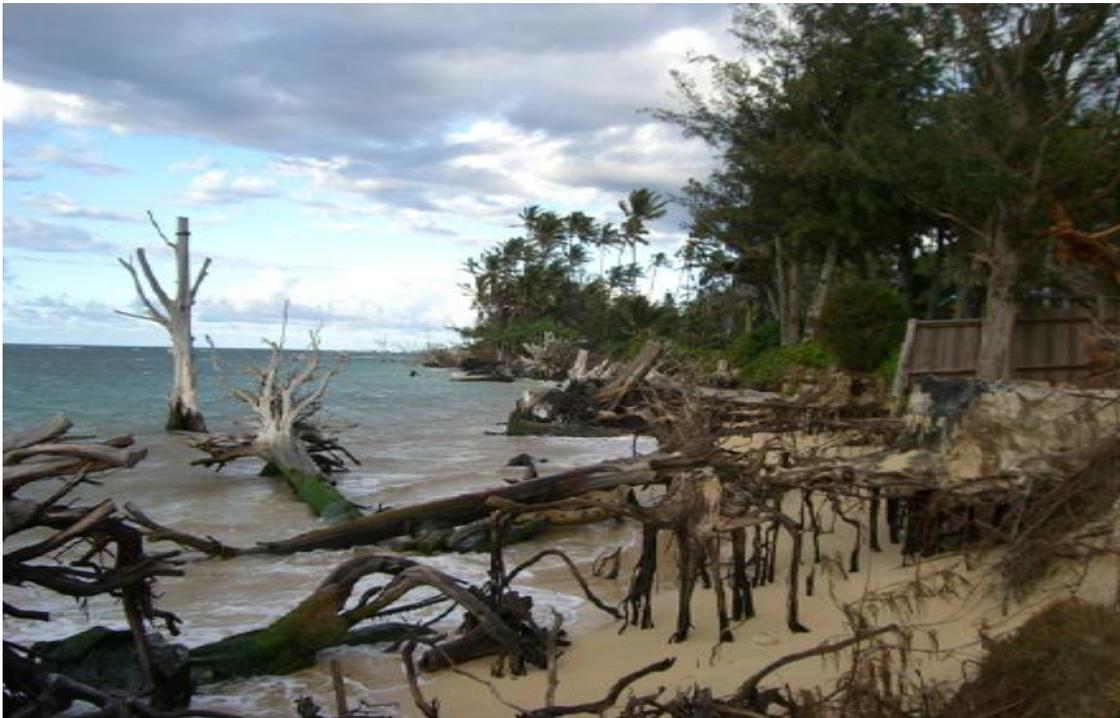
During the spring and summer seasons when strong trade winds typically occur, the east end of the Project Beach and land have eroded from northeasterly, short interval waves causing scouring and longshore sand transport to the west. The beach then has become unusable and unsafe (see Photo 1). This erosion is exacerbated by the adverse effects of the adjoining hardened shoreline to the east.

Photo 1 - Beach and Land Erosion Pre-Construction at Project Beach Looking East, 22 August 2006

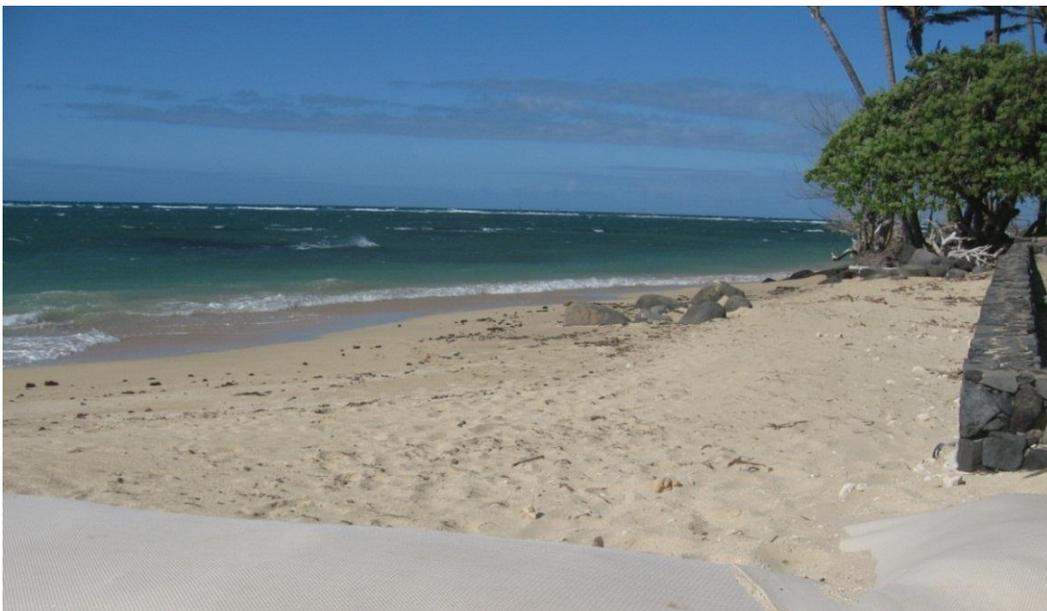
Beach Width and Beach Sand Volume - Updrift Area at Transect 12: There is a 70 foot long seawall in front of the tennis court on Lot A with rock piles in front of the seawall (see Appendix Photo 4 and Photos 18 and 19). Typically during the spring and summer seasons, the seawall has no beach in front due to beach scouring and sand loss from northeasterly trade wind waves and longshore sand transport currents. During previous years, the bottom of the seawall footing became exposed and undermined during the spring/summer.

Photo 18 - Updrift Beach Area at Transect 12 Showing Seawall at Right and Rock Pile at Beach, 29 August 2010

Assessment: The Dry Beach Width measurements and Dry Beach Sand Volume calculations at transect 12 have varied seasonally with a slight two year increase per Figures 12 and 13, which are also confirmed by Photos 18 and 19. In the last two years, there has been no exposed foundation and no significant erosion at transect 12; whereas the historic, Annual Erosion Hazard Rate from 1960 to 2001 at transect 12 was 1.5 feet per year (see Figure 15).

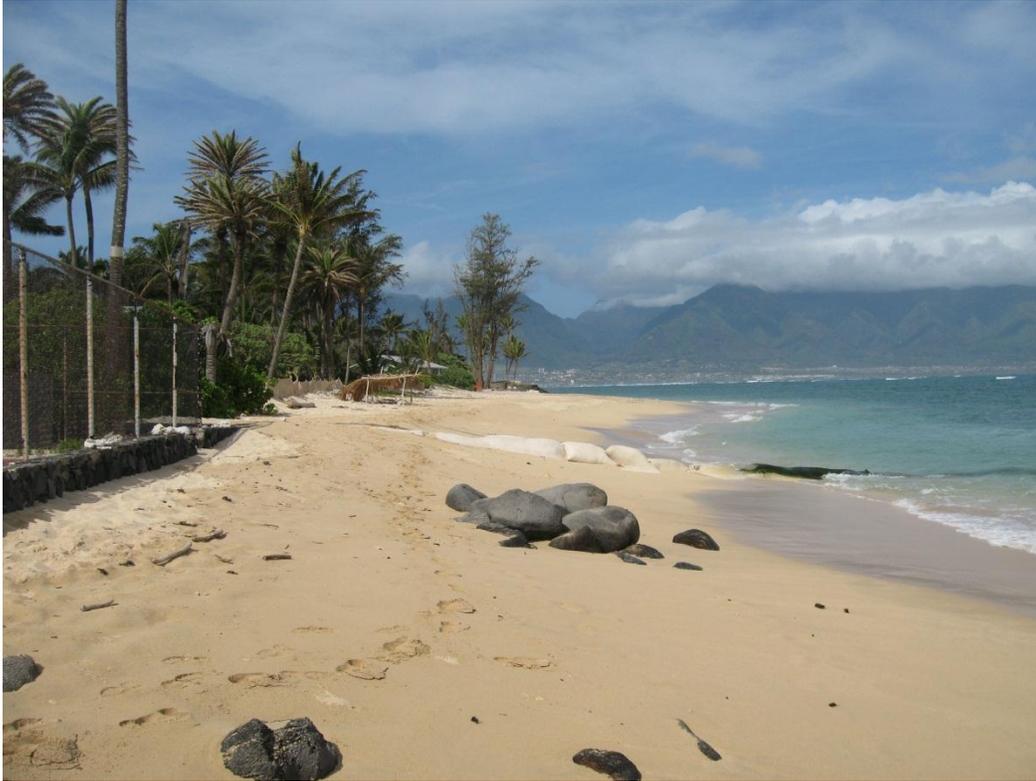
Photo 19 - Updrift Beach Area at Transect 12 Showing Seawall at Left and Top of Rock Pile at Beach, 4 April 2012

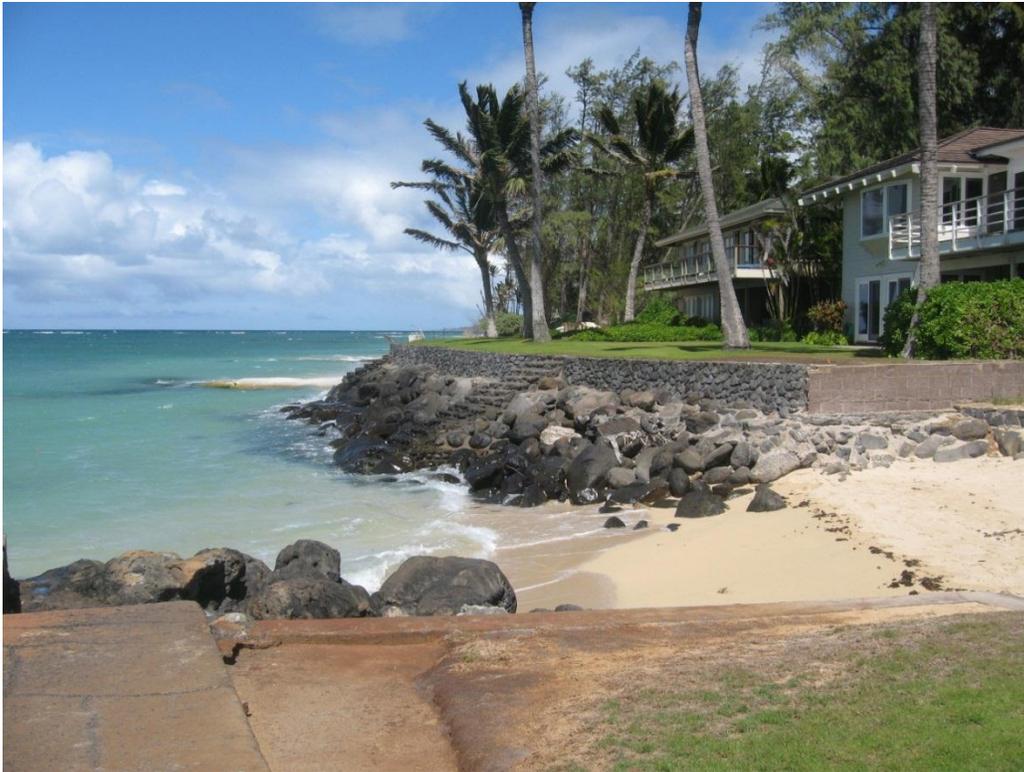
Photo 20 - At Transect 3 Near Ends of Seawall and Updrift Beach Cove With Perimeter Seawall, 17 August 2010

Transect 3 is located immediately downdrift of the Project Area and is approximately 160 feet from the nearest Project groin. Transect 3 is located approximately 20 feet west of the east end of a long seawall extending westerly, and there are rock piles in front, to the east and to the west of transect 3, which were formerly groins (see 1940 Appendix Photo 9). Immediately updrift of transect 3 to transect 4 is a small, sand beach cove approximately 50 feet wide with a perimeter seawall set back inland of the westerly seawall and the easterly revetment. This updrift beach cove did not significantly changed in its appearance of Beach Width and Beach Sand Volume during the 2010 summer and fall plus 2011 early winter seasons (see Photos 20 and 21), but it lost considerable Beach Sand Volume from the 11 March tsunami during the late 2011 winter season (see Photo 22). During the 2011 spring season, the beach cove re-gained considerable Dry Beach Width and Beach Sand Volume nearshore (see Photo 23); however, some ground under the perimeter seawall was still exposed, which was caused by the tsunami tidal waves undermining this wall upon impact and removing the sand below (see Photo 22). During the 2011 summer season, the beach cove gained sand initially and then lost sand in September with the return of a few north Pacific swells (see Photo 24). During the 2011 fall/ 2012 winter seasons, there was little change in the beach cove; however, sand returned to under the perimeter seawall (see Photos 25 and 26).

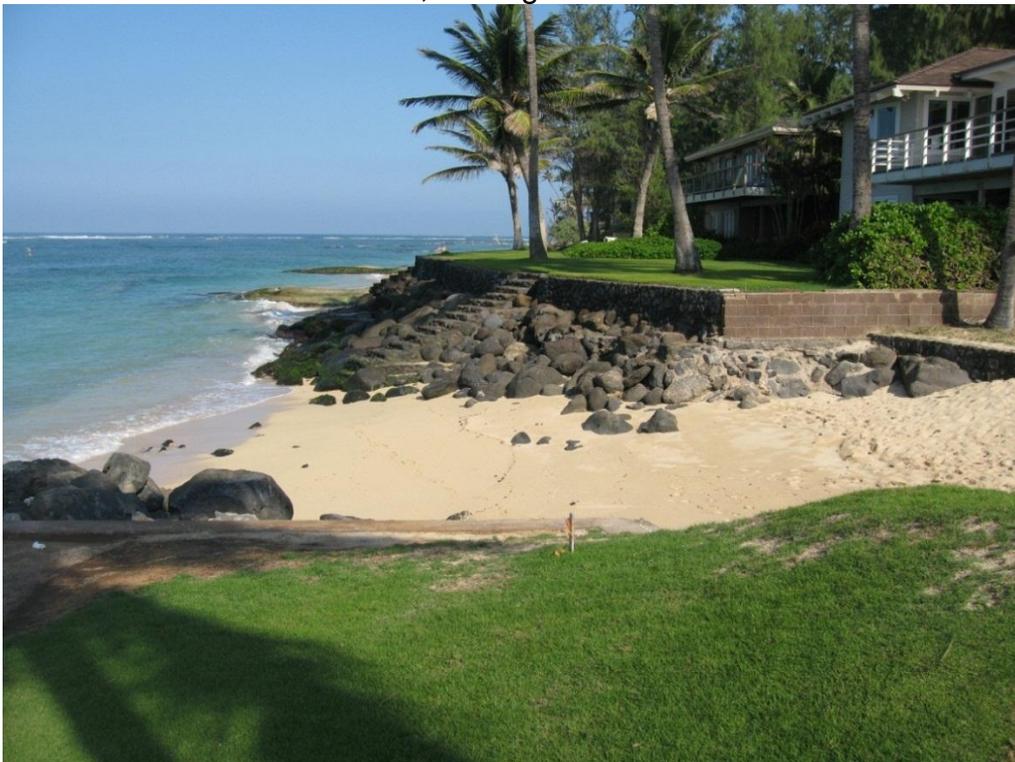
Photo 21 - At Transect 3 Near Ends of Seawall and Updrift Beach Cove With Perimeter Seawall, 13 December 2010

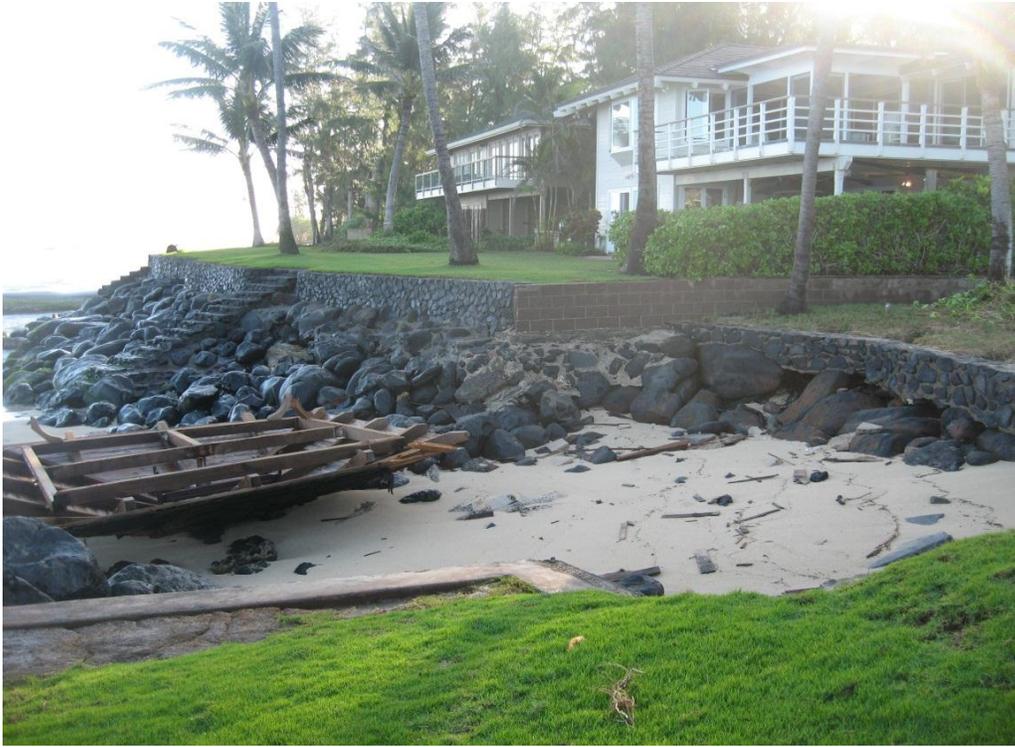
Photo 22 - At Transect 3 Near Ends of Seawall and Updrift Beach Cove with Perimeter Seawall, 11 March 2011- Immediately Post-Tsunami

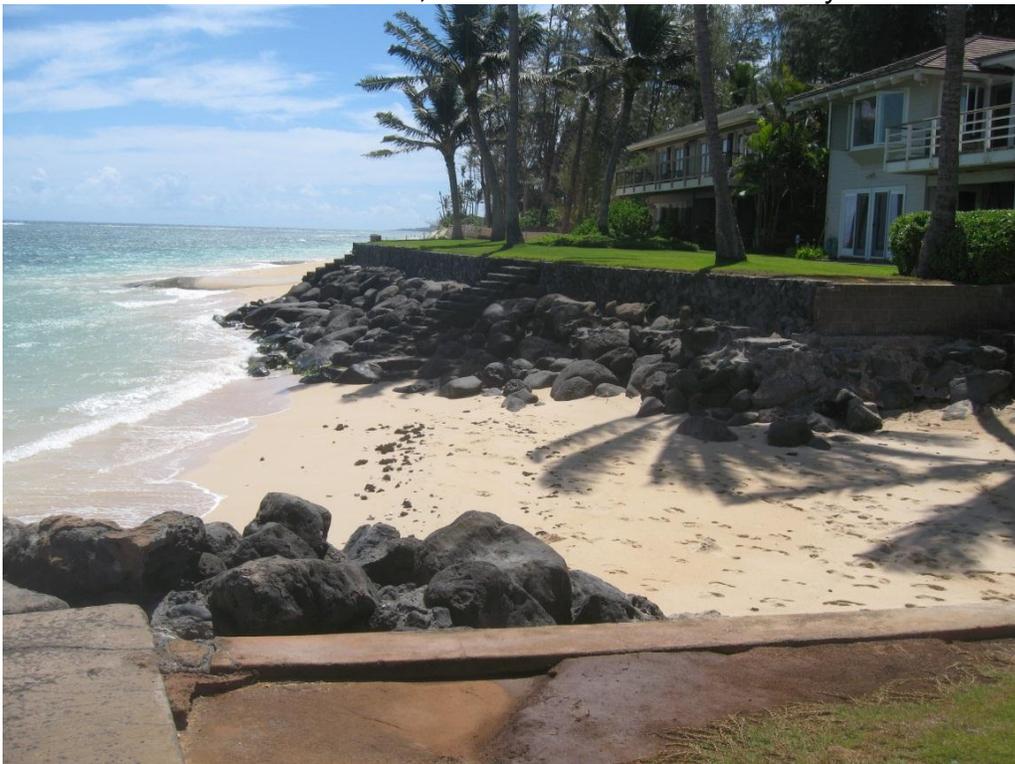
Photo 23 - At Transect 3 Near Ends of Seawall and Updrift Beach Cove with Perimeter Seawall, 29 June 2011

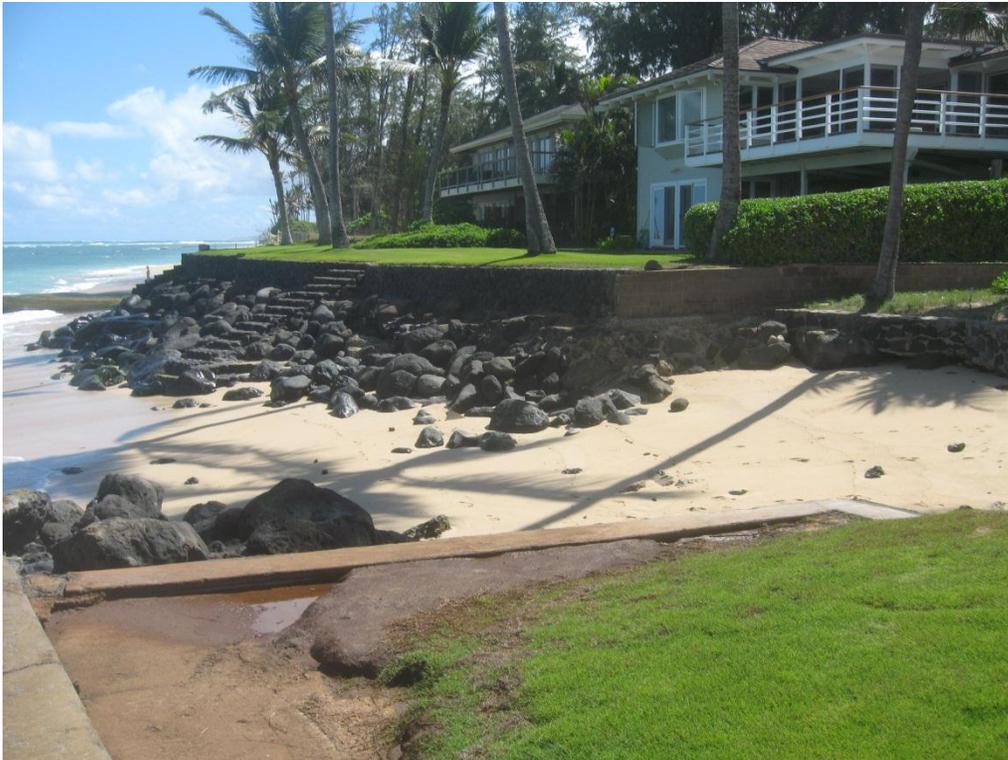
Photo 24 - At Transect 3 Near Ends of Seawall and Updrift Beach Cove with Perimeter Seawall, 1 October 2011

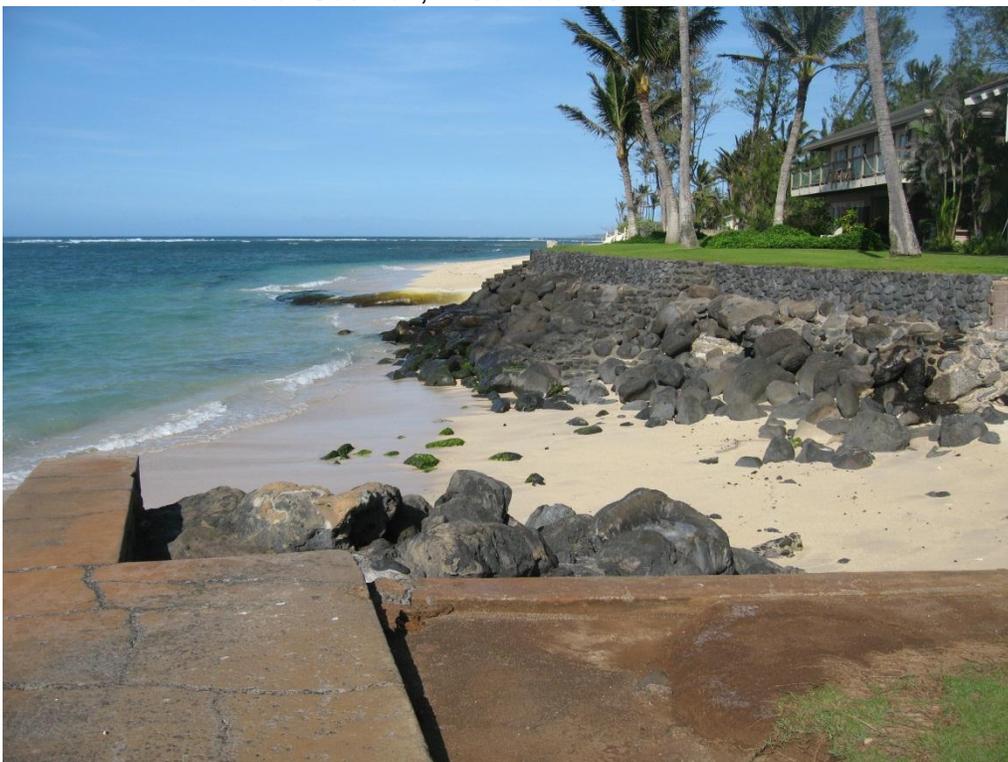
Photo 25 - At Transect 3 Near Ends of Seawall and Updrift Beach Cove with Perimeter Seawall, 4 April 2012

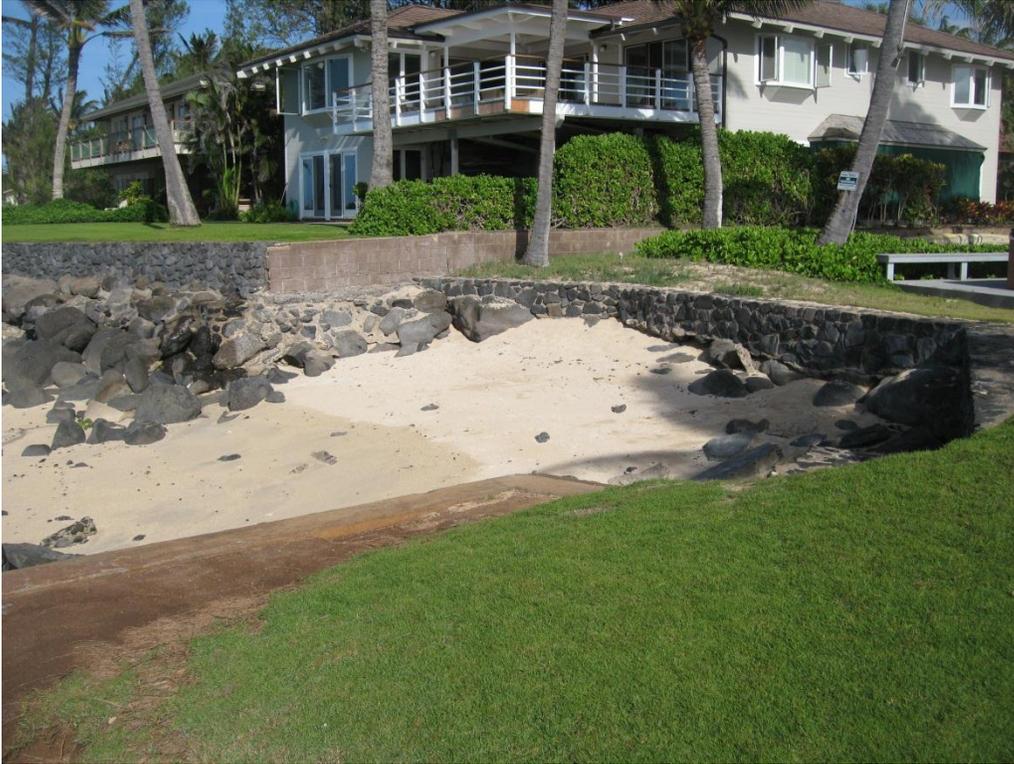
Photo 26 - At Transect 3 Near Ends of Seawall and Updrift Beach Cove with Perimeter Seawall, 4 April 2012

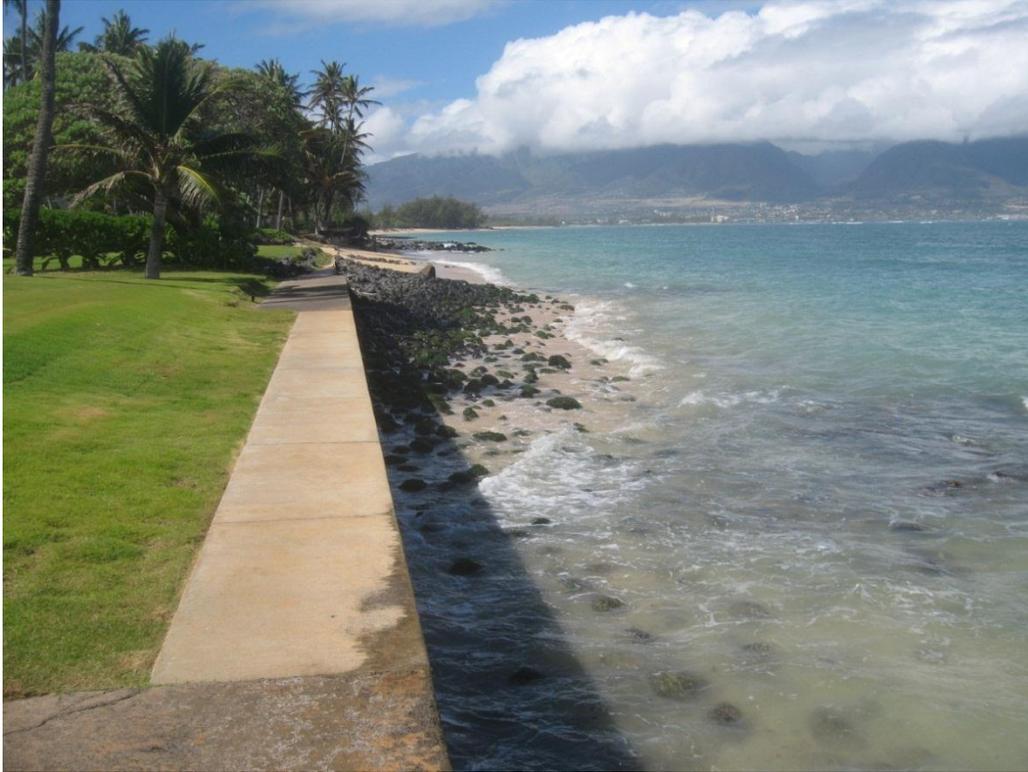
Photo 27 - Near Transect 3 Looking West Along Continuous Seawall with Large Rock Pile/Revetment at Transect 2 Beyond, 1 October 2011

Transect 2 is located approximately 160 feet downdrift and east of transect 3 and 180 feet west of the seawall end with a continuous seawall in between to the east. There is another 280 feet of seawall downdrift and west of transect 2 to Parcel 25 (see Appendix Photo 5 plus Photos 27 and 28), so transect 2 is near the middle of a 460 foot long, continuous seawall. There are several rock piles in front of the long seawall including large revetment type piles both sides of transect 2 (see Appendix Photos 5 and 8), and the rock plies were formerly rock groins per the 1940 aerial photograph (see Appendix Photo 9).
