SUBJECT: Draft Environmental Assessment (EA) for Conservation District Use Application (CDUA) MA-3633 for the Stable Road Beach Groins Project Located Upon Submerged Land Offshore of Spreckelsville, Maui, Makai of TMK:(2) 3-8-002:71, 74, 77 & 78

DRAFT ENVIRONMENTAL ASSESSMENT WITH FINDING OF NO SIGNIFICANT IMPACT

STABLE ROAD BEACH GROINS REPLACEMENT PROJECT

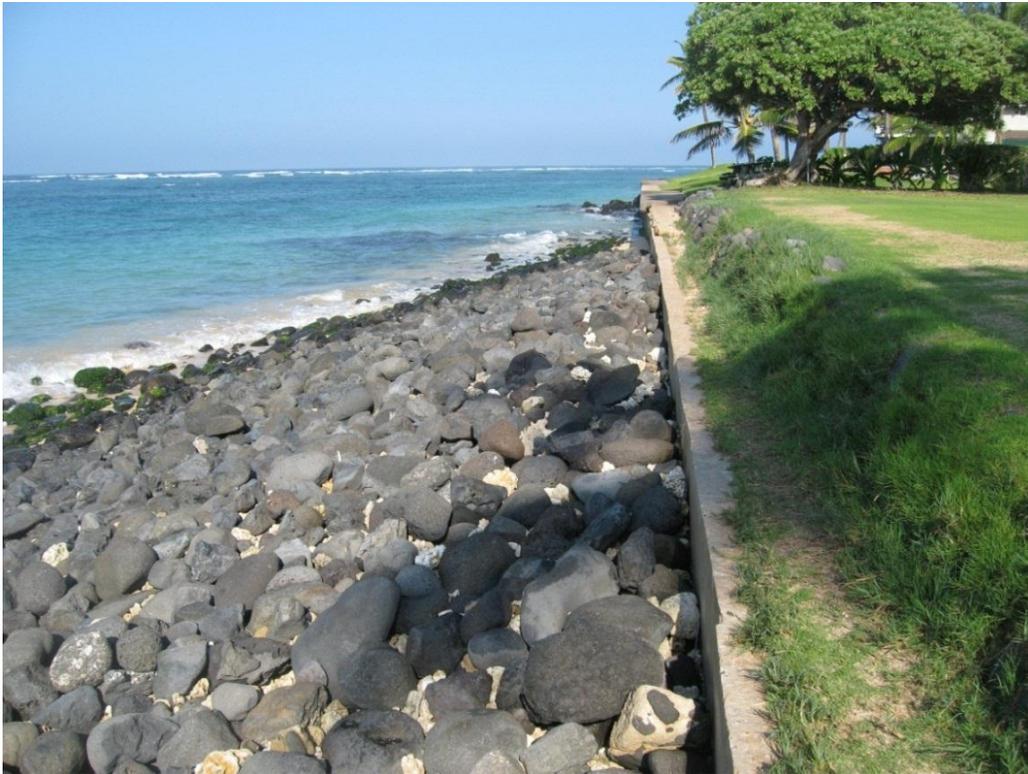
Photo 28 - Near Transect 2 Looking East Along Continuous Seawall with Large Rock Pile/Revetment Toward Transect 3 Beyond, 13 December 2010.

Transect 2 is located approximately 160 feet downdrift and east of transect 3 and 180 feet west of the seawall end with a continuous seawall in between to the east. There is another 280 feet of seawall downdrift and west of transect 2 to Parcel 25 (see Appendix Photo 5 plus Photos 27 and 28), so transect 2 is near the middle of a 460 foot long, continuous seawall. There are several rock piles in front of the long seawall including large revetment type piles both sides of transect 2 (see Appendix Photos 5 and 8), and the rock plies were formerly rock groins per the 1940 aerial photograph (see Appendix Photo 9).

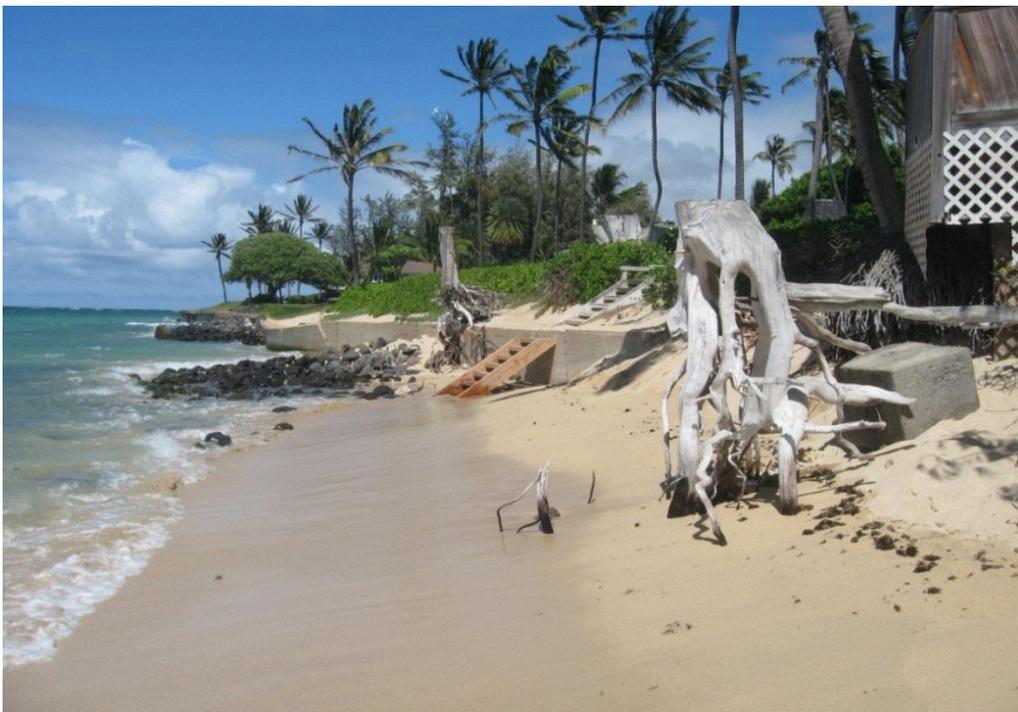
Photo 29 - Beach, Rock Groin and Seawall at West Half of Lot 1 and Parcel 25 (in Foreground) Near Transect 1 (at Stair), 17 August 2010

Photographic data visually shows the tsunami effect at transect 1. The most significant 2010 spring/summer beach sand loss at transect 1 in 2010 had occurred by mid-August, and the 17 August 2010 beach photograph (see Photo 29) shows 7 treads exposed at the lower stair located below the seawall at transect 1. Sand returned to this beach during the 2010 fall season, and as of 17 December 2010 only 2 treads were exposed at the same stair (see Photo 30). Also as of 17 December, sand was mostly covering the old rock groin immediately east of transect 1 as well as the seawall portion to the east. Sand also returned to this beach during the first two months of the 2011 winter season by 11 February when no lower stair treads were exposed (see Photo 31), and the average height of the seawall across Lot 1 was approximately .75 feet. The subsequent 11 March tsunami removed sand from this beach when 3 treads of the lower stair were exposed on March 11 (see Photo 32); however, a significant volume of sand returned to the beach after the tsunami a month later by 9 April (see Photo 33) when the top of the seawall west of transect 1 and the lower stair were no longer exposed. The tsunami did not push much sand from this beach onto the land at this location as it did Within the Project Area, so the sand removed from the beach by the tsunami was dispersed in the ocean.

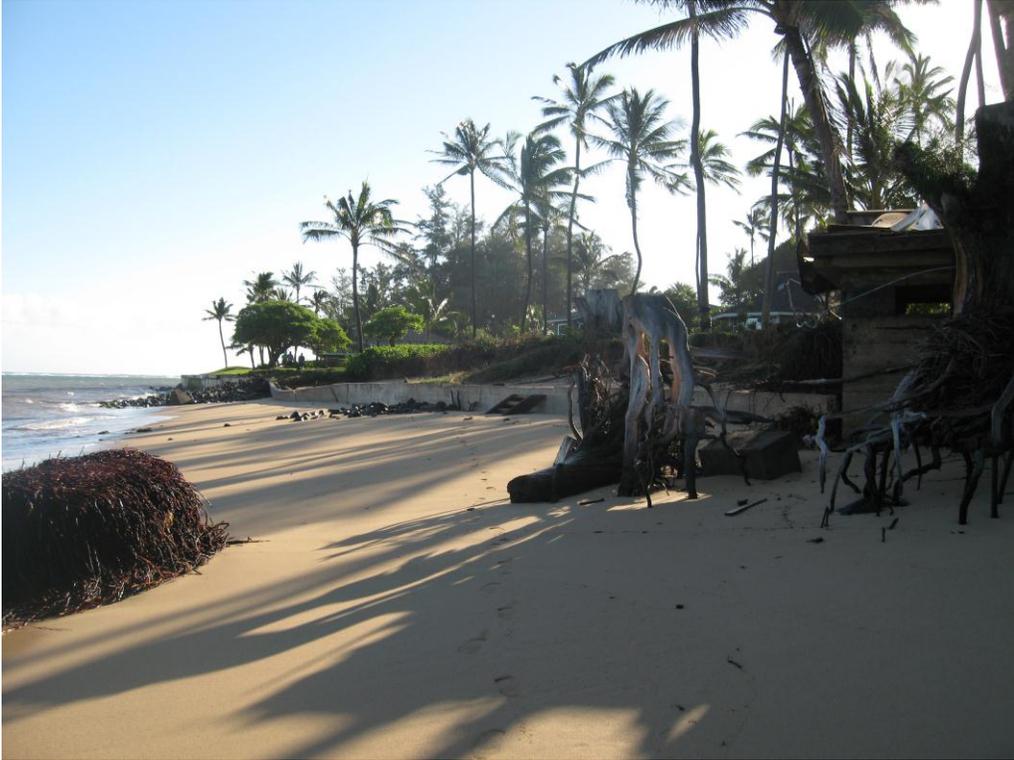
Photo 32 - Beach, Rock Groin and Seawall at West Half of Lot 1 and Parcel 2 Near Transect 1 (at Stair), 11 March 2011 Immediately Post-Tsunami

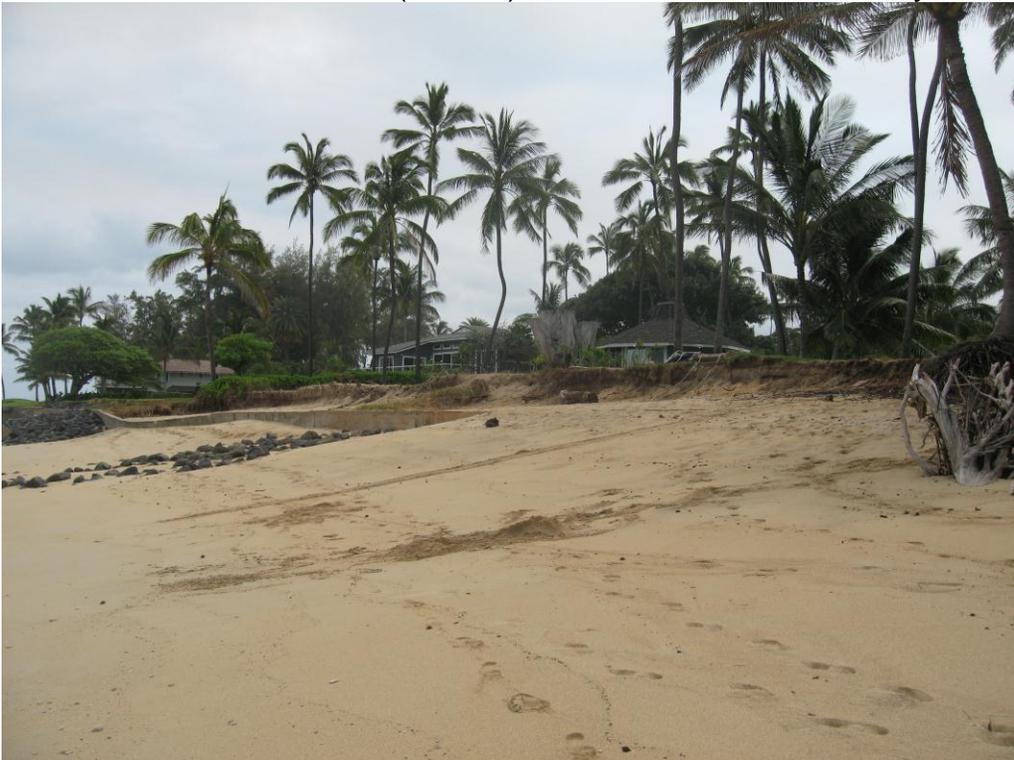
Photo 33 - Beach, Rock Groin and Seawall at West Half of Lot 1 and Parcel 25 Near Transect 1 (at Stair), 9 April 2011 Post-Tsunami

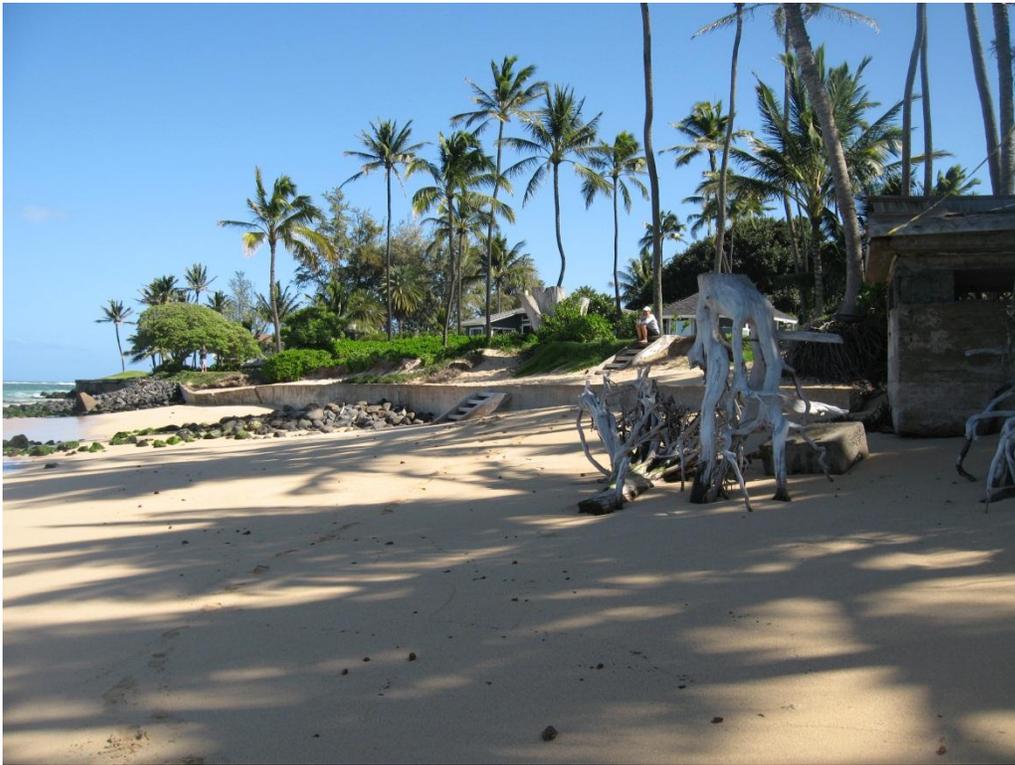
Photo 36 - Beach, Rock Groin and Seawall at West Half of Lot 1 and Parcel 25 Near Transect 1 (at Stair), 29 December 2011

It was anticipated that during the 2011 fall/2012 winter seasons, north Pacific waves would again dominate light trade wind weather as they did during the last two fall/winter seasons, and the beach would gain sand; however, the weather fluctuated between periods of high trade winds causing erosion and periods of north Pacific waves causing accretion resulting in the beach at transect 1 to be generally unchanged and not gain sand during the 2011 fall/2012 winter seasons from the 2011 summer condition (see Photos 35 and 36).

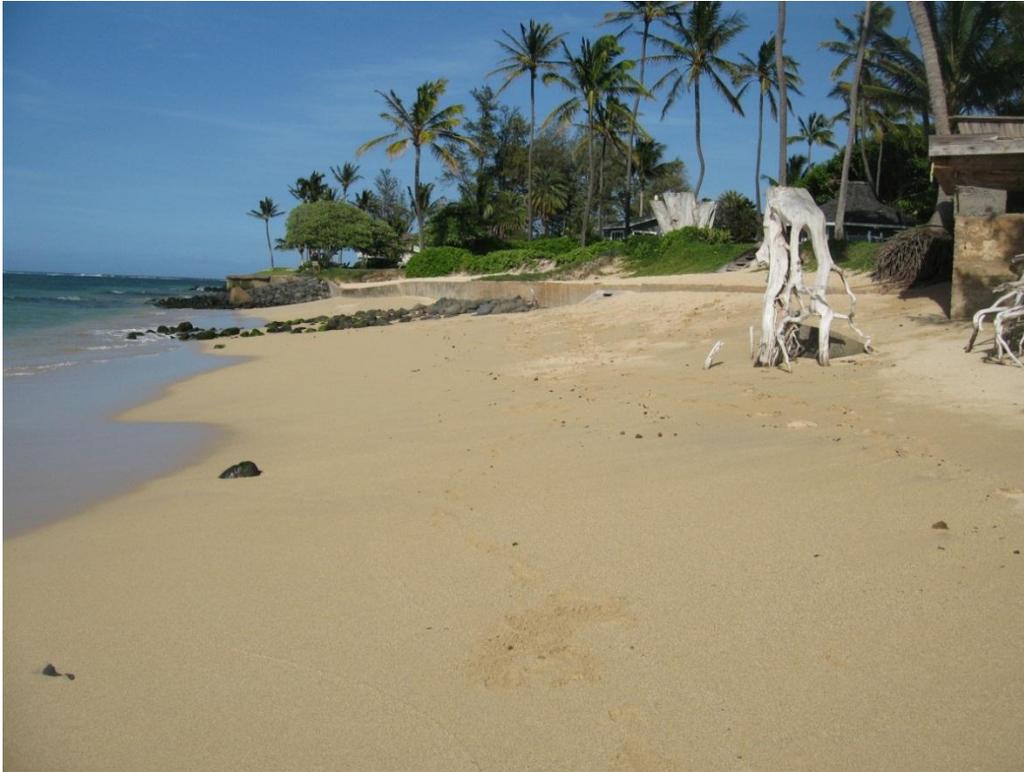
Photo 38 - Beach, Rock Groin and Seawall at West Half of Lot 1 and Parcel 25 Near Transect 1 (at Stair), 4 April 2012

Transect 1 is located at the west end of Lot 1 by the wooden stair (see Figure 1).

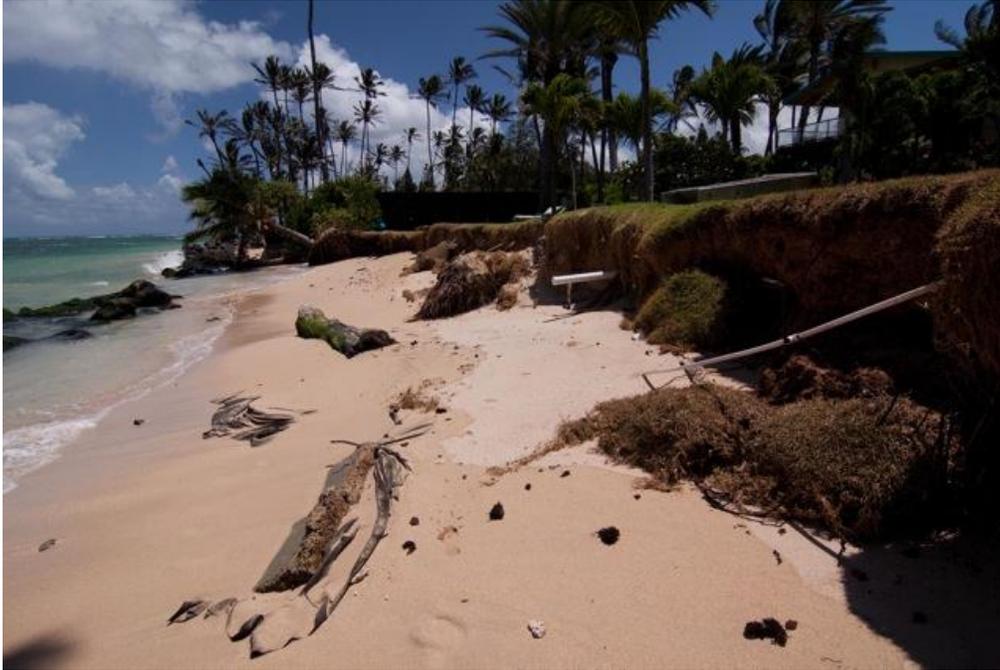
Photo 39 - East End of Project Beach, 4 August 2009

The Project Area pre-construction typically behaved as a littoral cell with spring/summer erosion starting at its east end from northeast trade winds (see pre-construction Photo 39), fall/winter erosion at its west end from north Pacific

swells (see pre-construction Photo 2) and with sand migrating back and forth with seasonal weather changes. Post-construction during the 2010 and 2011 spring plus summer seasons, the east end of the Project Beach experienced minimal beach erosion and no land loss (see Photo 40), which is very unique compared to previous years of significant beach sand and land loss during the same time of year (see Photo 39).

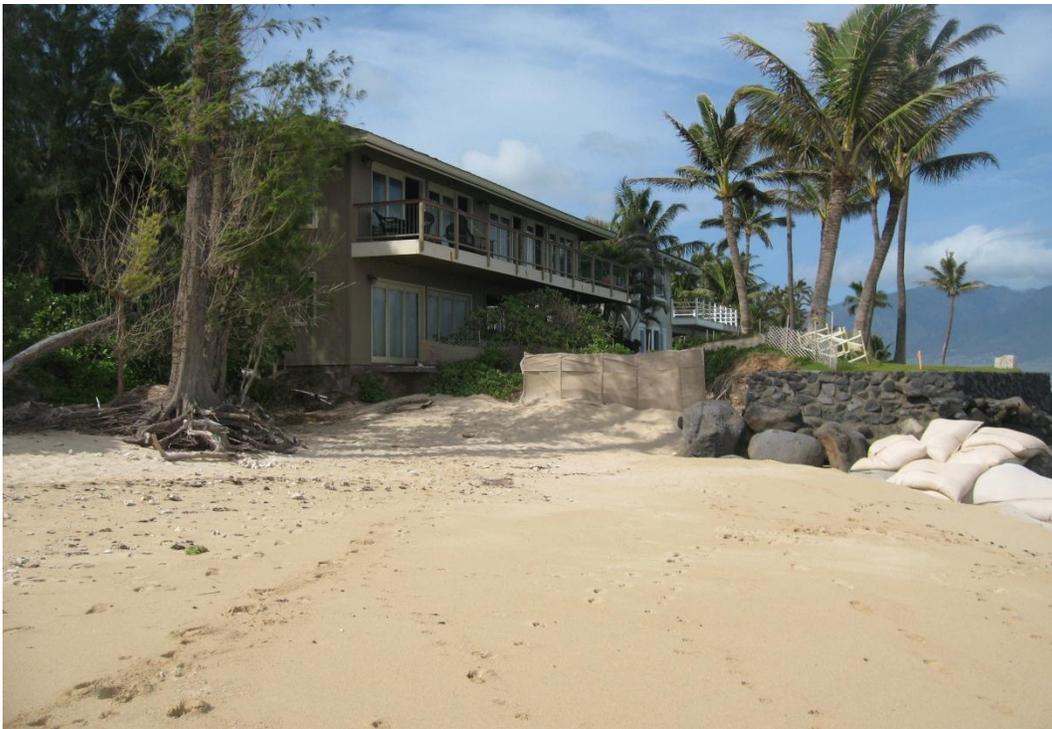
Photo 41 - West End of Project Beach, 4 April 2012

Post-construction during the 2010 fall and 2011 winter seasons, the west end of the Project Beach experienced minimal beach erosion and no land loss, except a minor amount from the 11 March tsunami, which is very unique compared to previous years of significant beach sand and land loss for the same time of year (see pre-construction Photo 2); plus it gained windblown sand during the 2011 spring and summer seasons (see Photo 41).

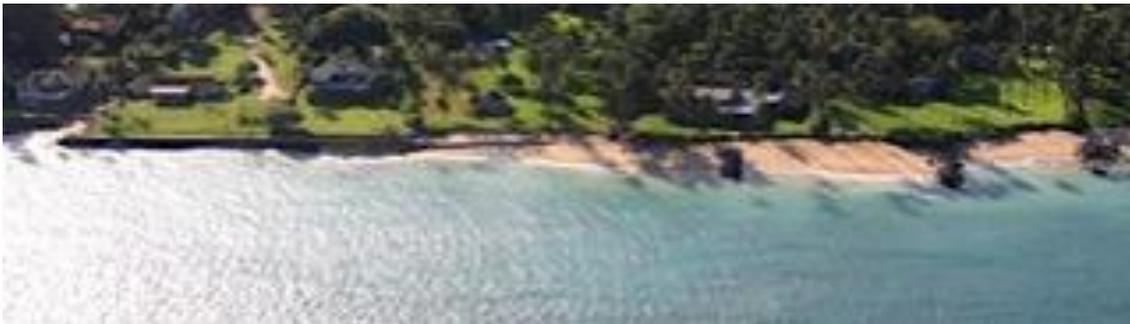
Seawall Effect on Beach Erosion Downdrift of Seawall - Seawalls have an increased erosion effect on immediate, downdrift beaches undergoing beach retreat, and the effect is more pronounced on beaches undergoing long-term retreat, due partly to a diminished beach width in front of the seawall and thus a decreased supply of sand sediment immediately updrift that may be transported longshore to downdrift beaches. The effect of the long seawall downdrift of the Project Area to the beach in front and downdrift of the seawall is a loss of beach in front of the seawall and a narrowing of the beach immediately downdrift of the seawall (see Photo 42).

Photo 42 – Lot 2 Seawall Beach Loss and Beach Narrowing Immediately Downdrift at Transect 1, 5 October 2011

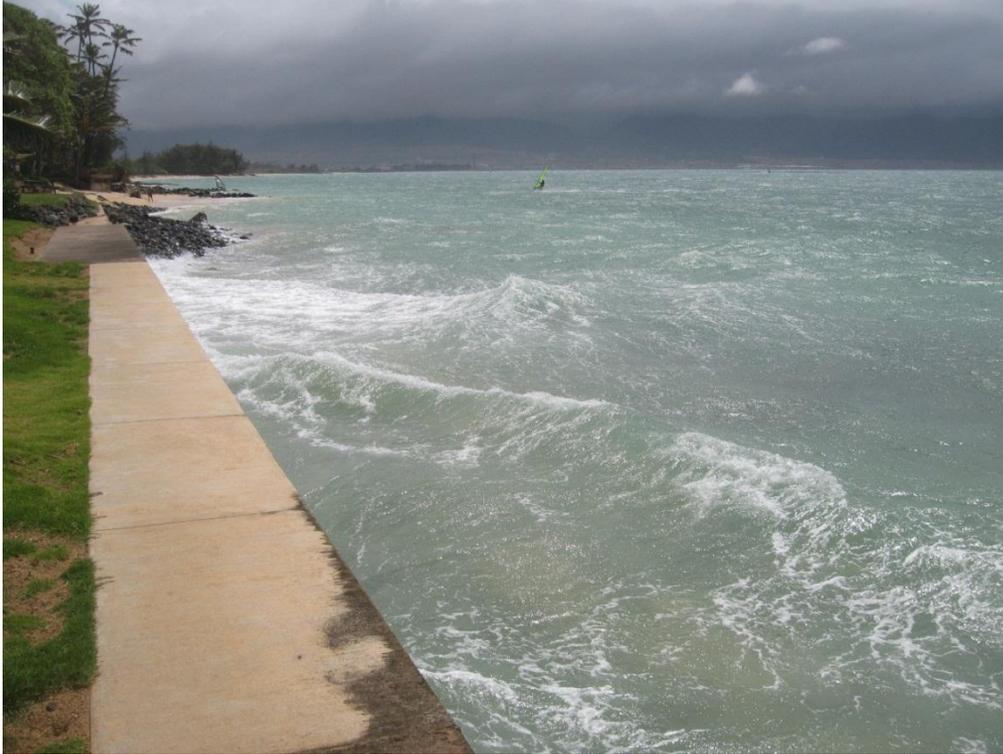
A contributing factor to downdrift beach loss is that the swash reflected by a seawall is directed seaward several seconds earlier than swash on the adjacent natural beach. This increases the backwash duration and velocity, which as a result increases the offshore transport of sand from the downdrift beach since the waves originate from updrift and reflect downdrift offshore (see Photo 43) (Tait and Griggs, 1990) . “All seawalls produce ‘flanking’ a phenomena where the land next to a wall experiences accelerated erosion” (C. Fletcher).

Photo 43 - Lot 2 Seawall Reflected Waves toward DOWNDRIFT BEACH at Transect 1, 10 June 2011

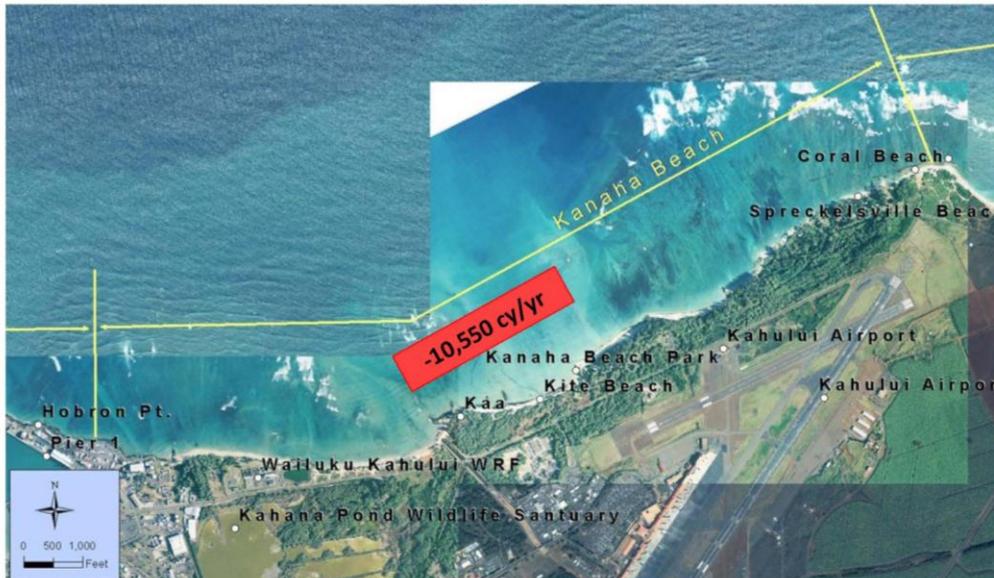
Figure 16 – Kanaha Littoral Cell Annual Beach Sand Volume Loss Map

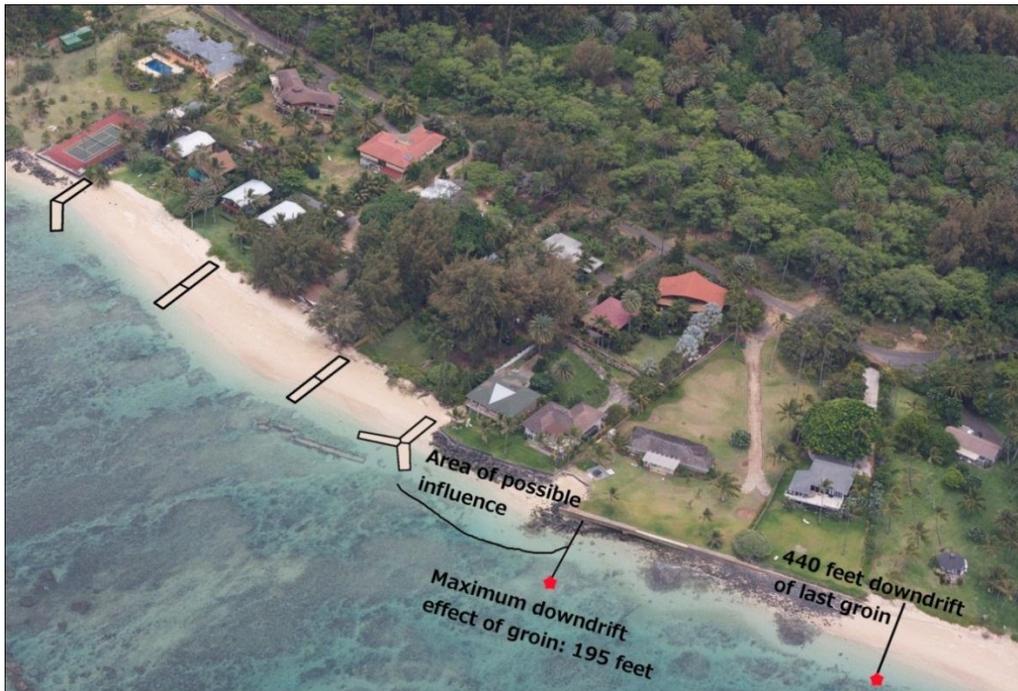
Figure 17 - Maximum Downdrift Effect of Project's Closest Groin

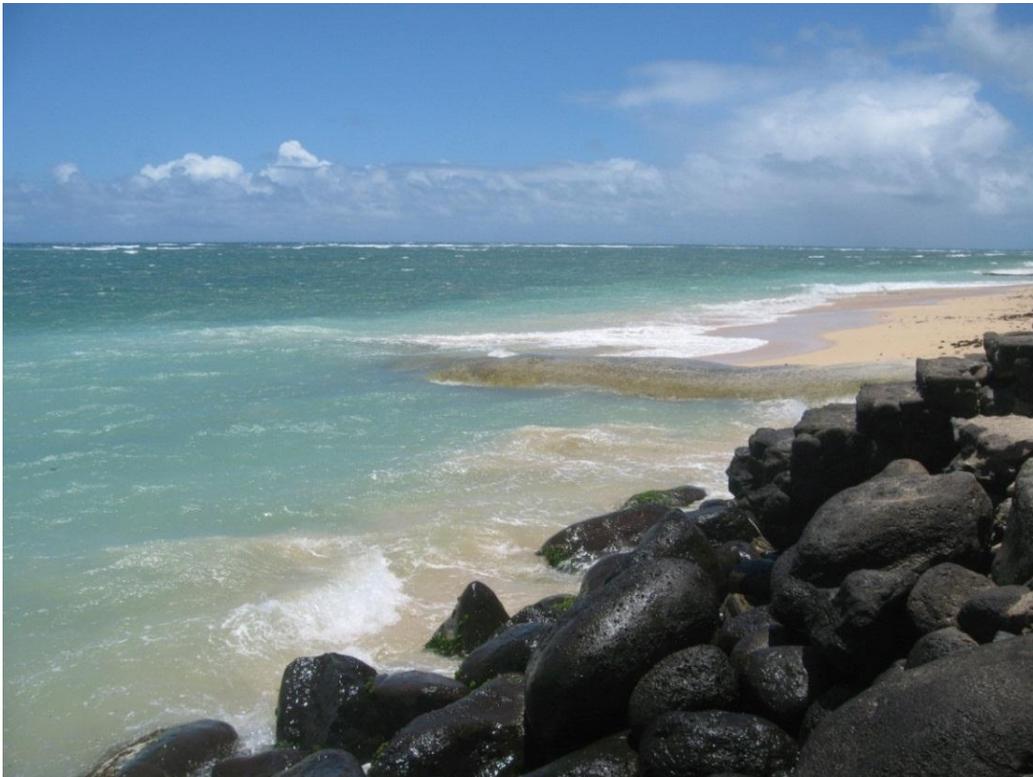
Water Flow and Sand Transport at Groins - After the beach nourishment work was completed in June 2010, the in-water ends of the Project's groins were submerged at mean to high tides which allowed wave energy and longshore sand transport to move over as well as around the submerged ends of the groins

Photo 44 - Longshore Sand Transport Downdrift Over and Around Project's West End Groin, 10 June 2011

in a downdrift direction. Longshore sand transport from updrift and within the Project Area around and over the groins was visually obvious after May 2010.

One of the downdrift residents claimed on 2 June 2011, the Project's west end terminal groin was trapping sand on the Project Beach and thus stopping longshore sand transport during the summer to the downdrift beaches. A photograph taken on 10 June shortly thereafter (see Photo 44) shows this groin and longshore sand transport with nearshore sand suspended in the water around, at the end and immediately downdrift of the groin near the rocks; the beach sand the same level as the top of the groin at its updrift side allowing water and sand to overflow the top of the groin; and the groin's easterly angled, seaward end totally submerged at a mean tide level. This is similar to the condition at the same location during the 2010 spring and summer seasons.

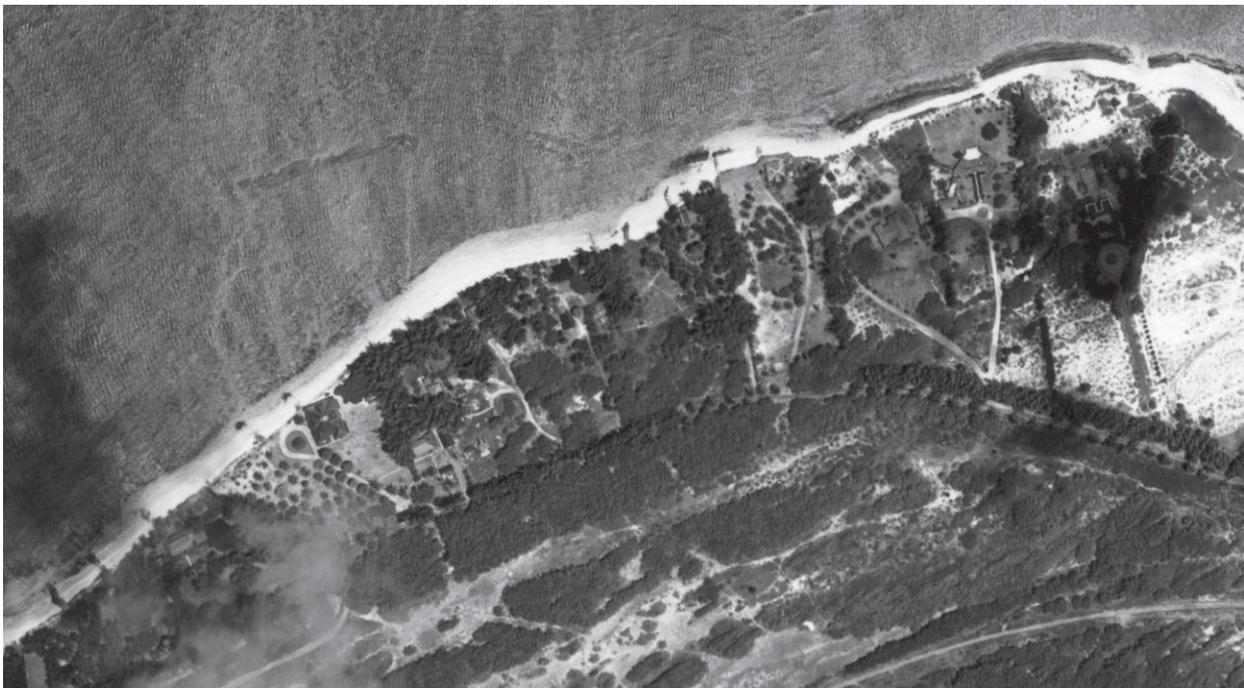
Photo 9 - Aerial View Showing Beaches, Seawall and Groins at Downdrift Lots 1 and 2, 1940

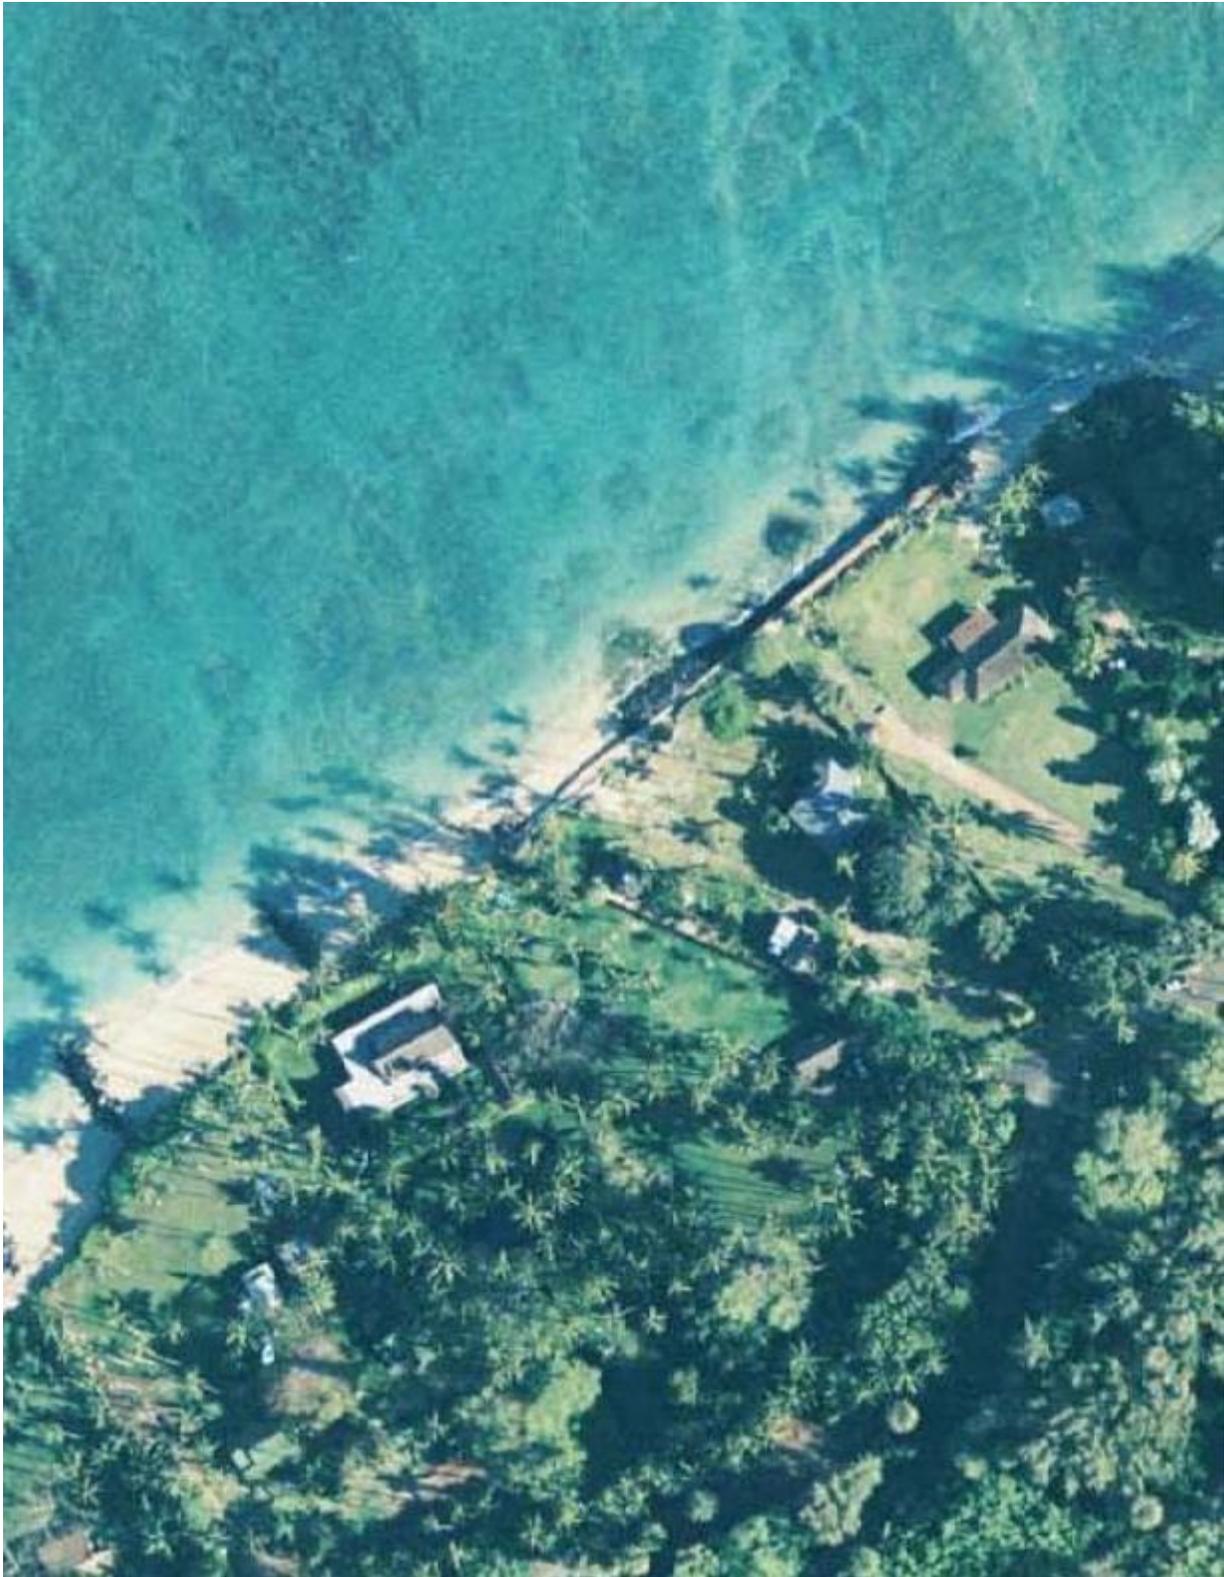
Photo 13 - Aerial View Showing Exposed Seawall Length, Height and Shadow in Front of Downdrift Lots 1 and 2, February 2002

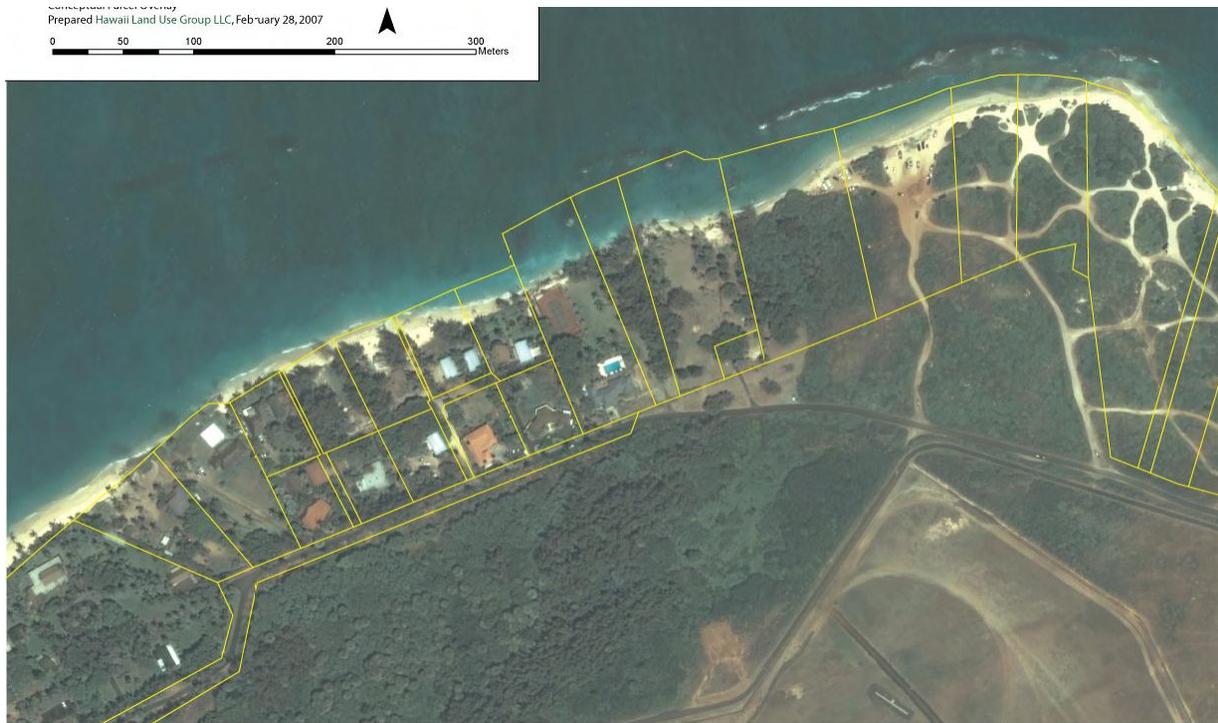
Photo 14 – Aerial View Showing No Beach at Downdrift Lot 2 and East Half of Lot 1, 2005

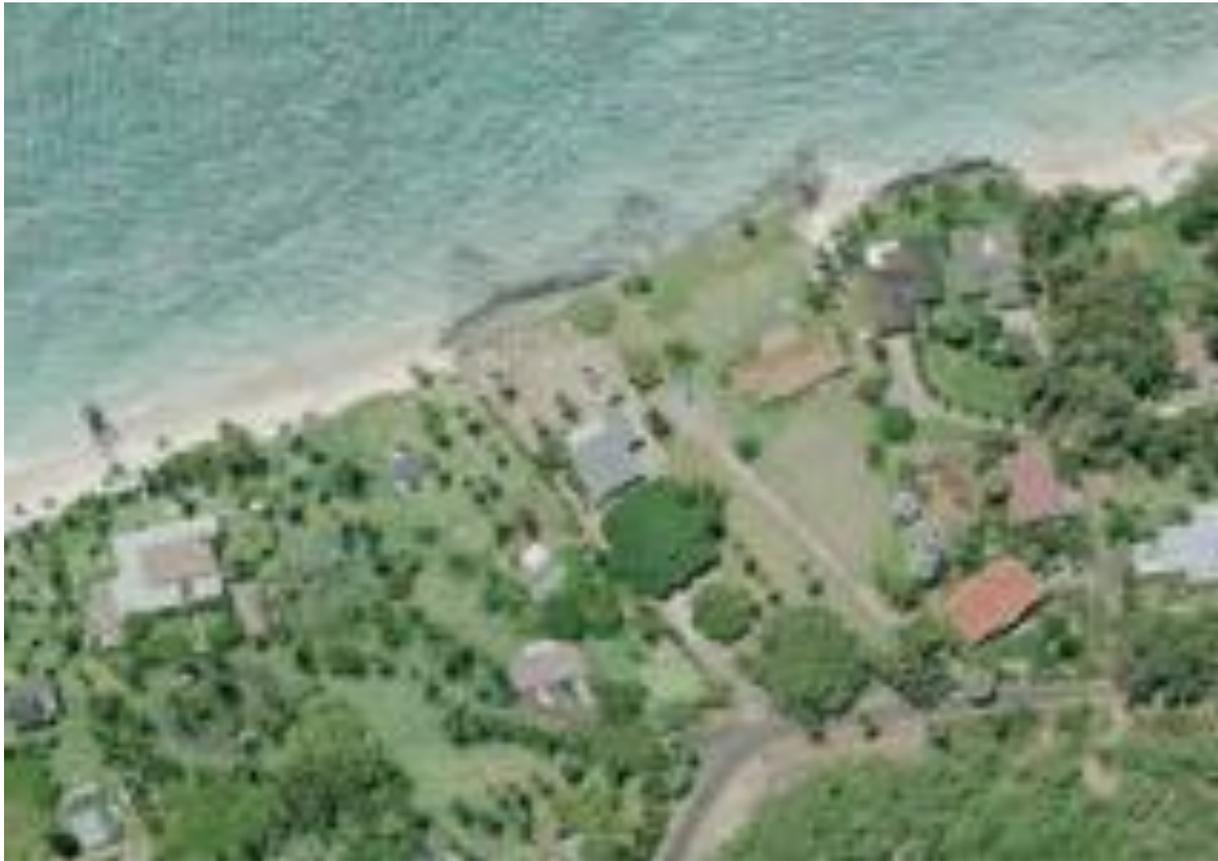
Photo 15 - Aerial View Showing No Beach at Downdrift Lot 2 and East Half of Lot 1, June 2007
