SUBJECT: Final Environmental Assessment (EA) for Conservation District Use Application (CDUA) MA-3633 for the Stable Road Beach Groins Project Located Upon Submerged Land Offshore of Spreckelsville, Maui, Makai of TMK:(2) 3-8-002:71, 74, 77 & 78

STABLE ROAD BEACH GROINS REPLACEMENT PROJECT

15 December 2012

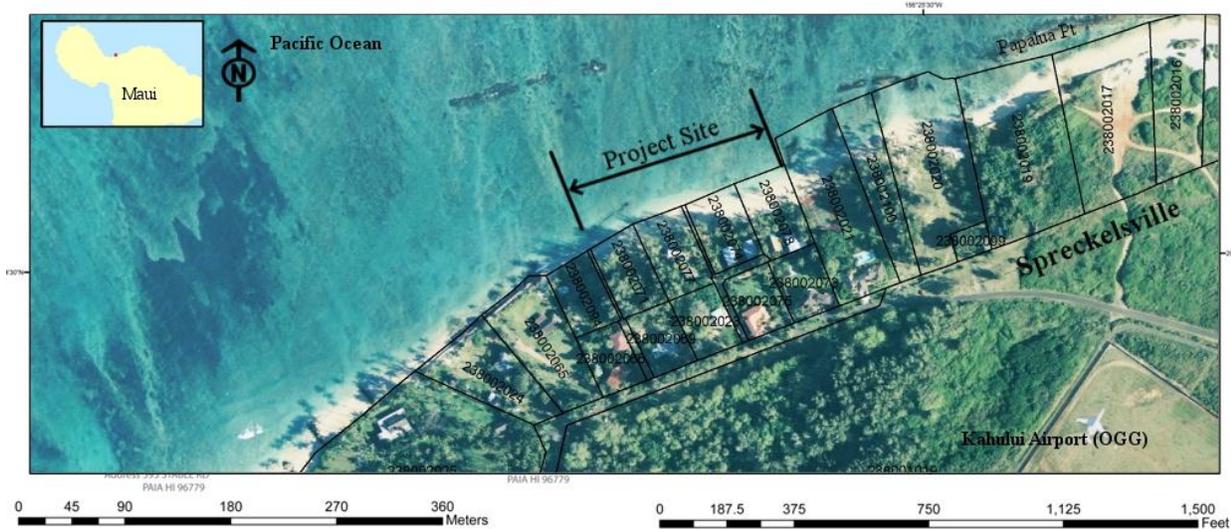
Figure 2 - Project Site/TMK Map (Fronting Lots 071, 077, 074 and 078)

The Project Beach is parallel to a portion of Stable Road and fronts four residential lots with TMK nos. (2) 3-8-002:071, 077, 074 and 078 (see Figure 2), and the Project Beach is flanked at each end with existing, hardened shoreline structures which define the extent and uniqueness of the Project Beach.

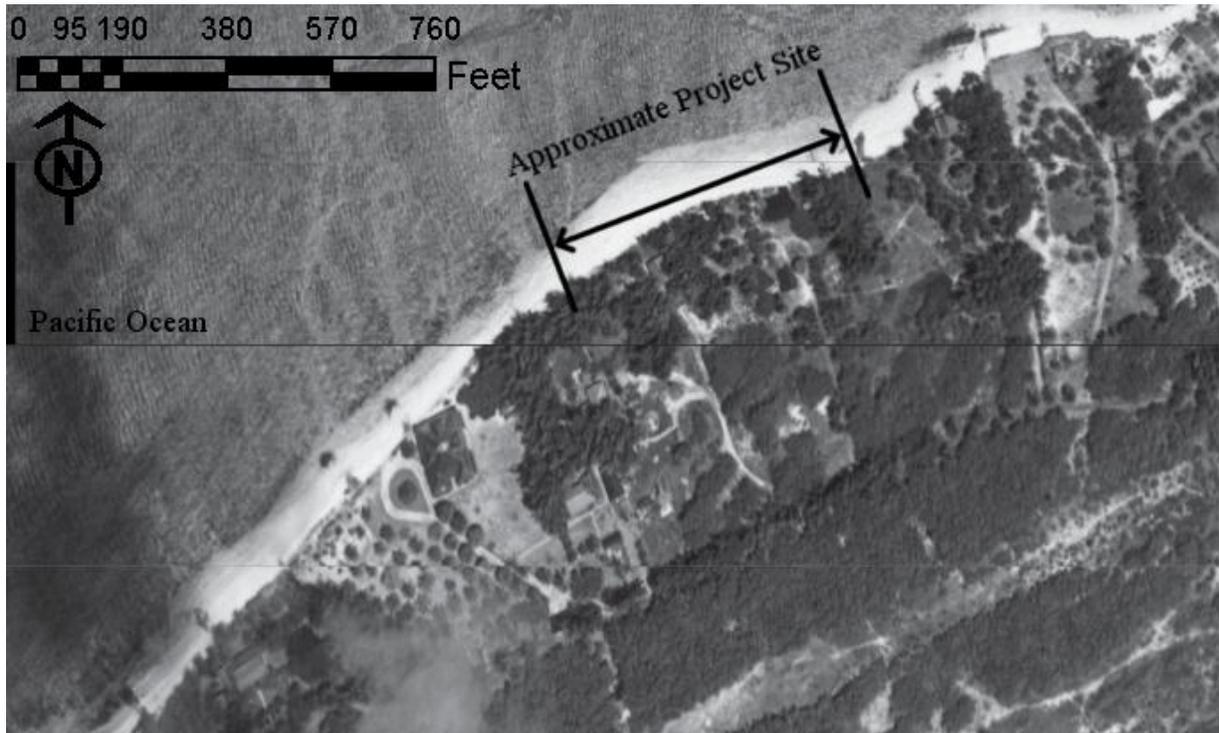
Photo 1 - Local Vicinity Aerial Photograph, 1940 - Note Seawall and Groins Southwest of Project Site

approximately 14 rock groins were constructed in front of this seawall and downdrift of it through Kanaha Beach Park further to the southwest to prevent beach loss (see Photo 1).

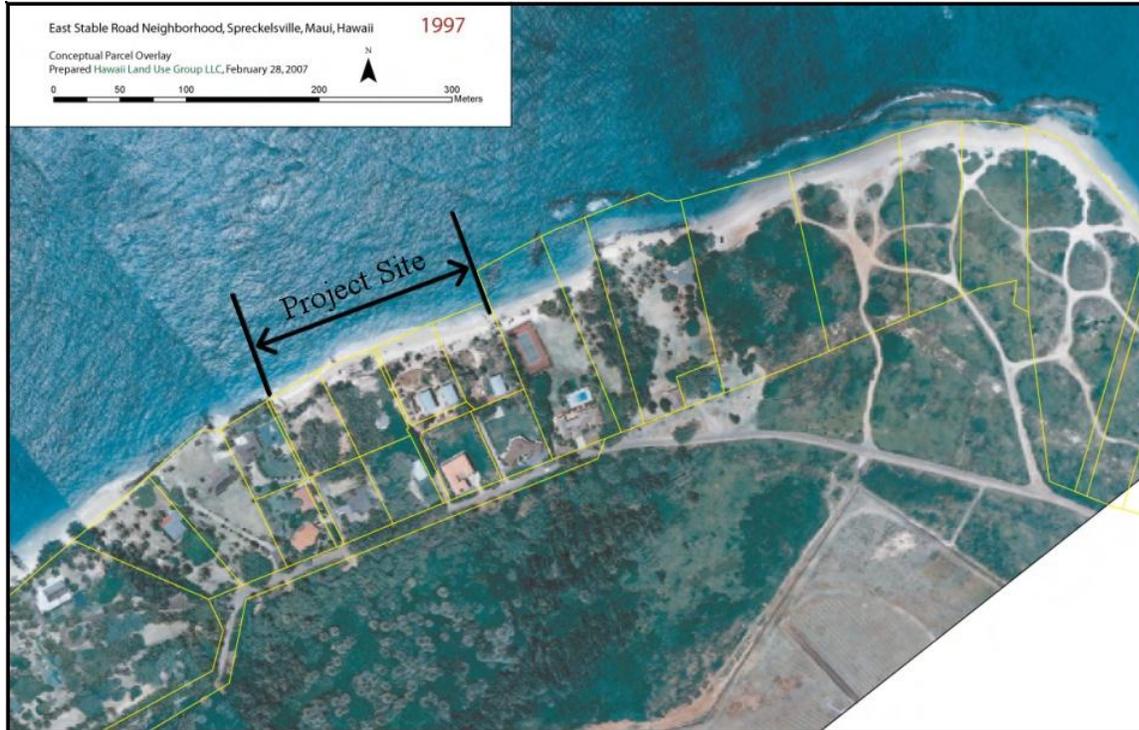
Photo 2 – Local Vicinity Aerial Photograph, 1997

In 1954, HC&S commissioned Doak Cox, a well-respected geologist from Oahu, to study how much more sand could be removed from Spreckelsville and Paia beaches for use by the Paia Lime Kiln without adversely affecting the beaches. His report “The Spreckelsville Beach Problem” recommended ceasing sand removal from these beaches; however, beach sand mining continued for another 25 years. By 1997, the beach in front at the east end of the downdrift seawall was lost (see Photo 2).

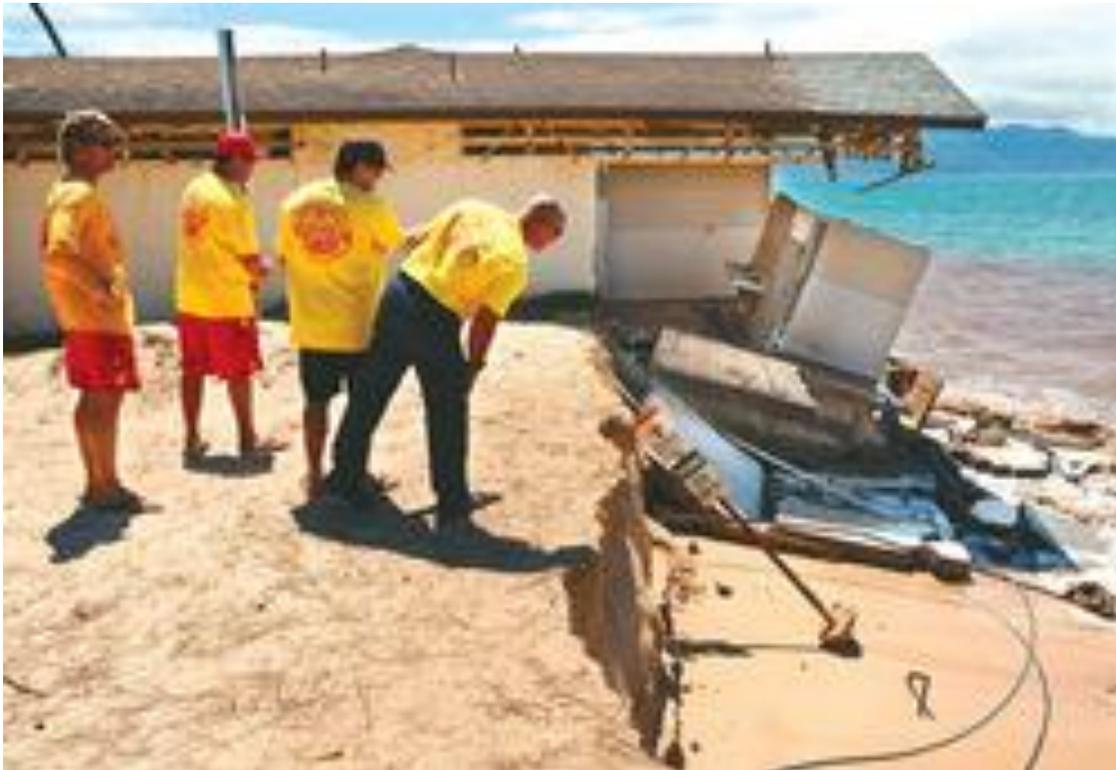
Photo 3 – Beach Erosion at Baldwin Beach Park, 25 August 2011

At Baldwin Beach Park the restroom building fell into the ocean at the end of summer in 2011 due to beach retreat causing the land under the building to be exposed and eroded (see Photo 3).

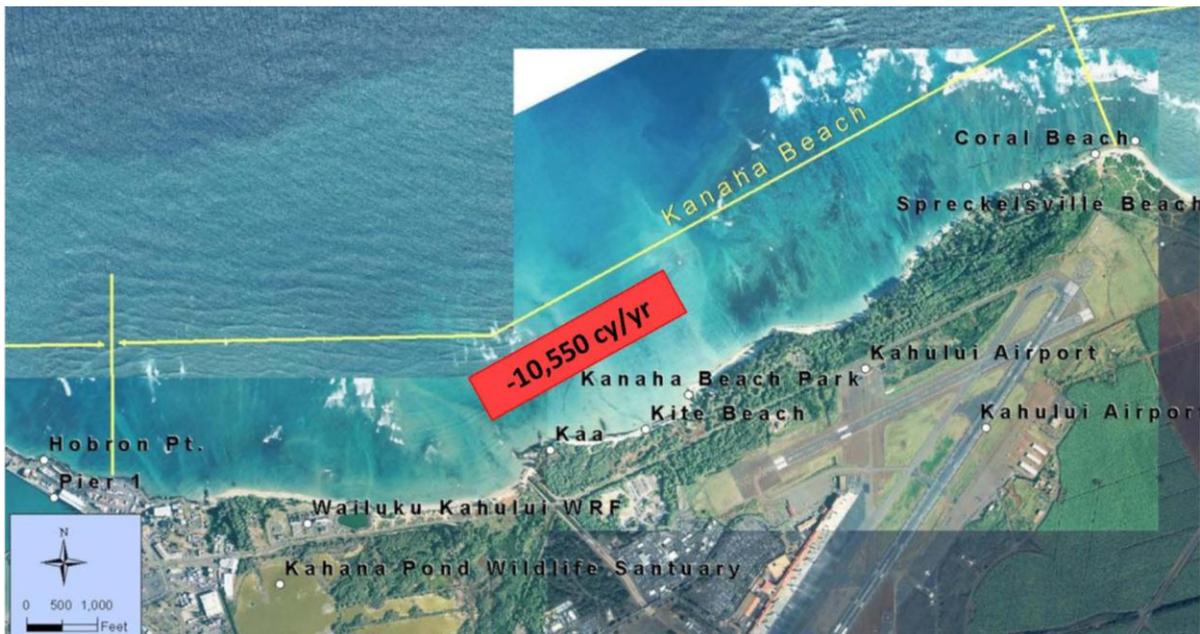
Figure 4 - Regional Annual Sediment Loss Map

A recent Regional Management Study by the U.S. Army Corps of Engineers of Maui's north shore region identified the Kanaha Littoral Cell, which includes the Project Area at its east end, as the fastest eroding cell on Maui's north shore with an annual sediment loss of 10,500 cubic yards for approximately 15,000 feet of shoreline (see Figure 4); whereas the next fastest eroding area is the updrift Baldwin Park cell, which has an annual loss of only 2,400 cubic yards. The theory for the high rate of erosion at the Kanaha cell is that after seven decades of sand mining of this coastal zone and updrift beaches 2.5 miles to Paia, the cell has a diminished, natural sediment supply updrift to sufficiently nourish its beaches.

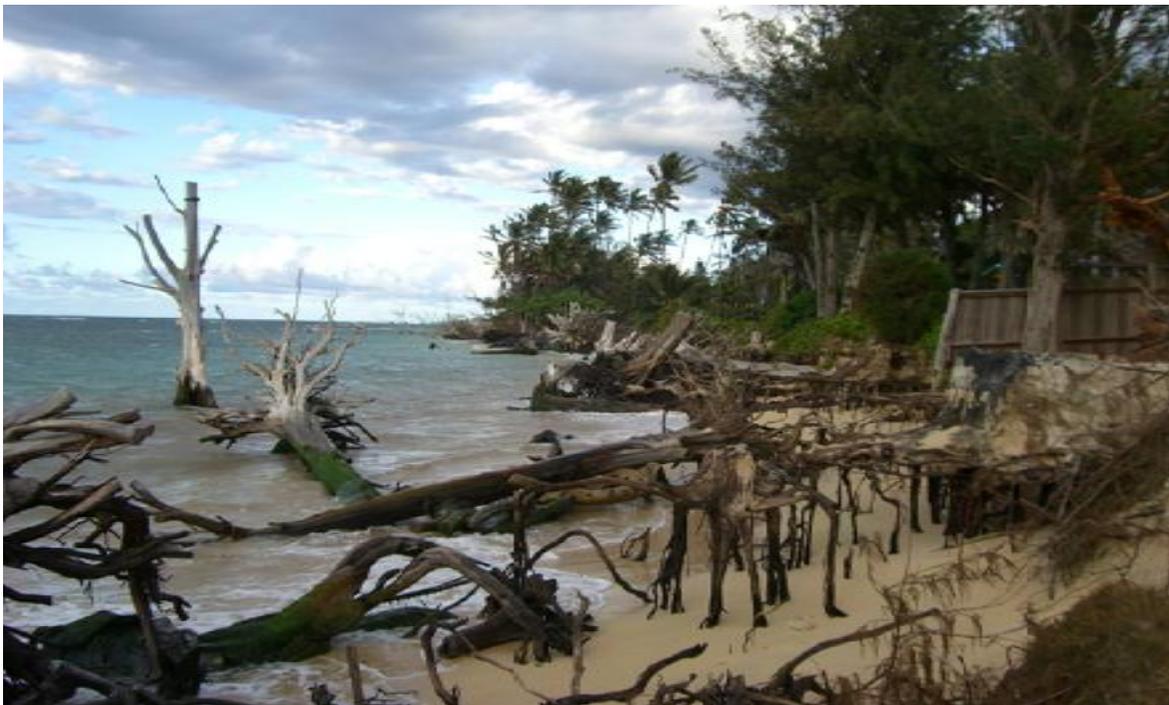
Photo 4 - Beach and Land Erosion at Project Beach Looking East, 22 August 2006

During the spring and summer seasons, the Project Beach typically has experienced beach erosion and land loss starting at its far east end due to seasonally strong trade winds combined with high tides plus from the adverse effect of the adjacent rock seawall fronting the tennis court. The Project Beach started experiencing higher than previous historic rates of beach erosion and land loss starting in 2006 (see Photo 4).

Photograph 8 shows the east end of the Project Beach full of sand post-construction in August 2010. August is historically the time of year when spring and summer seasons' trade winds result in the most severe beach erosion at the east end of the Project Beach (compare to pre-construction Photos 4, 6 and 7, pages 17-19).

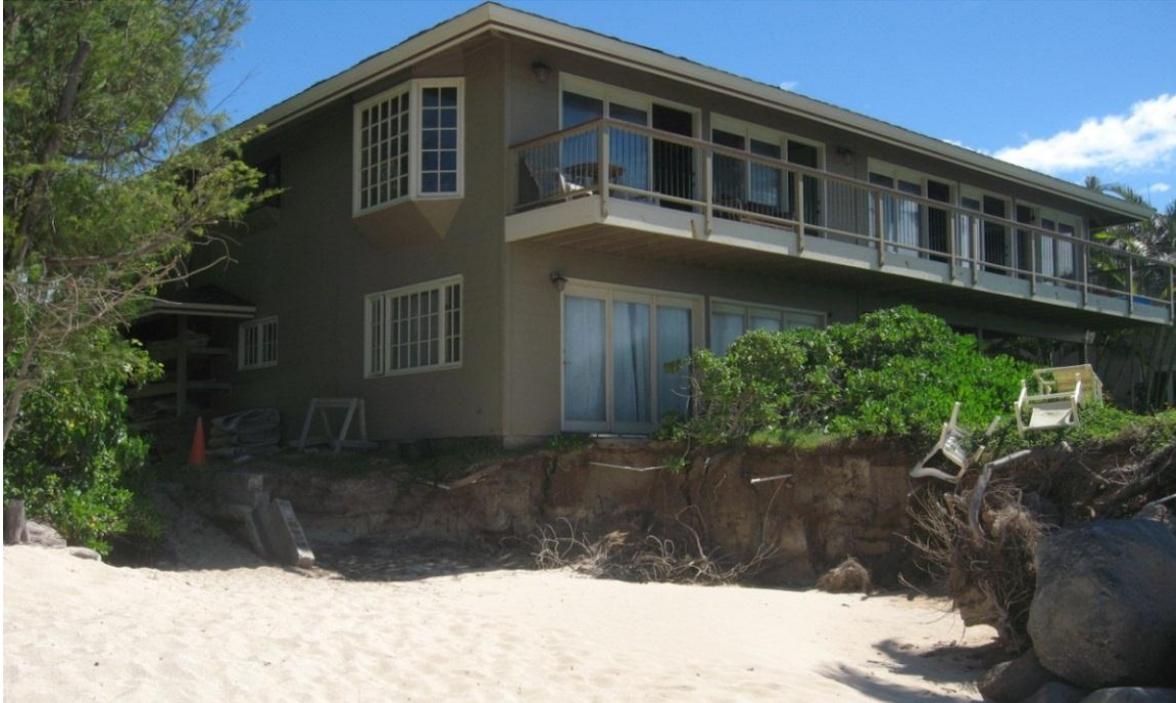
Photo 5 – Beach and Land Erosion at West End of Project Beach (Lot 3), 23 August 2010

During the fall and winter seasons, the Project Beach typically has experienced beach erosion and land loss starting at its far west end due to large surf from north Pacific swells combined with high tides plus from the adverse effect of the adjacent rock revetment and concrete seawall. The safety of the home on Lot 3 at this location is threatened (see Photo 5).

Photograph 9 shows the west end of the Project Beach, which has naturally gained sand over time without a significant fall and winter seasons' loss from large, north Pacific swells (compare to Photo 5, page 18 prior to the SSBN Evaluation Project).

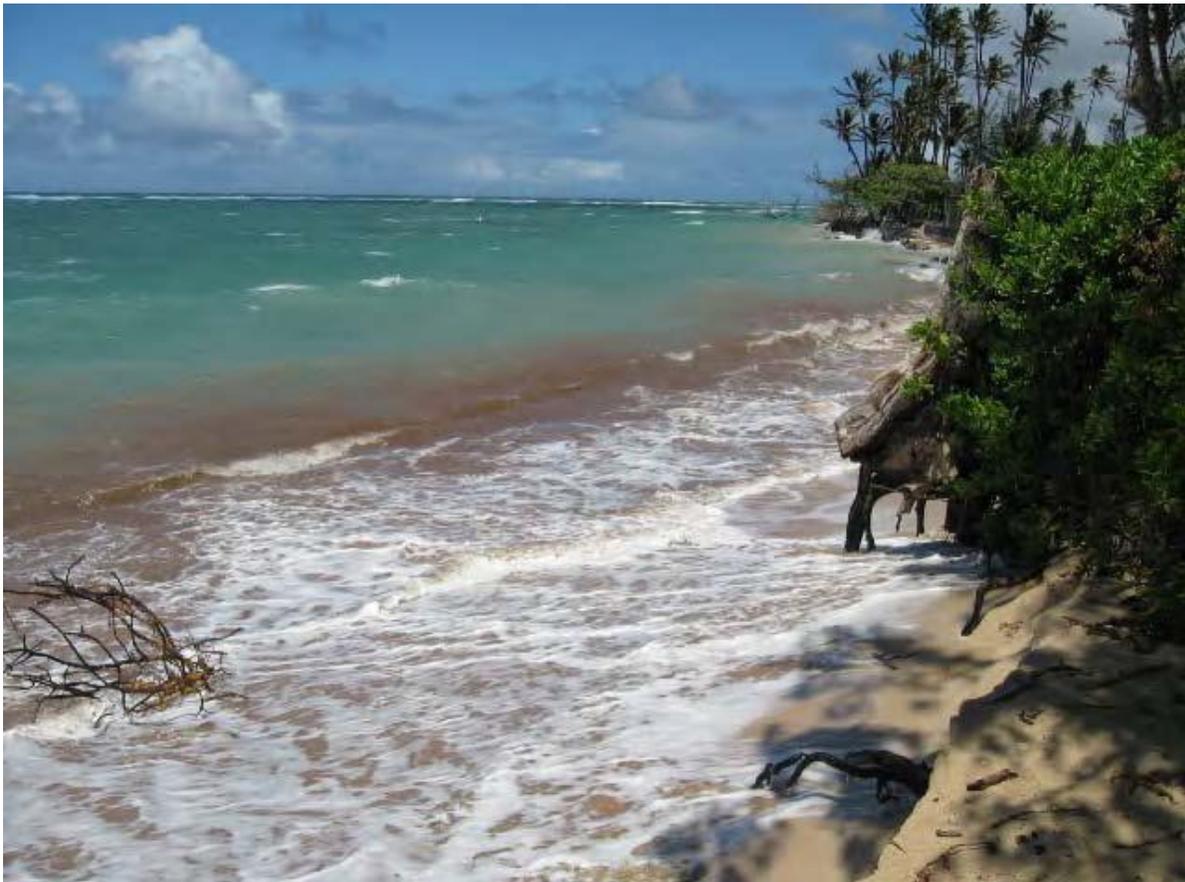
Photo 6 – Beach and Land Erosion Causing Pollution at Project Beach, August 2008

As beach sand erodes and is eventually lost, upland banks and vegetation are left exposed. The upland bank provides little or no resistance to erosion causing land, trees and vegetation to fall onto the beach and into the ocean. The dead vegetation restricts beach use and lateral beach access in addition to creating a safety hazard, especially during times of high tides and large waves (see Photo 4). The erosion of these historically terrestrial soils releases fine sediment and organic matter in the nearshore, increasing turbidity and impairing water quality (Photo 6).

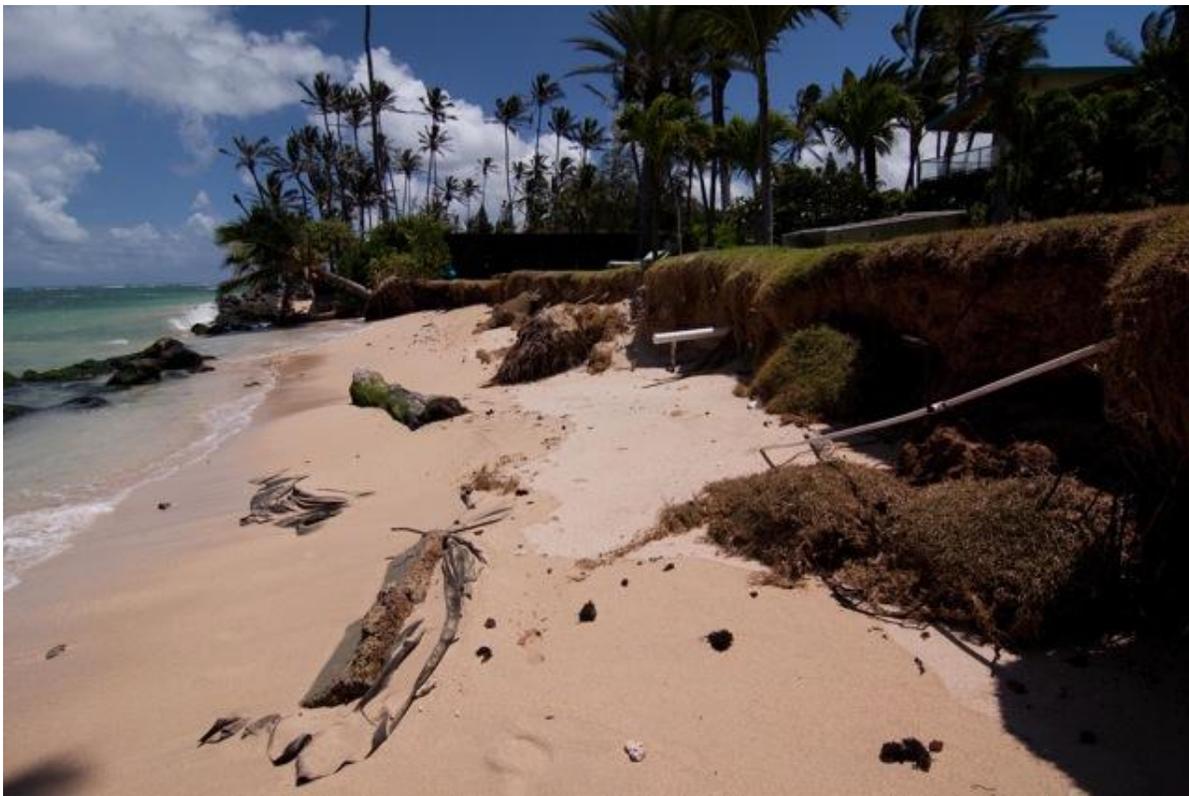
Photo 7 – Beach and Land Erosion Causing Pollution at Project Beach, 4 August 2009

The loss of beach area limits the available habitat for endangered species including the Hawaiian Monk Seal and the Hawaiian Green and Hawksbill Sea Turtles. The loss of upland vegetation along the shoreline has also reduced habitat for numerous shore birds (see Photo 7).

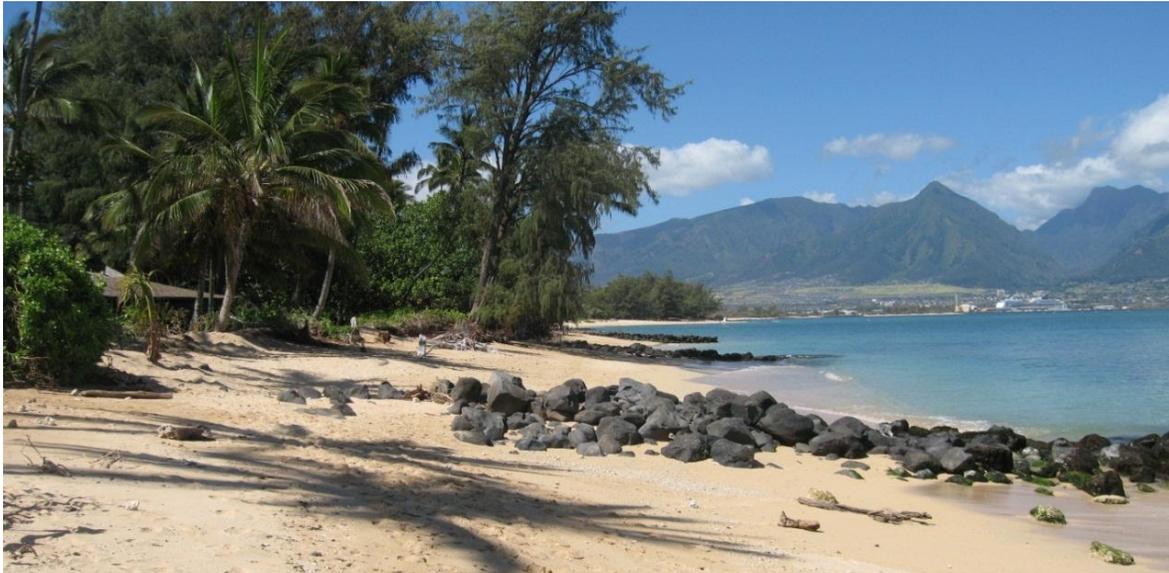
The replacement groins are proposed to be constructed with 1.5 ton (2 foot diameter +/-) rocks placed around a longitudinal core of smaller rocks for long-term groin stability (see Replacement Groin Cross Section in Figures 12 and 13). This design approach is consistent with the U. S. Army Corps of Engineers' standards which have been developed after many groin installation assessments.

Photo 11 - Existing Rock Groins Downdrift of Project Beach.

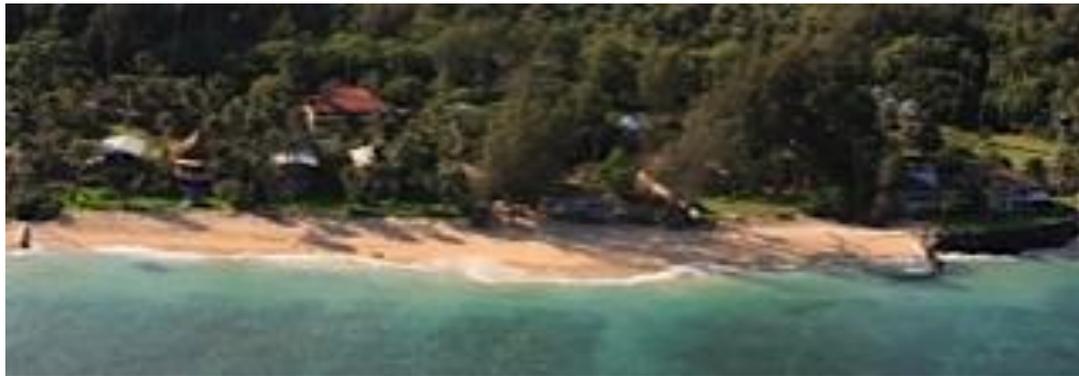
Photo 12 - Project Beach Aerial Photograph, 5 October 2011

Figure 7, page 25 indicates during the first year after the one year equilibrating period that Project Beach Width was stable during the 2011 summer. Photo 12 taken 5 October 2011 shows the SSBN Evaluation Project groin field full of sand since the middle groins are buried and sand is at the top of the terminal groins at their updrift side.

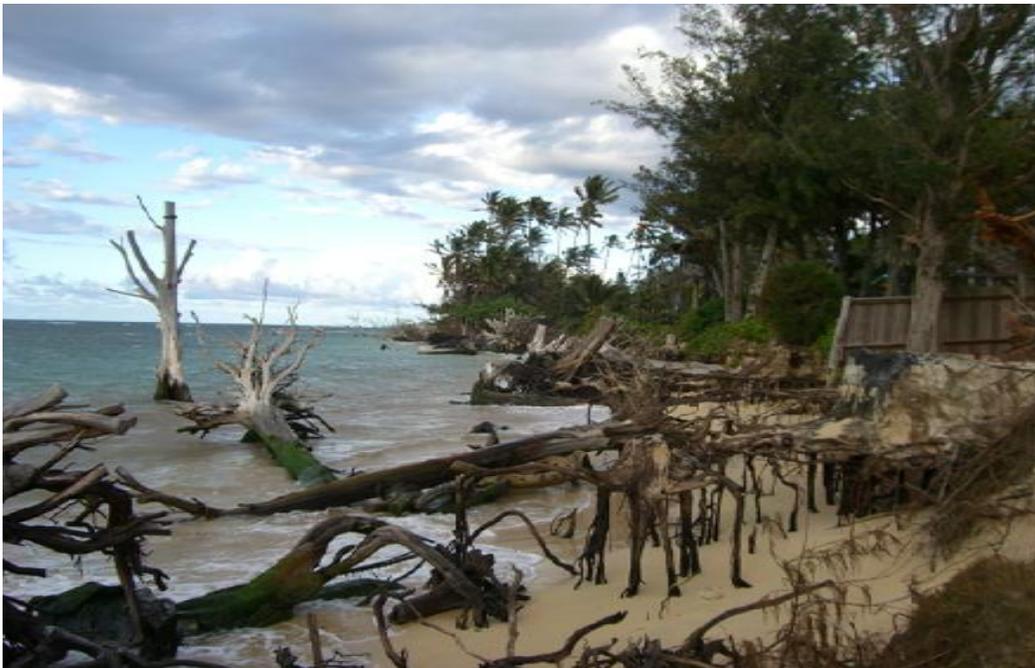
Photo 1- Beach and Land Loss at East End of Project Beach, 22 August 2006

Starting in 2006, the Project Beach experienced up to a three-fold increase in annual erosion compared to previous years with considerable seasonal beach sand loss and permanent land loss (see Photo 1).

- A seasonal loss of beach width and thus recreational use and lateral beach access, which is dangerous at high tides and during large surf (see Photo 1).
- A permanent loss of land falling into the ocean, thus jeopardizing water quality, marine life and reef health from exposed sewage leach field pipes with directly discharged sewage waste, reduced leach field areas, land based fertilizers, toxic chemicals and clay soil turbidity (see Photos 2 and 3).

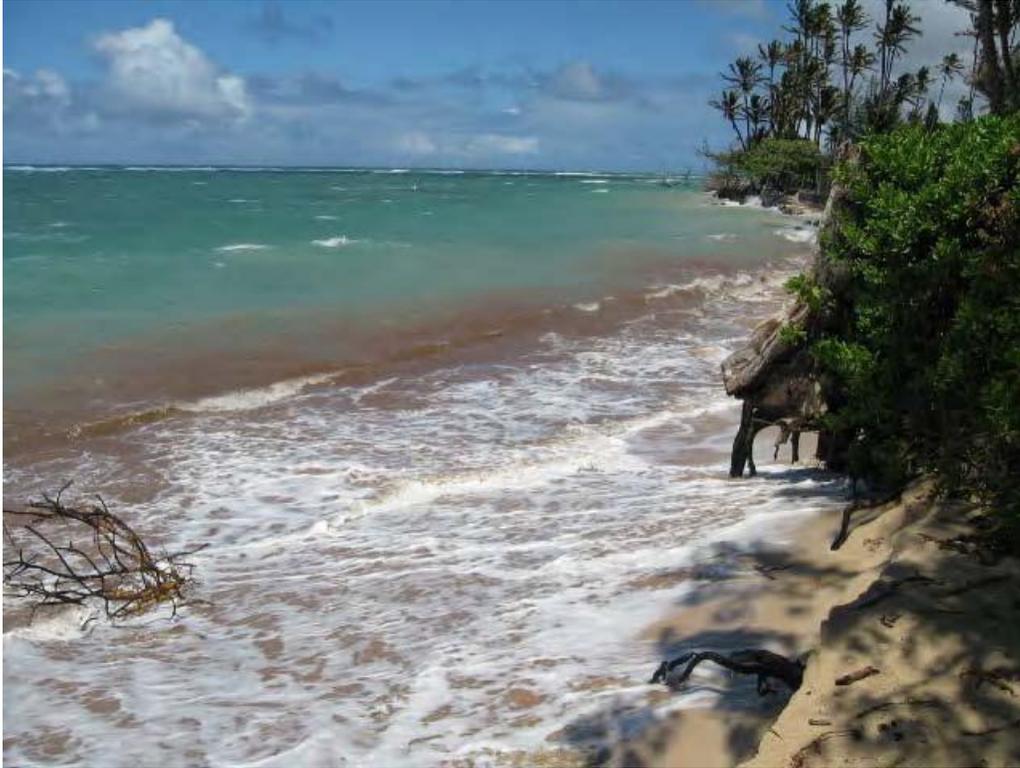
Photo 3 – Beach and Land Loss with Land Pollution at Project Beach, August 2008

- A loss of beach and shoreline, thus a loss of habitat to endangered species including the Hawaiian Monk Seal, Green and Hawksbill Sea Turtles plus shore birds (see Photo 3).
- The land of a home at the west end of the Project Beach has eroded to expose the building foundation, thus jeopardizing the home's safety and environment (see Photo 4).

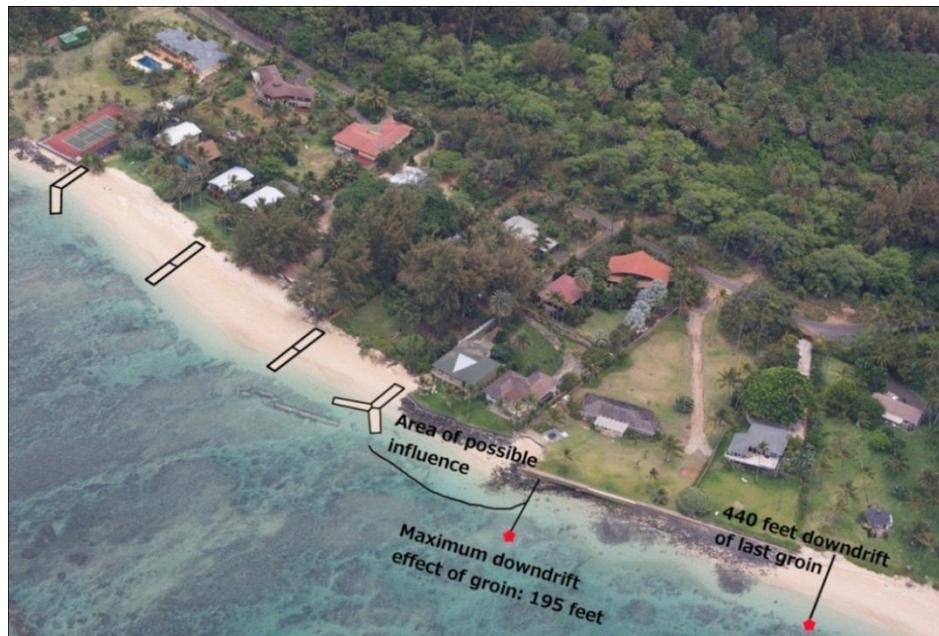
Figure 12 - Maximum Downdrift Effect of Project's Closest Groin

- Groin Maximum Downdrift Effect Distance - The U.S. Army Corps of Engineers' Shore Protection Manual, 1984 indicates the separation distance between the Project's closest groin and the beginning of the small, downdrift beach (460 feet) significantly exceeds the distance of Maximum Downdrift Effect of Groin, which is 195 feet for this Project (see Figure 5) based on a maximum ratio of 3 times the Project's groin length, since beyond this distance the groin and groin field loses its effect.
- No Groin Field Effect on Immediate Downdrift Beach - There has been no Beach Width or Beach Sand Volume reduction effect post-construction at the only immediate downdrift beach within the distance of Maximum Downdrift Effect of Groin, which is a small beach cove located between the downdrift rock revetment and the seawall (see Figure 12).

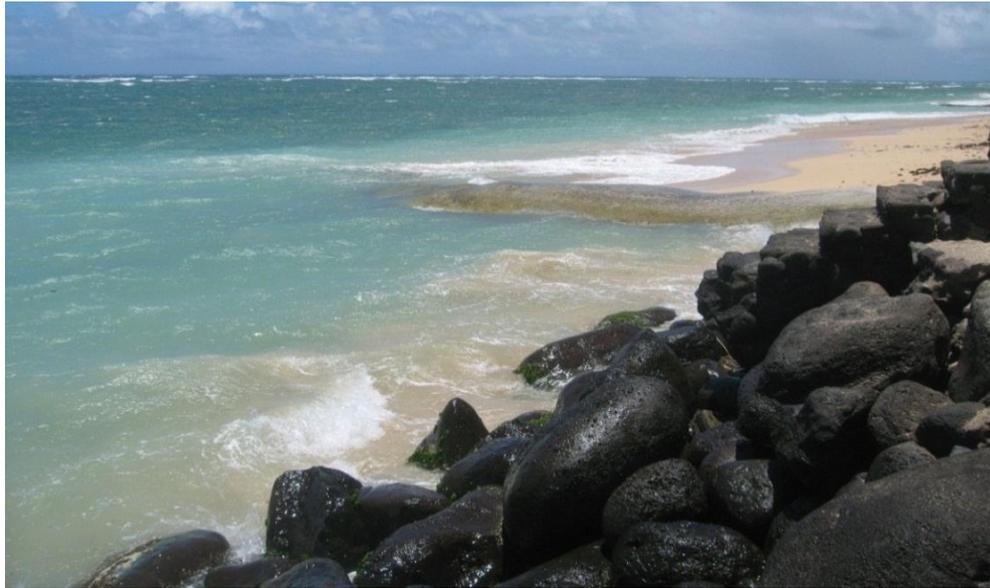
through the 2010 summer in the afternoons when the trade winds were typically the strongest and the tides the highest daily. Longshore sand transport was able to occur then because the seaward ends of the groins were submerged during moderate to high tides, thus allowing water and sand from nearshore turbidity and erosion to flow over the groins as well as around their seaward ends (see Photo 5).

Photo 5 – Longshore Sand Transport Downdrift Over and Around Project’s Closest, West End Groin, 10 June 2011

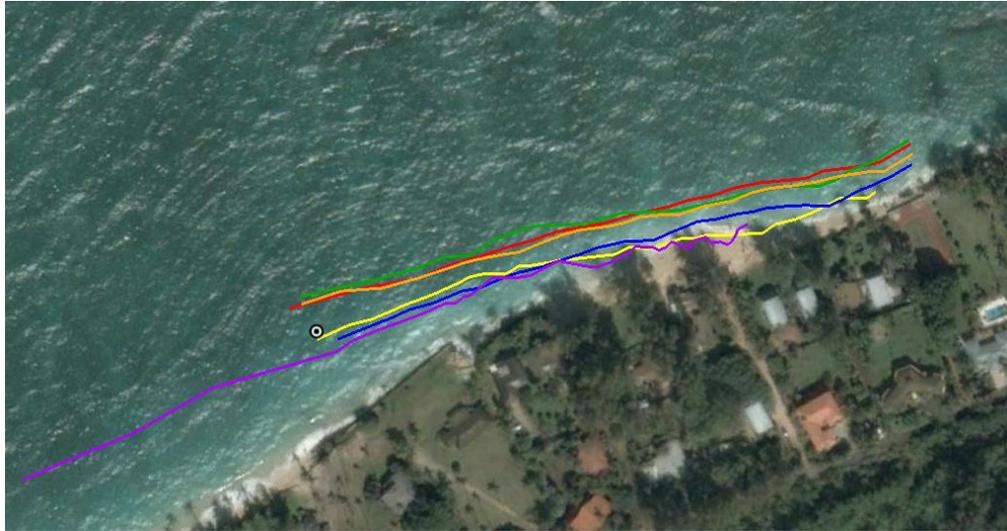
- Nearshore Current Direction - A study of nearshore ocean currents indicated the direction of current downdrift of the Project Area is divergent from the downdrift shoreline (see Figure 13), thus indicating the downdrift area may not receive much of the longshore transported sand from within and updrift of the Project Area, since most of the transported sand may bypass the downdrift beaches.

Figure 13 – Nearshore Current Direction

This study was performed when wind swells from trade winds were not significant. When the trade winds and swells increase typically in the afternoons during the spring and summer season, waves reflect from the downdrift seawall causing rebounding waves in an offshore direction and turbulence suspending sand longer, thus reducing the ability of the small, beach to receive and retain sand from updrift beaches via longshore transport.

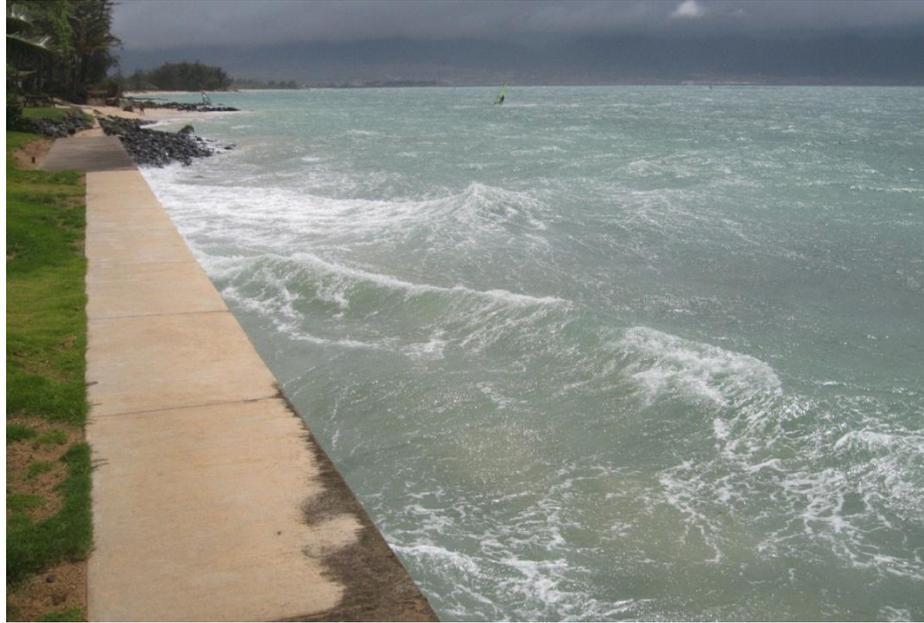
A contributing factor to downdrift beach loss is that the swash reflected by a seawall is directed seaward several seconds earlier than swash on the adjacent natural beach. This increases the backwash duration and velocity, which as a result increases the offshore transport of sand from the downdrift beach since the waves originate from updrift and reflect downdrift offshore (see Photo 6) (Tait and Griggs, 1990) .

Photo 6 – Seawall Reflected Waves from Lot 2 toward Small, DOWNDRIFT Beach Located at Transect 1, June 2011

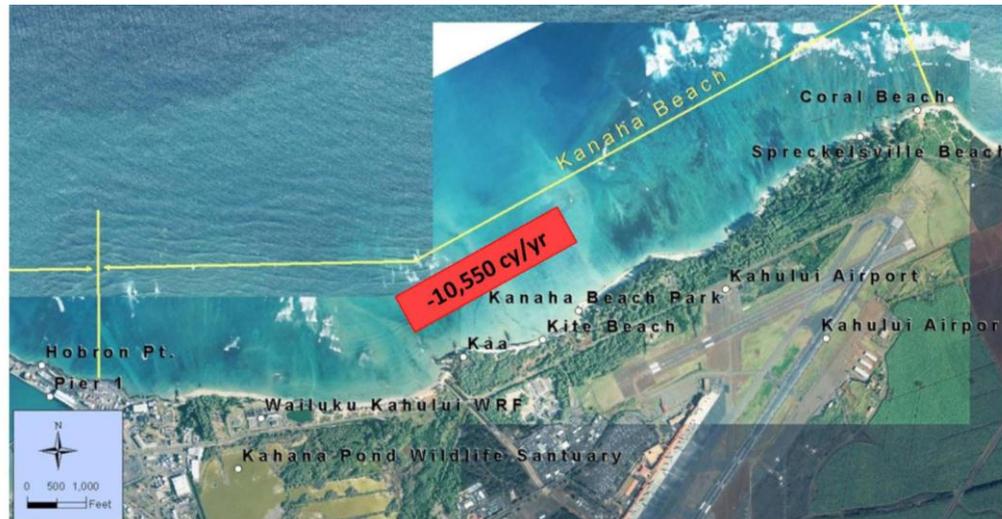
the U.S. Army Corps of Engineers stated that based on more recent 2007 aerial photographs, the long-term Annual Beach Erosion Rate for the Kanaha Littoral Cell, which includes the Within and Outside Project Areas, has significantly increased with a significantly increased annual beach sediment loss of -10,550 cu. yd. per year (see Figure 16).

Figure 16 – Kanaha Littoral Cell Annual Beach Sediment Loss

The Corps representatives also stated that there is a change in the long-term trend of the location of the most rapidly eroding zone in the RSM larger study region between Hookipa Beach Park to the east and Paukukalo to the west on Maui's north shore, and the most rapidly eroding zone has shifted from east to west along the coastal region to the Kanaha Littoral Cell.

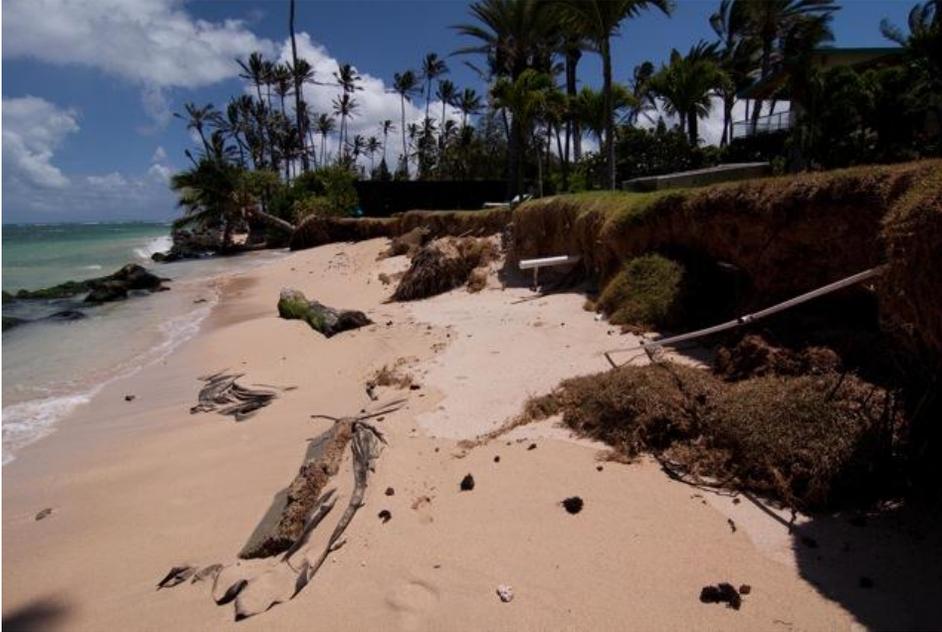
The Project Goals of Preserving the Project Beach and No Land Loss without adversely affecting the nearshore environment plus updrift and downdrift beaches has been obtained post-construction (see post-construction Photo 8 taken at the same time of year as the previous, pre-construction Photo 7).

Photo 7 - Beach and Land Loss within Project Area, 4 August 2009 - Pre-Construction

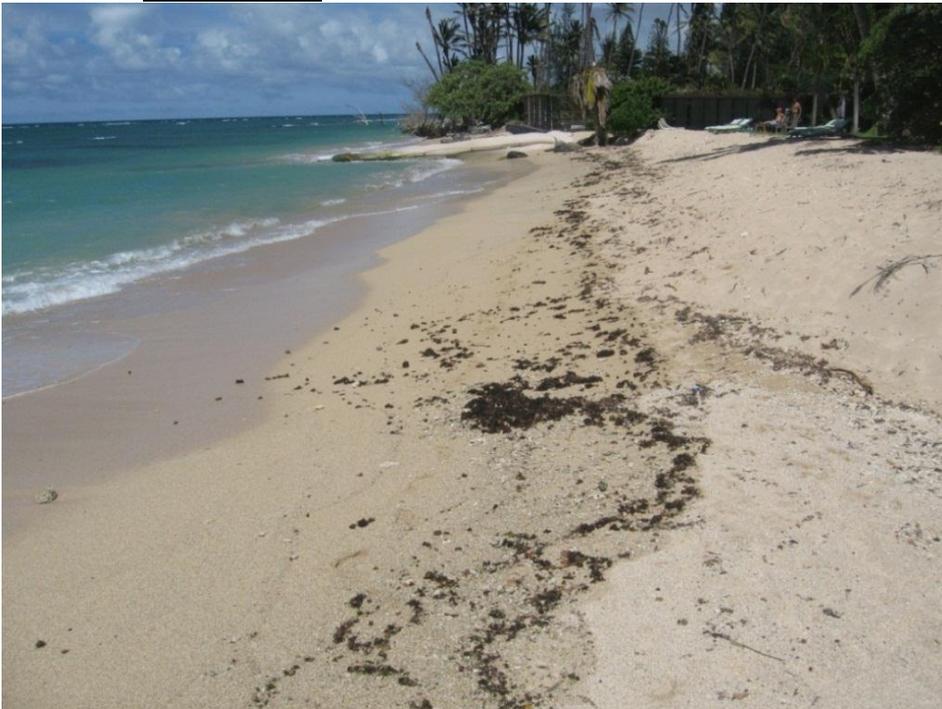
Photo 8 - Beach and Land Preservation within Project Area, 17 August 2010 - Post-Construction

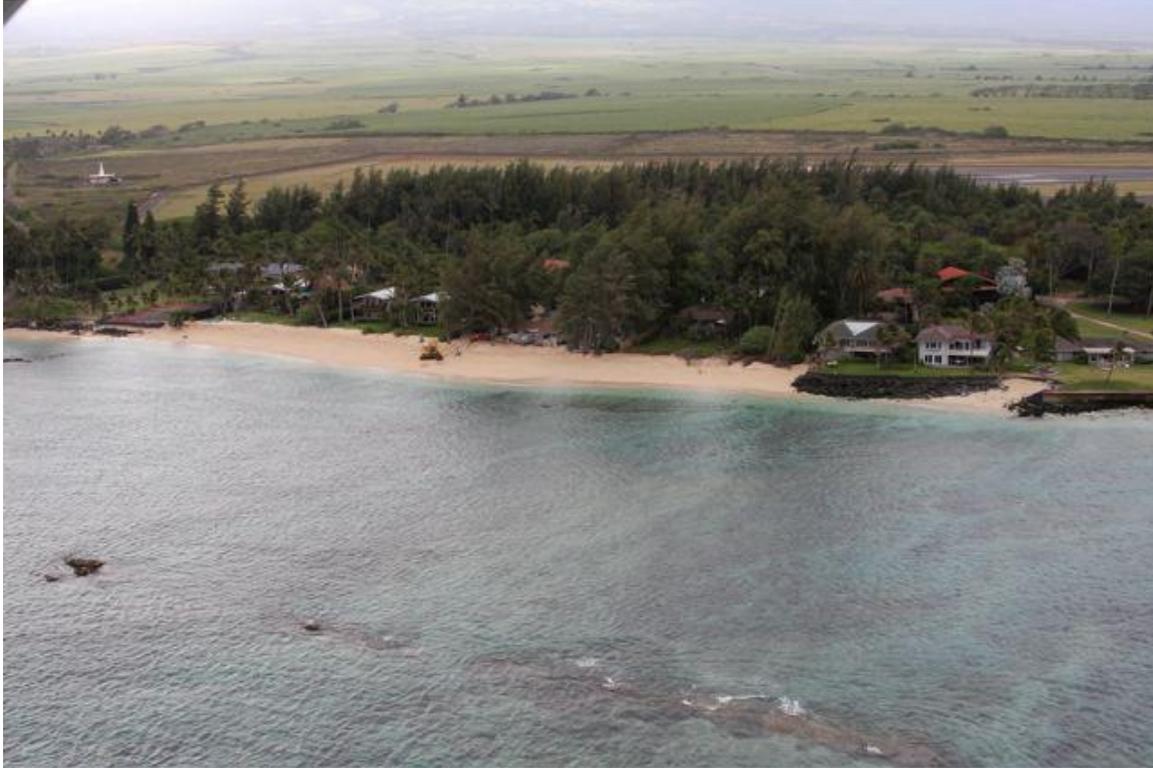
Photo 10 - Aerial View of Project and Updrift Areas Pre-Construction Showing Rock Pile in Front of Updrift Seawall at Left, 15 April 2010

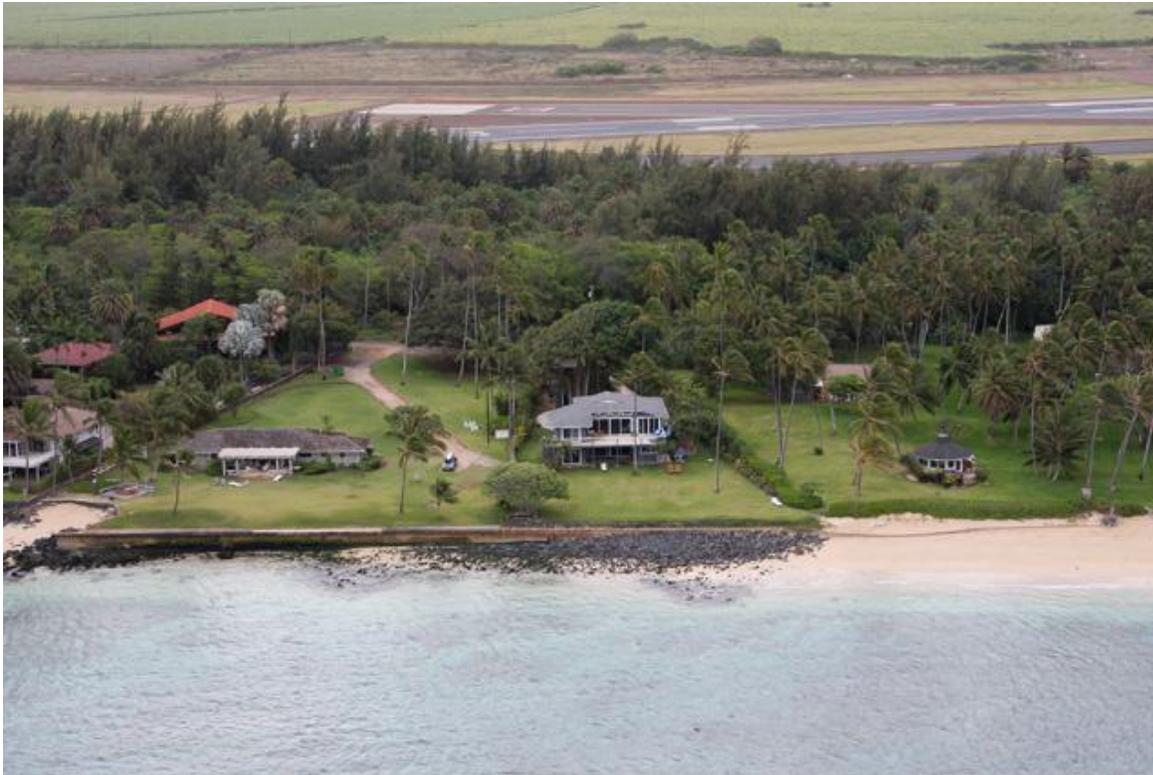
Photo 11 - Aerial View of Downdrift Area Pre-Construction Showing Lot 2 Seawall at Left and Lot 1 Seawall at Center with Rock Piles and at Right, 15 April 2010

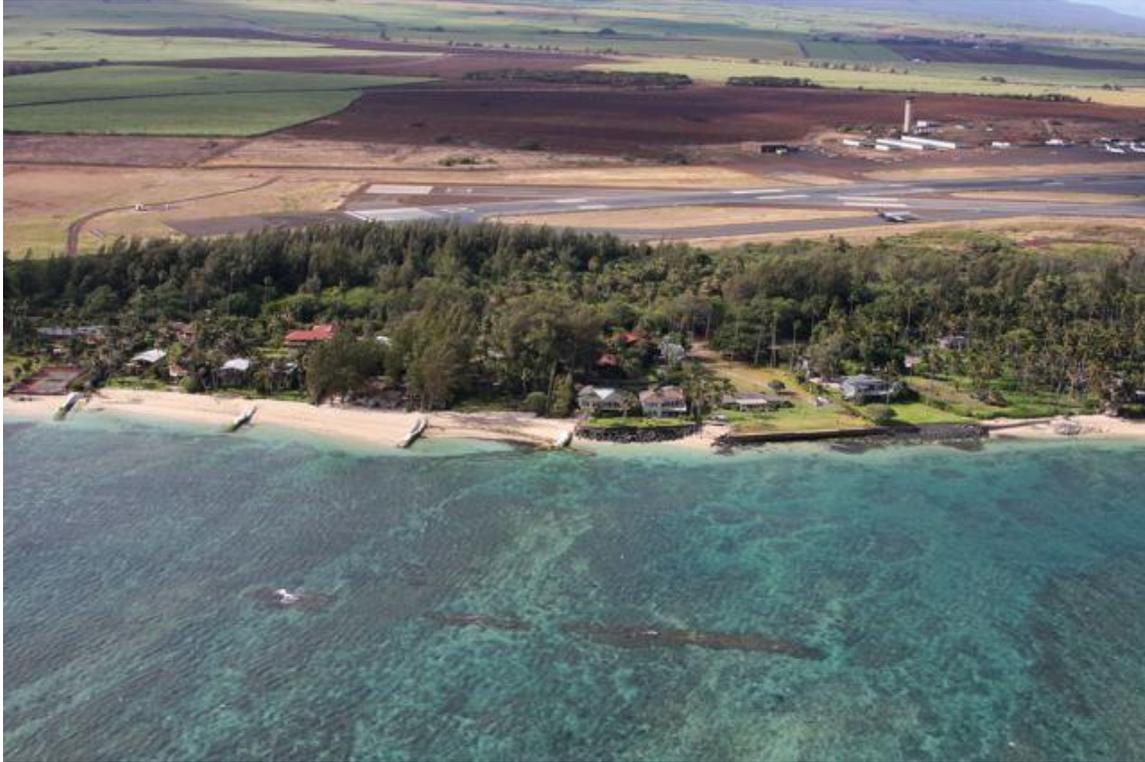
Photo 12 - Aerial View of Project and Updrift Areas Post-Construction, 30 June 2010

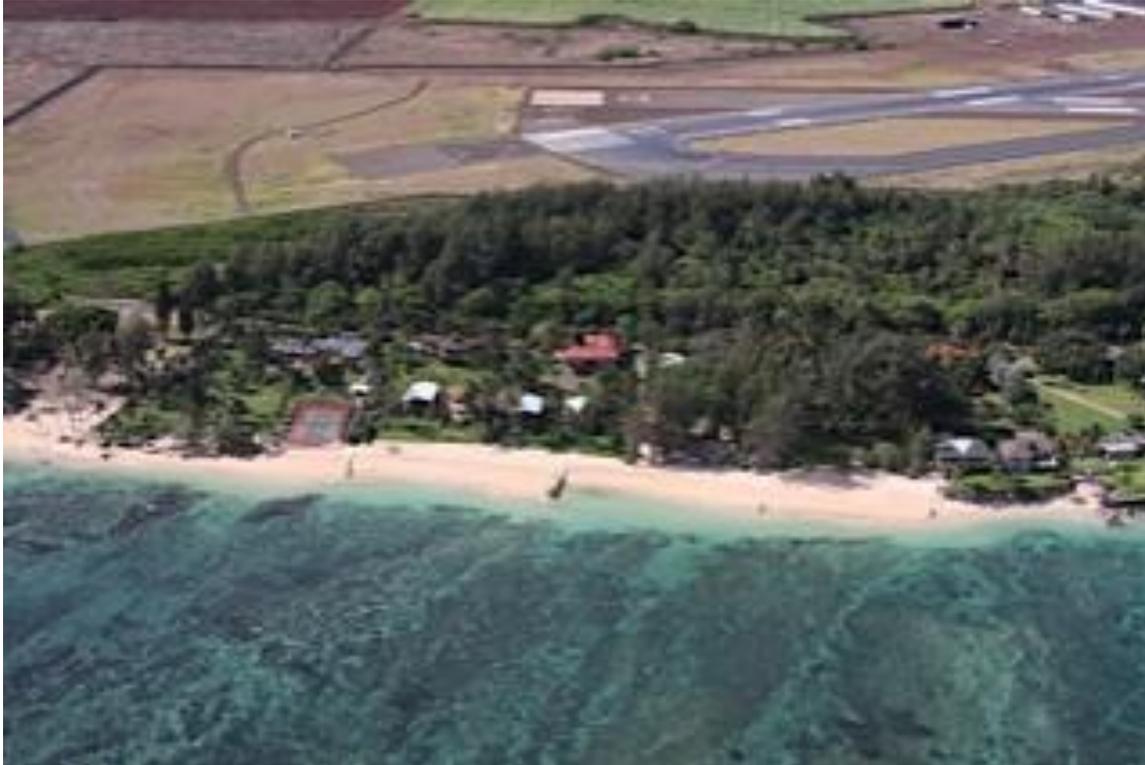
Photo 13 - Aerial View of Project and Updrift Areas Post-Construction, 29 June 2011

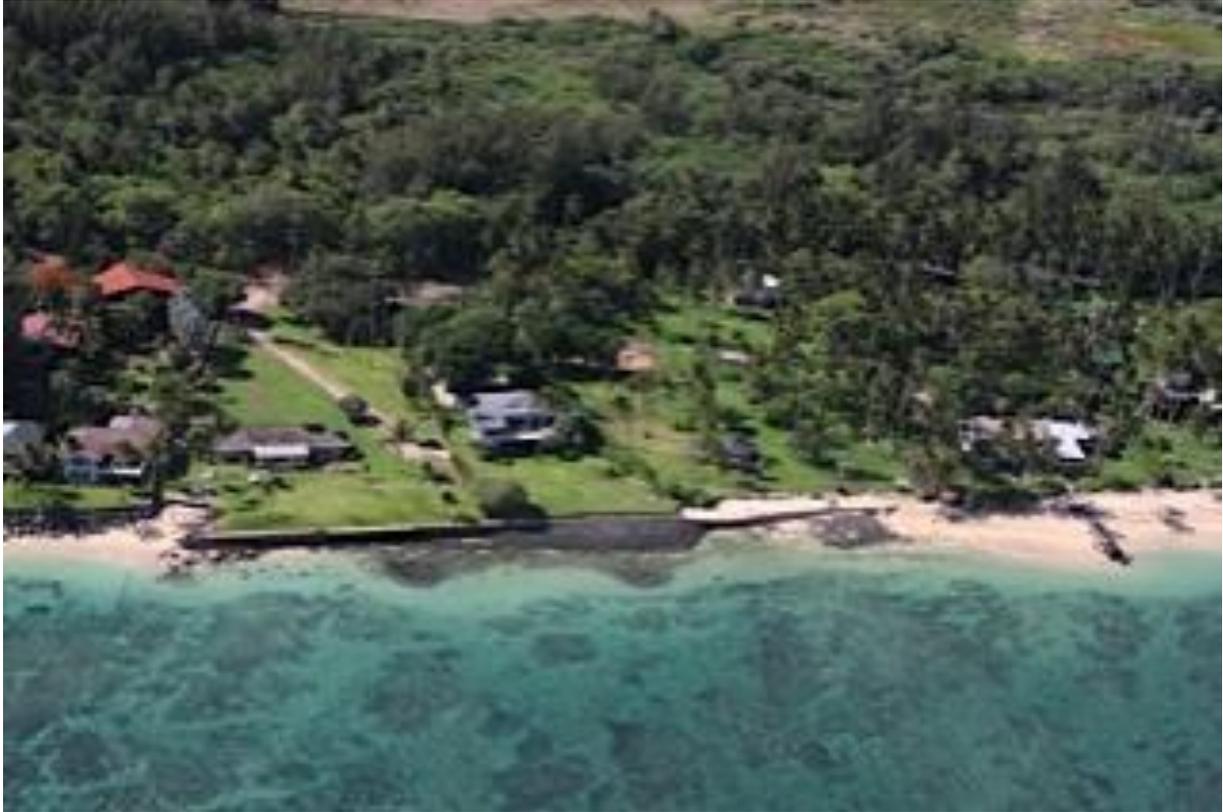
Photo 14 - Aerial View of Downdrift Area Post-Construction, 29 June 2011

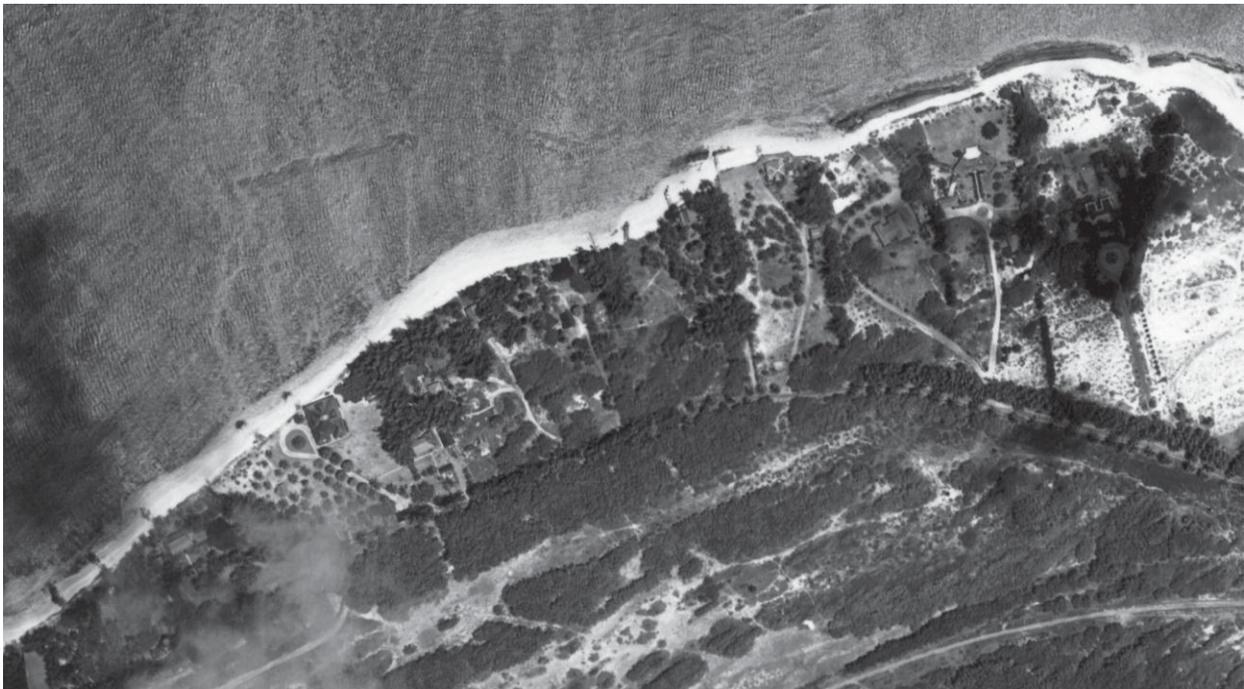
Photo 15 - Aerial View Showing Beaches, Seawall and Groins at Downdrift Lots 1 and 2, 1940
